Technical Report CERC-95-9
July 1995

US Army Corps
of Engineers
Waterways Experiment
Station

Monitoring of the Yaquina Bay Entrance North Jetty at Newport, Oregon; Summary and Results

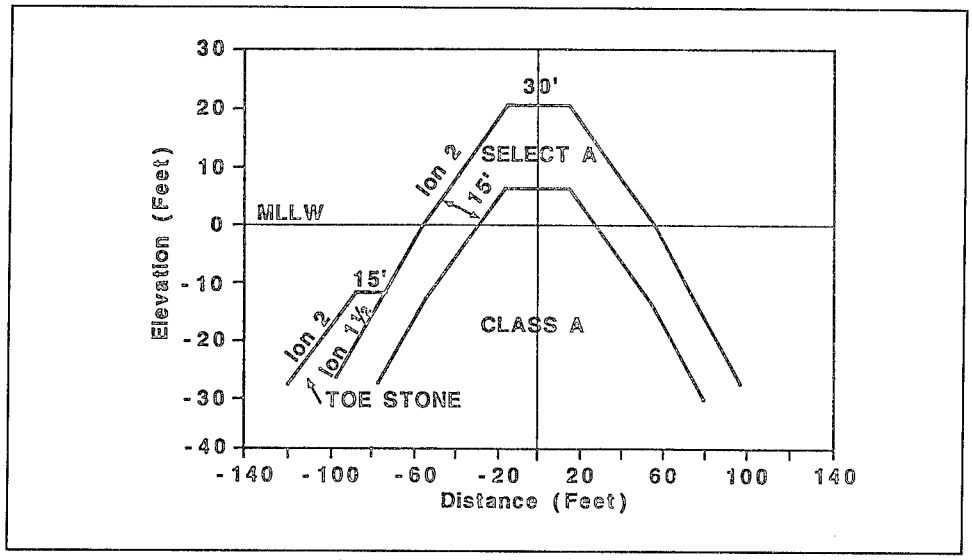
Figure 5. Yaquina Bay north jetty cross section, 1978 rehabilitation

Rehabilitation of the outer 140 m (460 ft) of the Yaquina Bay north jetty was authorized in 1976 and work was completed in September 1978 at an estimated cost of $4,400,000. Figure 5 shows the jetty cross section as designed for this rehabilitation. The class "A" core stone averaged 12.2 tonnes (13.5 tons) with minimum size of 9.2 tonnes (10.1 tons), and the select class "A" stone averaged 18 tonnes (19.8 tons) (minimum 13.5 tonnes (14.9 tons)), which was reduced from the armor stone size used on the 1966 jetty extension. The design wave height for this rehabilitation of the north jetty was 6.2 m (20.2 ft). In addition, a 4.6-m-wide (15-ft-wide) berm at -3 m (-10 ft) mllw was added to the channel side of the jetty, as shown on Figure 5.

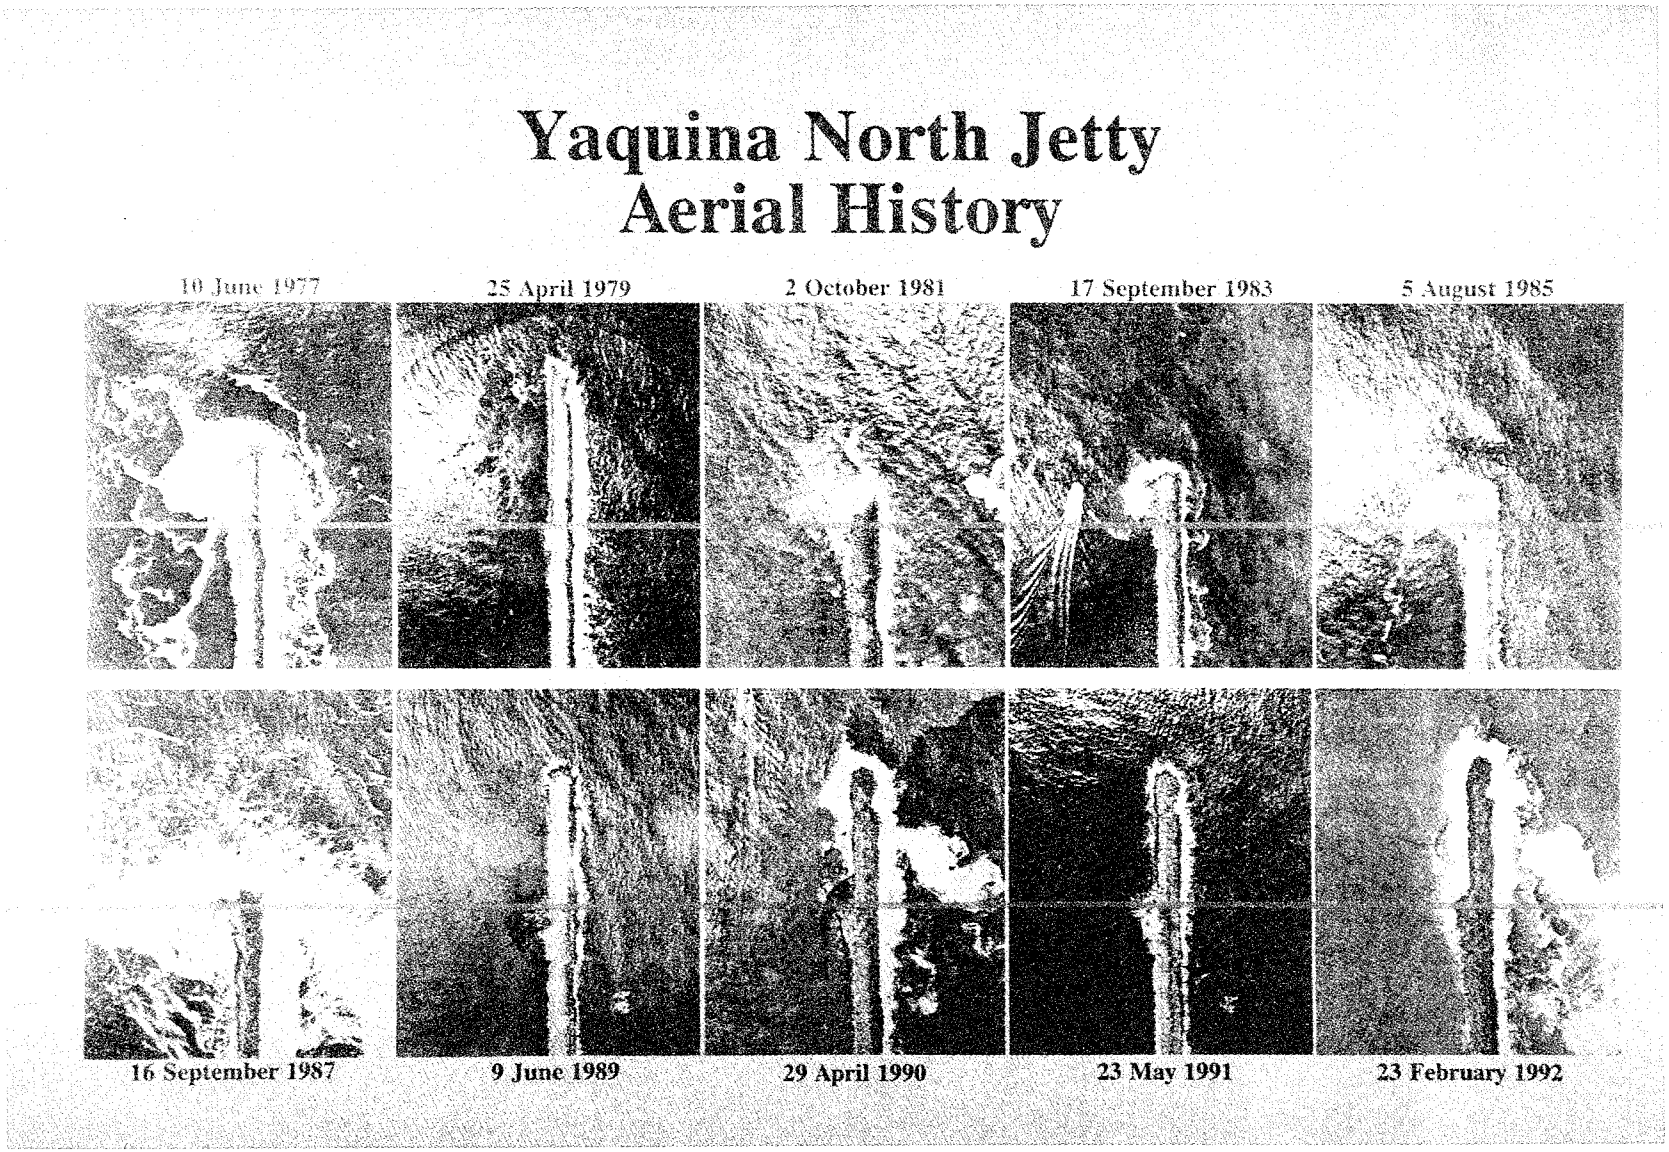
Almost immediately after completion of the north jetty rehabilitation, damage started to occur on the seaward tip of the structure. Aerial photographs indicated that 12 m (39 ft) of the tip was submerged by April 1979, with subsequent total submerged lengths of 68 m (224 ft) by October 1981, 115 m (379 ft) by September 1983, 124 m (406 ft) by August 1985, and 137 m (450 ft) by September 1987. This sequence of deterioration is shown by the aerial photographs in Figure 6 (the solid horizontal line on the figure is a common line of reference).

Figure 6. Yaquina Bay north jetty history from aerial photographs, 1977-1992

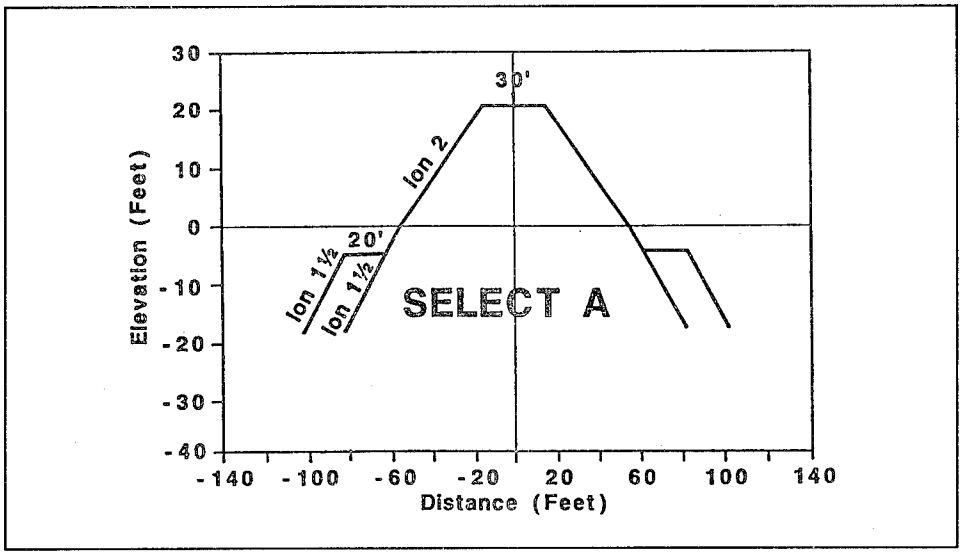
Figure 7. Yaquina Bay north jetty cross section, 1988 rehabilitation

Figure 7 shows the nominal design cross section for rehabilitation of the seawardmost 30 m (100 ft) of the north jetty. The key differences of this design from the 1978 repair were elimination of the class "A" stone core and an increase in the size of the select class "A" armor stone. Thus, the entire end cross section of the jetty was constructed of select class "A" stone having an average weight of 29.5 tonnes (32.5 tons) with a minimum weight specified as 26.9 tonnes (29.7 tons). In addition, a 6-m-wide (20-ft-wide) bench was now included on both sides of the jetty. Behind the select class "A" stone repair section, the next 30-m (100-ft) repair length was armored using class "A" stone with an average weight of 23.4 tonnes (25.8 tons) (minimum 18.7 tonnes (20.6 tons)). The landwardmost portion of the rehabilitation was performed using class "B" stone having an average weight of 16.3 tonnes (18.0 tons) (minimum 12.2 tonnes (13.5 tons)). Details of the 1988 rehabilitation plan are shown on Figure 8. (Note that jetty stations given on Figure 8 do not correspond to jetty stations as labeled for this monitoring study.)

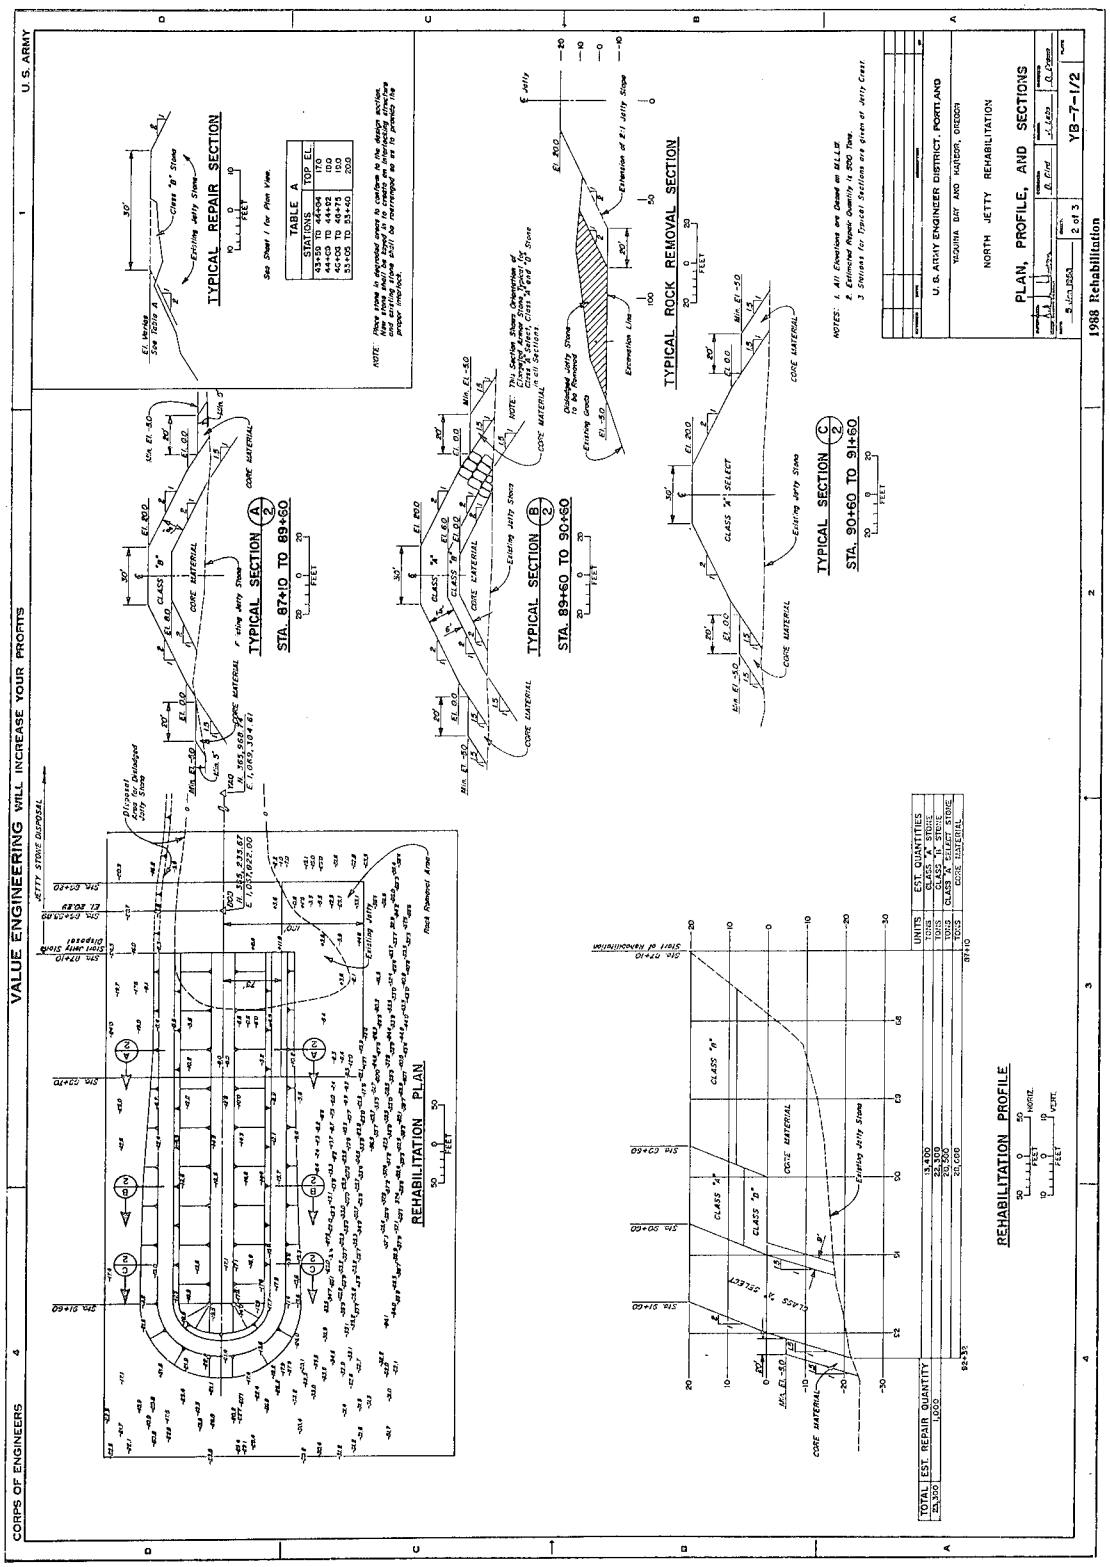
Figure 8. Yaquina Bay north jetty 1988 rehabilitation details

The increase in armor stone sizes over the 1966 extension and 1978 rehabilitation (summarized in Table 1) stems from an increase in design wave height from about 6.6 m and 6.2 m (22 ft to 20 ft), respectively, to 8.5 m (28 ft). This wave height increase was based on deep-water wave statistics that became available in WIS Report 16 (Corson et al. 1987). These statistics were propagated into shallow water using numerical wave transformation techniques to account for refraction and shoaling. Probability of occurrence for the design wave conditions was 5 percent in any given year.

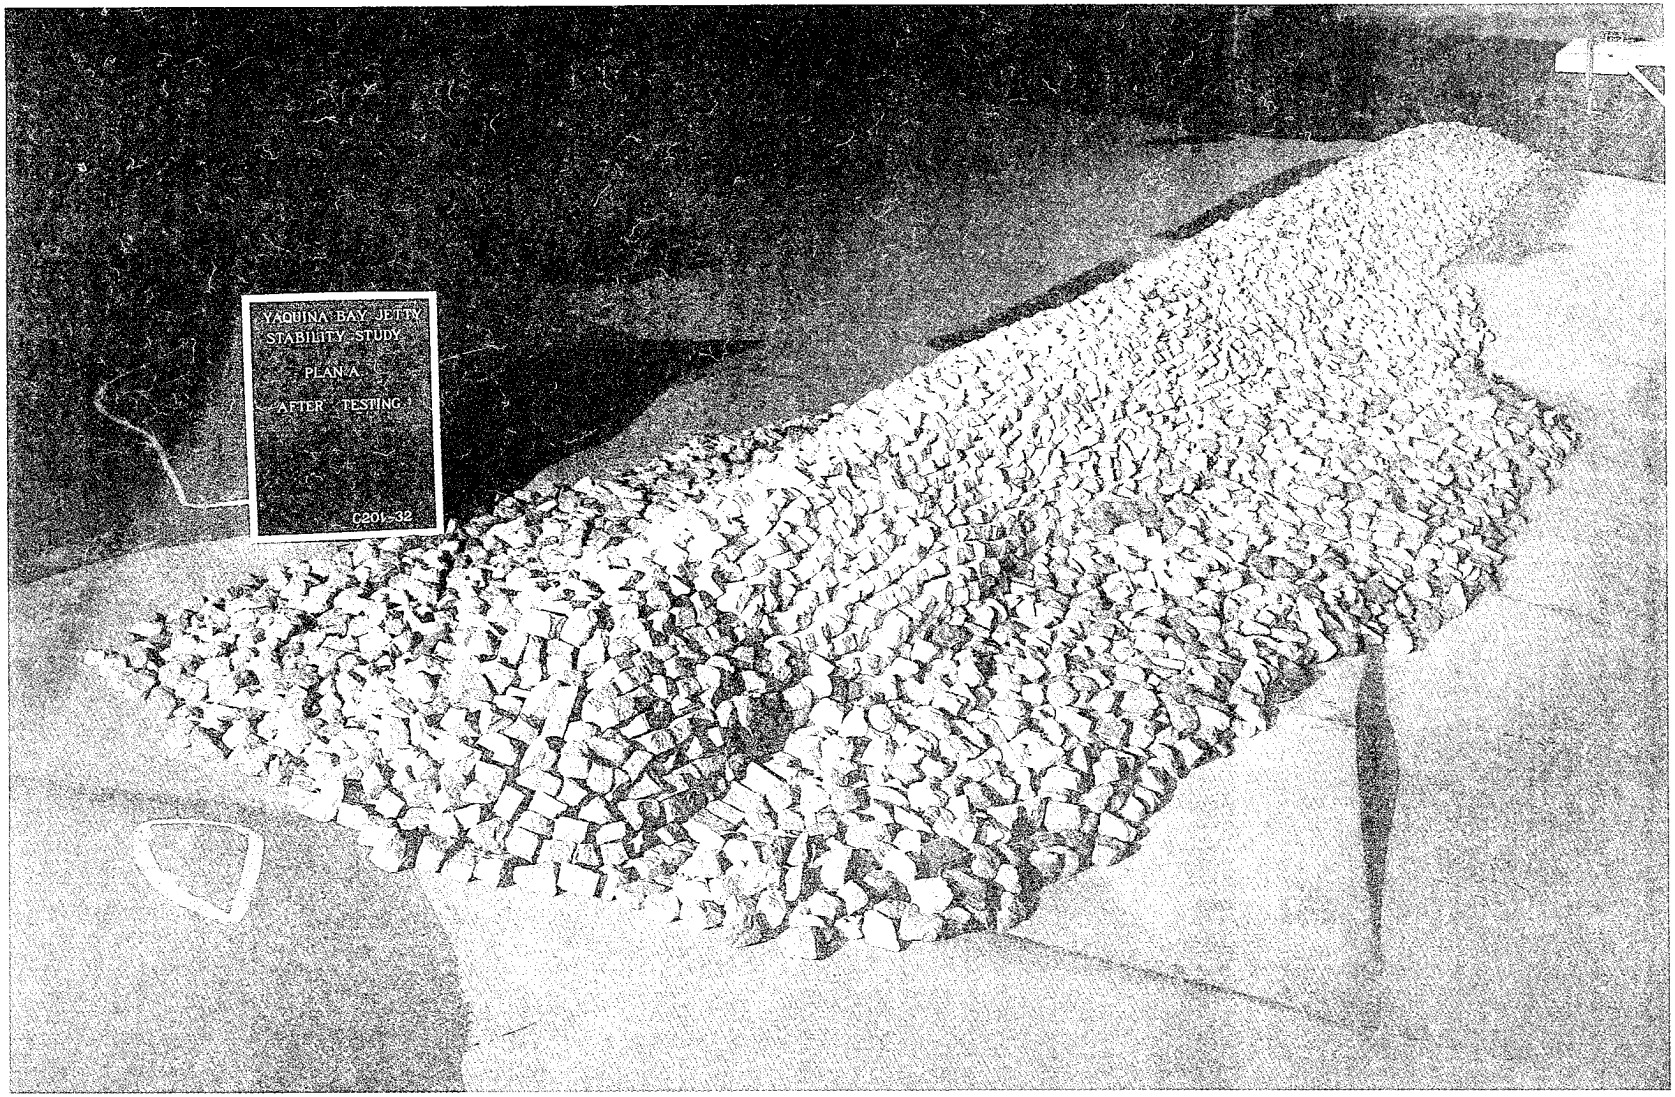
Figure 9. Photograph of 1986 physical model of Yaquina Bay north jetty

A three-dimensional small-scale physical model of the proposed north jetty rehabilitation was constructed and tested by CERC at WES in 1986 (Grace and Dubose 1988). The purpose of the small-scale model was to evaluate the armor stone stability for the proposed rehabilitation design. The 1-to-45 scale model featured molded bathymetry as obtained from nautical charts and other bathymetric surveys. Depth at the wave board represented the 18-m (58-ft)

contour in the prototype, and no wave guides were used. Figure 9 is a photograph showing the model of the north jetty.

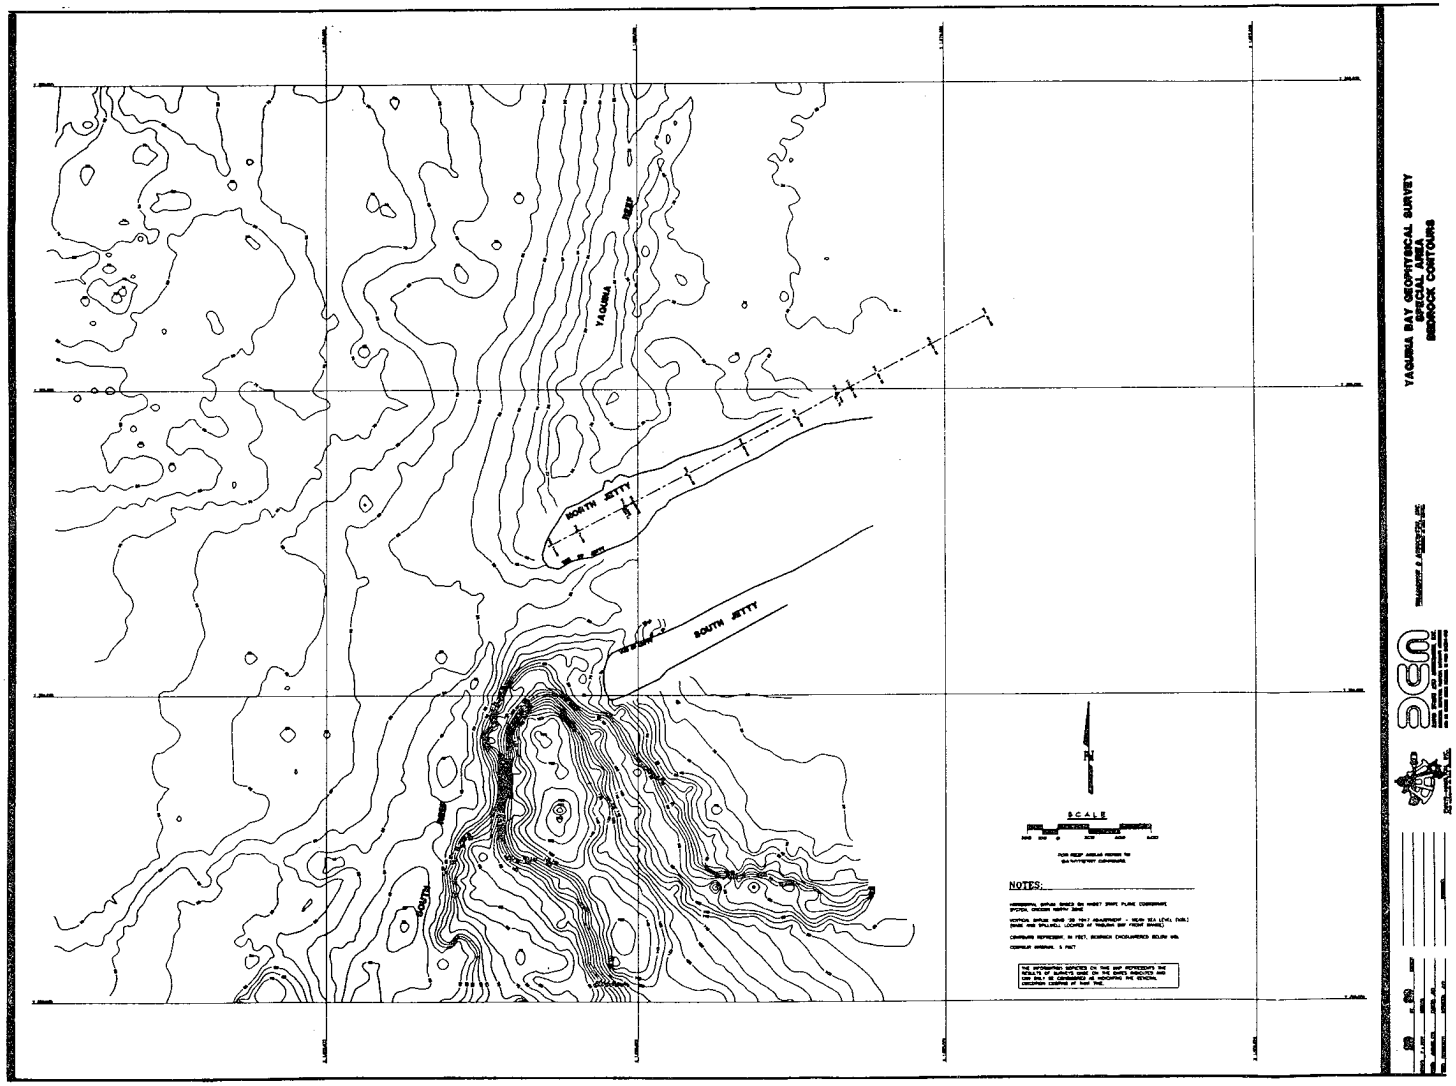
Figure 17. Yaquina Bay area depth-to-bedrock contours (relative to mean sea level)

A reduced map of the depth-to-bedrock contours (relative to mean sea level) for the General Area is shown in Figure 17 (reduction to report size has obscured much of the detail). The bedrock gradually slopes (approximately 5 deg westward) in an undulating pattern from approximately 9-m (30-ft) depths at Yaquina Reef and South Reef to bedrock depths averaging approximately 26 m (85 ft) in the offshore portion of the study area. A 17-m-deep (55-ft-deep) depression in the bedrock (saddle) is located between the south end of Yaquina Reef and the north end of South Reef. This depression was caused by an offsetting structural fault and by previous blasting and dredging to enlarge and deepen the entrance channel to Yaquina Bay (see Chapter 2).

A steep-sided bedrock channel directed approximately north-south borders the eastern (shoreward) edge of South Reef (see Figure 17). The observed maximum depth to bedrock in this channel is approximately 50 m (165 ft). About midway along the reef, the channel bends to the southeast in a direction opposite to that of the reef and becomes slightly shallower, with depth to bedrock averaging 44 m (145 ft). The eastern boundary of this channel slopes upward to form a fairly flat-lying platform with depth-to-bedrock averaging about 9 m (30 ft). A small saddle trending north to south is observed in the flat-lying bedrock with an average depth of 13 m (44 ft).

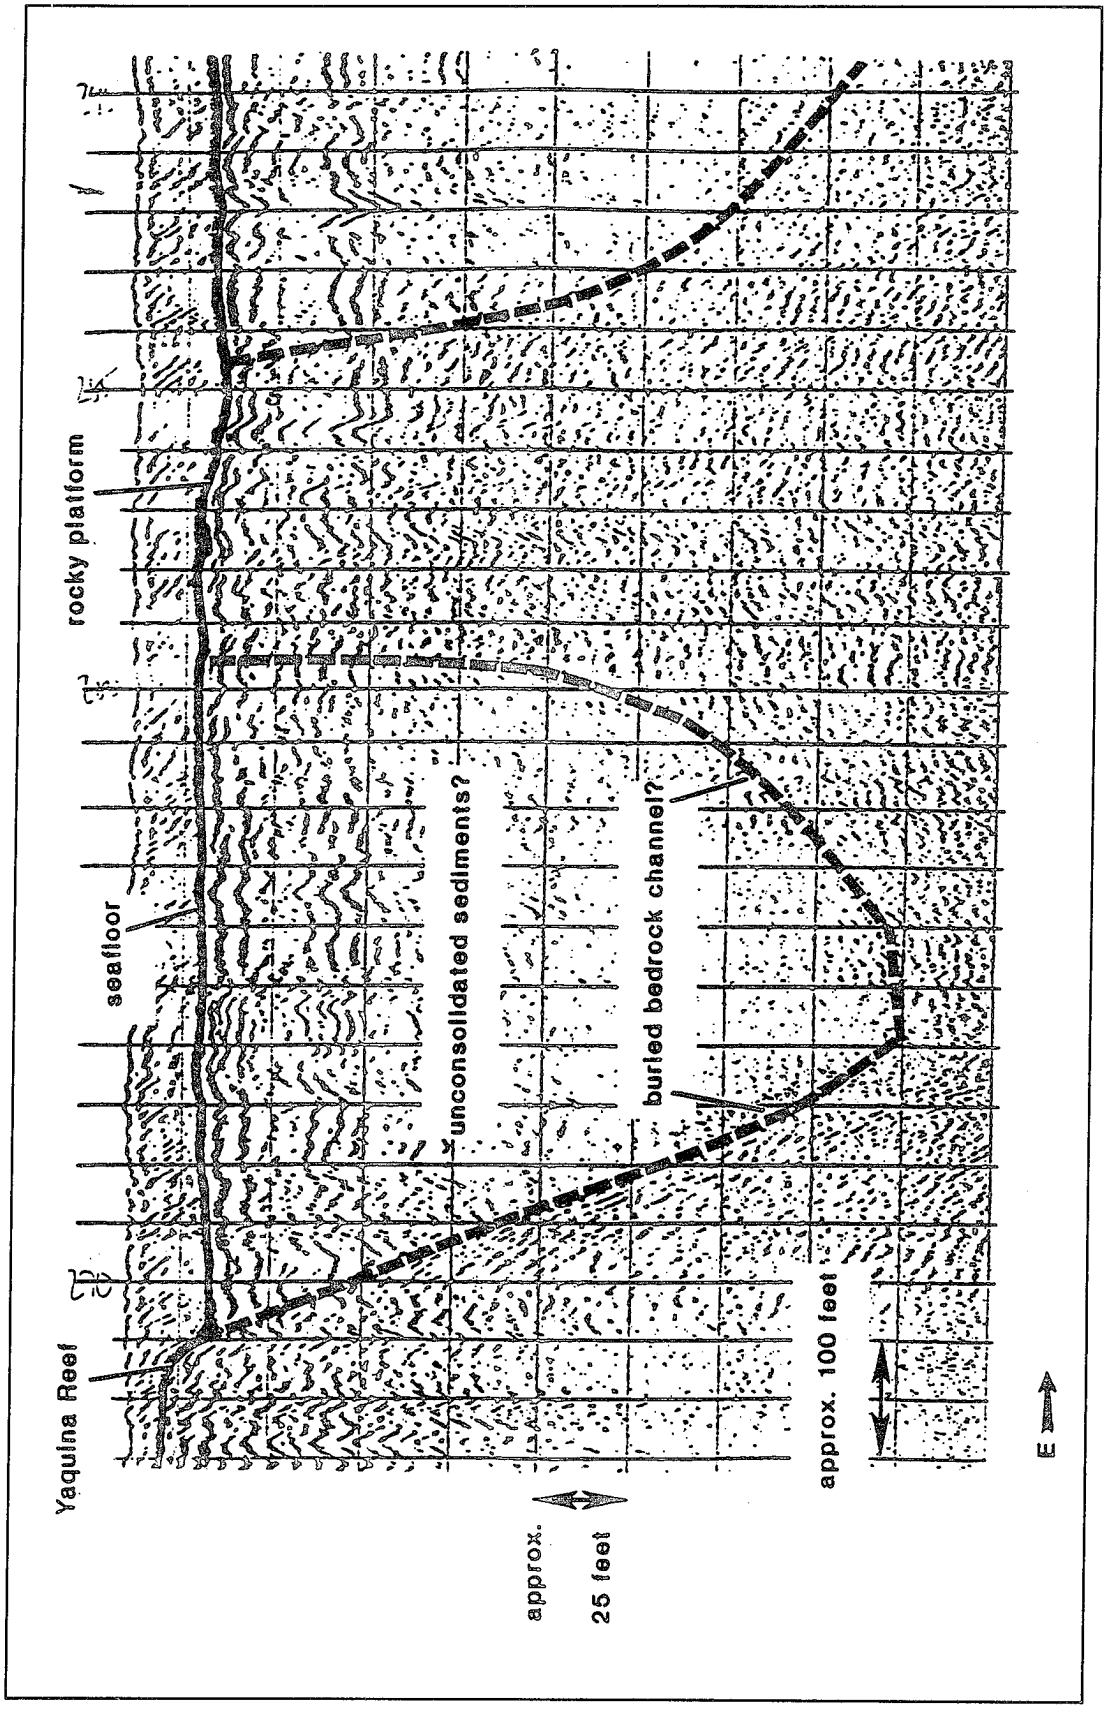
Figure 18. Seismic reflection profile showing buried bedrock channel

A shallow bedrock channel is located adjacent to the eastern edge of Yaquina Reef and follows the directional trend of the reef (slightly northeast to southwest). The southern end of the channel is interrupted by the presence of the north jetty. Figure 18 is a seismic profile showing an apparent bedrock channel configuration. Subsequent 1993 investigations of the apparent buried bedrock channel of unconsolidated sediments shown on Figure 18 indicate this channel does not exist and the area consists entirely of bedrock with only a thin veneer of overlying silts and sands.

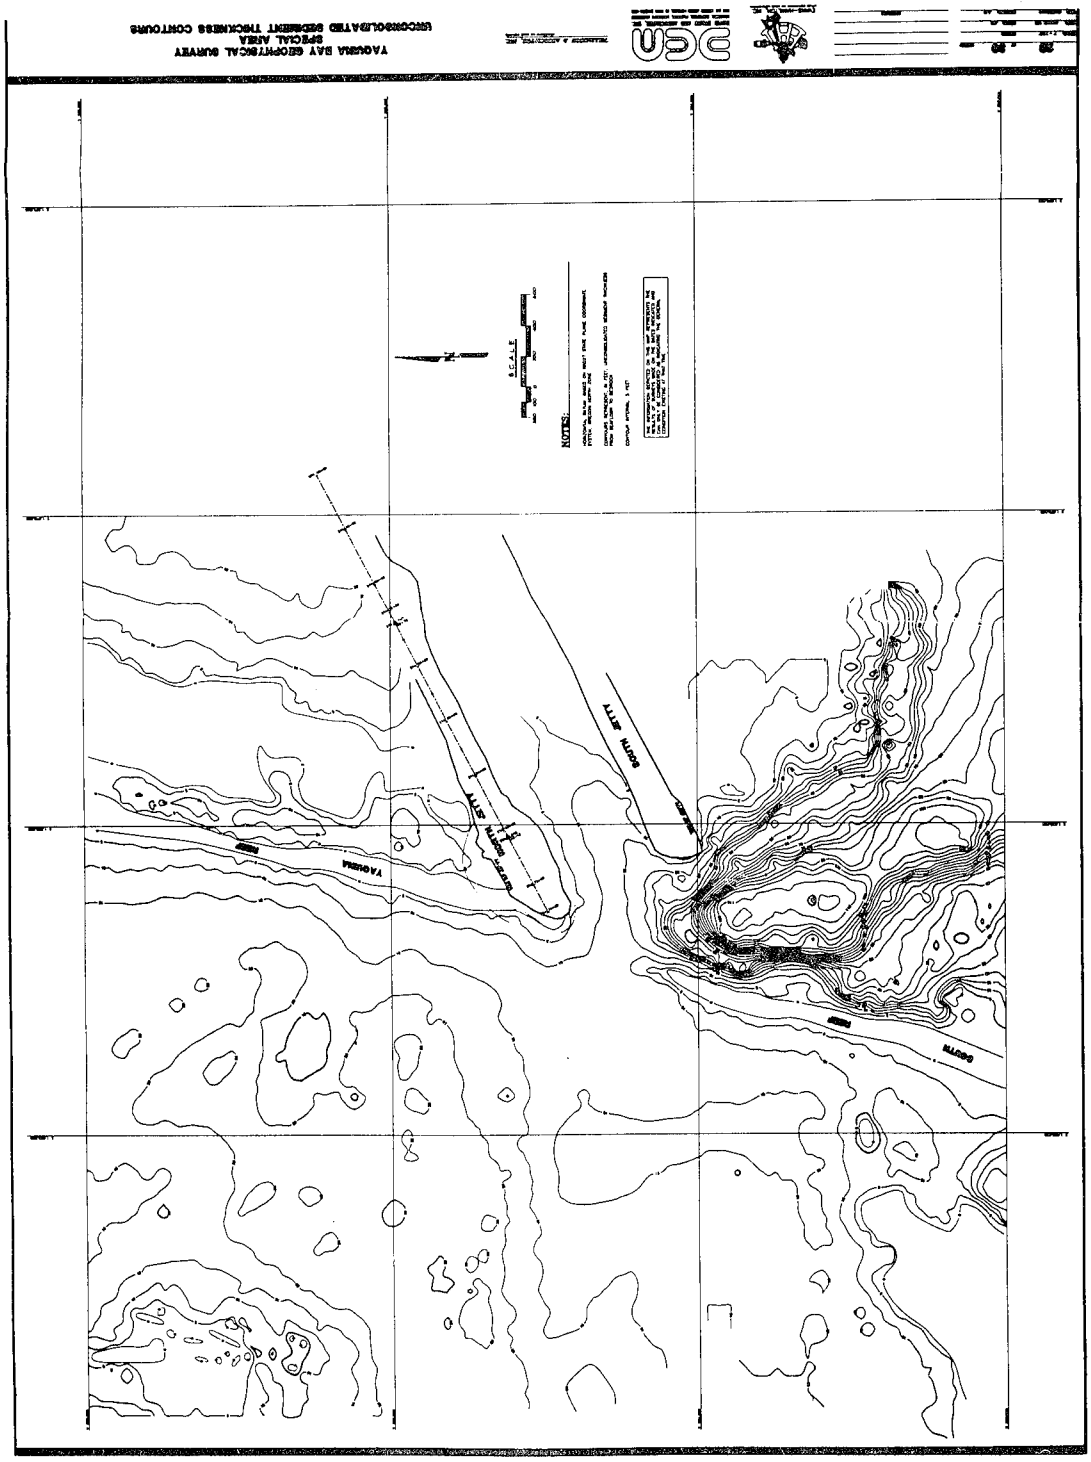
Figure 19. Yaquina Bay contours of unconsolidated sediment thickness

Figure 19 is a reduction of a contour map of unconsolidated sediment thicknesses as determined from the geophysical survey. No unconsolidated sediments overlay the western edges of Yaquina Reef, the tip of the north jetty, and South Reef. Unconsolidated sediments gradually increase in thickness westward of the reefs to approximately 5 to 6 m (15 to 20 ft), thinning slightly towards the south, where the thickness is approximately 1.5 m (5 ft),

and to the west of South Reef. Maximum sediment thickness is approximately 7.6 m (25 ft). In the northwest and southwest portion of the study area, discontinuous rock outcrops were observed with no sediment cover.

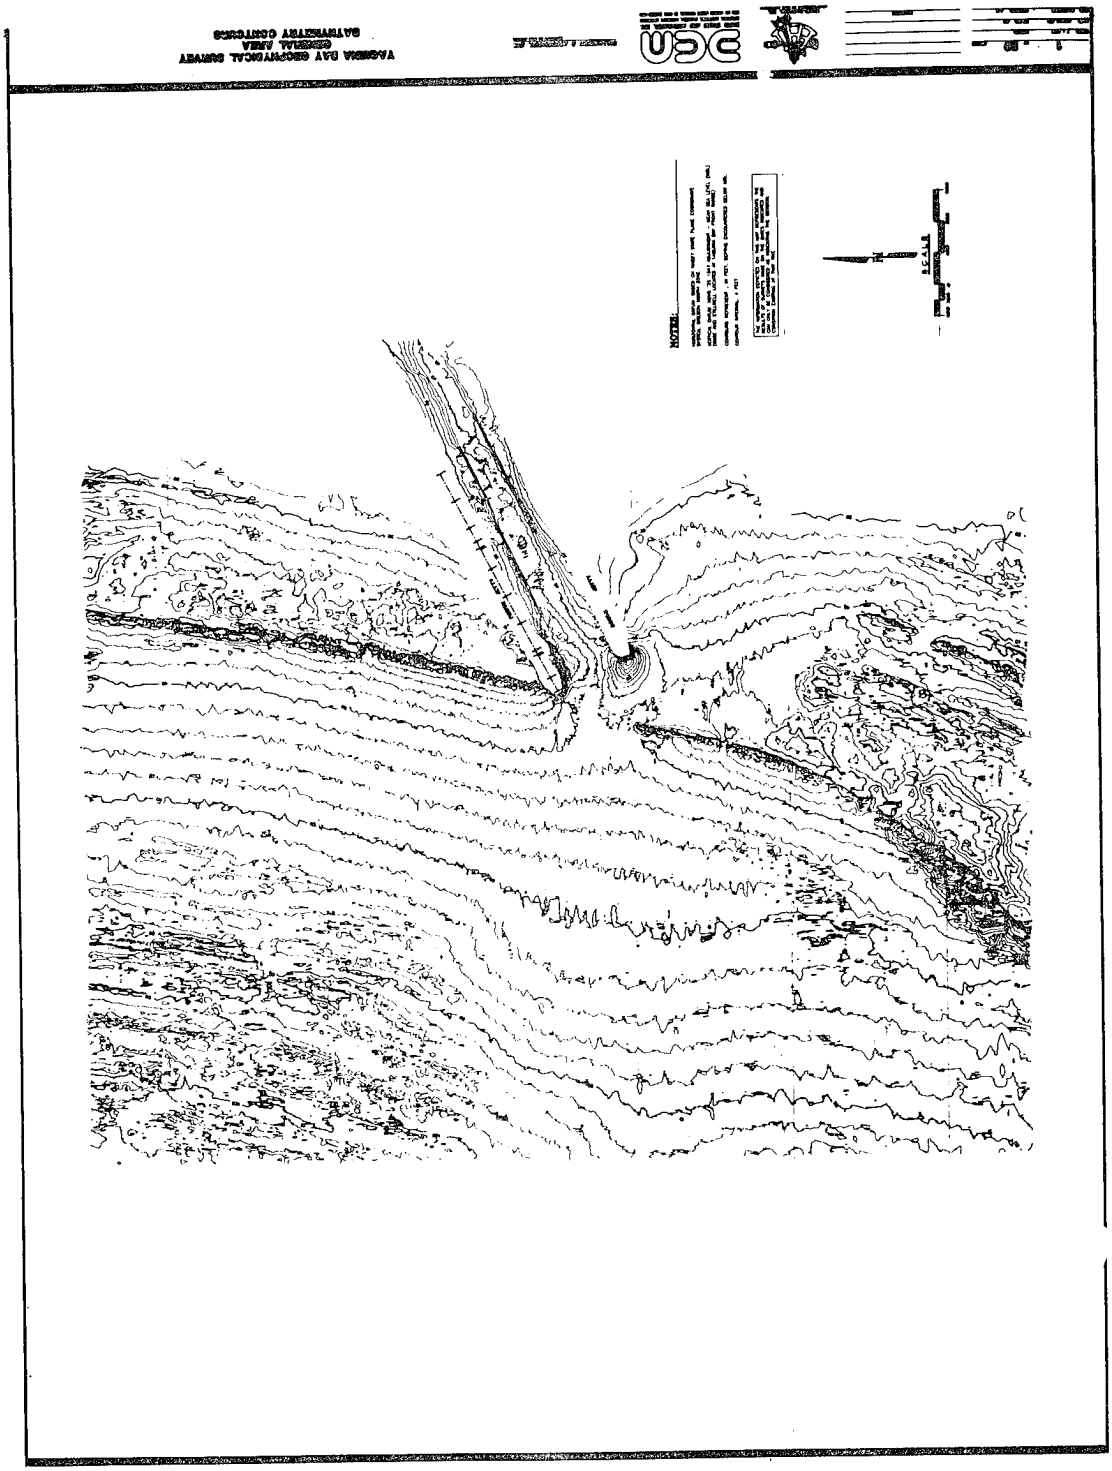
Figure 20. Yaquina Bay "General Area" detailed bathymetry

Detailed bathymetry of the survey area collected as part of this monitoring effort is shown in Figure 20. Bathymetry contours in the region west of Yaquina Reef, the jetties, and South Reef follow the gentle sloping trend of the bedrock, a westward-facing slope of approximately 5 deg. The bathymetry covered on Figure 20 ranges from about 23-m (75-ft) depths in the west, rising to depths between 6 and 9 m (20 and 30 ft) at the Yaquina and South Reefs.

The channel between the jetties has an average depth of 13 m (42 ft). Also, two deeper areas were observed in the vicinity of the jetties. One area approximately 18 m (60 ft) in depth is located southwest of and near the tip of the north jetty. The second deeper area is located at the tip of the south jetty, and it is approximately 18 to 21 m deep (60 to 70 ft deep).

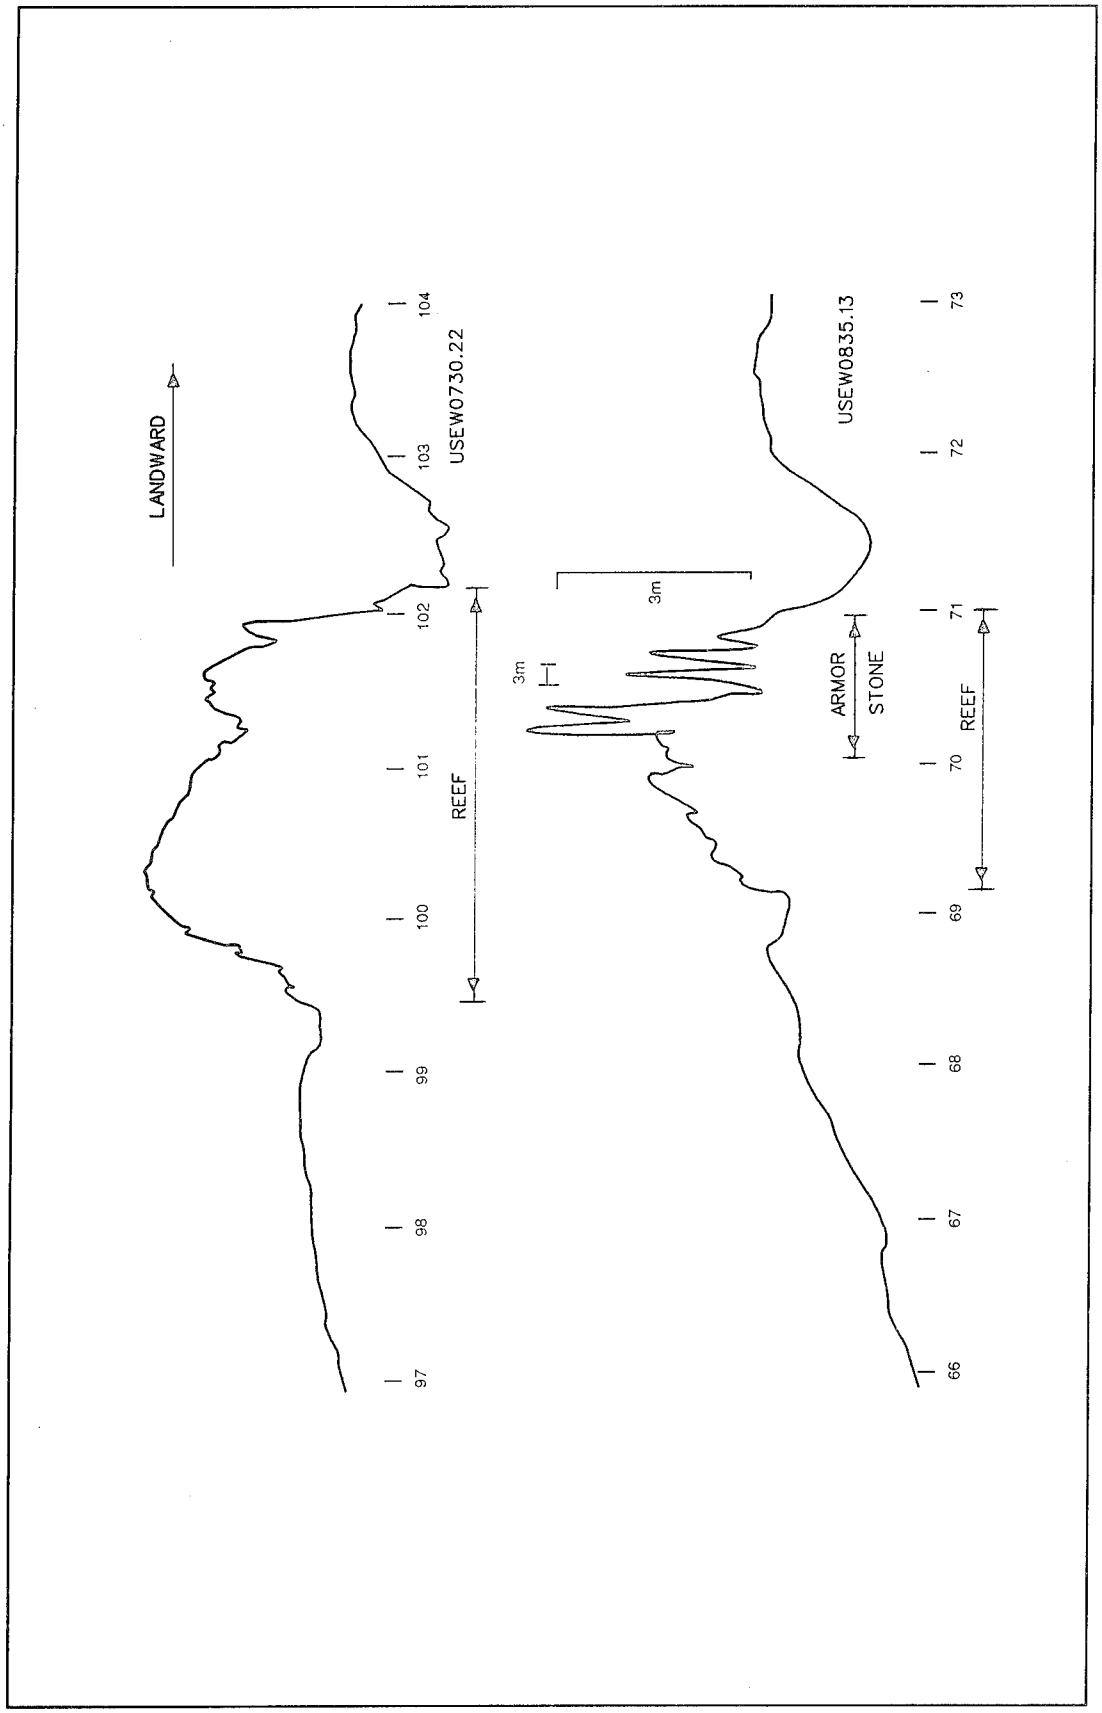
Figure 26. Examples of echo sounder traces transecting the Yaquina Reef

Between event marks 70 and 71 on the lower trace of Figure 26, there was a section of rock with pronounced "roughness elements." The general size of these roughness elements (2-3 m (7-10 ft)) is consistent with the diameter of armor stones used to construct the tip of the north jetty. The corresponding spatial positions of the roughness elements near event mark 71 was located on the side-scan sonar image shown in Figure 27. As labeled on the figure, there were three closely spaced rounded objects at this location that were interpreted to be jetty stones. The remainder of the rock section shown on the bottom trace of Figure 26 between event marks 69 and 70 is about as smooth as that in the top trace.

Aided by the side-scan sonar record shown in Figure 27, the bottom echo-sounder trace of Figure 26 was interpreted to be a section of the Yaquina Reef with jetty armor stones resting on the reef, whereas the top trace of Figure 26 shows a section of the Yaquina Reef without jetty stones. The noticeable dip

evident in both echo sounder traces landward (right) of the steep eastern face of the reef was interpreted to be a scour trench in unconsolidated sediments.

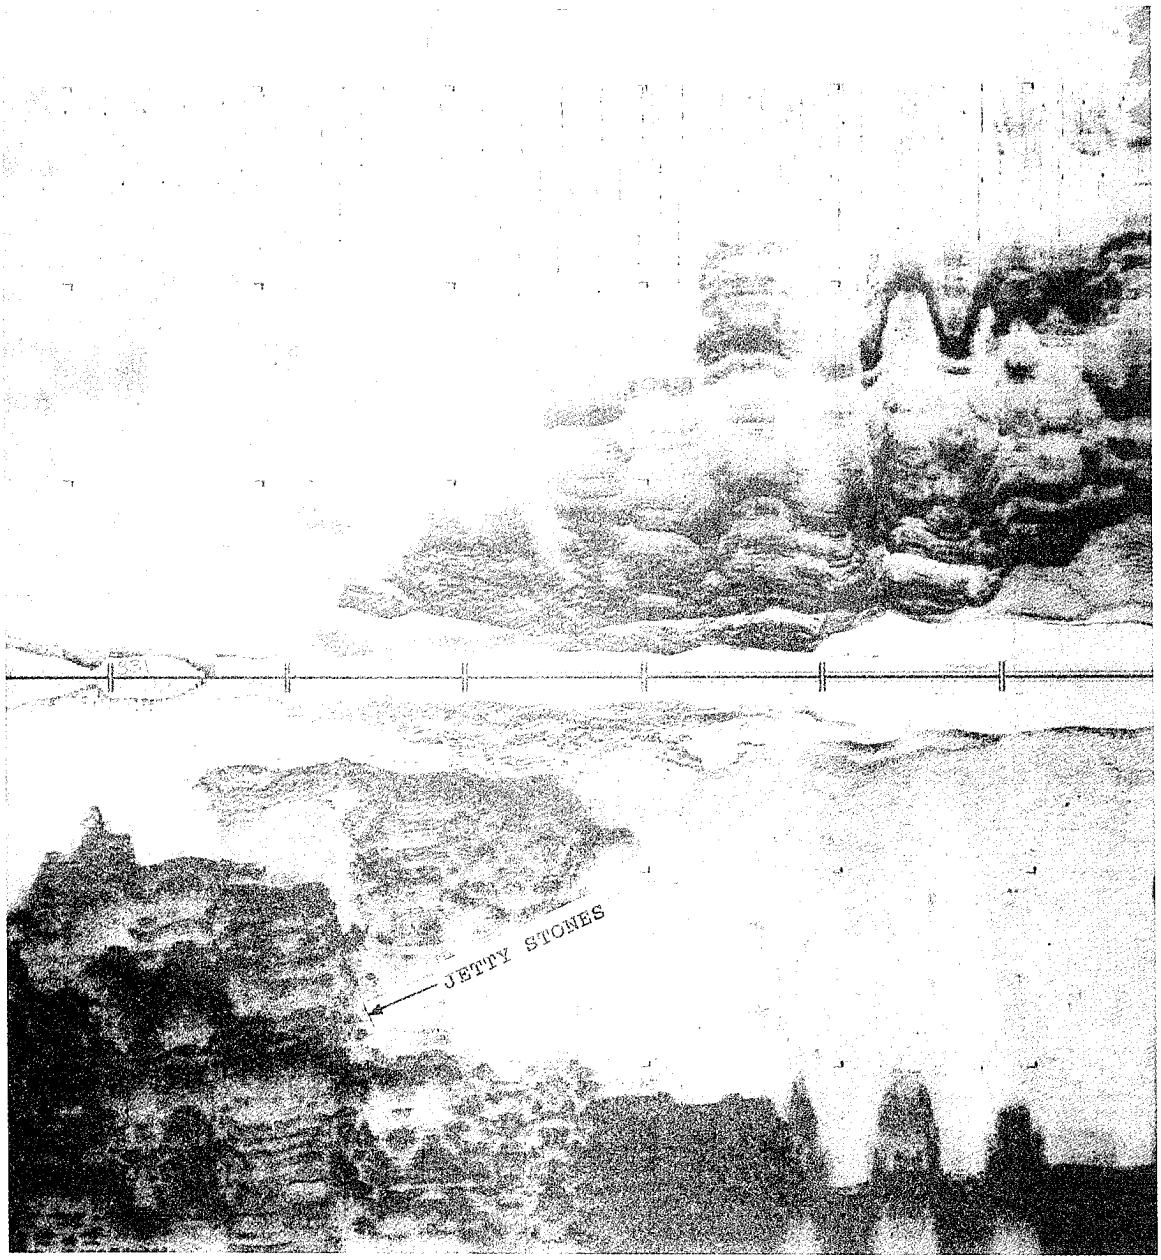
Figure 27. Side-scan sonar image from north side of the Yaquina Bay north jetty

accentuated by geometric distortion. This same area of the seafloor is shown with a more correct appearance in the upper right-hand portion of the side-scan sonar image of Figure 27. The tick mark on the far right side of the side-scan sonar track line shown in Figure 27 is at approximately the same east-west position as event mark 7 on the image given in Figure 29.

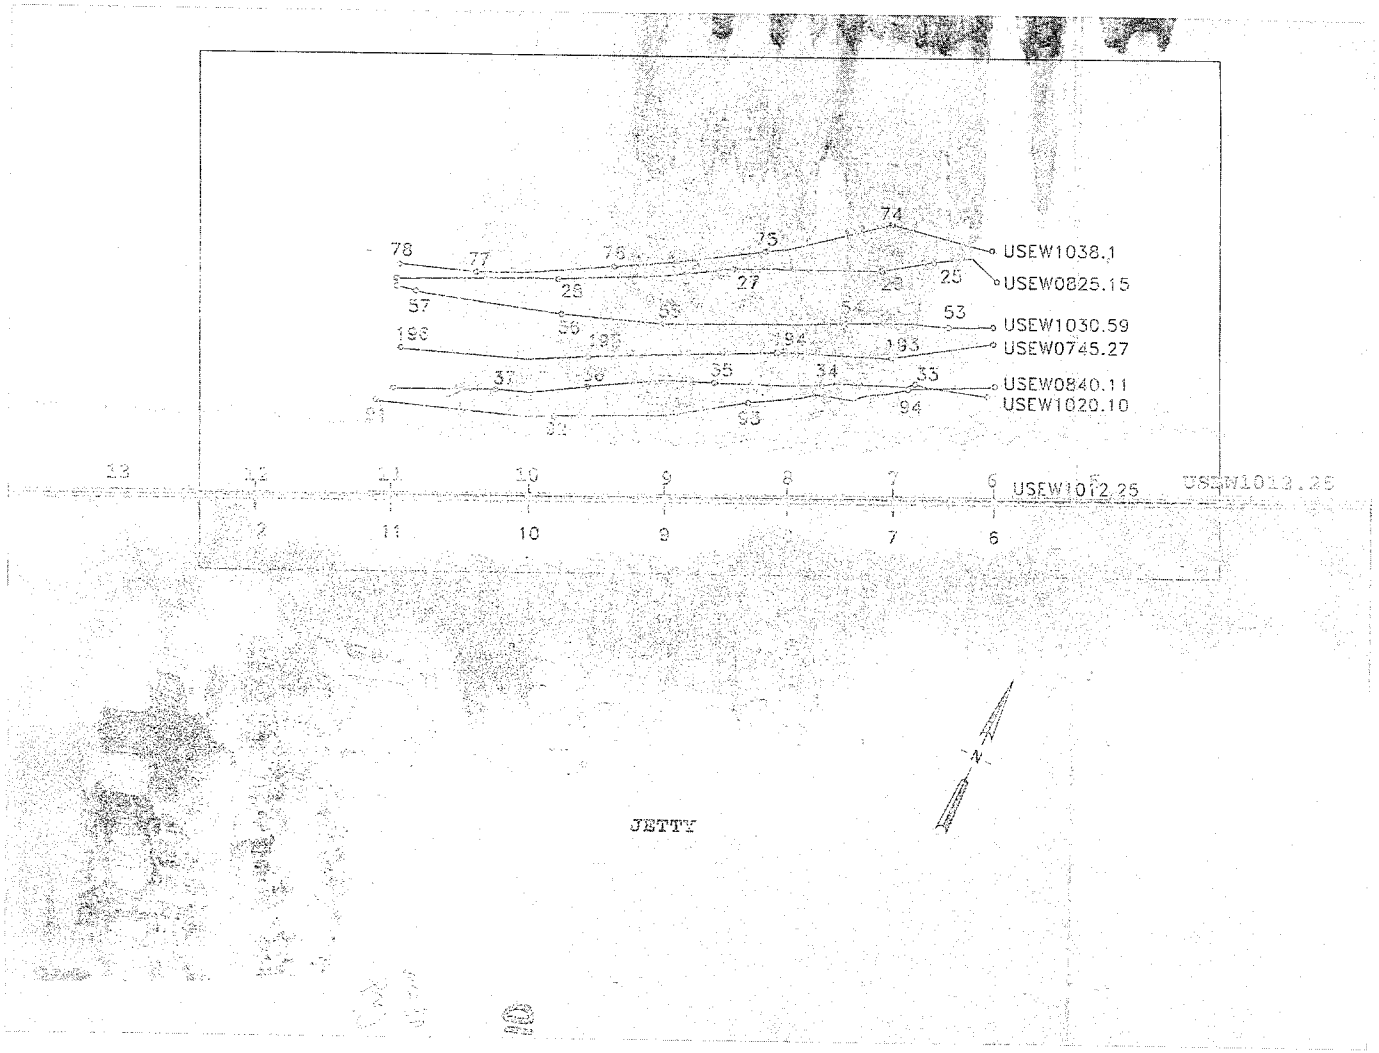
Figure 29. Side-scan sonar record along trackline USEW1012.25 for "north side of jetty" region

On the jetty side (bottom side) of the side-scan sonar tow fish track shown in Figure 29 (near side-scan sonar event marker 8), rounded strong reflectors can be seen in the side-scan sonar image that have length dimensions on the order of 2.5-3.0 m (8-10 ft). These rounded objects were interpreted to be individual jetty stones. Further seaward on the track line between event marks 9 and 13, there are no rounded images characteristic of jetty stones, which indicated an absence of jetty stones in this location.

The side-scan sonar image of Figure 29 depicted fingers of rock to the north (top side) of track line USEW1038.1. These rock fingers have been

Despite the geometric distortion problem, it is clear there are no rounded objects indicative of jetty armor stones on the side-scan sonar image near event mark 74 on track line USEW1038.1 (Figure 29). Therefore, it is concluded that the roughness element visible on the corresponding profile on Figure 30 is a result of the track line crossing the reef rock finger indicated on the side-scan sonar image at event mark 74.

A similar conclusion is drawn regarding the roughness elements shown on Figure 30 profile USEW0840.11 in the vicinity of event mark 93. As seen on Figure 29, this echo sounder track line overlays reef rock fingers, but there is no indication of armor stones in the image near event mark 93. The round image approximately halfway between event marks 93 and 94 along track line USEW0840.11 was most likely caused by the presence of a hole in the reef rather than an armor stone. Interpretation of the remaining four bathymetric profiles shown in Figure 30 resulted in the conclusion that all six echo sounder track lines crossed the Yaquina Reef to the north of any armor jetty stones.
