Technical Report CERC-95-9
July 1995

US Army Corps
of Engineers
Waterways Experiment
Station

Monitoring of the Yaquina Bay Entrance North Jetty at Newport, Oregon; Summary and Results

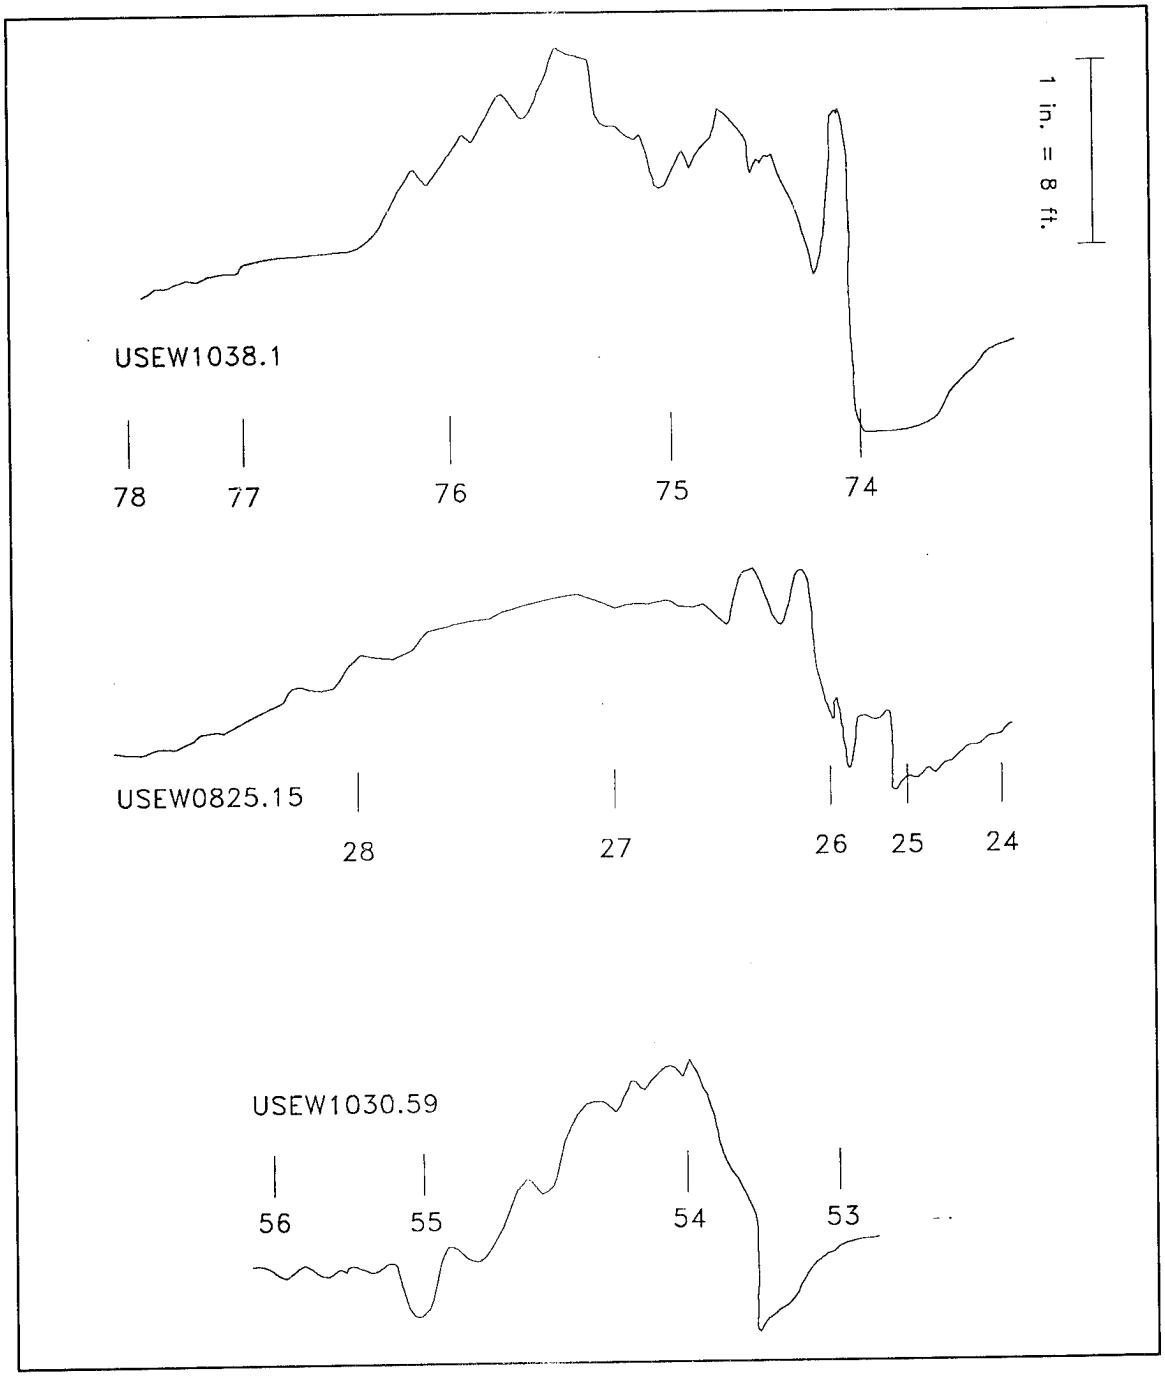
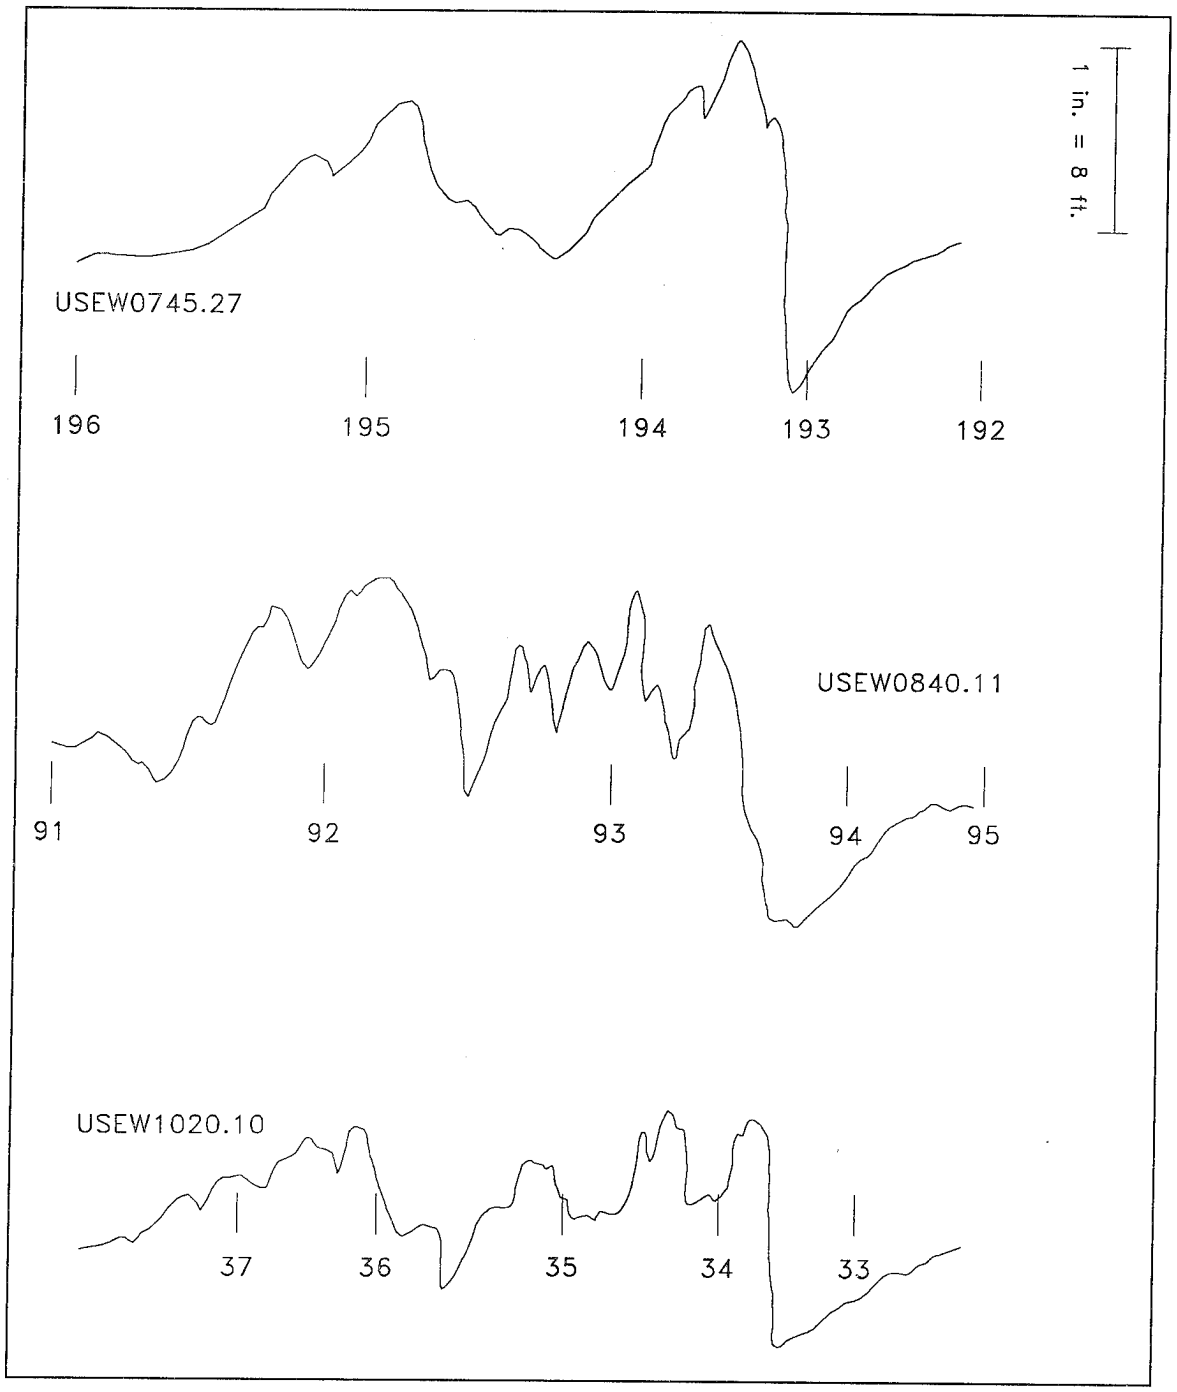
Figure 30. Echo sounder profiles for "north side of jetty" region (Continued)

Bottom profiles for the echo sounder trace lines overlain on Figure 29 are displayed in Figure 30. Generally, the profiles are arranged in order beginning with the most northerly profile and moving closer to the side-scan sonar track. The bathymetric traces are relatively smooth and hummocky with the exception of a roughness element near event mark 74 on track line USEW1038.1 (top profile on page 89), and some roughness elements around event mark 93 on track line USEW0840.11 (middle profile on page 90).

Despite the geometric distortion problem, it is clear there are no rounded objects indicative of jetty armor stones on the side-scan sonar image near event mark 74 on track line USEW1038.1 (Figure 29). Therefore, it is concluded that the roughness element visible on the corresponding profile on Figure 30 is a result of the track line crossing the reef rock finger indicated on the side-scan sonar image at event mark 74.

A similar conclusion is drawn regarding the roughness elements shown on Figure 30 profile USEW0840.11 in the vicinity of event mark 93. As seen on Figure 29, this echo sounder track line overlays reef rock fingers, but there is no indication of armor stones in the image near event mark 93. The round image approximately halfway between event marks 93 and 94 along track line USEW0840.11 was most likely caused by the presence of a hole in the reef rather than an armor stone. Interpretation of the remaining four bathymetric profiles shown in Figure 30 resulted in the conclusion that all six echo sounder track lines crossed the Yaquina Reef to the north of any armor jetty stones.

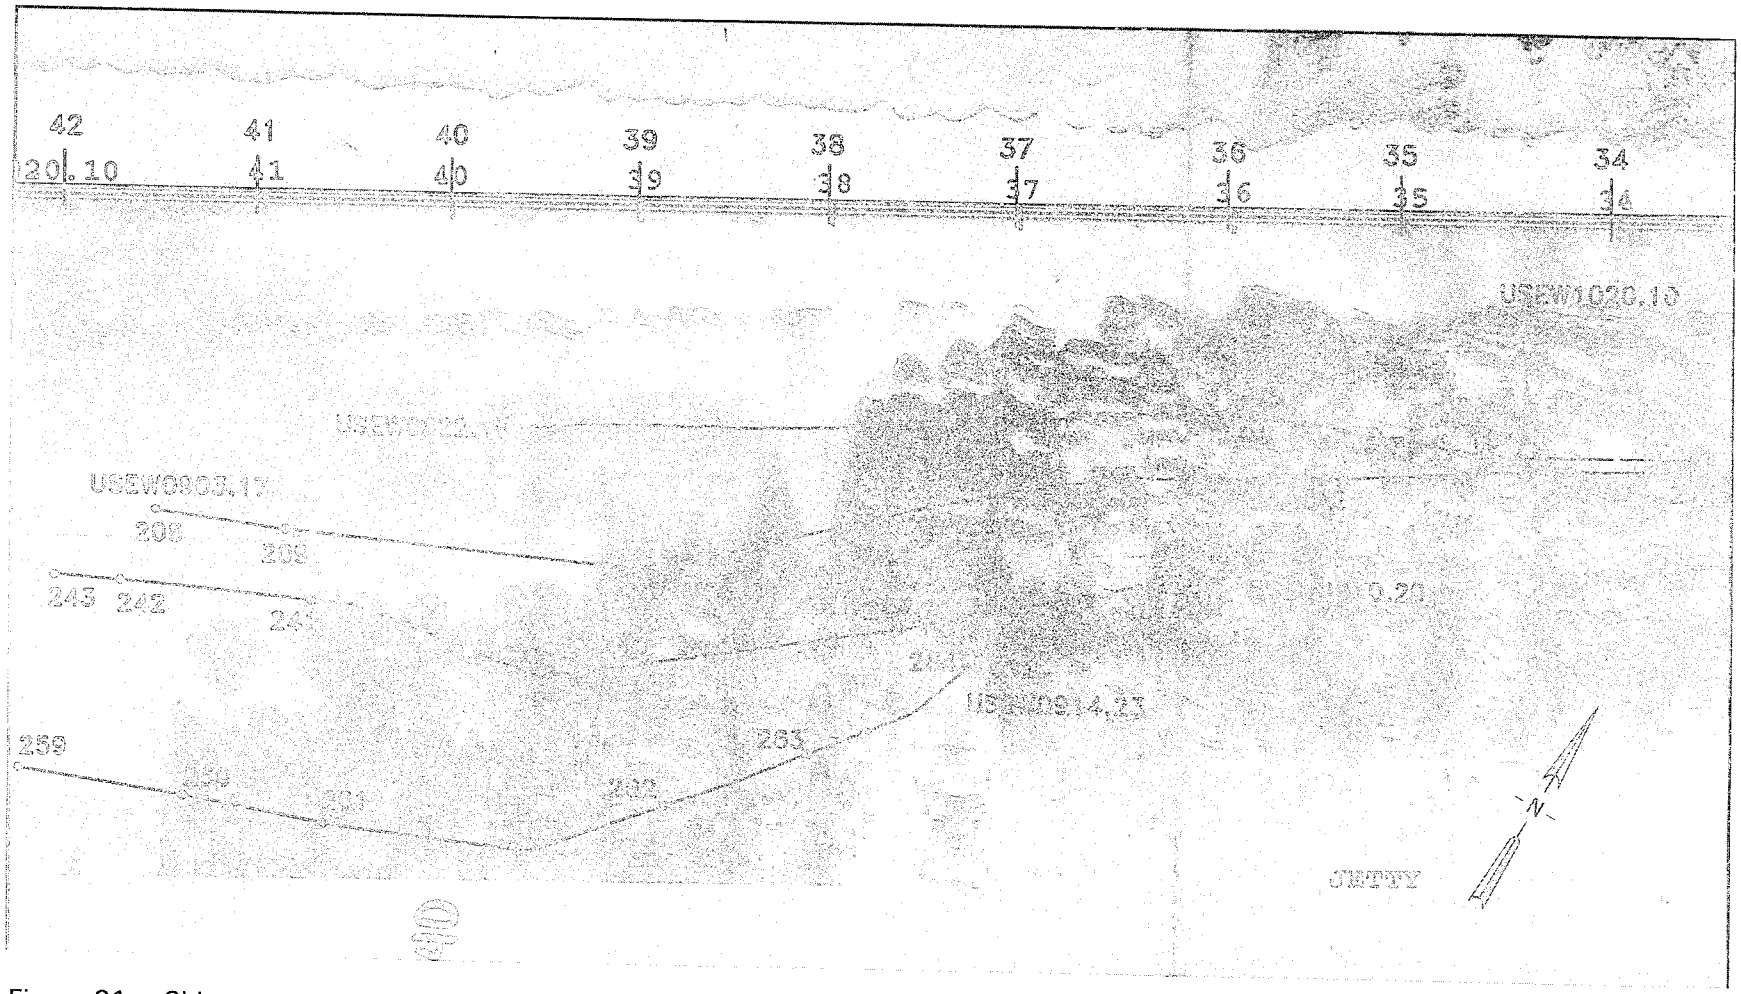
Figure 31. Side-scan sonar record along trackline USEW1020.10 for "northwest side of jetty" region

The side-scan sonar image of Figure 31 shows rounded objects in the vicinity of event marks 9 and 10 of echo sounder track line USEW0822.16, leading to the conclusion that the roughness elements observed in the corresponding bathymetric profile are the result of overlapping (i.e., stacked) jetty stones. In contrast, a pronounced roughness element displaying horizontal and vertical dimensions characteristic of an individual jetty armor stone is observed on this same bathymetric profile between event marks 10 and 11. In conclusion it appears that track line USEW0822.16 crossed the Yaquina Reef, beginning at event mark 8, until halfway between event marks 9 and 10, where it then crossed over the toe of the north jetty .

Along track line USEW0903.17 the side-scan sonar image of Figure 31 shows the transition from sand to rock to be approximately at event mark 210.

Along track line USEW0910.20 just to the landward side (right side) of event mark 241 (see Figure 31) the side-scan sonar data indicated a region that is definitely rock. However, the smooth region in the bathymetric profile for this area (see Figure 32 between event marks 241 and 239) is not at all representative of jetty armor stones. Consequently, there is little doubt that a

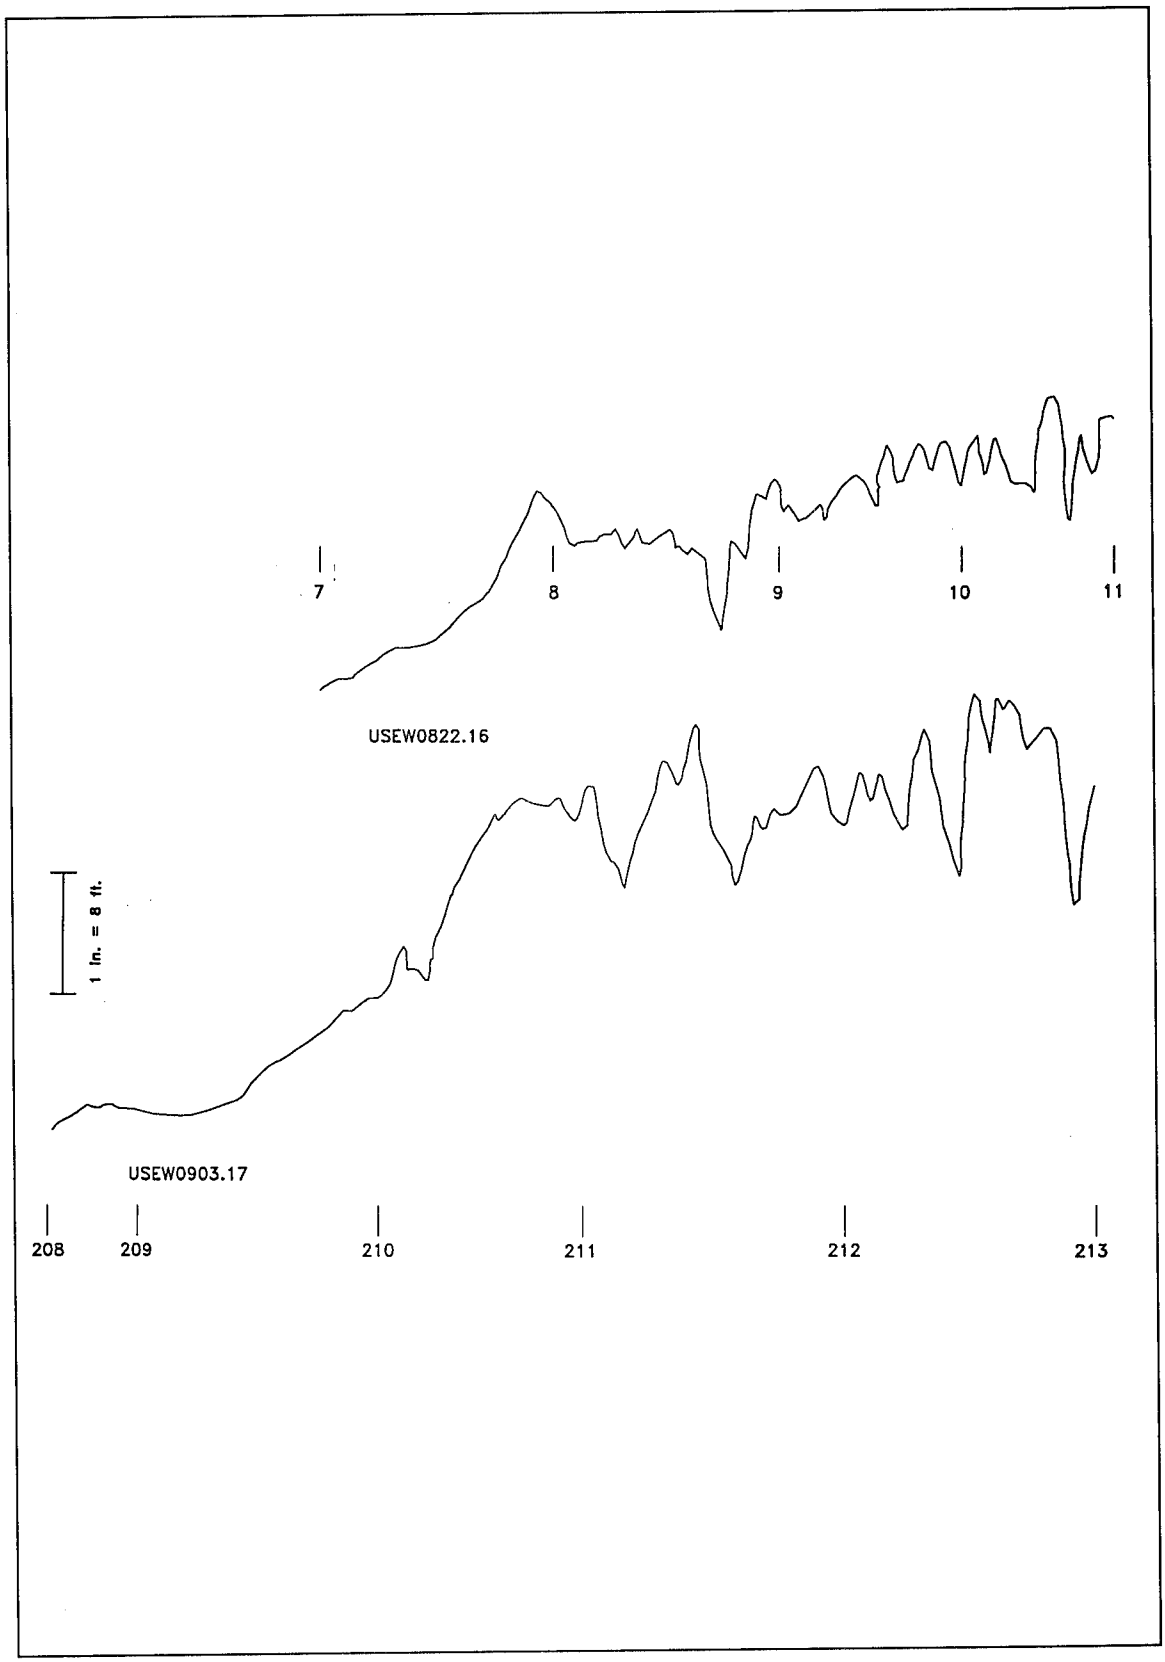
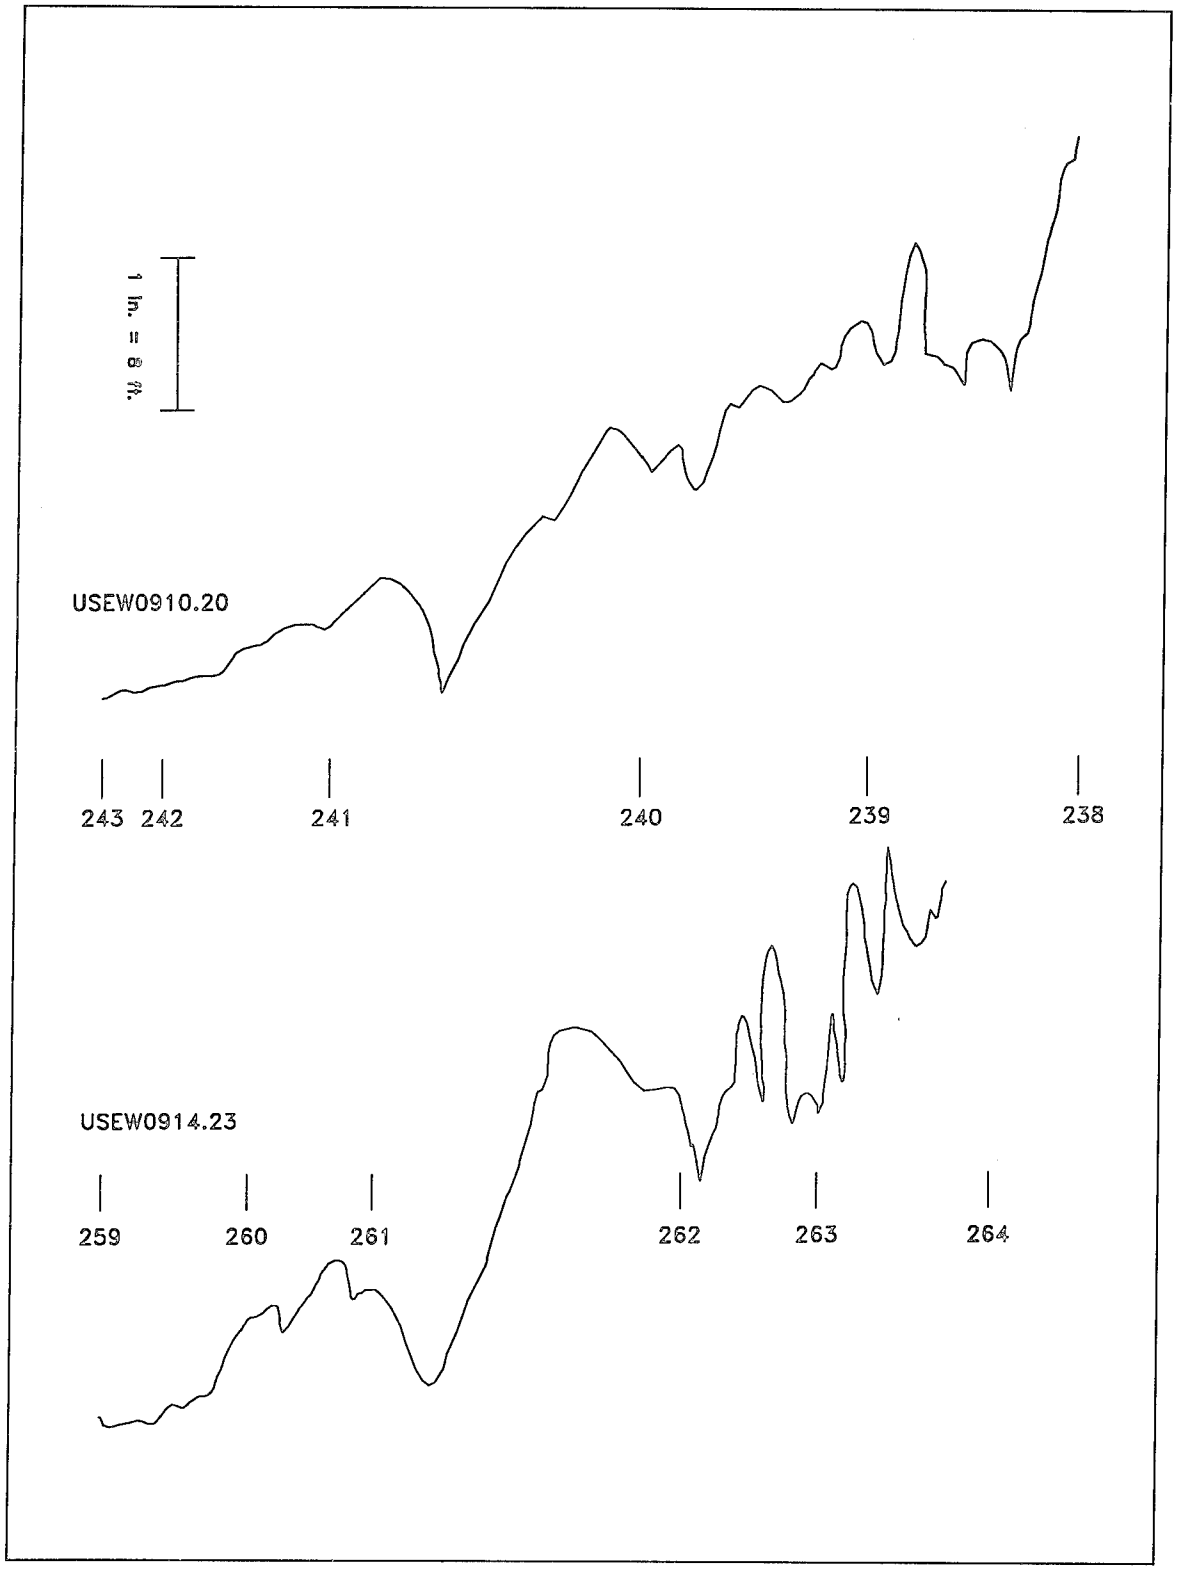
Figure 32. Echo sounder profiles for "northwest side of jetty" region (Continued)

On the corresponding bathymetric profile (bottom profile on page 93) there is a peaked bottom feature shown between event marks 211 and 212. Interpretation of the side-scan sonar record in this location concluded that this peaked feature is a wide rock finger. Around event mark 212 there are evenly spaced roughness elements similar to those seen around event mark 10 on track line USE0822.16. These roughness elements are also interpreted to be overlapping jetty stones. In conclusion, the interpretation for track line USEW0903.17 was that the track line crossed the Yaquina Reef beginning at event mark 210, and continued until event mark 212, where it then crossed over the toe of the north jetty.

Roughness elements also appeared on bathymetric profile USEW0910.20 near event mark 239 and on profile USEW0914.23 starting near event mark 262 and continuing toward event mark 264 (see Figure 32). These roughness elements were interpreted to be individual jetty stones resting on the seafloor. The corresponding side-scan sonar image of Figure 31 shows the transition from unconsolidated sediment to rock to be at event mark 241 along track line USEW0910.20 and at event mark 260 along track line USEW0914.23.

The interpretation for these two echo sounder track lines was that track line USEW09010.20 began crossing over the reef at event mark 241, and continued until mark 239 where it crossed over the jetty. Similarly, trackline USEW0914.23 started crossing the reef at event mark 260 until event mark 262, where it started crossing the jetty. Finally it is noted that all four bathymetric profiles clearly show the smooth hummocky appearance interpreted to be reef rock on their western end (left side of profiles in Figure 32).

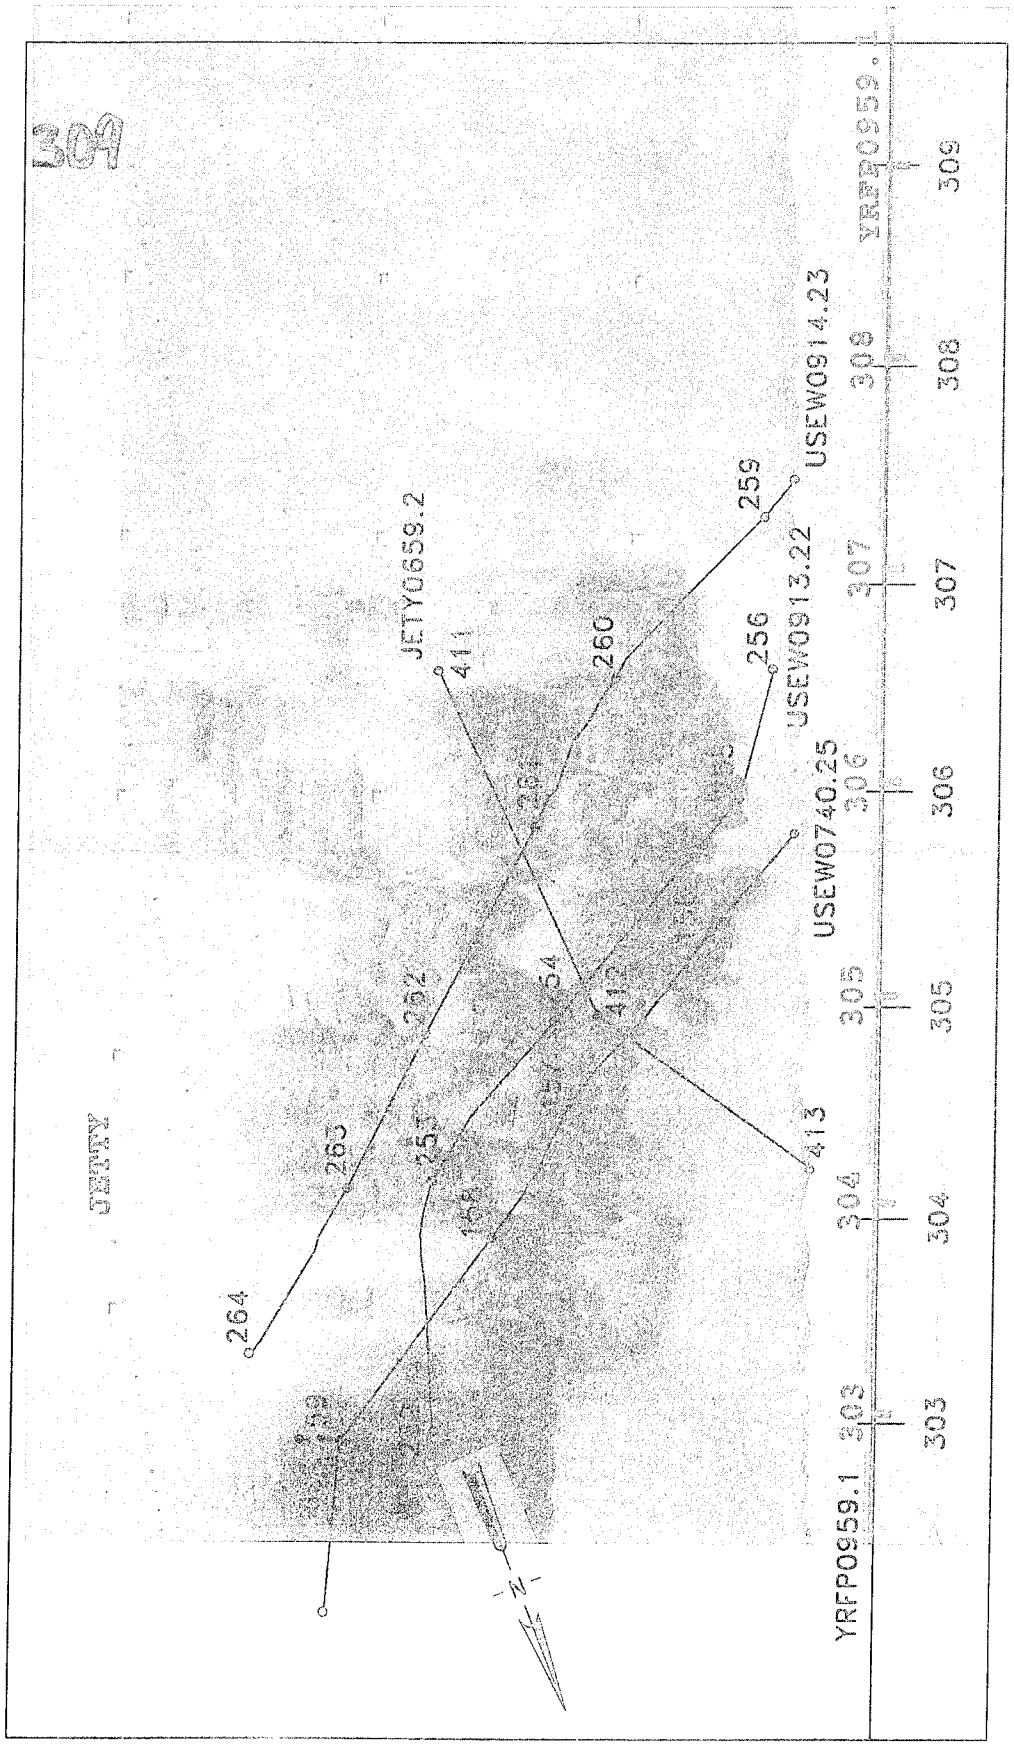
Figure 33. Side-scan sonar record along trackline YRFP0959.1 for "west side of jetty" region

Demarcation between unconsolidated sediments and reef rock is clearly discernable on the side-scan sonar image of Figure 33. This transition is just seaward of event mark 412 along trackline JETY0659.2, halfway between event marks 155 and 156 along trackline USEW0740.25, at event mark 255 along track line USEW0913.22, and halfway between event marks 259 and 260 along track line USEW0914.23.

corresponding side-scan sonar image of Figure 33 showed no rounded objects along this track line. However, there were light areas that may be areas of sand. The interpretation from the echo sounder and side-scan sonar data is that trackline JETY0659.2 passed entirely over reef rock which contained isolated sand pockets overlaying the Yaquina Reef.

The side-scan sonar image of Figure 33 was too dark to permit a clear interpretation along echo sounder track line USEW0913.22 in the region of event mark 252. Therefore, the bathymetric profile around event mark 252 cannot be interpreted with certainty. The small regular roughness elements present on this profile in Figure 34 around event mark 253 exhibit the shape of overlapping jetty armor stones, and this interpretation is confirmed by the rounded images returned from the side-scan sonar around this event mark. The bathymetric profile also has the smooth hummocky appearance of reef rock between the offshore boundary of the reef at event mark 255, shoreward until event mark 254. The conclusion for echo sounder trackline USEW0913.22 was that the track line crossed from unconsolidated sediments to reef rock near event mark 255 and passed over the Yaquina Reef until event mark 254, where the trackline crossed over the north jetty toe.

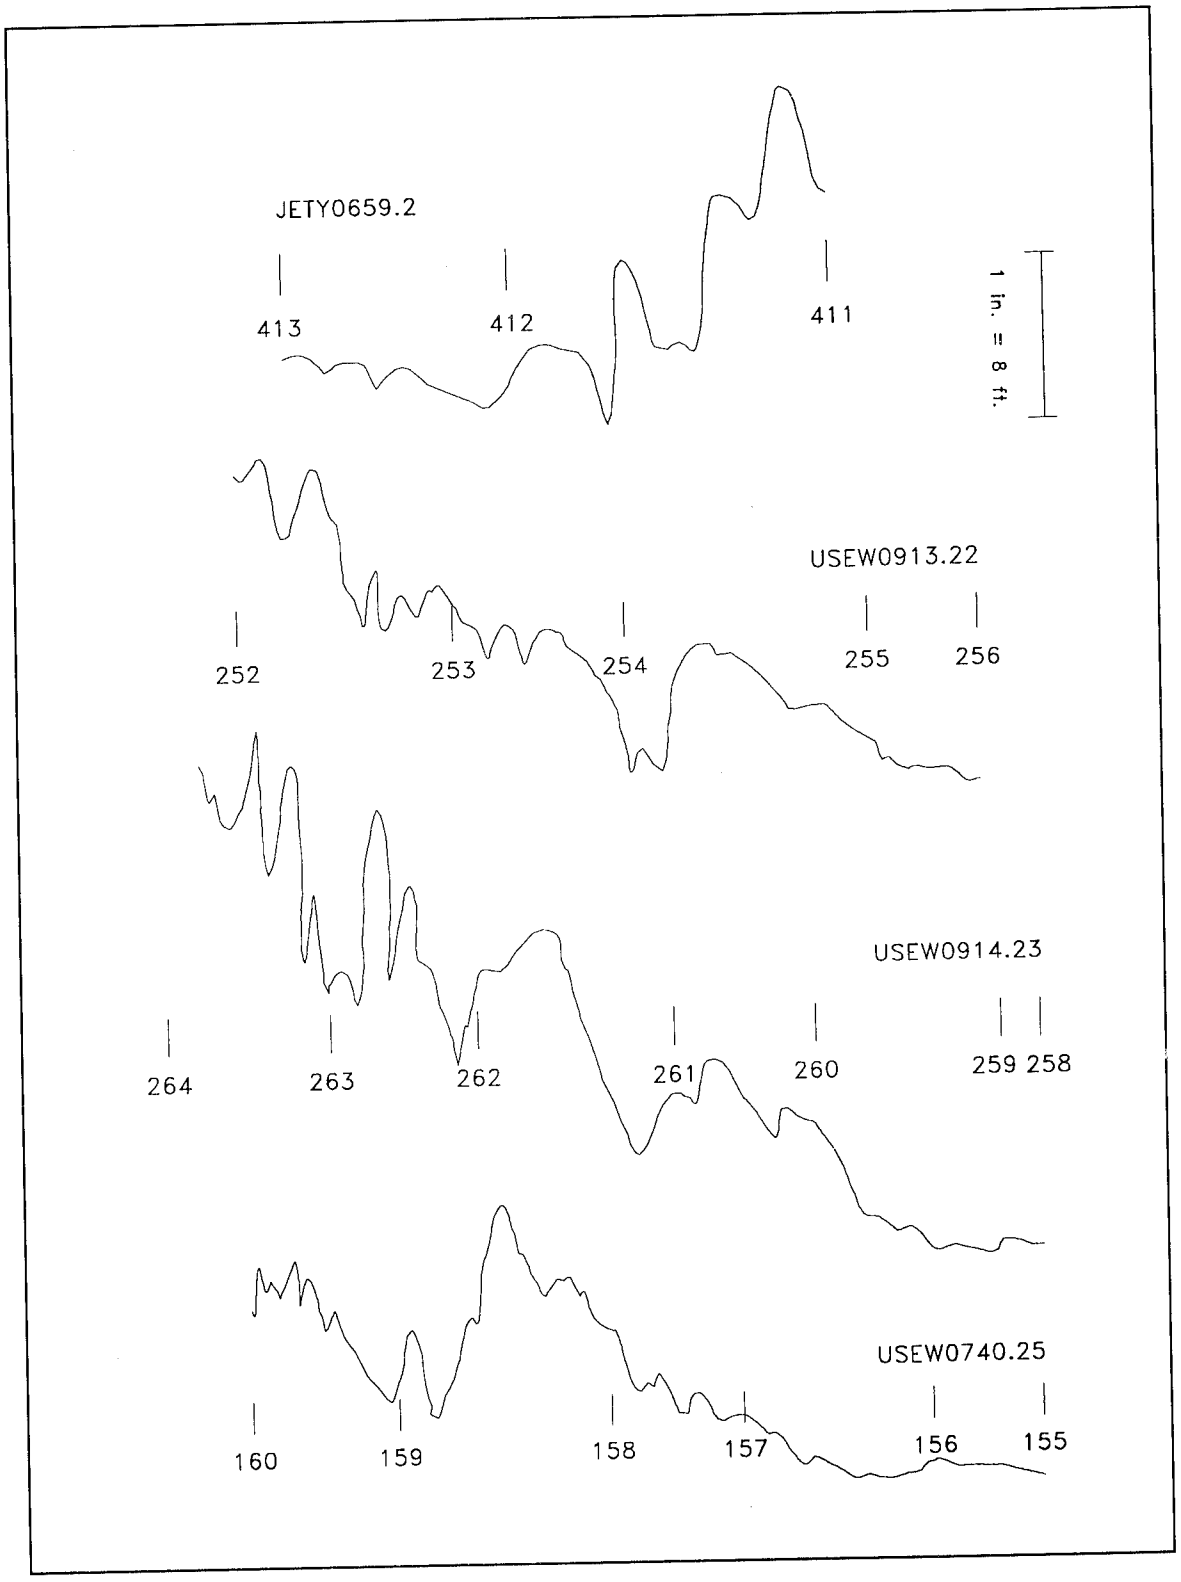
Figure 34. Echo sounder profiles for "west side of jetty" region

The bathymetric profile for track line JETY0659.2 shown on Figure 34 is relatively smooth, and the large roughness elements are generally wider in the horizontal and shorter in the vertical than those of individual jetty stones. The

The bathymetric profile for trackline USEW0740.25 shown on Figure 34 is also relatively smooth until halfway between event marks 159 and 160. Unfortunately, the corresponding side-scan sonar image is no help in this region because the return signal is very dark, and it is hard to discern any rounded features. It was tentatively concluded that trackline USEW0740.25 crossed over the seaward edge of the Yaquina Reef between event marks 155 and 156, and passed over the reef until between event marks 159 and 160 where small, regularly spaced roughness elements were recorded that may be overlapping jetty armor stones.

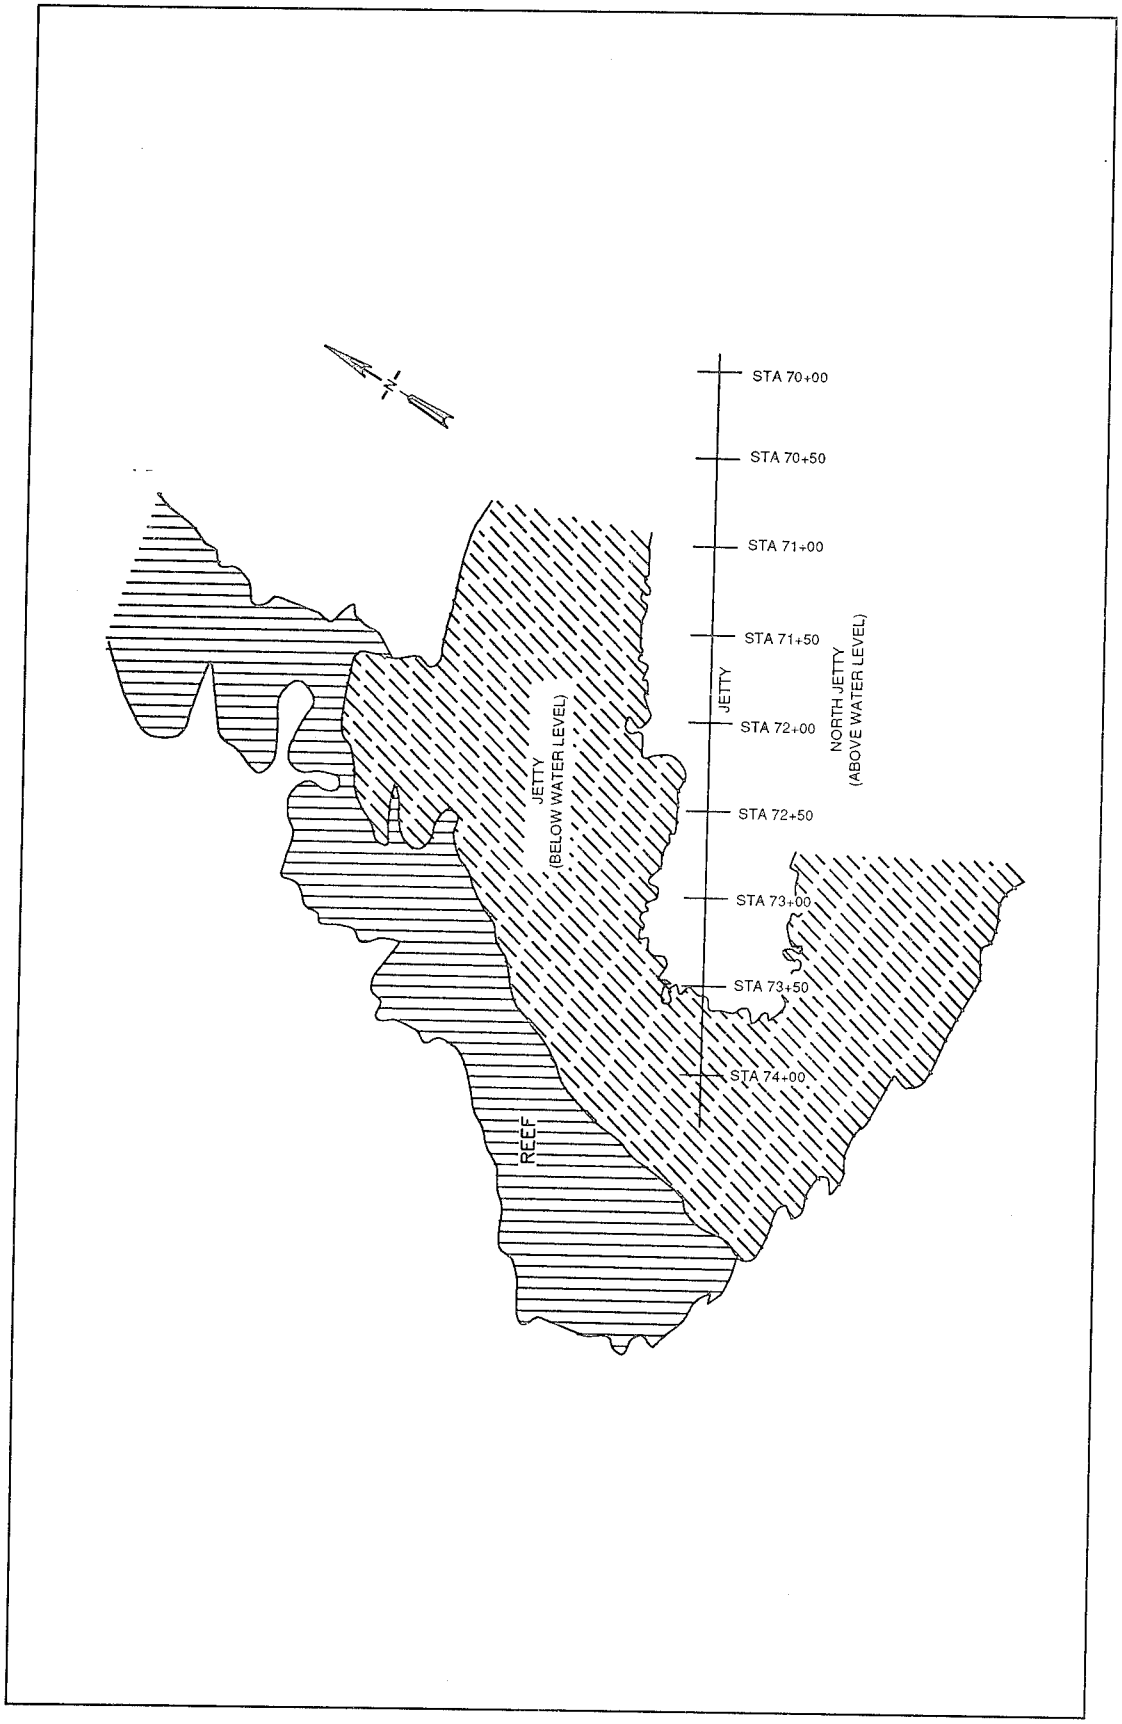
Figure 37. Position of Yaquina Bay north jetty relative to Yaquina Reef

The four side-scan sonar images presented in Figures 29, 31, 33, and 35 were used to delineate the border between rock and unconsolidated sand around the Yaquina Bay north jetty head. This demarcation line was drawn on Figure 37 to show its position relative to the above-water portion of the north jetty.

portion of the Yaquina Reef sticks out seaward of the northwest tip of the Yaquina Bay north jetty. However, interpreting roughness elements on the bathymetric profiles as jetty armor stones involved a certain degree of subjectivity. Therefore, the line marking the toe of the north jetty on Figure 37 is not absolutely definitive.

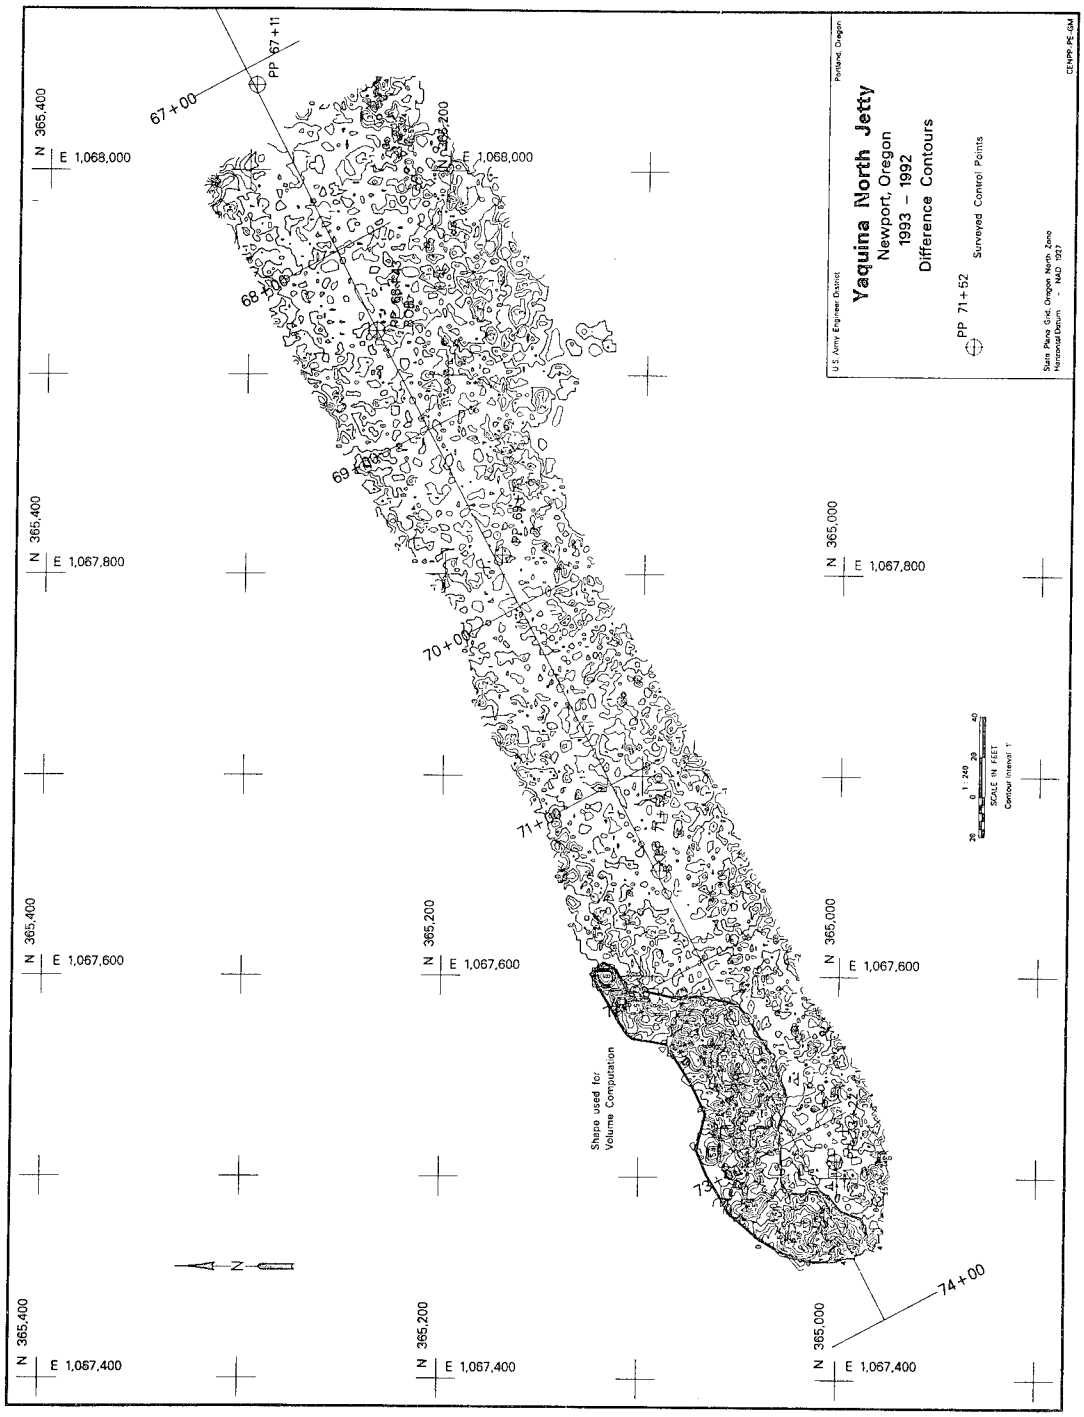
Figure 43. Difference between 1992 and 1993 north jetty contours

As mentioned, gridded elevations from different dates can be combined to produce difference contours. Figure 43 shows the difference contours found between stereo models for the 1992 and 1993 overflights. This figure is included only to give an impression of the product. The original products

have different colored contours to denote positive and negative differences, and they are far more informative than what is shown in black and white on Figure 43.

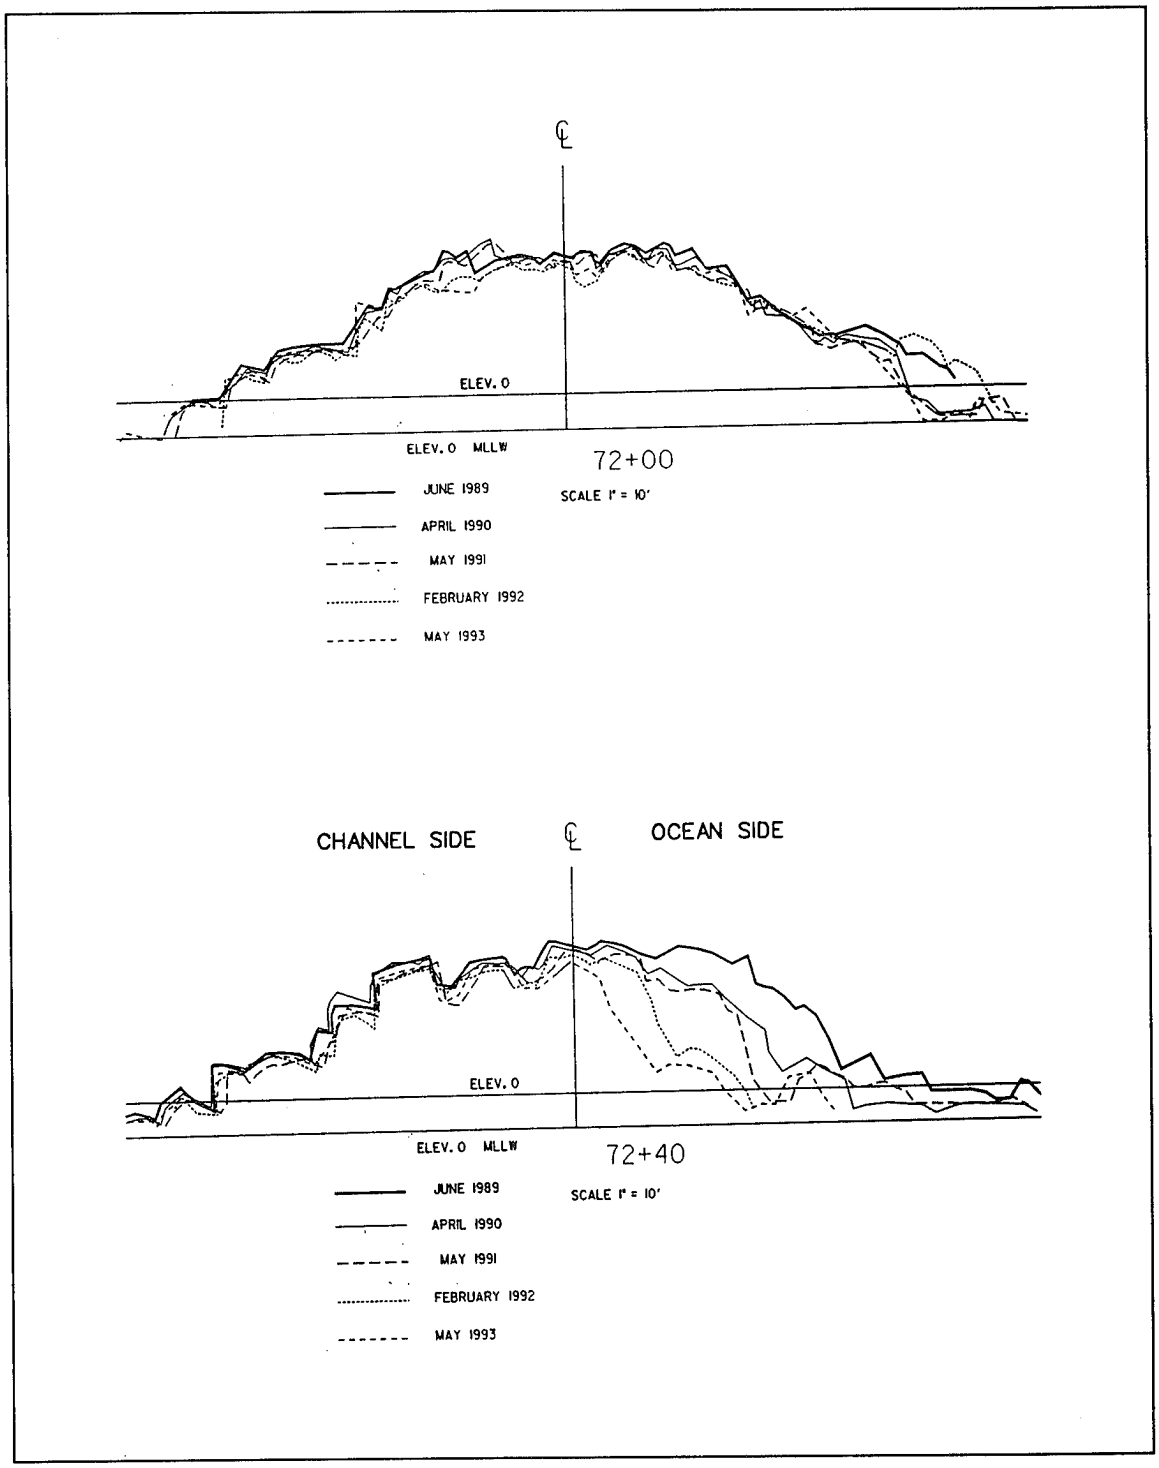
Figure 45. Stereo model jetty profile comparisons, ranges 72+00 and 72+40

c. The most profile change occurred in the vicinity of the "notch" (Figure 45, range 72+40). Significant damage occurred between the years 1989 - 1991. This was followed by a year when the only armor stone losses in the notch area occurred on the landward side of the notch. However, between the 1992 and 1993 overflights, massive profile losses occurred in the notch area to the extent that stones were lost over much of the structure's crest (see range 72+70, Figure 46).

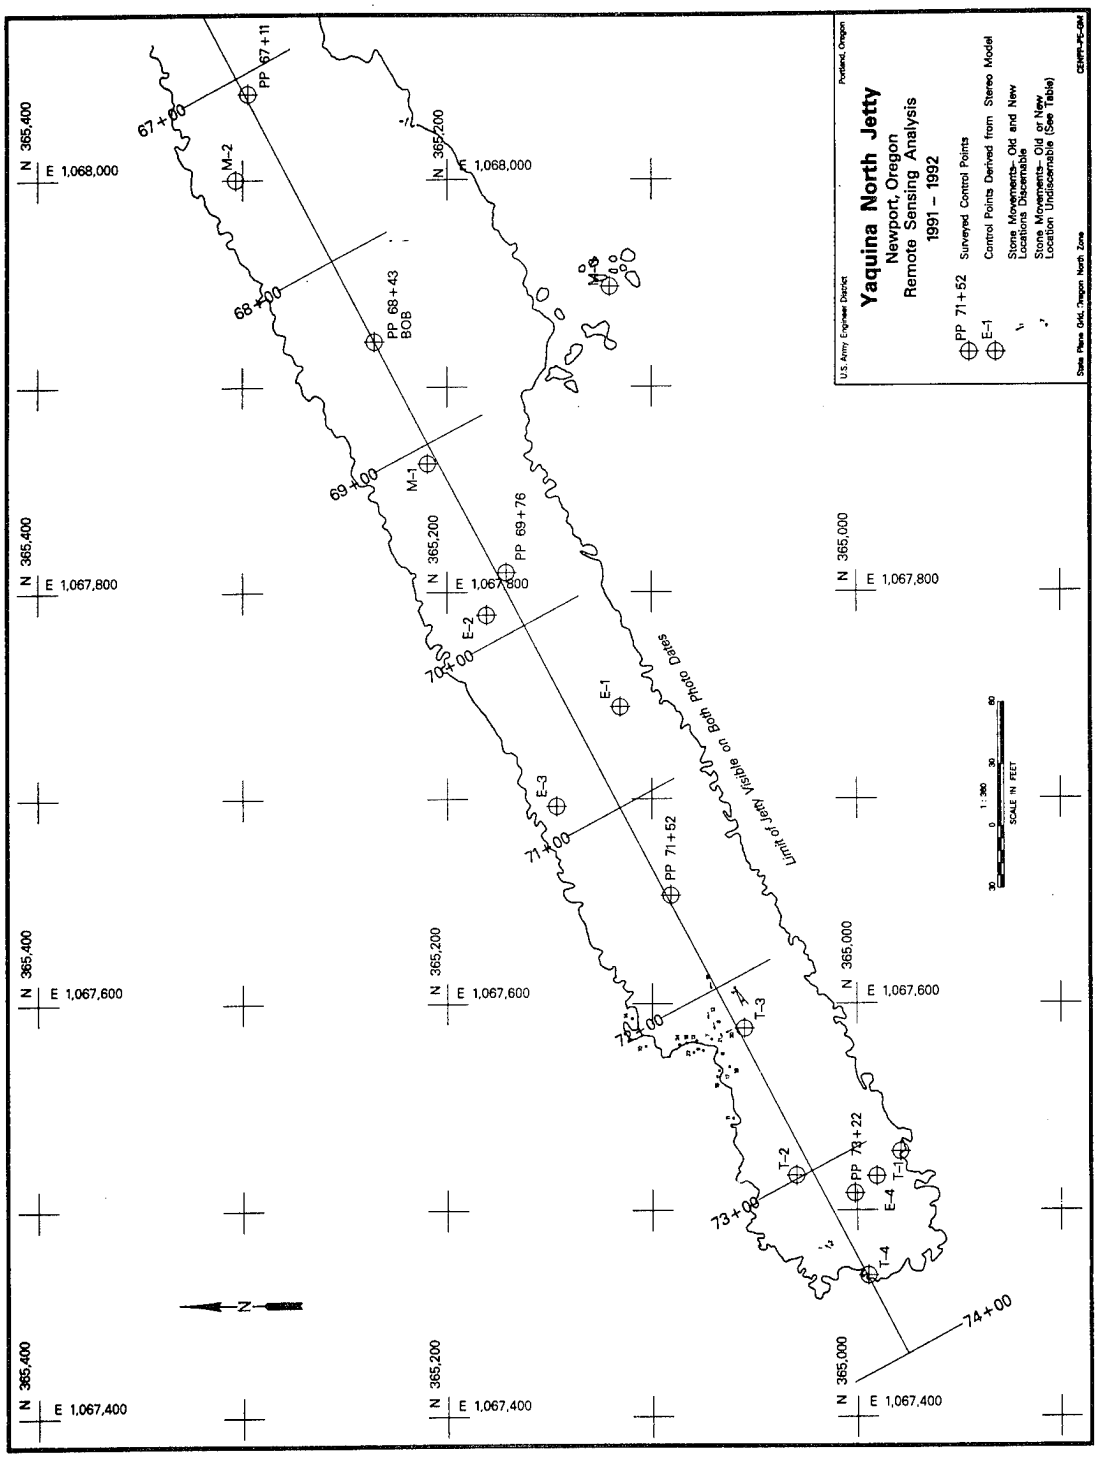
Figure 48. Individual armor stone movements between 1991 and 1992

Between the 1989 and 1990 photographs there was a significant amount of stone movement detected in the vicinity of the "notch" as the structure made its initial adjustment to the environmental conditions. The comparison between 1990 and 1991 showed little movement of stone in the notch area, with only four armor stones disappearing and three stones moving distances ranging between 1 and 3 m (3 and 10 ft).
