Technical Report CERC-95-9
July 1995

US Army Corps
of Engineers
Waterways Experiment
Station

Monitoring of the Yaquina Bay Entrance North Jetty at Newport, Oregon; Summary and Results

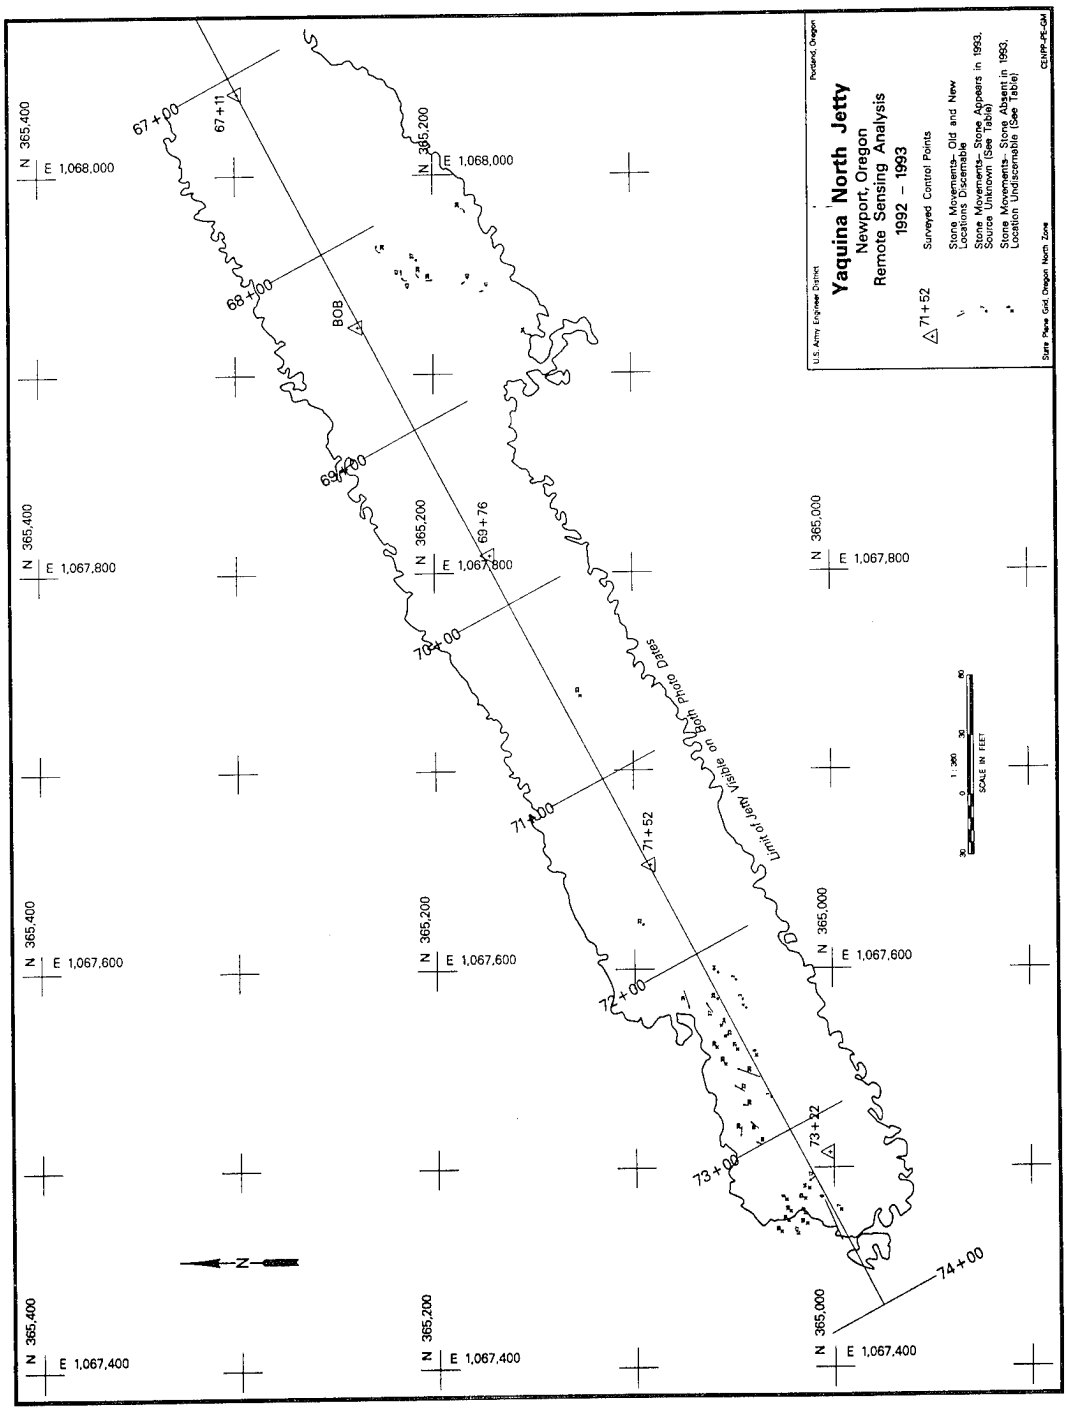
Figure 50. Individual armor stone movement between 1992 and 1993

The winter season between 1992 and 1993 resulted in the loss of approximately 17 identifiable armor stones as determined from aerial photography. Ten of the larger select class "A" stones were lost from the previously stable region at the very tip of the north jetty as shown on the stone movement drawing (Figure 50). More stones were undoubtedly lost from underneath the removed top stones, but the actual number cannot be determined because they cannot be identified on the earlier photographs. Curiously, eight stones on the 1993 photographs were identified that were not present in the 1992 photographs. It is presumed that these armor stones, located high on the crest near the jetty center line, were swept up the structure slope from the notch area or from somewhere below the waterline. Also, some stone movement was noted on the channel side of the north jetty around Station 68+50 (see Figure 50).

Figure 51 summarizes the stone movements that occurred between 1992 and 1993. Although most stone movements were less than 2 m (7 ft), there was one stone near the notch that moved about 3.4 m (11 ft) downslope and one stone at the tip that was displaced a total of 6.4 m (21 ft).

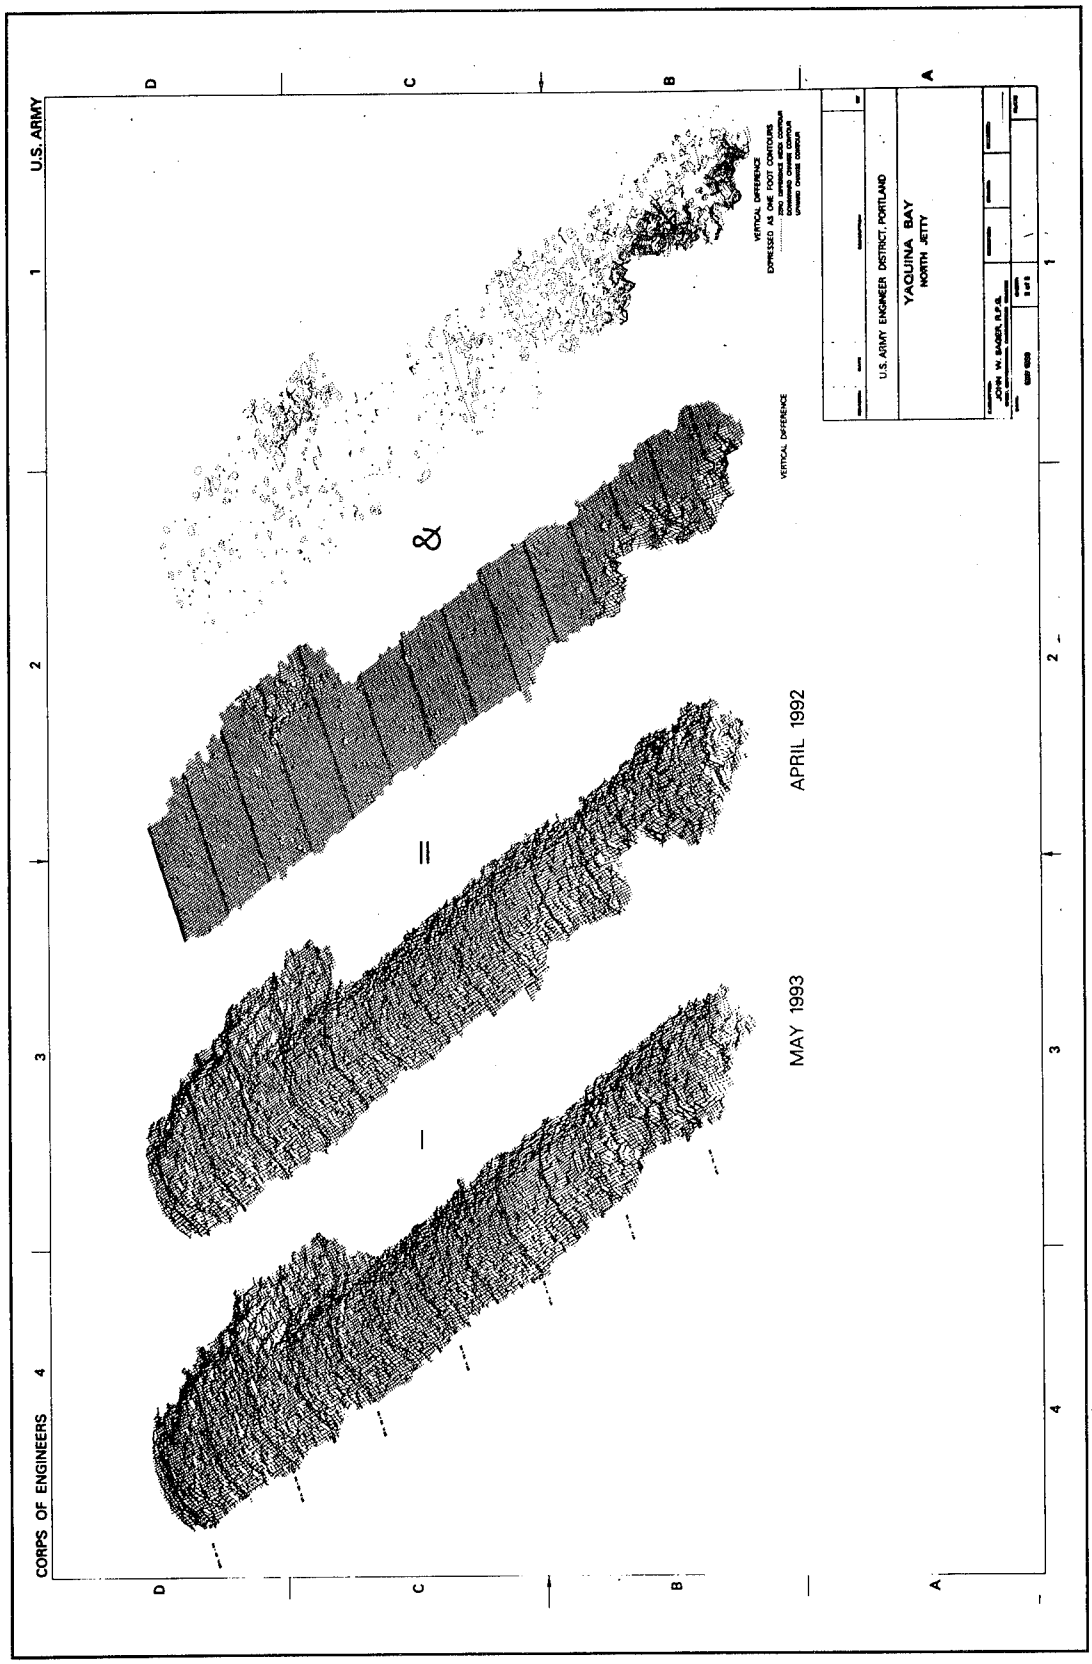
Figure 53 gives a visual impression of the stone loss that occurred between 1992 and 1993. Subtraction of the 1992 stereo-model orthographic projection "mesh" from the 1993 mesh produced a mesh showing just the changes in elevation between the two overflights, which translates into stone loss. Difference contours were also produced from the stereo-models.

Figure 53. Yaquina Bay north jetty stone loss between 1992 and 1993

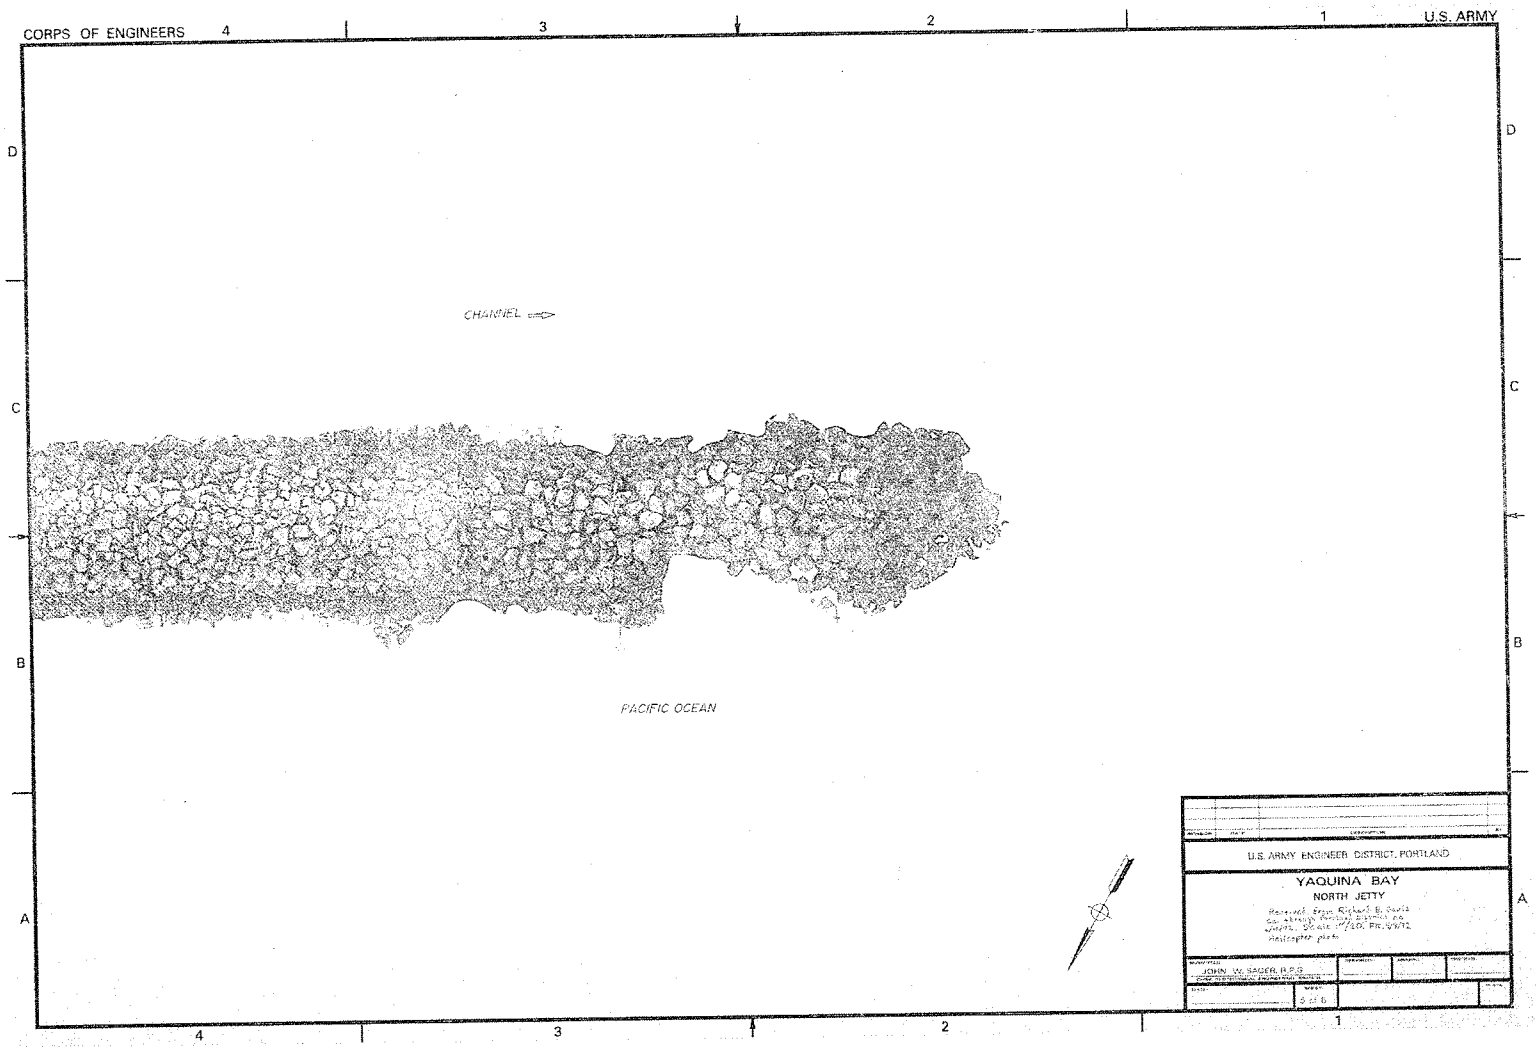
Figure 54. Helicoptor photograph of Yaquina Bay north jetty tip, 1992

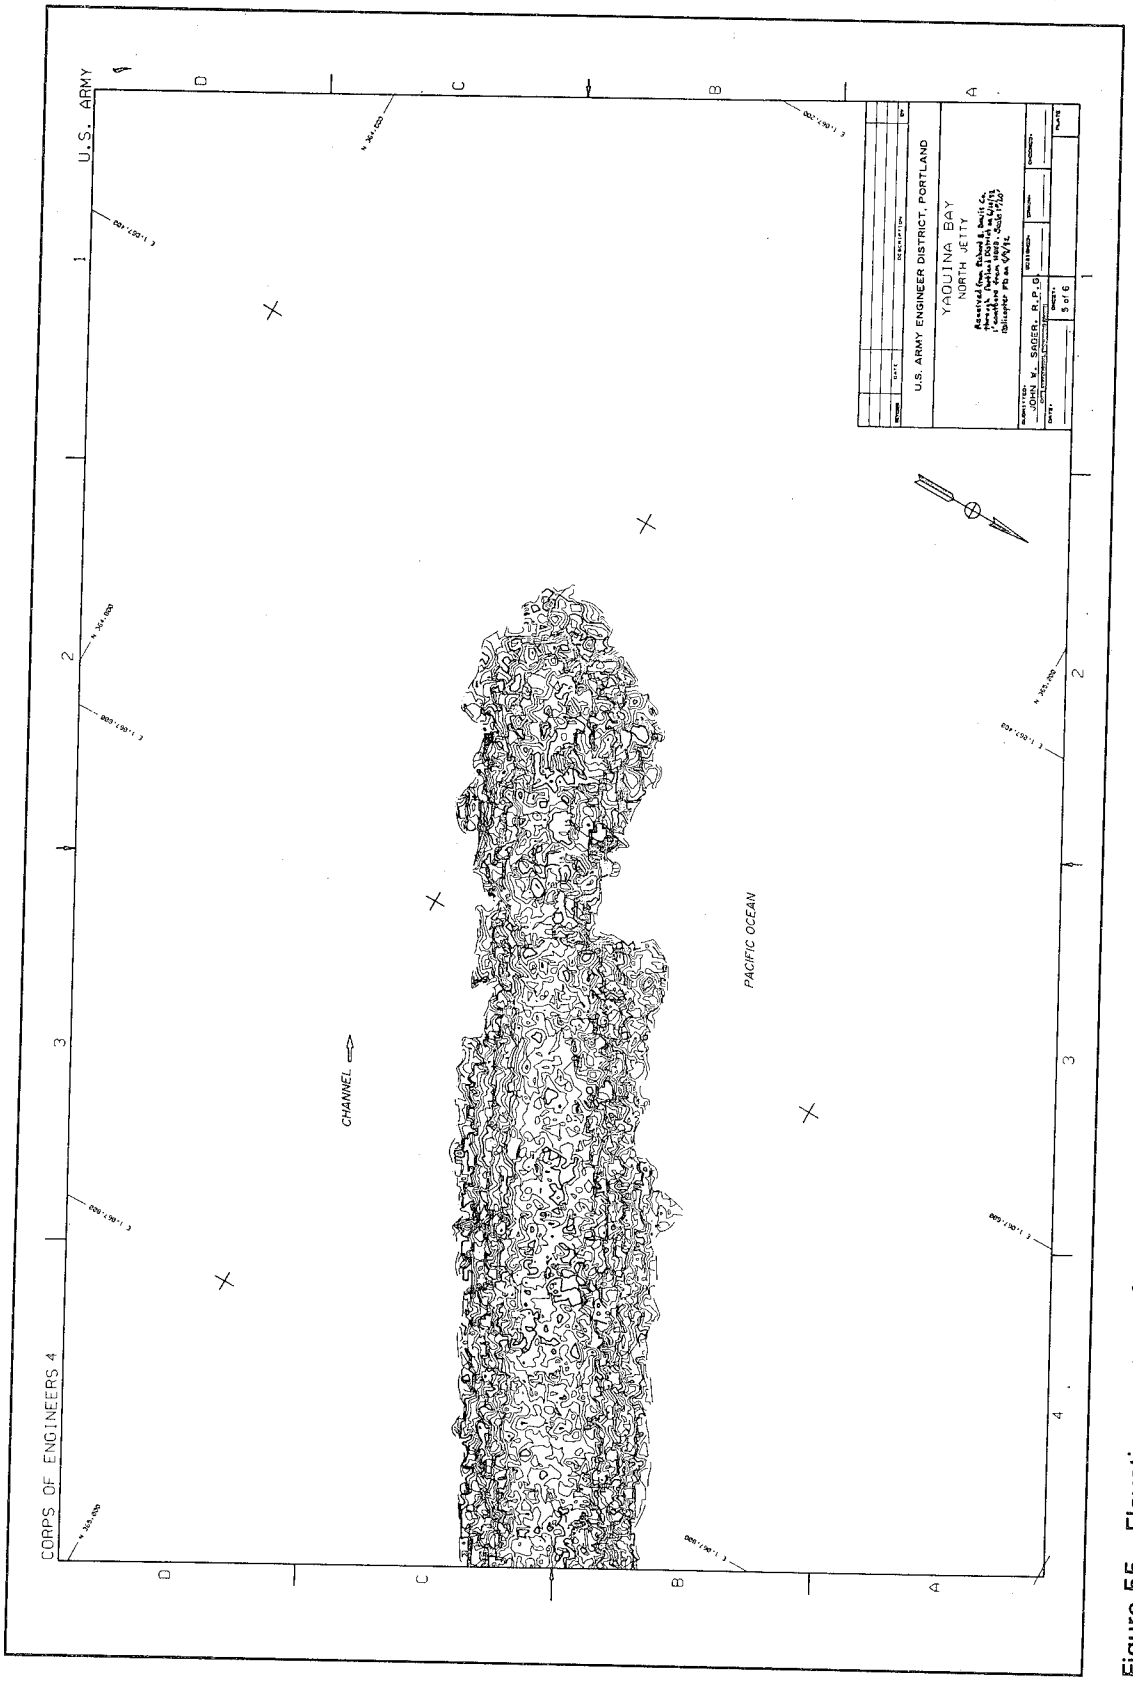
Figure 55. Elevation contours from the 1992 helicopter overflight

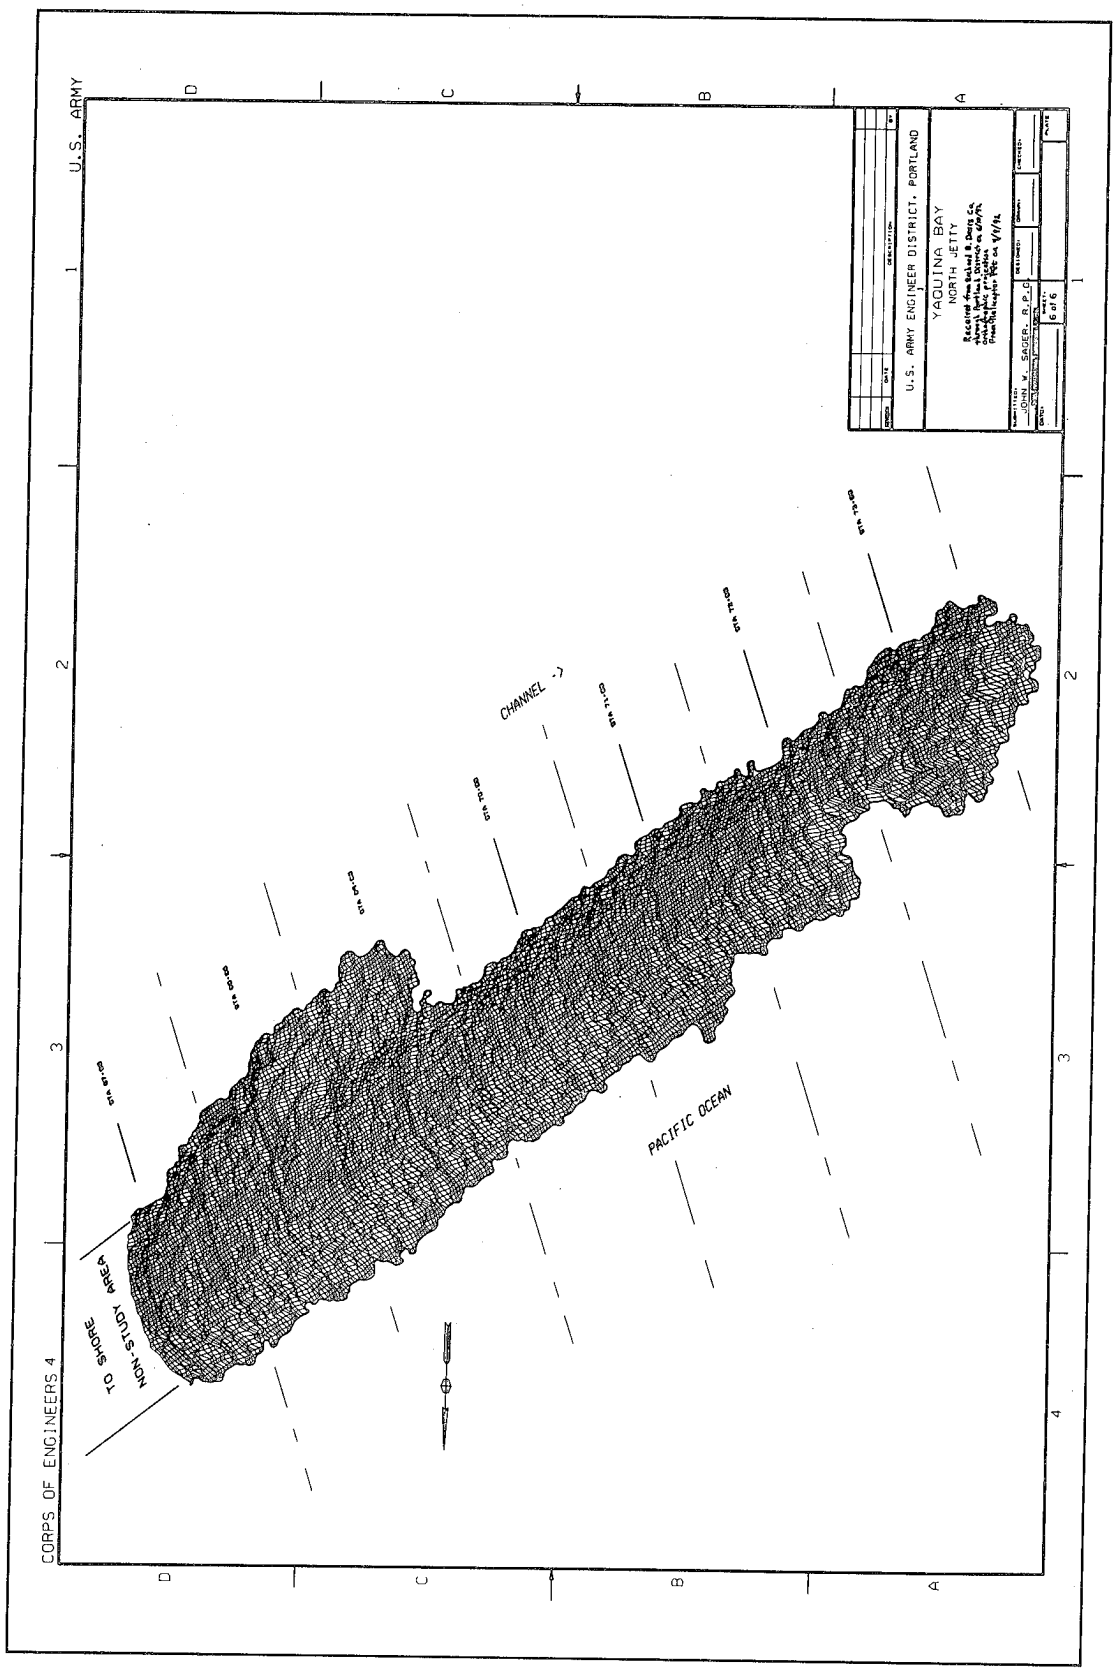
Figure 56. Orthogonal projection from the 1992 helicopter overflight

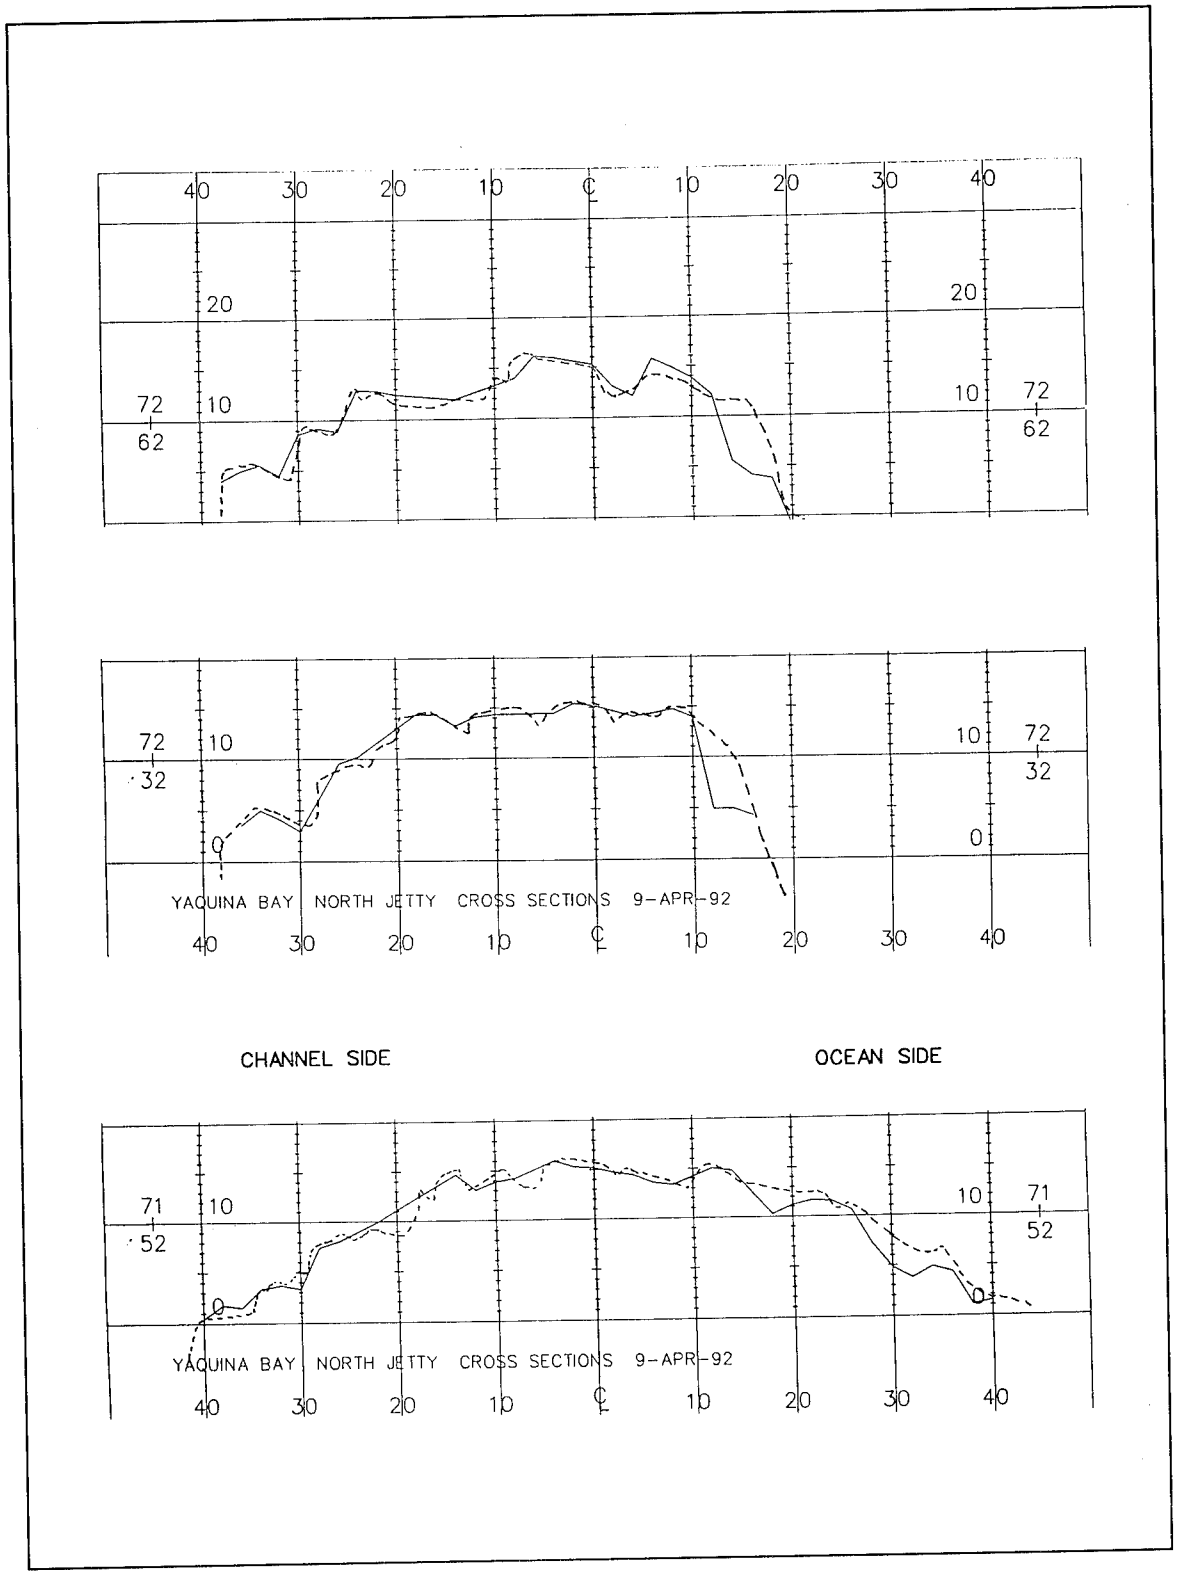
Figure 57 compares three of the 1992 helicopter cross sections (solid line) to the respective fixed-wing cross section (dashed line) that were obtained about 6 weeks earlier. For this limited comparison, reasonable agreement is observed overall, but isolated differences in elevation up to about 3 m (10 ft) are noted. This may be due to misalignment of the coordinate systems used in the two stereo models or interpretation of the stereo photographs. Whichever the case, it is not possible to state absolutely which profiles are correct without further ground-truth from land-based surveys.

Figure 57. Comparison between 1992 helicopter (solid line) and fixed-wing (dashed line) cross sections

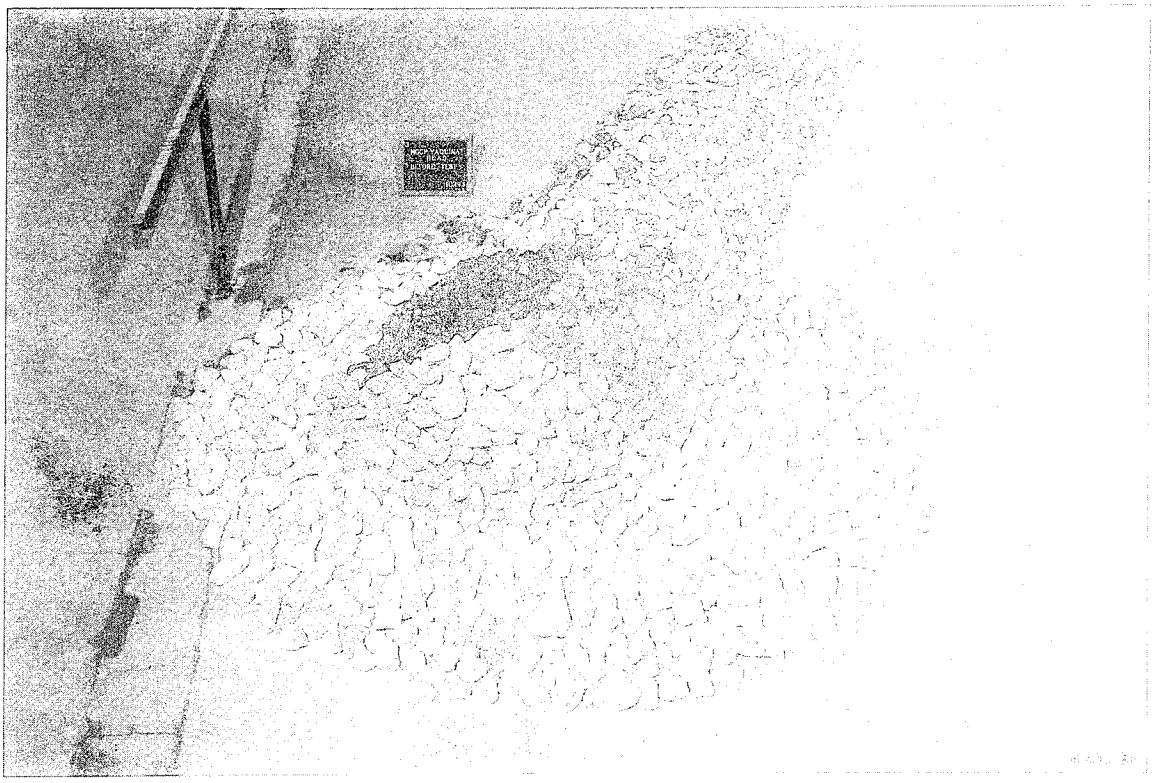
Figure 65 shows the reconstructed Yaquina Bay north jetty head prior to testing. The armor stones in different shaded regions of the structure had been painted so that damage would be easier to spot. Figure 66 shows the condition of the jetty head at the end of Test 6. Although it is difficult to see in the photograph, the armor underlayer had been exposed in an area that

Figure 65. Wave/current stability model prior to Test 6

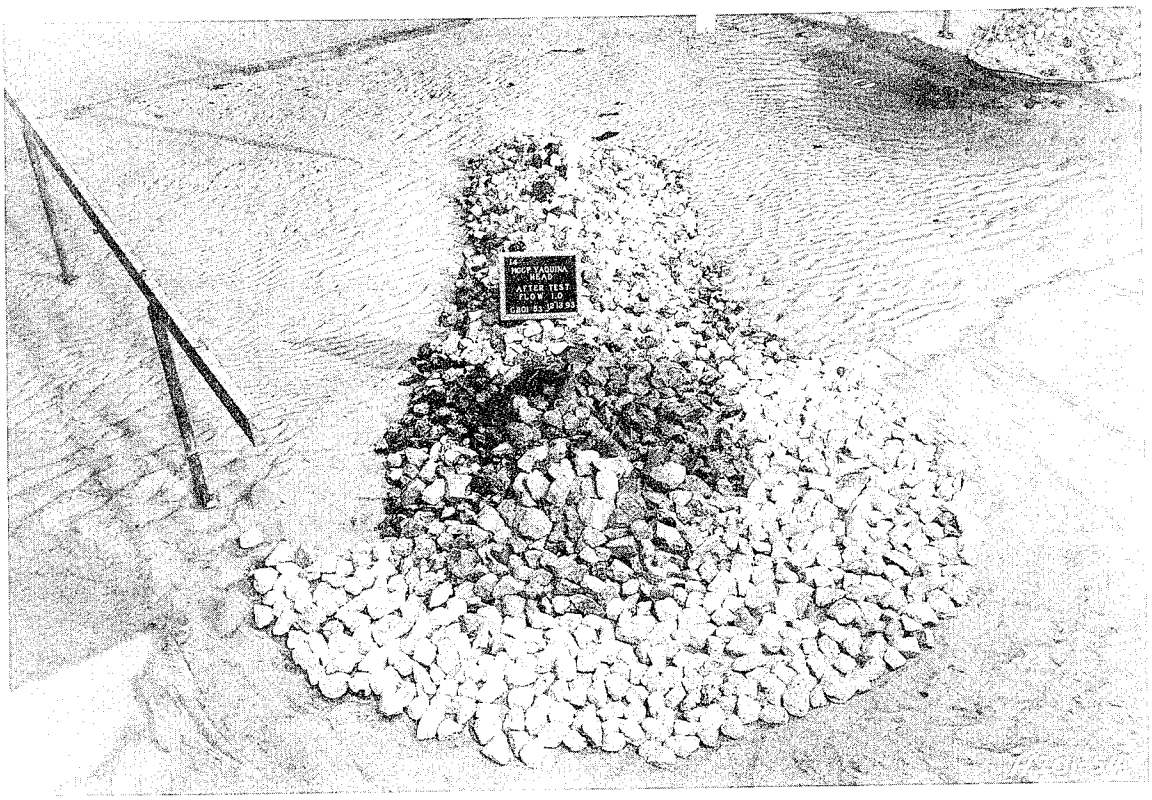
Figure 66. Wave/current stability model showing damage after Test 6

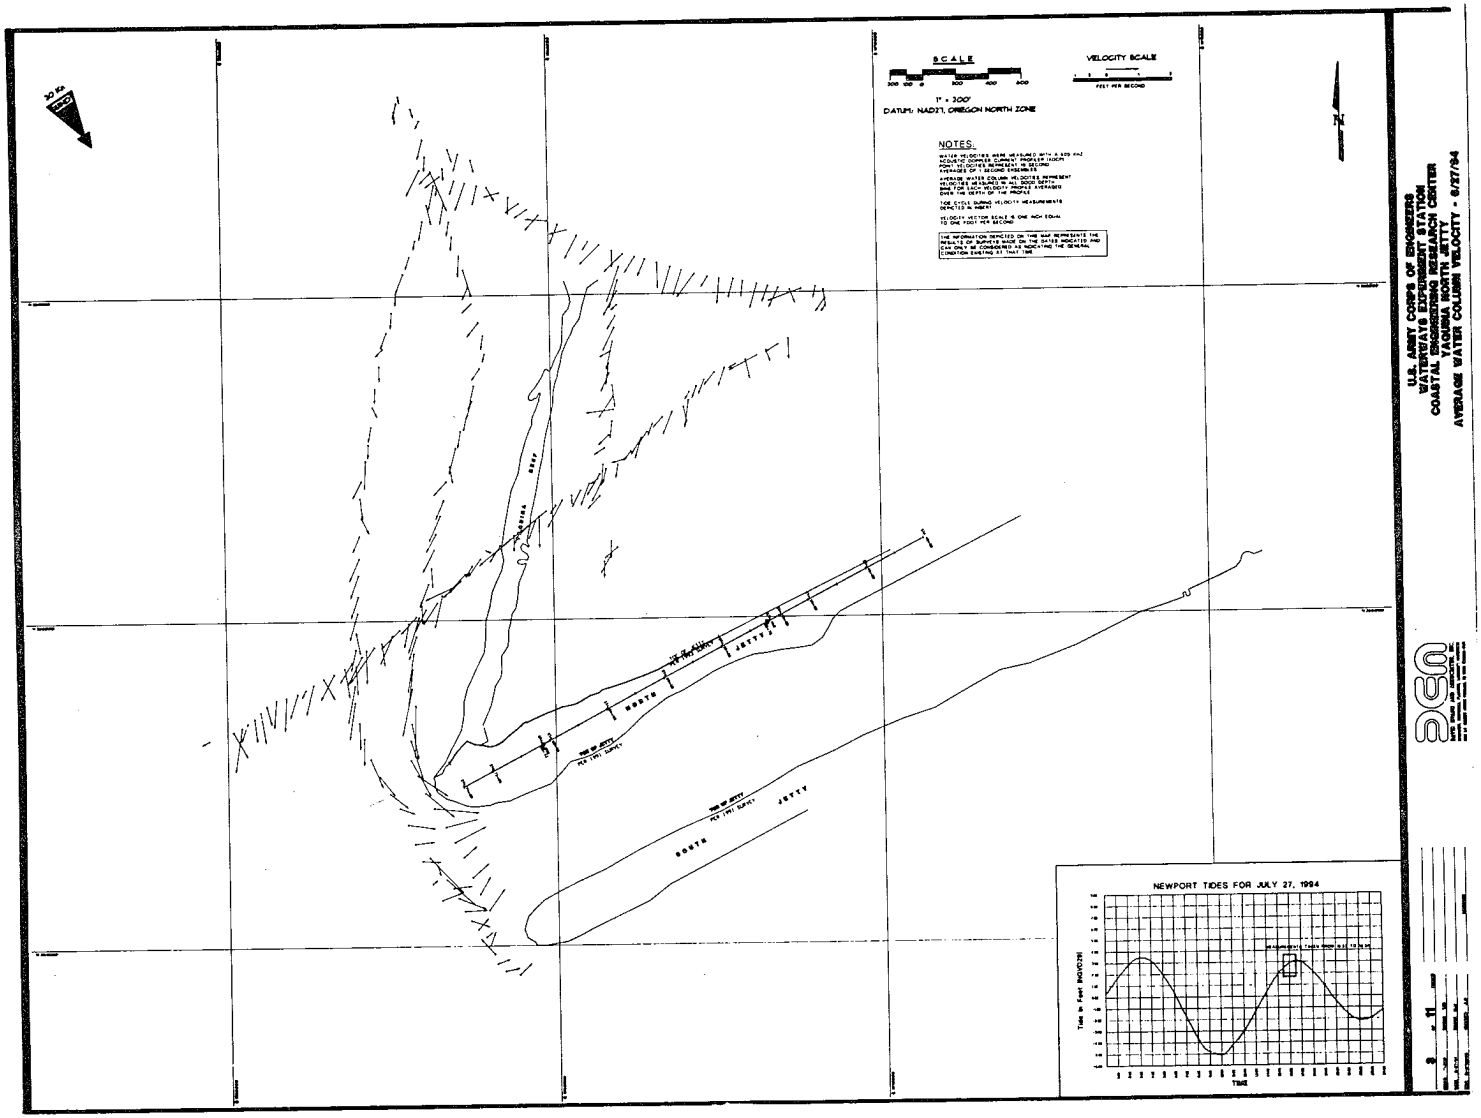
Figure 67. Depth-averaged current velocity vectors at Yaquina Bay north jetty (27 June 1994)

The currents shown on Figure 67 indicated a fairly uniform southerly longshore current of about 20-30 cm/s (0.7-1.0 ft/s). Closer to the north jetty, flow was directed seaward parallel to the jetty, but magnitudes on this trackline were not very large. From the data it cannot be determined if higher seaward velocities were present closer to the north jetty. Current magnitude increased close to the jetty tip due to flood currents in the entrance channel. Despite moderately rough conditions, flow velocities measured on June 27 did not appear to be out of the ordinary.

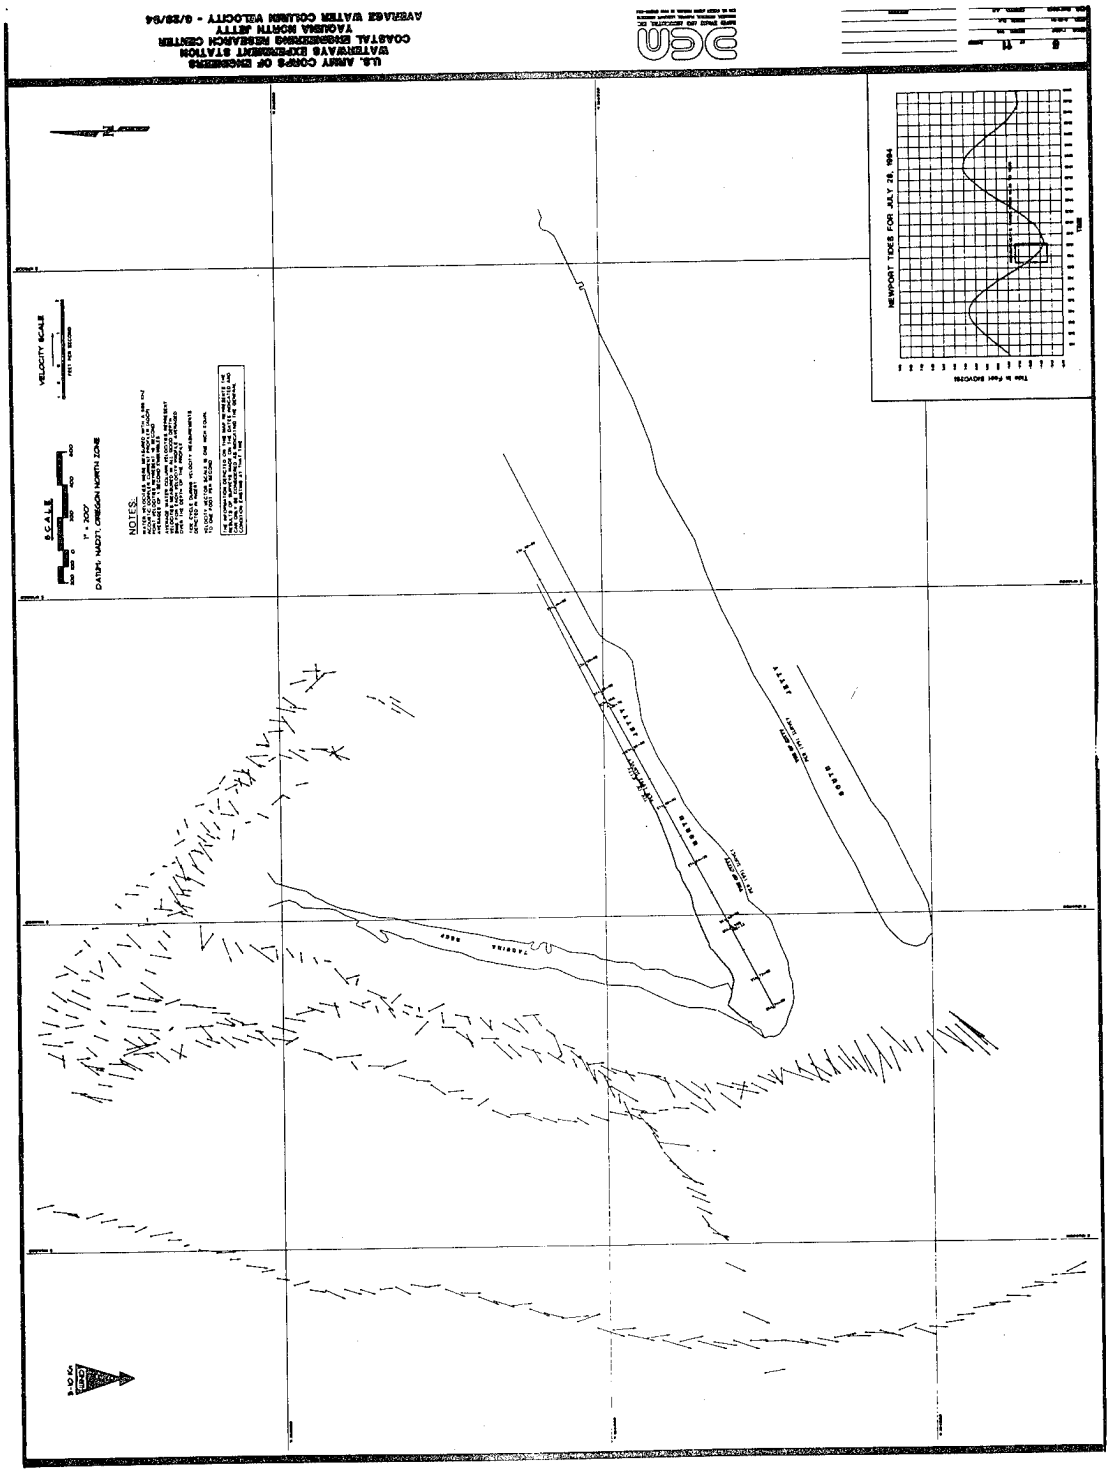
Waves consistently breaking over Yaquina Reef at low tide prevented the survey vessel from running tracklines landward of the reef parallel to the north jetty or parallel to the reef. Consequently, the vector plot of Figure 68 provides information primarily on current patterns seaward of the reef and entrance system. Close to the reef, the longshore current field exhibited fairly constant current magnitudes less than 30 cm/s (1 ft/s), but current direction varied substantially about the mean southerly direction. Farther offshore, the southerly longshore currents appeared more uniform both in magnitude and direction. Ebb currents were present across the Yaquina Bay entrance, but at this stage of the tide, little tidal influence was evident along the seawardmost trackline.

Figure 68. Depth-averaged current velocity vectors at Yaquina Bay north jetty (28 June 1994)

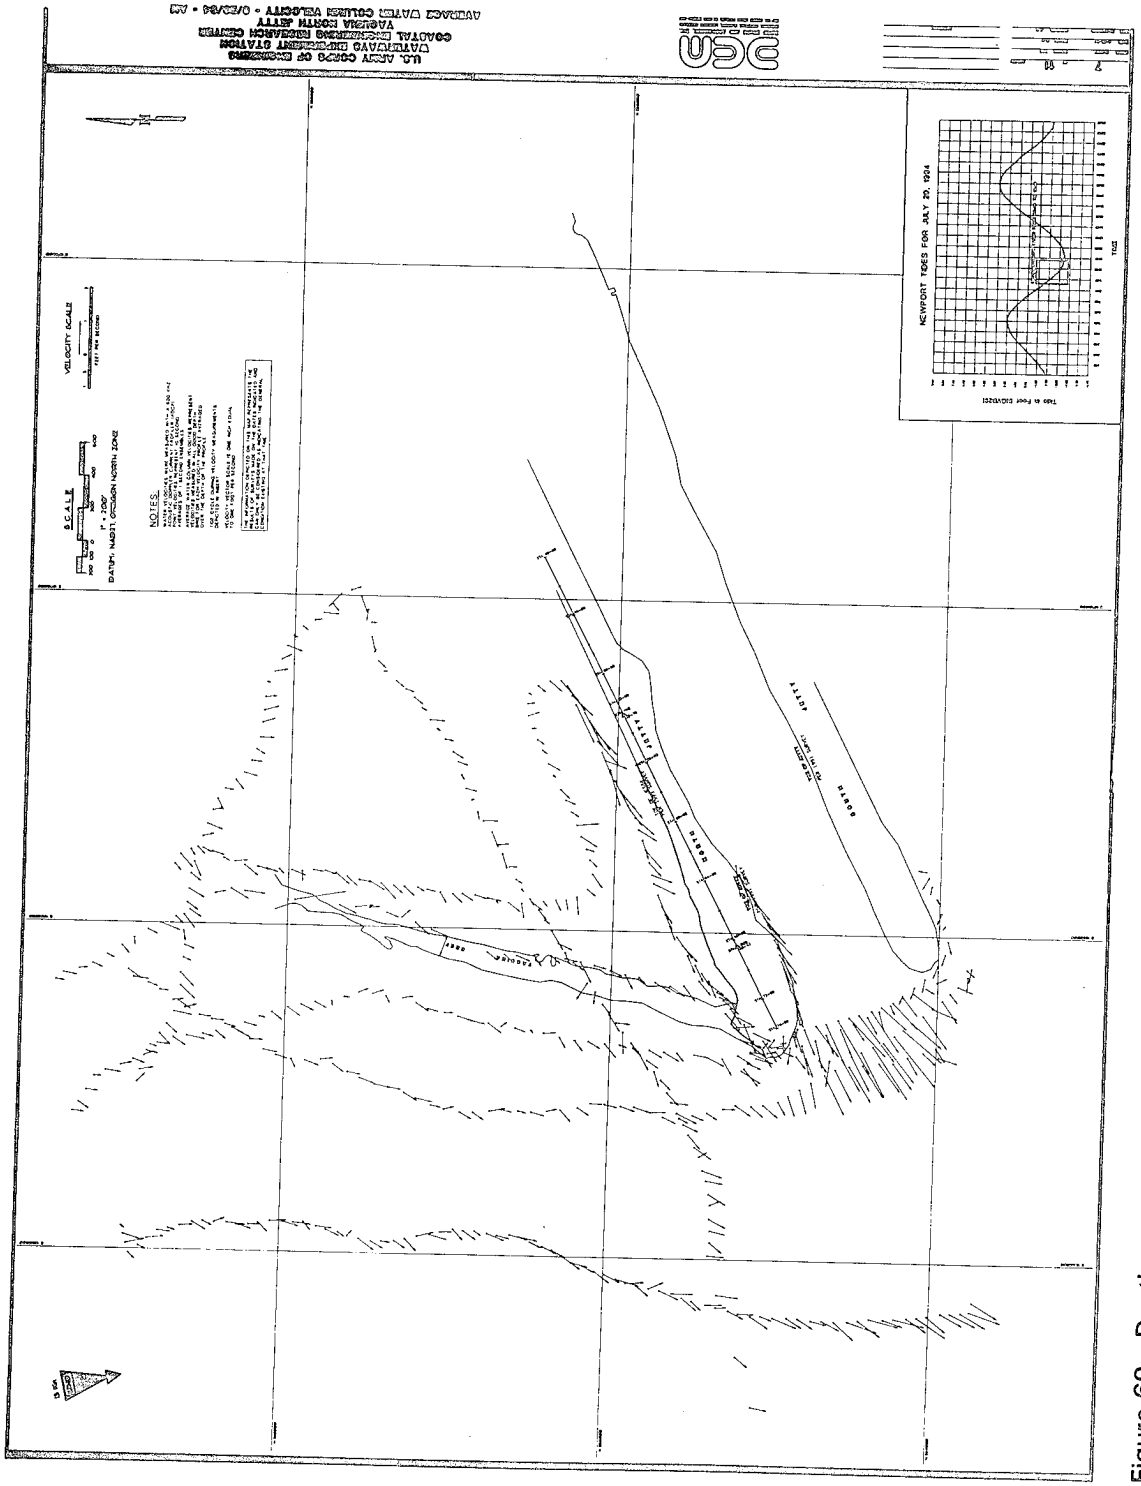
Figure 69. Depth-averaged current velocity vectors at Yaquina Bay north jetty (morning of 29 June 1994)

the lower corner of the figure. Longshore current velocities were relatively weak with average magnitudes around 10-20 cm/s (0.3-0.7 ft/s) during the survey period. However, even with this weak forcing, the role played by the north jetty in accelerating the longshore flow and redirecting it seaward is evident. Largest flow velocities on Figure 69 correspond to the ebb tidal flow at the navigation entrance.

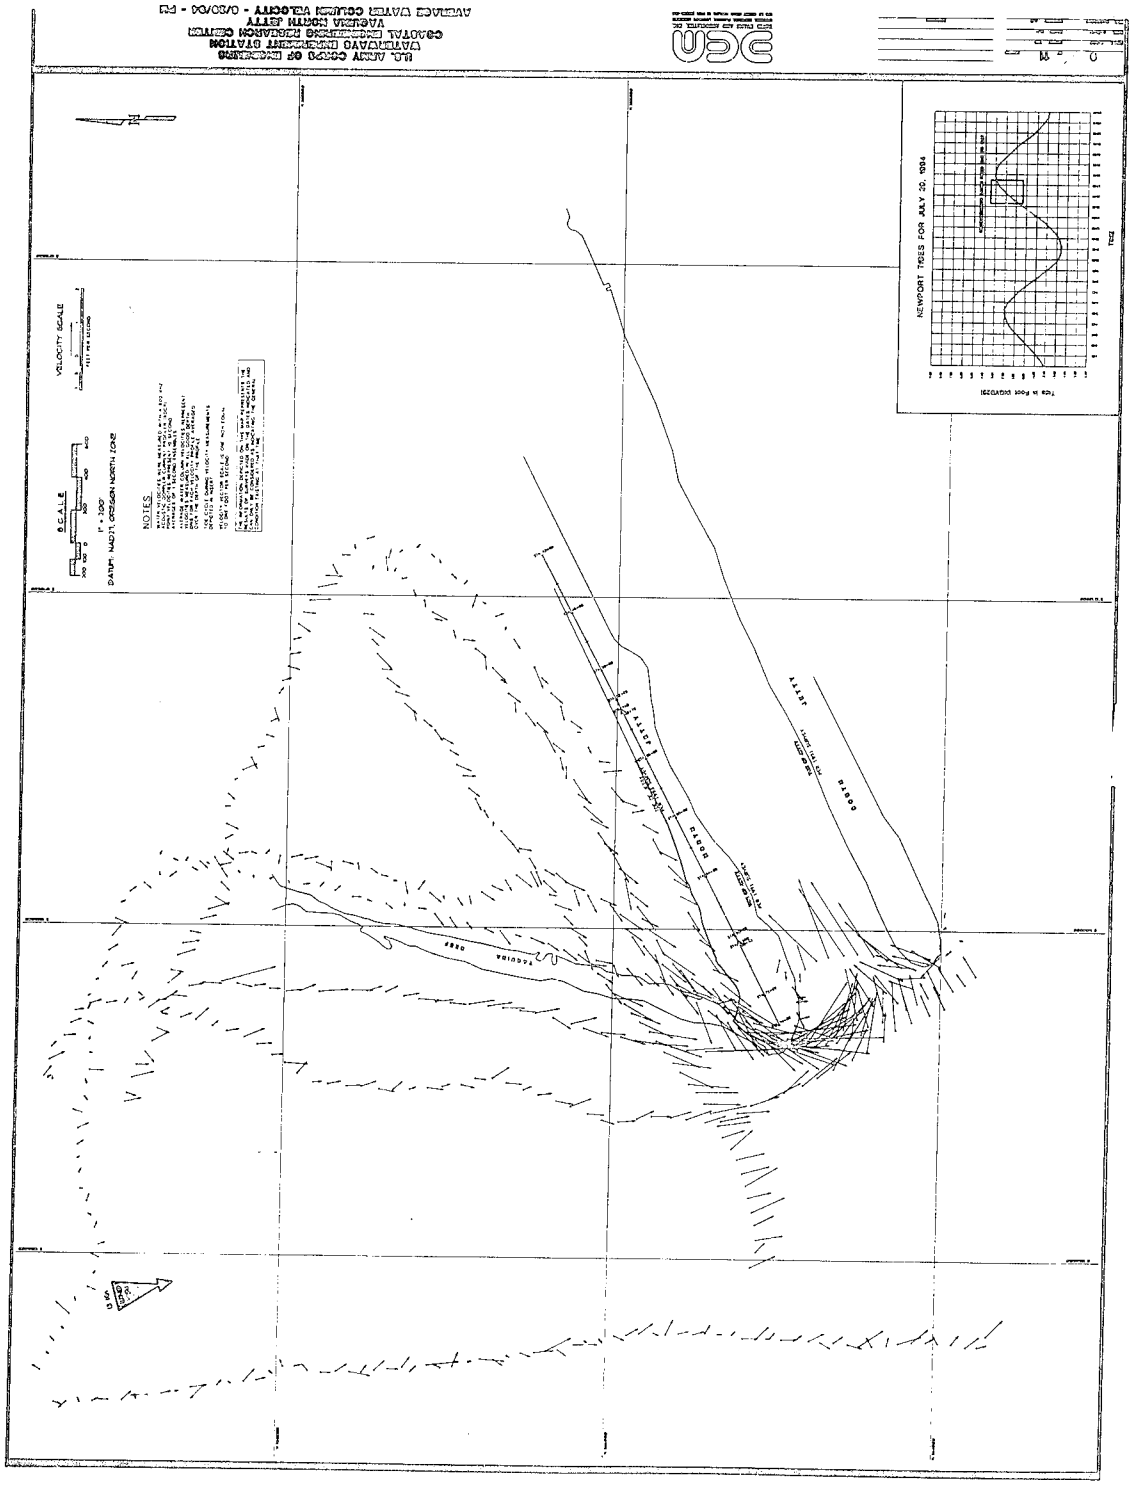
Figure 70. Depth-averaged current velocity vectors at Yaquina Bay north jetty (afternoon of 29 June 1994)

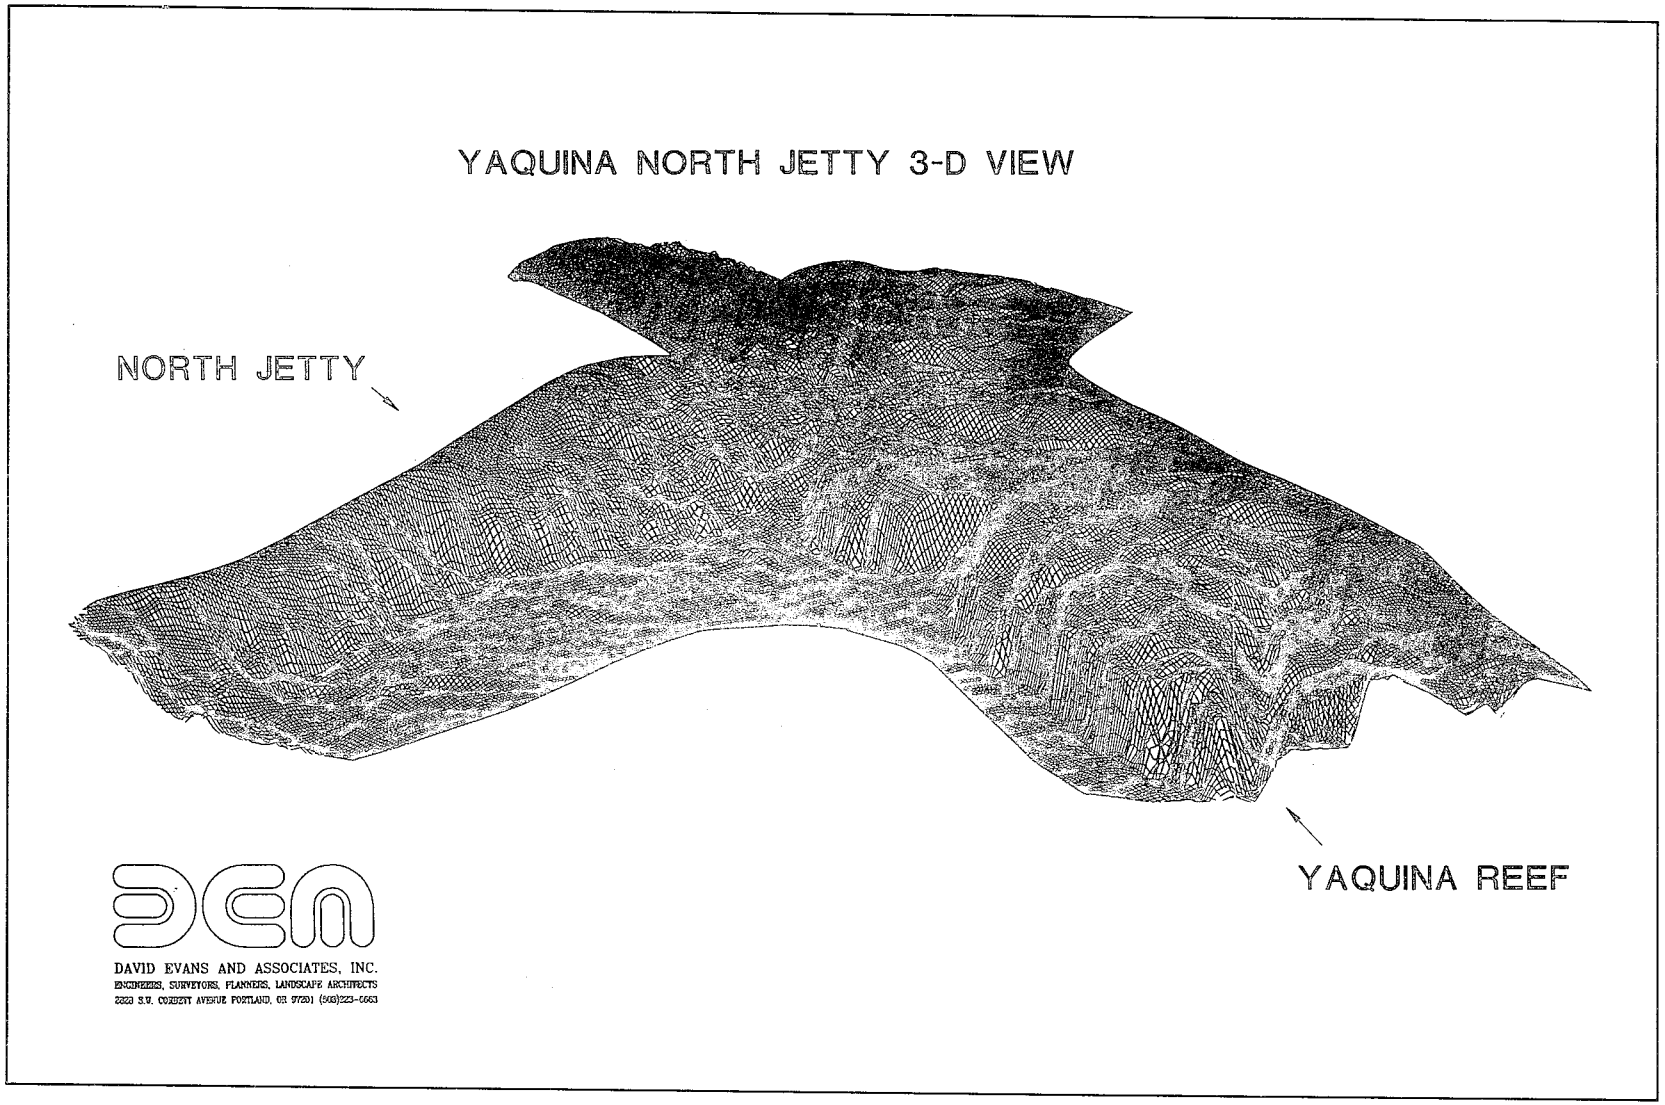
Corrected elevation and position data from all the SEABAT tracklines were used in a digital terrain model to create a three-dimensional "mesh" of the seafloor, Yaquina Reef, and underwater portion of the north jetty covered by the survey. Figure 72 presents a view of this mesh from a perspective landward of Yaquina Reef and to the northeast of the north jetty tip. The north jetty is shown extending seaward from the left of the figure and intersecting with the reef. The smooth line to the top of the jetty mesh portion represents the uppermost limit of SEABAT data.

Note in particular on Figure 72 that the north jetty underwater slope becomes very mild toward the location where the jetty intersects with Yaquina Reef. This mild slope is assumed to consist of relic armor stone left from the last two rehabilitations. Also notice the very steep face on the landward side of Yaquina Reef. This reef formation could have significance in helping to direct longshore flowing currents seaward along the jetty.

Figure 72. Orthographic "mesh" of Yaquina Bay north jetty and Yaquina Reef below-water bathymetry
