Technical Report CERC-95-9
July 1995

US Army Corps
of Engineers
Waterways Experiment
Station

Monitoring of the Yaquina Bay Entrance North Jetty at Newport, Oregon; Summary and Results

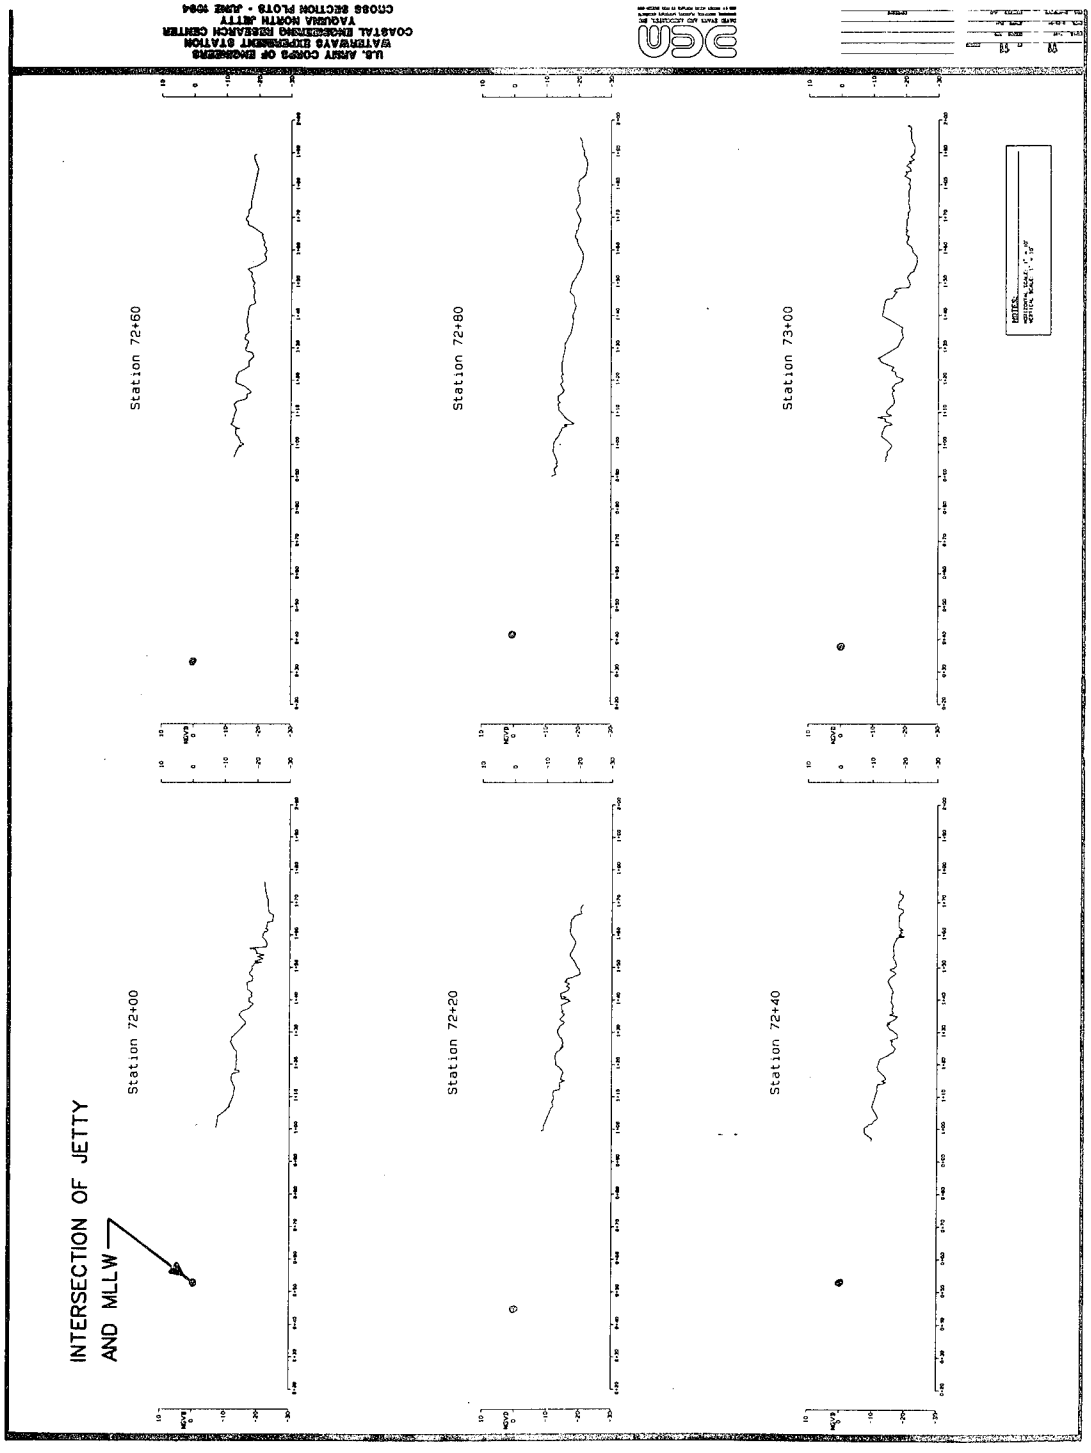
The SEABAT elevation data were referenced to the same coordinate system used to display the photogrammetric elevation results for the above-water portion of the jetty. This allowed construction of cross-section profiles from the 0.3-x 0.3-m (1-ft x 1-ft) mesh grid that corresponded to selected jetty stations. Underwater profile cross sections for north jetty stations 72+00 through 73+00 are shown on Figure 73. The profiles are drawn at a scale that is only slightly distorted. The black dot drawn on each profile represents the approximate position of the north jetty profile at the mllw datum. The gap

Figure 73. Underwater SEABAT profiles of the north side of the Yaquina Bay north jetty

between the dot and the profile is the region of the jetty that could not be surveyed by either photogrammetric methods or by SEABAT.

The two SEABAT tracklines along the north side of the Yaquina Bay north jetty provided sufficient data to detail the jetty's underwater configuration. As suspected, the underwater structure slope near the tip of the jetty is very mild, with slopes varying between 1:4 and 1:10. These mild slopes are the direct result of armor stones being displaced from previous jetty rehabilitations and moved down the slope. On a positive note, these mild armored slopes beneath the still-water level have provided a more stable foundation for the tip of the present north jetty, and this may help explain why the jetty has survived longer than its predecessors. Only time will tell whether the jetty will continue to erode or perhaps reach a stable (but functional) configuration that would not require additional rehabilitation.
