DOT/FAA/AR-01/27

Engine Debris Fuselage Penetration Testing, Phase I

August 2001

Final Report

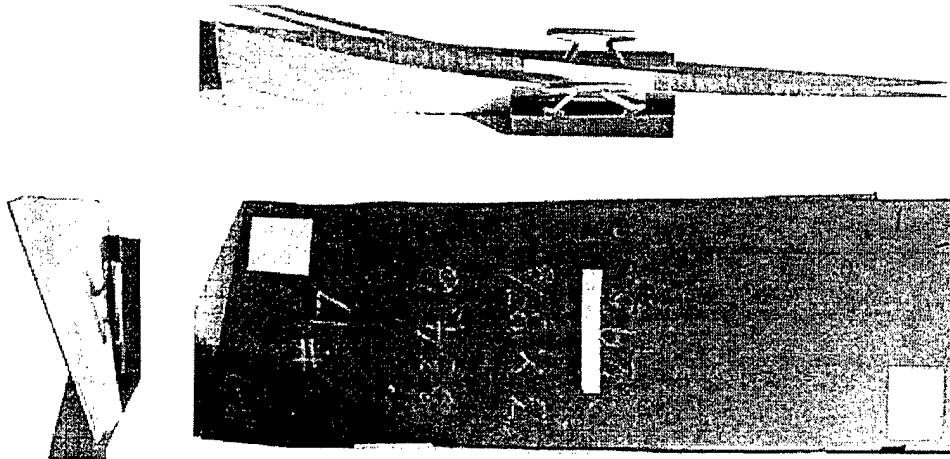
FIGURE 6. LARGE BLADE FRAGMENT USED IN SHOT 26B

Figures 6 and 7 show examples of the fan blade fragments used in these tests. They were cut from a used fan blade. The reflective tape was used to enhance the blade visibility in the high-speed film. Typically, after a test a blade was reusable. The corners would get chipped away but the fragments seldom broke up. The large blades were 7 to 9 in. long and about 3 by 0.25 inch thick. The medium size blades were about half the length of the large ones. SRI International shot some 25-gram 1.3 by 1.0 by 0.25 inch projectiles.

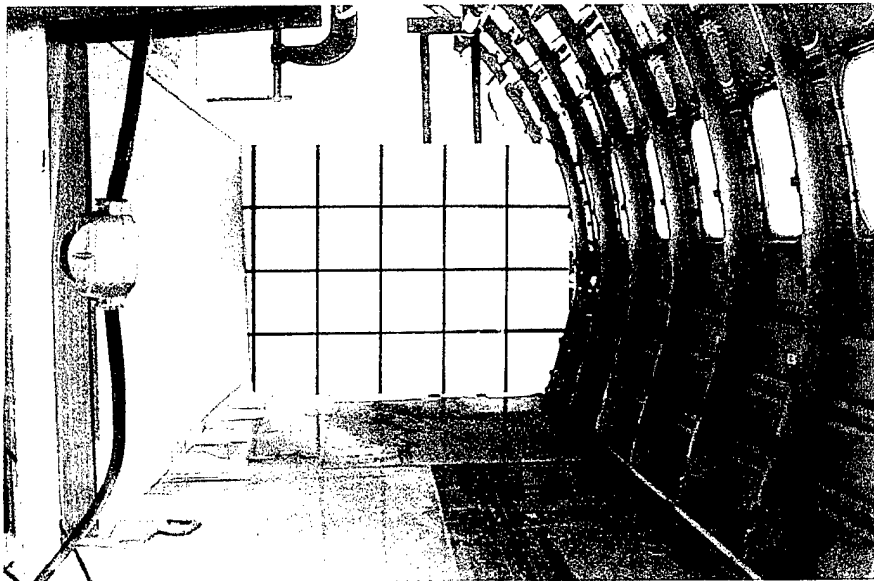
FIGURE 9. INTERIOR SETUP OF AIRCRAFT FUSELAGE

The interior, as shown in figure 9, displays the backboard and particleboard projectile catcher. The interior wall panels, trim, overhead stowage, and insulation were removed. Two, 2000 Watt cinema lights were used to illuminate the scene.

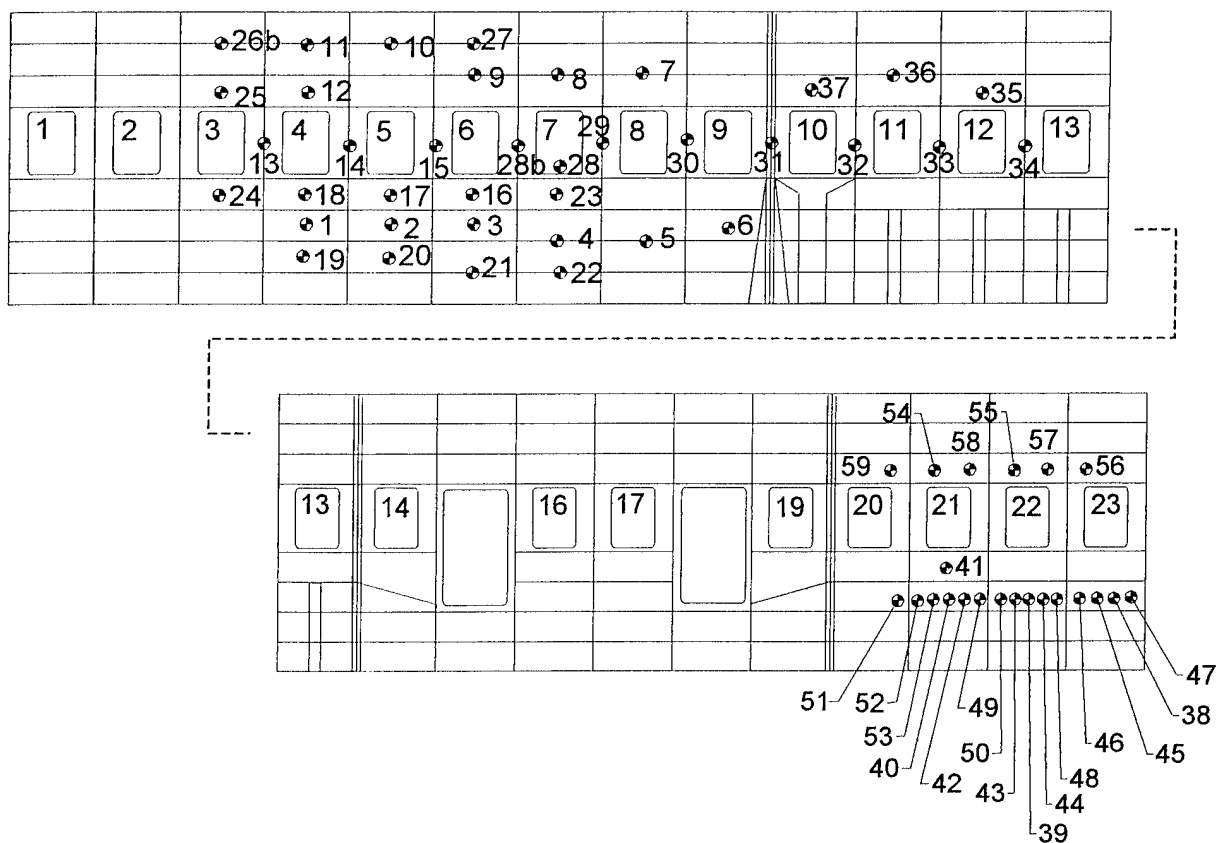
FIGURE 10. AIRCRAFT FUSELAGE SHOT MAP, INTERIOR VIEW

A map of the shot locations for the cabin area test is shown in figure 10. Each shot number and it's location on the fuselage are shown in the figure. The windows are numbered from aft forward. The complex structure shots, test 60-64 are shown in figure 11.

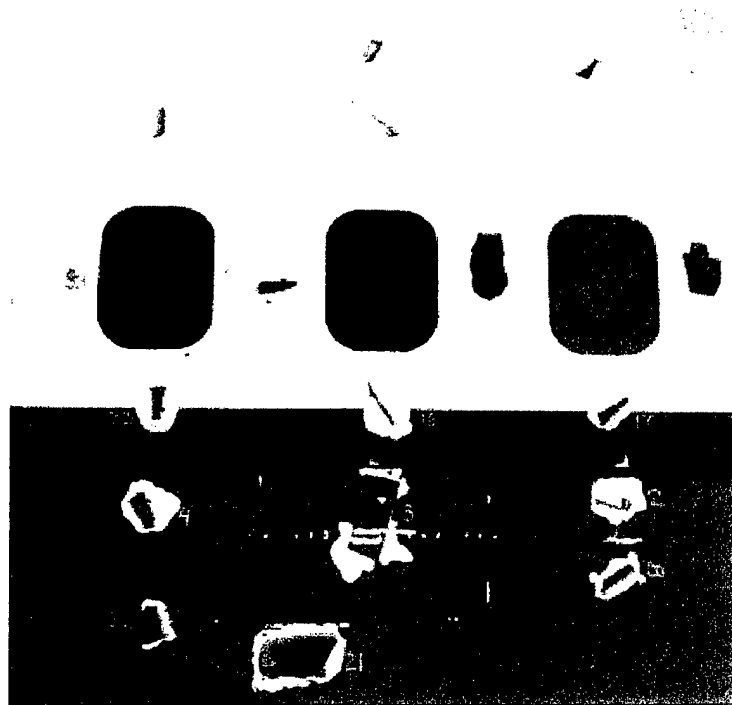
FIGURE 23. EXAMPLE EXTERIOR DAMAGE AREAS

Figures 23 and 24 show typical posttest impact areas from the inside and outside.
