ERDC/CERL TR-09-27

Corrosion Prevention of Rebar in Concrete in Critical Facilities Located in Coastal Environments at Okinawa

Final Report on Project FAR-16 for FY06

August 2009

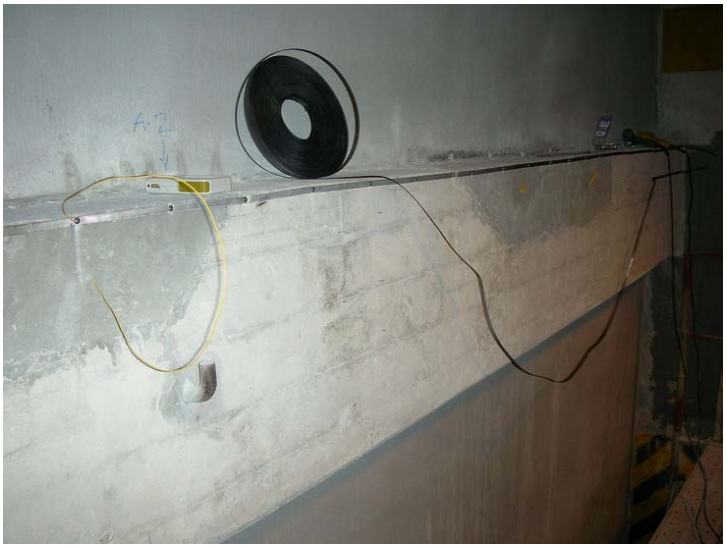
Appearance of the Ring Girder Side 2 prior to application of the LGC.

Installation of the titanium mesh component of the LGC.

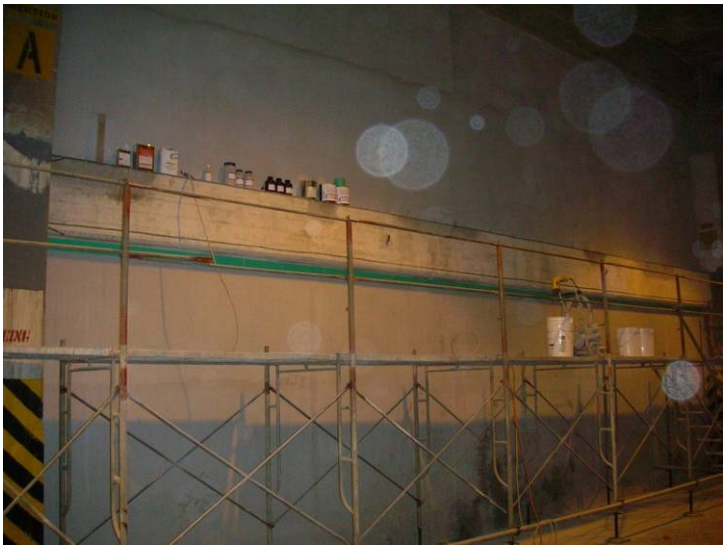
Appearance of the Ring Girder Side 2 immediately following application of the LGC.

Following spray application, touch-up performed by brush.

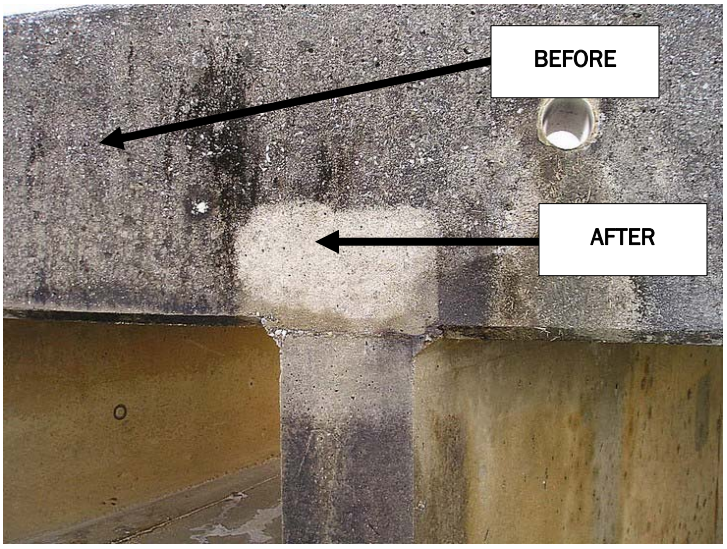
Deterioration and spalling pattern common to Culvert 2.

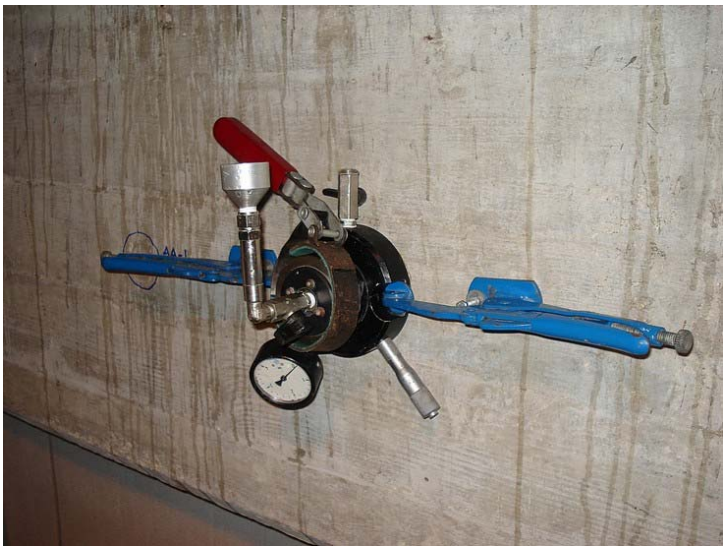
Galvapulse® Psion unit.

The points on the grid established during initial testing match exactly the points of the follow-up testing. The photograph also shows where the measurements were influenced by additional wire inside the repair installed to hold the patch in place during curing. During initial testing some of the repair areas could not be tested due to spalling.

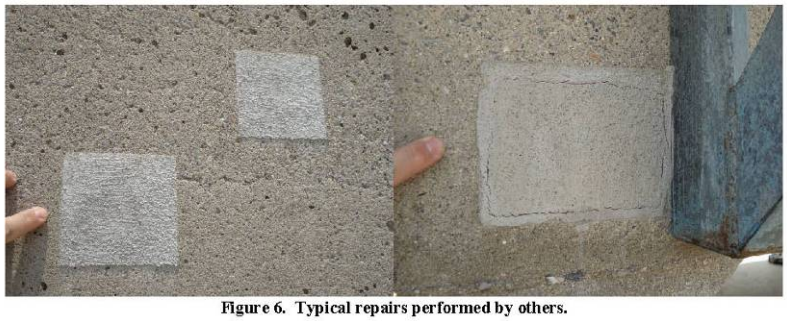
Figure 6. Typical repairs performed by others.

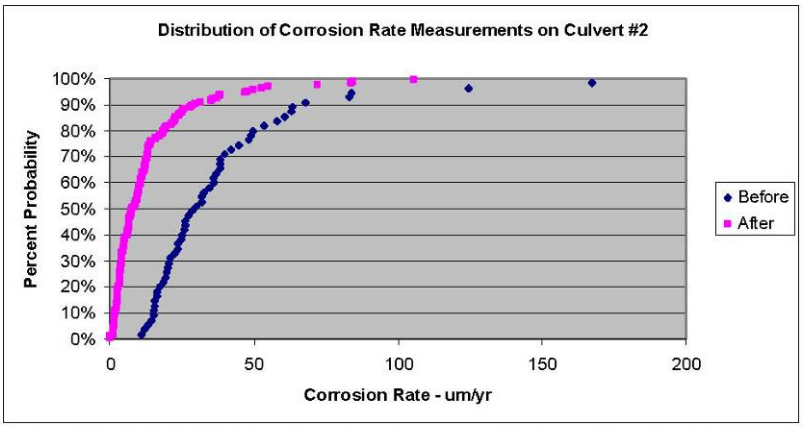
The reports from the Galvapulse instrument provide all of the individual measurements. As might be expected with a phenomena bounded on end (i.e., the corrosion rate cannot be less than 0), the data distributes itself such that the median and average do not coincide. To obtain better insight to the data, the corrosion rate data taken in each timeframe was plotted on a cumulative probability graph. Figure 8 shows the distribution of measured values. This representation of the data shows a clear reduction at all levels of corrosion. The reductions range from a factor of two to ten.

Figure 8. Probability distribution of corrosion rate measurements before and 6 months after inhibitor application.

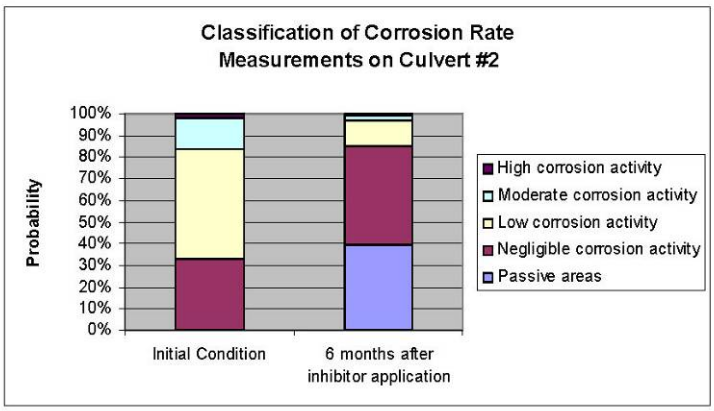
An alternative way to look at the same data is to classify the corrosion rate measurements as described by Frolund, et.al.[4] The quantity of corrosion rates in each of five broad categories of severity is expressed as a percentage of all measurements. Figure 9 shows this data before and after the inhibitor application. The data suggests that more than 80% of the structure has negligible corrosion activity after inhibitor application.

Figure 9. Corrosion activity before and after inhibitor application.

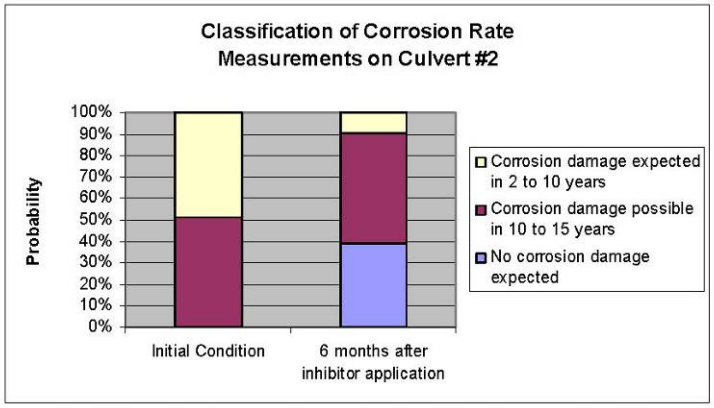
A similar classification technique developed by Clear attempts to correlate service life to corrosion rates.[5] Figure 10 shows the data from culvert #2 in this classification scheme. Based on this analysis, the structure initially could have expected corrosion damage on over 50% of the structure in 2 to 10 years without treatment. Subsequent to treatment, no corrosion damage is expected on 40% of the structure, and the majority of the remaining structure has corrosion damage possible in 10 to 15 years. Based on this analysis, it seems reasonable to conclude that the inhibitor treatment application has extended the service life of the structure by at least 10 years.

Figure 10. Corrosion damage projections for culvert #2 based on corrosion rate data.

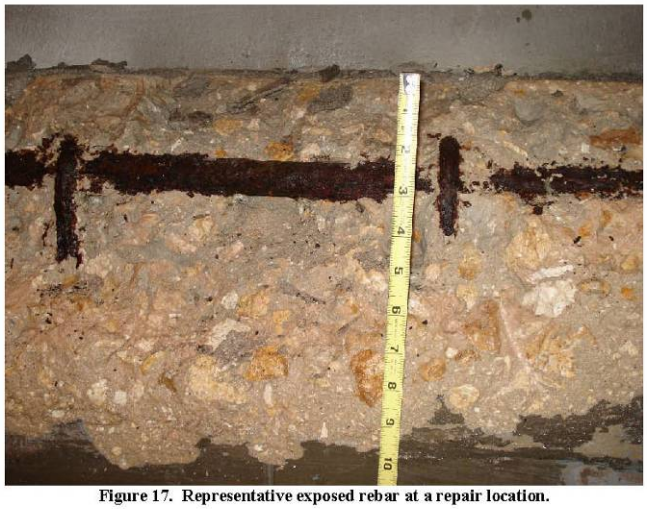
Figure 17. Representative exposed rebar at a repair location.

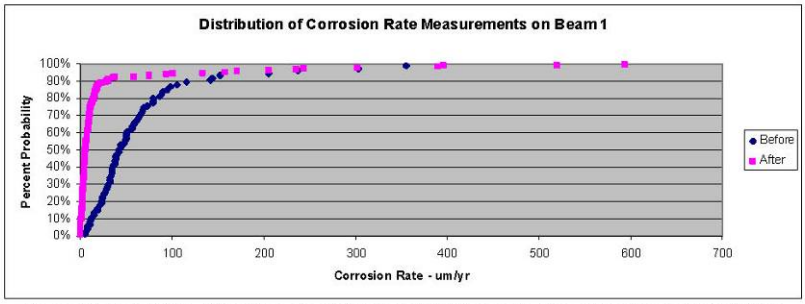
The cumulative probability plot in Figure 19 shows all of the corrosion rate measurements made before and after the inhibitor treatment. Note that a few of the measurements after treatment are actually higher than before treatment. Closer examination showed that these corrosion rates were impacted by the concrete patch repair. In 6 out of 10 cases, measurements over the patch areas exhibited a corrosion rate significantly higher than the average for Beam 1. If these data are eliminated from the average,[6] the inhibitor reduced the average corrosion rate to 11.3 µm/yr (0.44 mils per year), an 82% reduction of corrosion rate.

Figure 19. Probability distribution of corrosion rate measurements before and 6 months after inhibitor application.

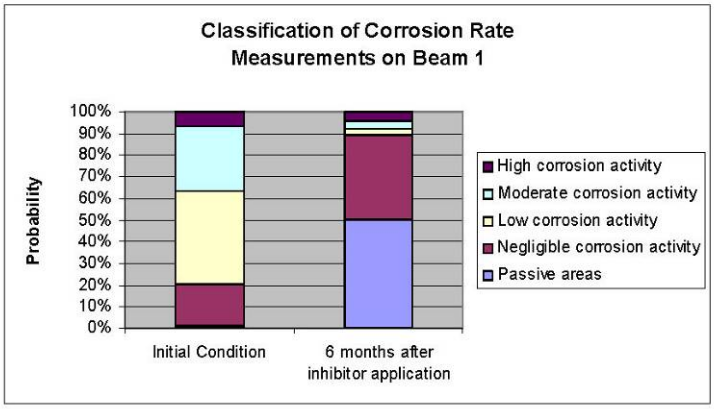
Figure 20. Corrosion activity before and after inhibitor application.

An alternative way to look at the same data is to classify the corrosion rate measurements as described by Frolund, et.al.[7] The quantity of corrosion rates in each of five broad categories of severity is expressed as a percentage of all measurements. Figure 20 shows this data before and after the inhibitor application. The data suggests that 90% of the structure has negligible corrosion activity after inhibitor application. Also note that the 7.5% of measurements in the moderate and high category correspond to the locations where the local patch material was used.

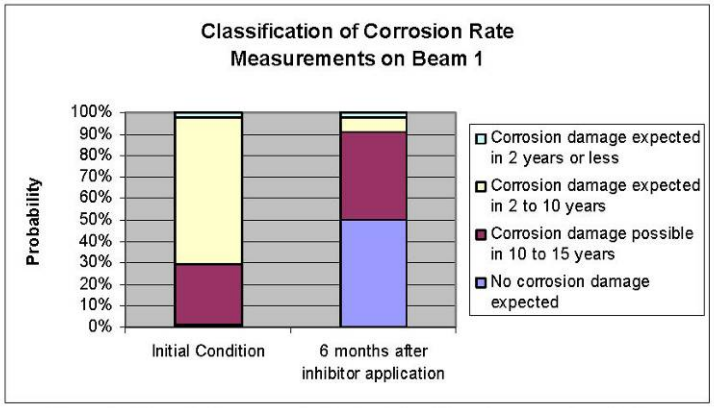
A similar classification technique developed by Clear attempts to correlate service life to corrosion rates.[8] Figure 21 shows the data from Beam 1 in this classification scheme. Based on this analysis, the structure initially could have expected corrosion damage on nearly 70% of the structure in 2 to 10 years without treatment. Subsequent to treatment, no corrosion damage is expected in half of the structure, and the majority of the remaining structure has corrosion damage possible in 10 to 15 years. By this analysis, it seems reasonable to conclude that the inhibitor treatment application has extended the service life of the structure by at least 10 years.

Figure 21. Corrosion damage projections for Beam 1 based on corrosion rate data.

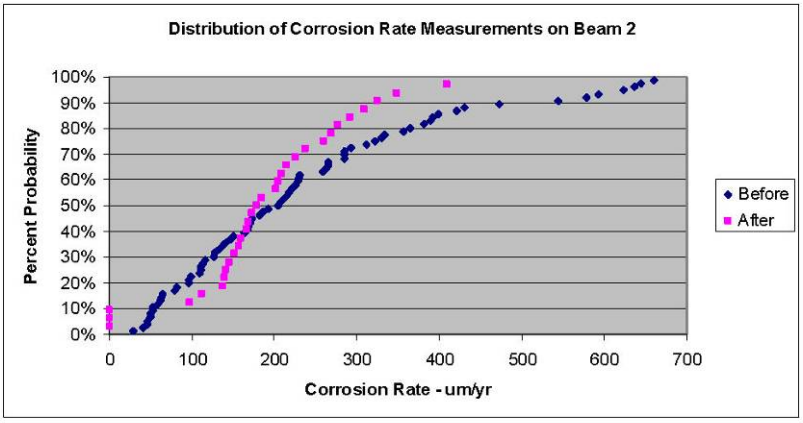
It was not possible to isolate the galvanic coating from the circuit during the Galvapulse measurements. Furthermore, it is not fully understood how the sacrificial system may impact the Galvapulse measurements. As a result, the corrosion rate measurements made after installation of the sacrificial coating may not accurately represent the change in corrosion rate due to the sacrificial coating.

Figure 24. Probability distribution of corrosion rate measurements before and 6 months after cathodic coating application.

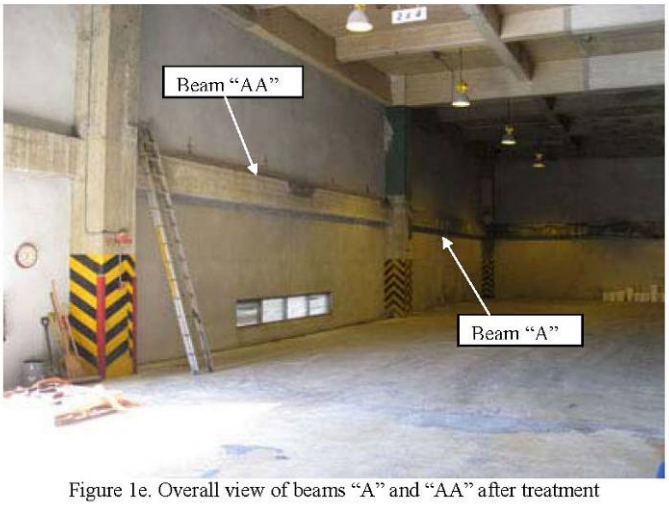
Figure 1e. Overall view of beams "A" and "AA" after treatment

Figure 1f. Overall view of beam "AA" after treatment; reportedly treatment consisted of vapor and liquid inhibitor application to the concrete beam surface

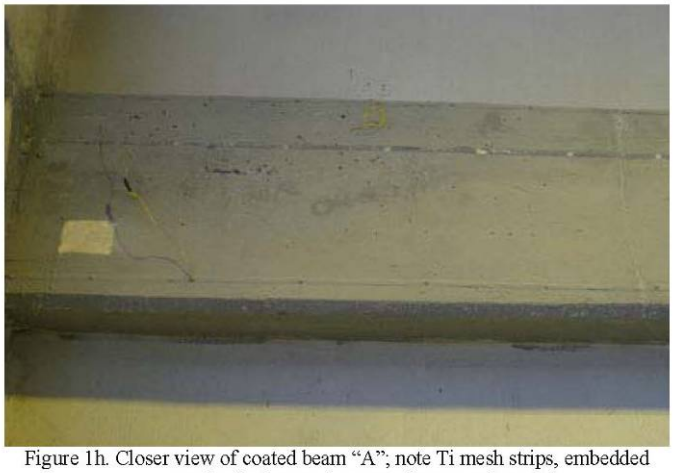
Figure 1h. Closer view of coated beam "A"; note Ti mesh strips, embedded test lead wires, and uncoated rectangular patch

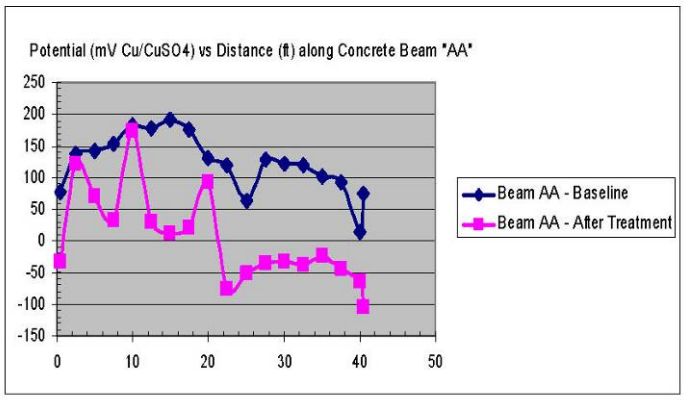
Figure 2c. Rebar half-cell potentials as a function of distance along beam "AA" before and after treatment

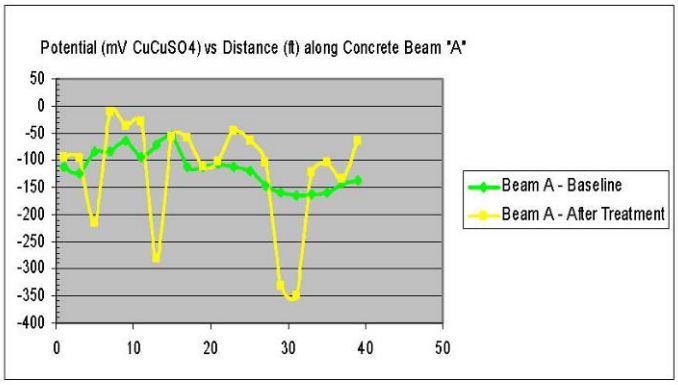
Figure 2d. Rebar half-cell potentials as a function of distance along beam "A" before and after treatment

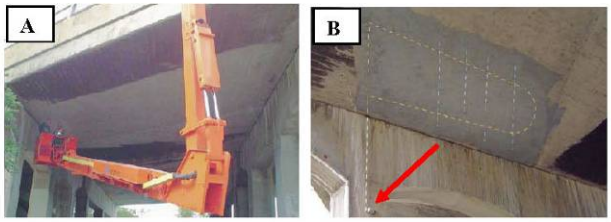
Figure 1. Corroded Rebar in horizontal beam underneath Gushikawa Patrol Bridge in Okinawa with failing rebar in concrete.
