# THE EXPLOSION OF THE DISPLAY FIREWORKS ASSEMBLY PLANT "MS VUURWERK" ON FEBRUARY 14, CULEMBORG, THE NETHERLANDS

25th DoD Explosives Safety Seminar  
18-20 August 1992, Anaheim, California

W.P.M. Mercx and H.H. Kodde

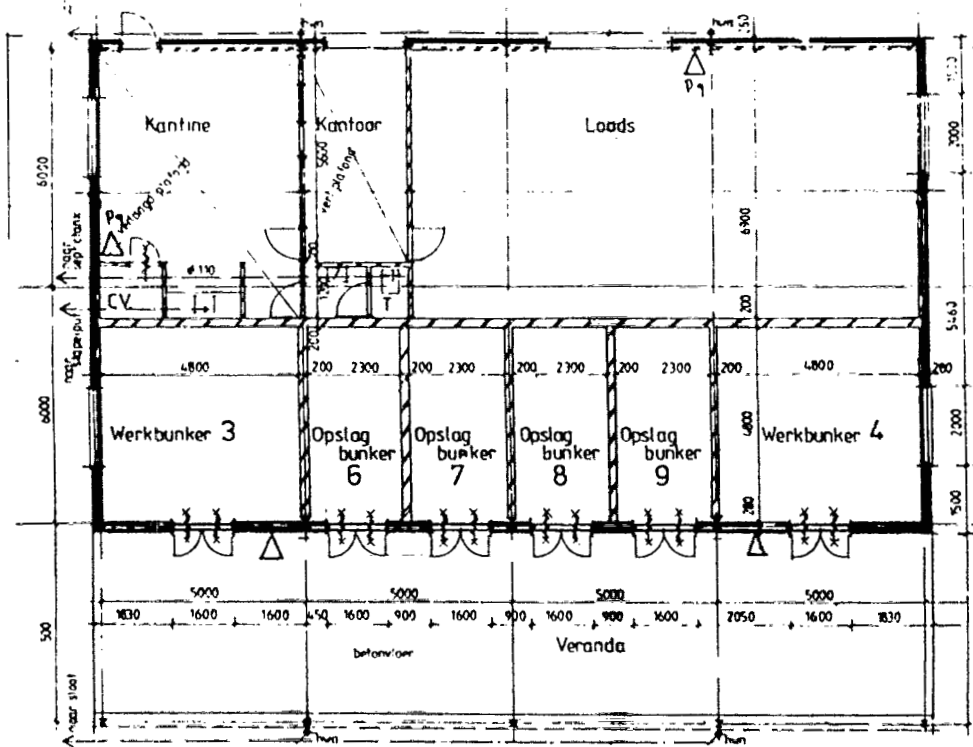
The first one consisted of the old bunker, an administration office, an assembling hall of 25 by 16 square meters and 5 small storage rooms. The other building 20 m east of the first one was built in 1990 and in service since a couple of months. It consisted of an assembling hall of 20 by 12 square meters, four storage rooms and two workrooms (see Figure 3). Figure 4 shows a section of the building. The walls of the storage rooms were made of 0.2 m thick unreinforced concrete blocks while the ceiling was made of concrete hollow core slabs. The inner wall of the cavity walls were also concrete blocks while the outer

wall was masonry. The assembly hall was composed of steel trusses covered with asbestos plates.

Figure 3 Lay out of the exploded building

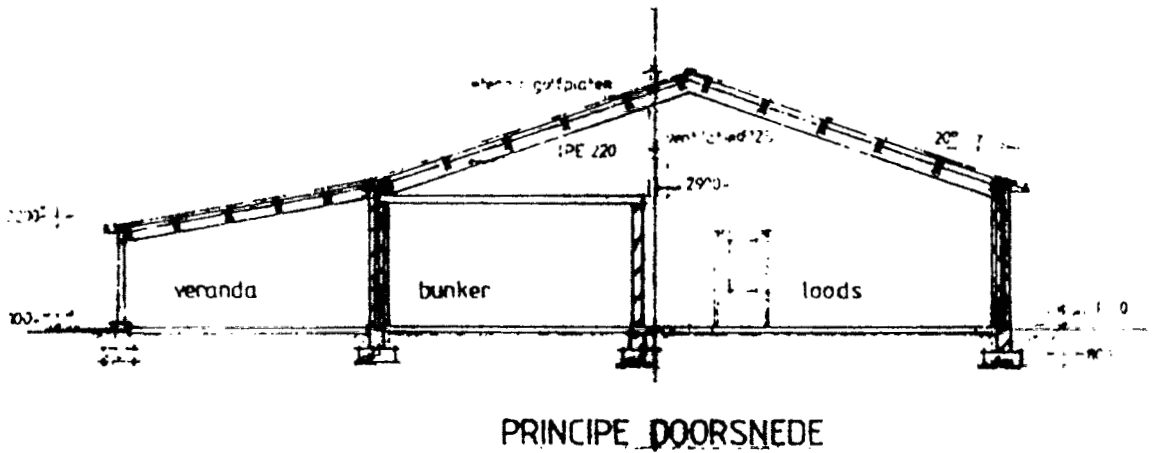
PRINCIPE DOORSNEDE

Figure 4 Section of the building before the explosion
