WT-1631 W)/21 / 1 OPERATION HARDTACK-PROJECT 37

DAMAGE 10 EXISTING EPG STRUCTURES (U)

W.J. Flathau, Project Officer and R.A. Cameron,

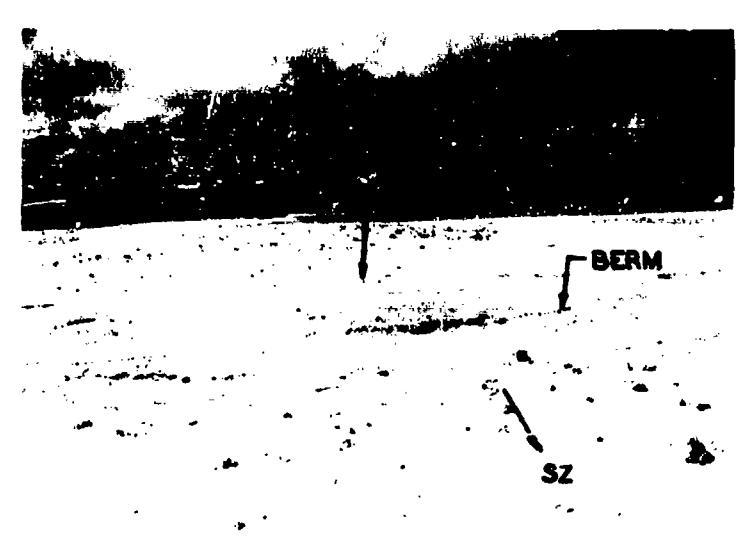
evident from Figure 3.10 that Shot Sycamore caused very little, if any, additional erosion. The structure was completely destroyed from the effects of Shot Poplar. Figure 3.11 shows there was hardly a trace that the structure once existed and only a slight trace indicating the location of the circular earth berm that once surrounded the structure.

Figure 5.11 Post-Poplar, (Item 2) Station 560.01, complete destruction of station. Station 1341 can be seen in background. Pressure level: Poplar, 1,200 psi.

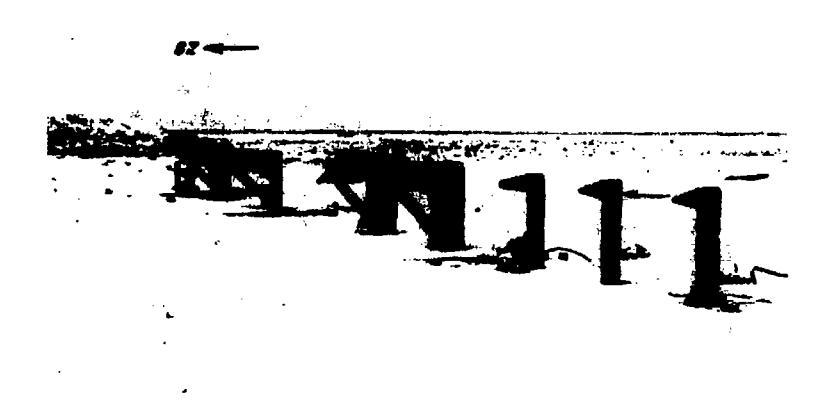
These stations received an estimated air pressure of 30, 6, 12, 10, and 1,200 psi from Shots Fir, Sycamore, Aspen, Cedar, and Poplar, respectively. The stations were undamaged from the first four thats except for slight erosion of the soil around the concrete foundations, (Figure 3.12); however, the force from Shot Poplar destroyed the steel drag members, leaving only the concrete bases (Figure 3.13).

Figure 3.12 Post-Fir, (Item 3) Stations 152.01 and 153.01. Pressure level; Fir, 30 psi.

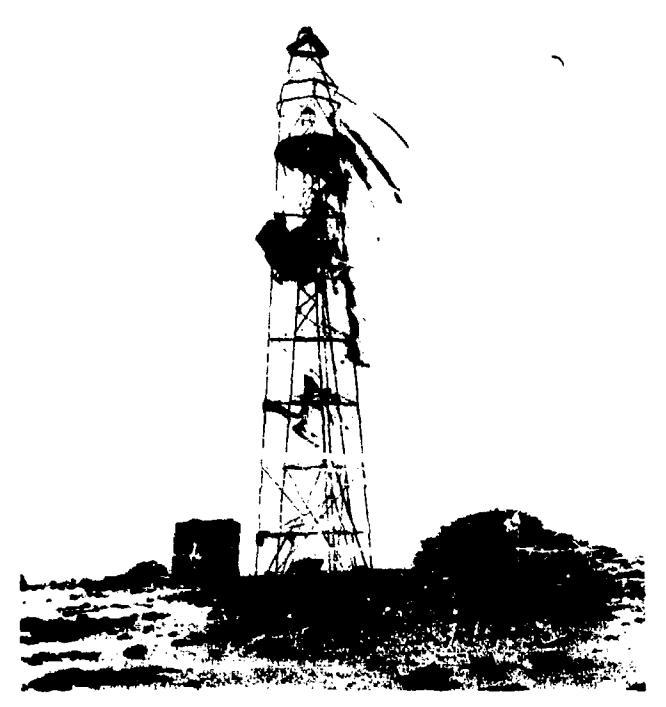
The air blast and water wave from Shot Fir swept nearly all vegetation from the island. Inundation caused from Shot Fir extended past Station 78.01 as can be seen in Figure 3.16. A light steel tower, shown in Figure 3.17, was located in the 25-psi air-overpressure range of Shot Fir and was completely destroyed, leaving no trace of the structure.

Figure 3.17 Preshot, steel tower on Site Charlie; completely destroyed by Shot Fir, 25 psi.

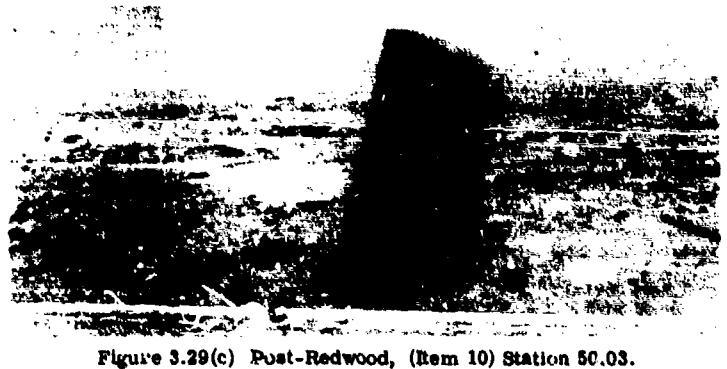
As a result of Shot Redwood, the two closest stations, 50.01 and 50.02, were destroyed. Station 50.03 was moderately damaged; the leeward pipe of the gage tower buckled laterally, leaving the whole tower tilting away from surface zero. Station 50.04, which had its base completely exposed (i.e., was not buried) was washed to the far side of the island. Stations 50.05 and 50.05 remained undamaged.

Station 50.03 which survived both shots is shown in Figures 3.29(b) post-Maple and 3.29(c) post-Redwood.

Pressure level: Redwood, 360 psi, 1,400 ca $\sqrt{\text{cm}^2}$.

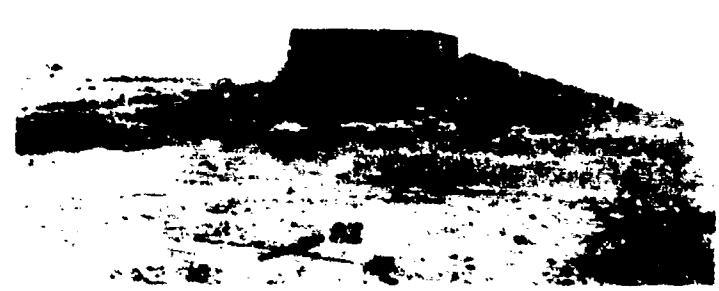
results of the film-badge readings are shown in Table 4.3. The water-wave action from Shot Walnut eroded the earth cover away from this structure, as shown in Figures 4.25 and 4.26. The dark area on the concrete walls represents the contact area of the preshot earth cover.

Figure 4.26 Post-Walnut, (Item 22) Station 3.4, side view showing scouring action of water wave; dark area represents original earth cover contact aren. Pressure level: Walnut, 32 psi.

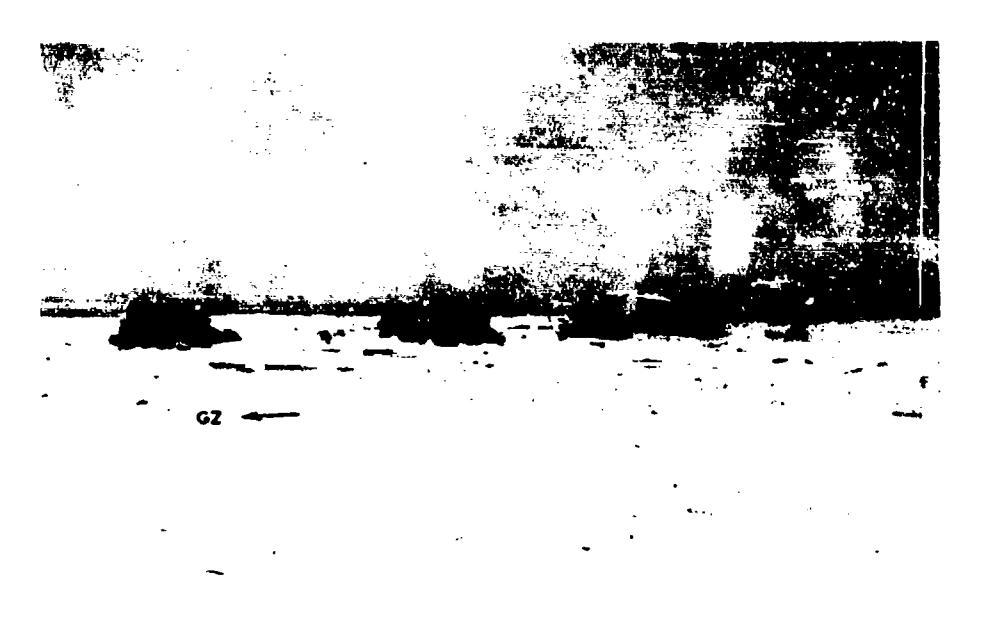
The earth mound approximately 15 feet above the ground surface for the station complex shielded the generators from the air blast to varying degrees. The generators were located approximately 40 feet from the intersection of the mound with the ground surface. The generator near the edge of the mound (least protected from air blast) was thrown 60 feet while the gen-

erator nerver the center of the mound (most prefected) was moved 2 feet. The other two generators were thrown distances of 20 and 40 feet. A postshot view of the four generators is shown in Figure 4.28 and a close-up of one of the generators is shown in Figure 4.29. No additional damage to or movement of the generators occurred as the result of Shots Yellowwood (11.5 psi) or Tobacco (1.8 psi). The Na. ? pontoon sections were not damaged from any of the shots; however, the air blasts from Shots Koa and Yellowwood moved the sections approximately 100 feet. Both the generators and pontoon sections underwent additional movement during Shot Walnut (28 psi). Movement from the remaining shots was not observed.

Figure 4.28 Post-Koa, (Item 23) generators. Pressure level: Koa, 38 psi.

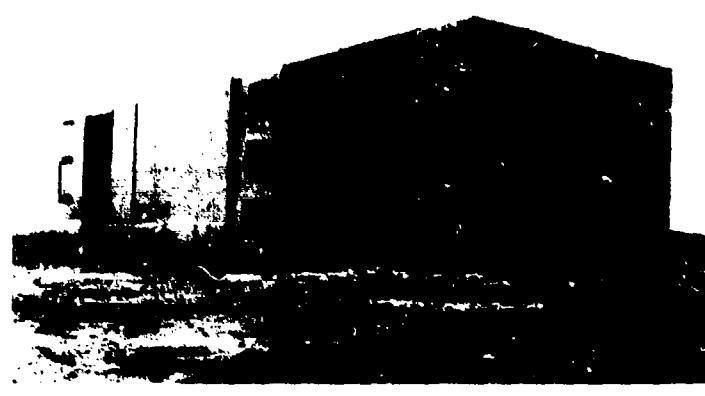
The structure responded appreciably to the effects of Shot Walnut (pressure level of 16 psi). Figures 4.40 and 4.41 show the overall damage, which can be compared with Figure 4.39 for pre-Walnut sumage. The corrugated siding on the metal buildings was damaged severally. Major damage was observed in Building 5; damage to the front face and first-floor columns is shown in

Figure 4.40 Post-Walnut, (Item 26) Station 3.1.1. Pressure level: Walnut, 16 psi.

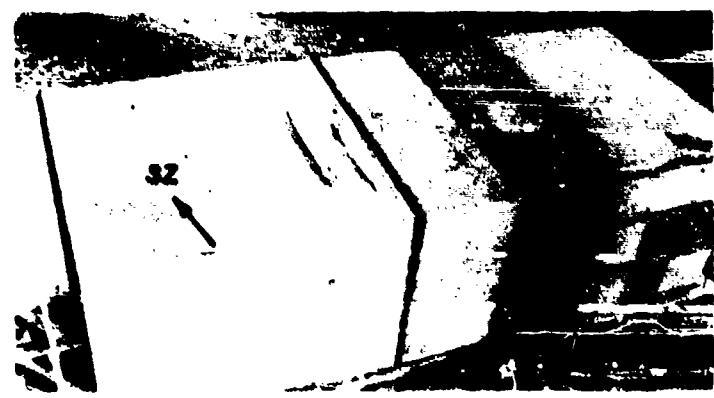
Figure 4.41 Post-Walnut, (Item 26) Station 3.1.1, aerial view. Pressure level: Walnut, 16 psi.

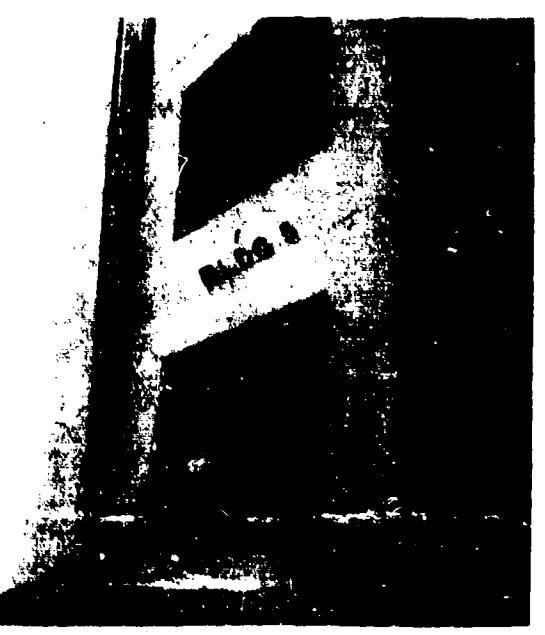
Figures 4.42 through 4.45. A pre- and post-Walnut view of Column 13C can be compared in Figures 4.36 and 4.45. The columns in the upper two floors of this building did not receive comparable damage as their first-floor counterparts (Figure 4.46). Evidently the first-floor columns took most of the moment and shearing forces while the second and third floors moved away from surface as a unit (Figure 4.42). The tops of the first-floor columns (Columns 13A, B, C and 14A, B, C) were displaced horizontally approximately 10 inches away from surface zero with respect to their bases (Table 4.5).

Figure 4.42 Post-Walnut, (Item 26) Station 3.1.1, close-up of Building 5, a reinforced-concrete frame structure. Pressure level: Walnut, 16 psi.

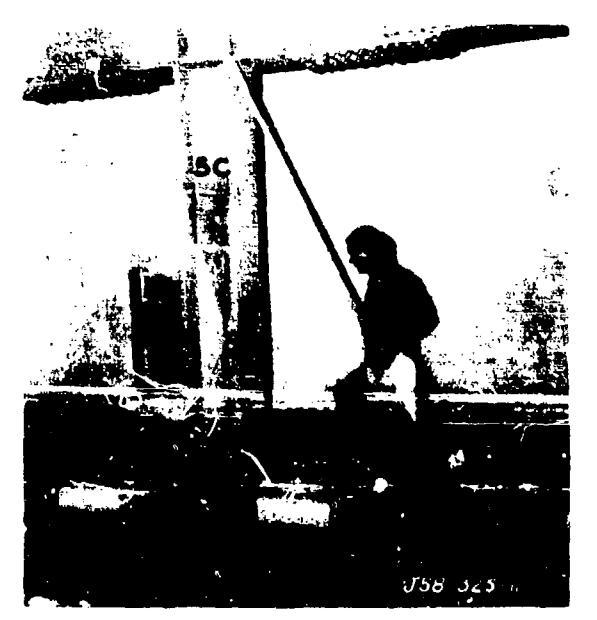
Figure 4.49; this picture also shows the suspended plumb bob that was used in measuring column offsets. The roof in Building 6 lifted upward 3 to 4 inches, tapering to its normal position at a point 7 or 8 feet from the front wall (Figure 4.50). The cracked roof section in Building 4 opened constint ably, being displaced a maximum of 10 inches at the center of the section adjacent to Column Line 10 and the north end of the building (Figures 4.51 and 4.52). The bottom bars (Nc. 4) of the slab failed in tension as was noted by the neck-down of the bars at the point of breakage.

Figure 4.49 Post-Walnut, (Item 26) Station 3.1.1, Column 5C, first floor of Building 2. Pressure level: Walnut, 16 psi.

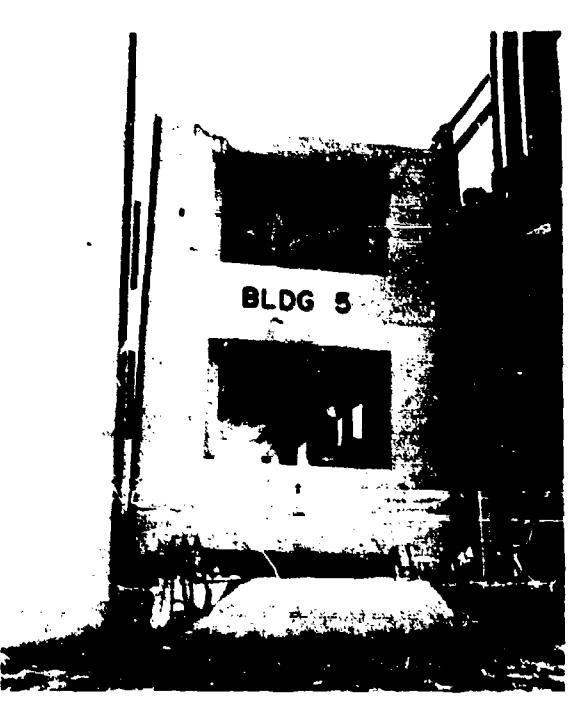
Figure 4.55 Post-Elder, (Item 26) Station 3.1.1, close-up of Building 5, first floor collapsed. Pressure level: Elder, 20 psi.

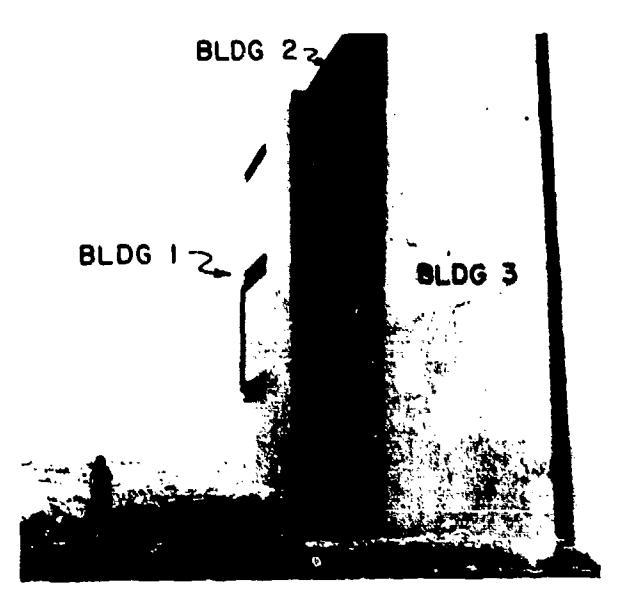
Figure 4.56 Post Elder, (Item 26) Station 3.1.1, close-up of Buildings 1, 2, and 3. Pressure level: Elder 20 psi.

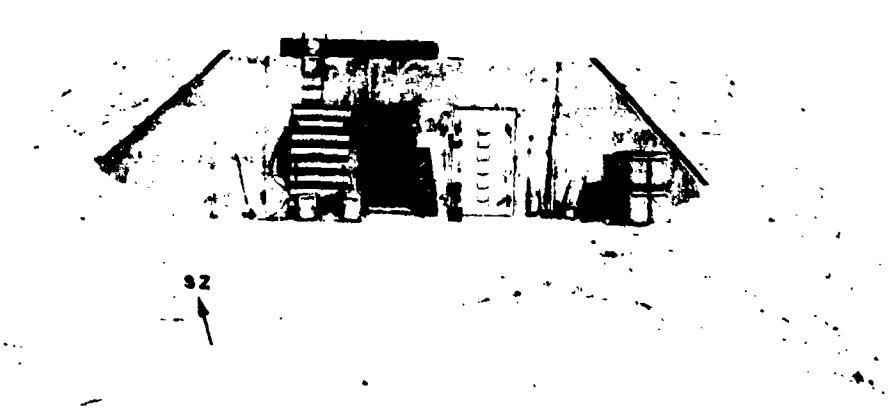
sure of 17 psi from Shot Elder. The antenna and ventilating devices on top of this station (Figure 4.72) were removed prior to Shot Elder.

Figure 4.72 Postshot, (Item 29) Station 77.02, recording station. Pressure level: Elder, 17 psi.

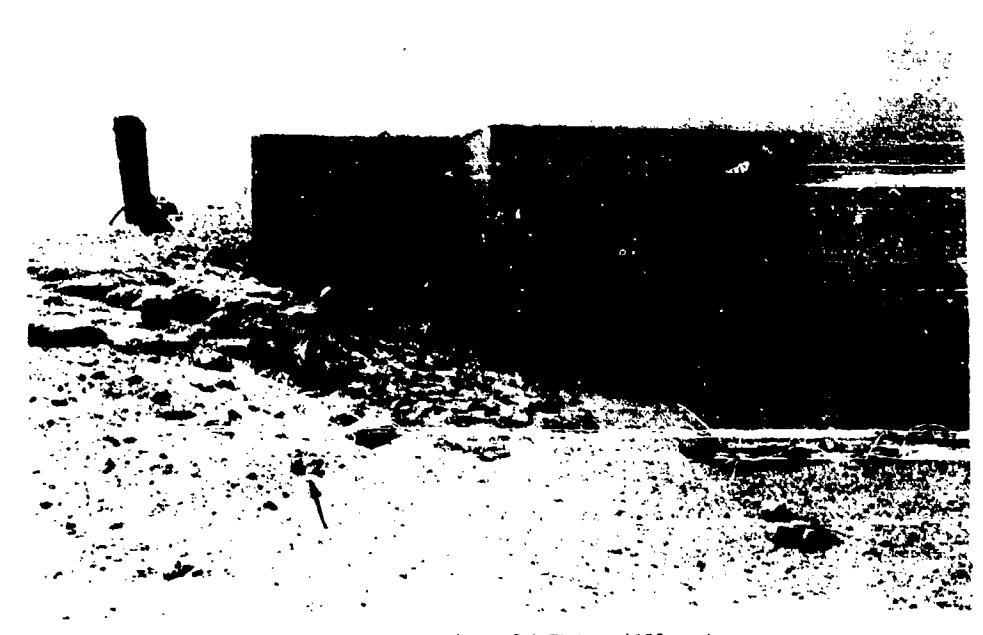
The structure was located in the 450-psi air-overpressure range for Shot Cactus and damaged only from that shot. The damage was confined to the side tunnel. A preshot view of the entrance (side away from ground zero) is shown in Figure 4.79 and a post-Cactus view is shown in Figure 4.80. Thermal radiation estimated to be 20 cel/cm^2 from Shot Butternut, which was fired after Shot Cactus, ourned the black paint off the wall surface as can be seen by comparing Figures 4.79 and 4.80. A preshot view of the entrance to the side tunnel is shown in Figure 4.81. A post-Cactus view, Figure 4.82, shows the damaged entranceway. Apparently the blast wave that entered the tunnel-like entrance (side-on to the shock front) was reflected at the tunnel's end. The resulting increase in pressure caused the tunnel walls and roof to separate and crack as though an explosion had occurred inside the tunnel. An interior crack near the junction with main structure showing the "buging" failure can be seen in Figure 4.83. The tunnel was not fastened with dowels to the main station but merely keyed.

Figure 4.80 Postshot, (Item 31) Station 1130, entrance. Pressure level: Cactus, 450 psi; Eutternut, 20 cal/cm².

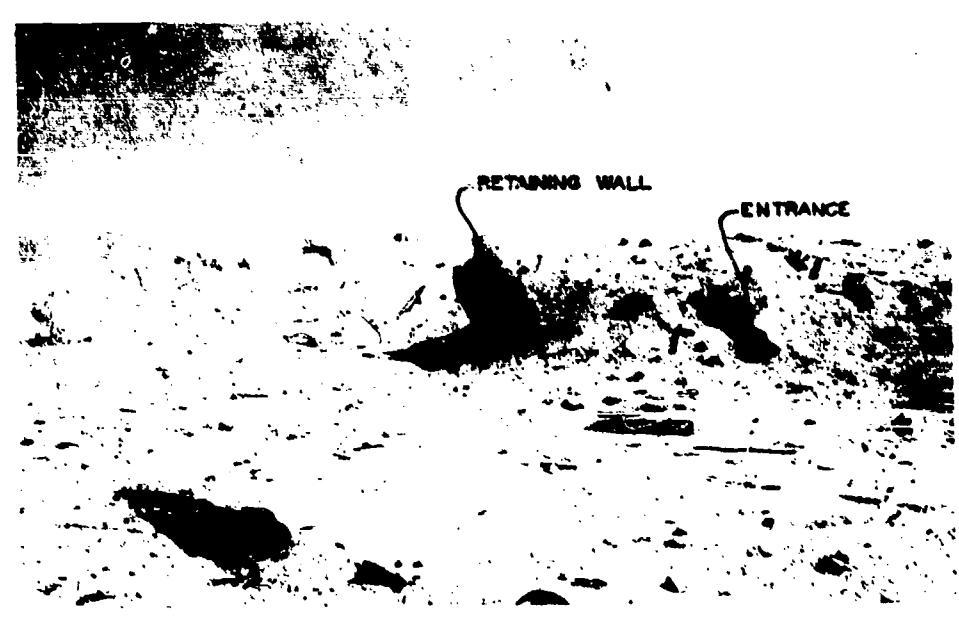
This station was located in the 1,600-psi air-overpressure range for Shot Cactus. As a result of the surcharge from this overpressure the timber entrance tunnel was filled in with sand and the adjoining retaining wall cracked and tilted outward 2 to 3 feet. A preshot view of the retaining wall is shown in Figure 4.88 and a post-Cactus view showing both the retaining wall and the entrance to the station is shown in Figure 4.89.

Figure 4.89 Post-Cactus, (Item 34) Station 1612, retaining wall and outrance to station. Pressure level: Cactus, 1,600 psi.

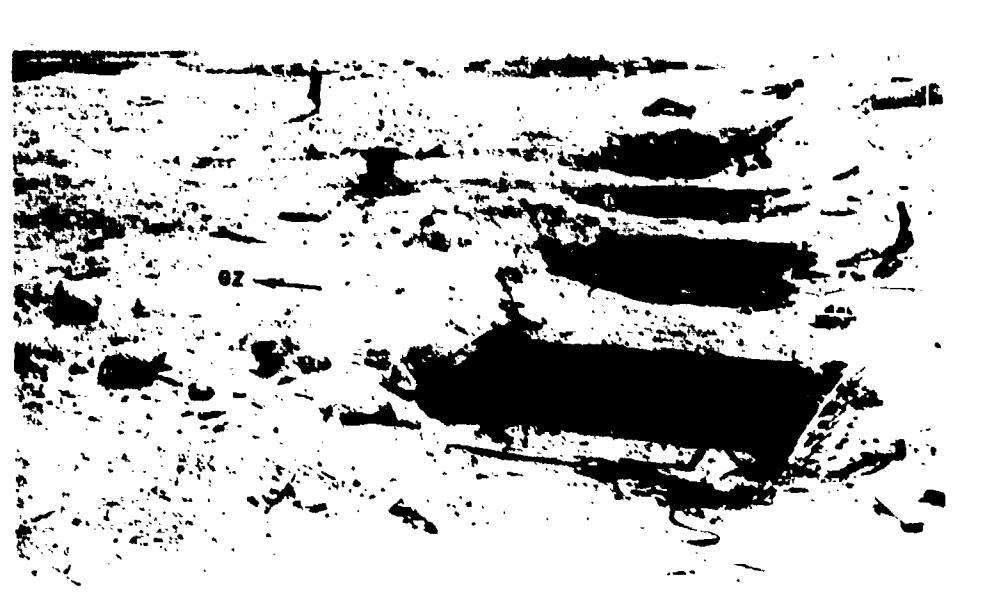
The air-blast wave smashed the far wall of each tower foundation, as shown in Figure 4.92. A typical failure pattern for the 48-inch, round, corrugated-metal pips leading to ground zero is shown in Figure 4.93.

Figure 4.93 Post-Cactus, (Item 35) Stations 1523.01 to 1523.04, 48-inch metal corrugated pipe leading to ground zero. Pressure level: Cactus, 450 psi.

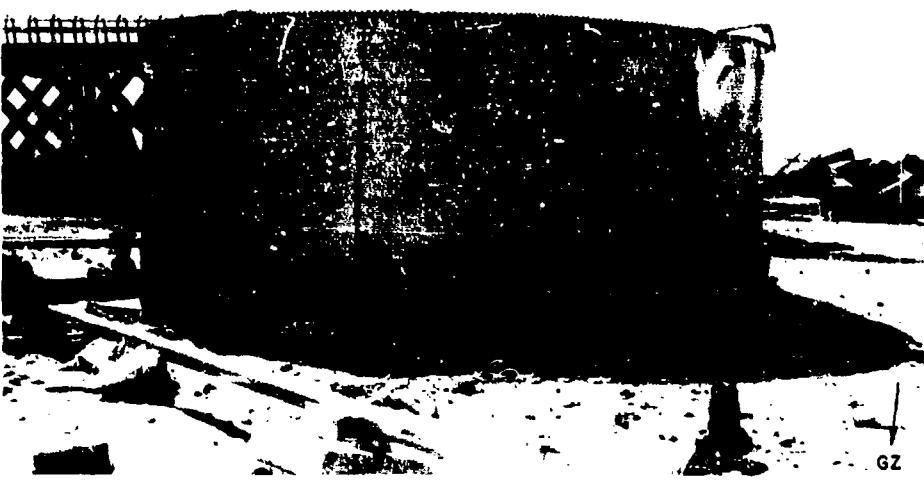
The tank was located in the 1.5-, 6.5-, 2.4-, 7.0-, 2.5-, 3.4-, 2.3-, and 3.4-psi air-overpressure zones for Shots Cactus, Butternut, Holly, Magnolia, Ro3e, Linden, Sequoia, and Pisonia. The tank was not affected by Shot Cactus but was damaged by Shot Butternut as shown in Figure 4.96. The tank was half full of water at that time. Shot Holly had no additional effects. The tank was damage u additionally by Shot Magnolia as seen by the local buckling failure around the top perimeter and the dishing of the roof as shown in Figure 4.97. No additional damage from the remain-

Figure 4.96 Post-Butternut, (Item 37) 21,000-gallon water tank. Pressure level: Butternut, 6.5 psi.

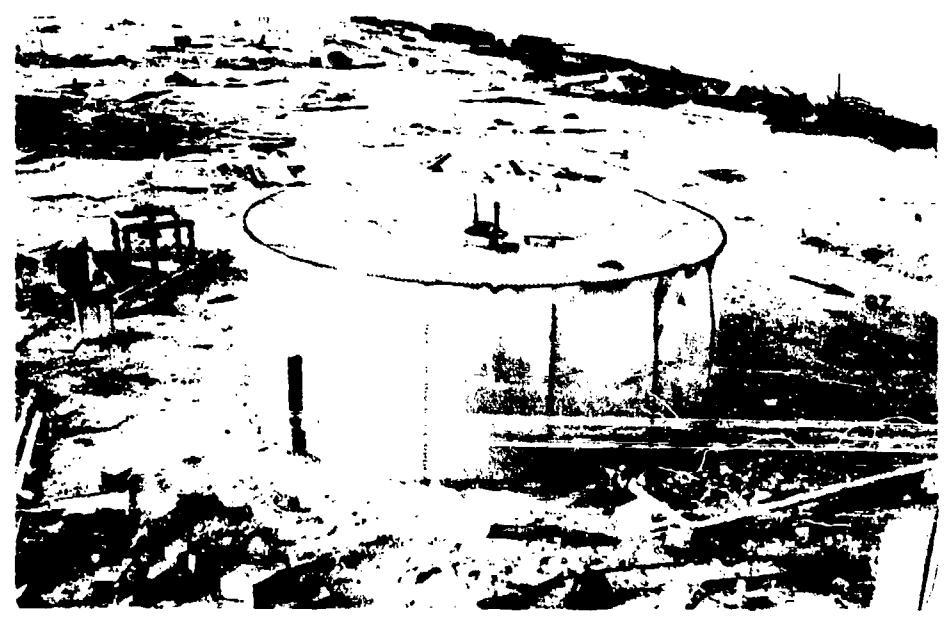
Figure 4.97 Post-Magnolia, (Item 37) 21,000-gallon water tank and Yvonne Camp area. Pressure level: Magnolia, 7.0 psi.

ing shots was observed. Even though the tank was badly dented near the upper rim none of the bolts or bolt holes showed signs of incipient failure, and it appeared that the tank with some minor repairs could easily be placed in use again. The above-ground connections of 4-inch and 2-inch water pipes and the exposed 4-inch, rising-stem, gate valves (125-psi rated) were unchamaged.

A 21,000-gallon water tank (Item 37) directly exposed to 6.5 and 7.0 psi of air overpressures received light damage. The roof was dished in, and there was a small amount of buckling of the sides above the level of liquid in the tank. In addition, it was noted that there was no damage to the exterior connecting piping.

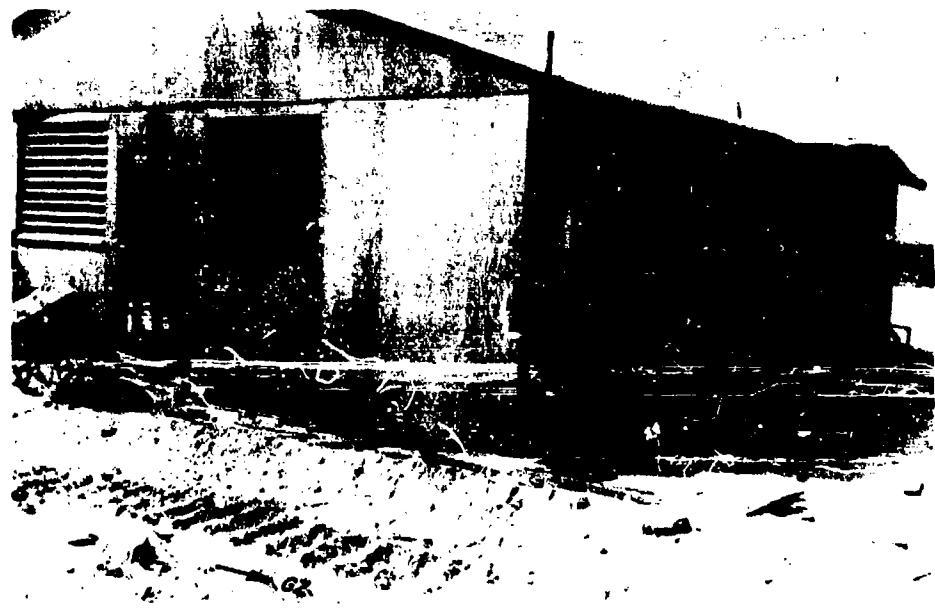
Figure 4.100 Post-Cactus, camp damage, latrine. Pressure level: Cactus, 2.0 psi.

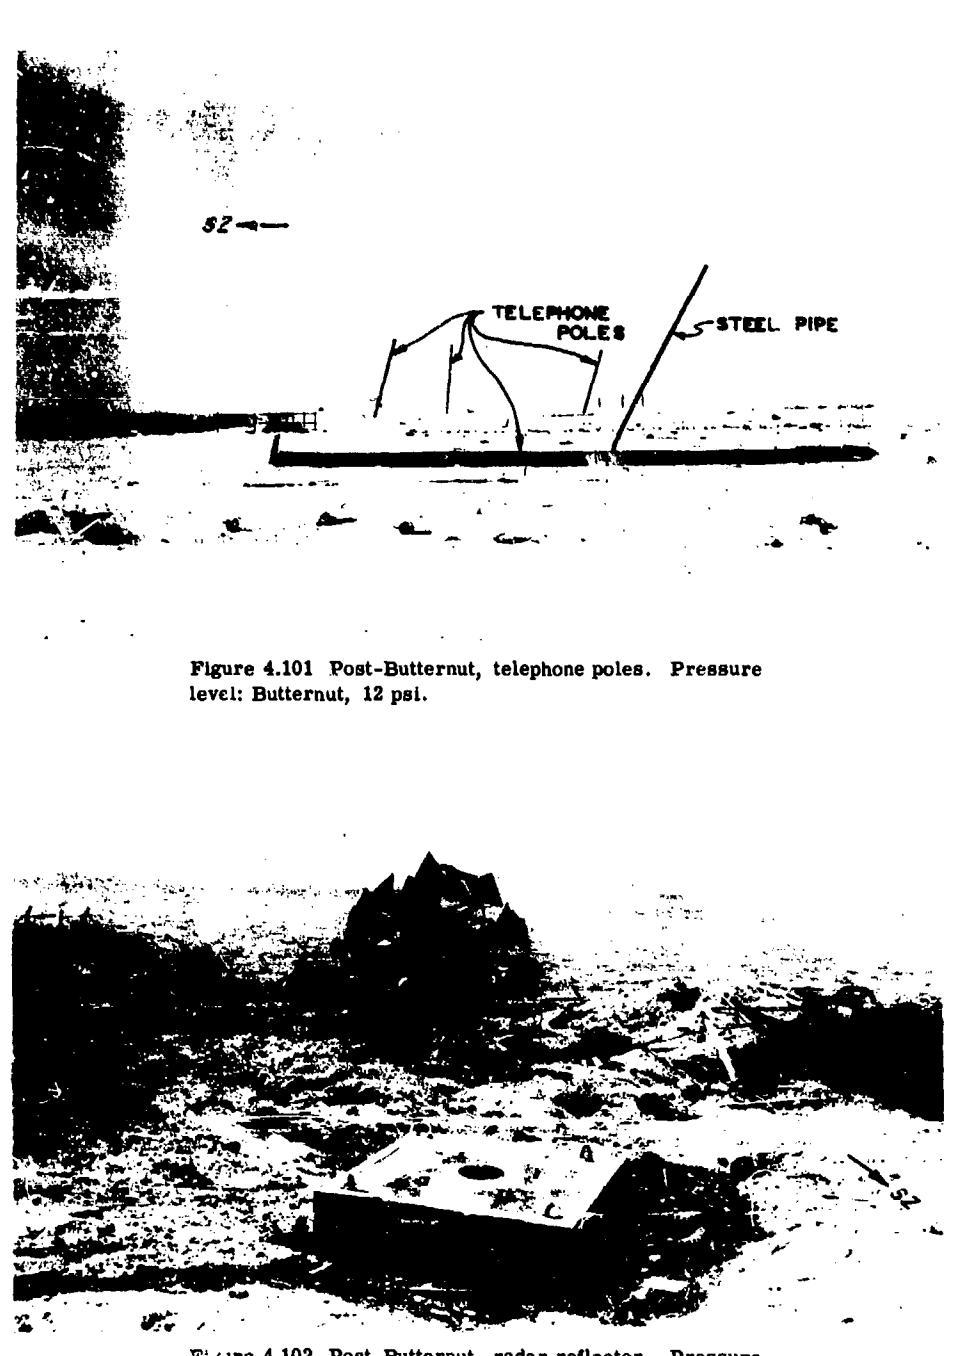
Physice 4.102 Post-Butternut, radar reflector. Pressure level; Butternut, 5.8 psi.

Radar Reflector. A multiunit, radar reflector, undamaged from the effects of Shot Cactus, was ripped from its concrete foundation and thrown 50 feet from the effects of Shot Butternut. A view of this station, which was located in the estimated 5.8-psi range from Shot Butternut, is shown in Figure 4.102.

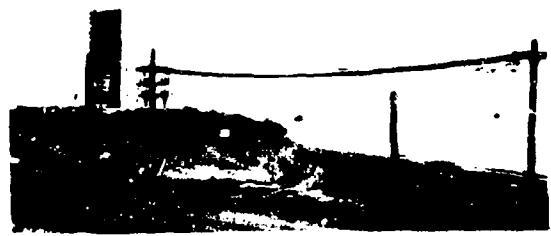
Figure D.2 Transformer station prior to wave arrival. Shot Oak, Site Elmer.
