# OPERATION CROSSROADS

BUREAU OF SHIPS INSTRUMENTATION GROUP

## SECTION IX

Displacements of  
Shock Mounted Equipment

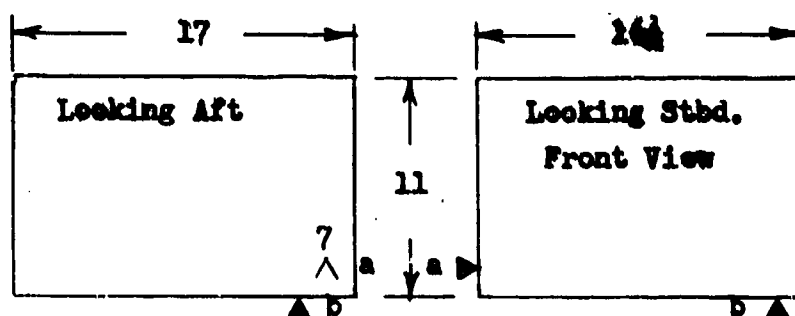
DD390 #5 Gages:

Baker: There was negligible shock and damage. In spite of the negligible shock intensity the displacement of the top of the tall narrow transmitter was 1.3 inches. This indicated the large displacements caused by rocking modes of poorly mounted equipment.

Location: On Model BN Transmitter and Receiver, type CFM-43ACB, in Radar Transmitter Room, Second Superstructure Deck. (Starboard aft corner of room.)

Type of Mounting: L type mounts on four bottom corners.  
Clearance about 1/8 inch.

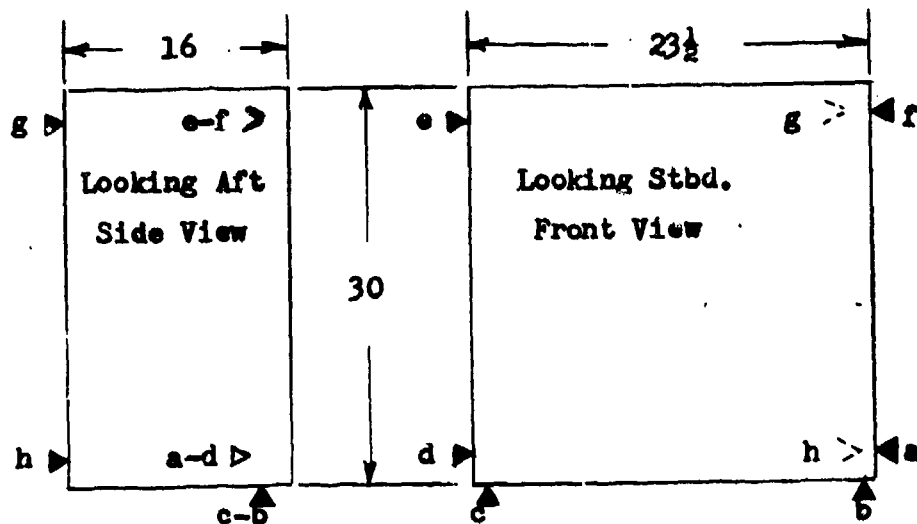
#### DD403 #1 Gages:

Location: On Radio Transmitter Model TDQ, in Radio Transmitter Room, First Superstructure Deck. The transmitter is in the starboard side of the room.

Type of Mounting: The unit is mounted in an angle iron frame to which it is attached by means of C type mounts on the four bottom corners.

Able: The starboard side of the transmitter room was pushed in about 3 inches. In spite of the bottoming of the mounts and the collisions of the unit with the angle iron framing, the TDQ appeared to be in good condition and to key properly. A near by transmitter.

properly. A near by transmitter model TBK had a tube broken and did not key properly.  
Baker: No data was obtained for this unit.

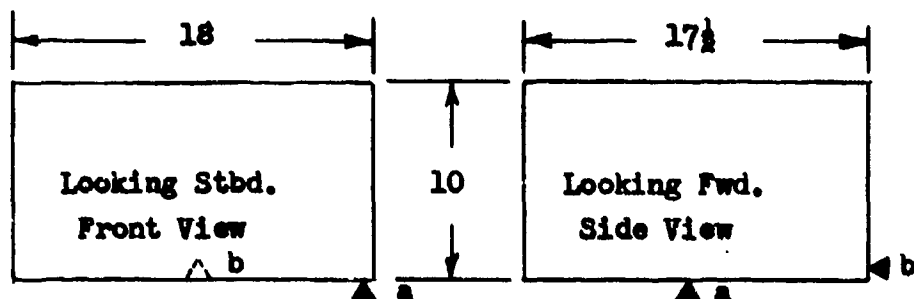
**DD403 #2 Gages:**

**Location:** On Model BCK Radio Receiver, Radio Transmitter Room, First Superstructure Deck. The unit is located on the starboard side above the TDQ.

**Type of Mounting:** L type mounts are under on the four bottom corners.

Able: The mounts bottomed, but the receiver remained in operable condition.

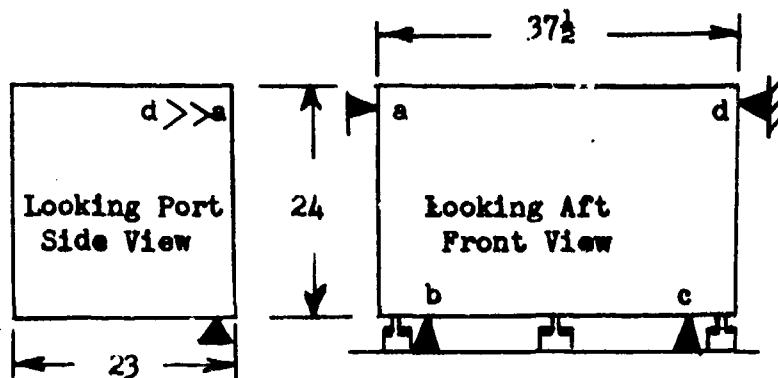
DD406 #1 Gages:

Able: The entire starboard side of the C.I.C. room was broken open by the blast. The Range and Train Indicator, which was located in the after port side of the room, suffered a considerable horizontal shock, but little vertically. The unit appeared to be in good condition.

Location: On Range and Train Indicator Model SG, in  
C.I.C. Room, Second Superstructure Deck. (Port Aft Side.)

Type of Mounting: Three long C type mounts run full depth across  
the bottom of the equipment. Clearance 1/2 inch.

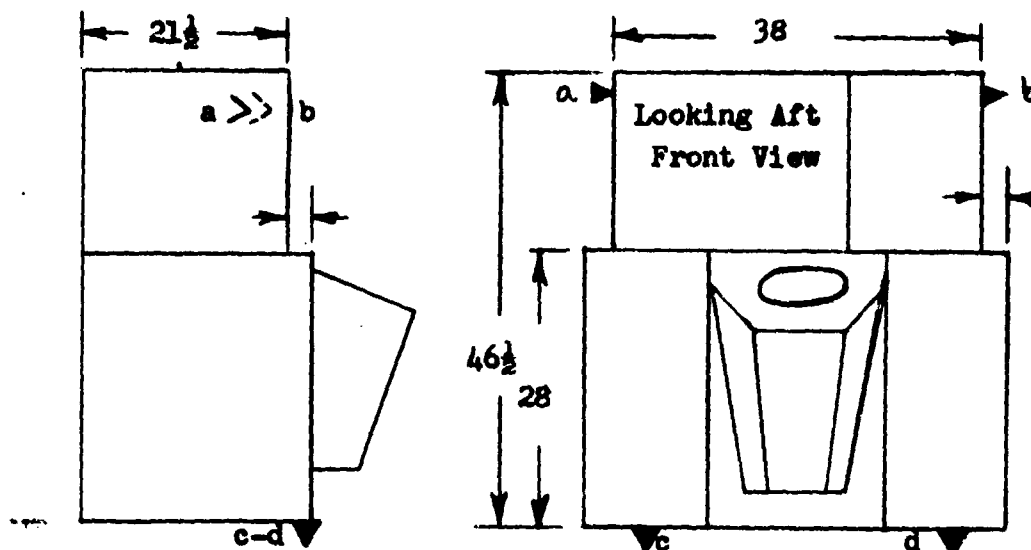
**DD406 #2 Gages:**

Able: Although the mounts bottomed the intensity of shock did not appear severe. There was no apparent damage to the unit.

**Location:** On Plan Position Indicator type CG, Starboard  
Aft Side of C.I.C. Room, on Second Superstructure Deck.

**Type of Mounting:** Short C type mounts on each of four bottom  
corners with L type mounts in back upper corners of lower unit.  
Clearance about 1/4 inch in vertical direction for bottom mounts.

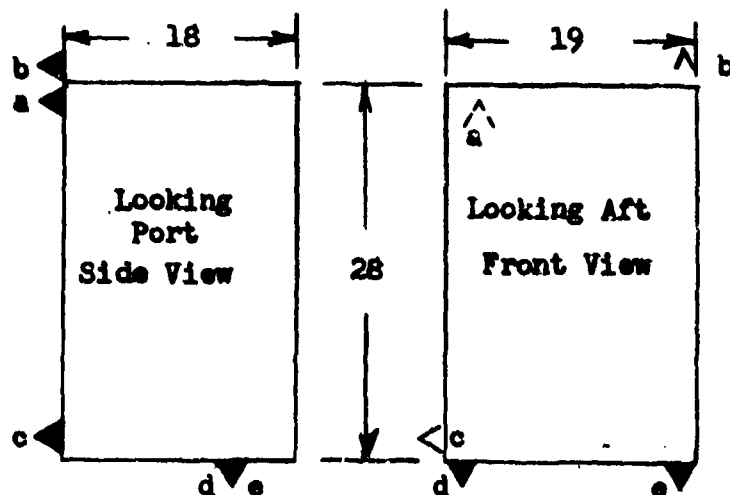
**DD 406 #4 Gages:**

**Location:** On Radio Transmitter Receiver type CFN, in Radar Transmitter Room, Second Superstructure Deck.

Type of Mounting: L type mounts are on the four bottom corners. Clearance 1/8 to 1/4 inch to shoulder.

No apparent damage to compartment.

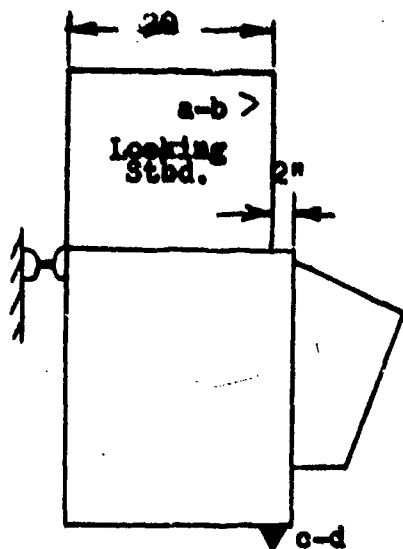
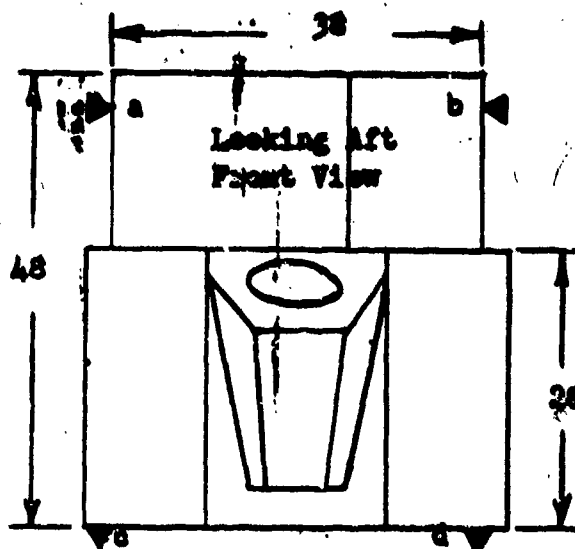
DD408 #2 Gages:

Location: On Plan Position Indicator type CG, in C.I.C. Room, Second Superstructure Deck (starboard aft corner of the room).

**Type of Mounting:** Short C type mounts under each bottom corner, and L type mounts in back upper corners of the lower unit. Clearance to bottom about 1/4 inch.

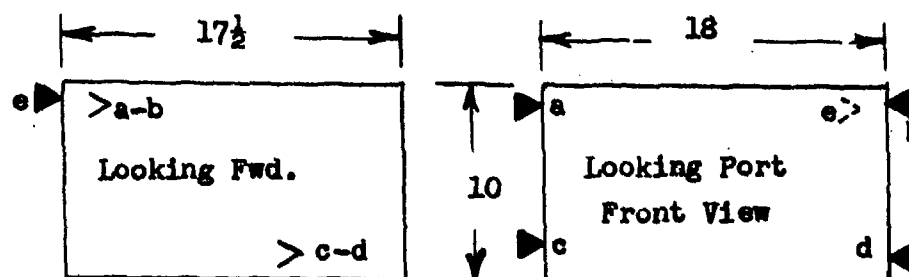
**DD410 #2 Gages:**

**Location:** On Model RCK Radio Receiver, in Radio Transmitter Room, First Superstructure Deck. (In Forward Port Corner above TDQ.)

**Type of Mounting:** L type mounts on four bottom corners. Clearance to shoulders of mounts is 1/8 inch.

Gage DD410 #2	a	b	c	d	e
Able	0.13	0.23	0.09	0.09	0.25
Baker	Room badly damaged by Baker test, no readings possible.

**Able:** There was negligible shock or damage caused by test Able.

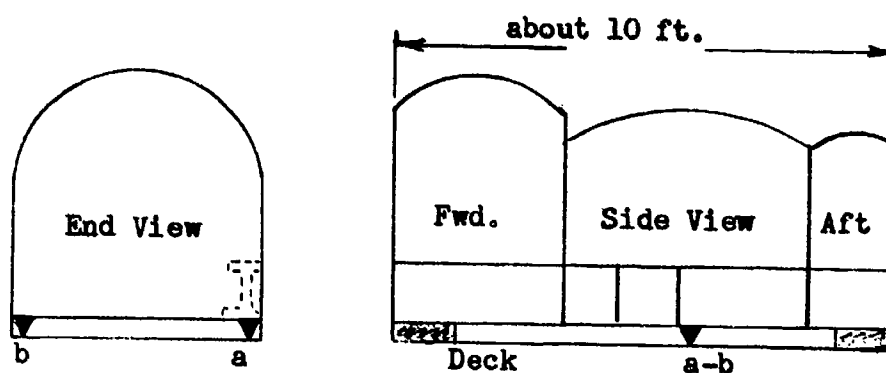
APA64 #1 Gages:

Location: On Turbo-Generator (BuShips Section 660 Special Item #11 #15), in Forward Cargo Hold Lowest Level.

Type of Mounting: The unit is solidly mounted at the four bottom corners, but it has a long unsupported span between its ends. The unit weighs about 15 tons.

Able: There was no measurable deflection of the long unsupported span of the turbo-generator caused by the Able test.

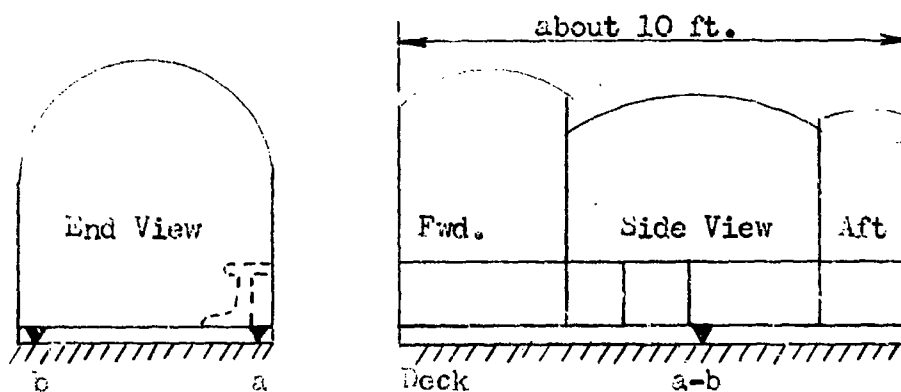
APA77 #2 Gages:

Location: On Turbo-Generator (BuShips Section 660 Special Item #12E1) in Forward Cargo Hold, Lowest Level.

\*The deflection for the Able test is believed caused by the impact of falling hatch covers striking the top of the unit.

Able: Except for the damage caused by falling hatch covers there were no shock effects caused by Able test.  
Baker: The deflection of the long unsupported span of the turbo-generator indicated minor shock intensities.

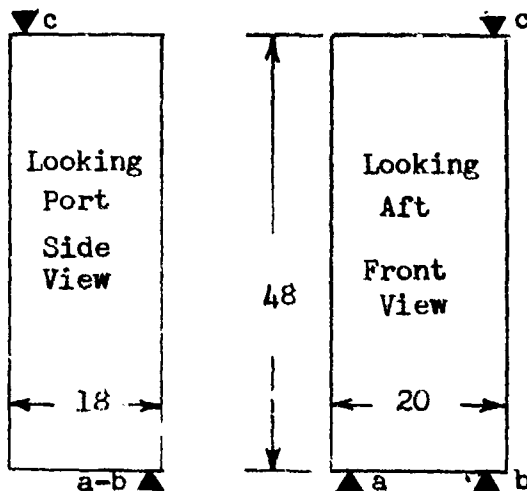
BB34 #4 Gages:

Location: On Radar Transmitter Model SK type CG-52ABH, in #2 Combat (frame 64) on the Flag Bridge.

Type of Mounting: Eight C mounts used on the bottom corners and on edges midway between corners, two C type mounts on upper back corners.

Able: There was no damage and negligible shock intensity registered by this equipment.

Baker: The mounting system was adequate to protect this radar from noticeable damage. However, the deflections were very large which indicated severe shock conditions.  
Type of damage caused by Baker test to Combat #2 compartment is indicated by the failure of the bonding of the sheer mounts (holding the gyro repeater) the train indicator was thrown out of place; and the optical range finder was broken out of the saddle.

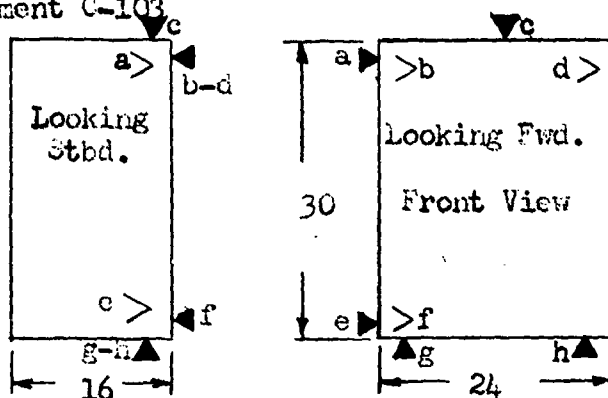
BB34 #5 Gages:

Location: On Radio Transmitter Model TD<sub>4</sub>, in Forward Starboard Corner of Radio Transmitter Room, on the Third Deck, Compartment C-103.

Type of Mounting: Short C type mounts at bottom corners. Clearance to bottom mount is 1/2 inch. The unit is mounted in an angle iron frame.

Baker: No shock mounted apparatus in this compartment appeared damaged although there was a considerable quantity of equipment, as fans, starting boxes, etc., broken loose from the bulkheads. It is evident that the damaging components of shock involved such small displacements that the clearances of about 1/2 inch provided sufficient protection with the type of mounts used.

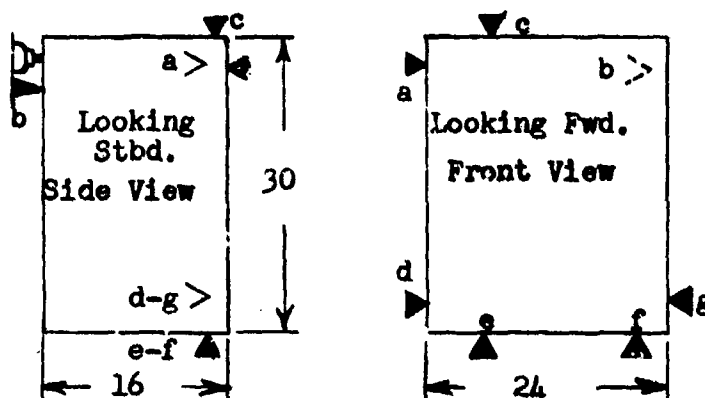
### CA24 #1 Gages:

Location: On Radio Transmitter, Model TSC, in Main Radio Room on the Communication Platform.

Type of Mounting: Short C type mounts on four bottom corners, L type mounts on two upper back corners. Vertical clearance to shoulders of mounts is 1/4 inch.

\*Broken

Able: Although there was very extensive damage just external to this compartment there was no visible damage within. The unit was mounted to the structures that were attached only to the deck. The major shock direction was vertical and the deflection was no greater than would be caused by a sustained acceleration of 5 g. There was no damage to the transmitter.

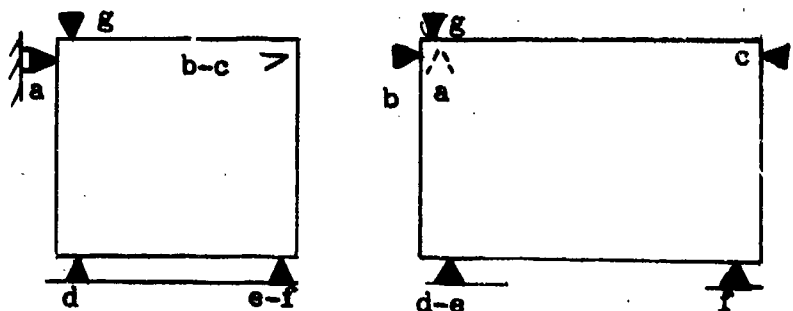
CA25 #3 Gages:

Location: On type CML-50ABH Automatic Gain Control Unit,  
in Radar Transmitter Room (frames 45-47).

Type of Mounting: L type mounts on four bottom corners. The mounts have collapsed so as to rest on their shoulders. The shoulders can compress 3/8 to 1/2 inch. The unit is mounted in an angle iron frame.

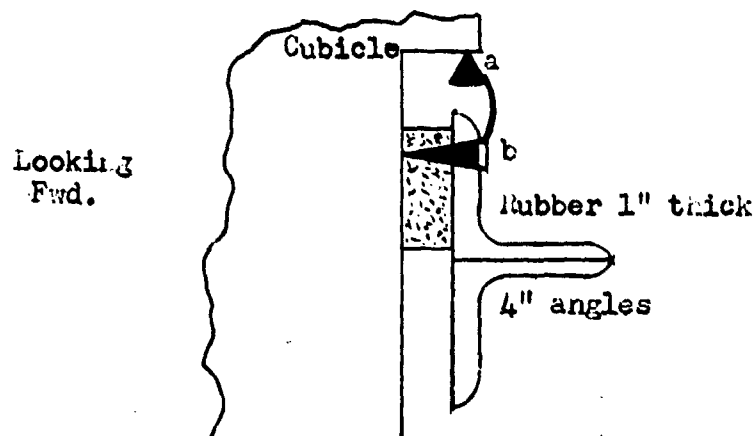
SS196 #1 Gages

Location: On Control Cubicle, Lower Starboard Edge about four feet from After Edge, in After Maneuvering Room. The gages are shown in the accompanying figure.

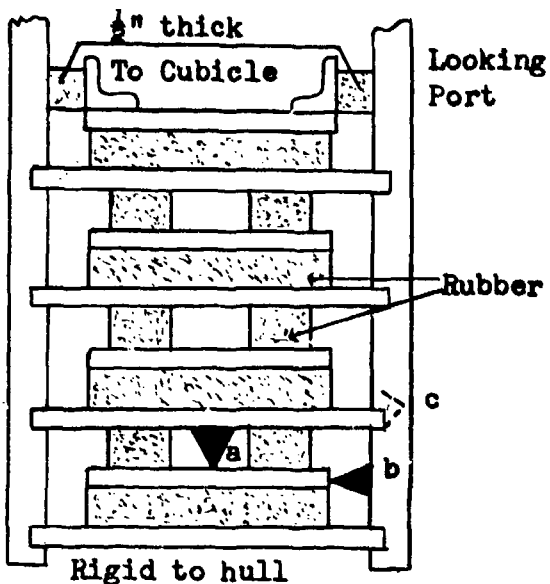
**SS196 #3 Gages:**

**Location:** On Control Cubicle, Upper Forward Starboard Corner, in After Maneuvering Room. Gage positions are shown in the figure below.

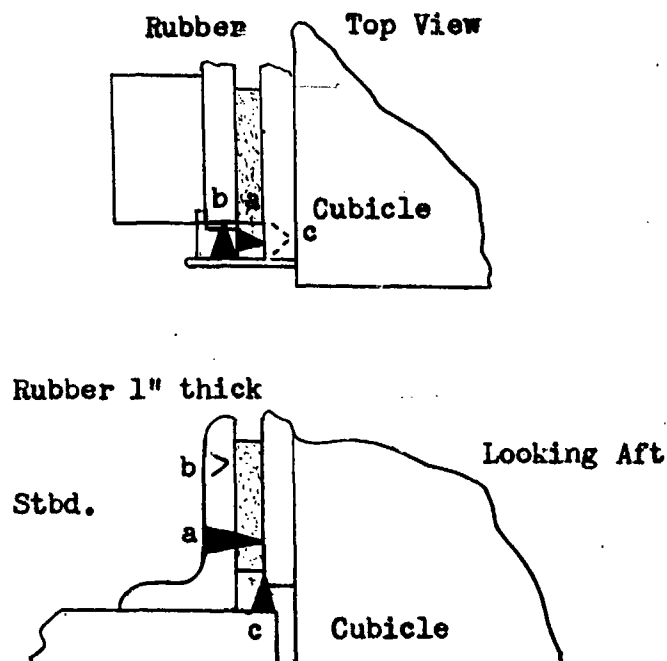
SS308 #1 Gages:

Location: On Control Cubicle, Lower Forward Starboard Mount in After Maneuvering Room. Gage positions are illustrated on the accompanying figure.

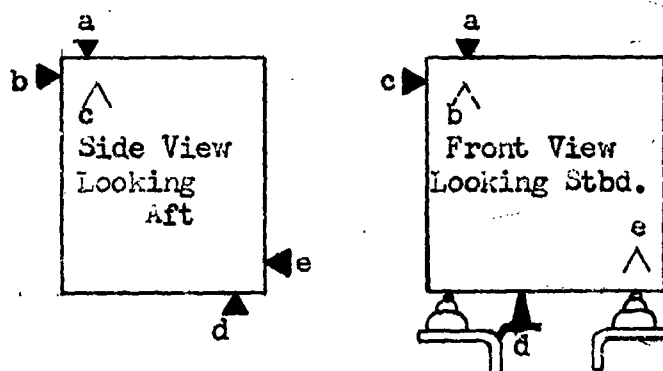
SS308 #3 Gages

Location: On Radar Transmitter-Receiver type CW-43AMF-1,  
in starboard After Corner of Conning Tower.

Type of Mounting: L type mounts on four bottom corners and on two upper back corners. Clearance of mounts about 1/4 inch before bumping on shoulder.

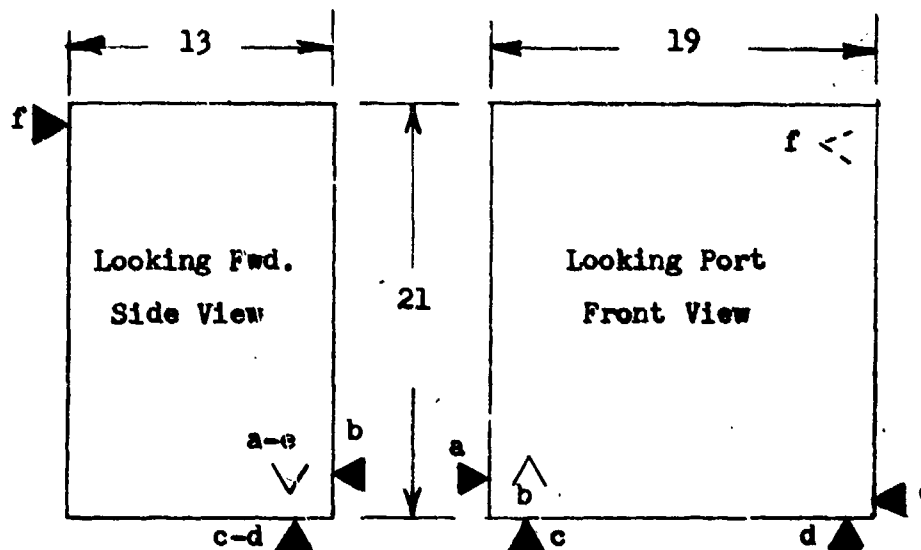
SS335 #4 Gages:

Location: On Model SJ-1 Radar Transmitter-Receiver type CW-43AAF-1, at Center of Port Side of Conning Tower.

Type of Mounting: L type mounts on four bottom corners and on two upper back corners. Clearance of mounts is about 1/4 inch to their shoulders which are about 1 inch thick.

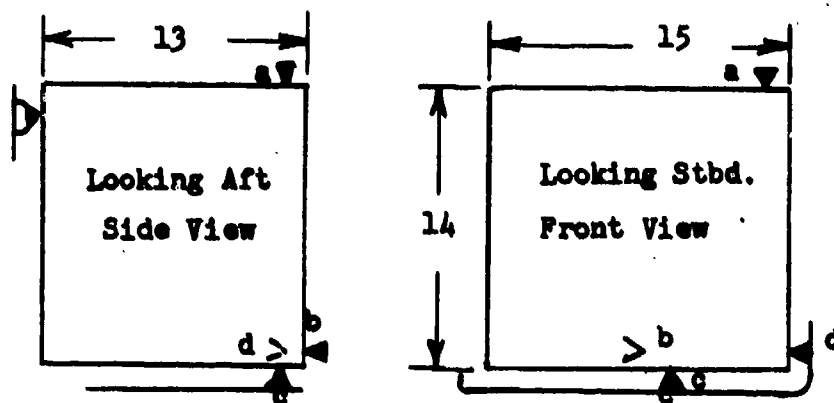
### SS335 #5 Gages:

Location: On Model SJ-1 Radar Main Control Unit type  
CBB-23ADH, at Center of Starboard Side of Conning Tower.

Type of Mounting: L type mounts on each of four bottom corners and on the two top back corners. Clearance 1/16 to 1/8 inch to shoulders of mounts.

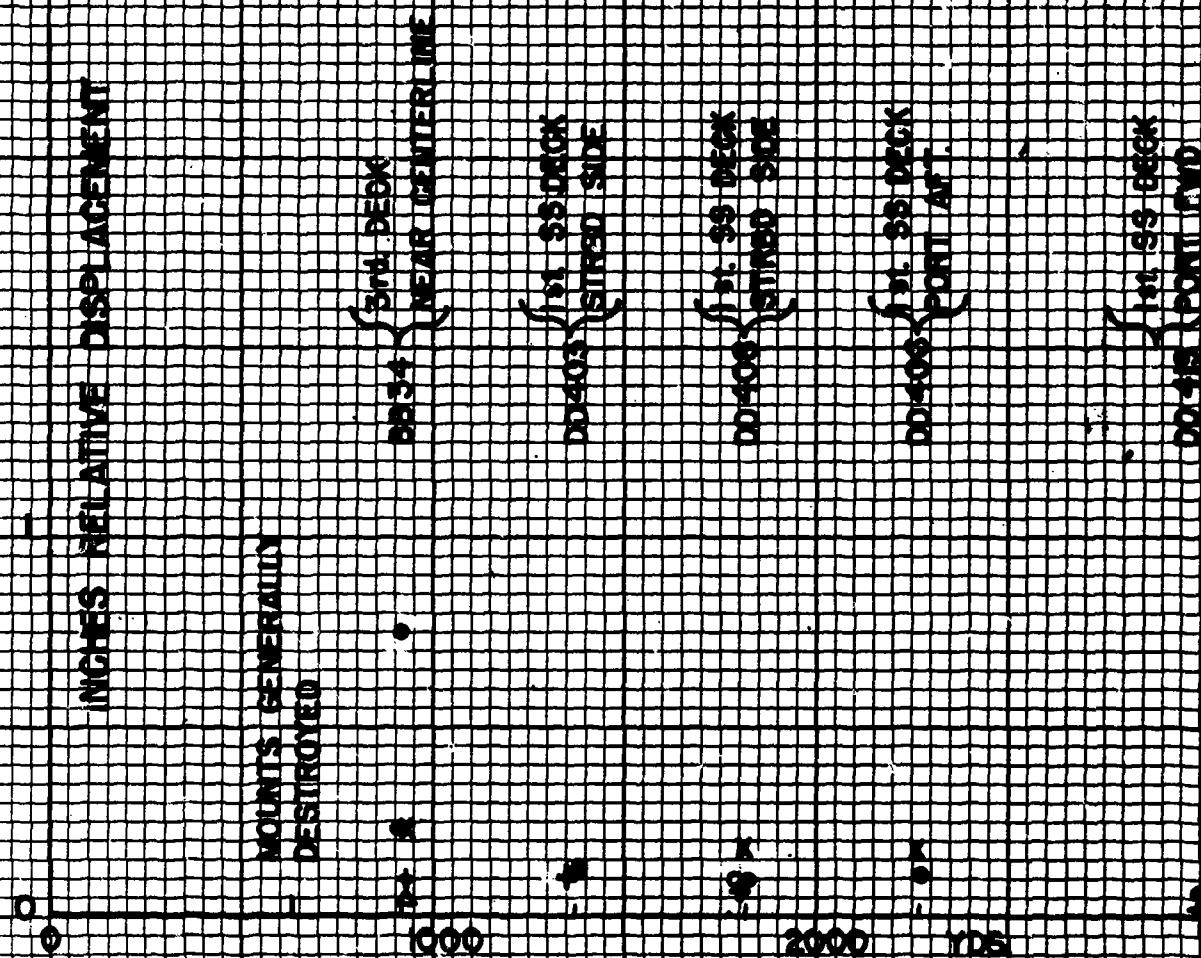
# MAXIMUM RELATIVE DISPLACEMENT OF RADIO TRANSMITTER, MODEL TD2, WITH RESPECT TO ITS SUPPORTS

NATURAL FREQ.: VERTICAL 12 CPS (STATICS DEF. 0.07")  
ROCKING - 8 TO 10 CPS  
(BOTH LOWER MODES)
