# BUREAU OF SHIPS GROUP

## TECHNICAL INSPECTION REPORT

### WELDING

OPERATION CROSSROADS

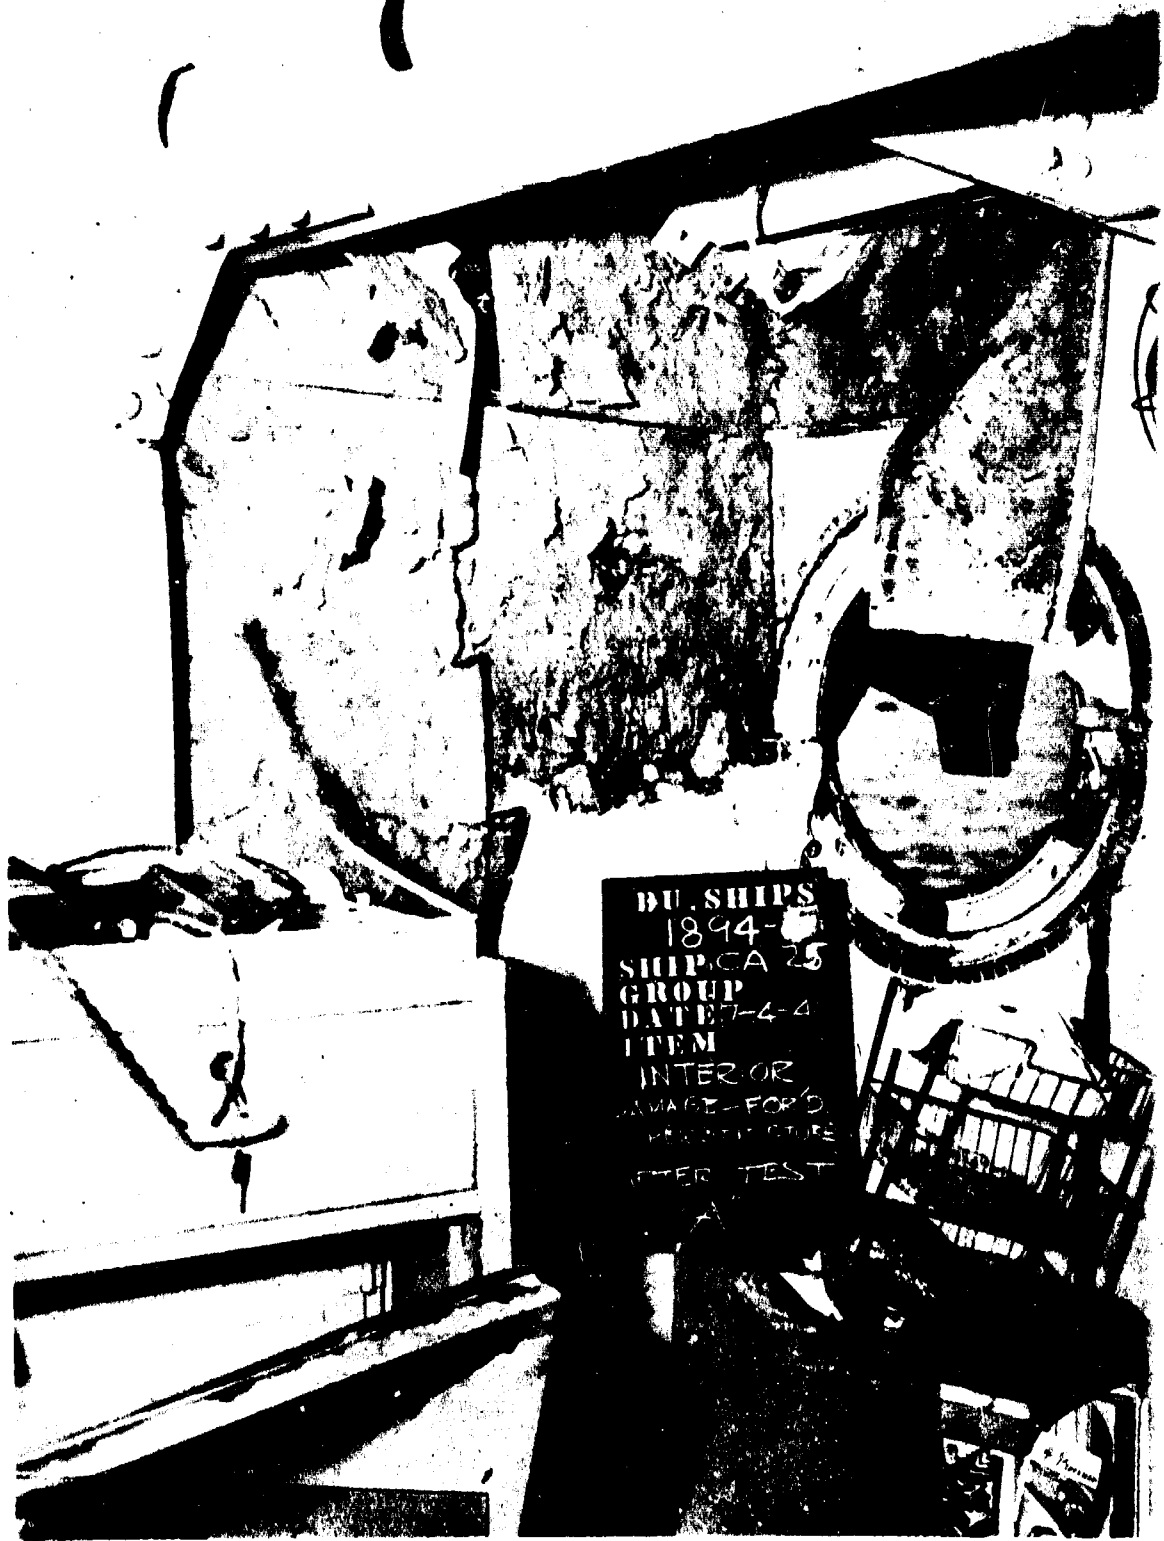
AA-CR-80-1894-5. USS SALT LAKE CITY (CA25). Damaged fibre glass insulation in forward superstructure.
