TECHNICAL INSPECTION REPORT

OPERATION CROSSROADS.

U.S.S. ARKANSAS (BB33).

TEST ABLE.

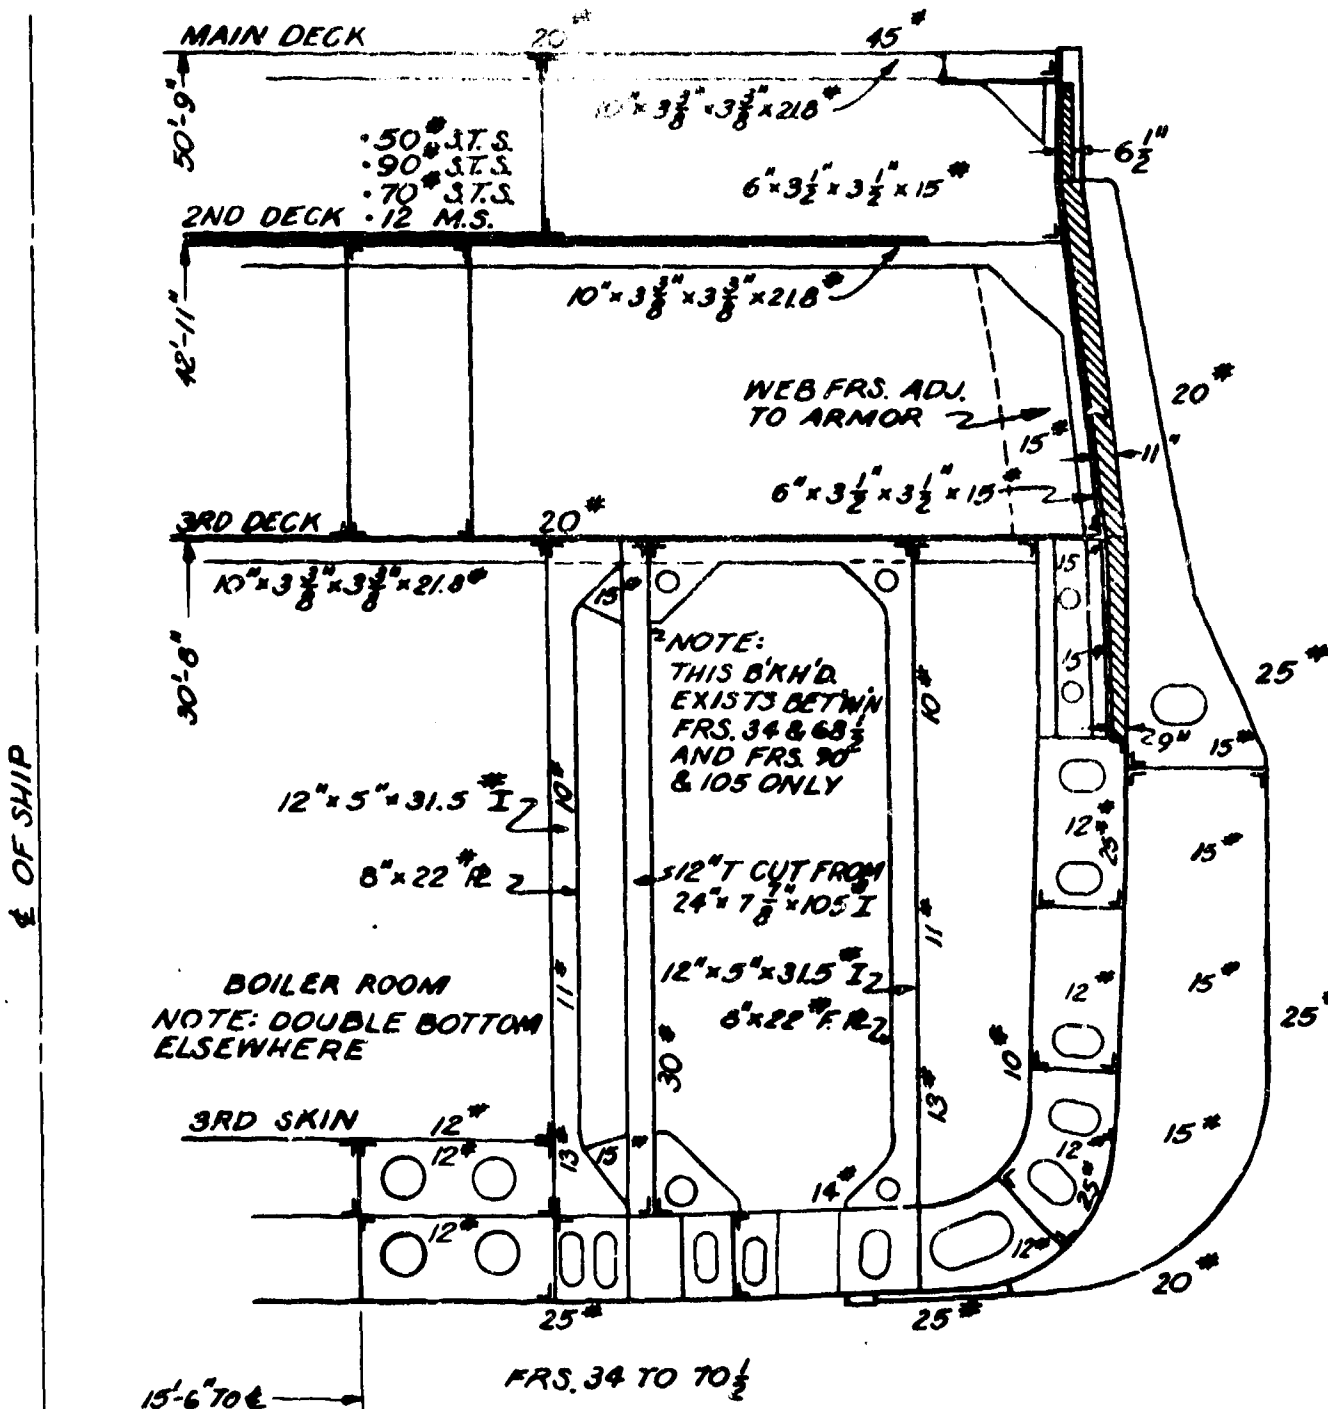
MIDSHIP SECTION  
TEST A

The hull above the waterline along the starboard side aft is dished generally. The interior structure is generally undamaged except on the second deck aft at about frame 125 where deflection of the main deck has caused considerable damage to structure below.

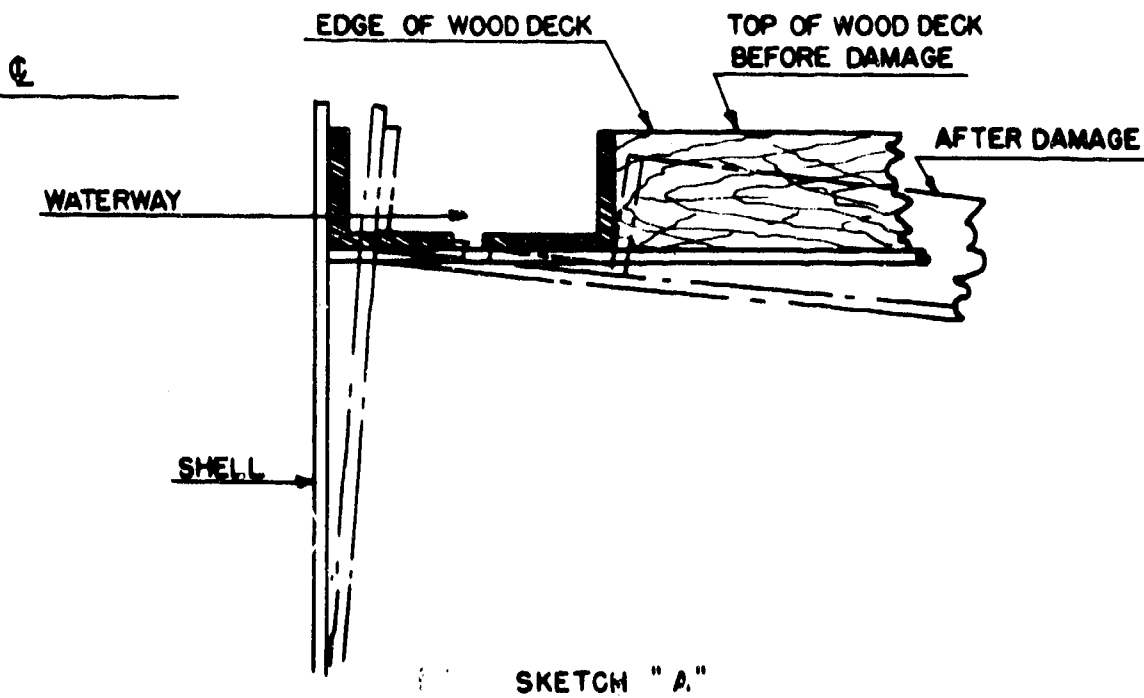
SKETCH "A."

DEFLECTIONS WERE MEASURED FROM STRINGS STRETCHED LONGITUDINALLY ON THE DECK. ENDS OF THE STRING WERE EXTENDED TO PORTIONS OF THE DECK REASONABLY FREE OF ANY DEFLECTION. IN THIS RESPECT, IT WAS NECESSARY TO ASSUME THAT THE EDGE OF THE WOOD DECK ALONG THE SIDES WAS LEVEL WHICH IS UNTRUE. DISHING OF THE DECK CAUSED THIS EDGE TO PULL INBOARD AND DOWN. SEE SKETCH "A".
