TECHNICAL INSPECTION REPORT

U.S.S. PENSACOLA (CA24)

TEST ABLE

VOLUME 1 OF 2

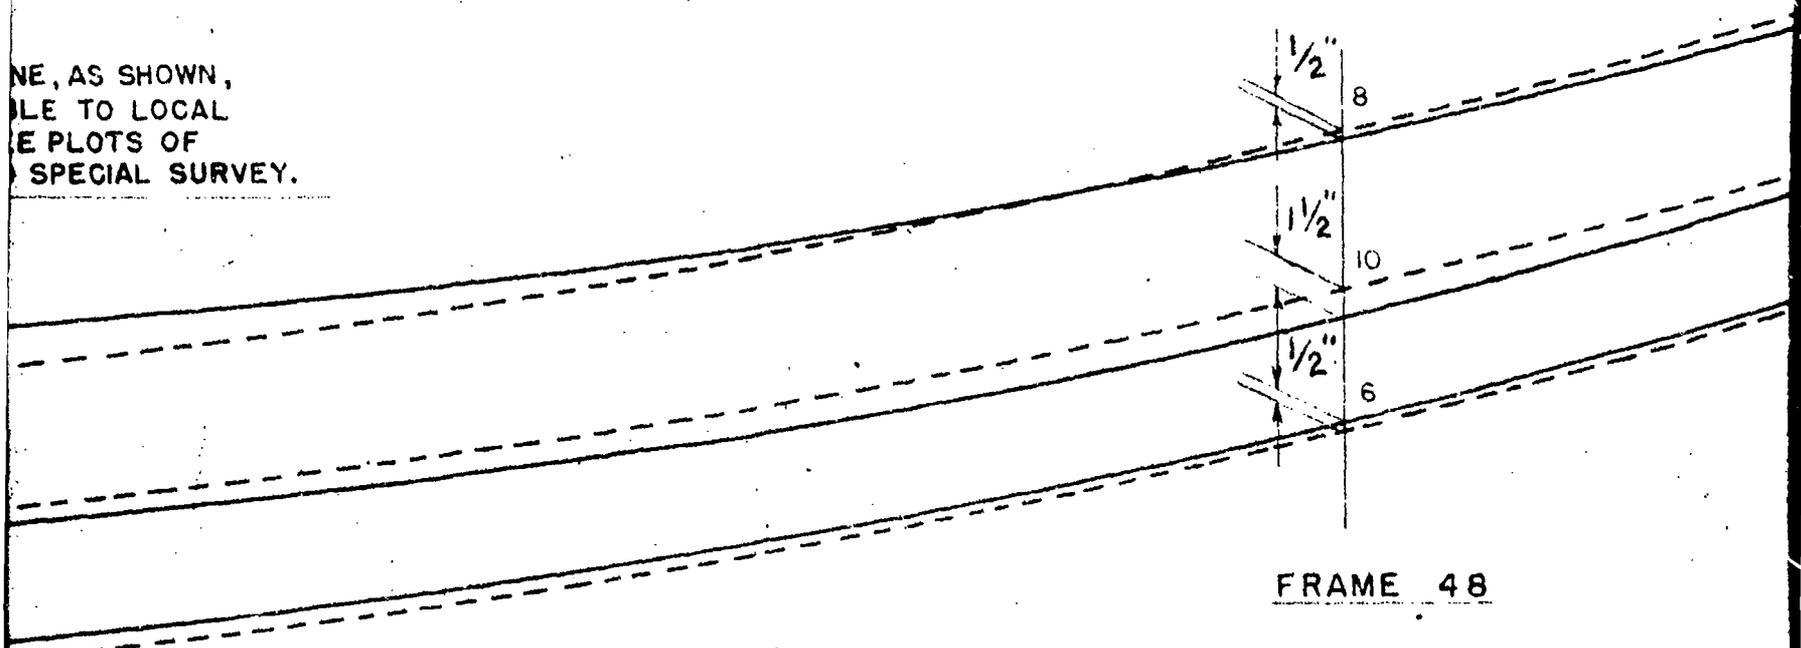
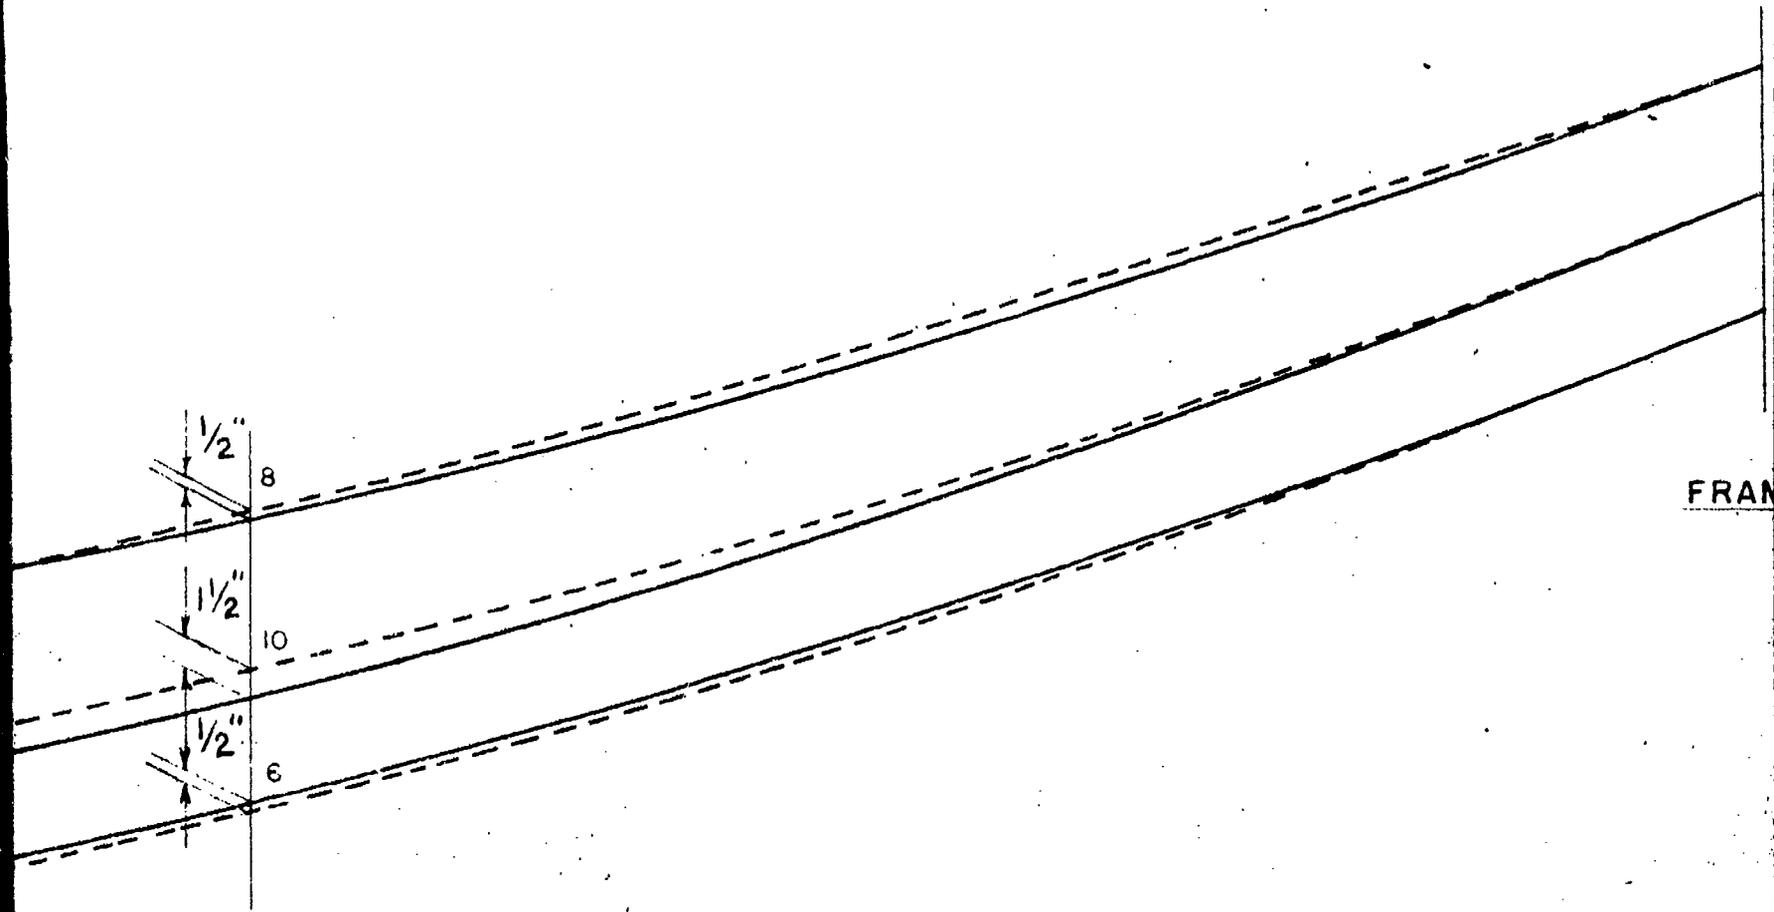
FRAME 48

——— BEFORE TEST
----- AFTER TEST

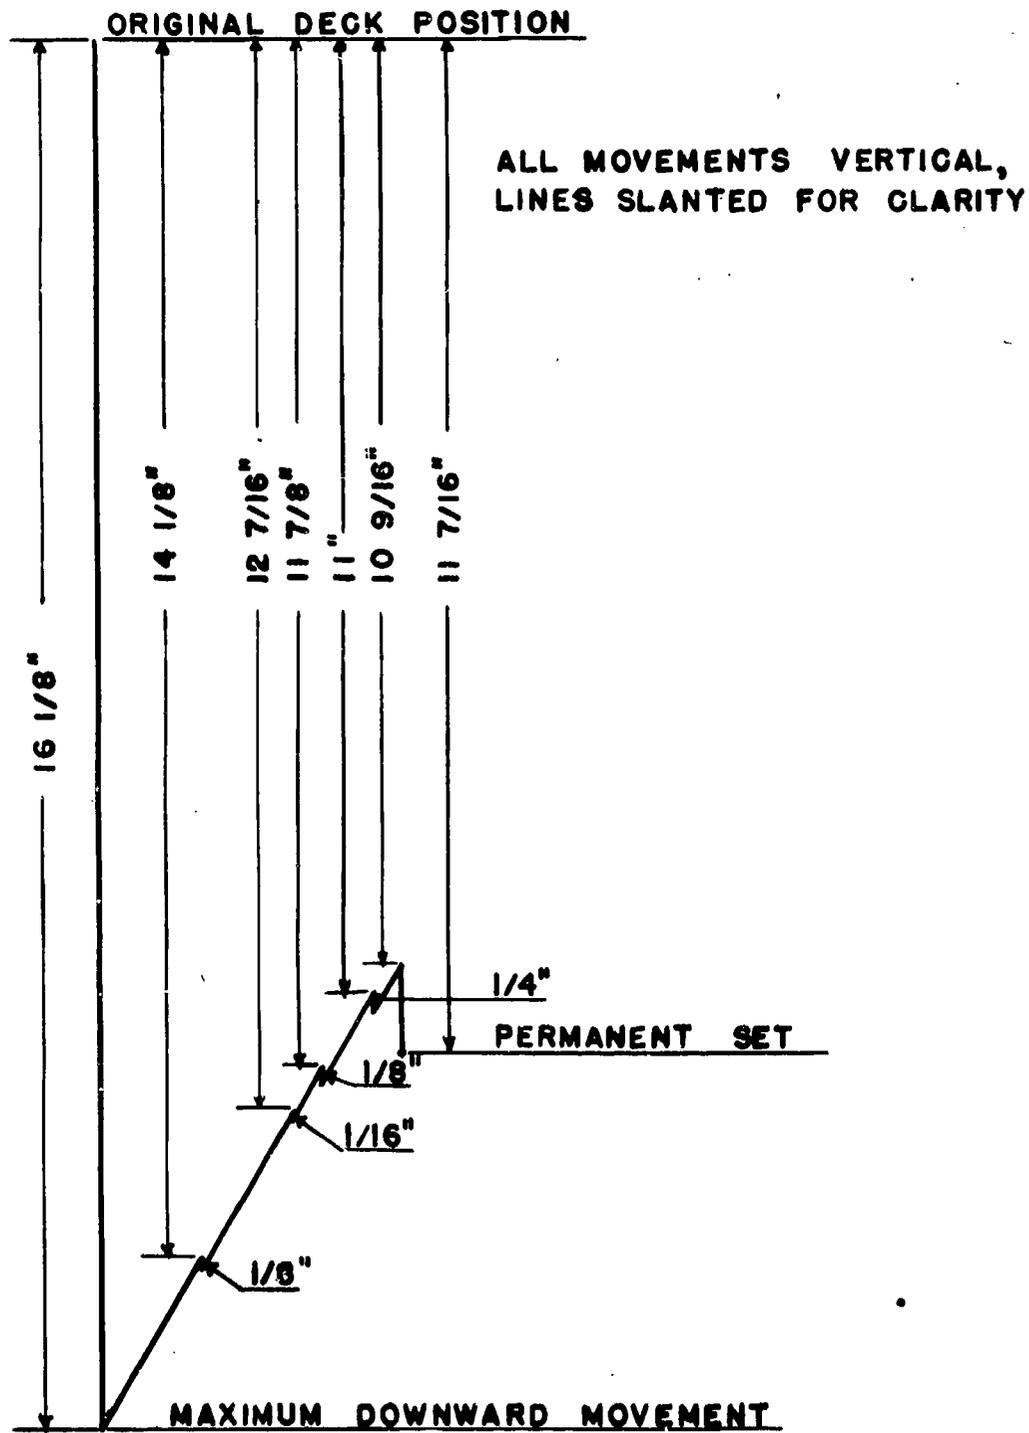
U.S.S. PENSACOLA, TEST ABLE, PLOT OF MAIN DECK
MOVEMENT. SCRATCH GAGE LOCATION, 2ND. DECK
FRAME 124 STBD. 8'-2" OFF CENTER LINE.
