BUREAU OF SHIPS GROUP TECHNICAL INSPECTION REPORT

U.S.S. SALT LAKE CITY (CA25)

TEST ABLE

OPERATION CROSSROADS

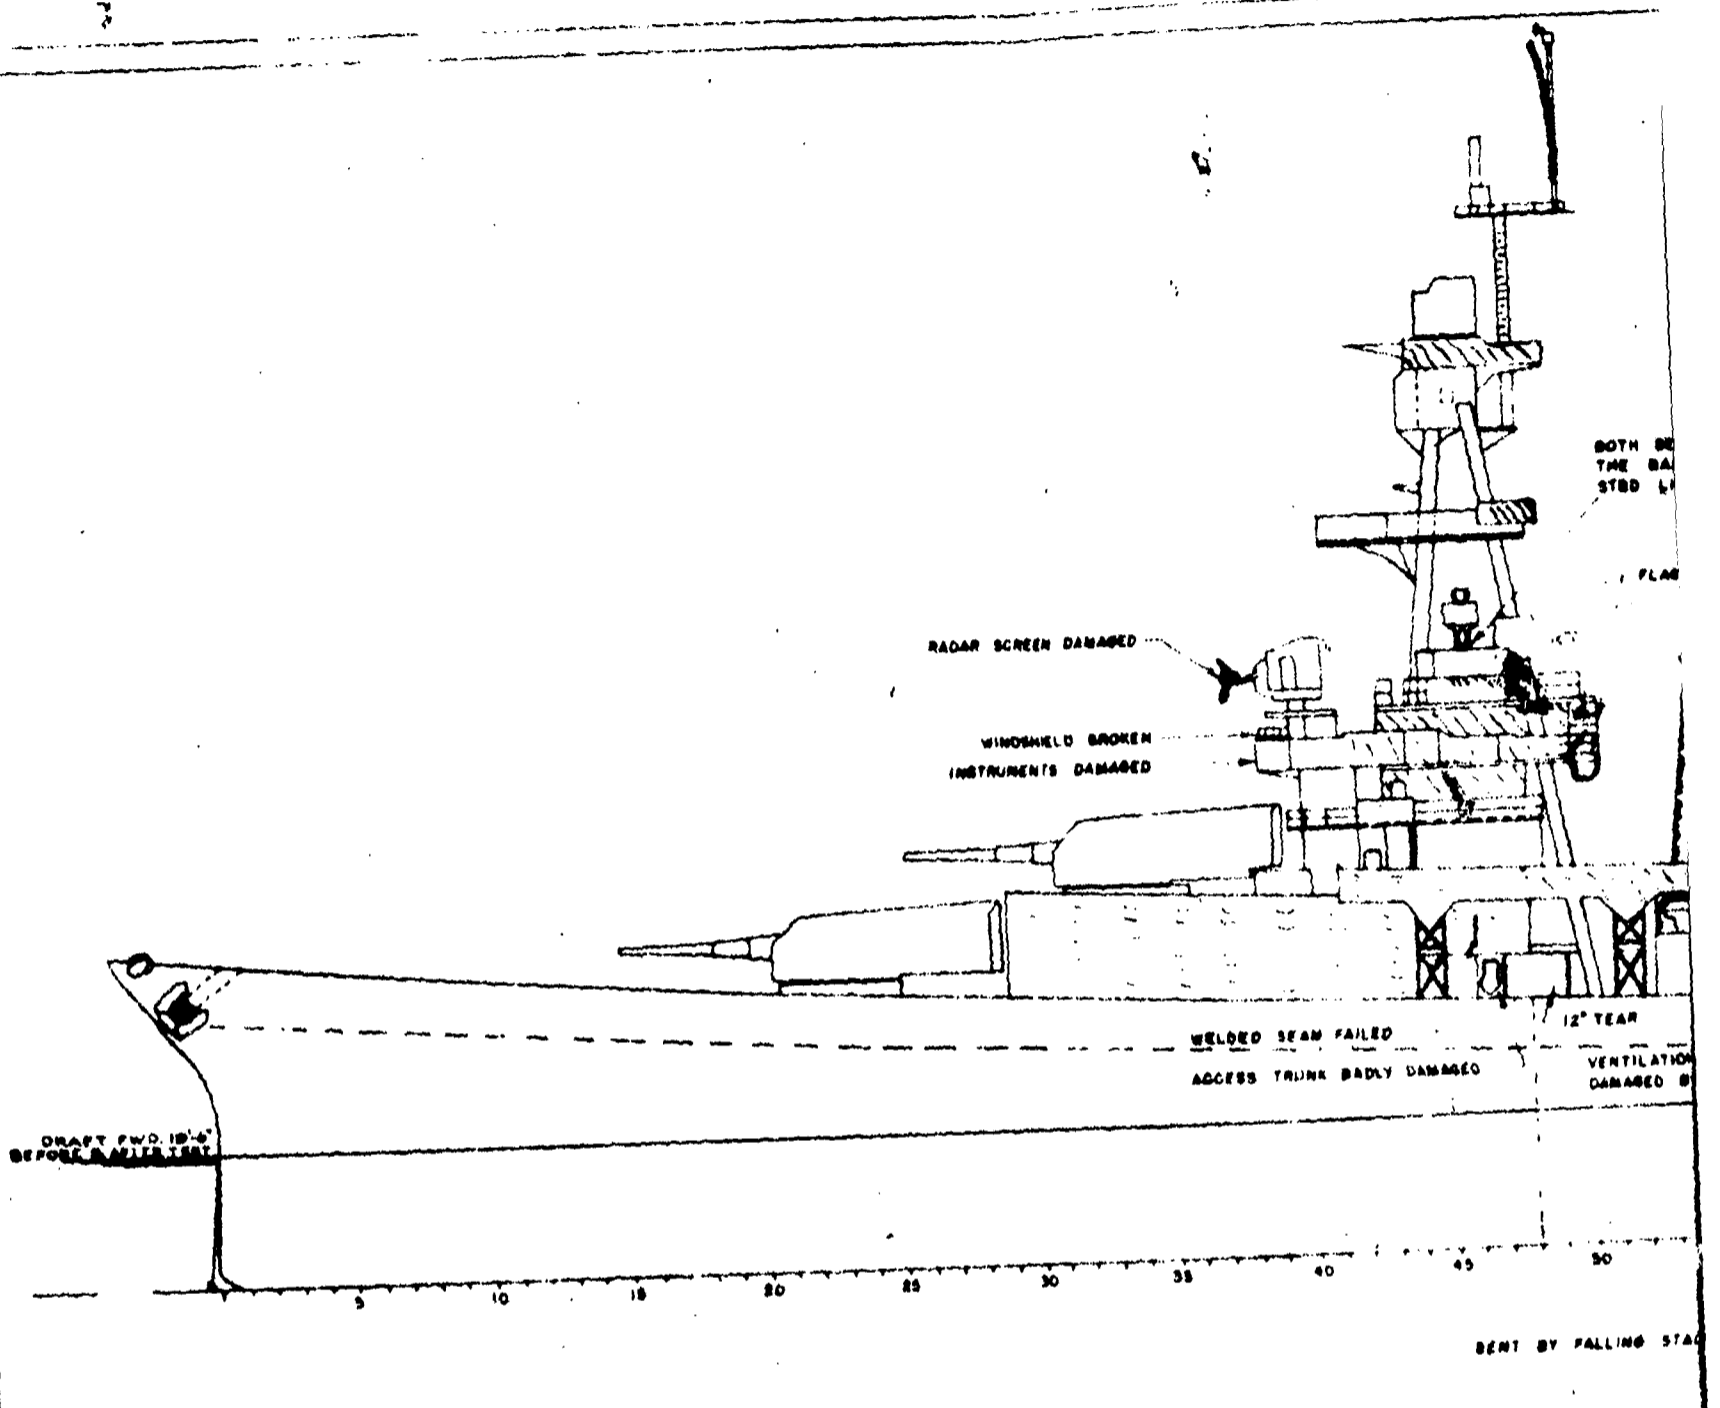
DECK TORN AT EXHAUST VENT

STACK TORN AWAY ABOVE DECK

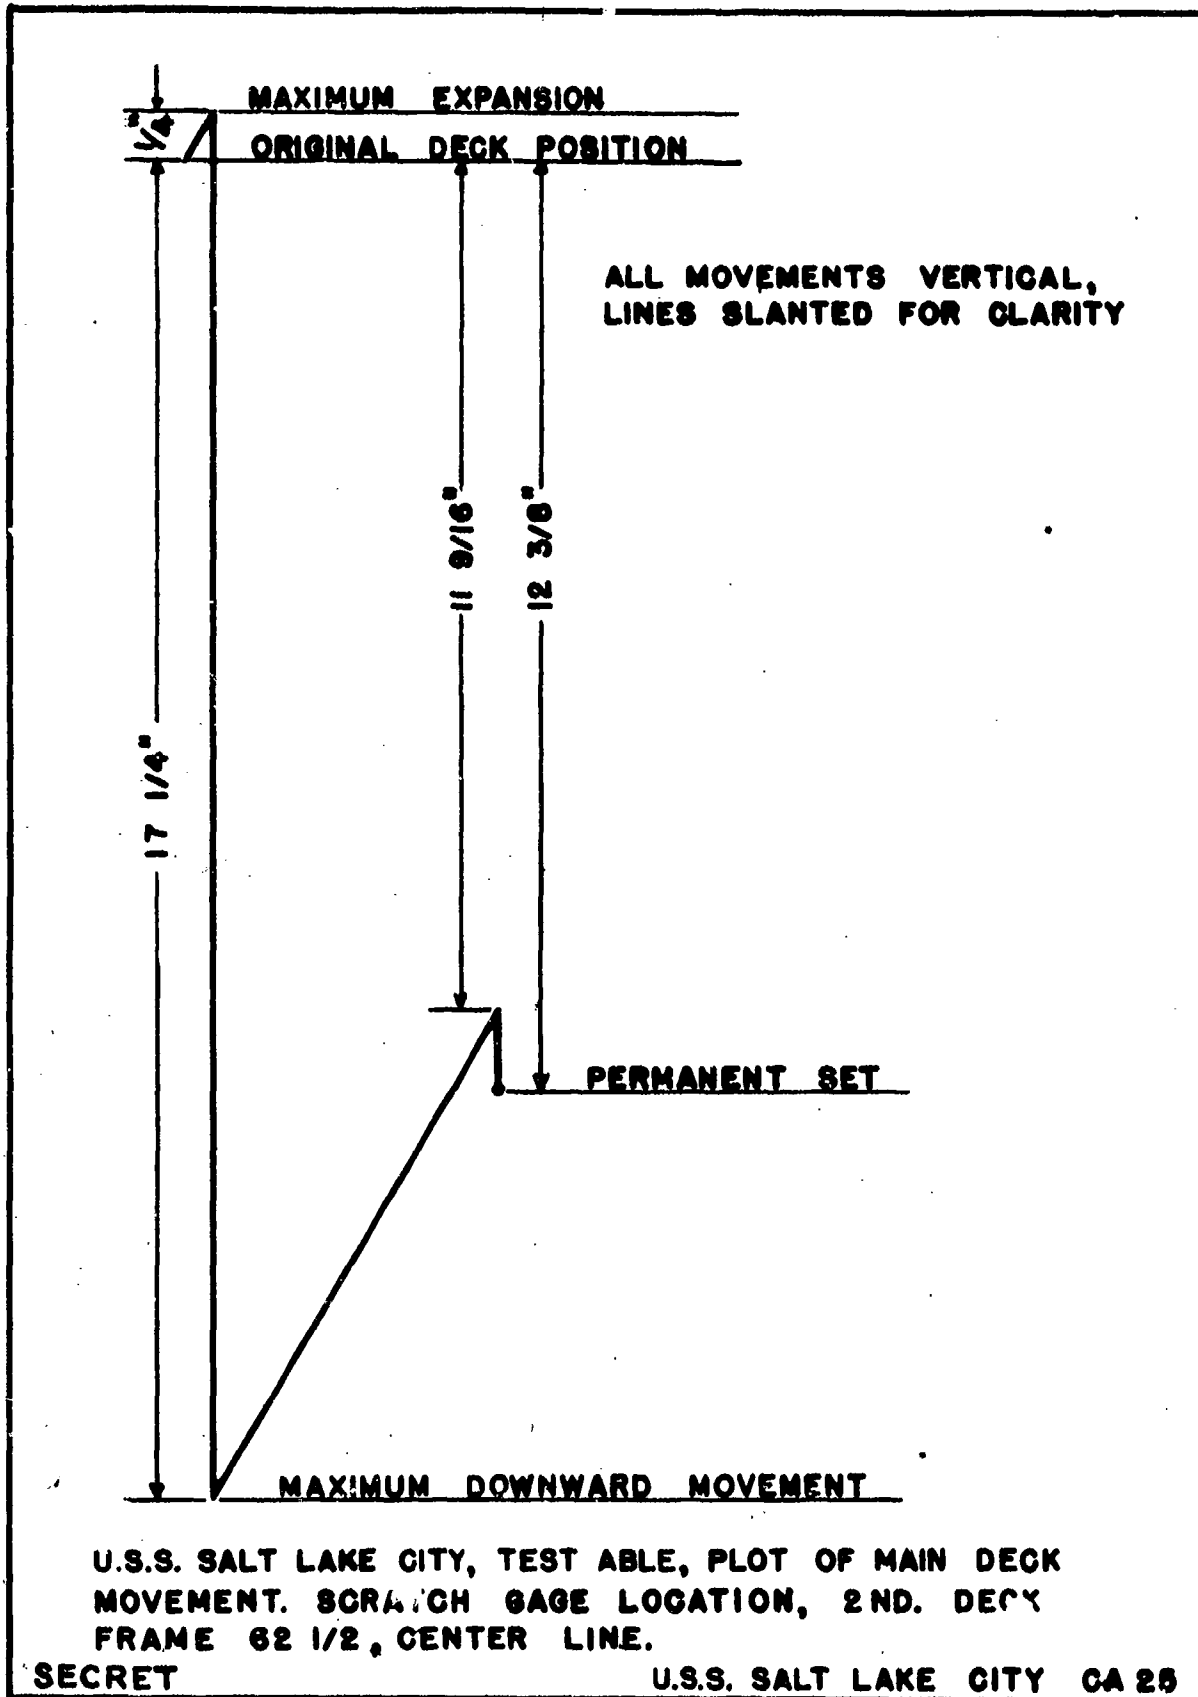
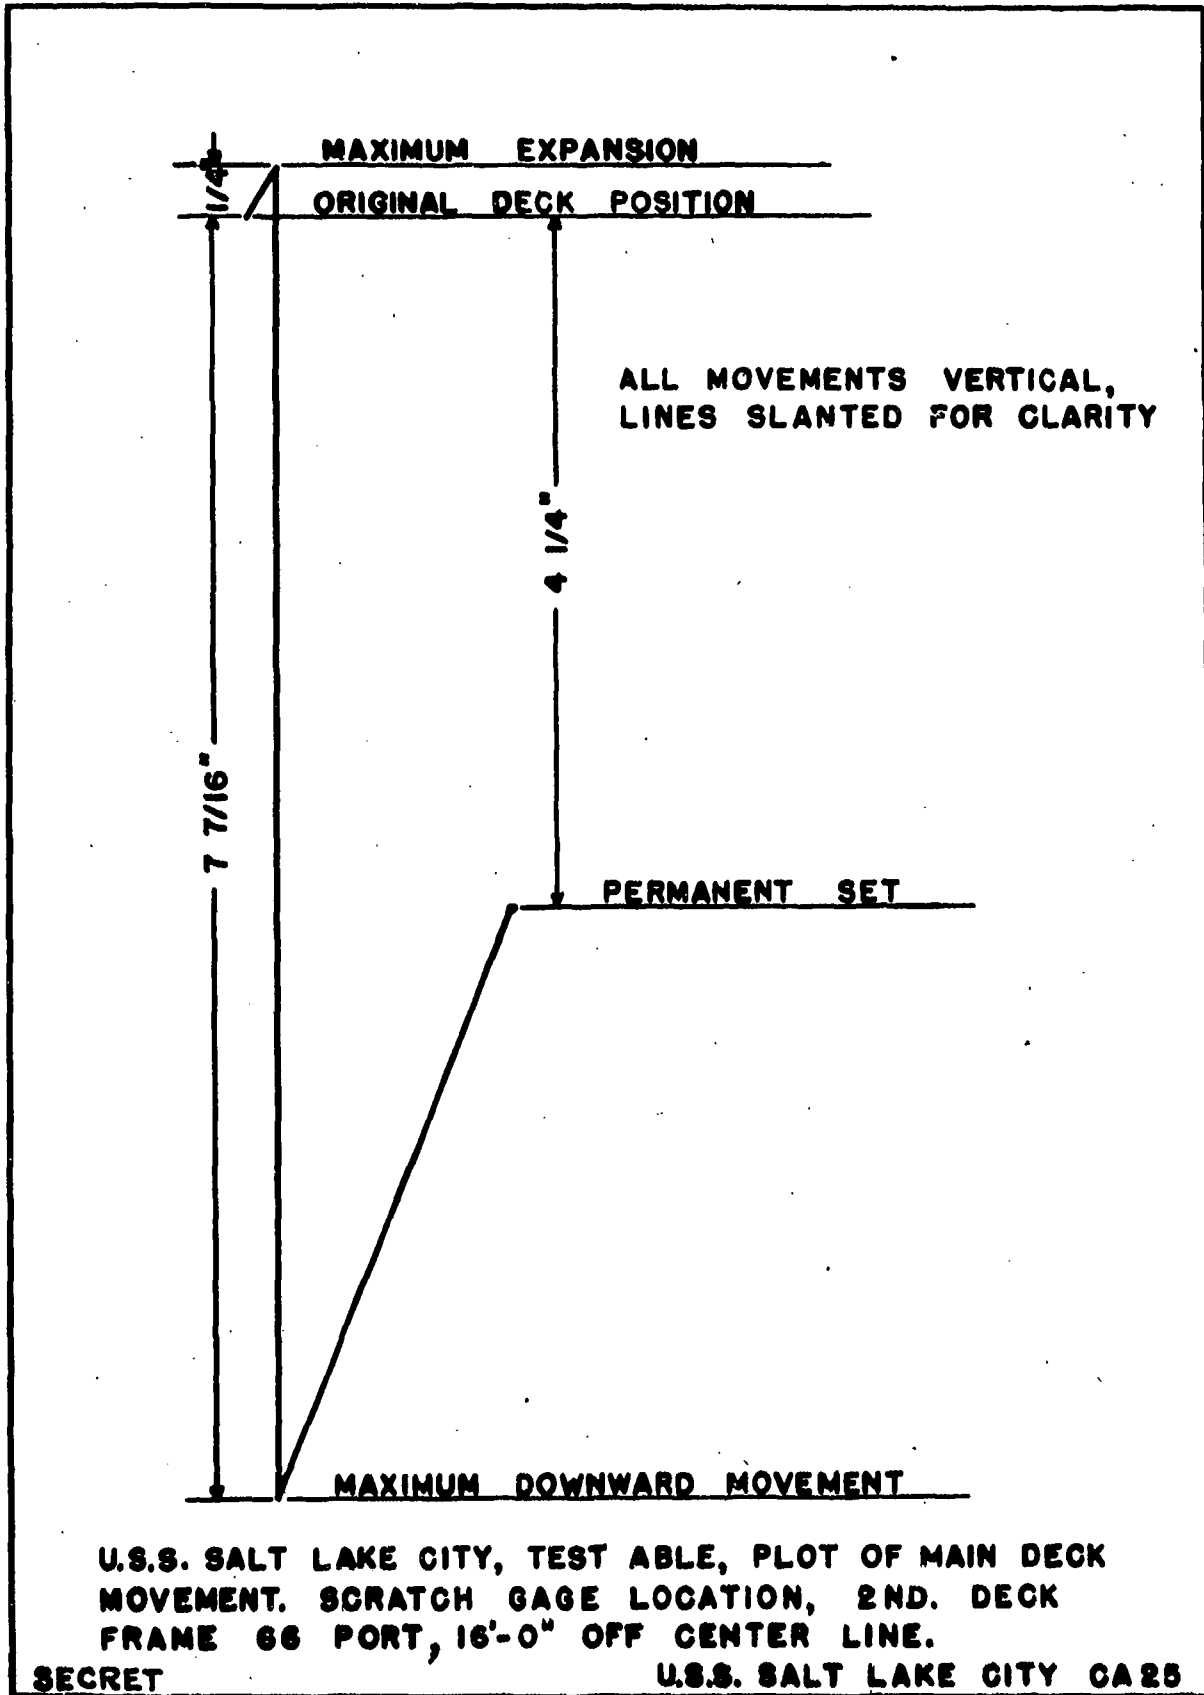
U.S.S. SALT LAKE CITY, TEST ABLE, PLOT OF MAIN DECK
 MOVEMENT. SCRATCH GAGE LOCATION, 2ND. DECK
 FRAME 66 STBD., 16'-0" OFF CENTER LINE.

Light topside structure is damaged extensively. Both stacks are demolished. The principal structural damage is to the main deck. Maximum deflection of the deck is 16 3/4 inches at frame 66.

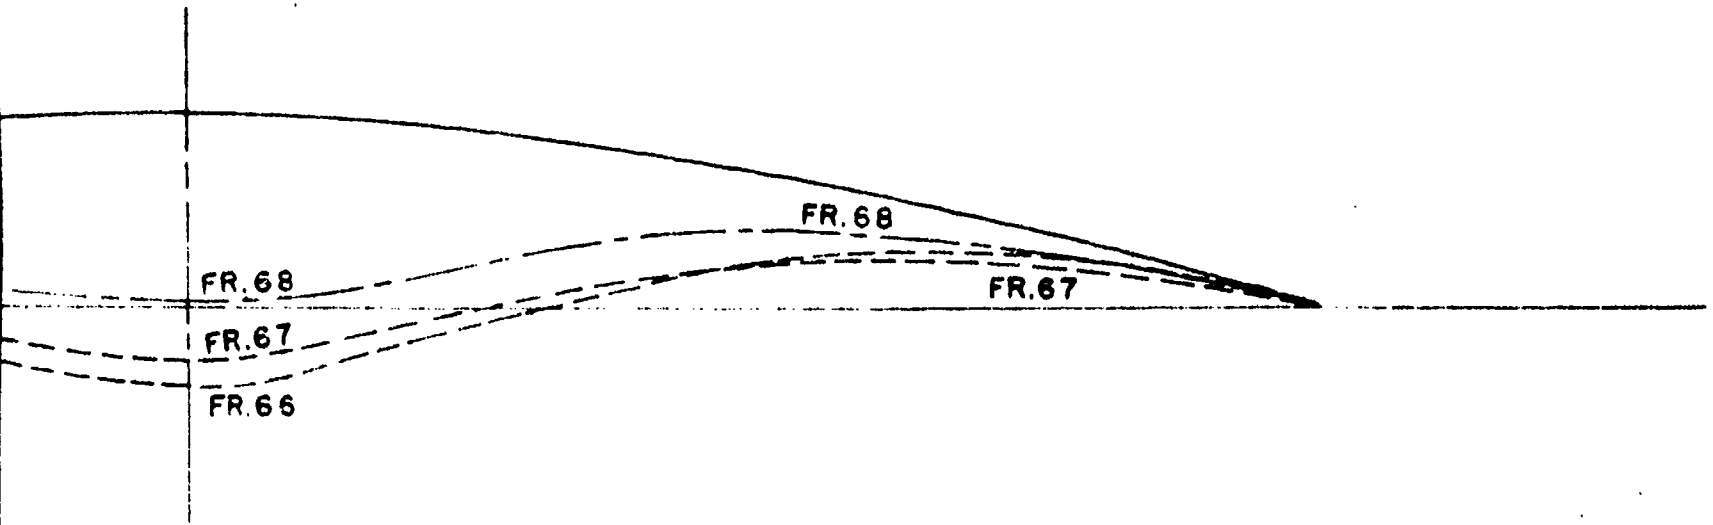
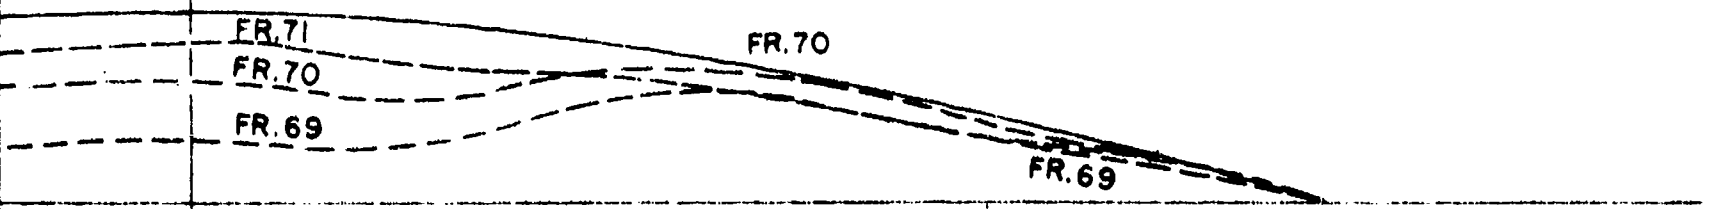
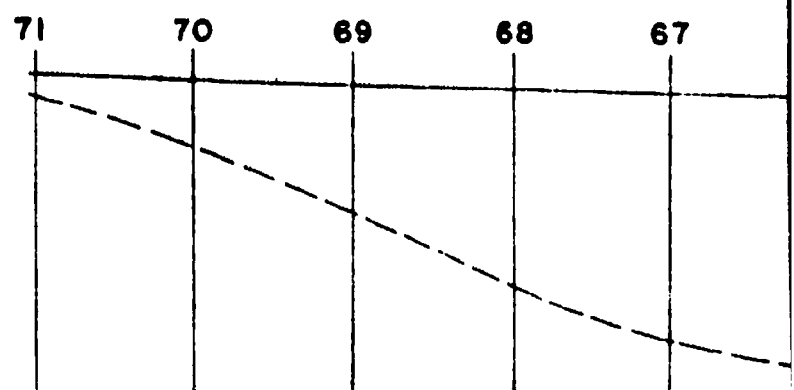
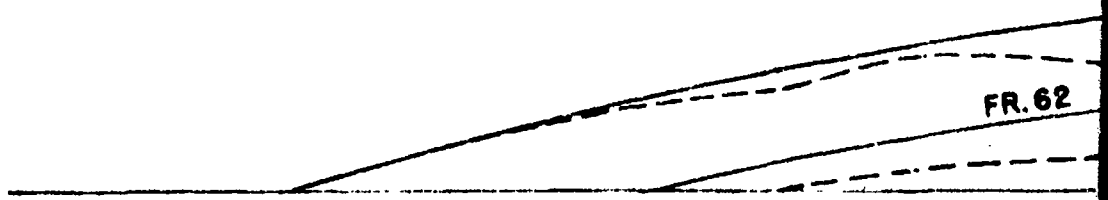
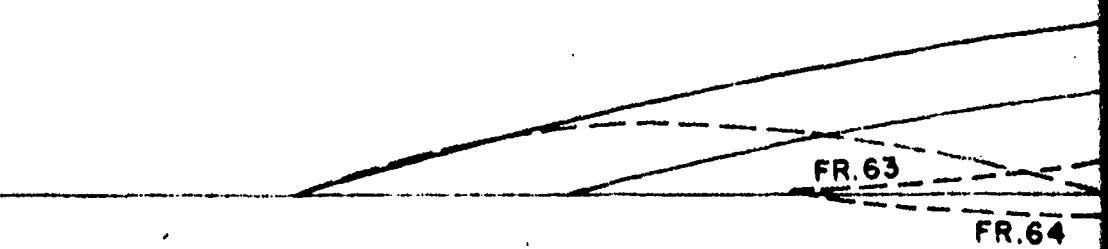
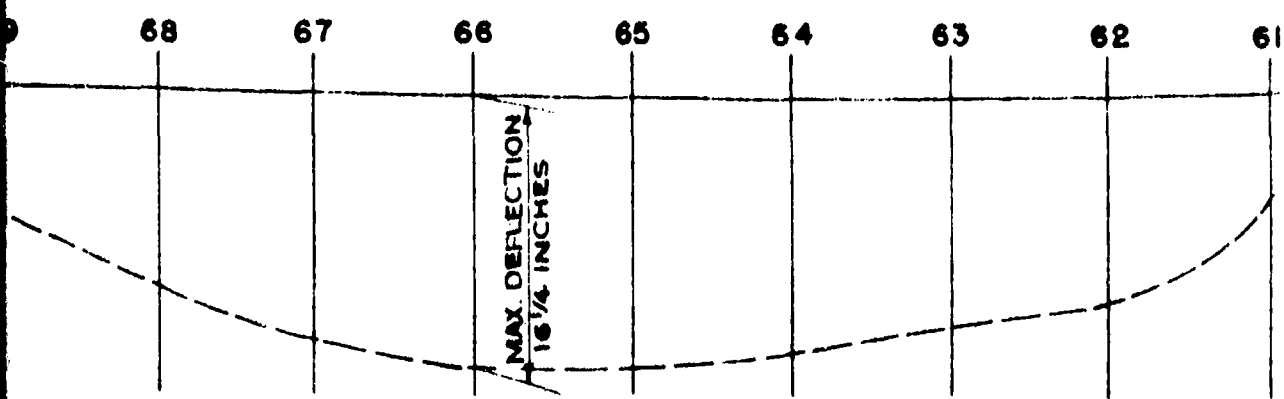
SECRET
 U.S.S. SALT LAKE CITY LA 20
 DEFLECTION OF MAIN
 DECK, FRAMES 61--7
 TEST ABLE
 NAVY DEPT. BUREAU OF SHIPS

Blast pressure is the major cause of damage to this ship. The principal damage is the severe deflection of the main deck between the forward and after deckhouses, and the buckling of the stanchions below. The pressure was downward and from the port quarter. Critical plating thickness seems to be about 10# plate.
