BUREAU OF SHIPS GROUP TECHNICAL INSPECTION REPORT

OPERATION CROSSROADS. U.S.S. INDEPENDENCE (CVL22)

TEST ABLE

VOLUME 1 OF 4 [W]

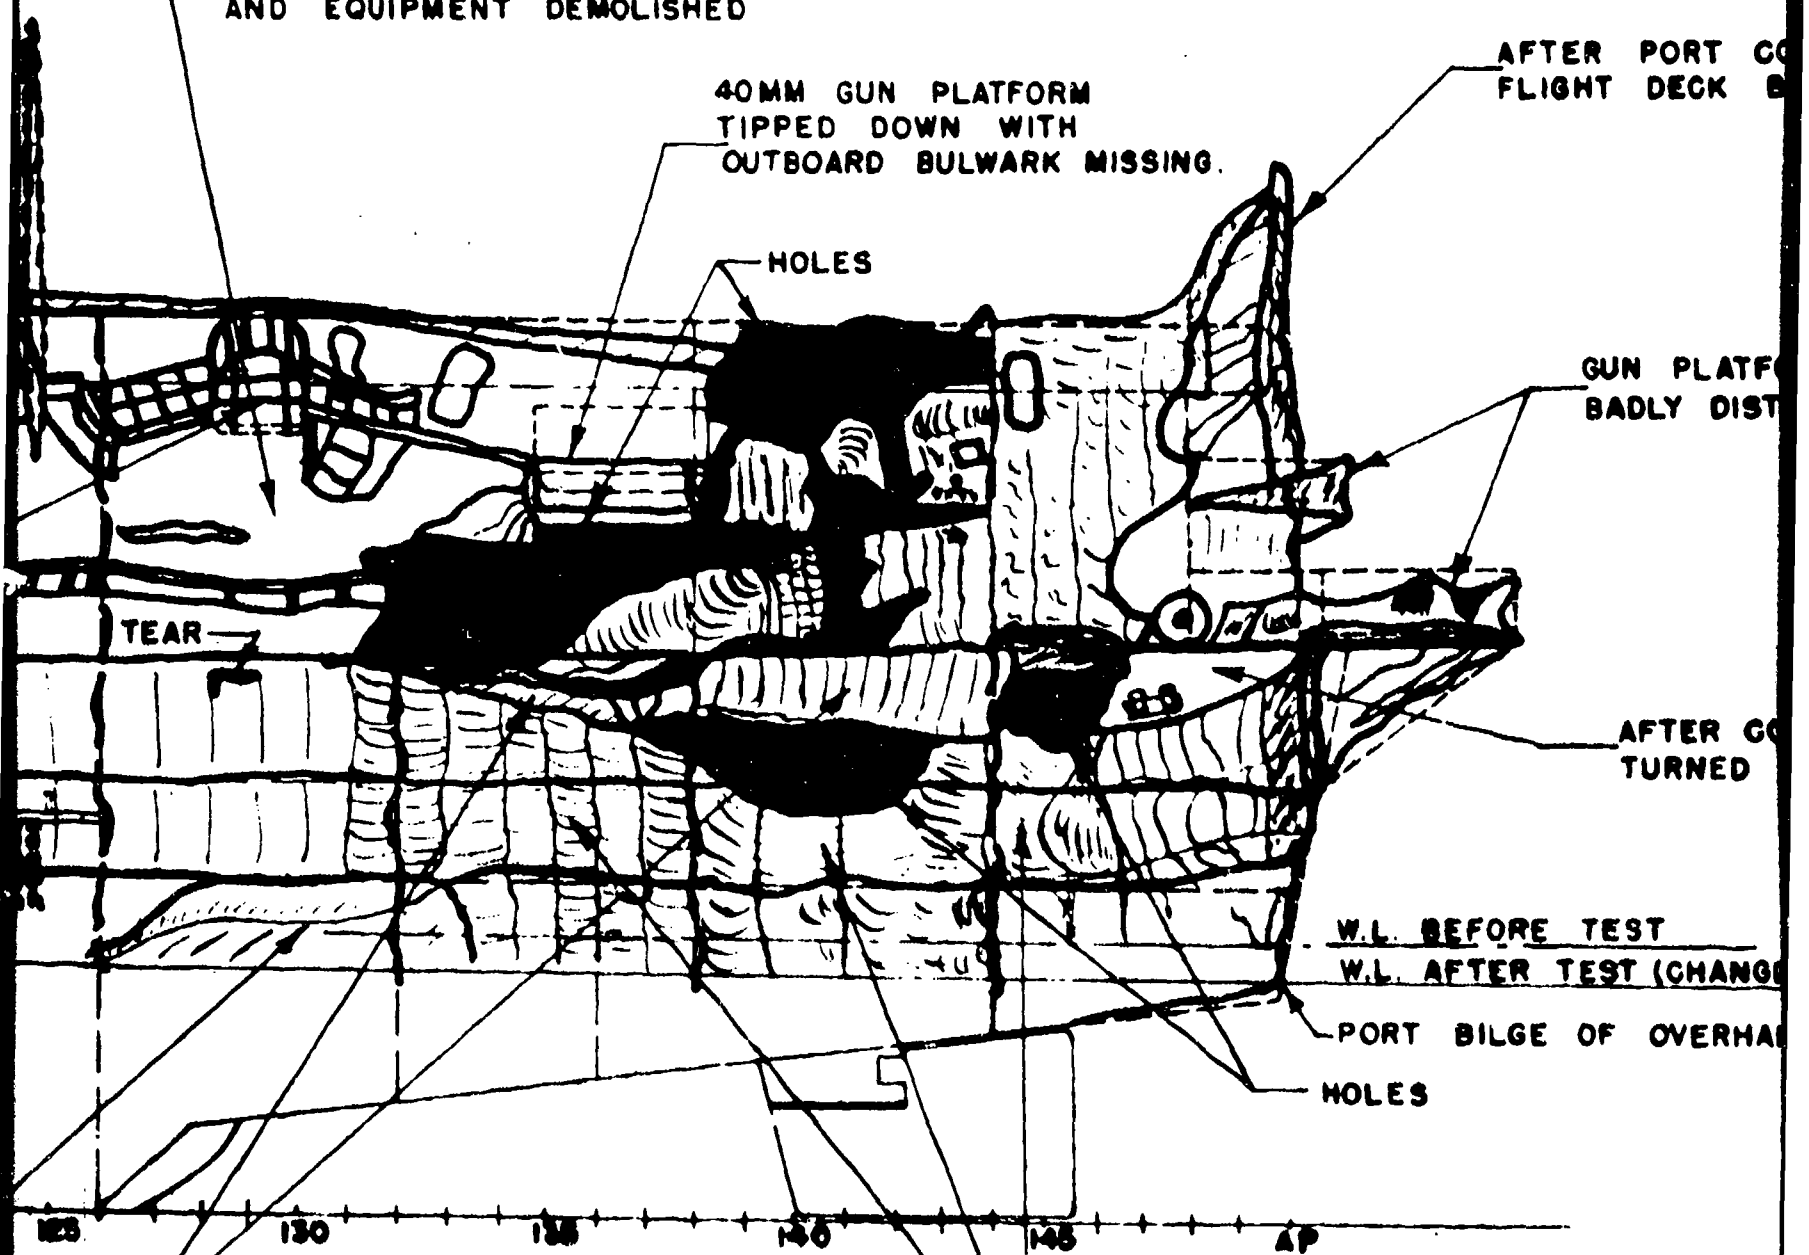
AFTER PORT CORNER OF
FLIGHT DECK BLOWN UPWARD.

GUN PLATFORM BULWARKS
BADLY DISTORTED AND TORN.

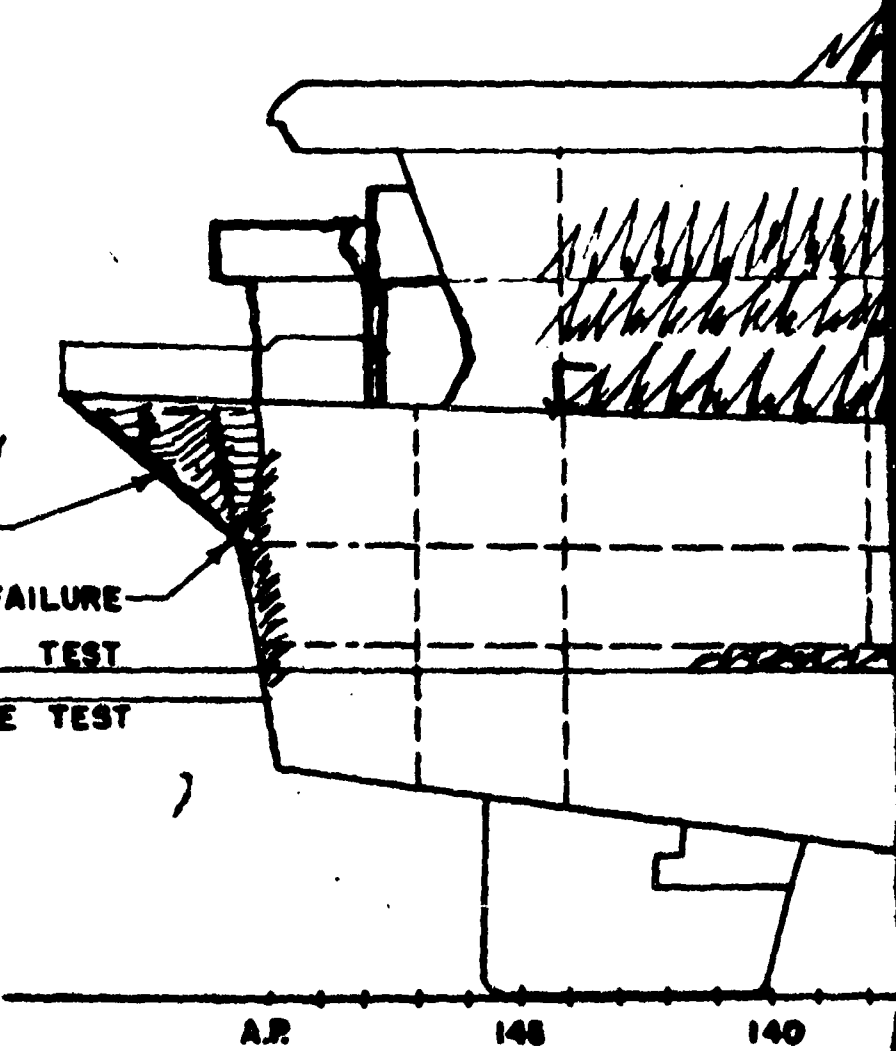
COMPTS. ABOVE MAIN DK. AFT C
GUTTED BY FIRE. 12 TORPEDOES
EXPLODED WITH LOW ORDER DE

MAIN DECK COVERING IGNITED BY
FROM FIRE BELOW.

ROLLER CURTAINS BLOWN AWAY

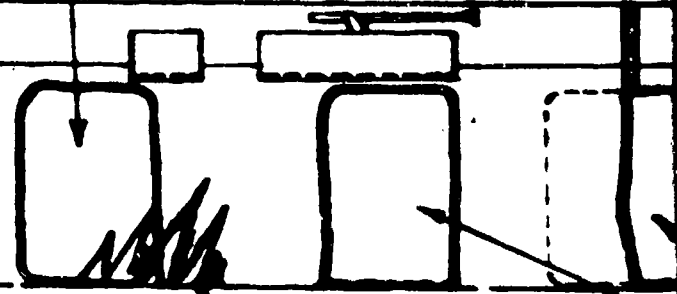
TRAILER BURNED

TEAR IN PLATING

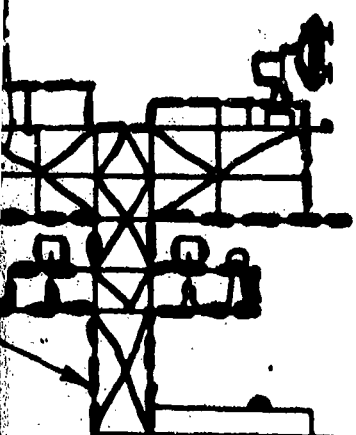
DEFLECTED SLIGHTLY TO STBD.

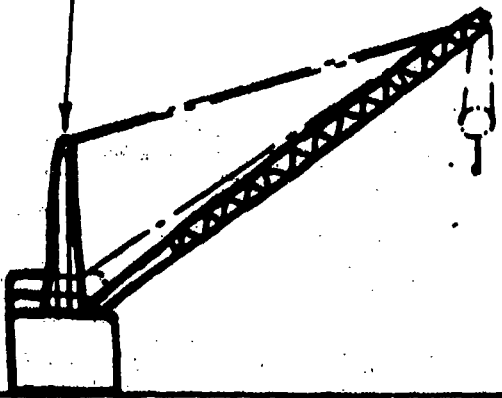
CARRIED AWAY

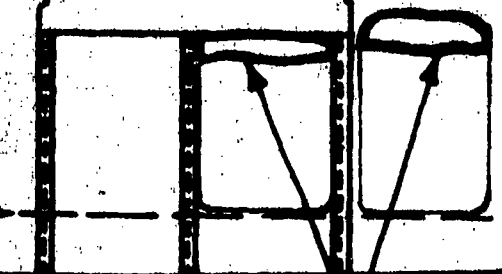
ROLLER CURTAINS
BLOWN AWAY

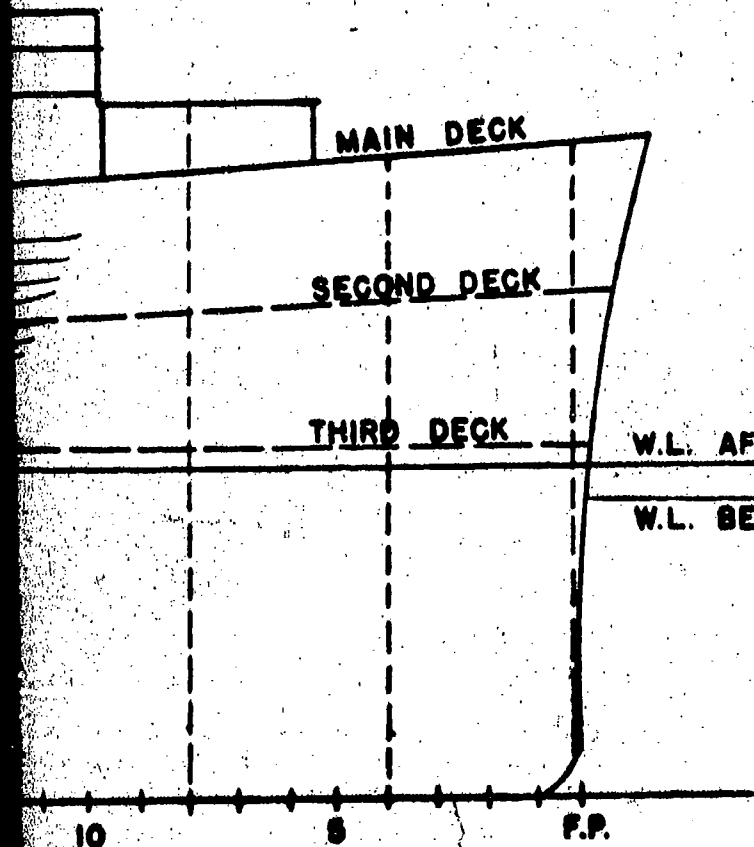
W.L. AFTER TEST DUE TO 5° STBD. LIST.

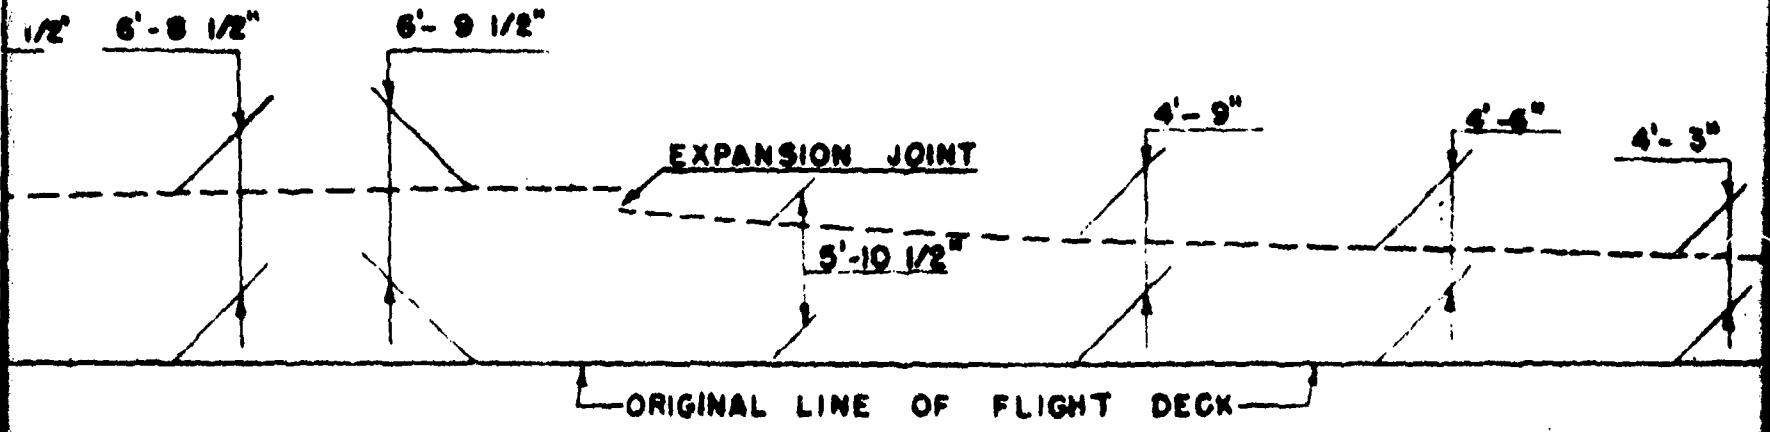
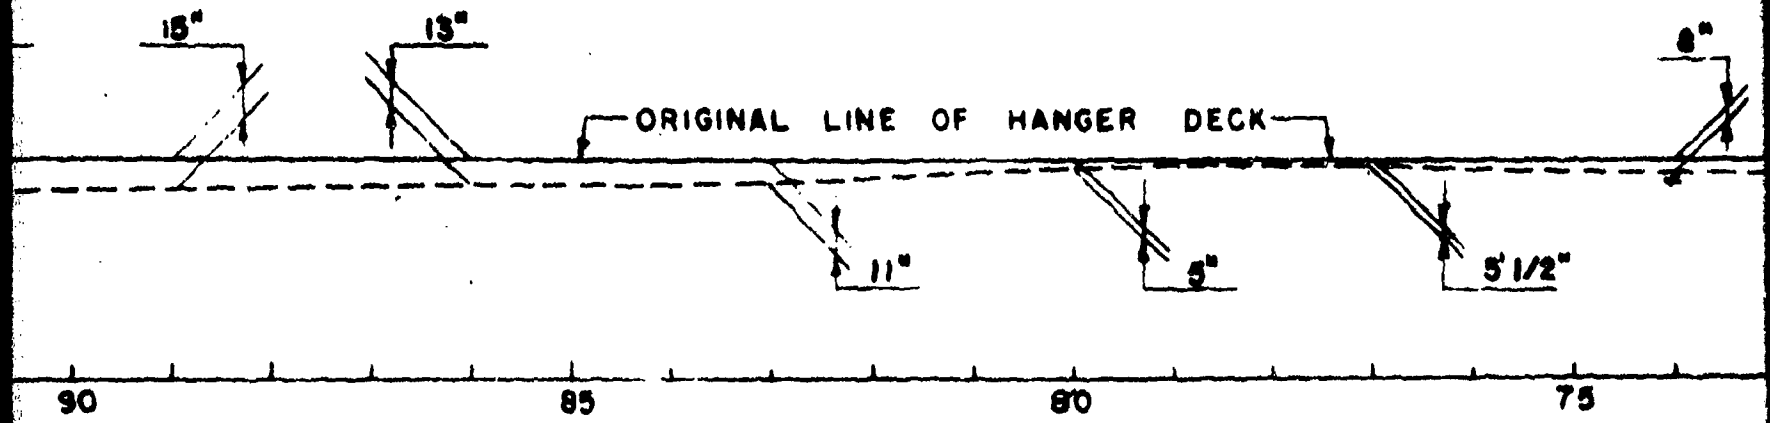
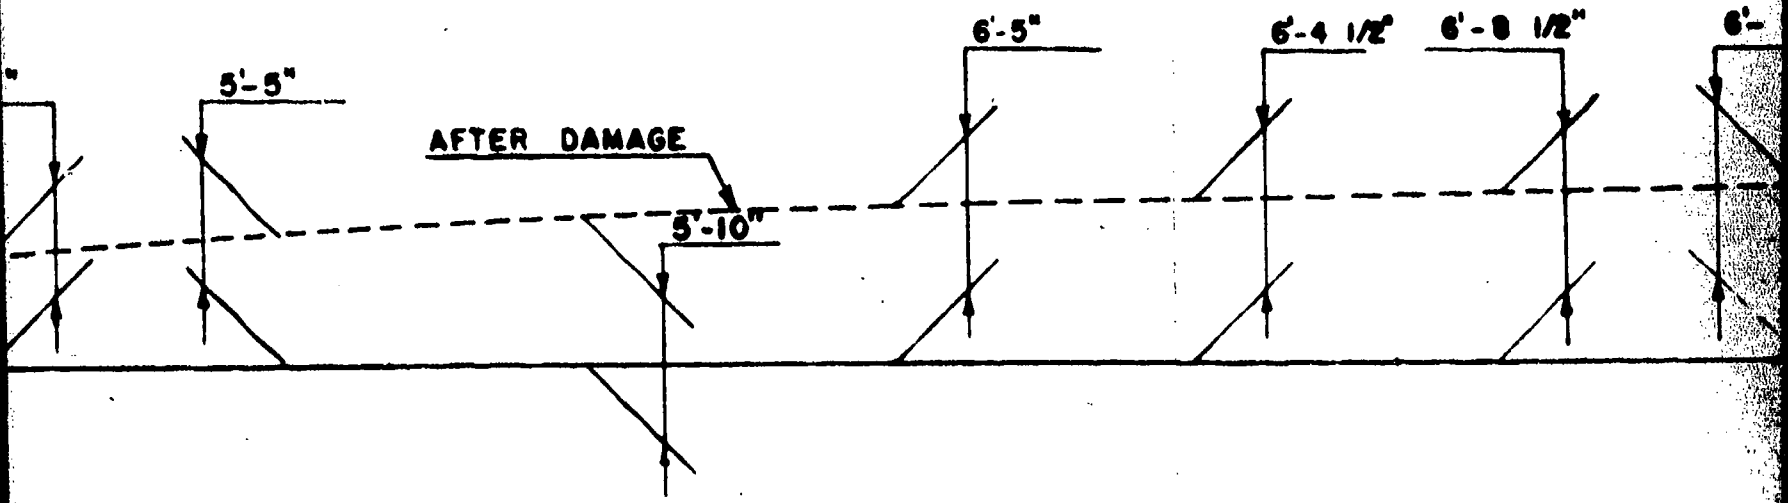
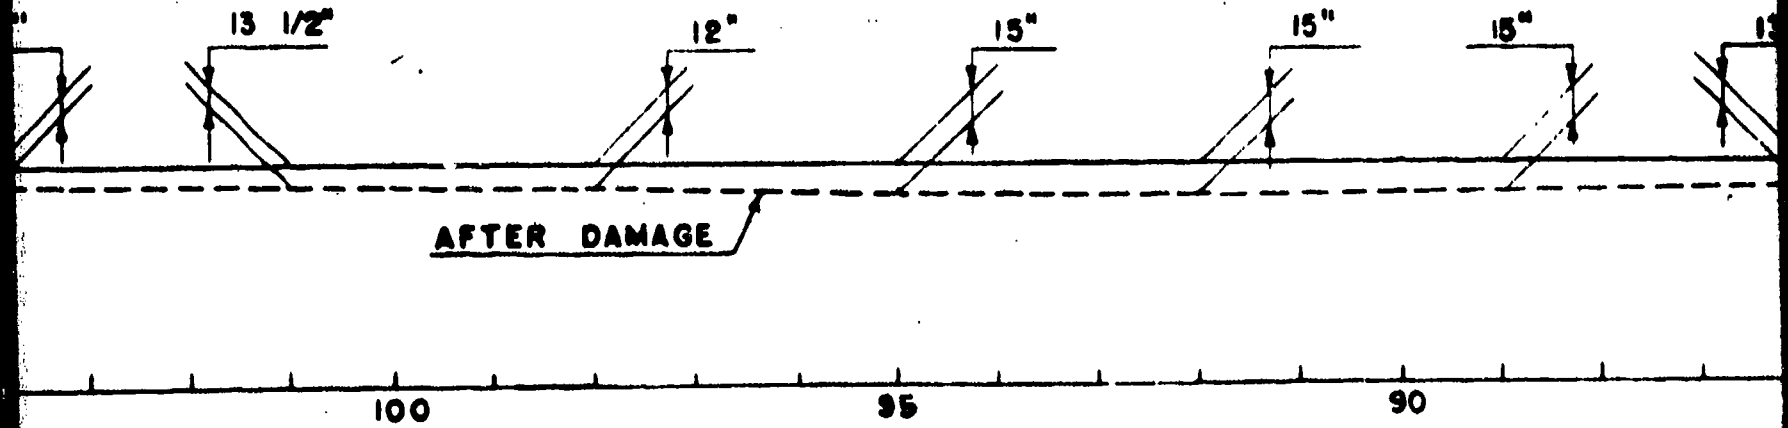
PLATE NO. 3

Beginning at the expansion joint, frame 63 1/2, the flight deck is very sharply hipped along the centerline with the wood decking broken, and several feet of the thin steel deck plating below is split. Between the expansion joints at frames 63 1/2 and 84 1/2 the deck, on the starboard side, begins to rise at the deck edge and progresses in a straight line to the hip at the centerline. On the port side between these frames there is little change from the normal position of the deck between the edge and approximately eleven feet inboard of it. From here the deck peaks sharply in a straight line to the hip at the center. In addition to the transverse deformation, the longitudinal run of the deck rises from 63 1/2 in a fair curve to about 7 feet above normal at frame 84 1/2. The sharp peaking disappears at about frame 80 where it fades into a smooth arch which continues past the expansion joint at frame 84 1/2. Except for the splintering of the wood at breaks along the centerline the surface of the deck is in materially good condition.

Between the expansion joints at frames 84 1/2 and 111 1/2, the flight deck drops in a relatively smooth curve from about 7 feet above normal to a generally normal position at 111 1/2. The ridge in this area is more pronounced because the deck maintains its normal position for about nine feet inboard of the deck edge both port and starboard, thus making a much sharper angle of rise. The wood decking here is also splintered and broken and the thin steel plating

ELEVATION
 FLIGHT DECK & HANGER DECK CENTERLINE
 SCALE - 1/8" = 1'-0"

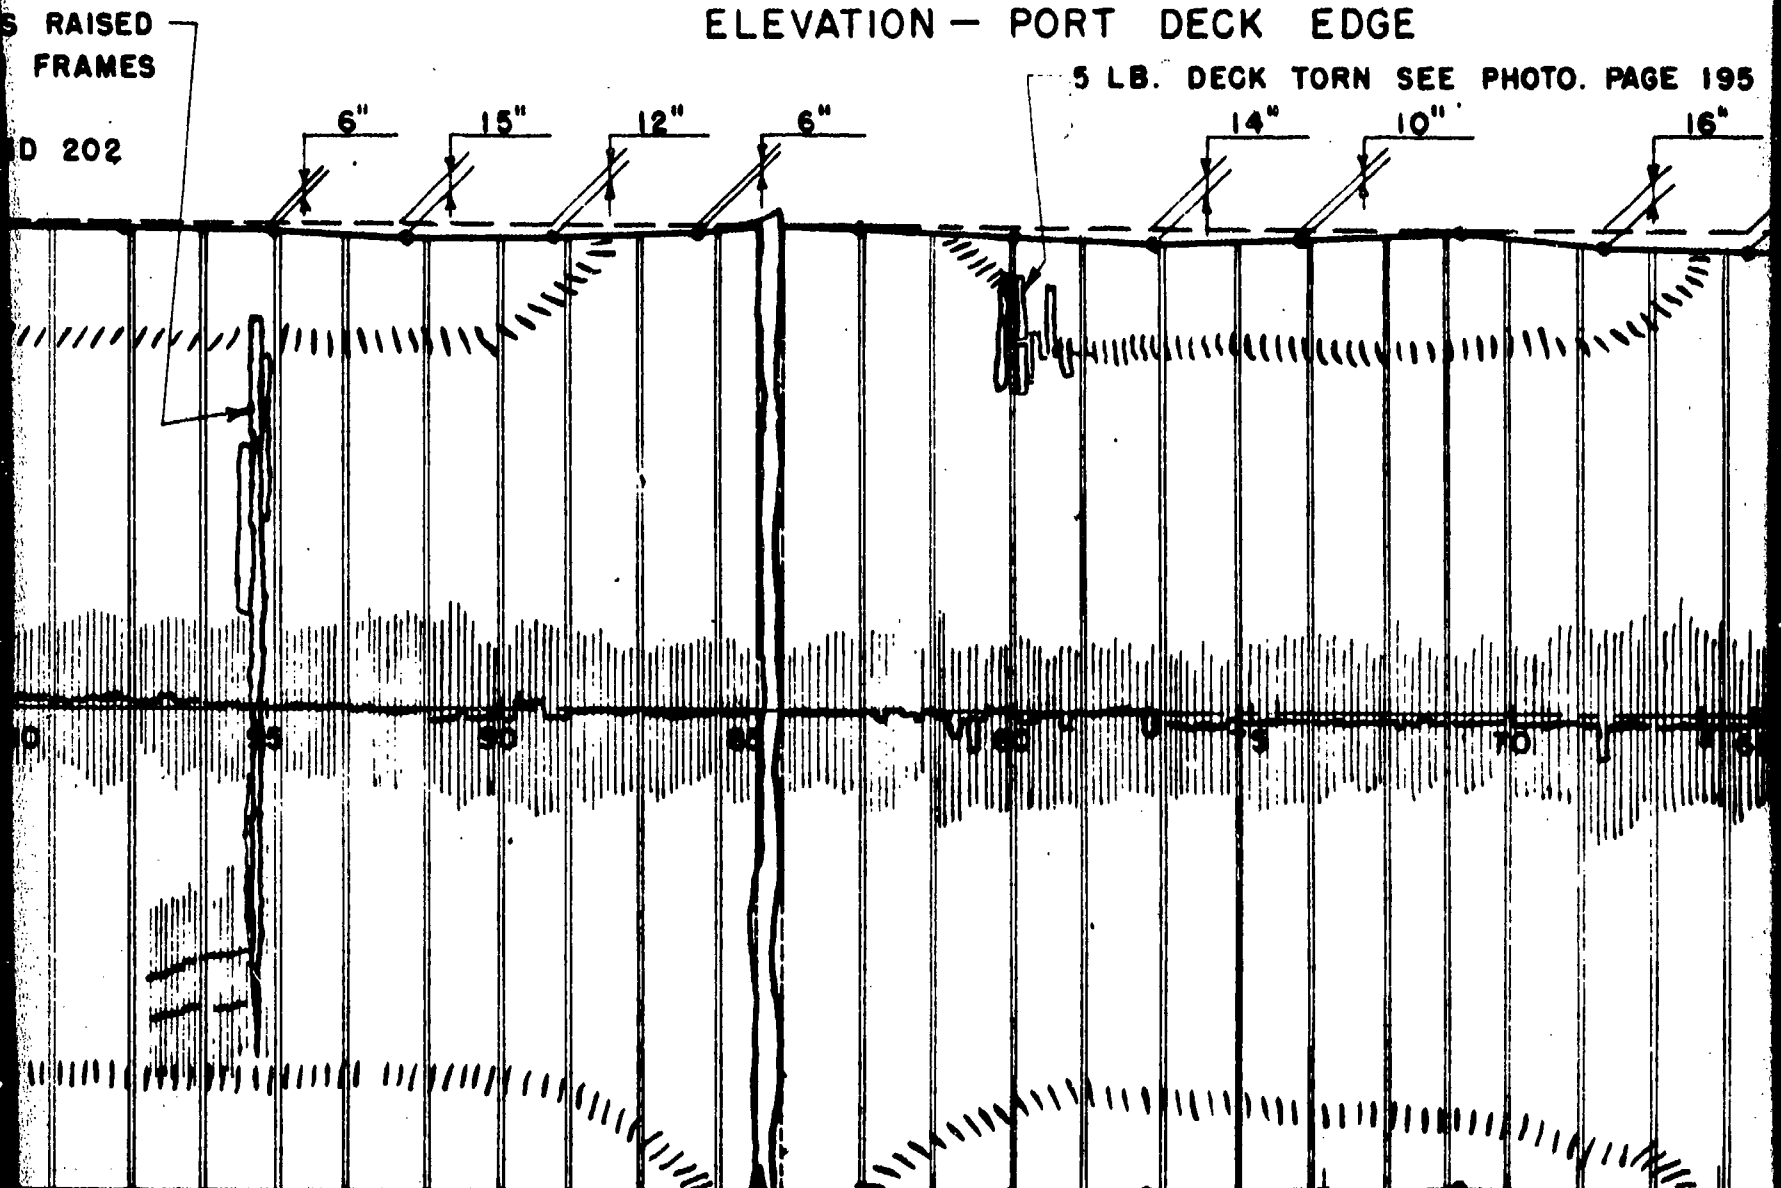
EXPANSION JOINT DISTORTED AND SPREAD APART.

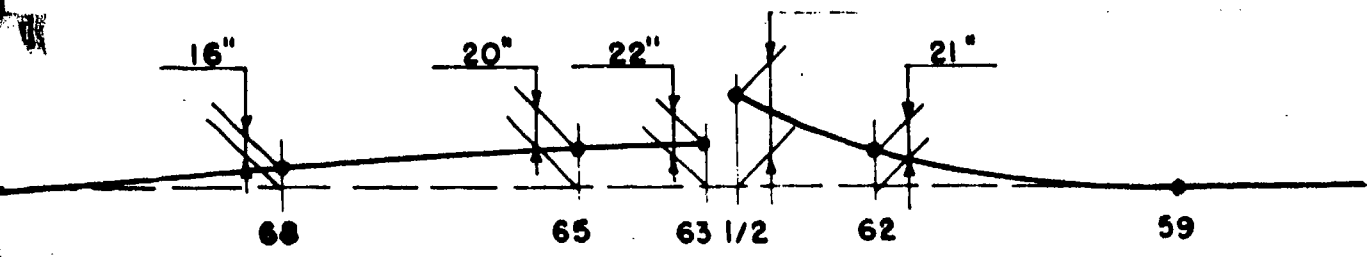
FLIGHT DECK ABREAST AND FORWARD OF FORWARD ELEVATOR IS SLIGHTLY DISTORTED BUT ESSENTIALLY UNDAMAGED.

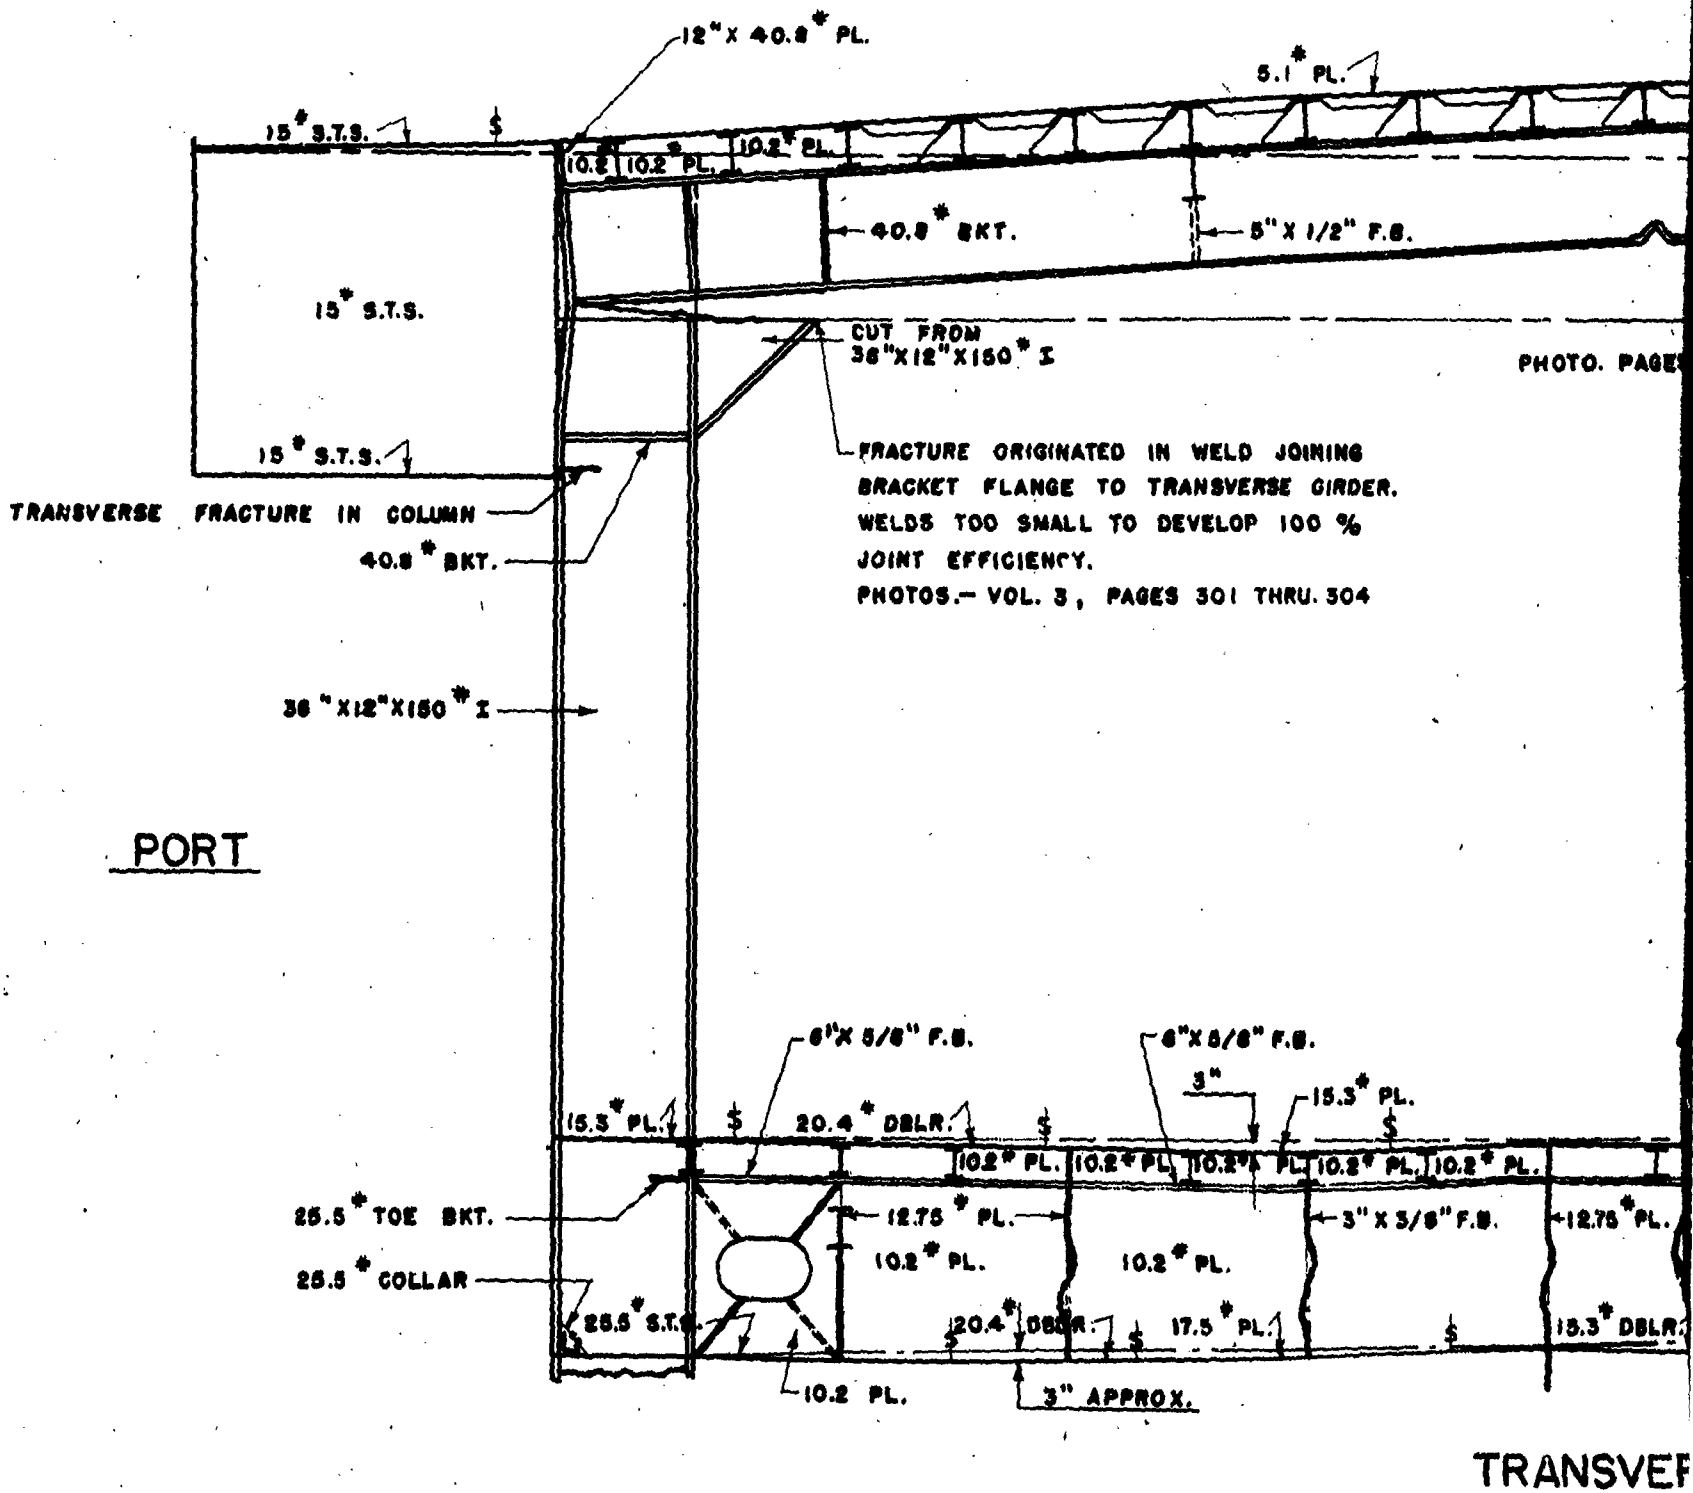
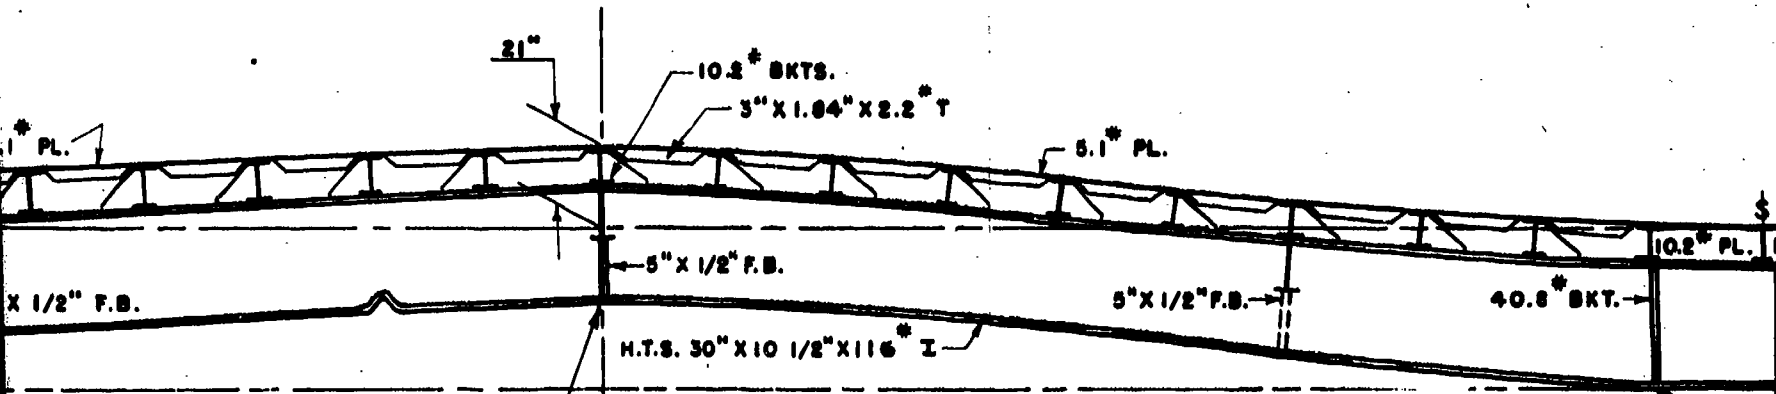
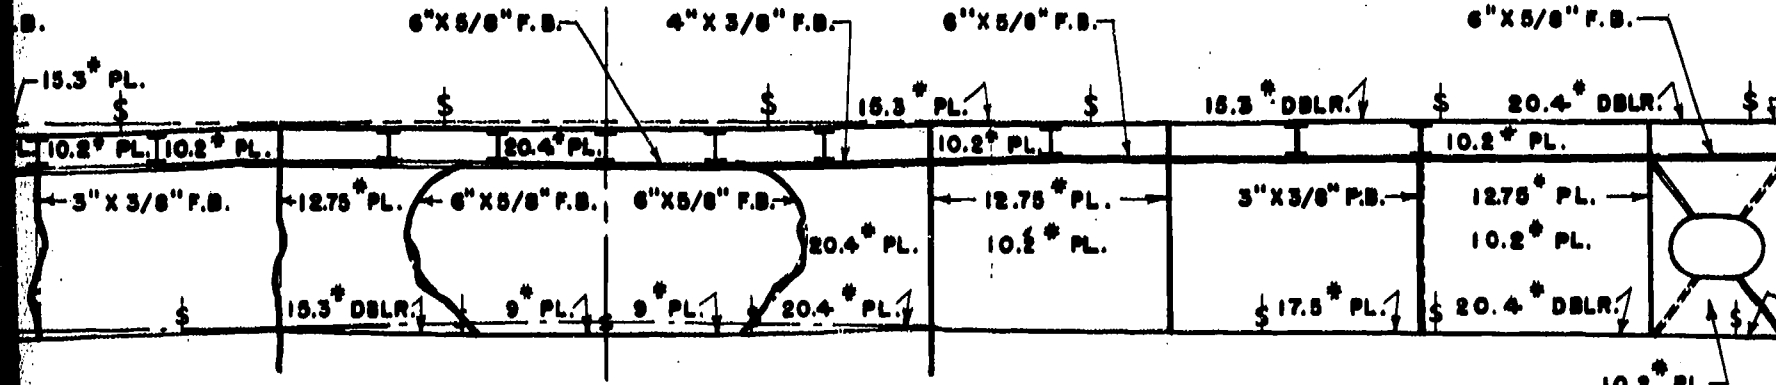
PLATE NO. 5 10384

PHOTO. PAGES 305-308

FRACTURE ORIGINATED IN WELD JOINING
TRIPPING BRACKET TO INBOARD FLANGE
TO COLUMN
PHOTOS. - VOL. 3, PAGE 309

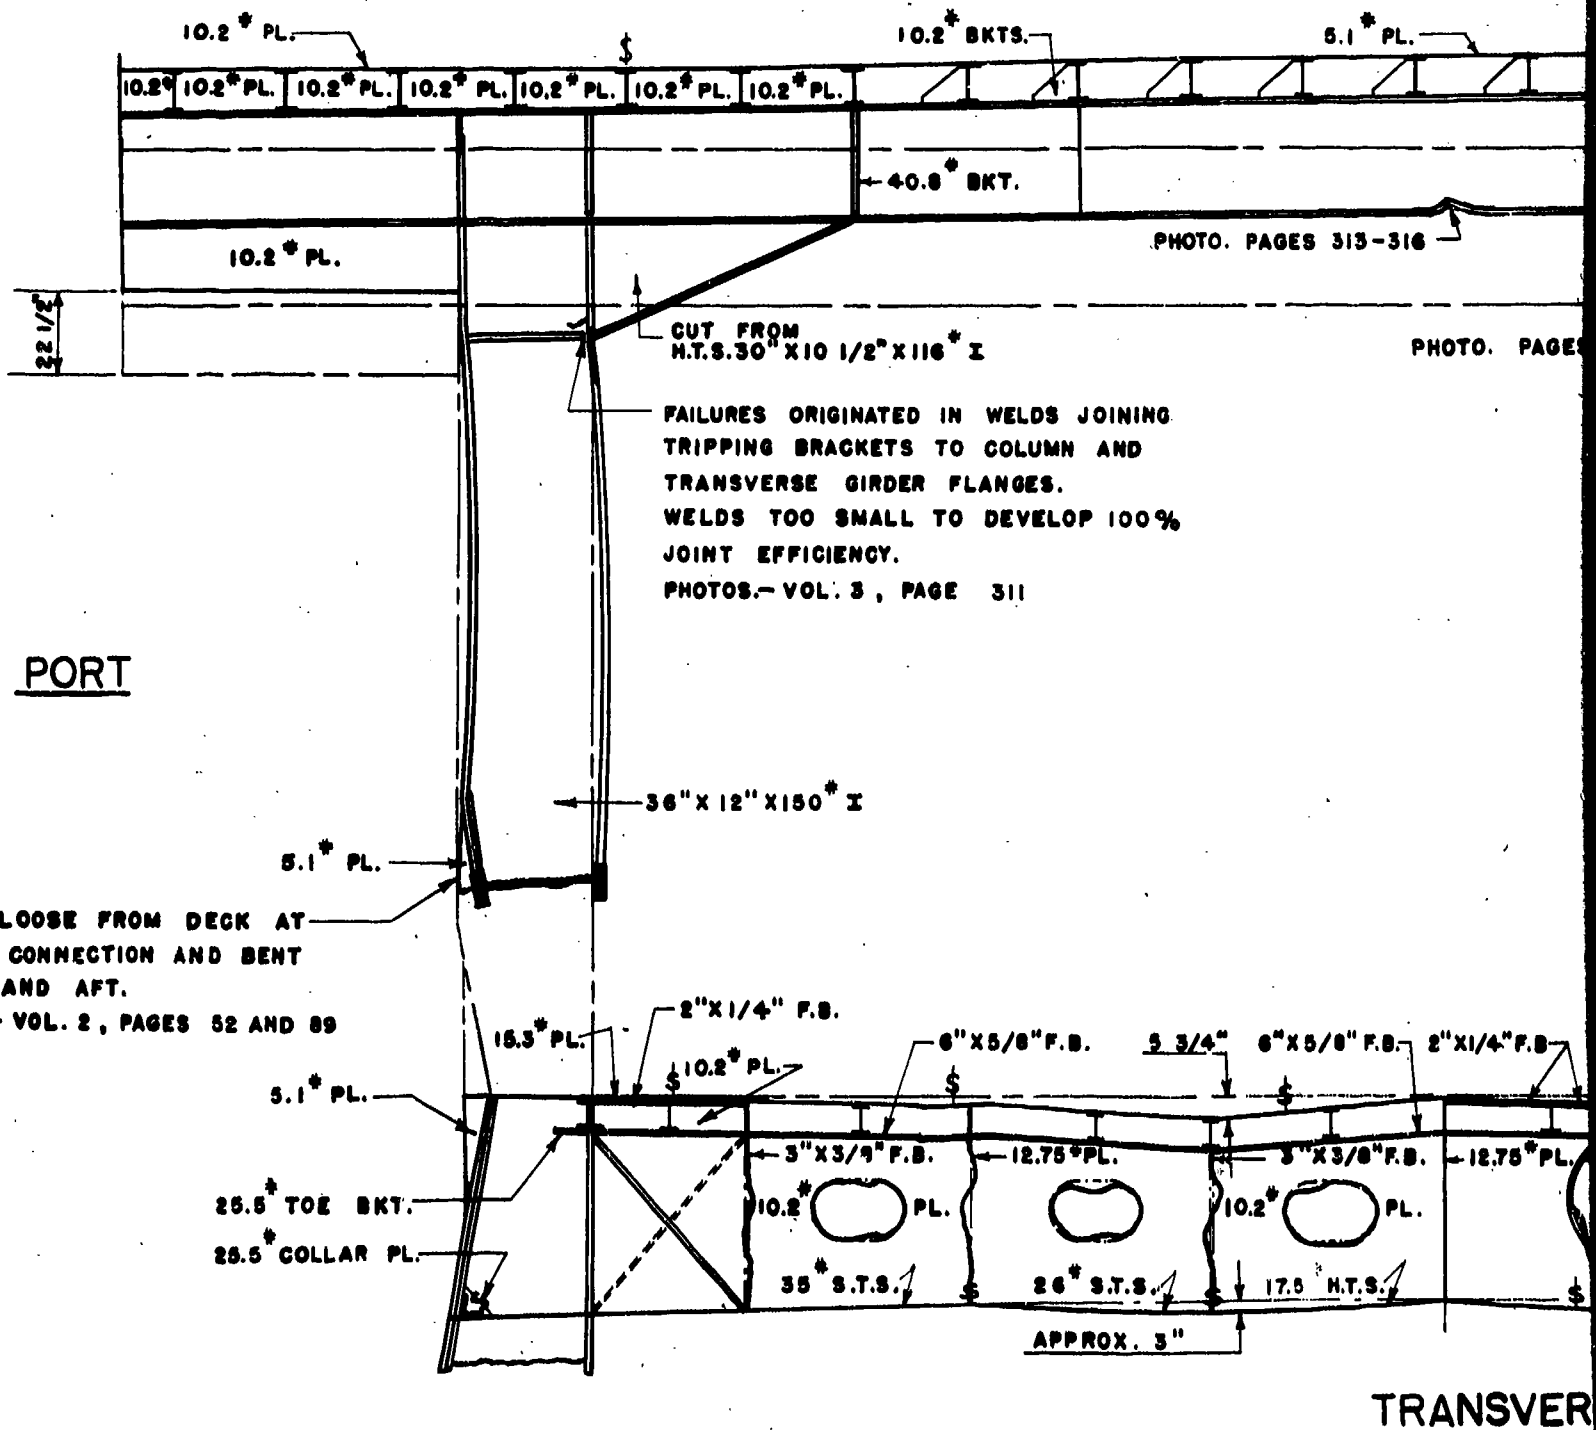
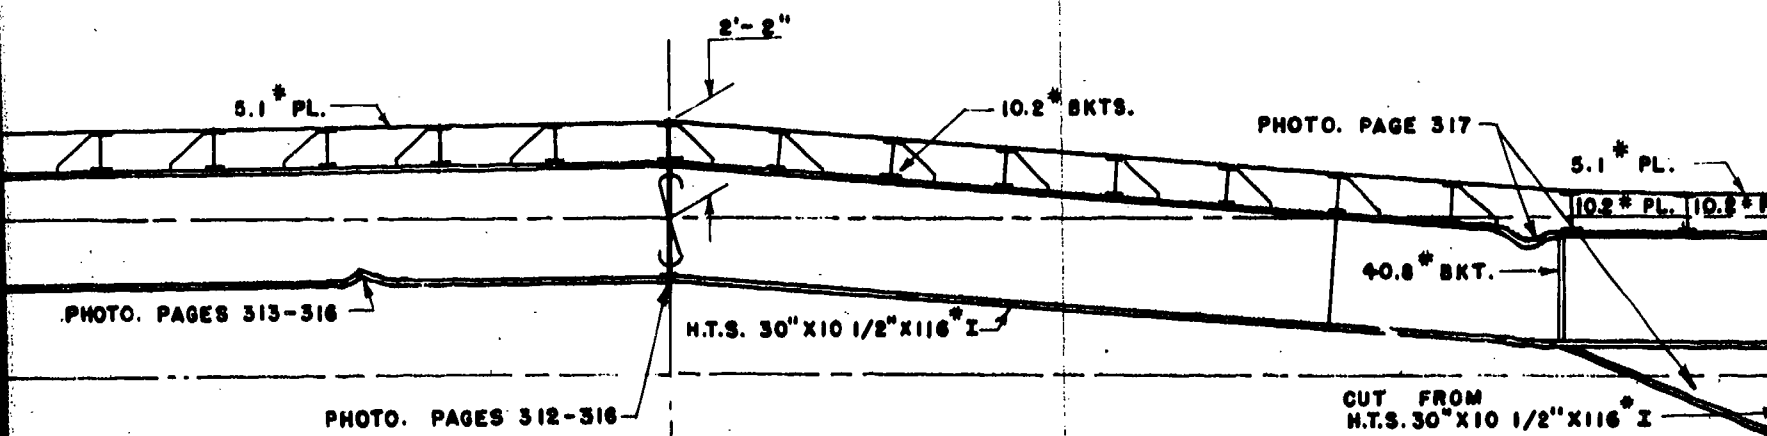
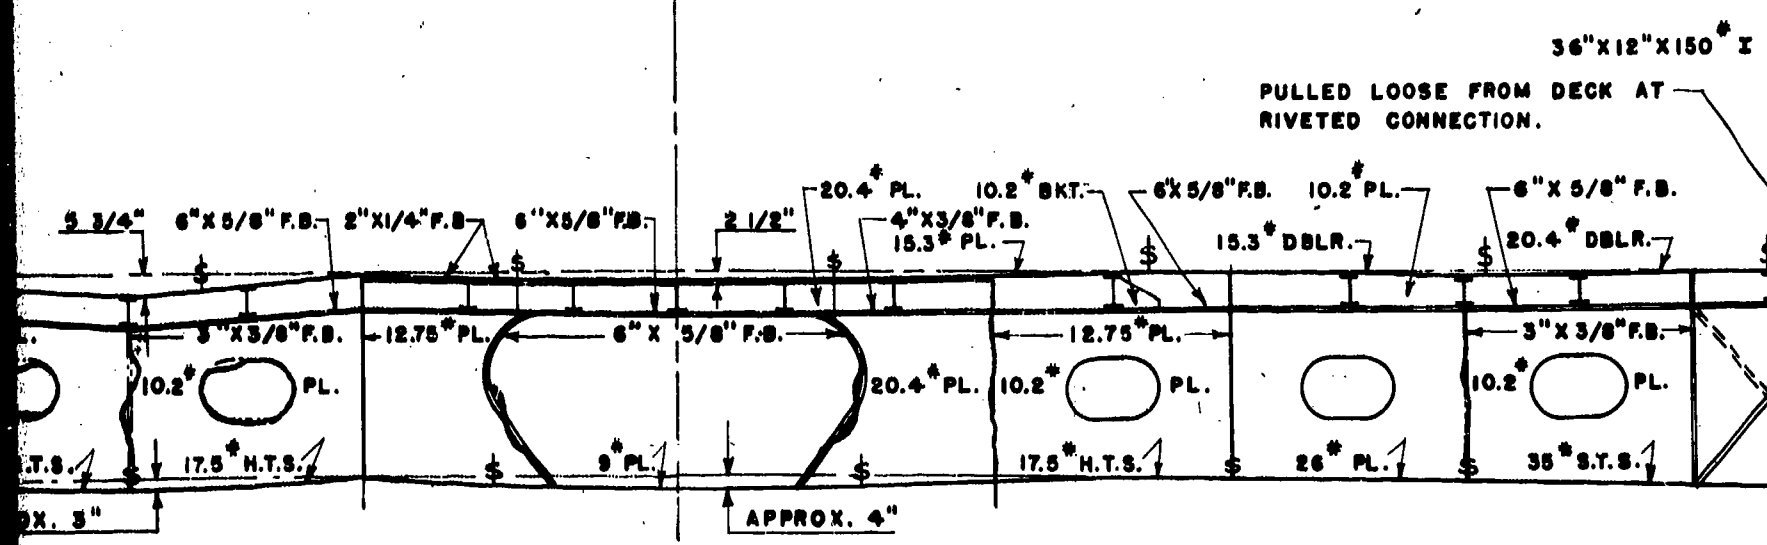
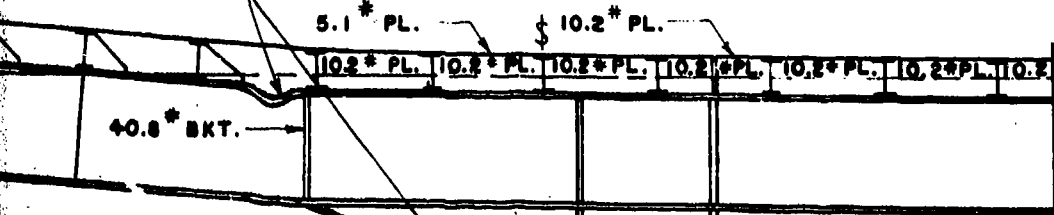
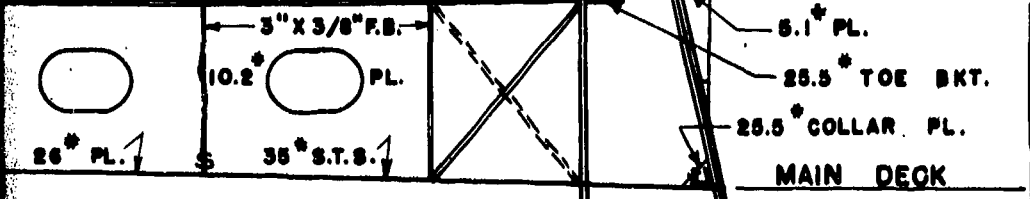
TRANSVERSE SECTION AT FR. 62
LOOKING FORD.

PULLED LOOSE FROM DECK AT
RIVETED CONNECTION.

FRACTURE ORIGINATED IN WELD JOINING
 BRACKET FLANGE TO COLUMN.
 WELD TOO SMALL TO DEVELOP 100%
 JOINT EFFICIENCY.
 PHOTOS.- VOL. 3 PAGES 329, 330

FRACTURE OF
 OF GIRDER
 LINE BUTT.
 PHOTOS.- VOL. 3

PULLED LOOSE FROM DECK
 AT RIVETED CONNECTION
 PHOTO. PAGES 327, 328

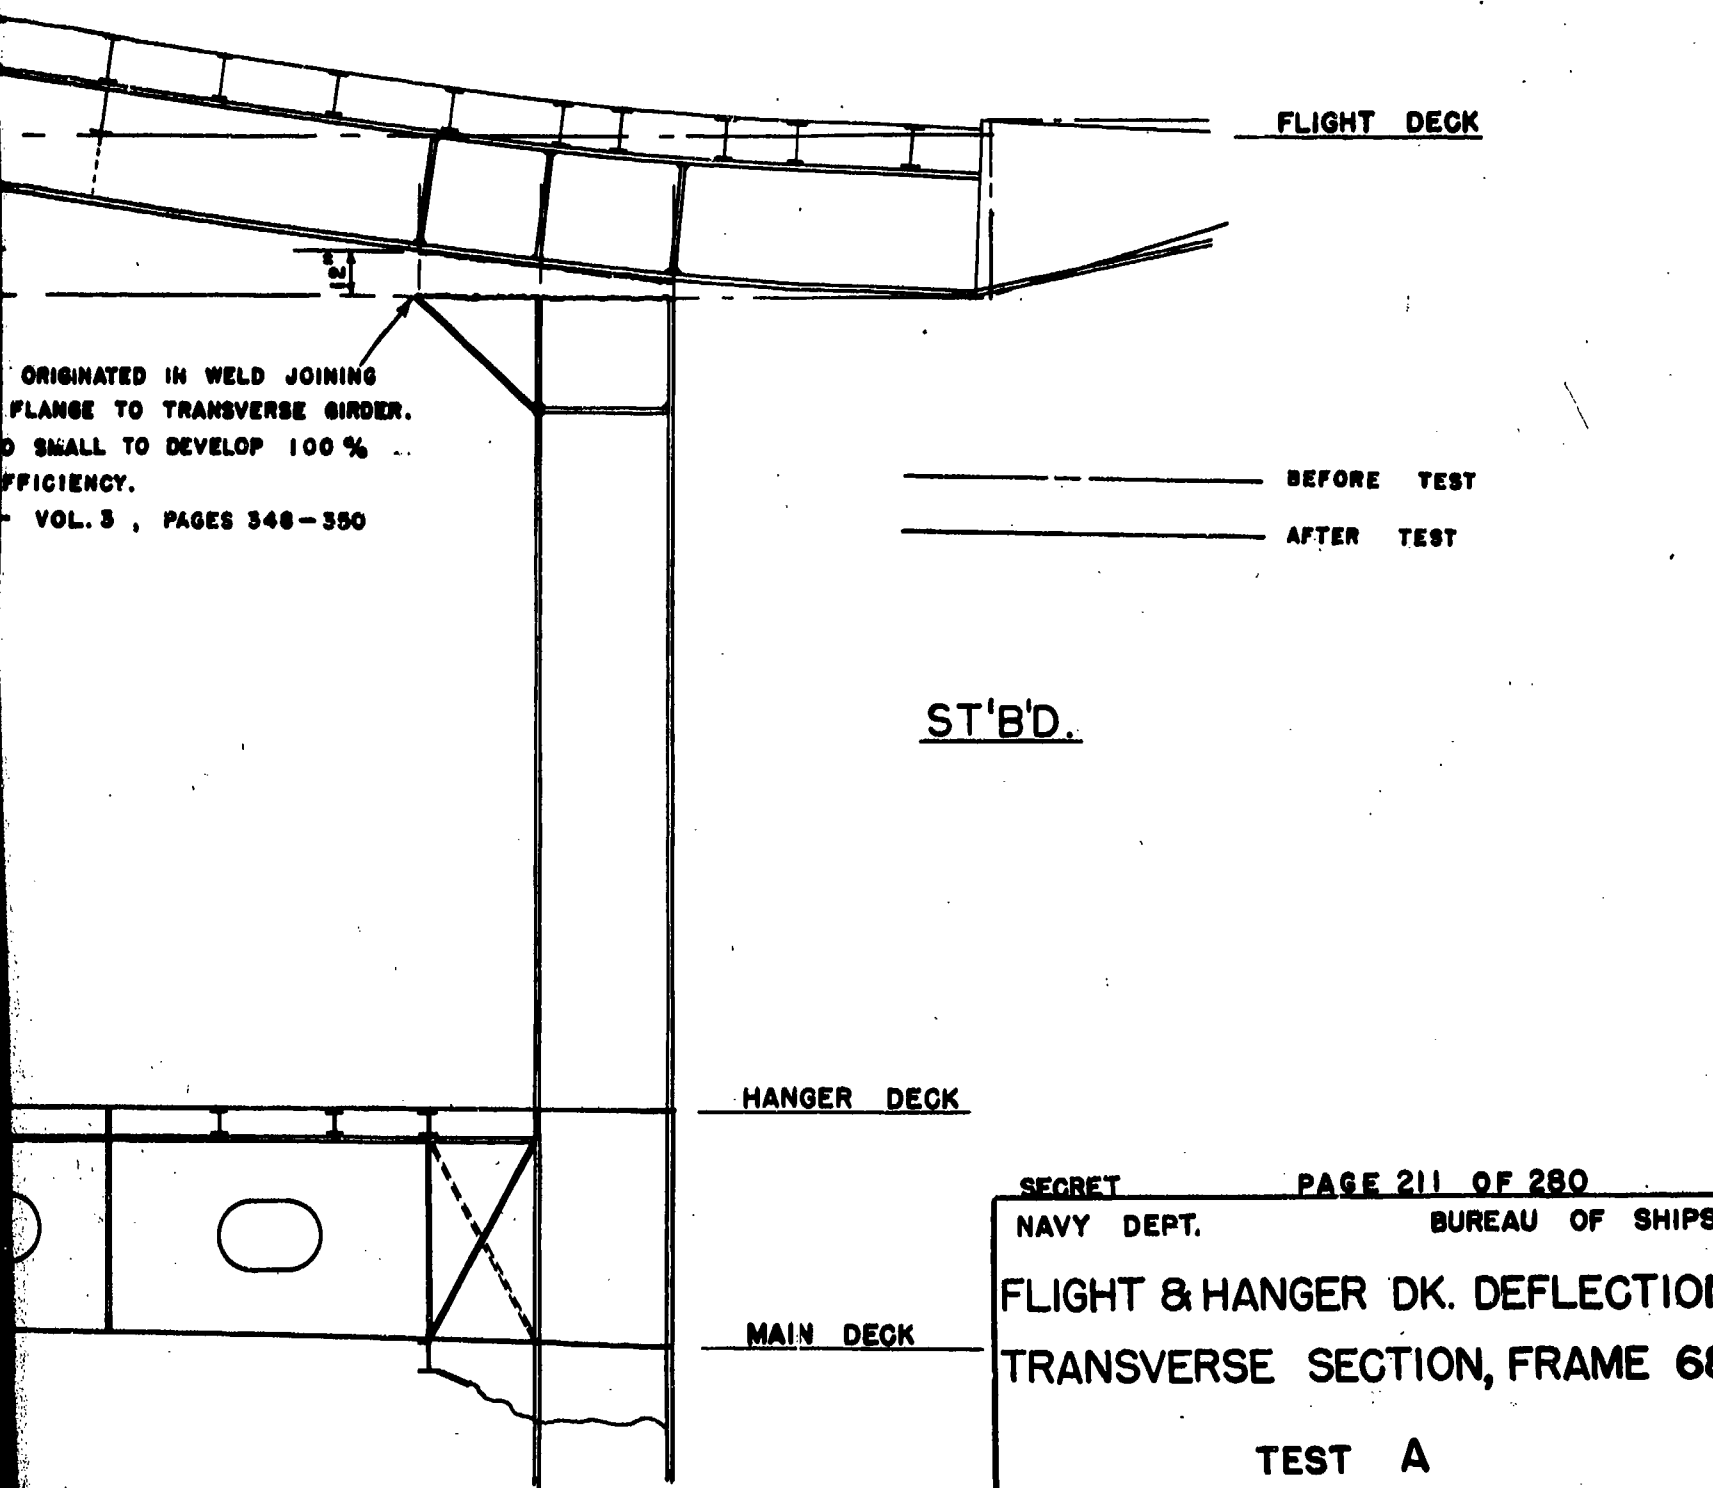
TRANSVERSE SECTION AT FR. 68
LOOKING FORD.

FRACTURE ORIGINATED IN WELD JOINING
BRACKET FLANGE TO TRANSVERSE GIRDER.
WELD TOO SMALL TO DEVELOP 100 %
JOINT EFFICIENCY.
PHOTOS.— VOL. 3 , PAGES 346 - 350

ORIGINATED IN WELD JOINING
 FLANGE TO TRANSVERSE GIRDER.
 TOO SMALL TO DEVELOP 100 %
 EFFICIENCY.
 VOL. 3 , PAGES 348 - 350

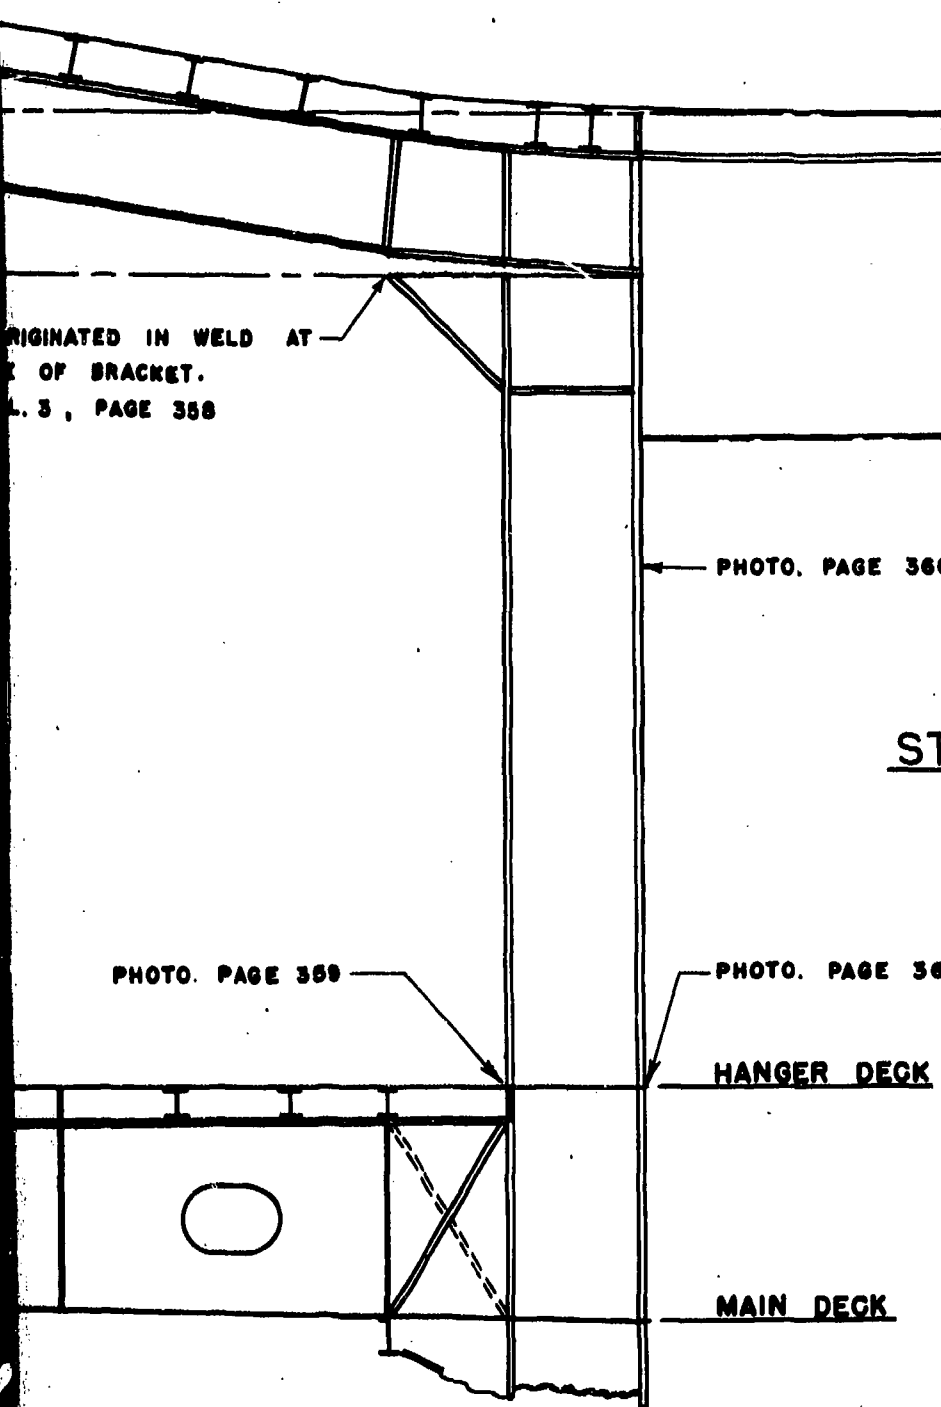
TRANSVERSE SECTION AT FR. 71
LOOKING FORD.

FRACTURE ORIGINATED IN WELD AT INBOARD TOE OF BRACKET.
PHOTOS.— VOL. 3, PAGE 358

ORIGINATED IN WELD AT
OF BRACKET.
L. 3, PAGE 358
