BUREAU OF SHIPS GROUP TECHNICAL INSPECTION REPORT

OPERATION CROSSROADS. U.S.S. INDEPENDENCE (CVL22)

TEST ABLE

VOLUME 1 OF 4 [W]

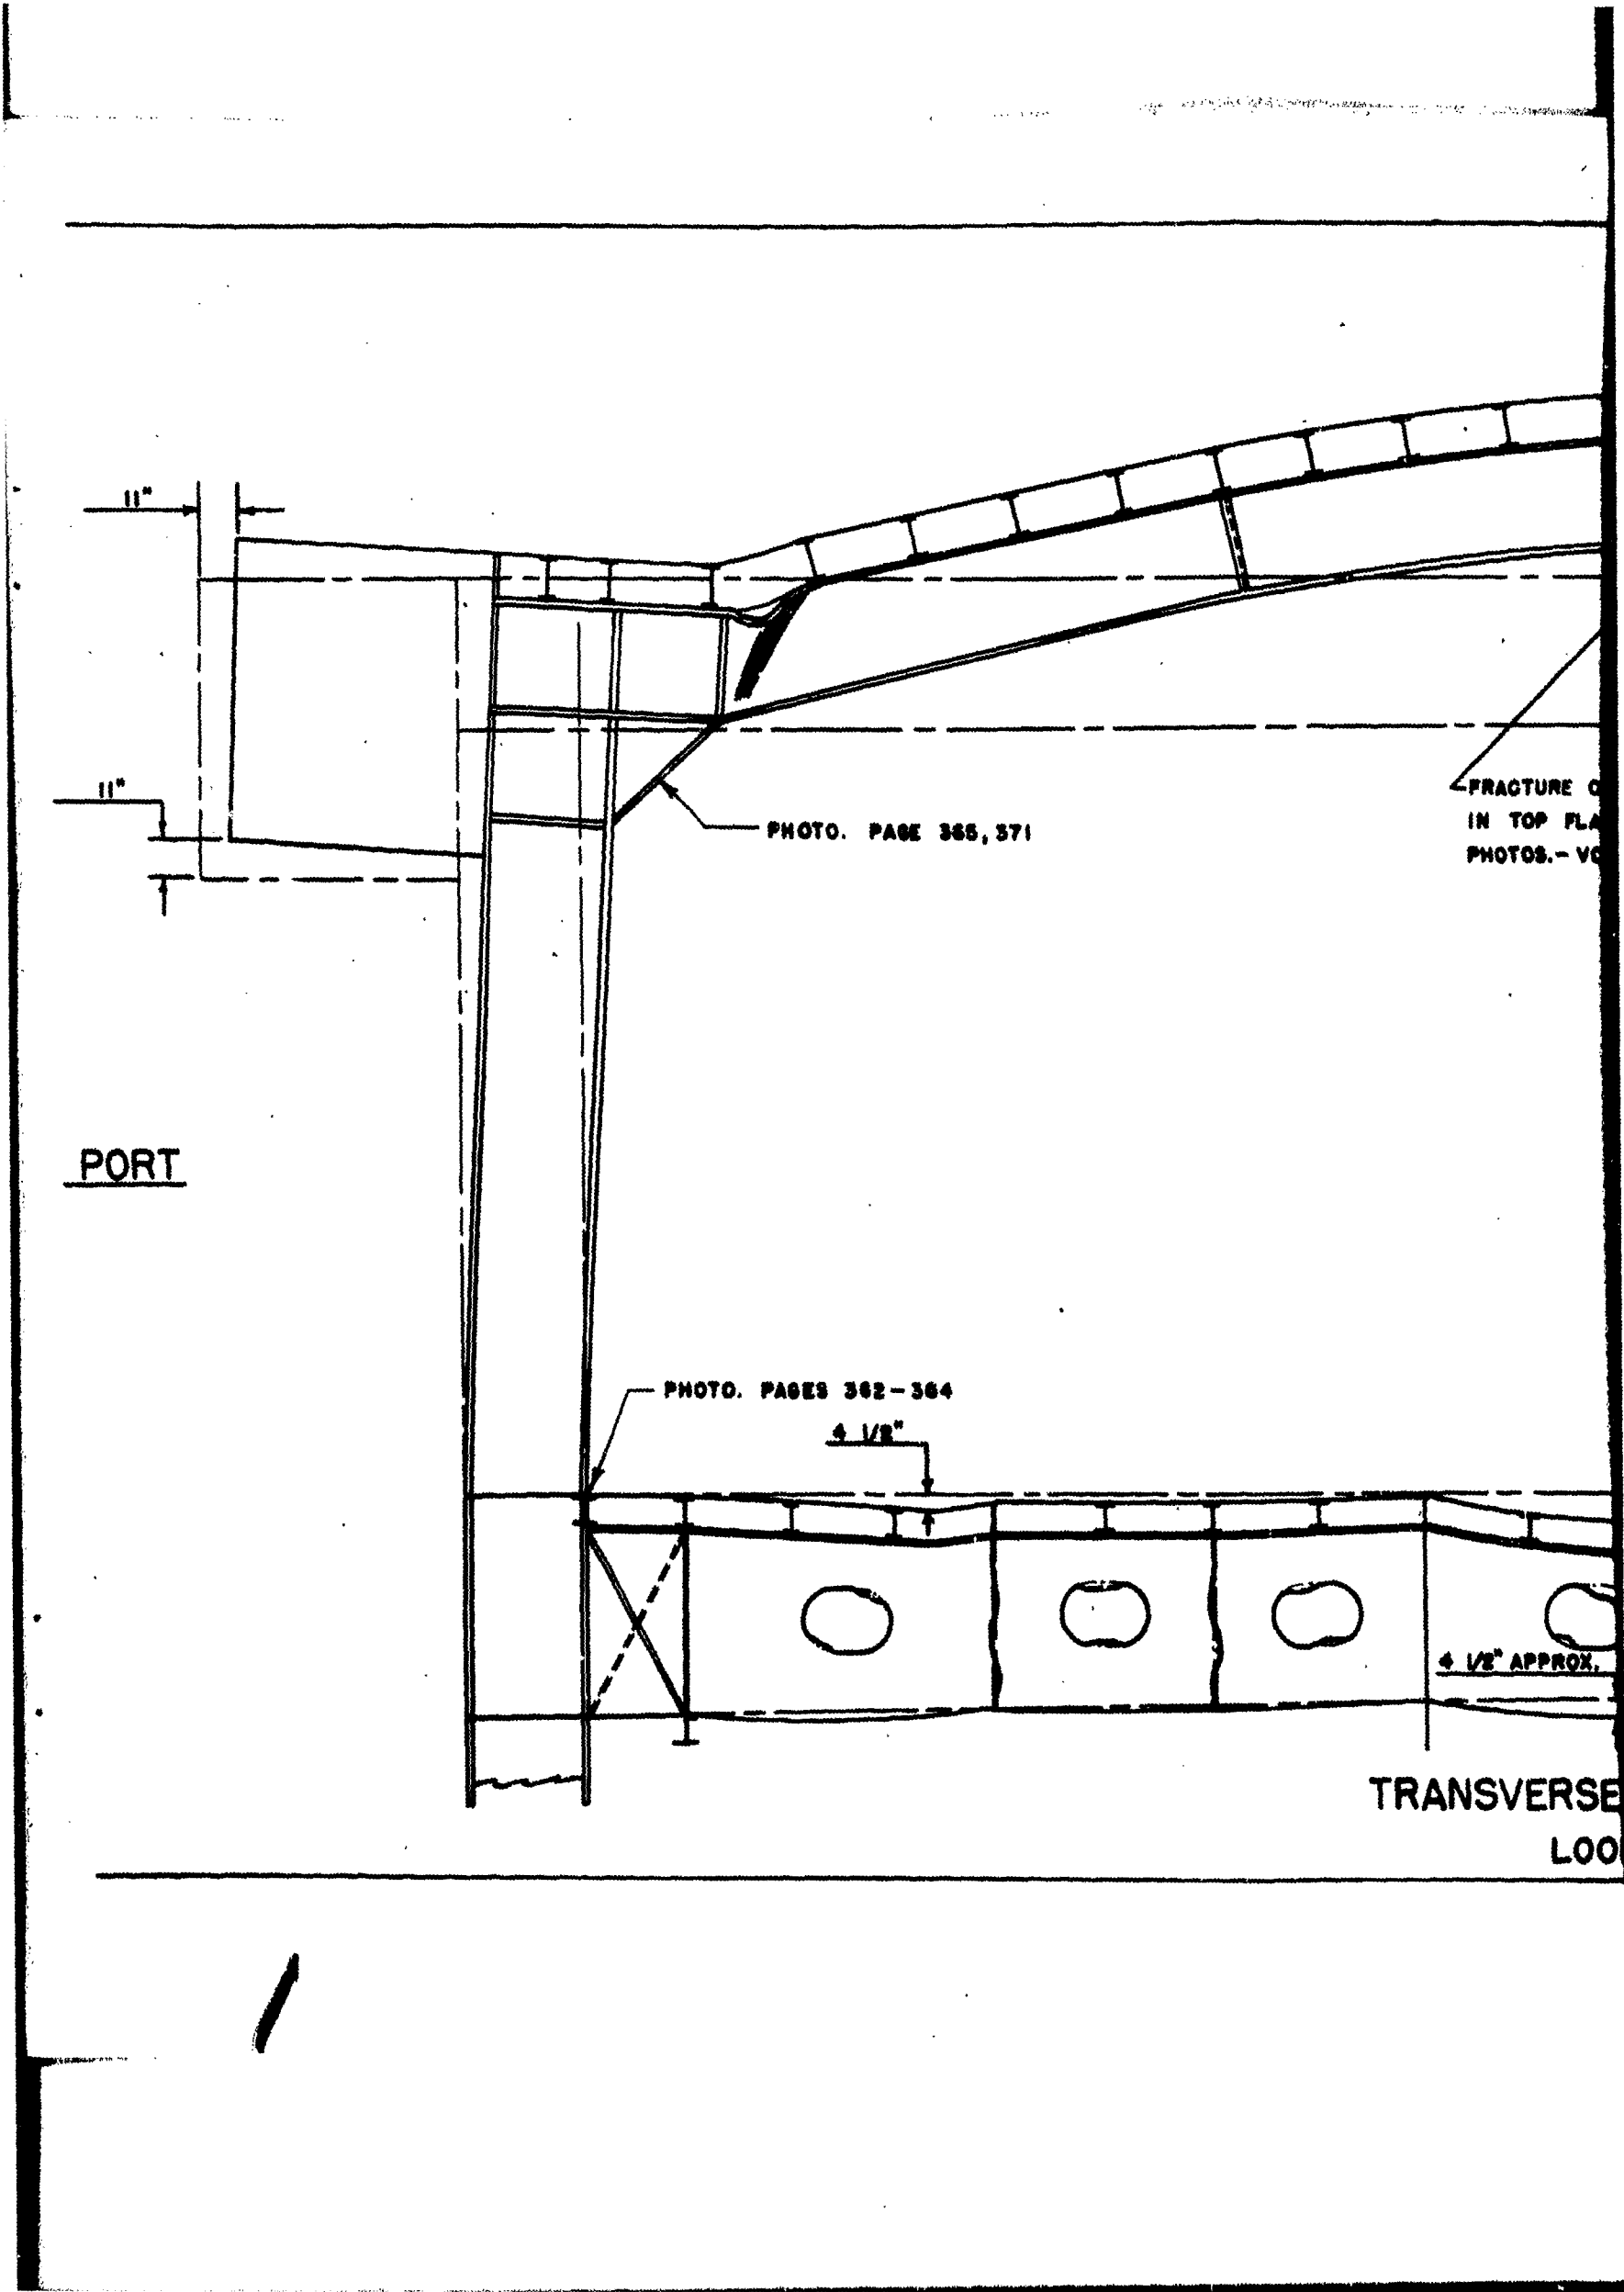
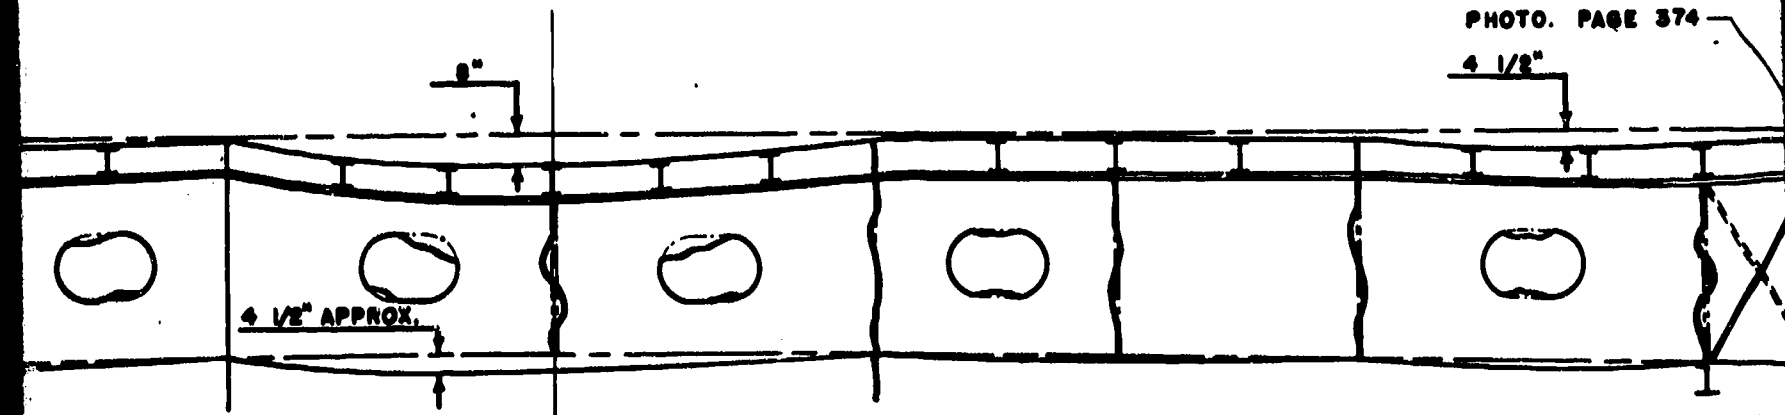
TRANSVERSE SECTION AT FR. 74
 LOOKING FORD.

← FRACTURE ORIGINATED AT EDGE OF WELD
 IN TOP FLANGE OF GIRDER.
 PHOTOS.- VOL. 3, PAGES 366-369, 375, 376

FRACTURE ORIGINATED AT UPPER EDGE
 OF WELD JOINING GIRDER AND
 BRACKET FLANGES.
 DISCONTINUITY IN STRUCTURAL DESIGN
 OF CONNECTION CONTRIBUTED TO FAILURE.
 PHOTOS.-VOL. 3, PAGES 370, 372

FRACTURE ORIGINATED AT UPPER EDGE
OF WELD JOINING GIRDER AND
BRACKET FLANGES.
DISCONTINUITY IN STRUCTURAL DESIGN
OF CONNECTION CONTRIBUTED TO FAILURE.
PHOTOS.-VOL. 3, PAGES 370, 372

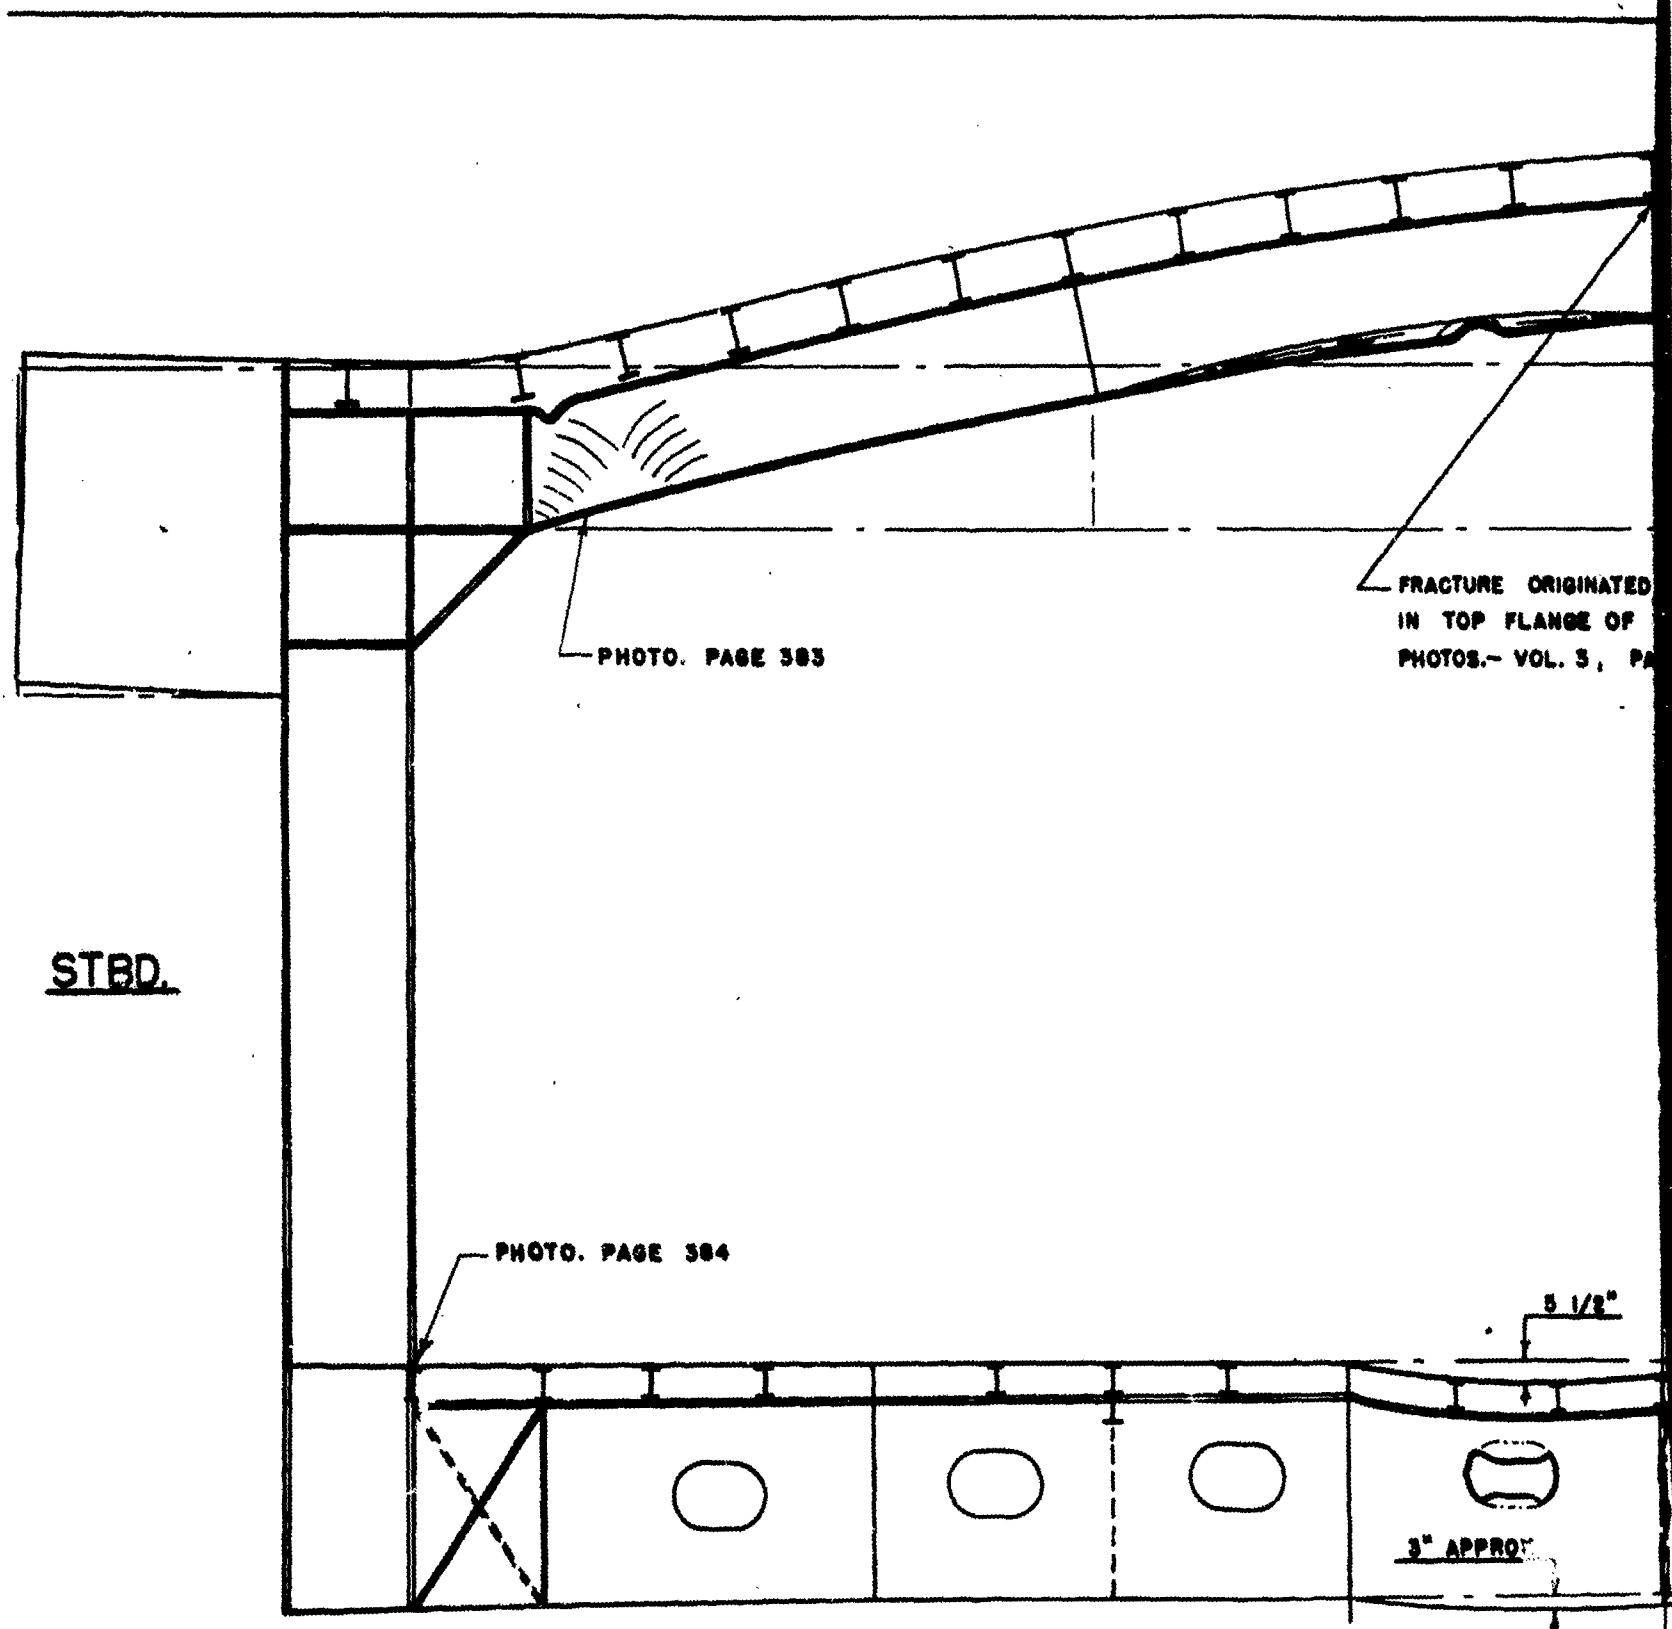
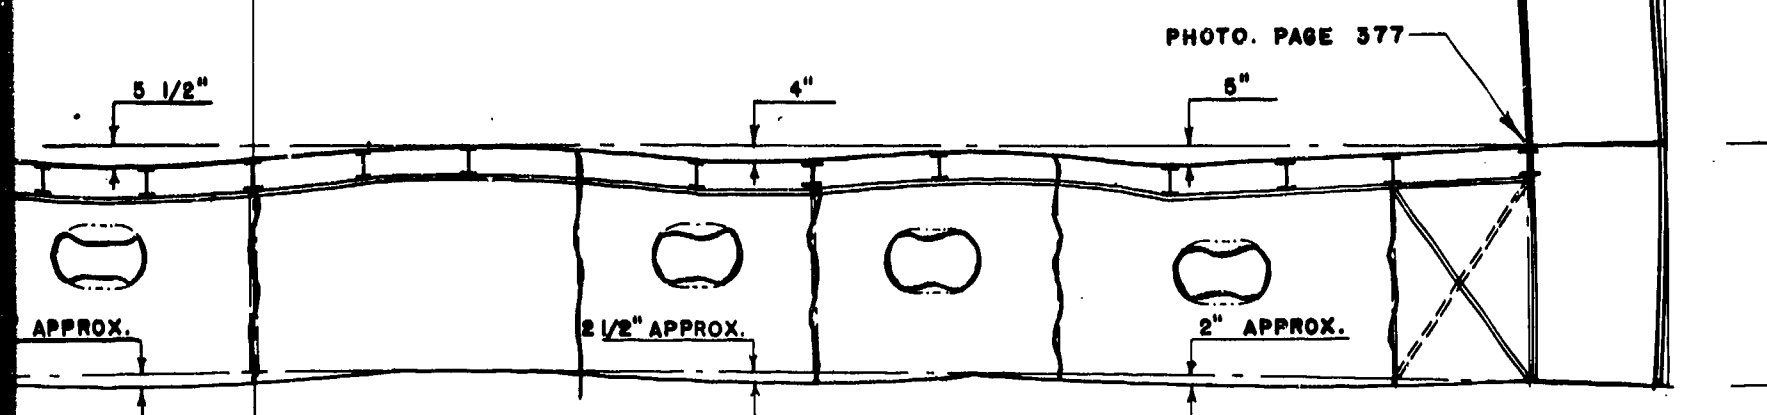
VERSE SECTION AT FR. 77
LOOKING AFT.

RACTURE ORIGINATED AT EDGE OF WELD
TOP FLANGE OF GIRDER.
PHOTOS.- VOL. 3, PAGES 379 - 382

SLIGHT FRACTURE WITH ORIGIN AT UPPER
EDGE OF WELD JOINING COLUMN AND
BRACKET FLANGE.
PHOTOS.- VOL. 3 PAGE 378

FRACTURE WITH ORIGIN AT UPPER
 WELD JOINING COLUMN AND
 FLANGE.
 VOL. 3 PAGE 378

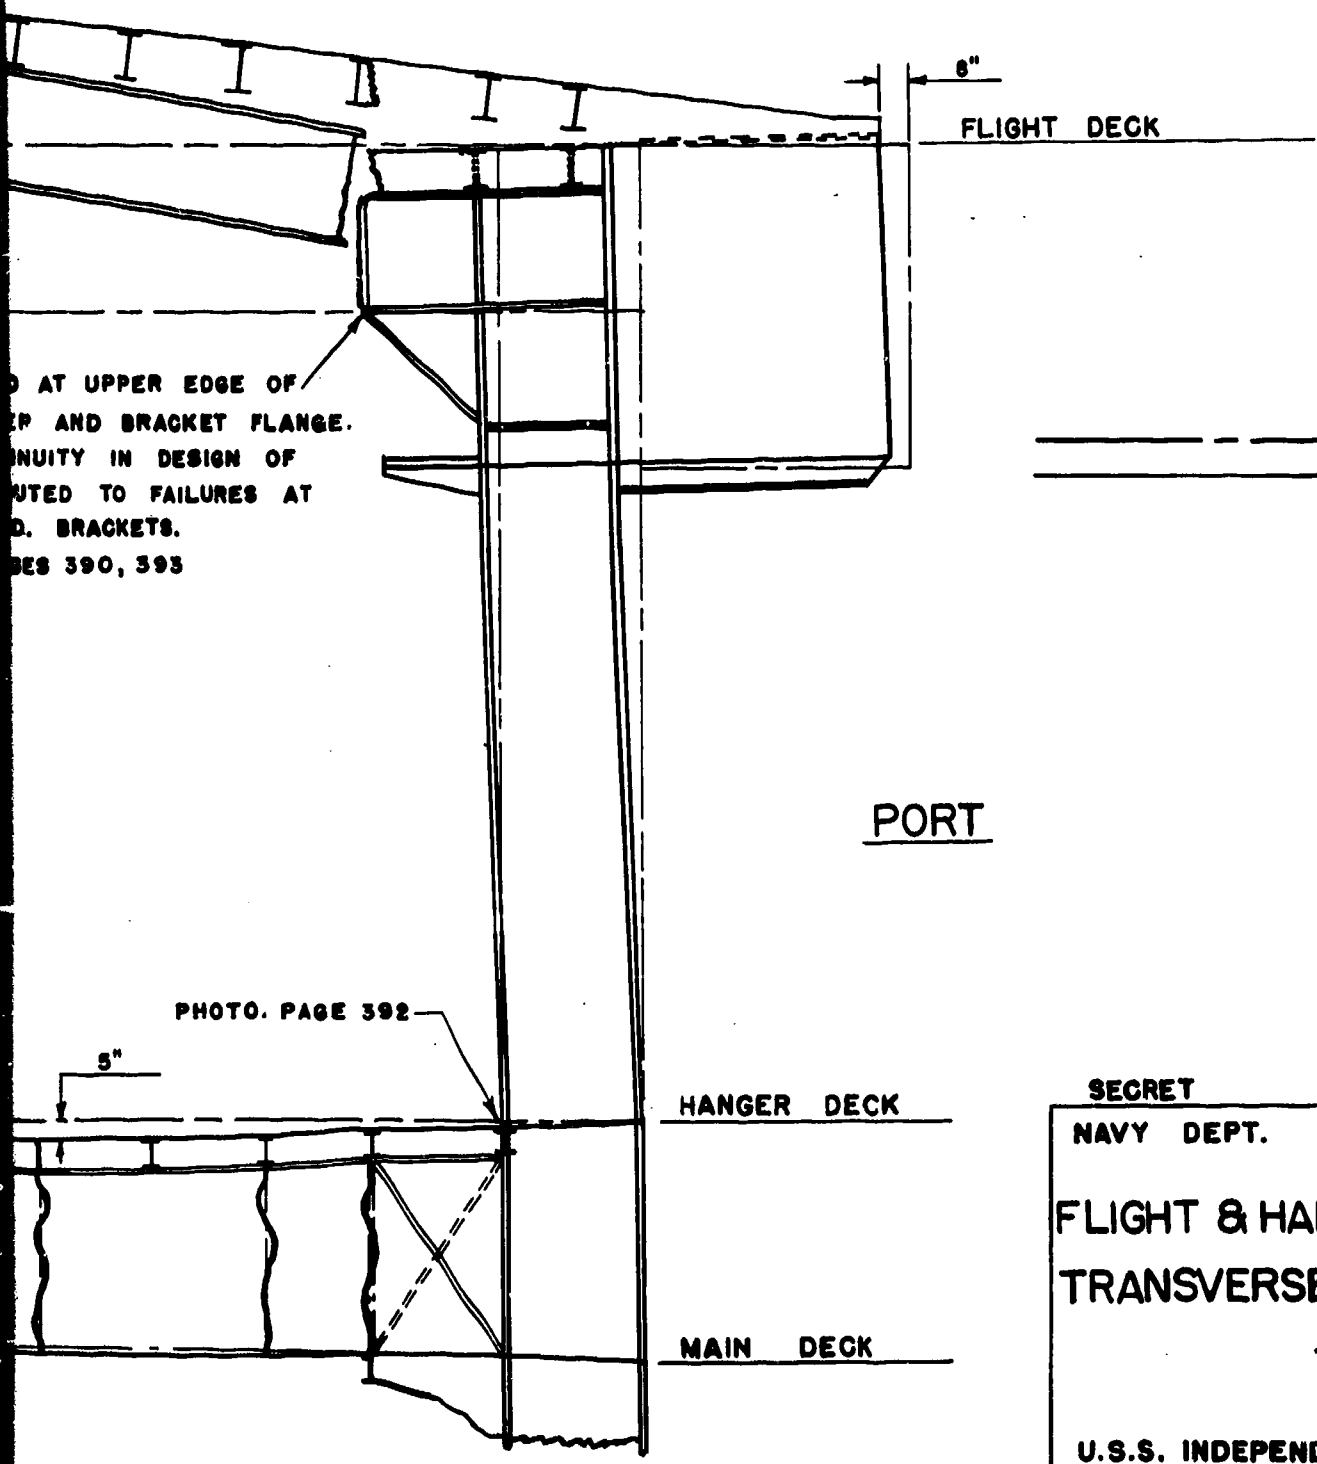
TRANSVERSE SECTION AT FR.80
LOOKING AFT

FRACTURE ORIGINATED AT UPPER EDGE OF WELD JOINING GIRDER AND BRACKET FLANGE. STRUCTURAL DISCONTINUITY IN DESIGN OF CONNECTION CONTRIBUTED TO FAILURES AT BOTH PORT AND STBD. BRACKETS. PHOTOS.- VOL. 3, PAGES 390, 393

D AT UPPER EDGE OF
 EP AND BRACKET FLANGE.
 INUITY IN DESIGN OF
 UTED TO FAILURES AT
 D. BRACKETS.
 RES 390, 393

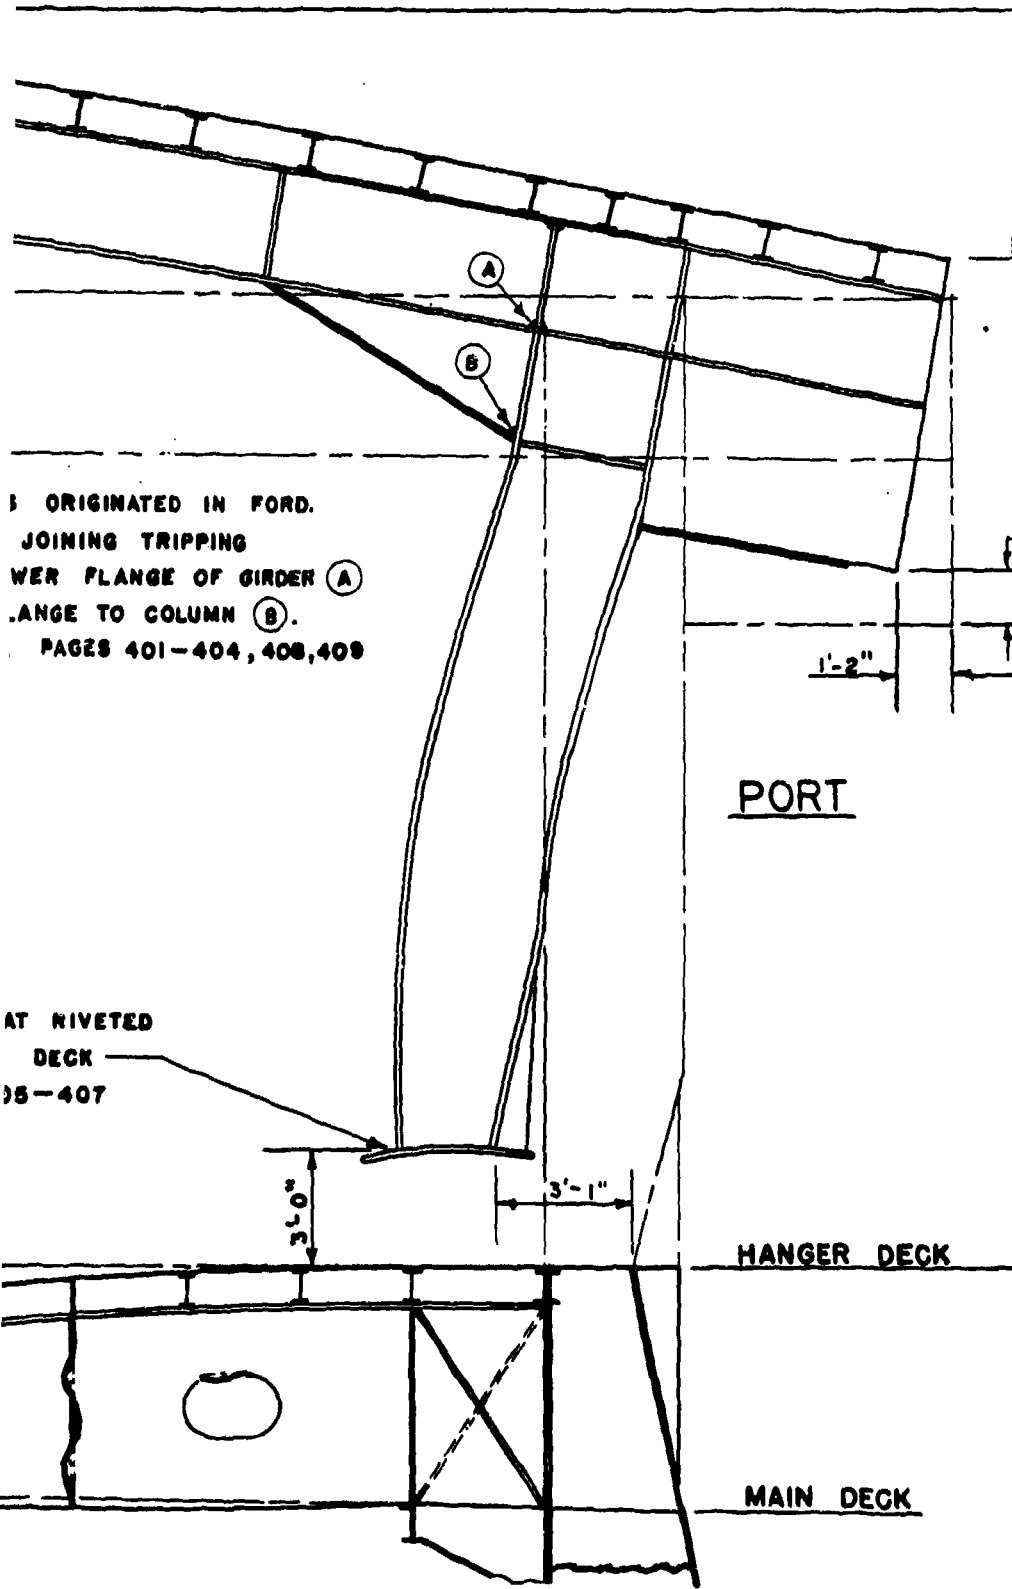
TRANSVERSE SECTION AT FR. 83
LOOKING AFT.

FRACTURE ORIGINATED AT AFTER END OF BUTT WELD IN LOWER FLANGE OF GIRDER. INCOMPLETE WELD PENETRATION CONTRIBUTED TO FAILURE.
PHOTOS.- VOL. 3, PAGES 399, 410-414

SMALL FRACTURES ORIGINATED IN FORD. END OF WELDS JOINING TRIPPING BRACKET TO LOWER FLANGE OF GIRDER (A) AND BRACKET FLANGE TO COLUMN (B).
PHOTOS.- VOL. 3, PAGES 401-404, 408, 409

PULLED LOOSE AT RIVETED CONNECTION TO DECK
PHOTO. PAGE 405-407

ORIGINATED IN FORD.
 JOINING TRIPPING
 MEMBER FLANGE OF GIRDER (A)
 RANGE TO COLUMN (B).
 PAGES 401-404, 408, 409

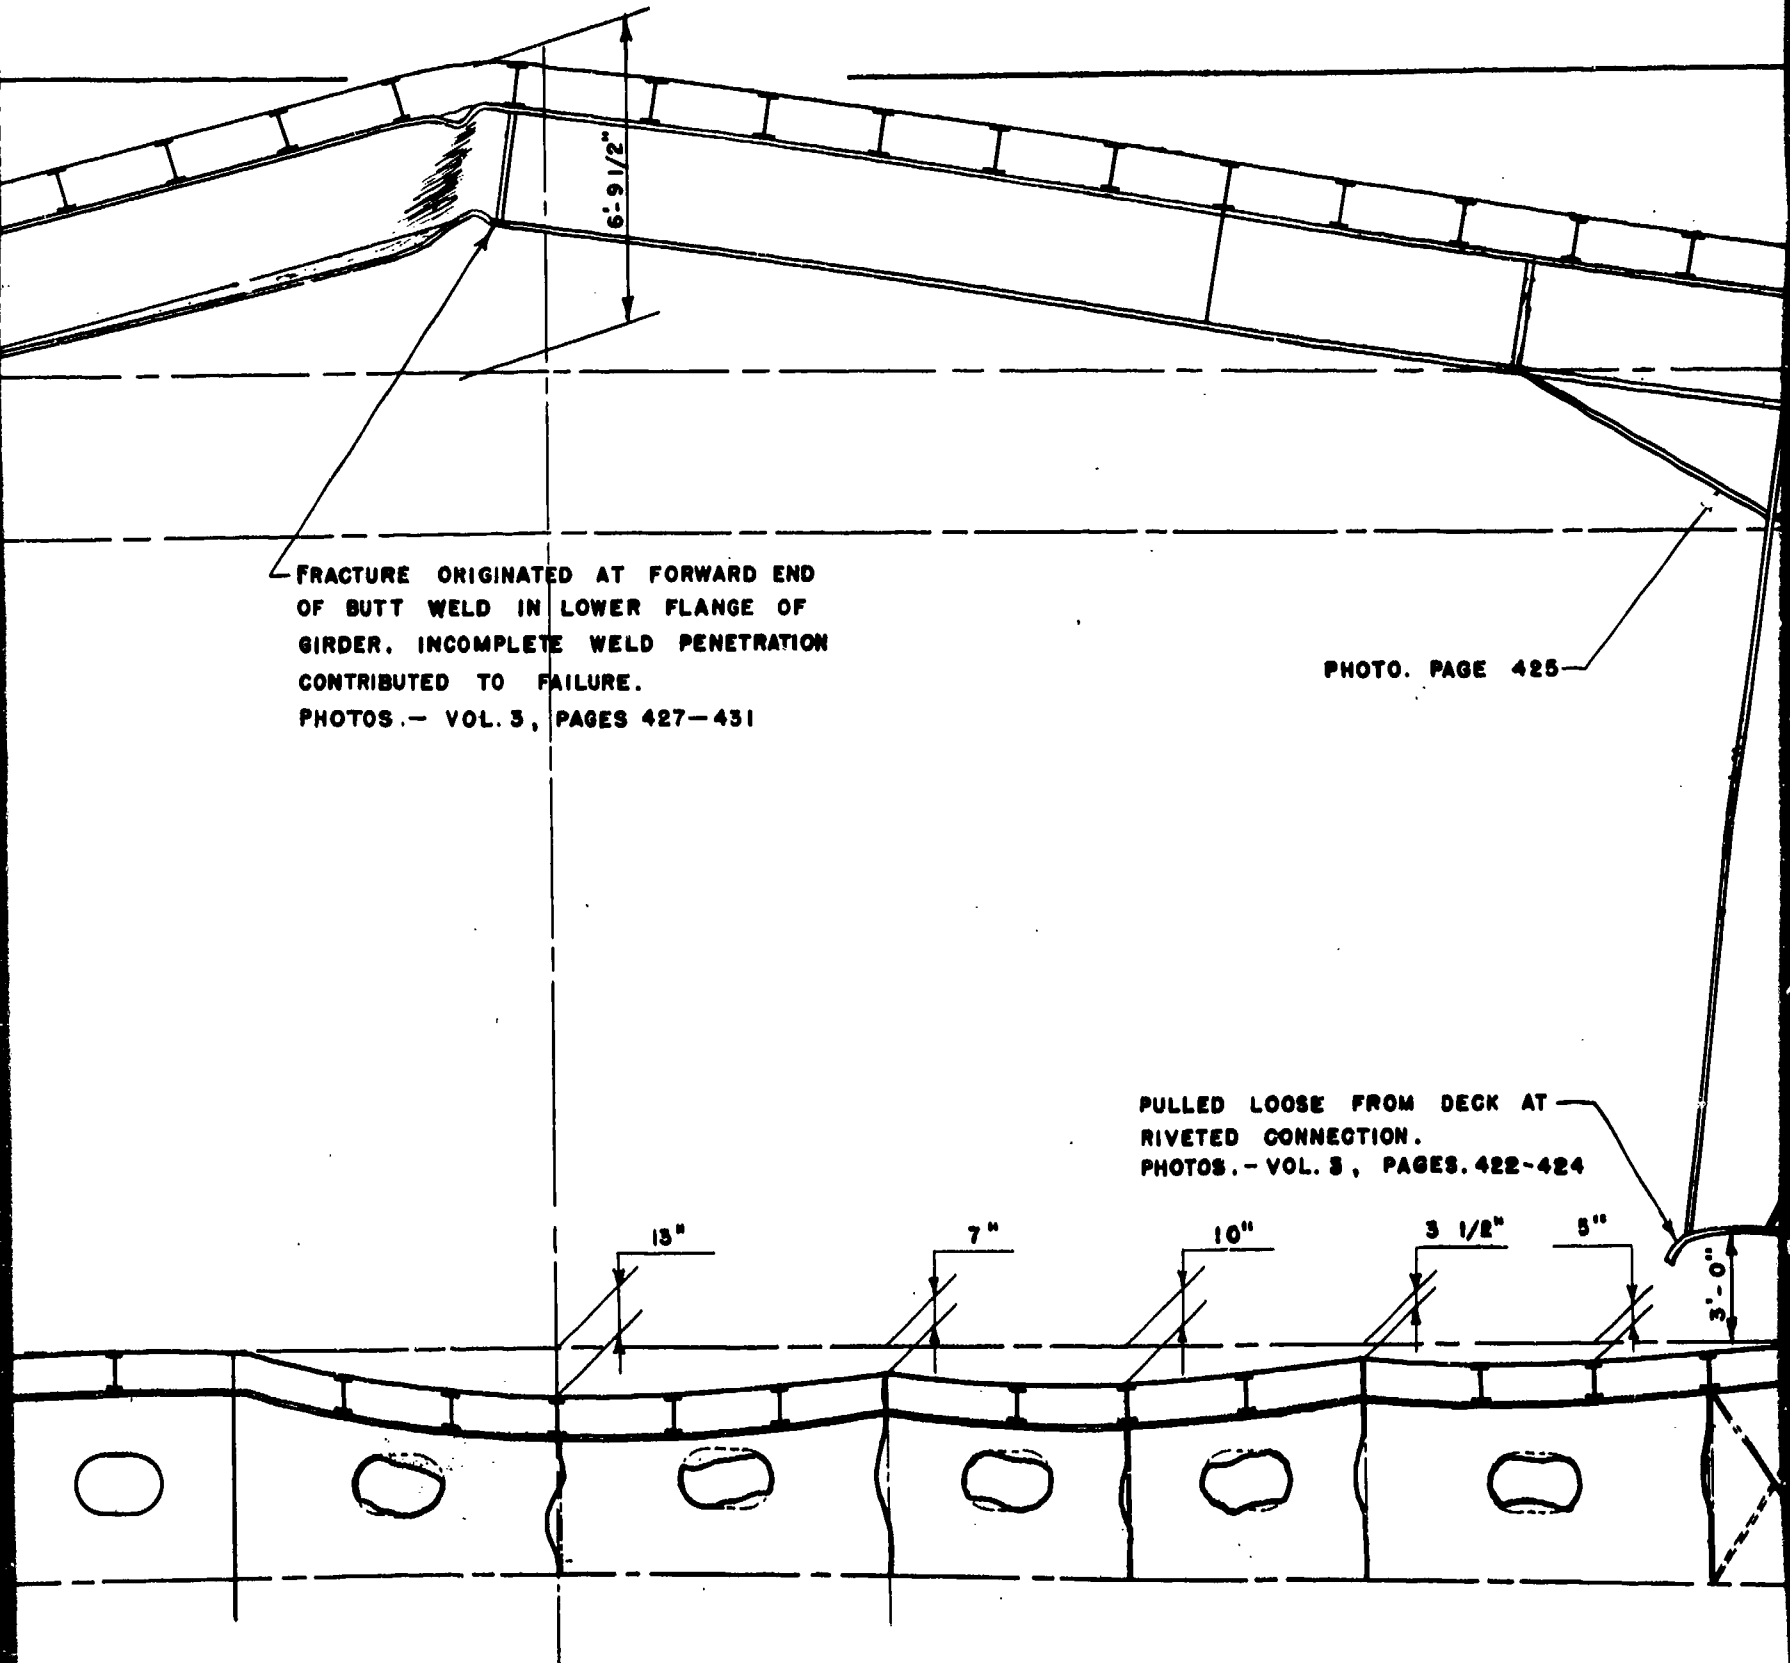
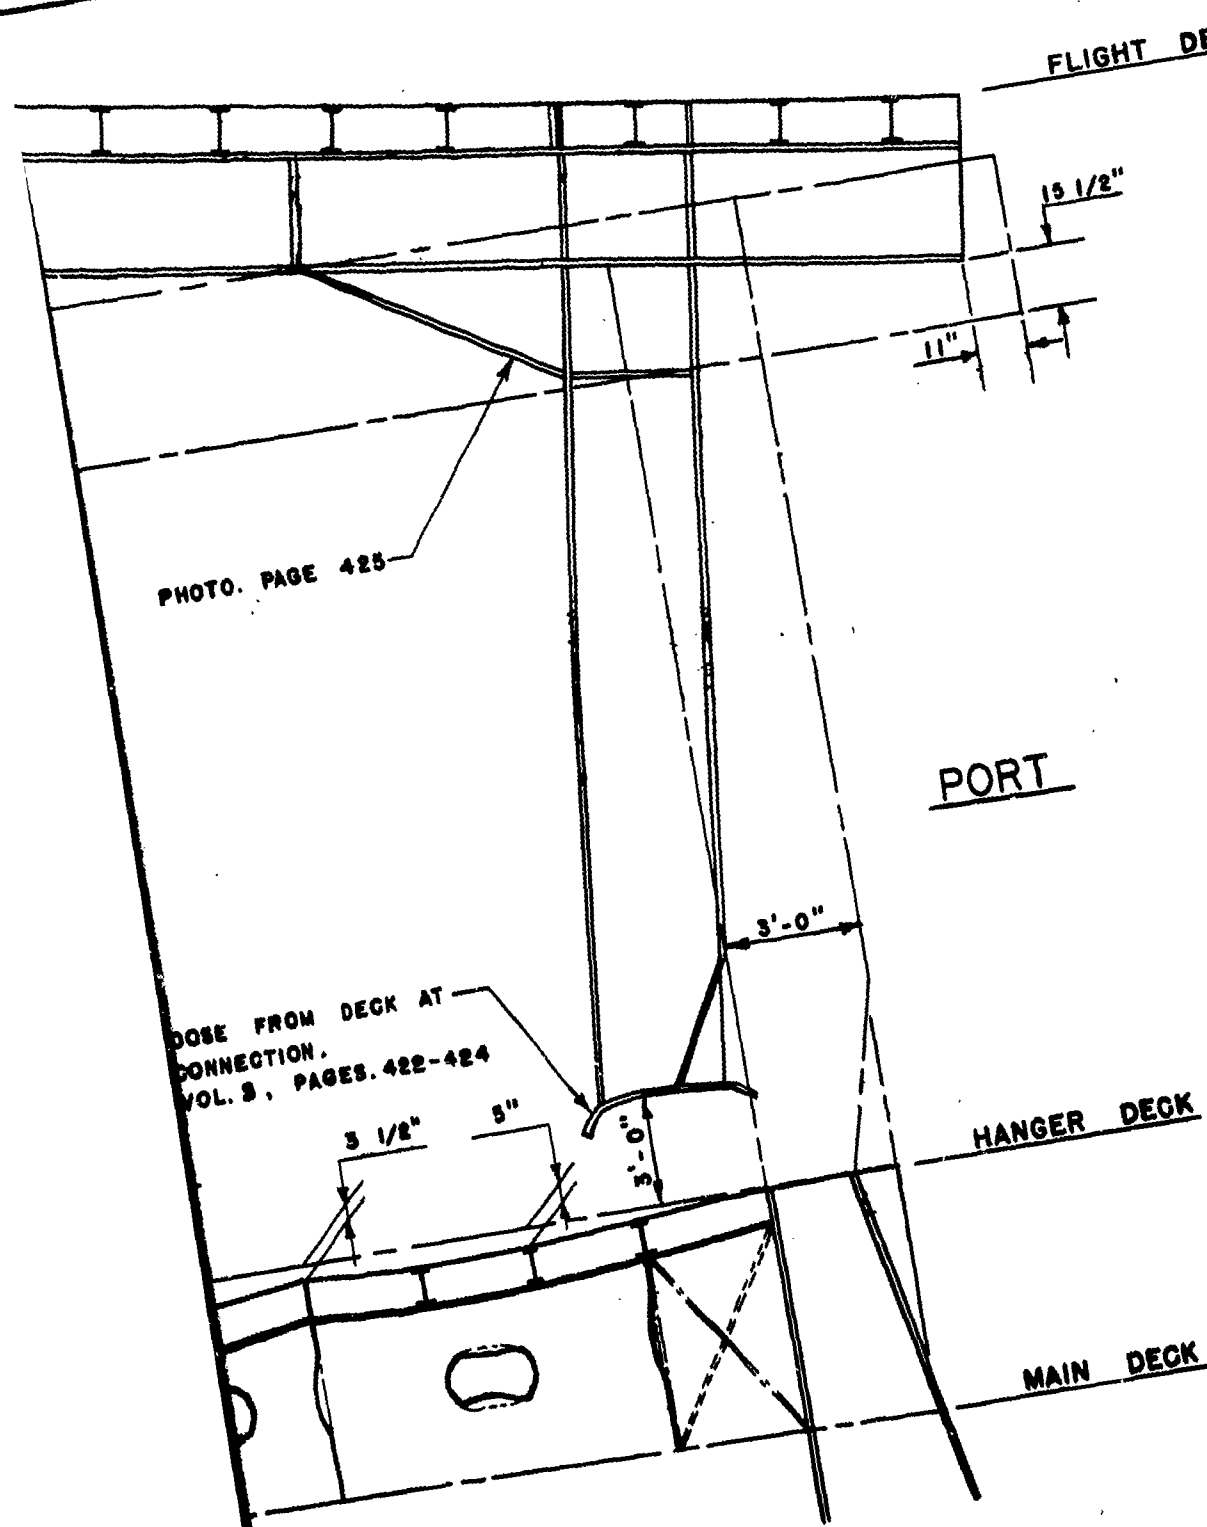
TRANSVERSE SECTION AT FR. 86
LOOKING AFT.

FRACTURE ORIGINATED AT EDGE OF WELD JOINING BRACKET FLANGE TO COLUMN. STRUCTURAL DISCONTINUITY IN DESIGN OF CONNECTION CONTRIBUTED TO FAILURE.
PHOTOS.— VOL. 3, PAGES 432--435

FRACTURE ORIGINATED AT EDGE OF BUTT WELD JOINING GIRDER. INCOMPLETE WELD CONTRIBUTED TO FAILURE.
PHOTOS.— VOL. 3, PAGES 432--435

PULLED LOOSE FROM DECK AT RIVETED CONNECTION.
PHOTOS.— VOL. 3, PAGES 436-438

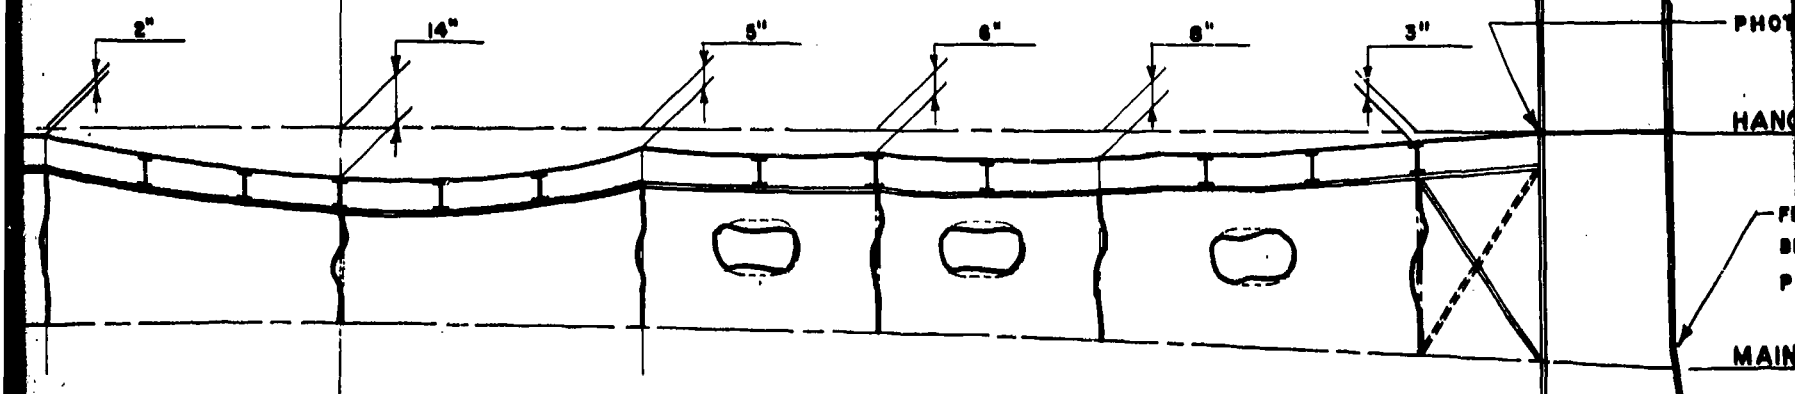
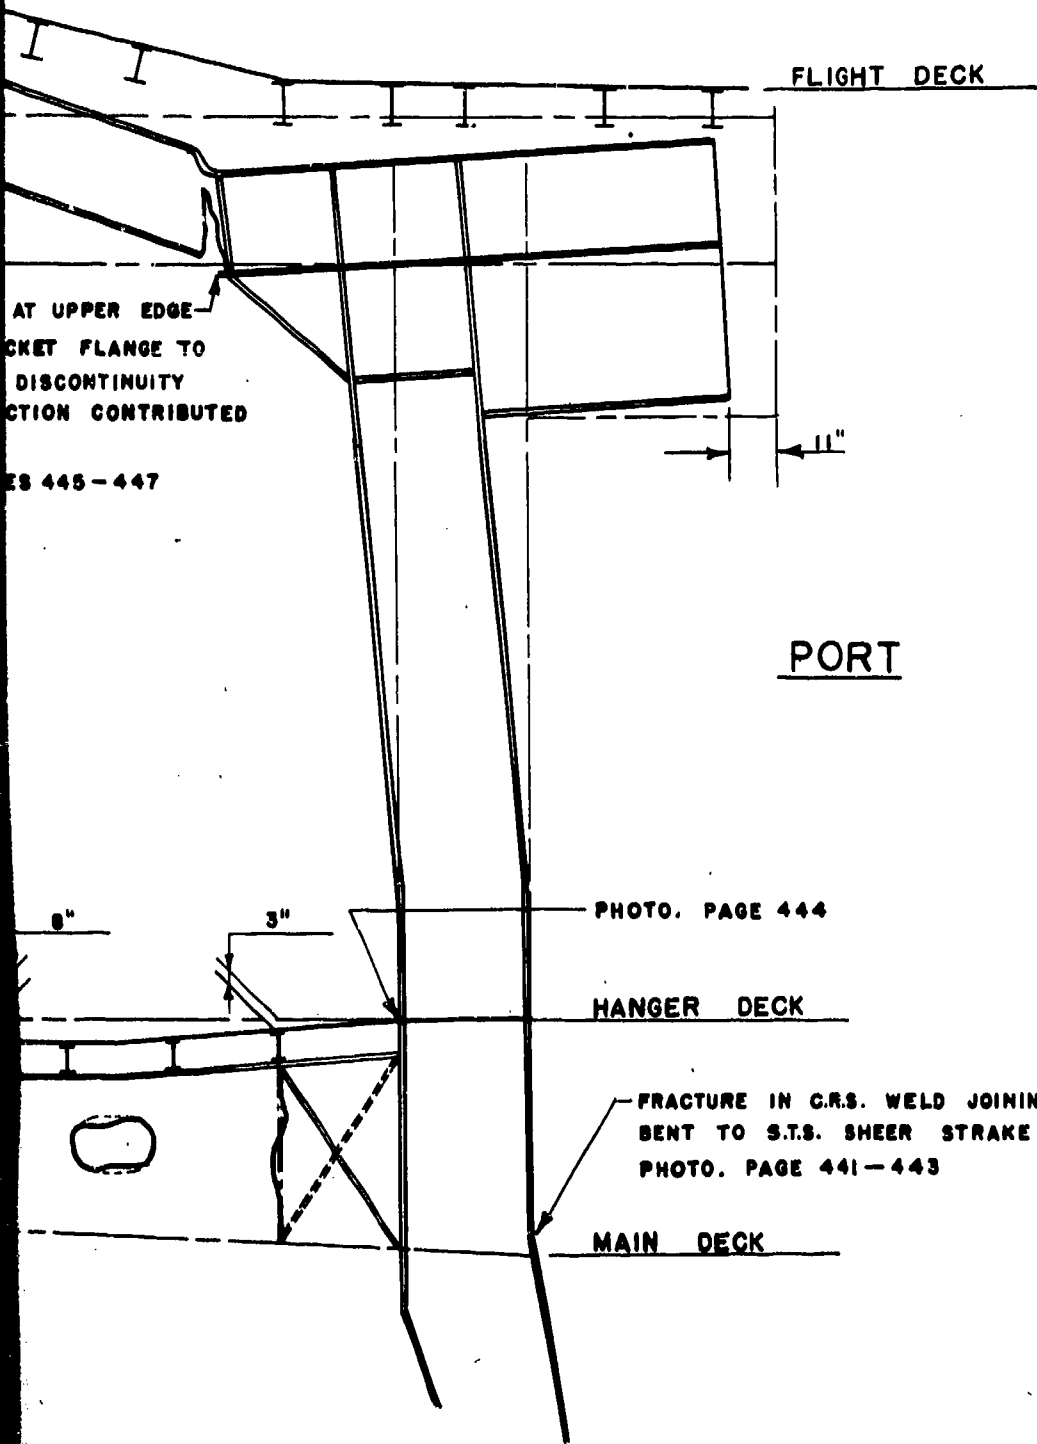
TRANSVERSE SECTION AT FR. 89
LOOKING AFT

FRACTURE ORIGINATED AT FORWARD END OF WELD BETWEEN TRIPPING BRACKET AND LONGITUDINAL BRACKET.
PHOTOS.— VOL. 3, PAGES 448—450

FRACTURE ORIGINATED AT UPPER EDGE OF WELD JOINING BRACKET FLANGE TO GIRDER. STRUCTURAL DISCONTINUITY IN DESIGN OF CONNECTION CONTRIBUTED TO FAILURE.
PHOTOS.— VOL. 3, PAGES 445—447

FRACTURE IN C.R.S. WELD JOINING
 BENT TO S.T.S. SHEER STRAKE.
 PHOTO. PAGE 441-443

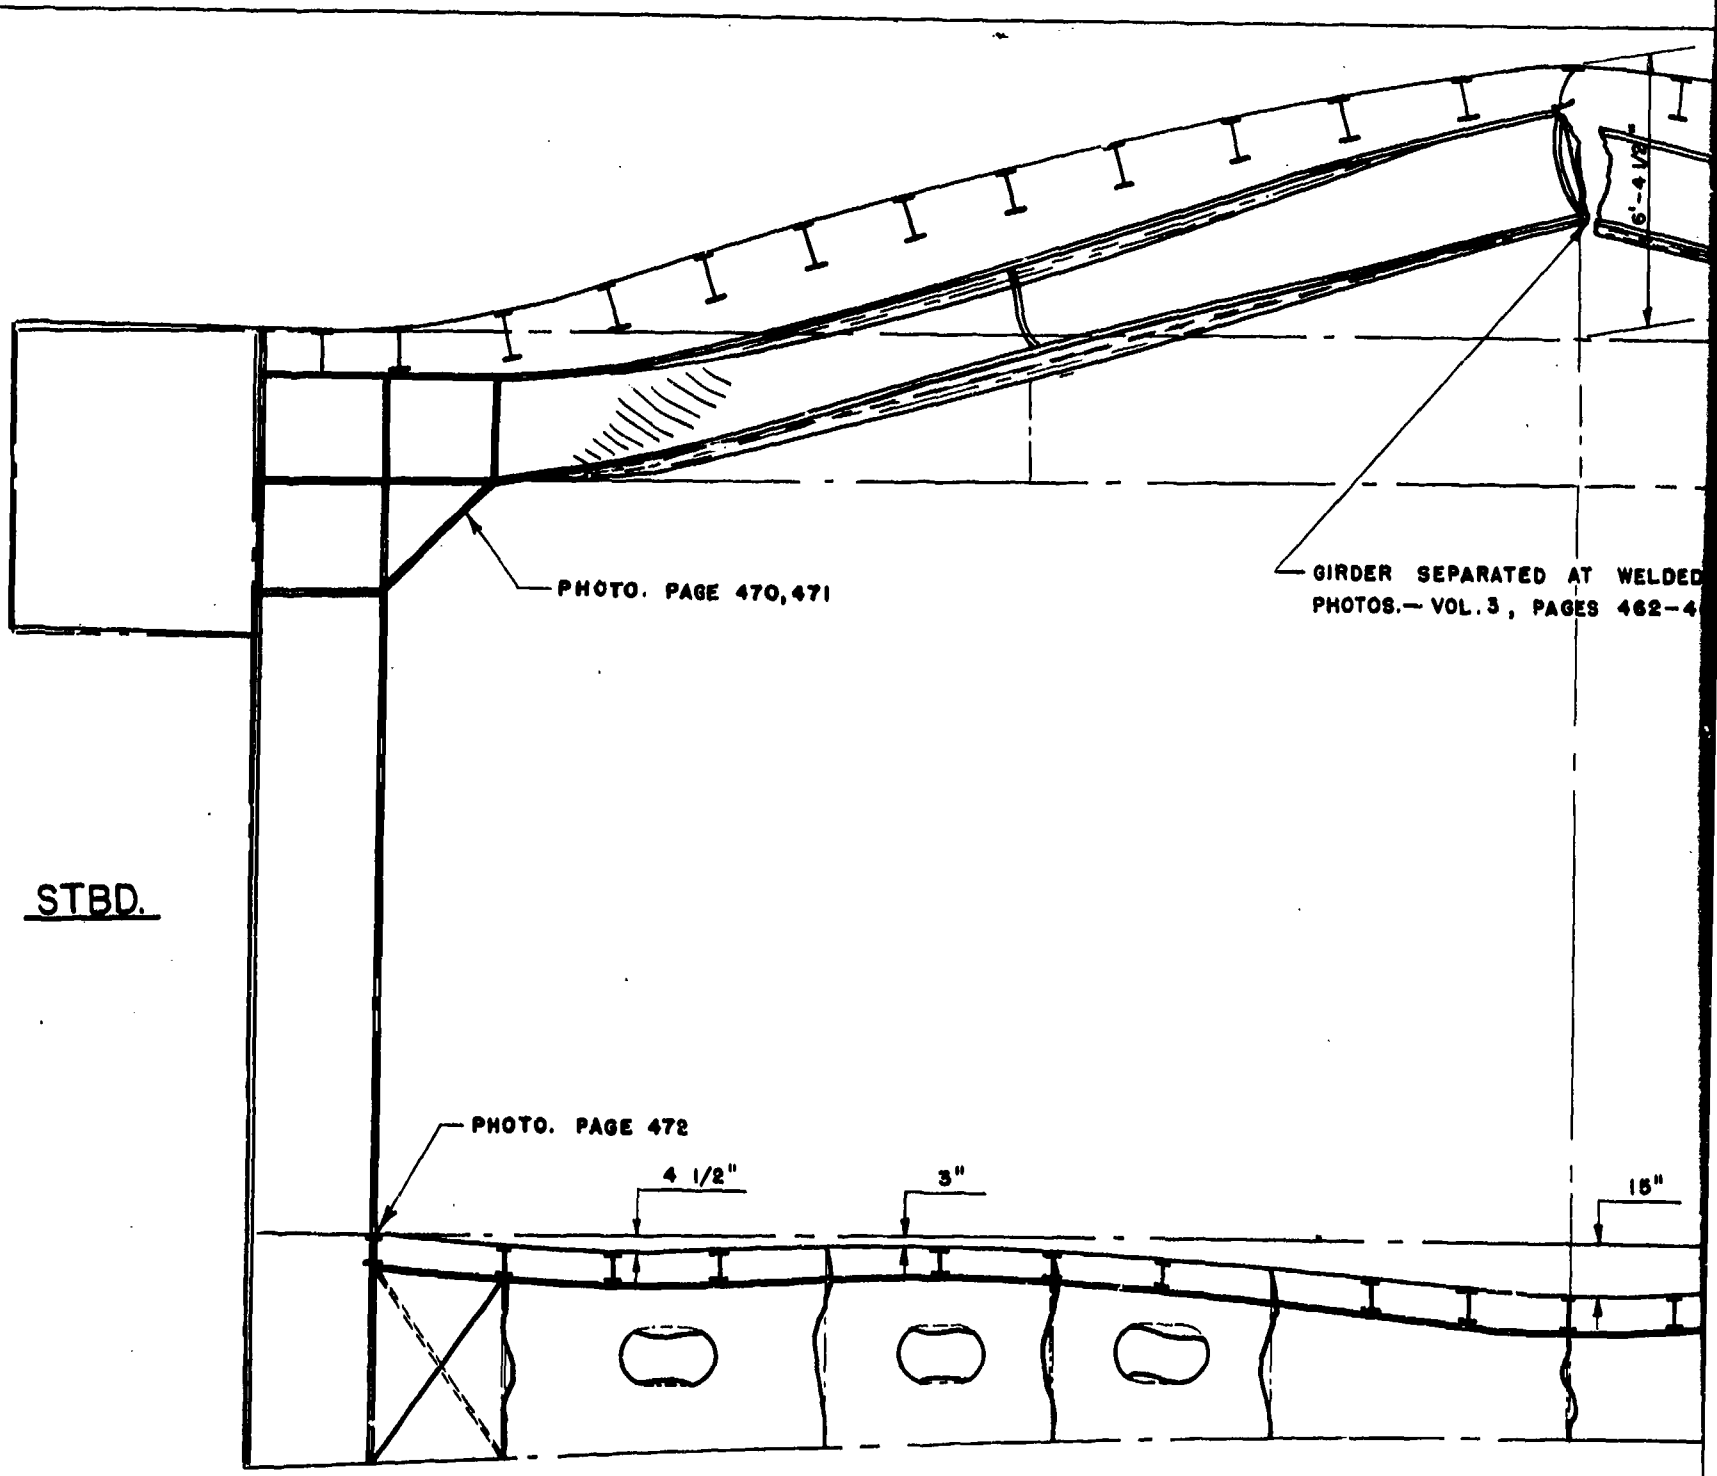
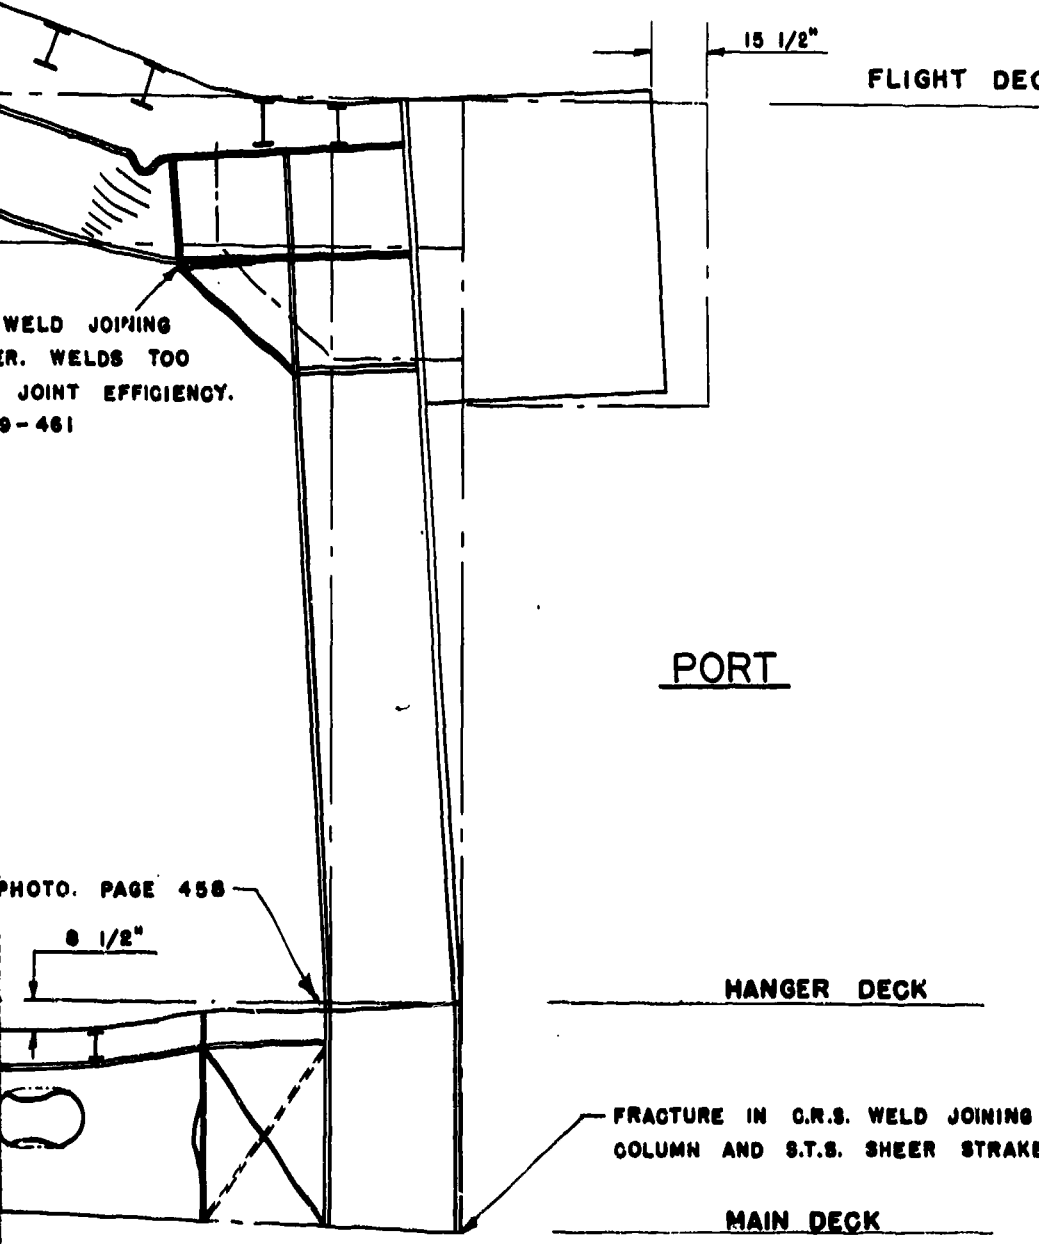
VERSE SECTION AT FR.92
 LOOKING AFT.

PHOTO. PAGE 470, 471
