BUREAU OF SHIPS GROUP TECHNICAL INSPECTION REPORT

OPERATION CROSSROADS. U.S.S. INDEPENDENCE (CVL22)

TEST ABLE

VOLUME 1 OF 4 [W]

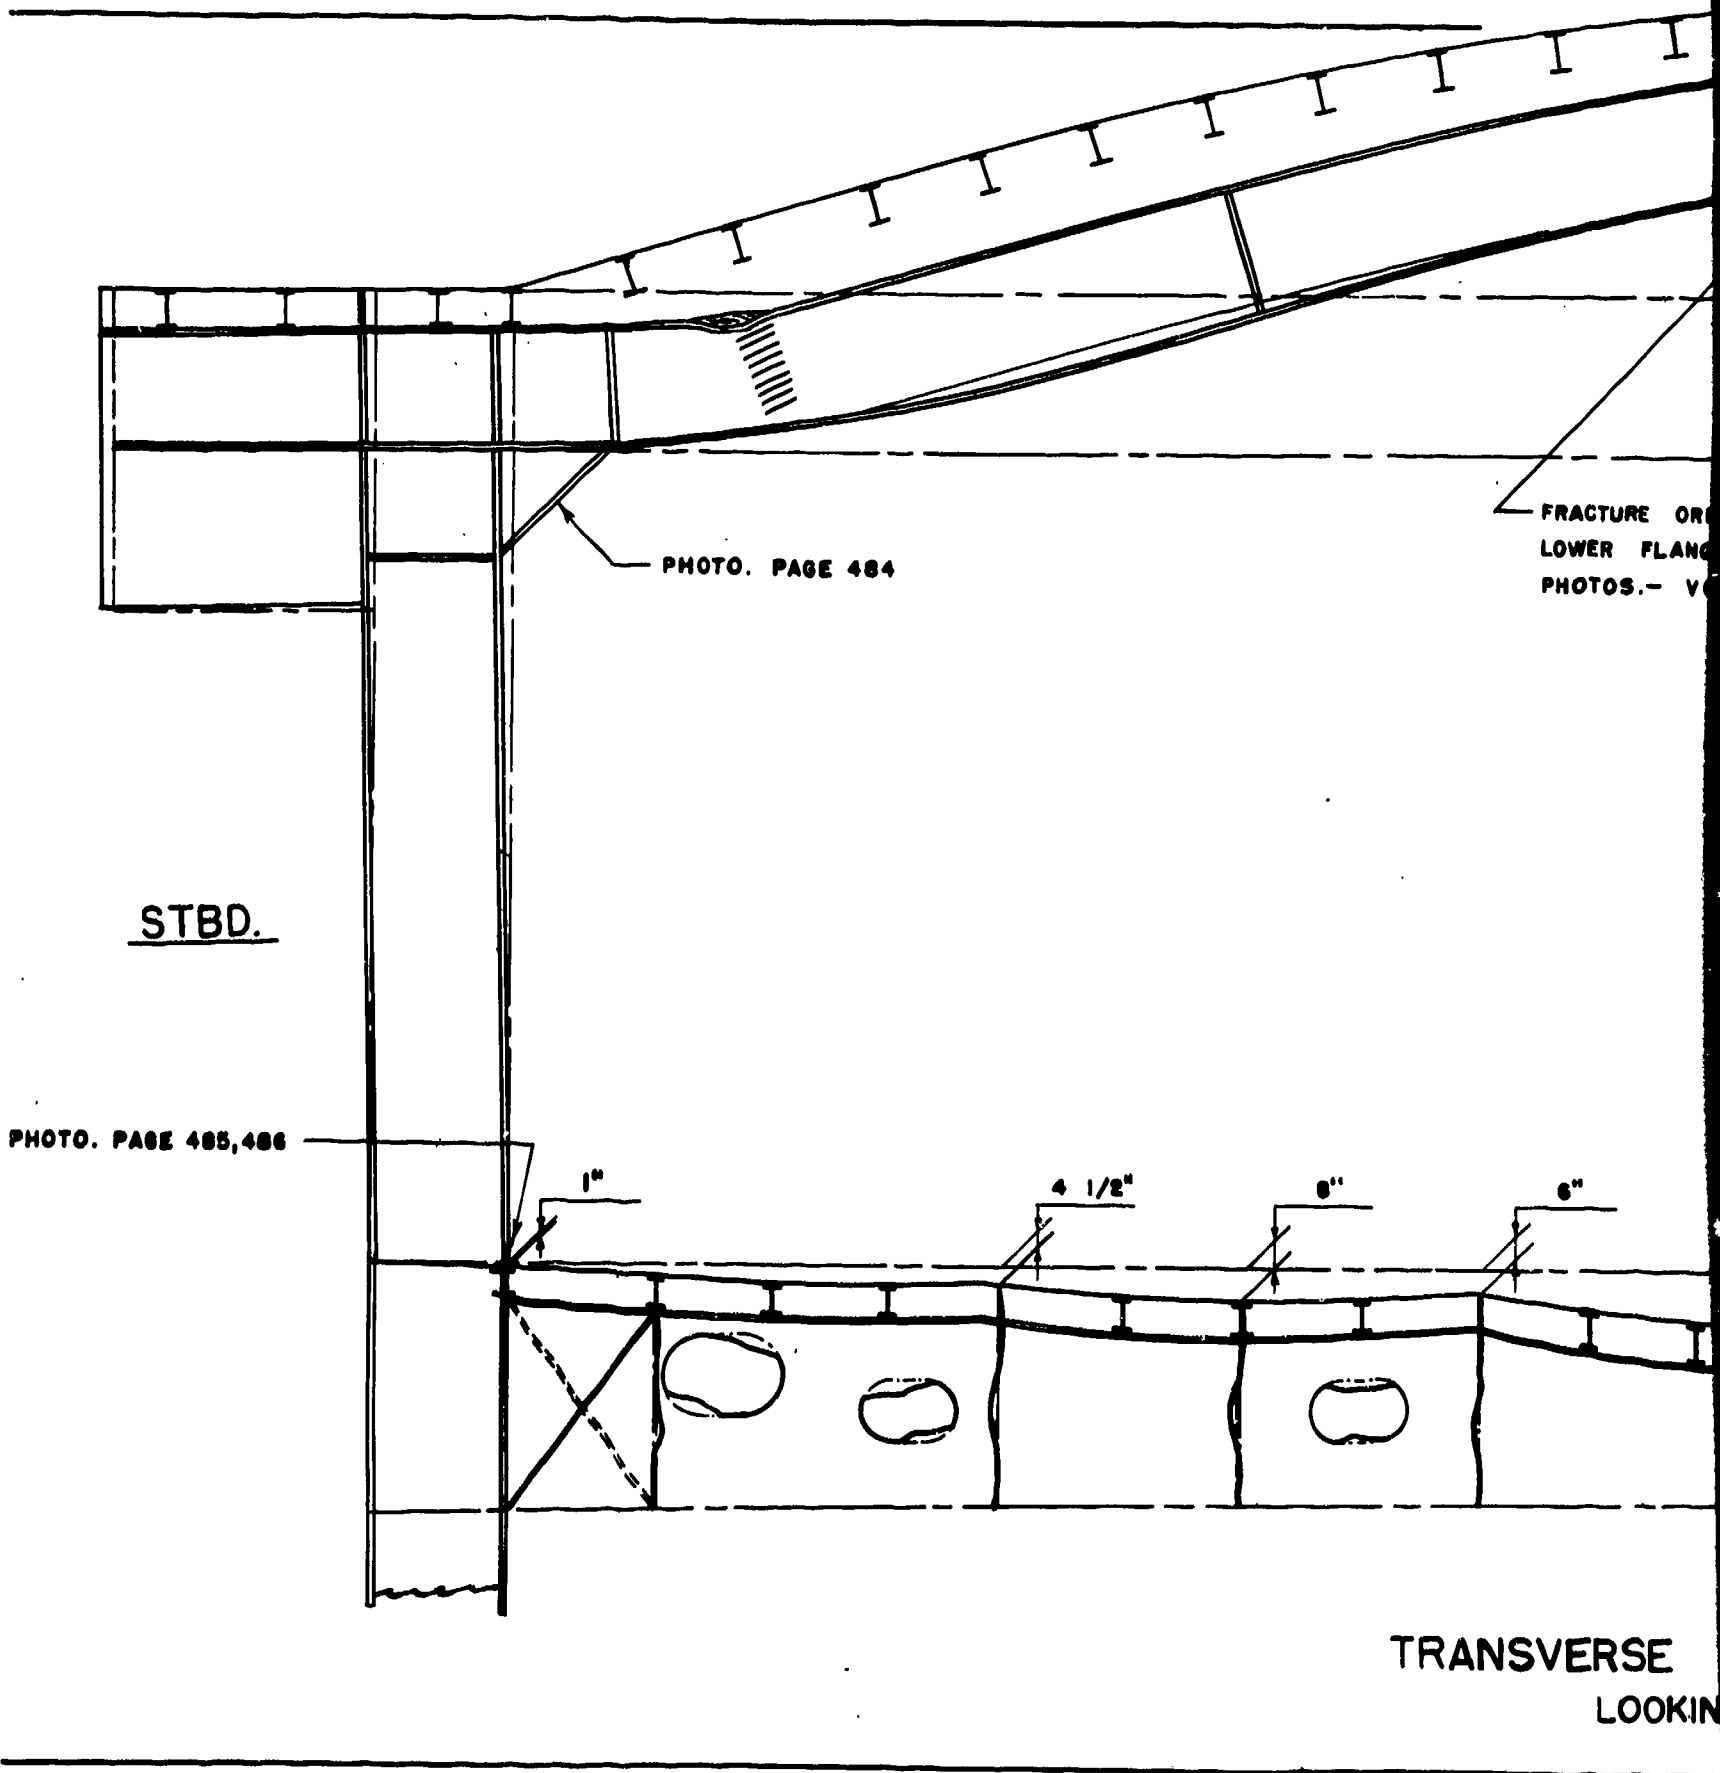
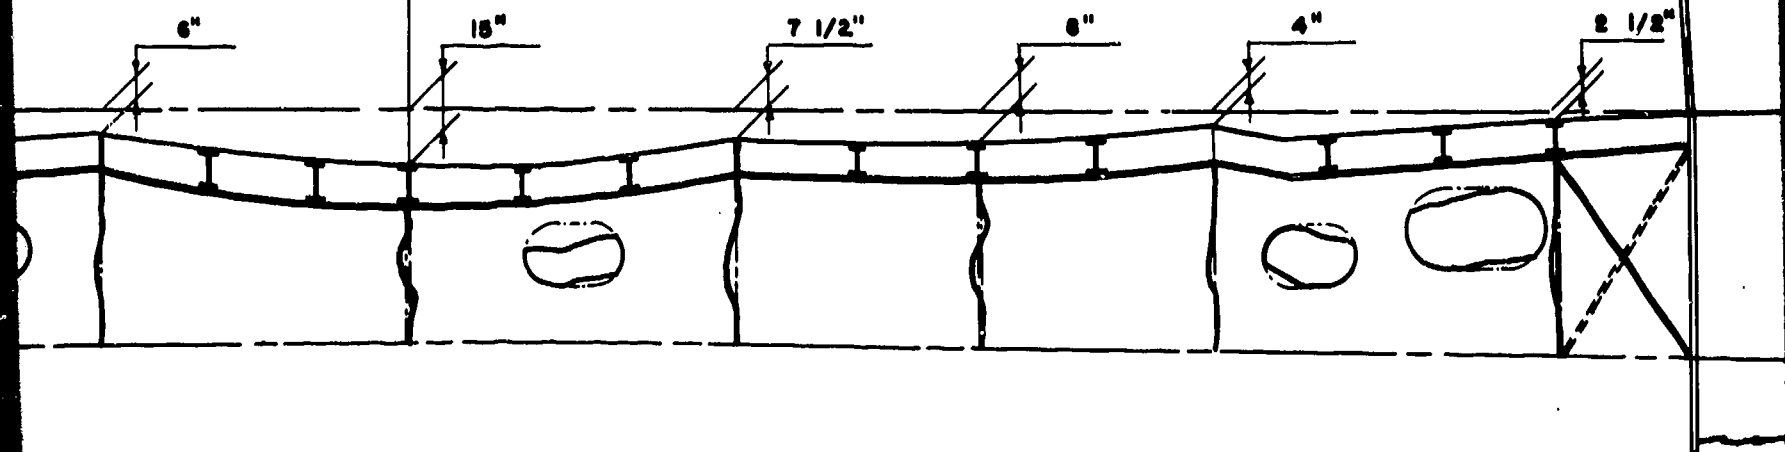
TRANSVERSE SECTION AT FR. 95
 LOOKING AFT

FRACTURE ORIGINATED IN BUTT WELD IN
 LOWER FLANGE OF GIRDER.
 PHOTOS.- VOL. 3, PAGES 475-483

FRACTURE ORIGINATED IN WELD JOINING
 BRACKET FLANGE TO TRANSVERSE GIRDER.
 WELDS TOO SMALL TO DEVELOP 100%
 JOINT EFFICIENCY.
 PHOTOS.- VOL. 3, PAGES 473, 474

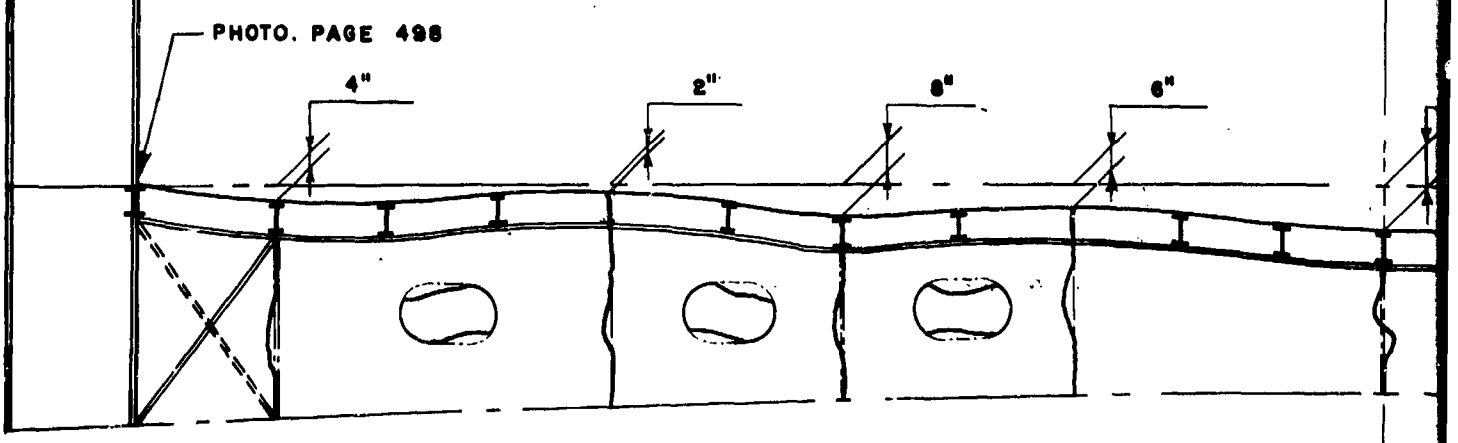
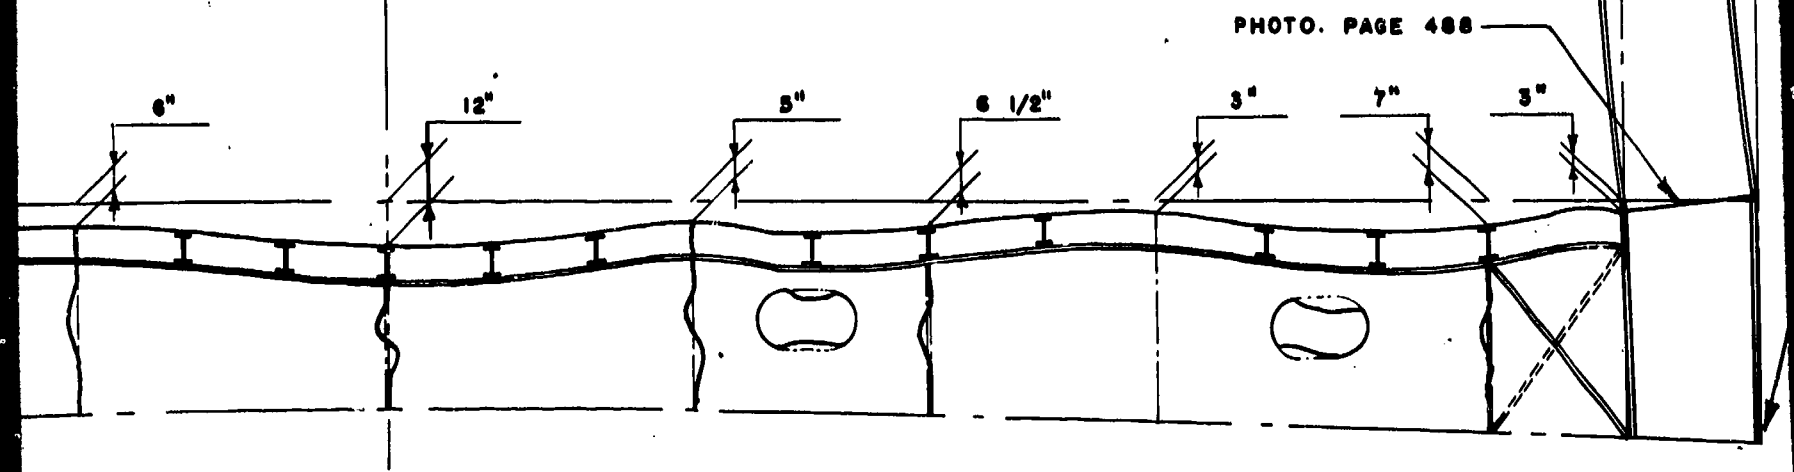
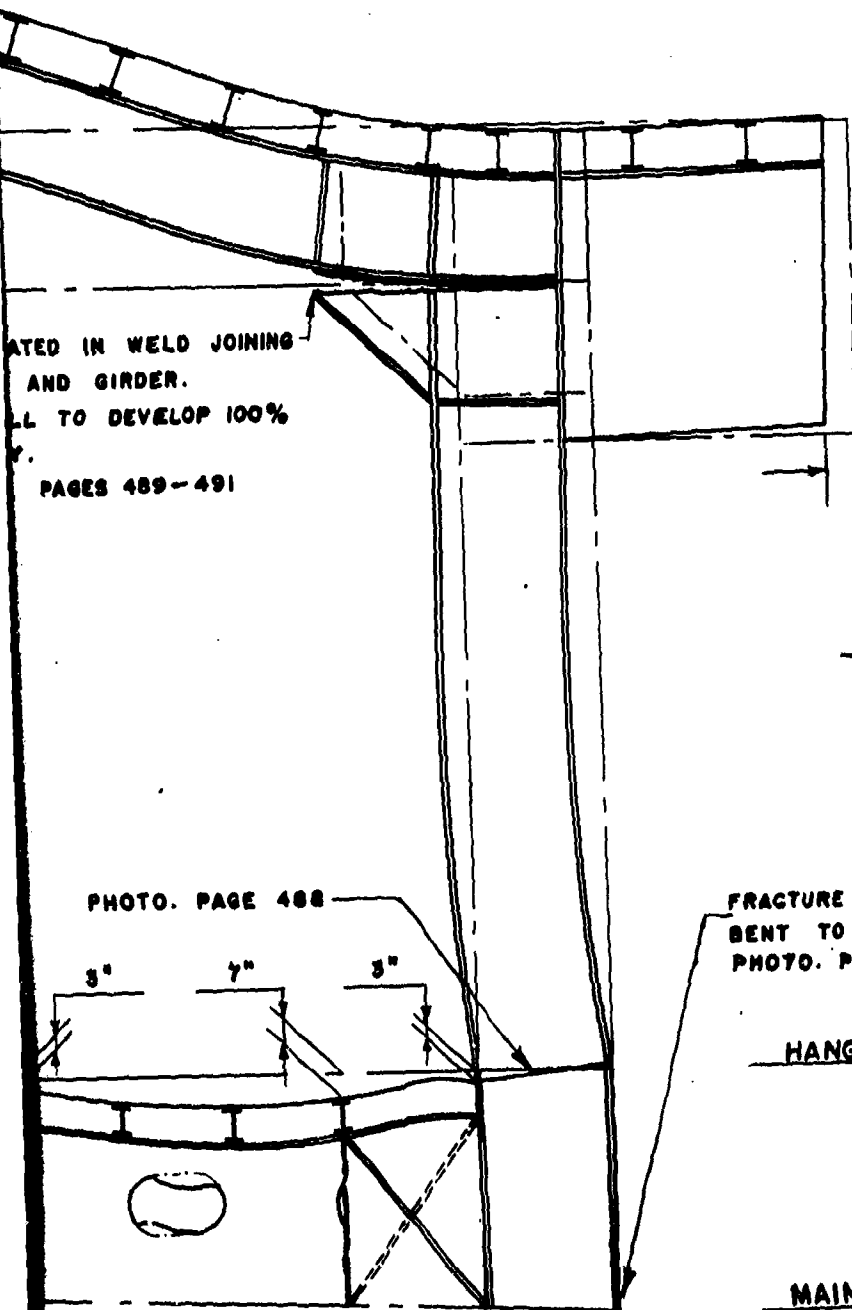
TRANSVERSE SECTION AT FR. 98
 LOOKING AFT

FRACTURE ORIGINATED AT BUTT WELD
 IN LOWER FLANGE OF GIRDER.
 PHOTOS.— VOL. 3, PAGES 492-495

FRACTURE ORIGINATED IN WELD JOINING
 BRACKET FLANGE AND GIRDER.
 WELDS TOO SMALL TO DEVELOP 100%
 JOINT EFFICIENCY.
 PHOTOS.— VOL. 3, PAGES 489-491

PHOTO. PAGE 488

ATED IN WELD JOINING
AND GIRDER.
LL TO DEVELOP 100%
PAGES 489-491

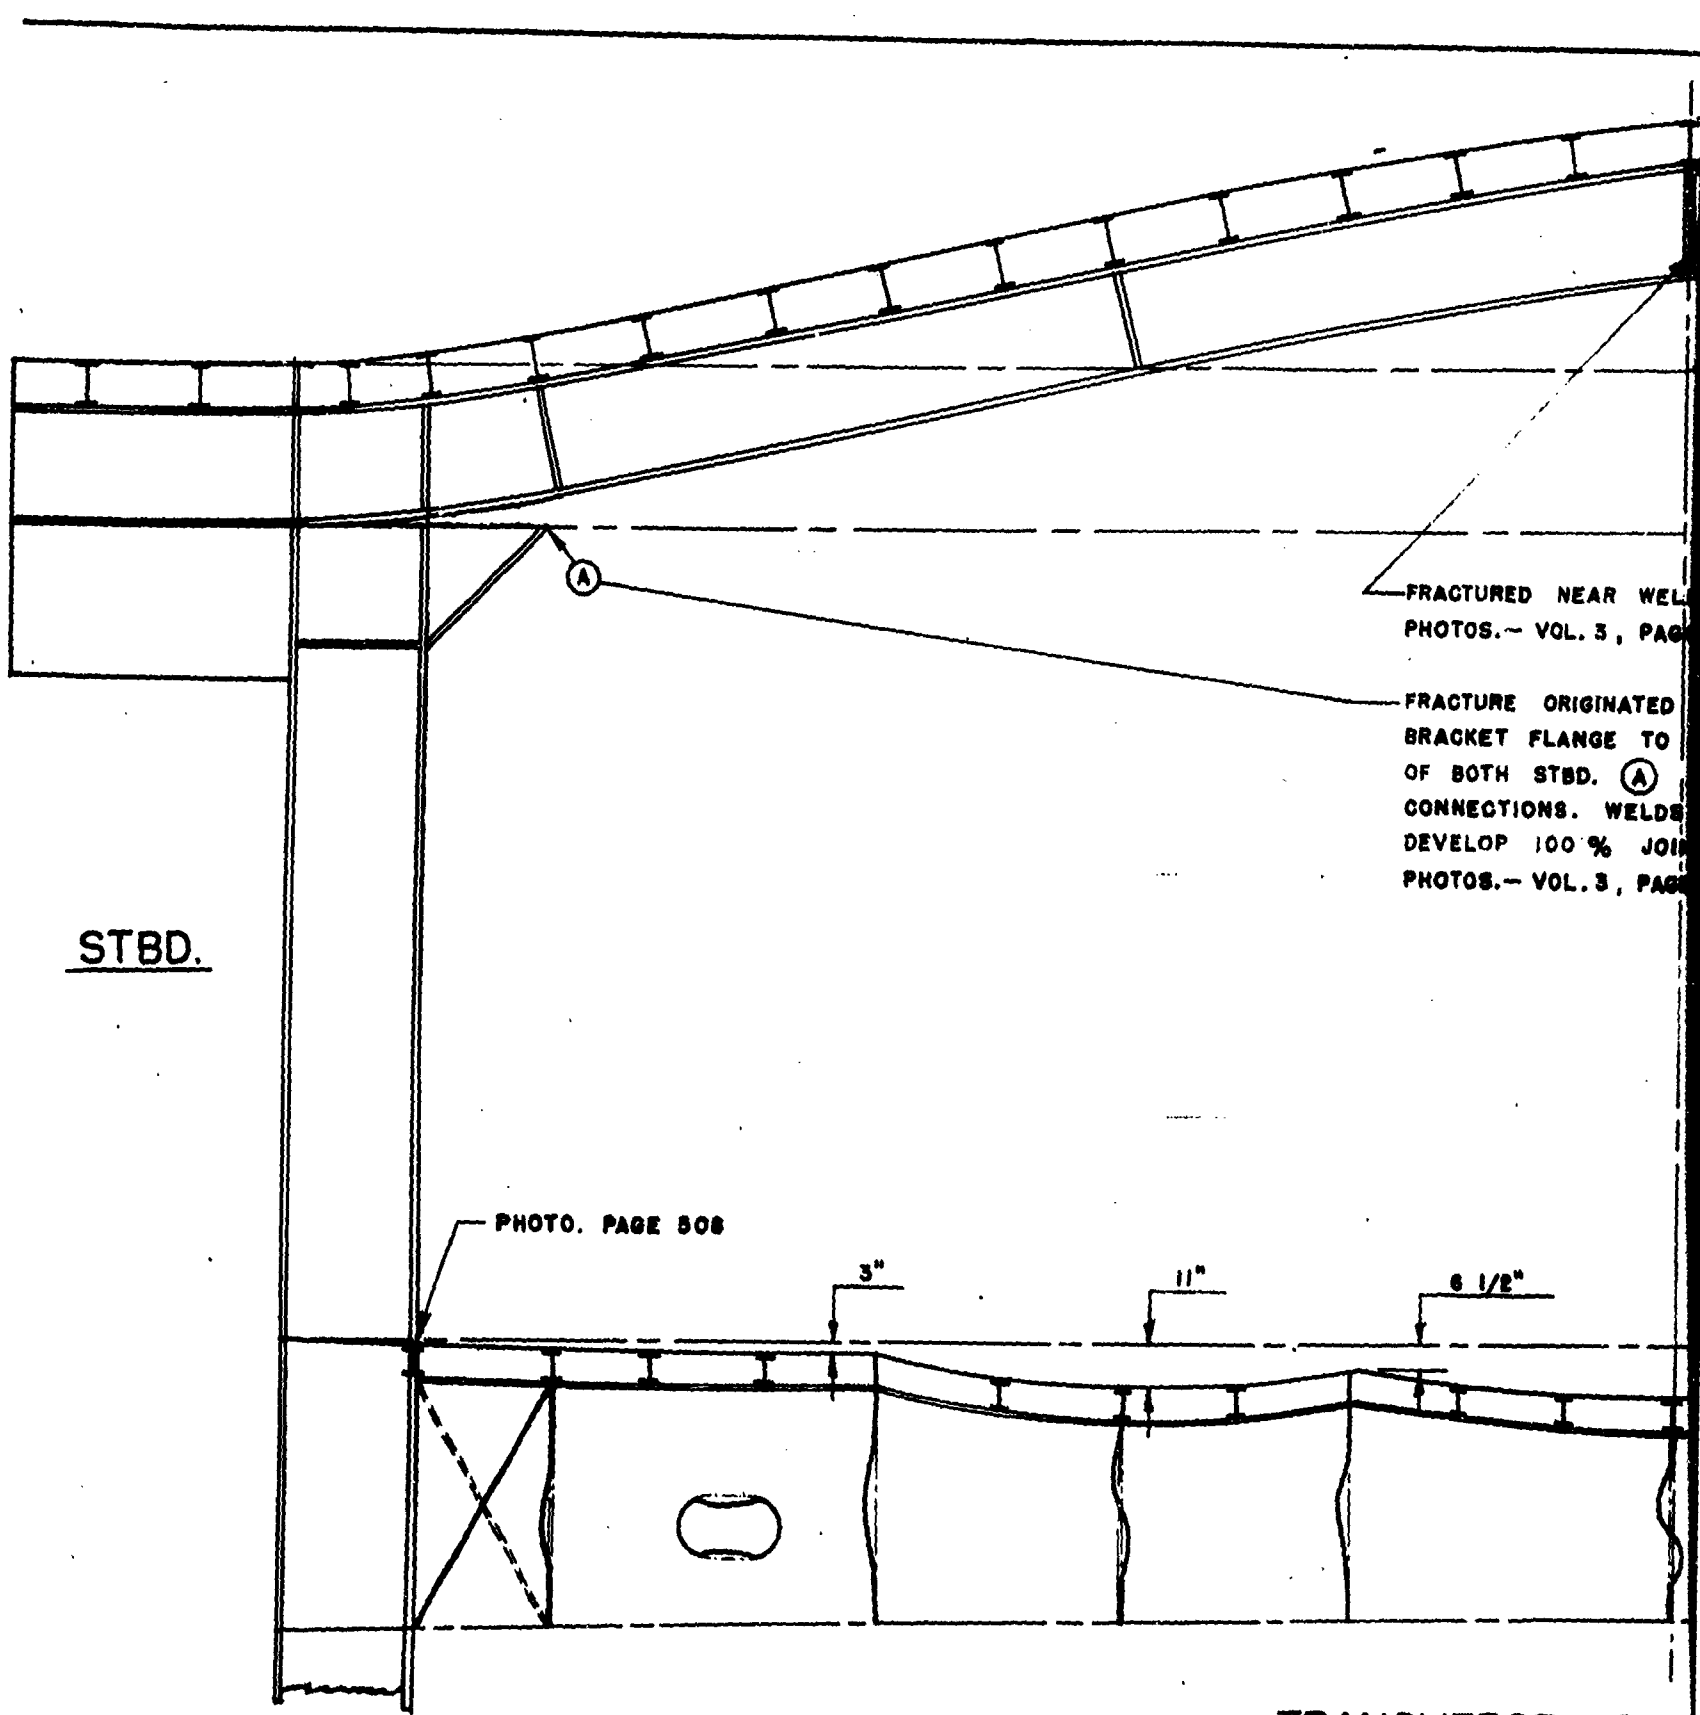
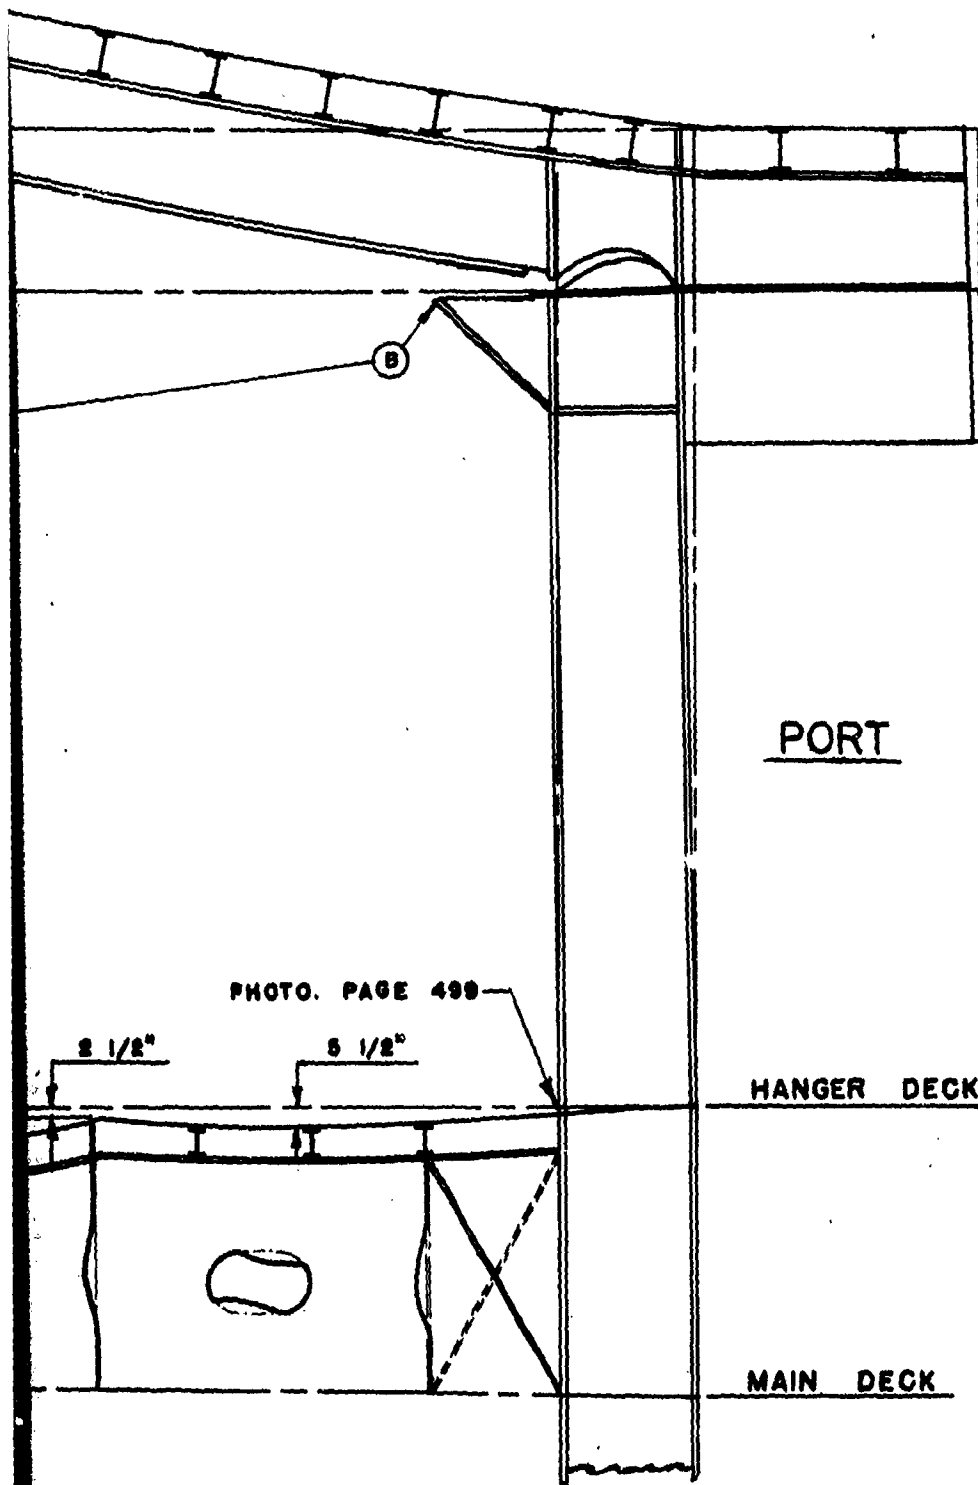
TRANSVERSE SECTION AT FR.101
 LOOKING AFT

FRACTURED NEAR WEL
PHOTOS.— VOL. 3, PAGE

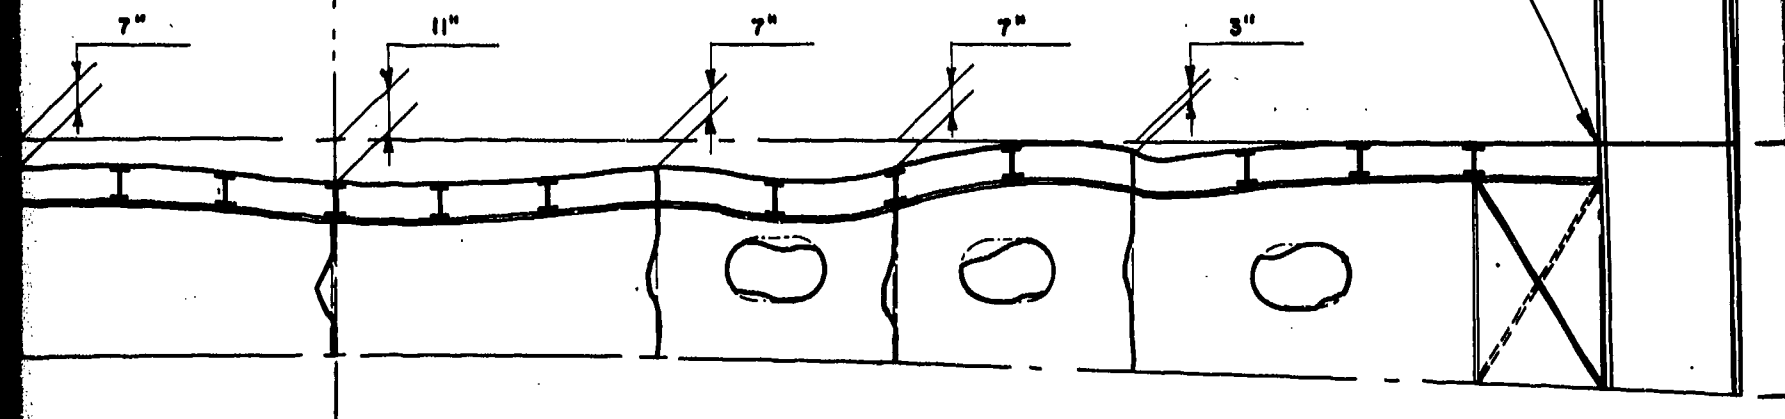
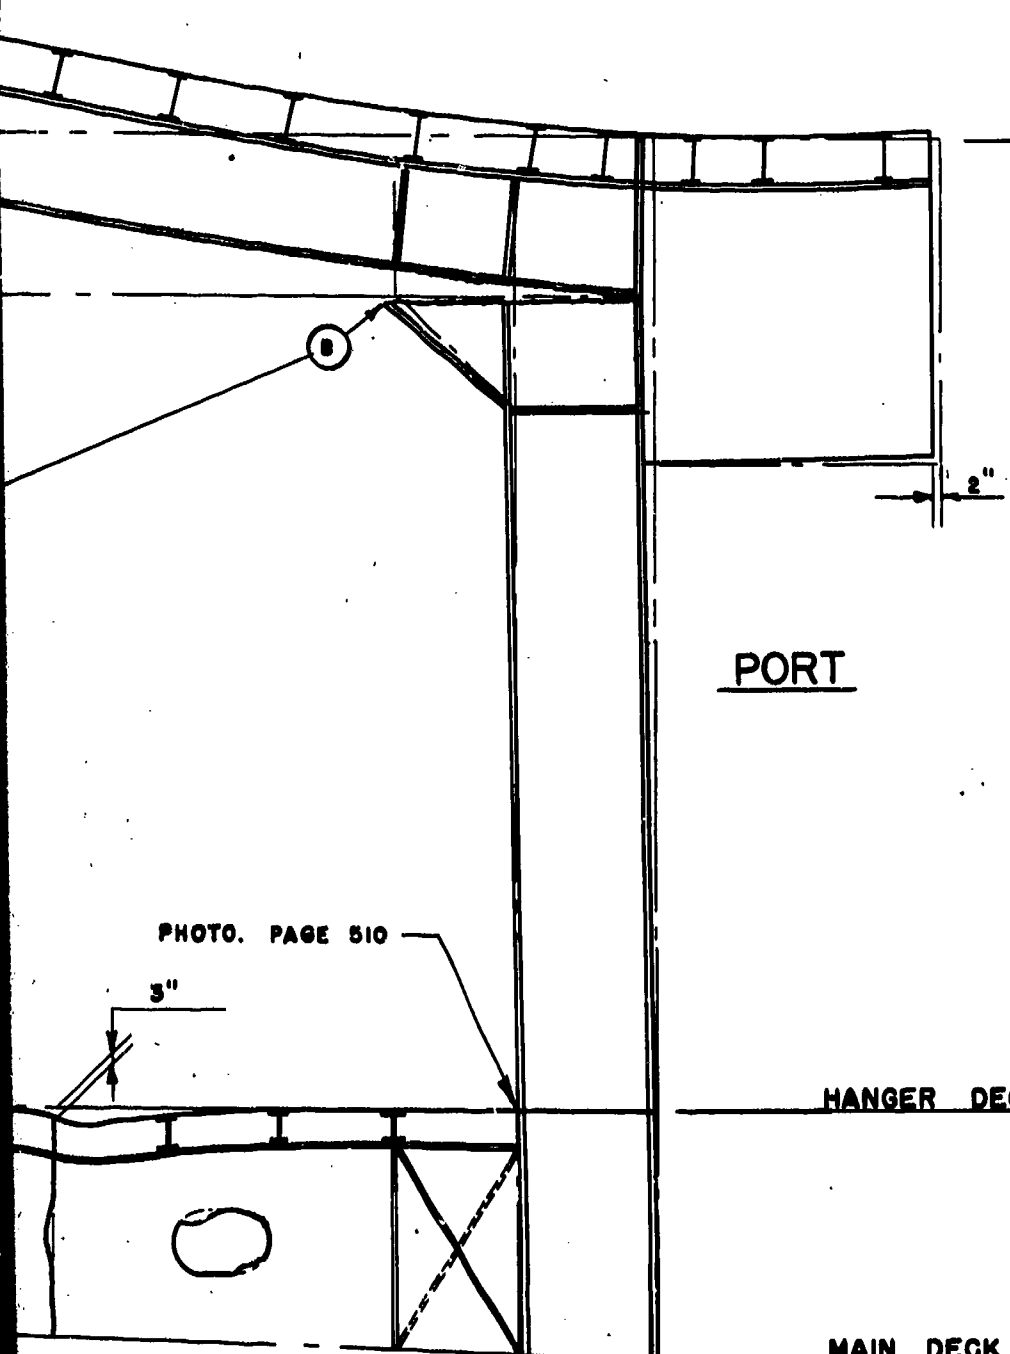
TRANSVERSE SECTION AT FR. 104
LOOKING AFT

PHOTO. PAGE 510

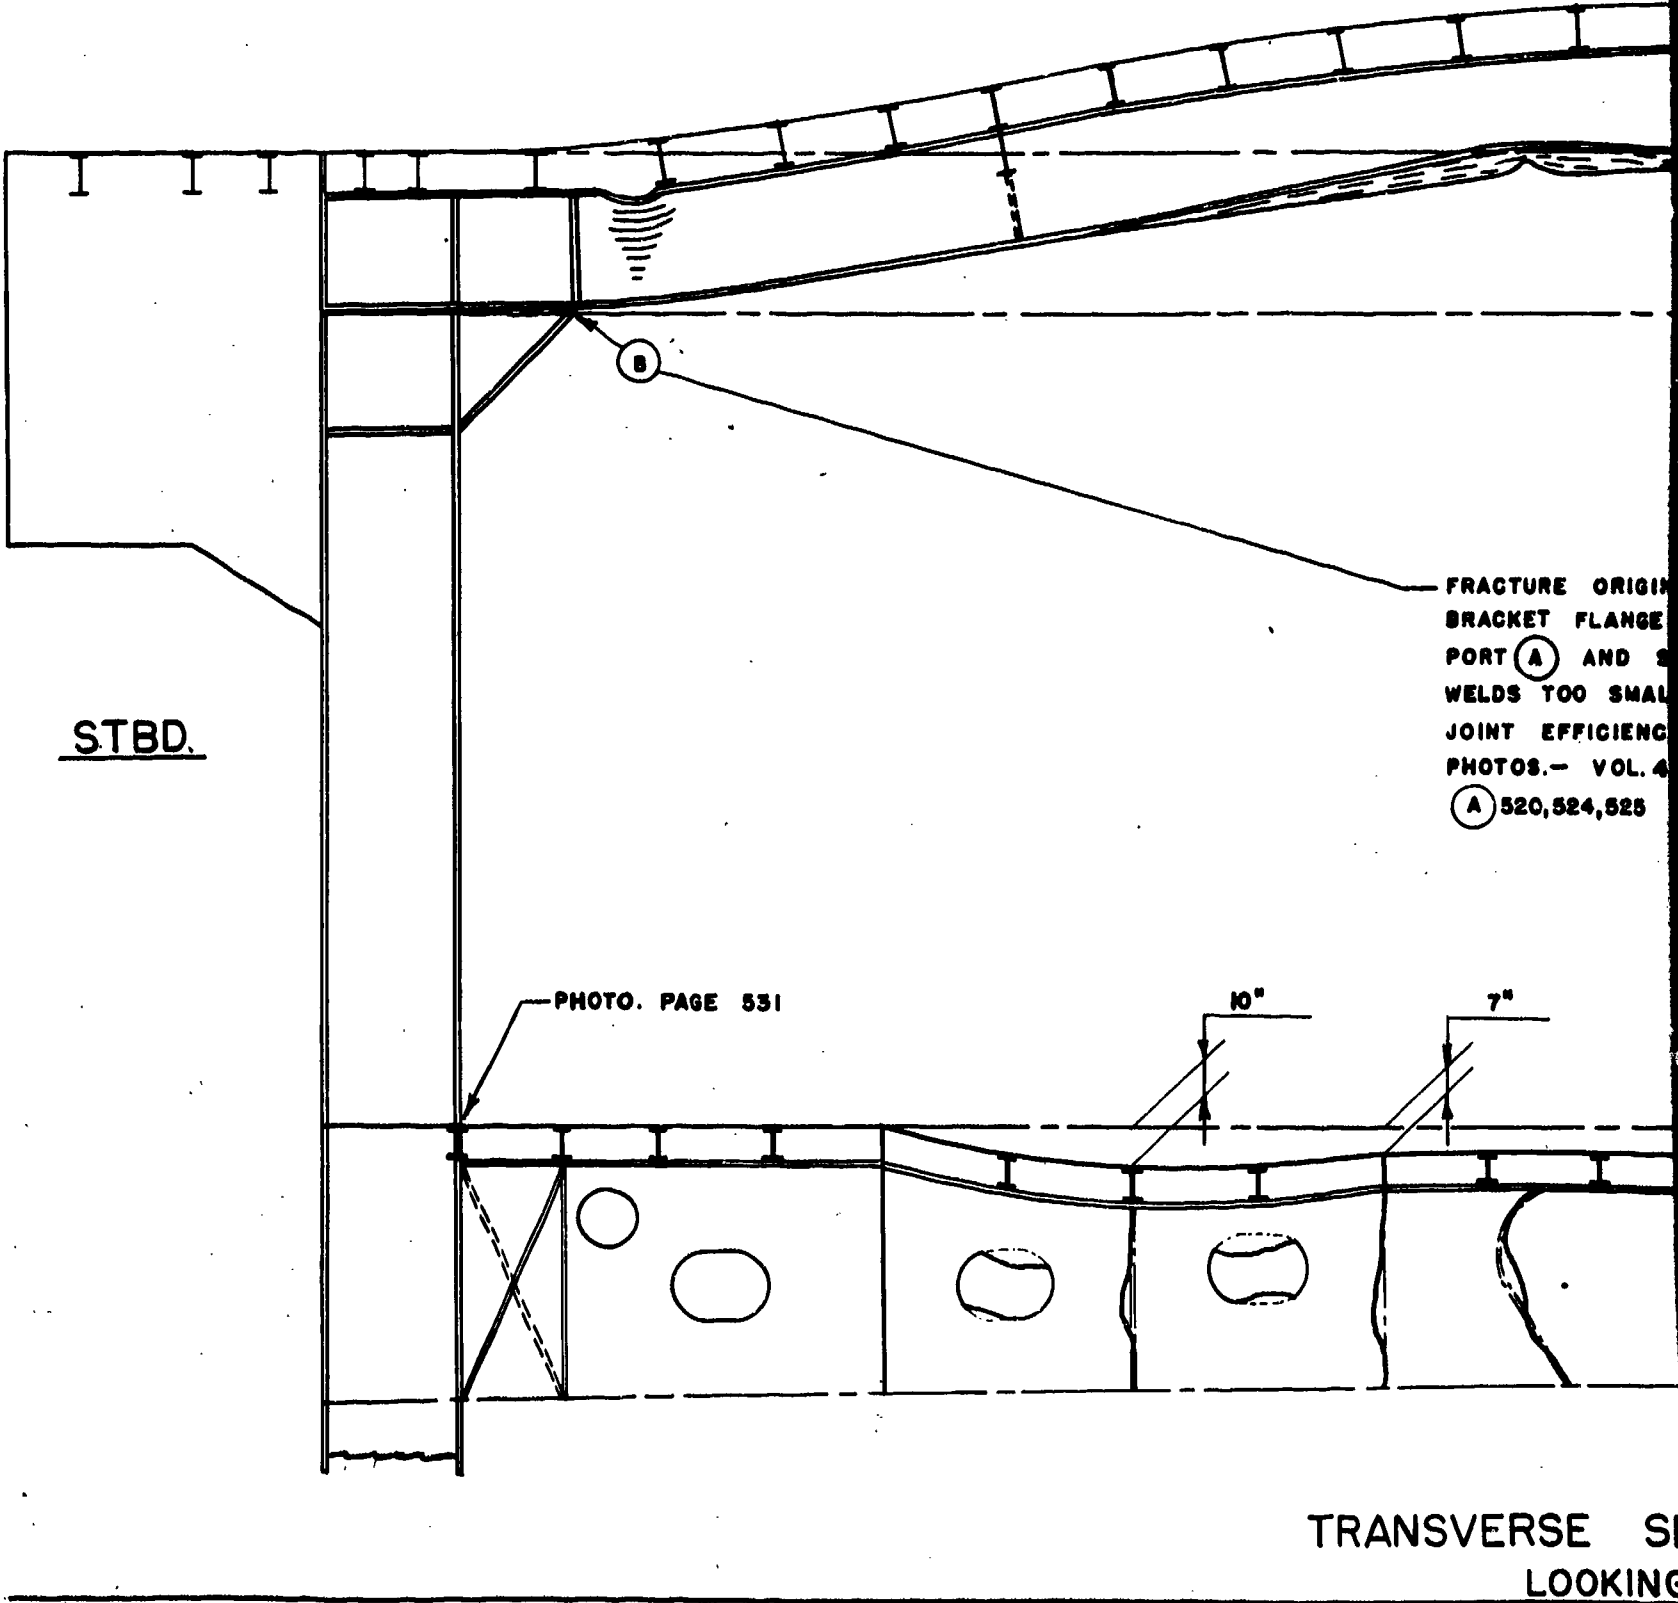
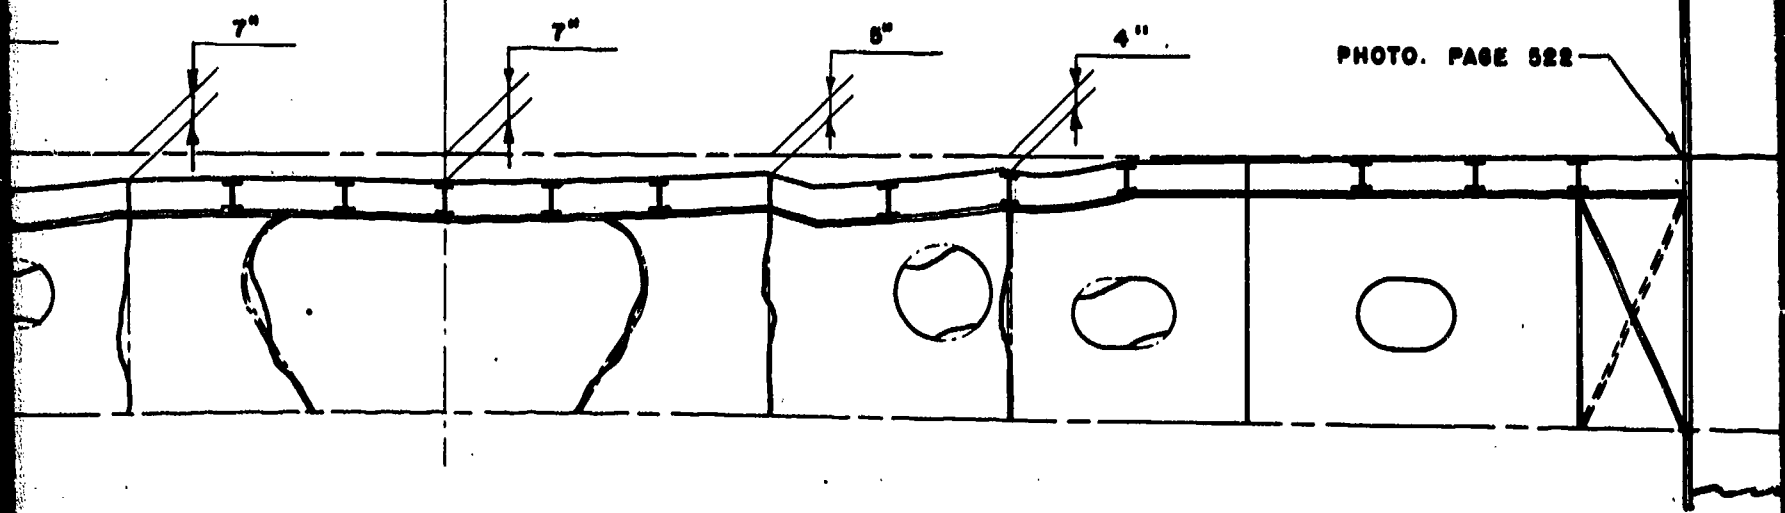
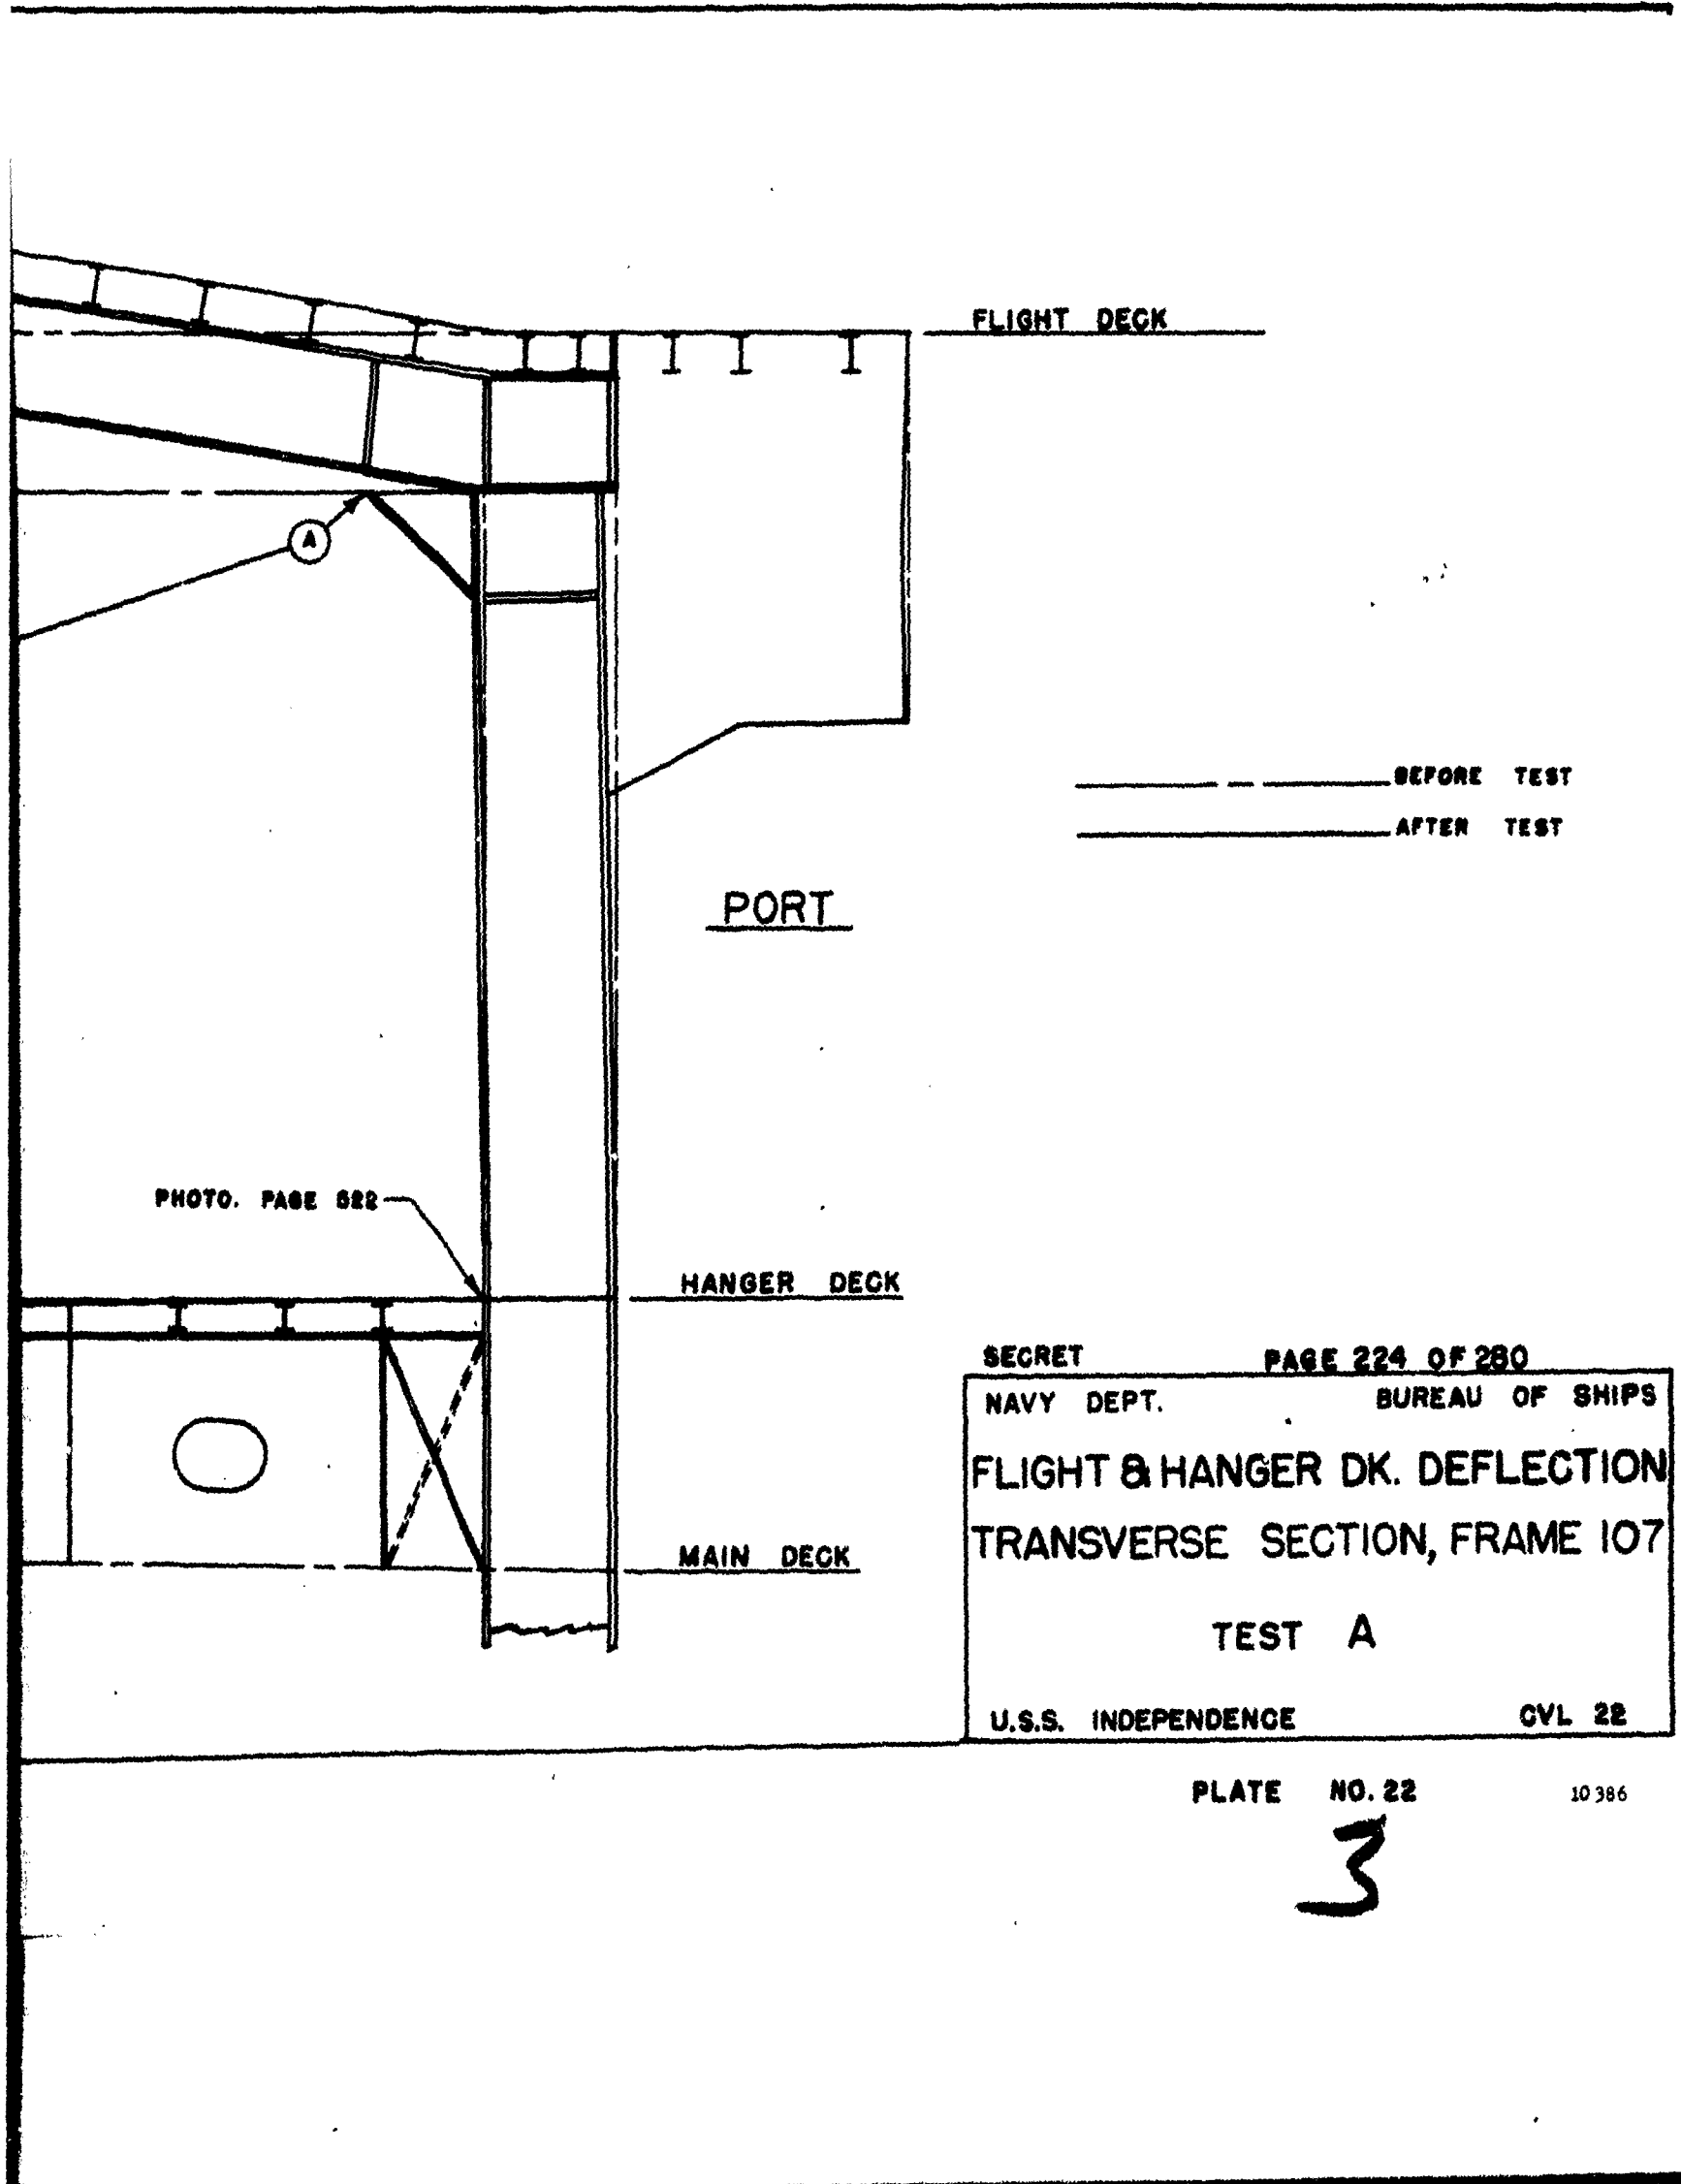
PLATE NO. 22 10 386
 3

FRACTURE ORIGIN
BRACKET FLANGE
PORT (A) AND
WELDS TOO SMALL
JOINT EFFICIENCY
PHOTOS.— VOL. 4
(A) 520,524,525

FRACTURE ORIGINATED IN WELDS JOINING BRACKET FLANGE AND GIRDER IN BOTH PORT (A) AND STARBOARD (B) CONNECTIONS. WELDS TOO SMALL TO DEVELOP 100% JOINT EFFICIENCY. PHOTOS.- VOL. 4, PAGES (A) 520, 524, 525 (B) 523, 530

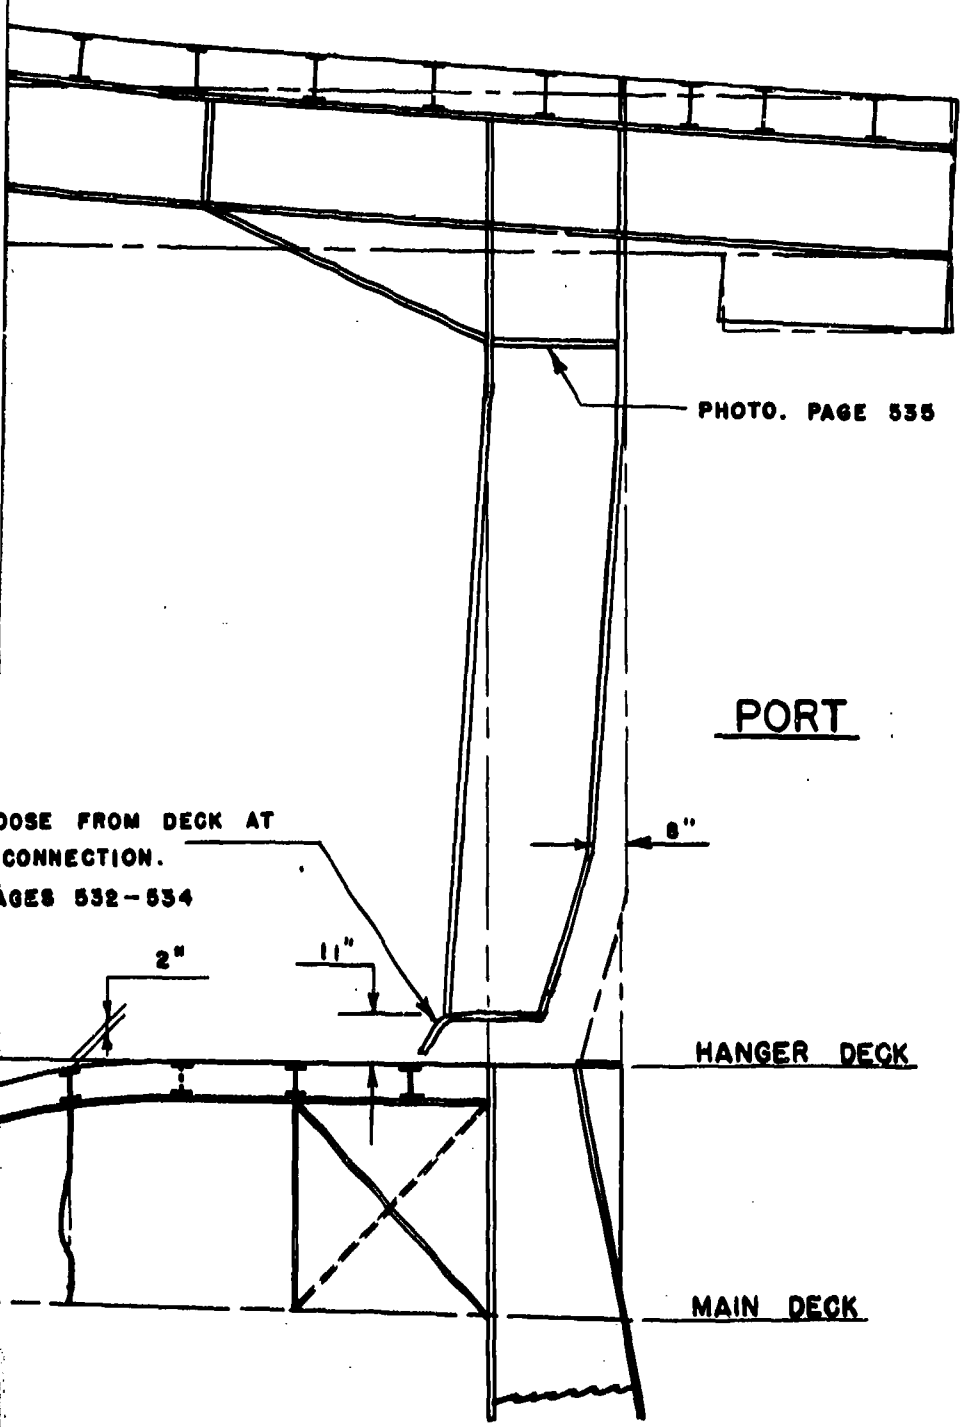
TRANSVERSE SECTION AT FR. 110
LOOKING AFT

PHOTO. PAGE 535
