BUREAU OF SHIPS GROUP TECHNICAL INSPECTION REPORT

OPERATION CROSSROADS. U.S.S. INDEPENDENCE (CVL22)

TEST ABLE

VOLUME 1 OF 4 [W]

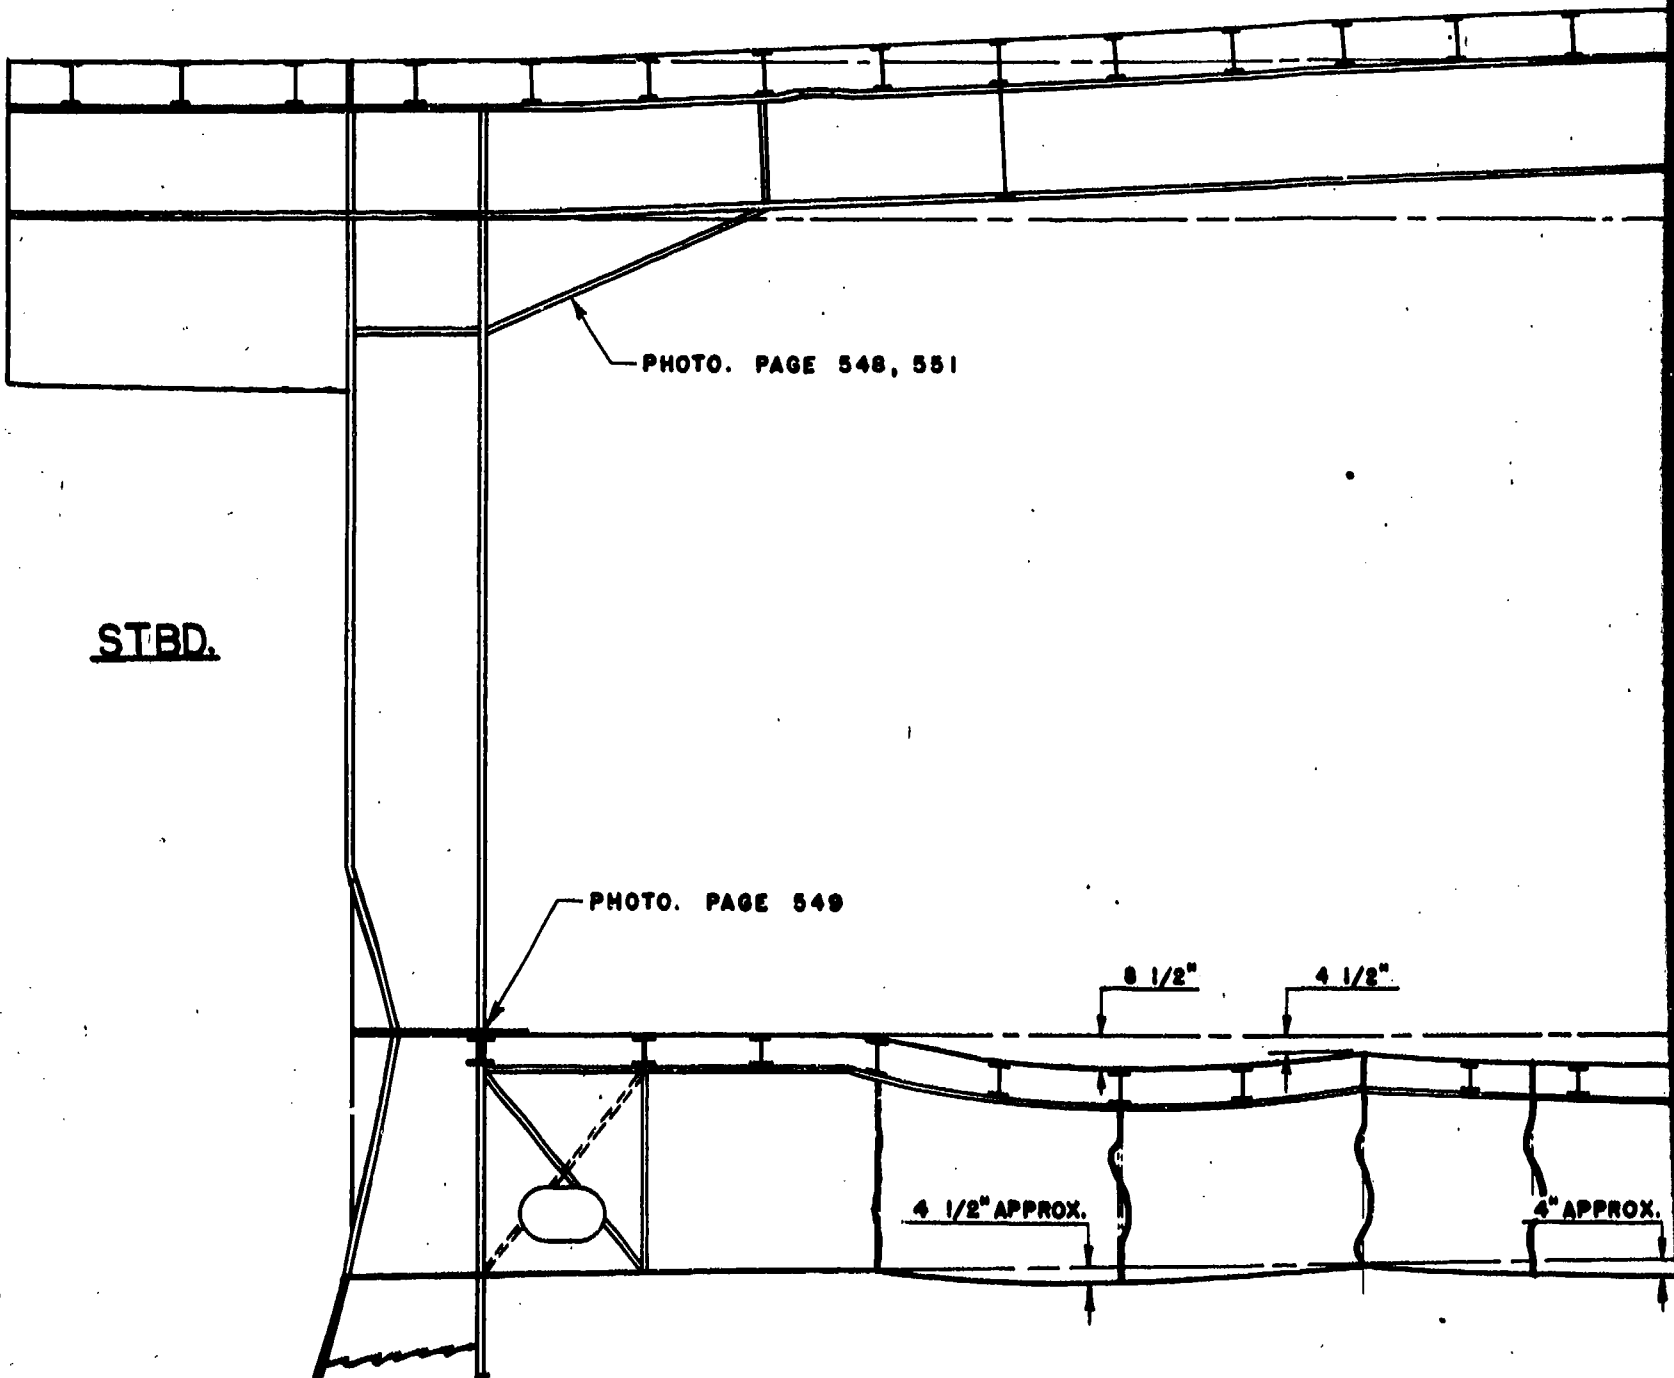
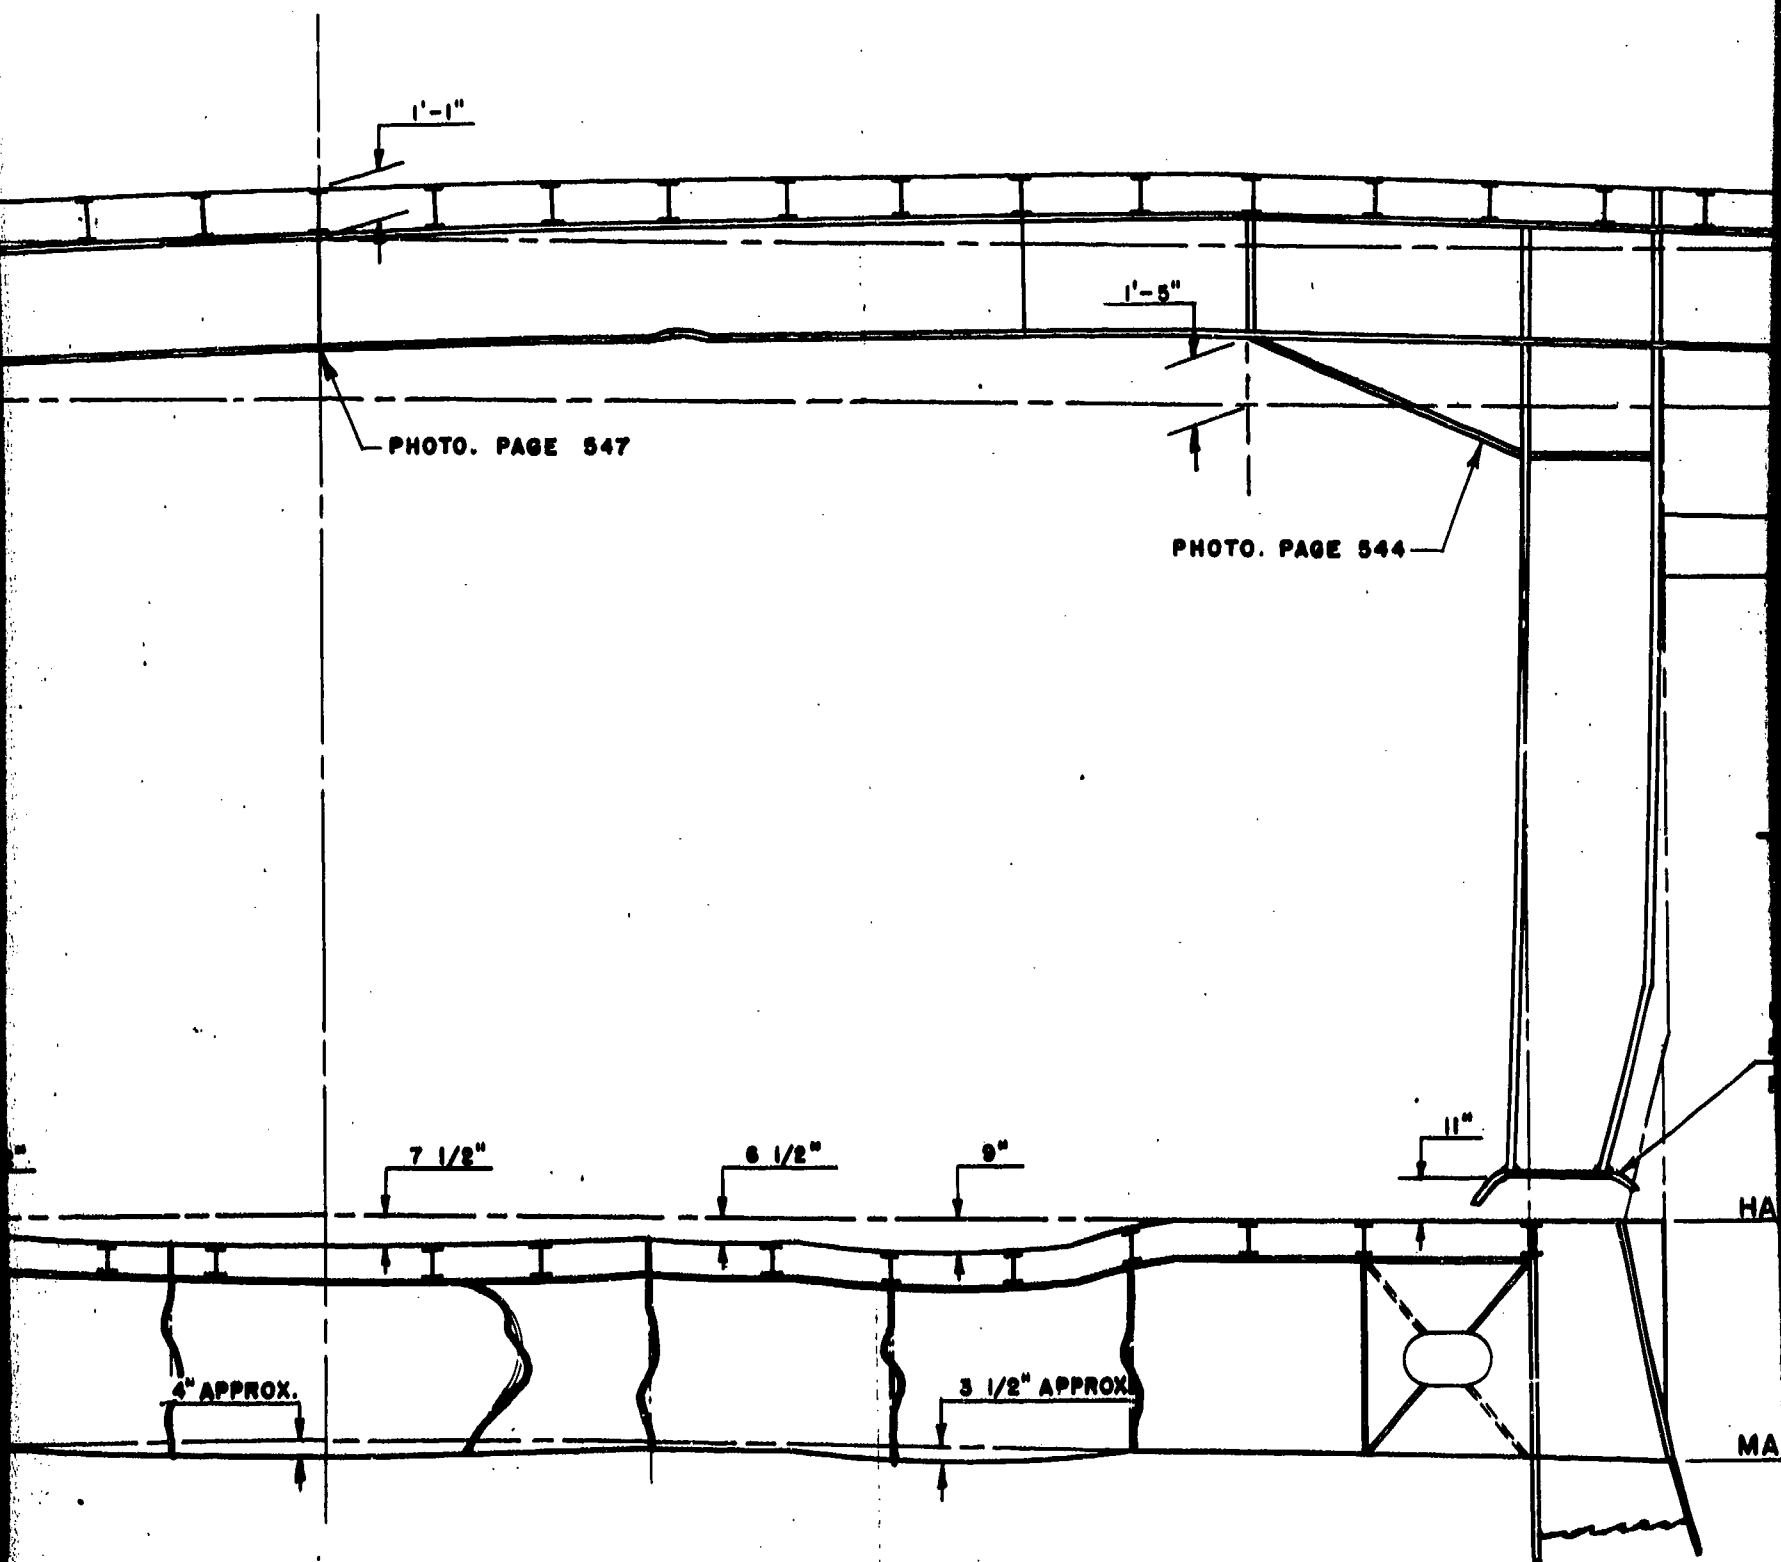
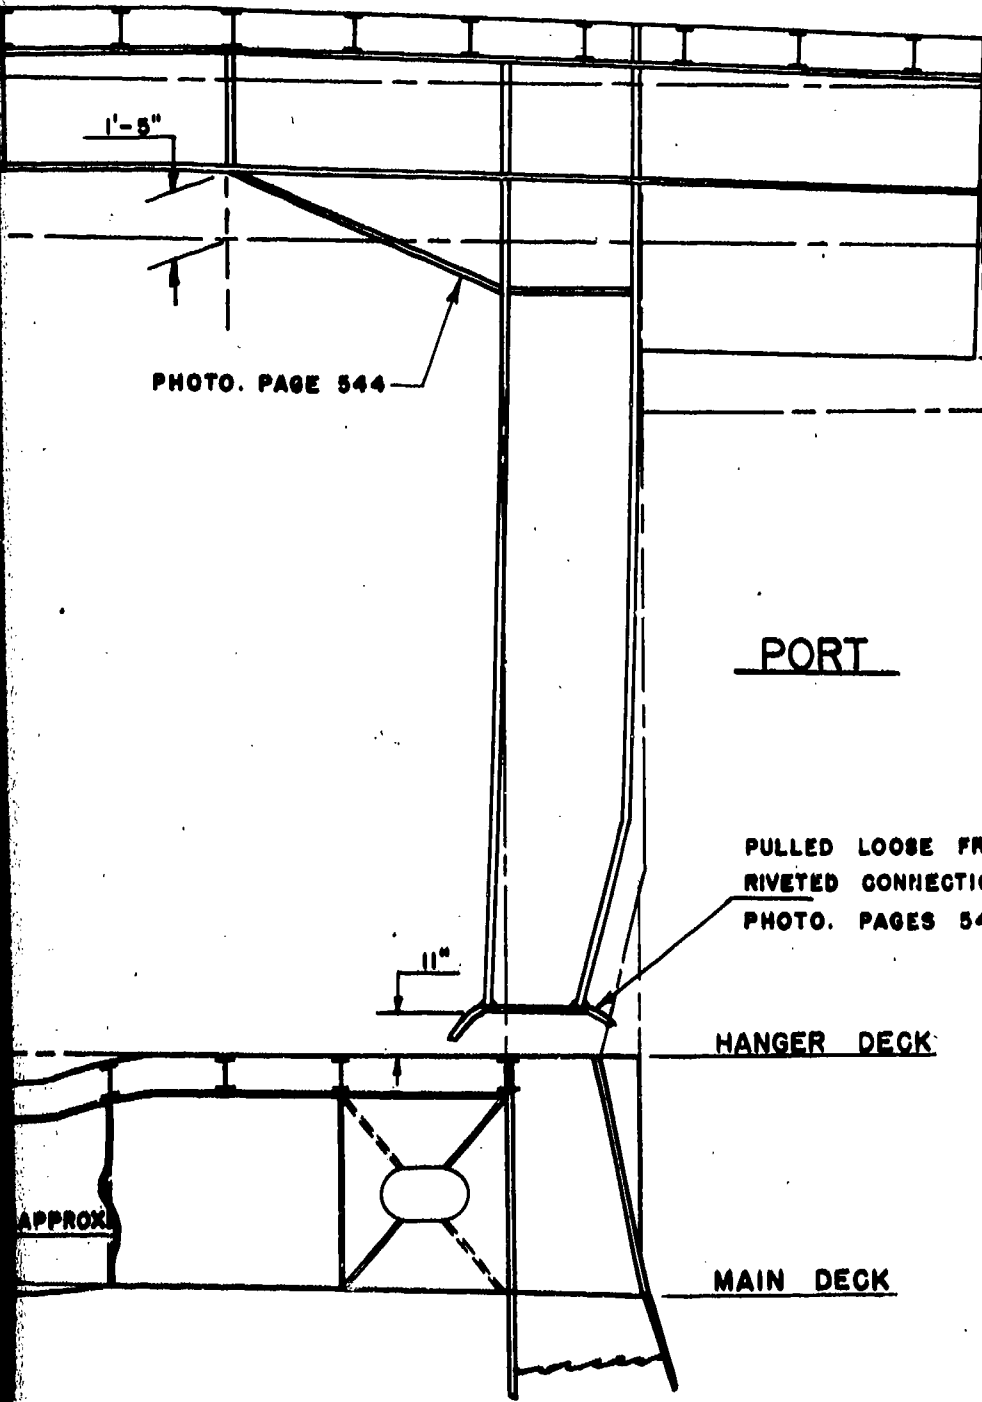
TRANSVERSE SECTION AT FR. 113
LOOKING AFT

PHOTO. PAGE 548, 551

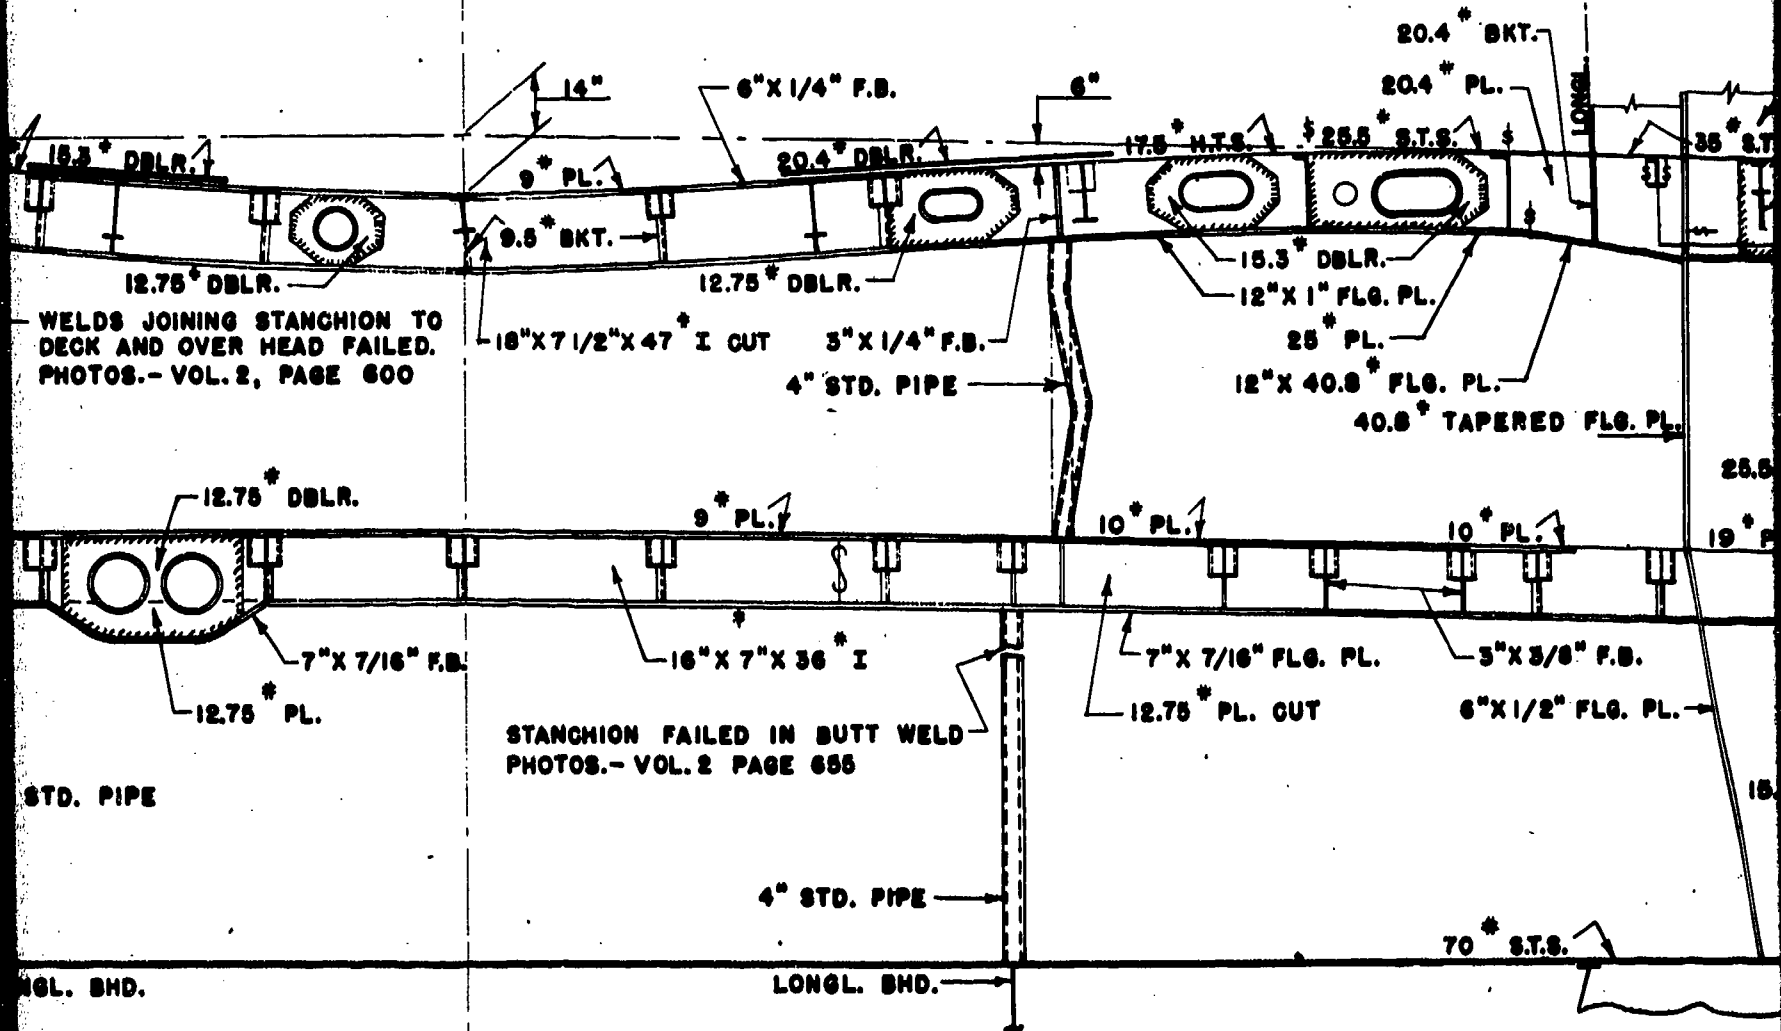
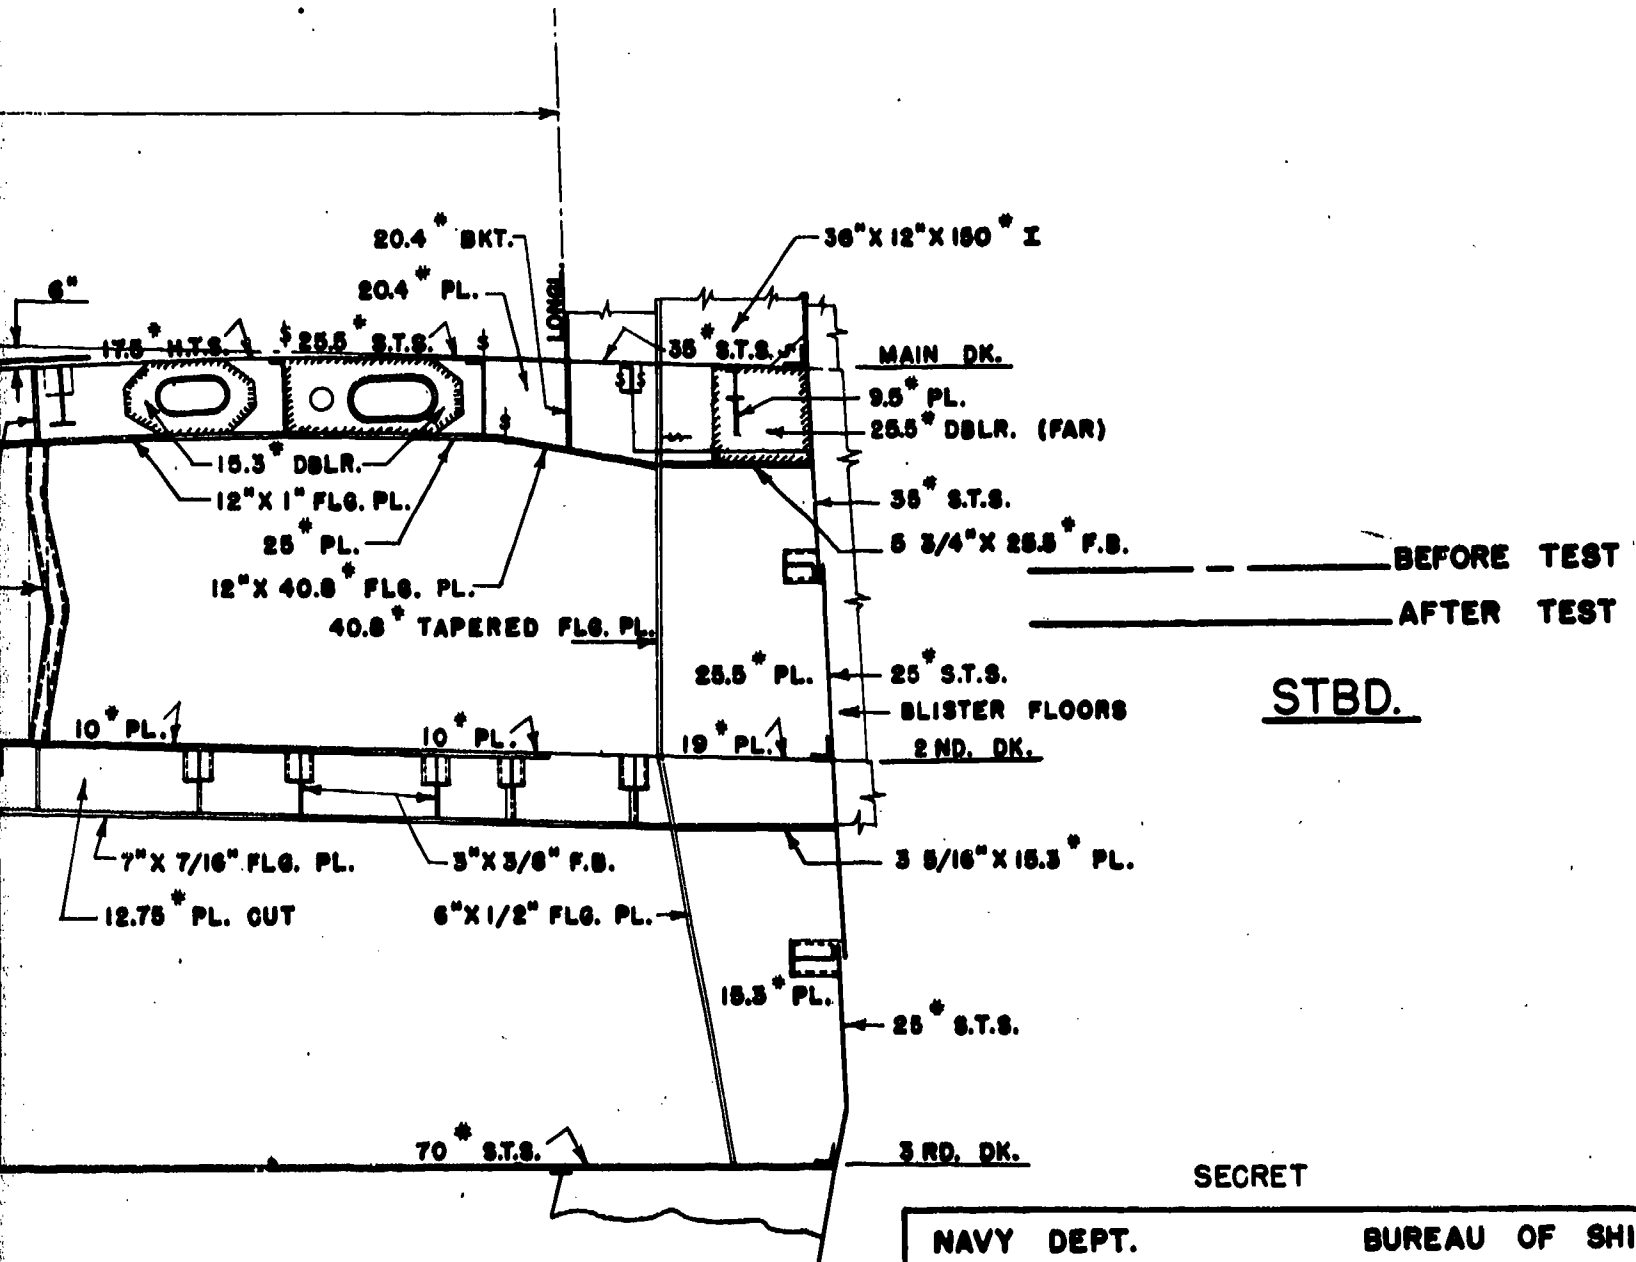
TRANSVERSE SECTION AT FR. 53
LOOKING FORD.

NAVY DEPT. BUREAU OF SHIPS
 MAIN & 2ND. DECK DEFLECTION
 TRANSVERSE SECTION, FRAME 53
 TEST A
 U.S.S. INDEPENDENCE OVL 22

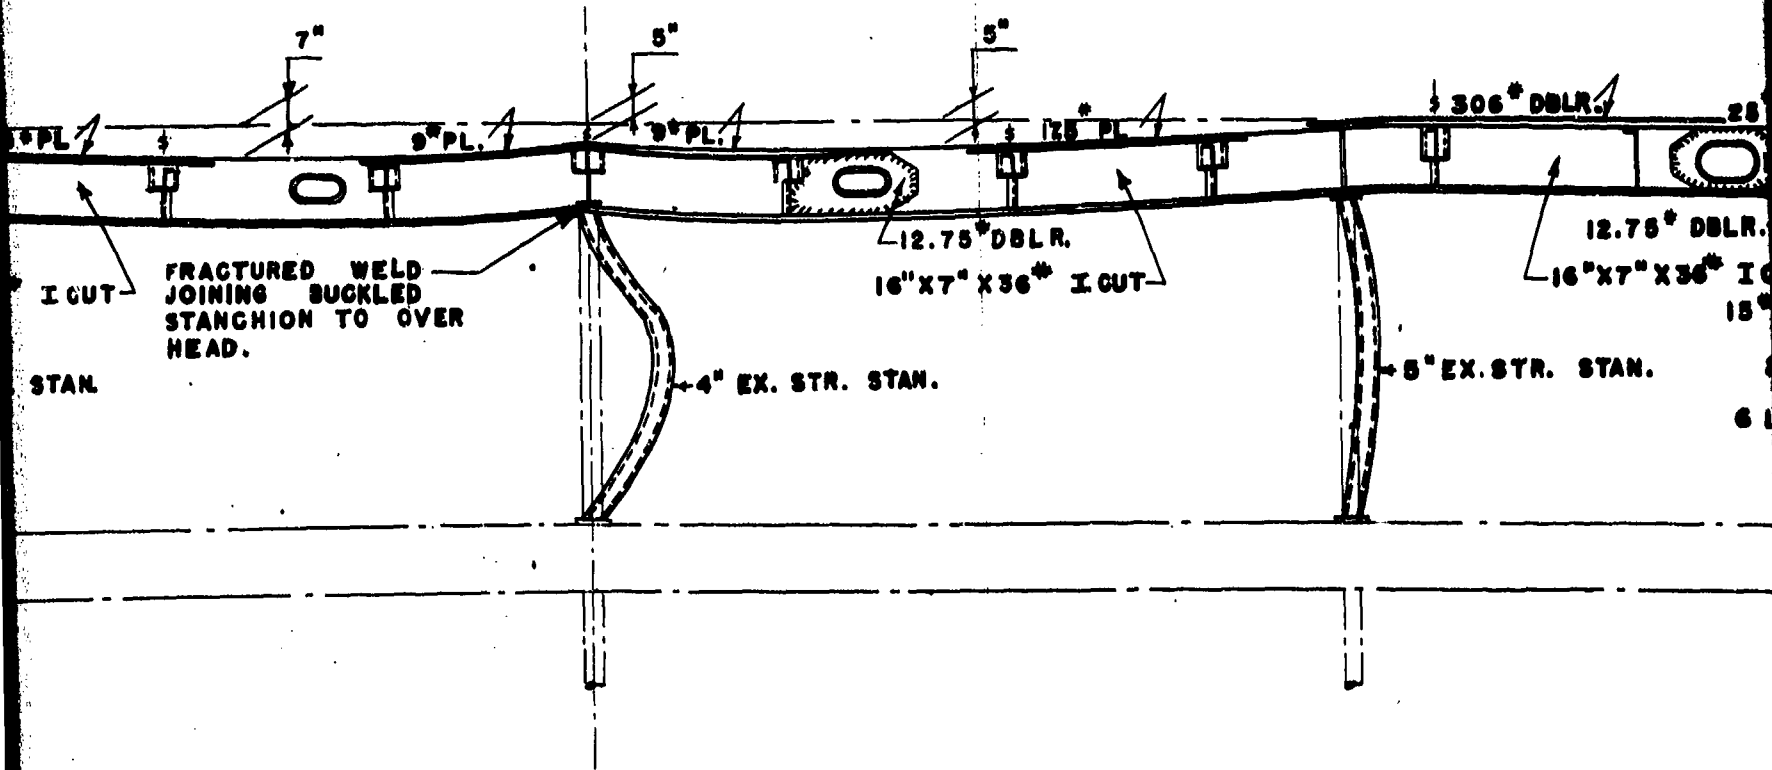
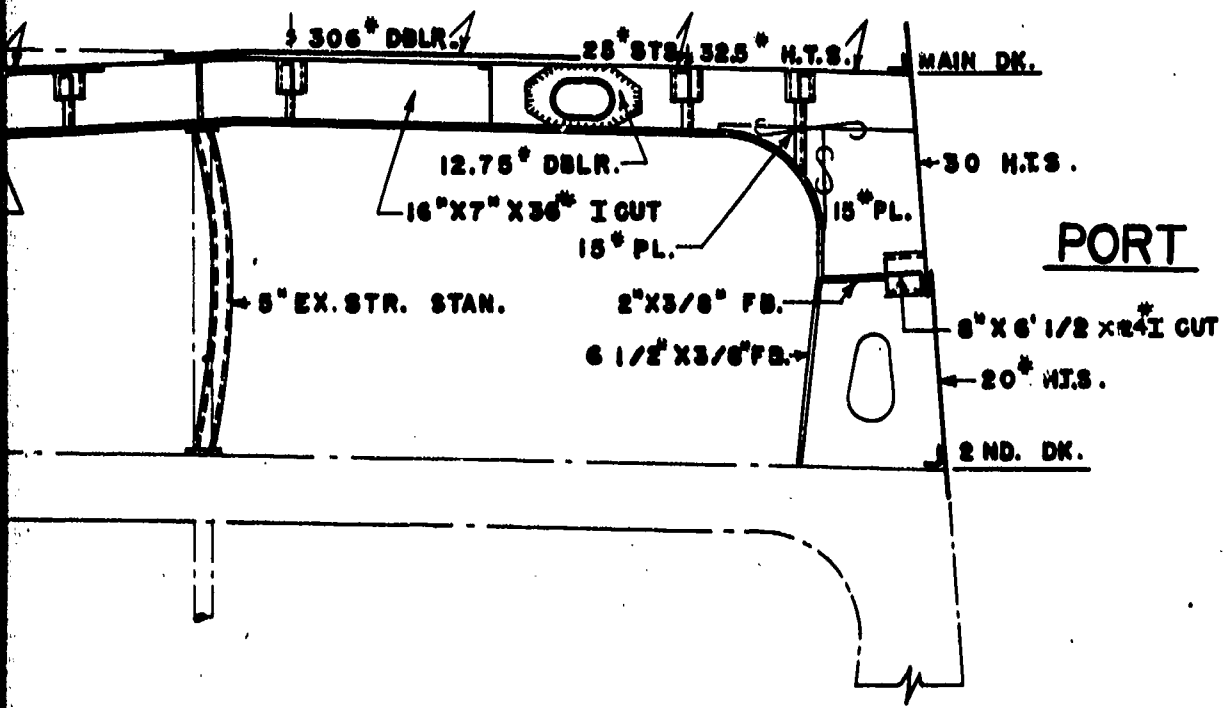
TRANSVERSE SECTION AT FR. 108
 LOOKING AFT.

2 1/2 inches. At quarter span points on either side of the stanchion the deflection increases to approximately 4 1/2 inches. At frame 108 the centerline stanchion is severely buckled by a 5 inch downward deflection of the overhead. Quarter span stanchions, starboard and port, are buckled to a lesser degree by deflection of the overhead at these locations of 2 and 1 inches respectively. Plate 27 and photograph page 623 indicate the damage inflicted in this area. From frame 108 aft to frame 113 the downward deflection of the overhead gradually decreases until at the bulkhead 113 the deflection is 4 1/2 inches at the starboard quarter breadth, 4 inches at the centerline and approximately 3 1/2 inches at the port quarter breadth. See plate 32. The downward movement of the overhead resulting from the force of the trapped blast in the hangar space above, buckled bulkhead 113 severely at the second deck level as shown on photos page 626 and 627. Tears occur near the top just to port of center. The buckles shown are from 6 to 12 inches deep and run from low port to high starboard, probably indicating, in addition to the downward deflection of the overhead a slight starboard movement of the main deck with respect to the structure beneath. This movement becomes increasingly apparent as one progresses aft from C-201-L. Photo page 625 shows a crippled mid-height port shell longitudinal and other evidence of deformation such as cracked paint on the shell plating. The slight inward deflection of the port shell begins to be apparent in this area, and becomes more pronounced as one progresses aft. Between frames 113 and 119 the overhead is deflected downward approximately 2 1/2 to 3 inches with a maximum deflection in this space of approximately 10 inches occurring at bulkhead 119 on the port side. The inward deflection of the port shell is more apparent here than in C-201-L. Photo page 628 shows the downward deflection of the overhead at bulkhead 119 and clearly indicates the inward movement of the port shell and the starboard movement of the main decks, overhead, with respect to the structure beneath. The buckle in the photograph runs from low outboard to high inboard. Damage to the bulkhead 119 is shown schematically on plate 33. Deflection of the overhead at frame 115 in this area is shown on plate 25. Starting just forward of bulkhead 113 there is a compression wrinkle in the second deck caused by the inward movement of the shell. This wrinkle extends through compartment C-202-L and on aft of bulkhead 119. It is about four inches high at bulkhead 119. Structure on the second decks between frames 119 and 126

NAVY DEPT. BUREAU OF SHIPS
 MAIN & 2ND DECK DEFLECTION
 TRANSVERSE SECTION, FRAME 108
 TEST A
 U.S.S. INDEPENDENCE OVL. 22

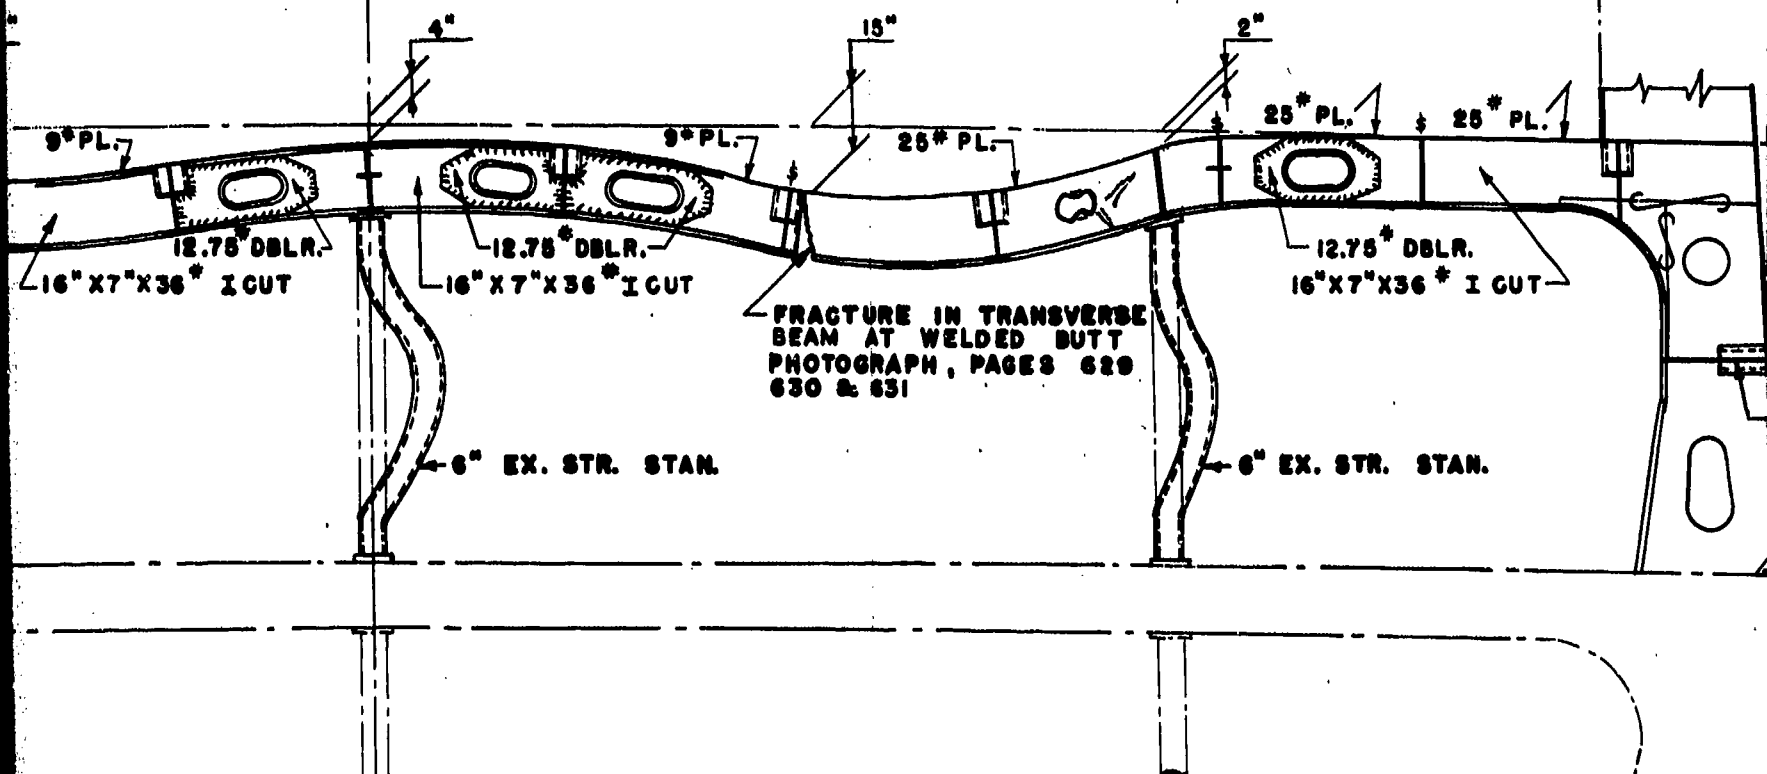
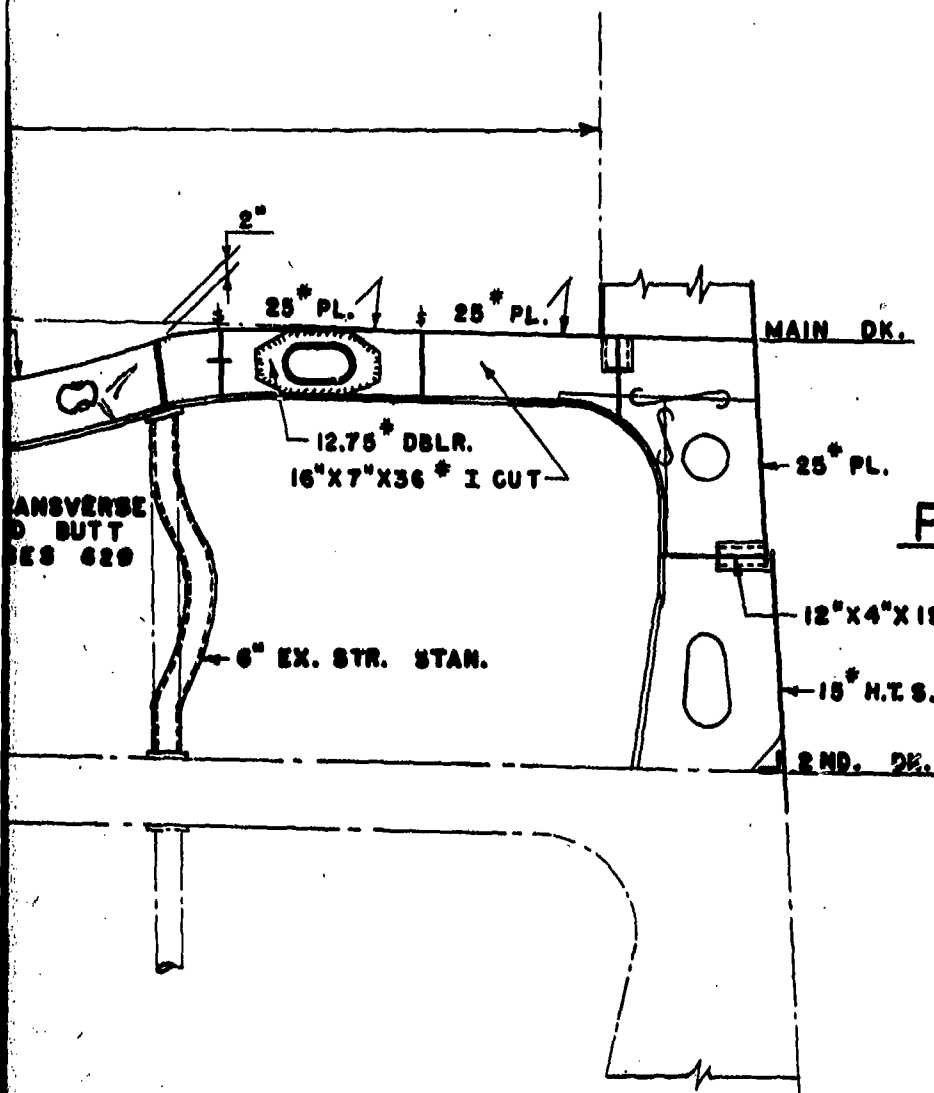
TRANSVERSE SECTION AT FR. 122
LOOKING AFT.

is in way of the after elevator pit where the main deck was directly exposed to the force of the blast wave which penetrated the hangar. In this area the overhead was badly deflected with depressions at frame 122 of 12 inches at the starboard quarter breadth, 4 inches at the centerline, and 15 inches at the port quarter breadth. As shown on plate 28, port, starboard and centerline stanchions failed by buckling. The transverse beam at frames 122 fractured in an inferior arc weld at a butt joint in way of an intersecting deck longitudinal. See photos pages 629, 630, and 631. As a result of the further starboard displacement on the main deck with respect to the structure below, bulkhead 126 shows numerous diagonal buckles running in general from low port to high starboard. See photo pages 634. The wrinkle in the second deck on the port side continues on through this compartment, increasing perceptibly as it runs aft, as shown on photo page 633. The inward movement of the port shell in way of bulkhead 126 as indicated by the buckling of the bulkhead in way of the mid-height shell longitudinal is shown on photo page 635. Wrinkling of the bulkhead further inboard in way of the wrinkle in the second deck is shown at the lower left in the photograph.

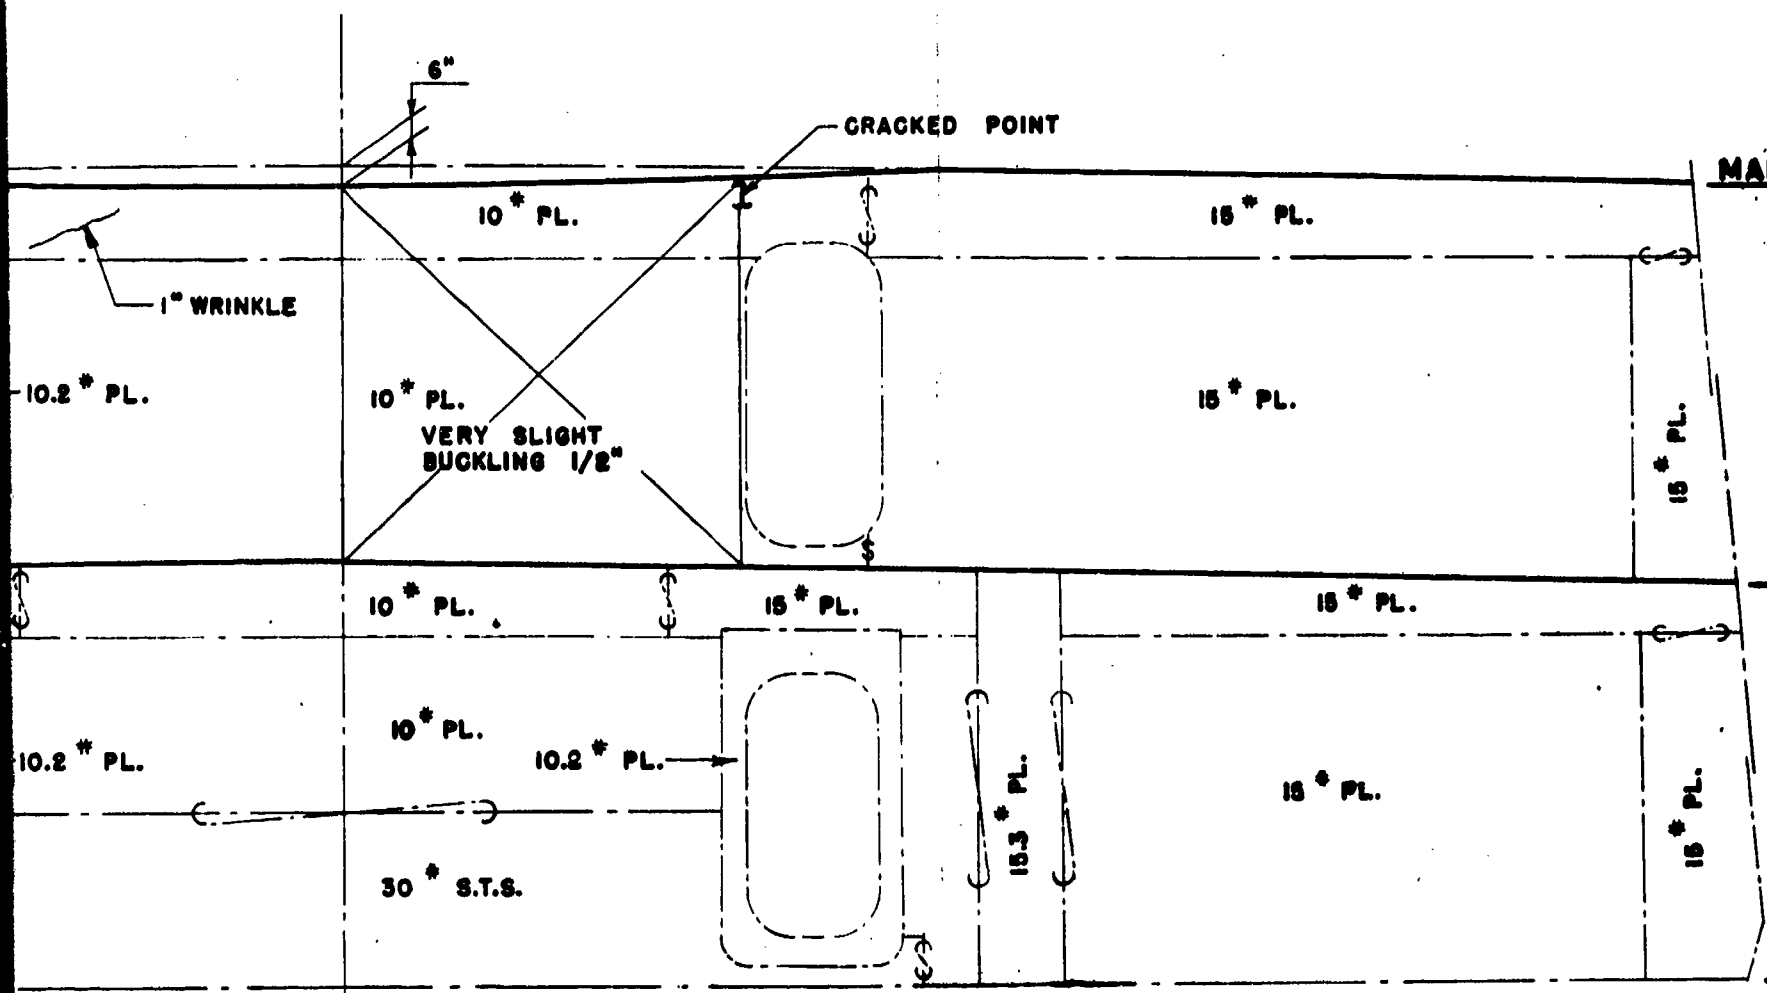
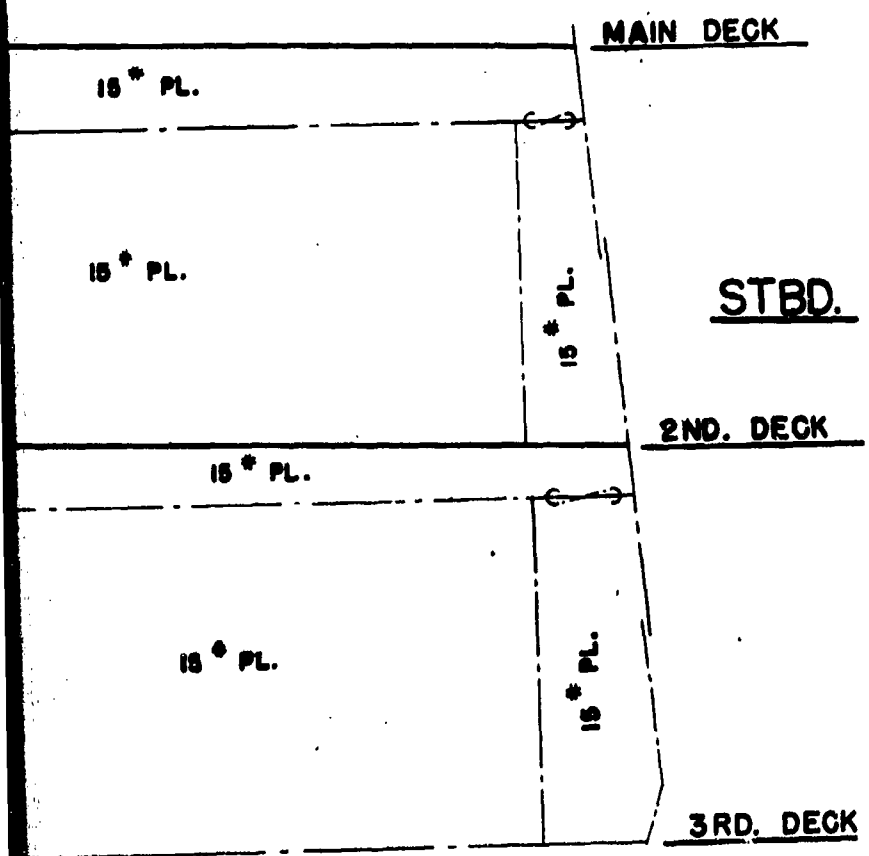
TRANSV. O.T. & W.T. BHD. 57
 LOOKING FORD.

SECRET
 NAVY DEPT. BUREAU OF SHIPS
 MAIN & 2ND. DECK DEFLECTION
 TRANSVERSE BULKHEAD FR. 57
 TEST A
 U.S.S. INDEPENDENCE CVL 22

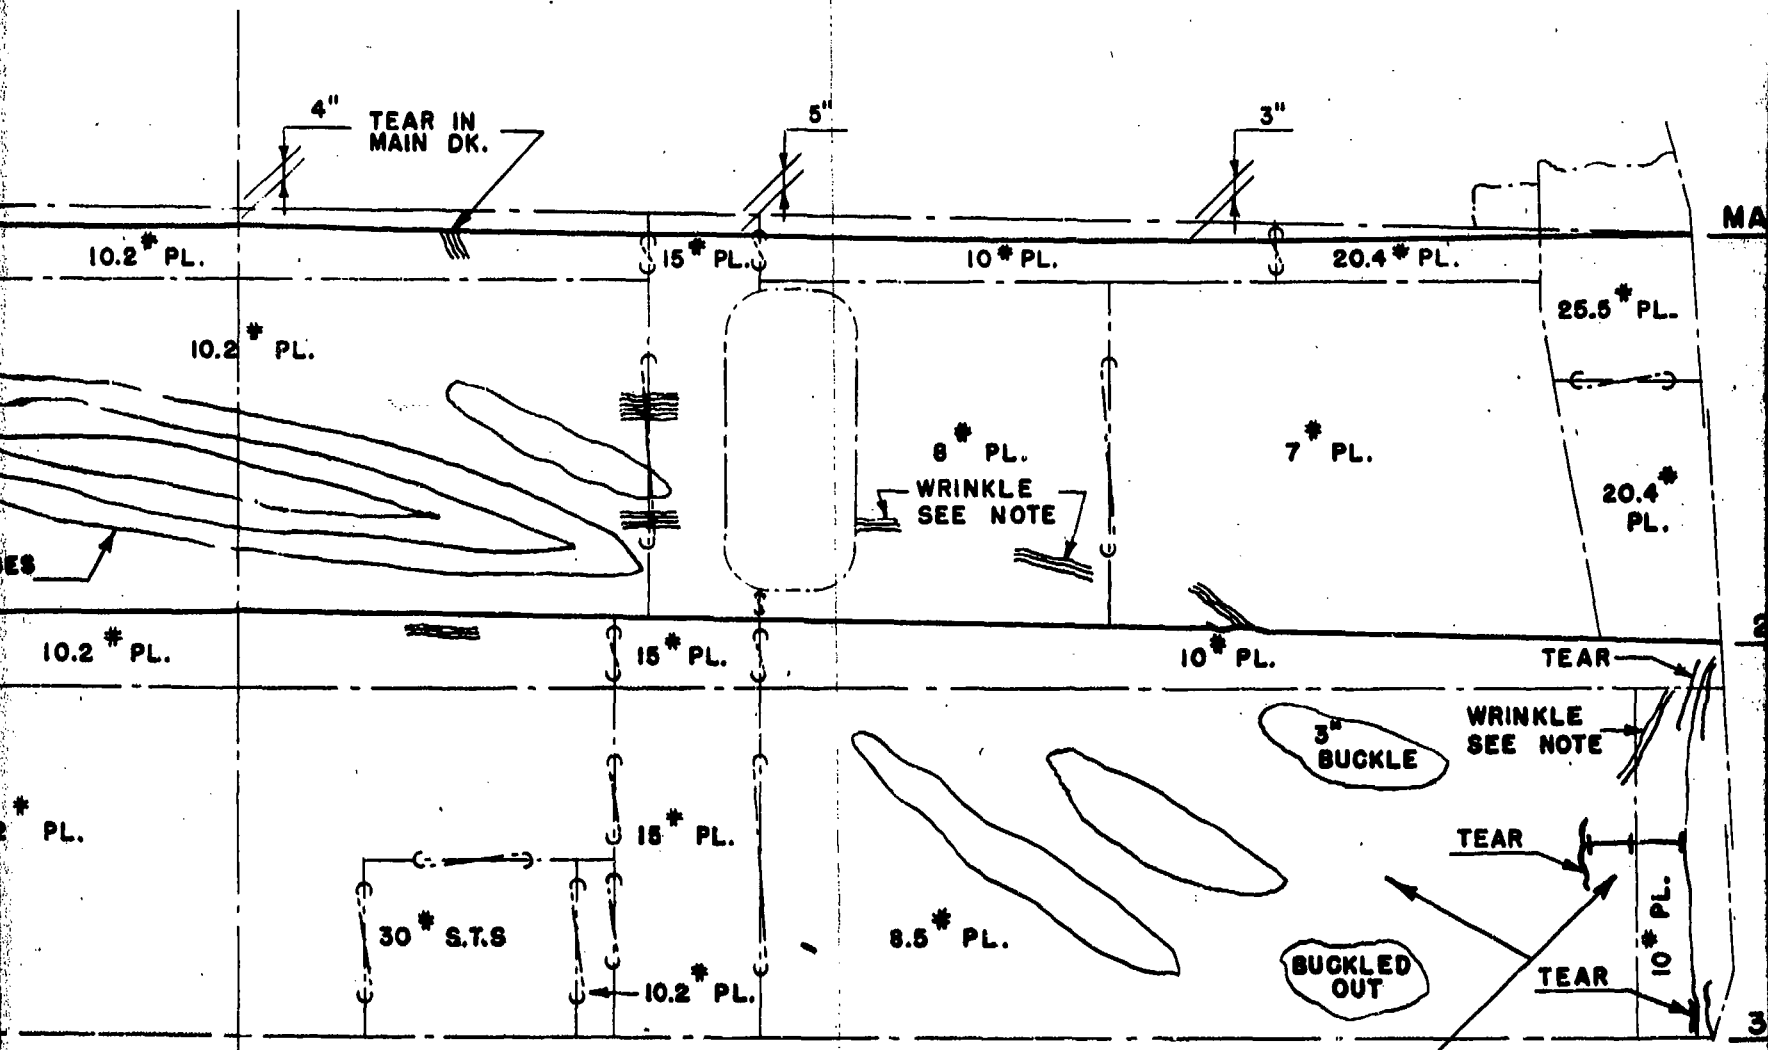
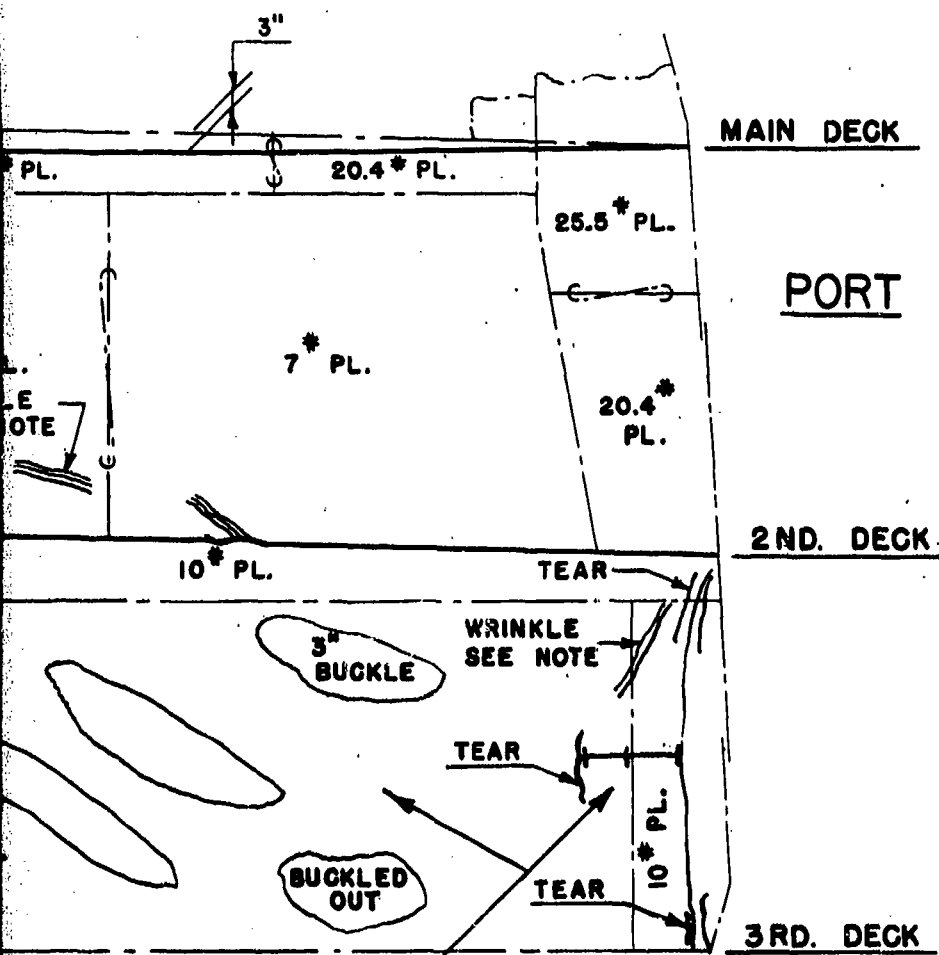
V. OT. & W.T. BHD. 113
 LOOKING AFT.

PHOTO. PAGES 668-670
