BUREAU OF SHIPS GROUP TECHNICAL INSPECTION REPORT

OPERATION CROSSROADS. U.S.S. INDEPENDENCE (CVL22)

TEST ABLE

VOLUME 1 OF 4 [W]

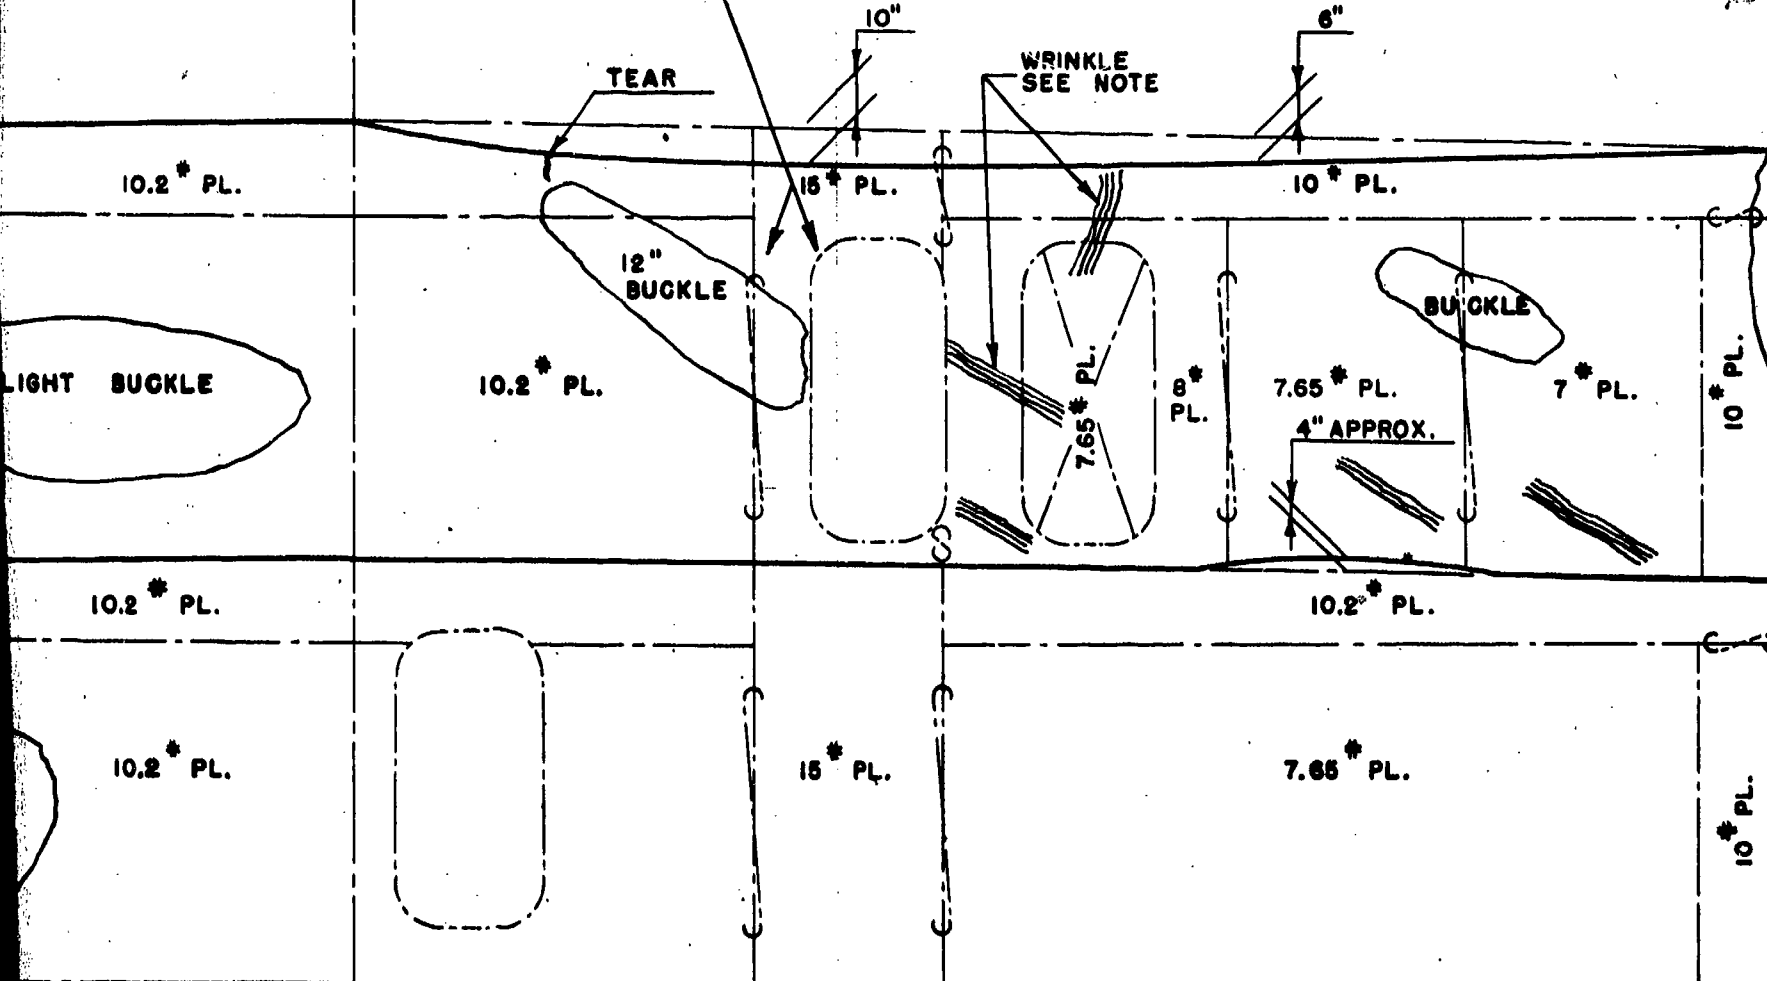
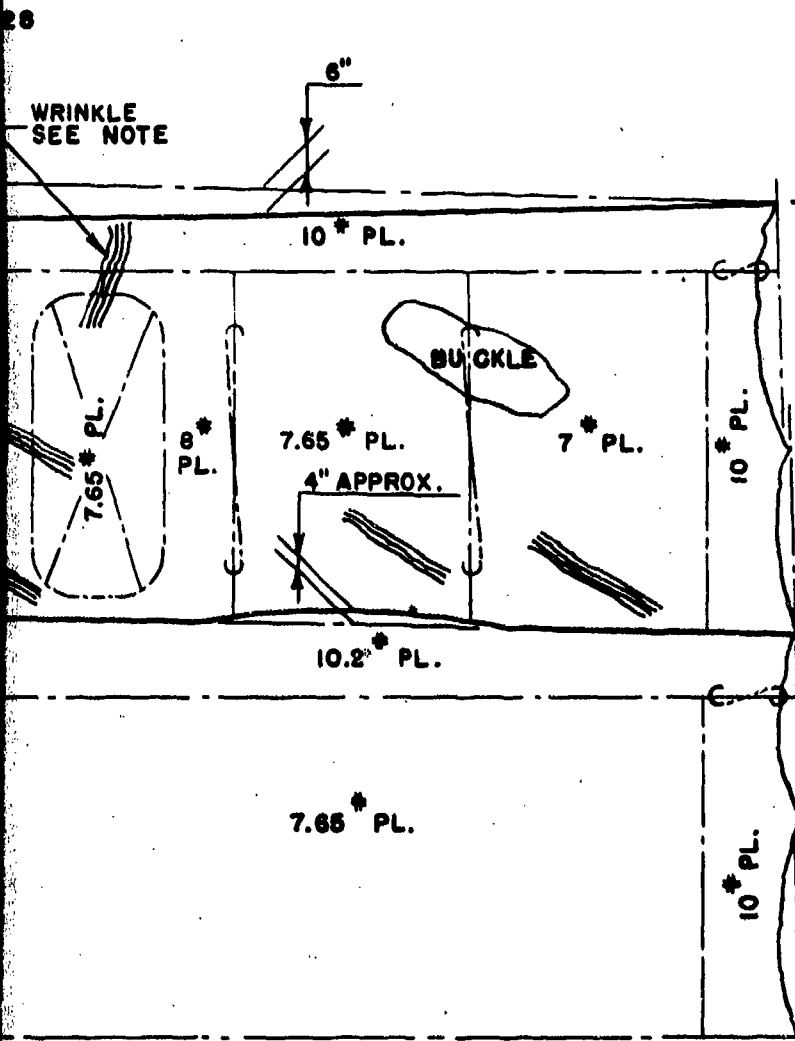
TRANSV. O.T. & W.T. BHD. 119
LOOKING AFT

PHOTO. PAGE 628

SECRET
 NAVY DEPT. BUREAU OF SHIPS
 MAIN & 2ND. DECK DEFLECTION
 TRANSVERSE BULKHEAD FR 119
 TEST A
 U.S. INDEPENDENCE CVL 22

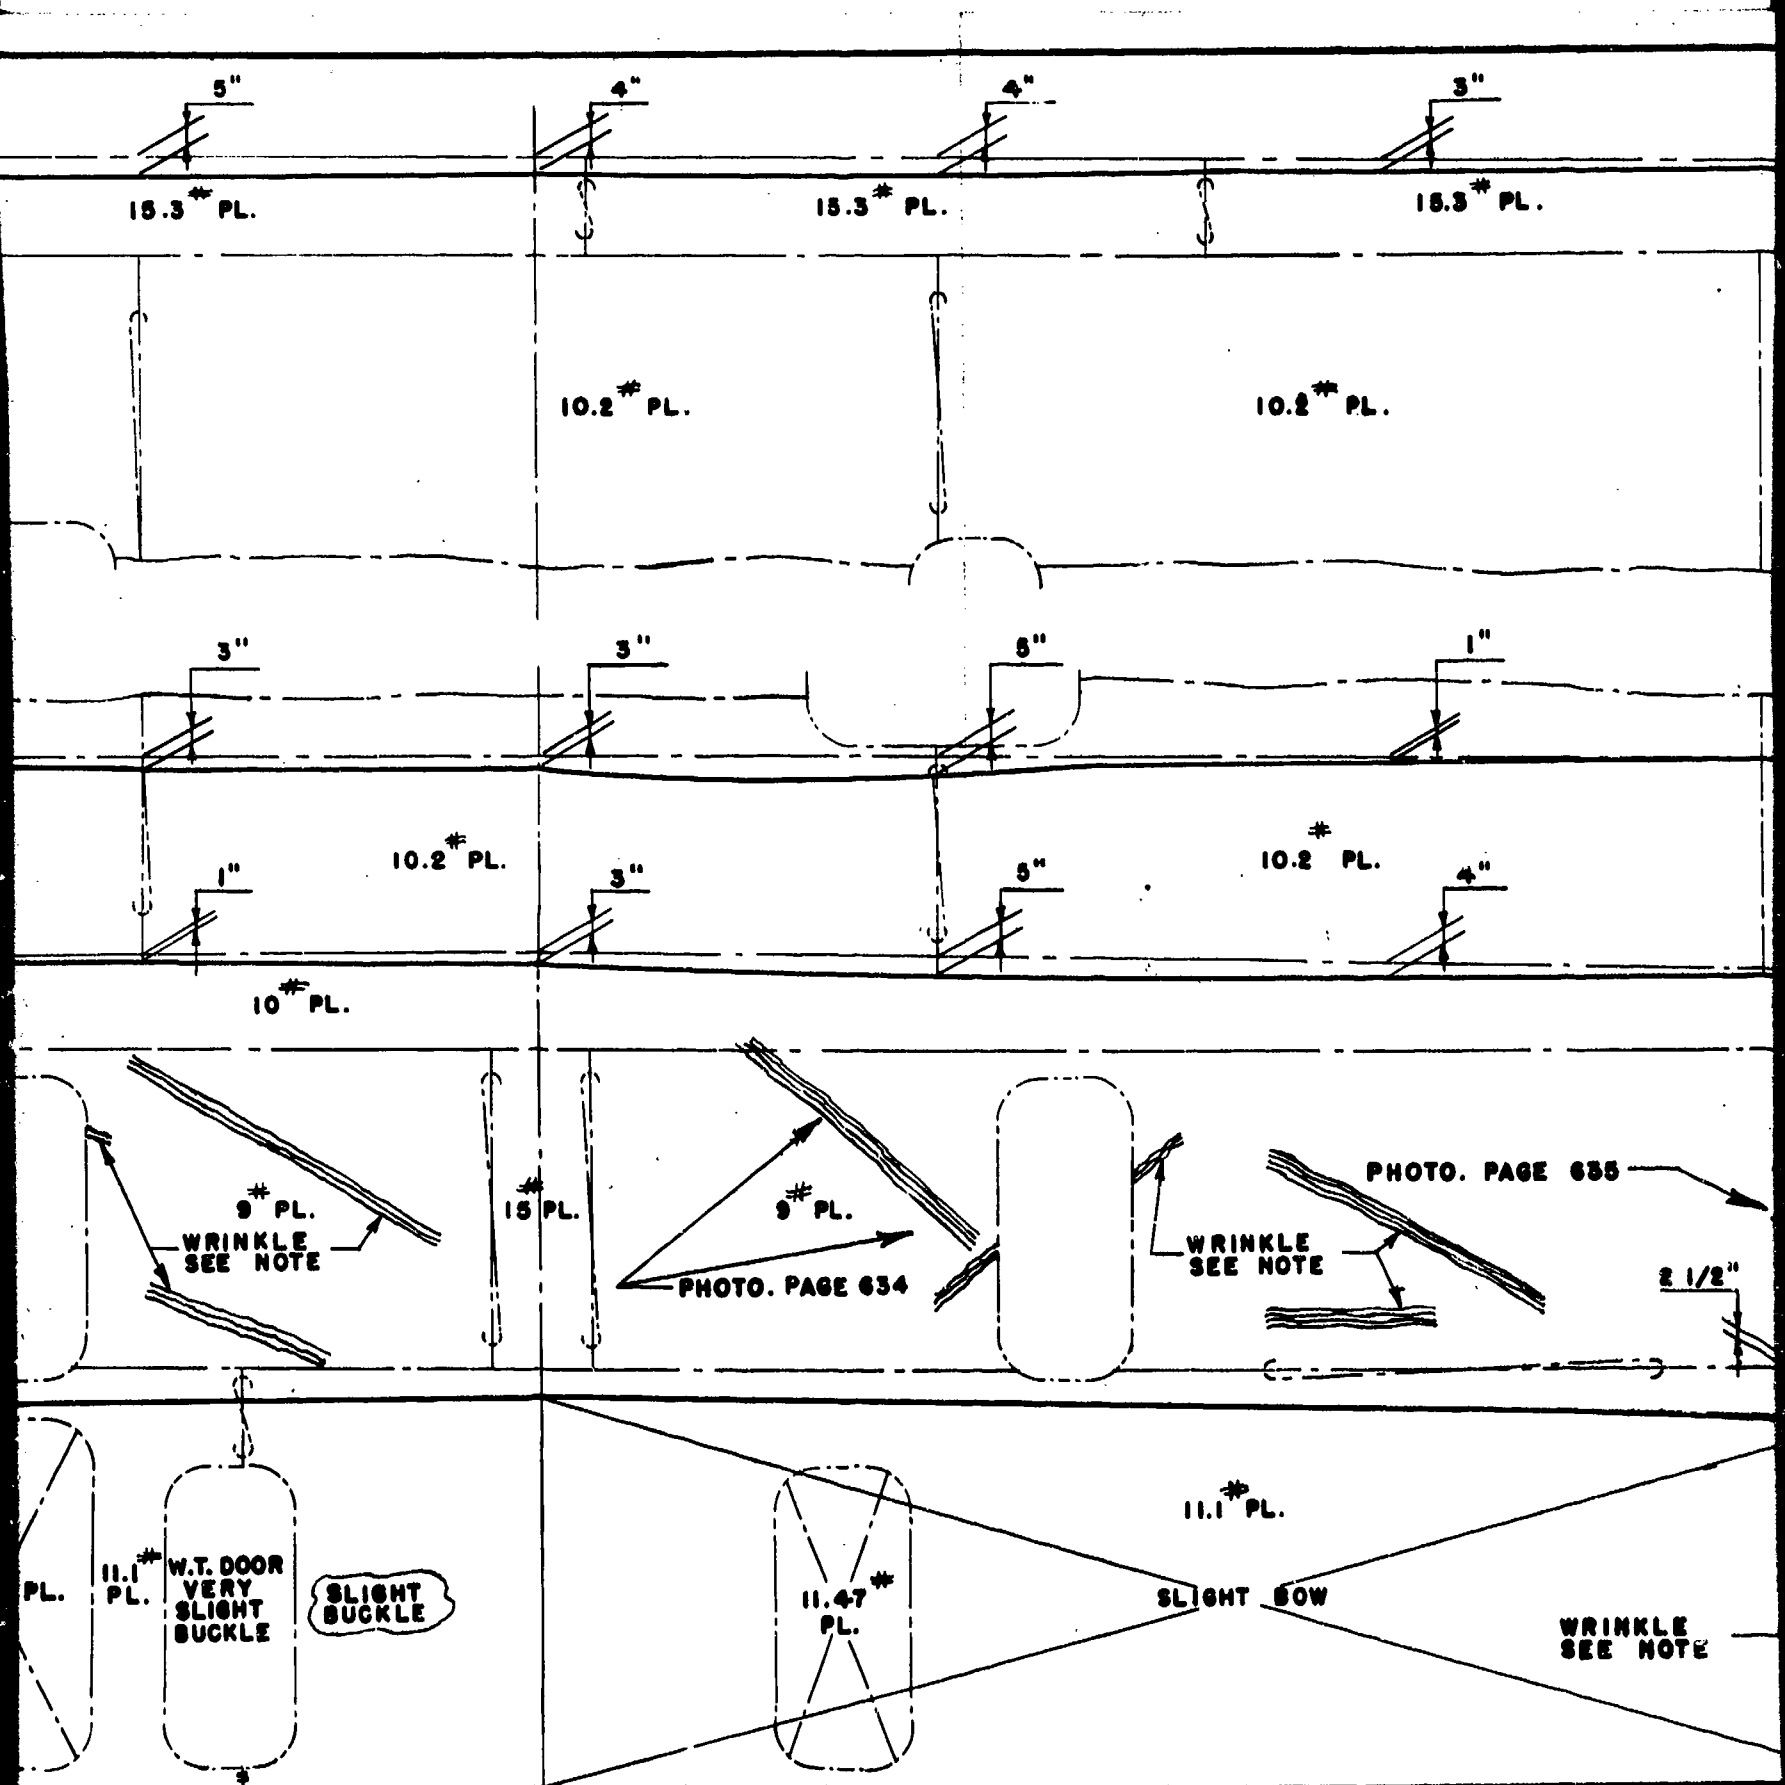
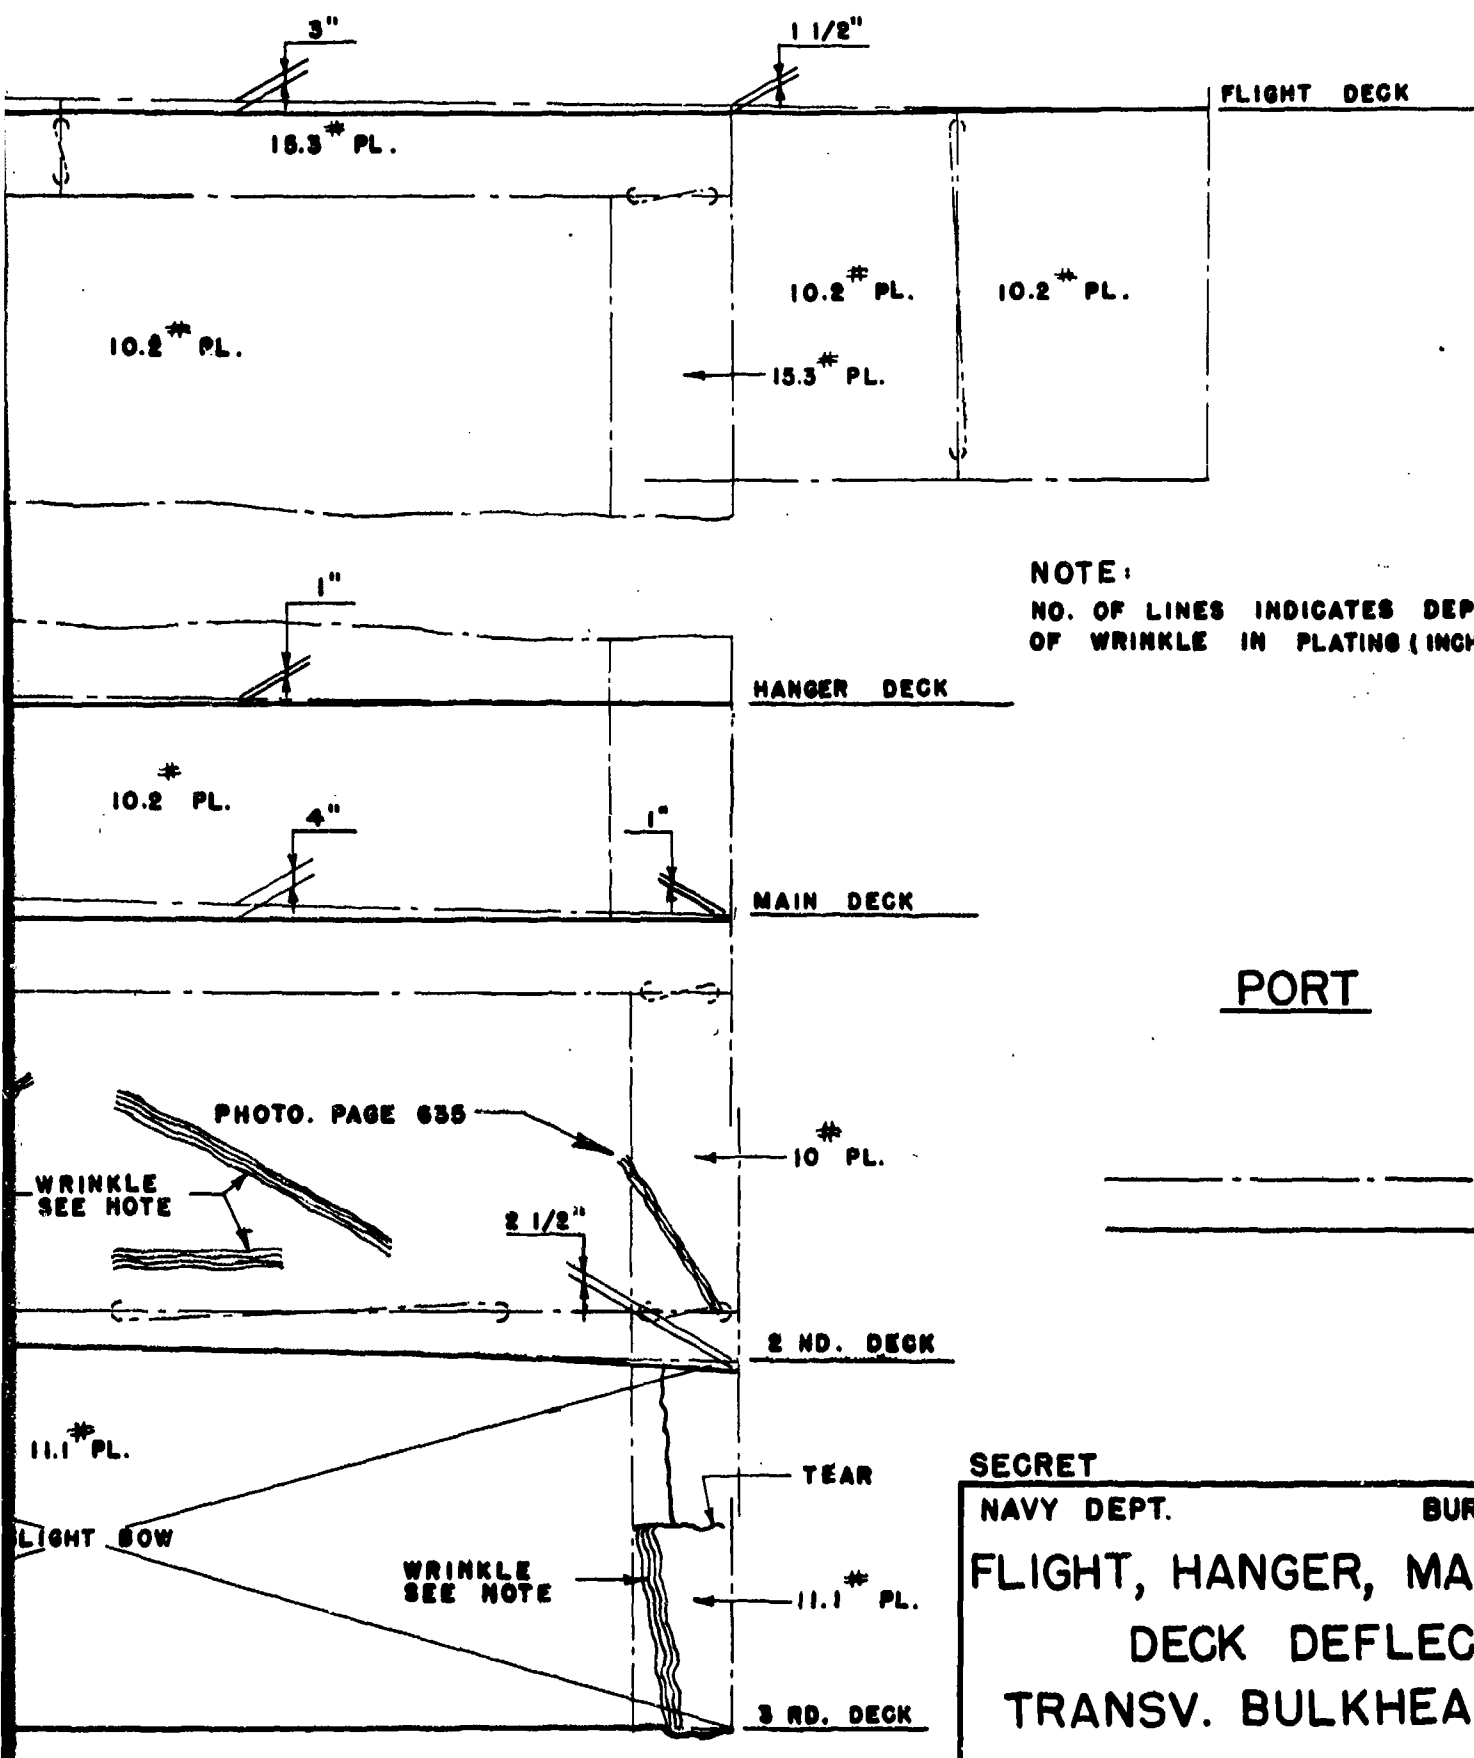
TRANS. WT. & O.T. BHD. 126
 LOOKING AFT.

PHOTO. PAGE 679

SECRET
 NAVY DEPT. BUREAU OF SHIPS
 FLIGHT, HANGER, MAIN & 2 ND.
 DECK DEFLECTION
 TRANSV. BULKHEAD, FR. 126
 TEST A
 U.S.S. INDEPENDENCE CVL 22

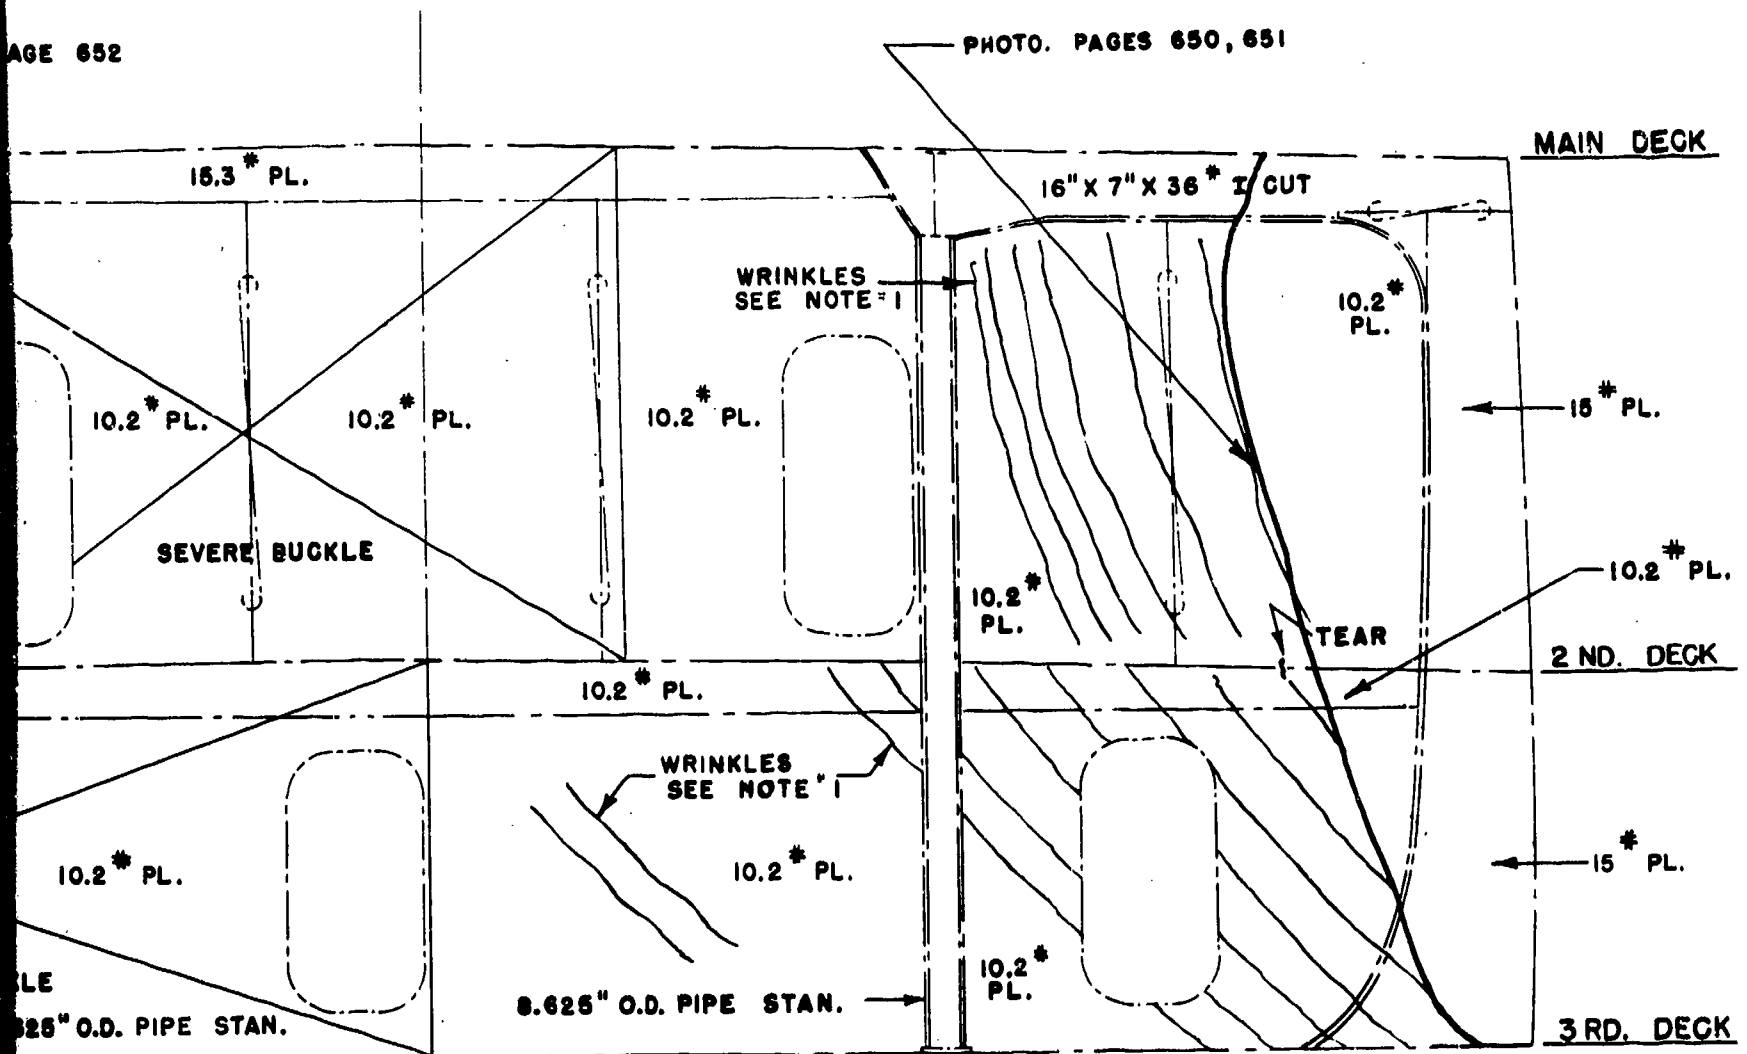
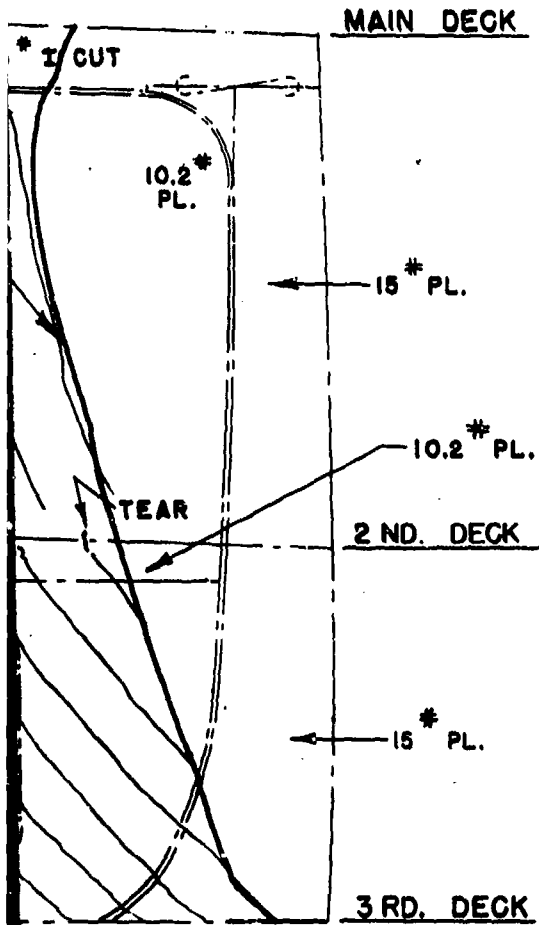
TRANSV. W.T. BHD. 144
LOOKING AFT.

PHOTO. PAGES 650, 651

NOTE:
 1. NO. OF LINES INDICATES DEPTH OF WRINKLE IN PLATING (INCHES).
 2. NO DATA AVAILABLE REGARDING DECK DEFLECTION. SHELL DAMAGE INDICATED TAKEN FROM PHOTOS.

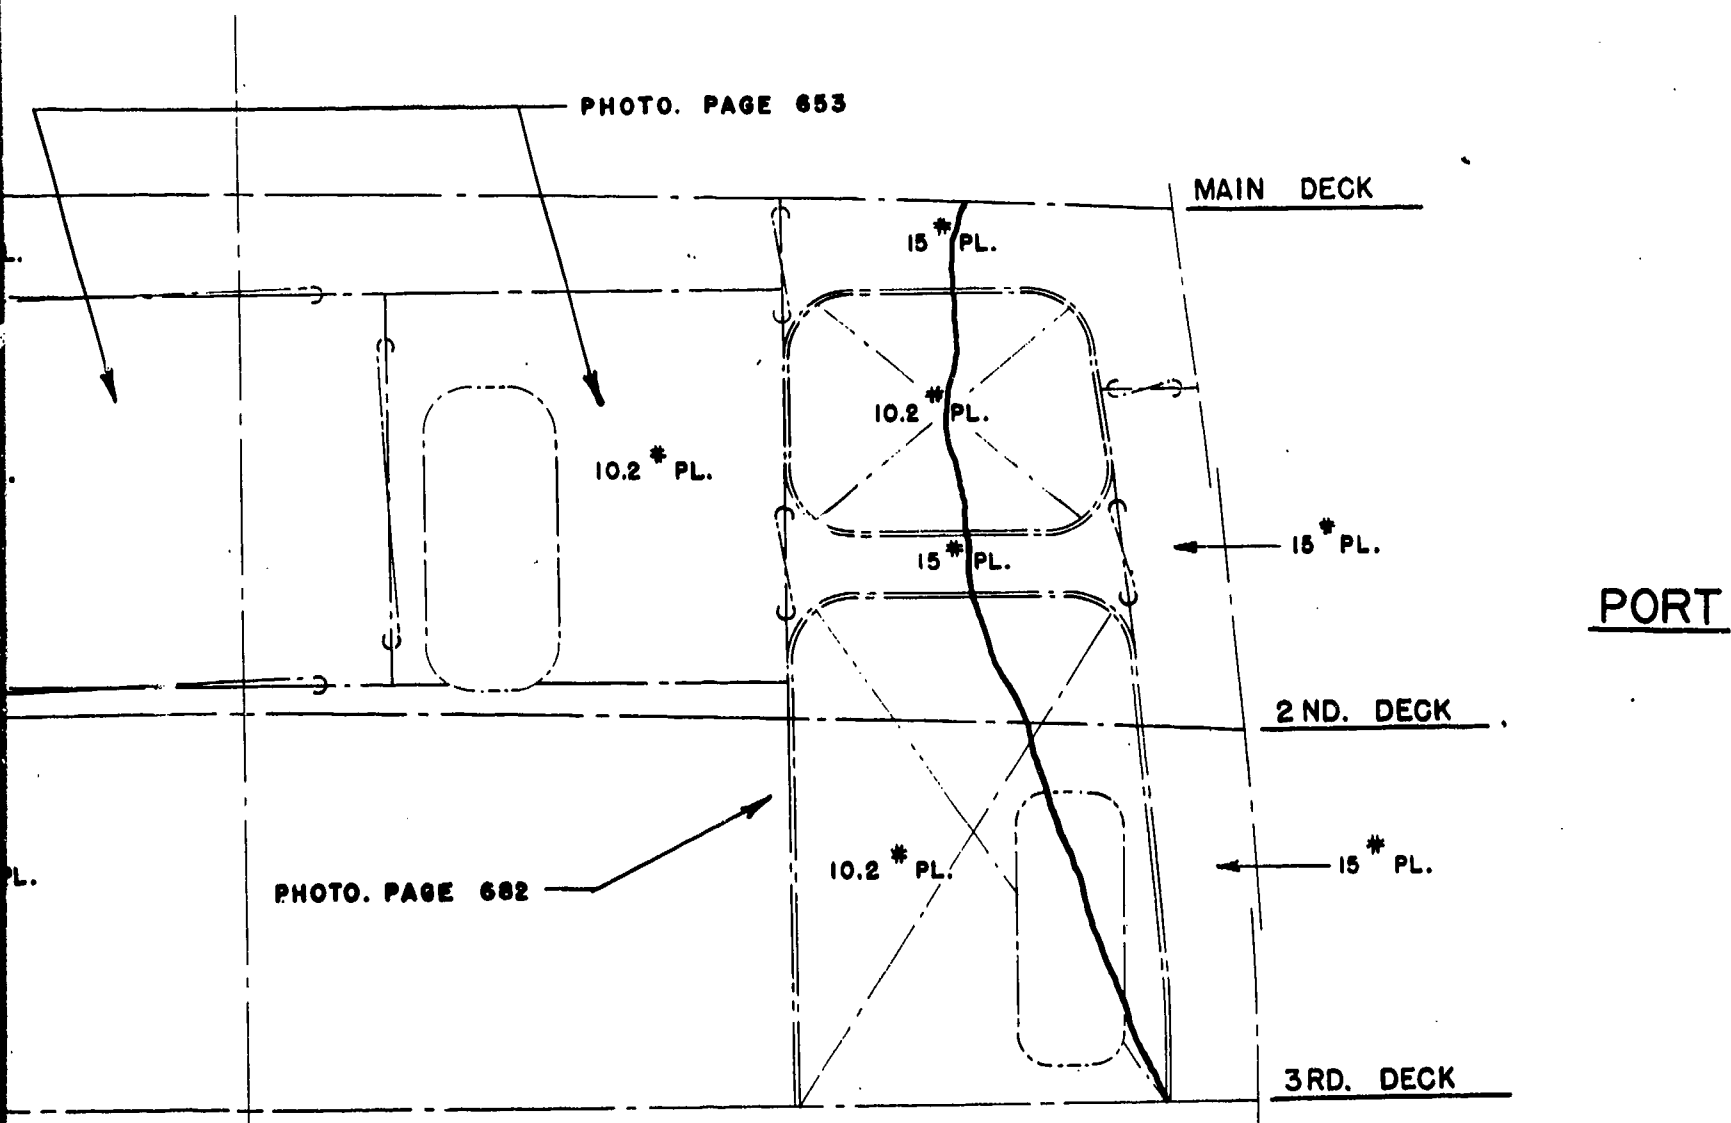
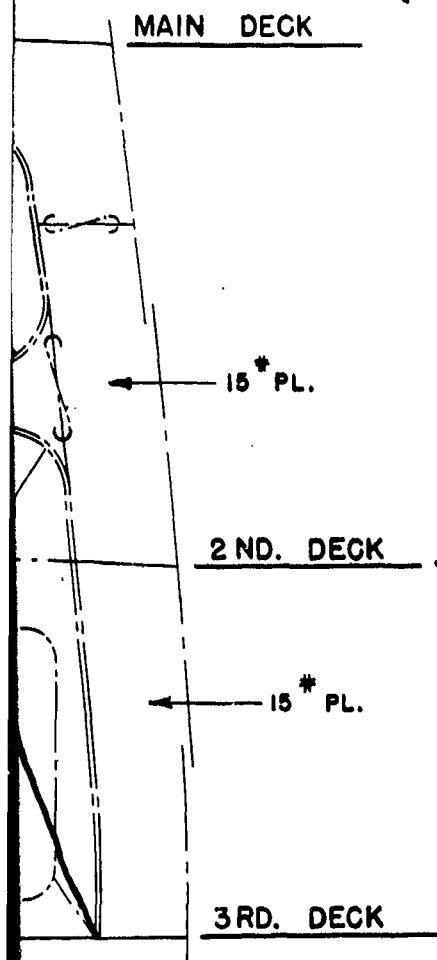
NAVY DEPT.	BUREAU OF SHIPS
MAIN & 2ND. DECK DEFLECTION	
TRANSVERSE BULKHEAD FR. 147	
TEST A	
U.S.S. INDEPENDENCE	CVL 22

NOTE:
 NO DATA AVAILABLE REGARDING DECK &
 BULKHEAD DEFLECTION. SHELL DAMAGE
 INDICATED TAKEN FROM PHOTOS.

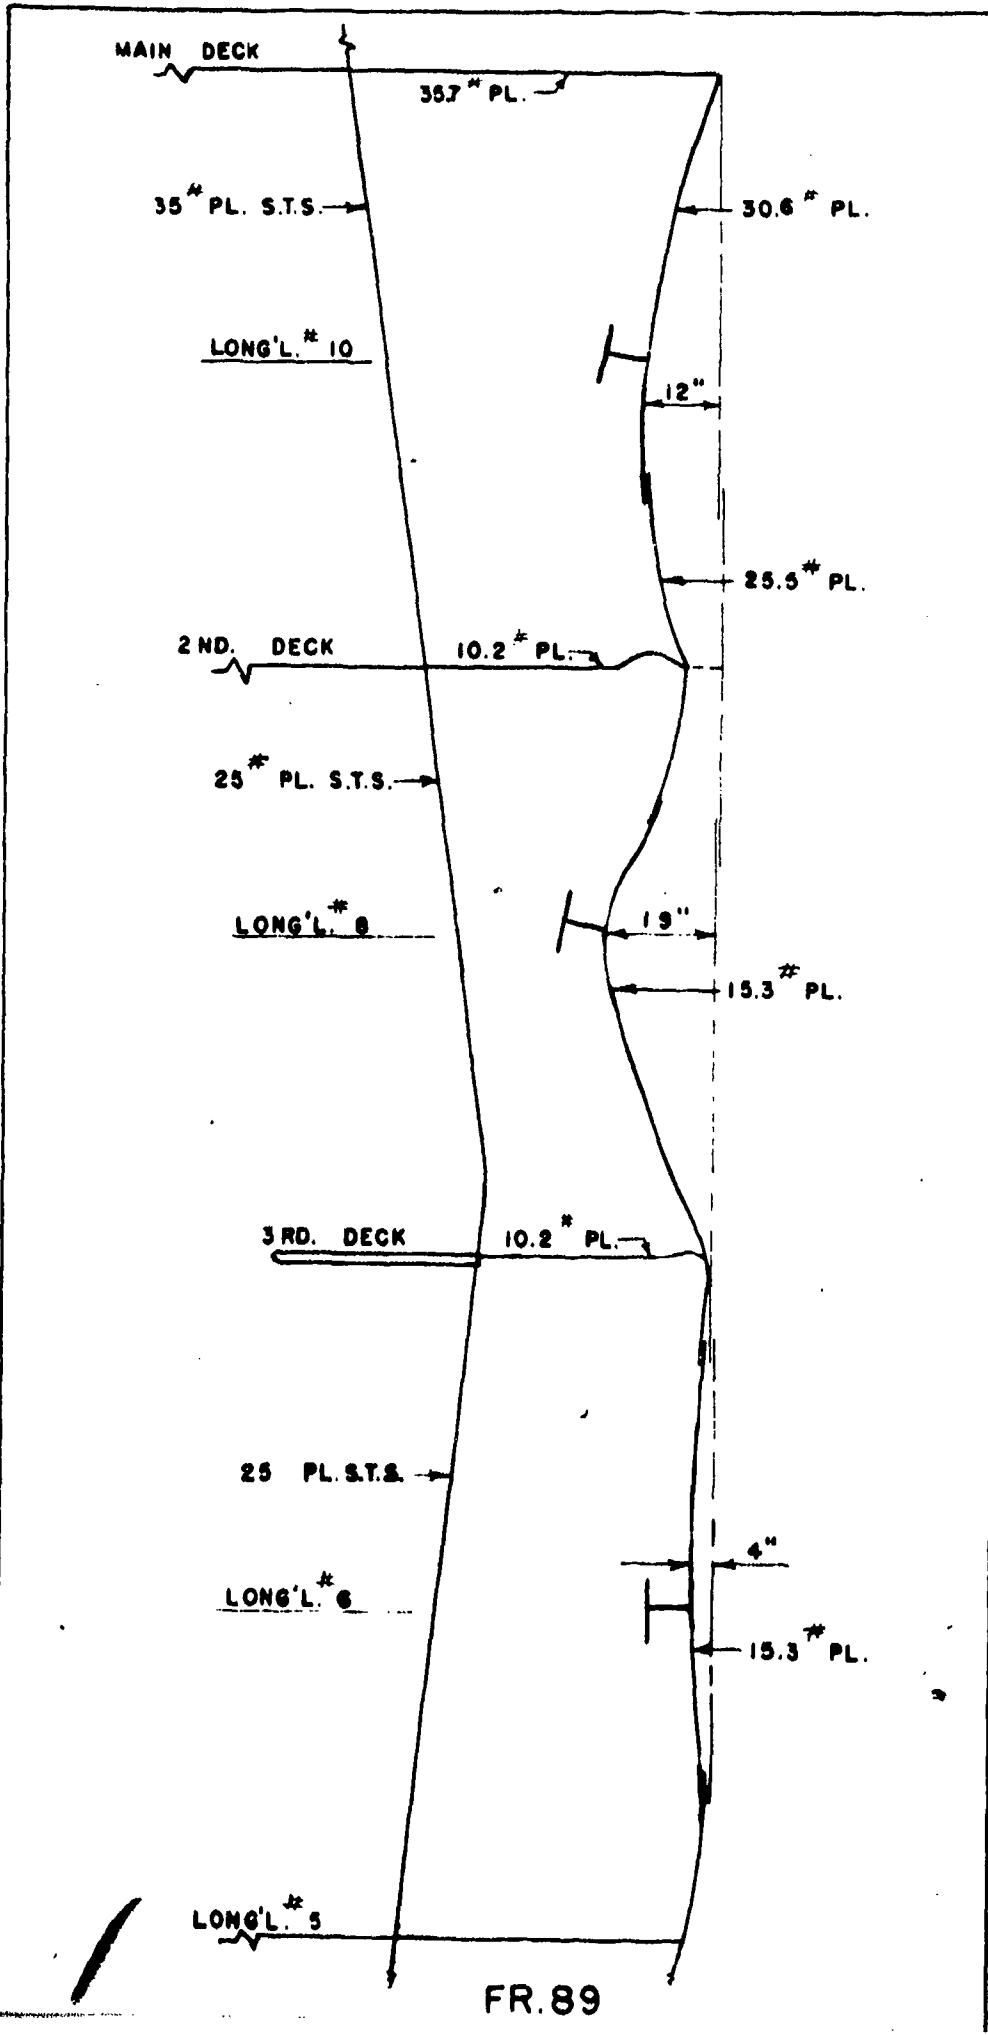
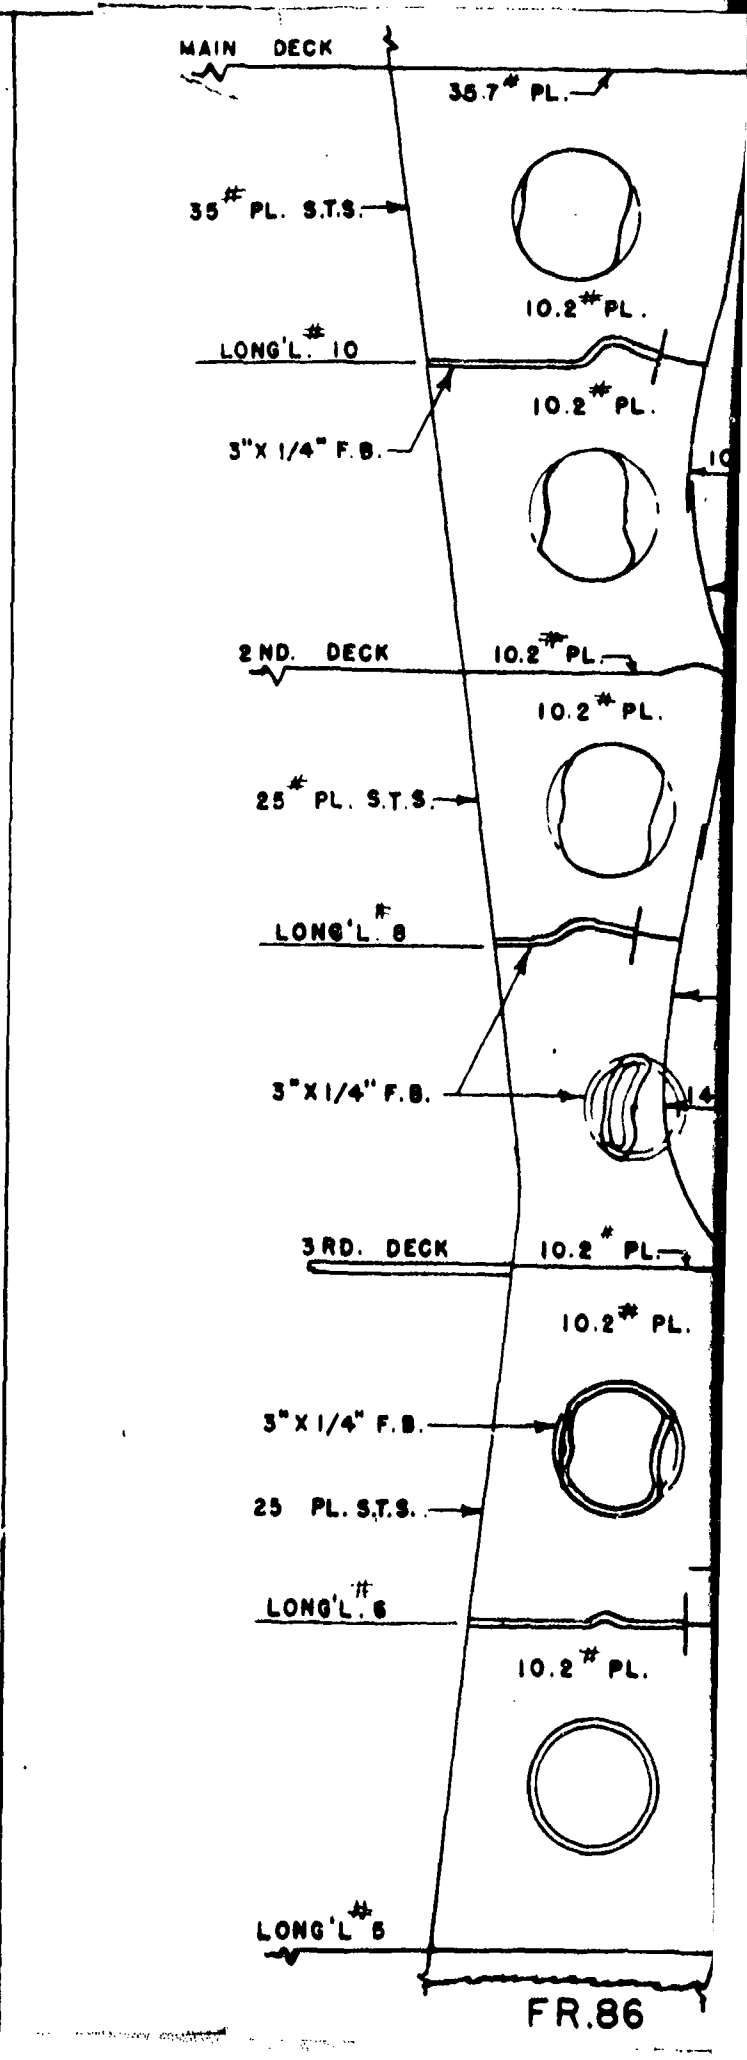
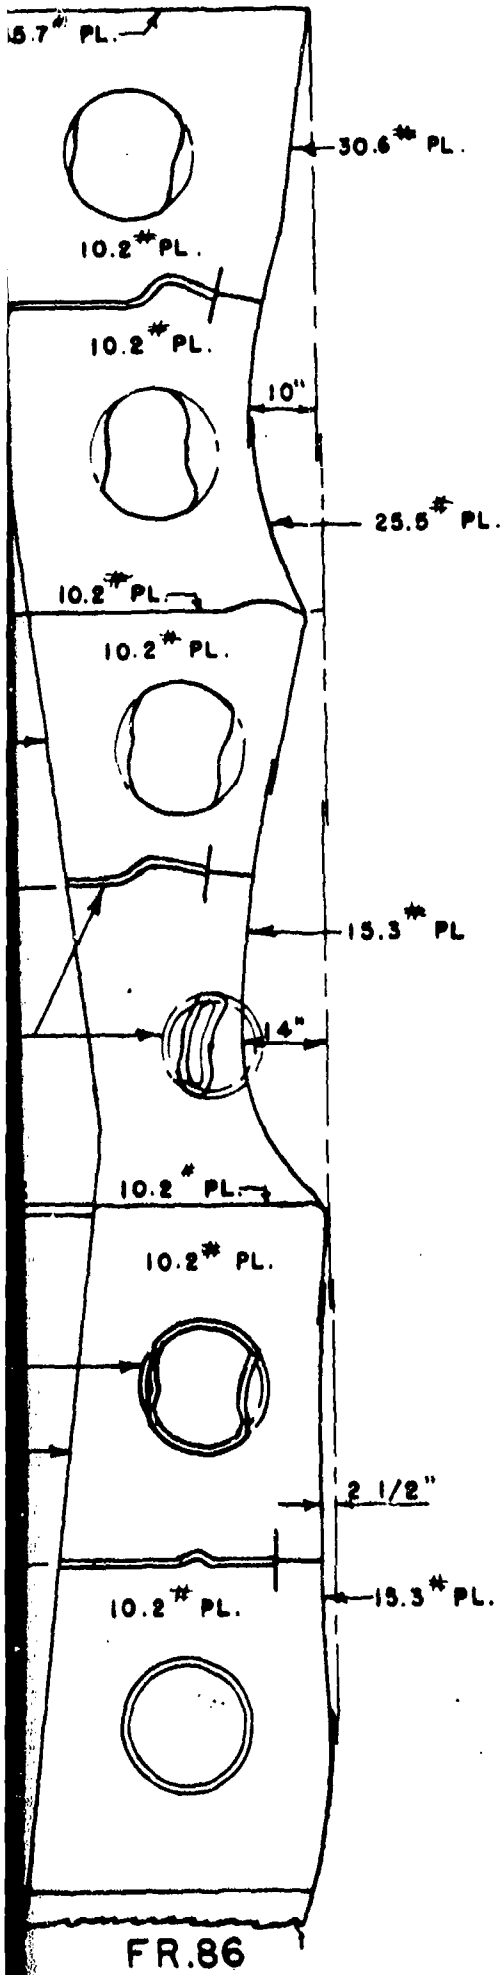
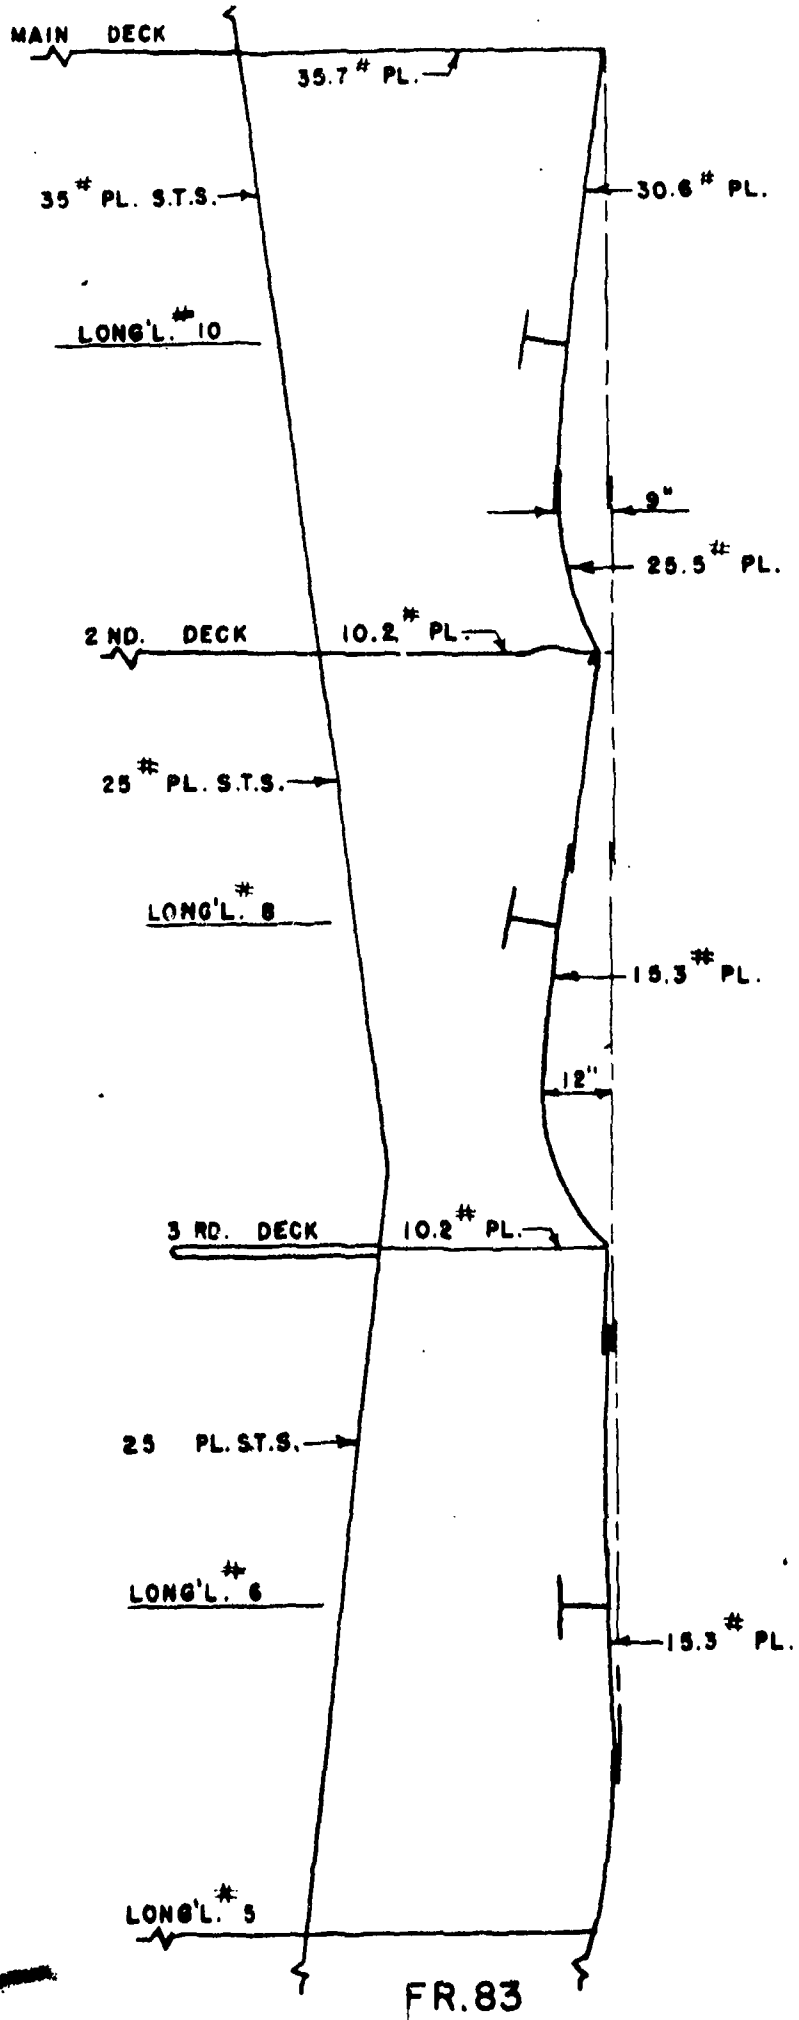
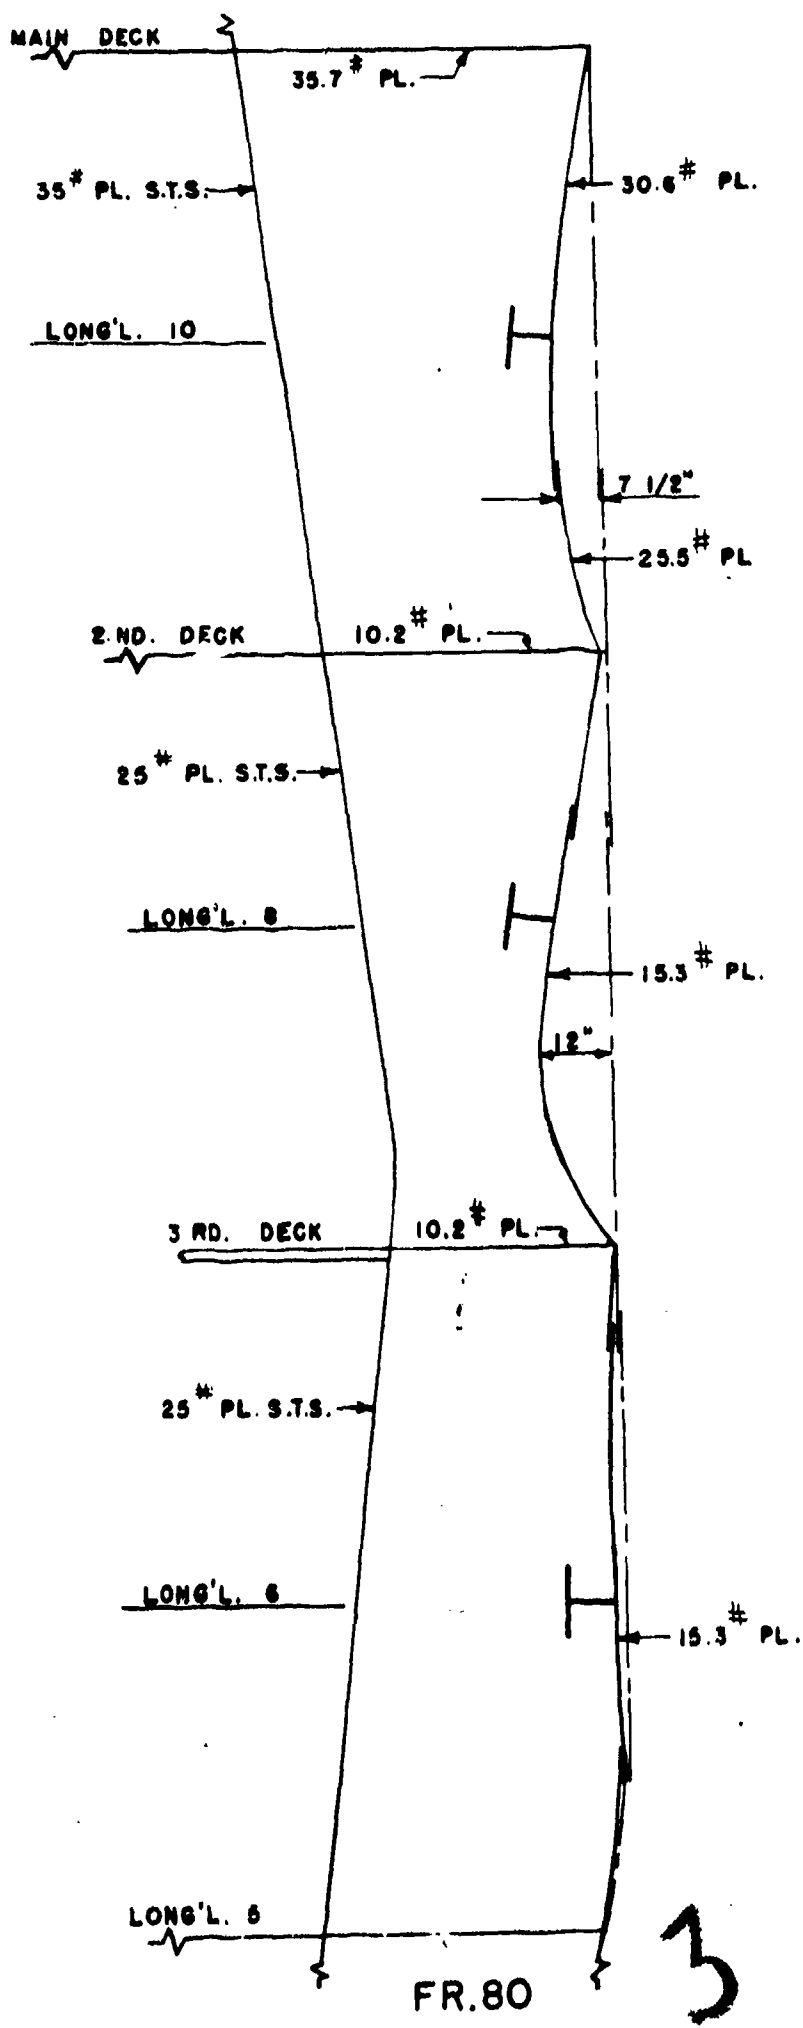
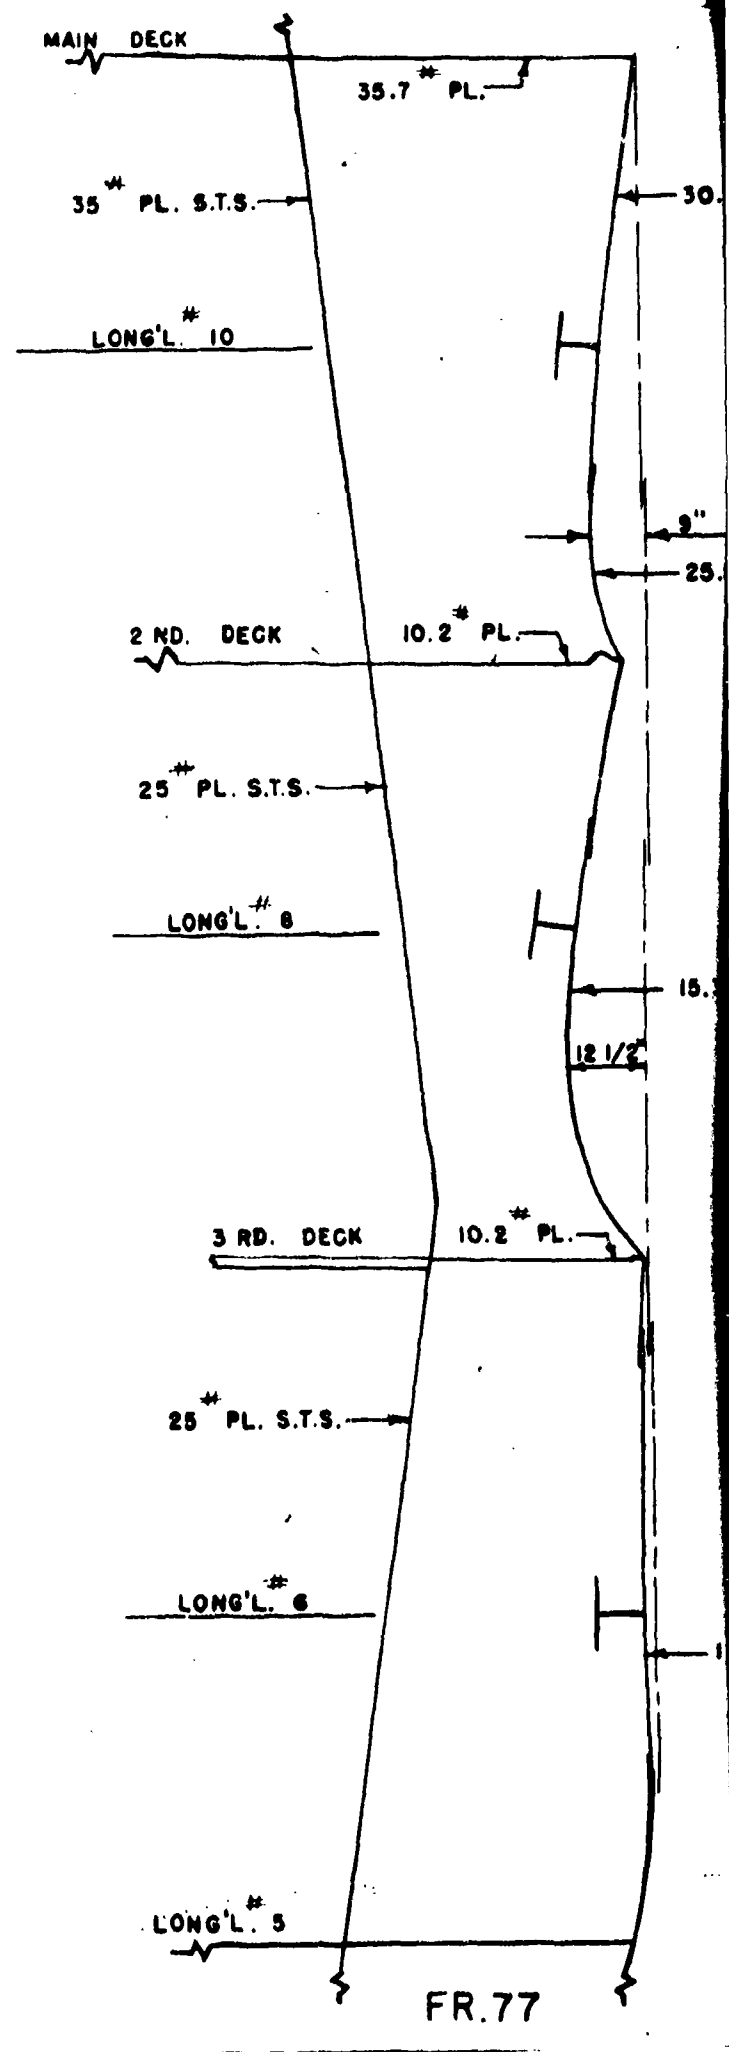
BLISTER DAMAGE
FRS. 71-89, PORT SIDE

1. NO DATA AVAILABLE REGARDING DEFLECTION OF INNER SHELL PLATING.
2. ALL SECTIONS ARE SHOWN PORT SIDE LOOKING AFT.
3. FWD. OF FR. NO. 71 DEFLECTION DIMISHES TO "0" AT FR. 59, FWD. OF FR. 59 LIGHT WASH BOARD EFFECT.

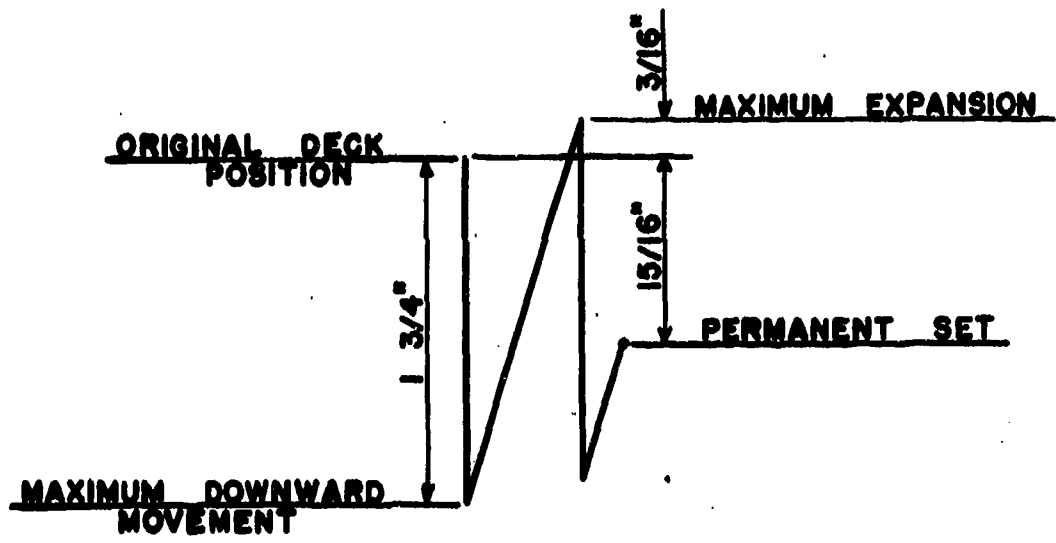
PLATE No. 44
PAGE 2400 F 280

ALL MOVEMENTS VERTICAL,
LINES SLANTED FOR CLARITY.

U.S.S. INDEPENDENCE, TEST ABLE, PLOT OF MAIN DECK
MOVEMENT. SCRATCH GAGE LOCATION, 2ND. DECK
FRAME 63 PORT 16'-0" OFF CENTER LINE.
