BUREAU OF SHIPS GROUP TECHNICAL INSPECTION REPORT

OPERATION CROSSROADS. U.S.S. INDEPENDENCE (CVL22)

TEST ABLE

VOLUME 1 OF 4 [W]

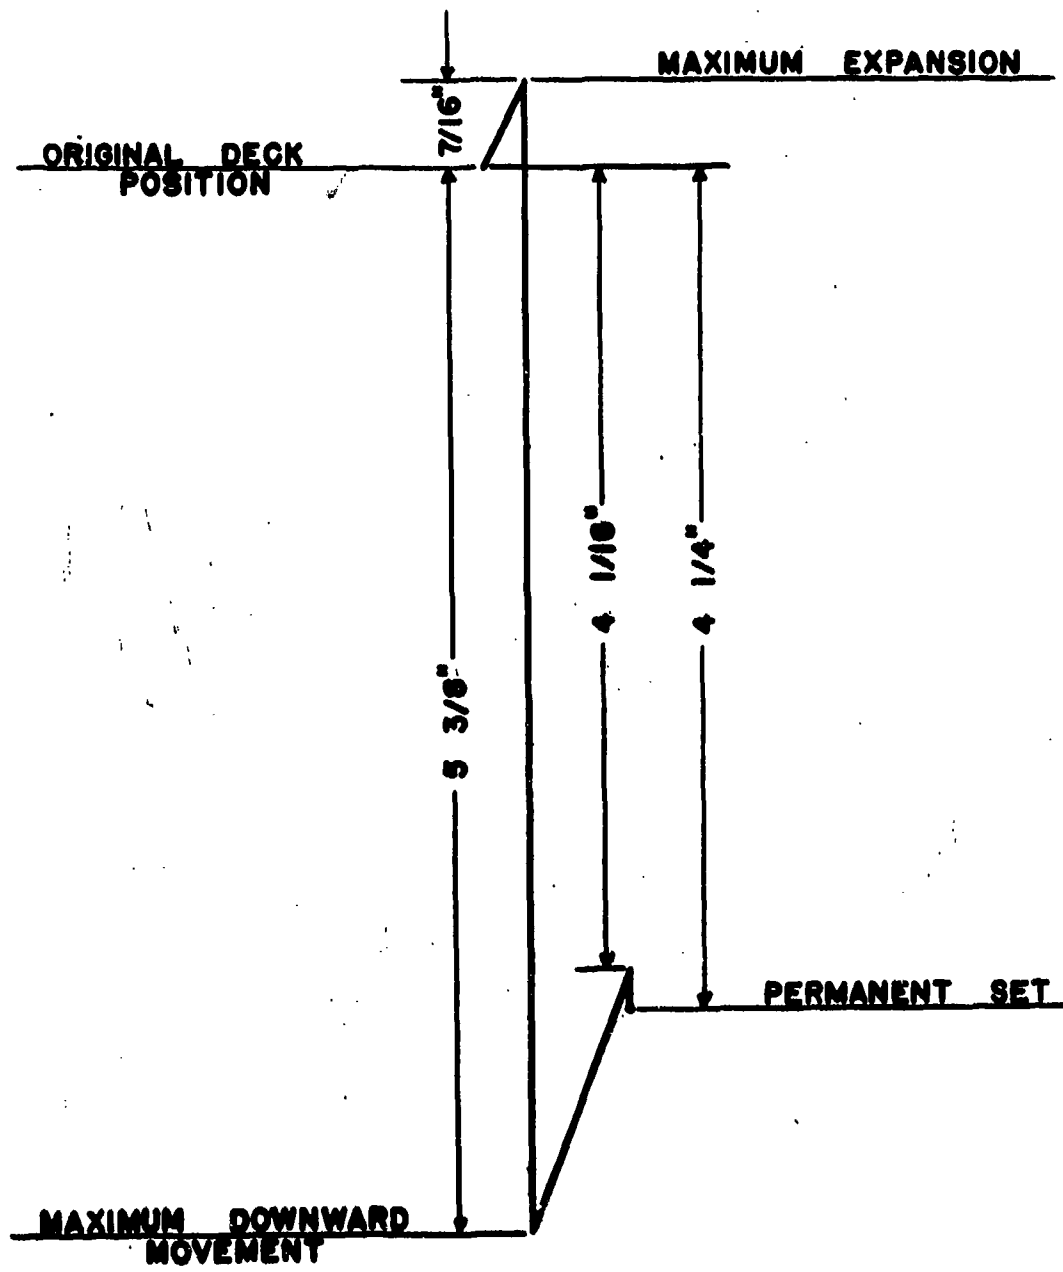
PLATE NO. 46

ALL MOVEMENTS VERTICAL,
LINES SLANTED FOR CLARITY.

U.S.S. INDEPENDENCE, TEST ABLE, PLOT OF MAIN DECK
MOVEMENT. SCRATCH GAGE LOCATION, 2 ND. DECK
FRAME 120 STD. 16'-7" OFF CENTER LINE.

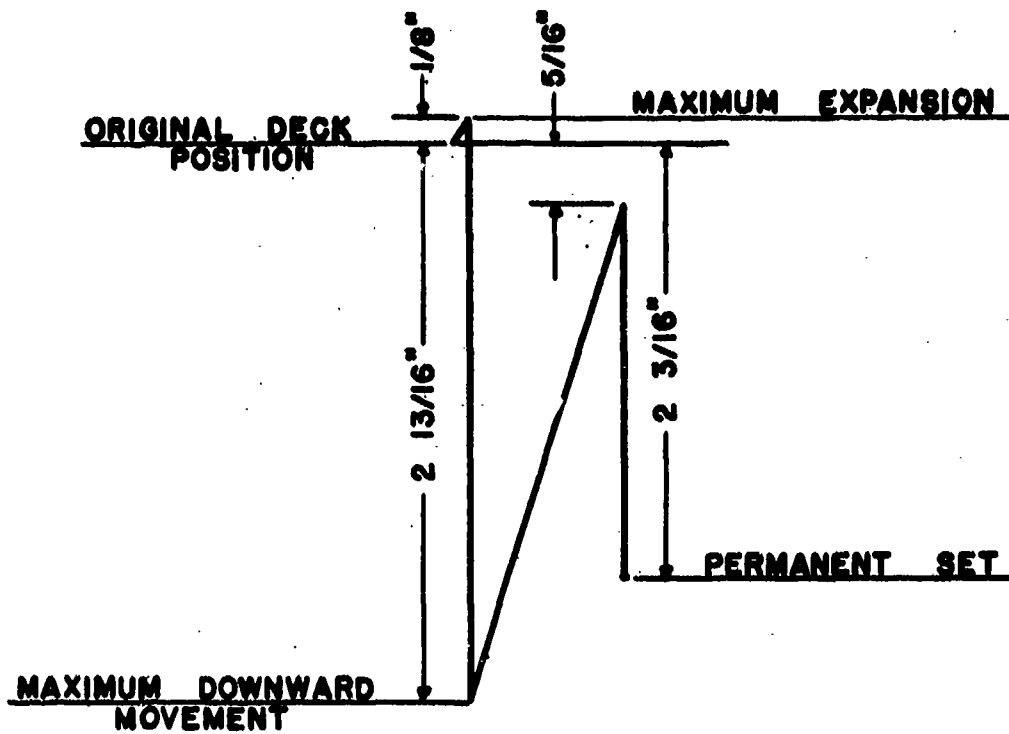
PAGE 2490 F 280

ALL MOVEMENTS VERTICAL,
LINES SLANTED FOR CLARITY.

U.S.S. INDEPENDENCE, TEST ABLE, PLOT OF MAIN DECK
MOVEMENT. SCRATCH GAGE LOCATION, 2 ND. DECK
FRAME 121 CENTER LINE.

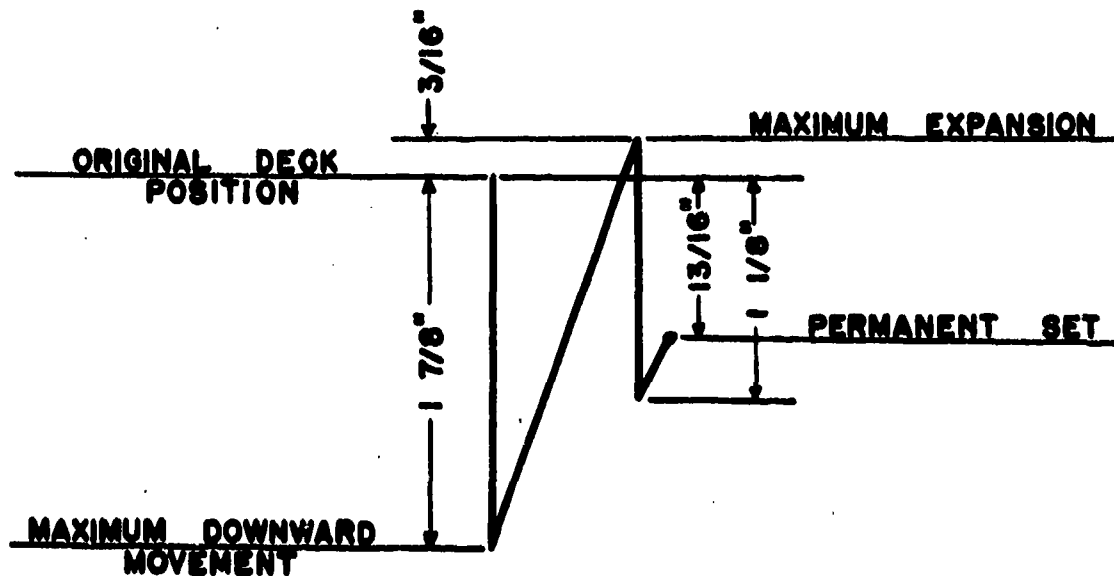
PLATE NO. 48
PAGE 250 OF 280

ALL MOVEMENTS VERTICAL,
LINES SLANTED FOR CLARITY.

U.S.S. INDEPENDENCE, TEST ABLE, PLOT OF MAIN DECK
MOVEMENT. SCRATCH GAGE LOCATION, 2ND. DECK
FRAME 124 CENTER LINE.
