U.S.S. INDEPENDENCE (CVL22)

TEST ABLE

OPERATION CROSSROADS

BUREAU OF SHIPS GROUP
TECHNICAL INSPECTION REPORT

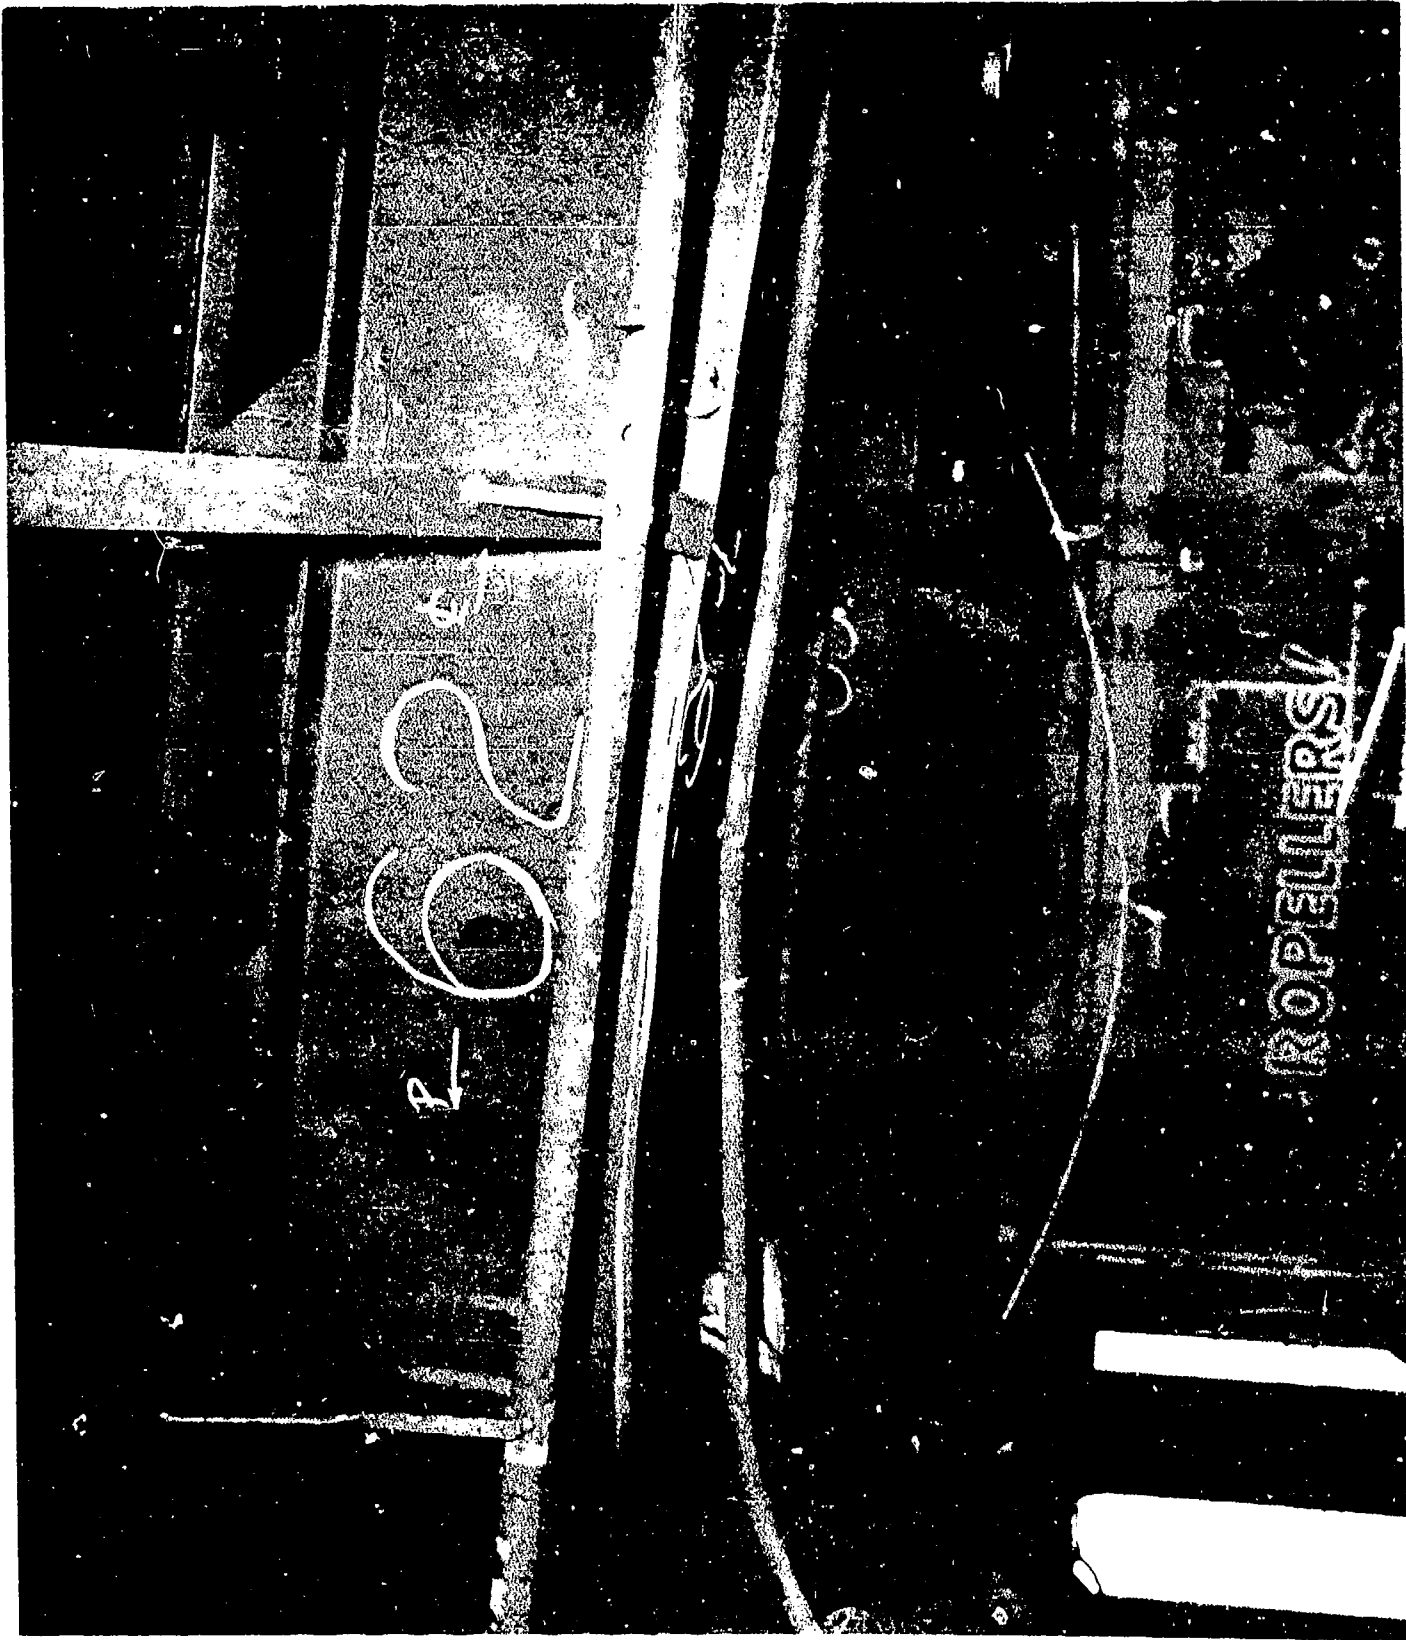
AA-CR-59-2222-1. Flight deck Bent 62, port side, looking forward. Note ripples in lower flange.

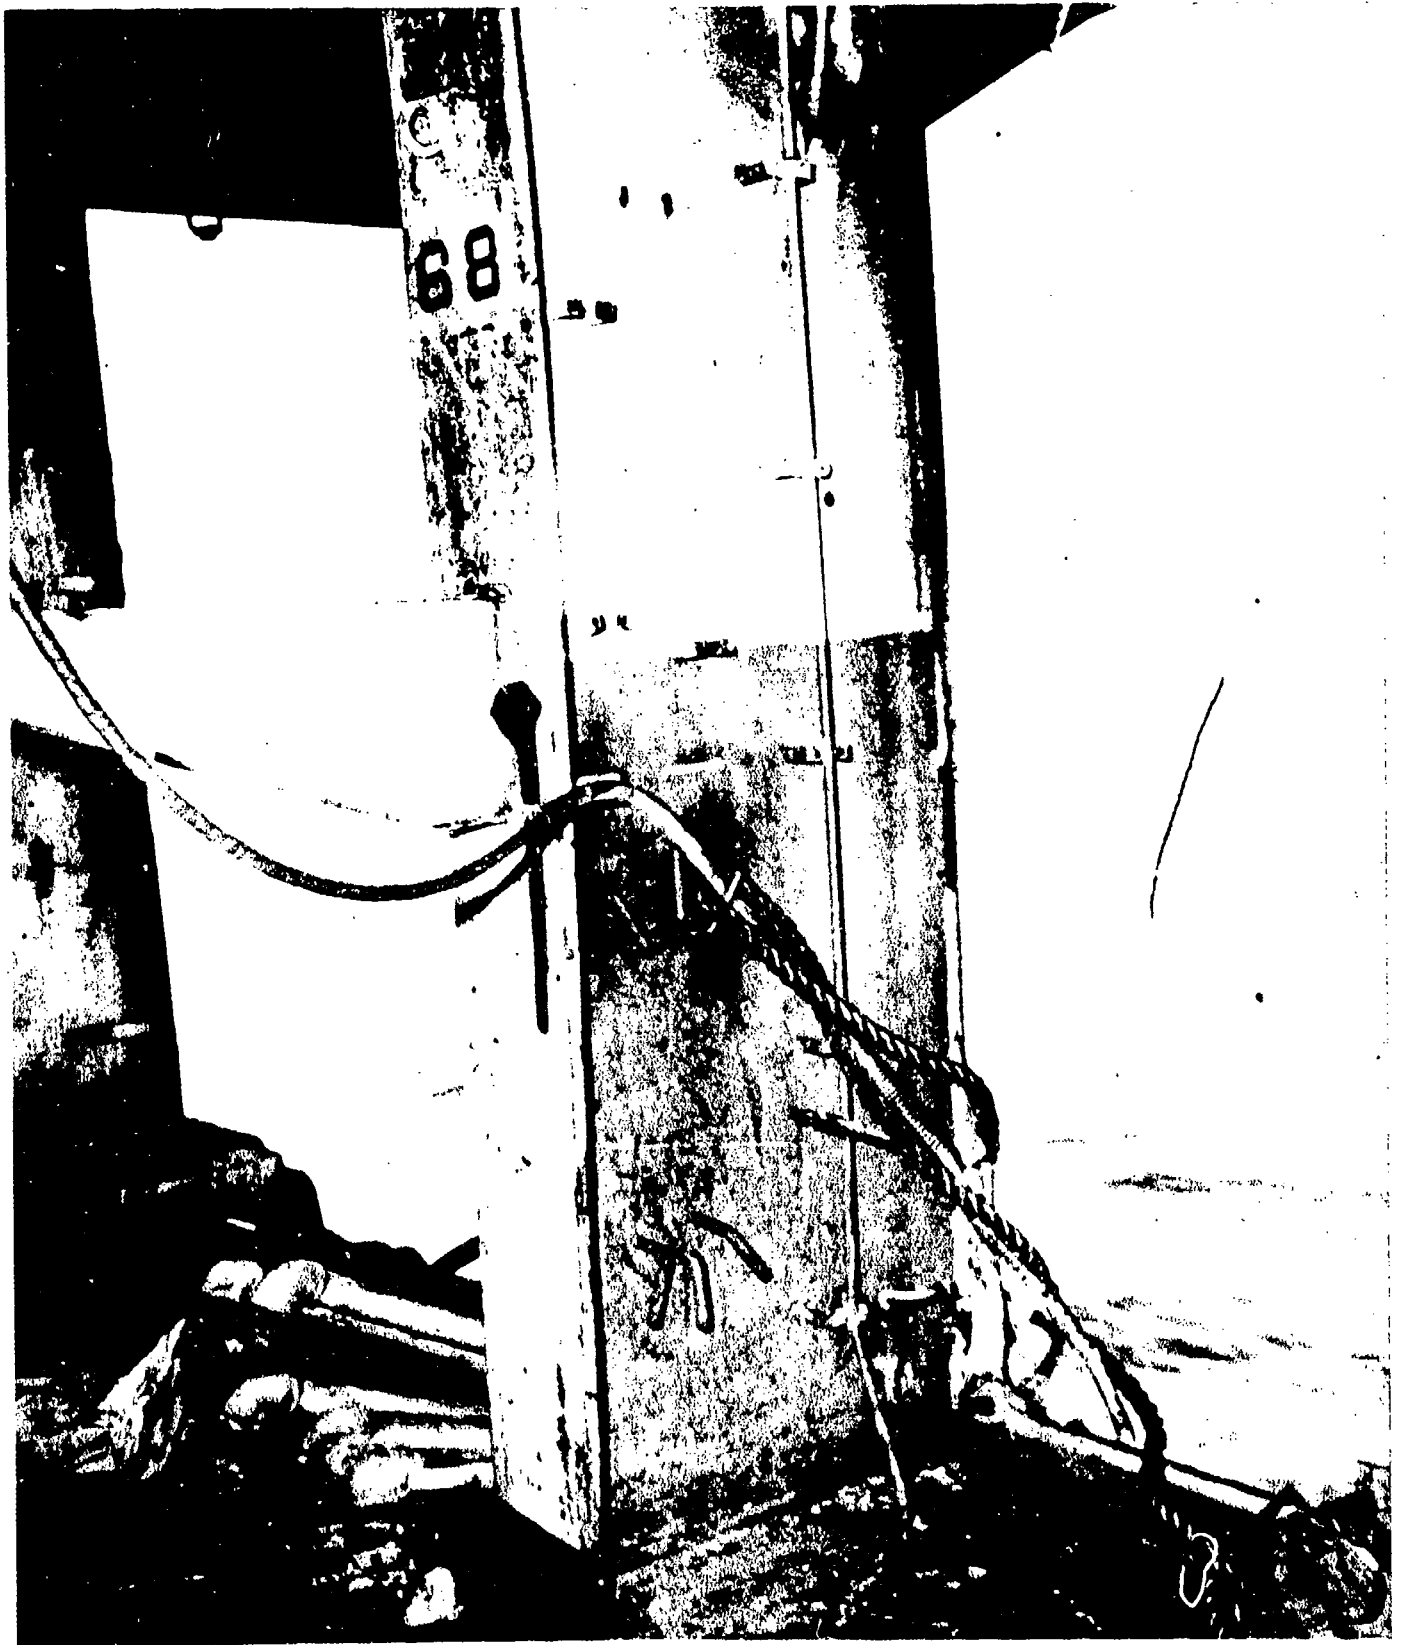
AA-CR-80-4186-3. After Baker - Flight deck Bent 68, port bottom, looking aft.

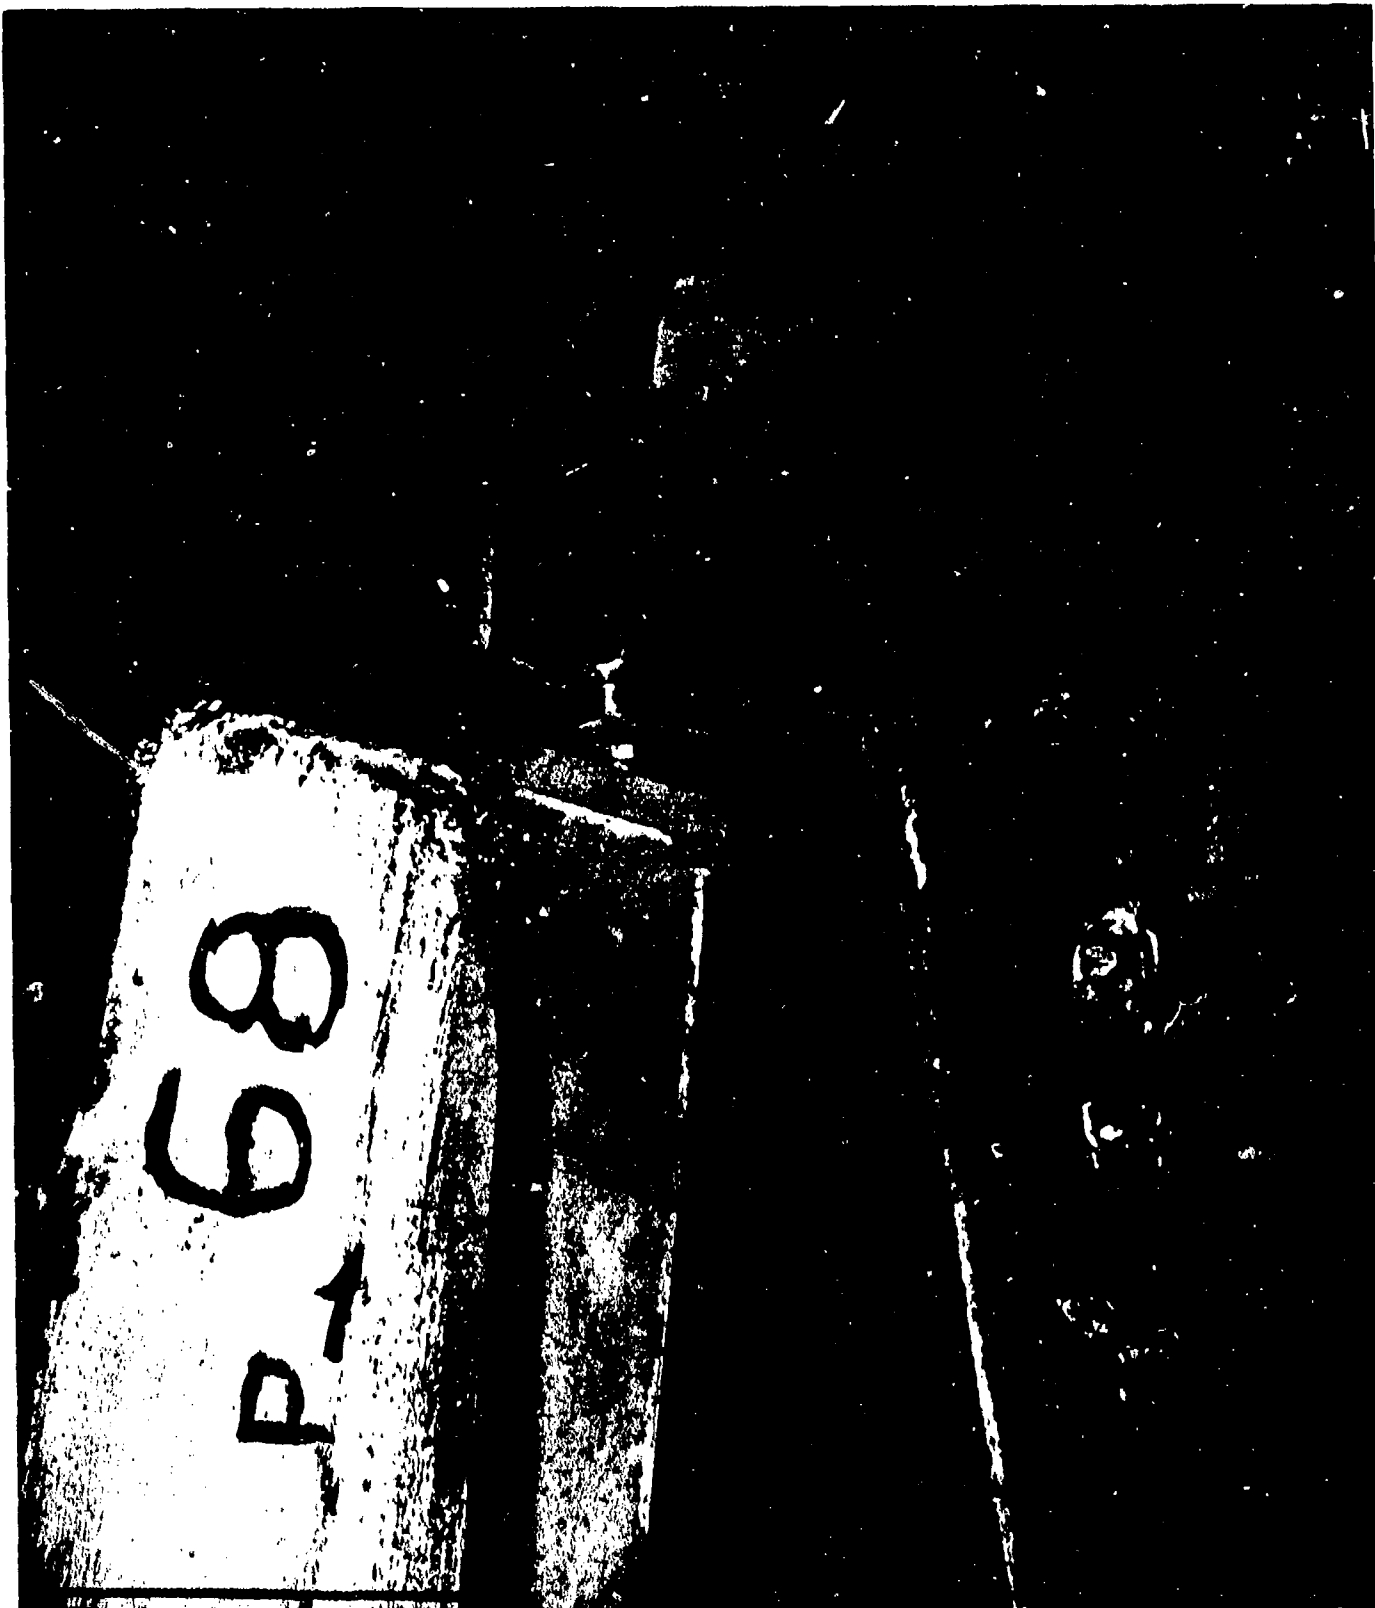
AA-CR-59-4149-4. Flight deck Bent 68, port side, outboard view. Frac-
ture in vertical member below bracket connection. Looking upward and
aft.

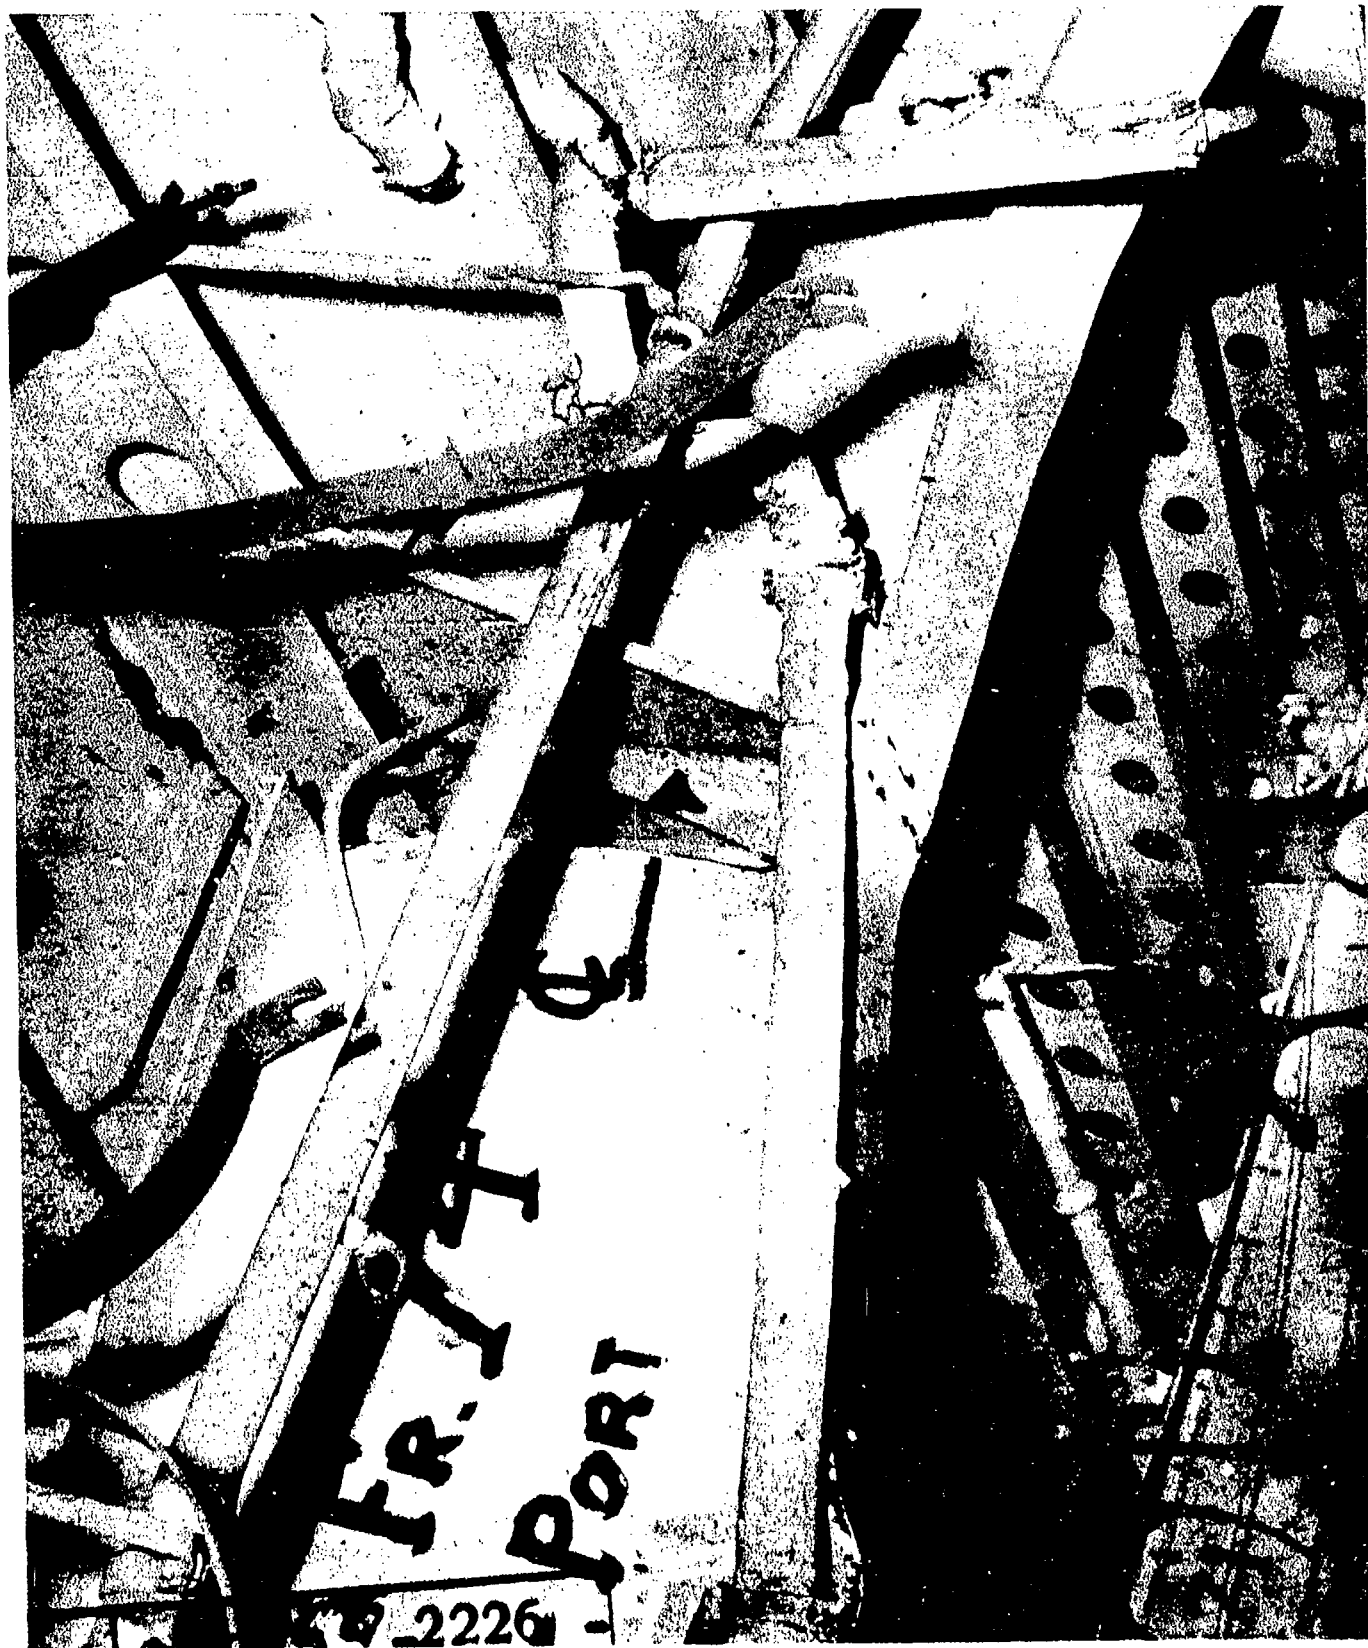
AA-CR-59-2226-9. Flight deck Bent 74, looking forward, showing tear in girder to port of centerline.

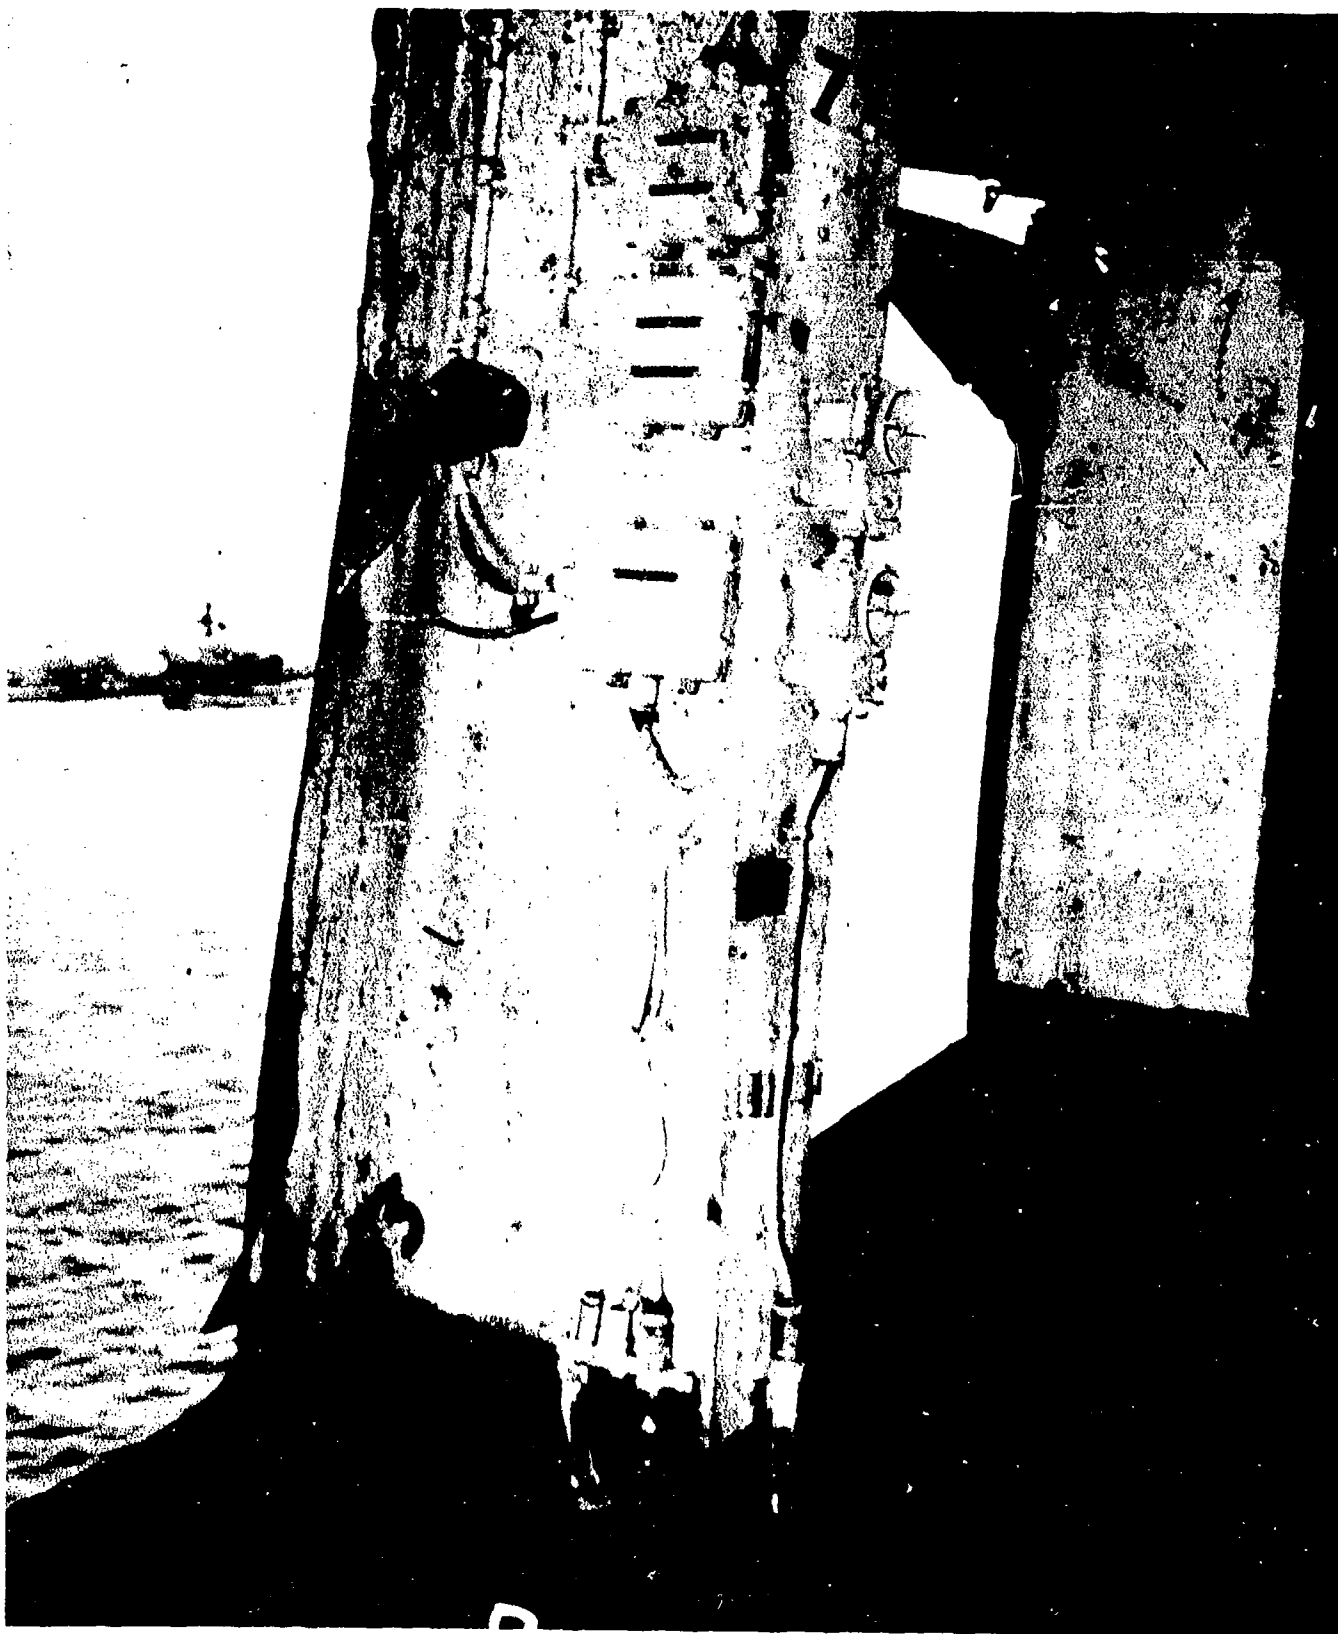
AA-CR-80-4186-8. After Baker - Flight deck Bent 77, port bottom, looking forward.

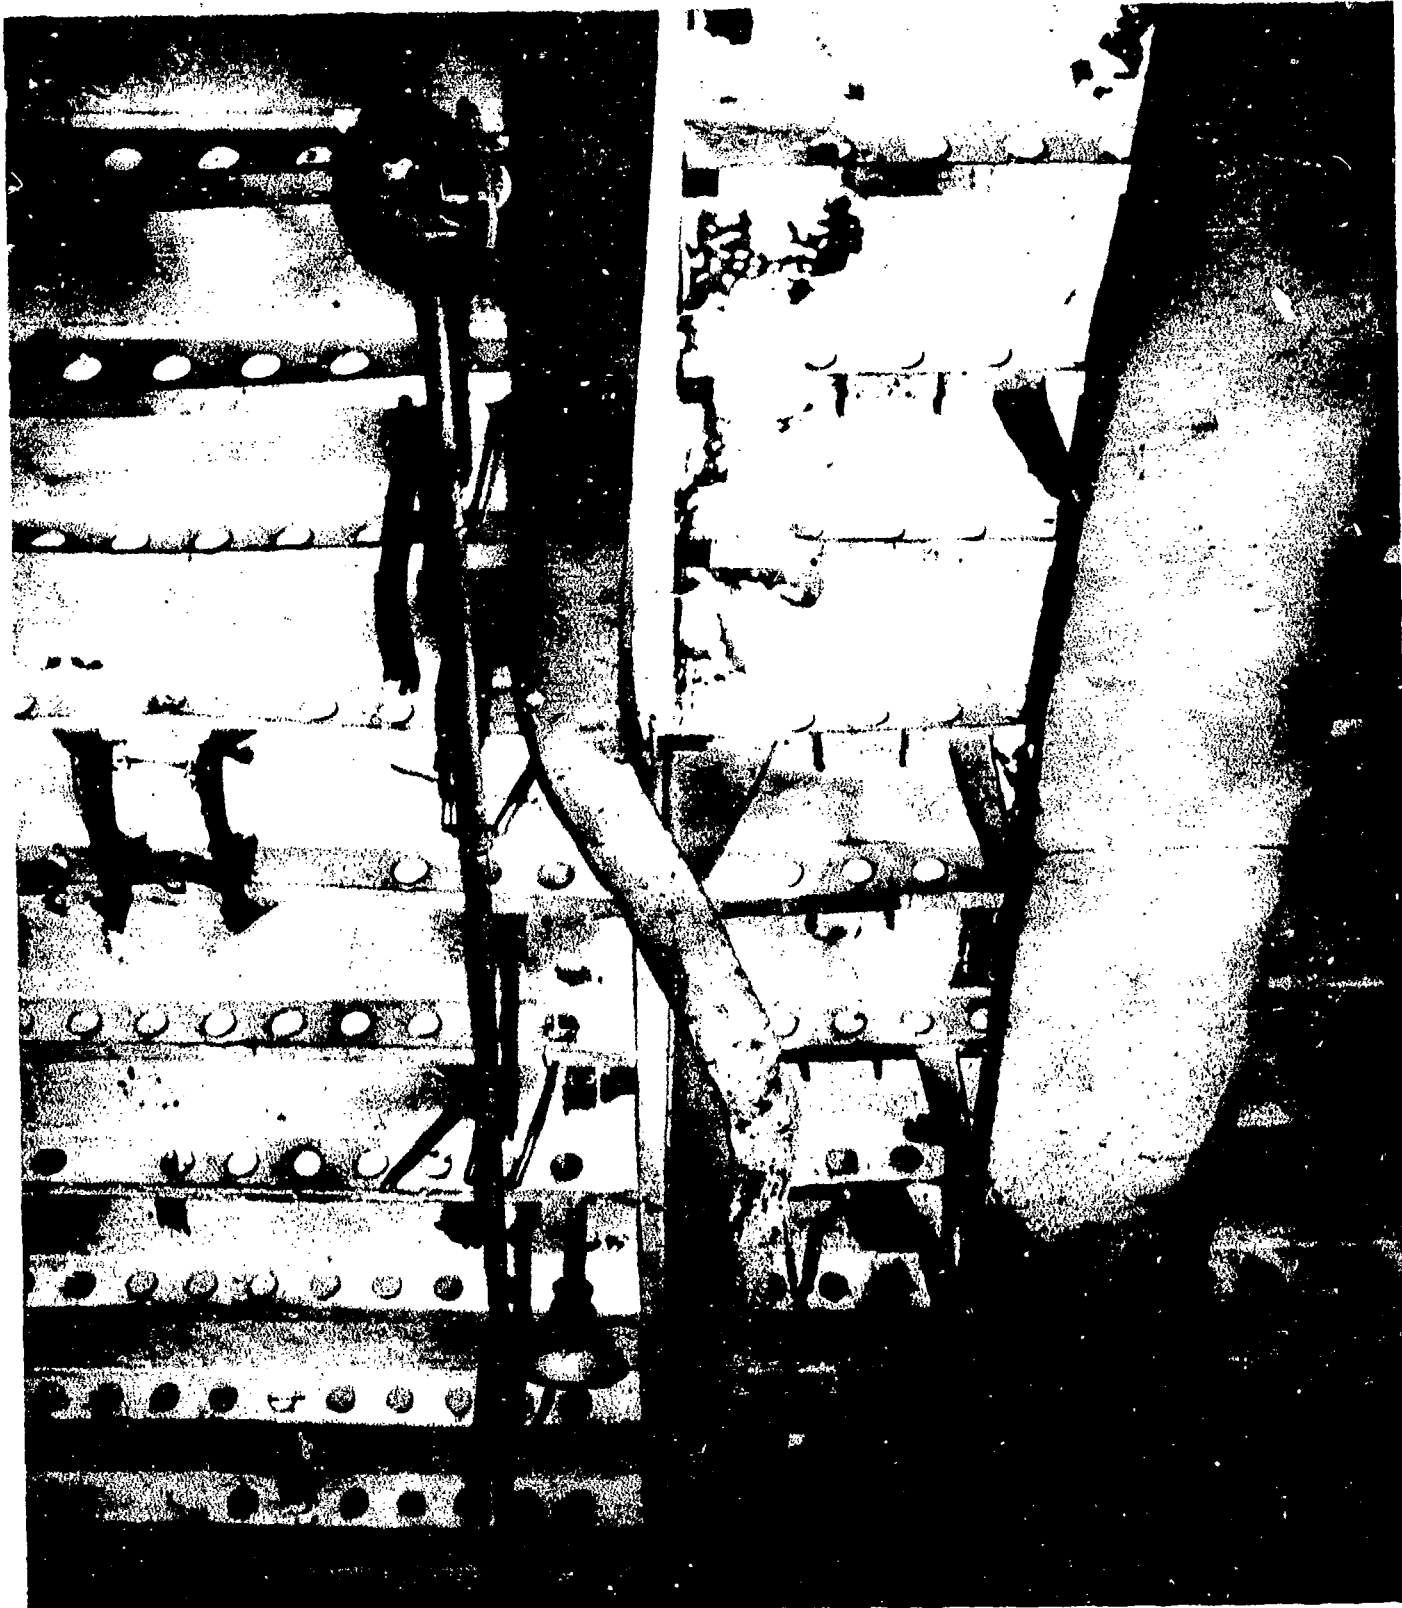
AA-CR-65-1735-12. Under side of flight deck, showing warping of Bent girder 77 at centerline. Looking to starboard.

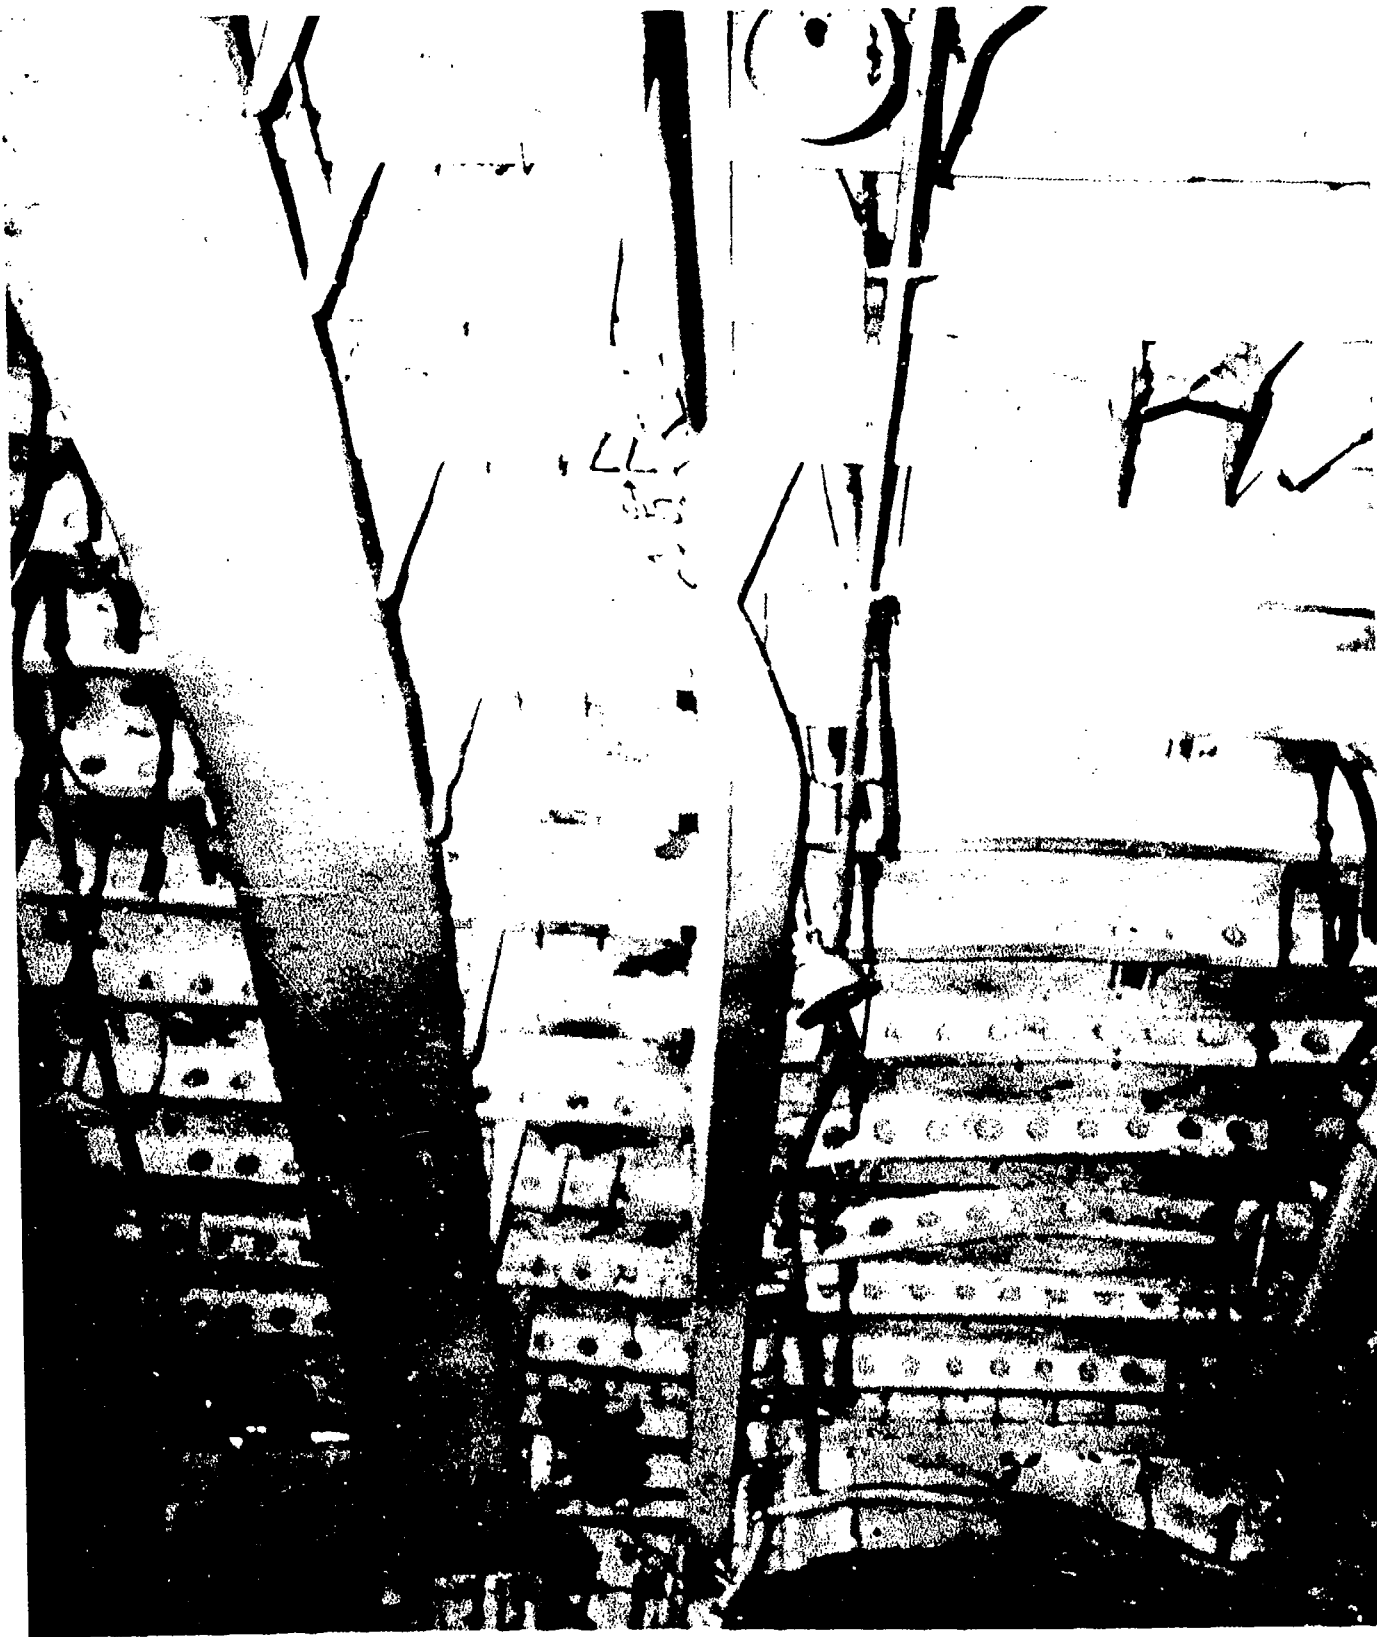
AA-CR-100-4162-10. Flight deck Bent 77, showing deformation of transverse girder at centerline. Looking to port.

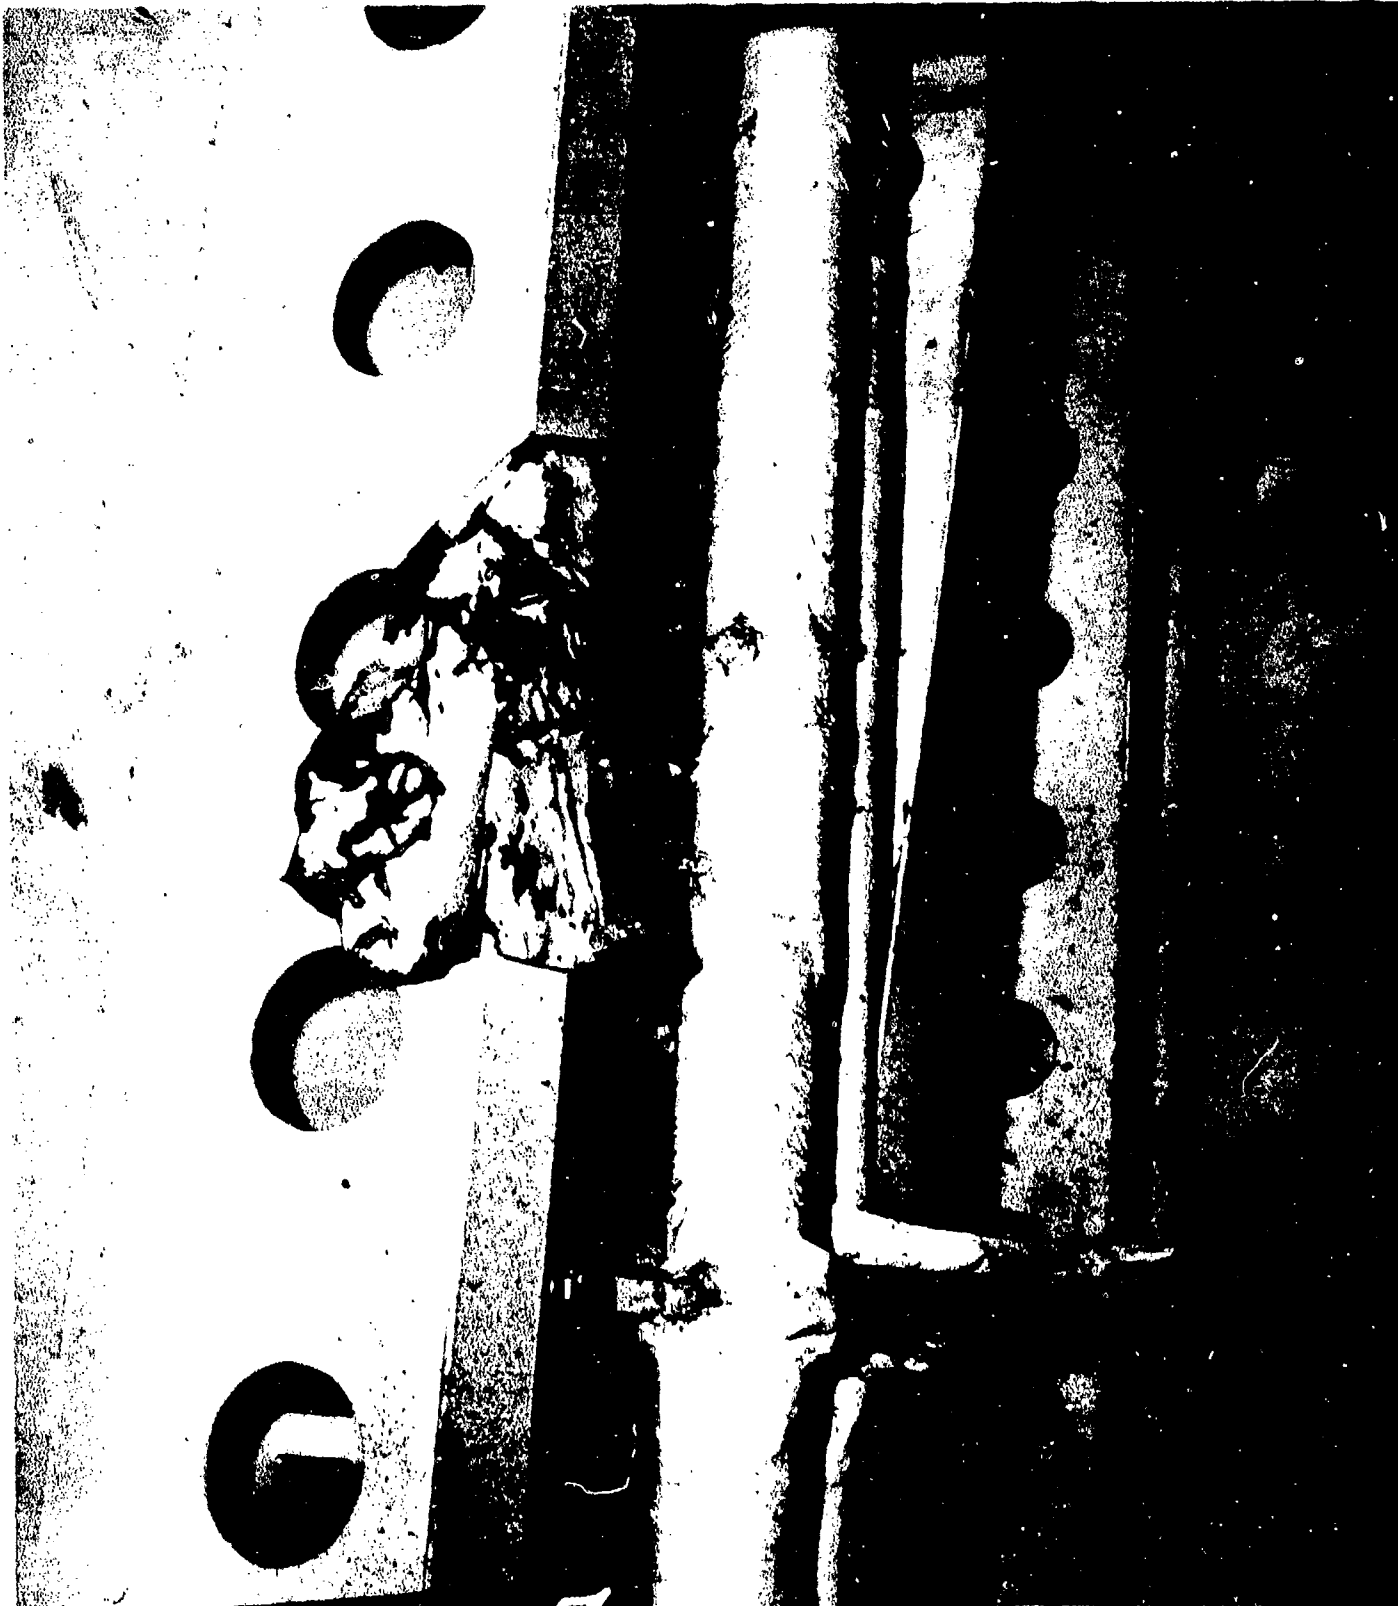
AA-CR-59-2226-7. Piece of sheet metal molded over flight deck longitudinal, frame 79, starboard side.

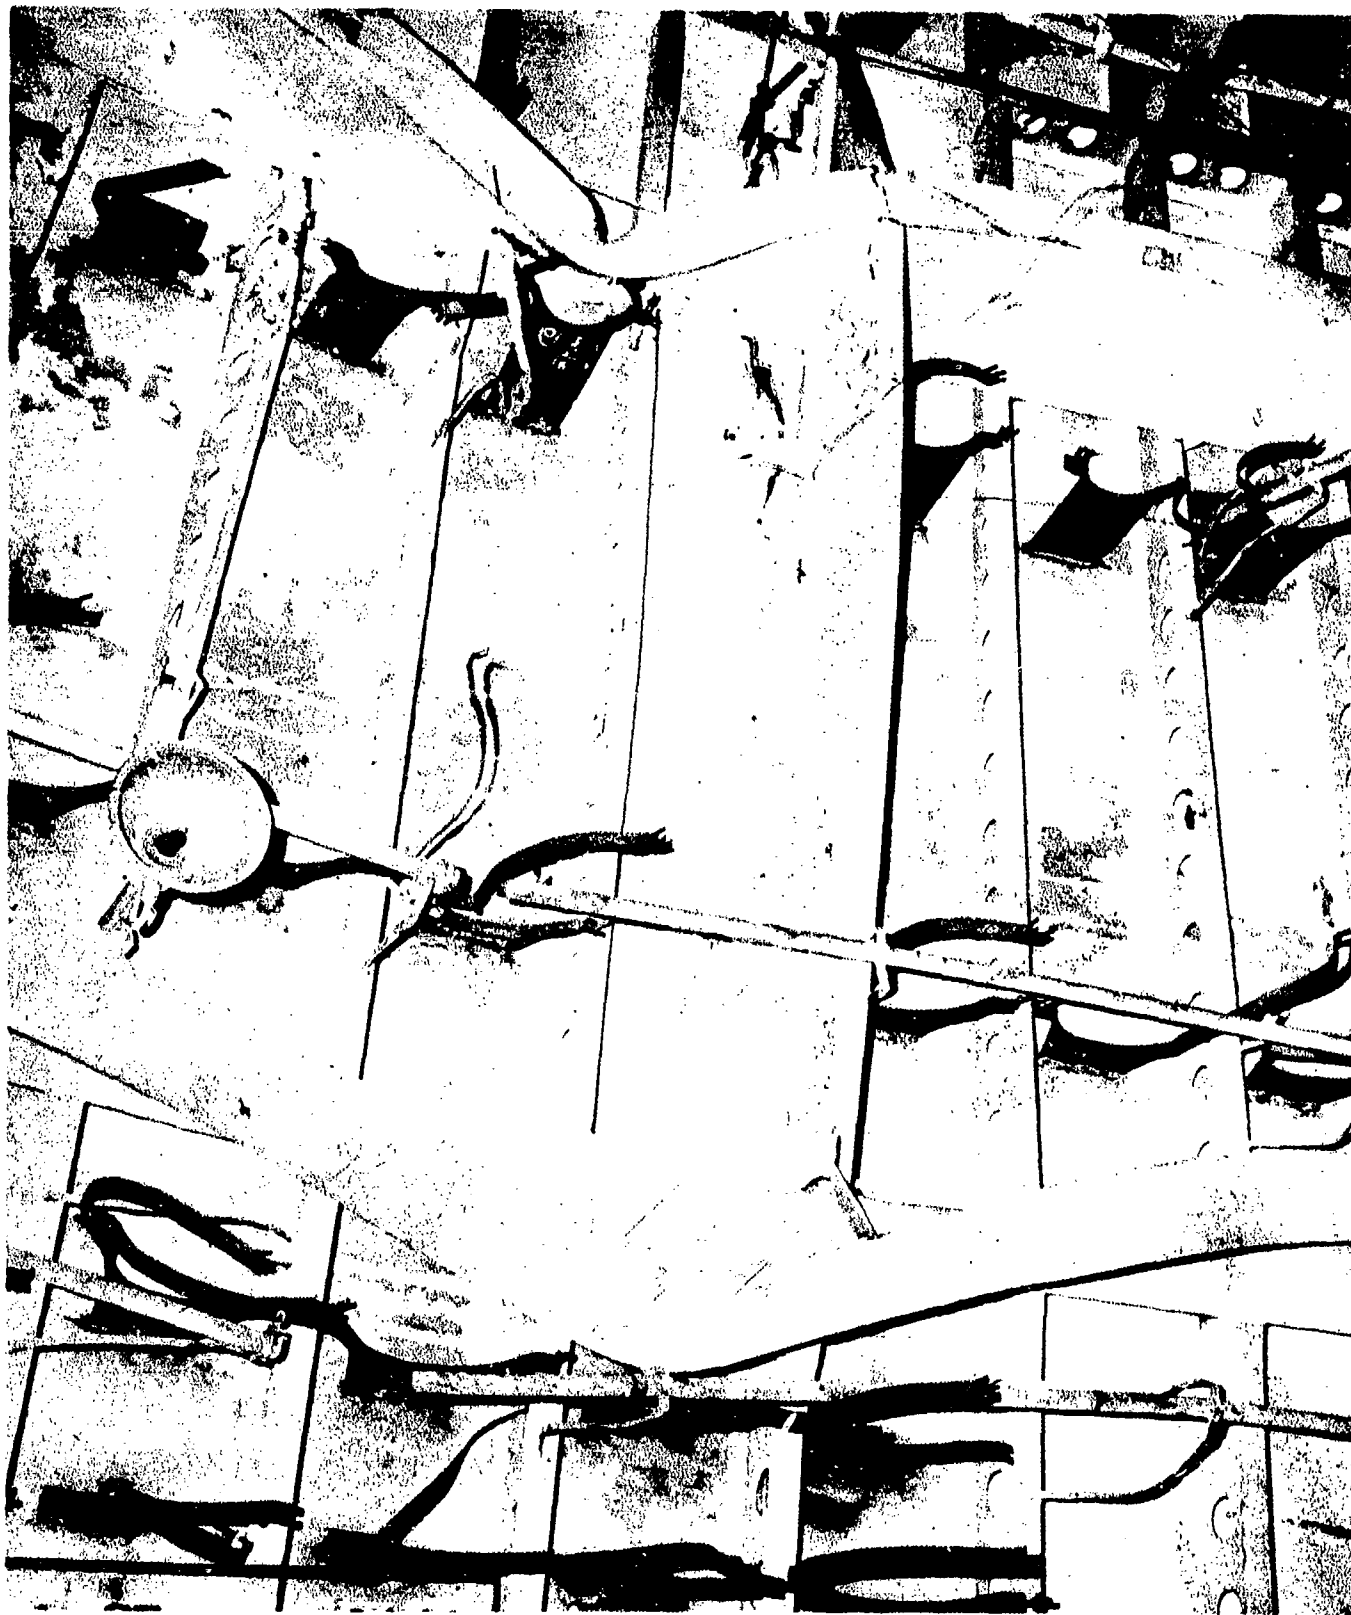
AA-CR-175-2119-1. Flight deck Bents 80 and 83, centerline, looking aft from frame 78.

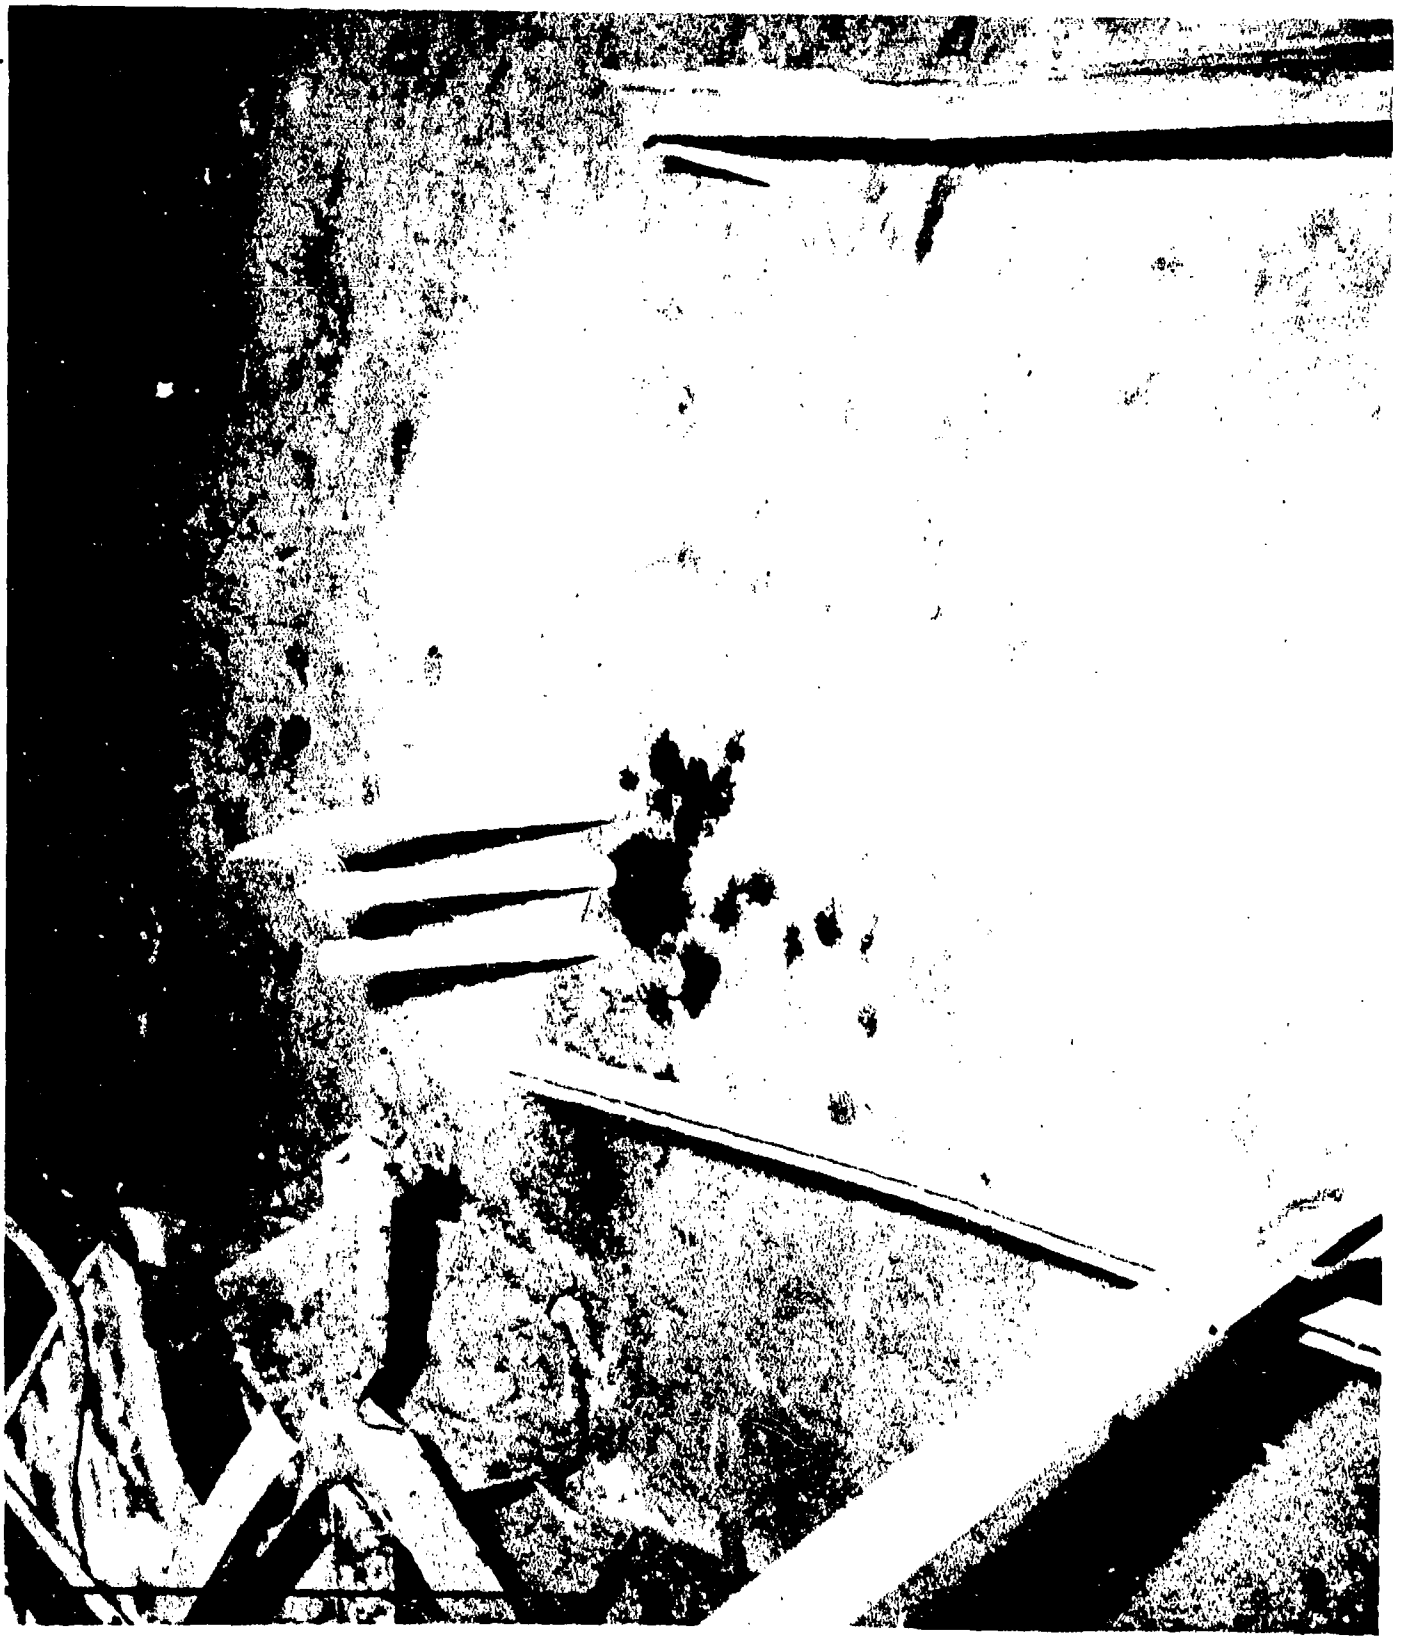
AA-CR-100-4160-12. Hangar. Detail in way of Wobble Bent deck pad 83, port side.
