U.S.S. INDEPENDENCE (CVL22)

TEST ABLE

OPERATION CROSSROADS

BUREAU OF SHIPS GROUP
TECHNICAL INSPECTION REPORT

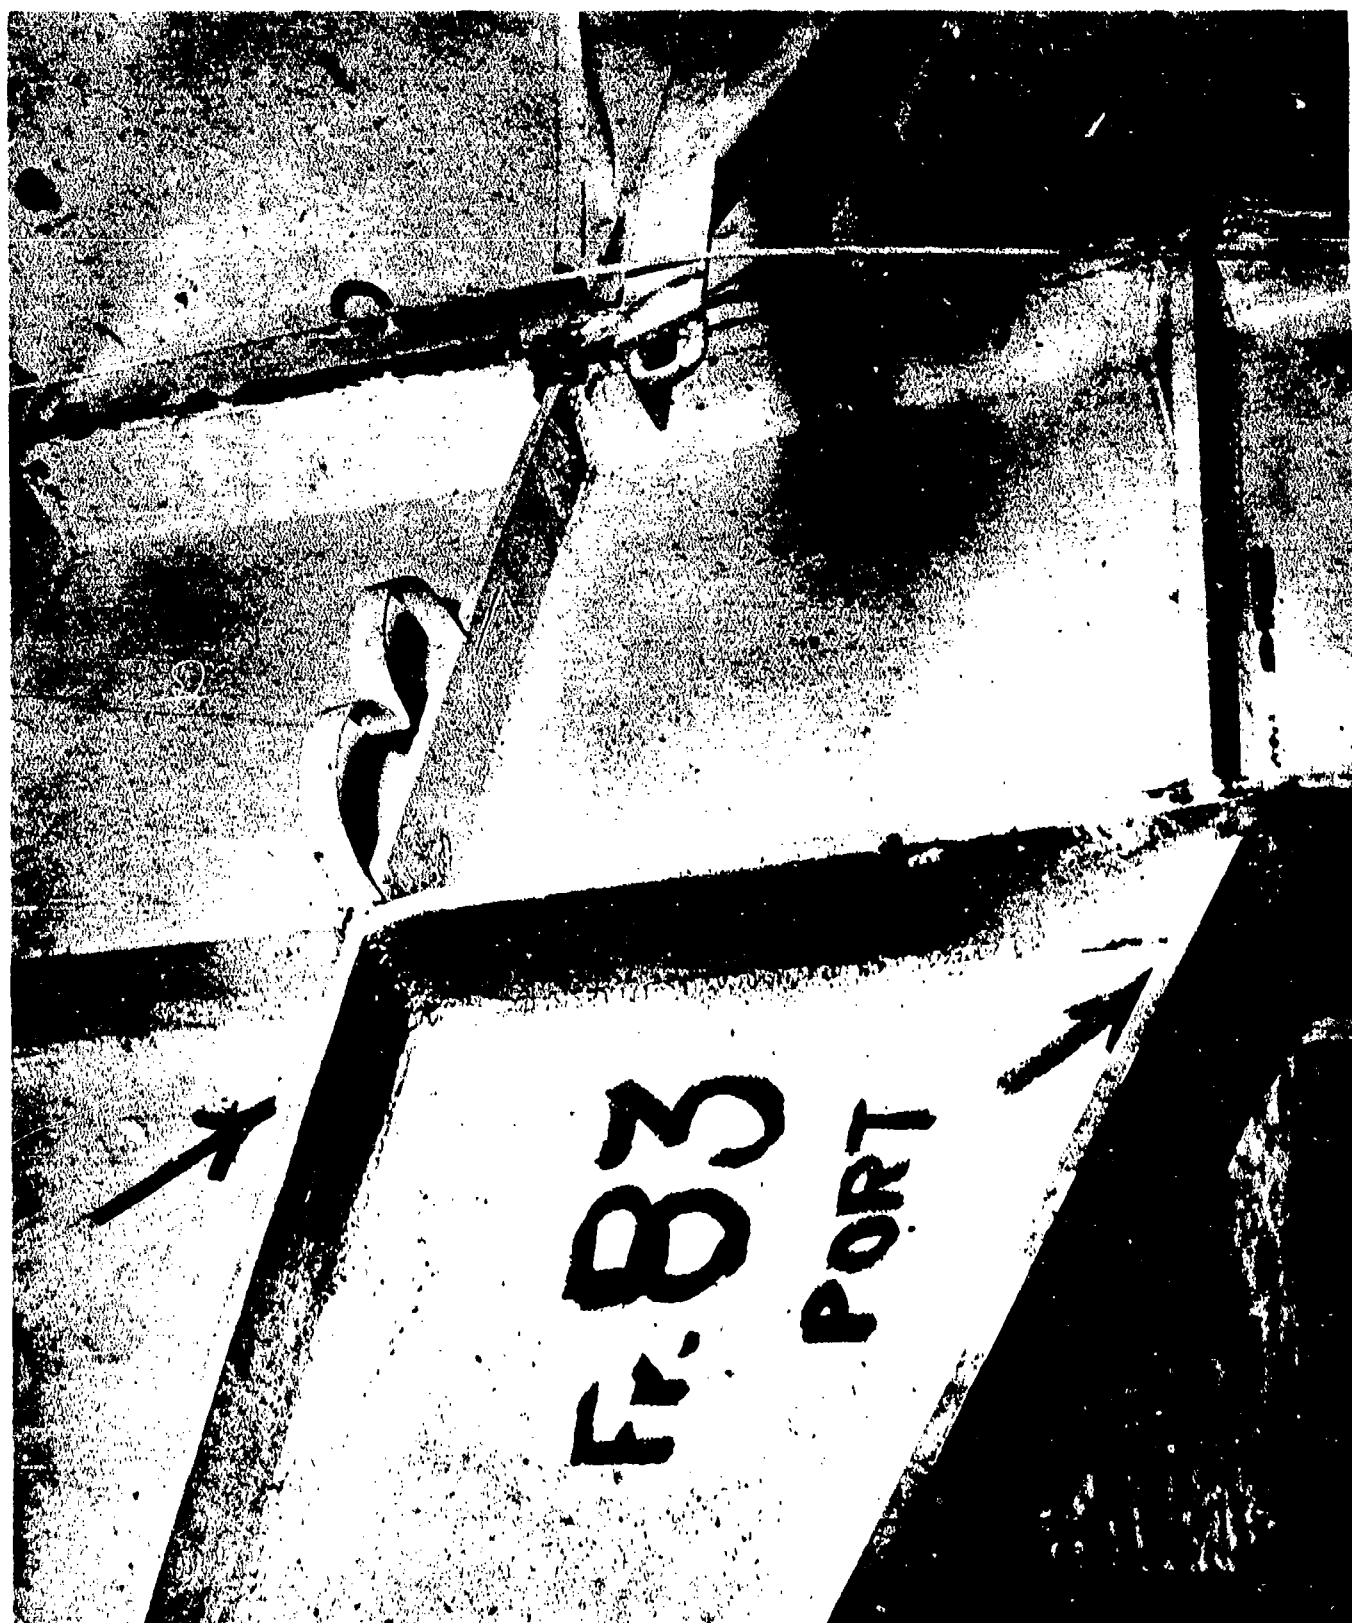
AA-CR-59-2223-7. Flight deck Bent 83, port side failure of welds in overhead connection. Looking aft.

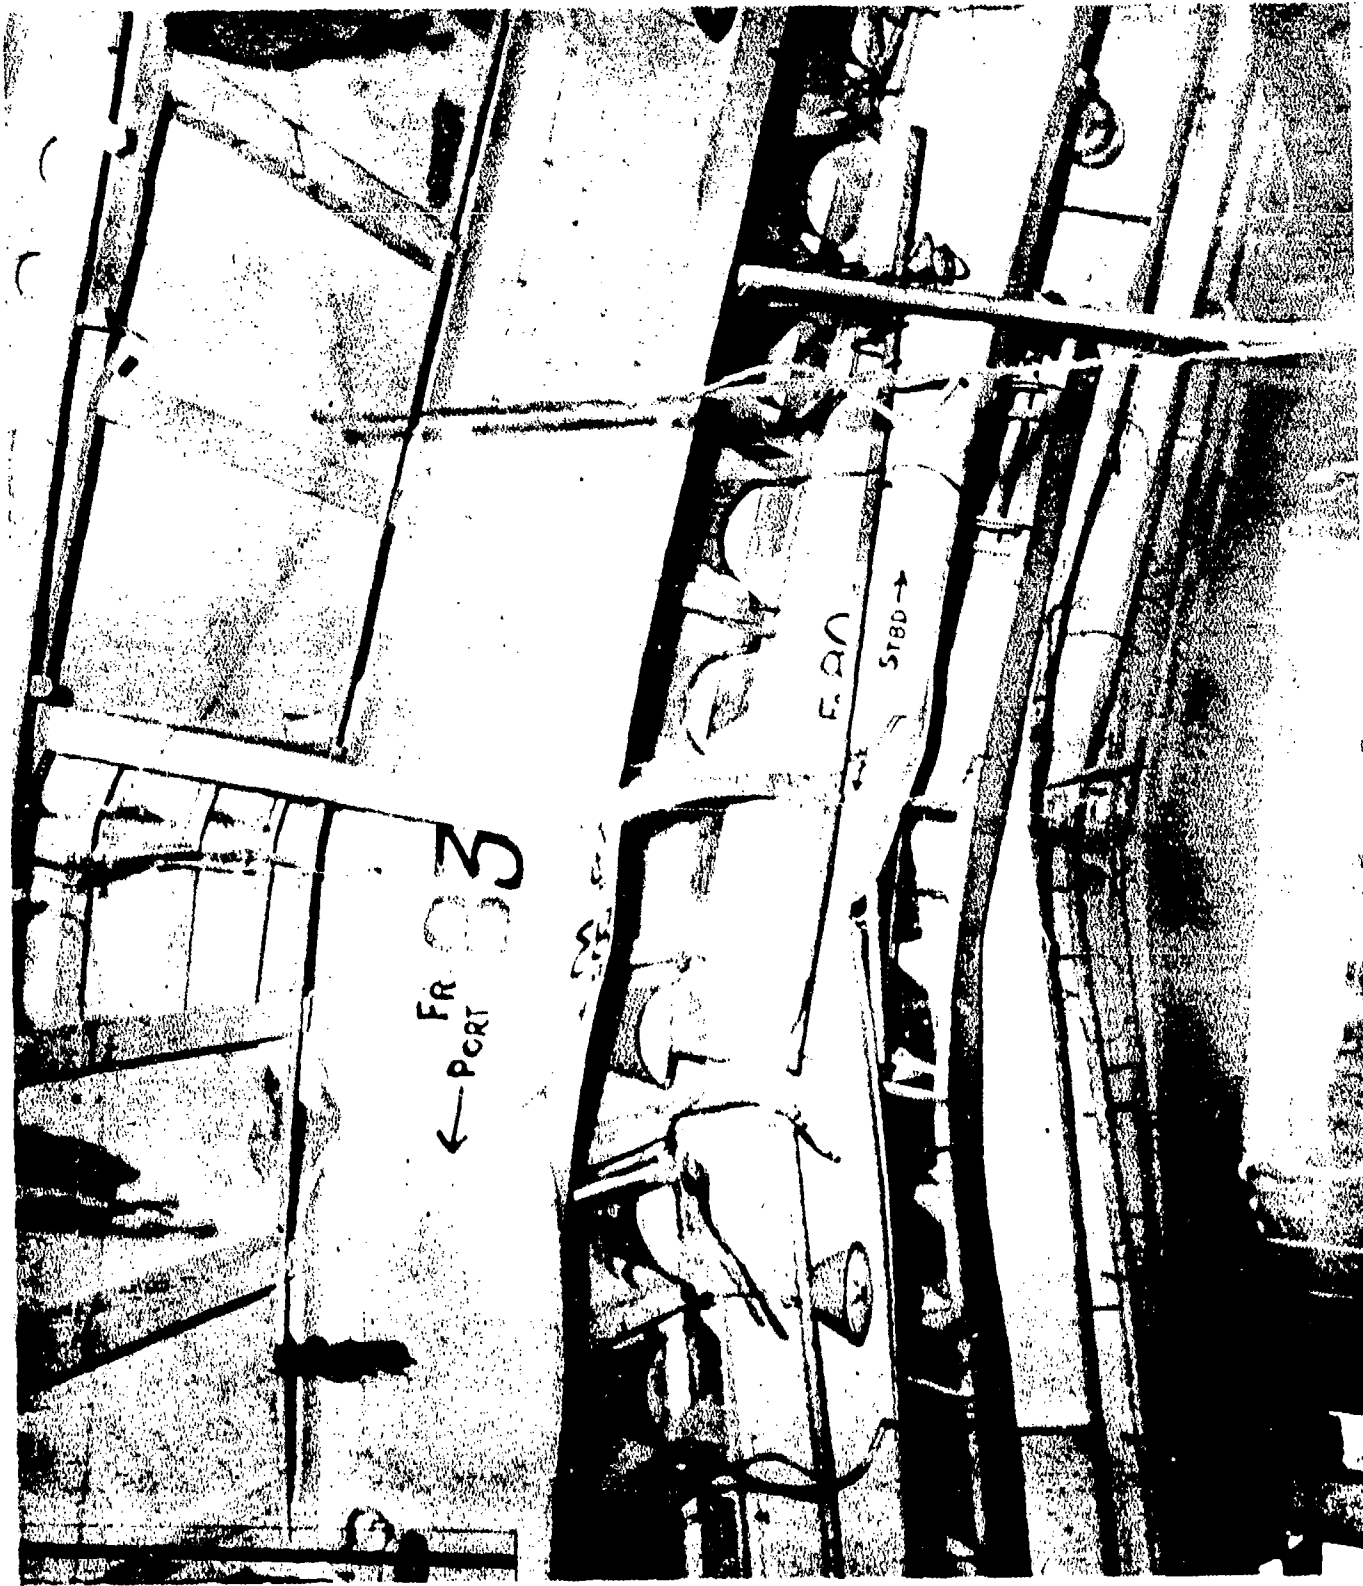
AA-CR-59-2225-3. Flight deck Bent 83, showing deformation of transverse girders near centerline. Looking forward.

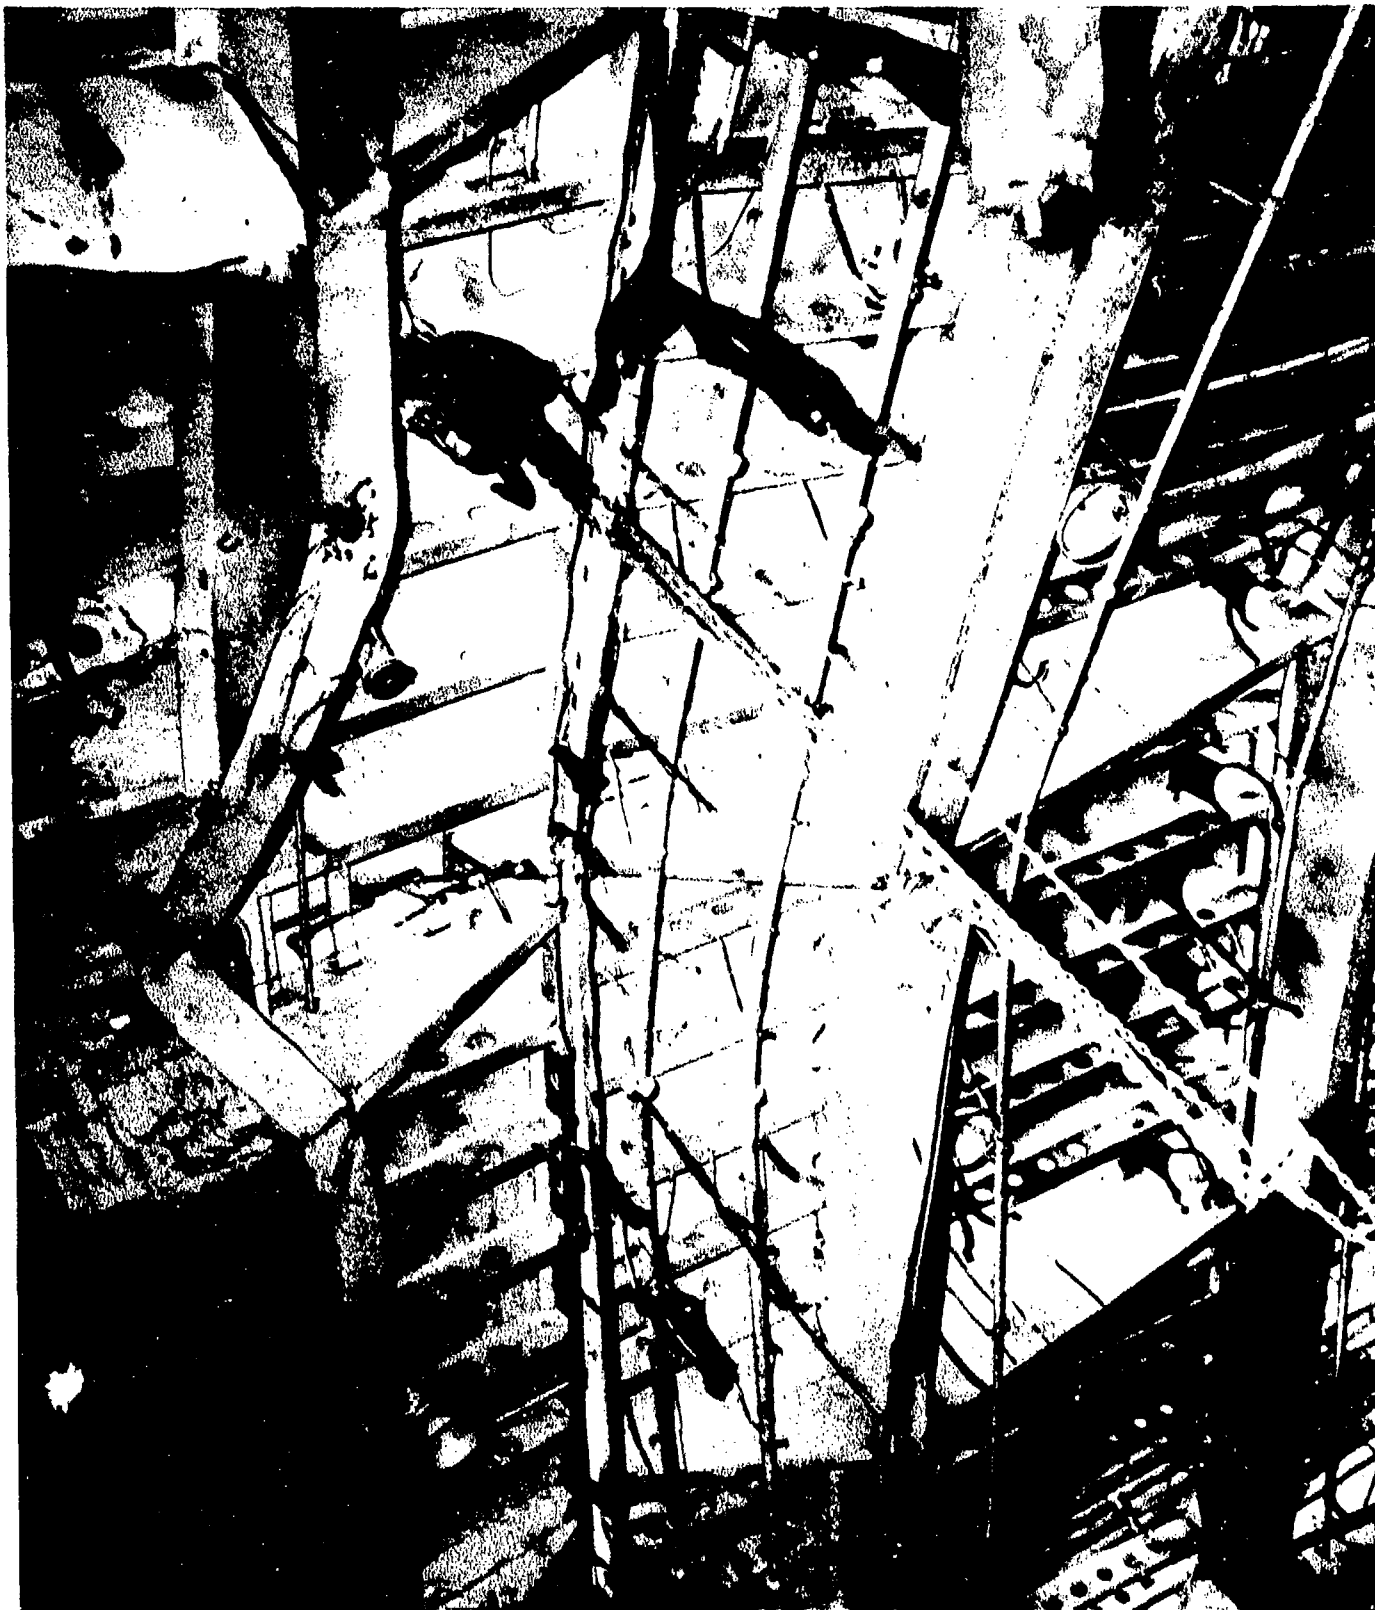
AA-CR-93-2071-7. Underside of flight deck, looking upward and slightly aft from bent 80. Note distorted pipes and pipe hangers.

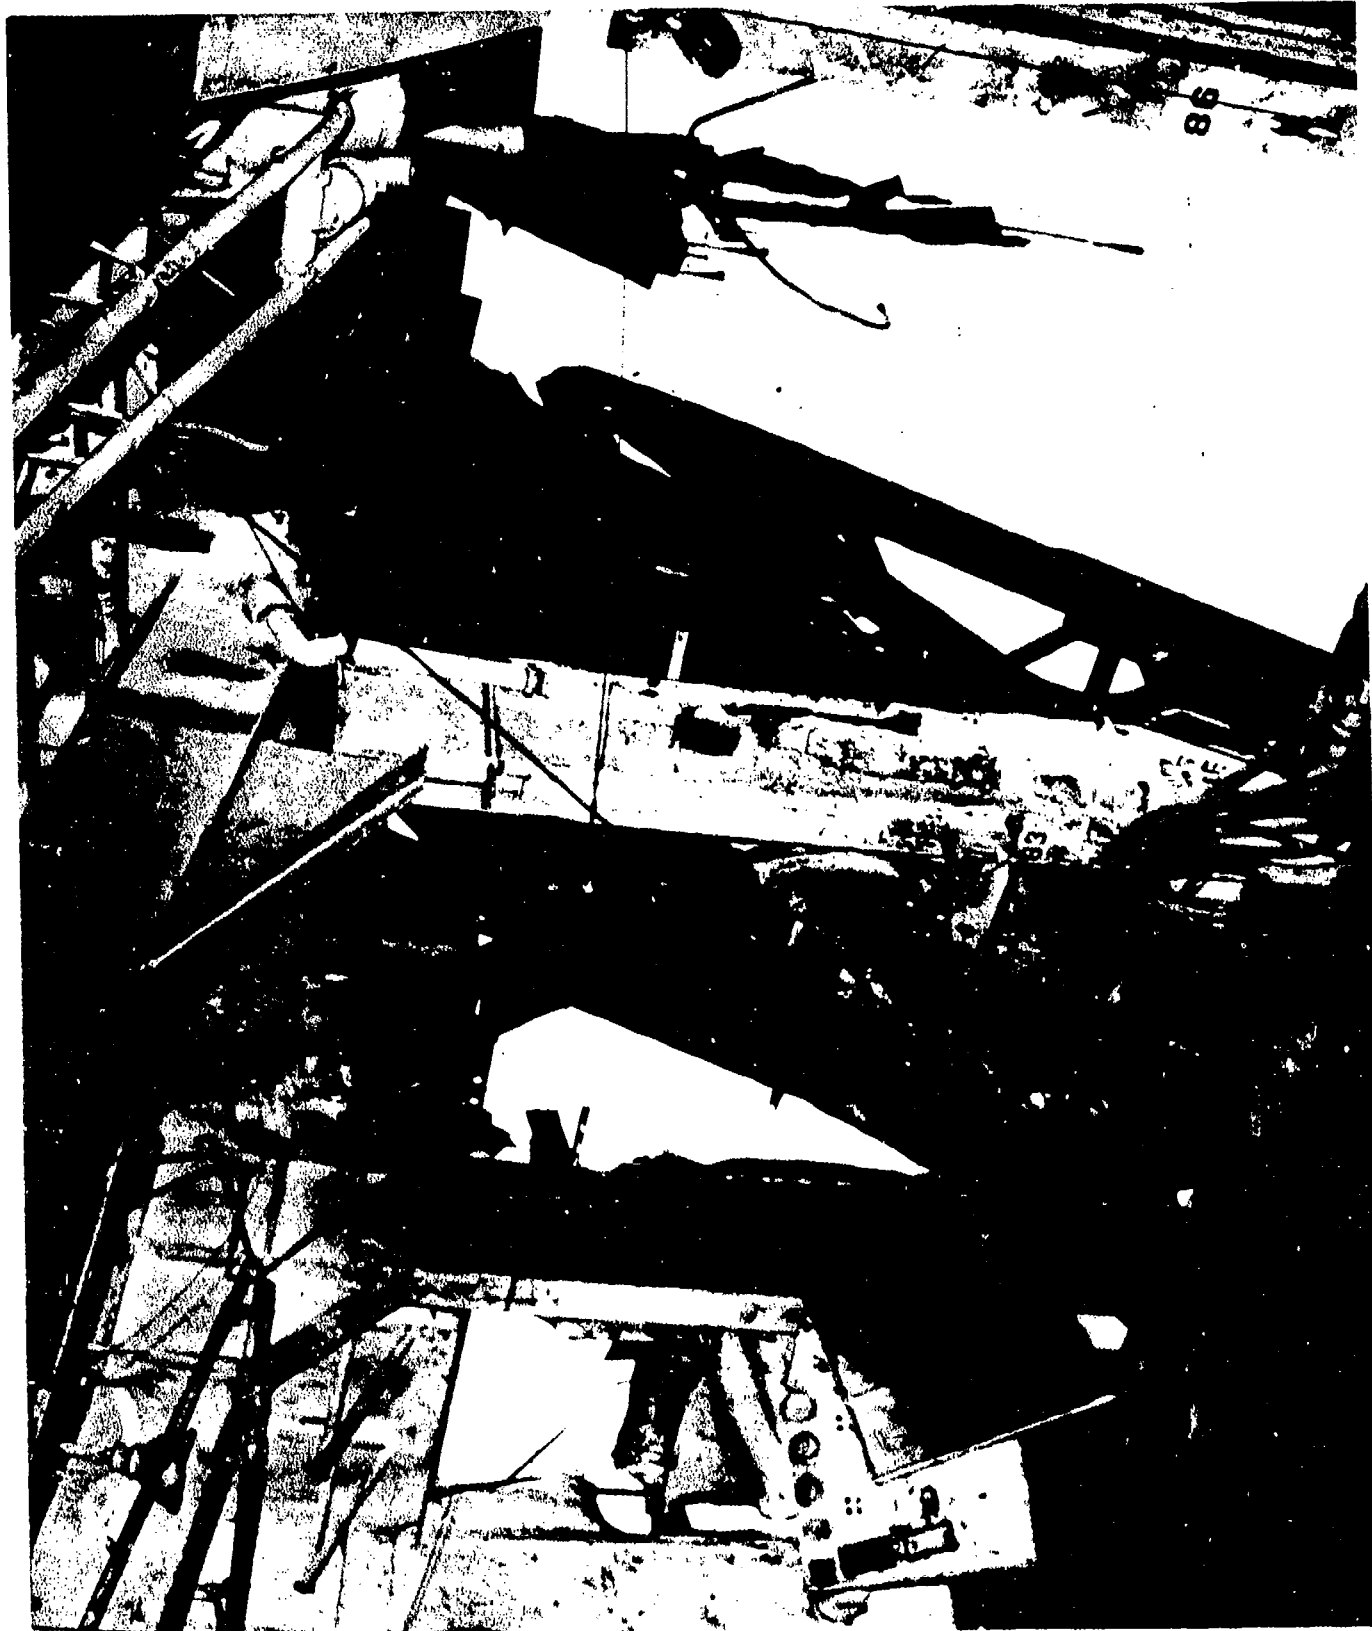
AA-CR-59-2225-5. Hangar-General view between Bents 77 and 86.
Looking forward and to starboard.

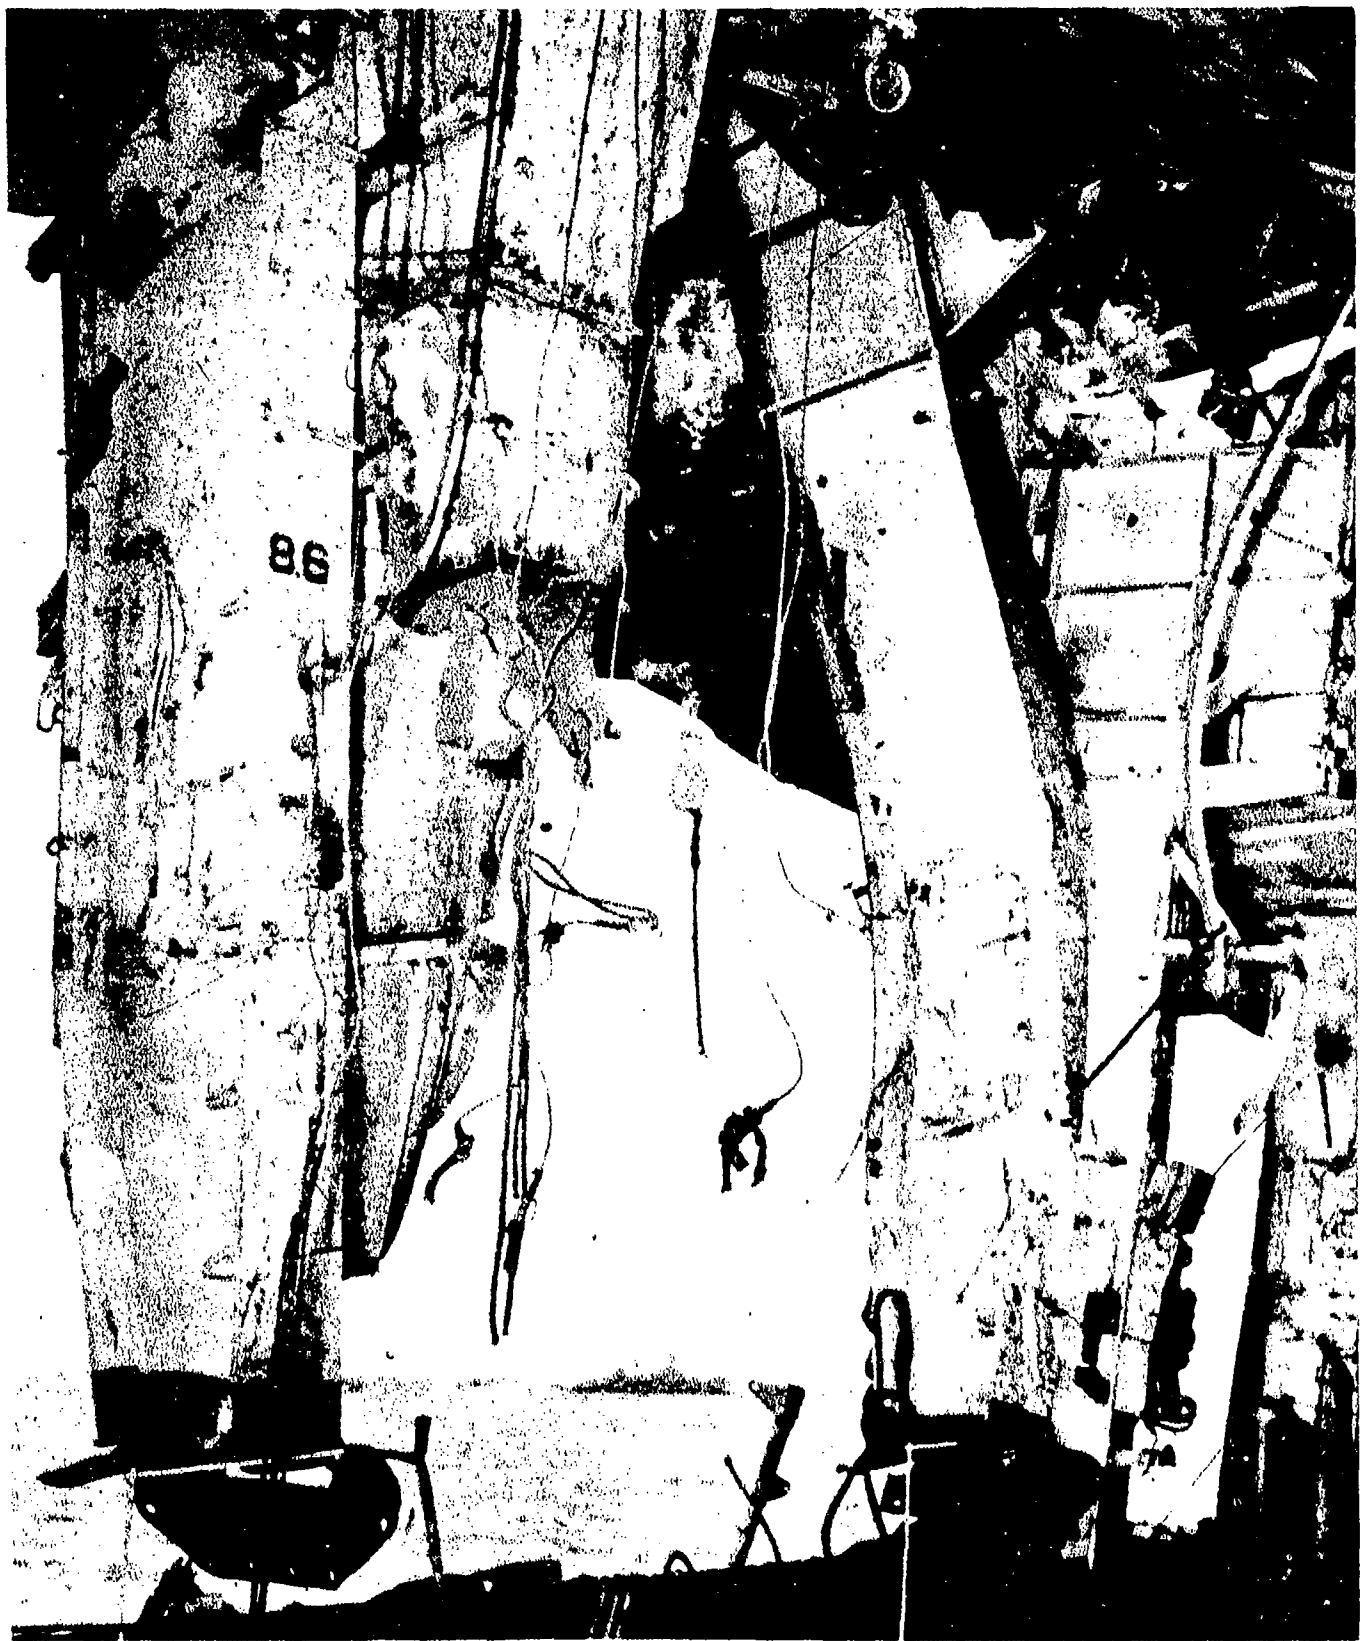
AA-CR-175-2131-5. Hangar. Wobble Bents 83 and 86, port side. Looking forward and outboard from bent 89.

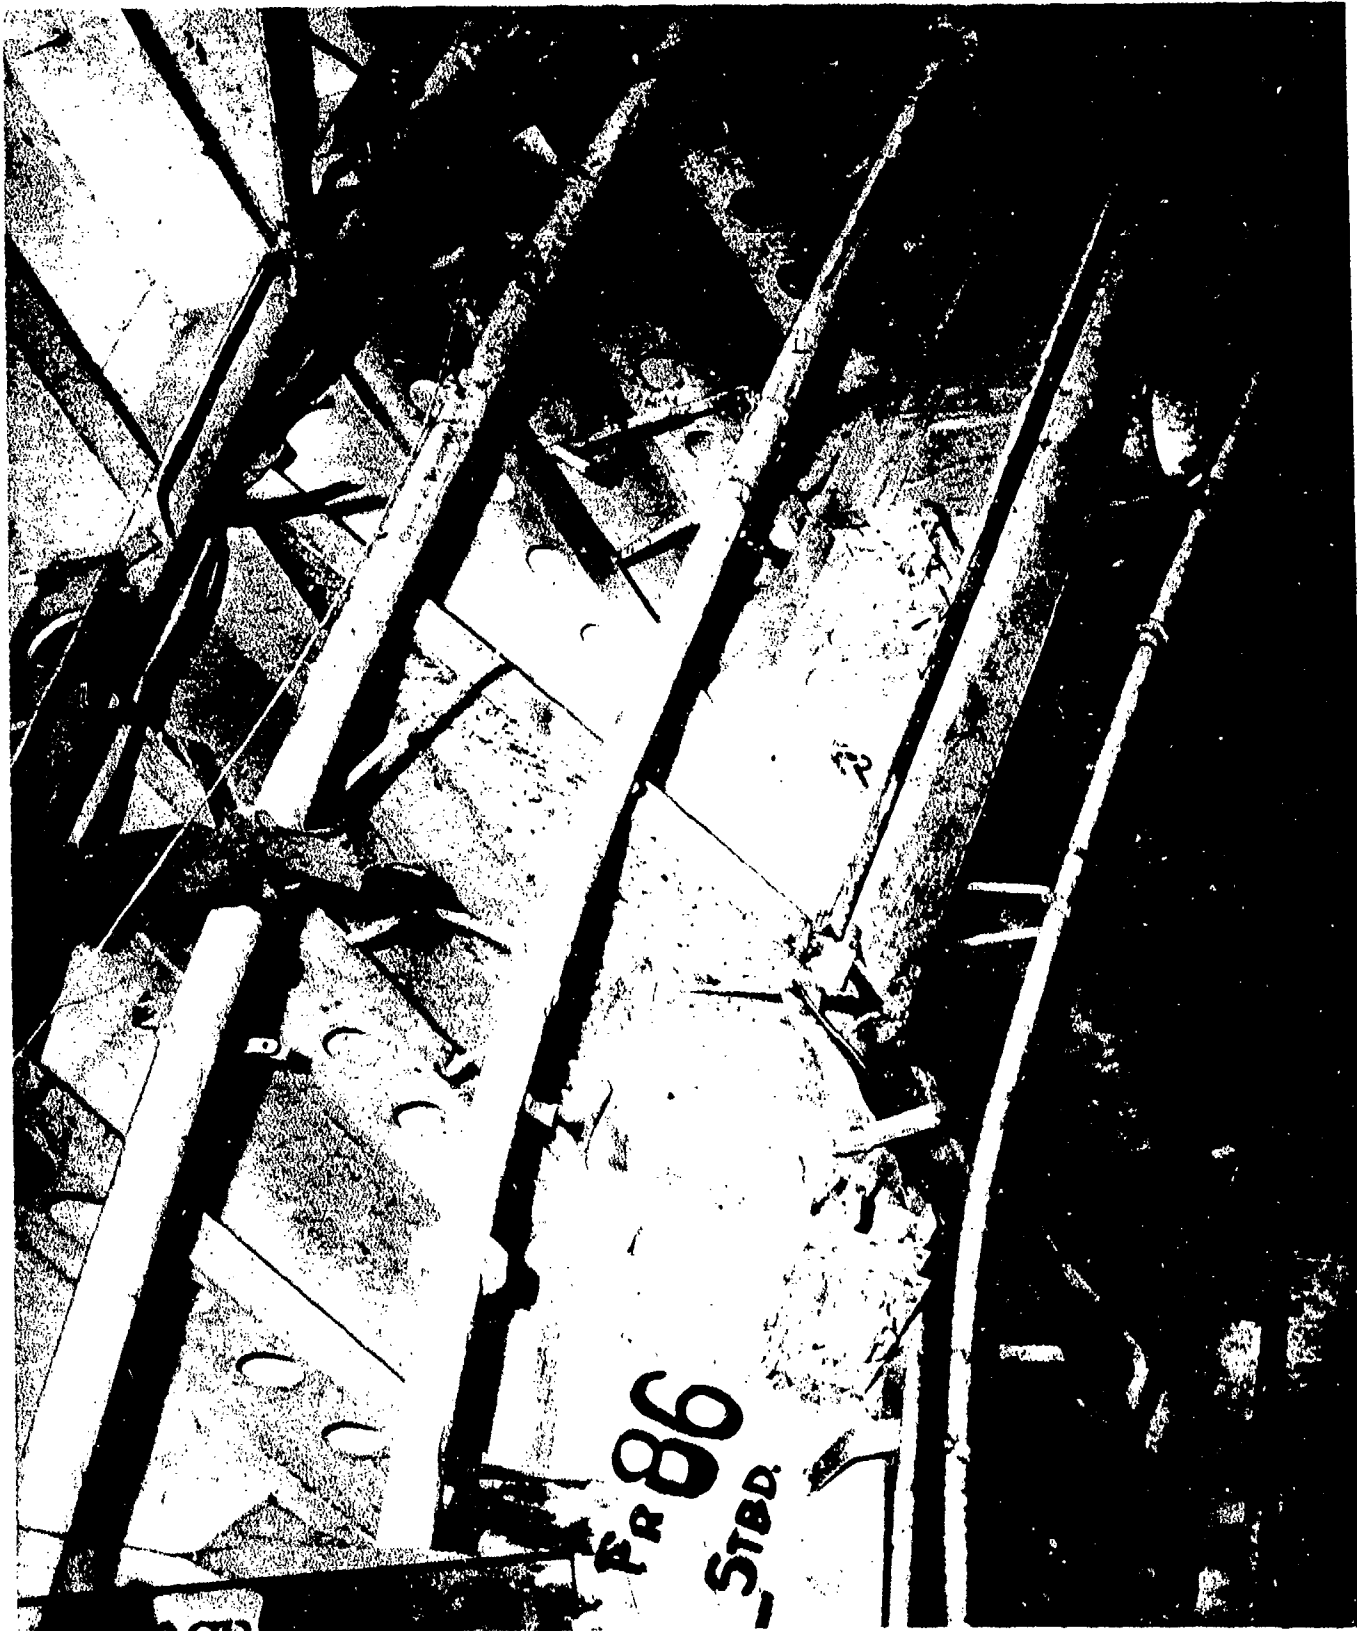
AA-CR-59-2226-2. Flight deck Bent 86. Looking aft and to port at centerline damage.

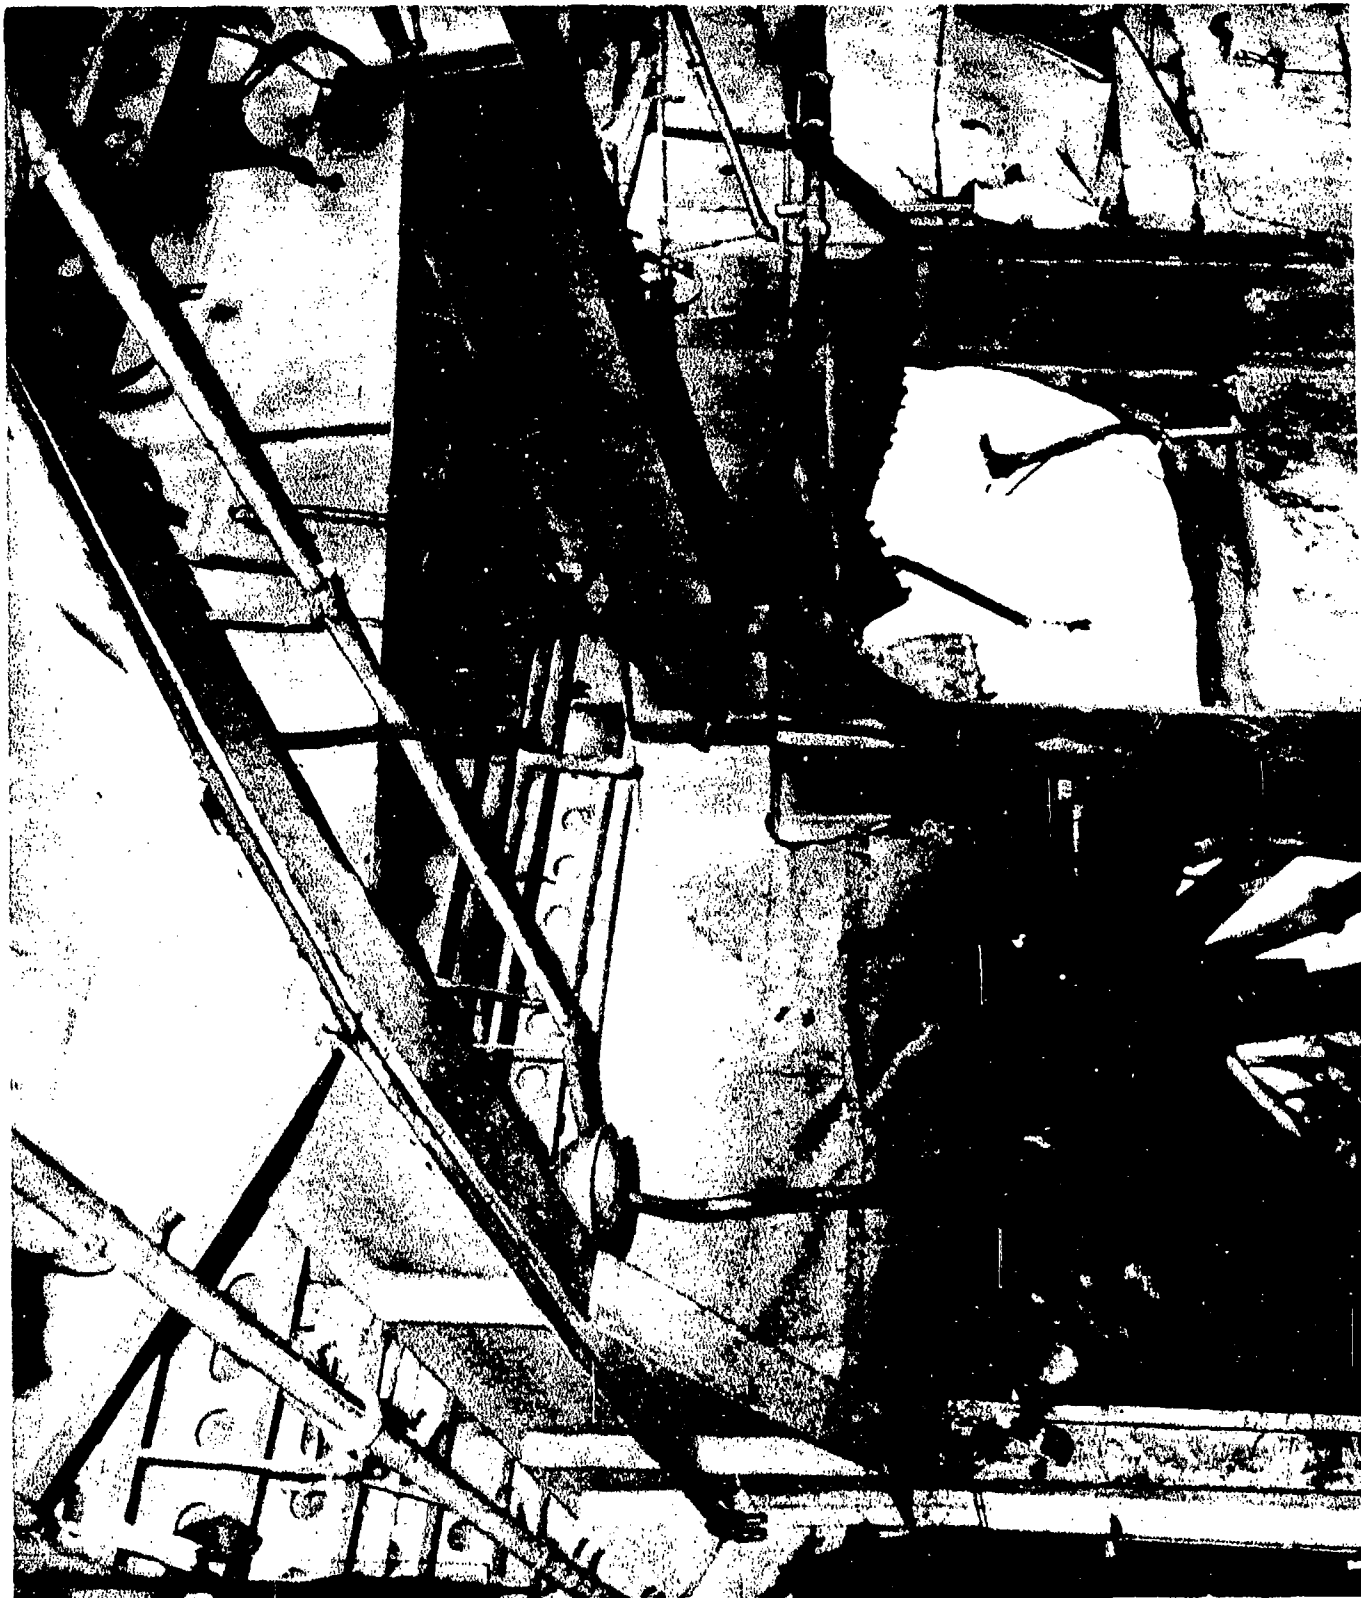
AA-CR-59-2225-10. Underside of flight deck between Bents 86 and 95, starboard side looking aft. Note twist in lower flange of girder of Bent 86.

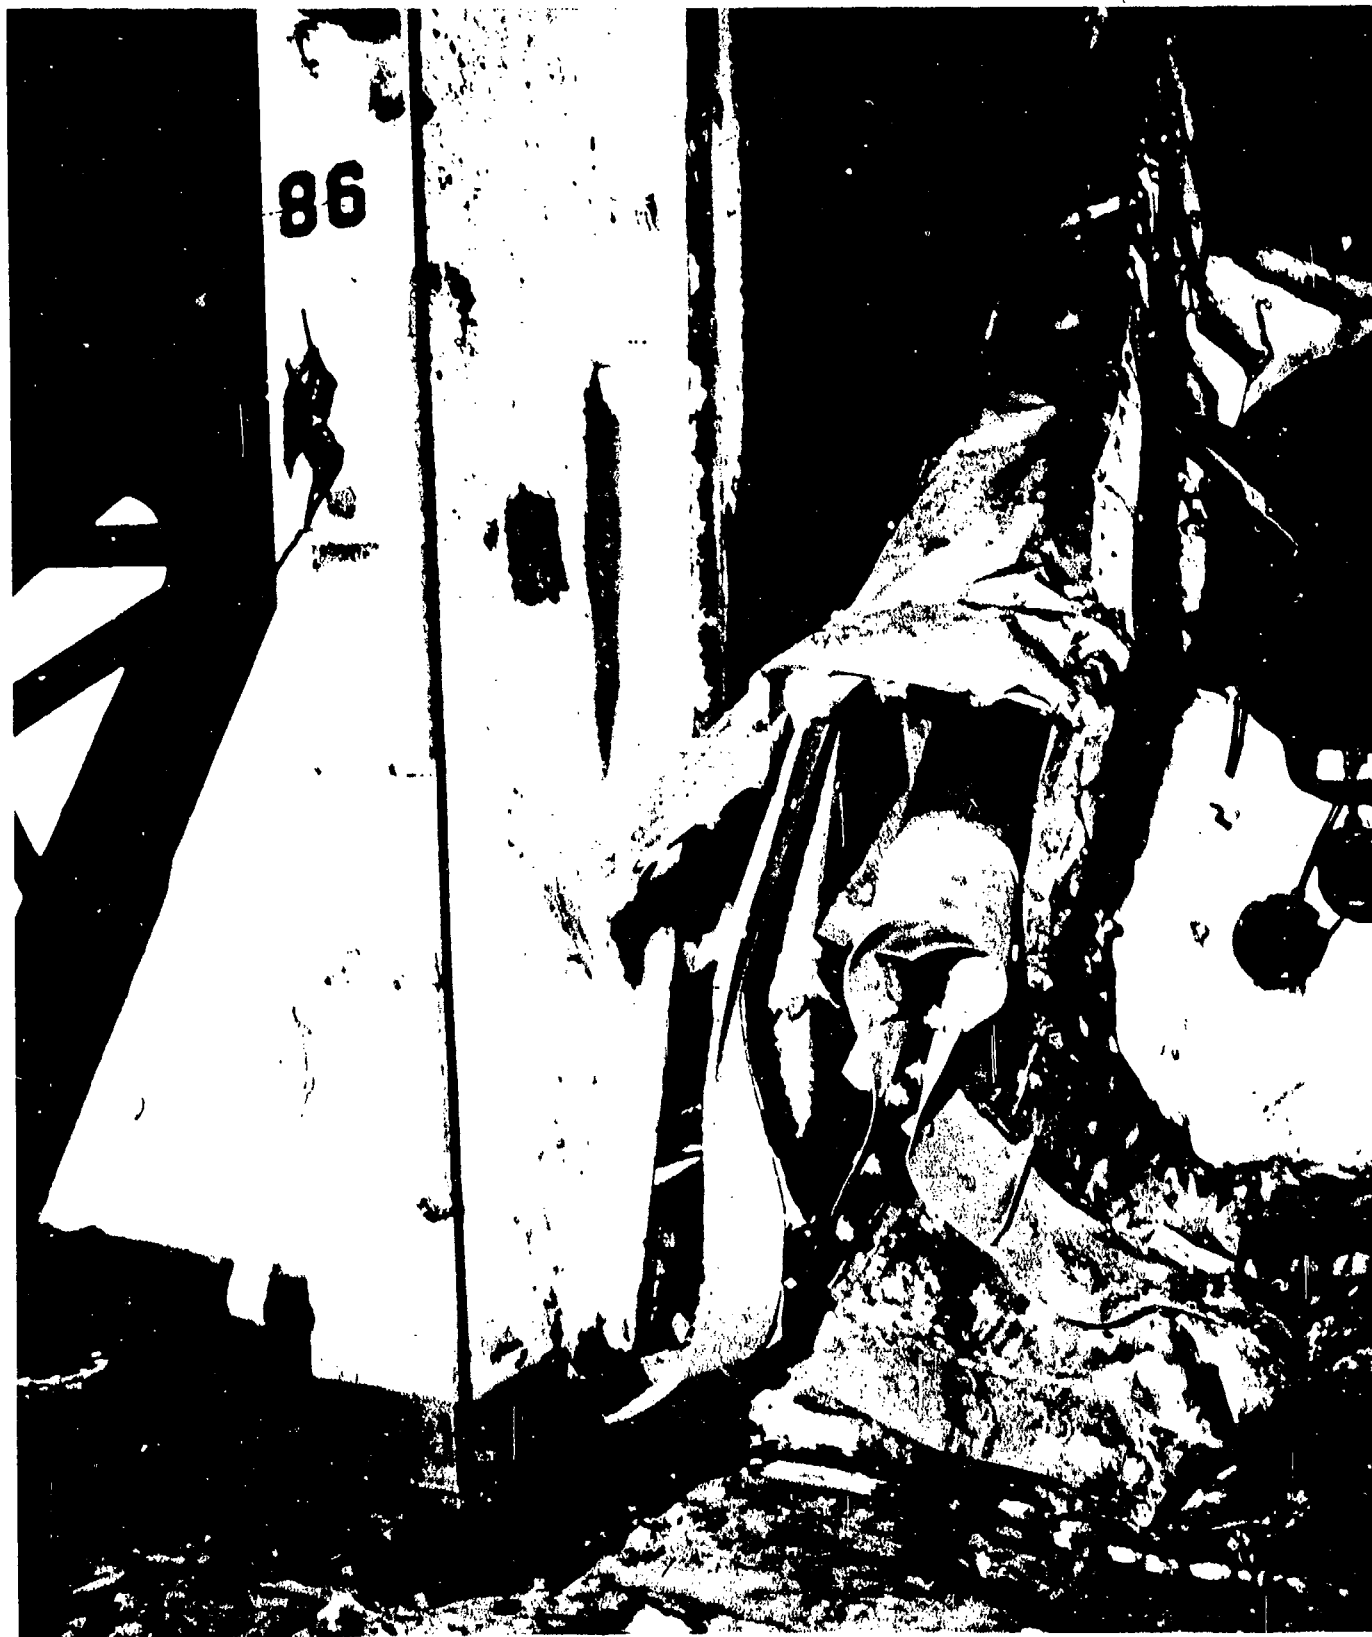
AA-CR-80-4187-4. After Baker. Flight deck Wobble Bents 86 and 83, starboard bottom, looking forward.

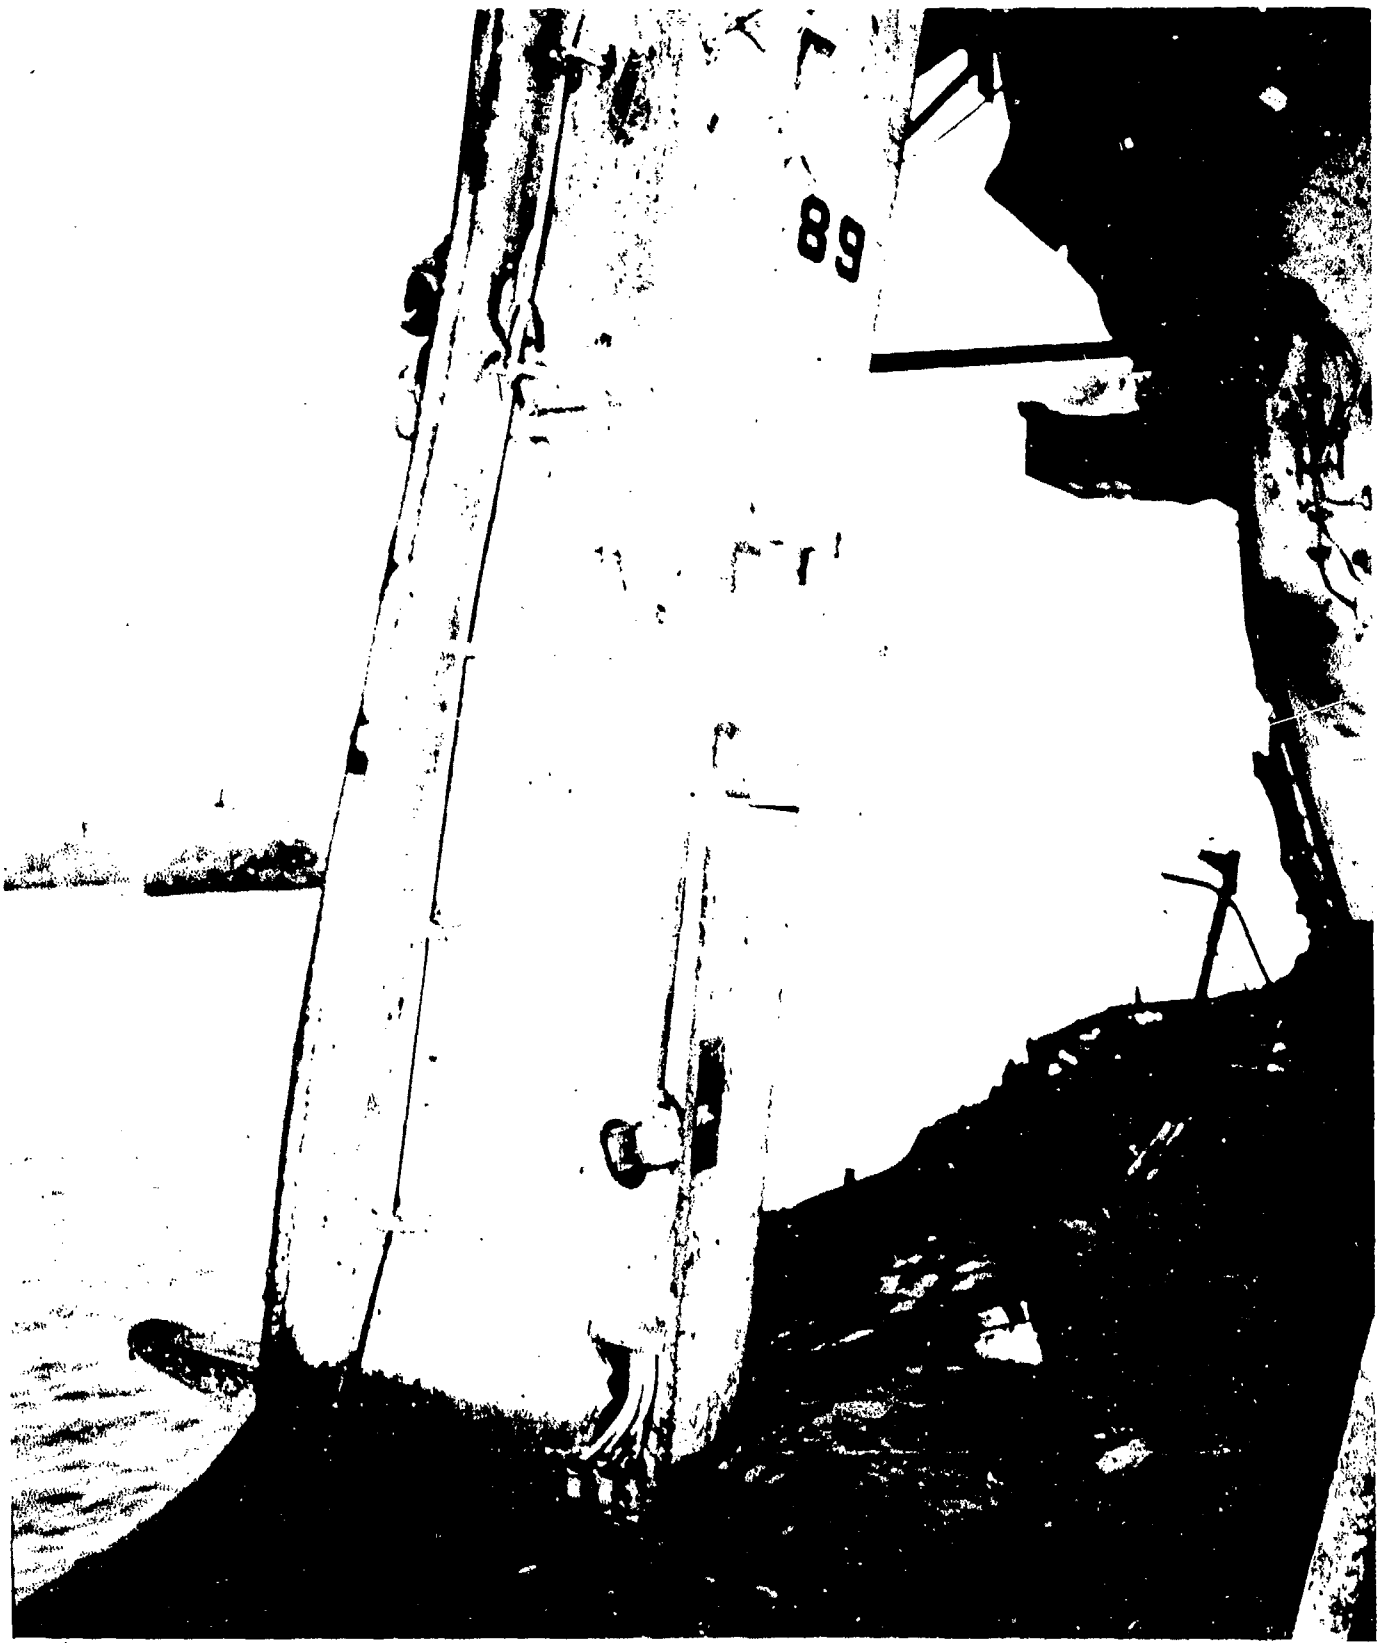
AB-CR-80-4187-6. After Baker. Flight deck Bent 89, port bottom, looking forward.

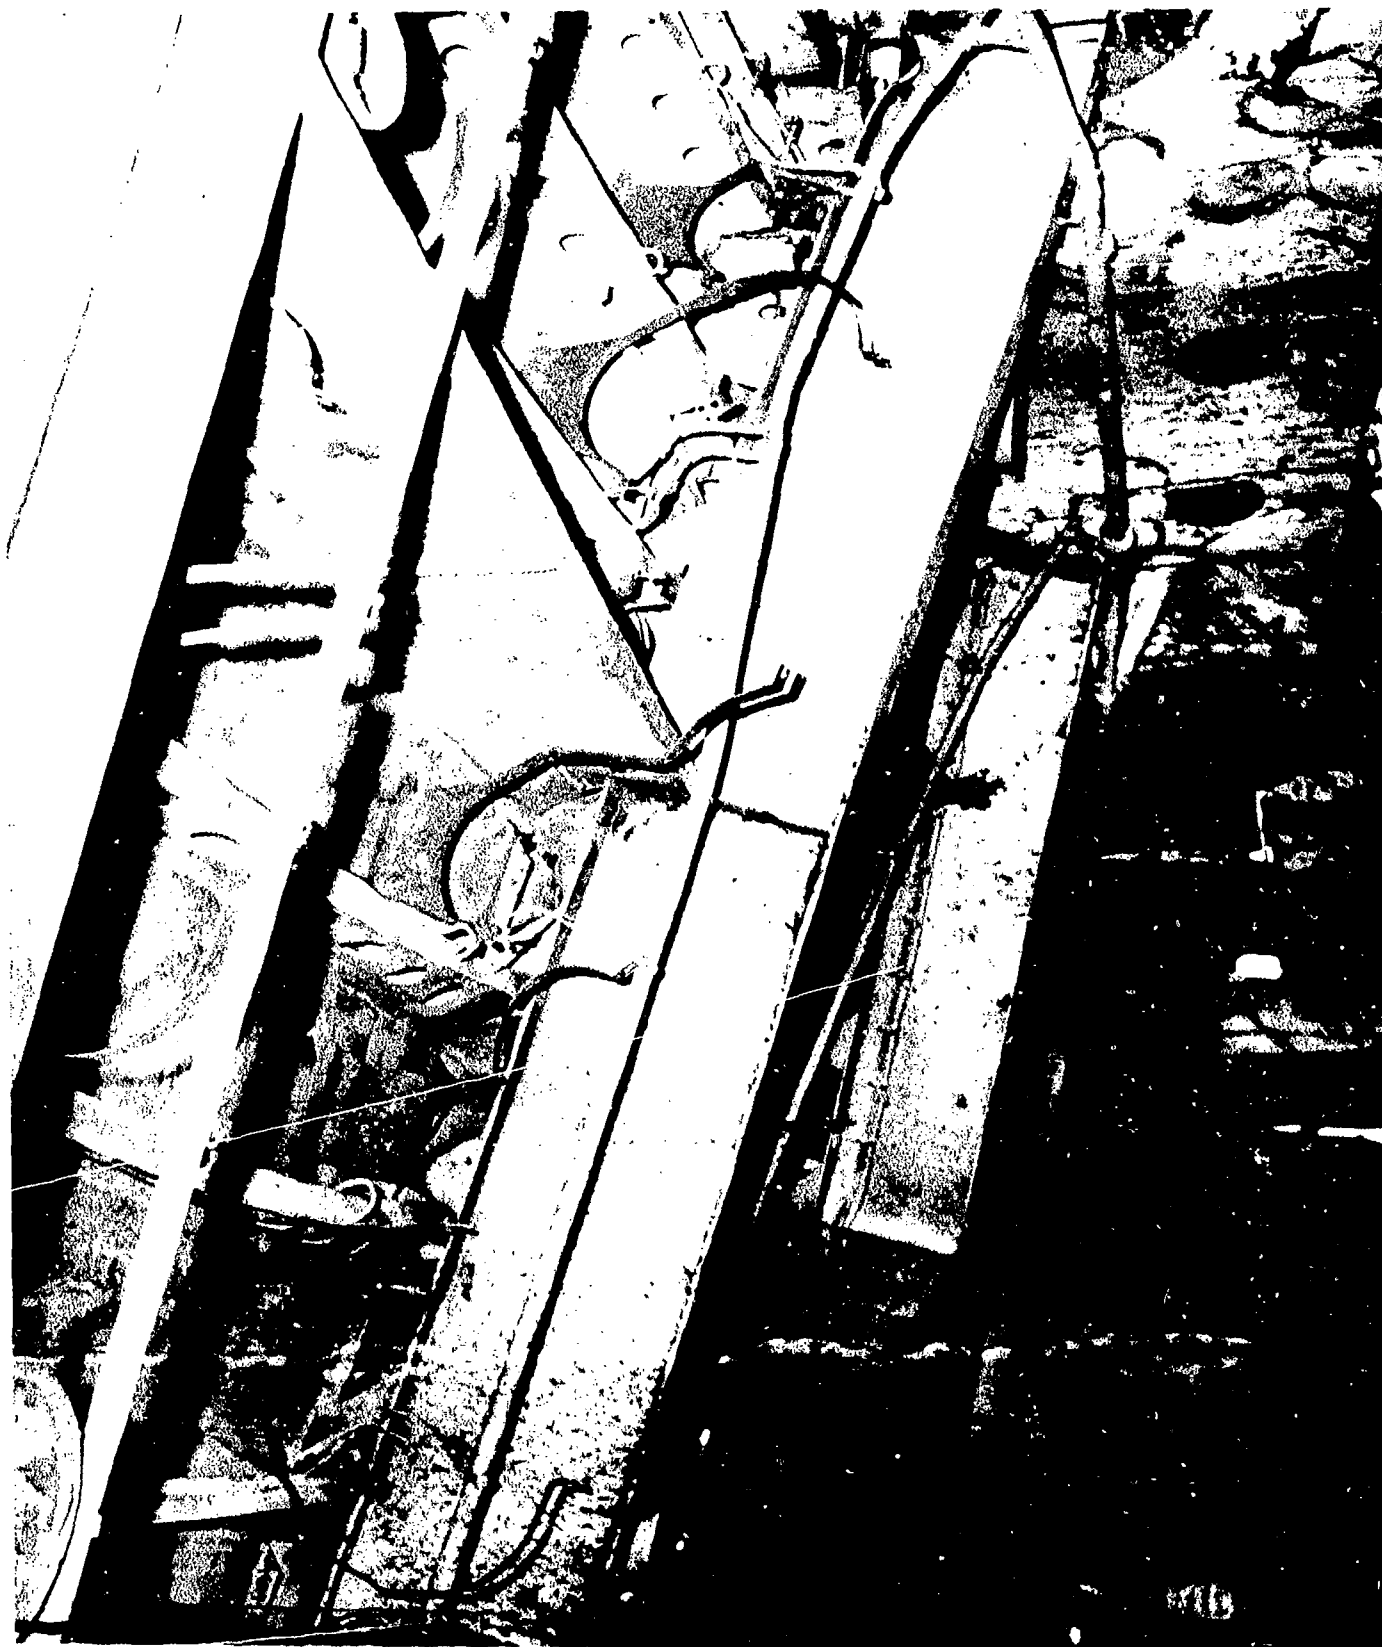
AA-CR-59-2225-11. Underside of flight deck. Looking aft from Bent 86, port side.
