U.S.S. INDEPENDENCE (CVL22)

TEST ABLE

OPERATION CROSSROADS

BUREAU OF SHIPS GROUP
TECHNICAL INSPECTION REPORT

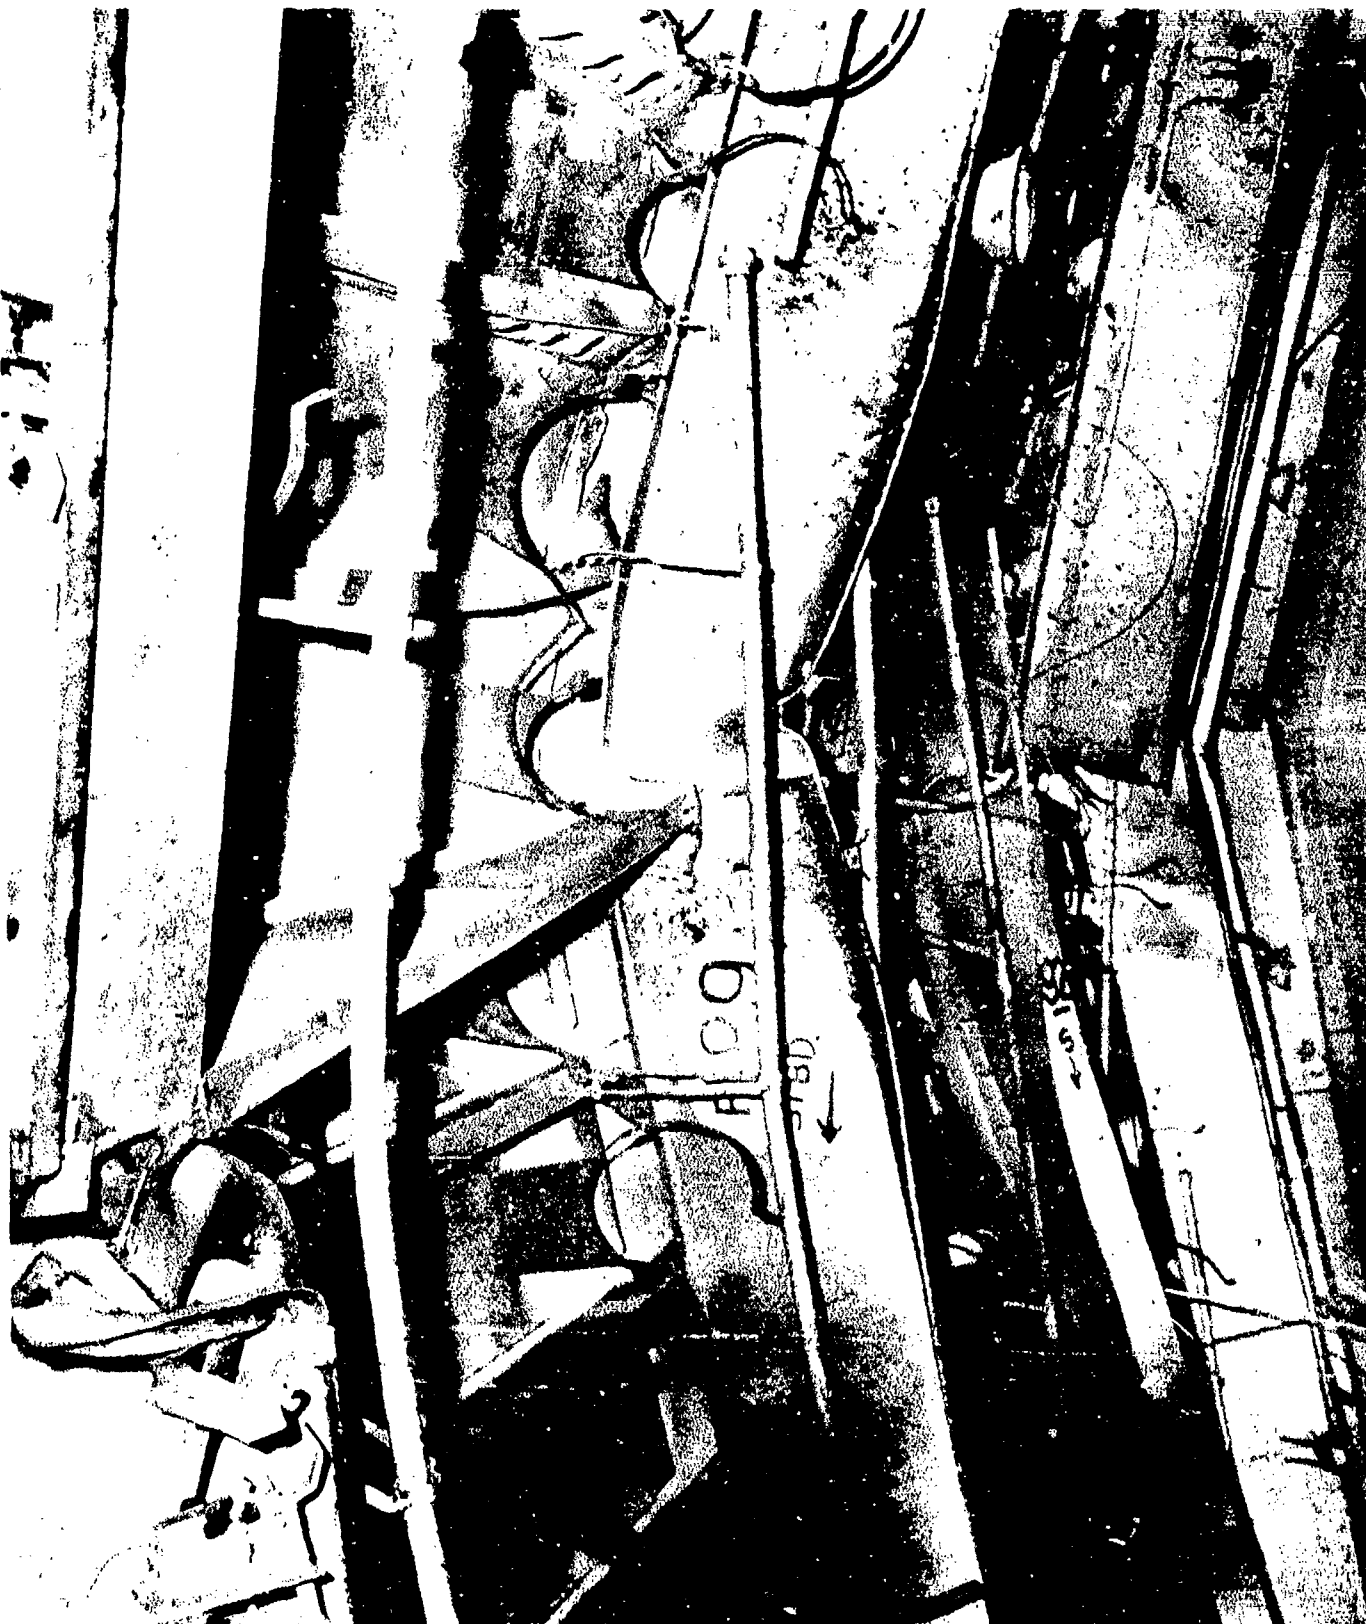
AA-CR-59-2225-9. Underside of flight deck at bent 86, looking aft along centerline. Note failures at bent girders 86 and 89.

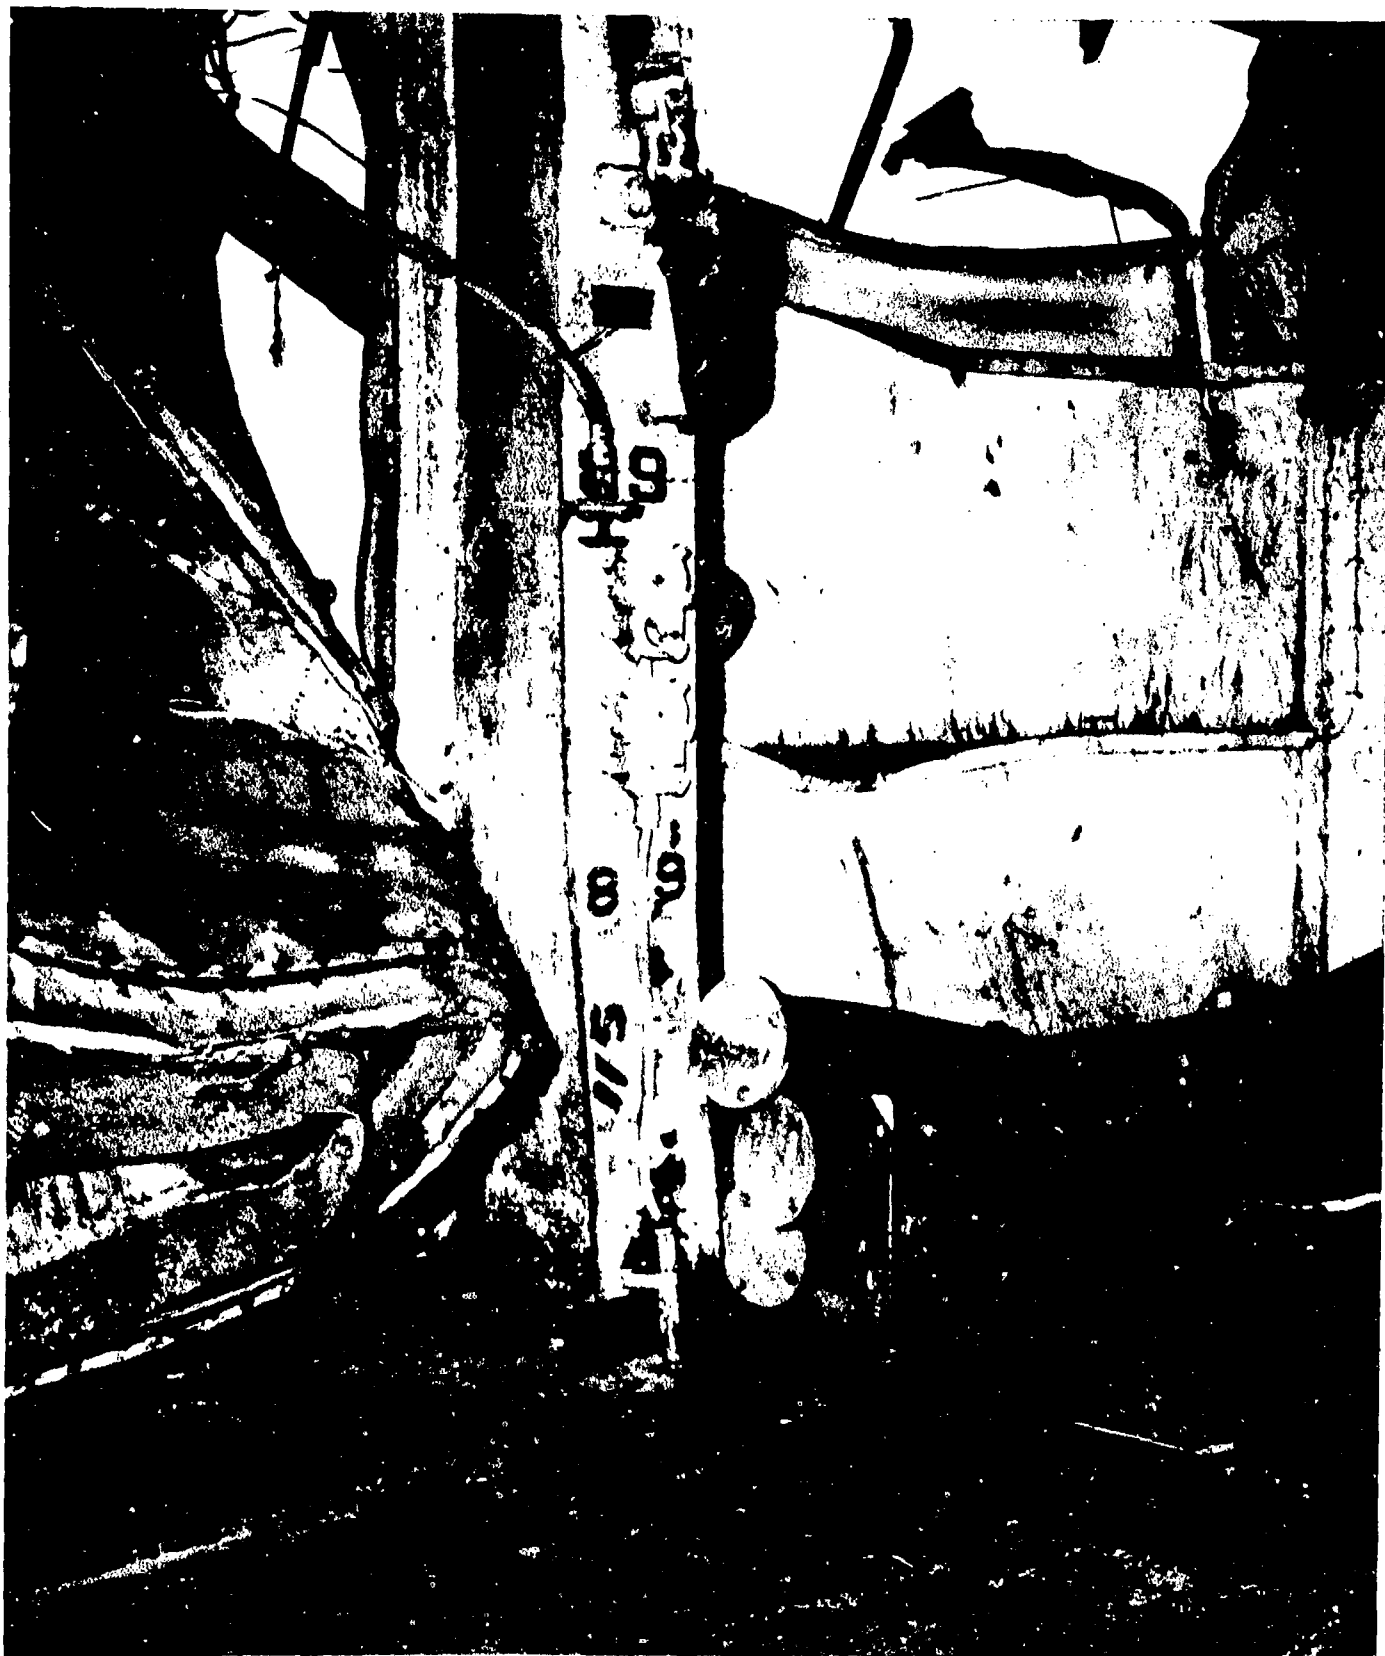
AA-CR-80-4187-7. After Baker - Flight deck Bent 89, starboard bottom, looking aft.

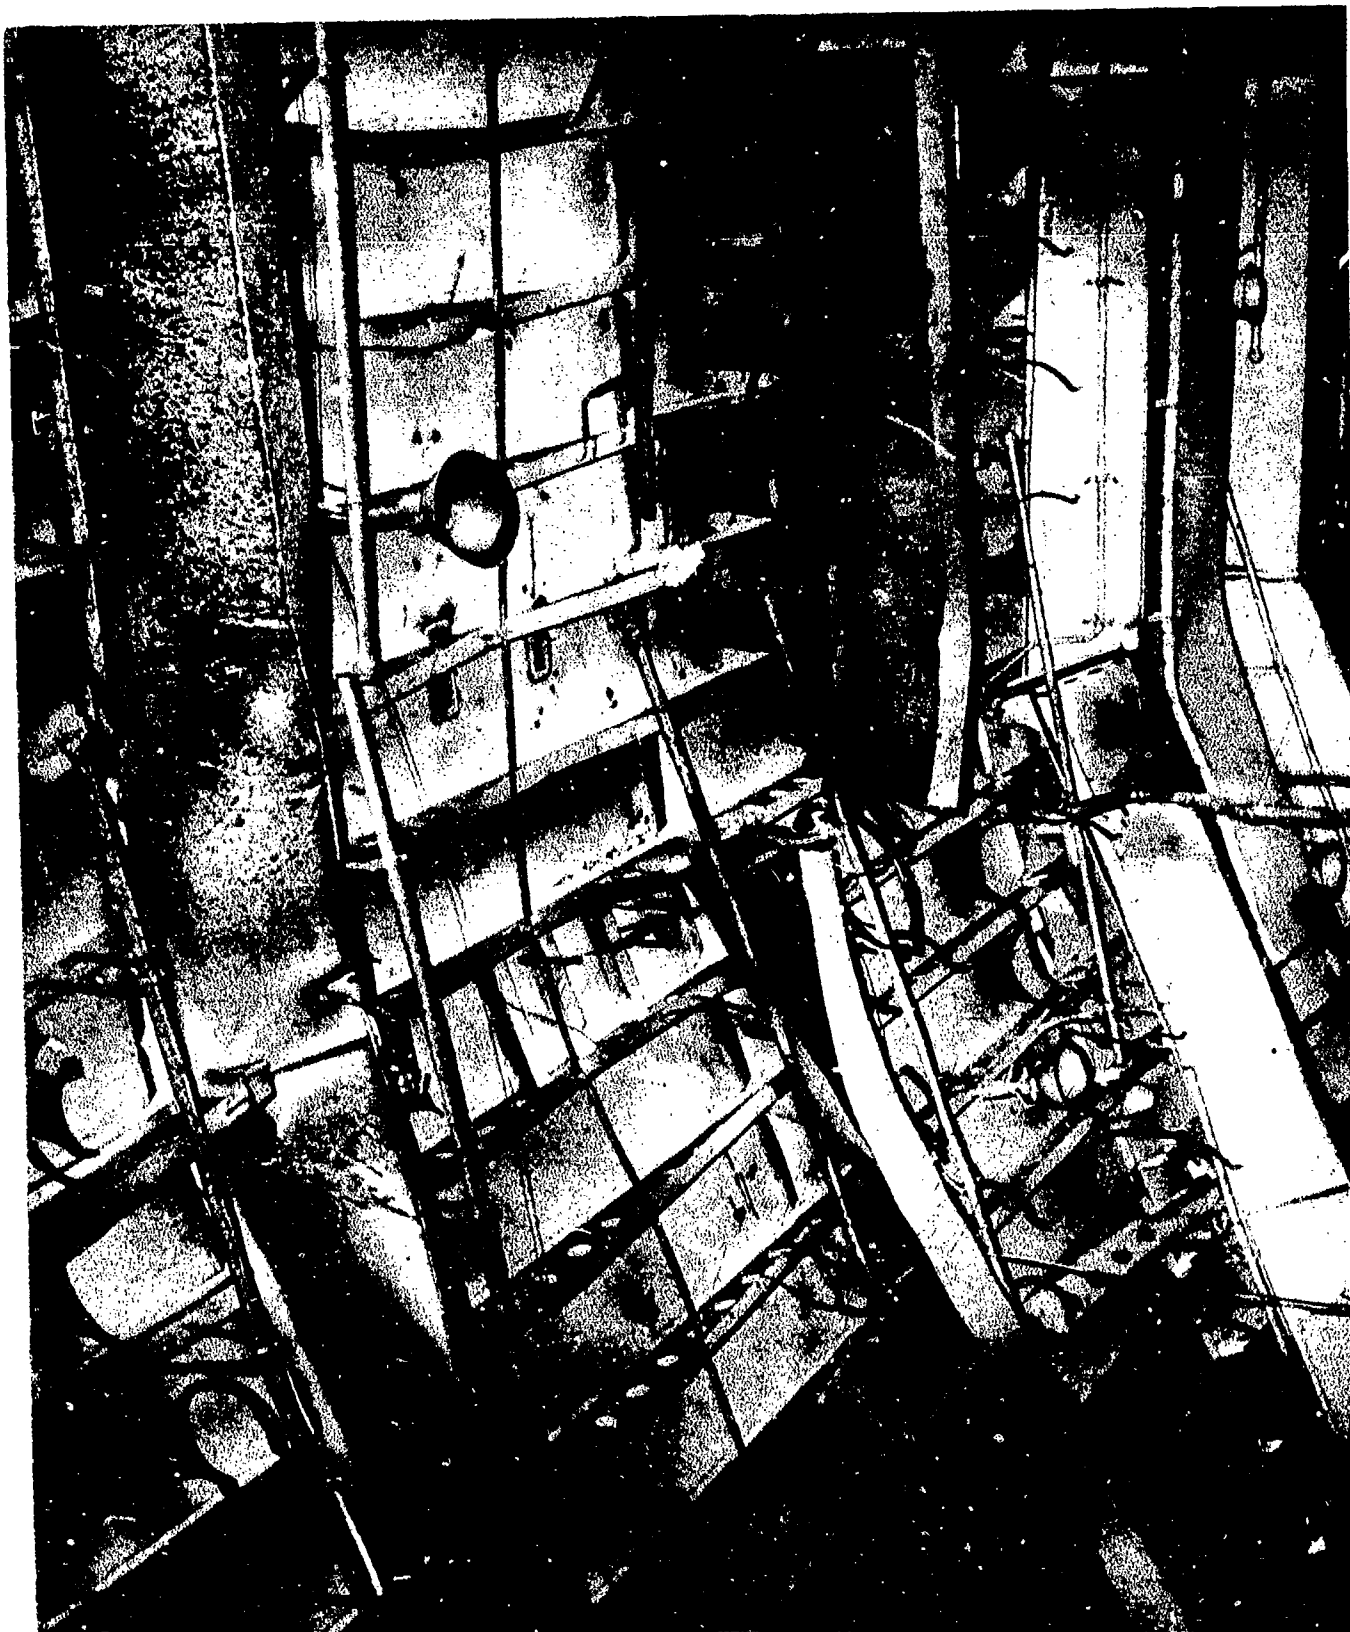
AA-CR-175-2118-11. Centerline joints, flight deck bents 89, 92 and 95 from bent 86.

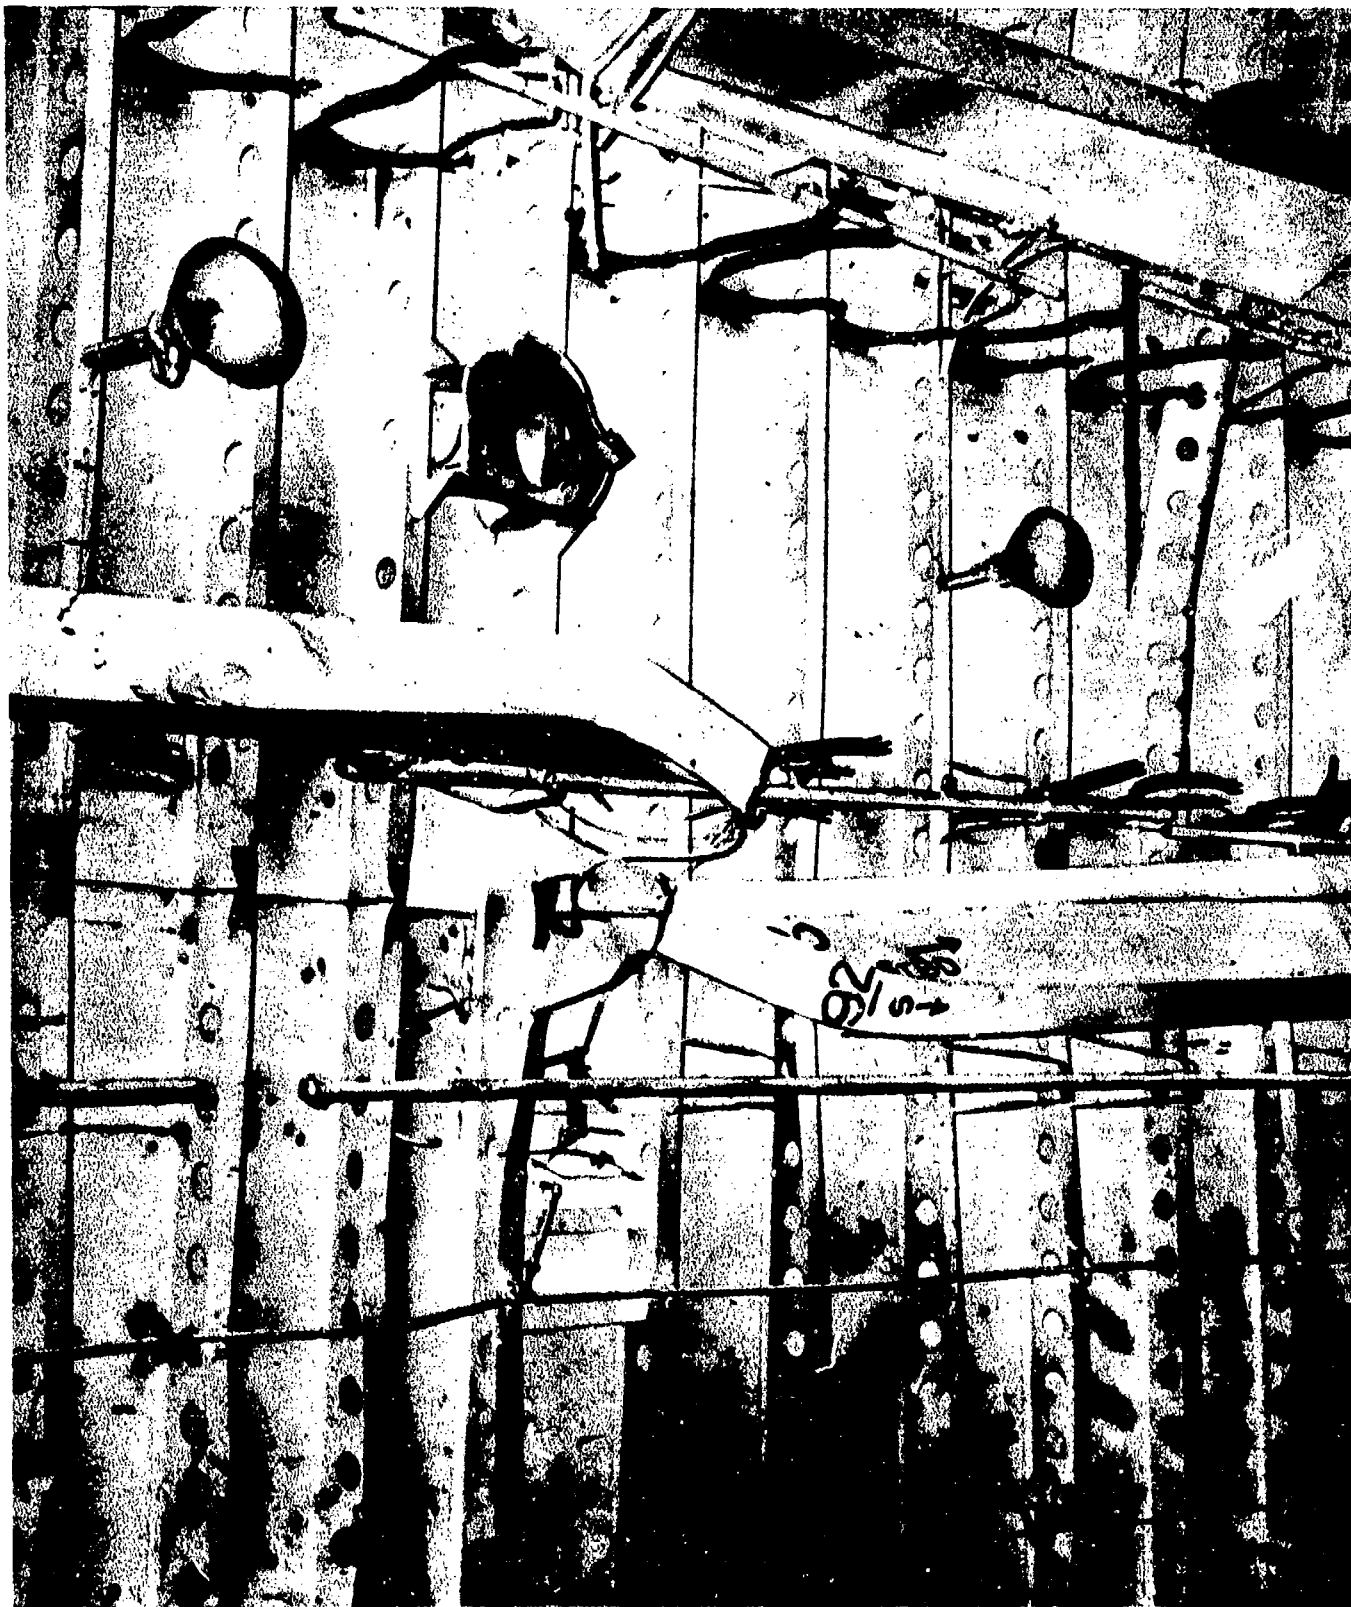
AA-CR-59-2224-9. Flight deck bent girder 92, looking to starboard.

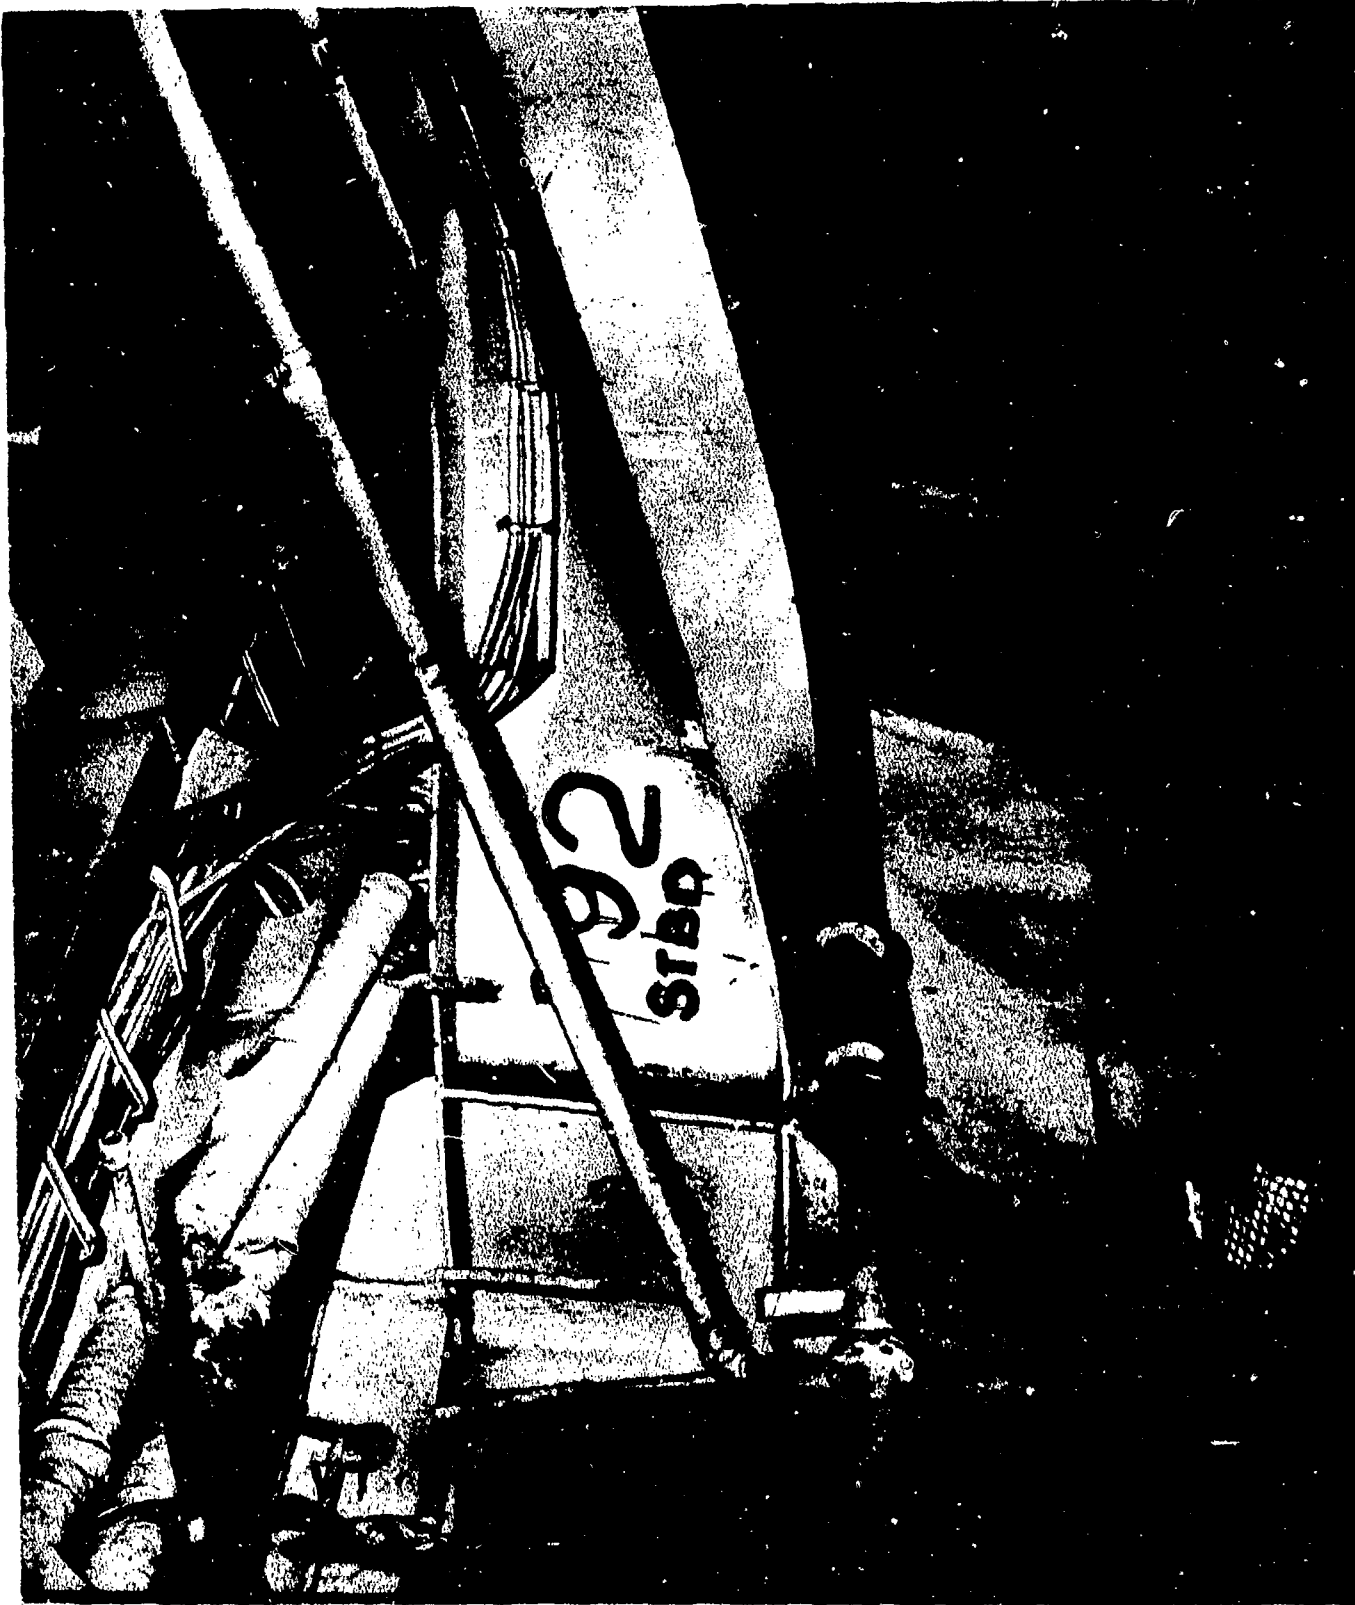
AA-CR-59-4149-7. Flight deck Bent 92. Starboard upper corner, looking aft.

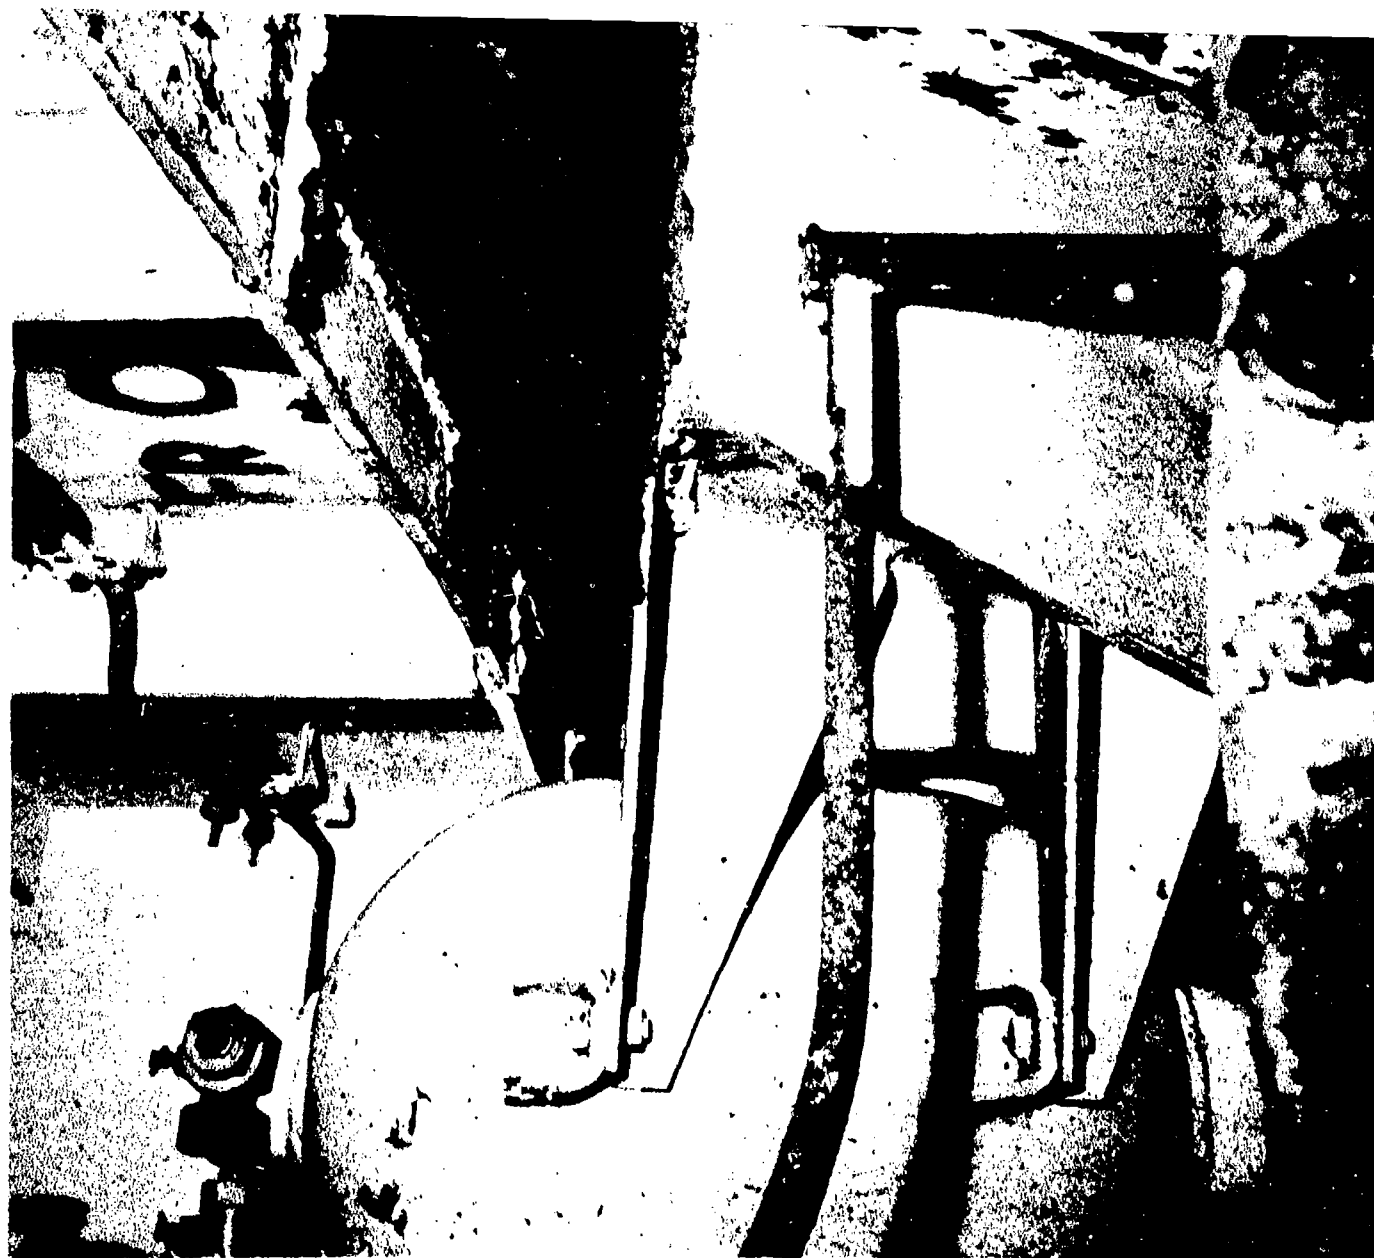
AA-CR-59-4152-9. Flight deck Bent 95, port side showing failure of overhead connection in fillet welds along upper edge of bracket. Looking forward and to port.

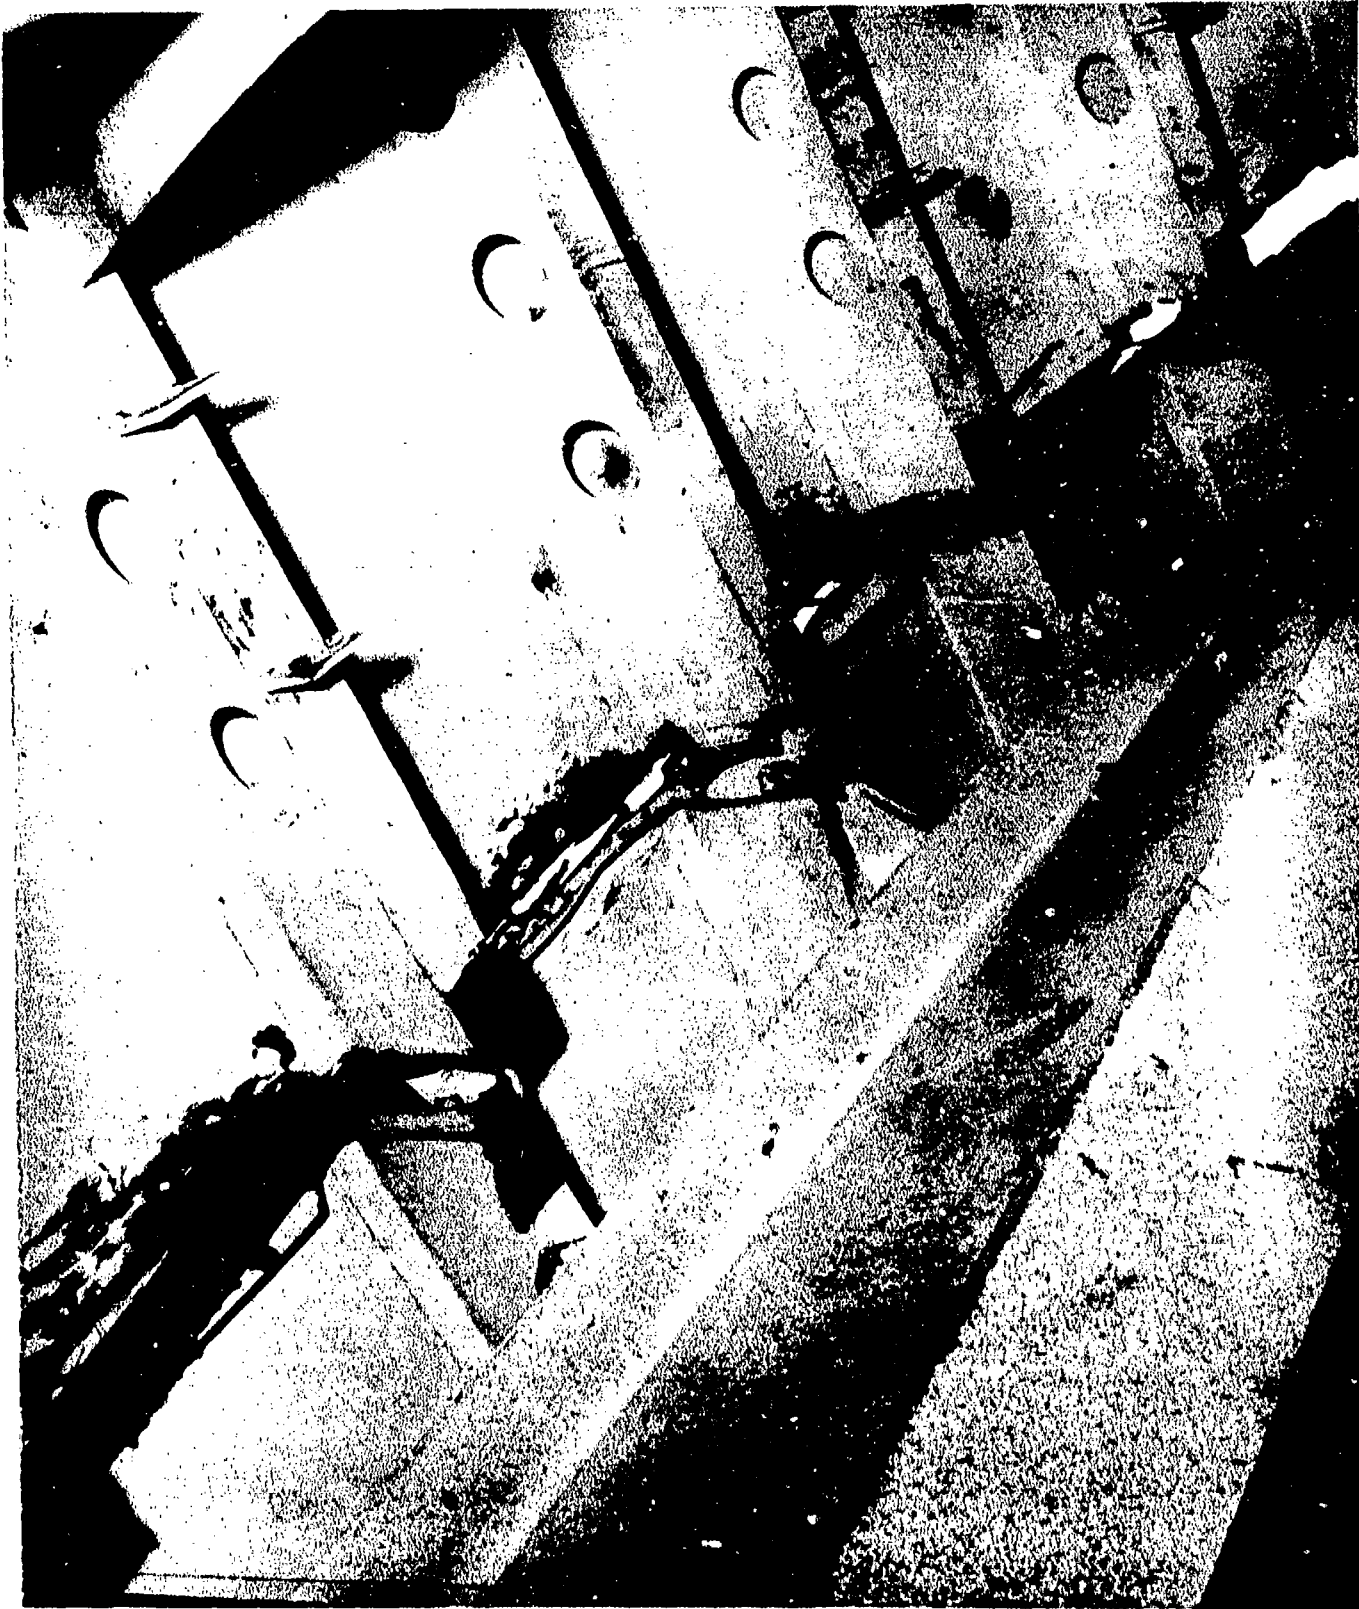
AA-CR-59-2225-2. Flight deck at Bent 95, looking to starboard, showing transverse tear in deck plating on port side of centerline.

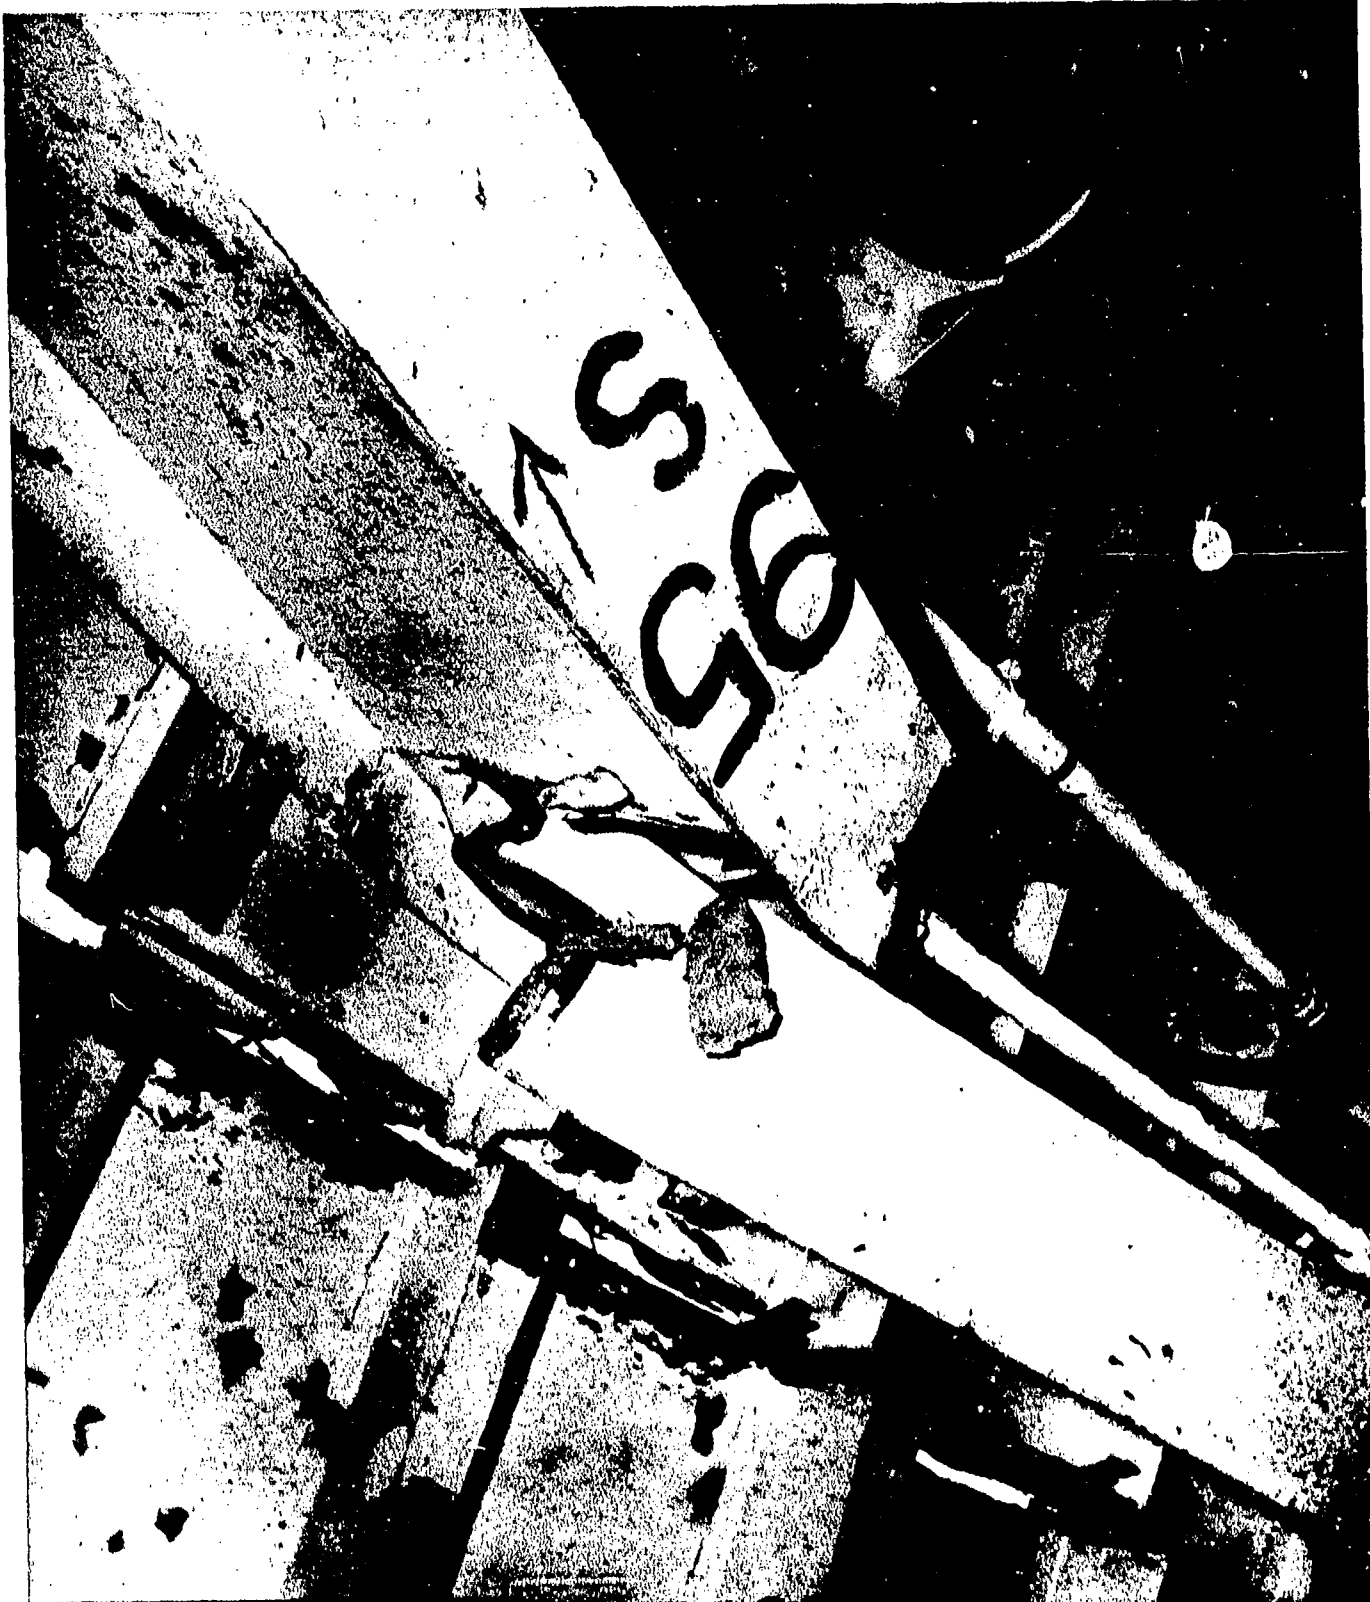
AA-CR-59-4151-3. Flight deck Bent 95, looking to port at centerline break. Note transverse tear in flight deck.

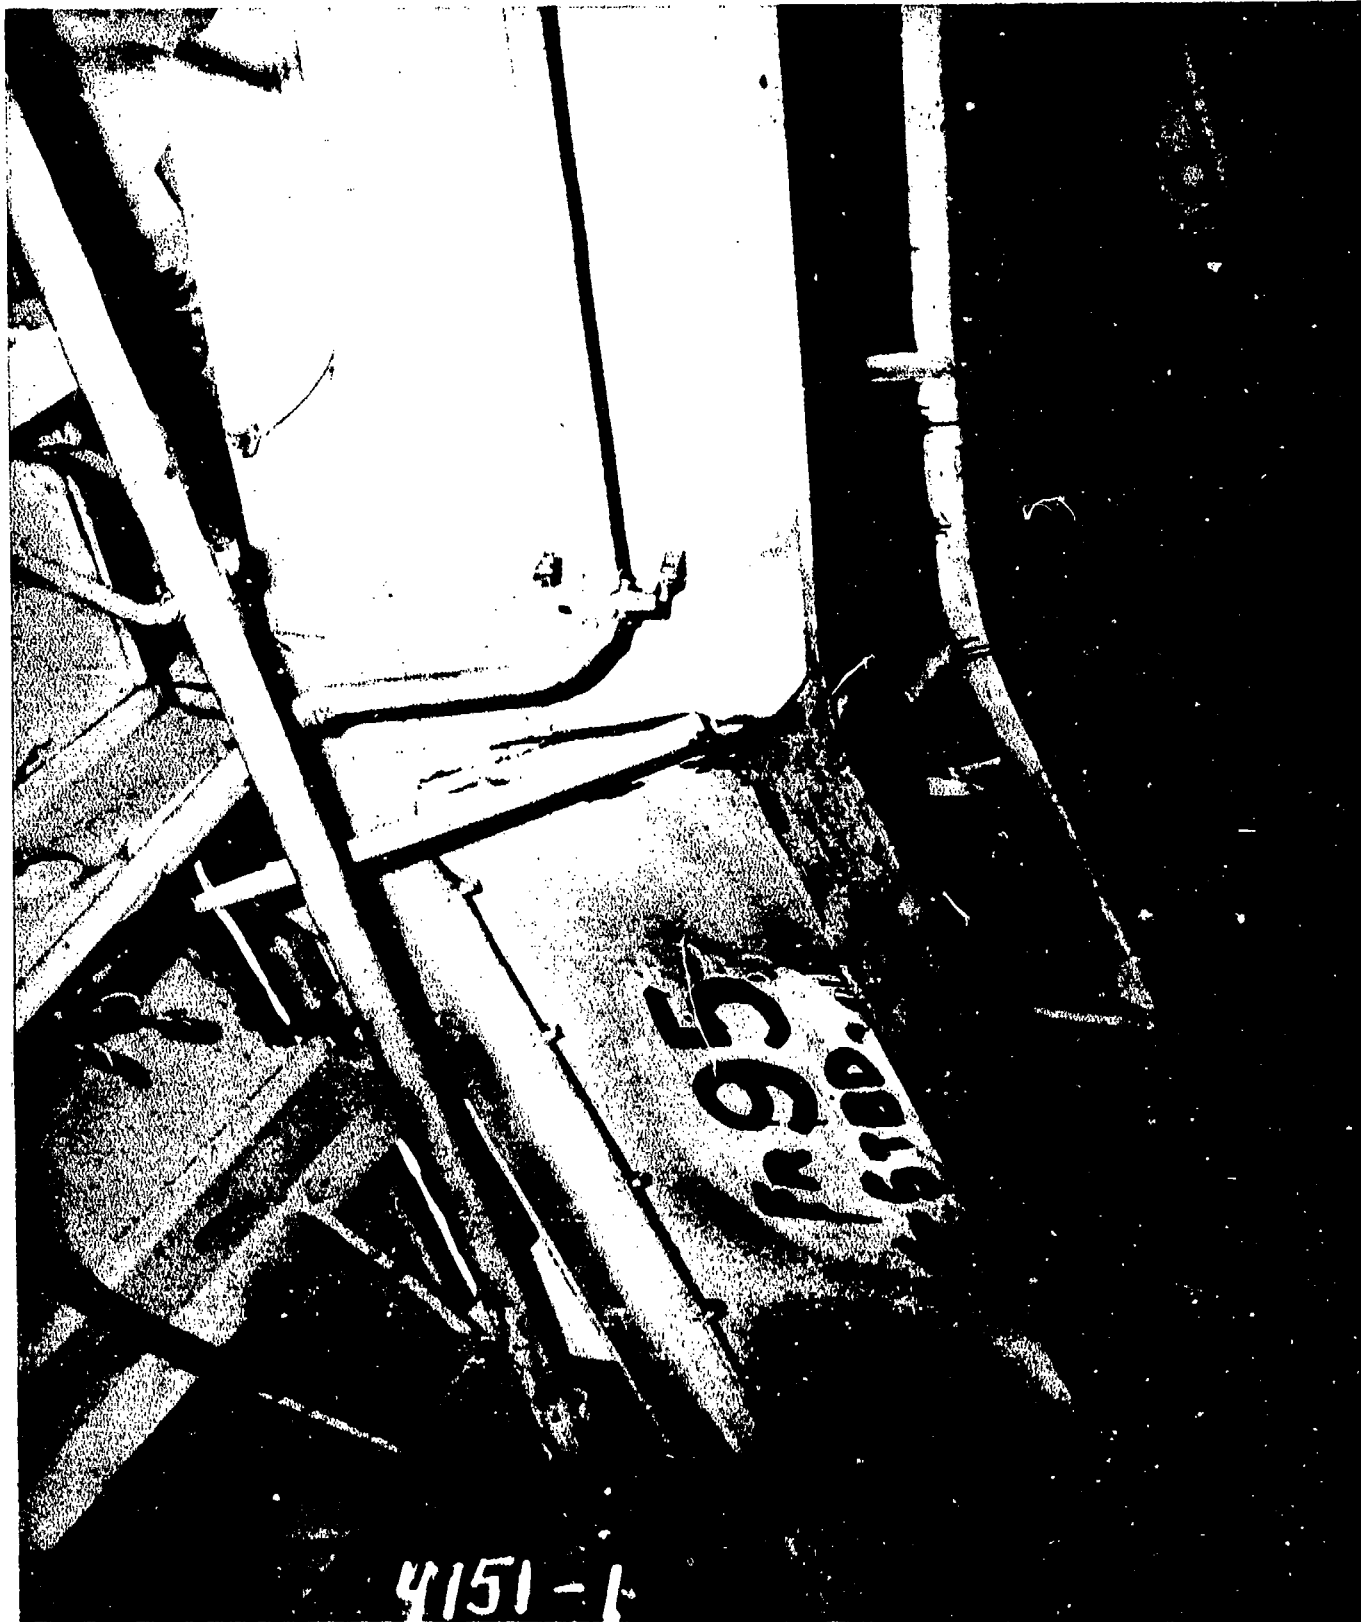
AA-CR-59-4151-1. Flight deck Bent 95, showing failure of transverse girder at welded centerline butt. Looking aft and to starboard.

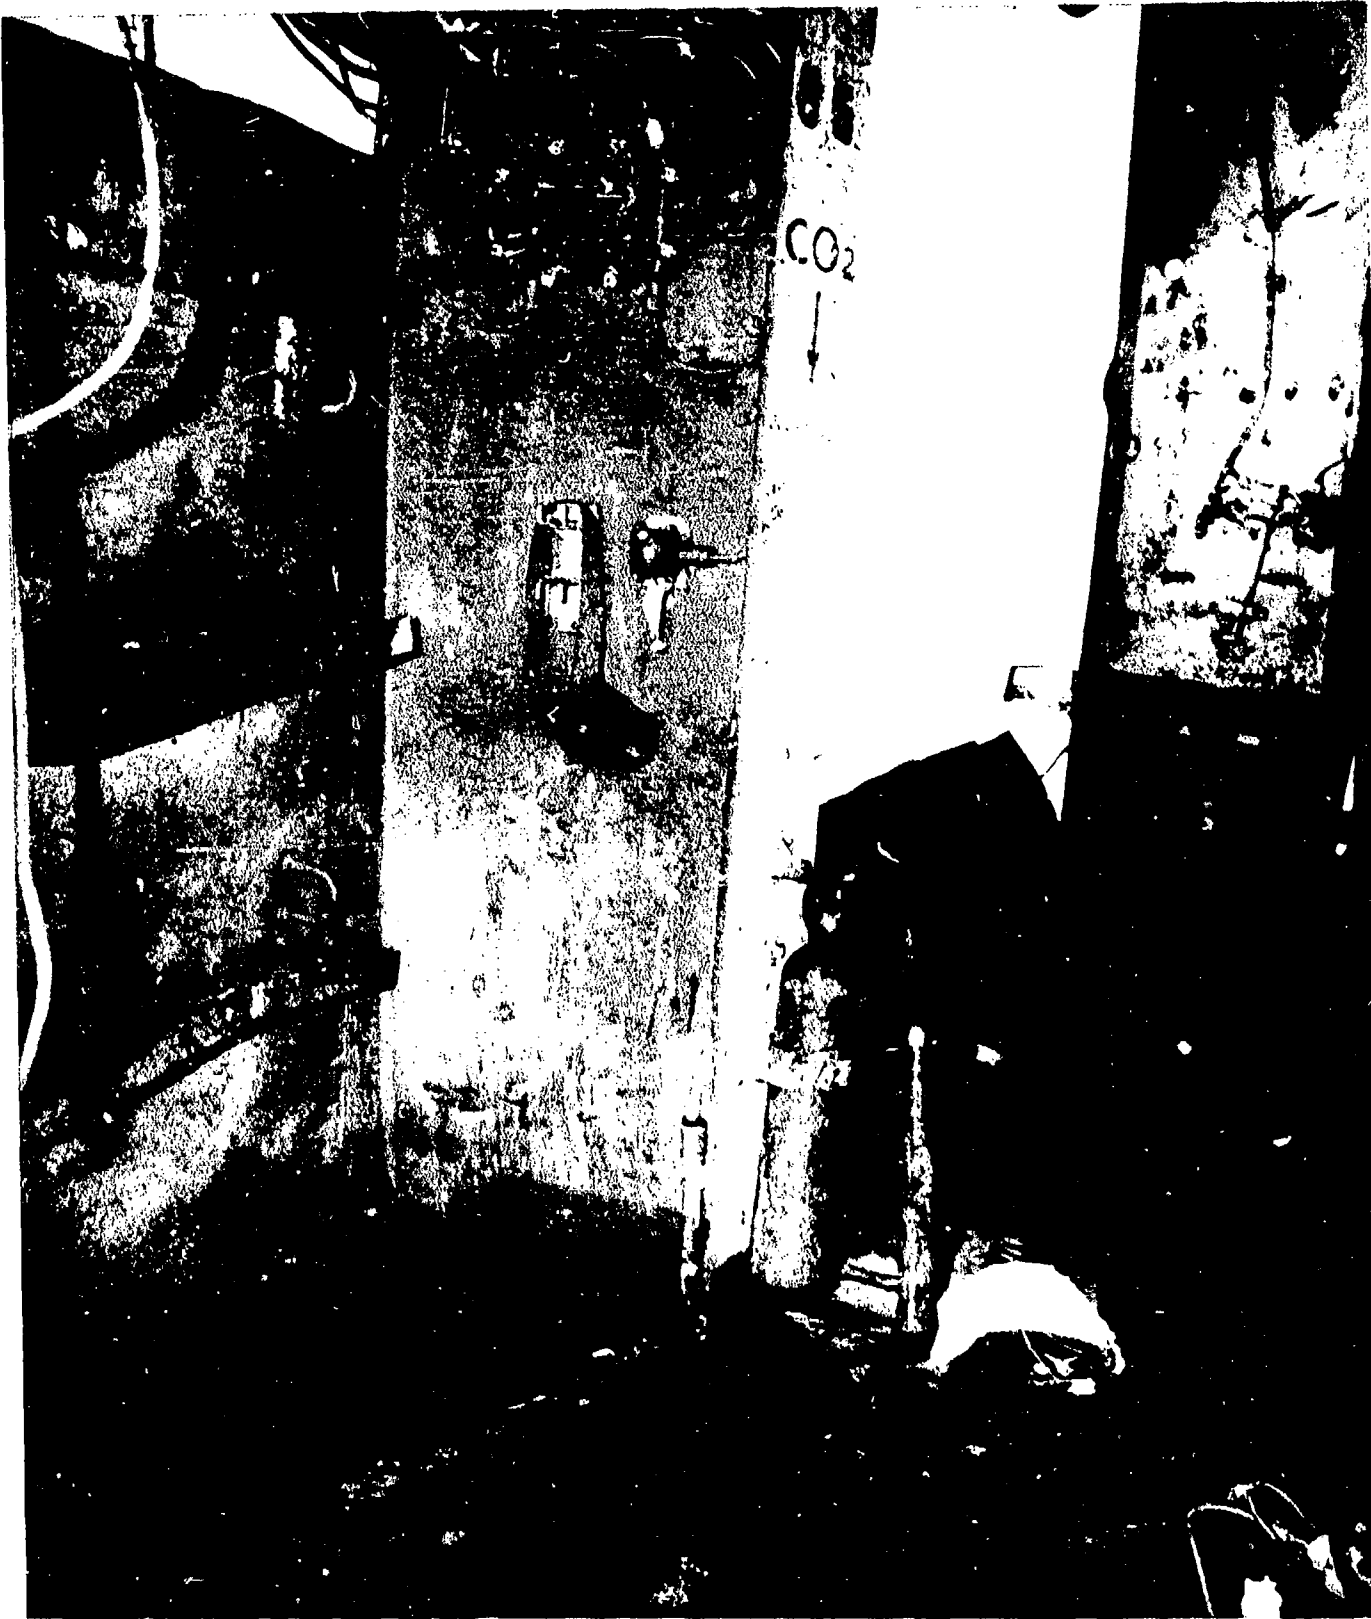
AB-CR-80-4187-11. After Baker - Flight deck Bent 95, port bottom, looking forward.
