U.S.S. INDEPENDENCE (CVL22)

TEST ABLE

OPERATION CROSSROADS

BUREAU OF SHIPS GROUP
TECHNICAL INSPECTION REPORT

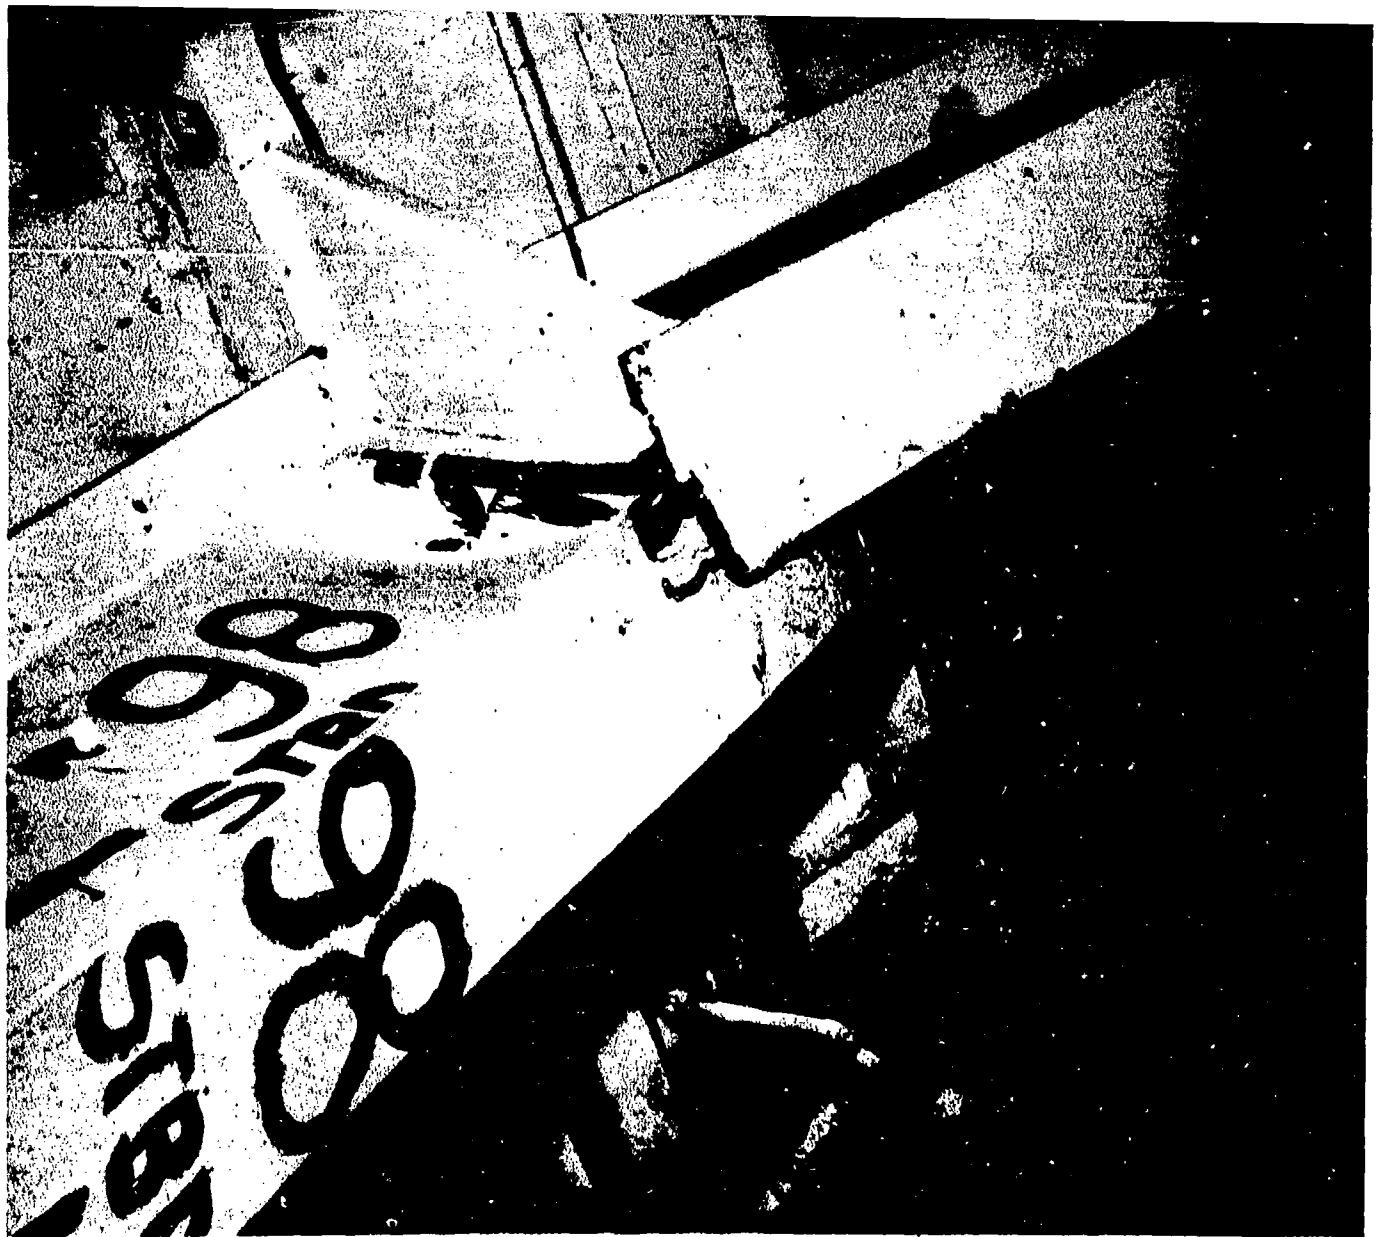
AA-CR-100-4151-4. Flight deck Bent 98, showing failure of centerline butt at weld. Looking aft and to port.

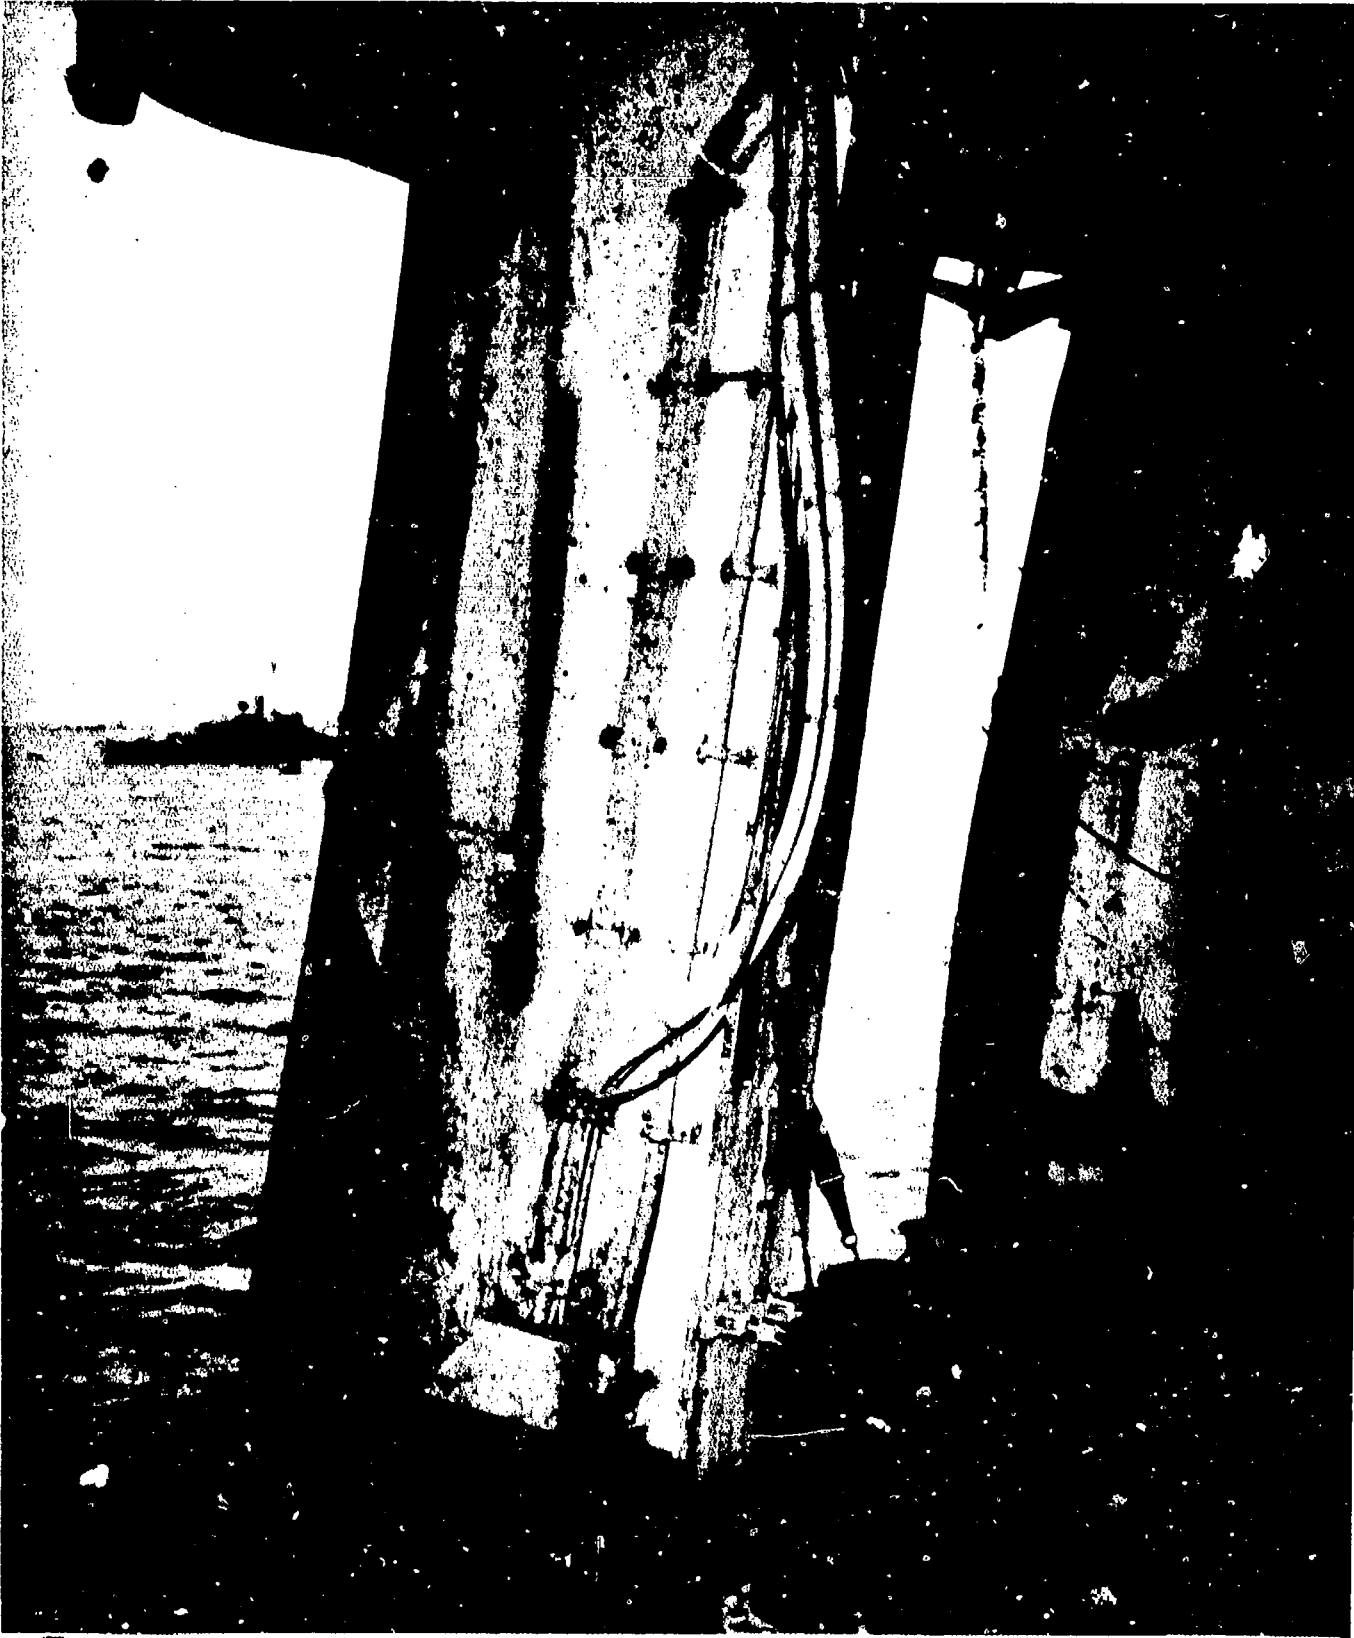
AB-CR-80-170-4. After Baker. Flight deck Bent 101, port bottom, looking forward.

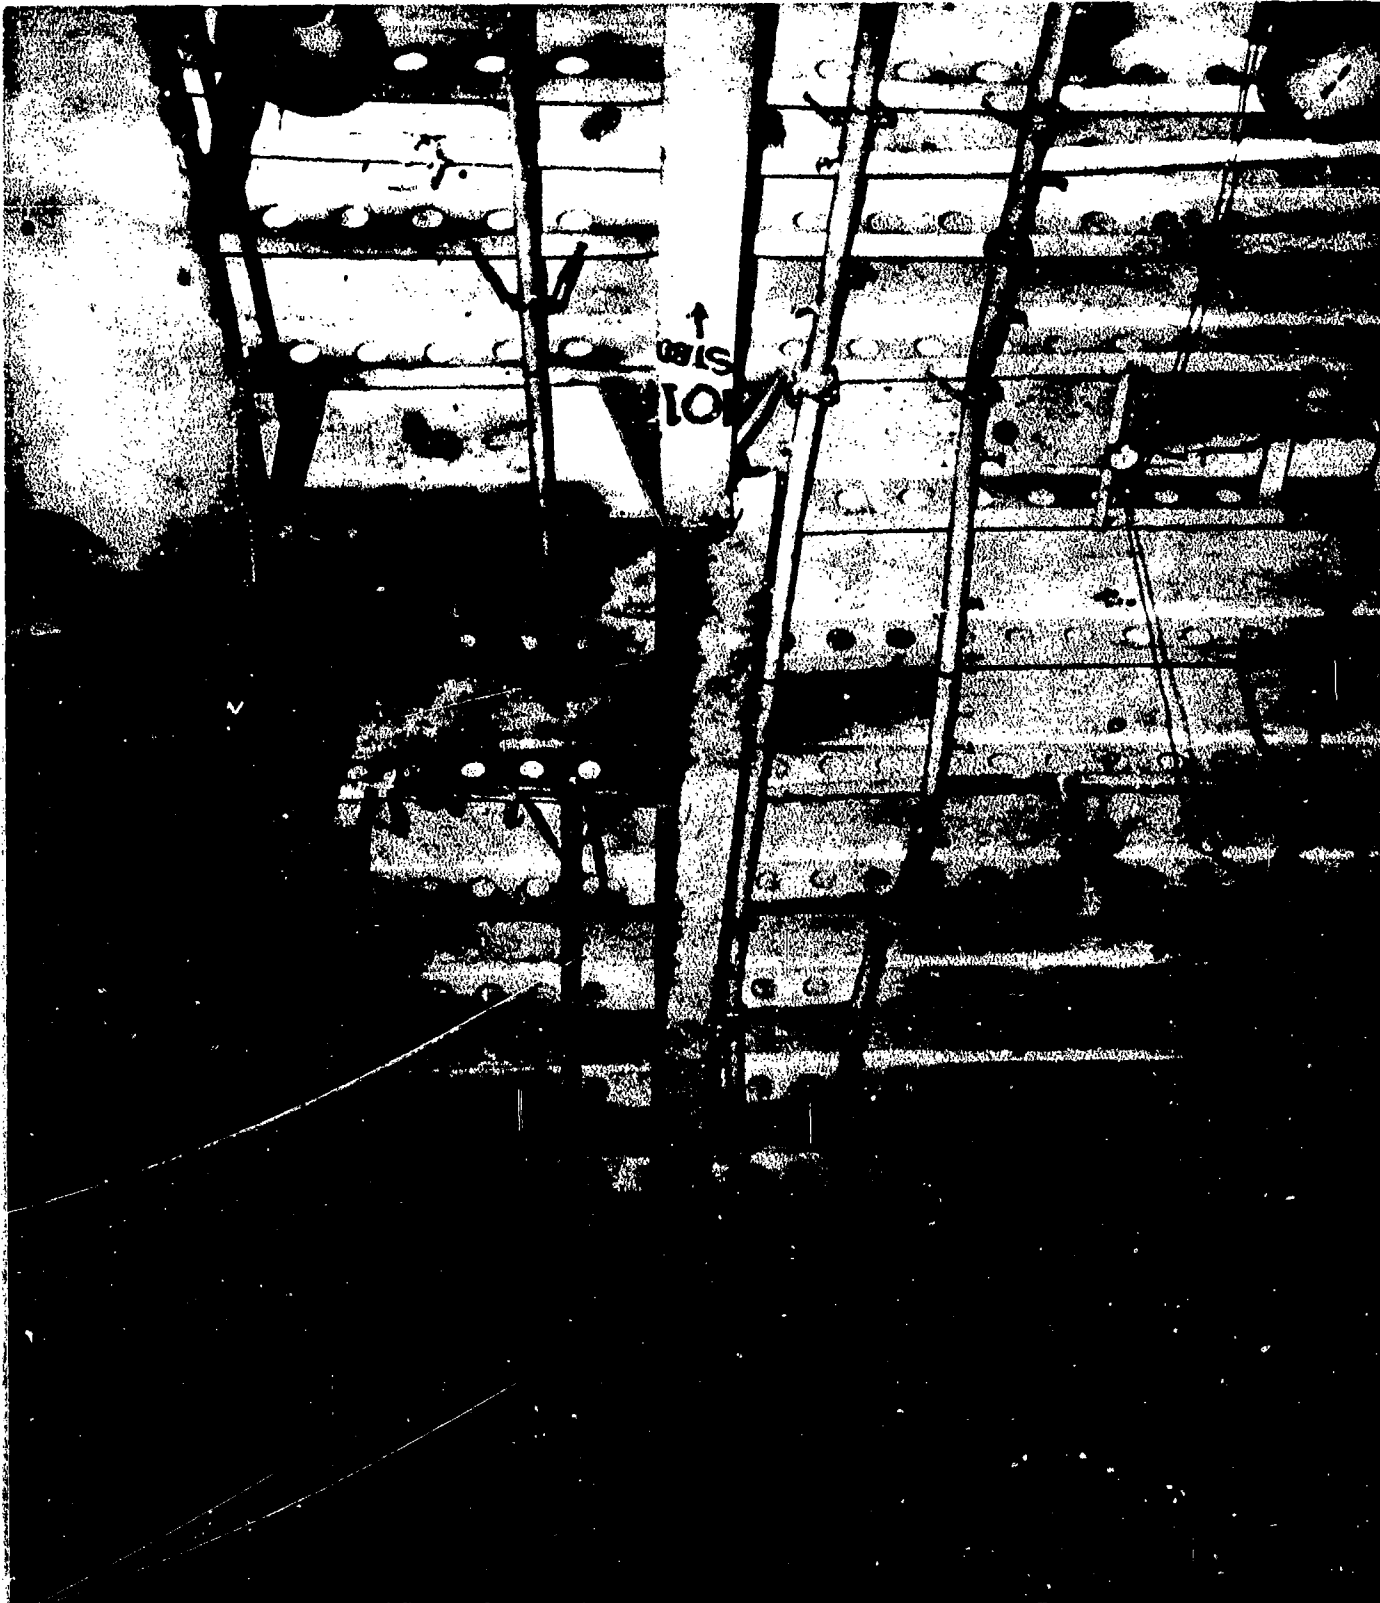
AA-CR-100-4161-9. Flight deck Bent 101, showing failure at centerline butt weld. Looking to port.
