# BUREAU OF SHIPS GROUP TECHNICAL INSPECTION REPORT

## U.S.S. INDEPENDENCE (CVL22)

### TEST ABLE

### OPERATION CROSSROADS

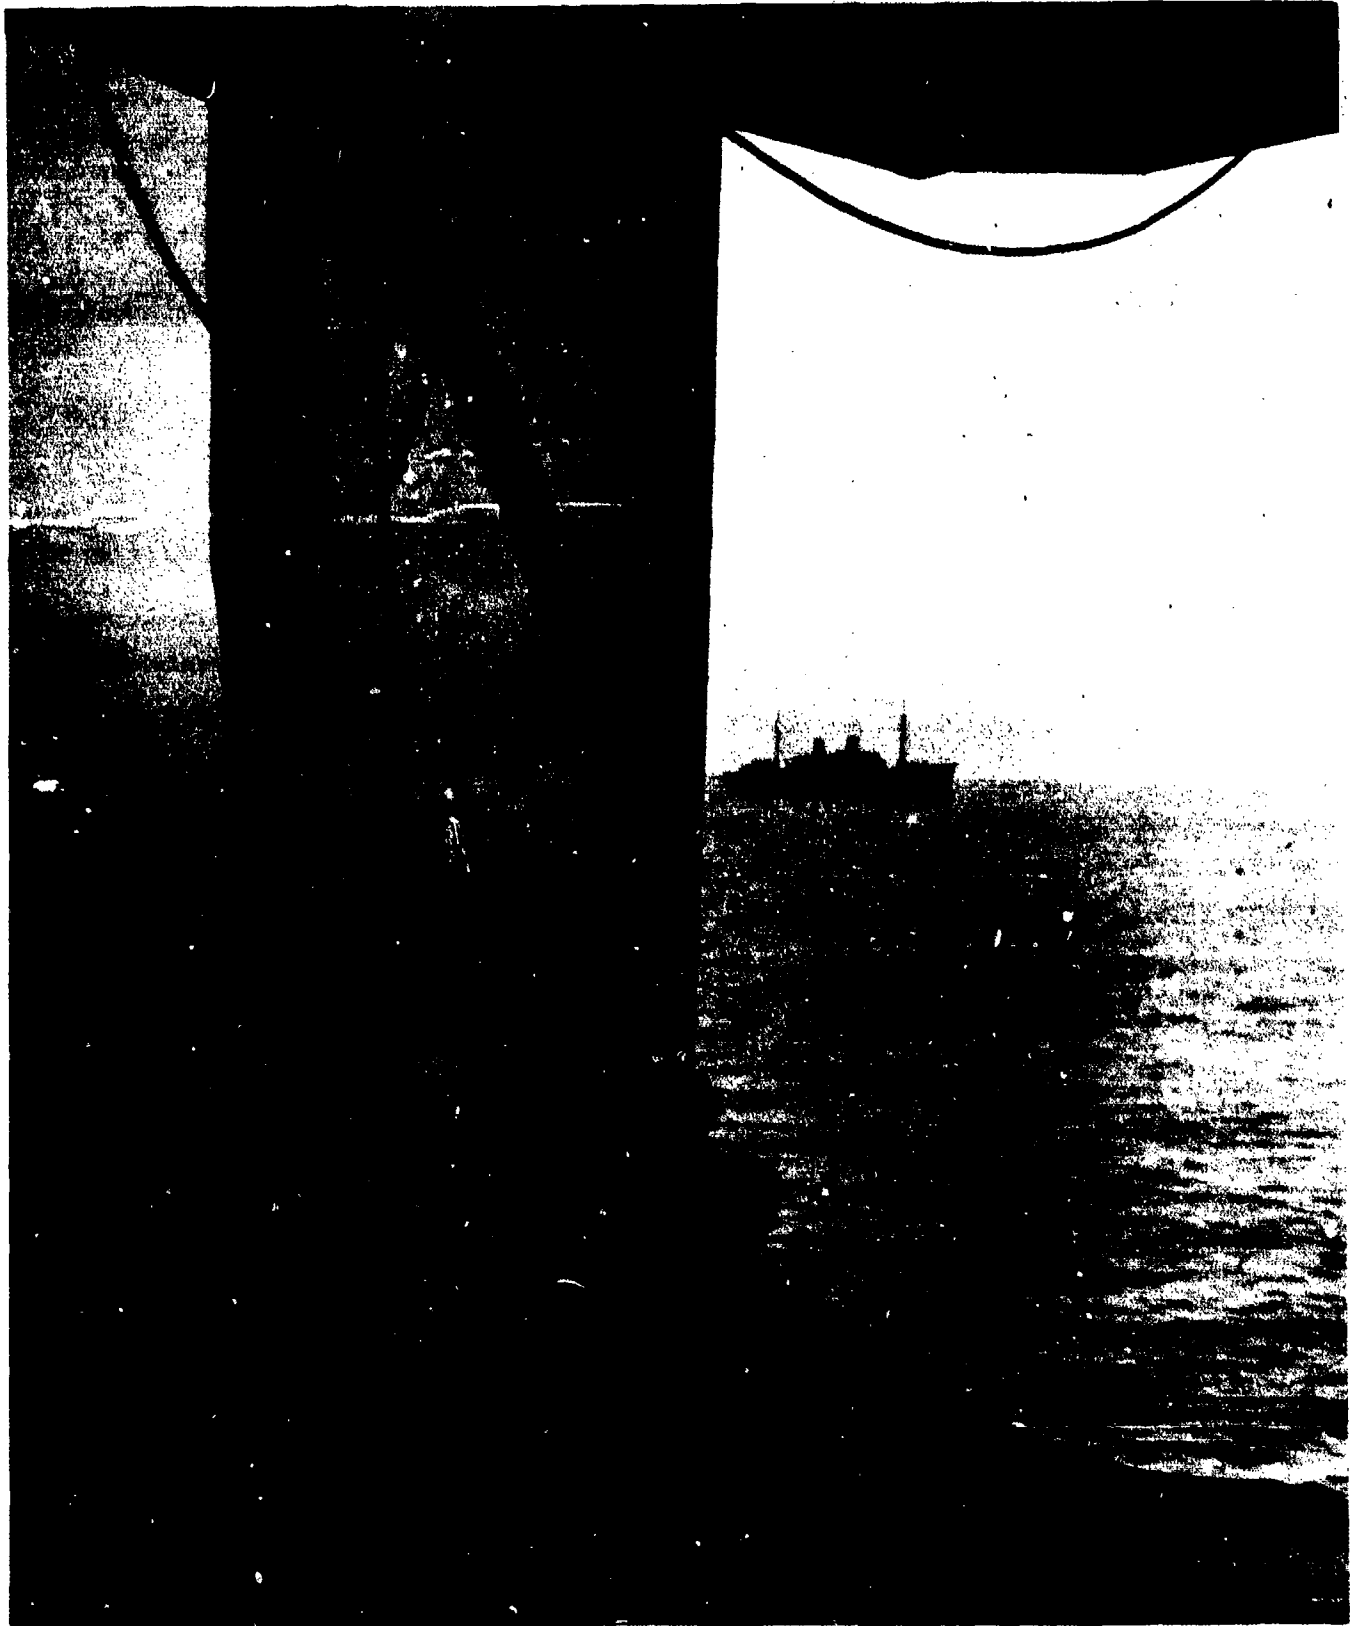
AA-CR-80-170-7. After Baker. Flight deck Bent 104, port bottom, looking aft.

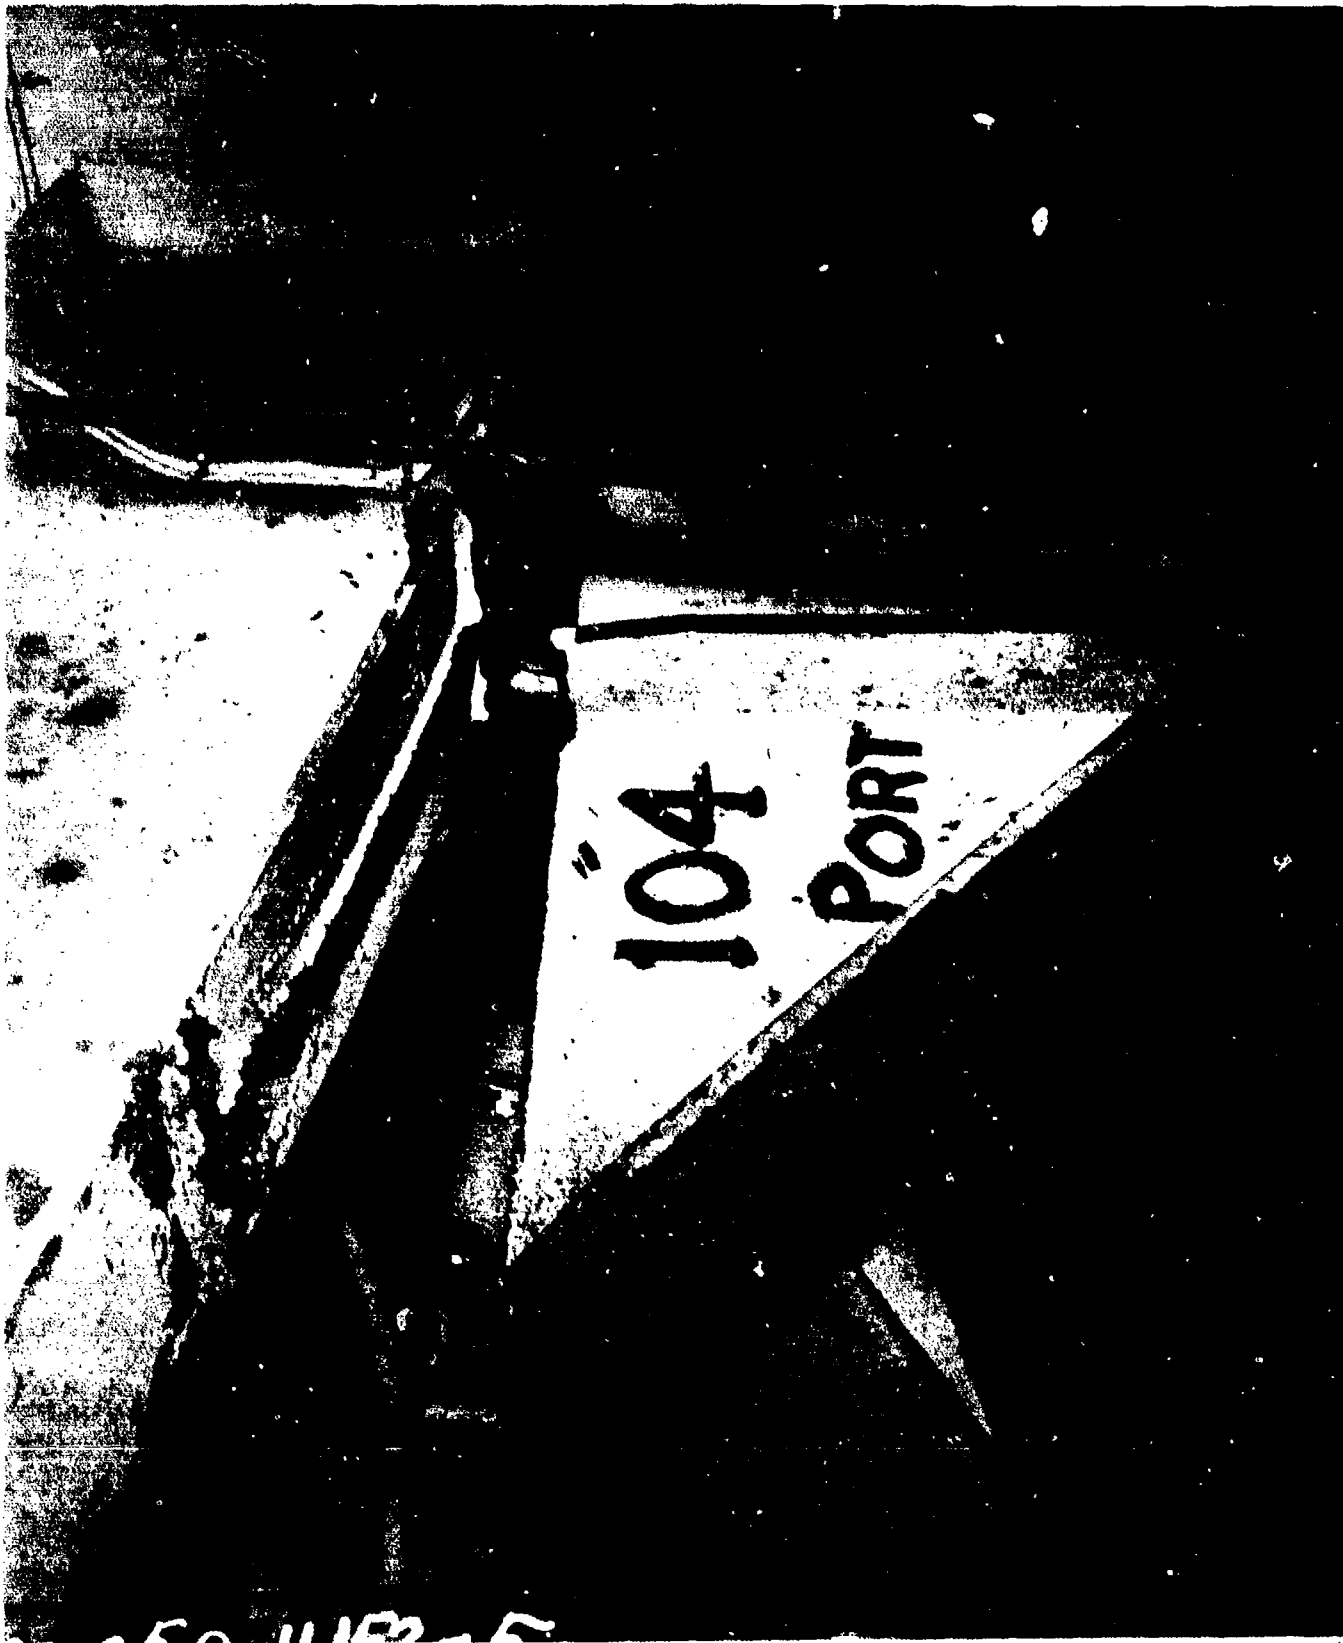
AA-CR-59-4152-5. Flight deck Bent 104, port side overhead connection, showing failure of weld along upper edge of bracket and column. Looking aft.

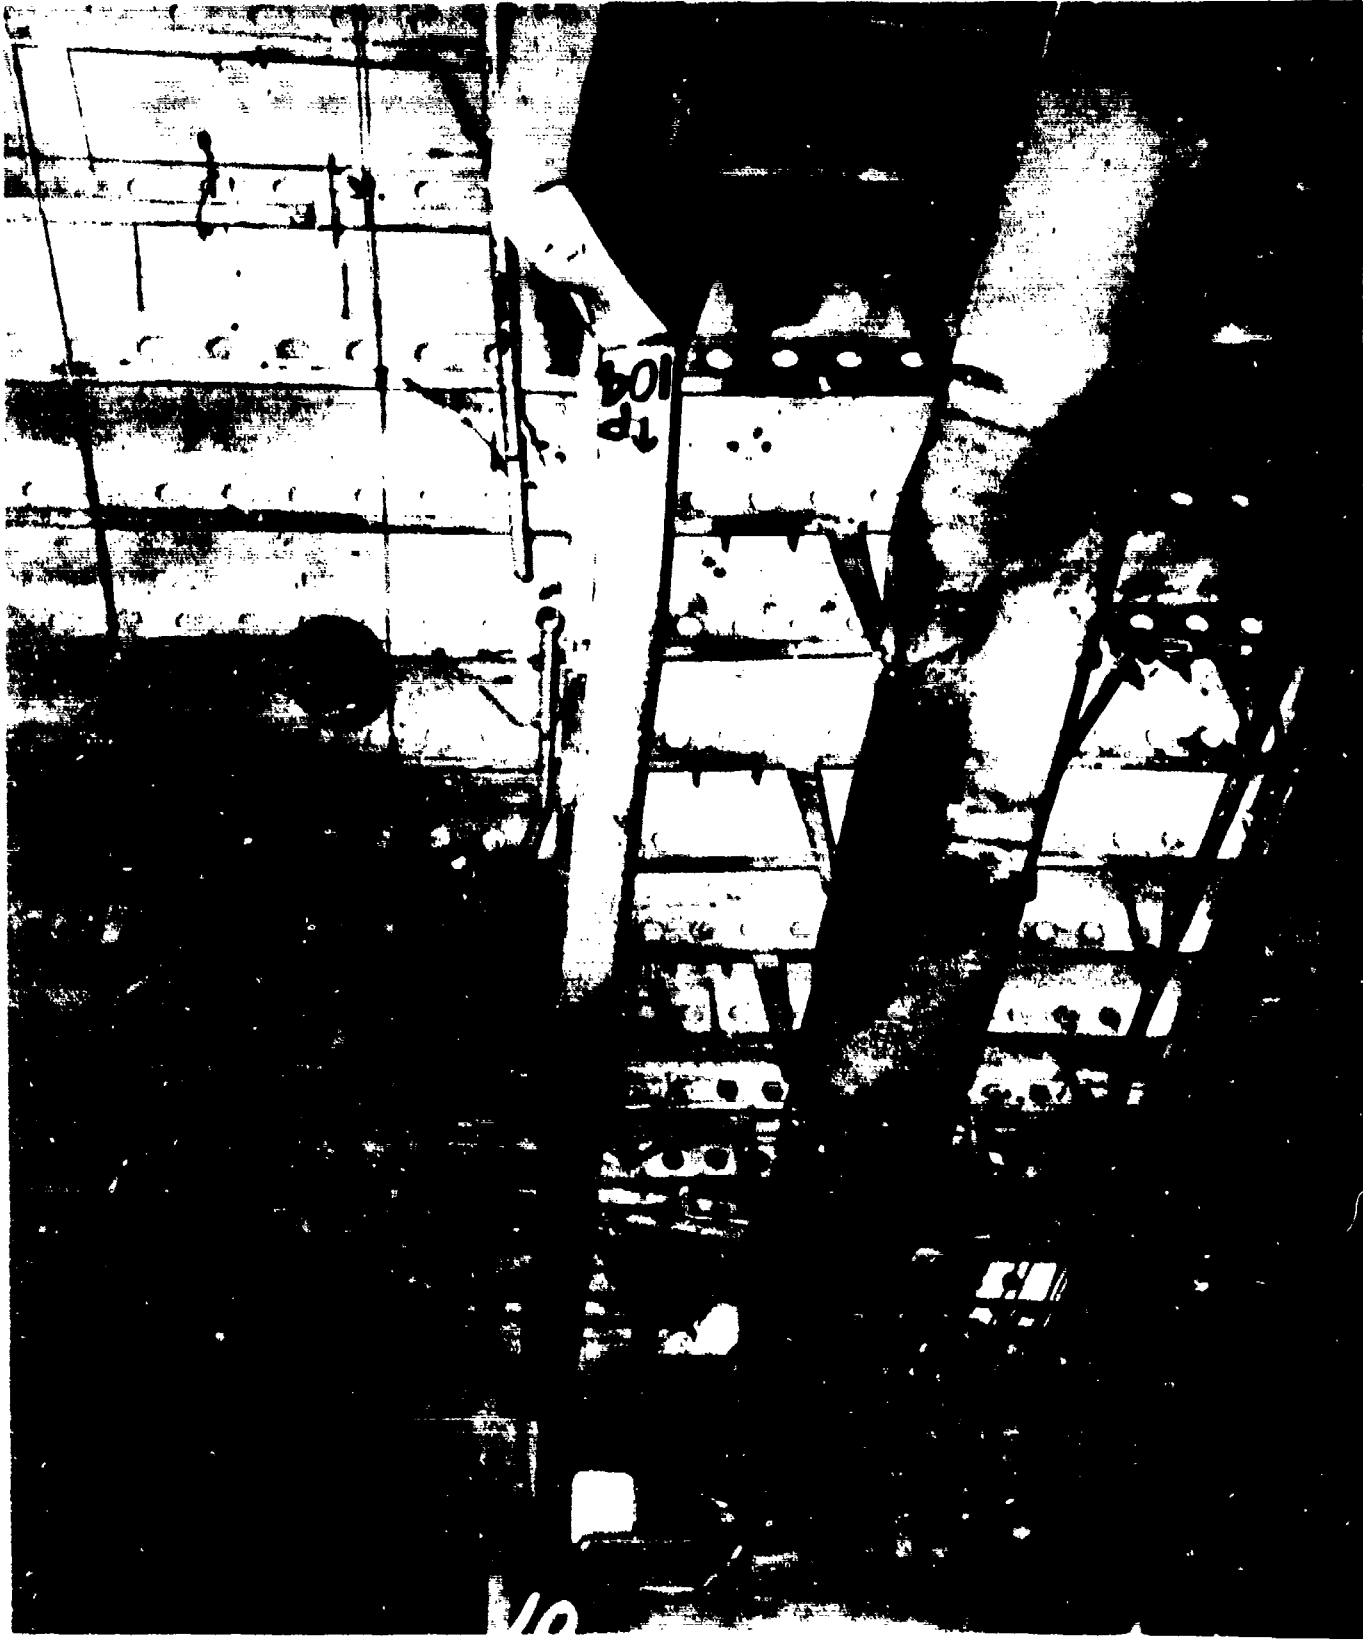
AA-CR-100-4161-10. Underside of flight deck, looking to port, showing deformation of bent girders 104 at centerline.

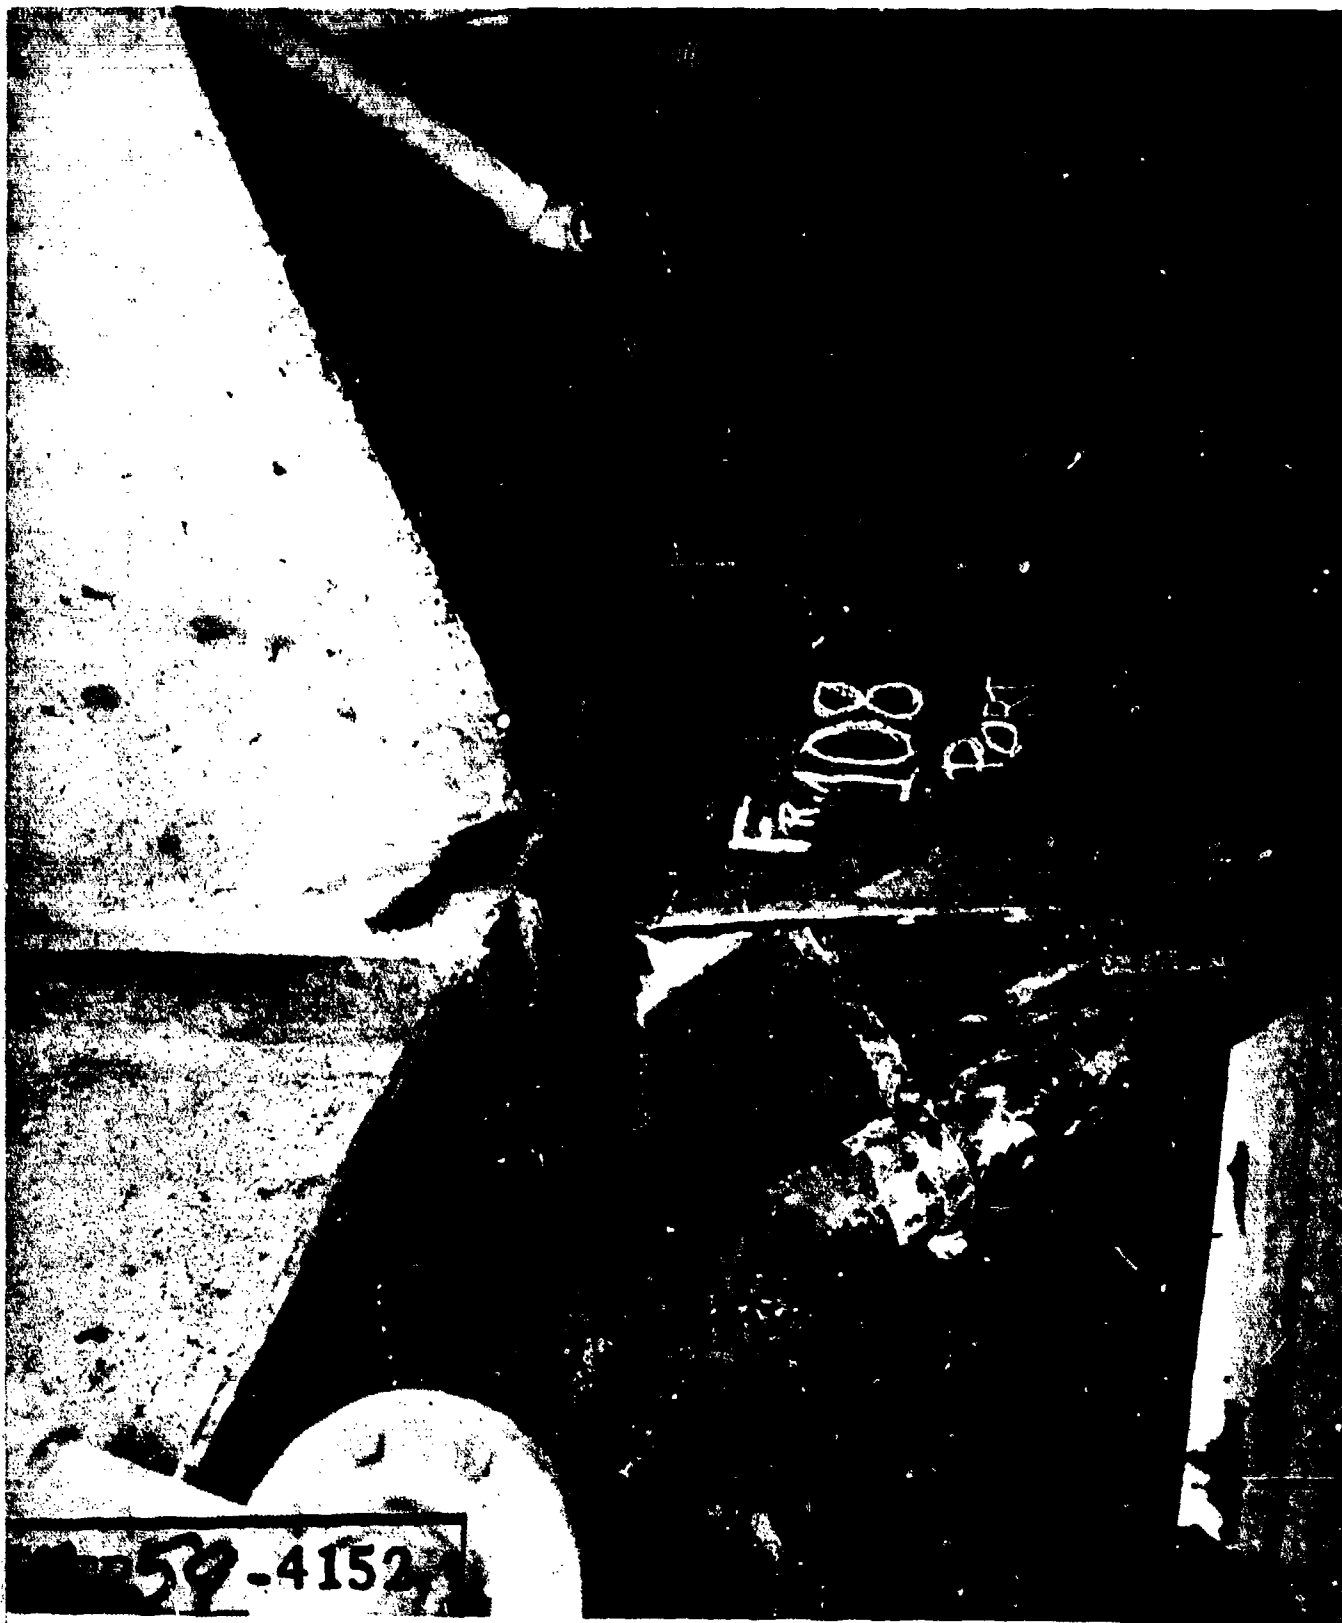
AA-CR-59-4152-3. Flight deck bent 107 (not 108). Upper port corner, looking aft.

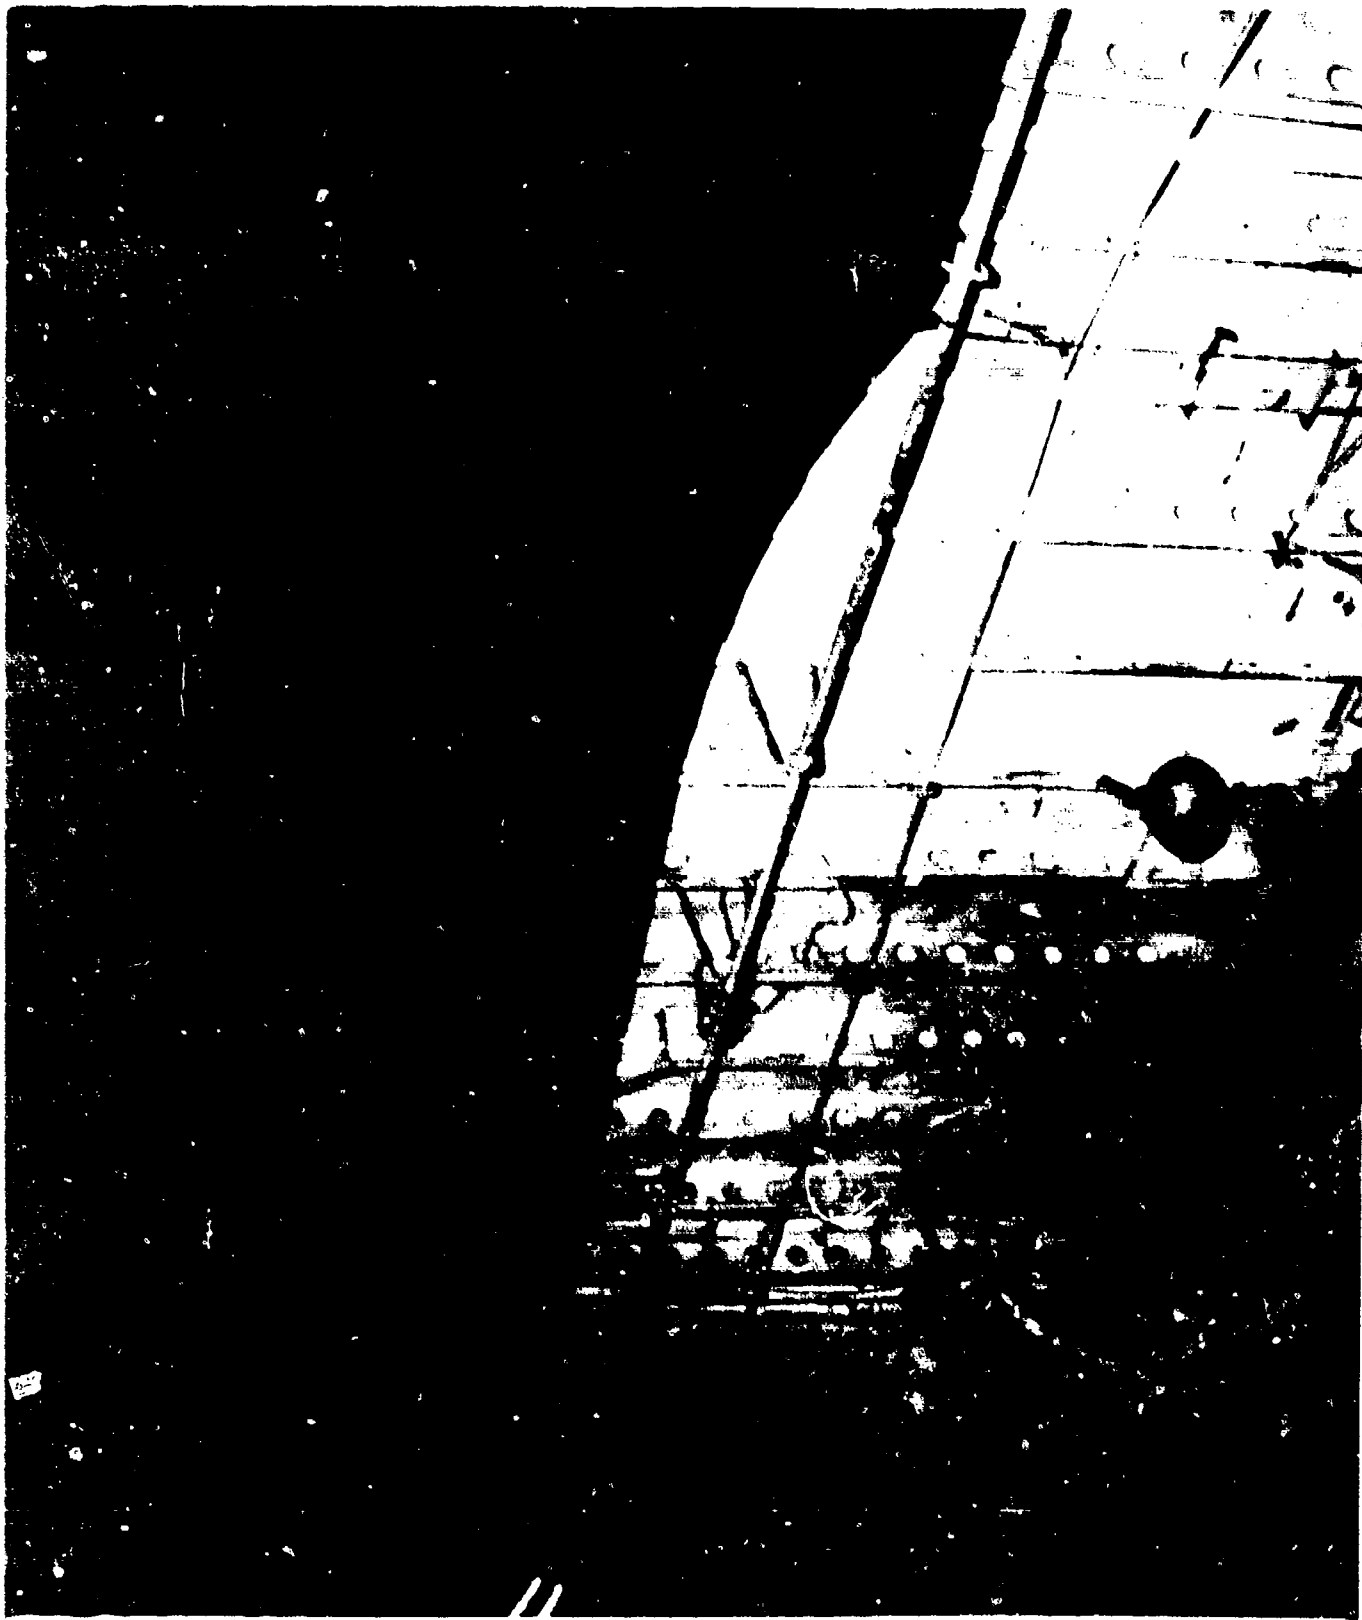
AA-CR-100-4161-11. Flight deck Bent 107, showing distortion near centerline. Looking to port.

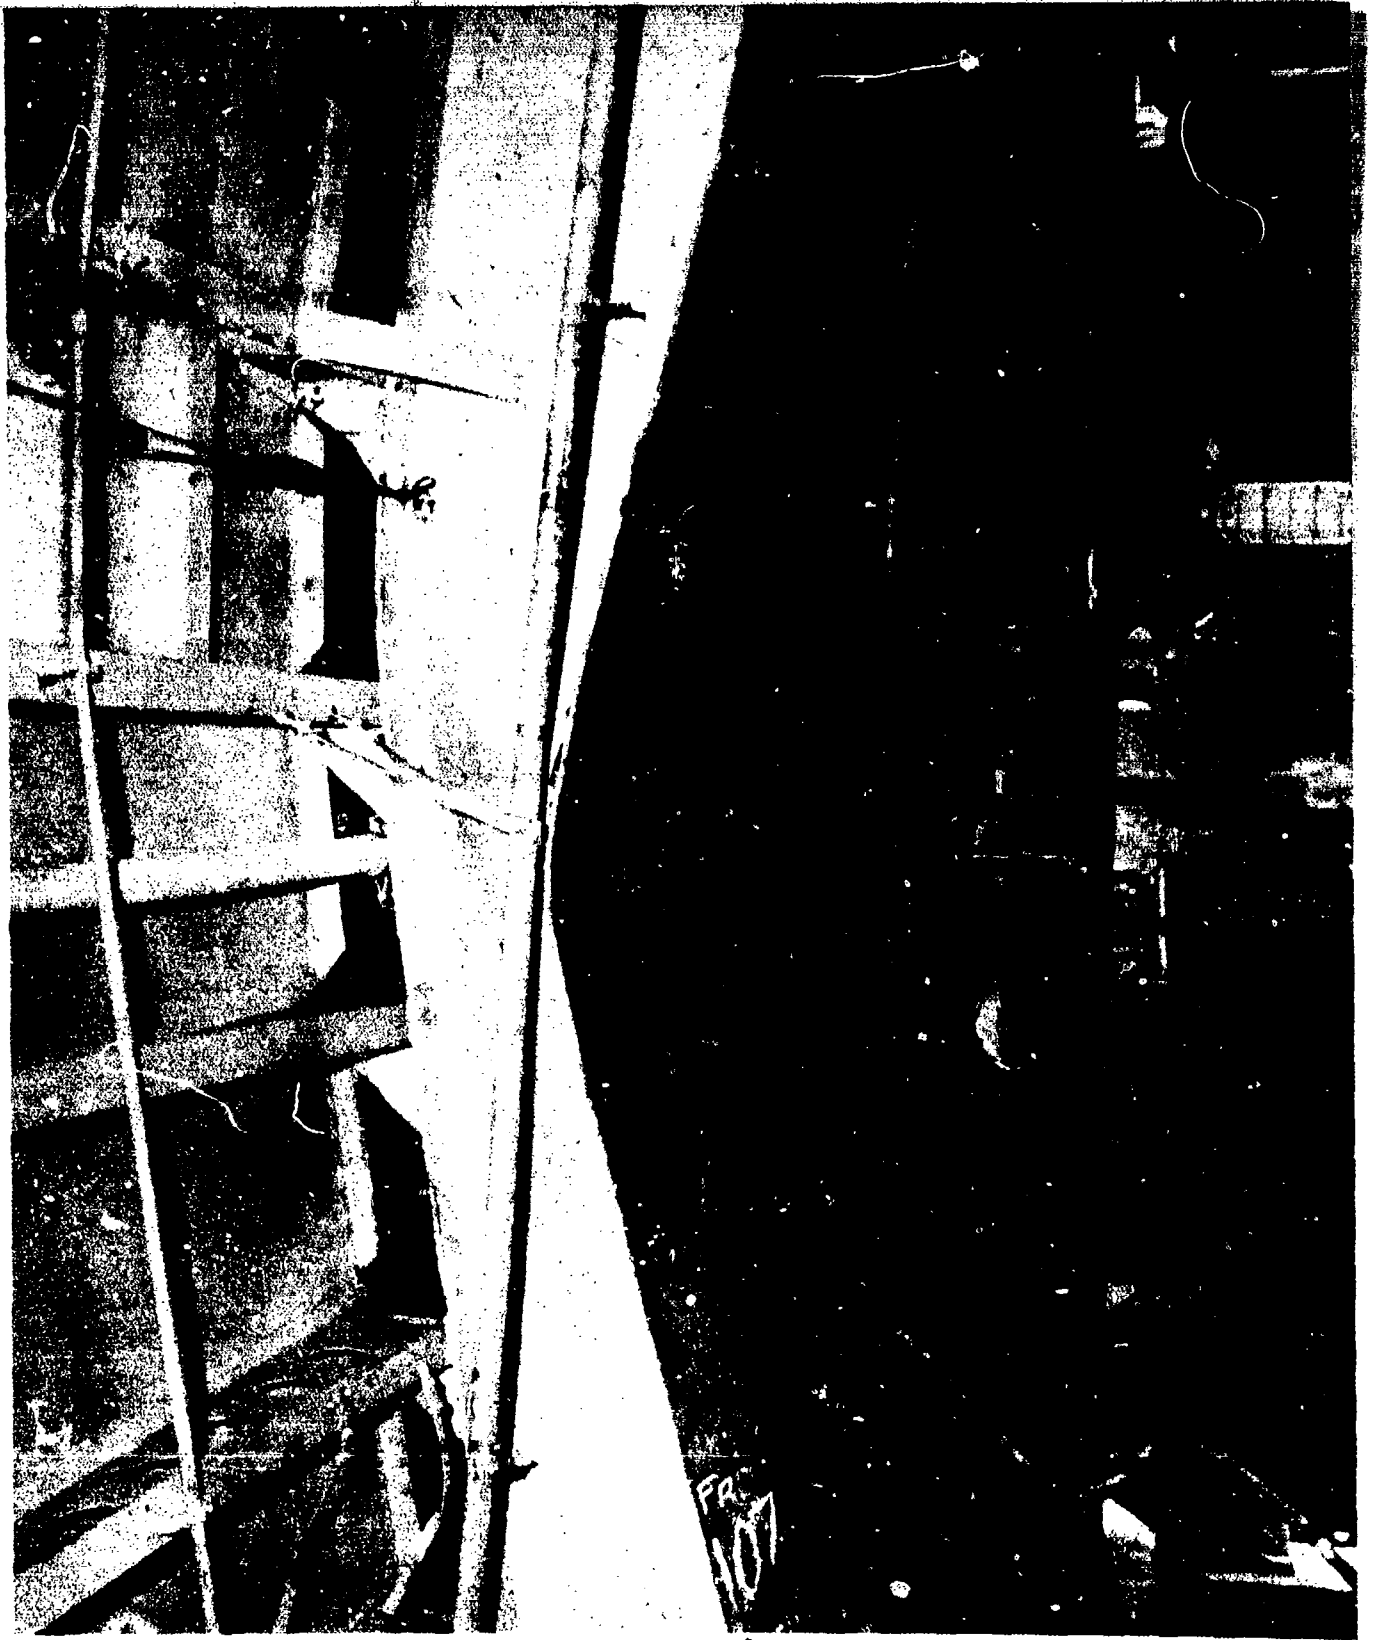
AA-CR-59-4152-2. Flight deck bent girder 107, looking aft, showing buckle to starboard of centerline.

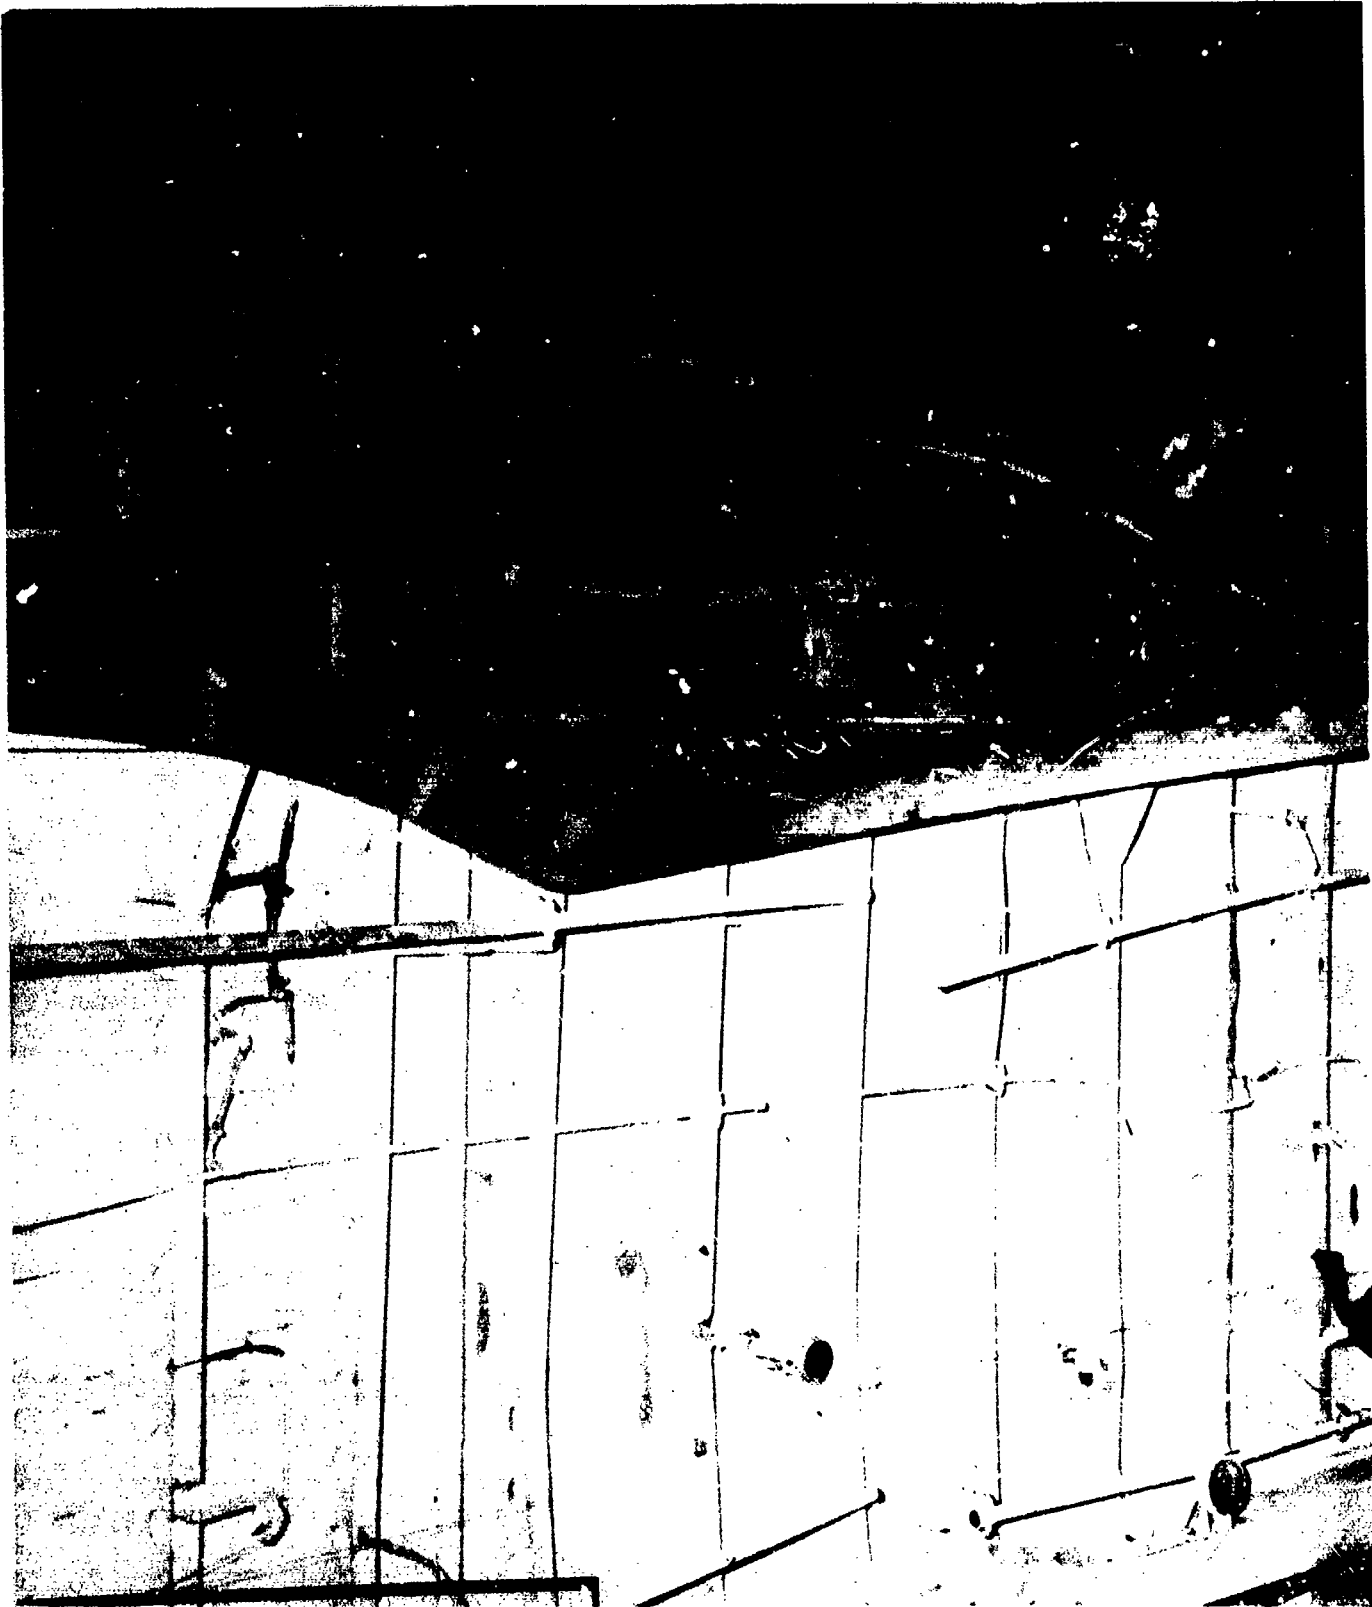
AA-CR-59-4151-7. Flight deck bent girder 107, looking up and to starboard.

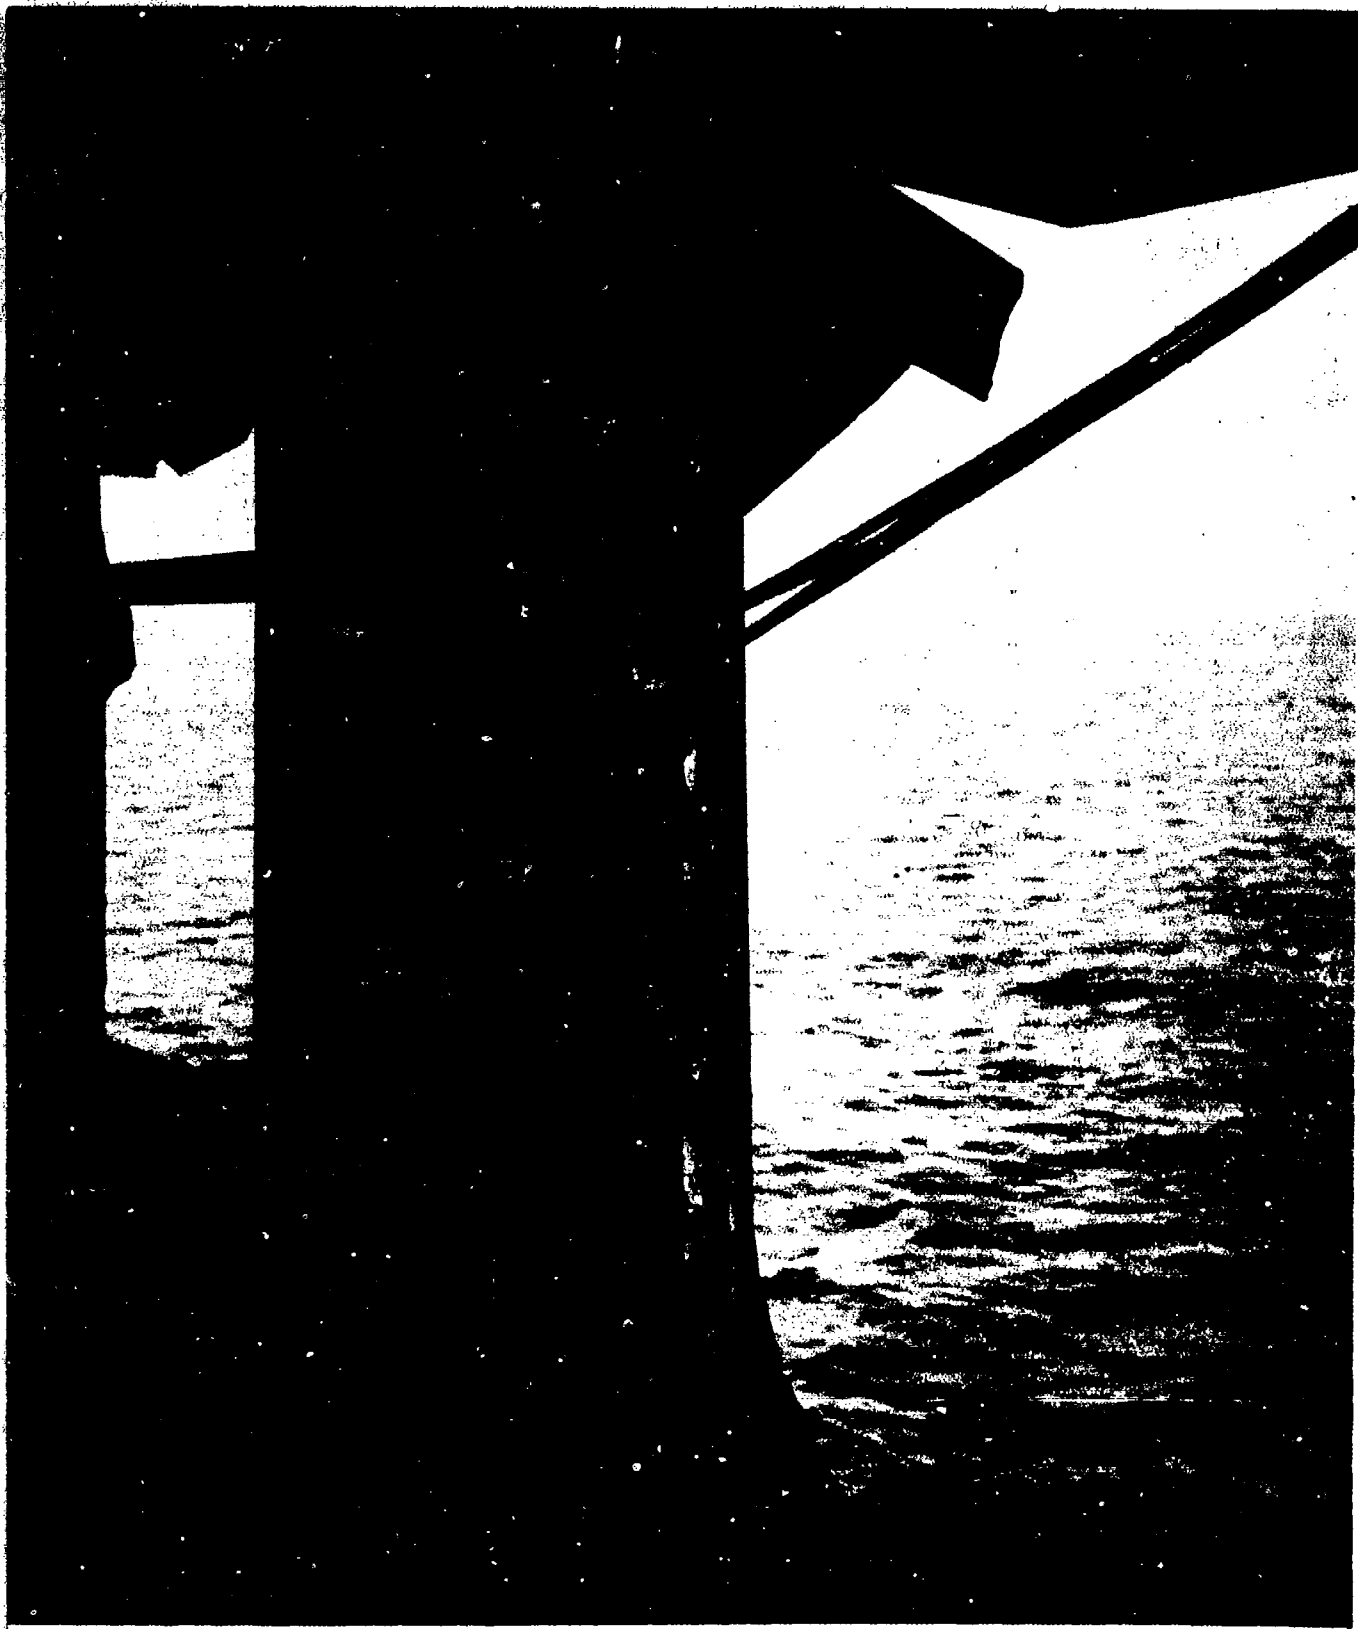
AA-CR-80-170-10. After Baker. Flight deck Bent 107, starboard bottom, looking forward.

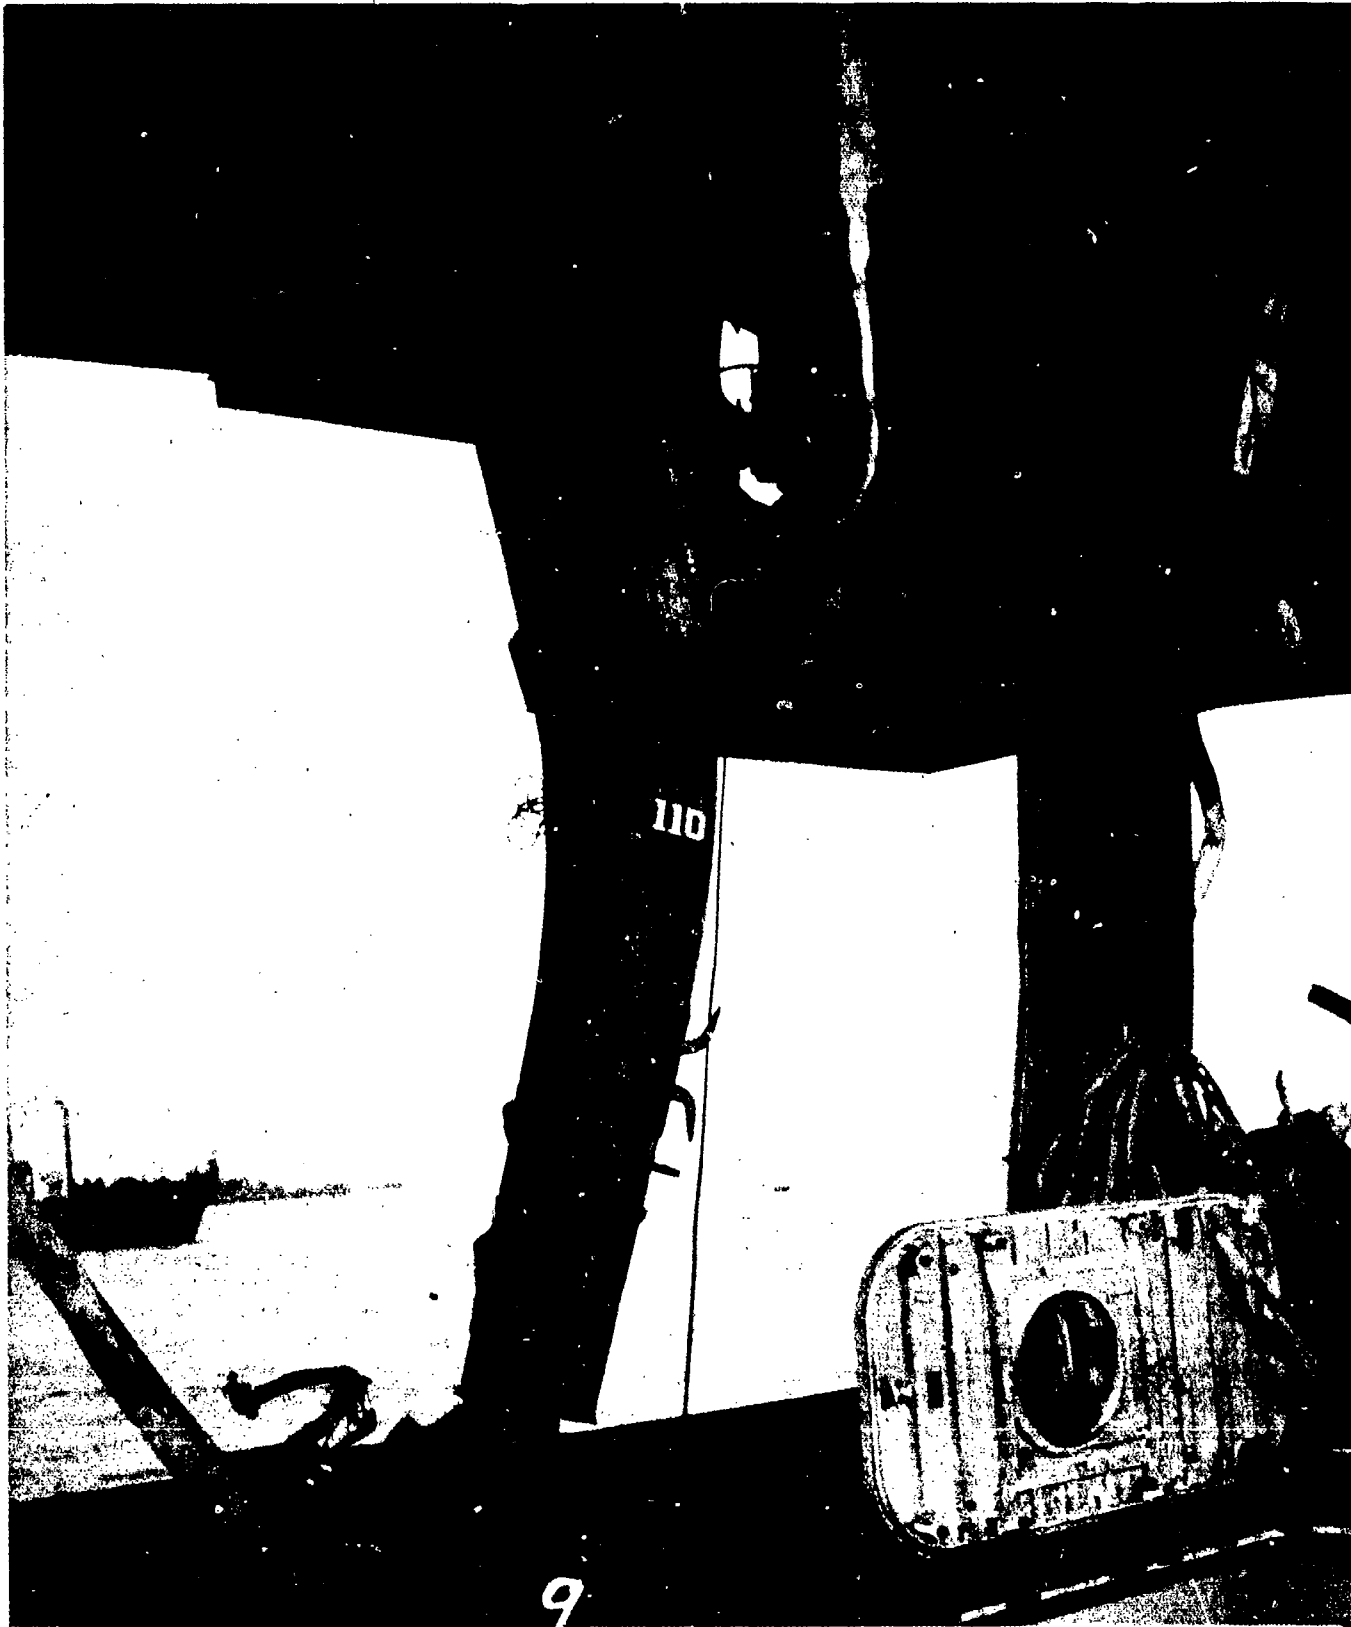
AA-CR-175-2131-9. Bent 110, port side, looking outboard from center-line.

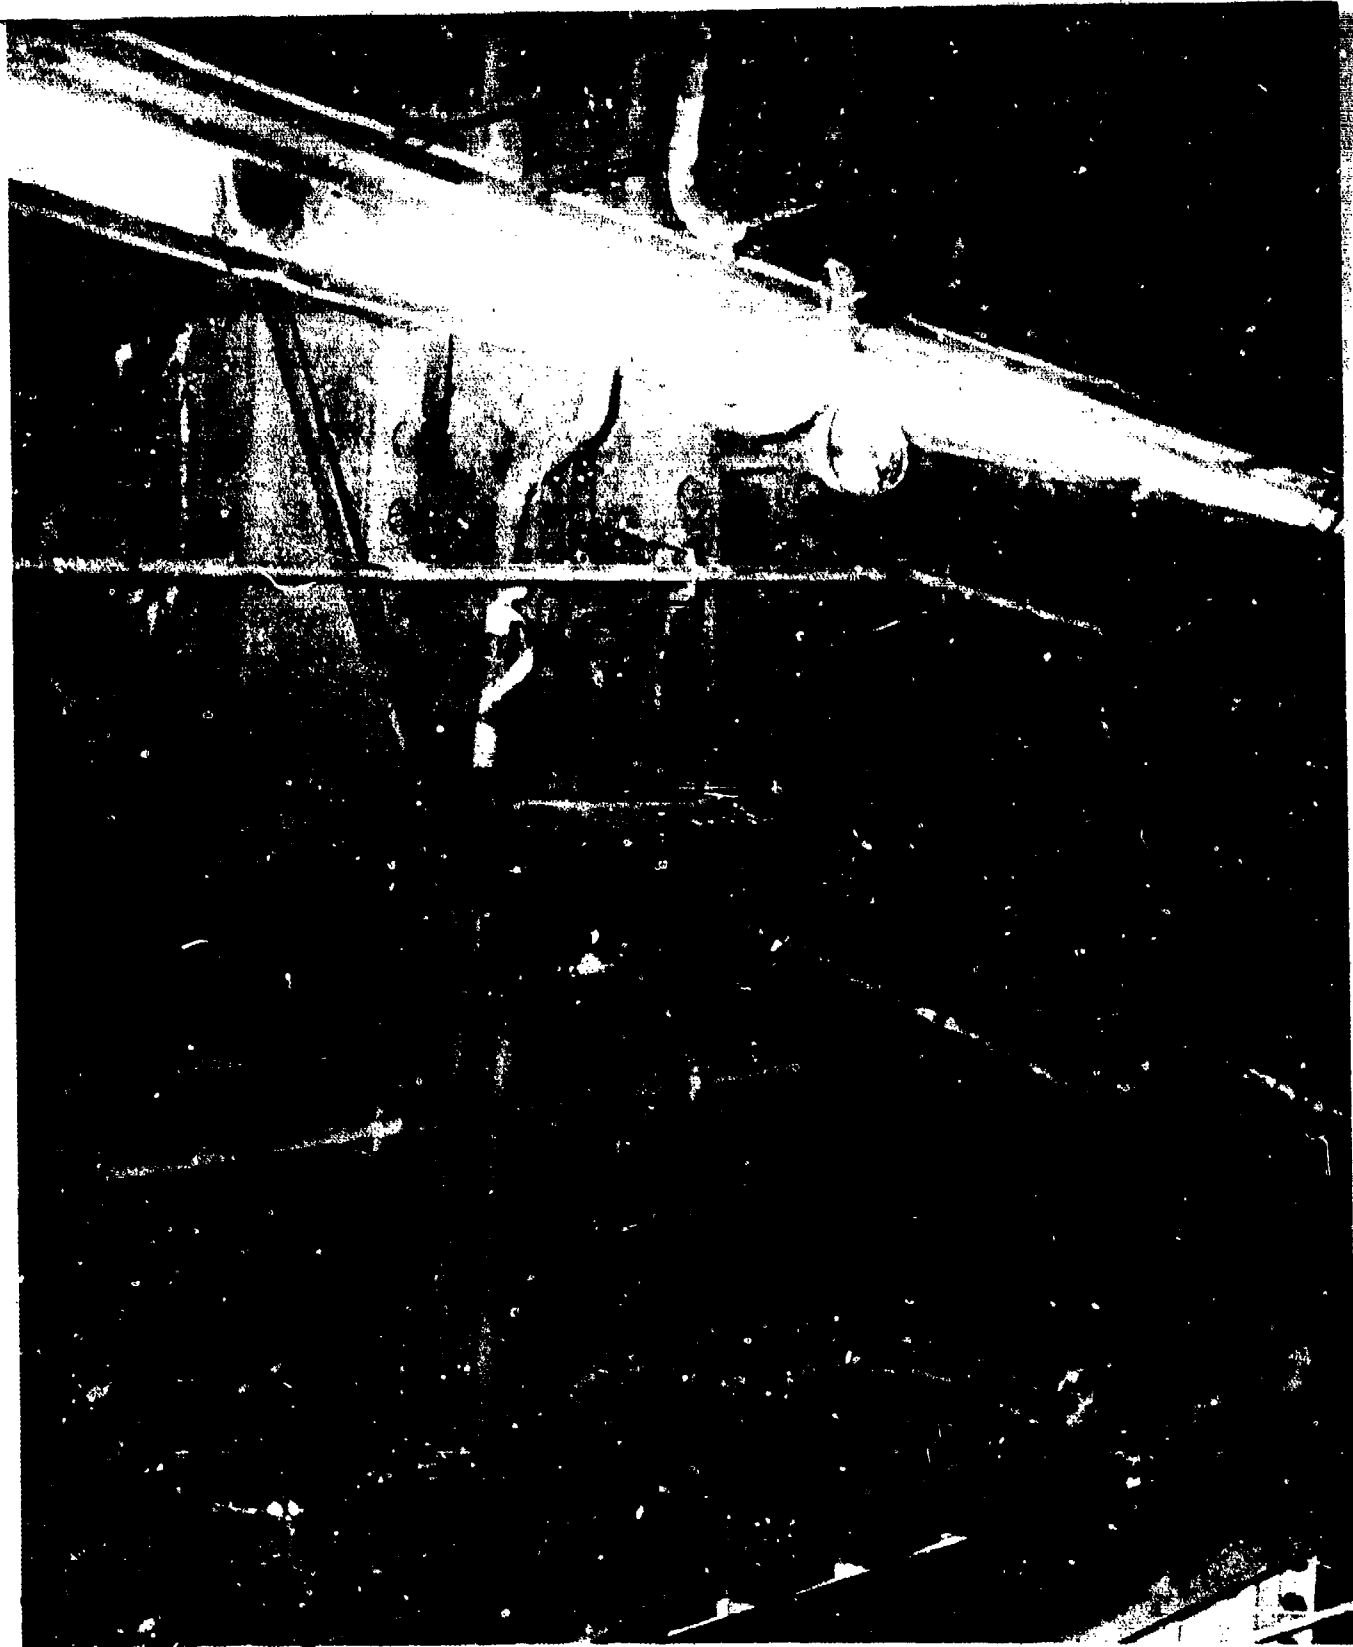
AA-CR-59-4151-8. Underside of flight deck showing distortion of Bent girder 110. Looking up and to starboard. Note opening of expansion joint at frame 111 1/2.
