# BUREAU OF SHIPS GROUP TECHNICAL INSPECTION REPORT

## U.S.S. INDEPENDENCE (CVL22)

### TEST ABLE

### OPERATION CROSSROADS

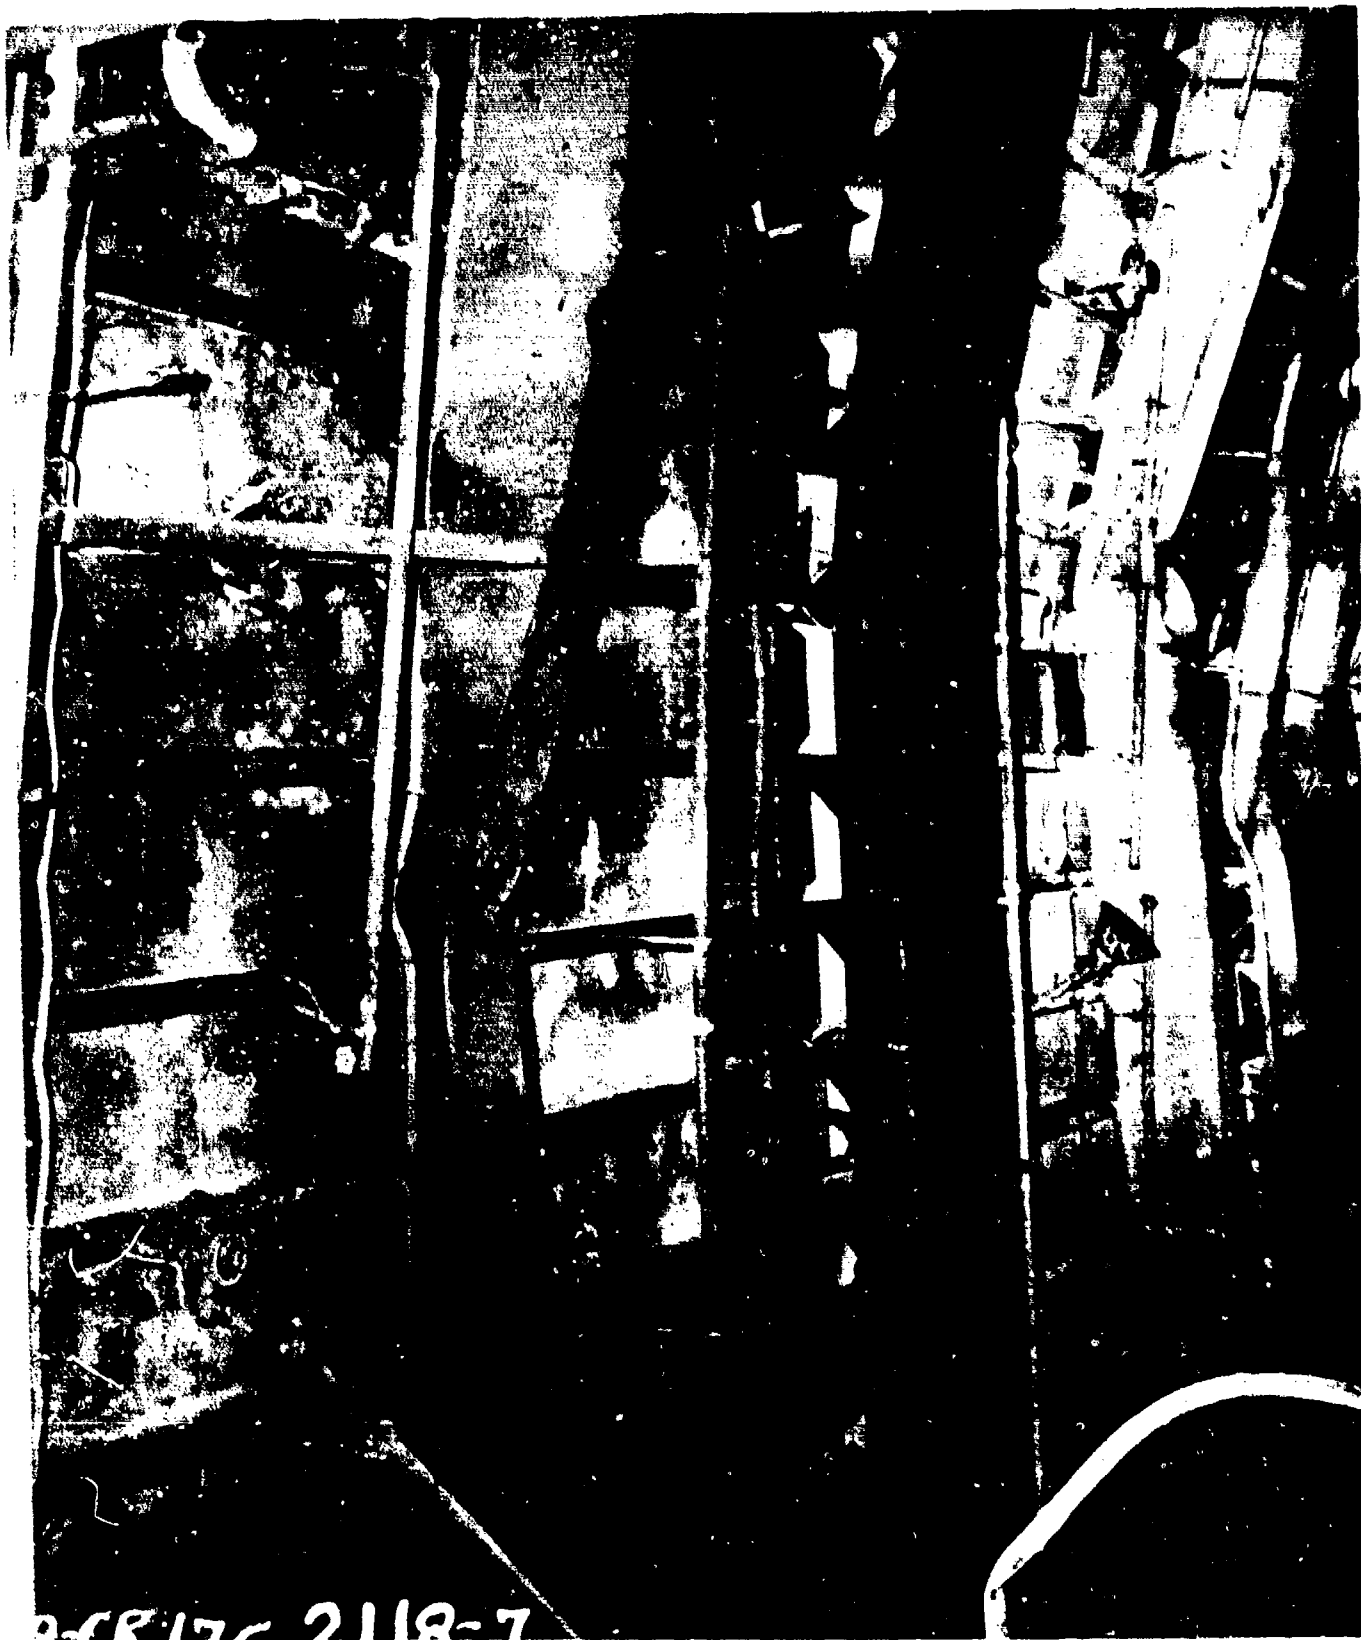
AA-CR-175-2118-7. Underside of flight deck, Bent girder 110, looking forward from bent 115 along centerline.

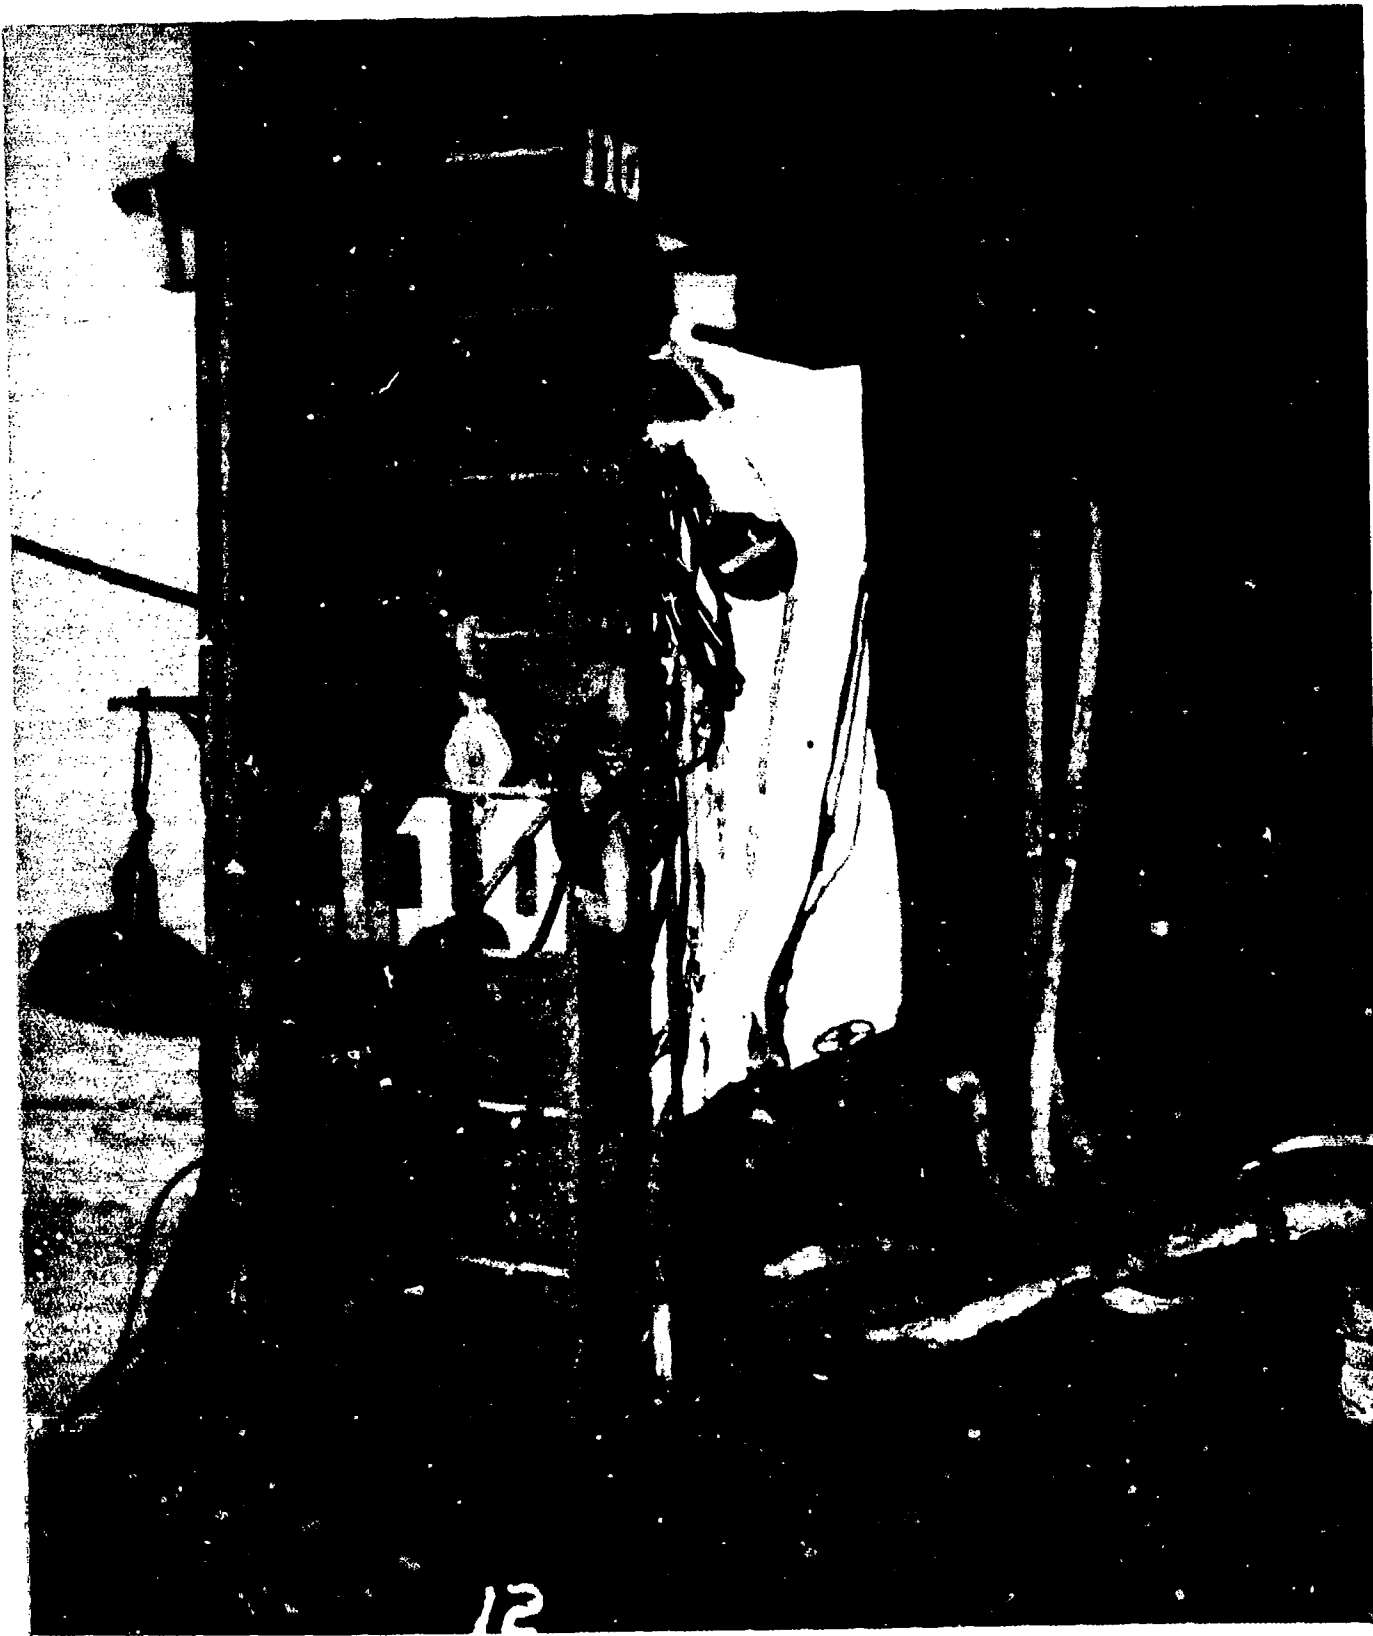
AB-CR-80-170-12. After Baker - Flight deck Bent 110, starboard bottom, looking aft.

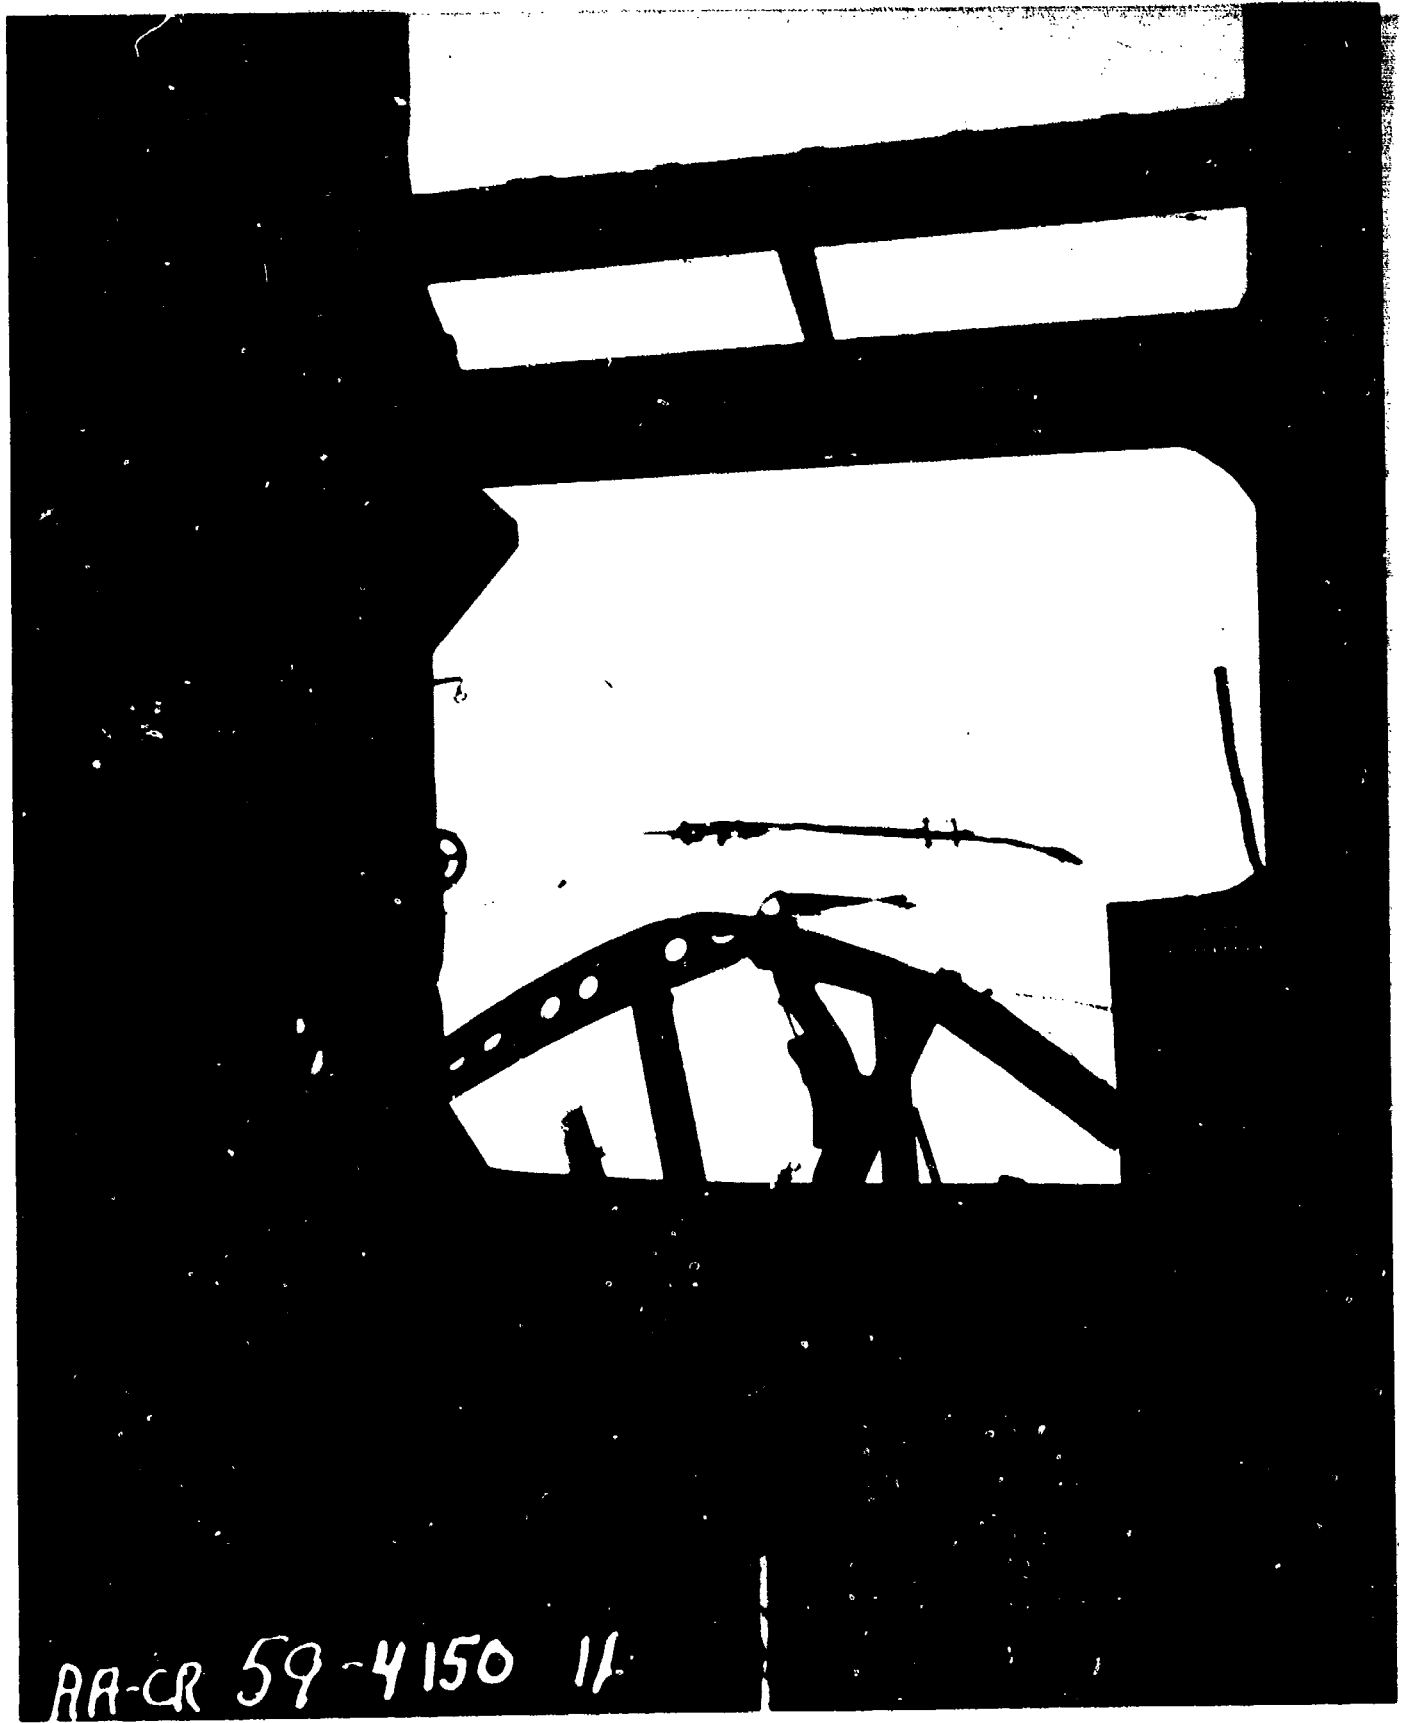
AA-CR-59-4150-11. Flight deck Bents 124 and 121, port side. Looking to port from elevator well. Note elevator guide rail on Bent 121.

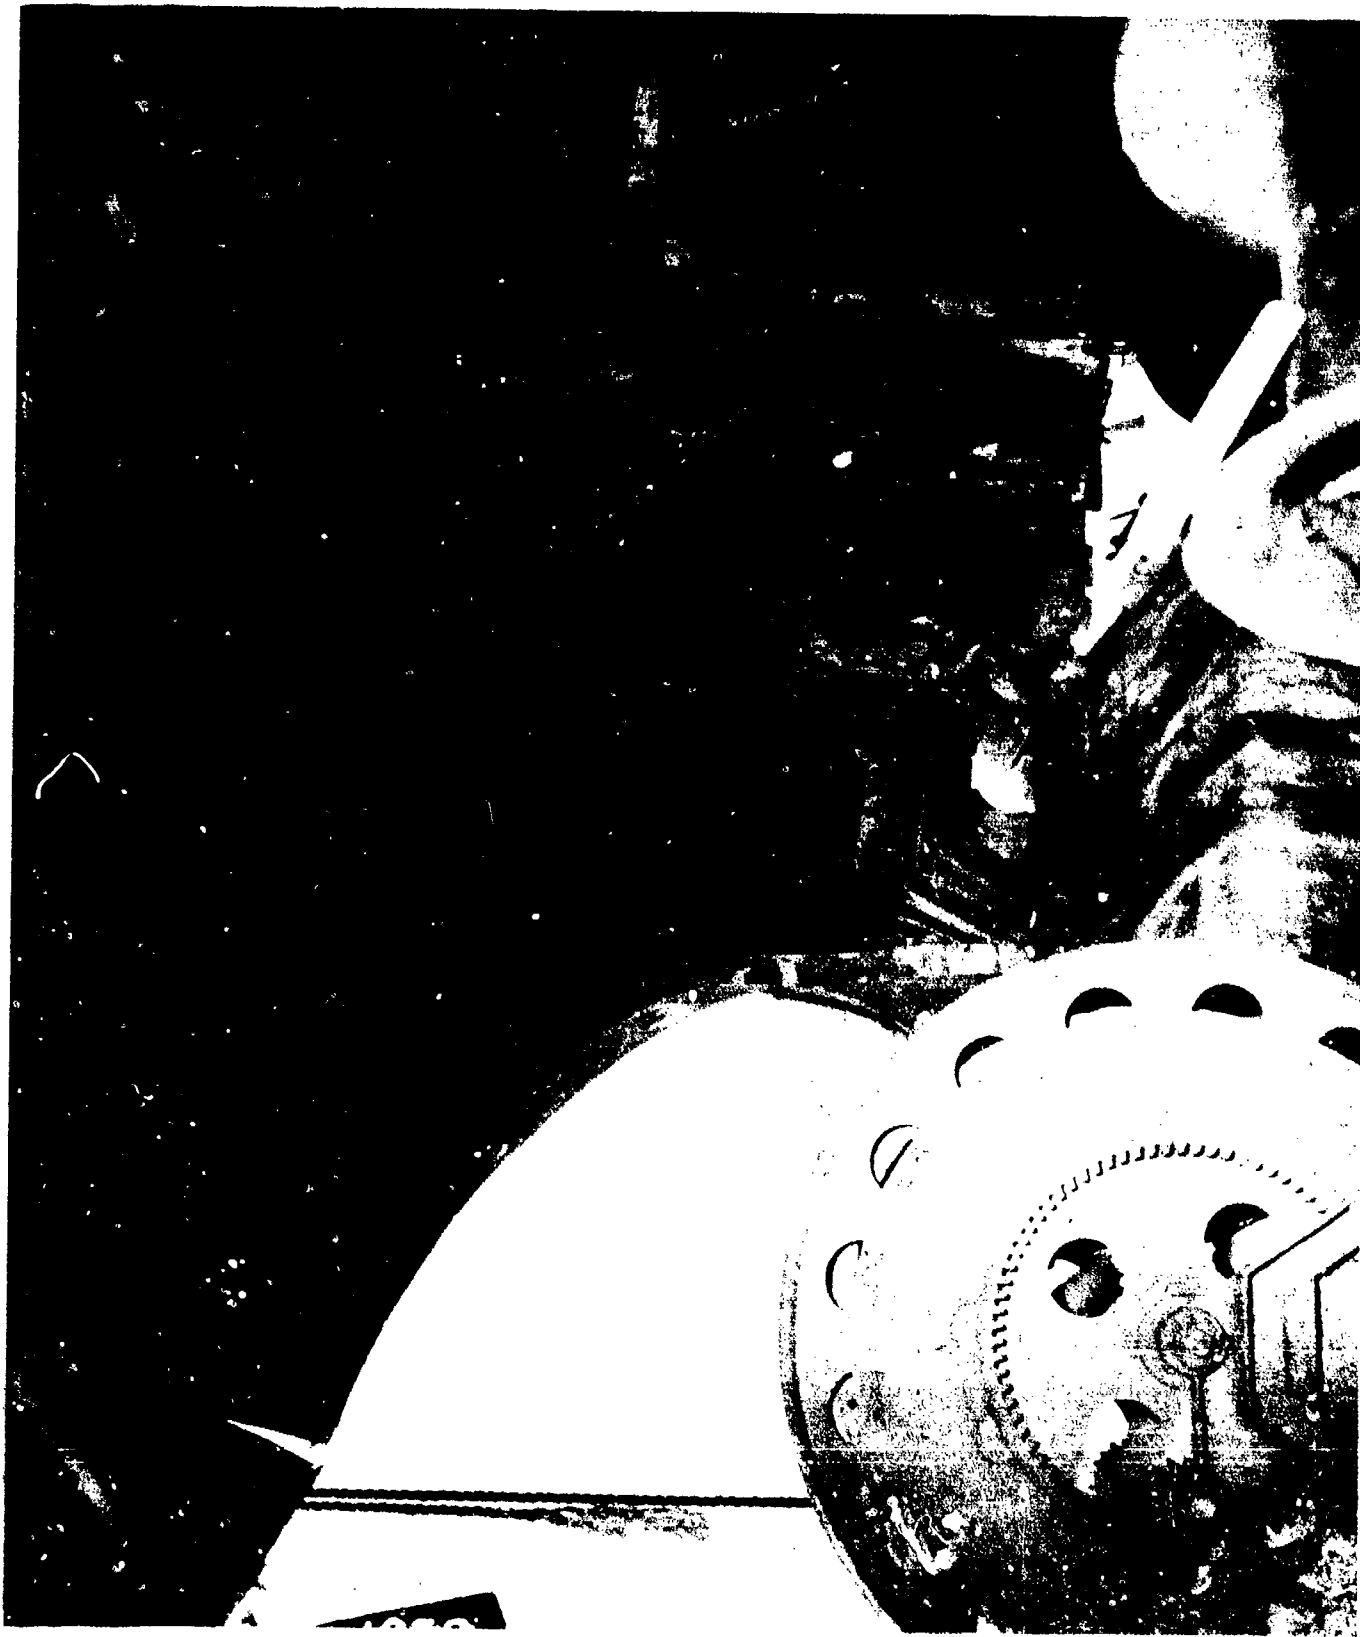
AA-CR-93-1999-5. Main deck, port side fashion plate, frame 147, looking to port from centerline.

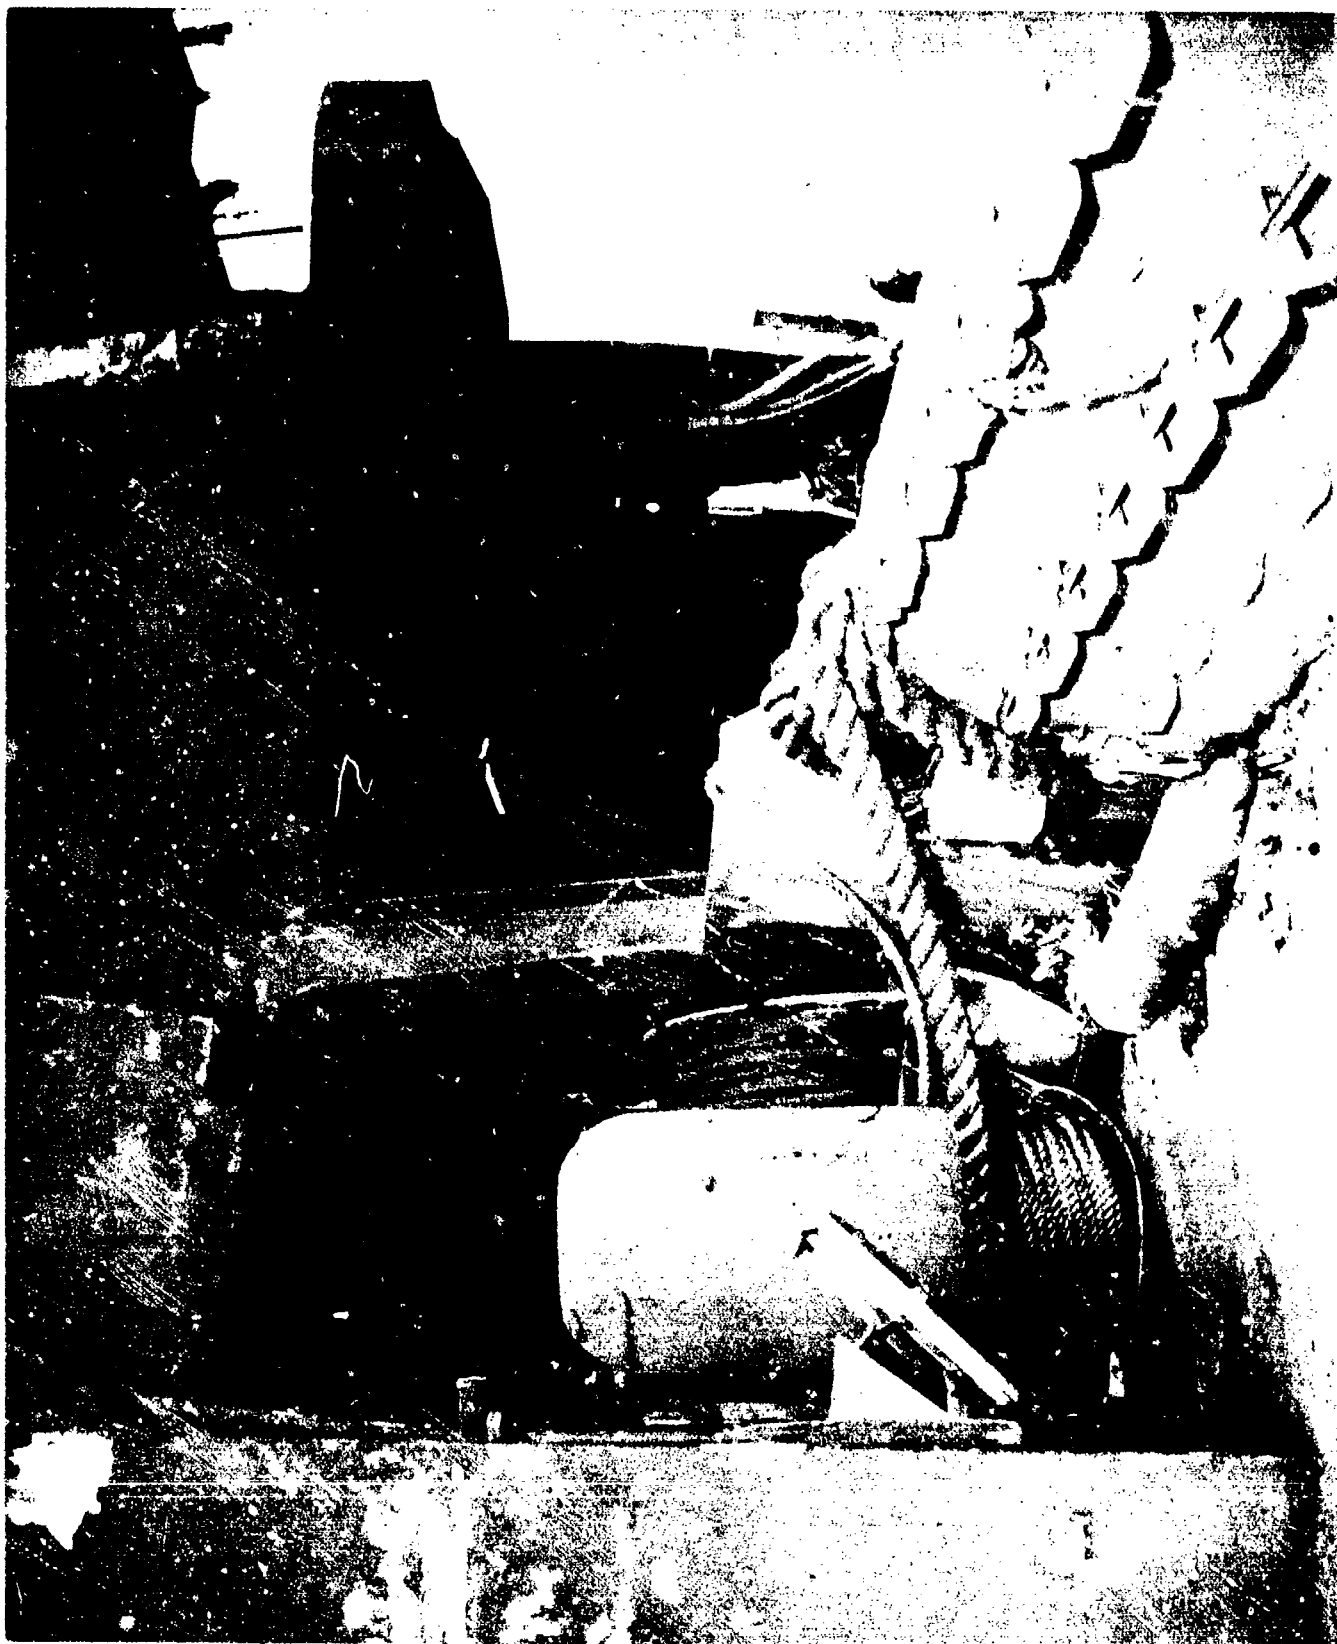
AA-CR-175-2041-11. Main deck, looking forward from 40mm gun sponson starboard side. Note stanchion broken loose at welded overhead connection.

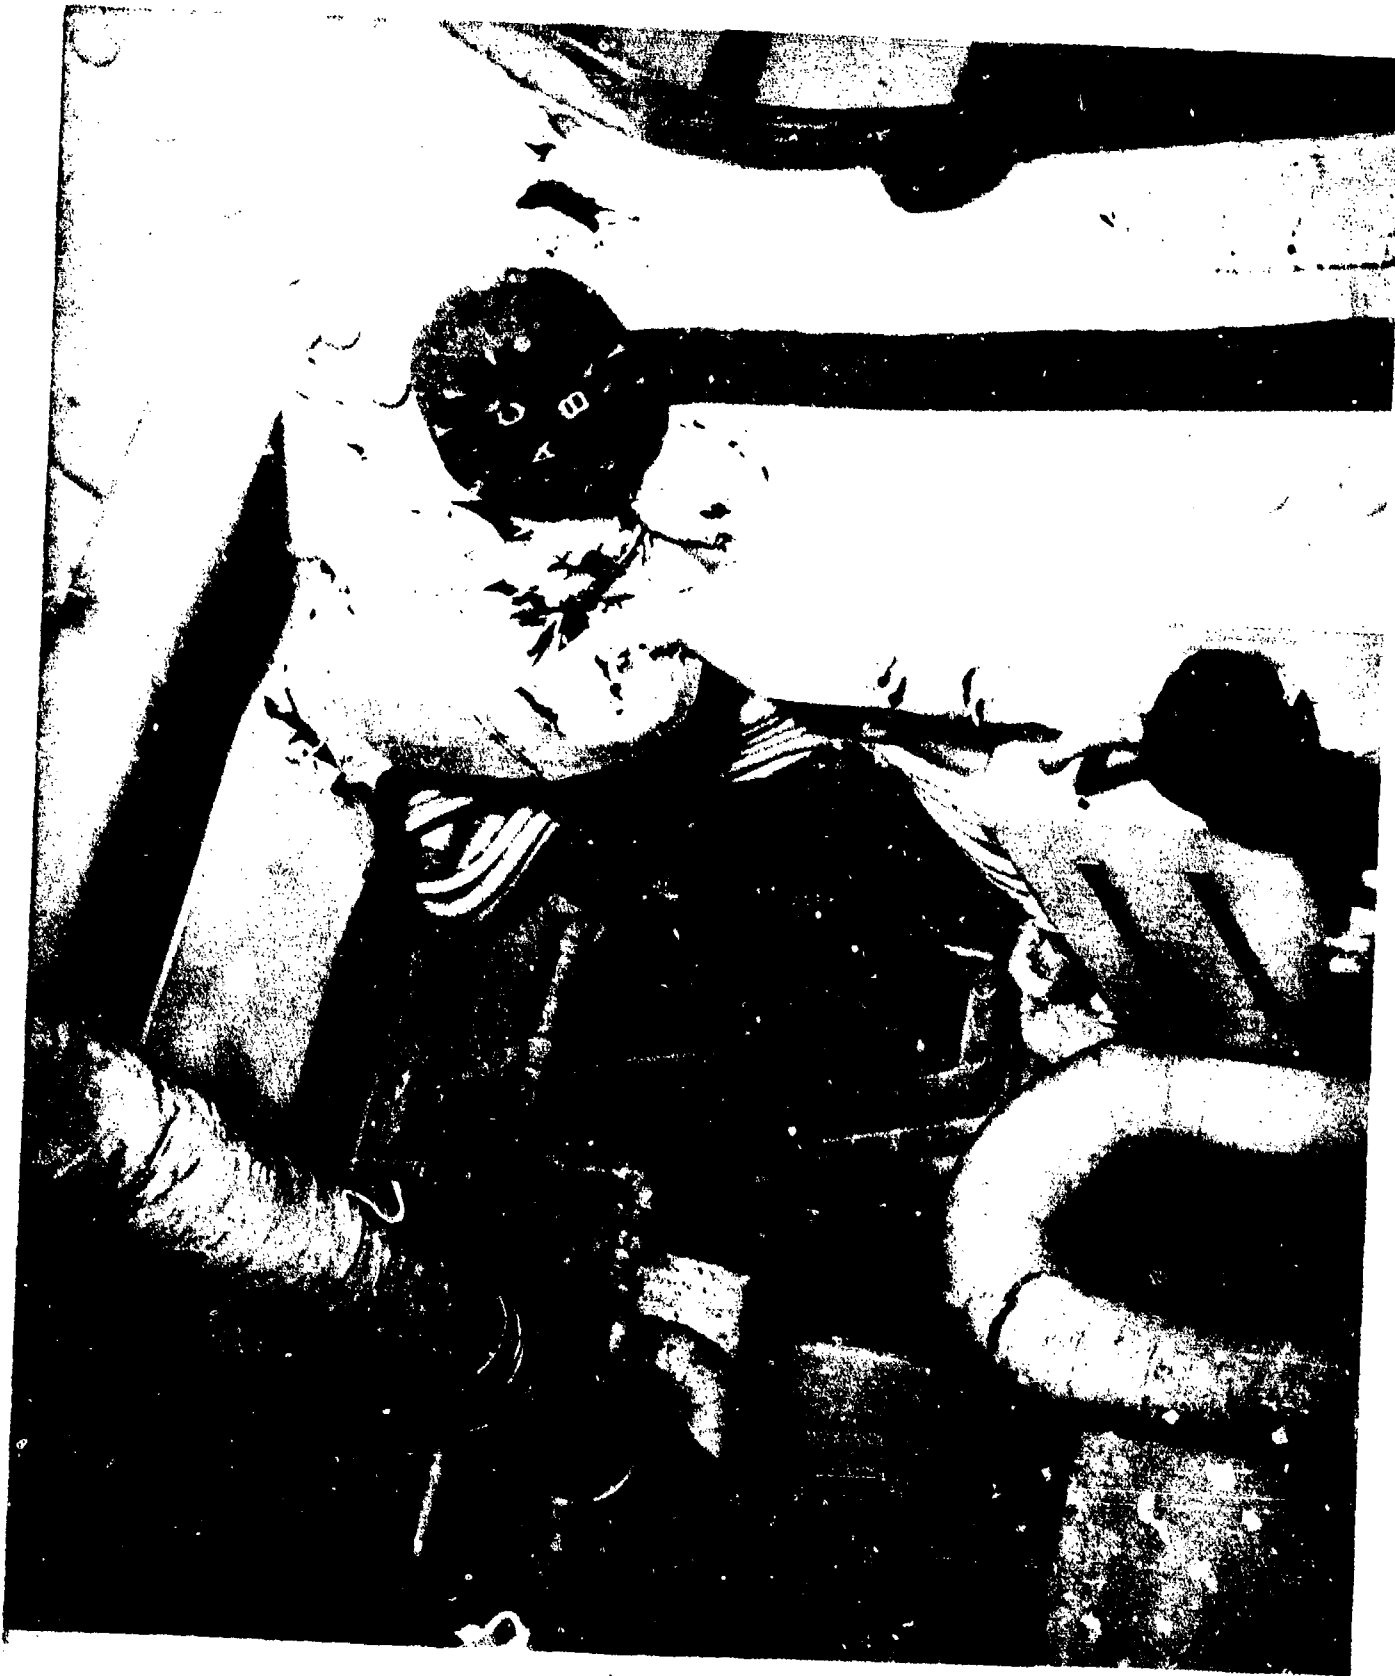
AA-CR-59-2087-9. Second deck, A-211-L. Buckling of bulkhead 49 just to starboard of centerline. Looking forward and to port.

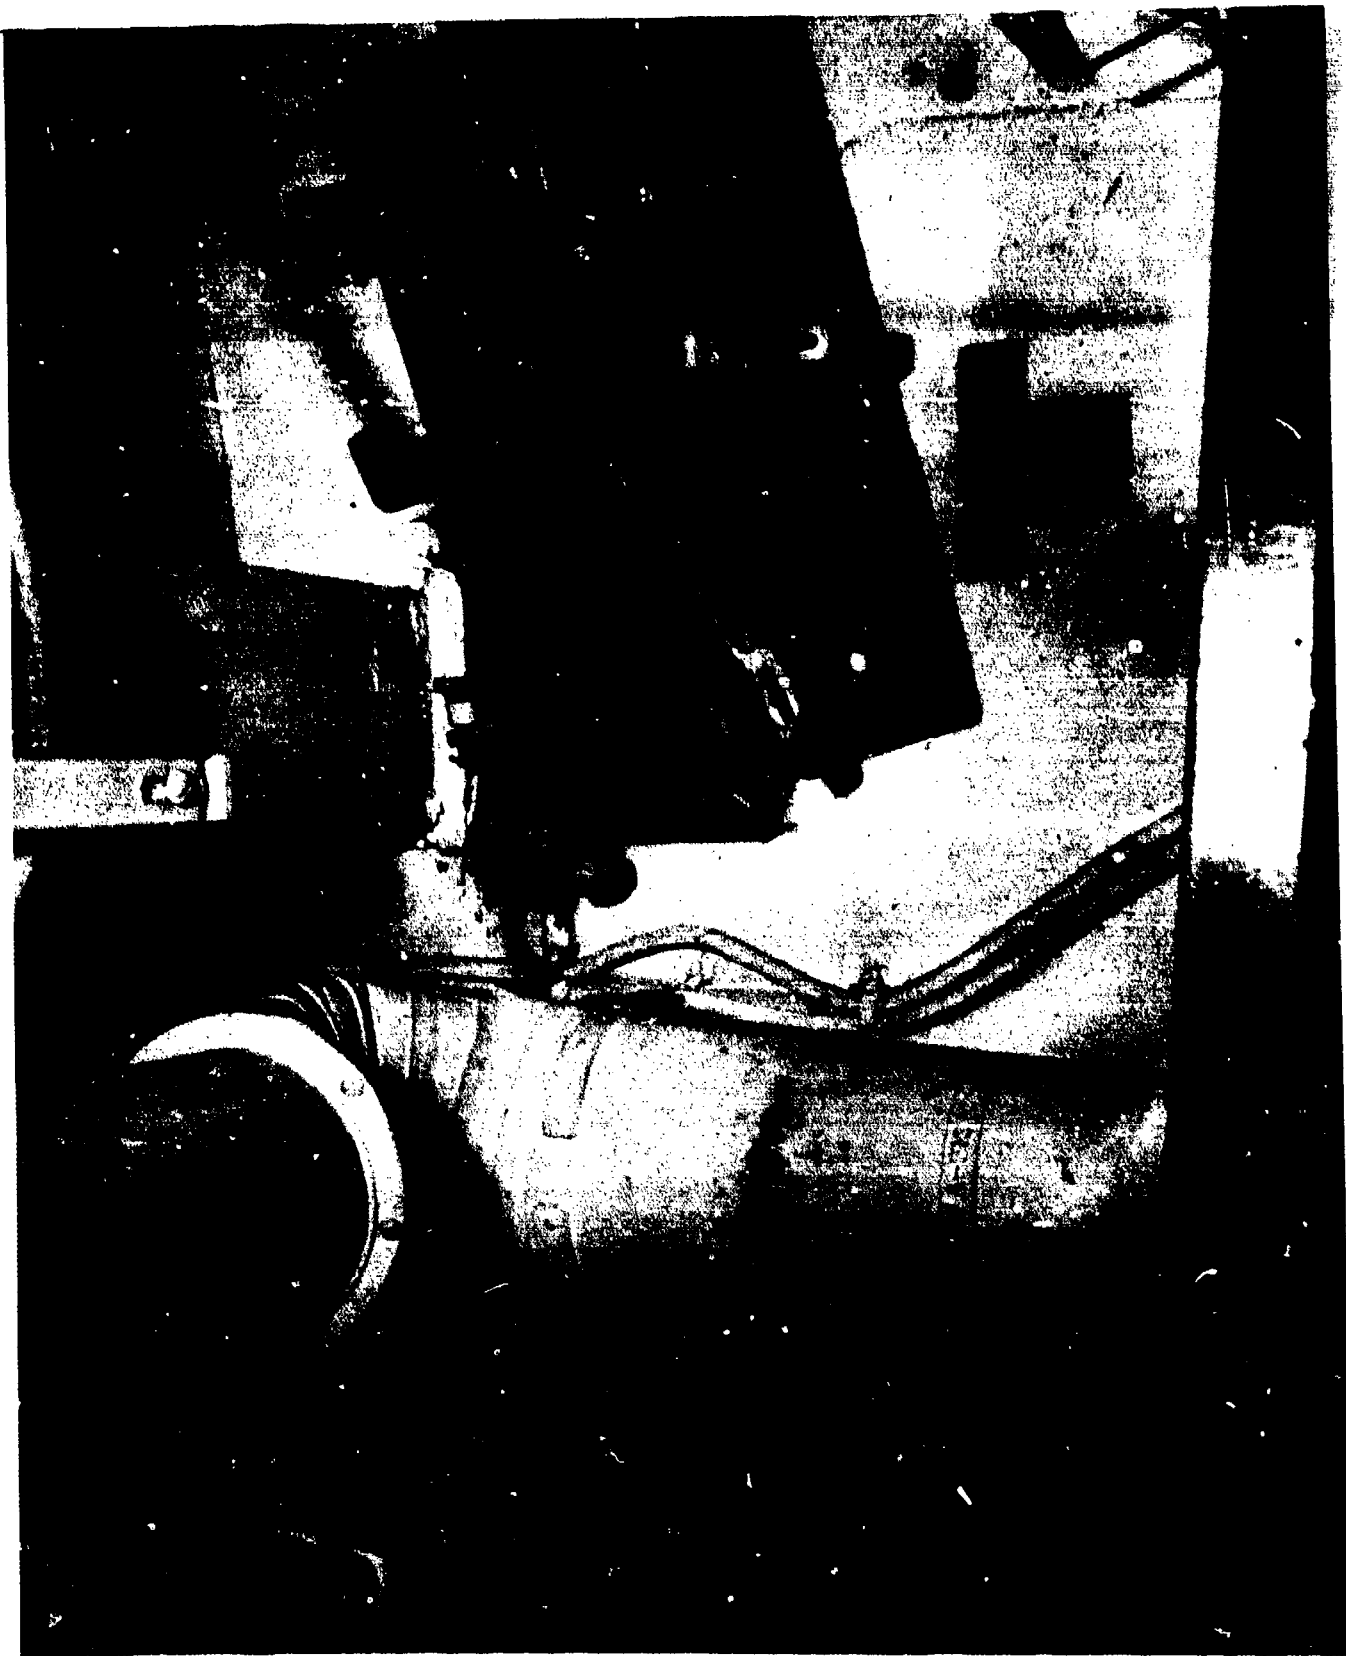
AA-CR-59-2087-12. Second deck, supply office, looking forward at port side of bulkhead 49, for opposite side, see 2087-11.

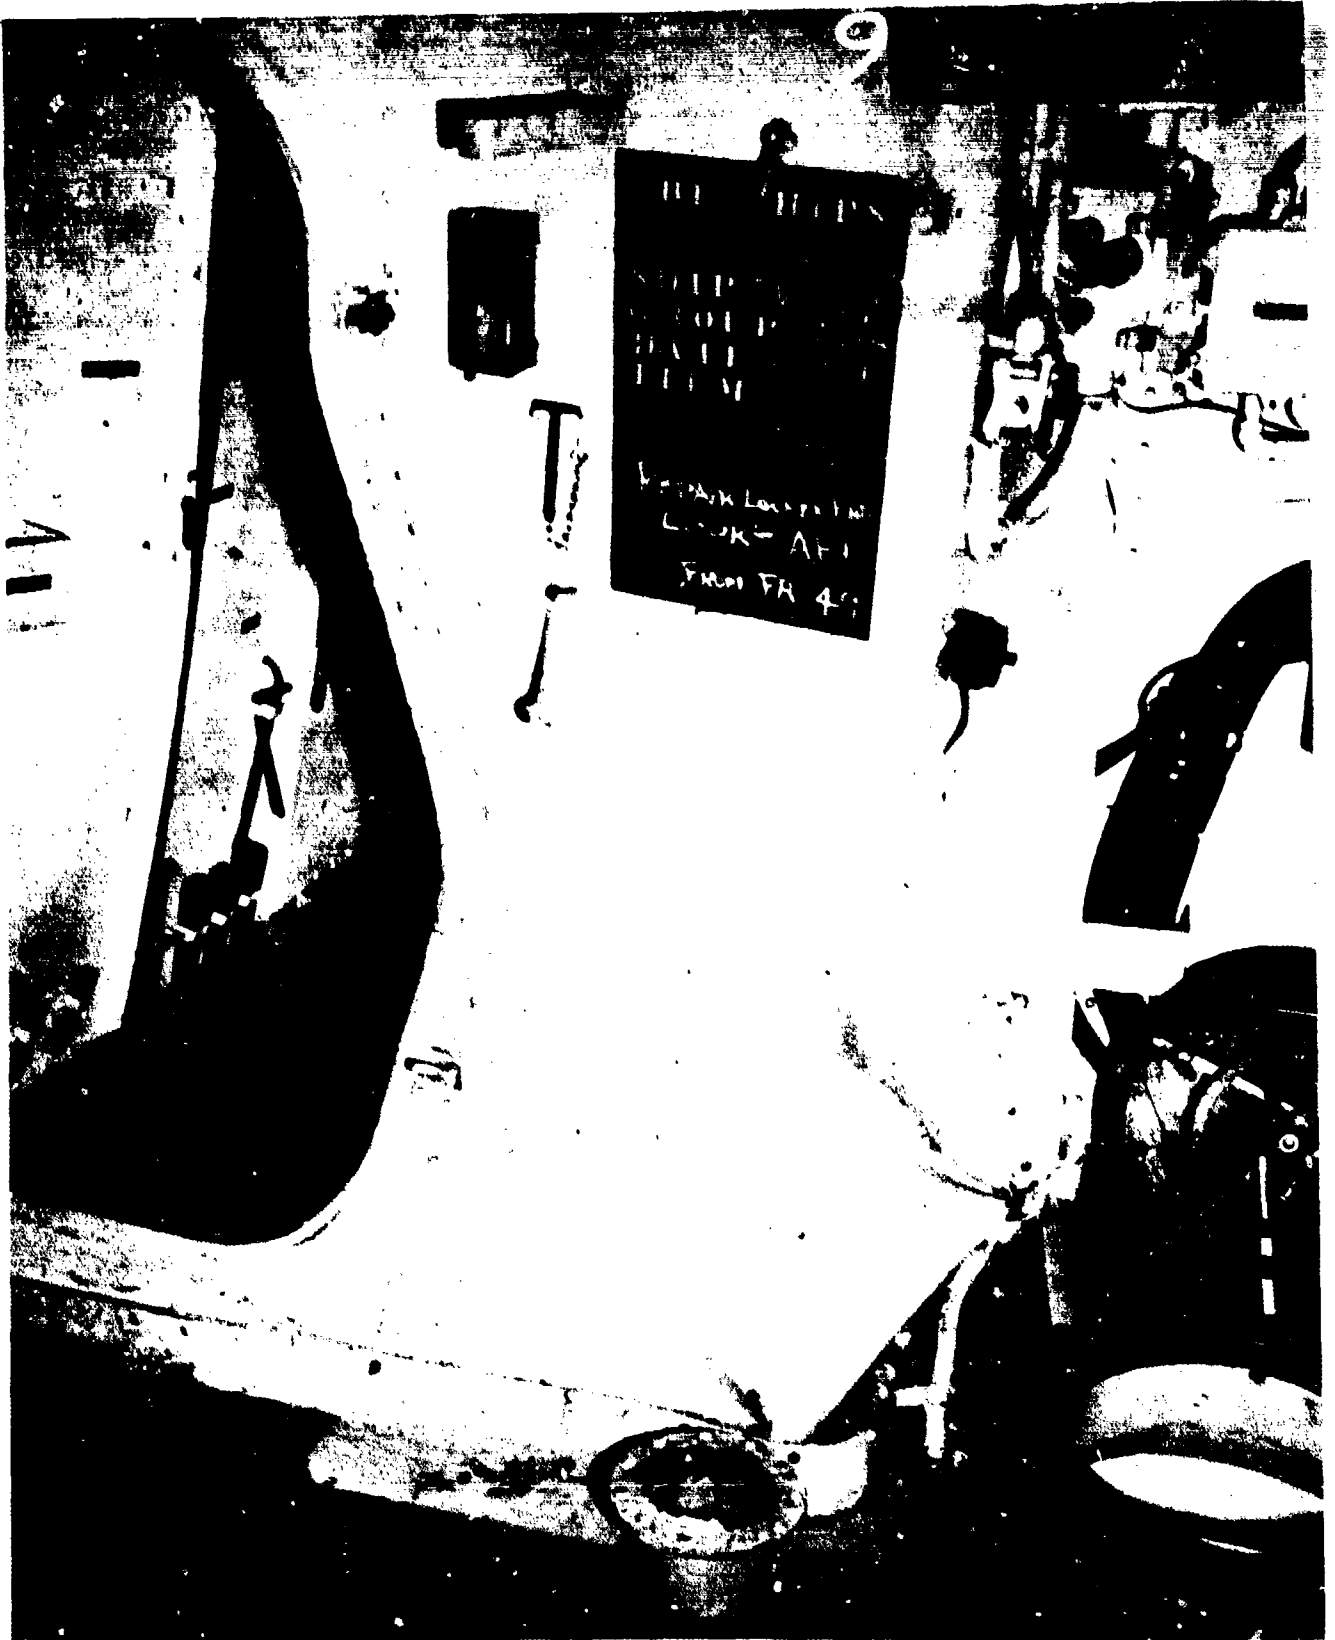
AA-CR-175-2133-6. Second deck, A-211-L. Looking aft from bulkhead 49 at repair party locker, frame 53, starboard side.

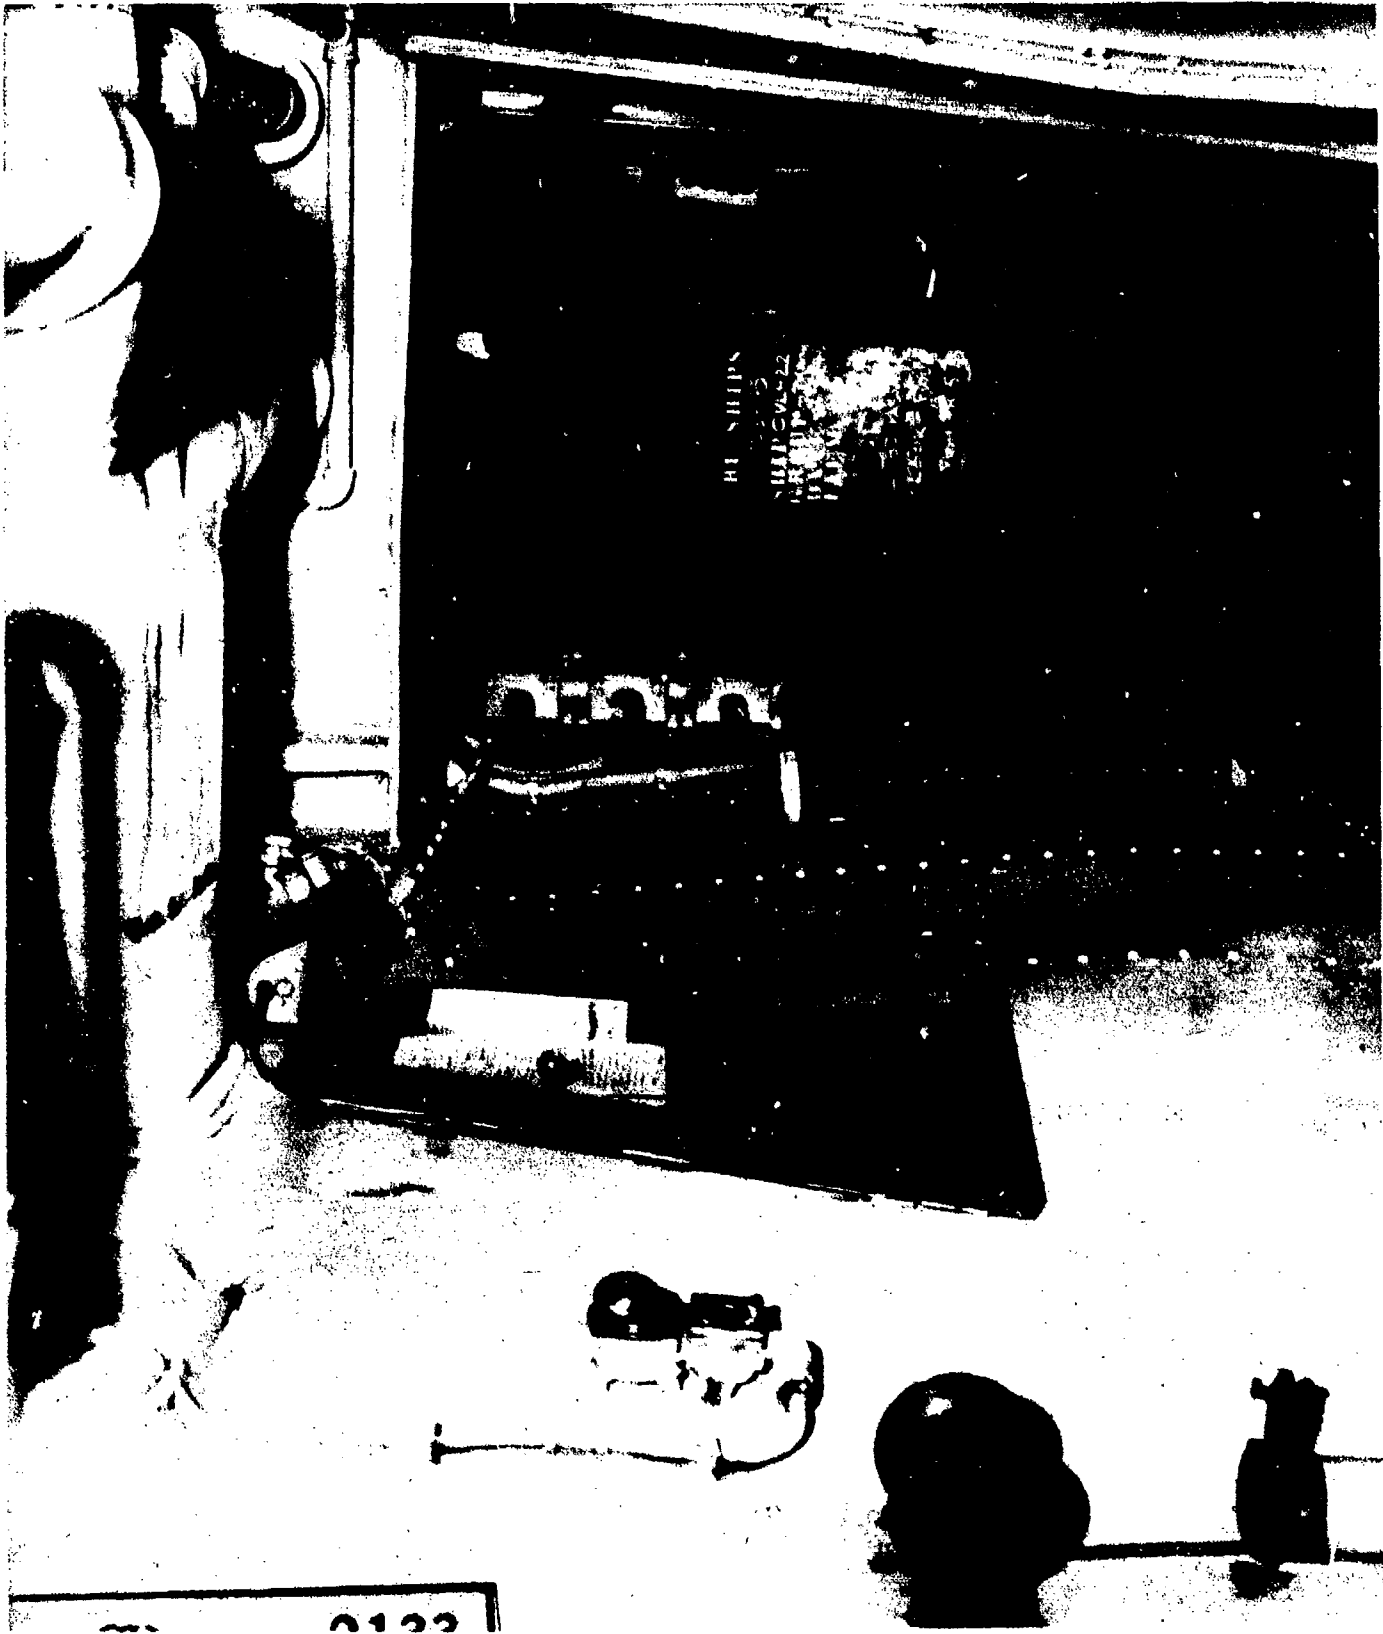
AA-CR-175-2133-5. Second deck. A-211-L. Passage on starboard side, -  
looking forward from frame 57.

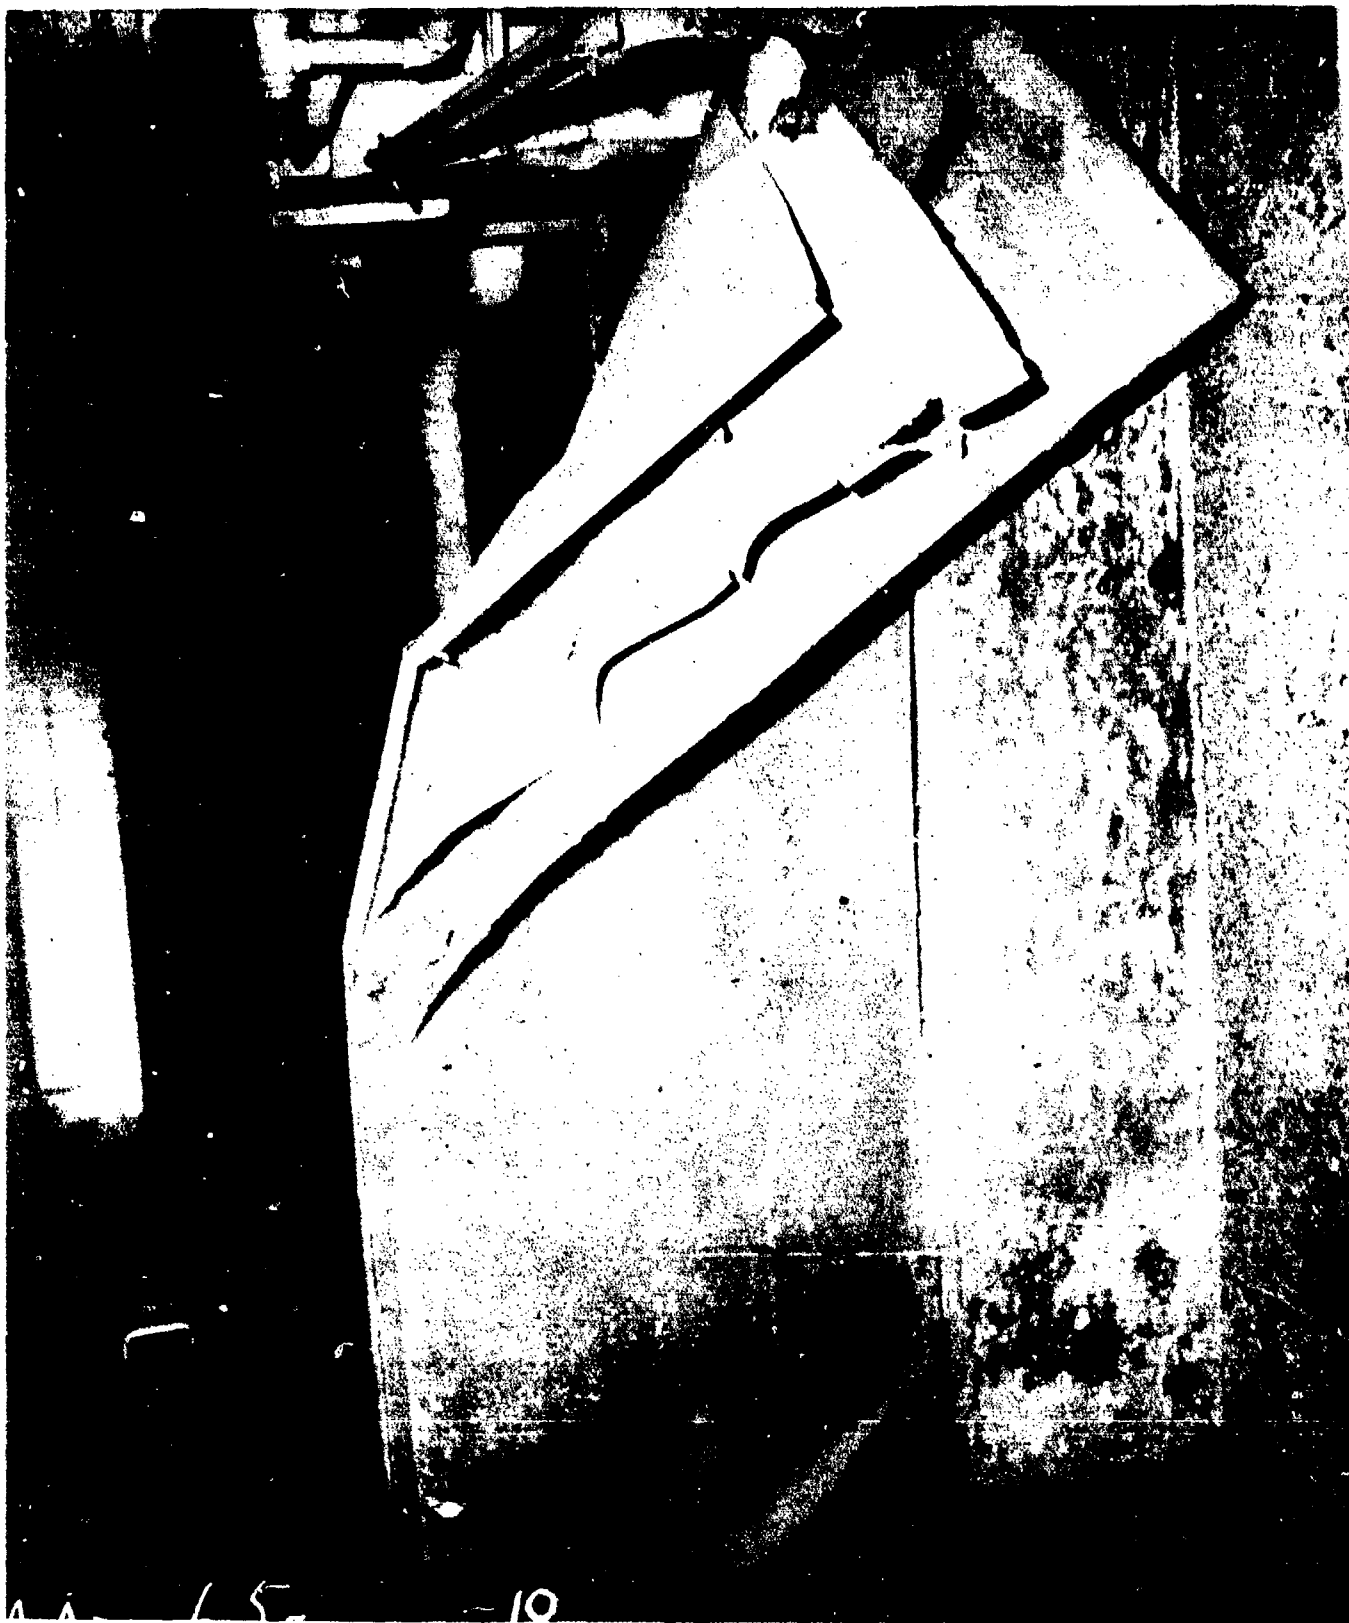
AA-CR-65-1735-10. Second deck, B-201-1L. Buckling of ventilation intake port side, frame 63, looking forward.
