# BUREAU OF SHIPS GROUP TECHNICAL INSPECTION REPORT

## U.S.S. INDEPENDENCE (CVL22)

### TEST ABLE

### OPERATION CROSSROADS

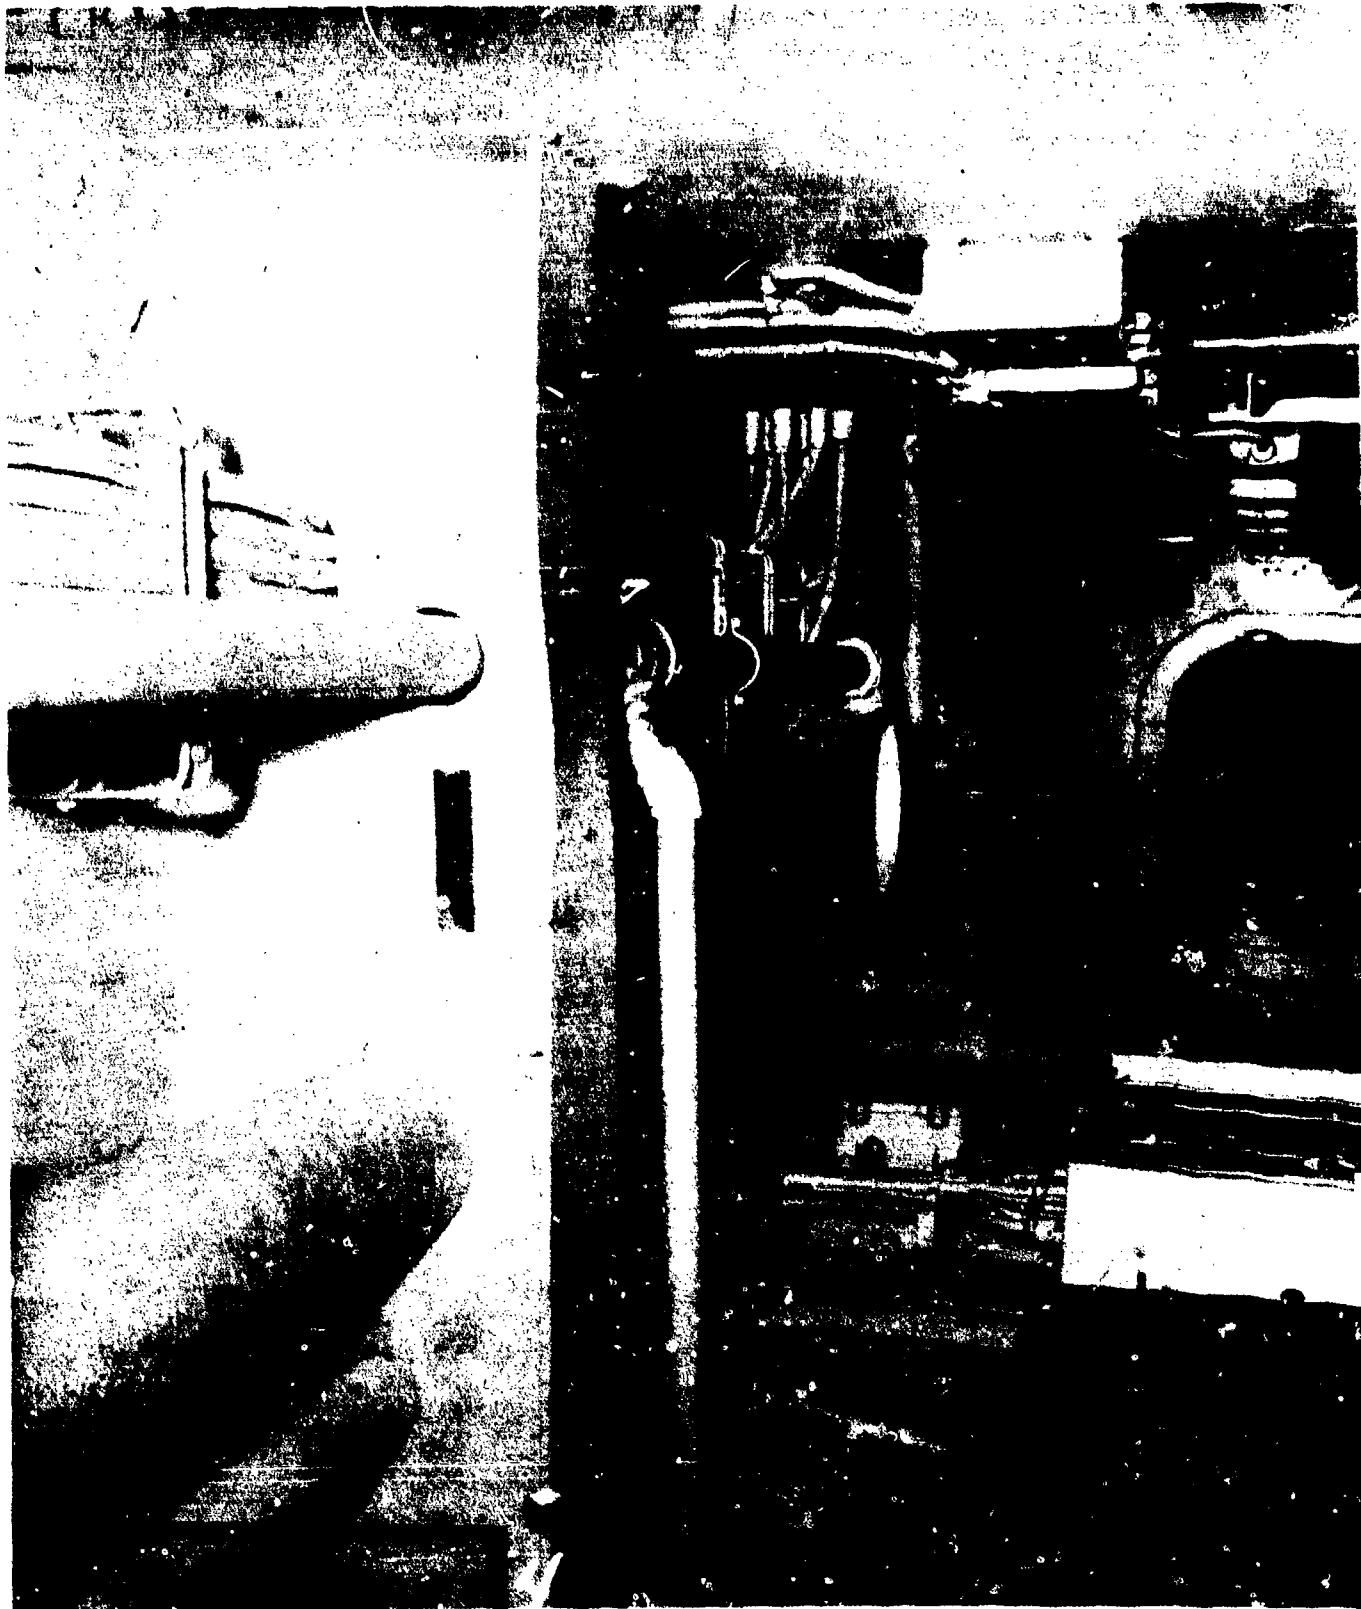
AA-CR-59-2088-4. Second deck, port passage, looking forward from frame 74. Note number of cuts through web of beam which tended to weaken it.

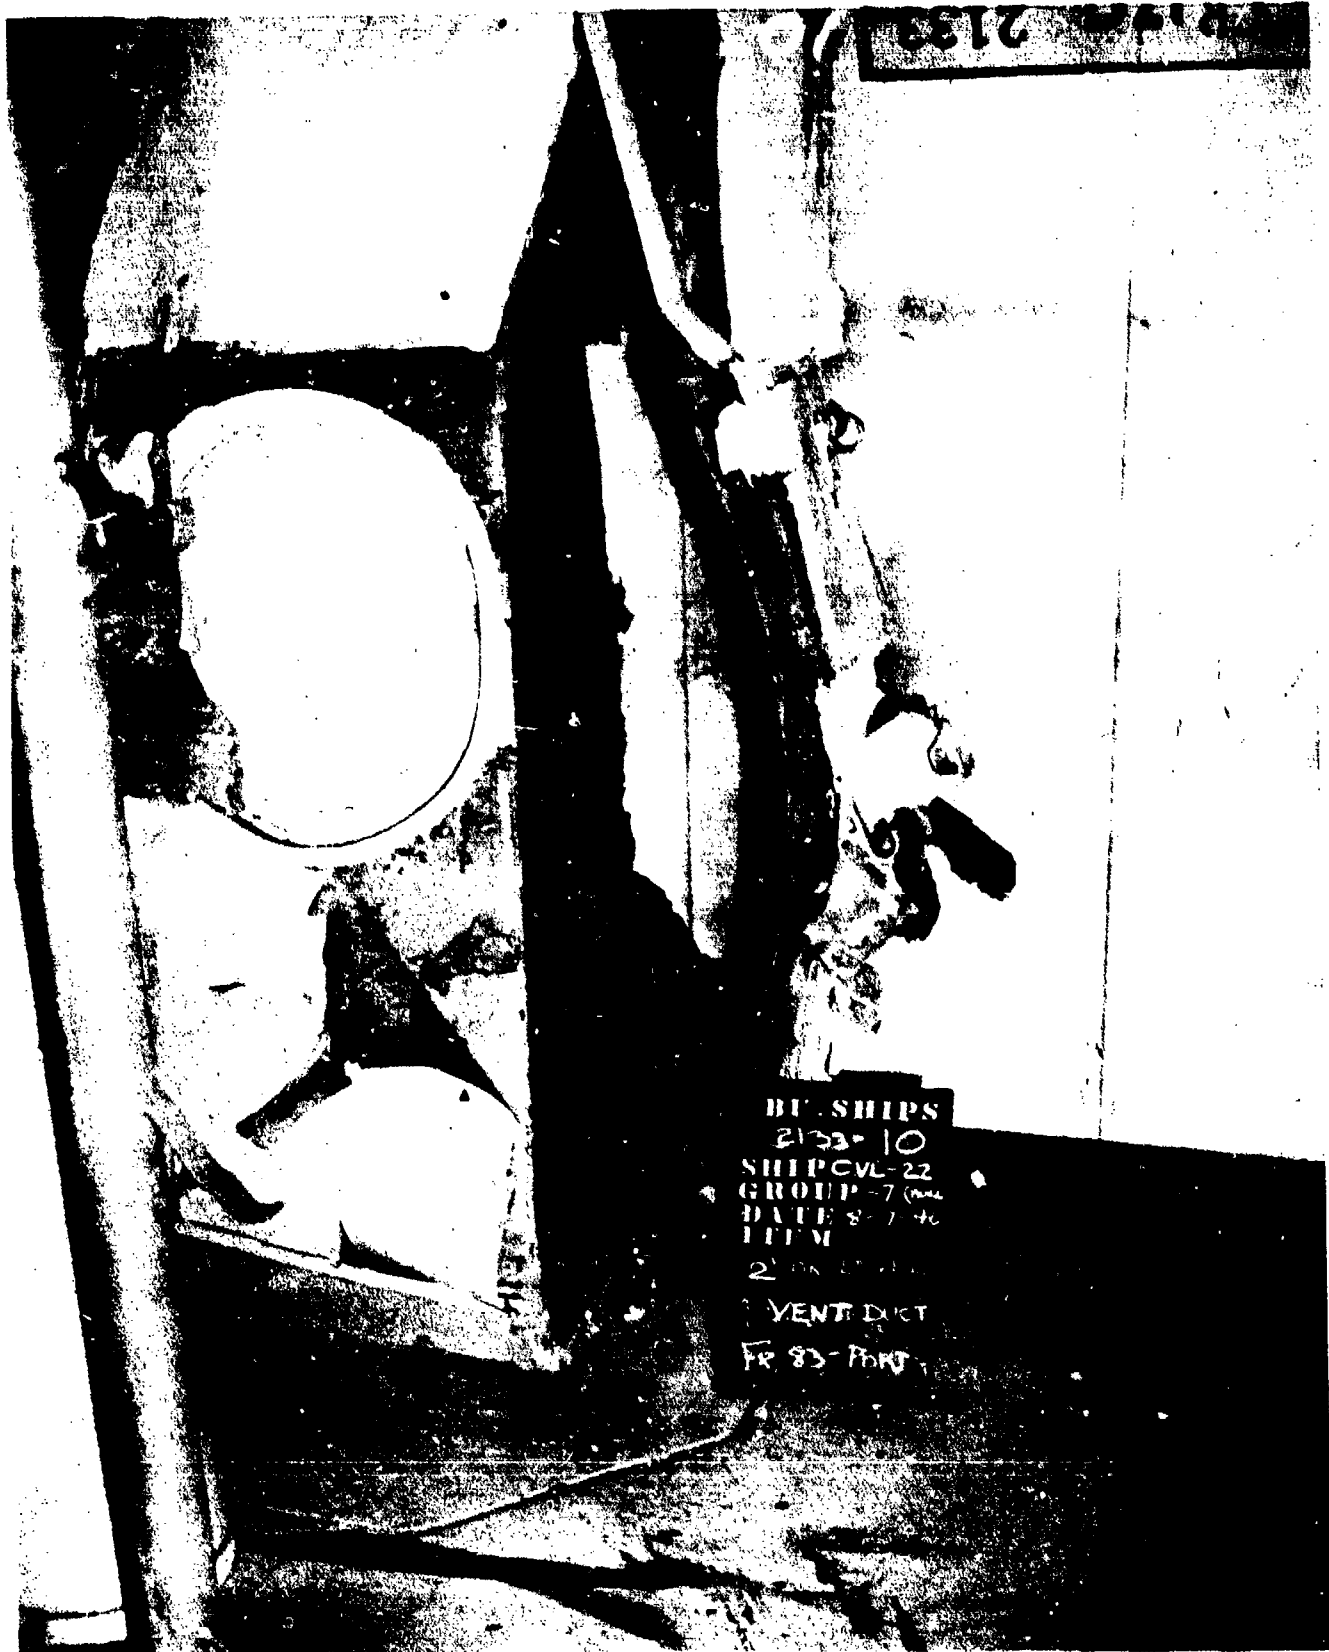
AA-CR-175-2133-10. Second deck, B-203-L. Blast damage to arc welded ventilation duct in mess attendants berthing space on port side at frame 83. Looking inboard and aft.

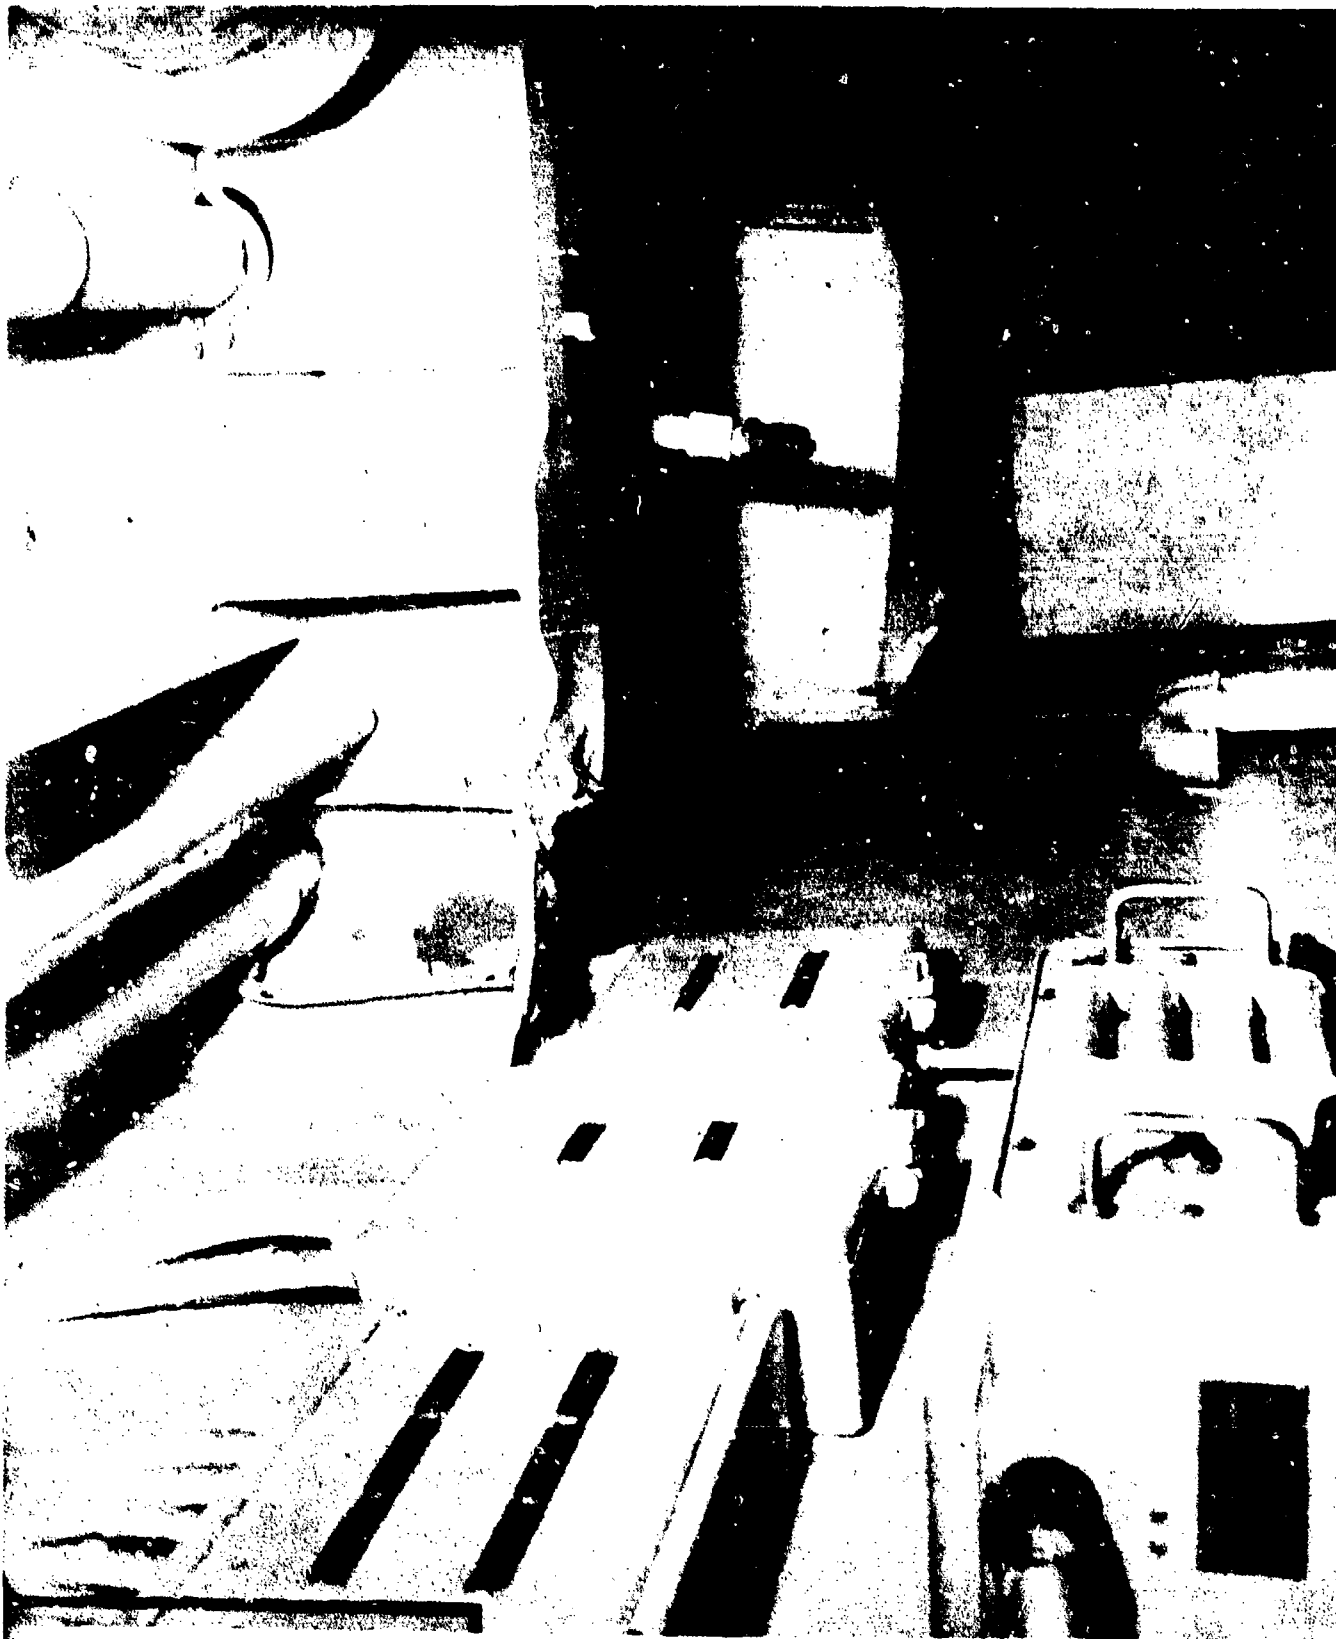
AA-CR-59-2088-6. Second deck, B-203-L, port side passage, looking aft, showing failure of transverse main deck beam 88. Shear failure in beam is possible result of access hole for pipes. Fore and aft bulkhead not buckled.

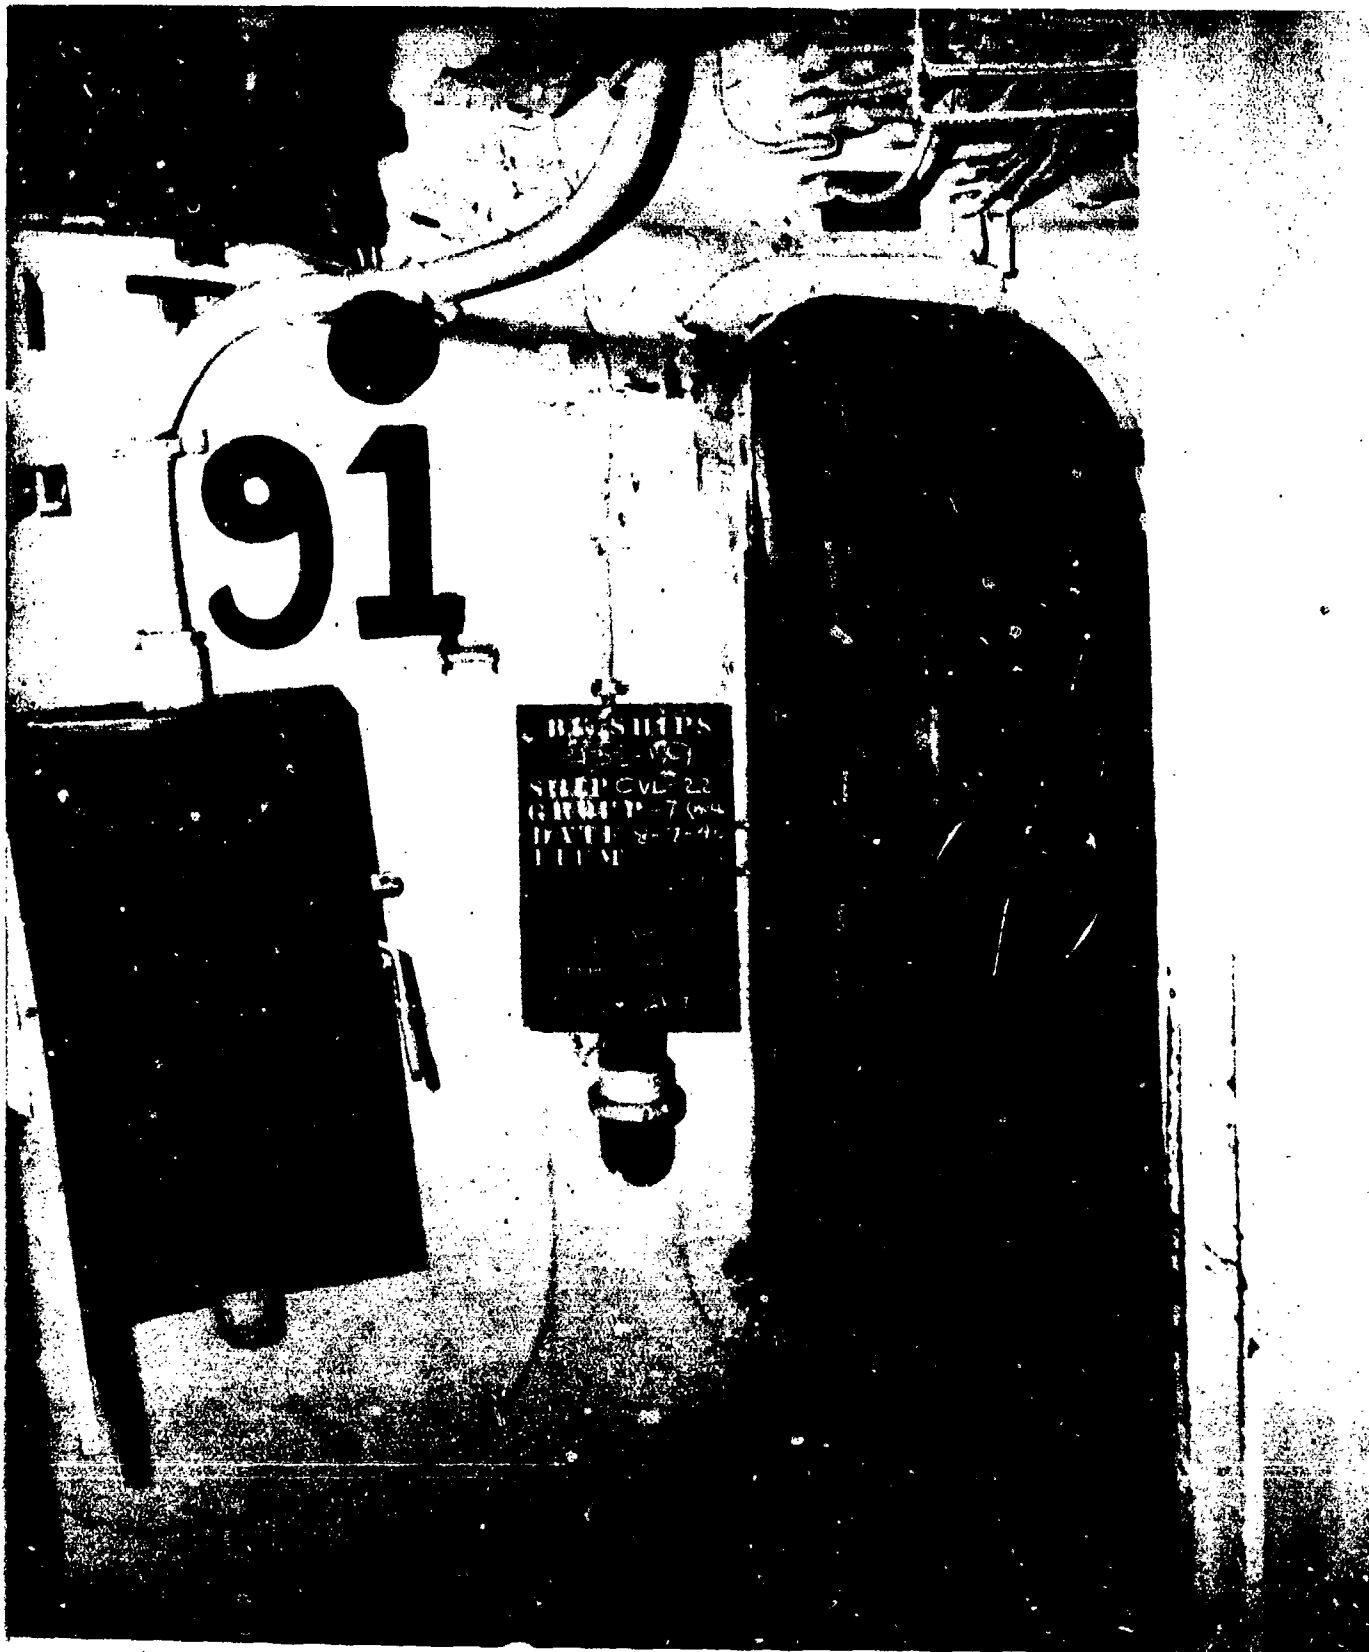
AA-CR-175-2133-9. Second deck, B-203-L. Port side passage, looking aft at bulkhead 91. Note W.T. door.

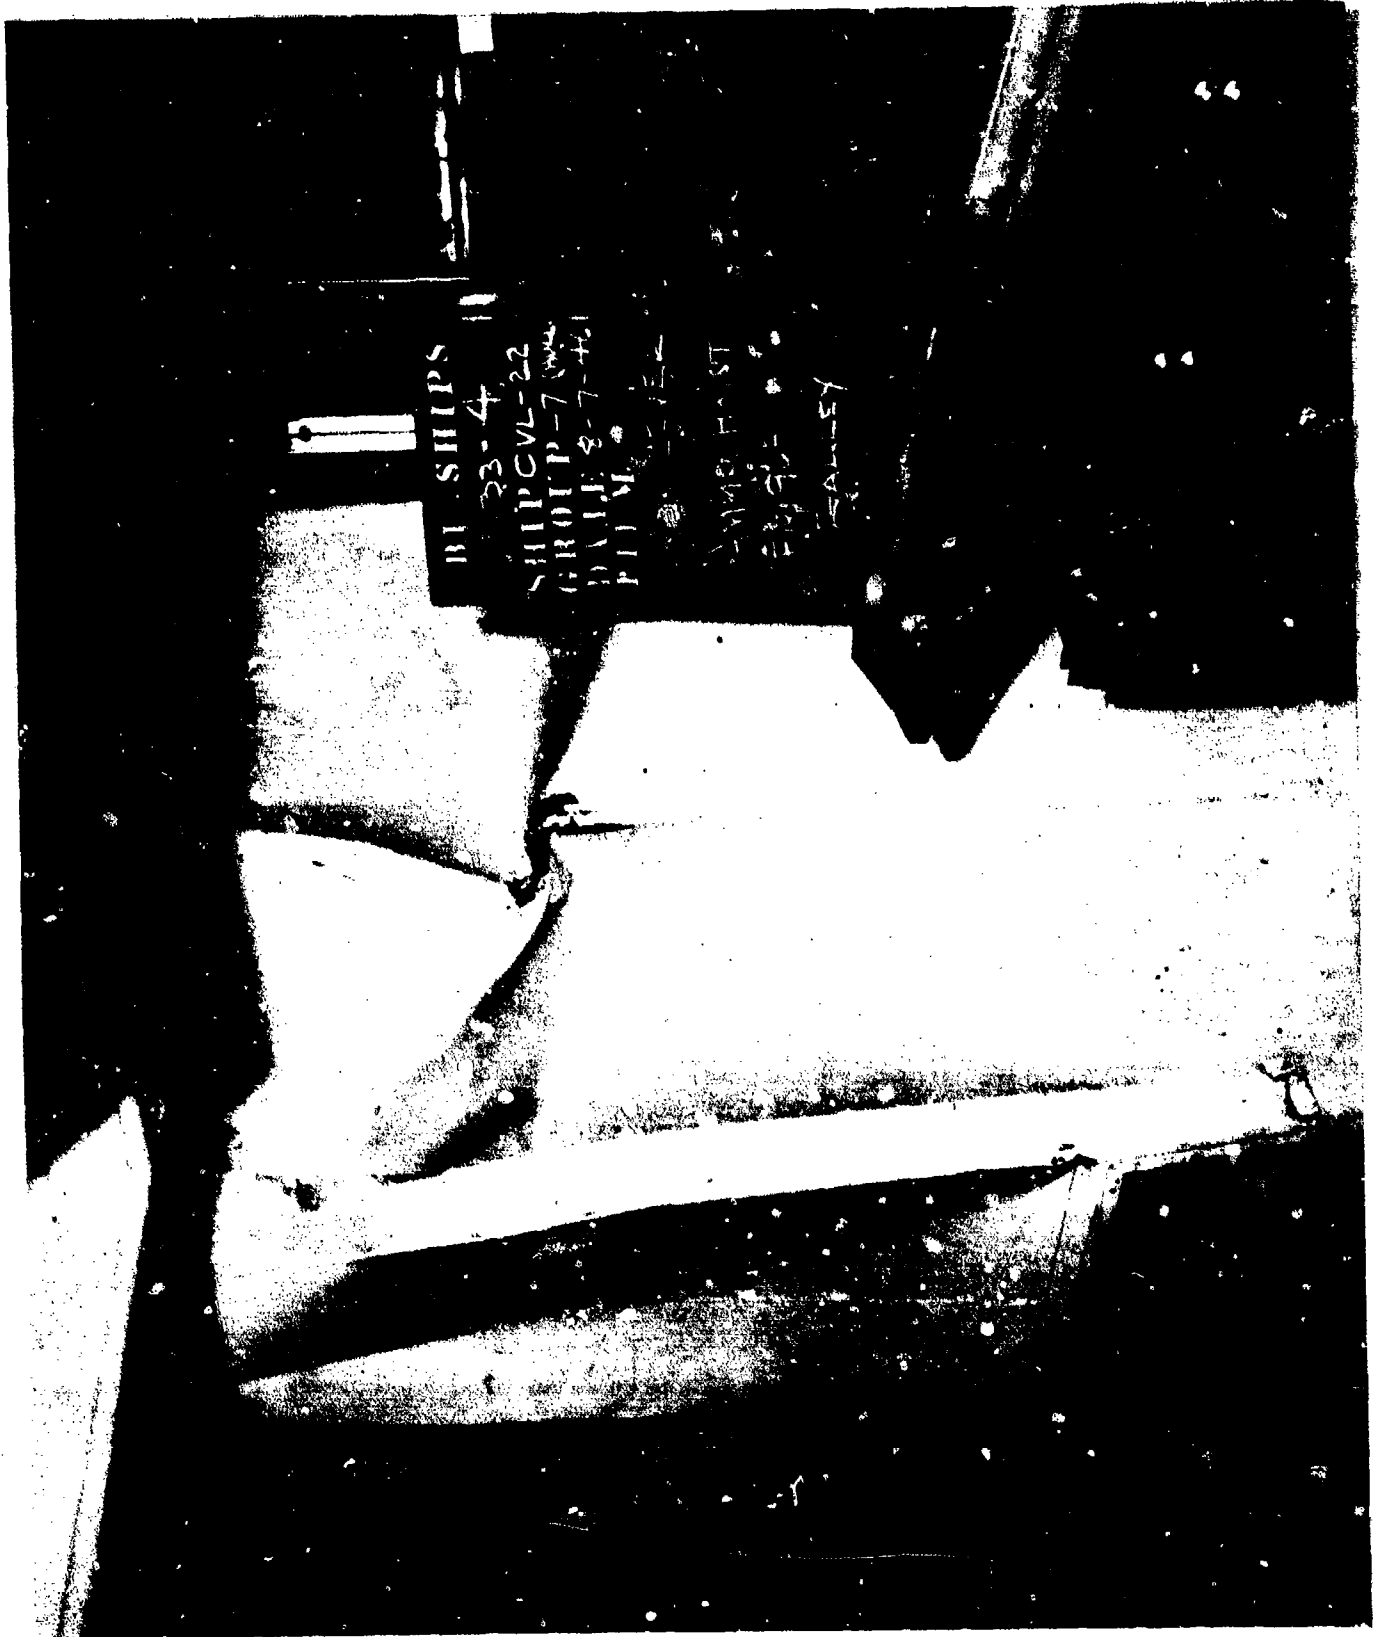
AA-CR-175-2133-4. Second deck, crews galley, frame 97, looking to starboard from centerline at dumb waite, trunk and oven.

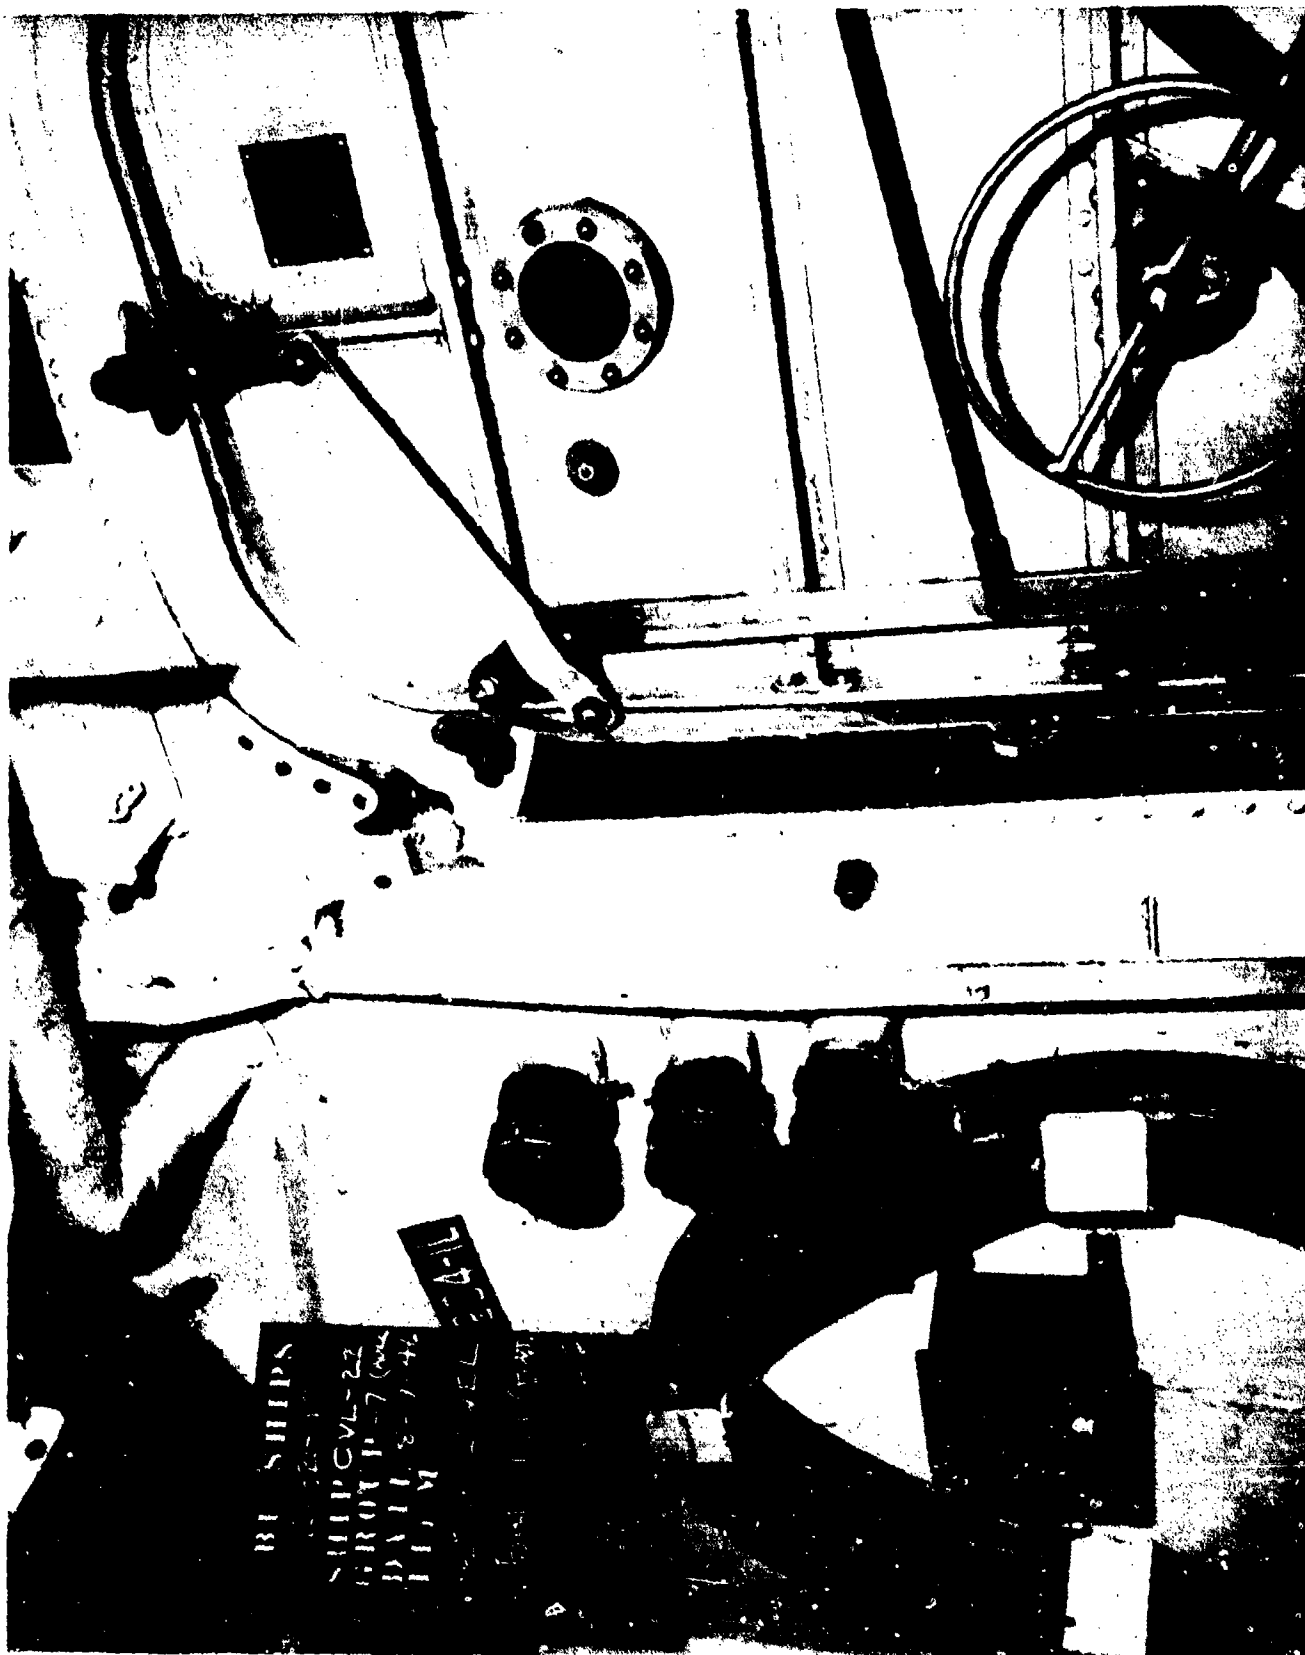
AA-CR-175-2132-10. Second deck, looking aft on port side at W.T. door in bulkhead 101. Note condition of bulkhead for opposite side, see 2115-5.

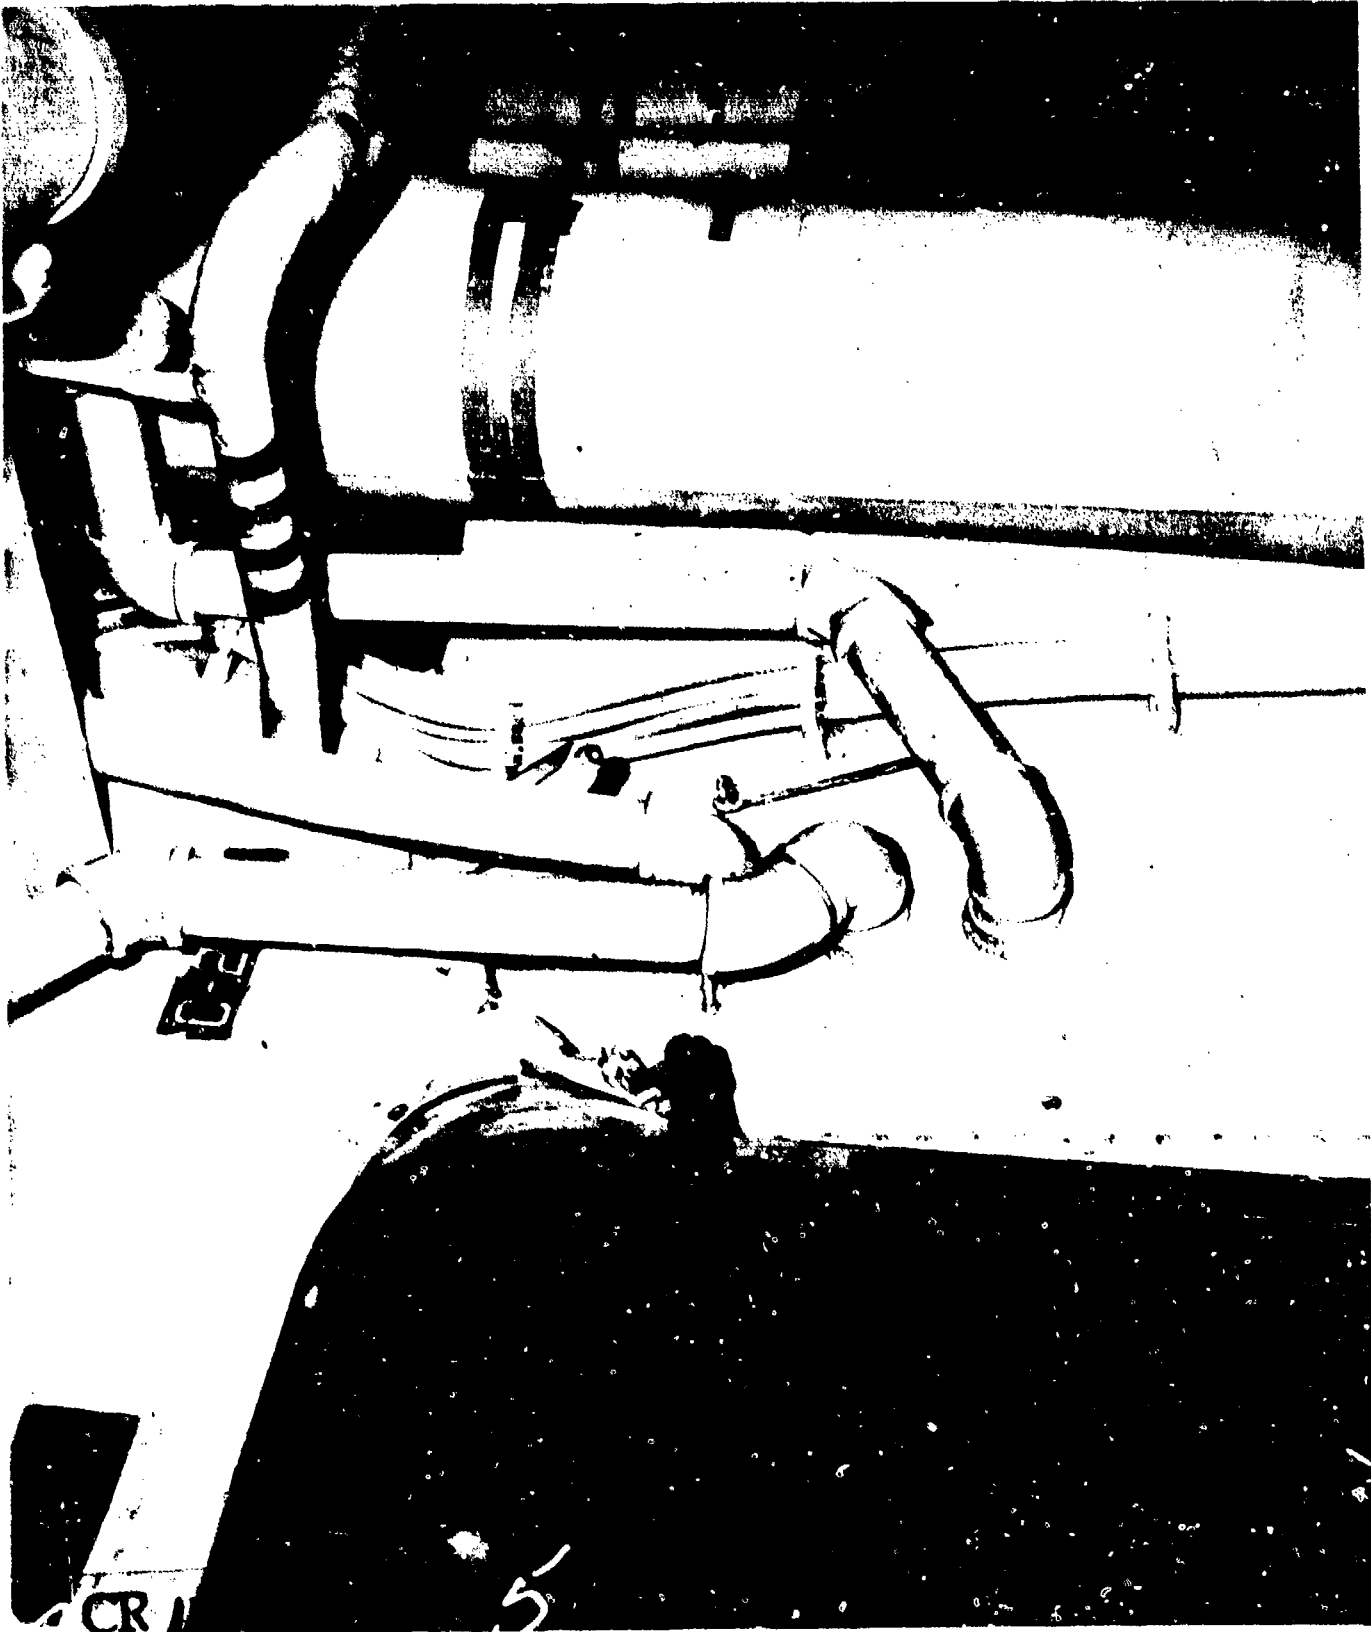
AA-CR-175-2115-5. Second deck, C-201-L. Looking forward on port side at W.T. door and bulkhead 101. Note buckle across top of door. For opposite side, see 2132-10.

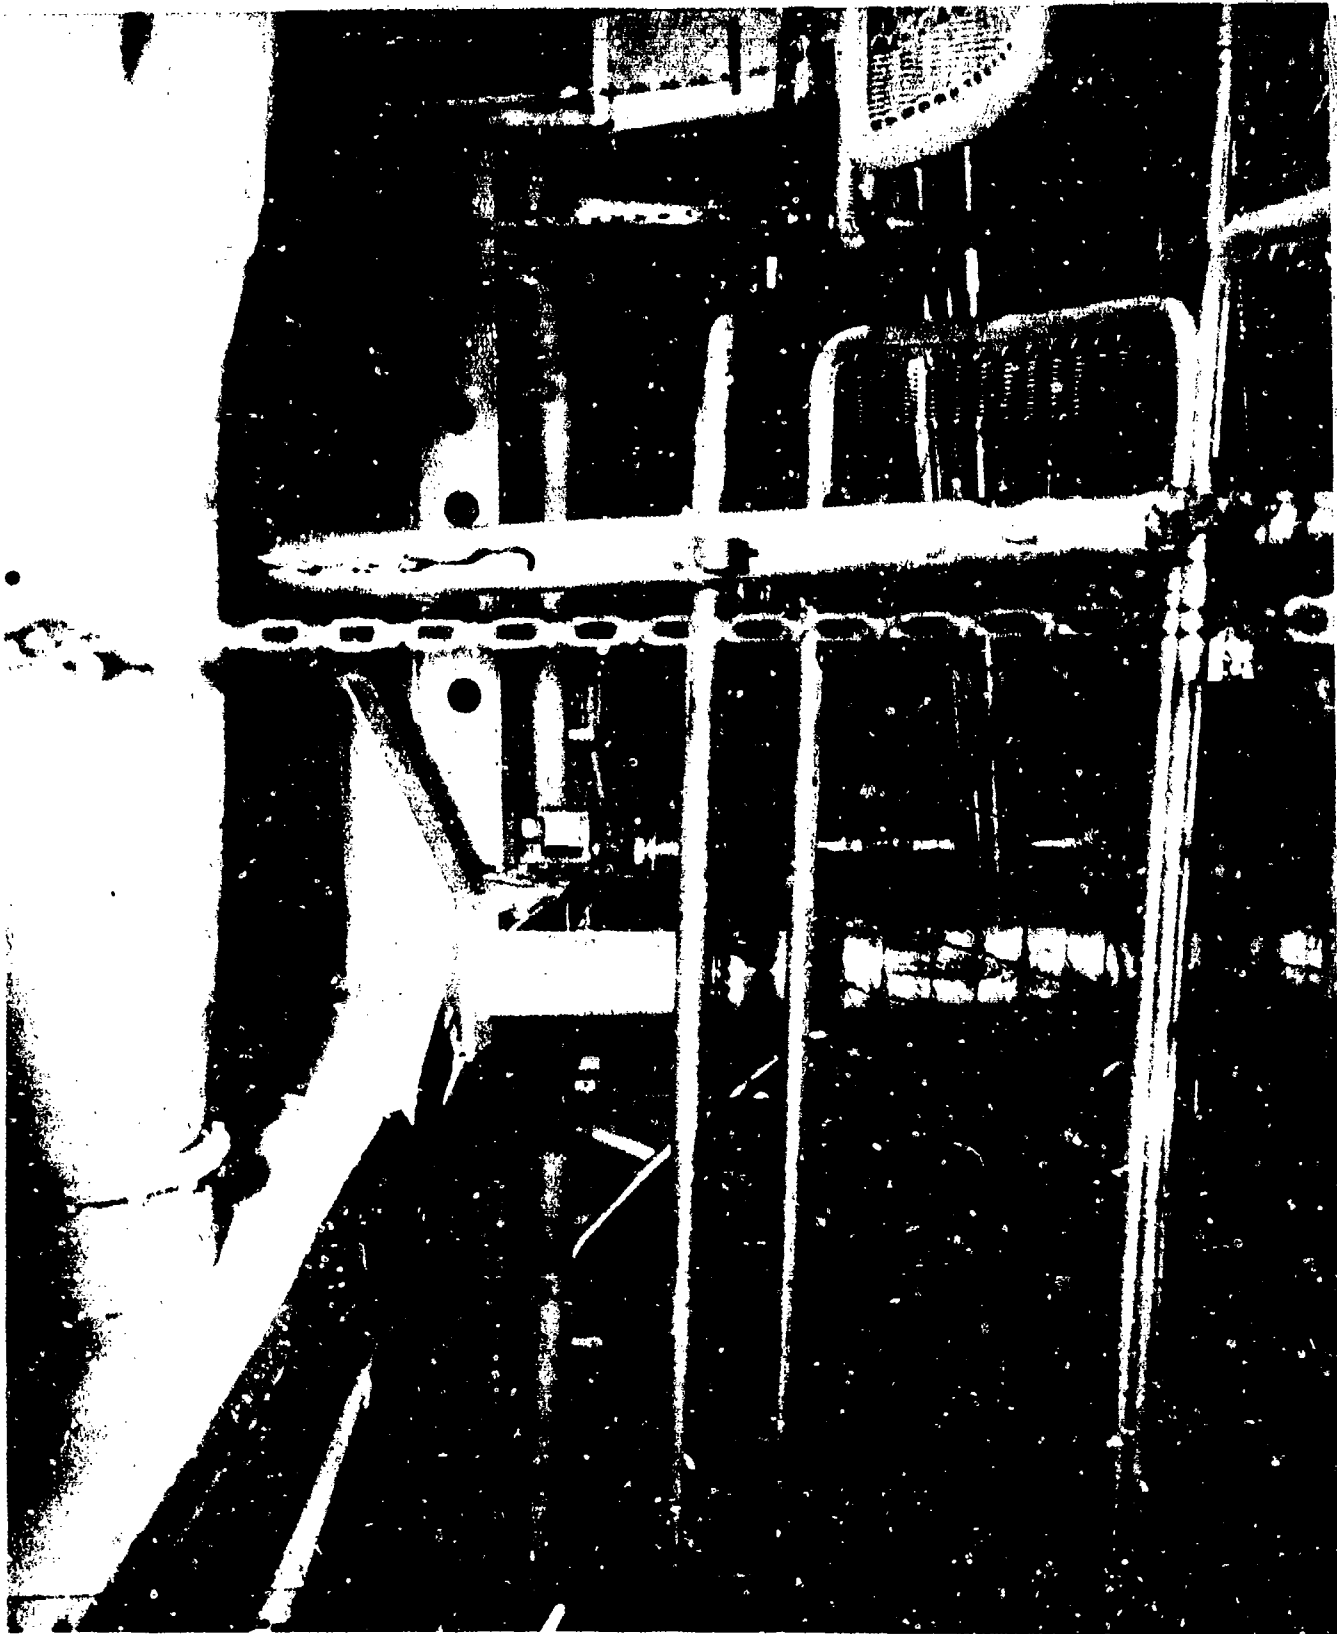
AA-CR-175-2115-6. Second deck. C-201-L, crews berthing, showing buckled transverse main deck beam at frame 103. Looking forward and to starboard.

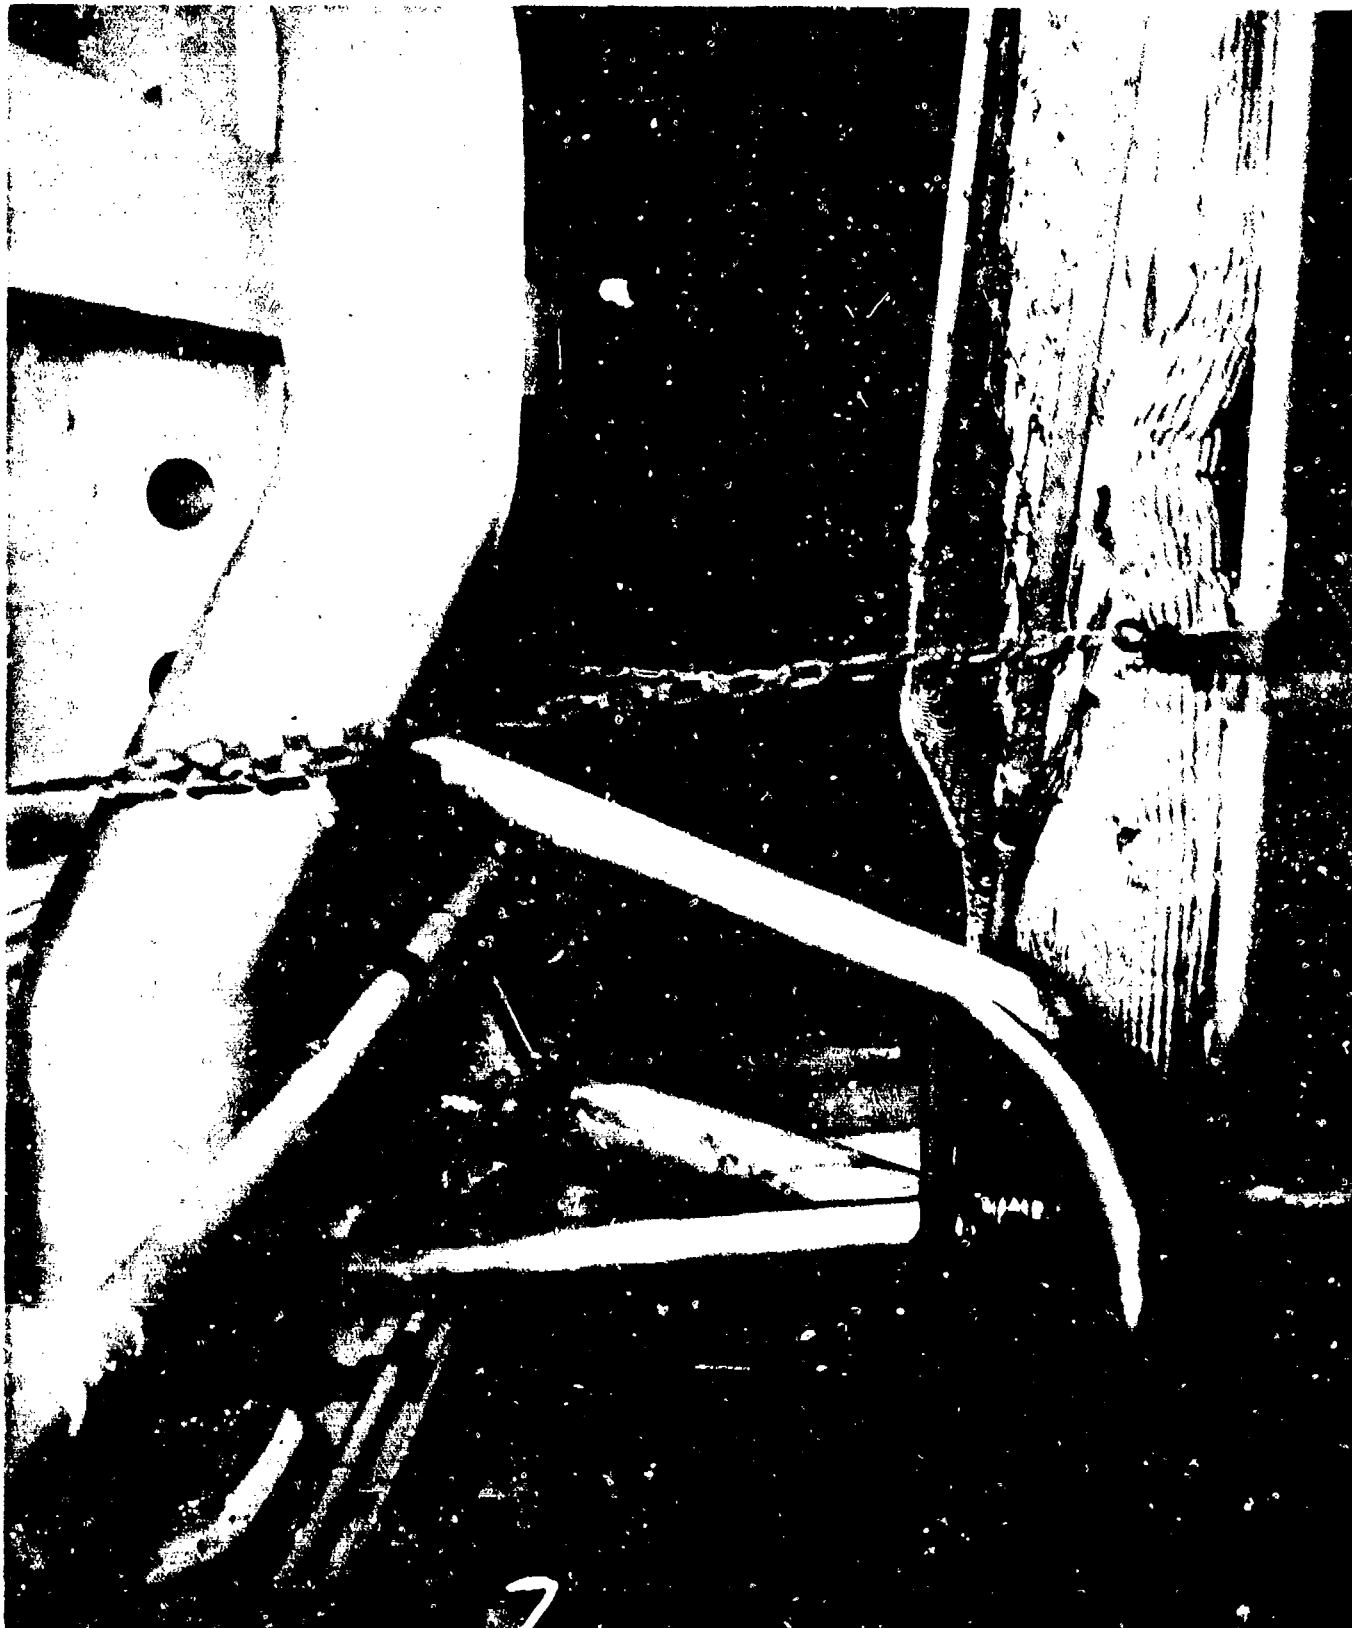
AA-CR-175-2115-7. Second deck, C-201-L, showing buckled centerline stanchion at frame 106. Looking to starboard.

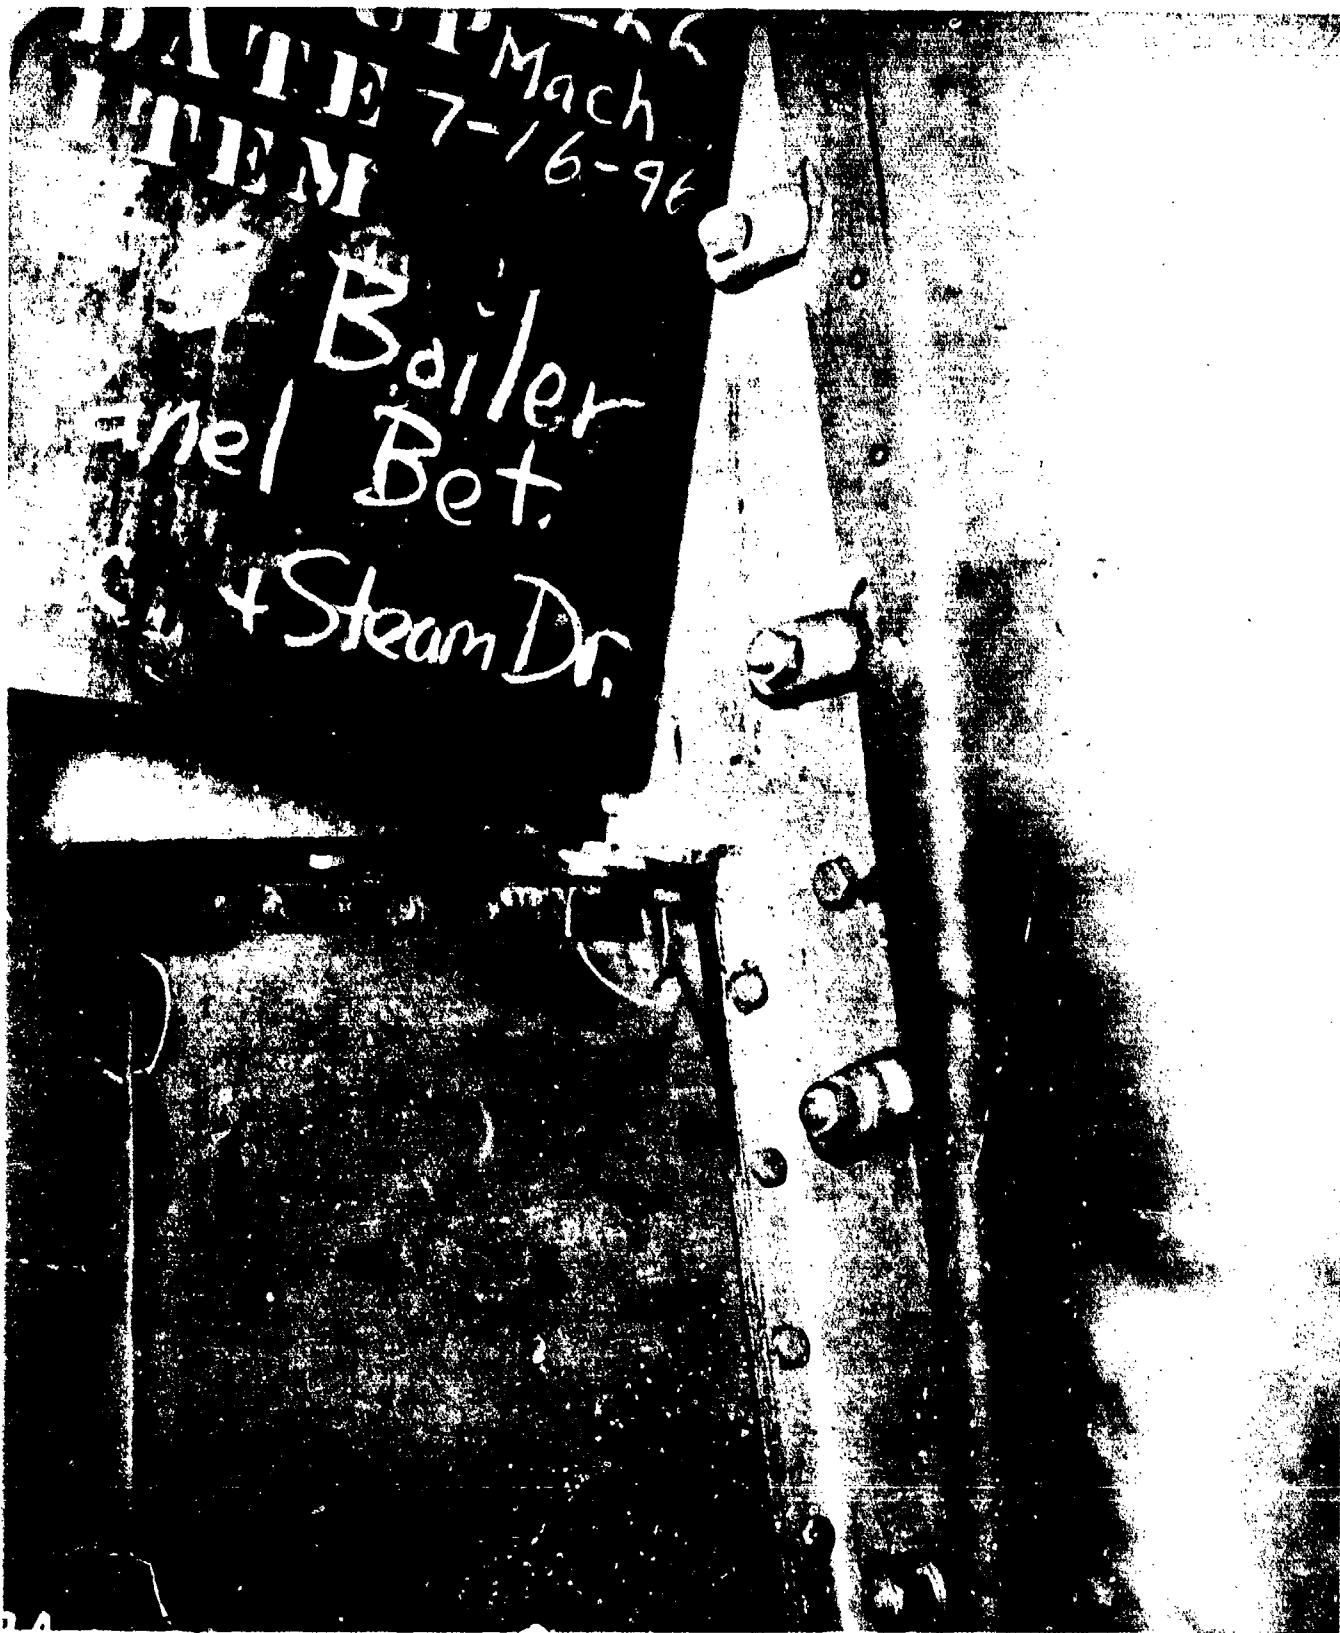
AA-CR-62-2172-8. #3 Boiler panel, between economizer and steam drum.
