# BUREAU OF SHIPS GROUP TECHNICAL INSPECTION REPORT

## U.S.S. INDEPENDENCE (CVL22)

### TEST ABLE

### OPERATION CROSSROADS

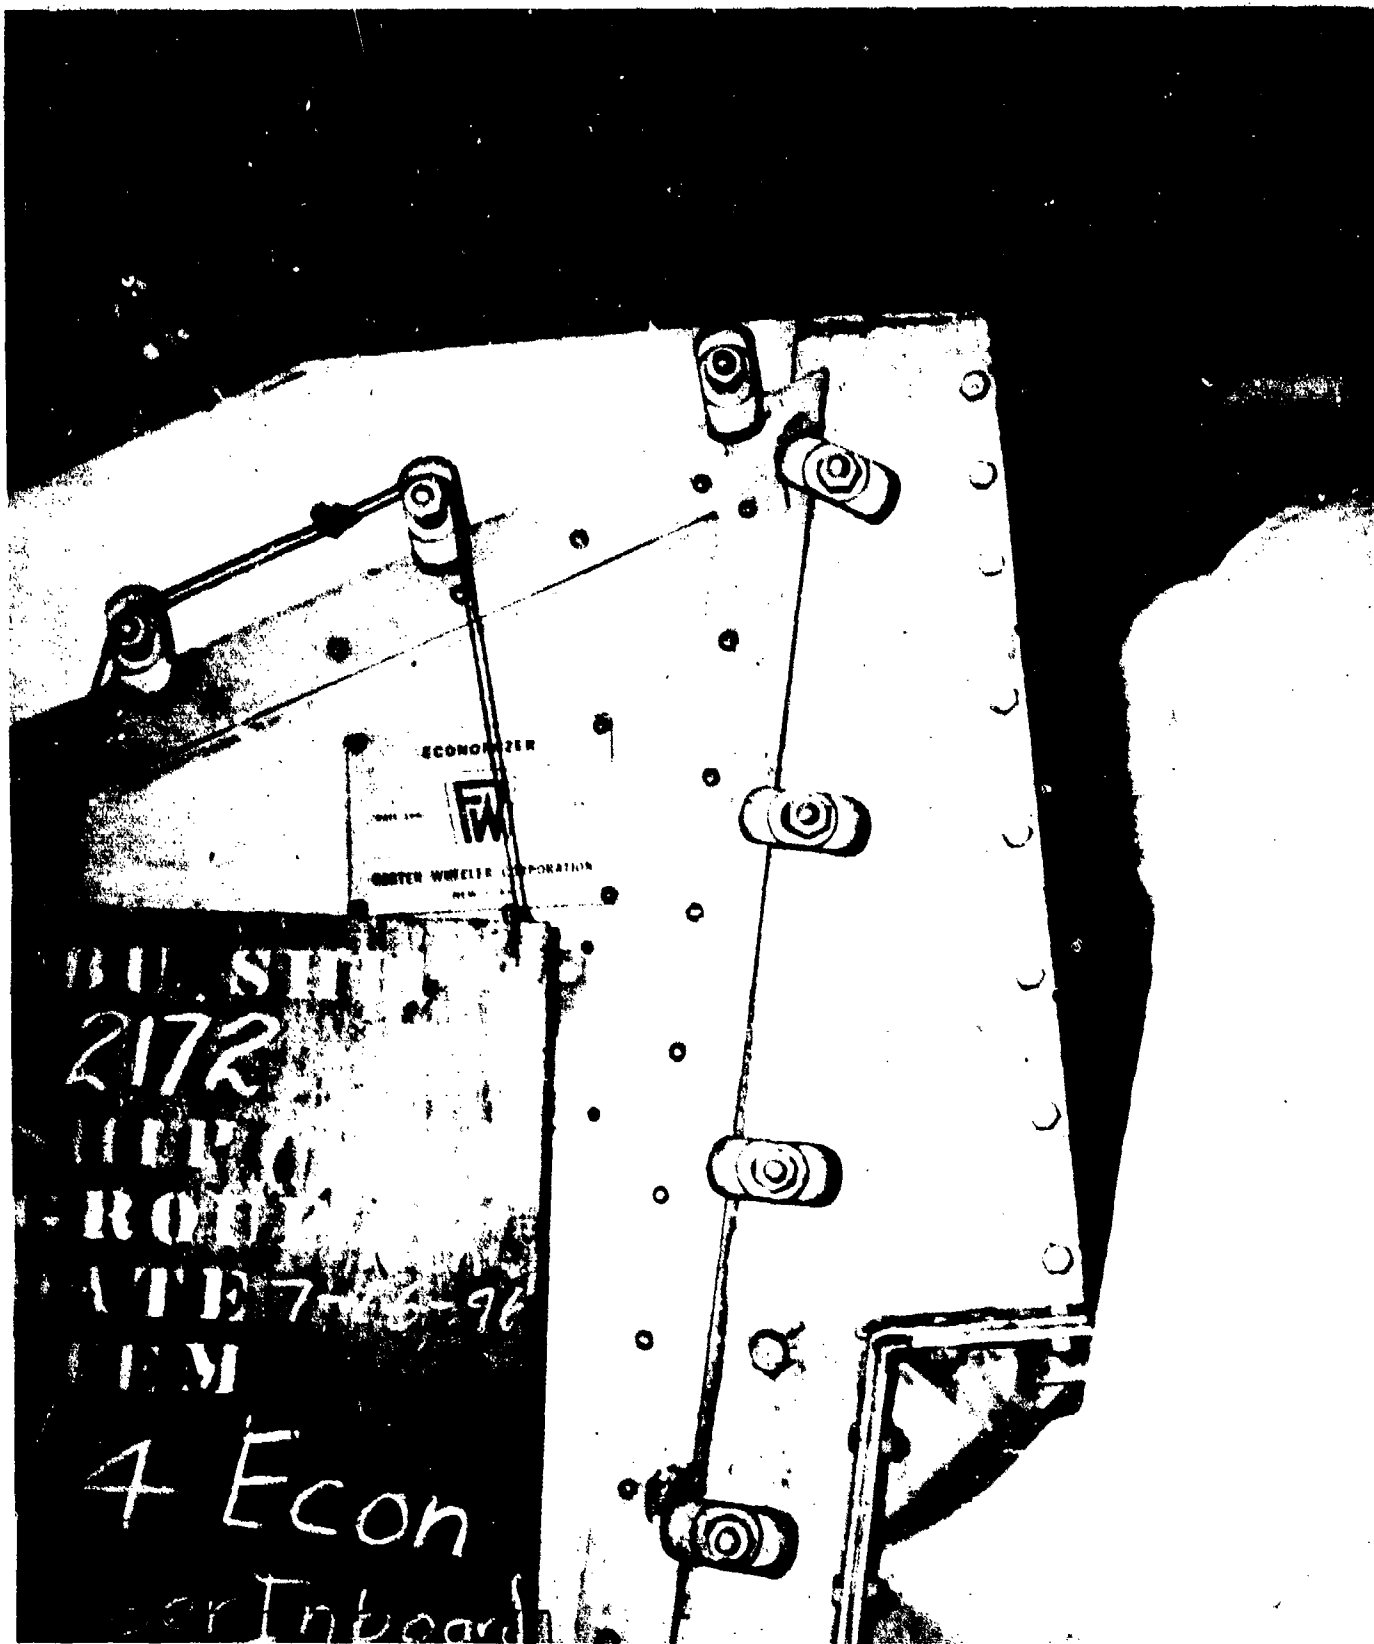
AA-CR-62-2172-7. Economizer, upper front inboard corner.

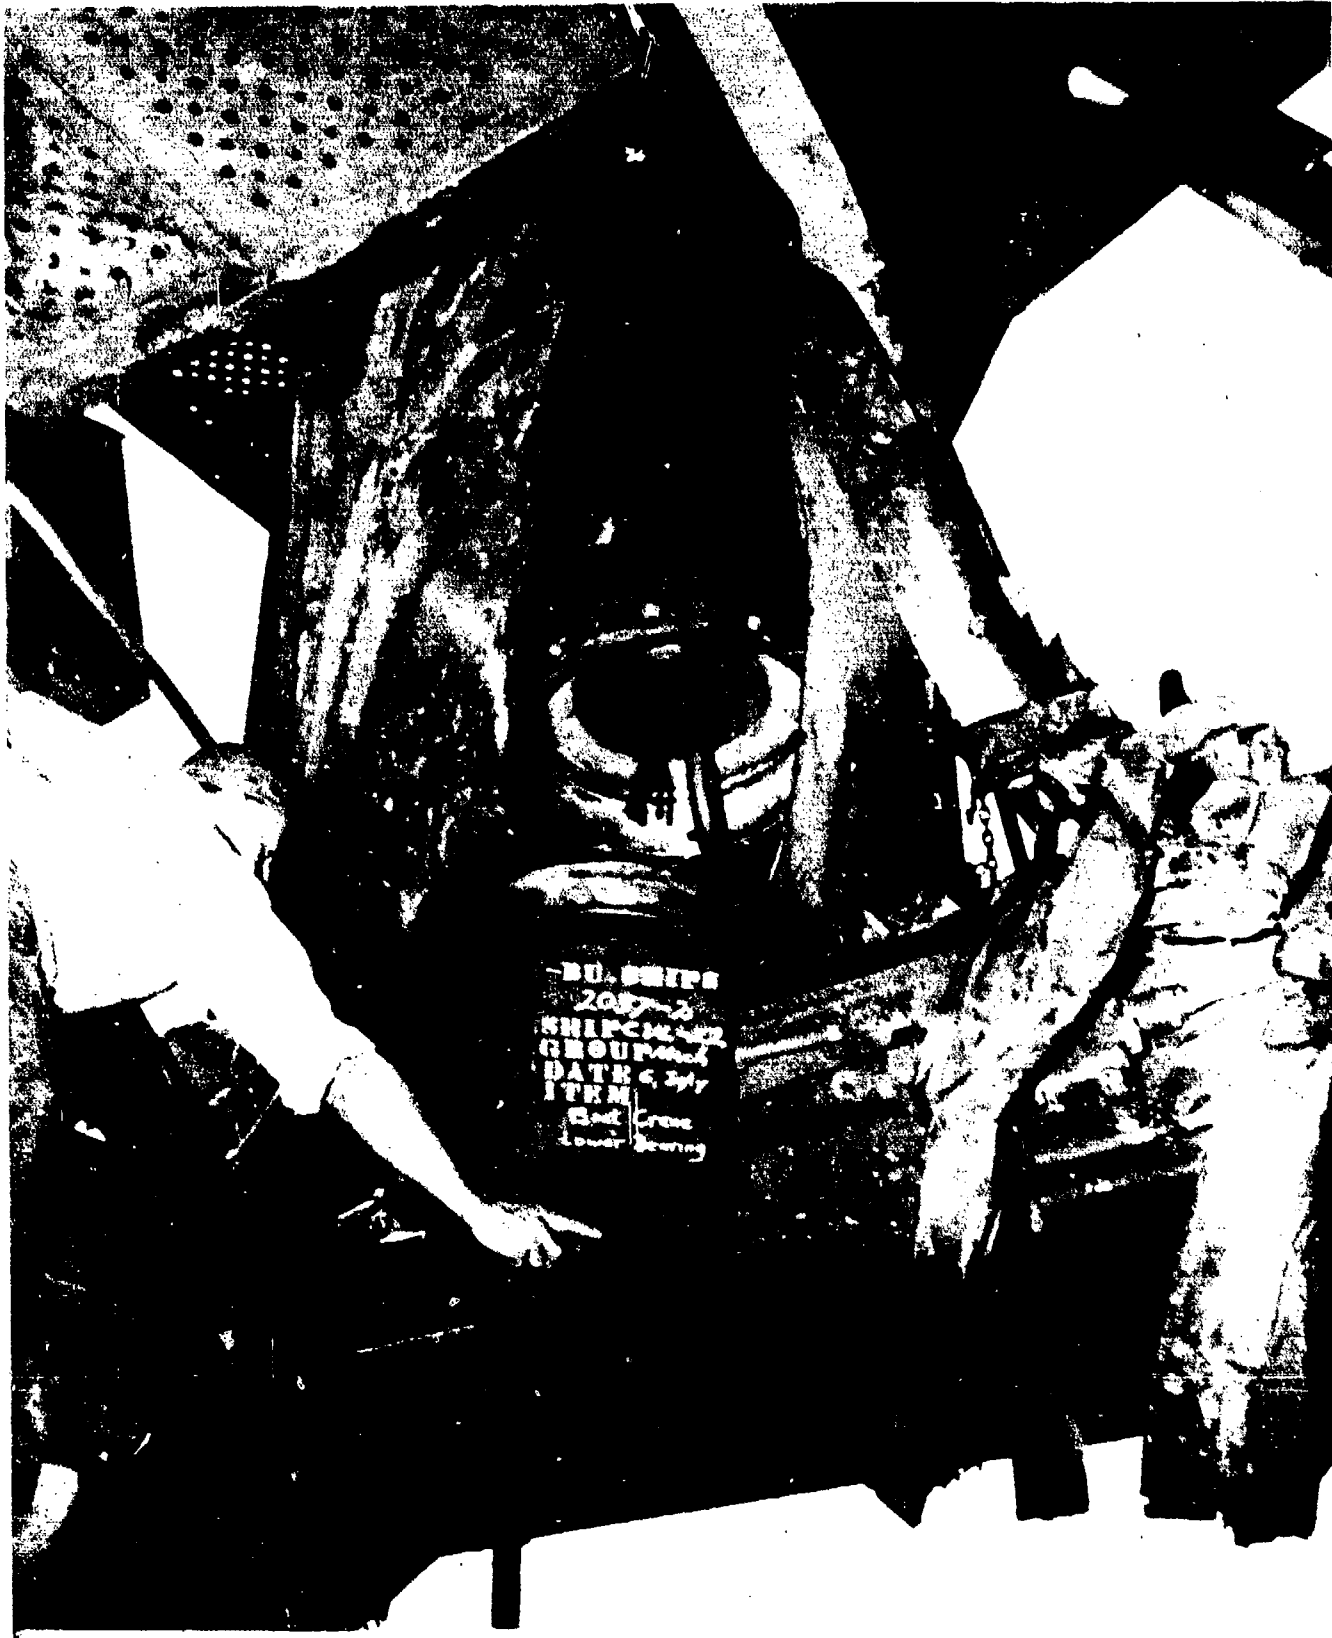
AA-CR-175-2037-2. Boat crane, lower bearing.

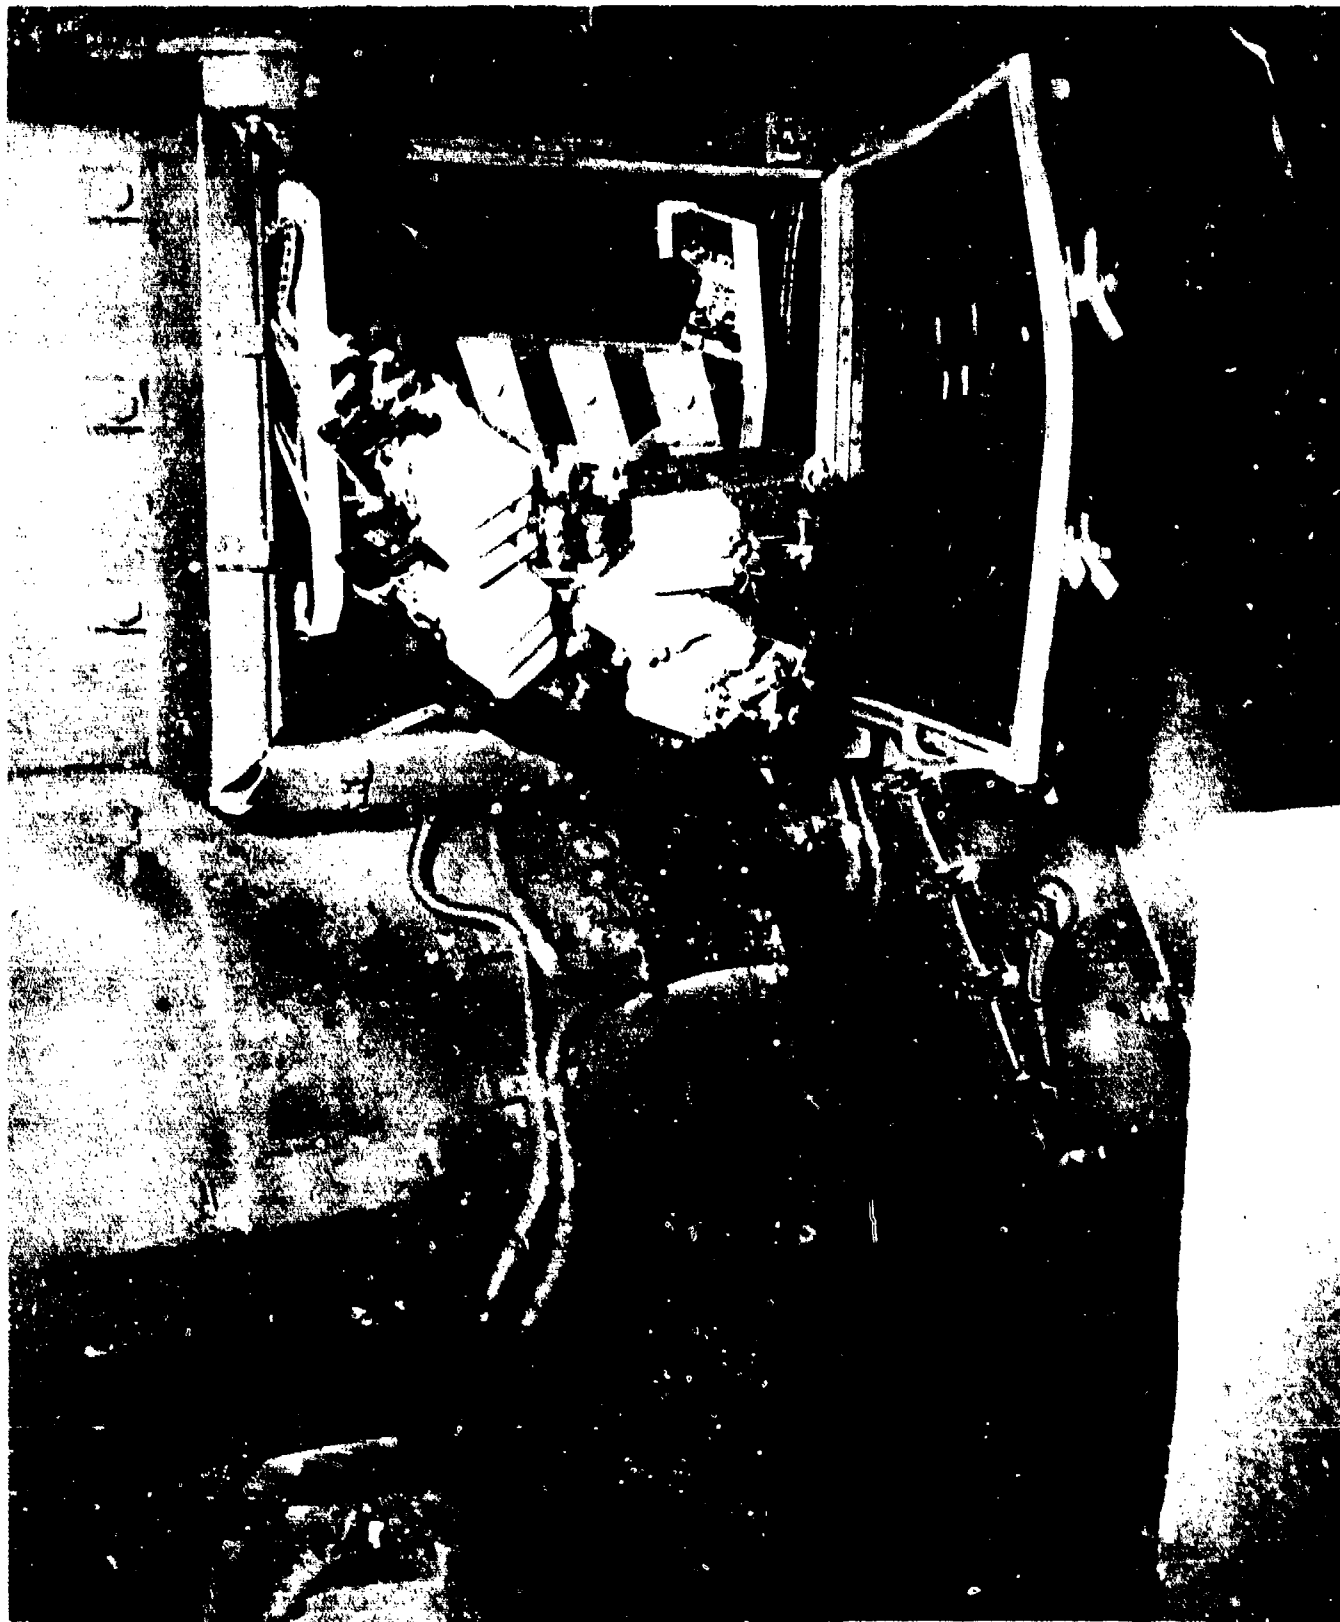
AA-CR-62-1881-6. Damaged transformer and power panel # 3-101-1 on gallery deck level frame 103 starboard in gun crew shelter, view looking aft.

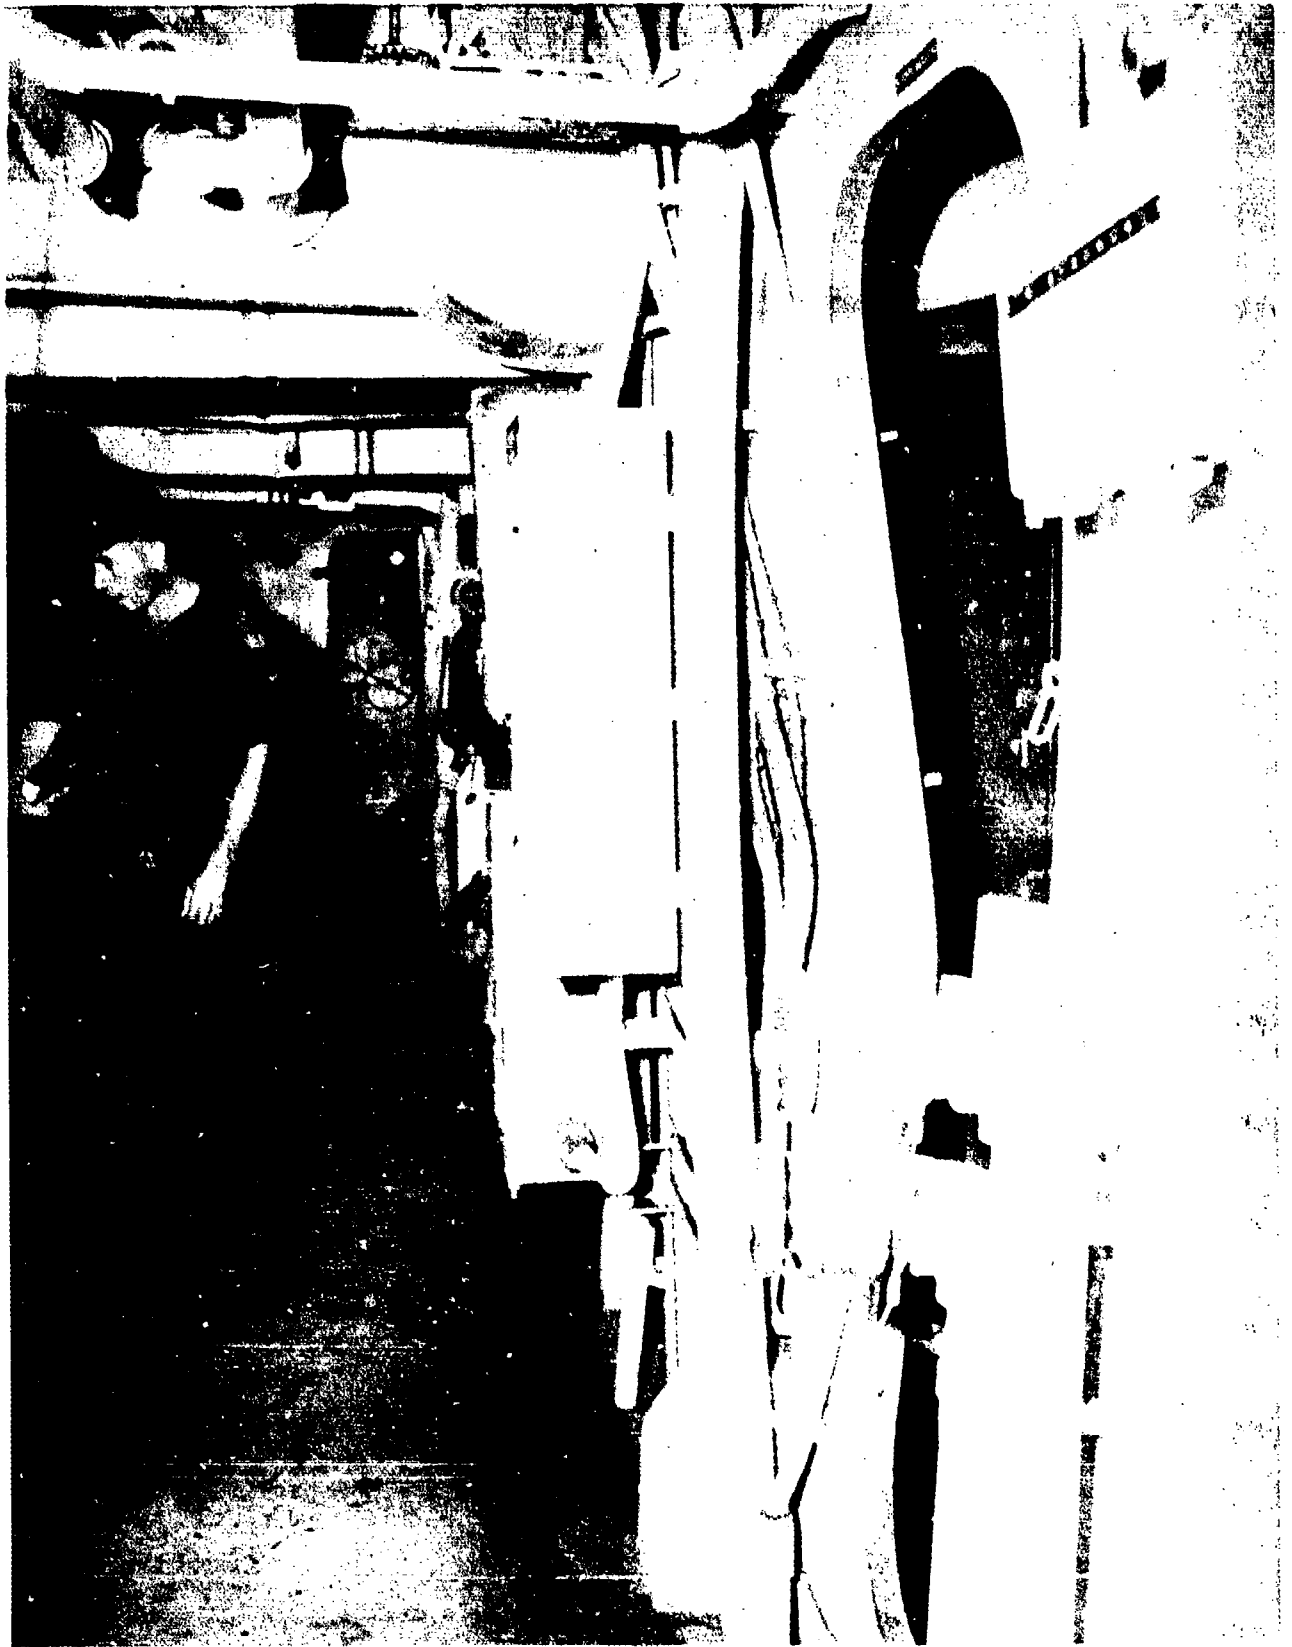
AA-CR-82-1916-6. Lighting distribution panel 2-72-2 mounted on angle bar extending from deck to deck frame 71 starboard side second deck. Supports buckled and cable partially pulled out of panel due to deflection in deck. View looking aft.

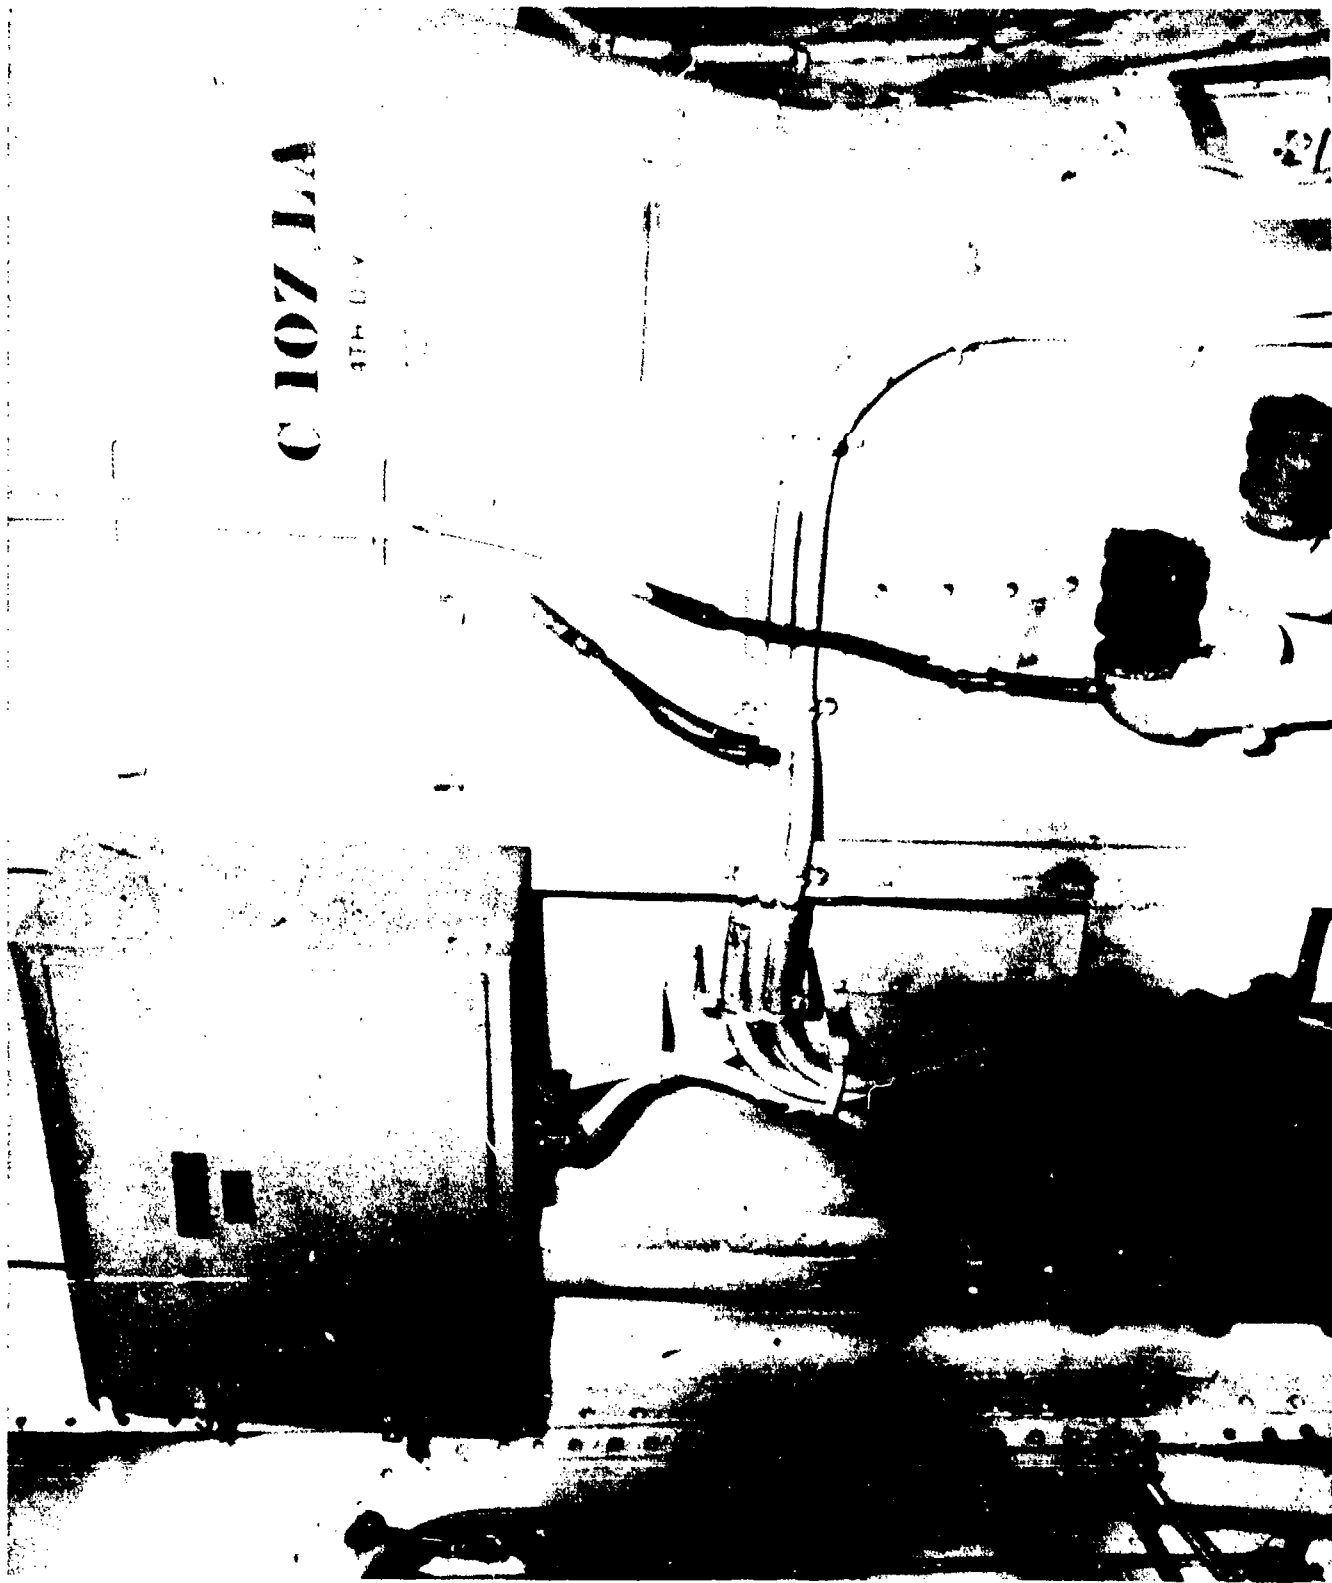
AA-CR-82-1918-12. Cable left hanging after a single phase transformer for 40MM machine gun system was dislodged from bulkhead by bomb blast pressure. Power panel and transfer switch were subjected to heat from fire in adjacent compartment. View looking aft to frame 136 main deck.

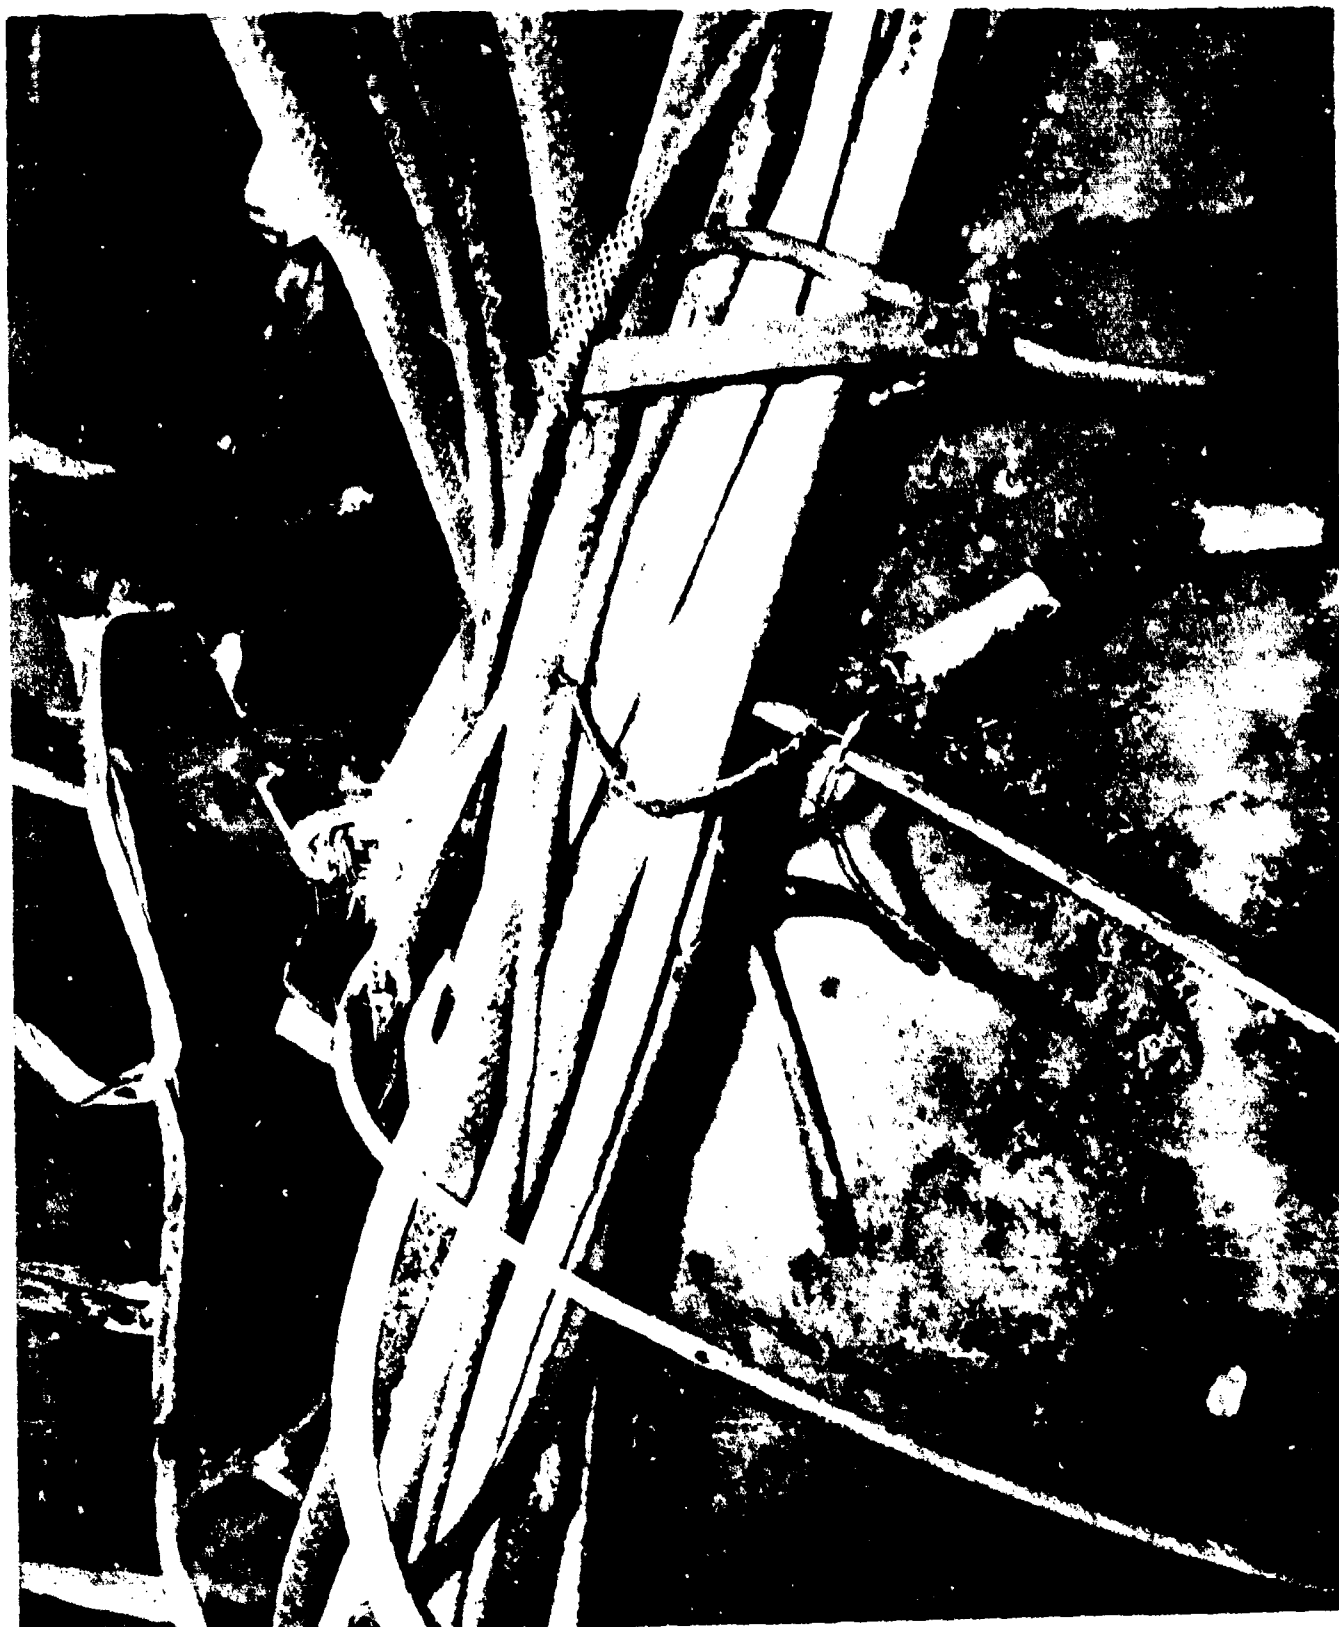
AA-CR-234-1989-12. Damage to a MHFA-44 cable. Note sheath and conductors blown out. Located on top of air defense station.

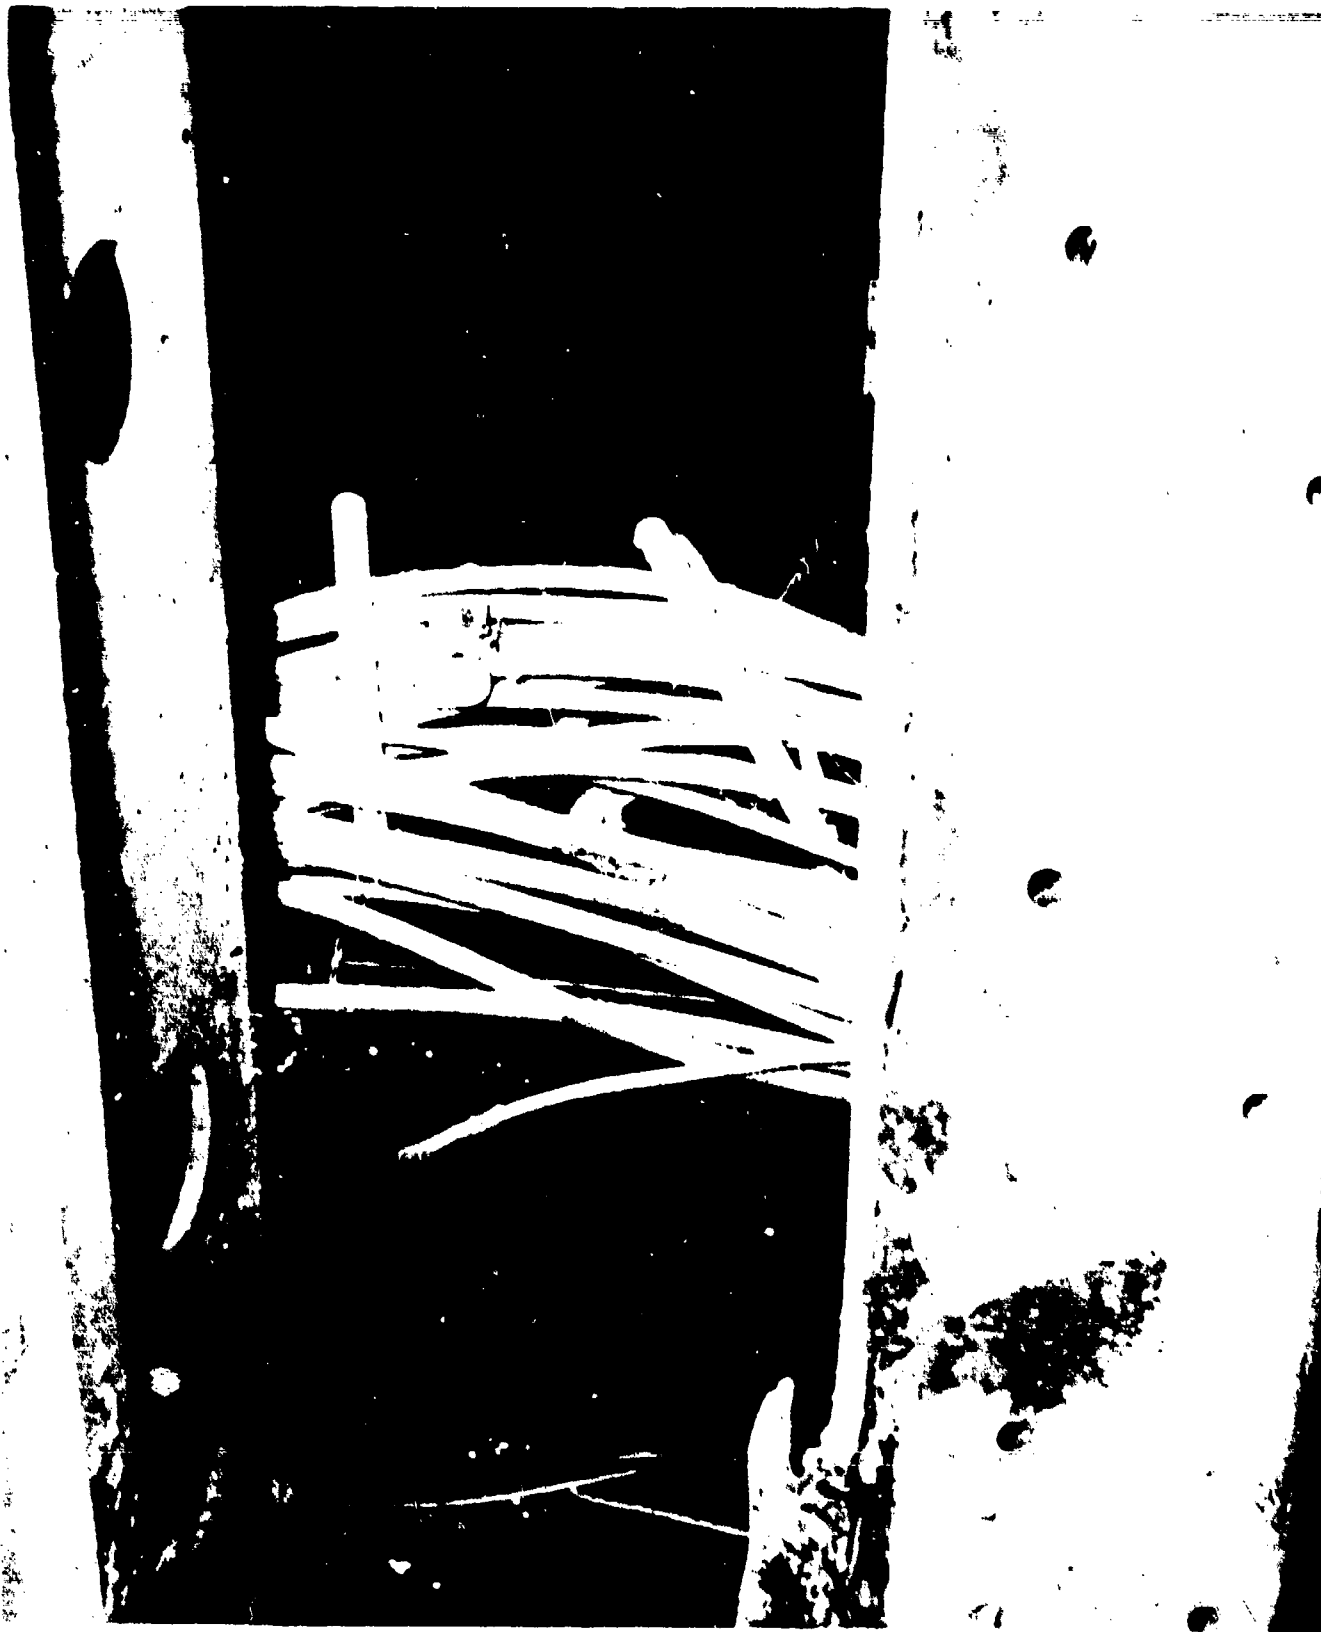
AA-CR-82-1920-1. Wireway under flight deck. Deck separated at expansion joint. Only two or three cables severed. Frame 112P side view looking down and outboard from flight deck.

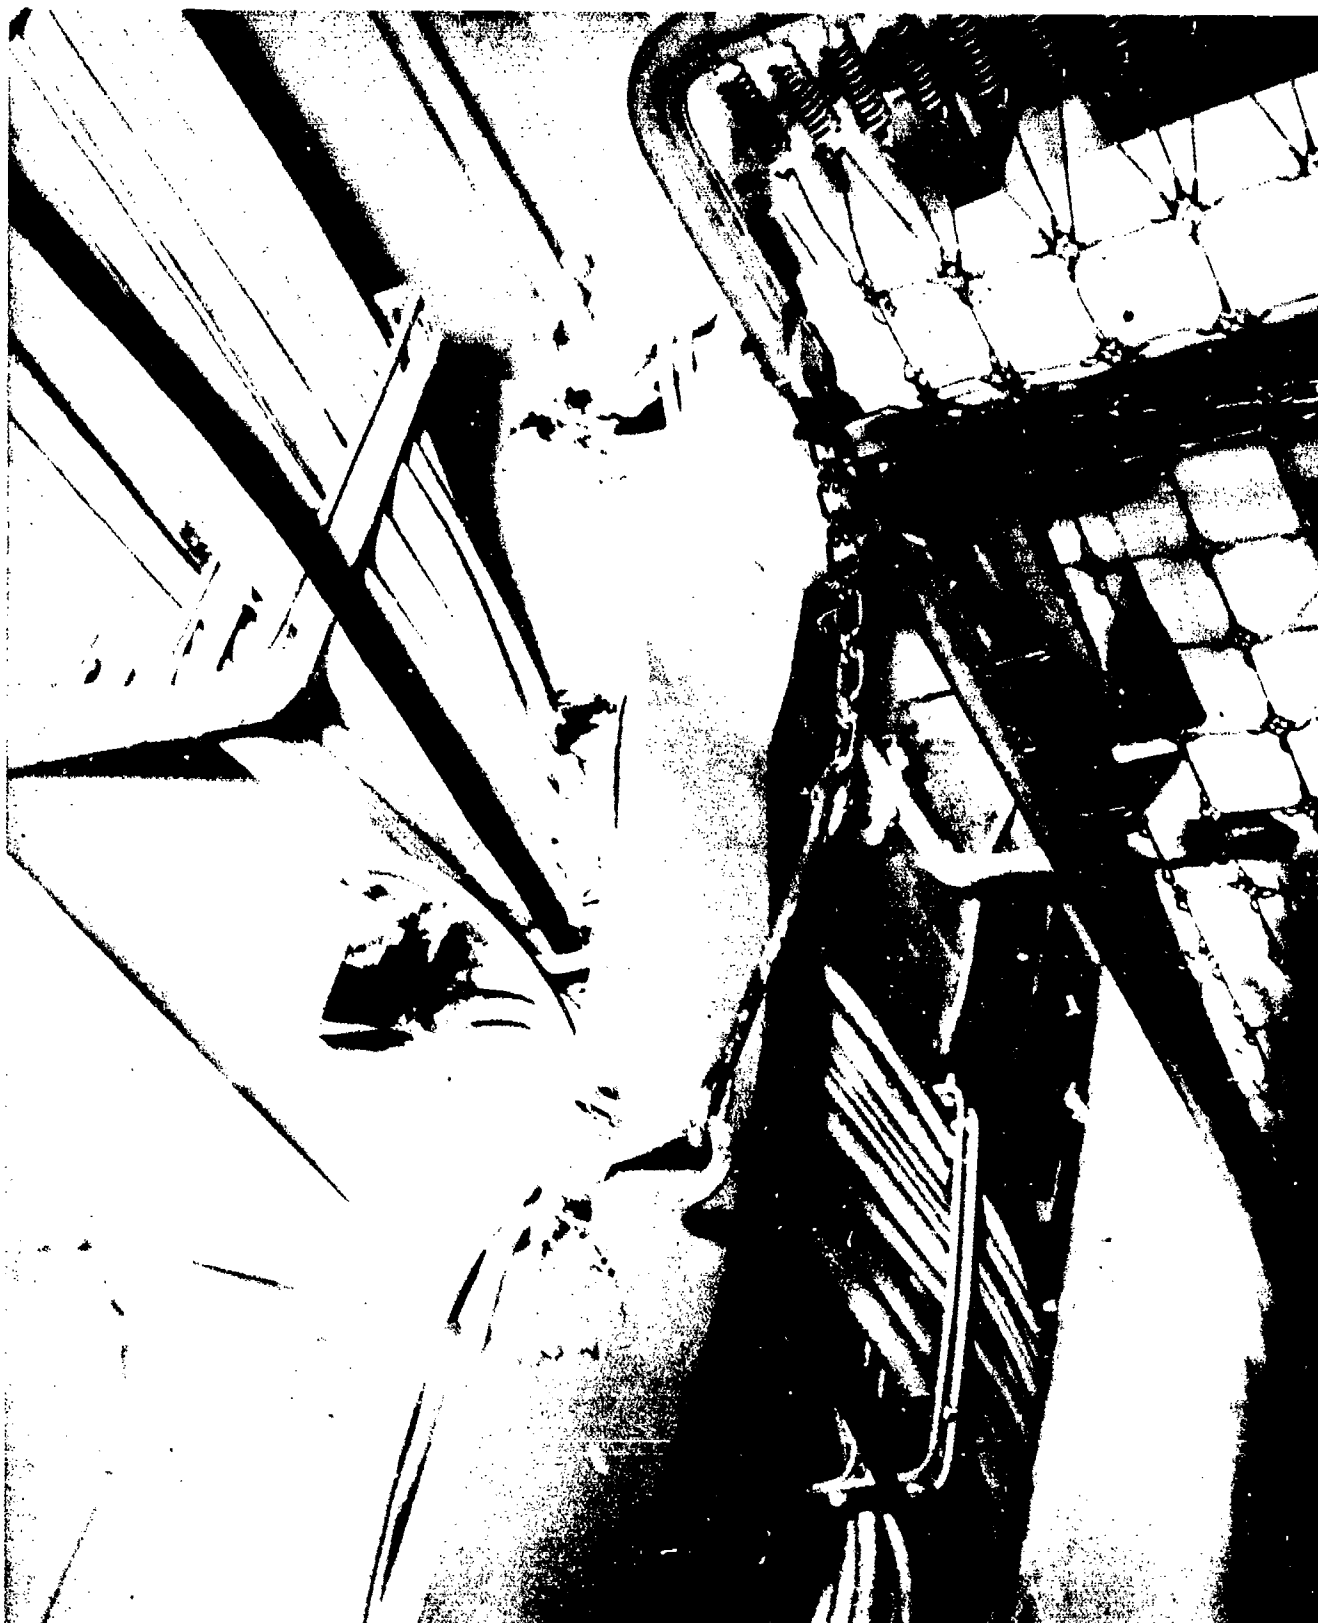
AA-CR-82-1917-2. Cable through lightening hole in girder on 2nd deck, frame 116 port side. Damaged due to buckle in girder web. View looking aft.

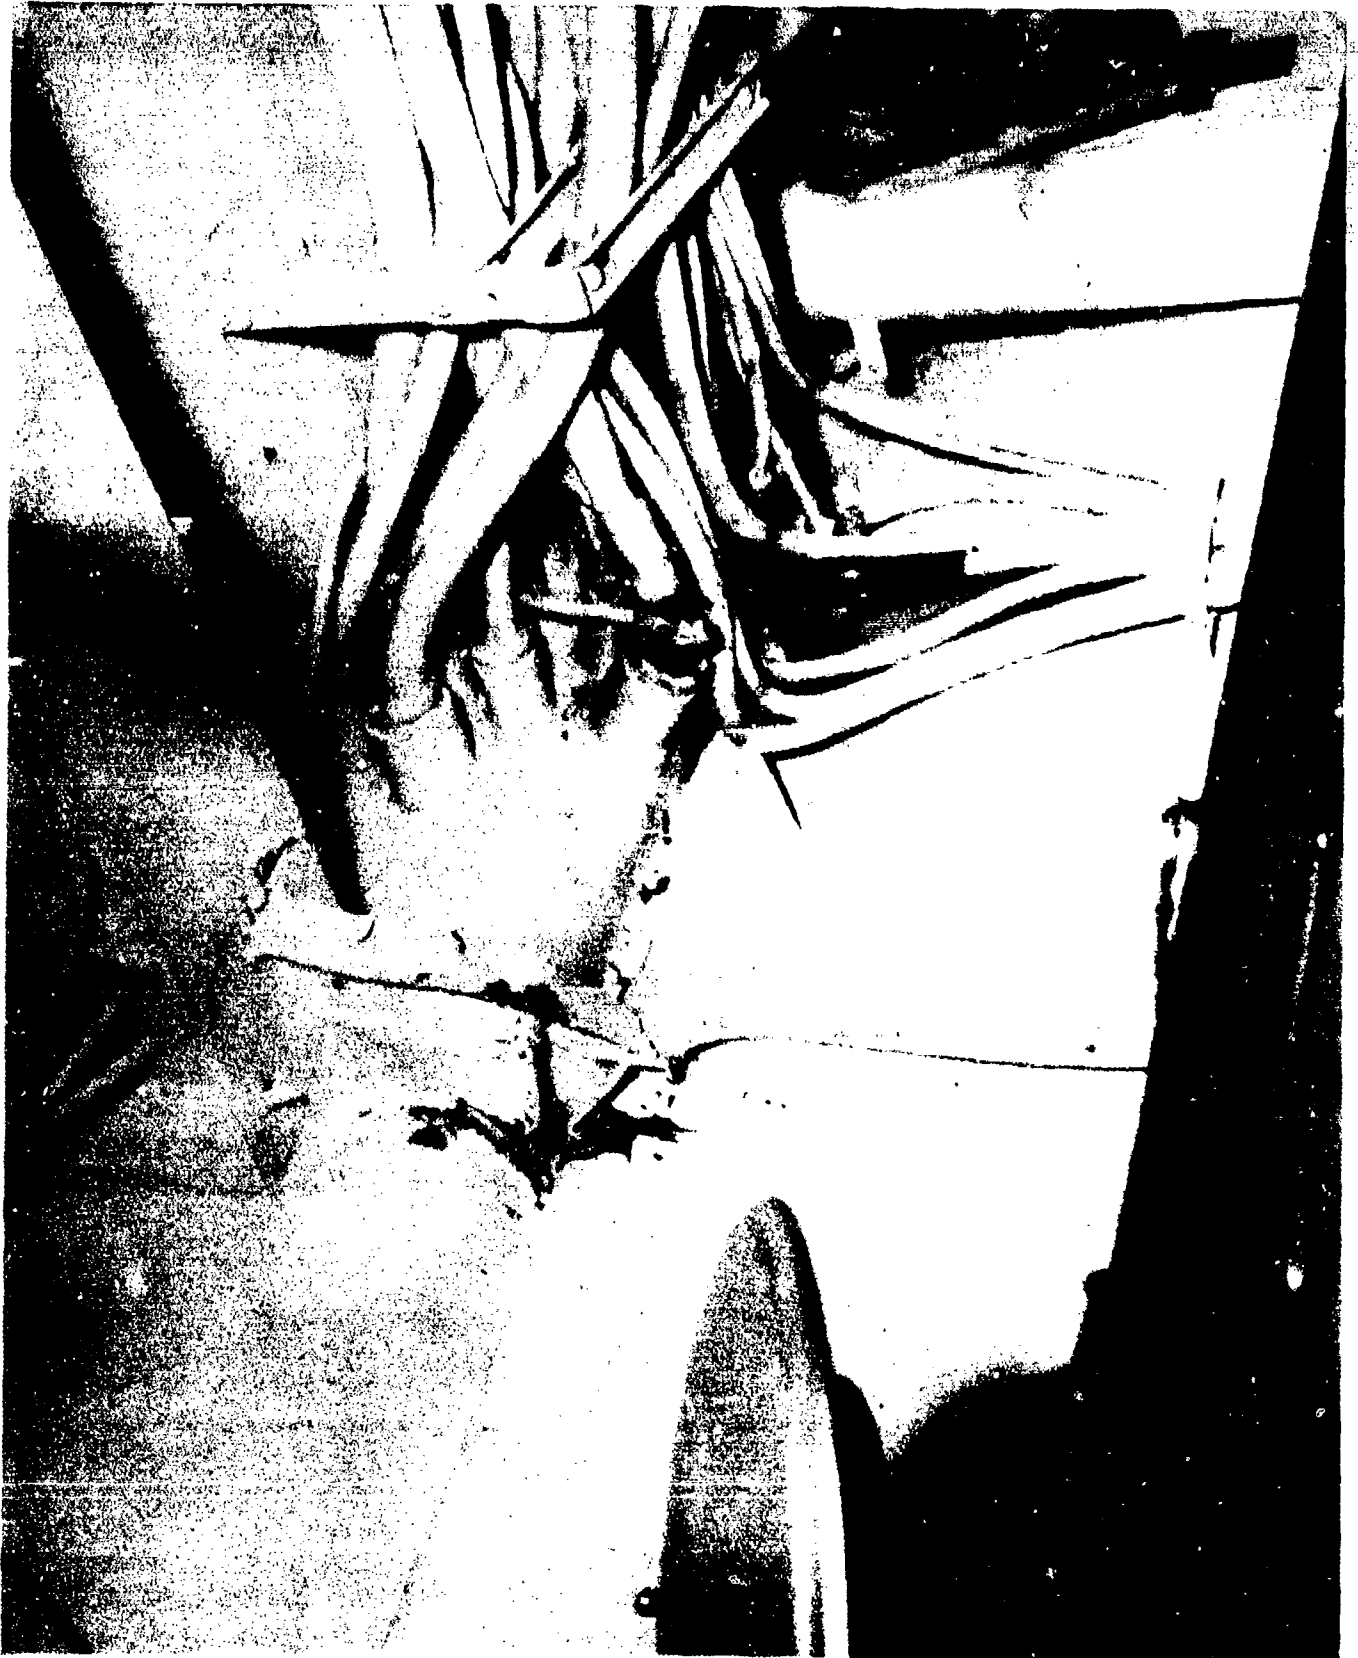
AA-CR-82-1916-3. Stuffing tube area through bulkhead 49 port side, second deck, break in cable due to deflection of tube area, view looking up and forward.

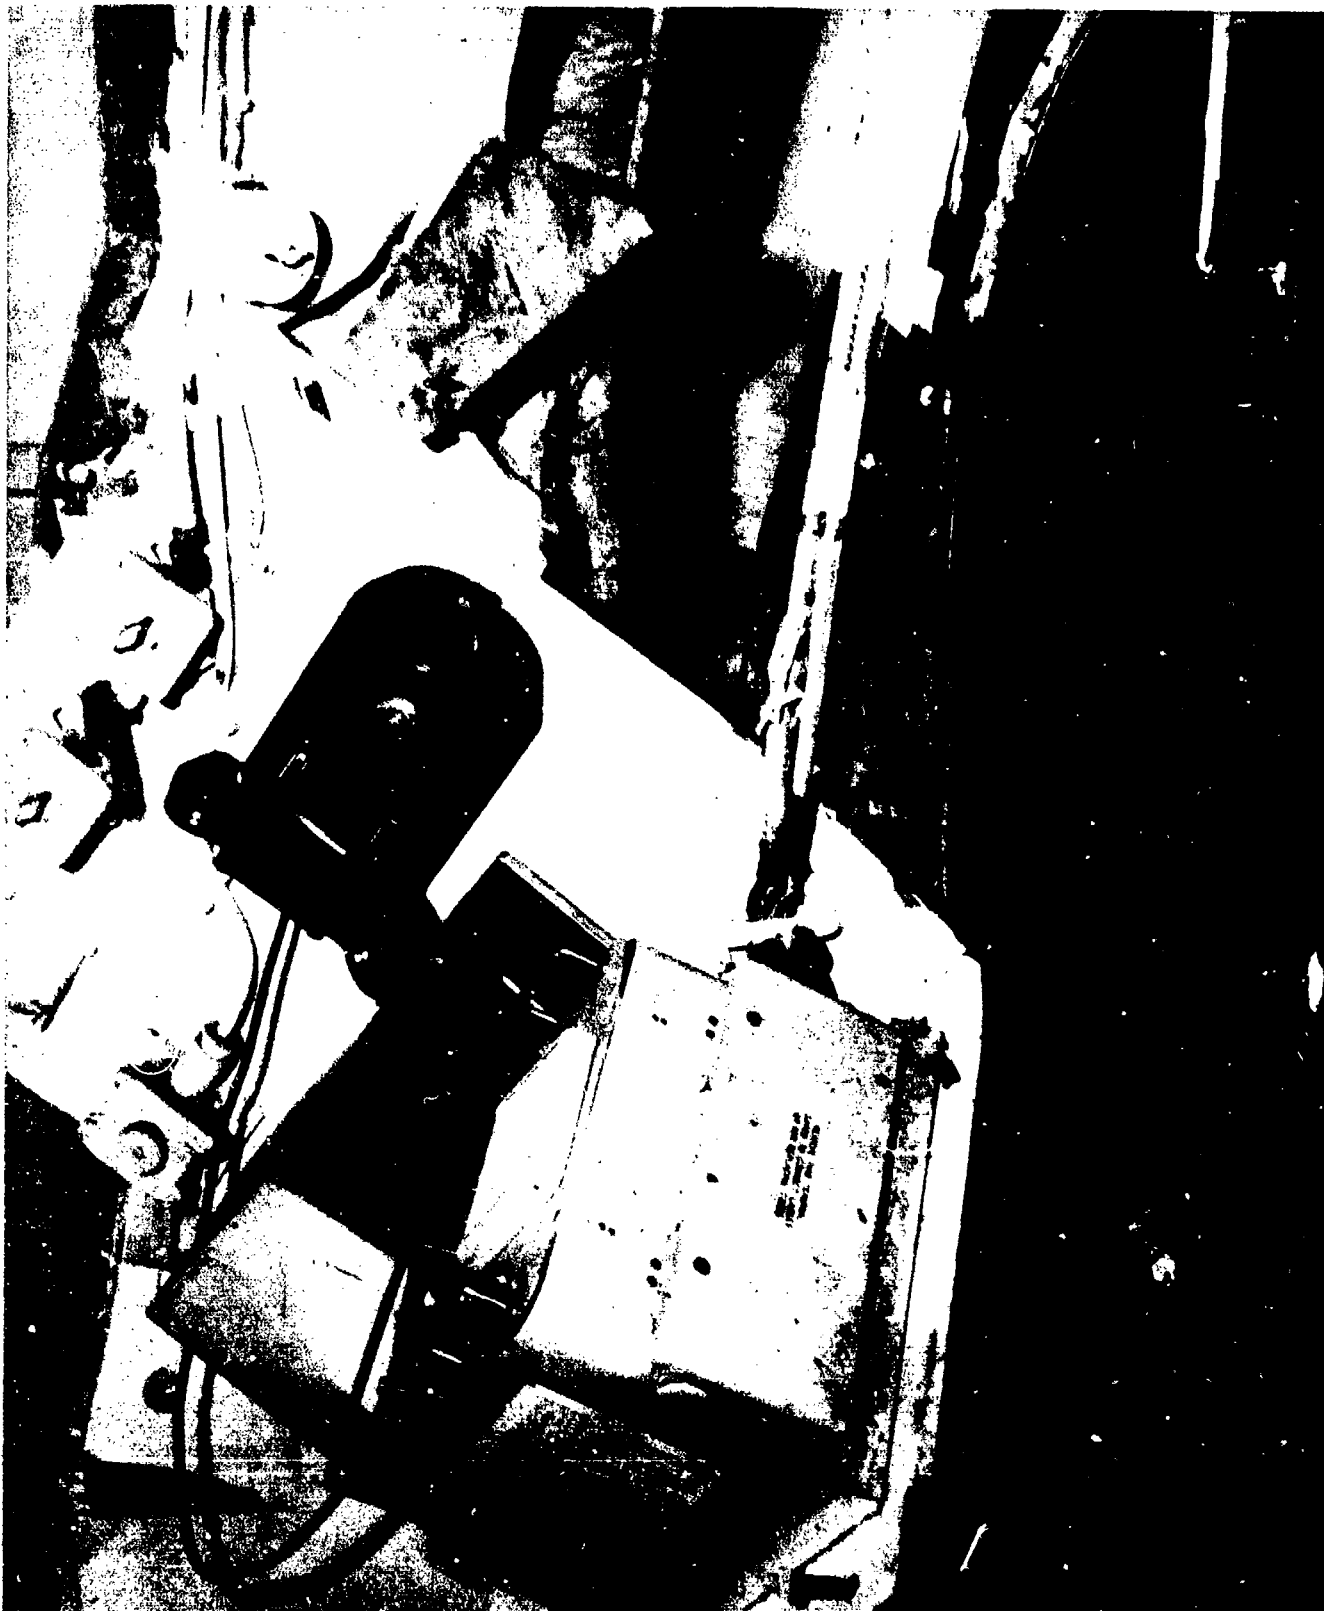
AA-CR-82-1920-5. Wiring and wiring equipment etc. on metal joiner bulkhead, frame 40 port side galley deck. Damage due to failure of bulkhead. View looking aft and to starboard.
