# BUREAU OF SHIPS GROUP TECHNICAL INSPECTION REPORT

## U.S.S. INDEPENDENCE (CVL22)

### TEST ABLE

### OPERATION CROSSROADS

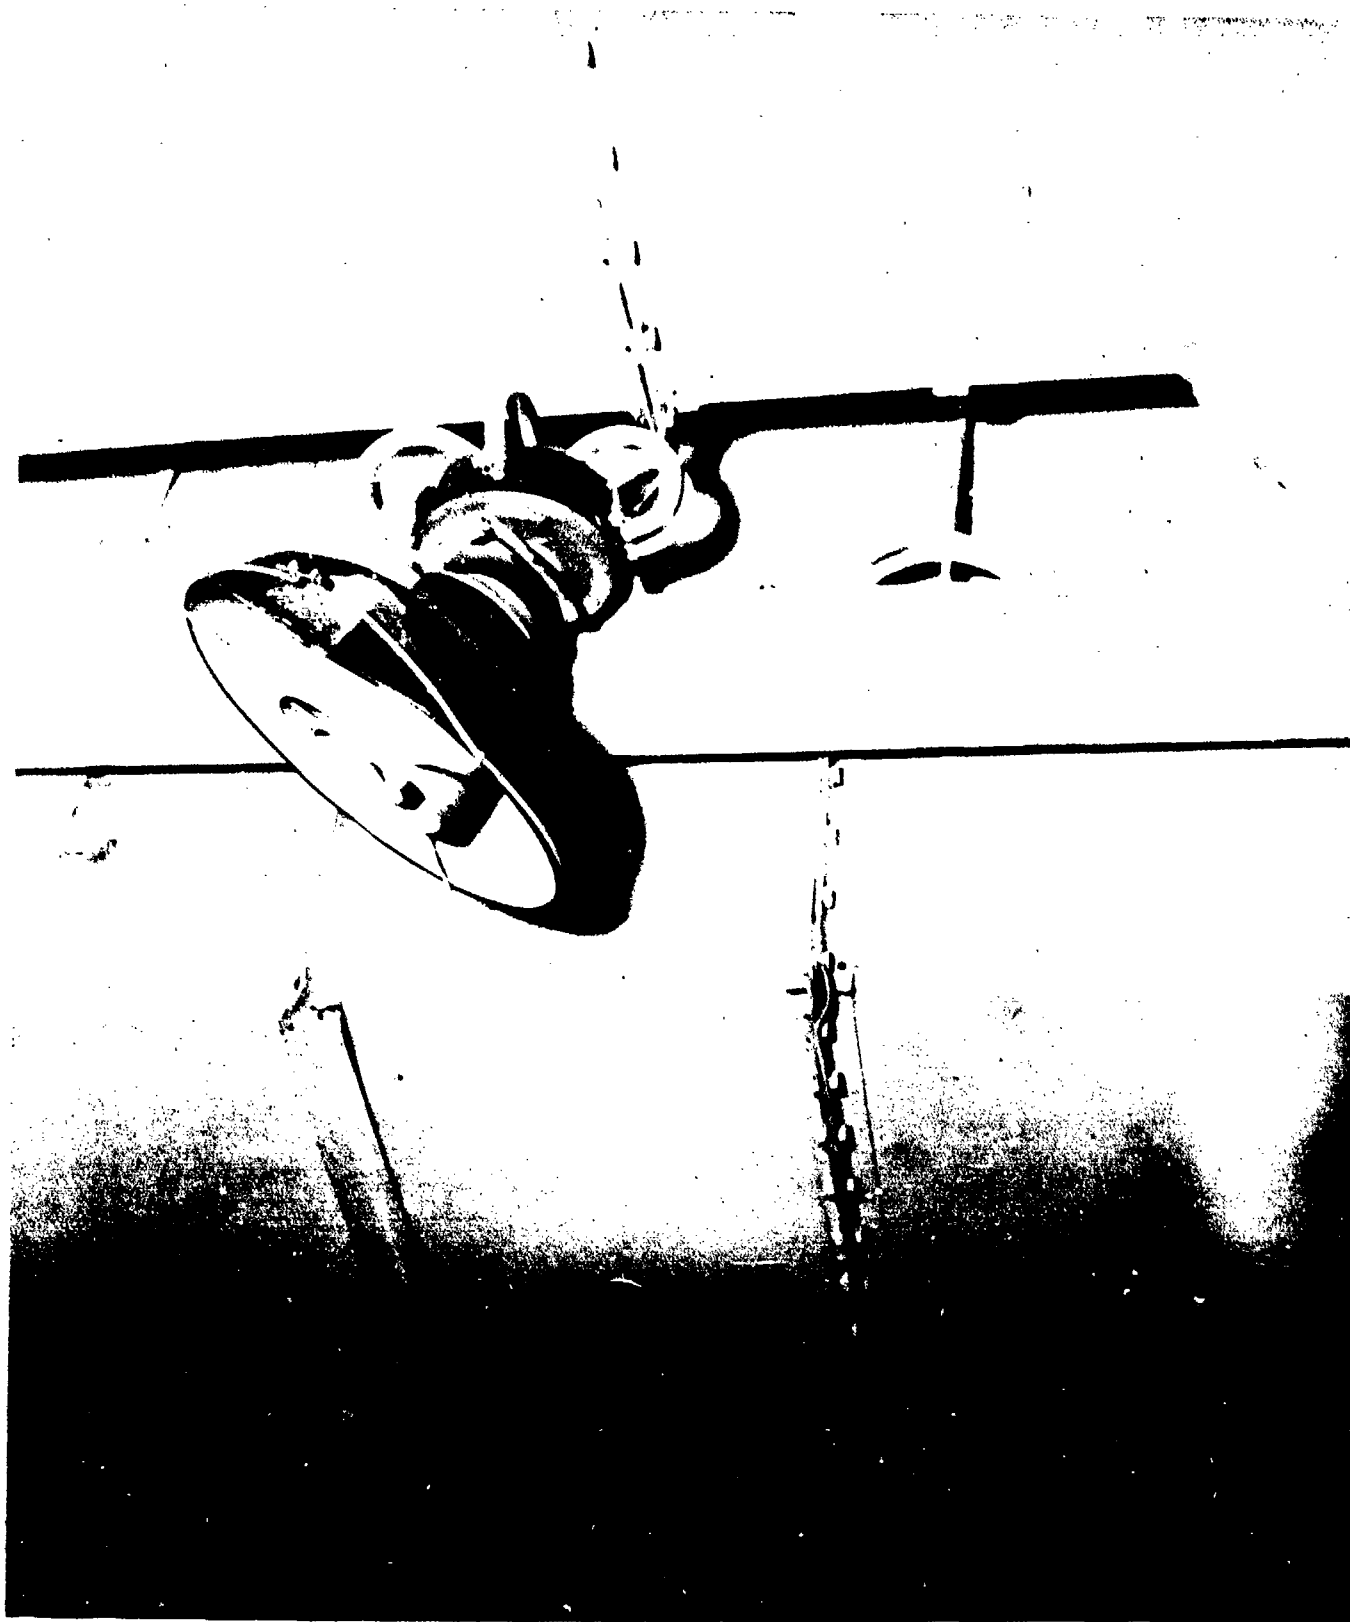
AA-CR-82-1920-7. Type "R-III" lighting fixture in state room frame  
36 starboard side galley deck. Light damaged by falling clothes locker.  
View looking aft.

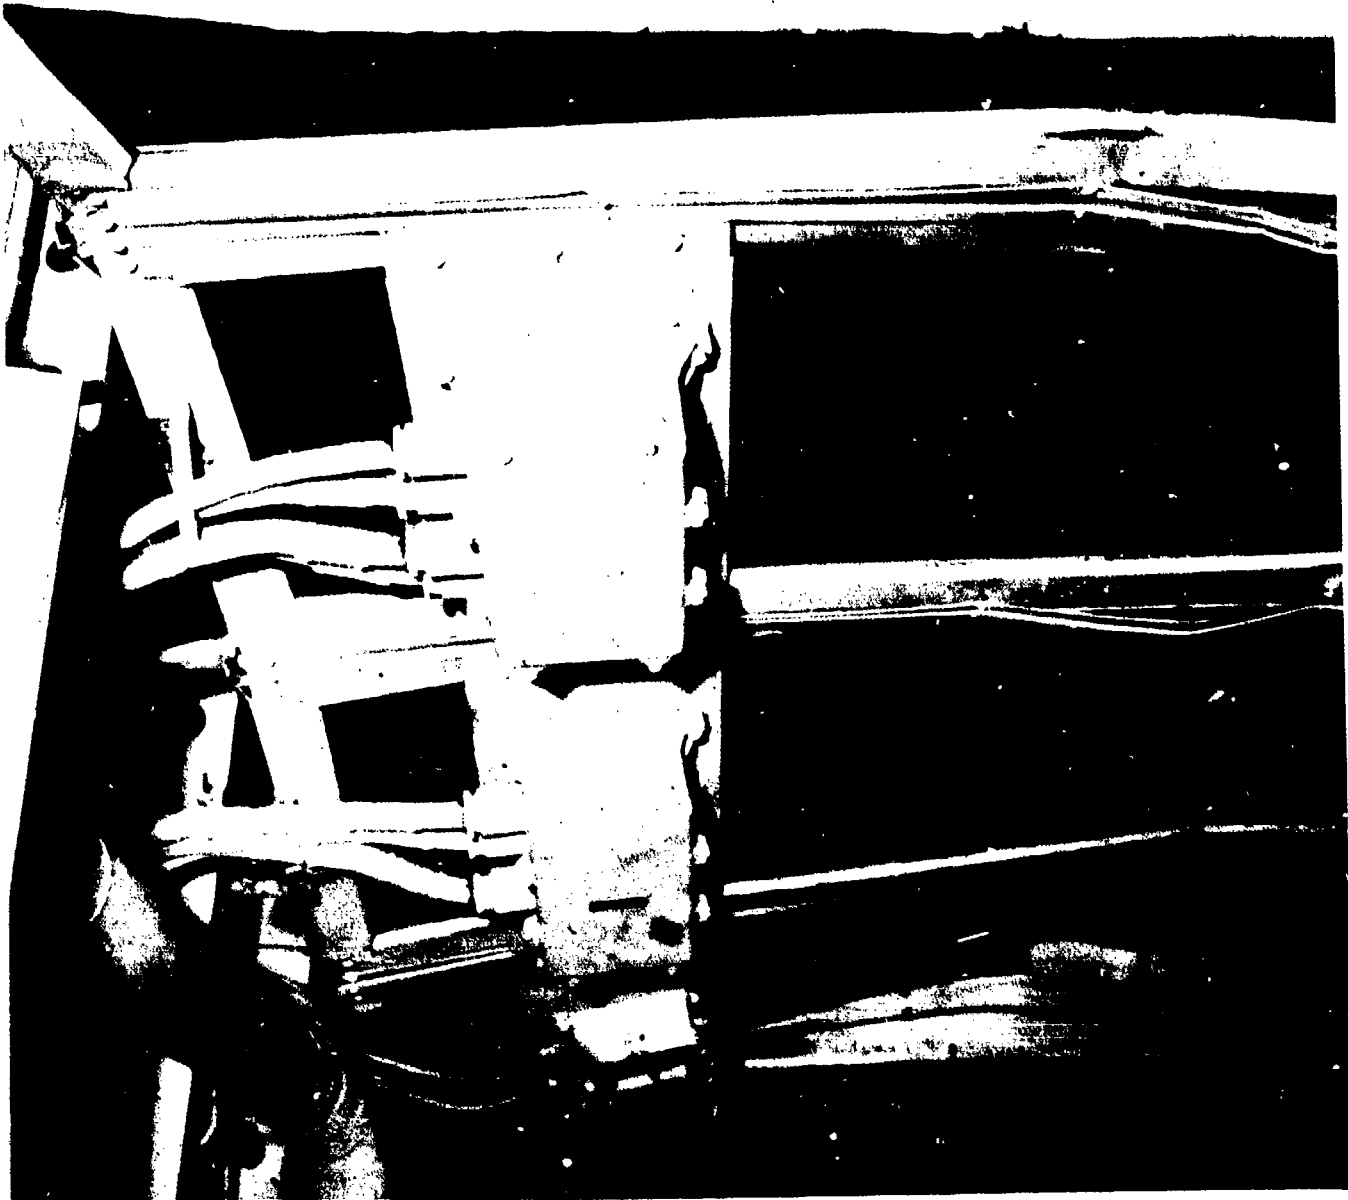
AA-CR-62-1882-5. Distribution connection boxes located on bulkhead frame 44 port side athwartship passage on foscle deck. View looking to port and forward.

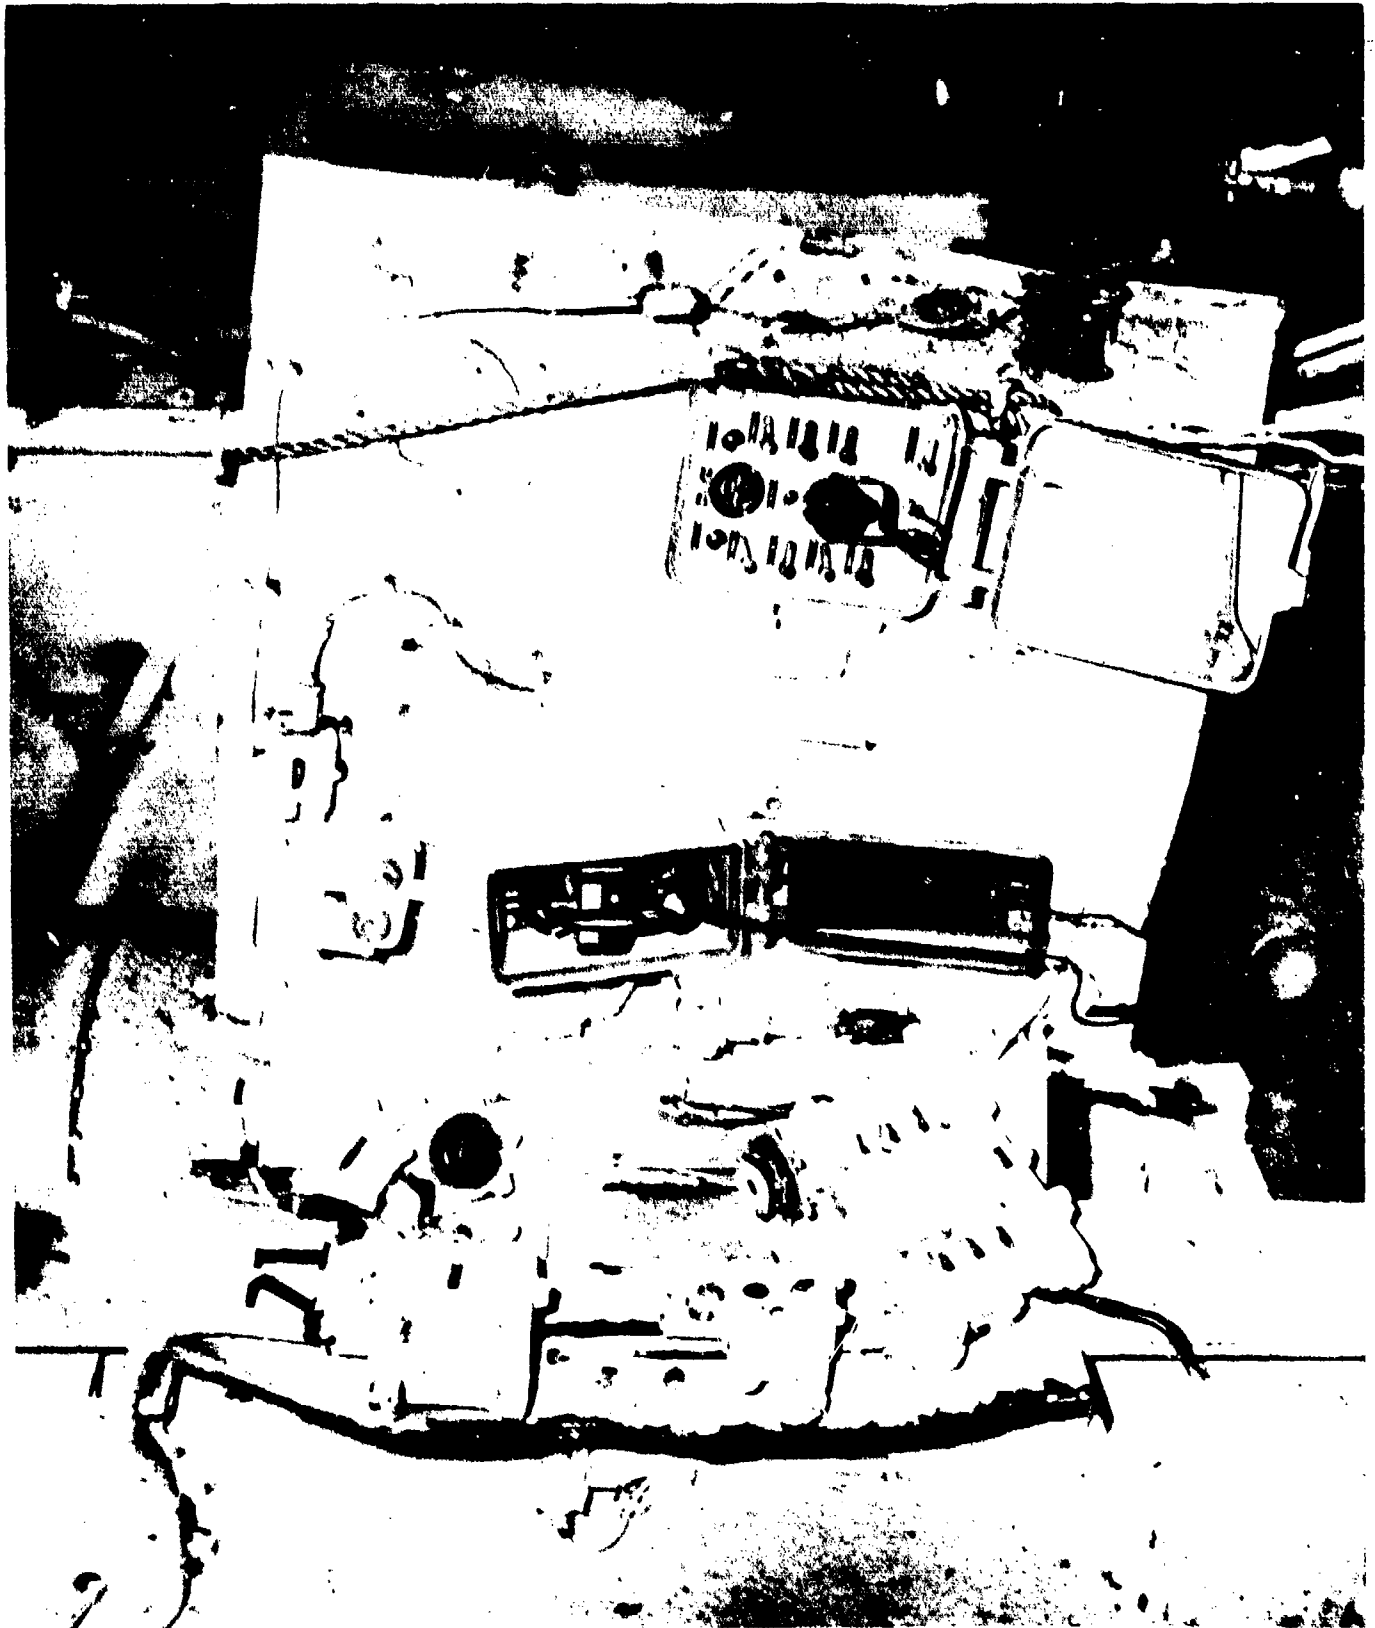
AA-CR-82-1917-6. Communication and control equipment at quarter deck station, frame seventy one starboard side hangar space. View looking starboard and aft.

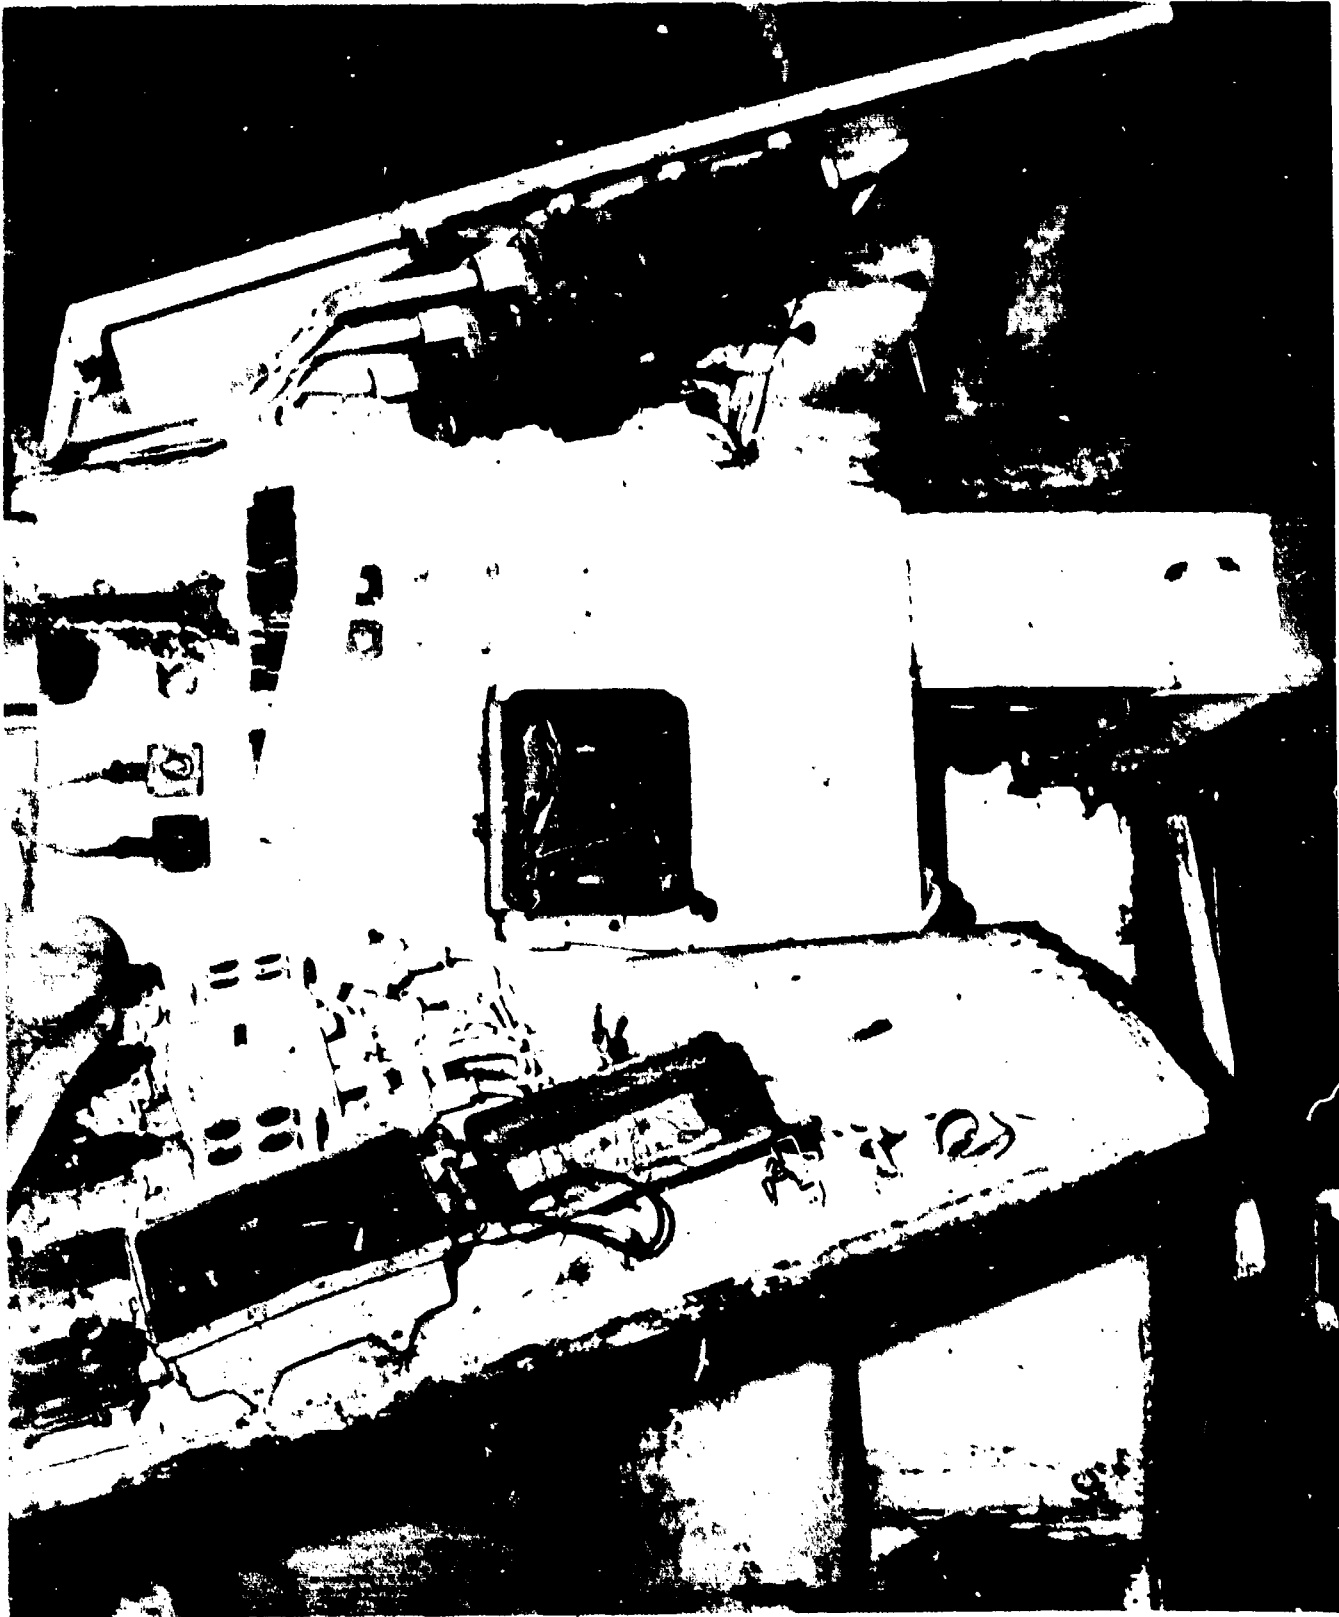
AA-CR-82-1917-7. Water curtain control switches, communication equipment and gasoline trunk ventilation controls frame 80 starboard side hangar space, view looking to starboard.

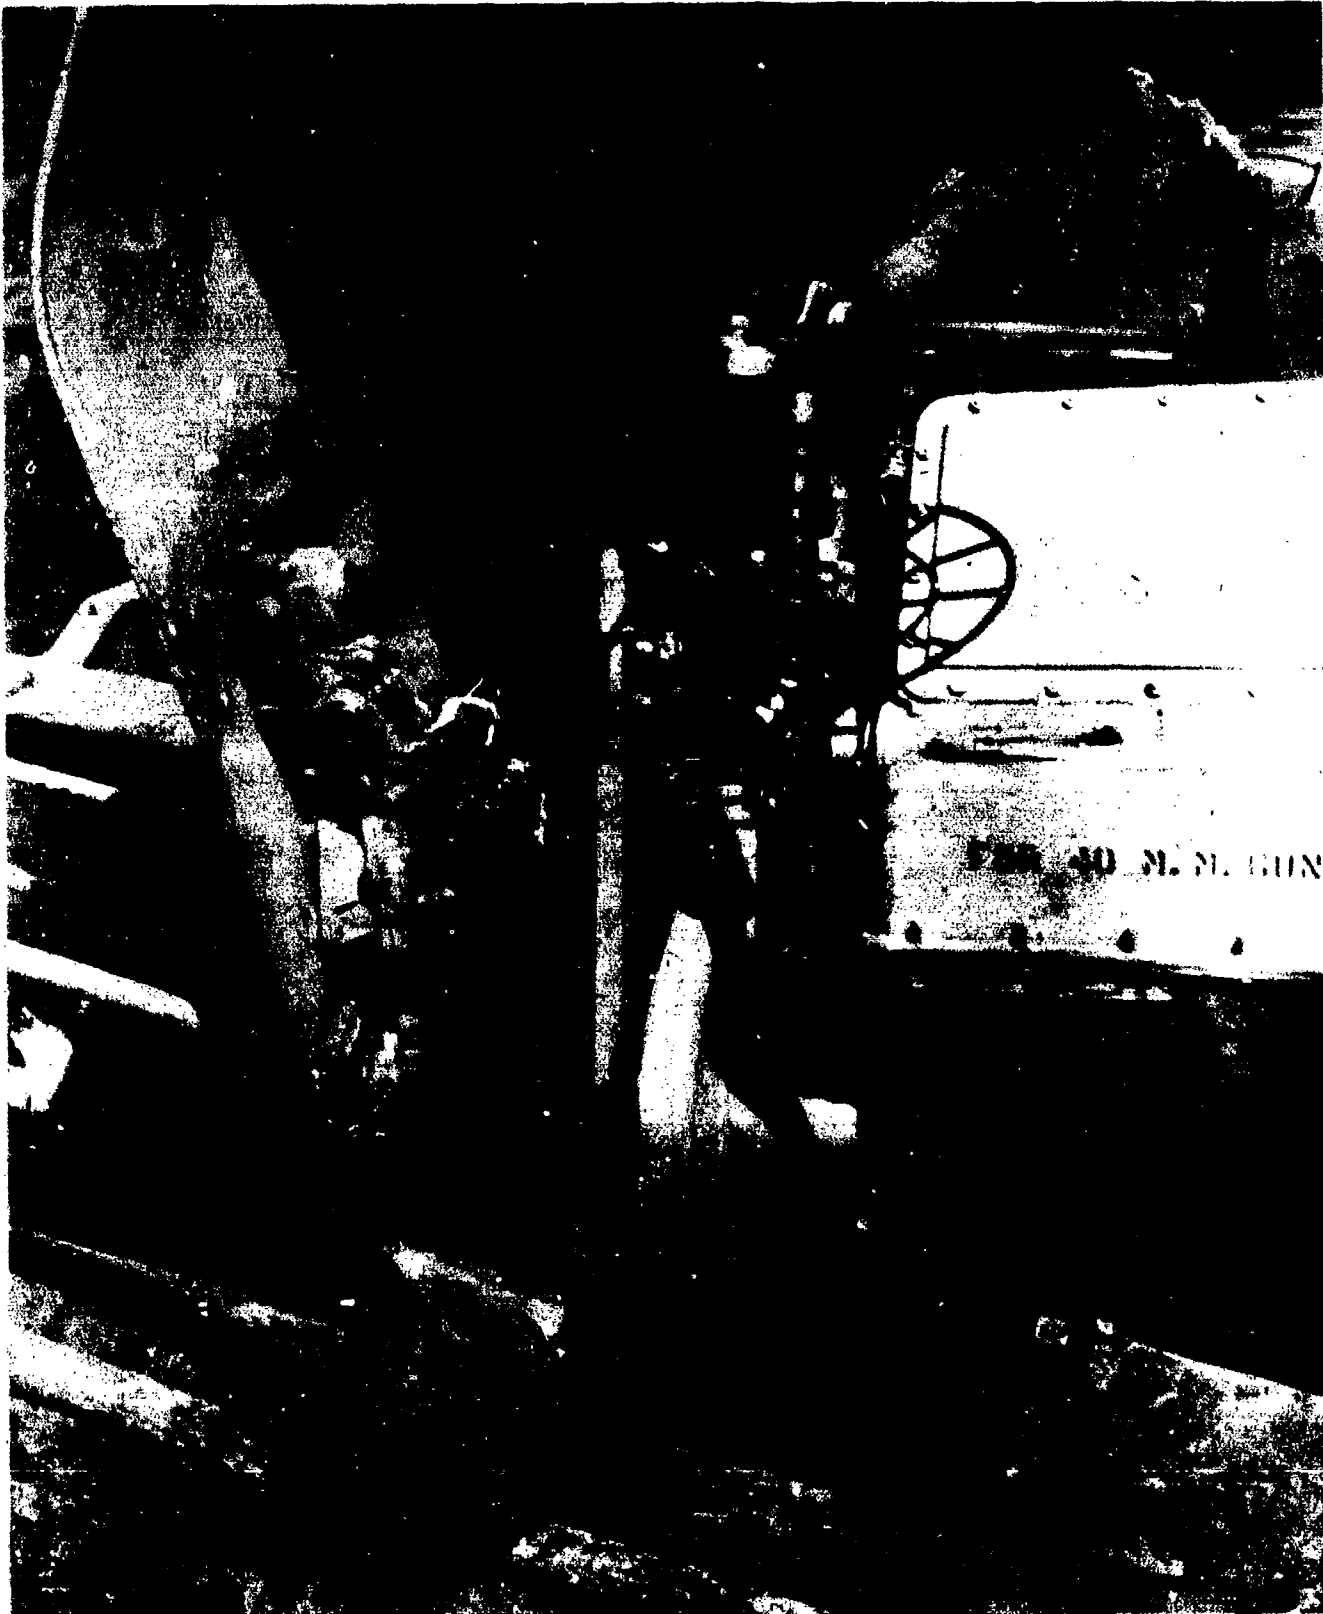
AA-CR-82-1919-10. Mounting failures and cable damage to fire control equipment on shield of MK51 gun director located at frame 28 port side galley deck. View looking down and outboard from flight deck.

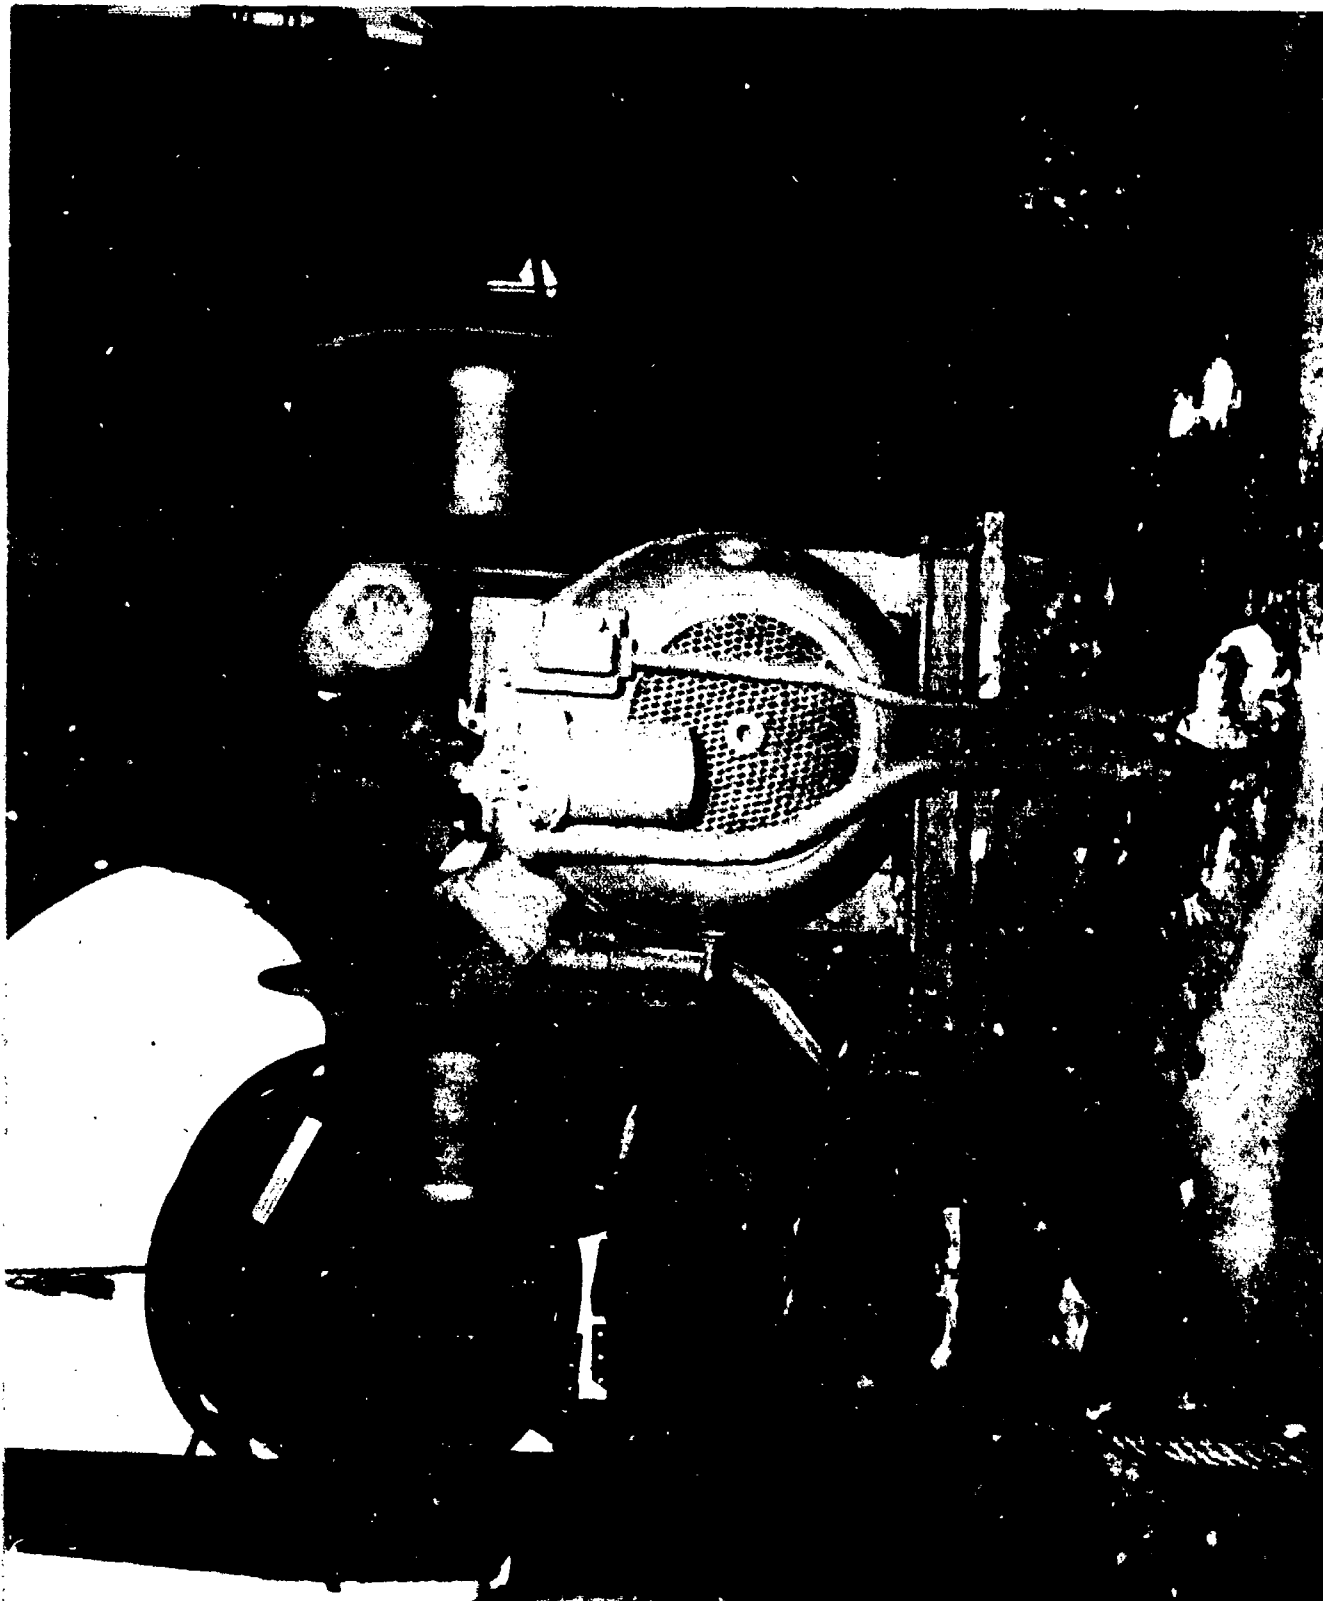
AA-CR-82-1918-11. Winch apparently undamaged in spite of deflection in deck in way of stern working capstan. View looking to port on main deck aft.

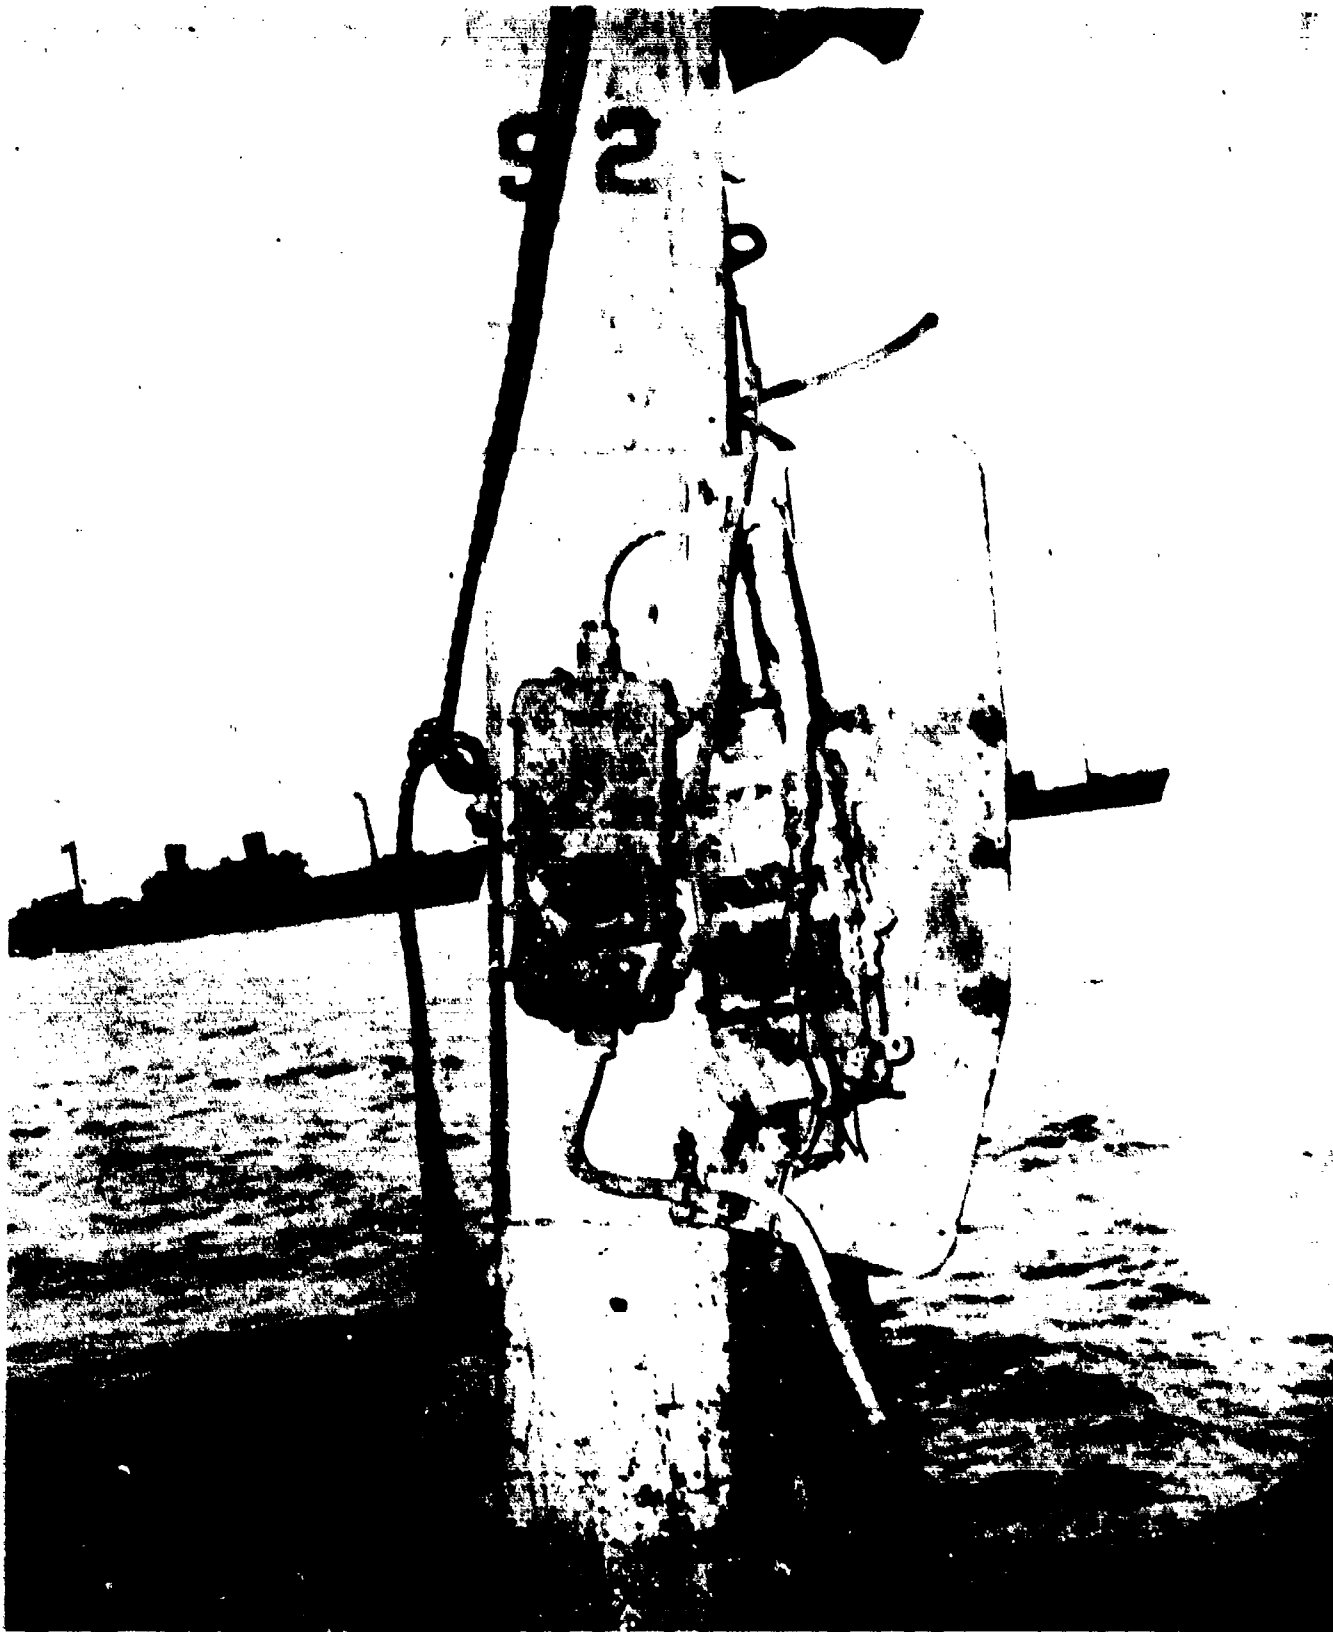
AA-CR-82-1918-5. Damage to water curtain control switches, located frame 8 port side hangar space. One switch missing. View looking outboard.

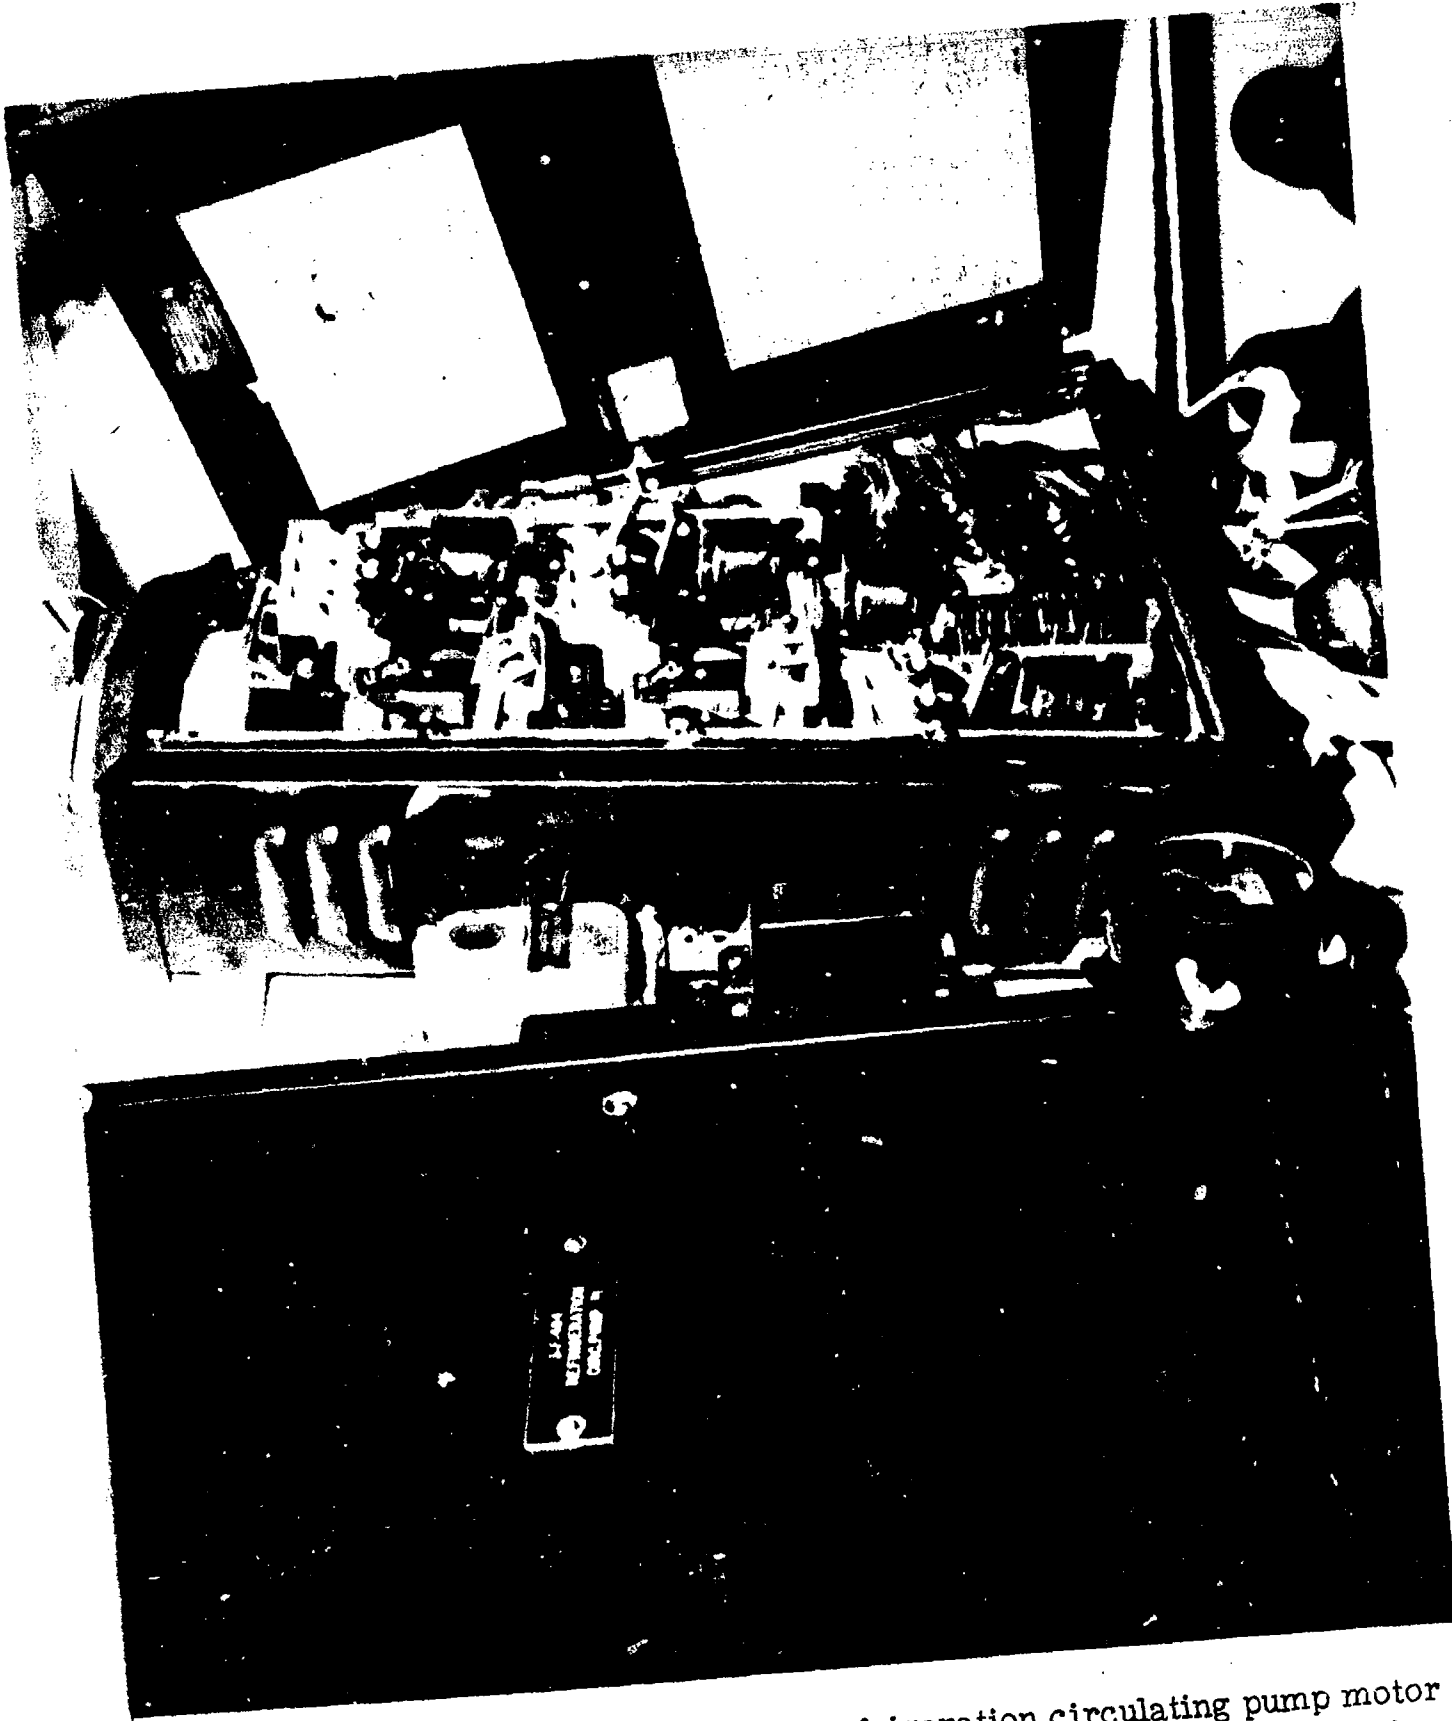
AA-CR-82-1916-12. Controller for refrigeration circulating pump motor #2 located on bulkhead 126 port side 3rd deck in ice machine room. View looking aft.

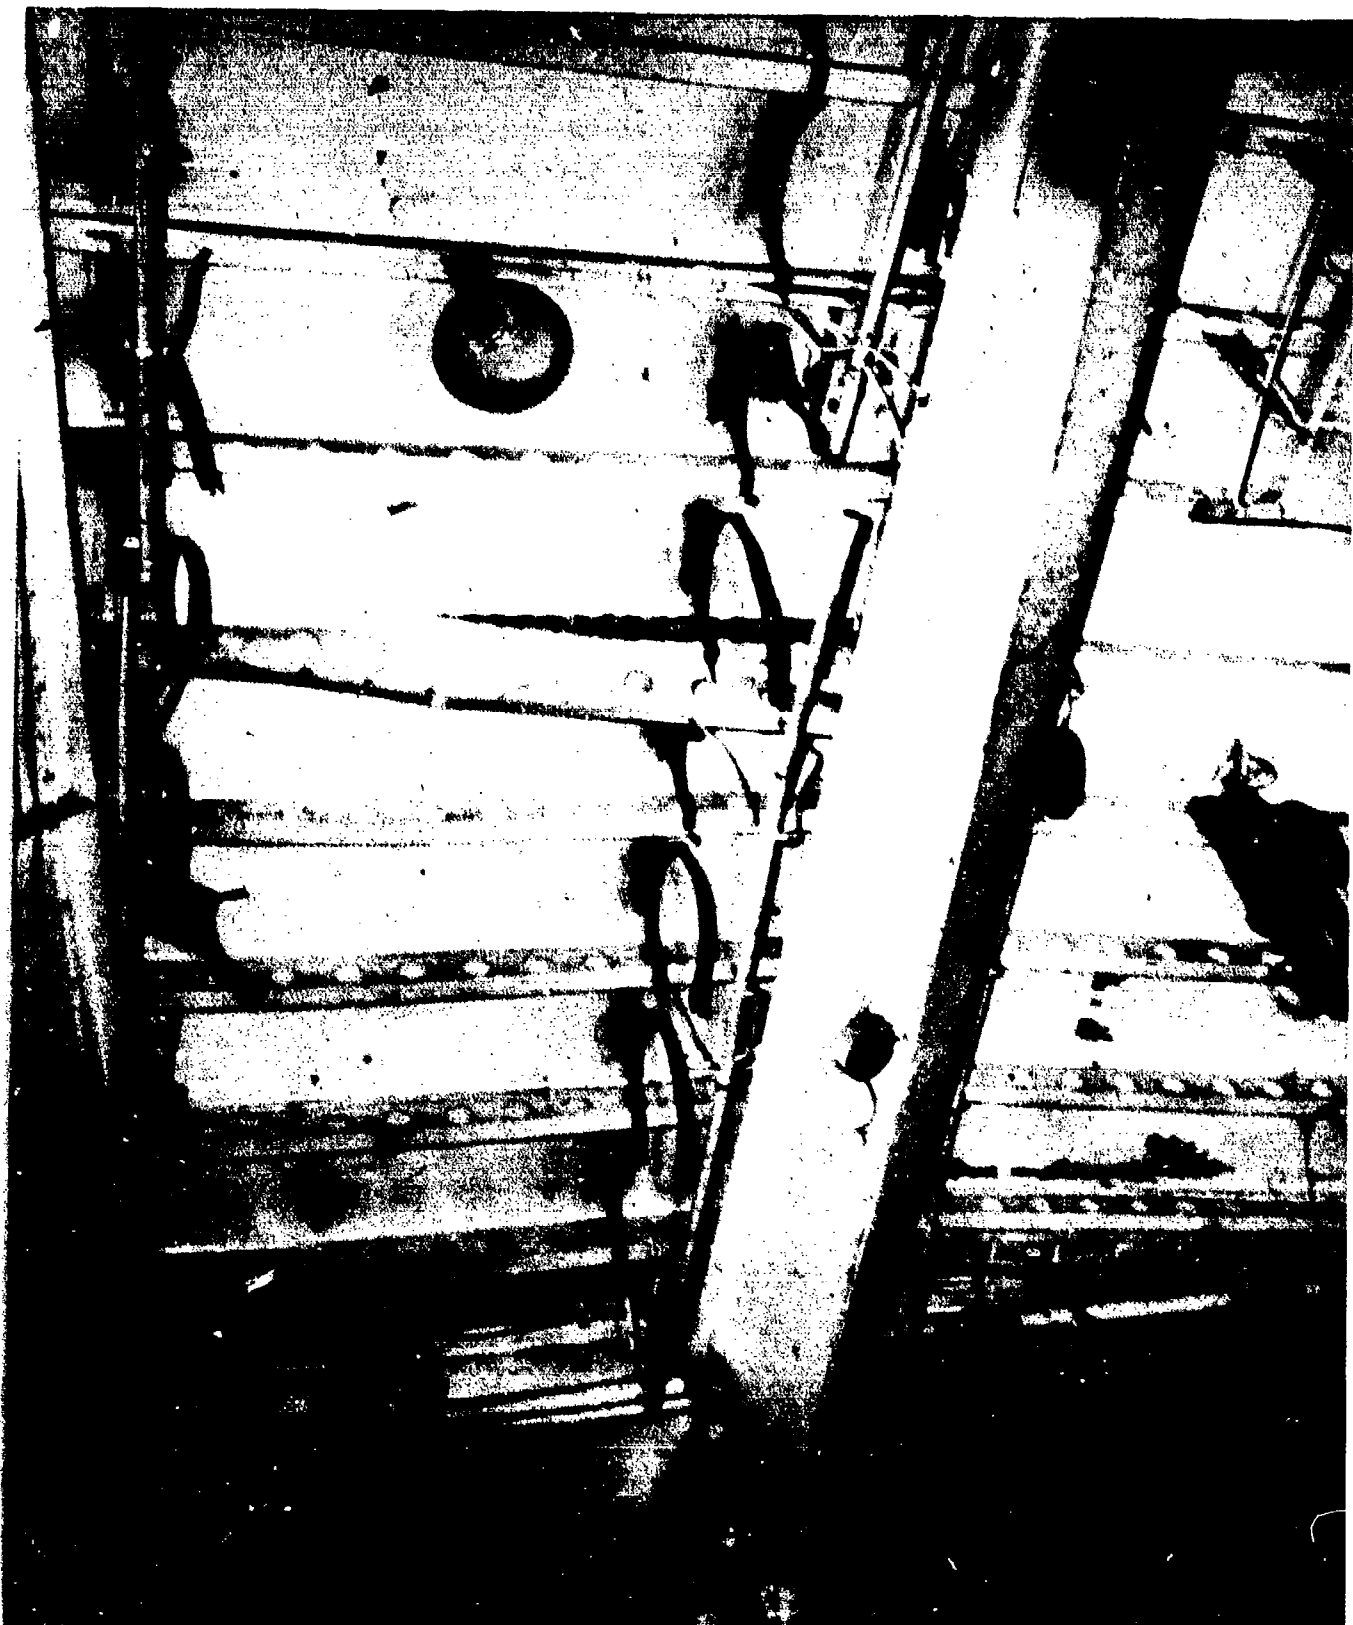
AA-CR-62-1882-4. Lighting fixtures and 3MC reproducers on under side flight deck in hangar space. View looking up and outboard frame 92-95 starboard side.

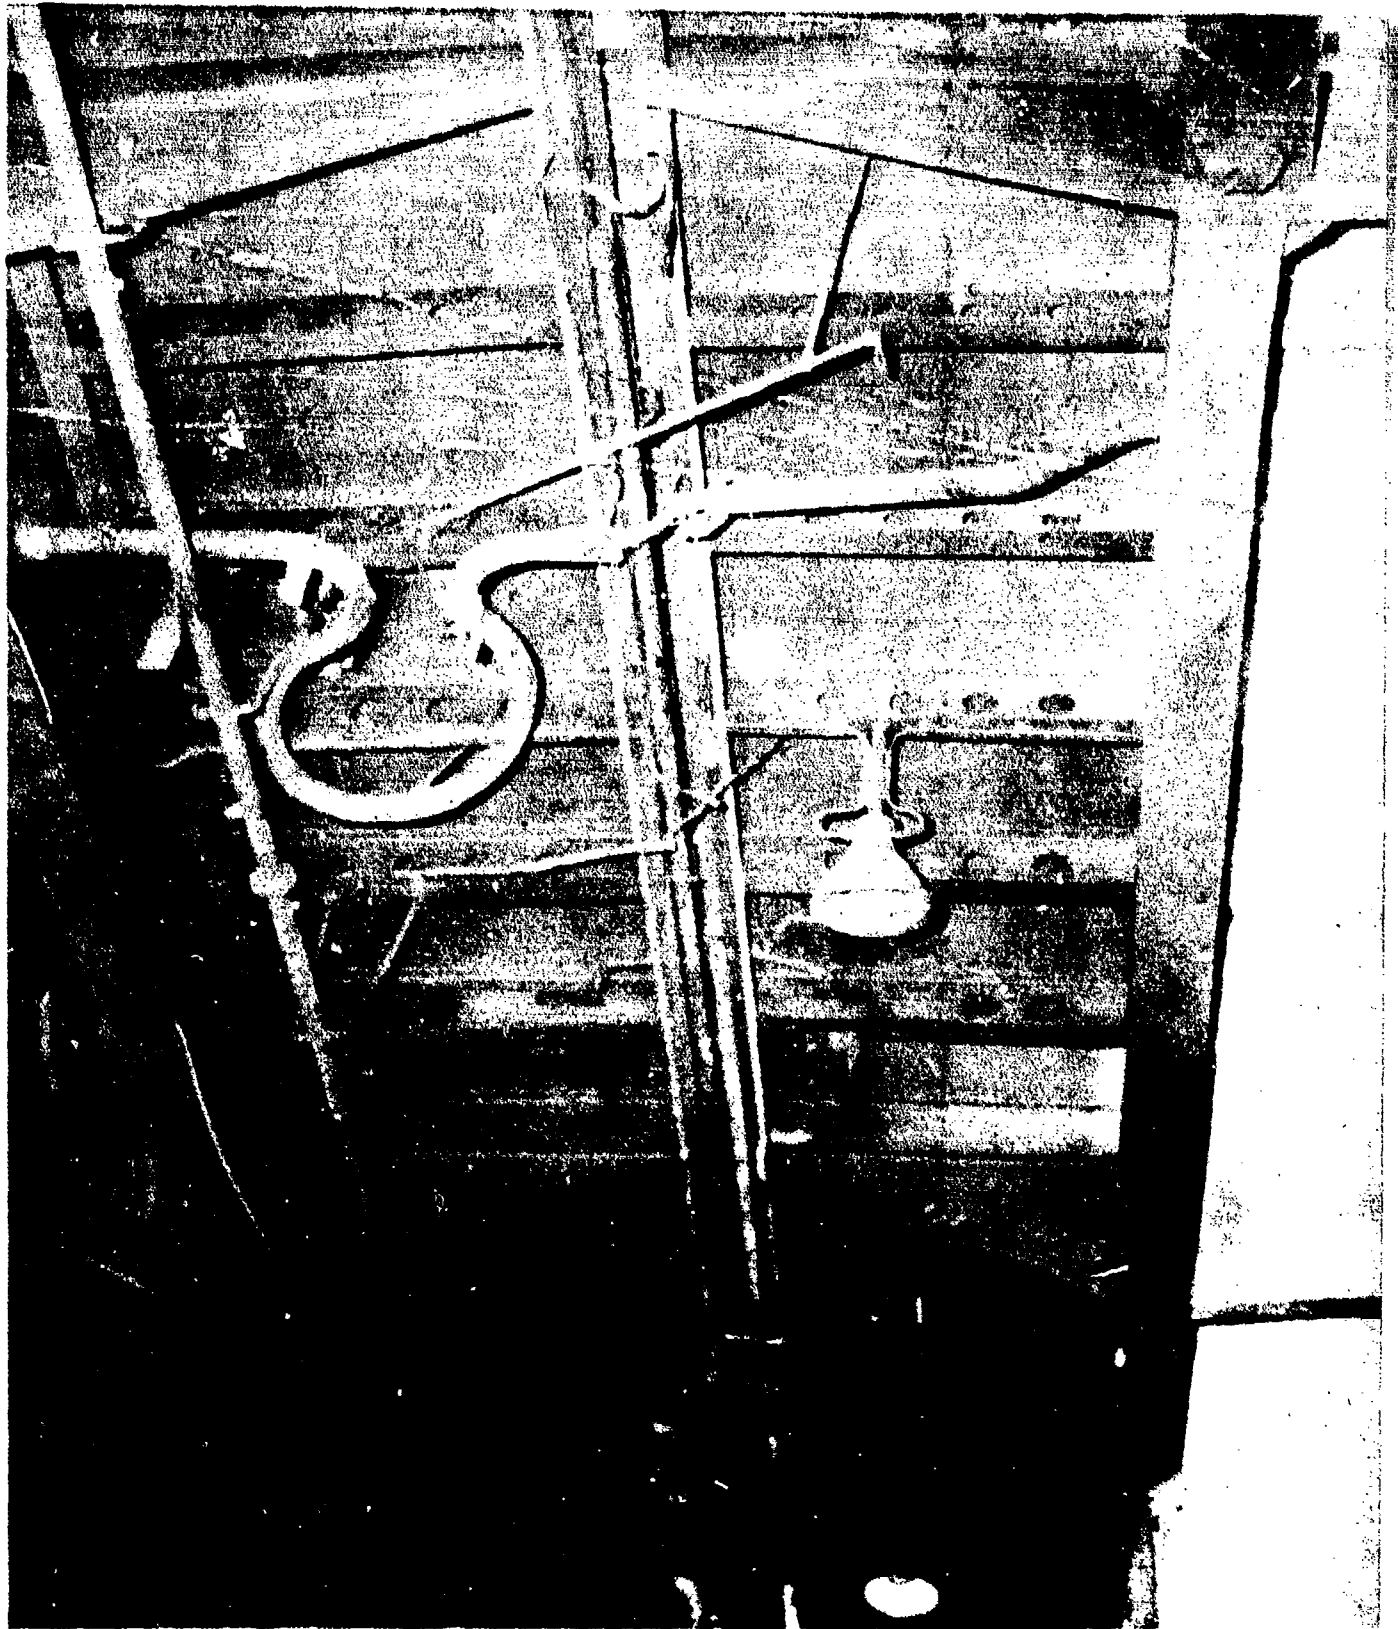
AA-CR-82-1917-10. Lighting fixtures on underside of flight deck. Frame 64 starboard side, in hangar space. View looking up and to starboard.
