# BUREAU OF SHIPS GROUP TECHNICAL INSPECTION REPORT

## U.S.S. INDEPENDENCE (CVL22)

### TEST ABLE

### OPERATION CROSSROADS

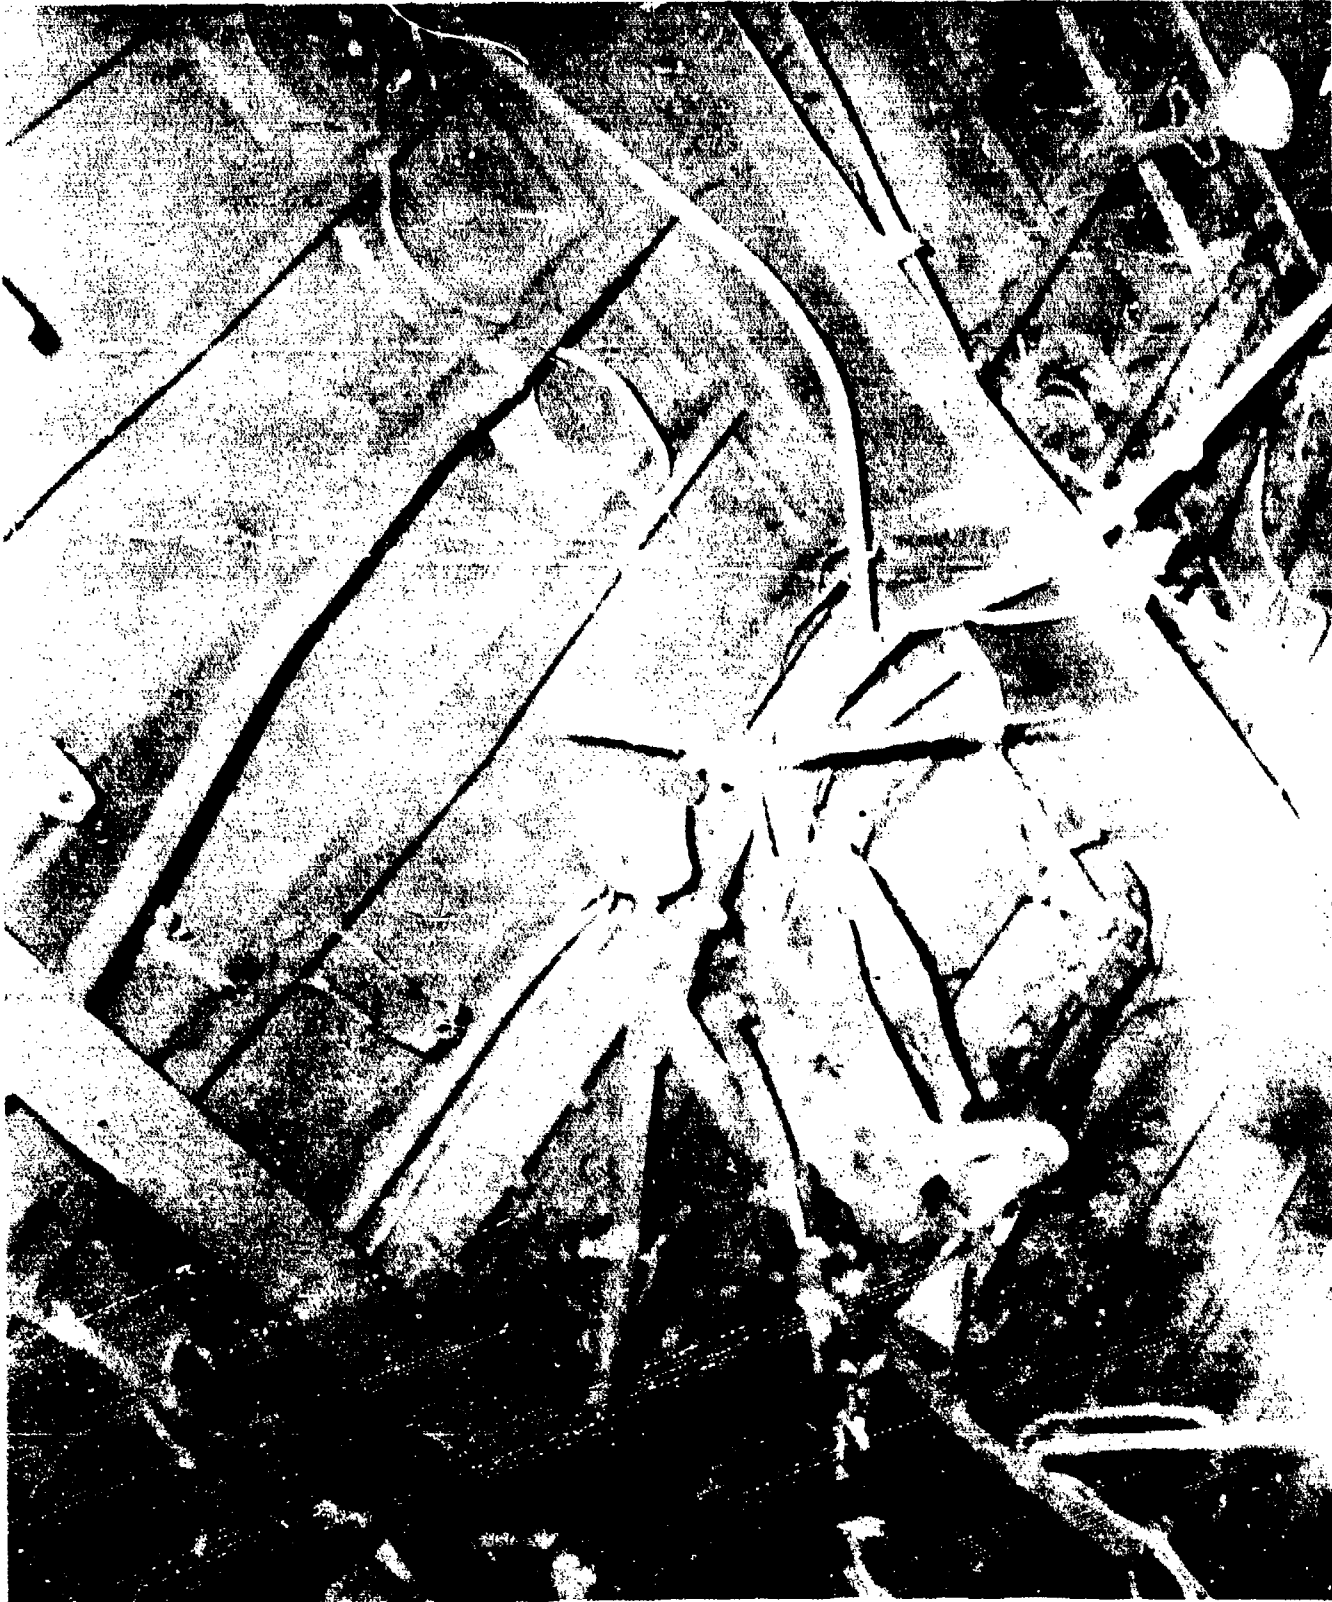
AA-CR-82-1917-11. Lighting fixtures on underside of flight deck frame  
60 port side hangar space. View looking upward to port.

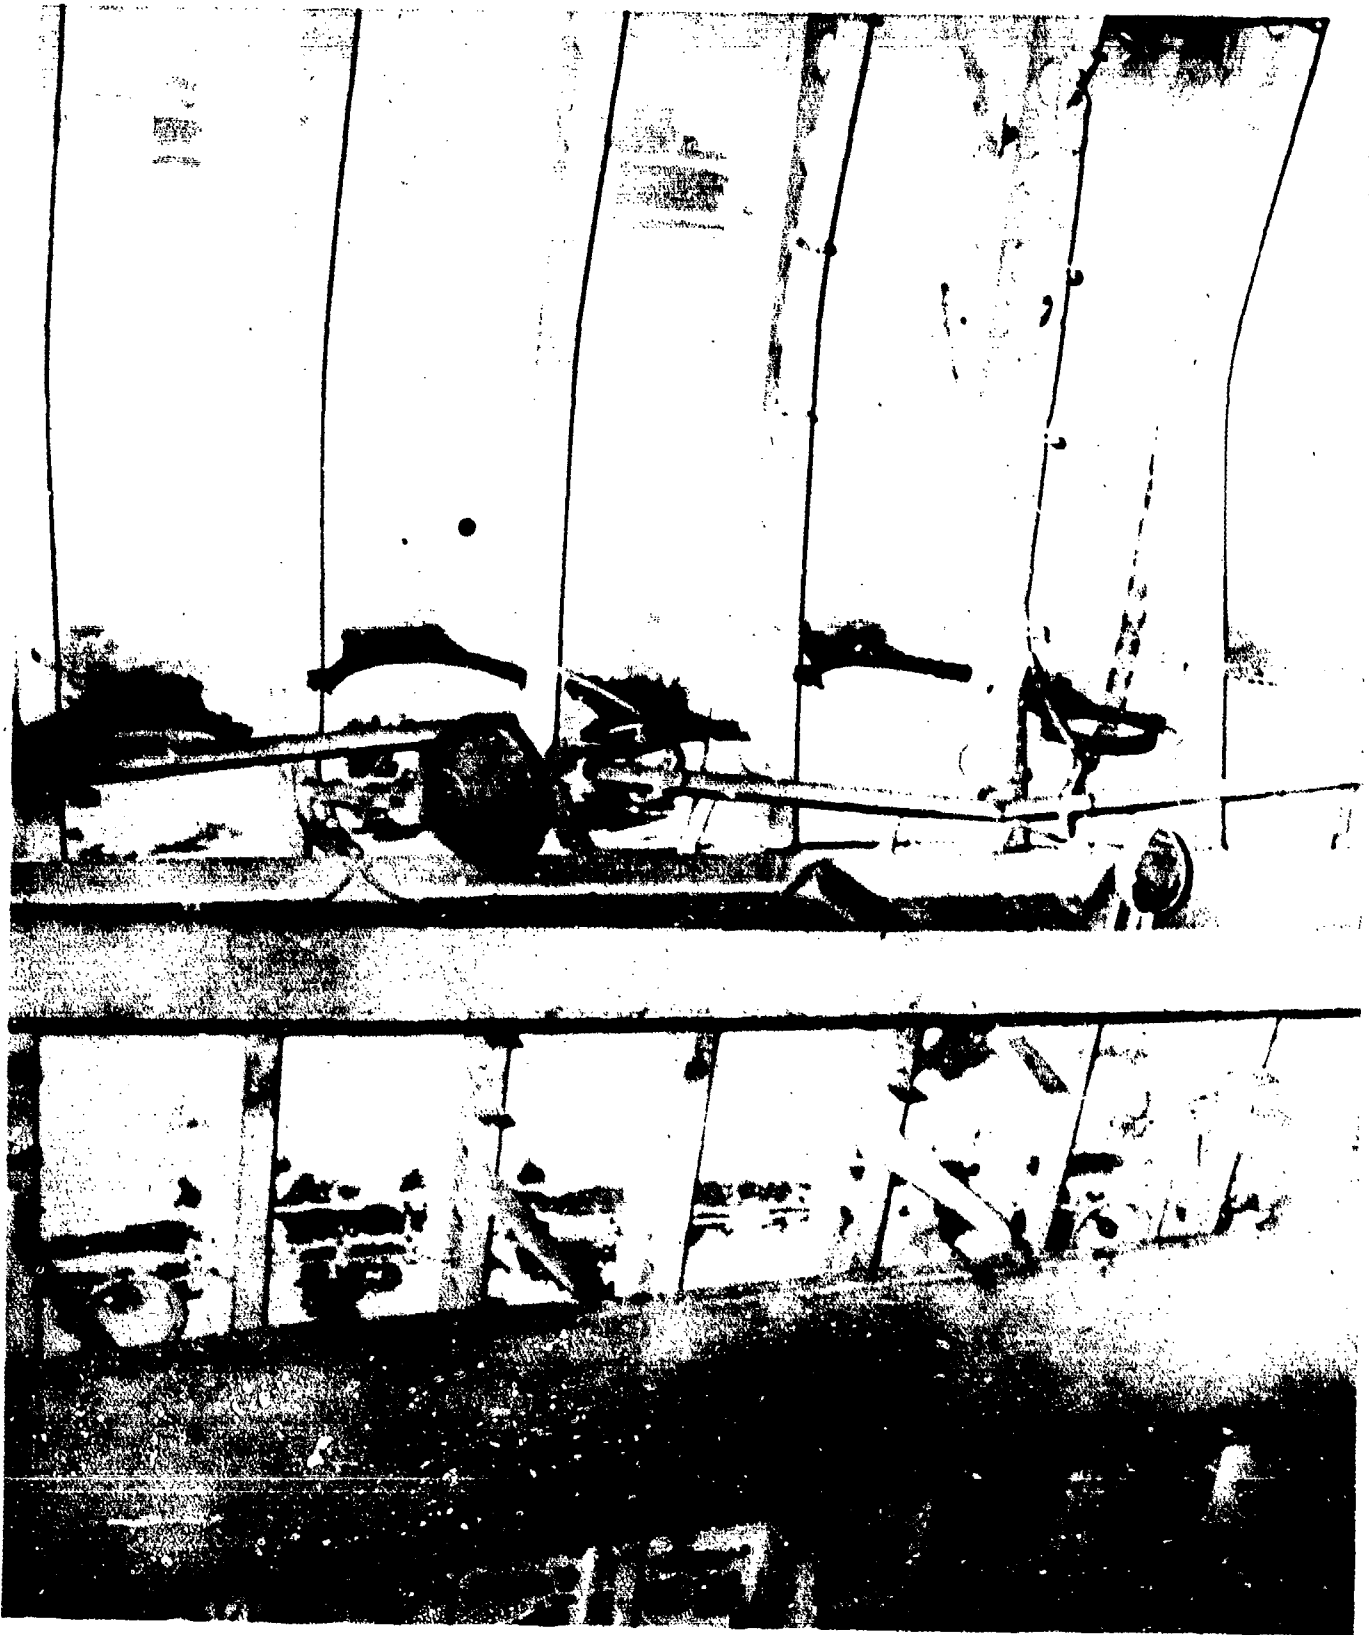
AA-CR-82-1917-12. Lighting fixtures and "3MC" reproducer on under side of flight deck, frame 77 port side hangar space. View looking up and to port.

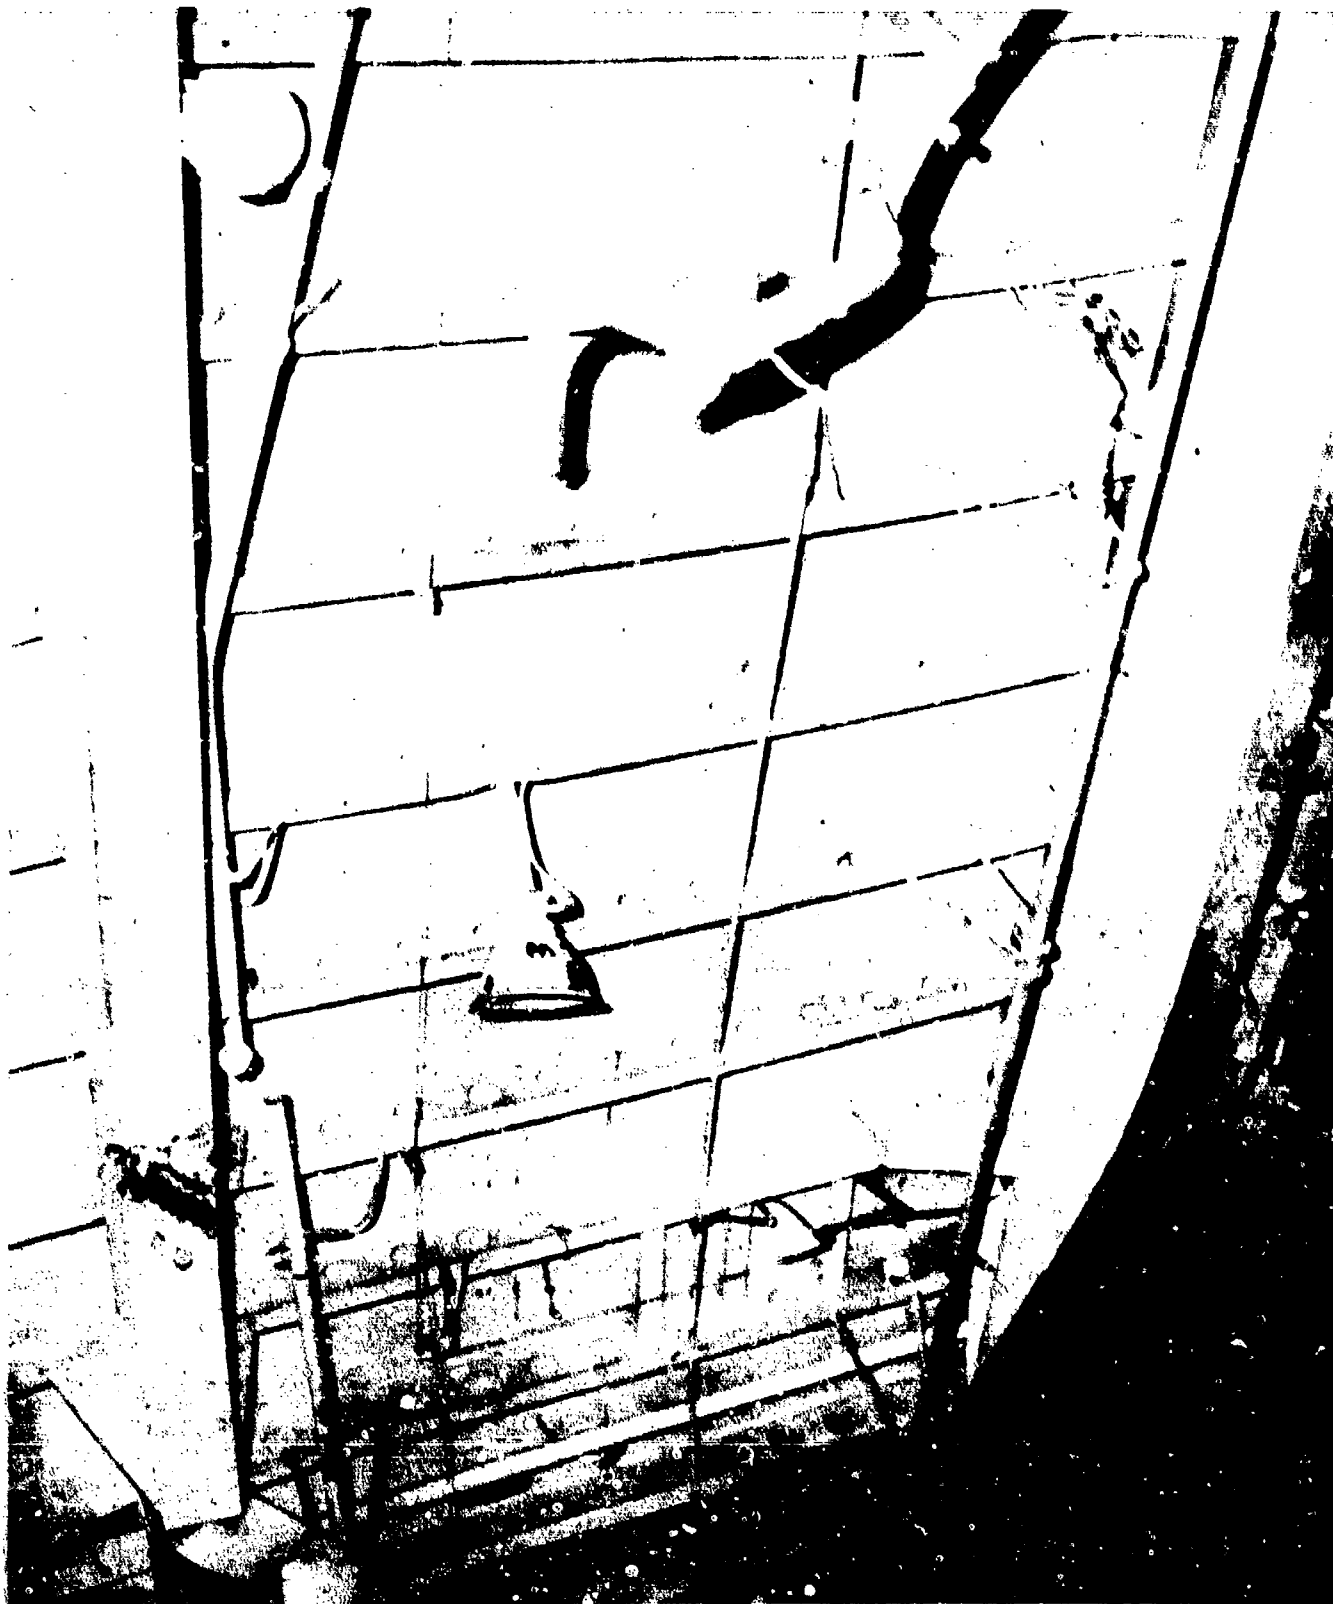
AA-CR-82-1919-4. Damage to lighting fixtures under flight deck in hanger space, frame 105. View looking up and to centerline.

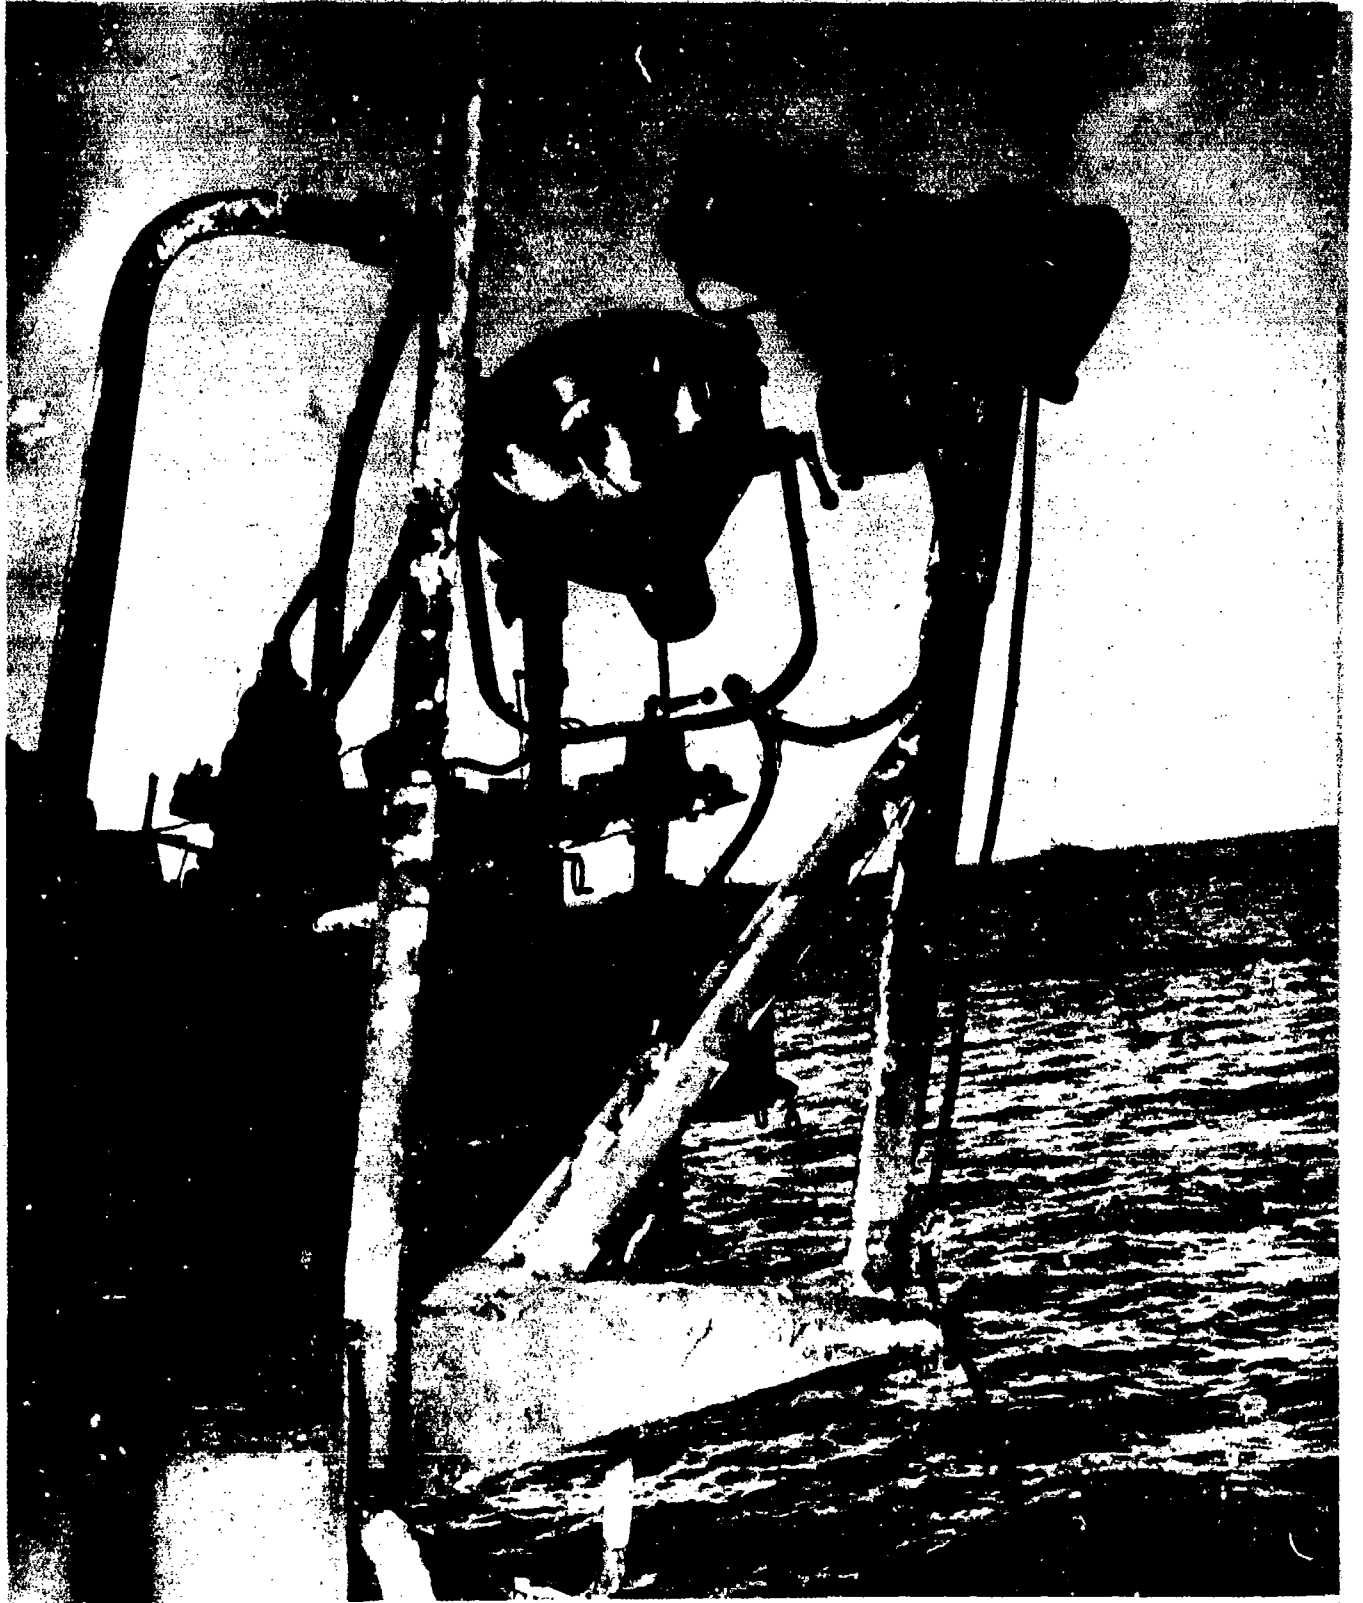
AA-CR-234-1985-11. 500W flood light and "3MC" reproducer mounted off gallery deck walkway frame 125 starboard. Note damage to speaker, light operable, flexible cable severed.

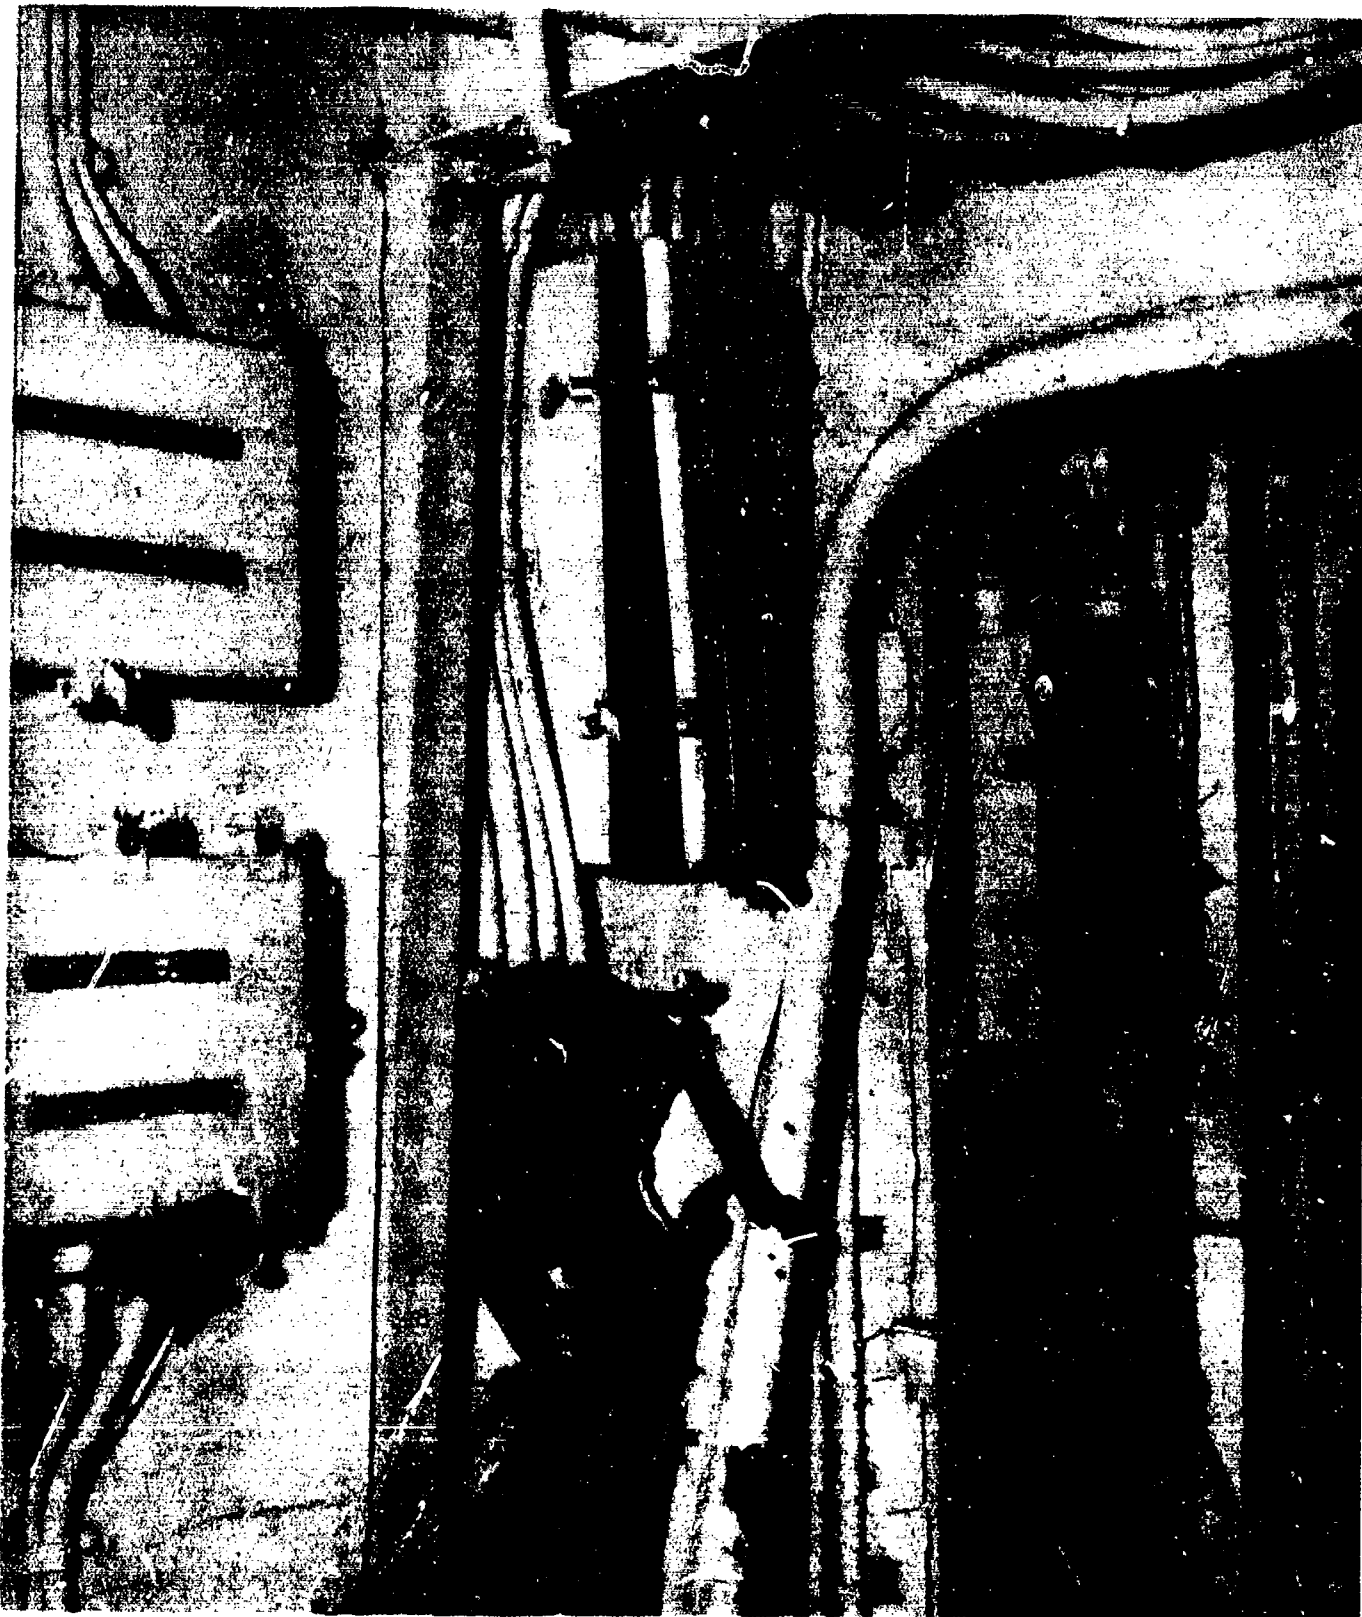
AA-CR-234-1989-8. A 4x and 12x lighting distribution box, frame 54 in flight deck control station. Enclosures damaged by inboard deflection of bulkhead.

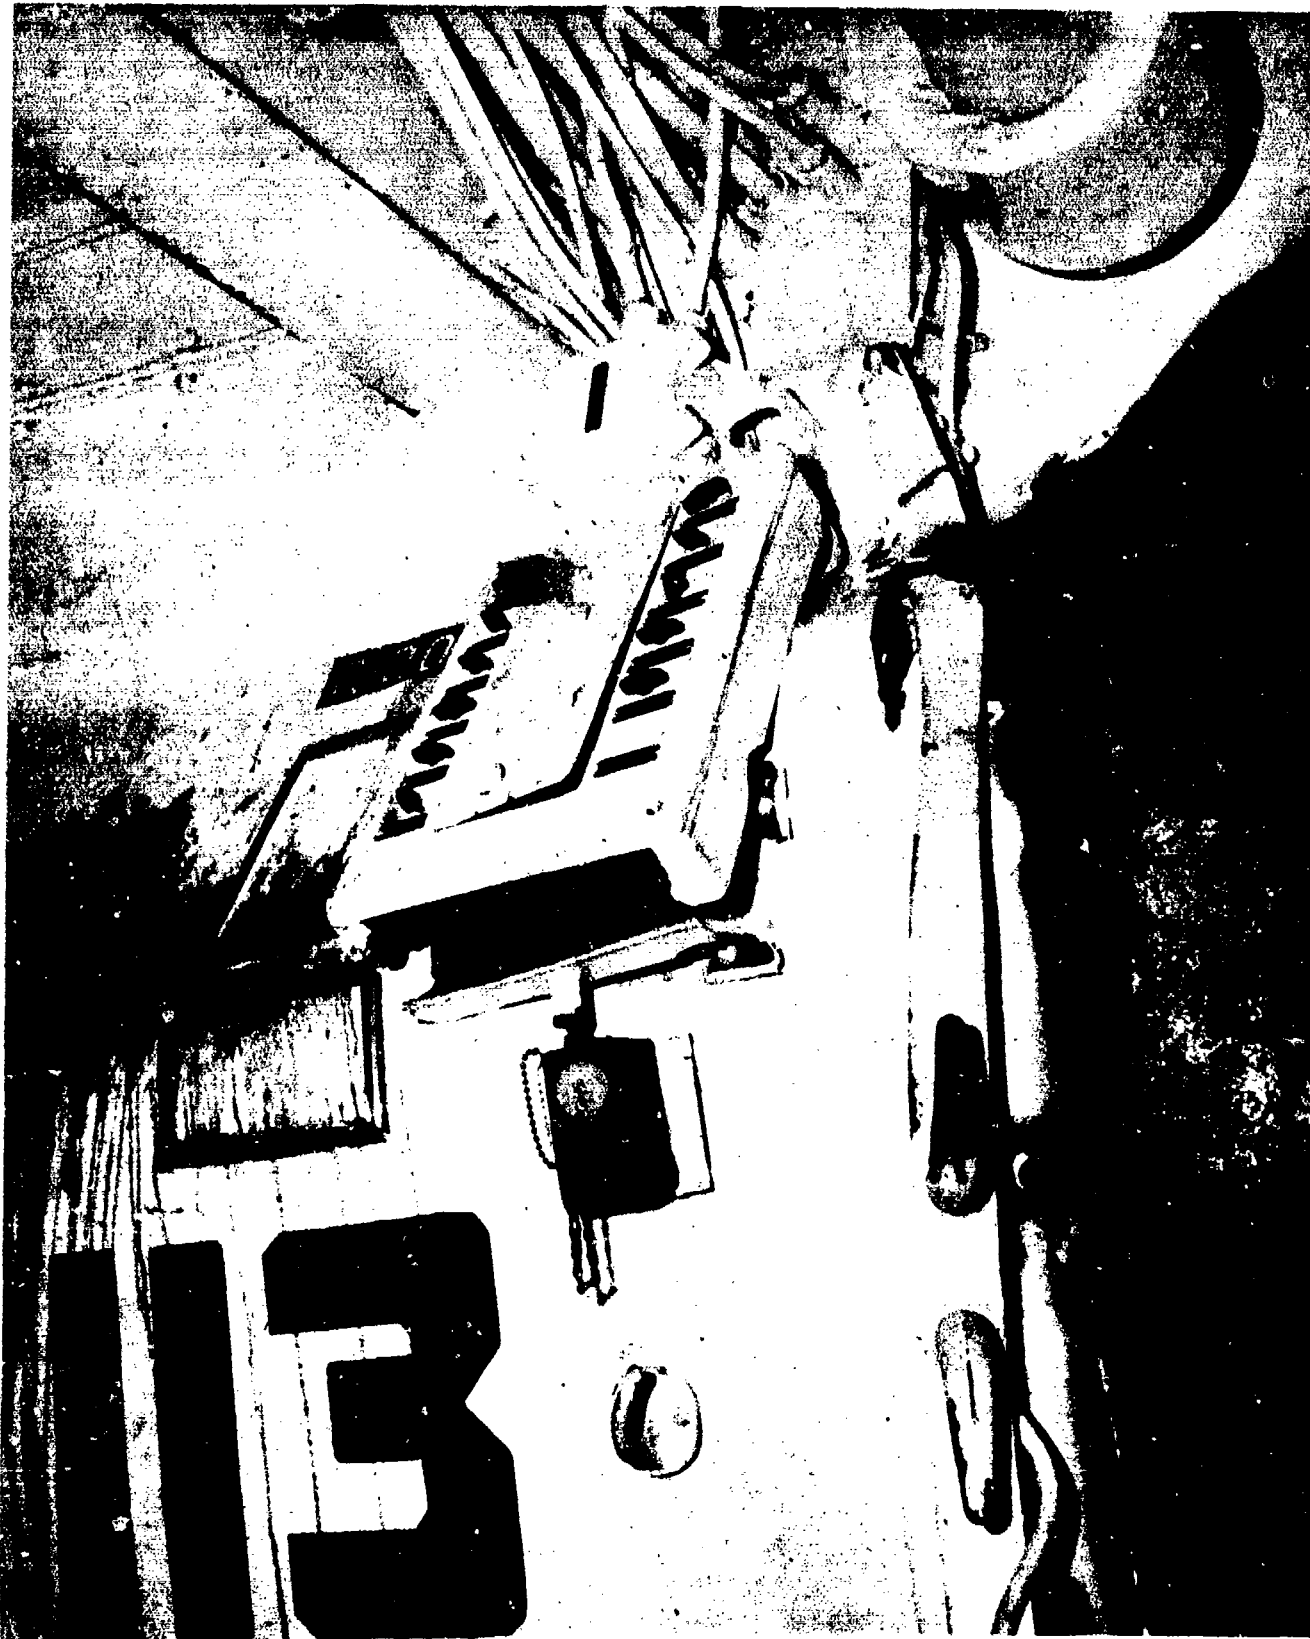
AA-CR-82-1916-10. "12T" lighting distribution box on bulkhead 113 starboard side second deck enclosure broken due to buckle in bulkhead. View looking forward.

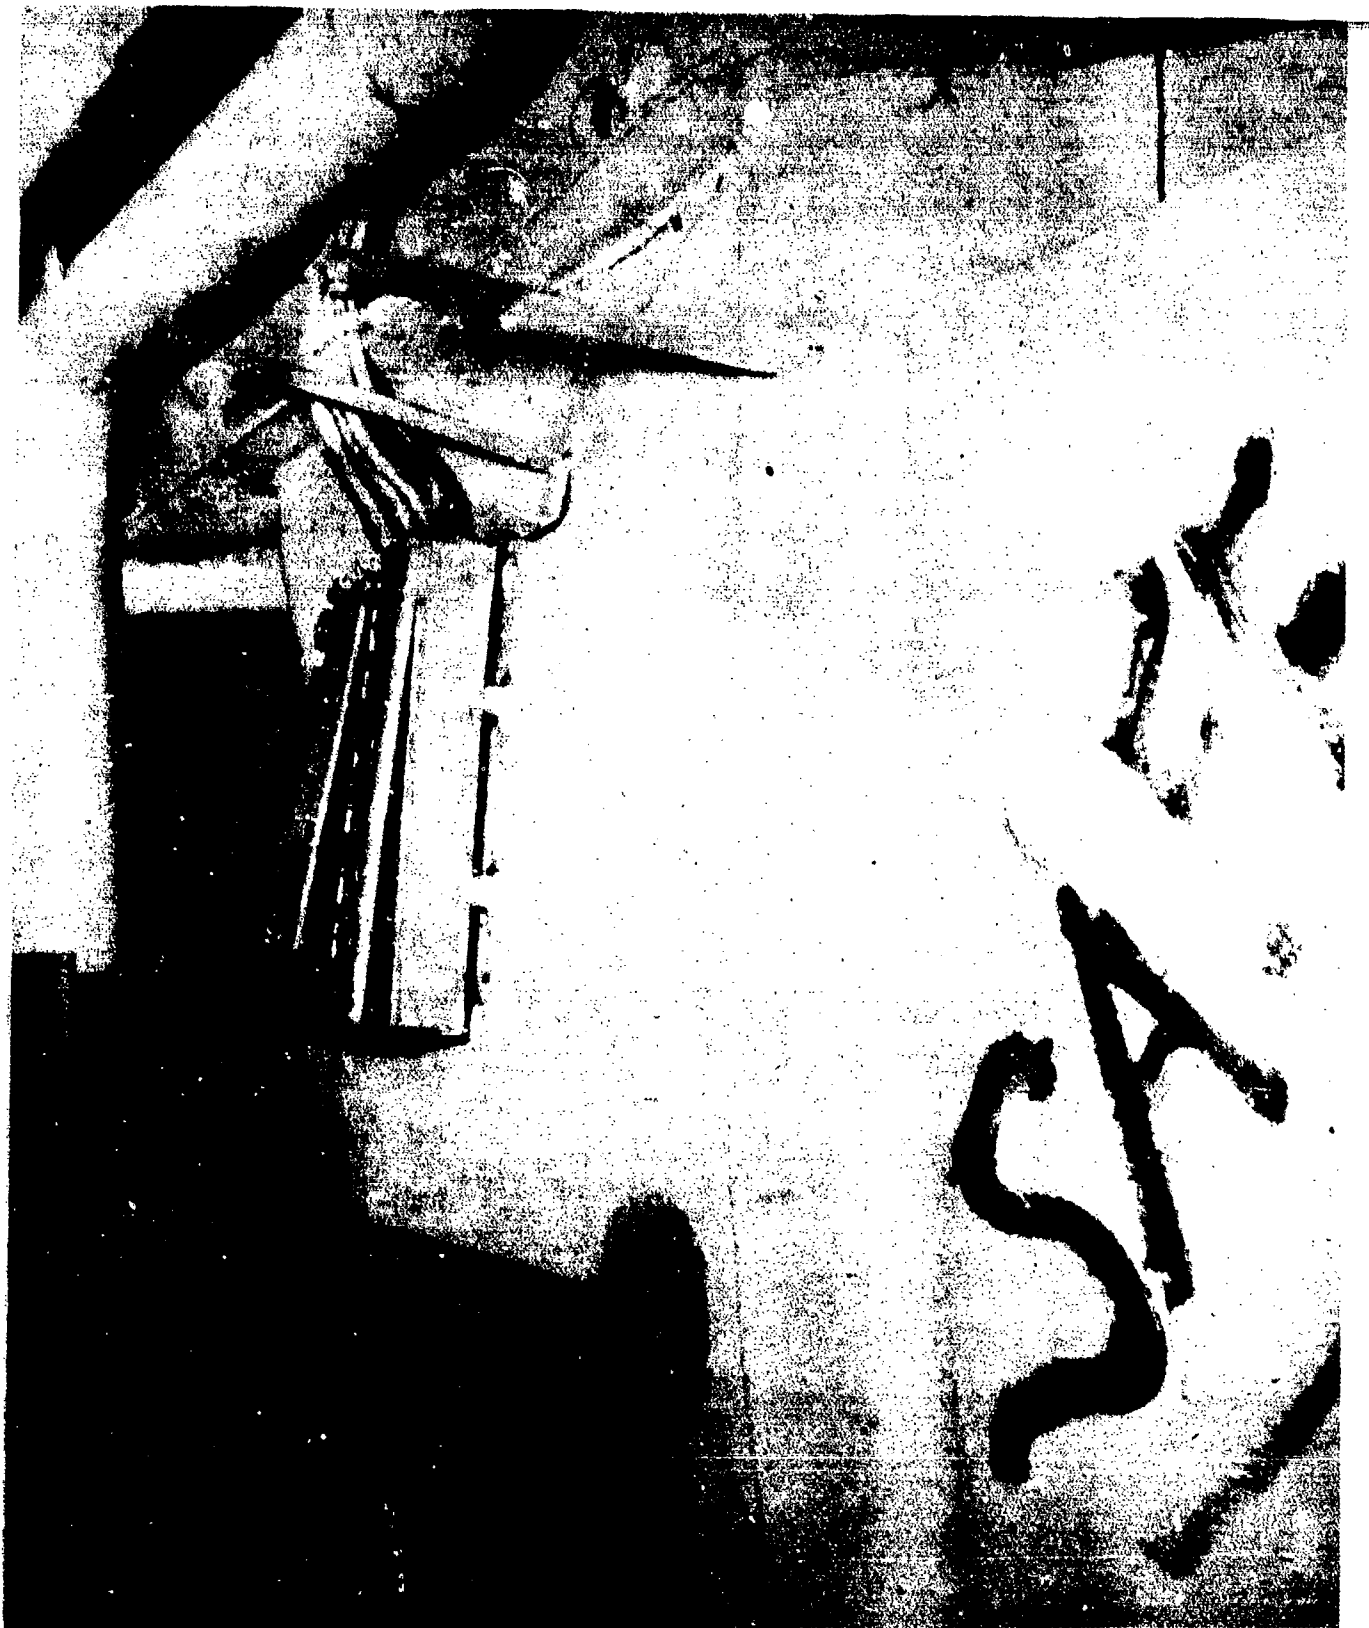
AA-CR-82-1917-3. "12X" lighting distribution box located on trunk, frame 104 port side 3rd deck, cover and enclosure distorted due to buckle in bulkhead. View looking to port.

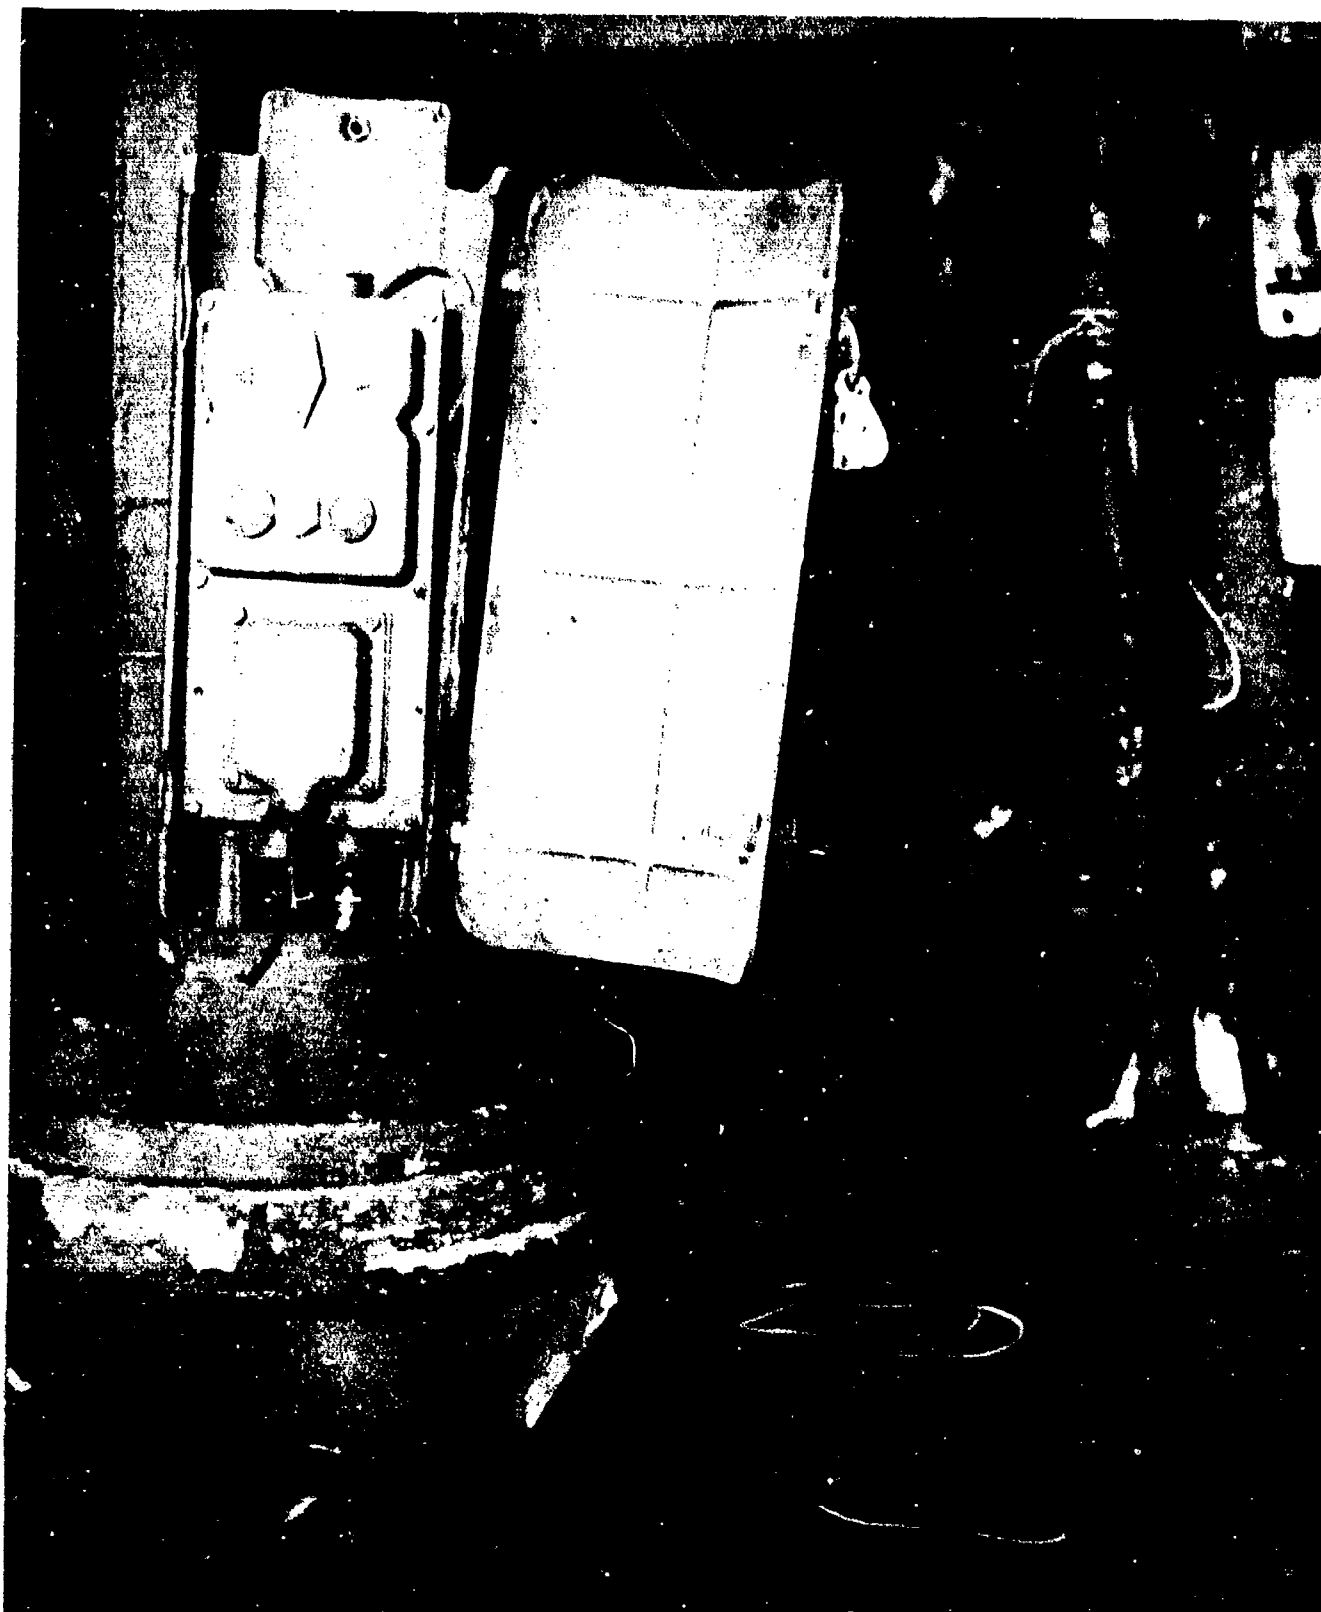
AA-CR-62-1880-12. Broken pedestal of starboard pelorus on air defense station, overlooking forward.

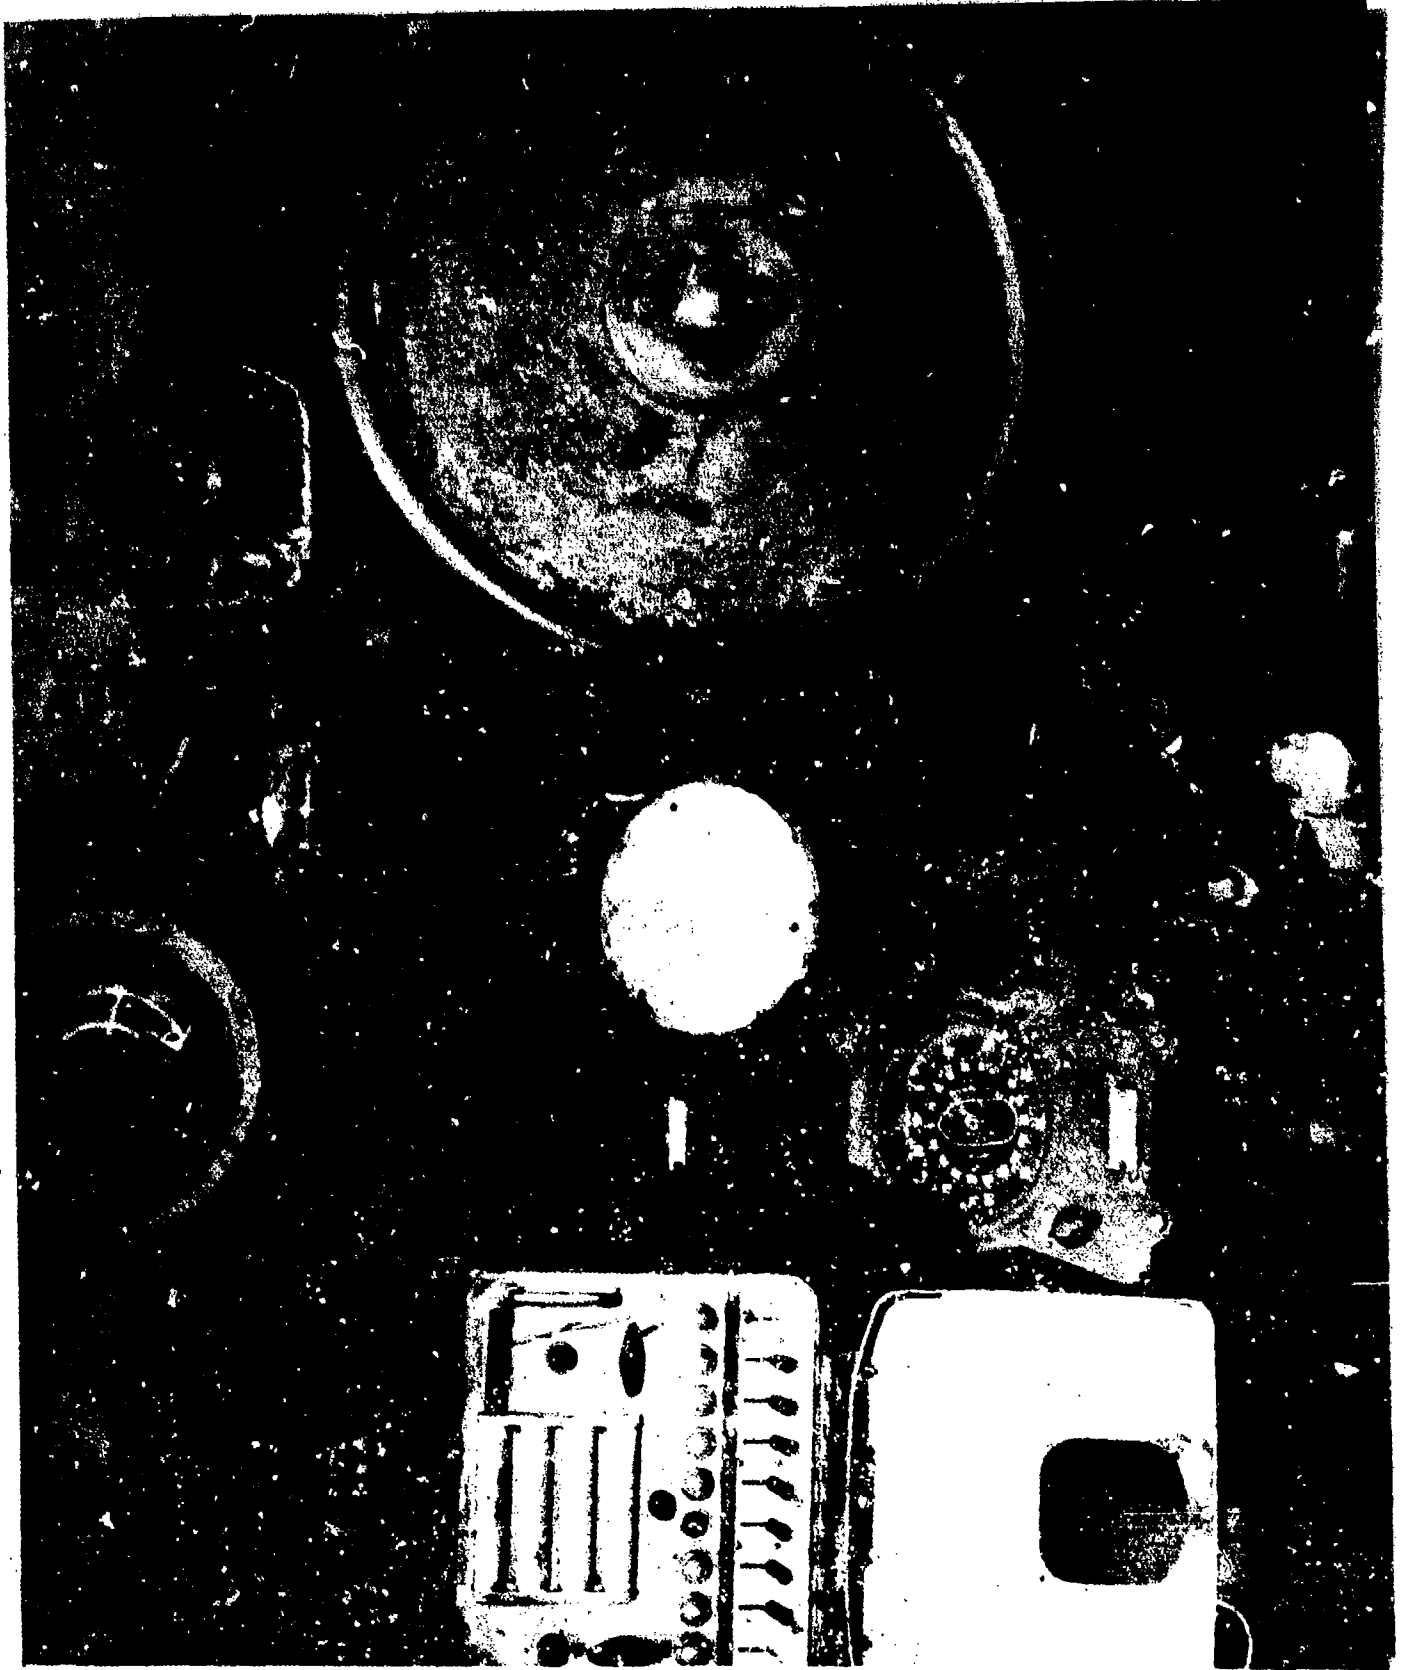
AA-CR-62-1881-1. Navigation equipment located on forward blast shield of air defense level at open steering station, overlooking forward.

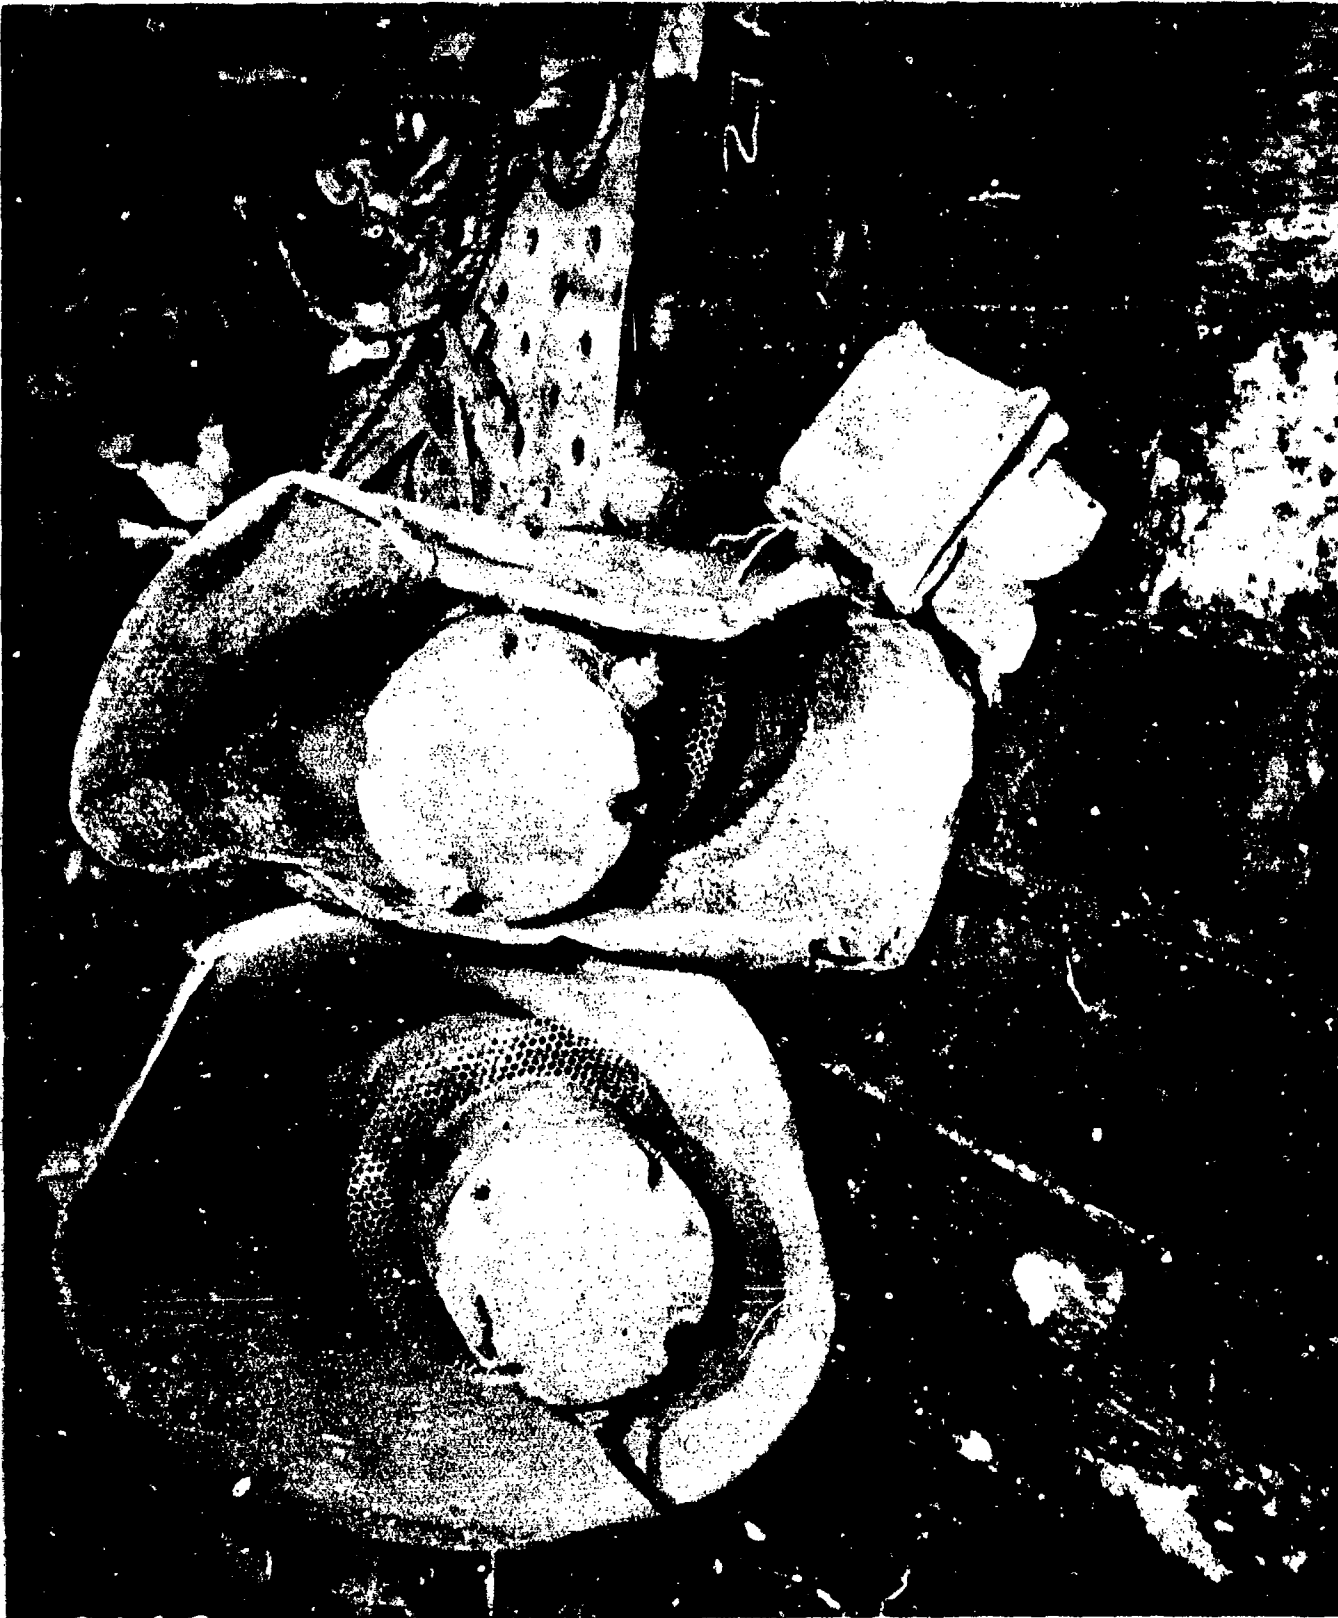
AA-CR-62-1880-10. Two 3MC reproducers laying on flight deck, which were broken loose from foundations on port bulkhead island structure above flight deck, overlooking and down to starboard.
