BUREAU OF SHIPS GROUP TECHNICAL INSPECTION REPORT

OPERATION CROSSROADS. U.S.S. CONYNGHAM (DD371) TEST ABLE [U].

DIRECTOR OF SHIP MATERIAL
JOINT TASK FORCE ONE

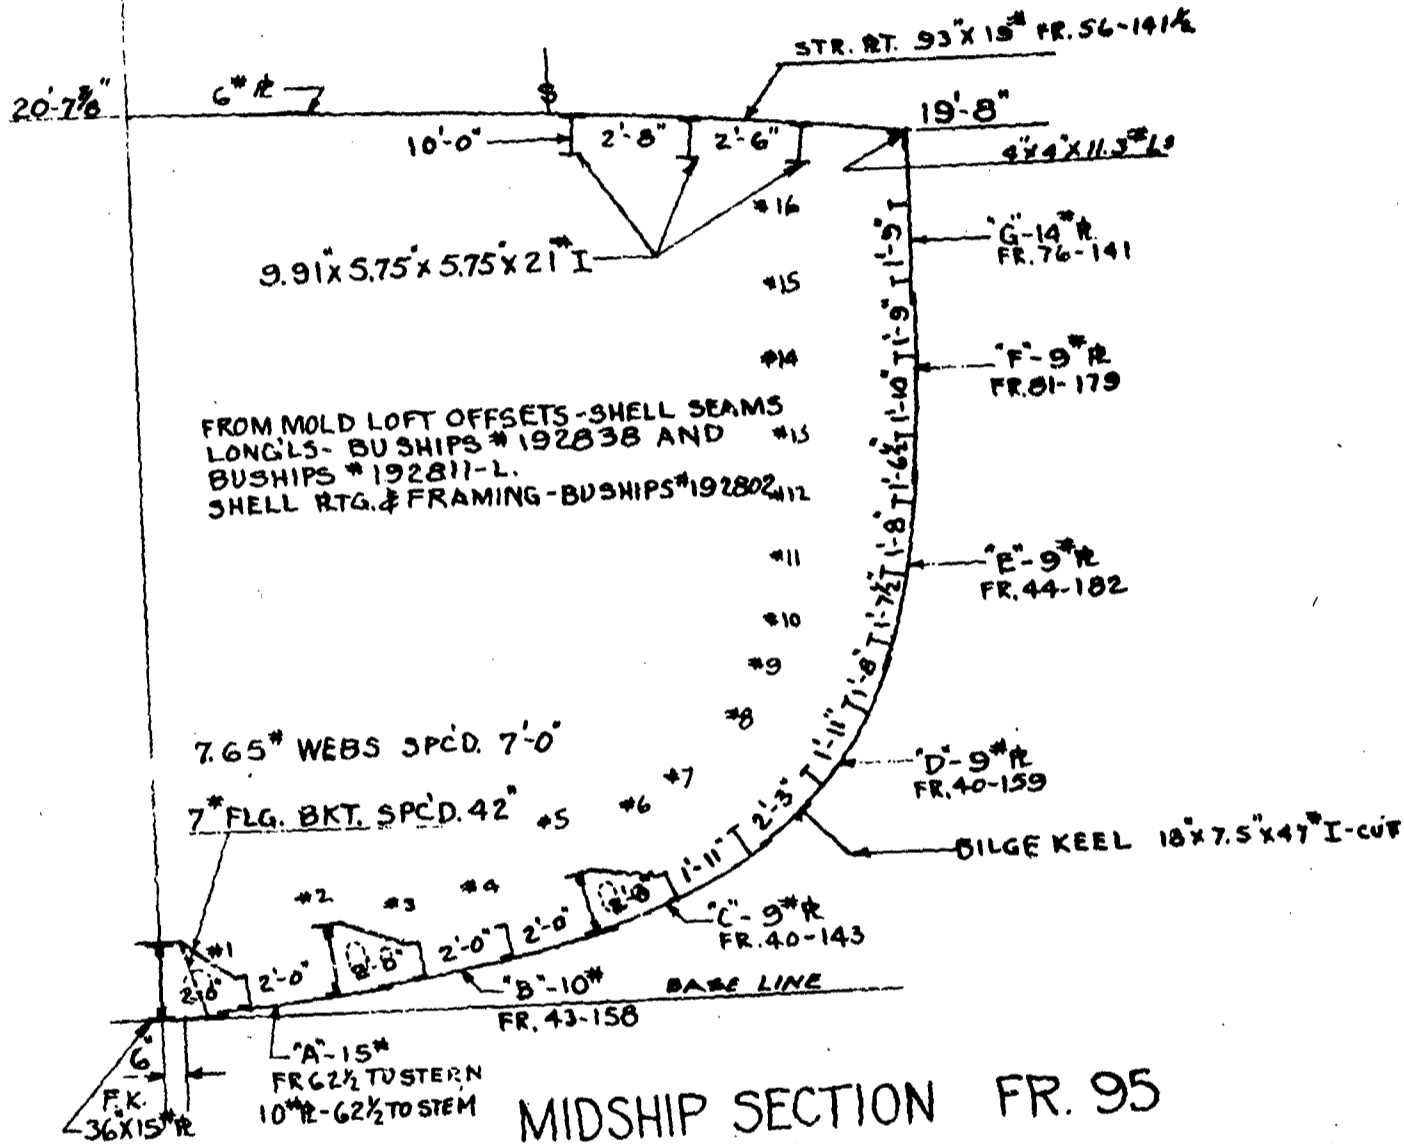
- LONG L1 - 9" x 2 1/16" x 13.4" E
- " 2-19" x 7" R 3" x 2" x 4.1" L6
- " 3#4 - 9" x 2 1/16" x 13.4" E
- " 5 - 17" x 7" R 3" x 2" x 4.1" L6
- " 6 - 8" x 2 1/4" x 2 1/4" x 11.5" E
- " 7 - 8" x 5.06" x 7.07" T
- " 8 THRU 11 - 6" x 3.06" x 7.07" T
- " 12-13-14 - 5" x 2.69" x 4.48" T
- " 15#16 - 5" x 1 1/2" x 1 1/4" x 6.7" E
- V.C.K. 21" x 12" R DBLS. 3" x 3" x 6.1" L7 TAB
