**BUREAU OF SHIPS GROUP**  
**TECHNICAL INSPECTION REPORT**

**6 OPERATION CROSSROADS.**  
**U.S.S. HUGHES (DD410)**  
**TEST ABLE [U].**

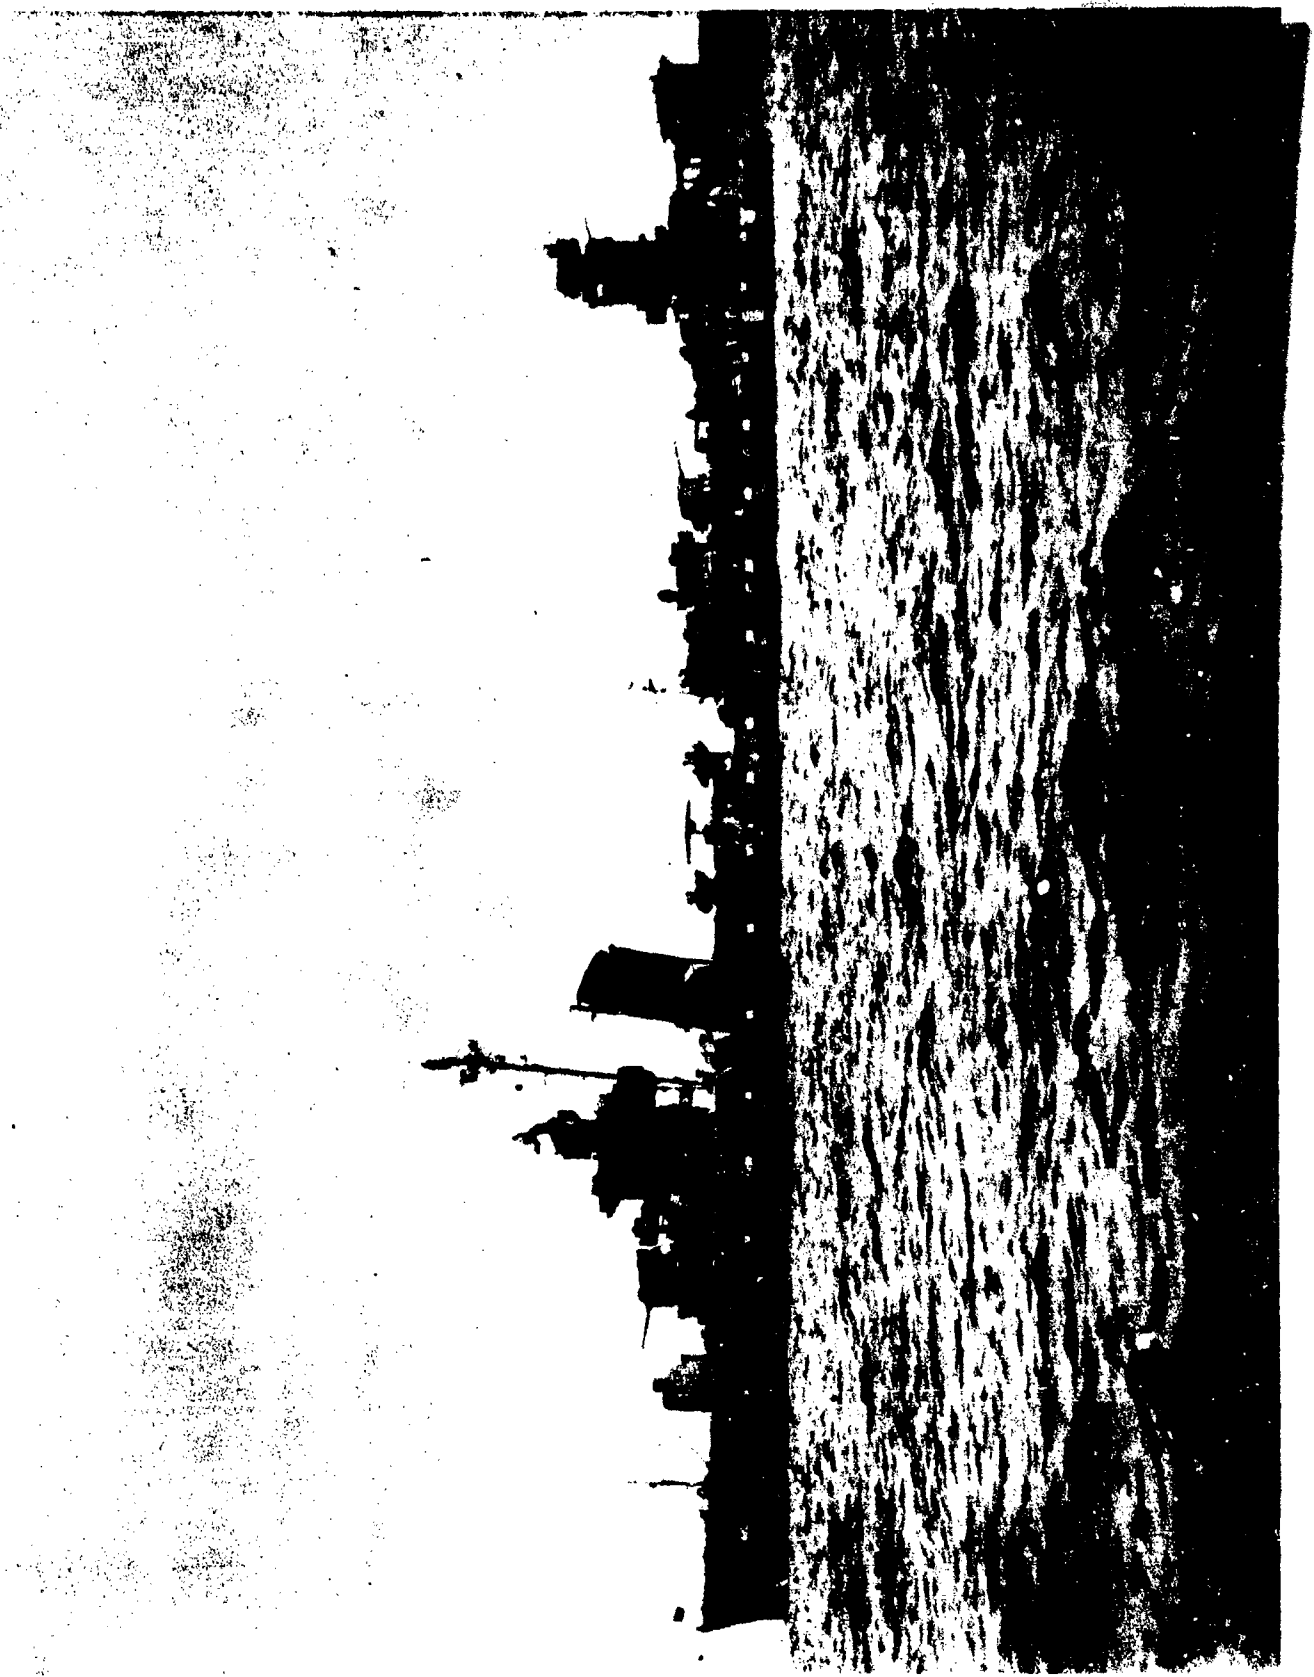
BA-CR-196-163-17 JUN 46

BA-CR-196-163-17. General view of port side before Test A.

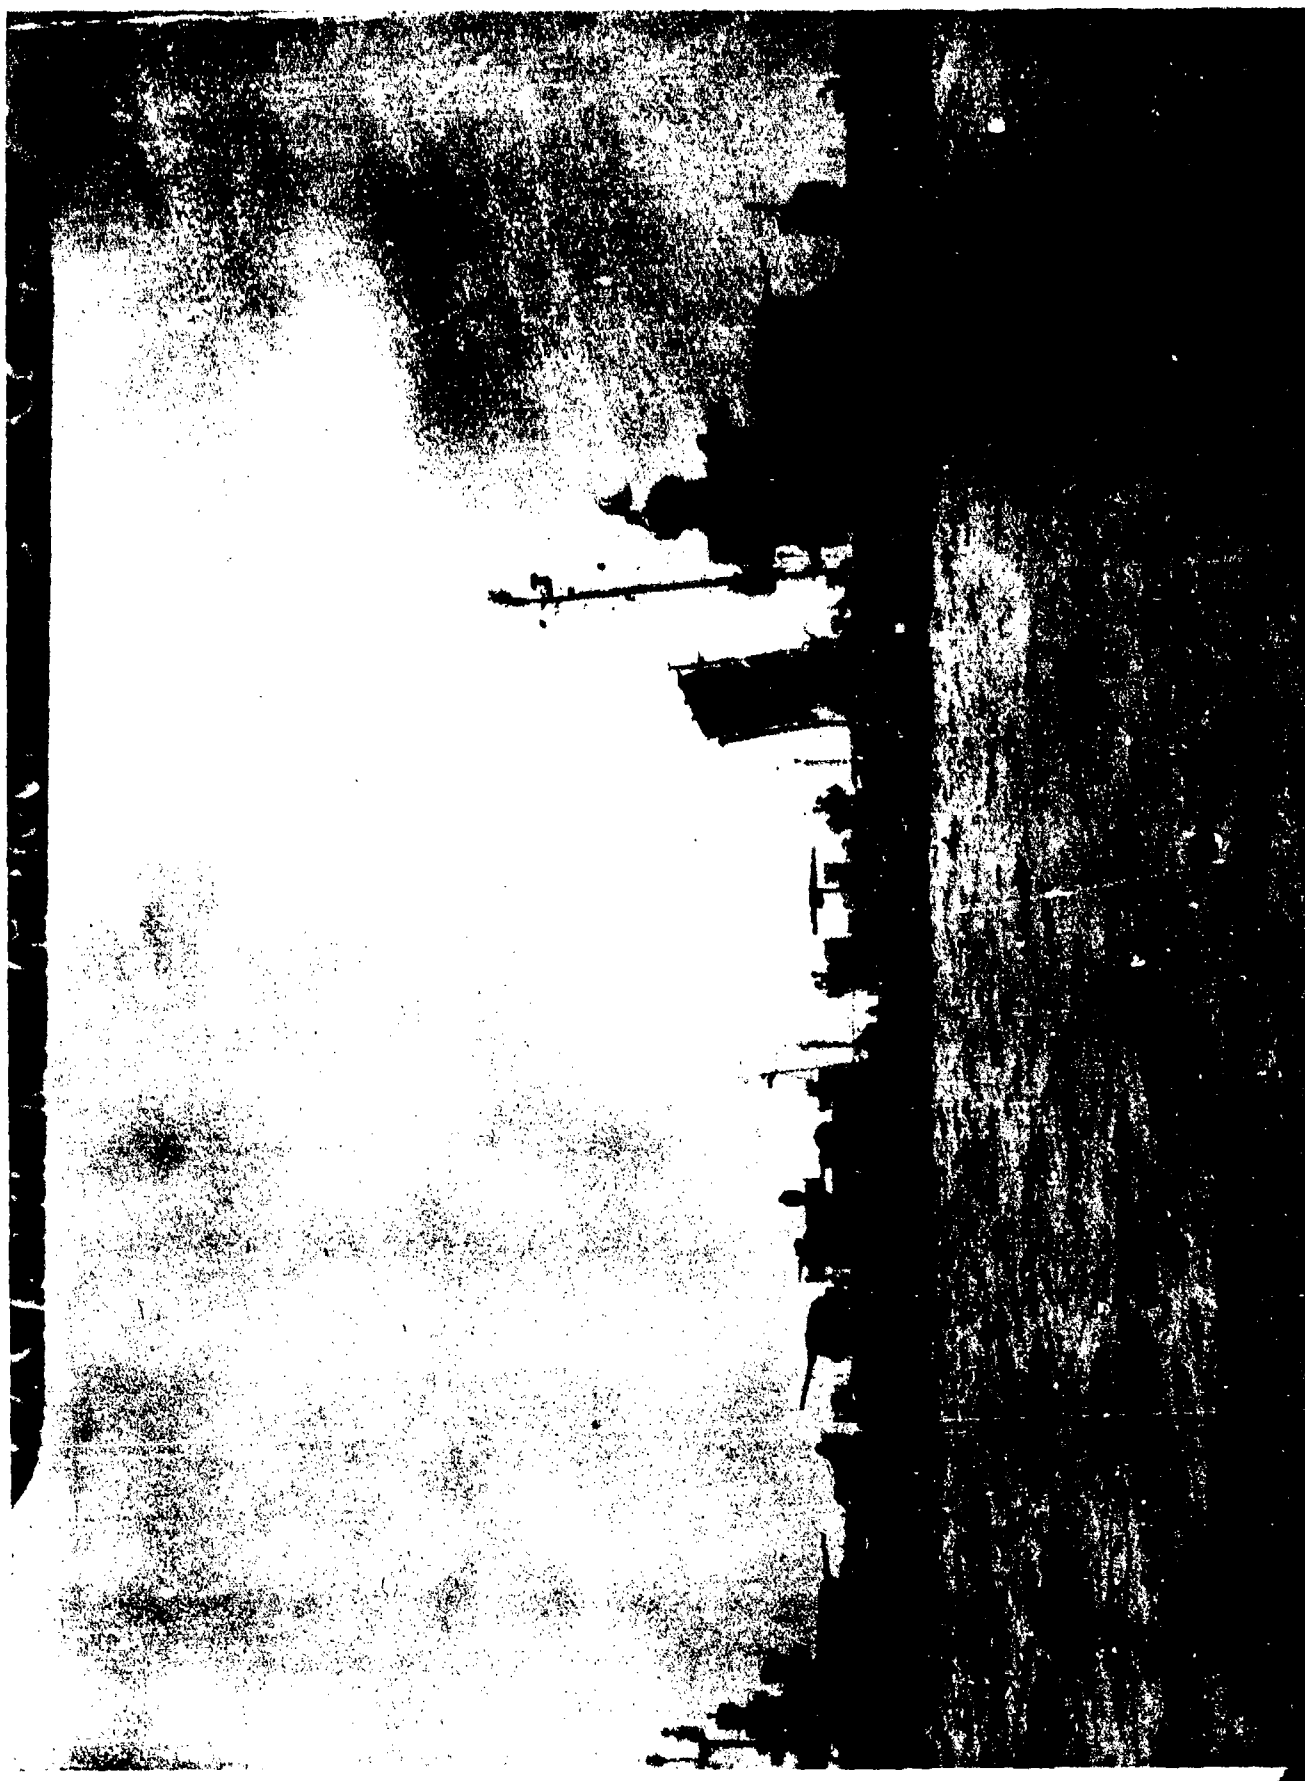
BA-CR-196-163-18. General view of starboard side before Test A

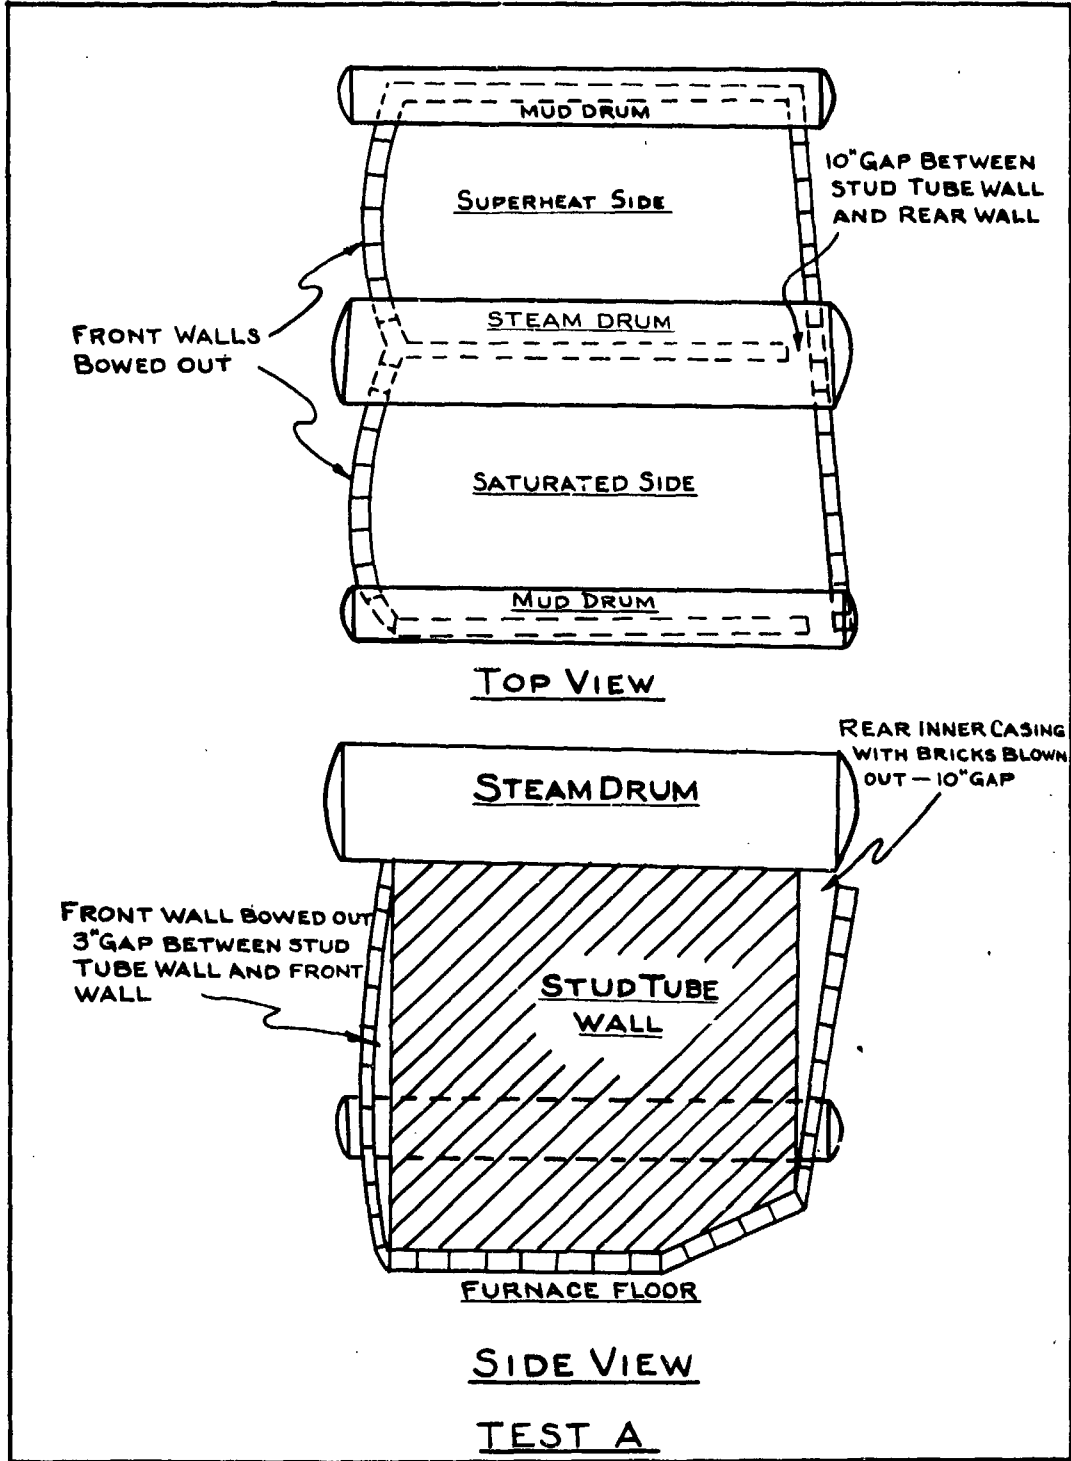
(e) Steam Water Drums and Heaters - These units were examined for cracks and found to be undamaged. They received no material or operational damage. The boiler was subjected to a hydrostatic test of 600 # revealing no change in condition as that before Test Able.
