TECHNICAL INSPECTION REPORT

OPERATION CROSSROADS.
U.S.S. CRITTENDEN (APA 77)
U.S. NAVY
U.S. BUREAU OF SHIPS
U.S. NAVY REPORT DIRECTLY FROM THE FIELD
TEST ABLE.
U.S. NAVY Support Agency
Washington, D. C. 20301
VOLUME 2 [U].

OPERATION CROSSROADS

BUREAU OF SHIPS GROUP
TECHNICAL INSPECTION REPORT

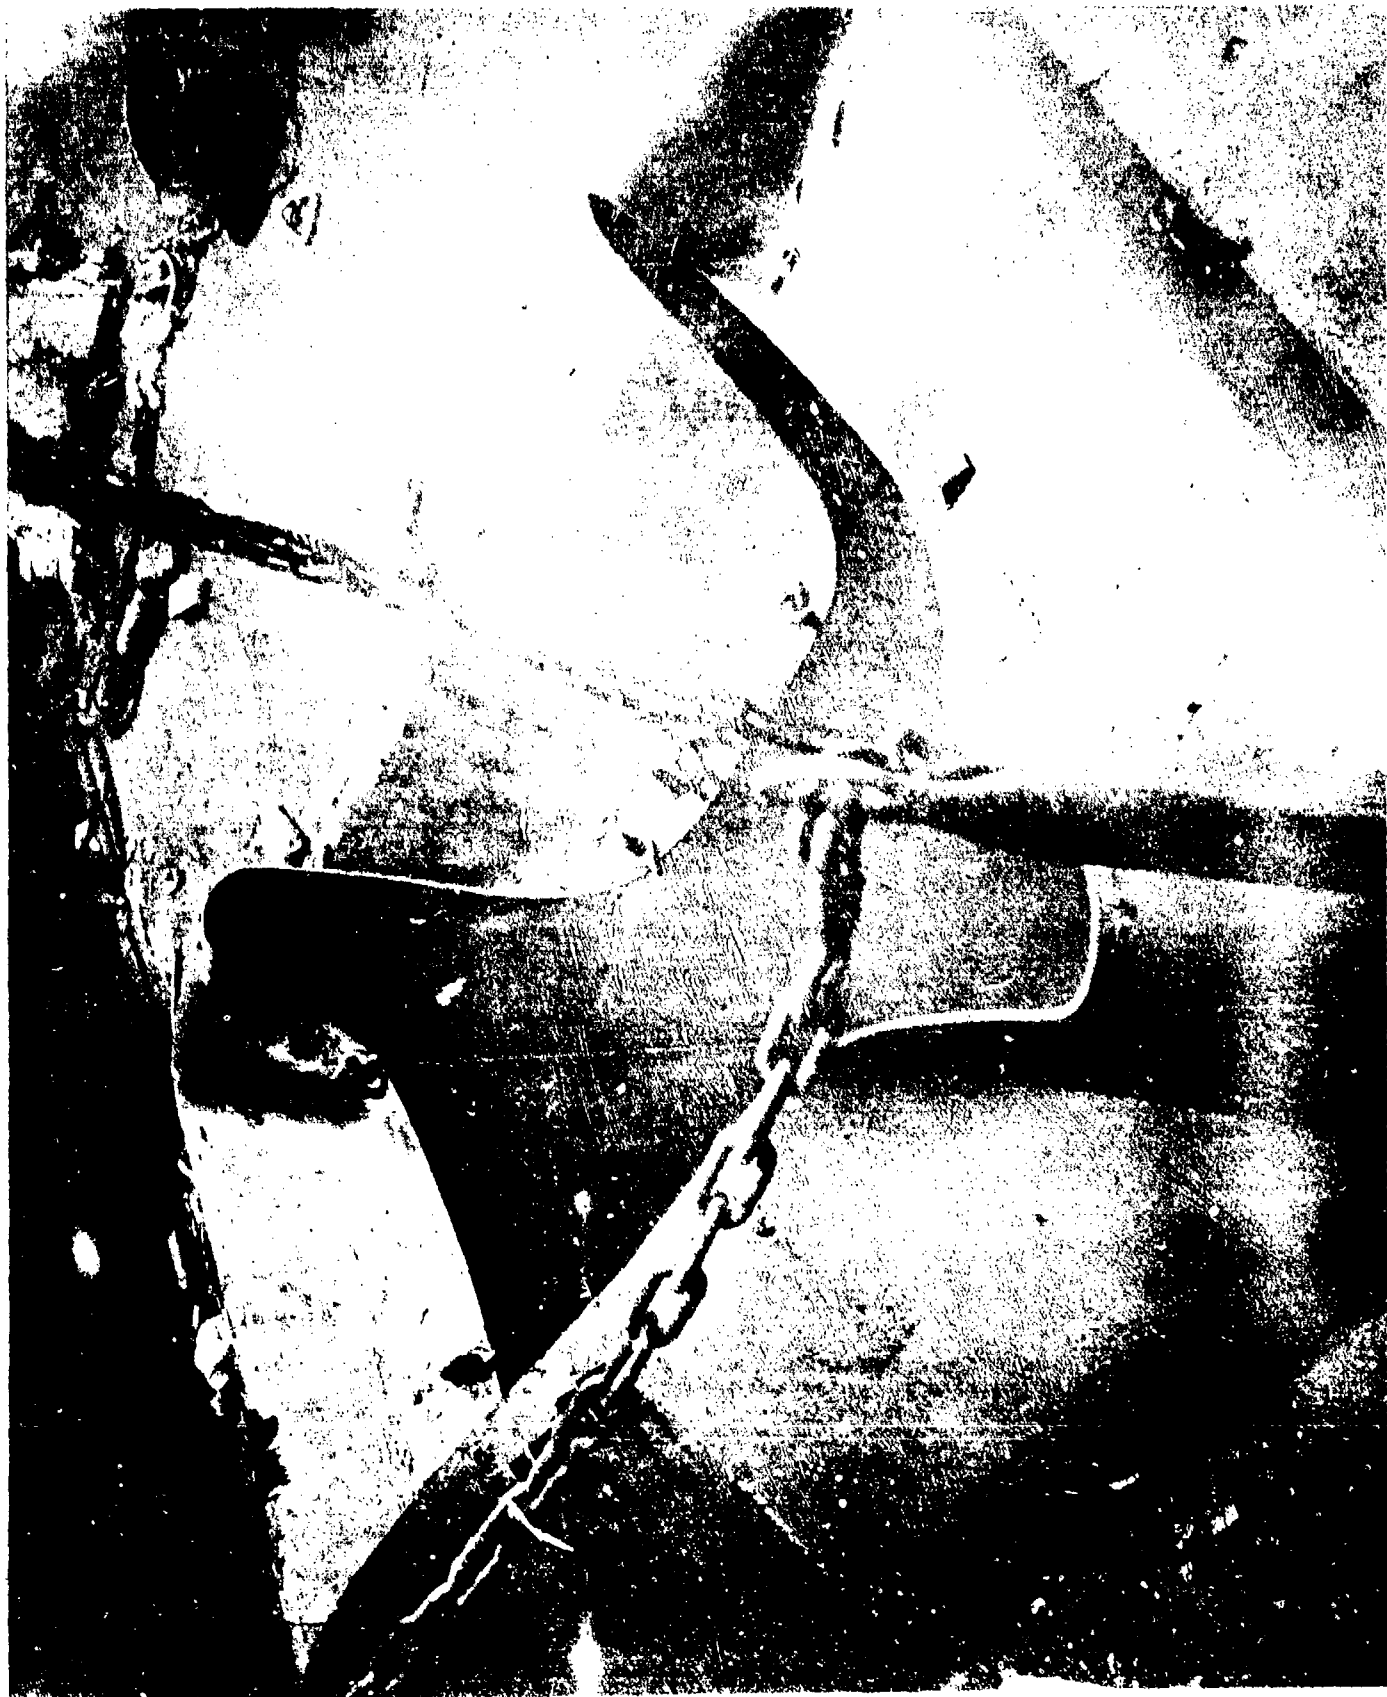
AA-CR-98-1961-1. Looking aft and to port on upper deck showing damage -
to coaming of ammunition trunk hatch.

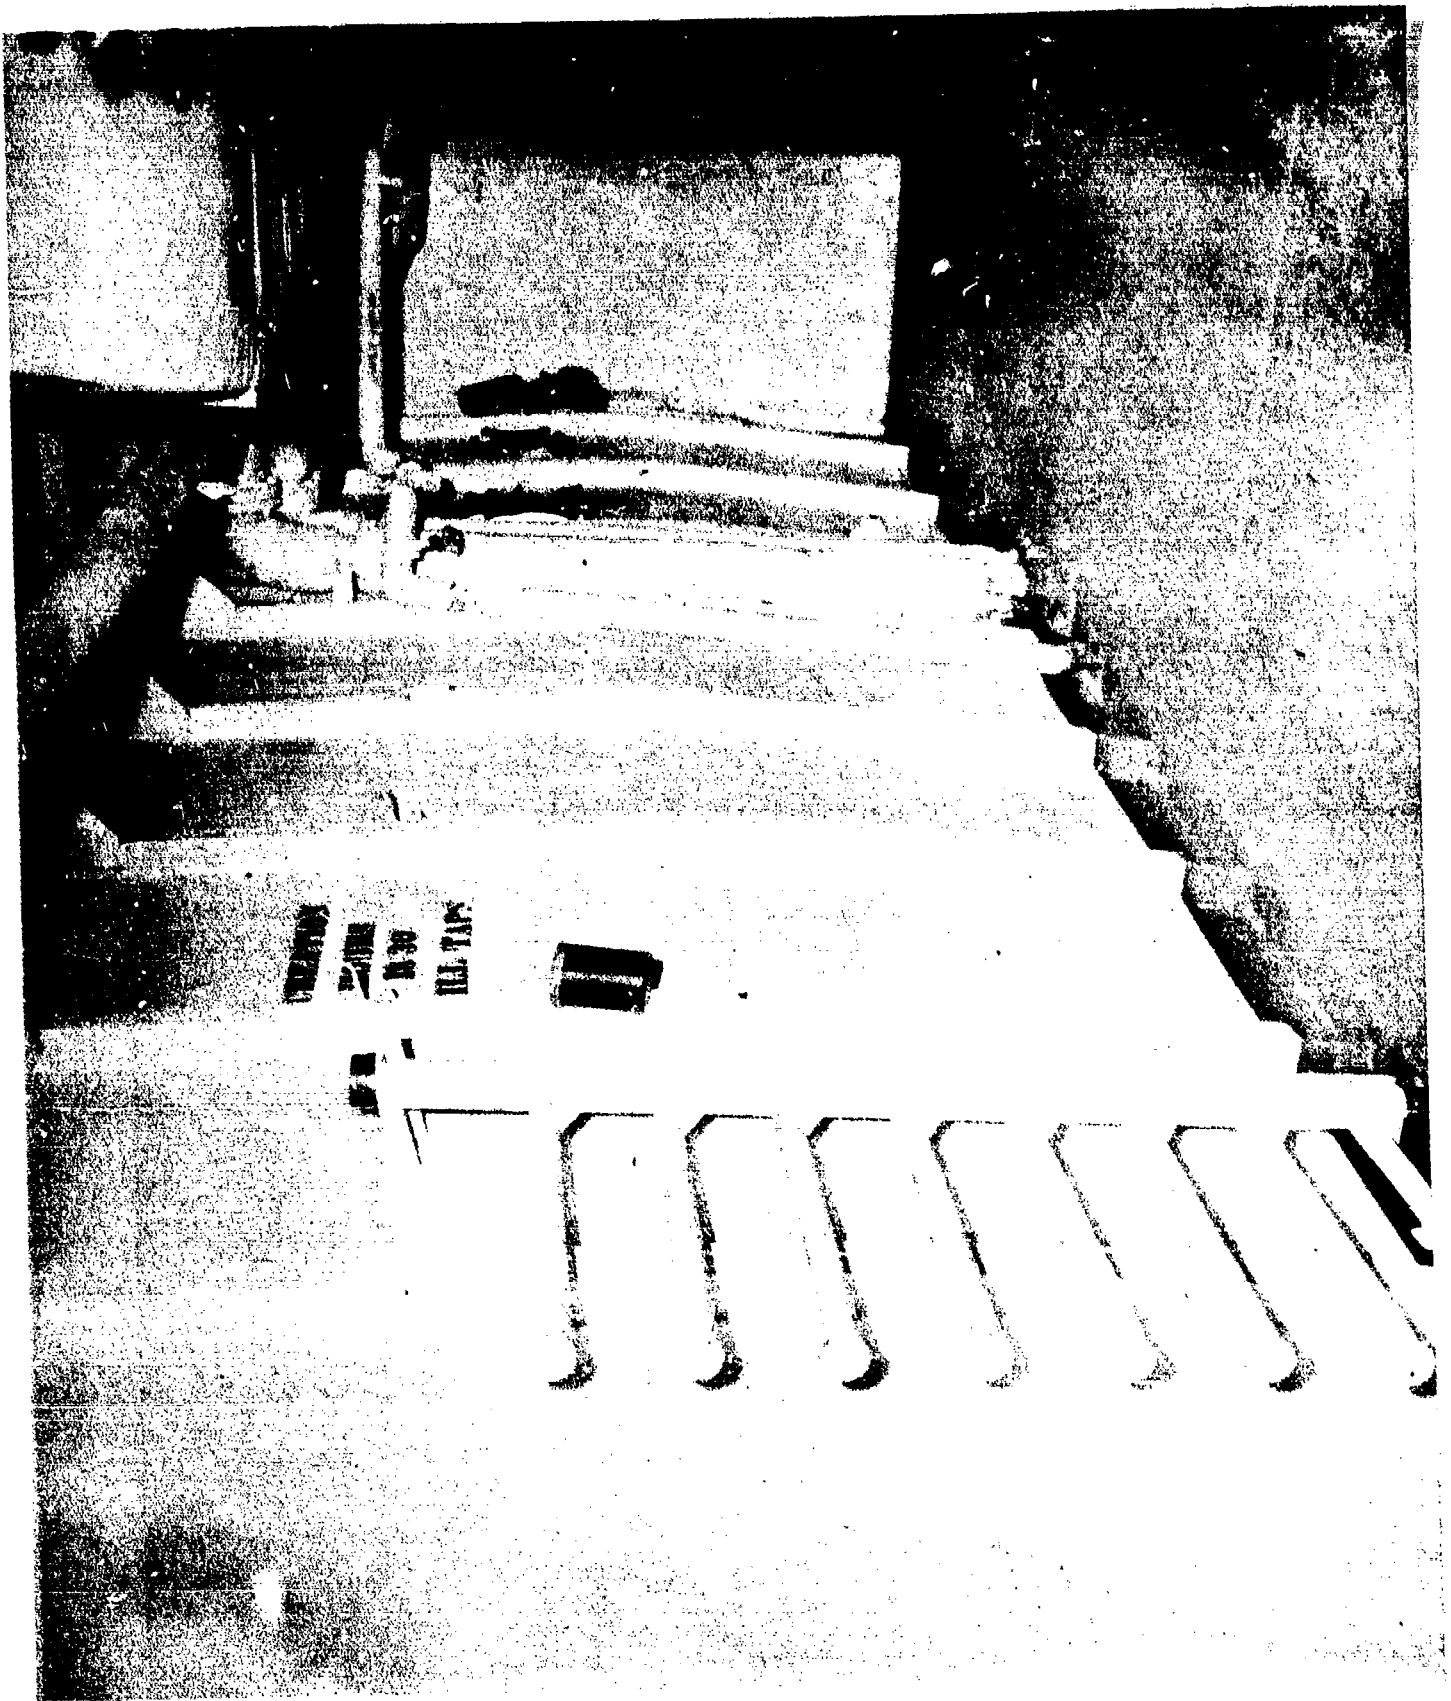
AA-CR-80-1908-10. Looking aft and to starboard on main deck in troop mess compartment B-102L showing dishing of starboard well deck longitudinal bulkhead, frames 70 to 80.

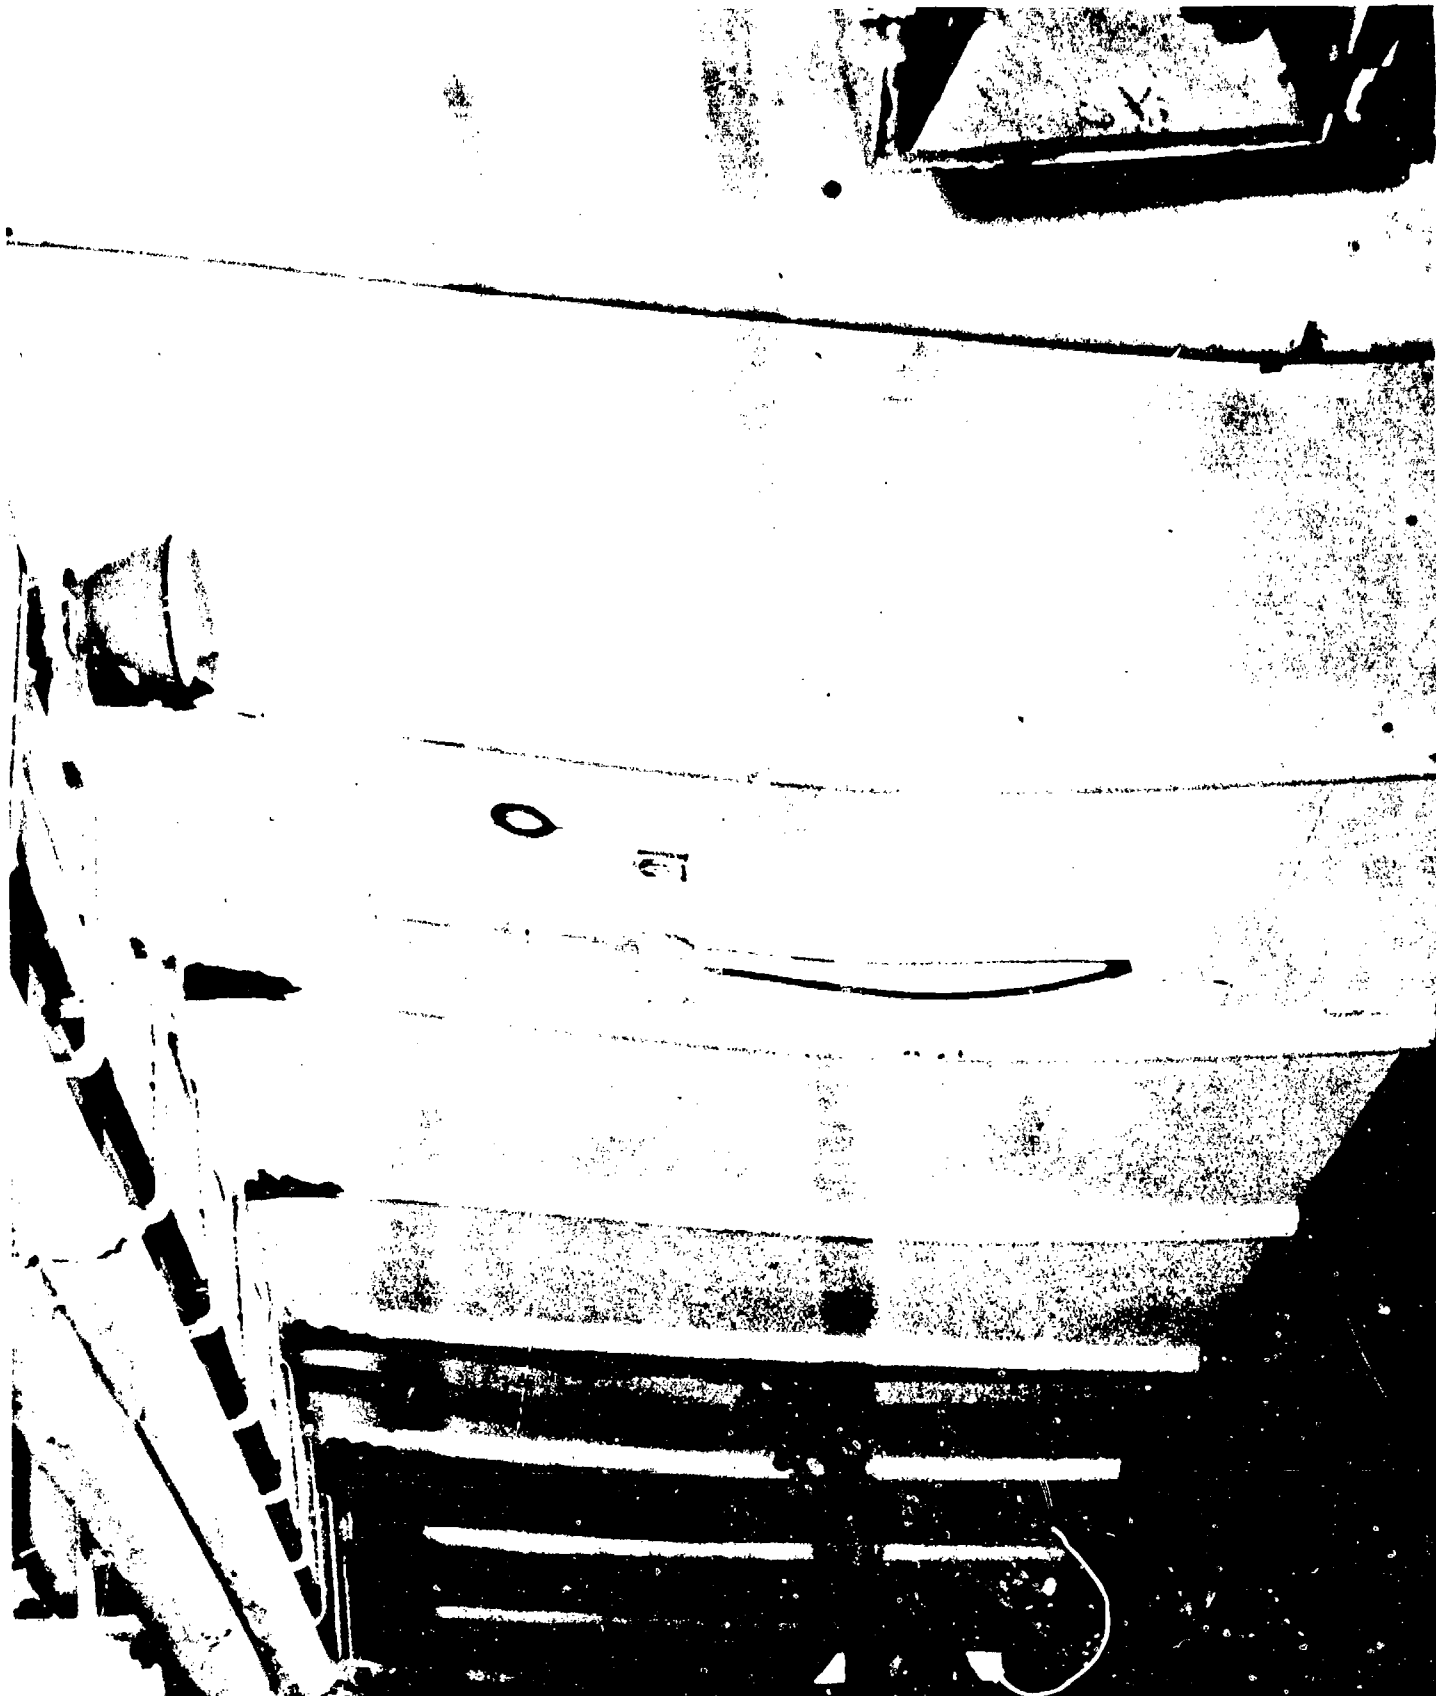
AA-CR-88-2101-6. Deflected light structural bulkhead, main deck, along port edge of forward cargo hatch.

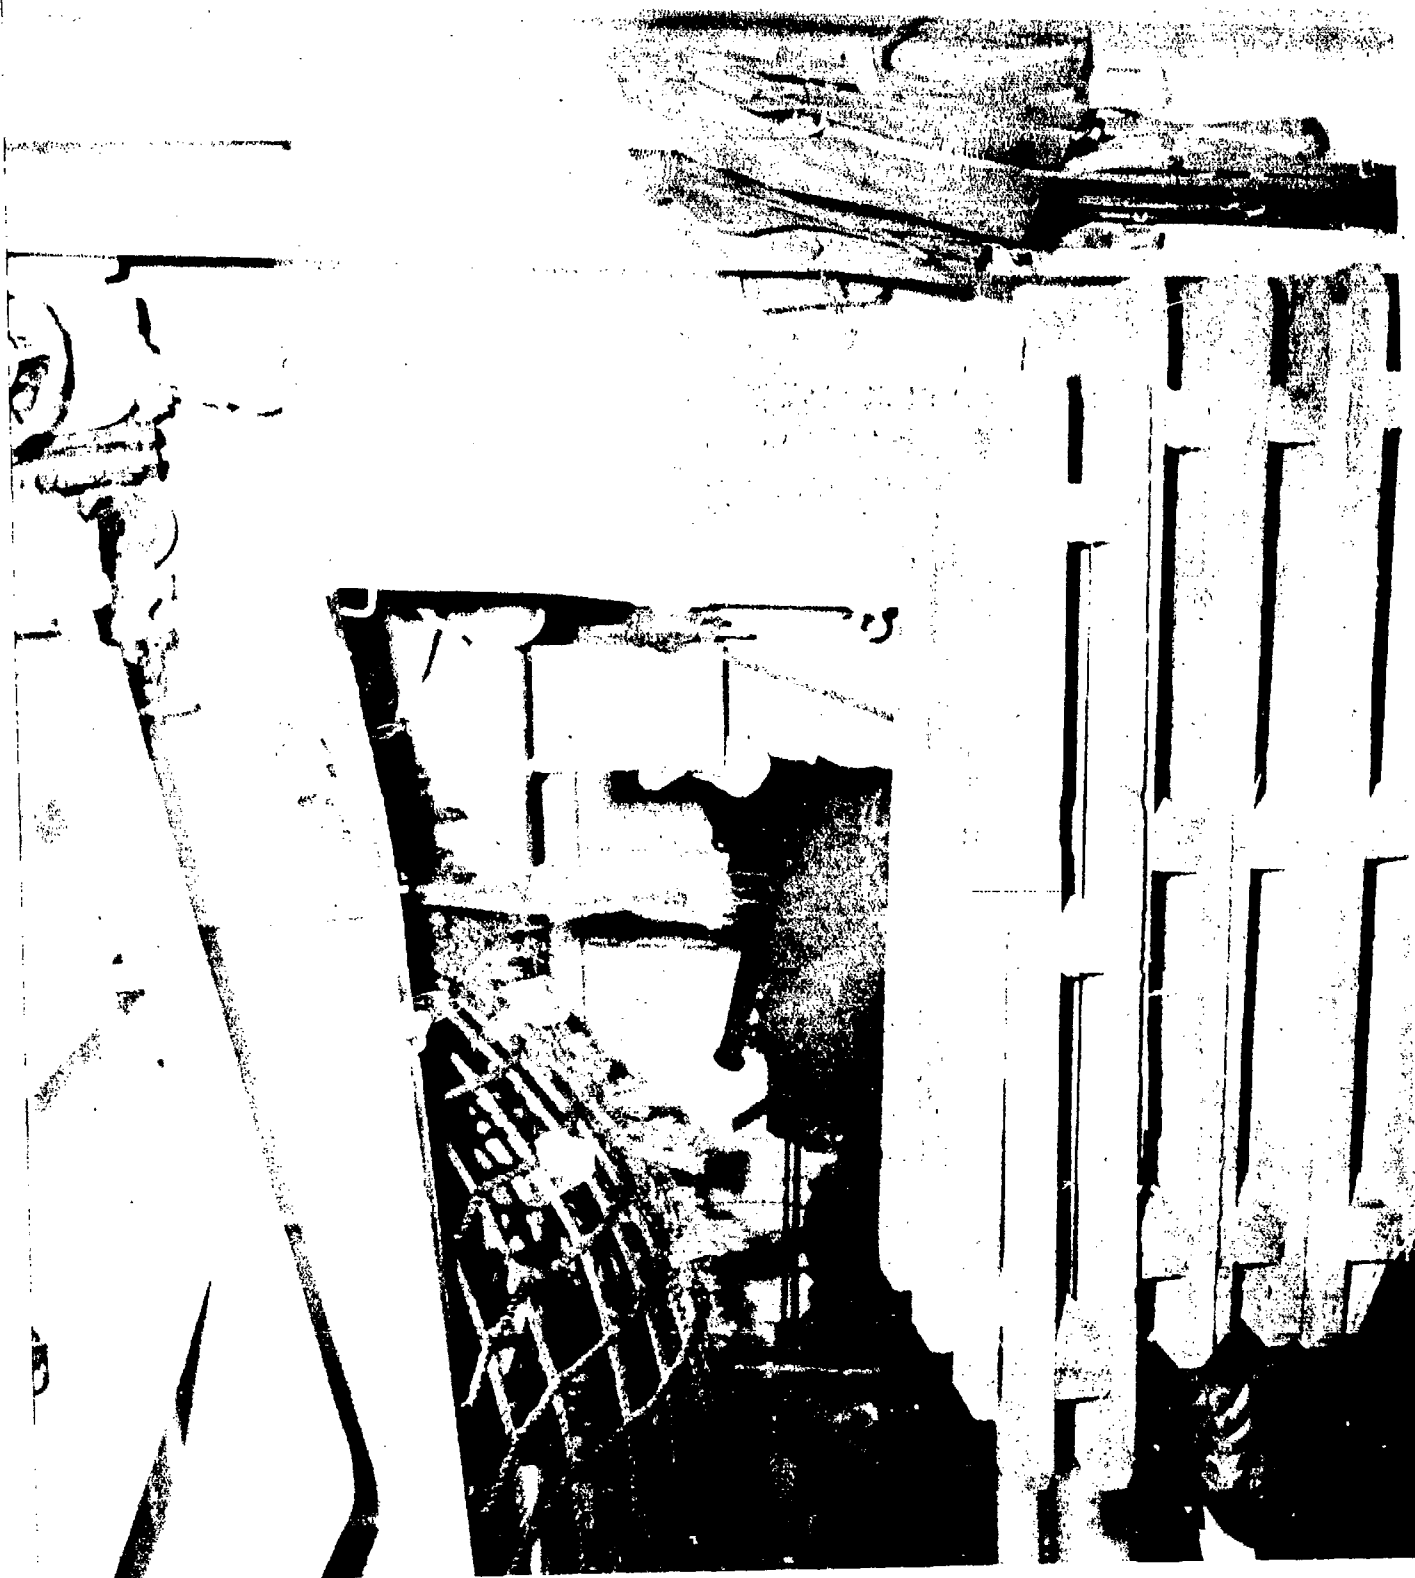
AA-CR-100-1890-9. Looking to port along bulkhead 40 on first platform in forward cargo hatch area showing damage to column in way of starboard coaming of hatch.

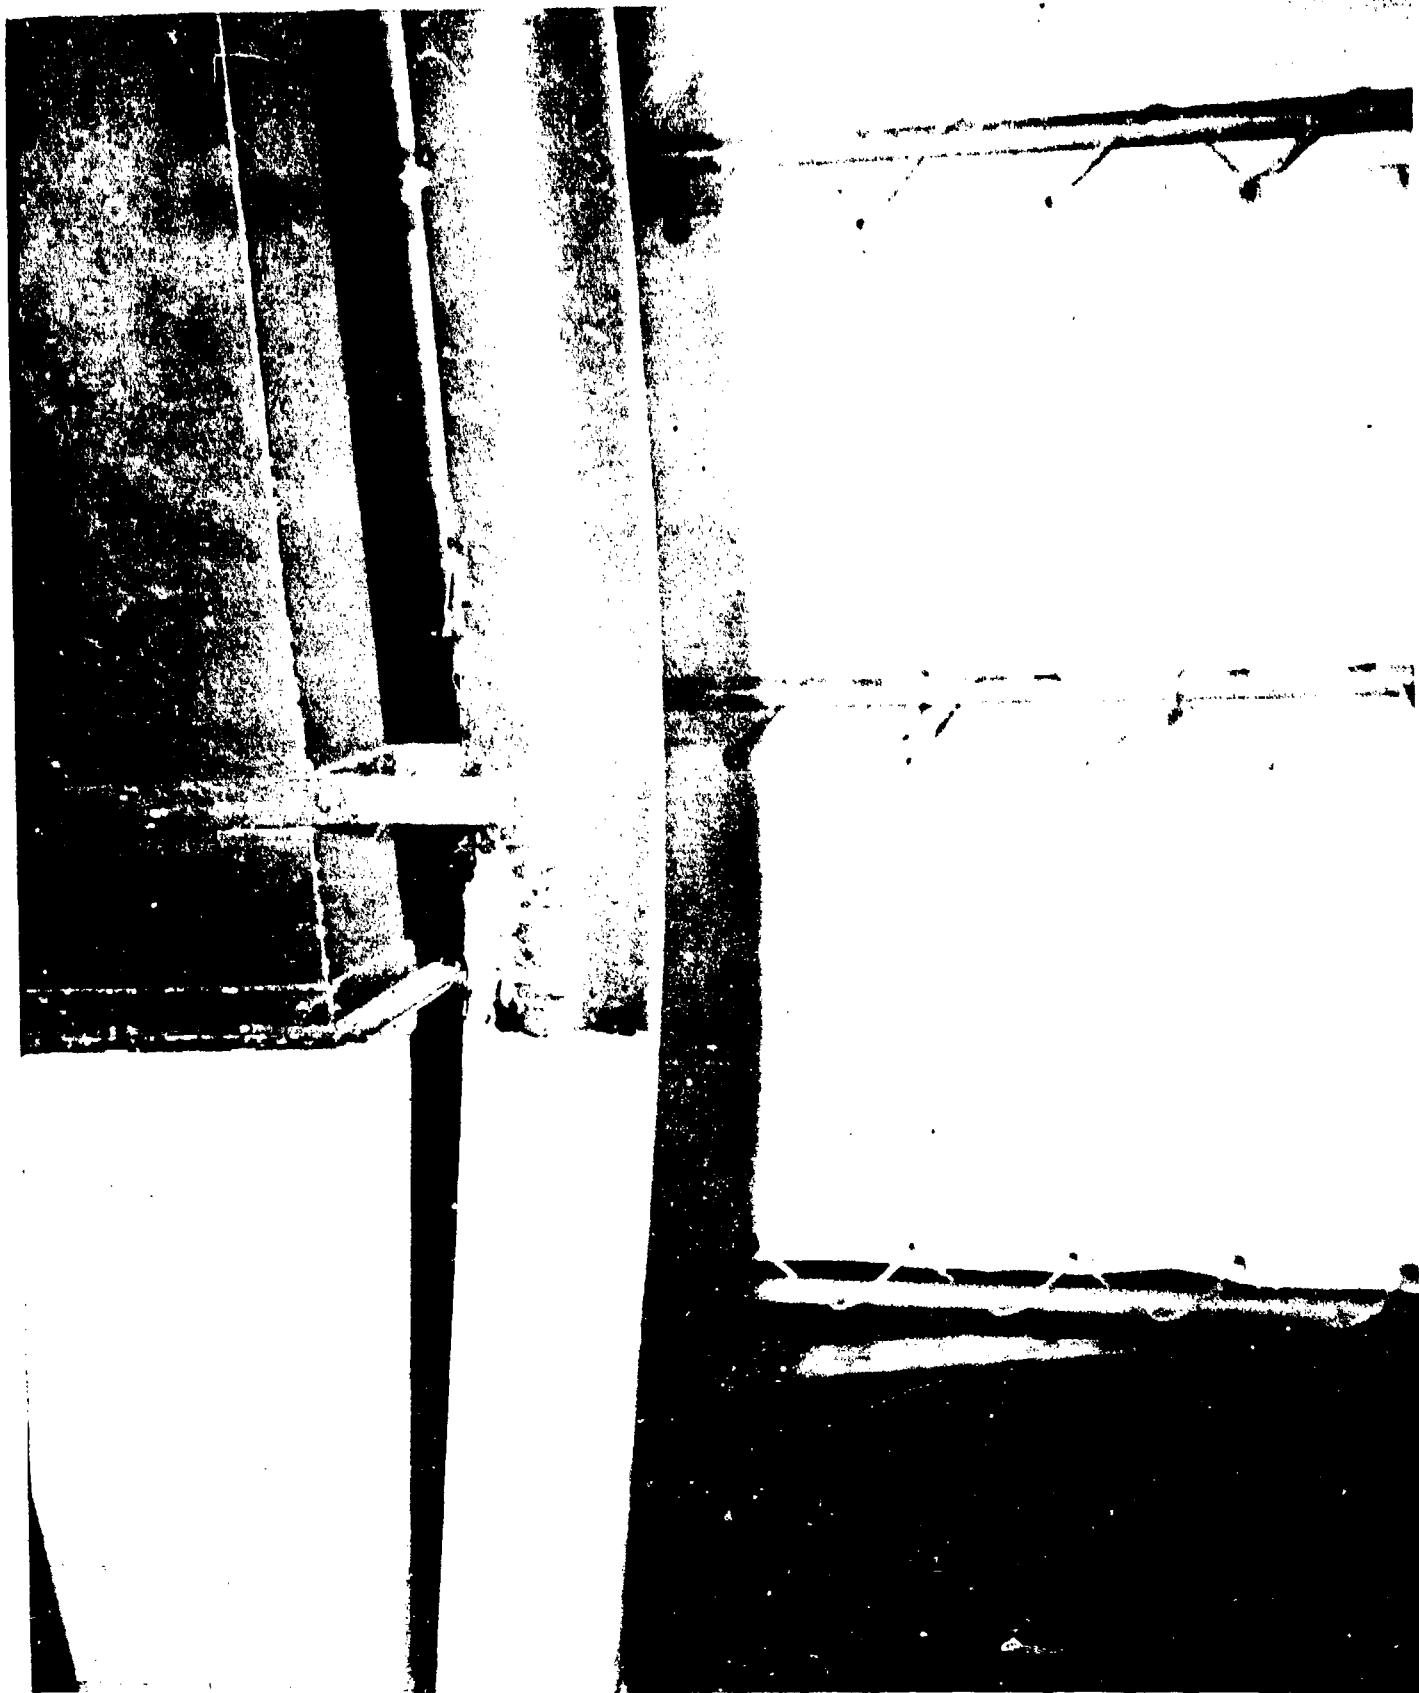
AA-CR-80-1908-9. Looking to port on main deck in after troop berthing space showing deflection of port stanchion at frame 129.

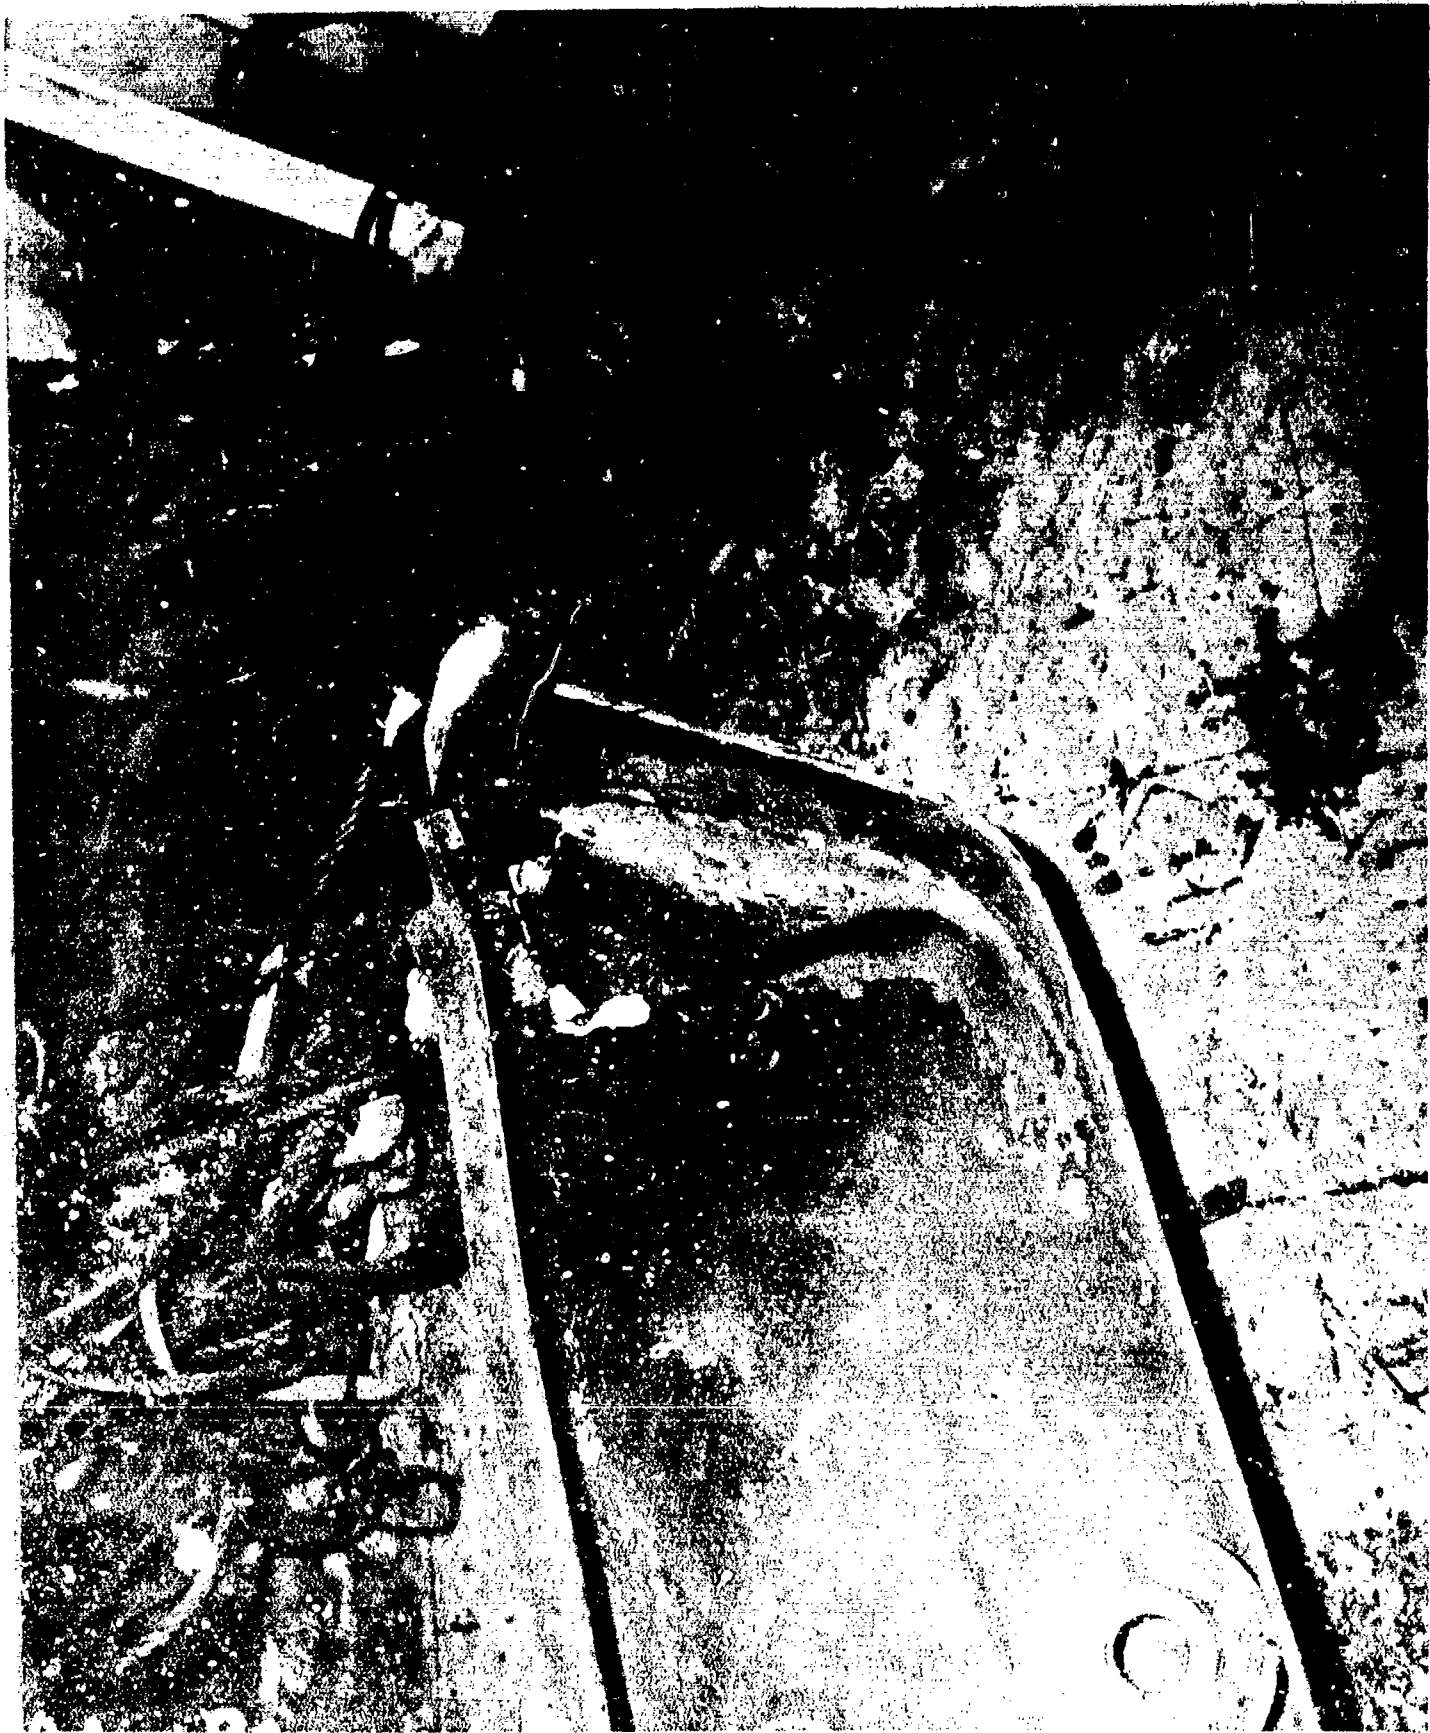
AA-CR-60-1908-4. View in after cargo hold showing close-up of end
of strong-back from upper deck level.

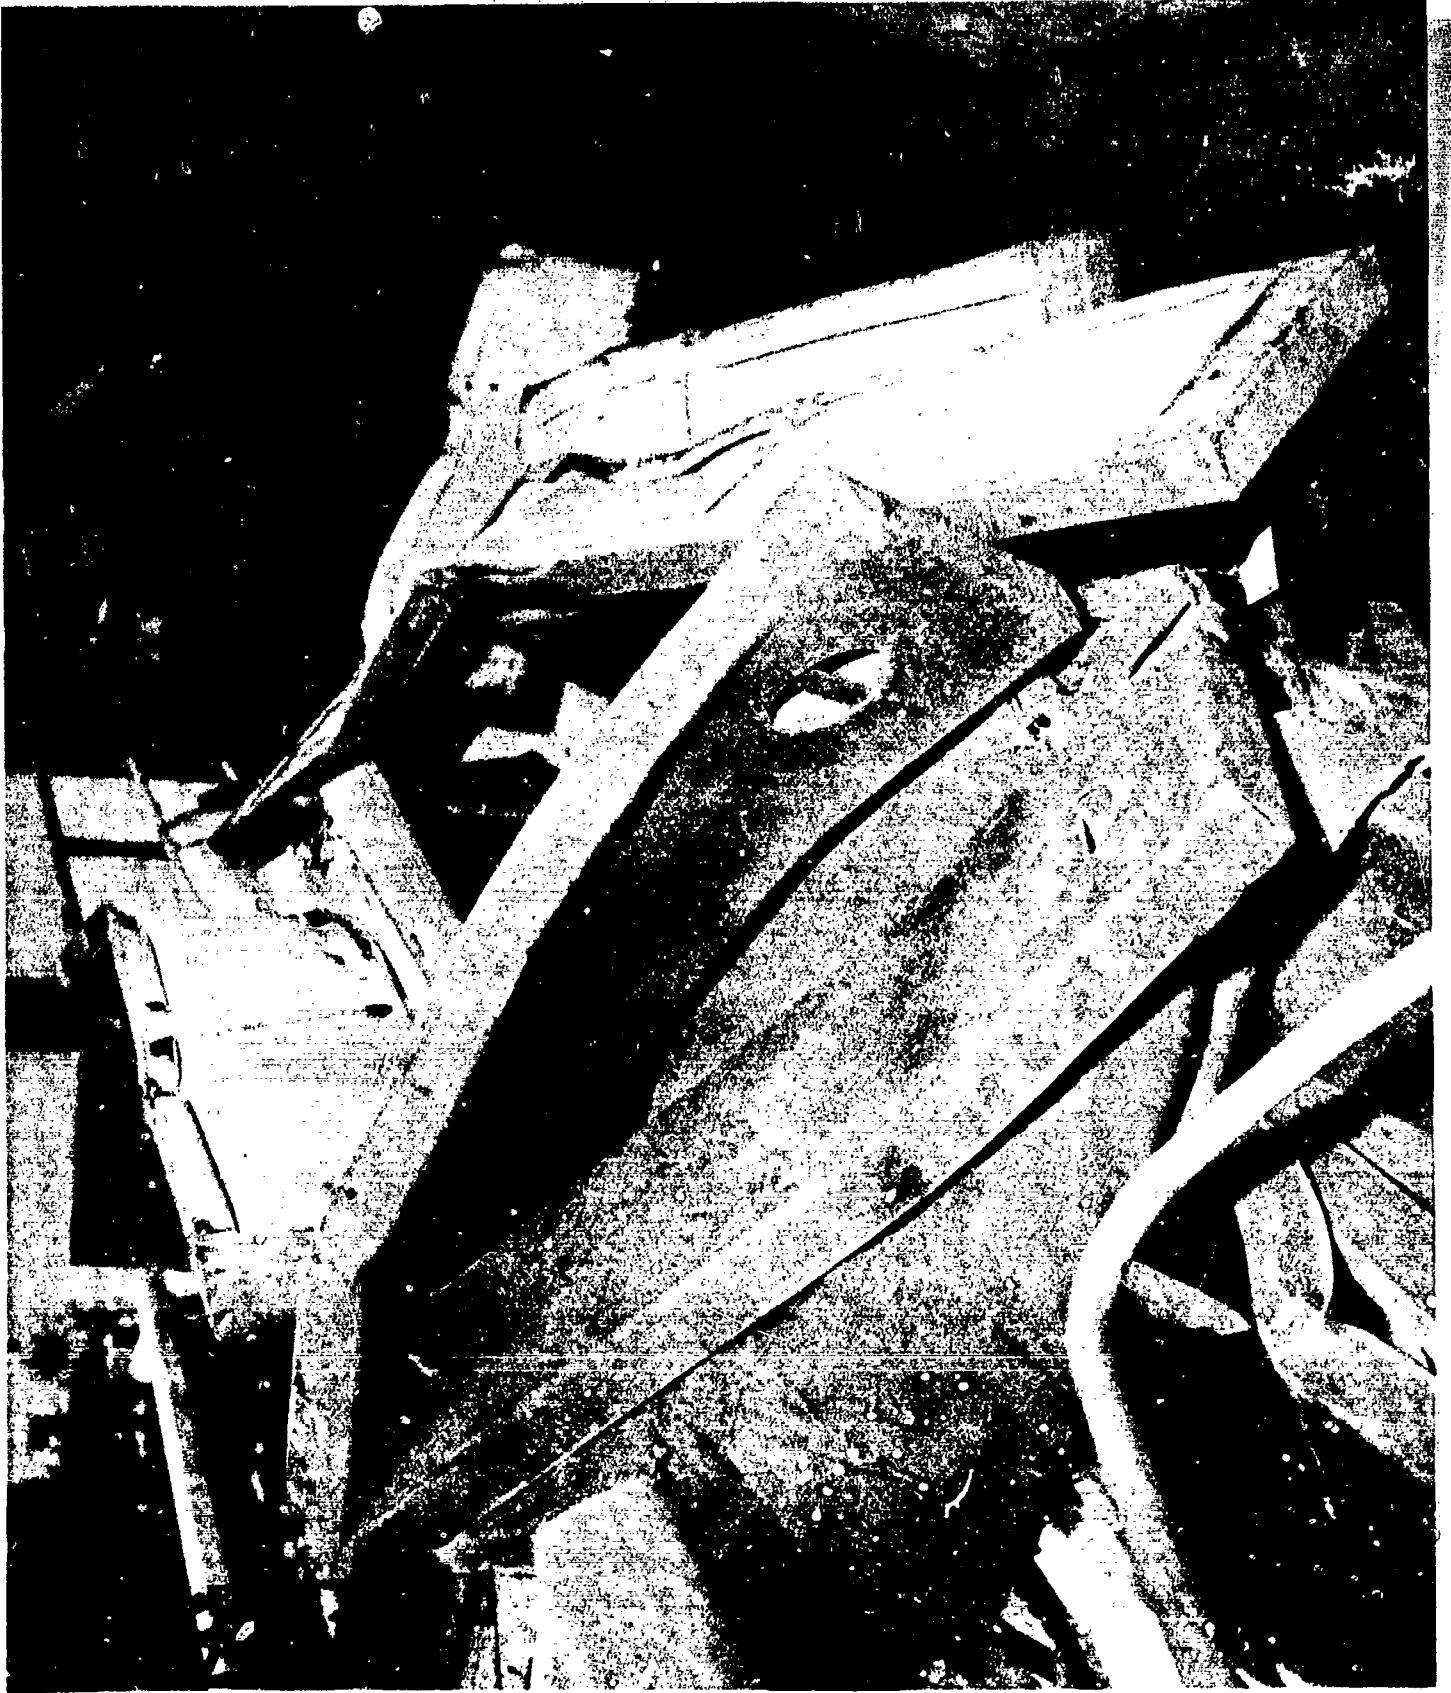
AA-CR-80-1907-3. Bent upper deck hatch cover panels.

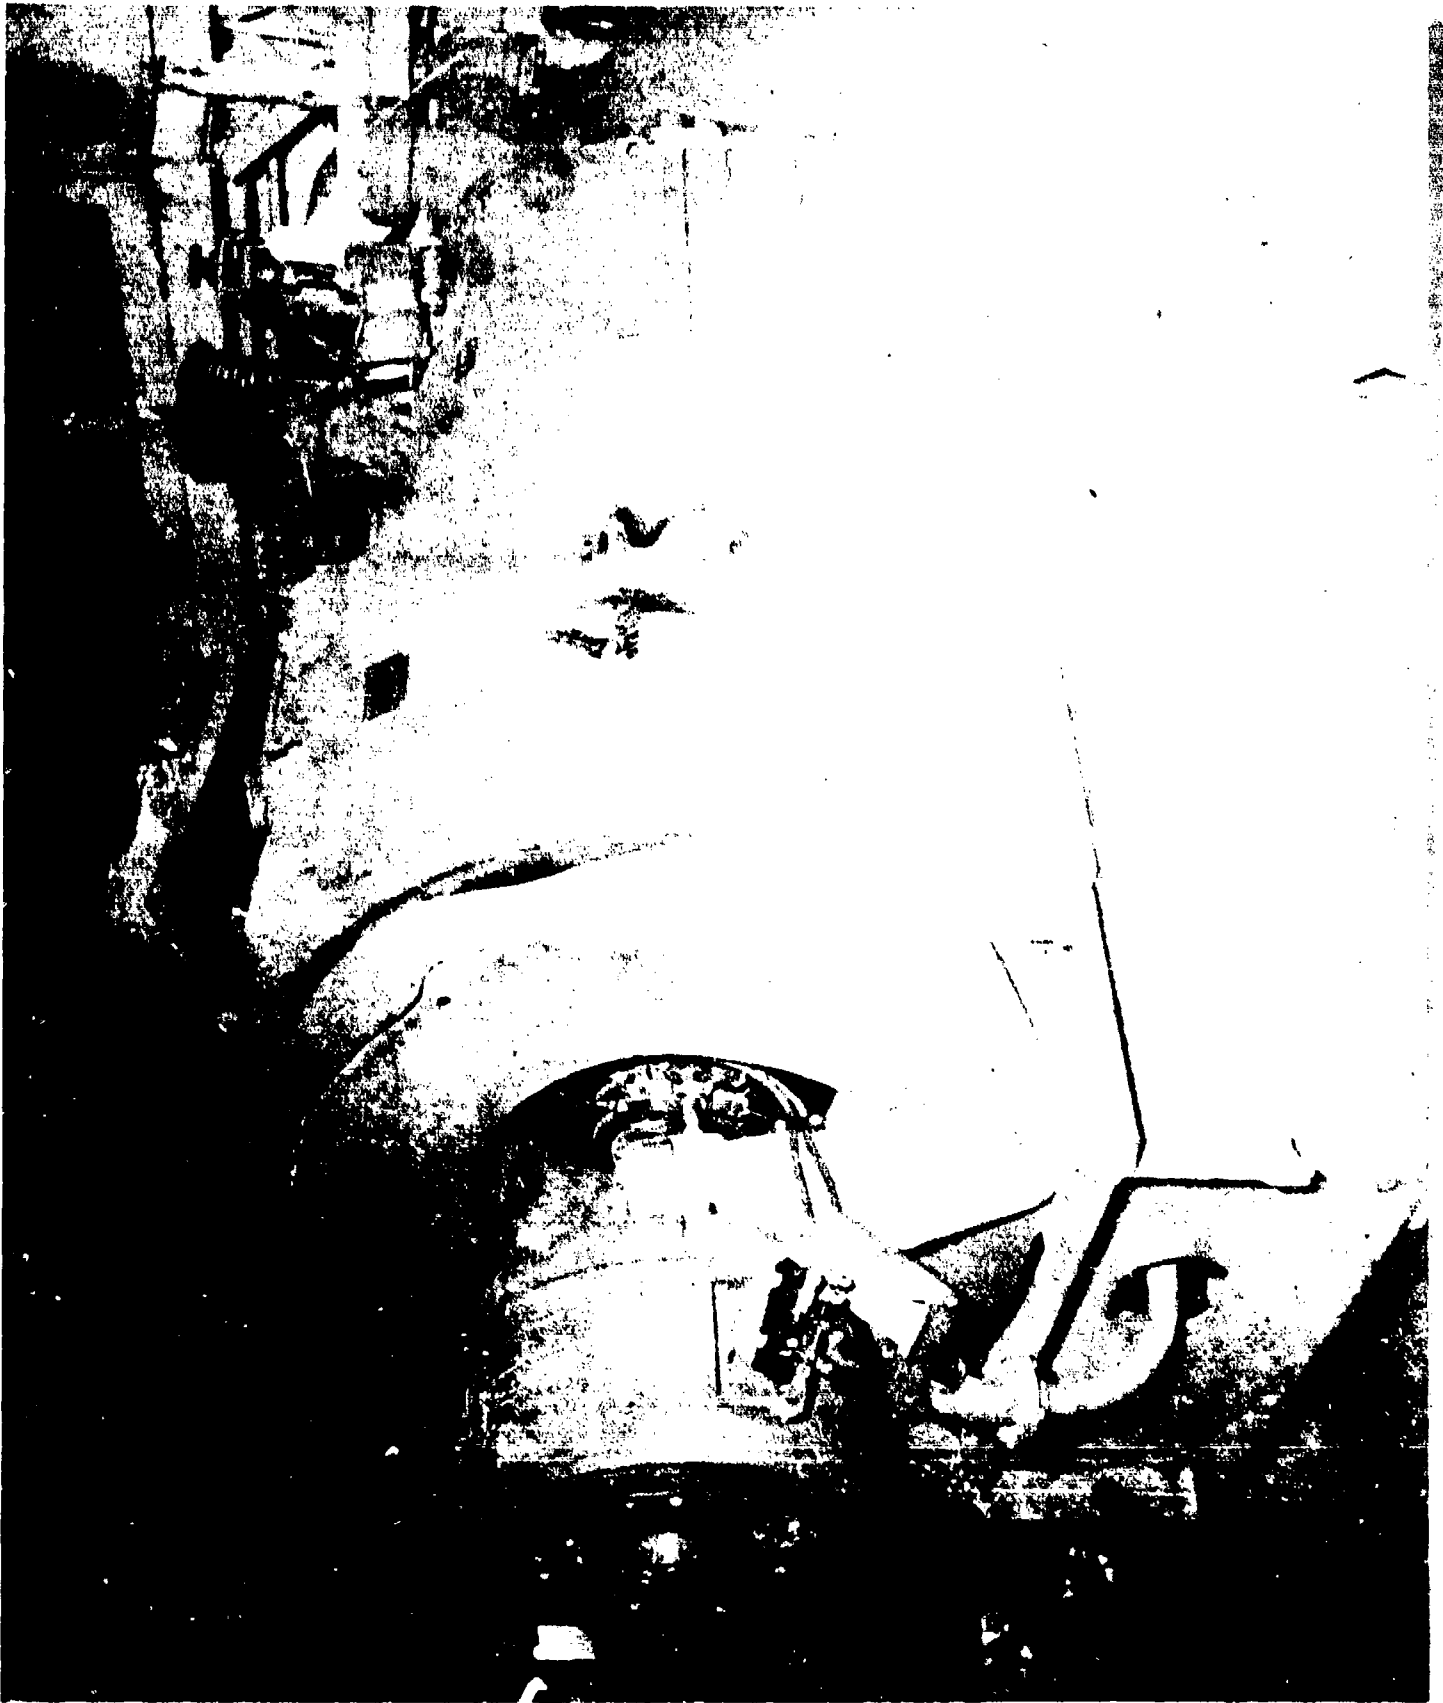
AA-CR-78-1949-6. 400 K.W. turbo generator located in the forward cargo hold. Shown after the debris was cleared away. Code 660, 12E1.

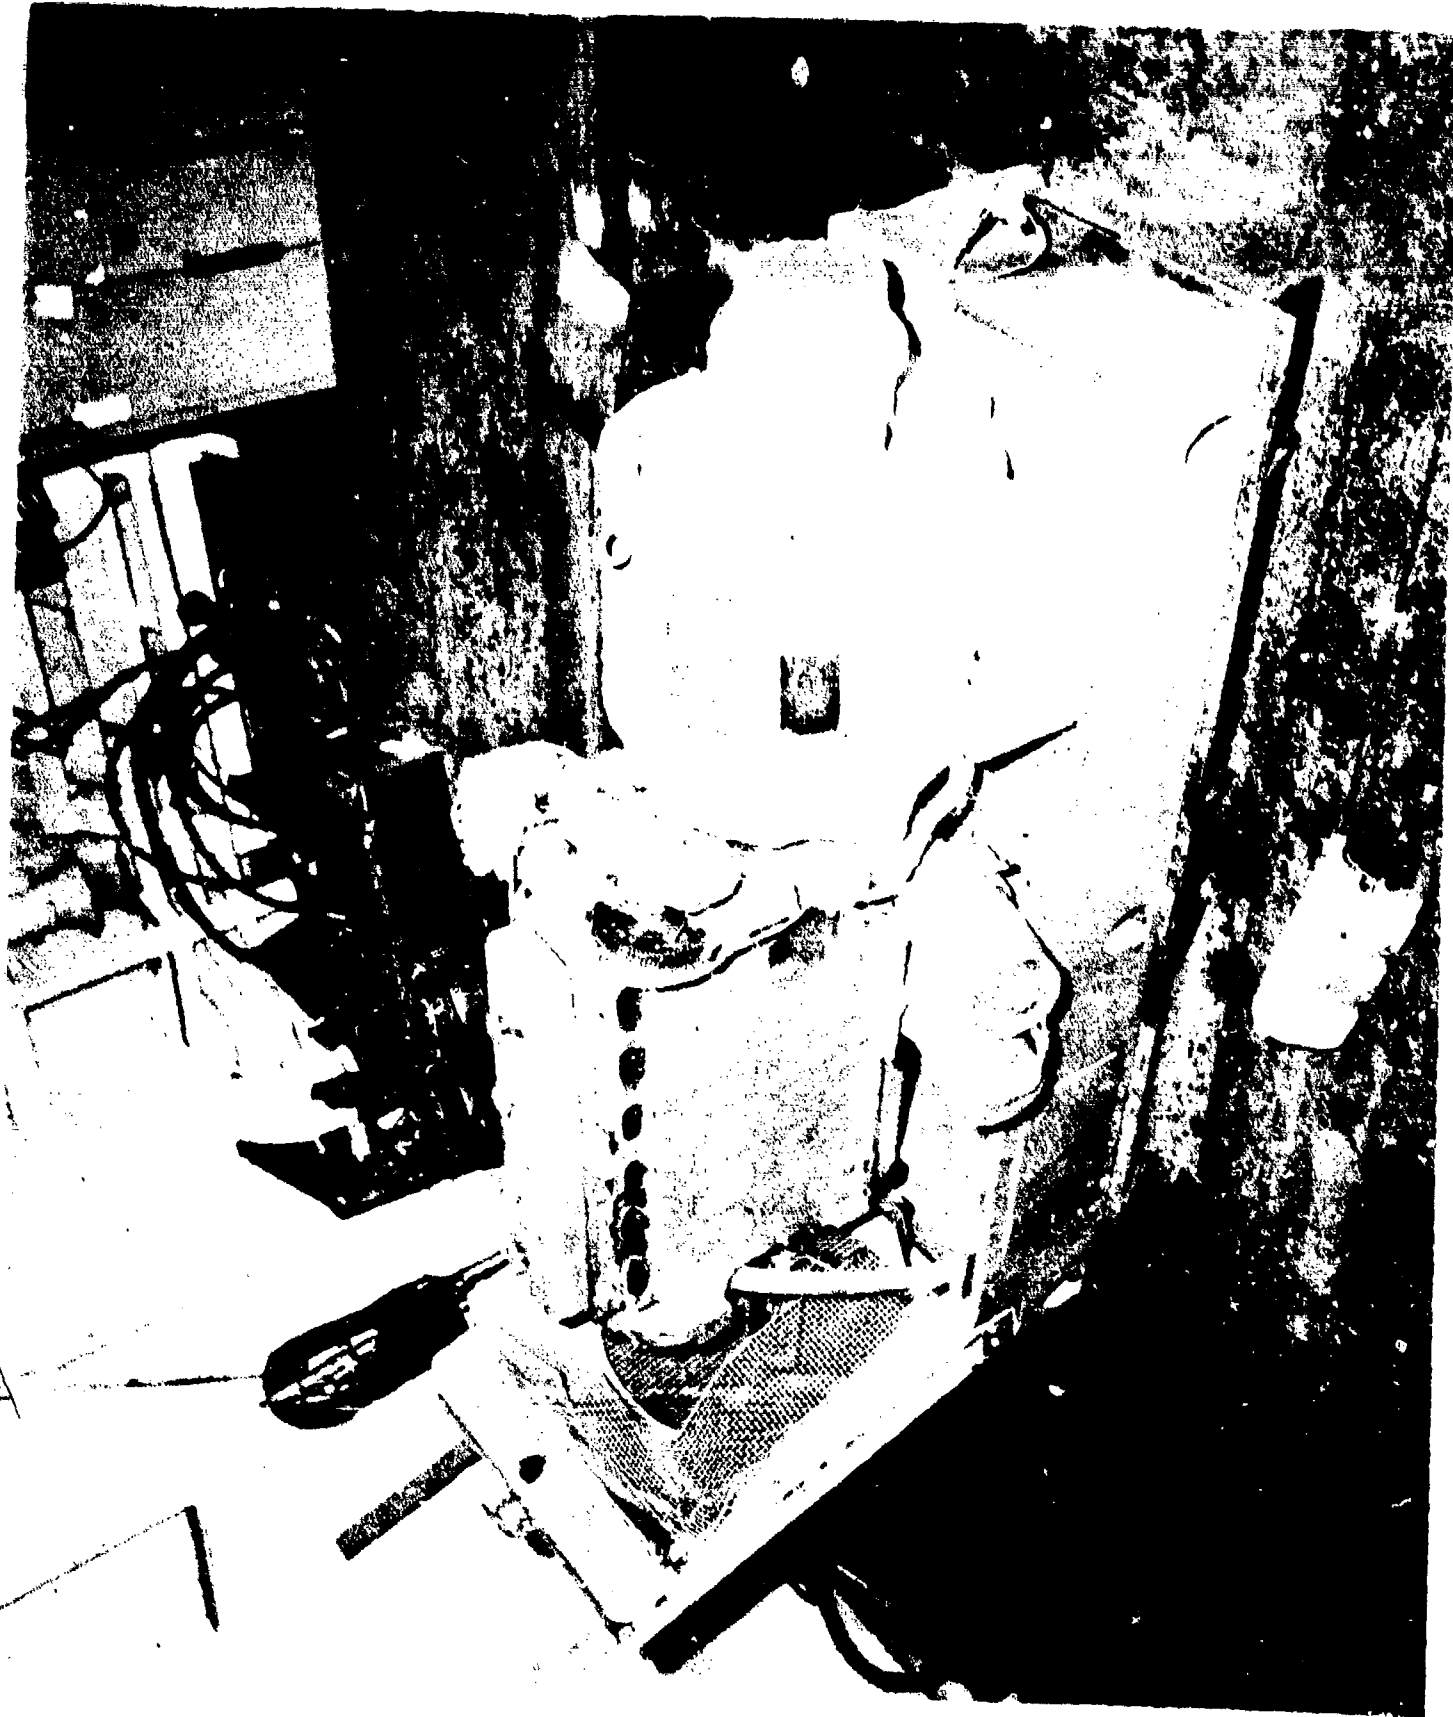
AA-CR-78-1949-3. Diesel generator located in the forward cargo hold. Shown after the debris was cleared away. Code 660, 12E3.
