TECHNICAL INSPECTION REPORT

OPERATION CROSSROADS.
U.S.S. CRITTENDEN (APA 77)
U.S. NAVY
U.S. BUREAU OF SHIPS
U.S. NAVY REPORT DIRECTLY FROM THE FIELD
TEST ABLE.
U.S. NAVY Support Agency
Washington, D. C. 20301
VOLUME 2 [U].

OPERATION CROSSROADS

BUREAU OF SHIPS GROUP
TECHNICAL INSPECTION REPORT

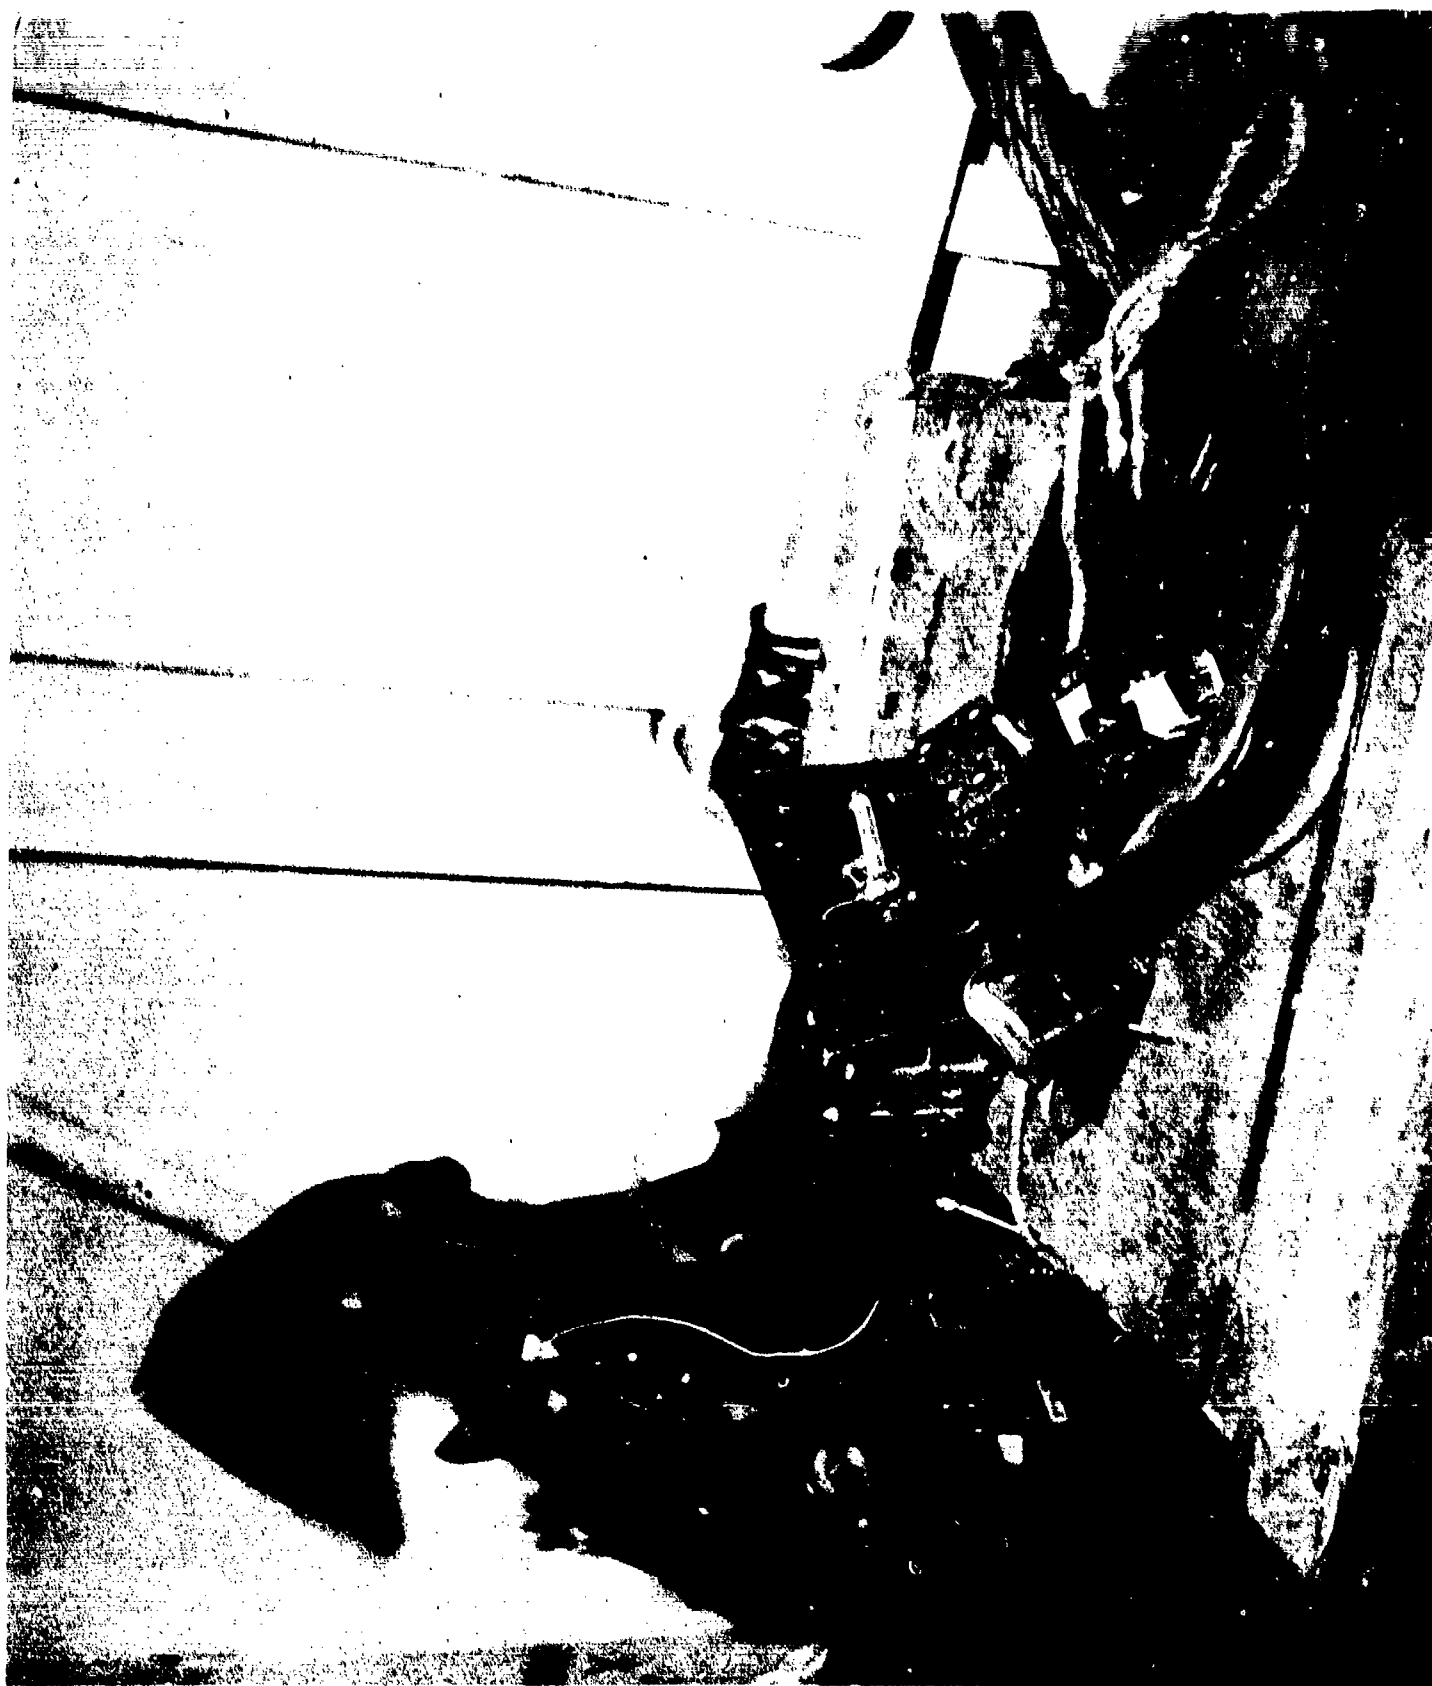
AA-CR-78-1949-11. Control panel for the diesel generator 12E3.
Located in the forward cargo hold. Shown after the debris was cleared
away.

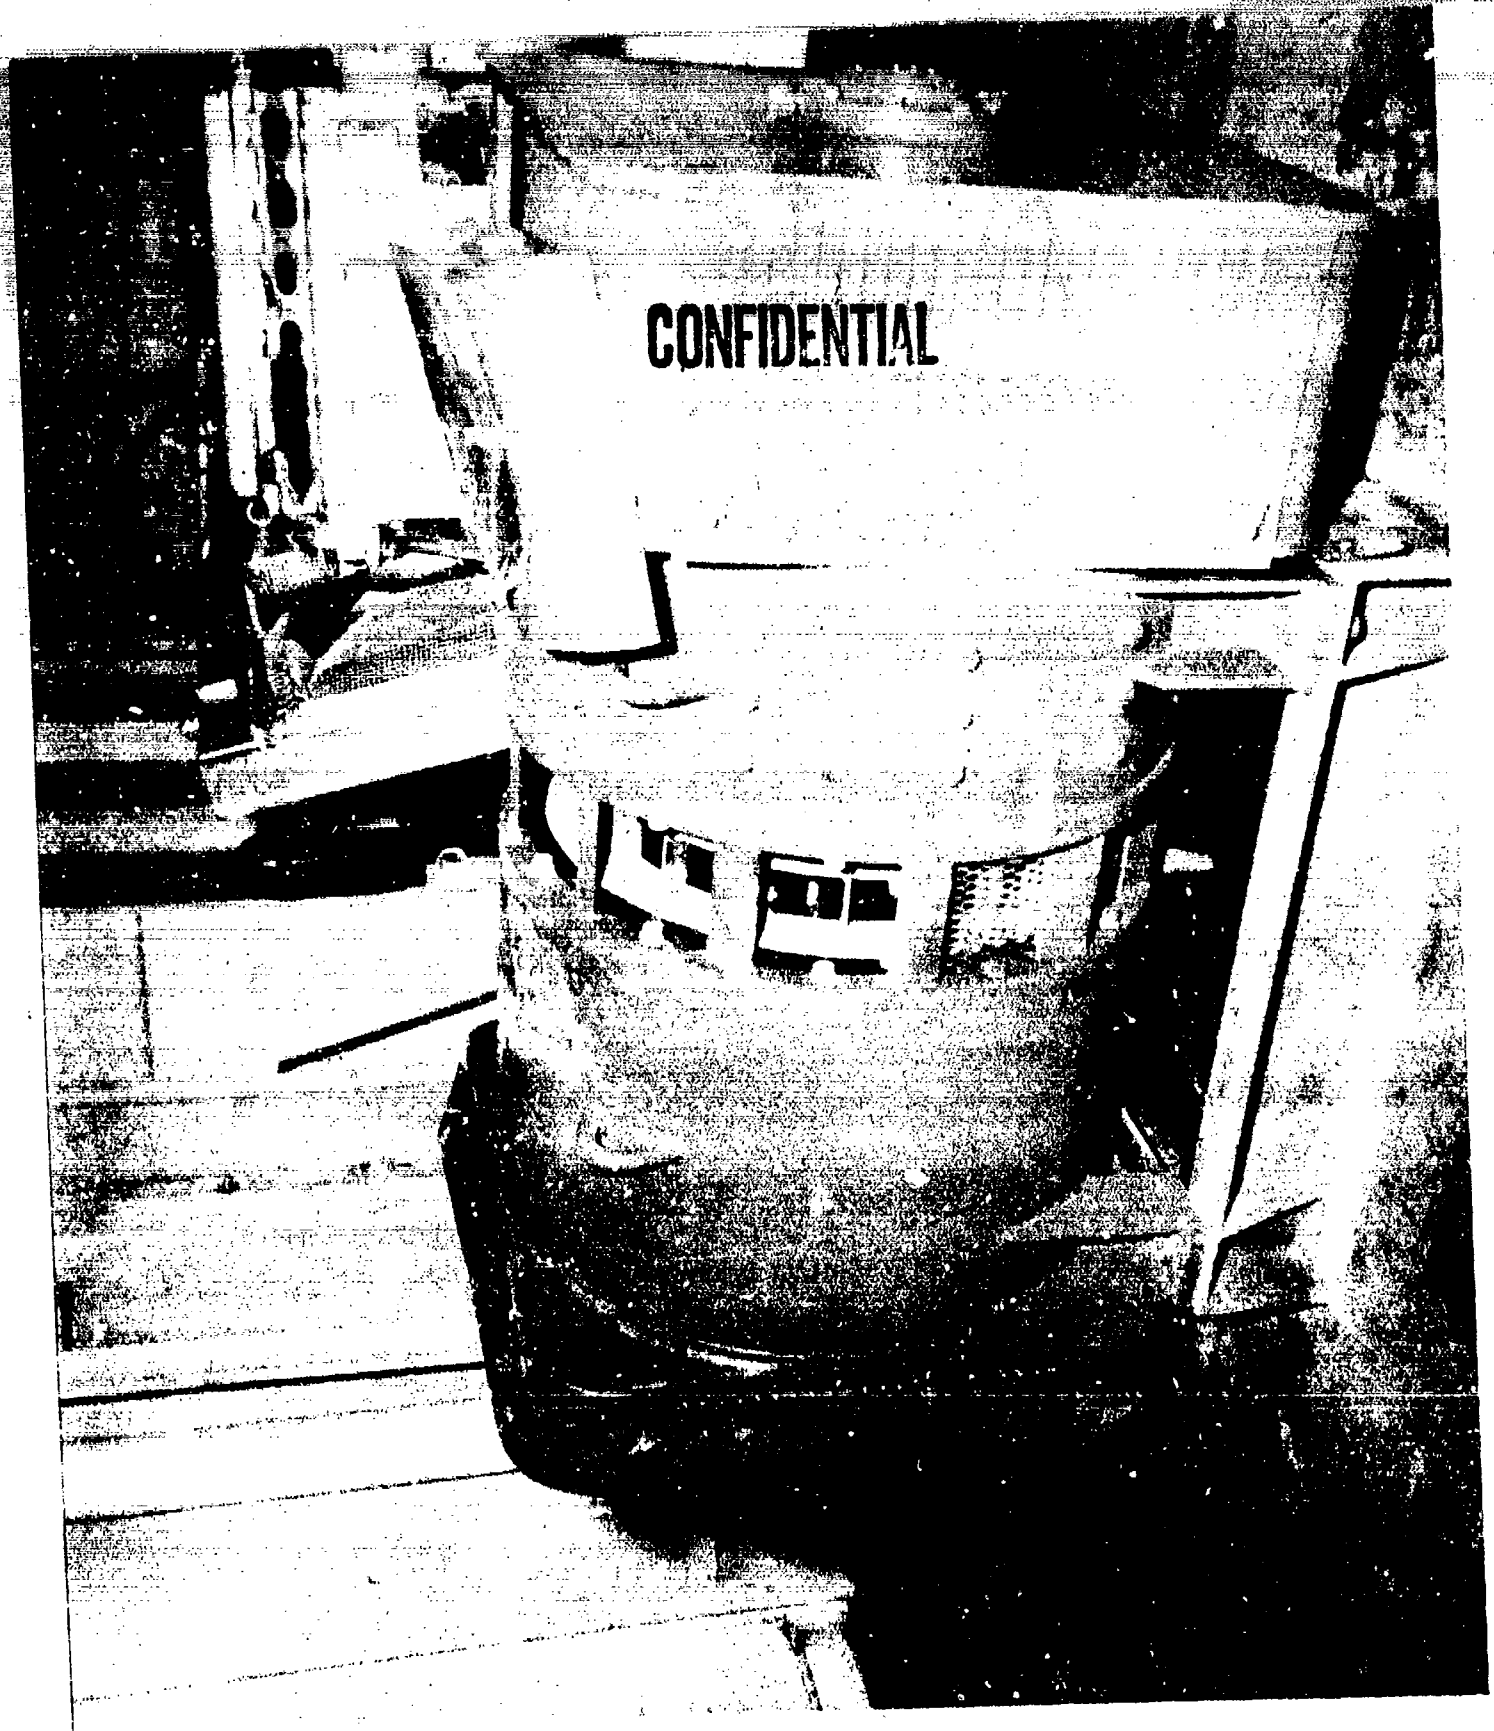
AA-CR-78-127-7. 75 K.W. M-G set located in the forward cargo hold. Shown after the debris was cleared away. Code 660, 12E4.
