TECHNICAL INSPECTION REPORT

OPERATION CROSSROADS
U.S.S NEVADA (BB36).

TEST ABLE.

VOLUME I [u] (8)

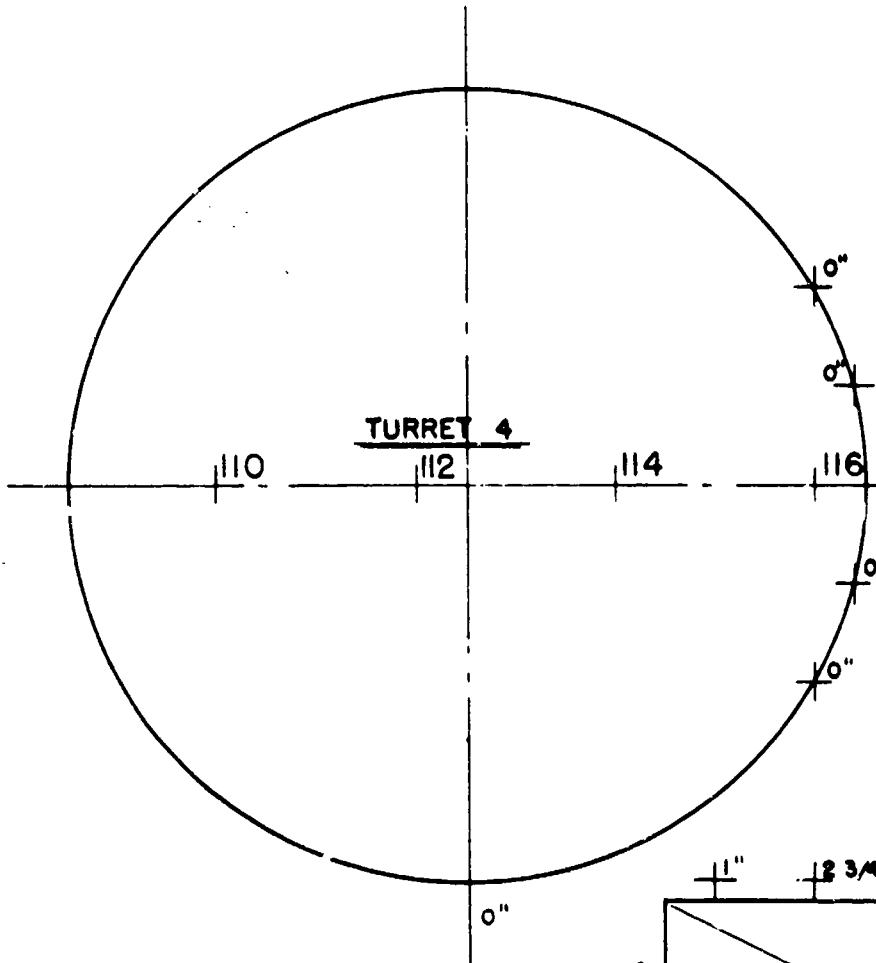
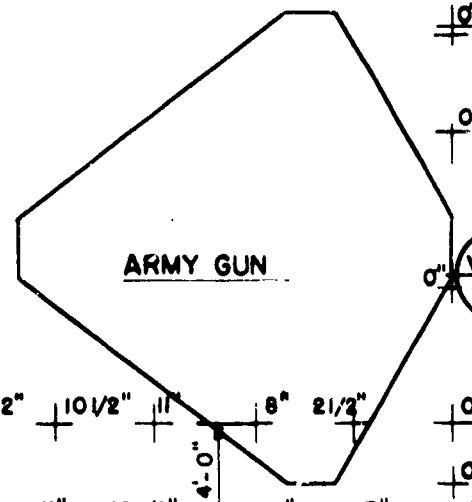
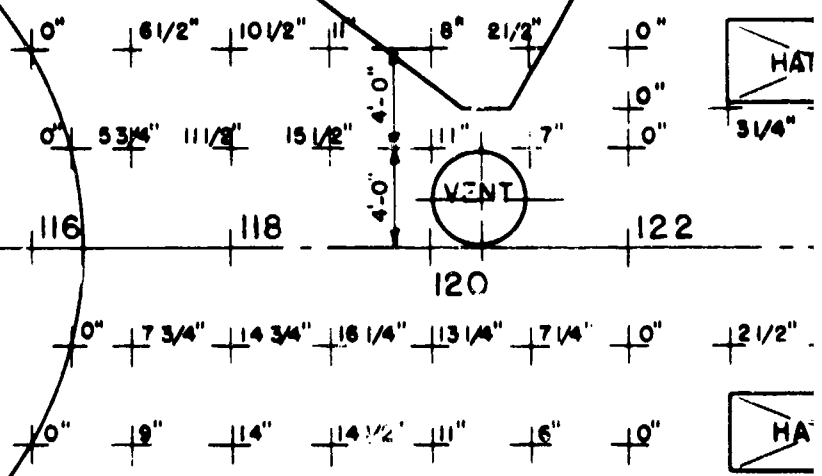
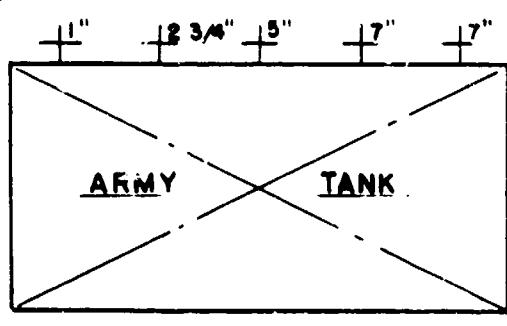
PLAN OF MAIN DECK
FR. SPACING 4'-0"

A rectangular section of the main deck, extending longitudinally between frames 88 and 91, port side, failed in two places. The longitudinal failure lines were 29 feet off the centerline and 13 feet off the centerline through a single riveted seam. The opening is approximately 20 feet long by 16 feet wide and is in way of machinery access plate. The failure appears to be attributable, primarily, to a lack of supporting stanchions.

There is heavy deflection of the main deck aft as a result of blast. The most severe depression is slightly aft of No. 4 turret (Figures 1 and 2). This depression pulled the deck away from the after face of No. 4 barrette. The maximum deflection in this area is about 16 1/2 inches. Between frames 122 and 132 the maximum deflection is about 14 inches. The deflections of the main deck are accompanied by failure of supporting stanchions and distortion of connections of the deck beams to the shell stiffeners. The second deck is deflected aft of the armor from bulkhead 122 to about frame 134, the maximum being about 12 inches. The damage diminishes as it goes deeper into the ship.
