TECHNICAL INSPECTION REPORT

(6) OPERATION CROSSROADS,  
U.S.S. NEW YORK (BB34).

TEST BAKER *[initials]*

OPERATION CROSSROADS

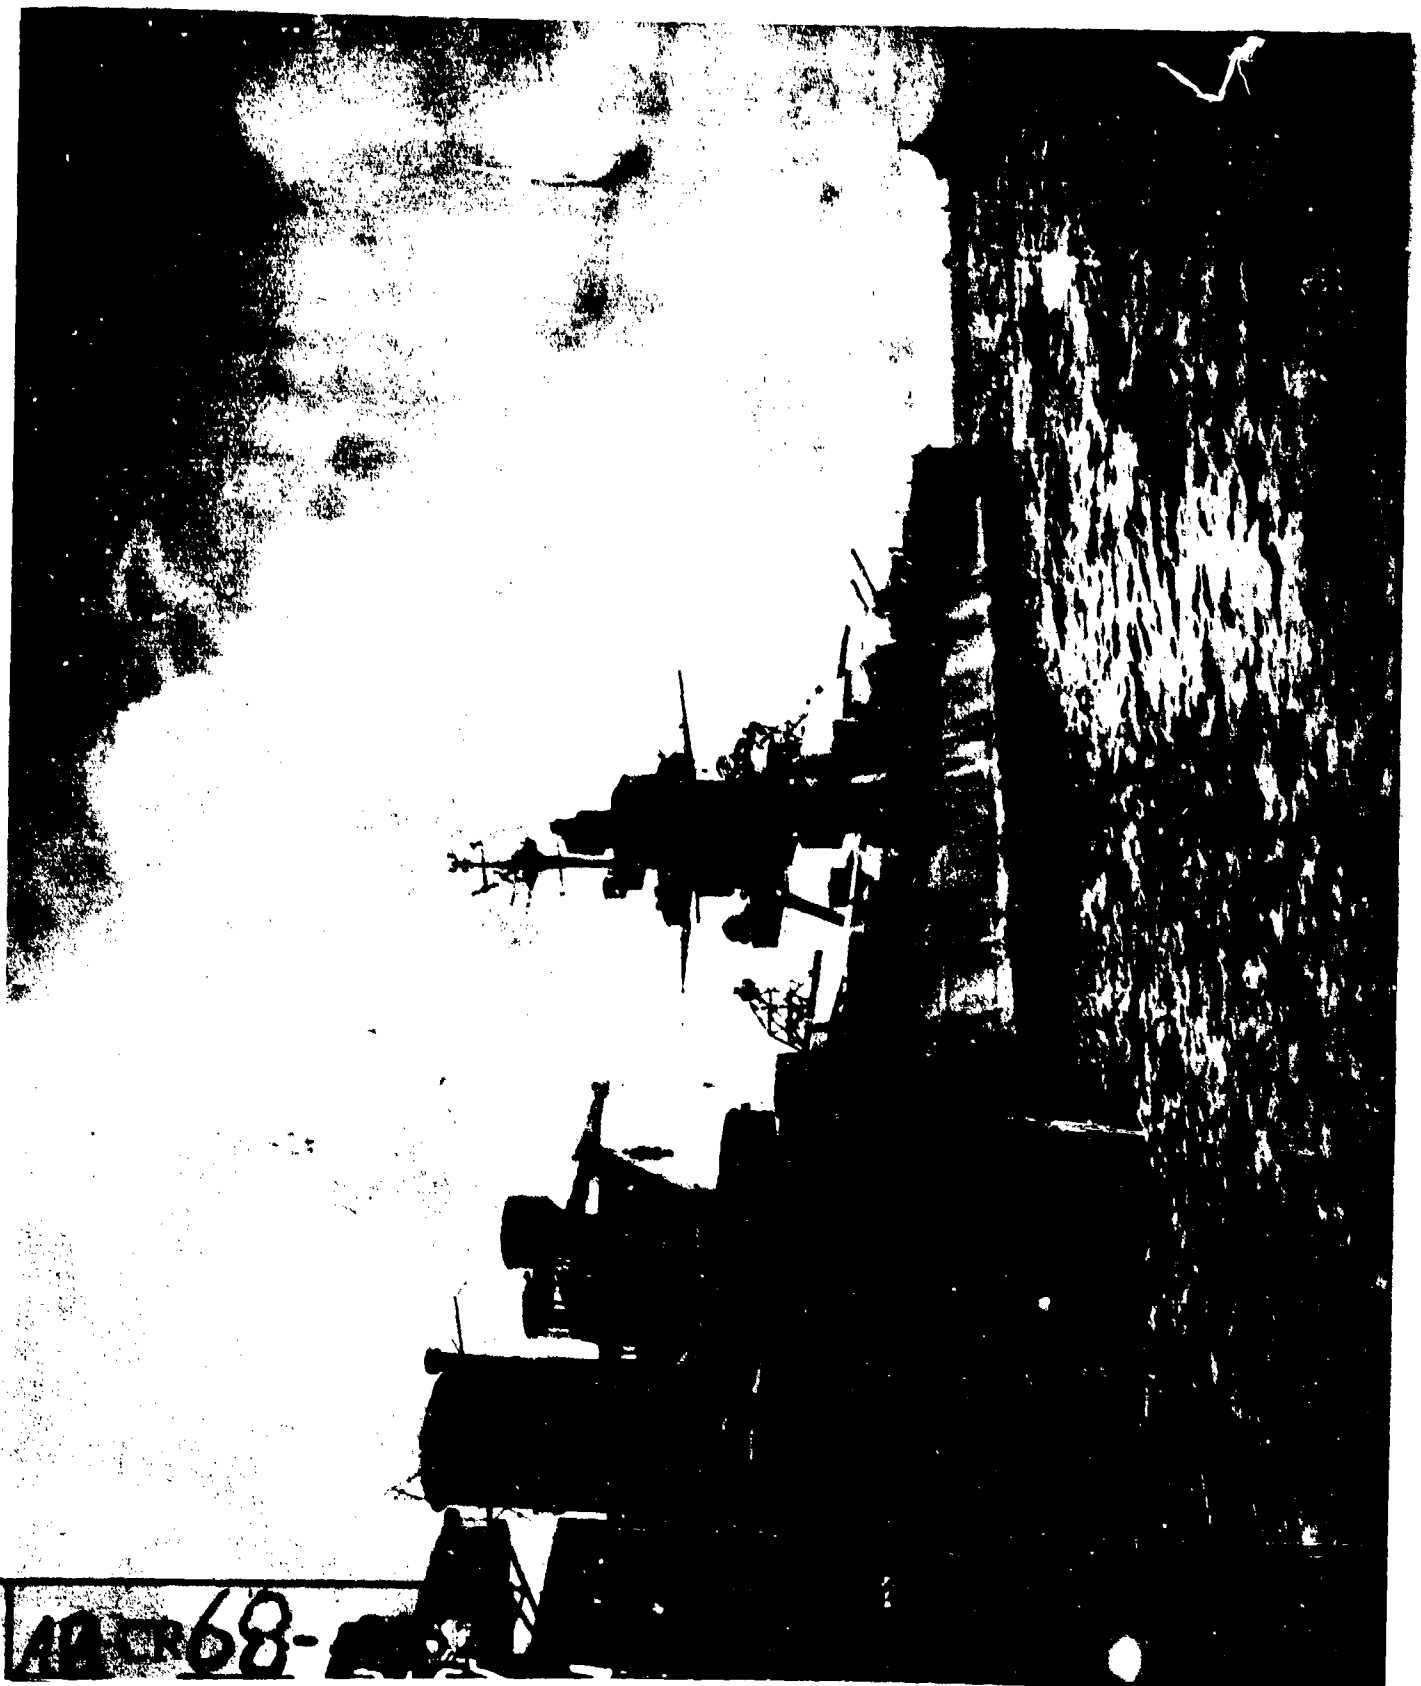
AB-CR-68-2152-3. Port shell plating and after superstructure, looking aft on port side.
