BUREAU OF SHIPS GROUP
TECHNICAL INSPECTION REPORT

⑥ OPERATION CROSSROADS.
U.S.S HUGHES (DD410).
TEST BAKER.

VOLUME II [u] ⑧

USS HUGHES (DD410)

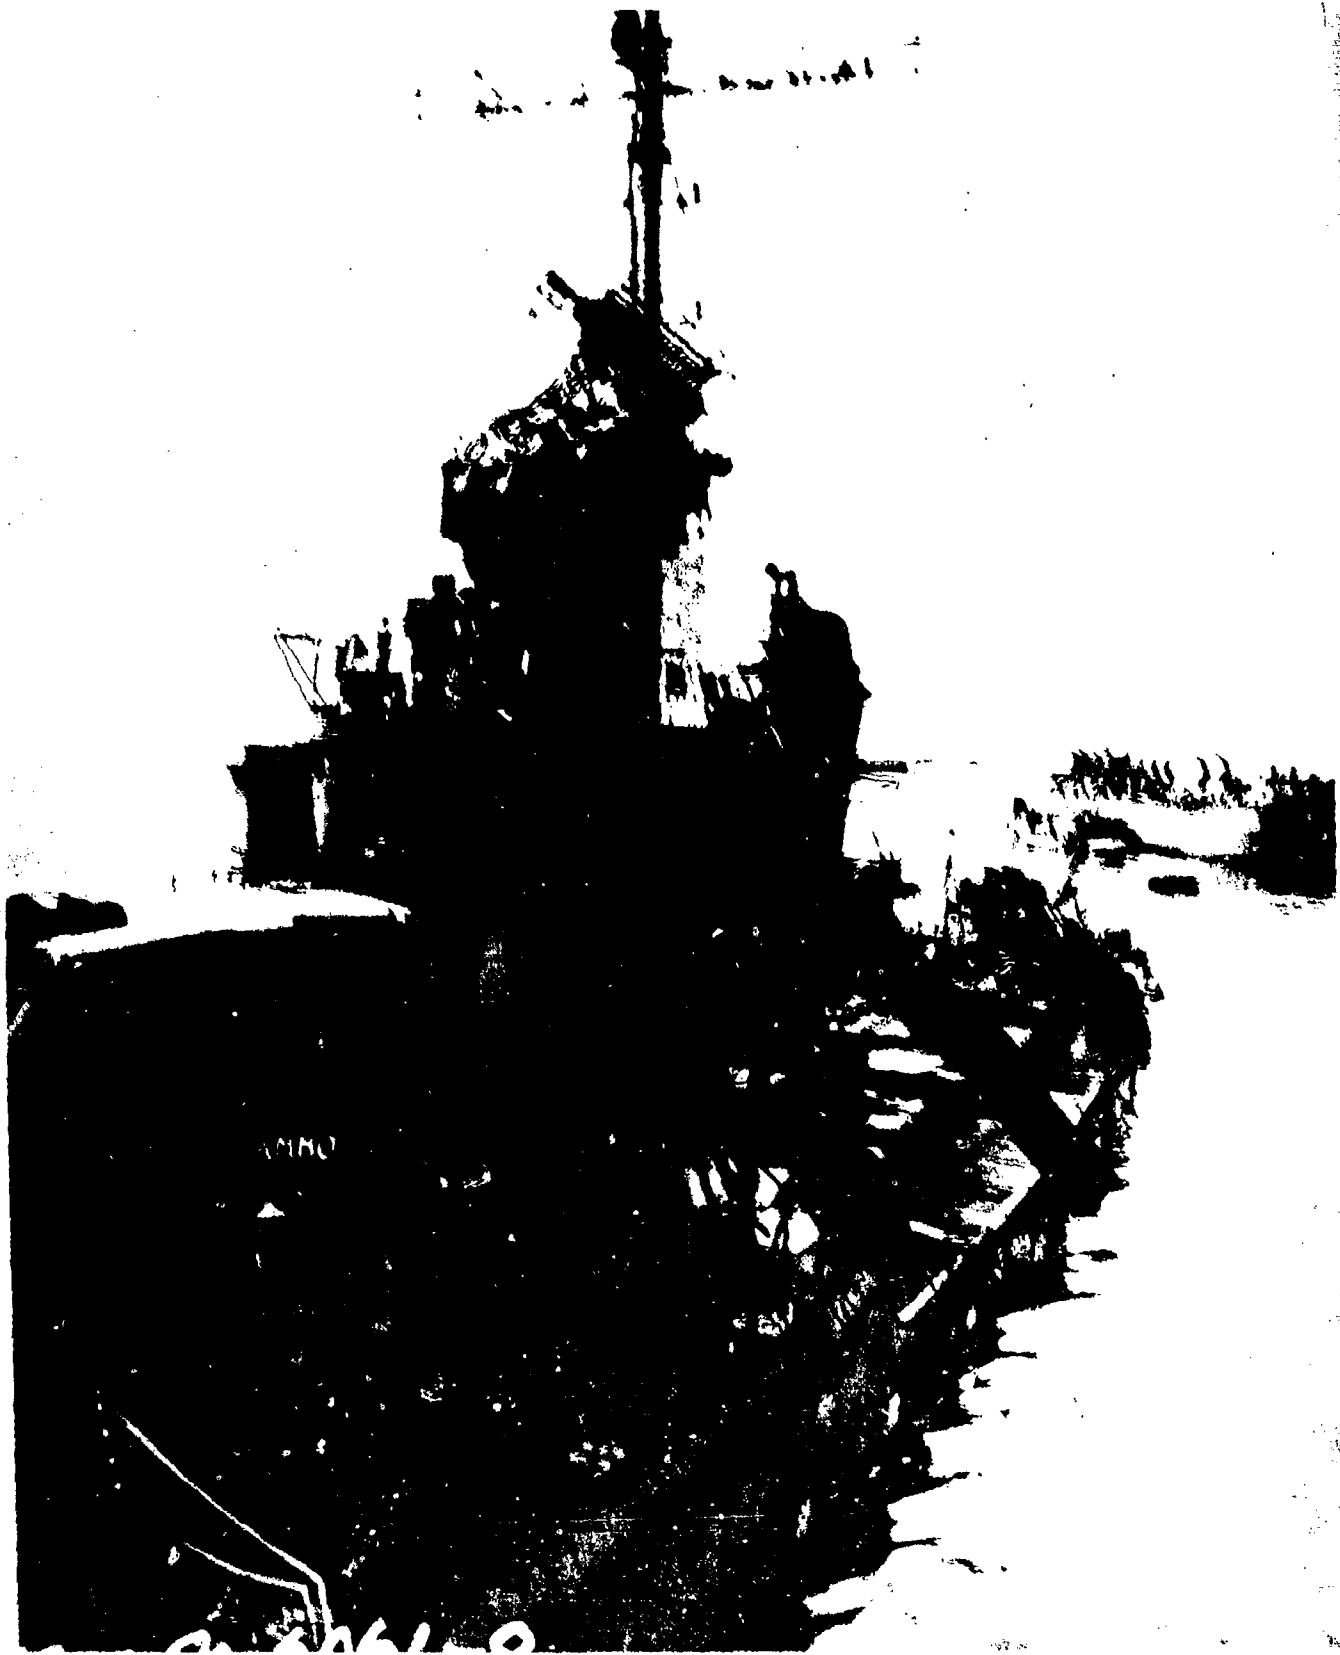
AB-CR-80-2061-8. Forward face of superstructure from port bow before beaching.

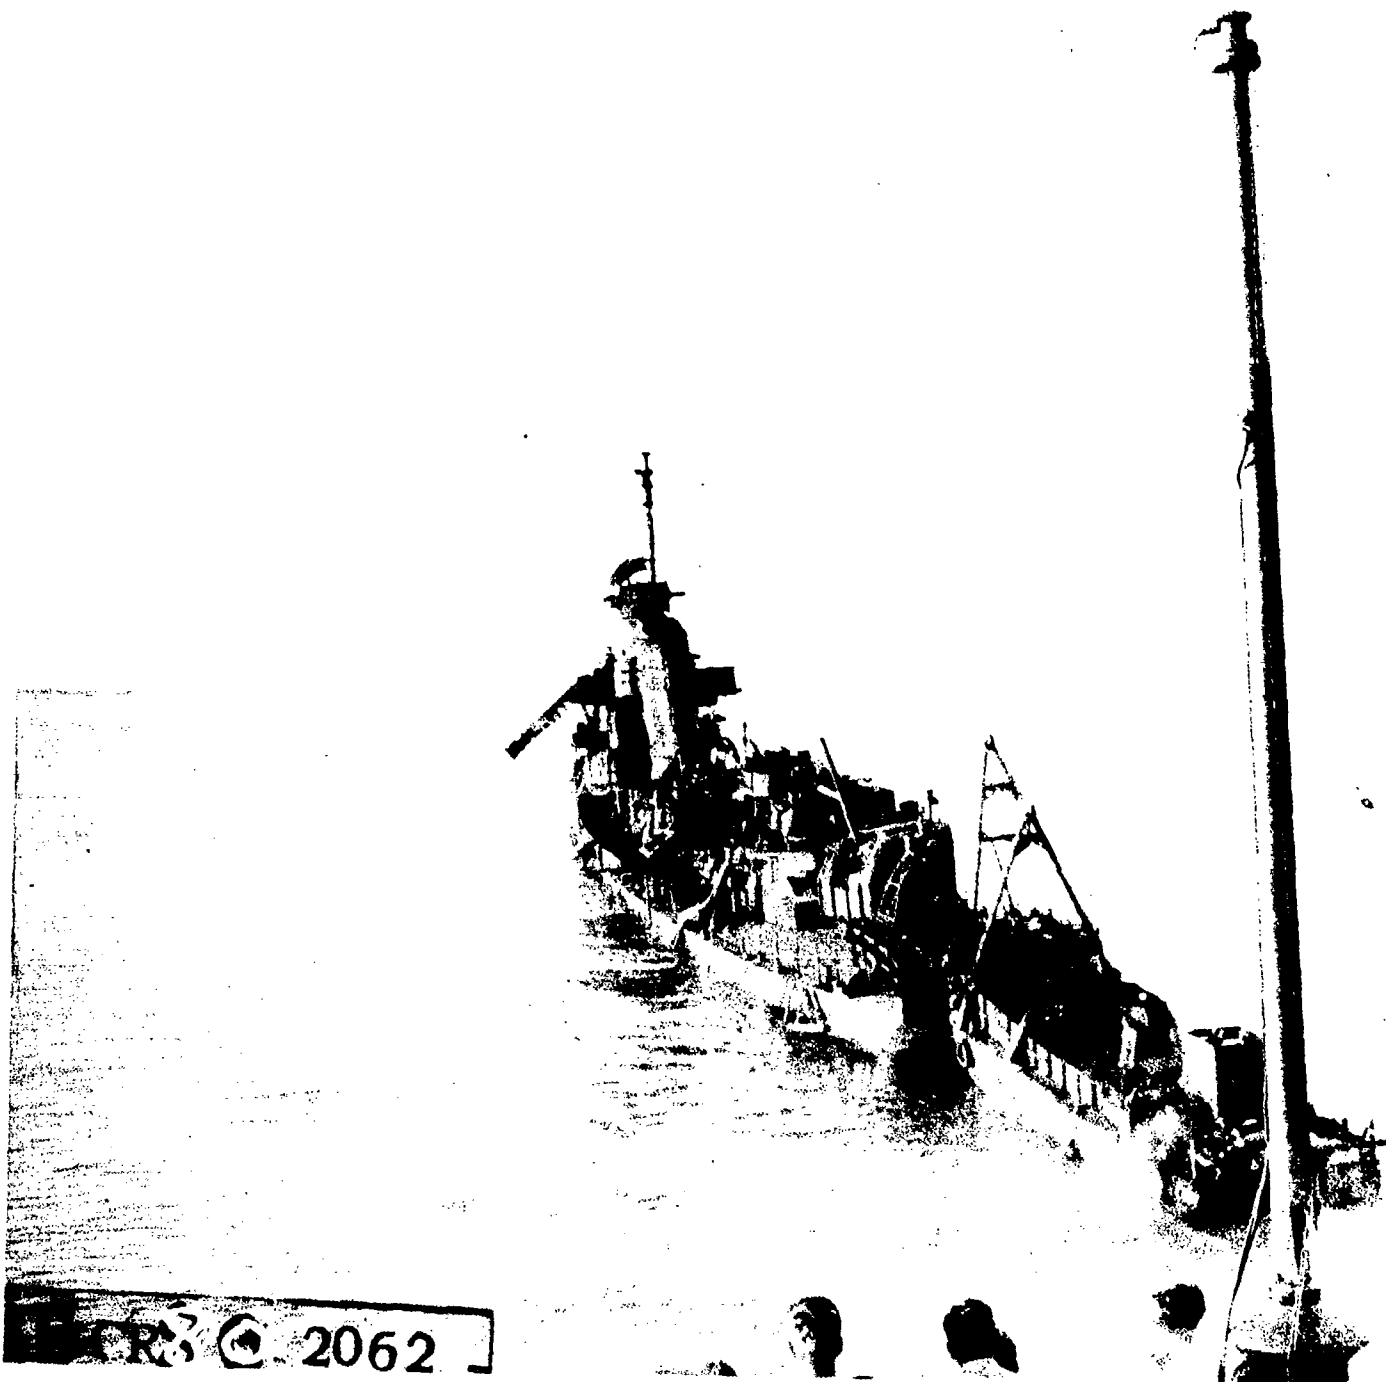
AB-CR-80-2062-6. View of superstructure from stern to port, during beaching operations.

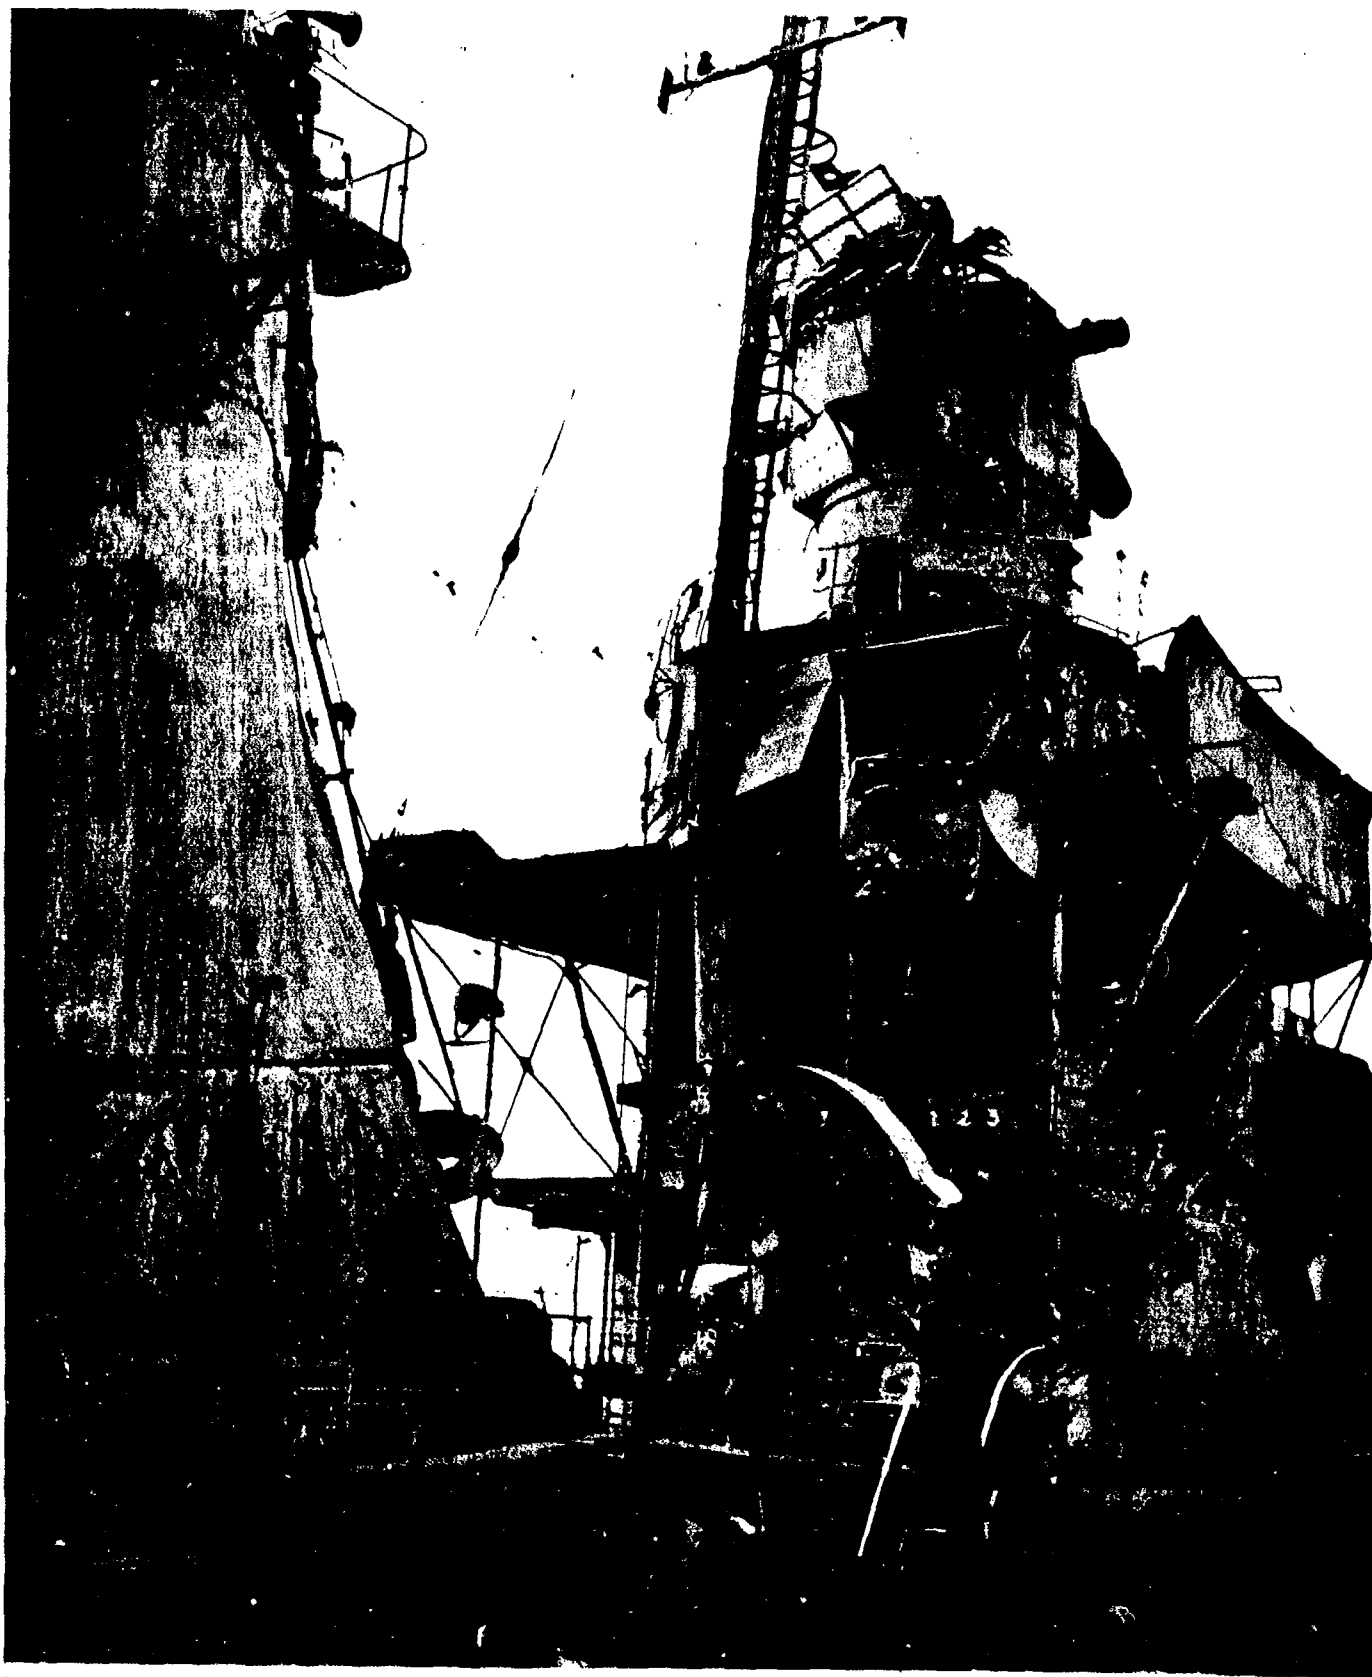
AB-CR-76-2076-12. Starboard and after faces of forward super-structure looking forward and to port. Port flag bag is carried away.

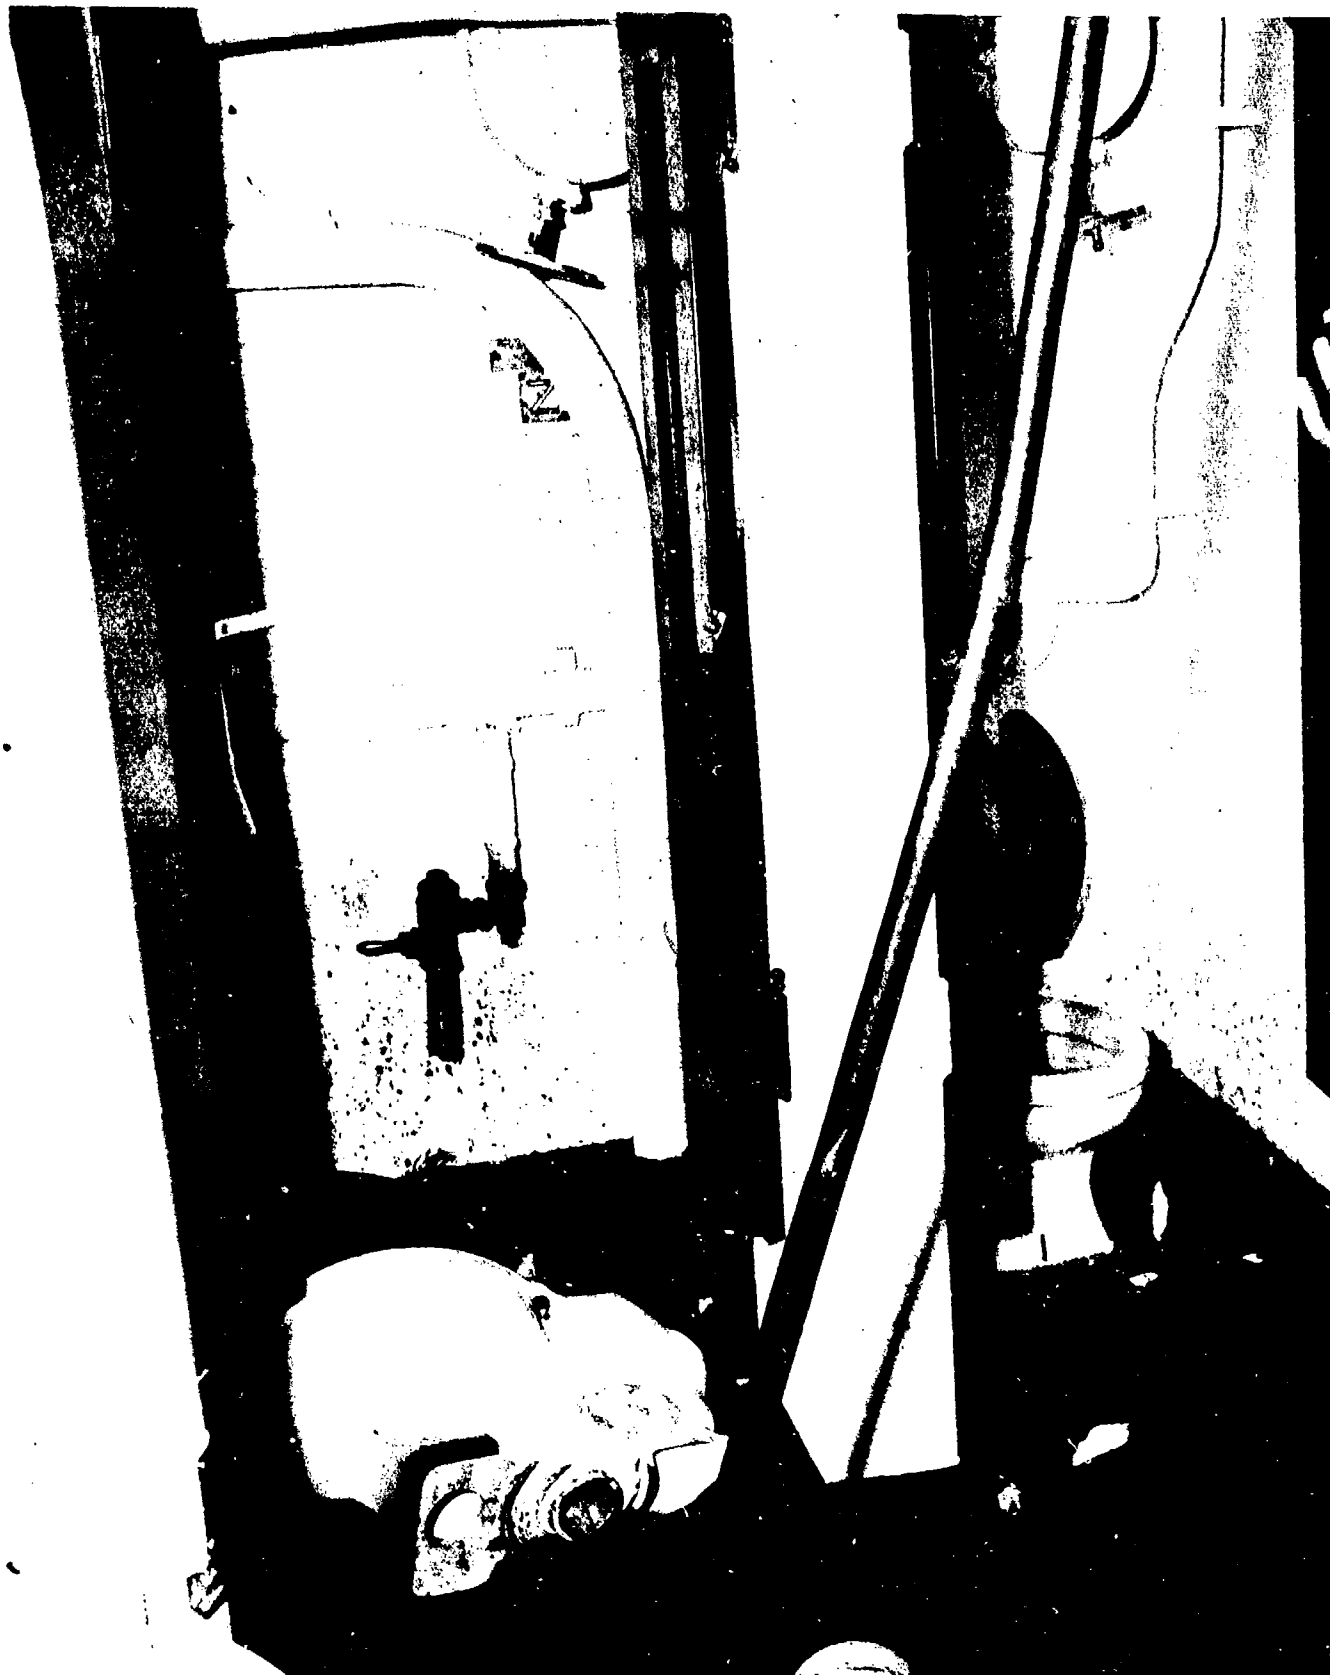
AB-CR-100-4211-4. Looking forward on main deck port side, to bulkhead 25 showing broken toilet bowl, piping and ammunition cans.

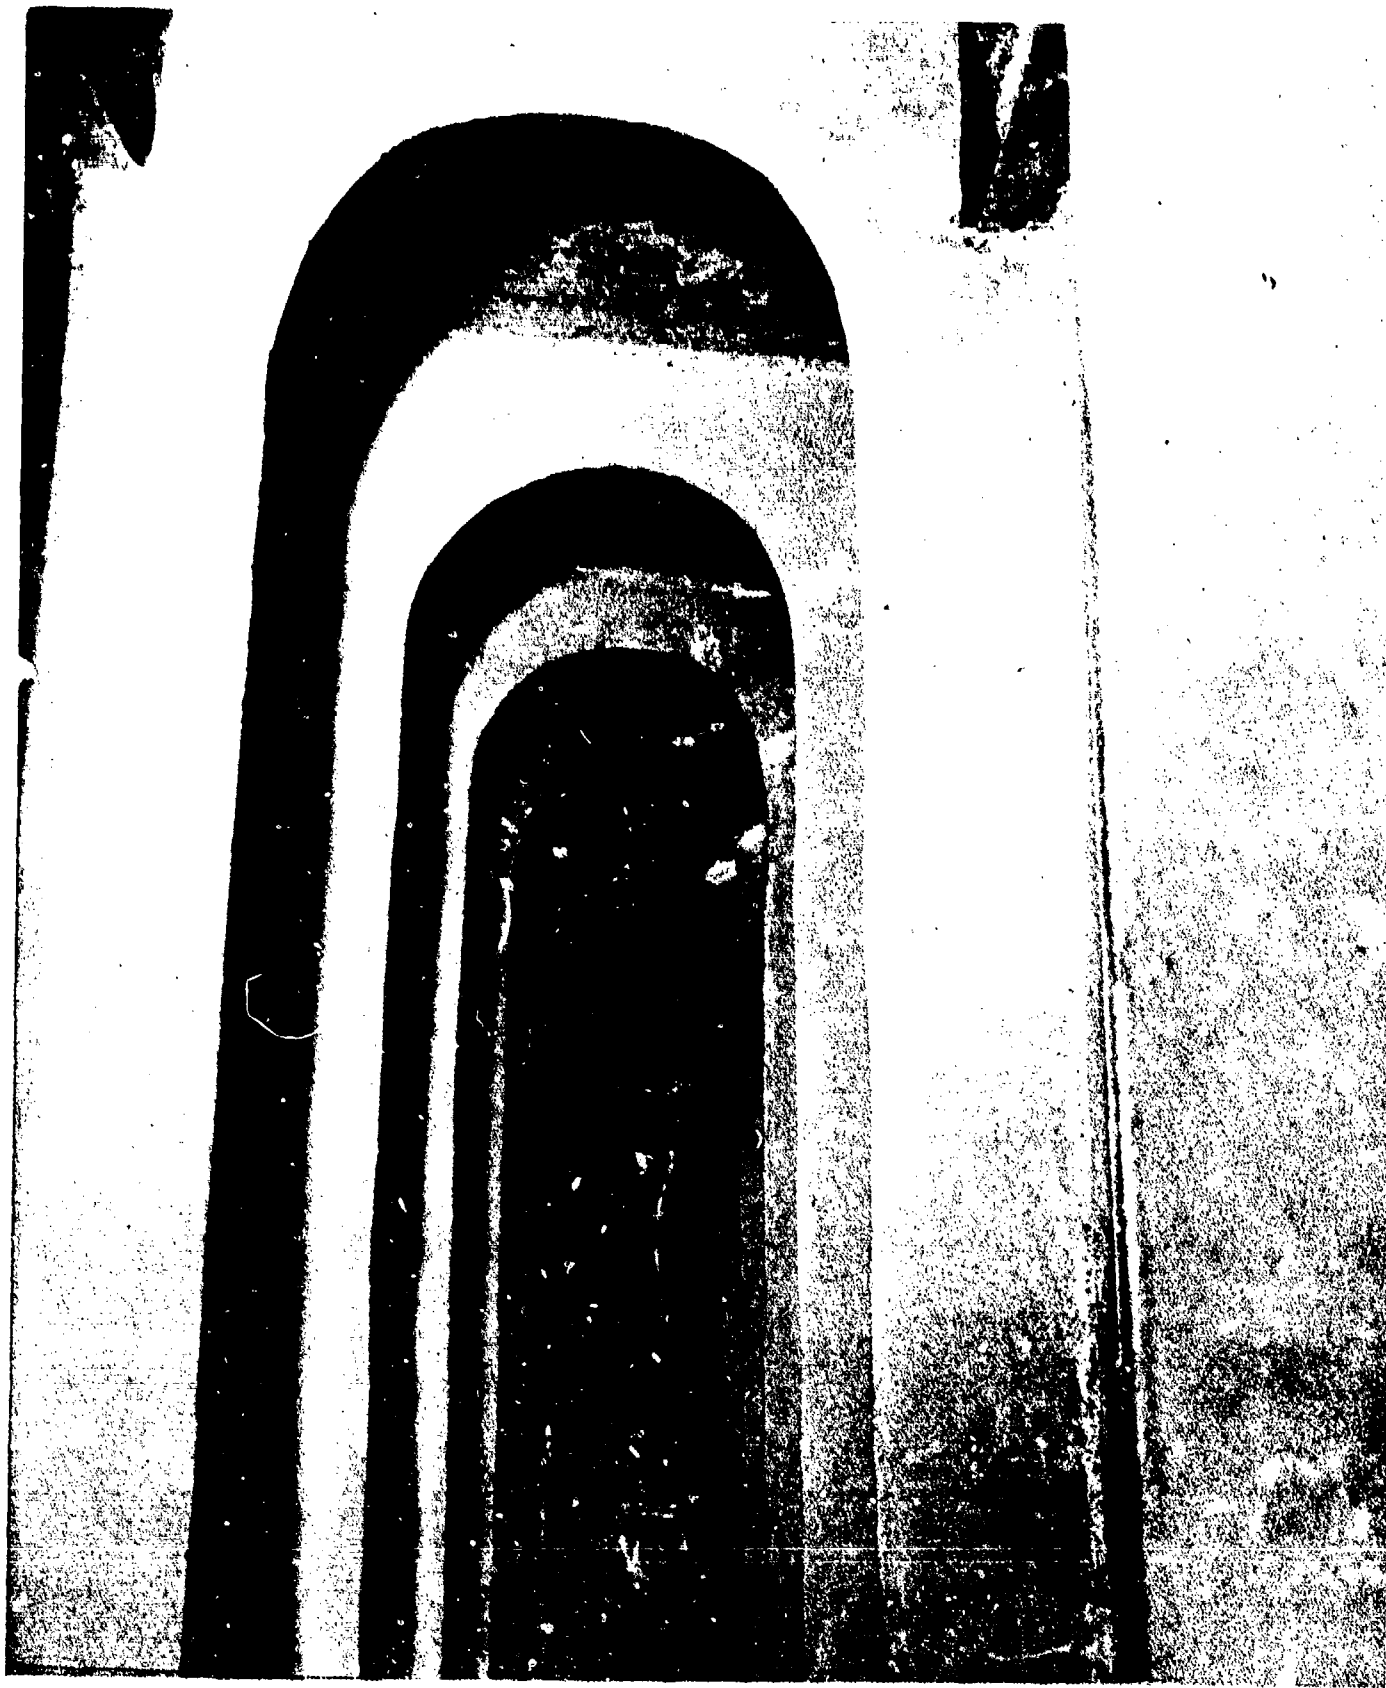
AB-CR-234-4061-1. A-401W. Buckling of floors in peak tank, bulkheads 6 to 14, looking aft about 6 feet above keel.

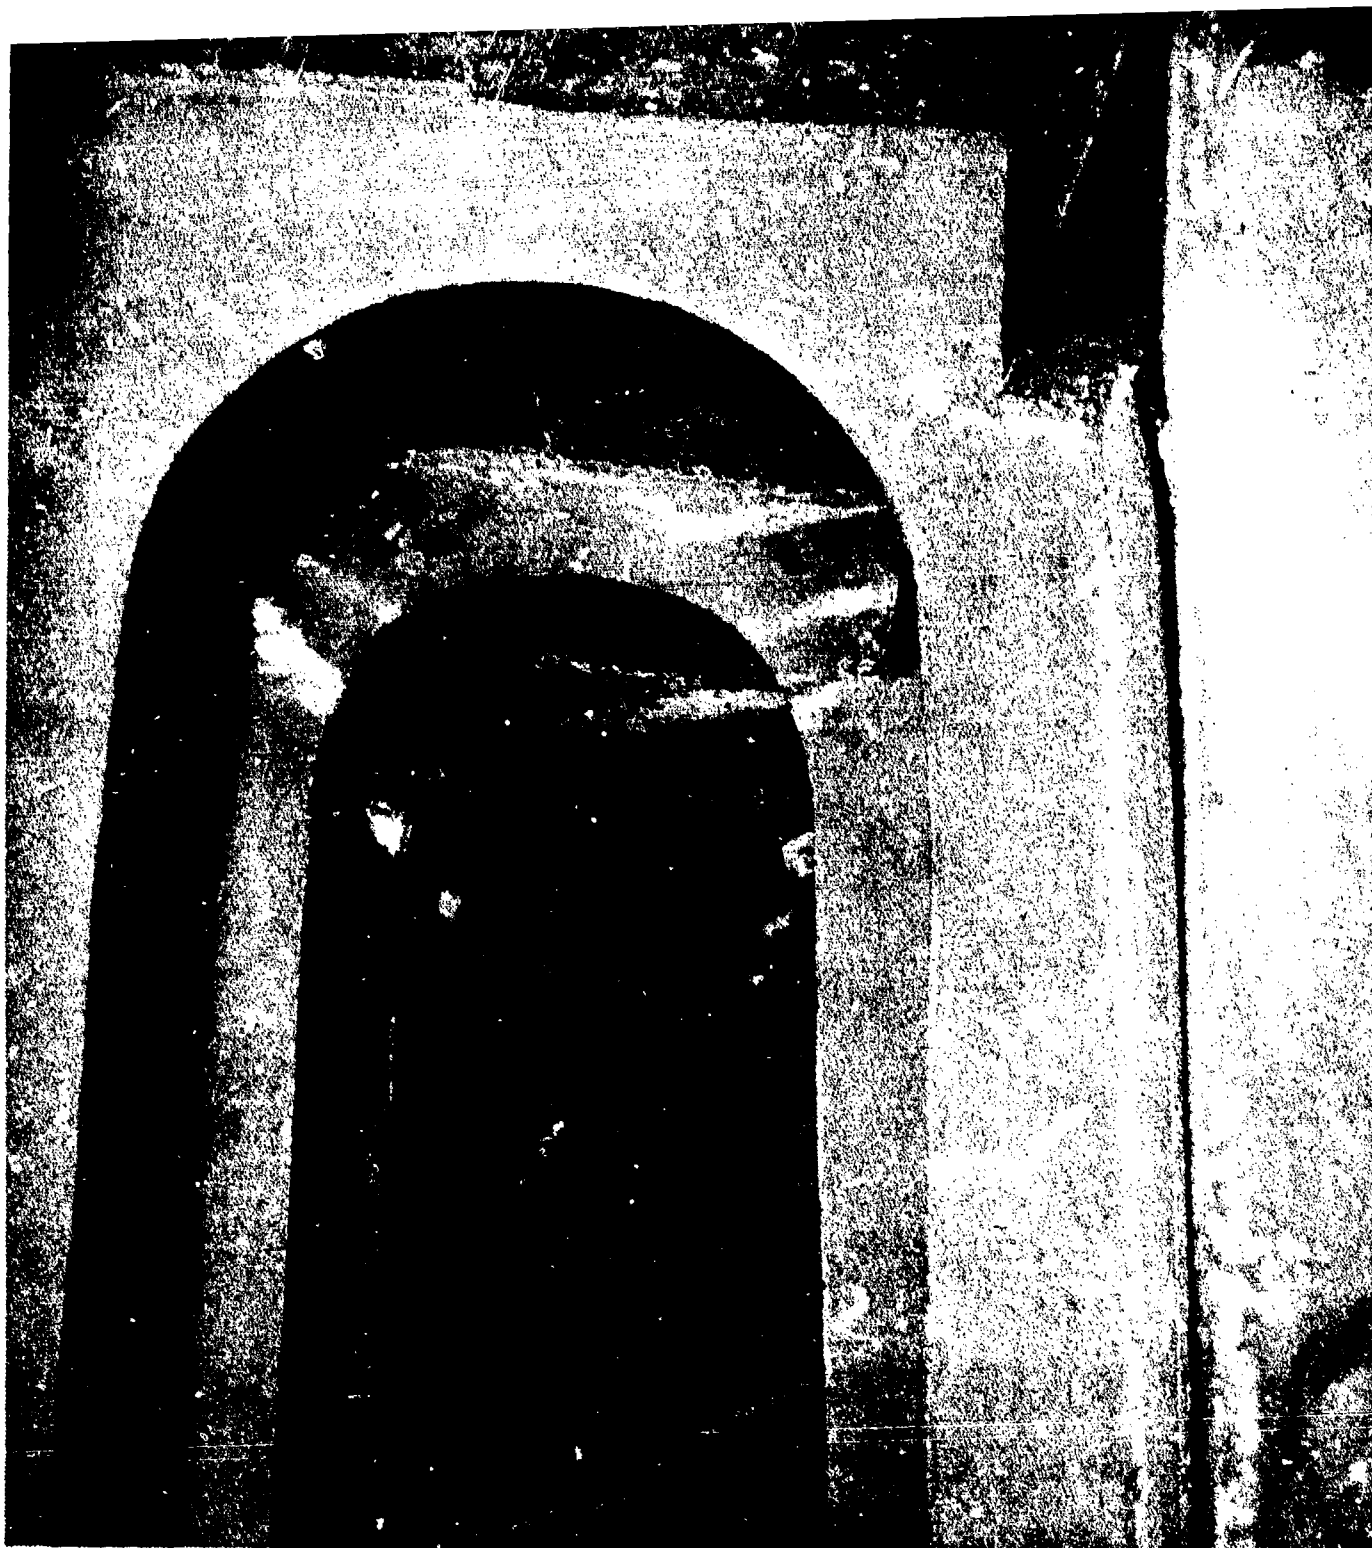
AB-CR-234-4061-2. A-401W. Buckling of floors in peak tank, bulkheads 6 to 14, looking aft.

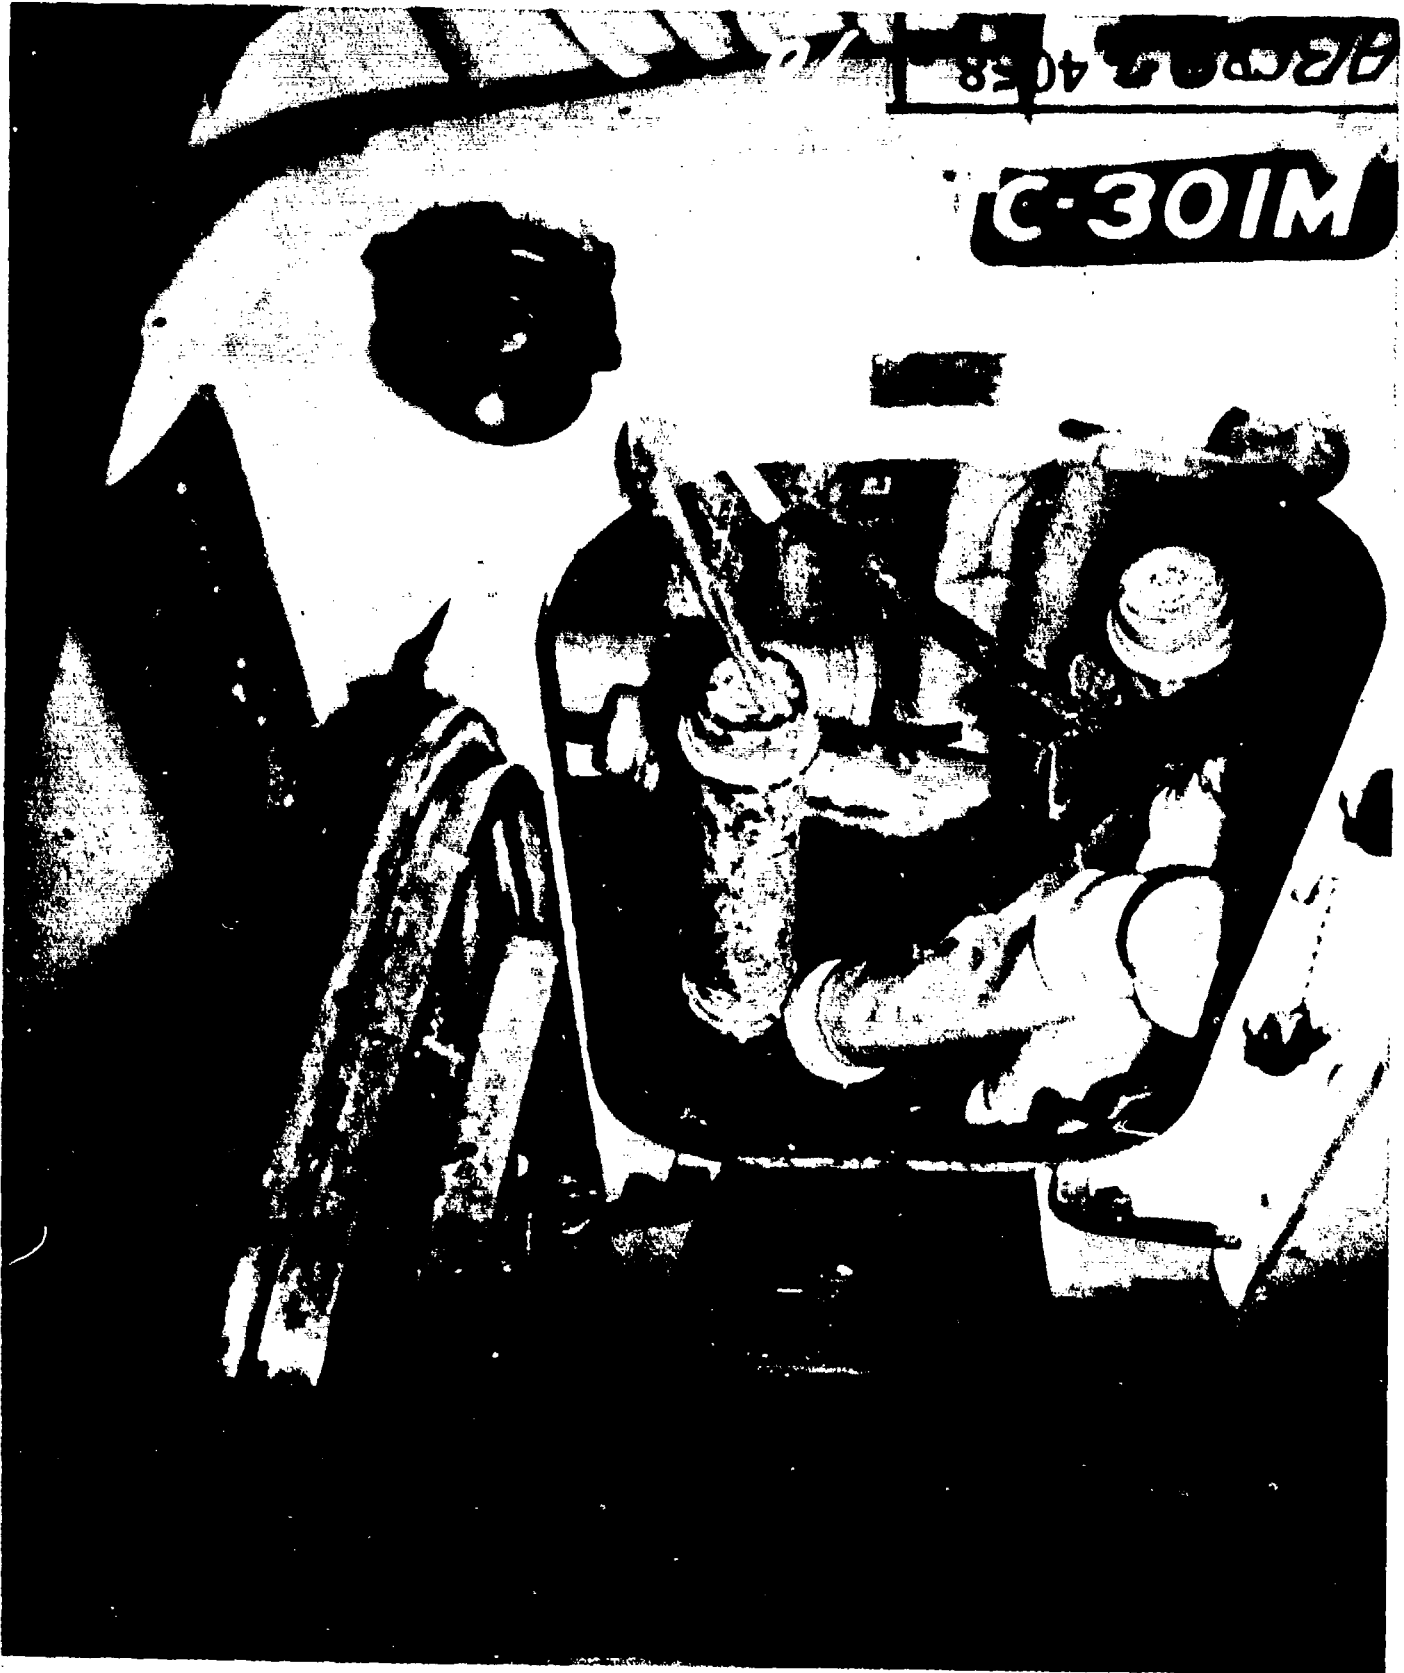
AB-CR-97-4058-10. C-201L. Looking down and aft through 1st platform hatch at frame 146 into 5" handling room C-301M and through door to C-302M, 5" powder.

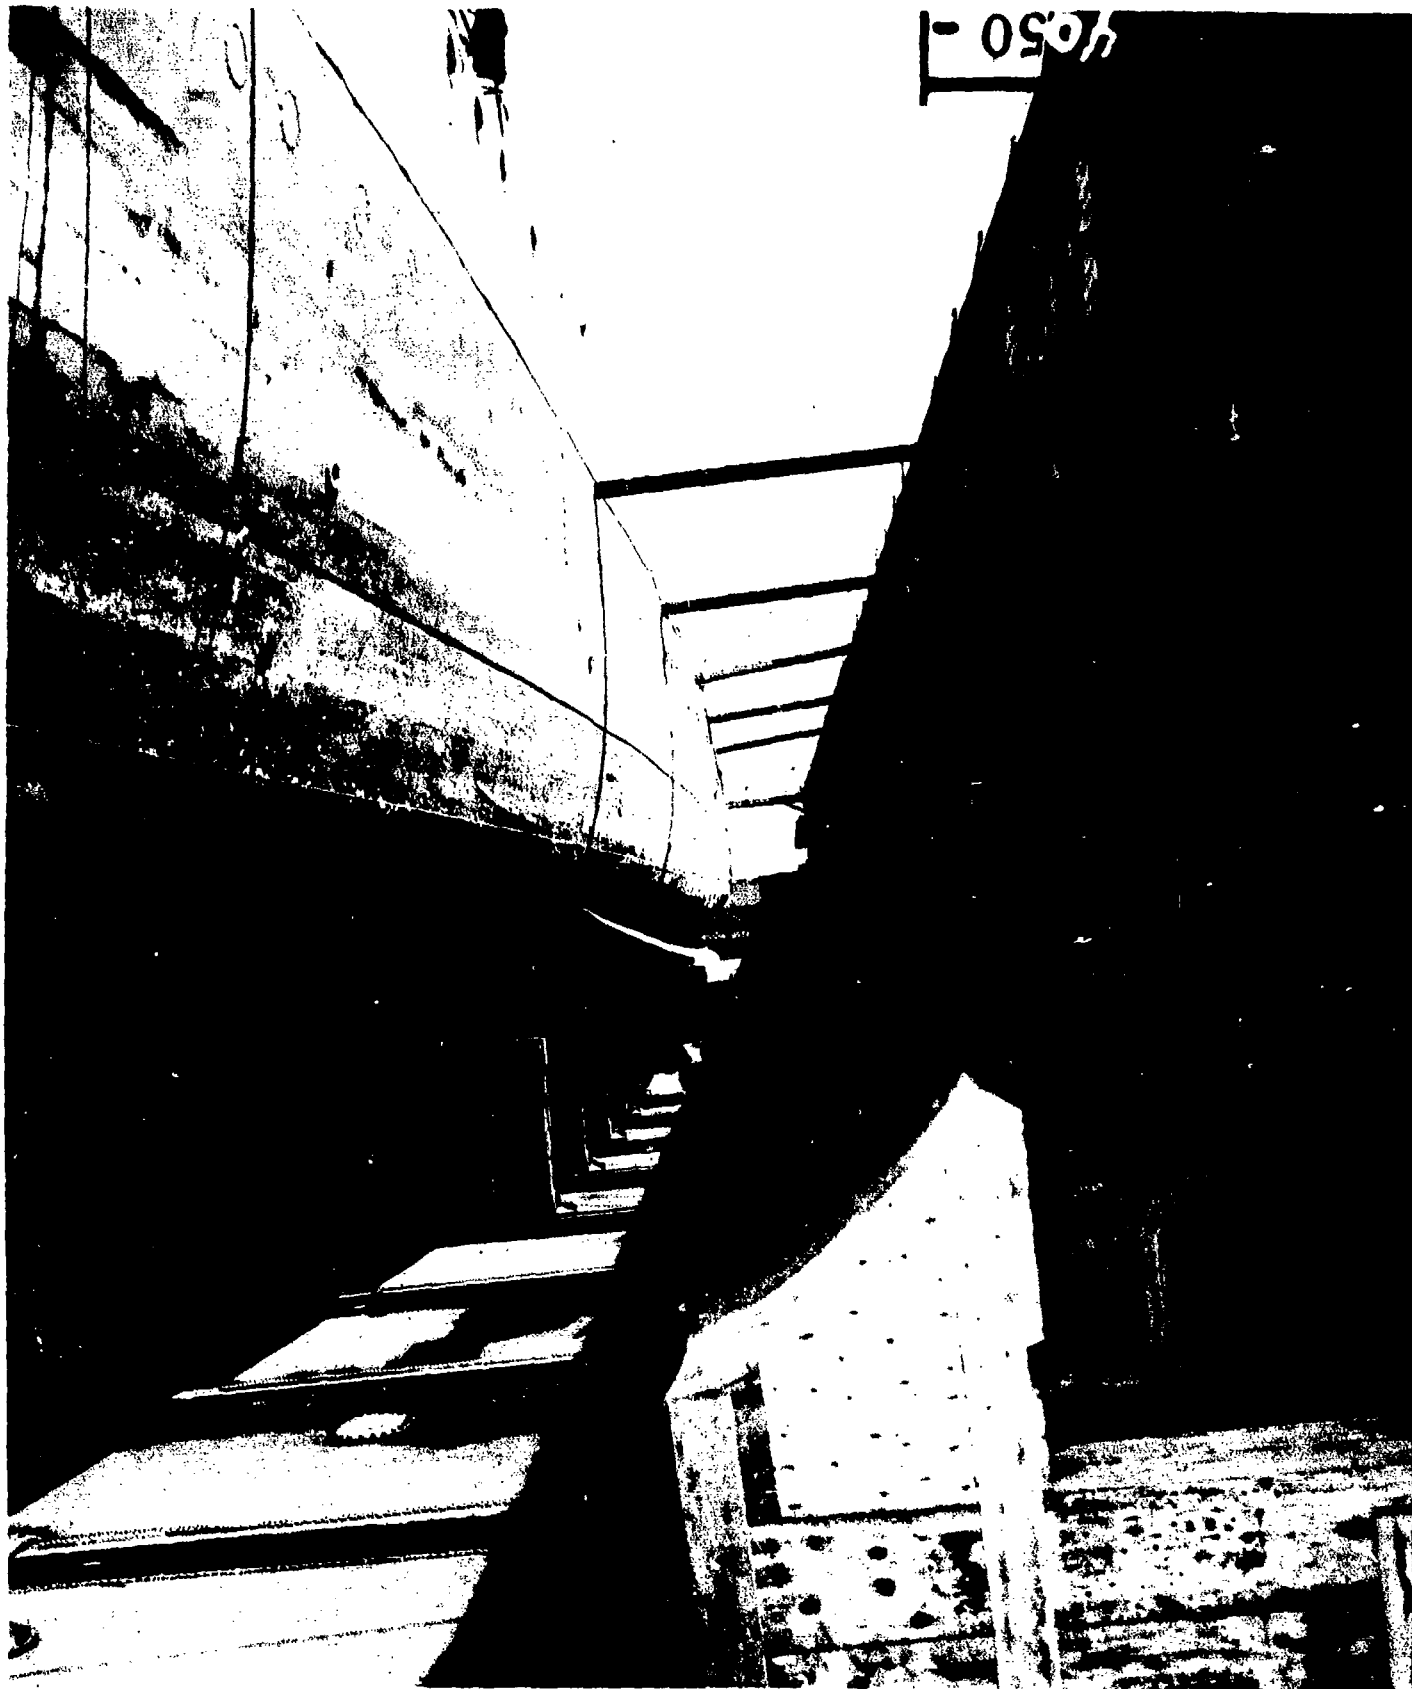
AB-CR-97-4050-10. Port shell looking aft, frames 40-60.

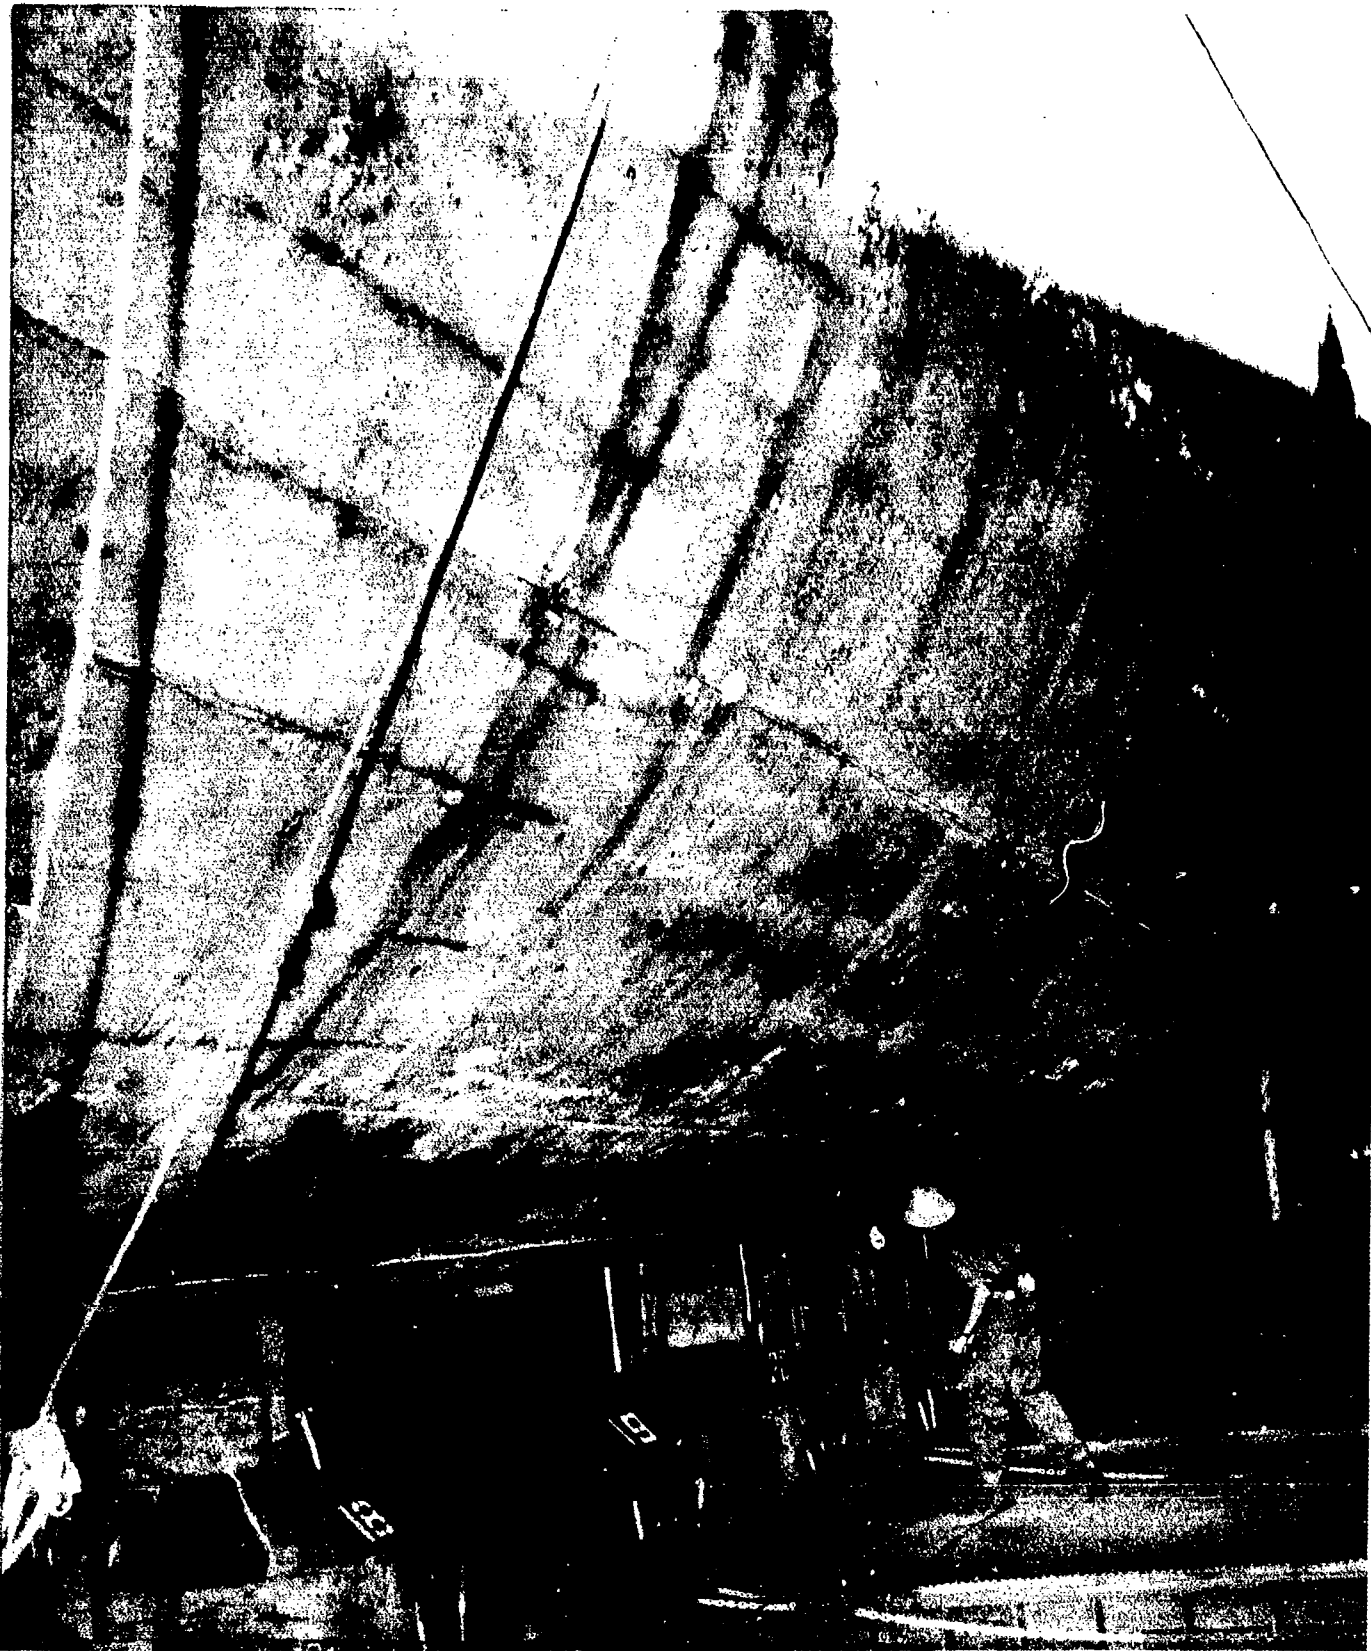
AB-CR-97-4048-3. Port shell looking aft, frames 40-60.

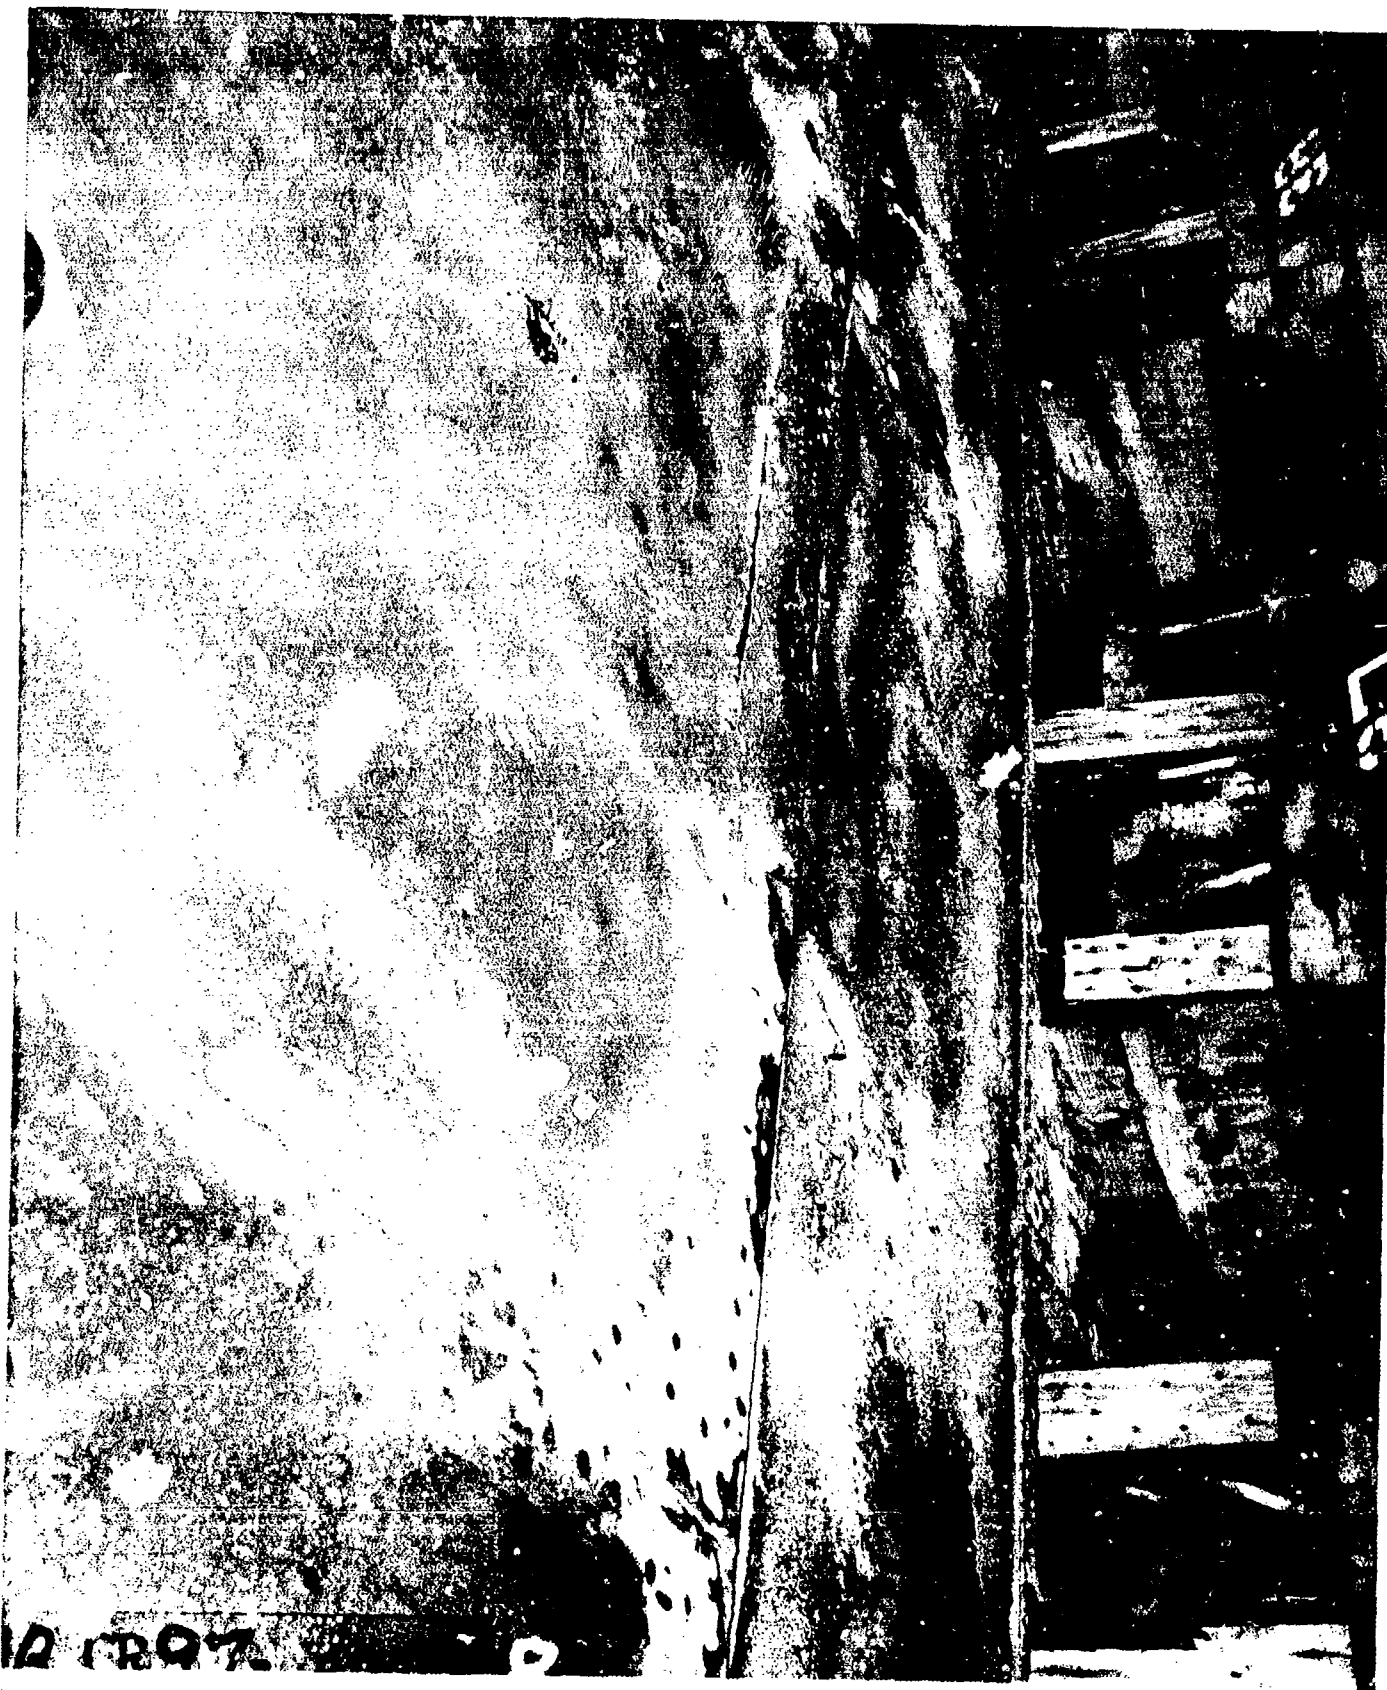
AB-CR-97-4048-8. Port bottom shell looking aft, frames 105-110.
