BUREAU OF SHIPS GROUP
TECHNICAL INSPECTION REPORT

⑥ OPERATION CROSSROADS.
U.S.S HUGHES (DD410).
TEST BAKER.

VOLUME II [u] ⑧

USS HUGHES (DD410)

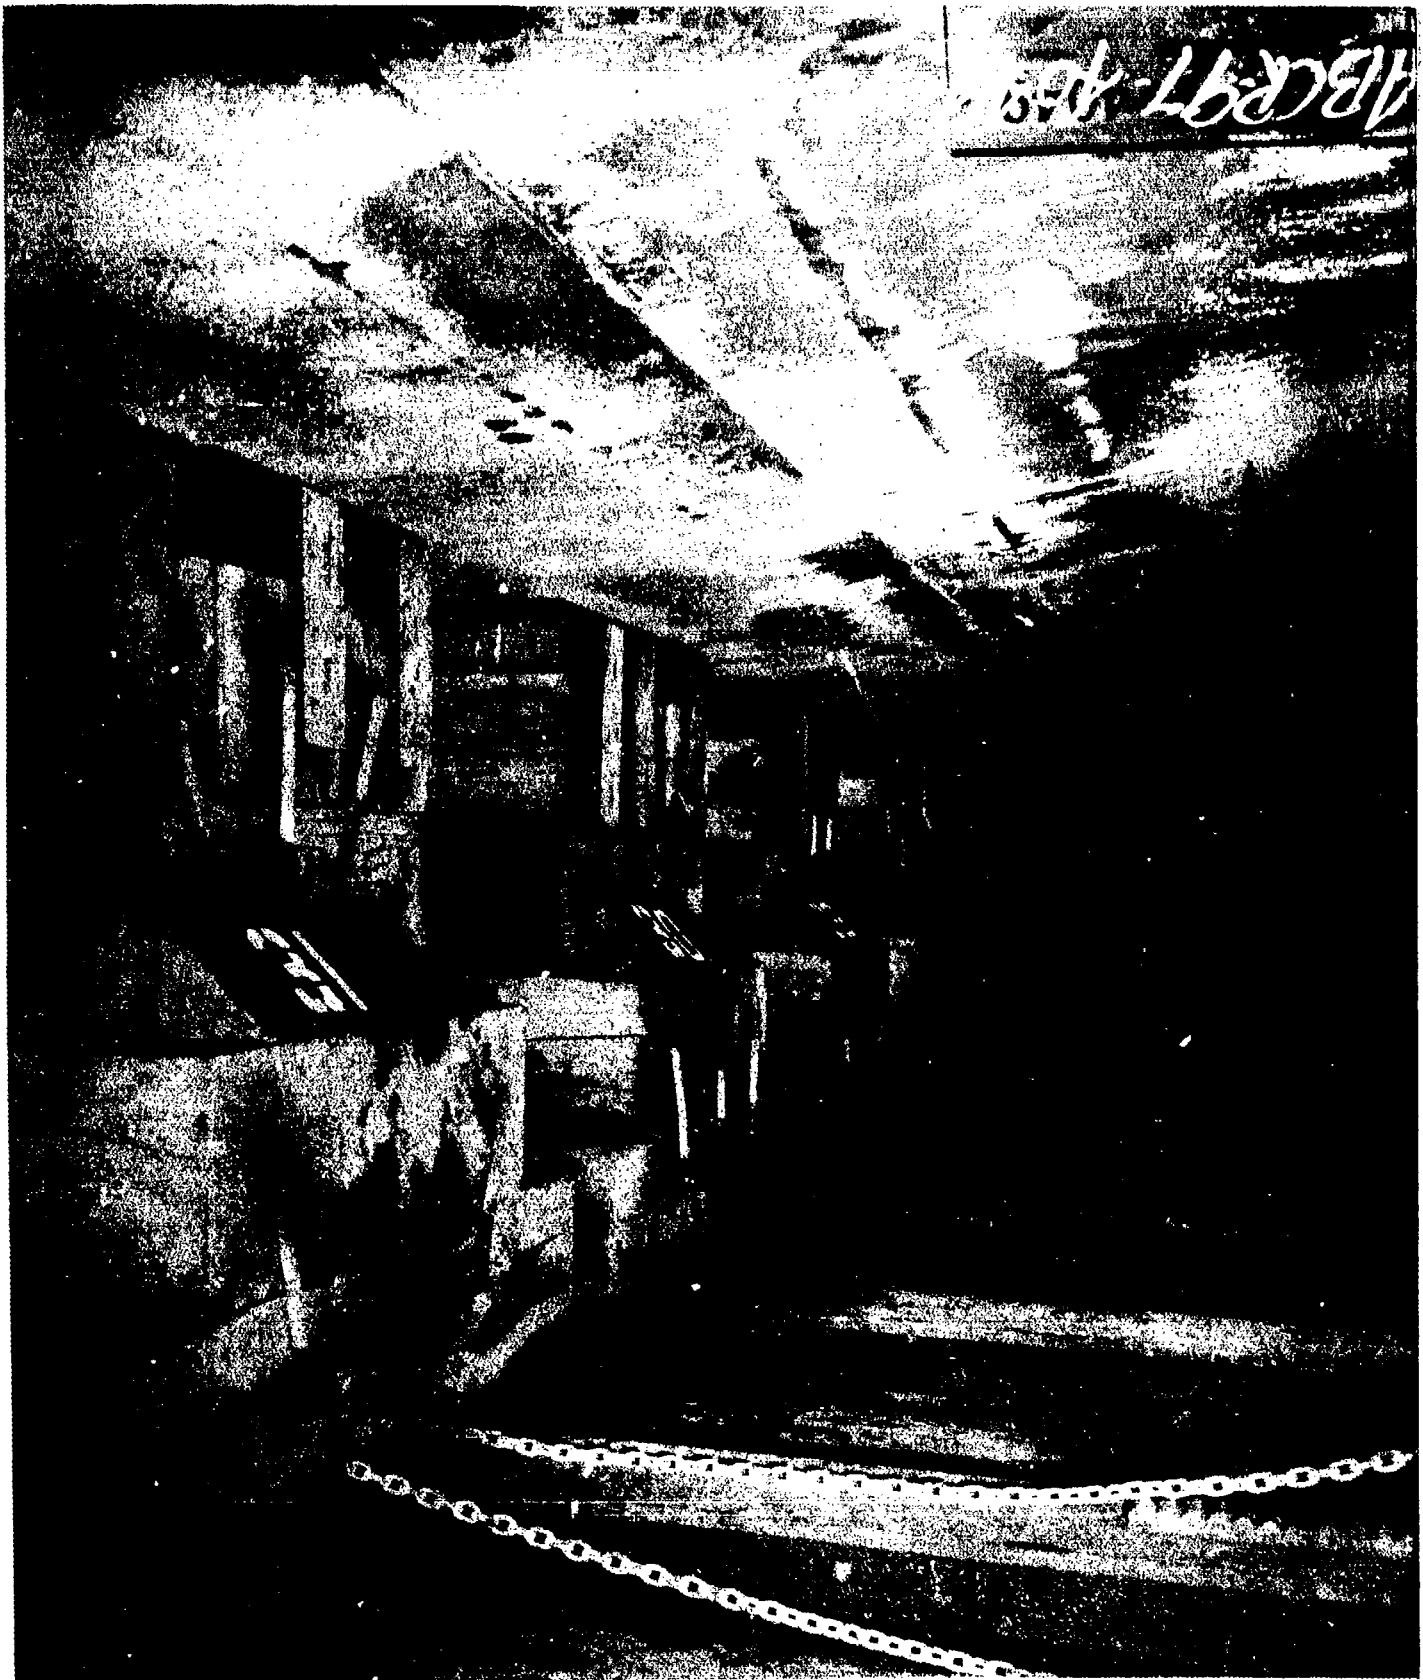
AB-CR-97-4049-10. Starboard bottom shell, looking forward from Frame 90 along garboard strake, note white coral sand imbedded in paint during grounding.

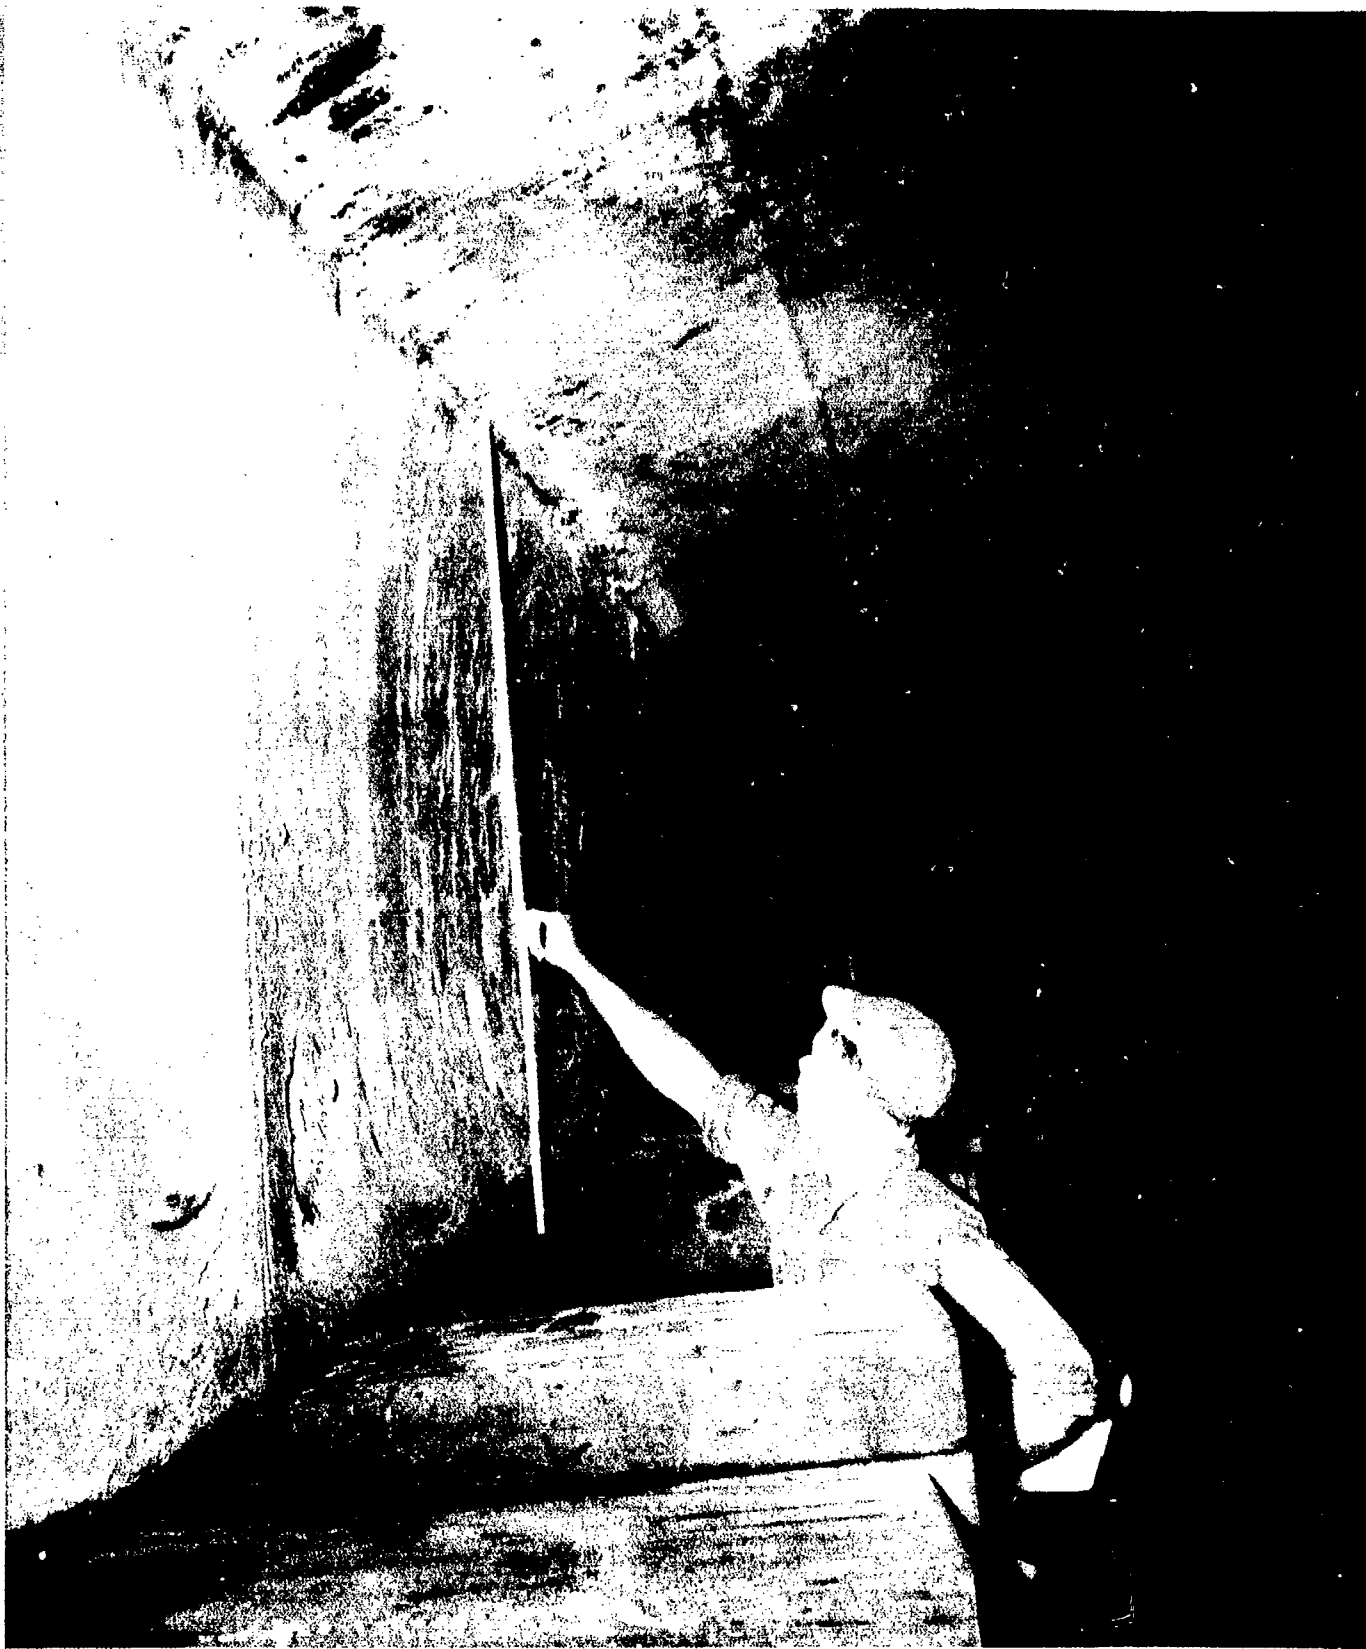
AB-CR-234-4060-9. Starboard side of skeg looking forward (Note dishing).

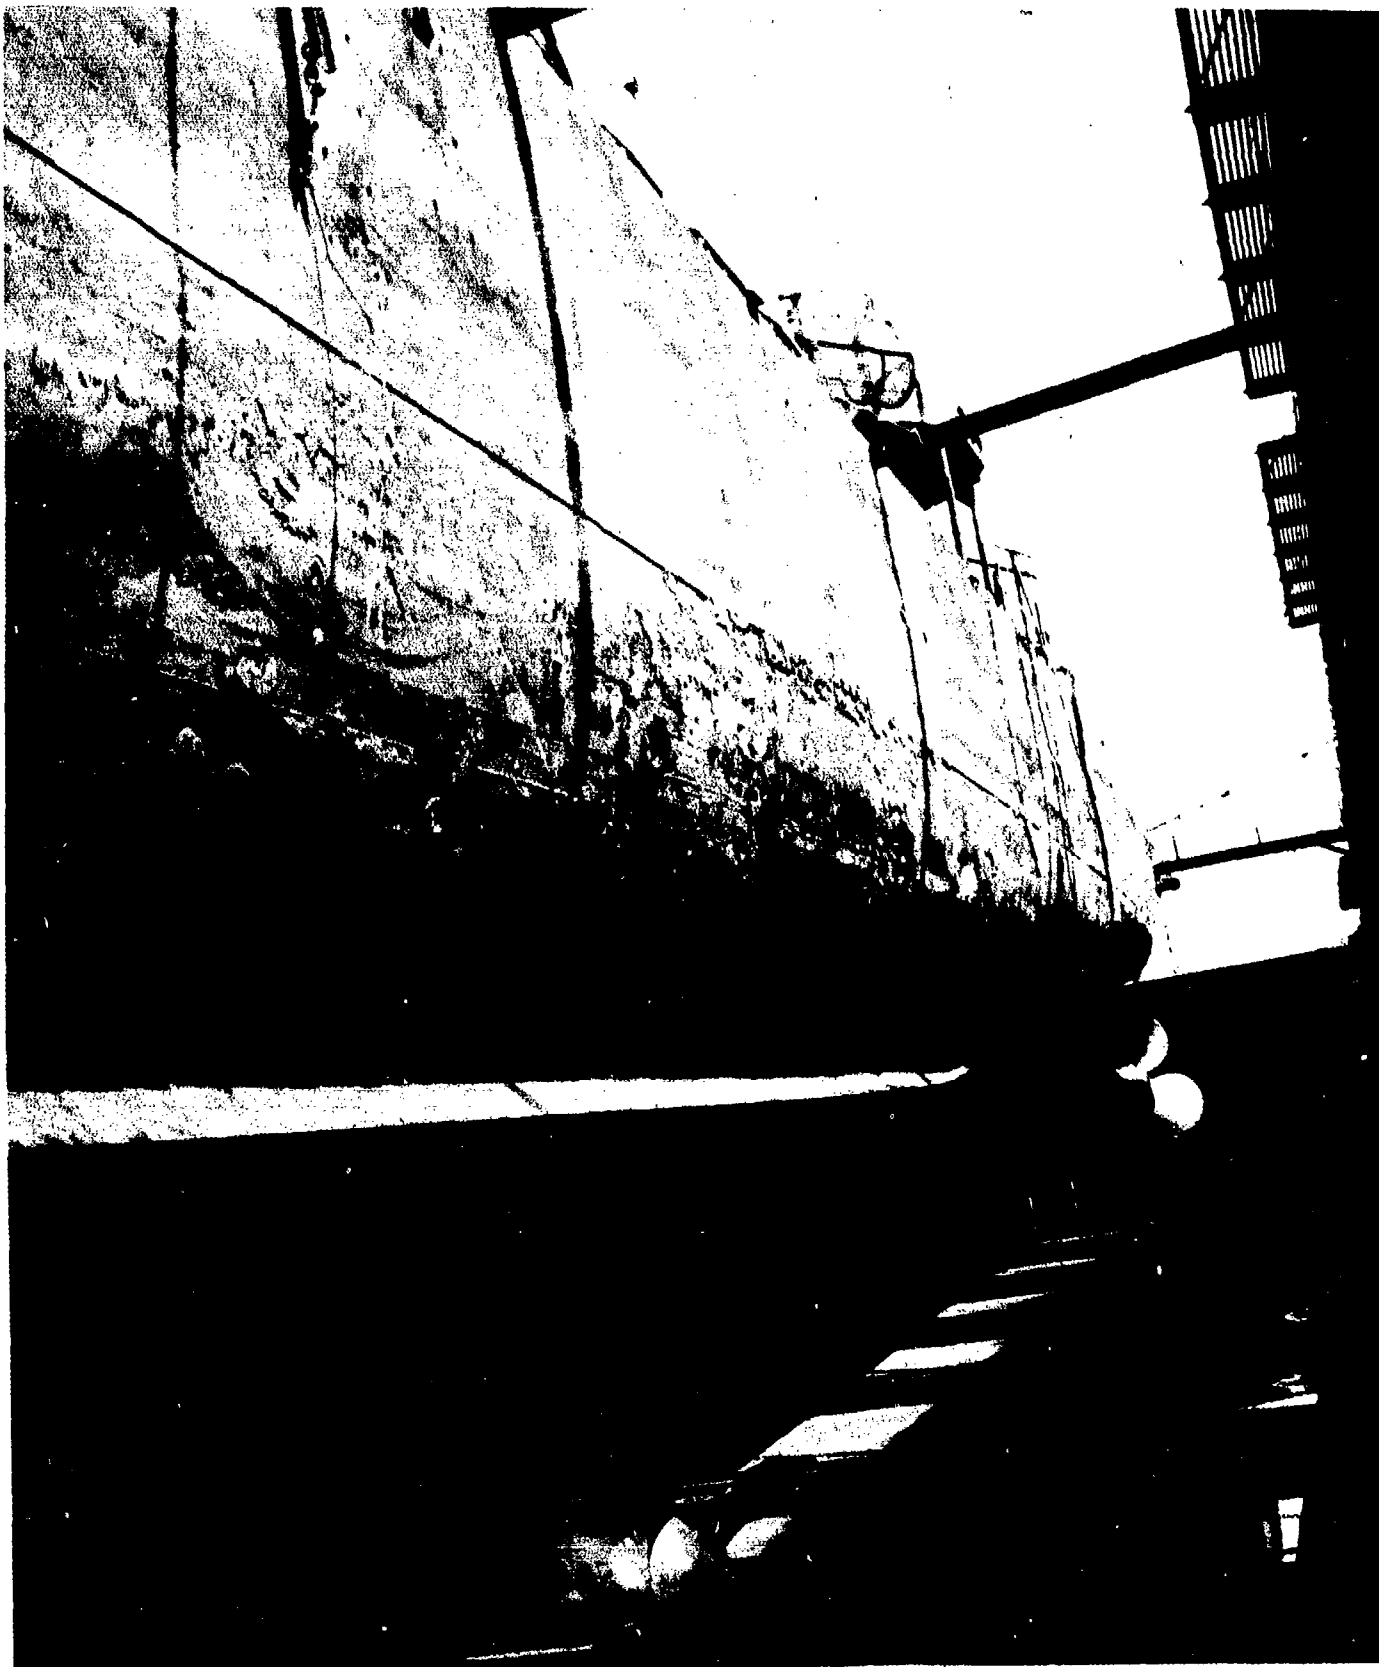
AB-CR-97-4057-1. Port shell looking aft, frames 100-130.

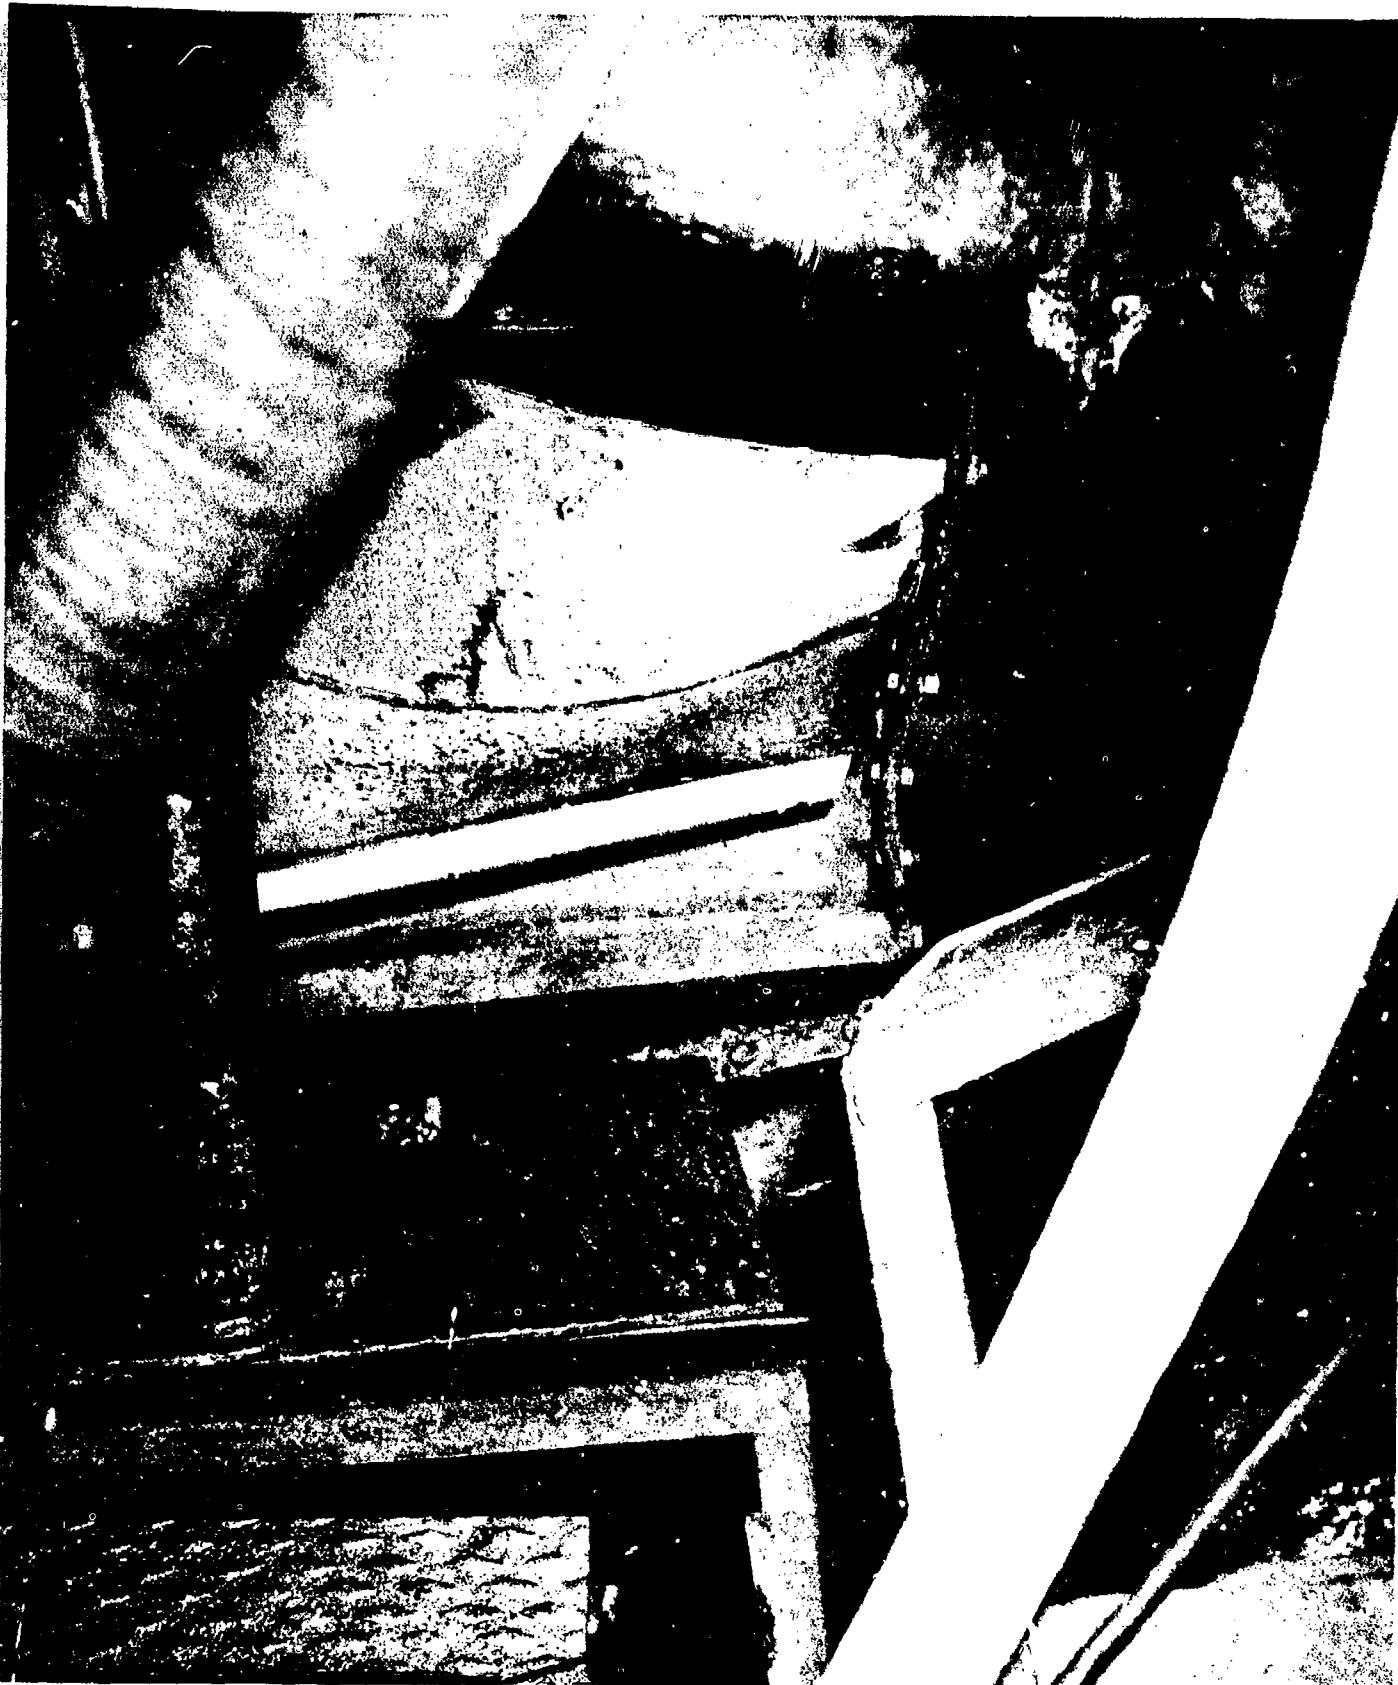
AB-CR-76-2076-9. No. 1 boiler, lower front casing, starboard side.

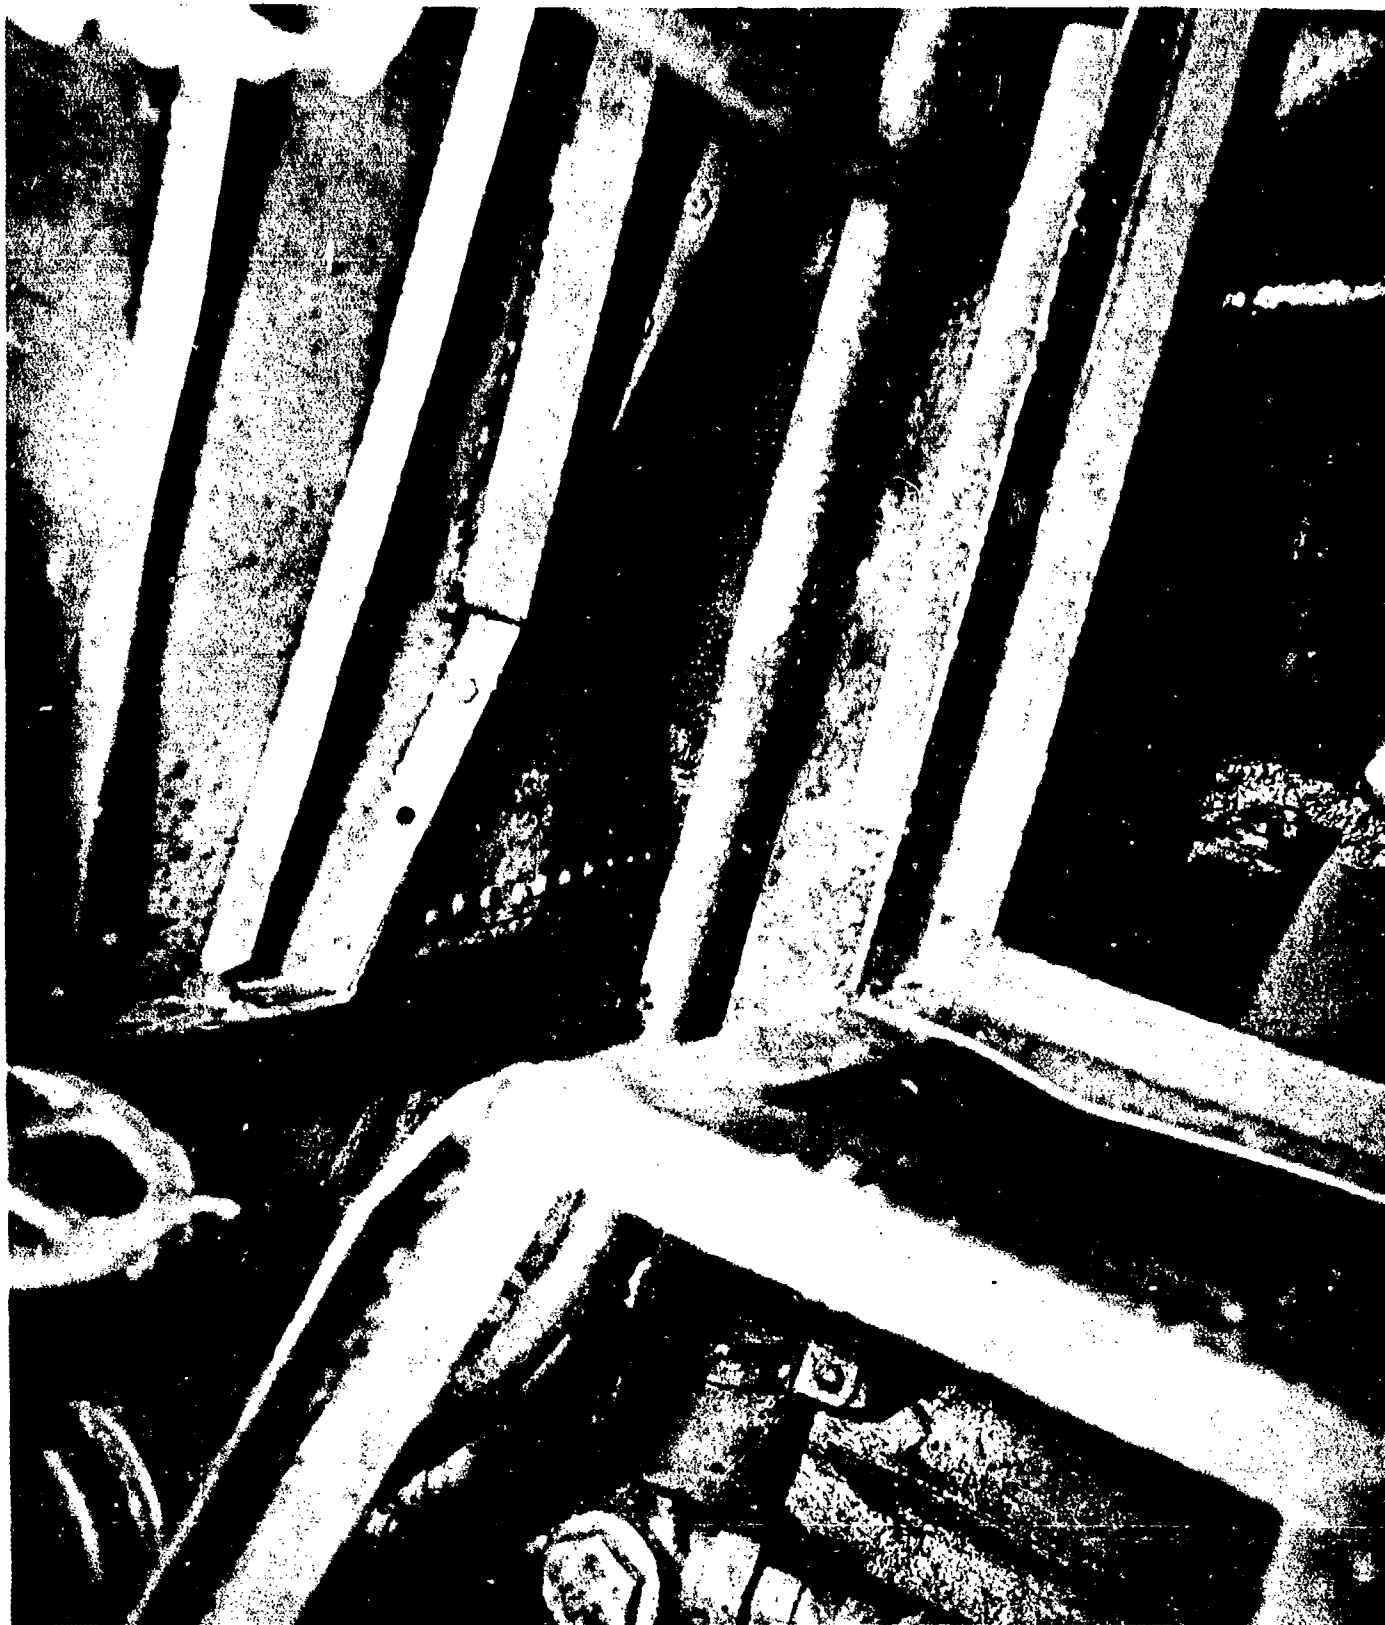
AB-CR-76-2076-10. No. 2 boiler, lower front casing, starboard side.

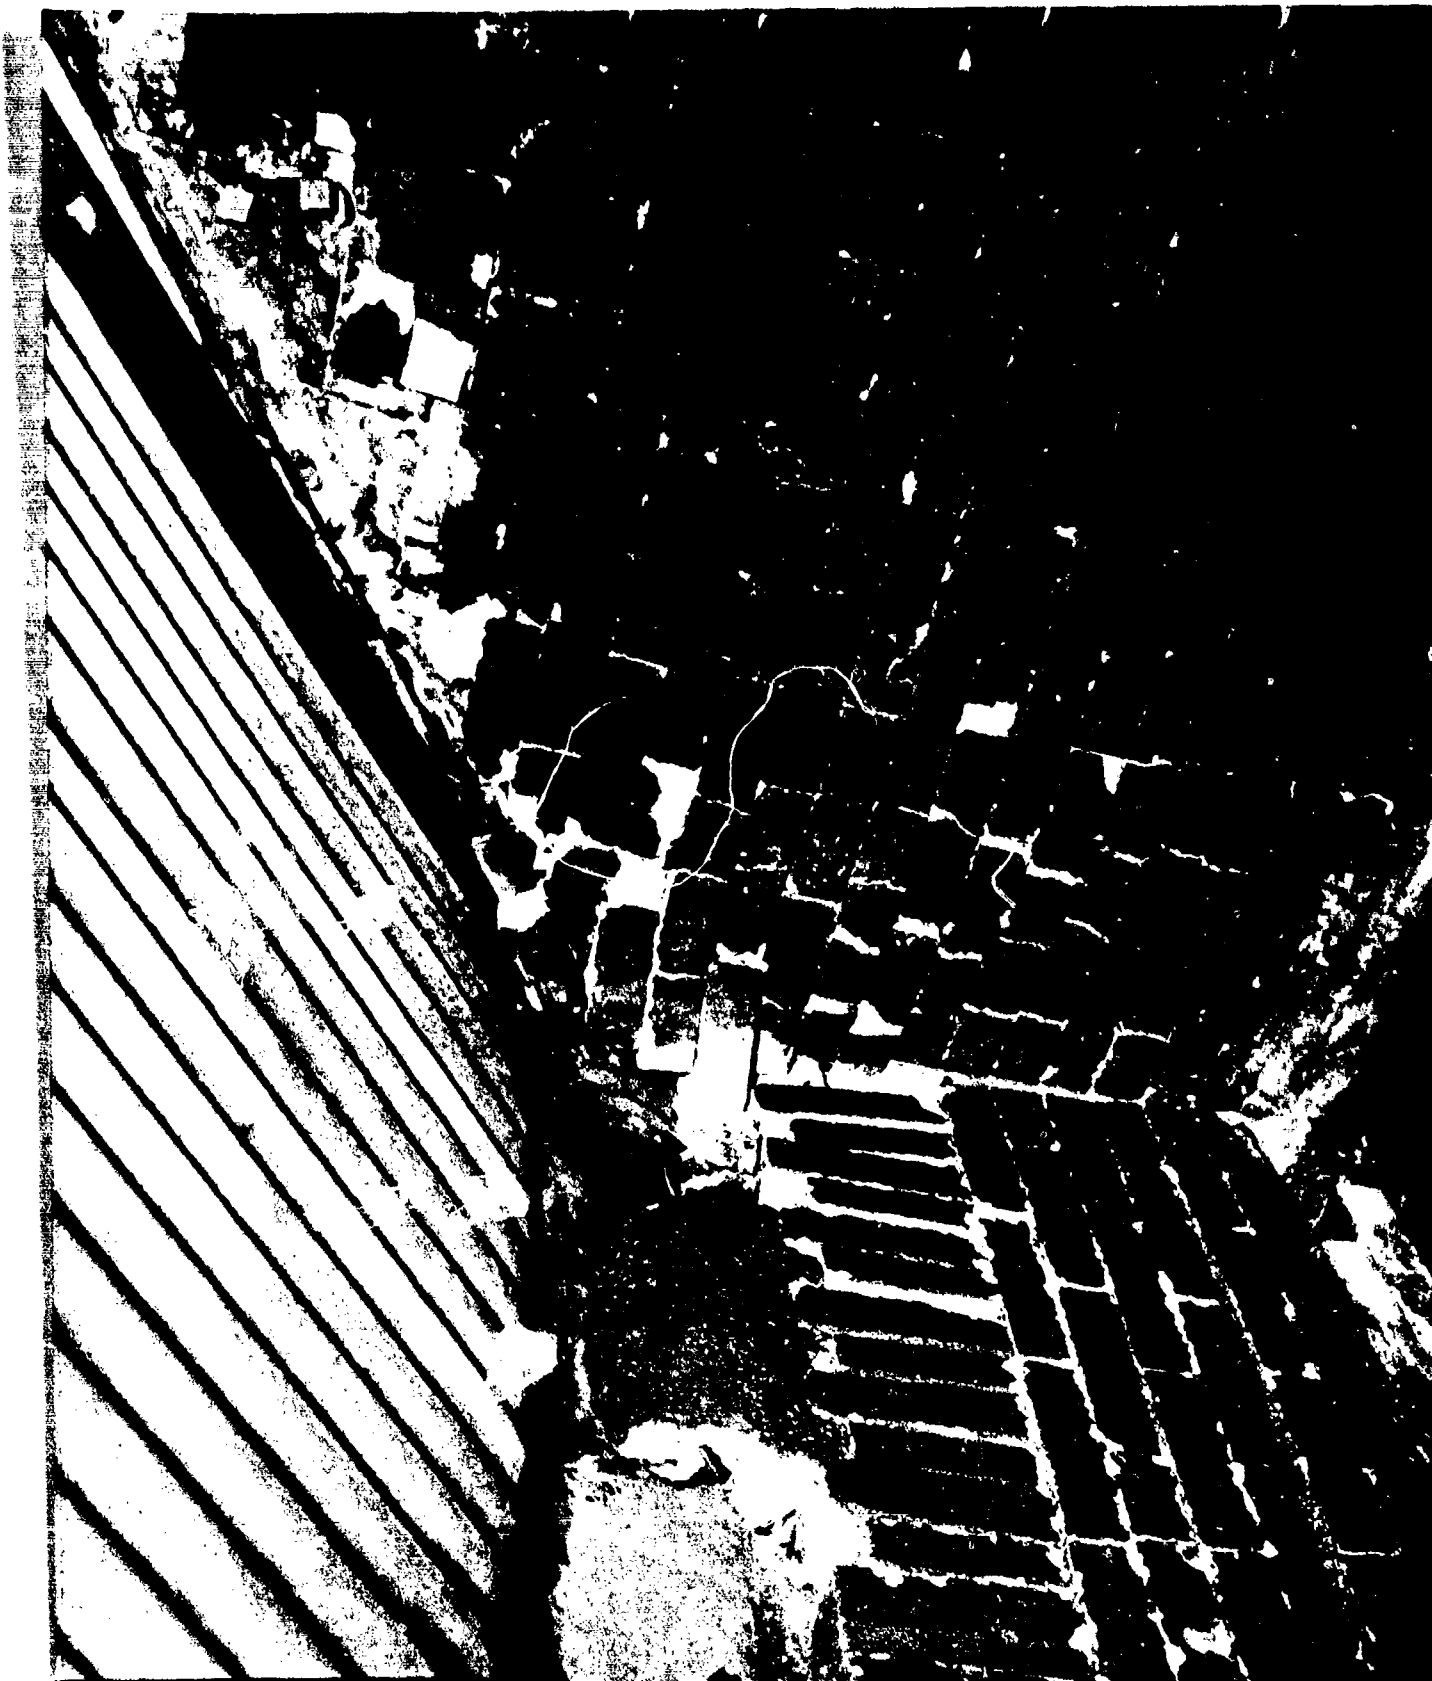
AB-CR-76-2075-8. No. 2 boiler, superheater side furnace, rear outboard corner showing rear and side wall.

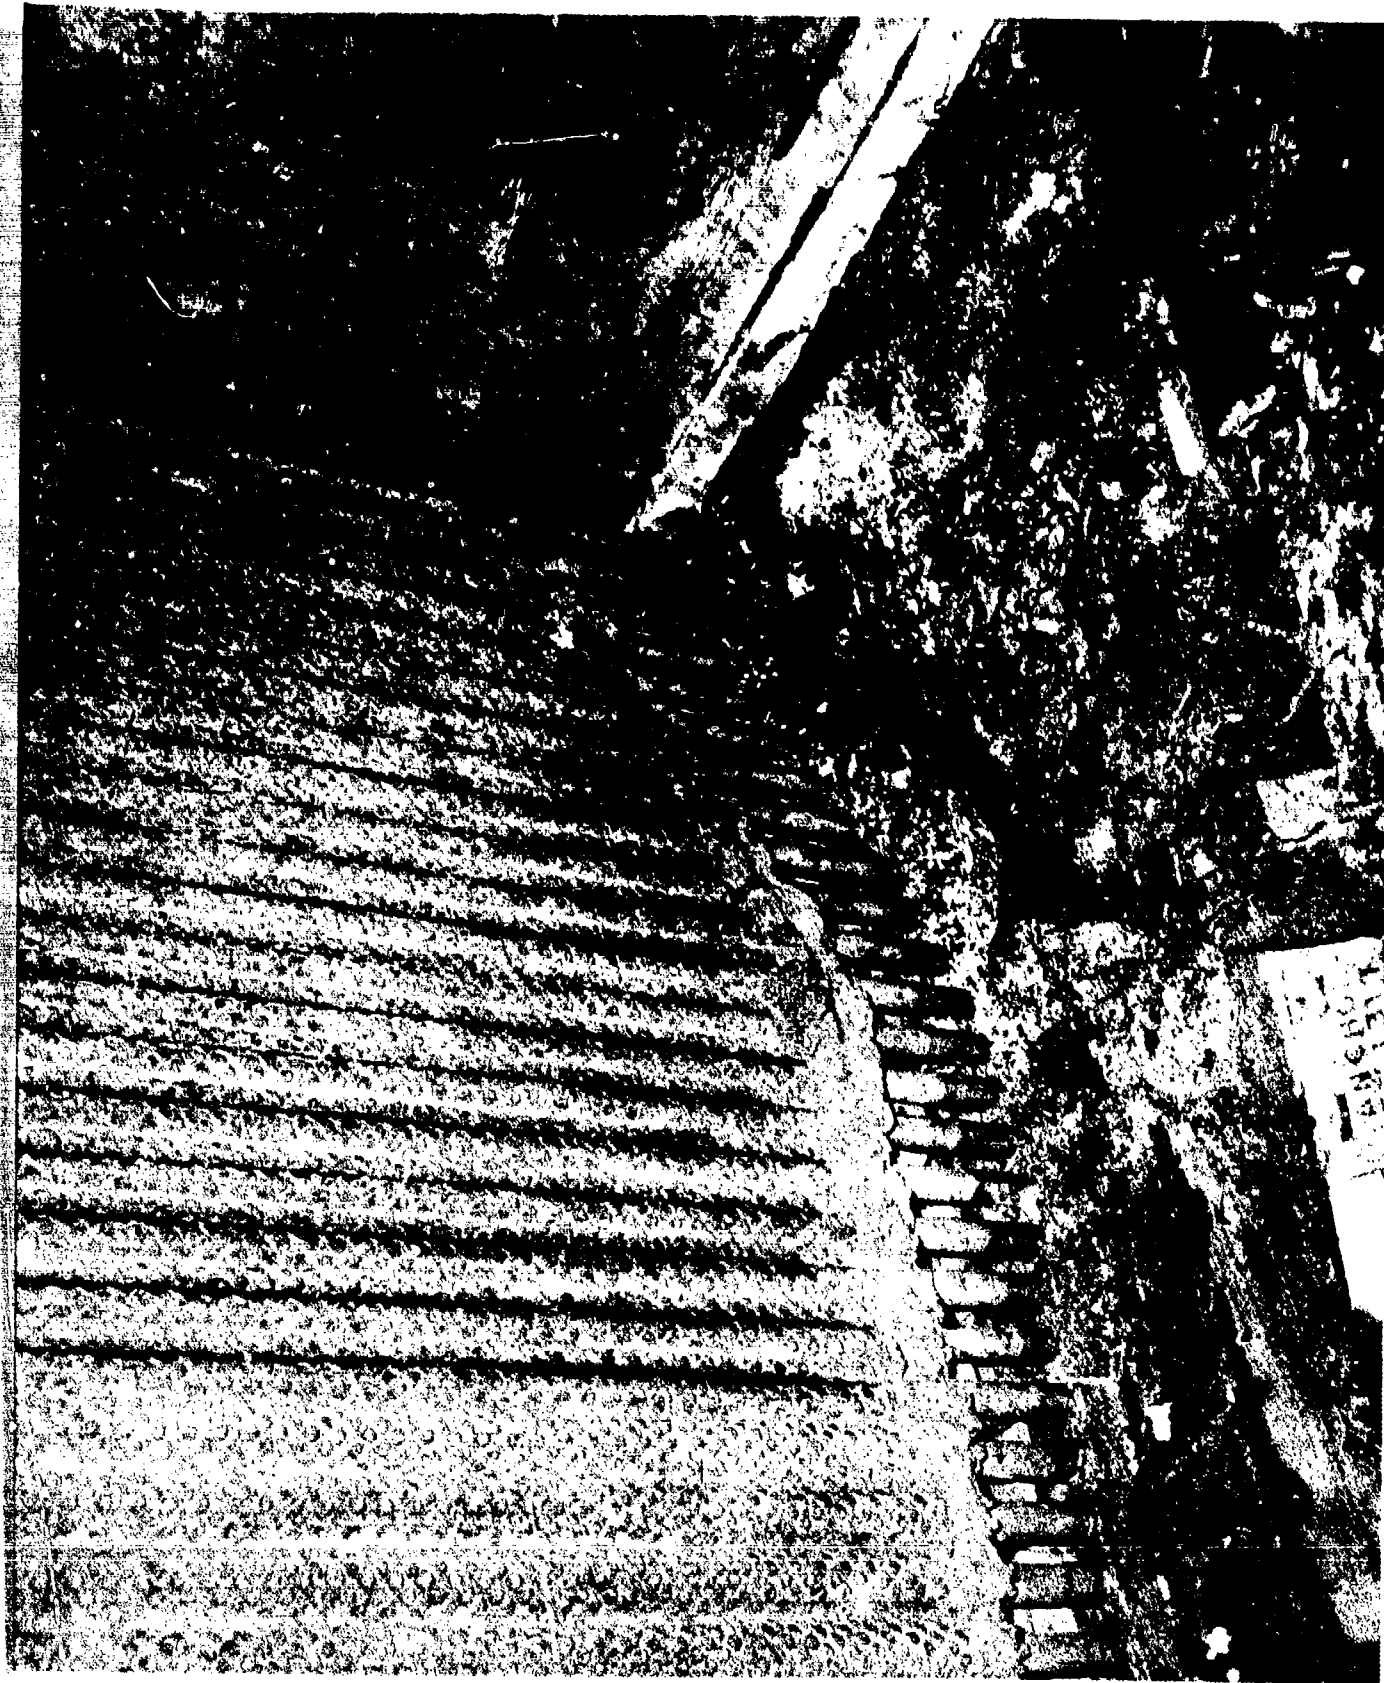
AB-CR-76-2076-3. No. 2 boiler, saturated side furnace, floor at rear inboard corner.

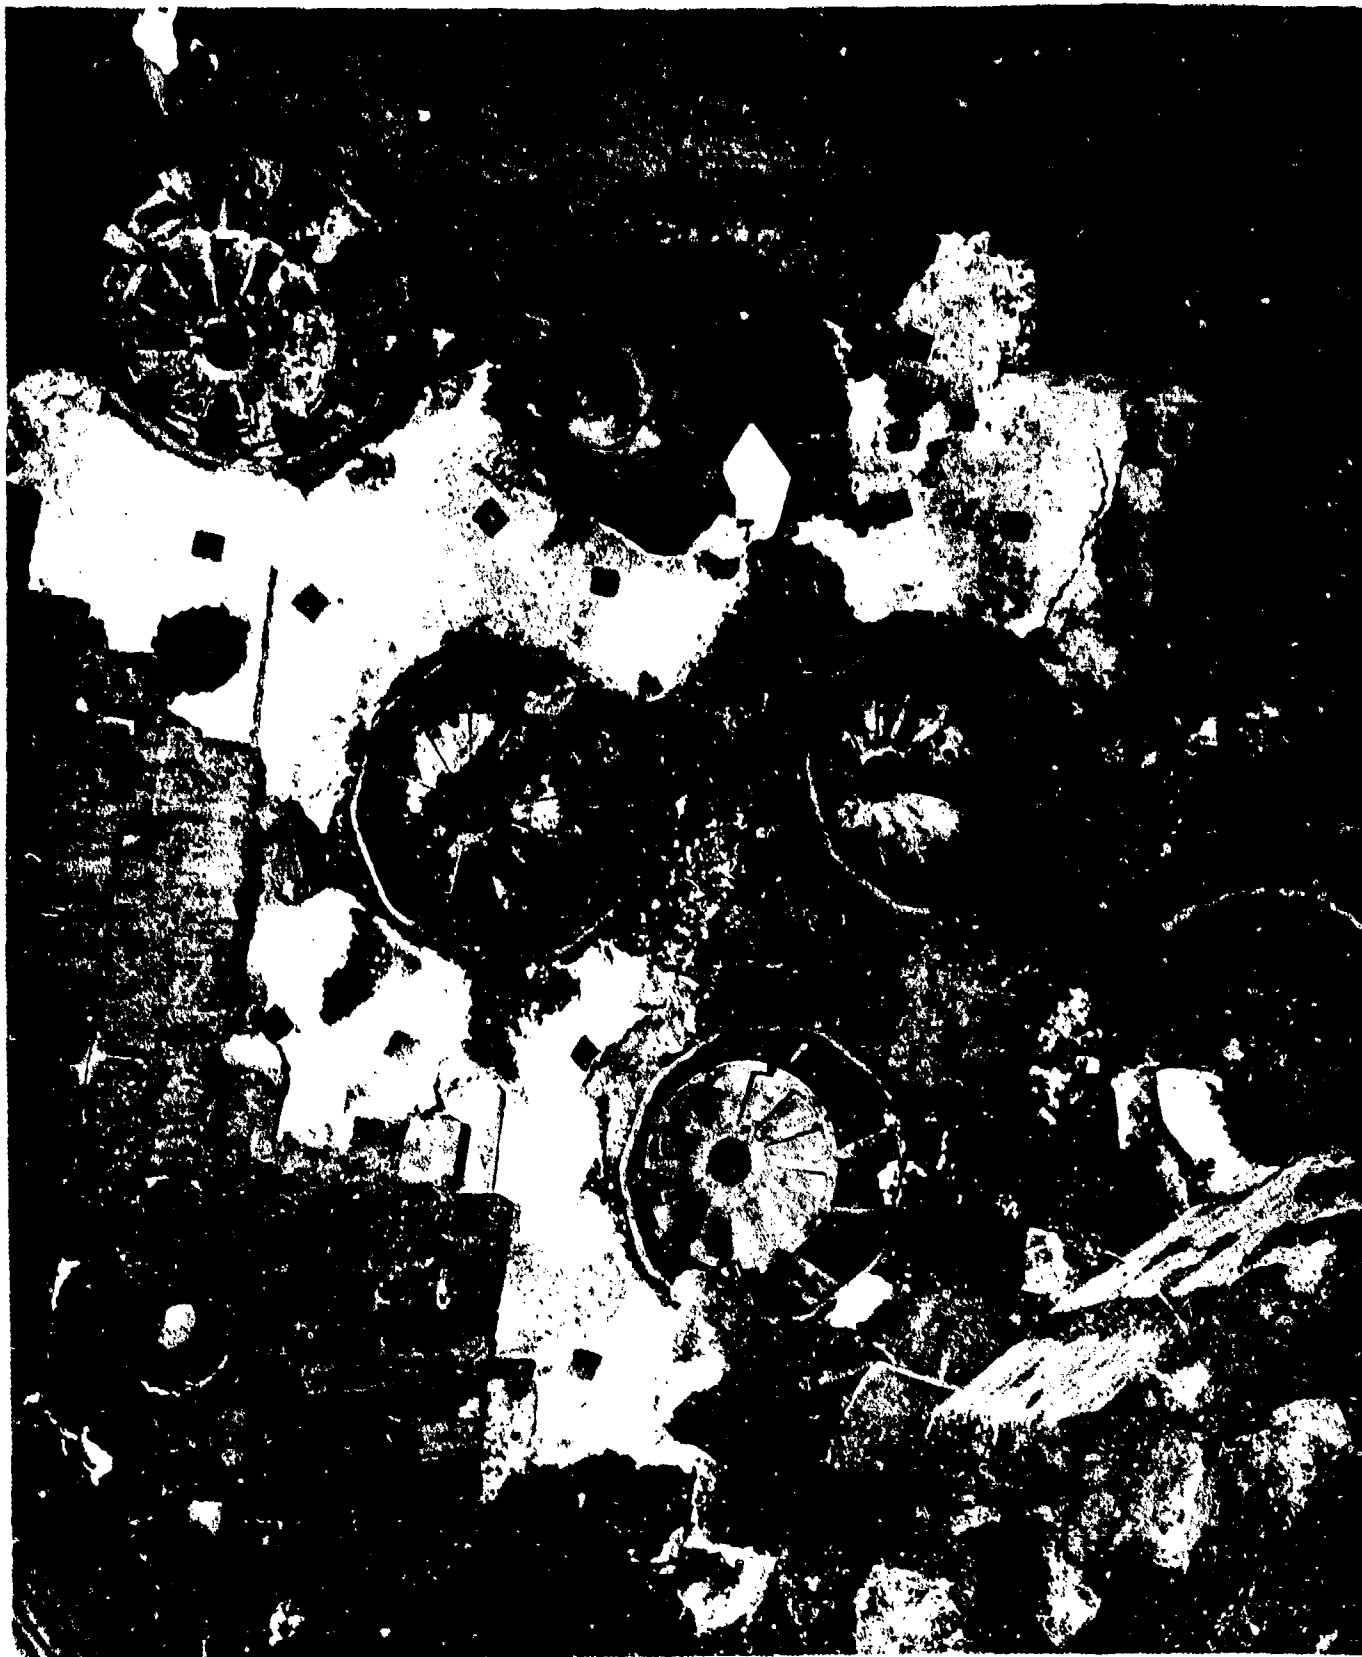
AB-CR-76-2076-2. No. 2 boiler, saturated side furnace, front wall.

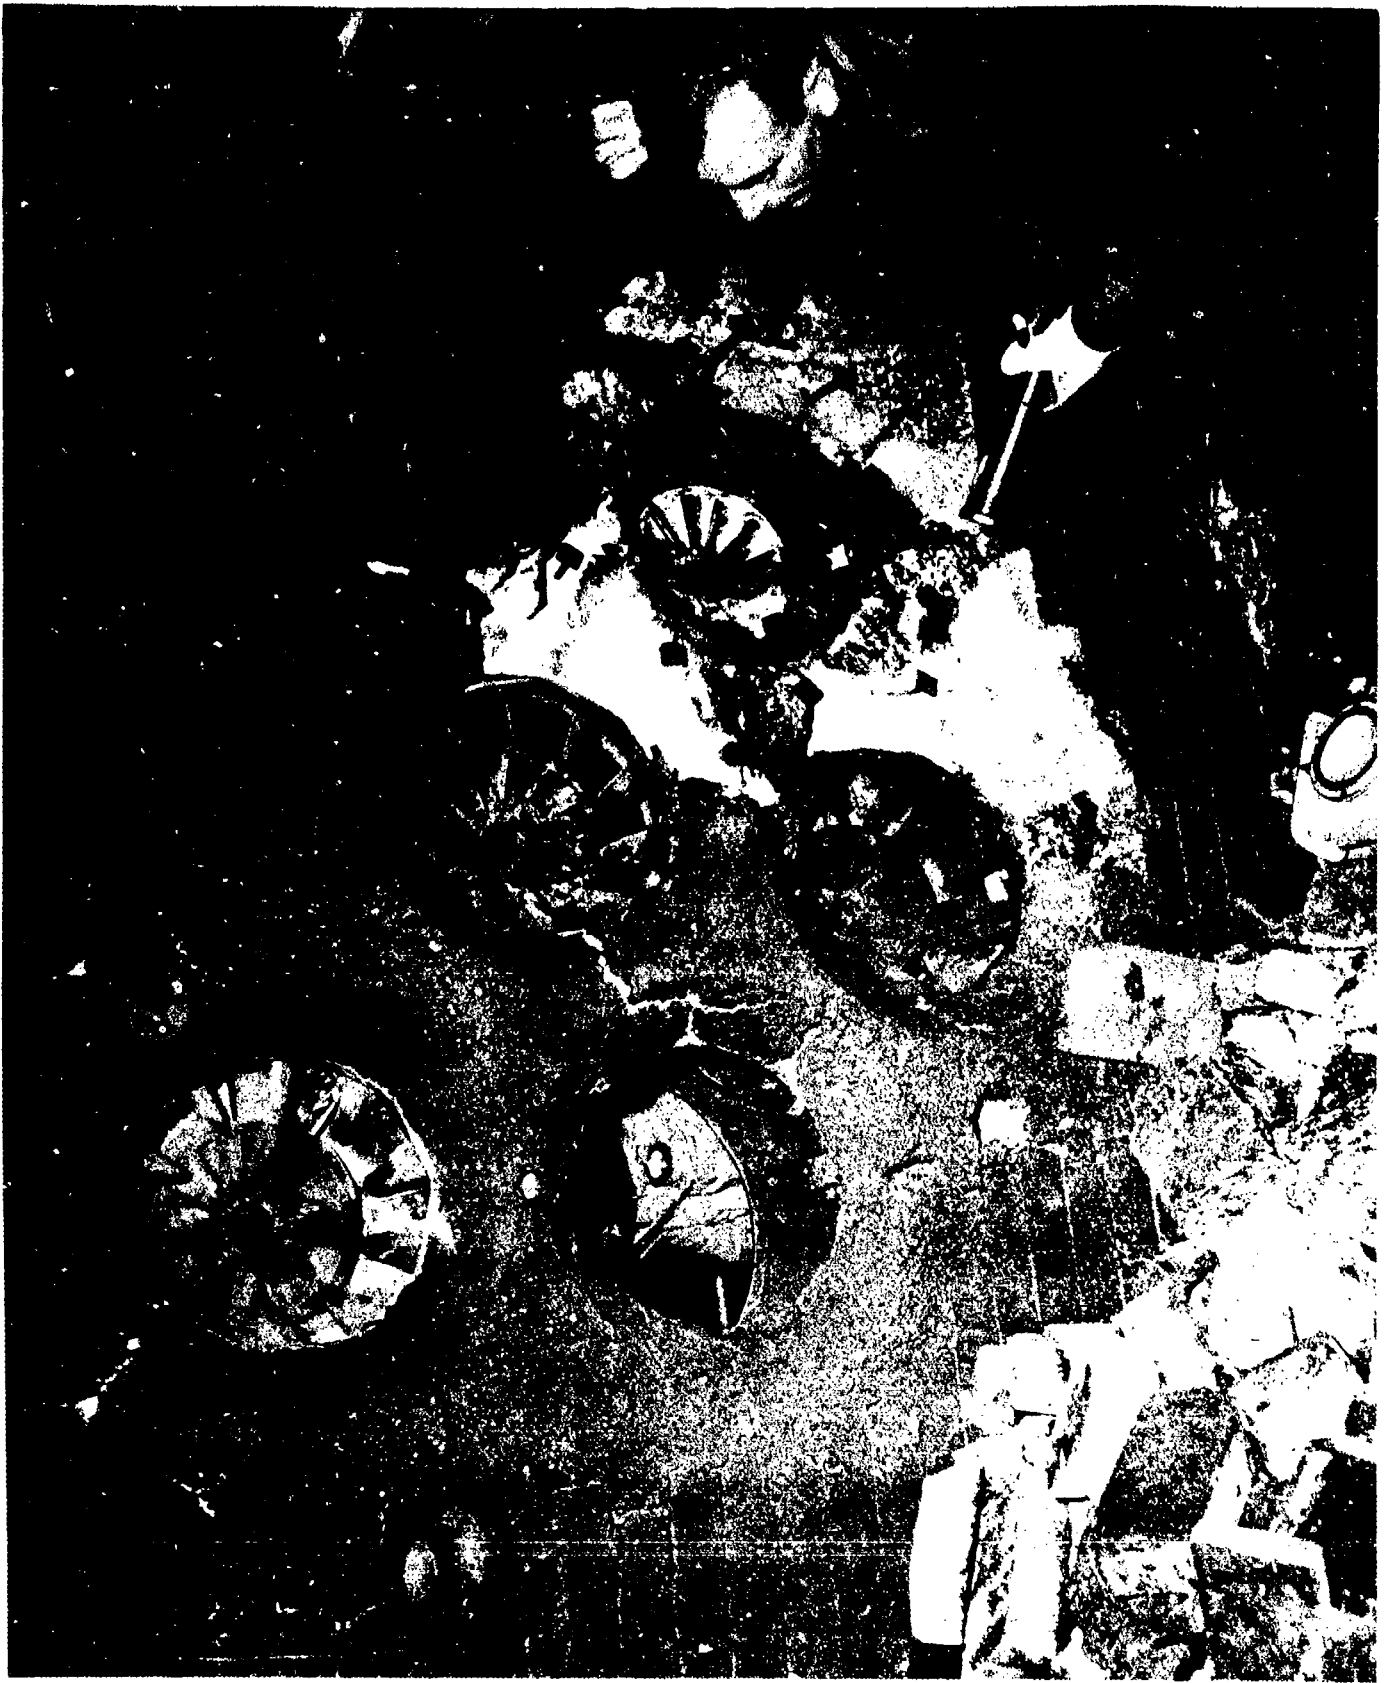
AB-CR-76-2075-10. No. 2 boiler superheater side furnace, front wall.
