BUREAU OF SHIPS GROUP
TECHNICAL INSPECTION REPORT

⑥ OPERATION CROSSROADS.
U.S.S HUGHES (DD410).
TEST BAKER.

VOLUME II [u] ⑧

USS HUGHES (DD410)

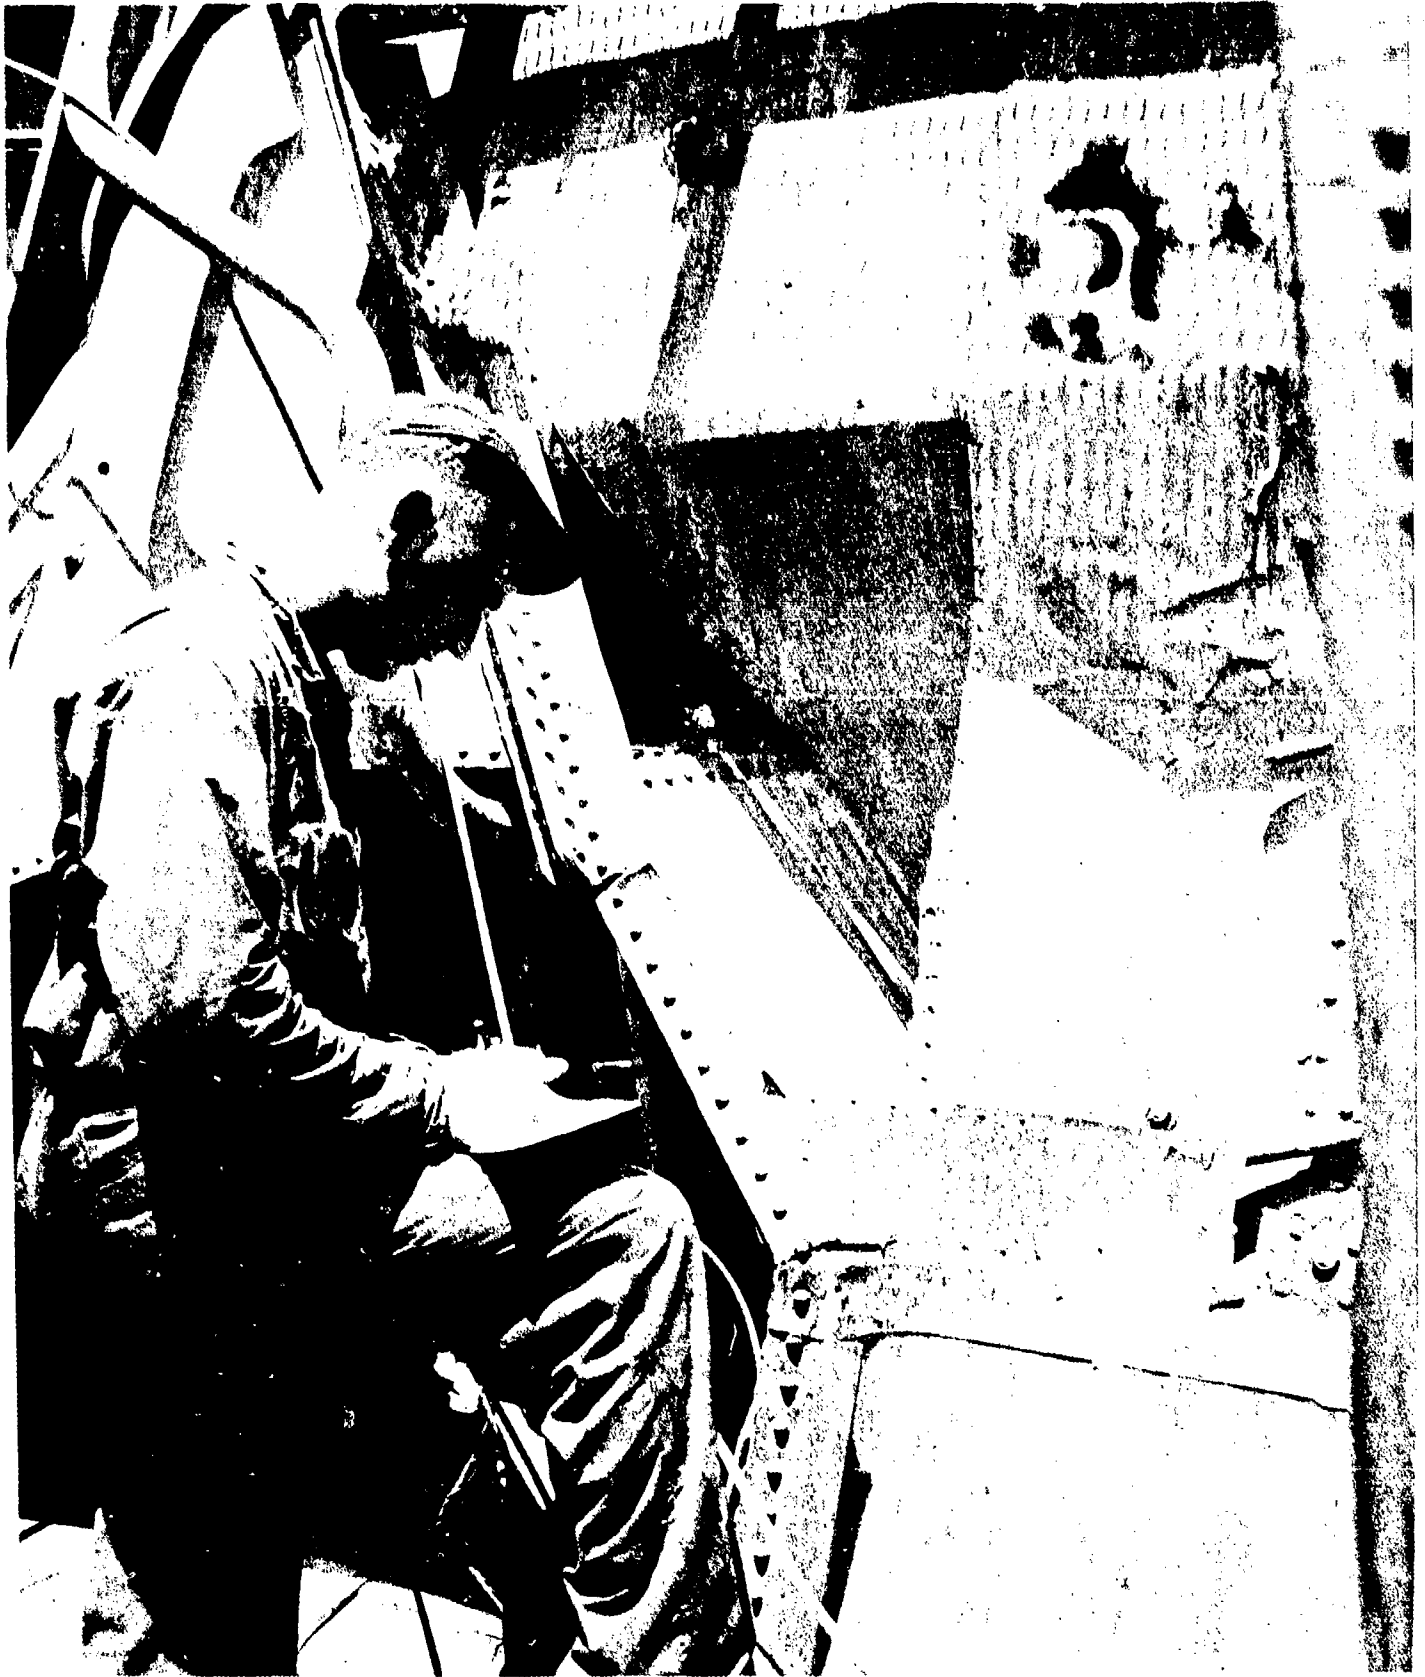
AB-CR-76-2078-1. No. 2 boiler uptake, port side.

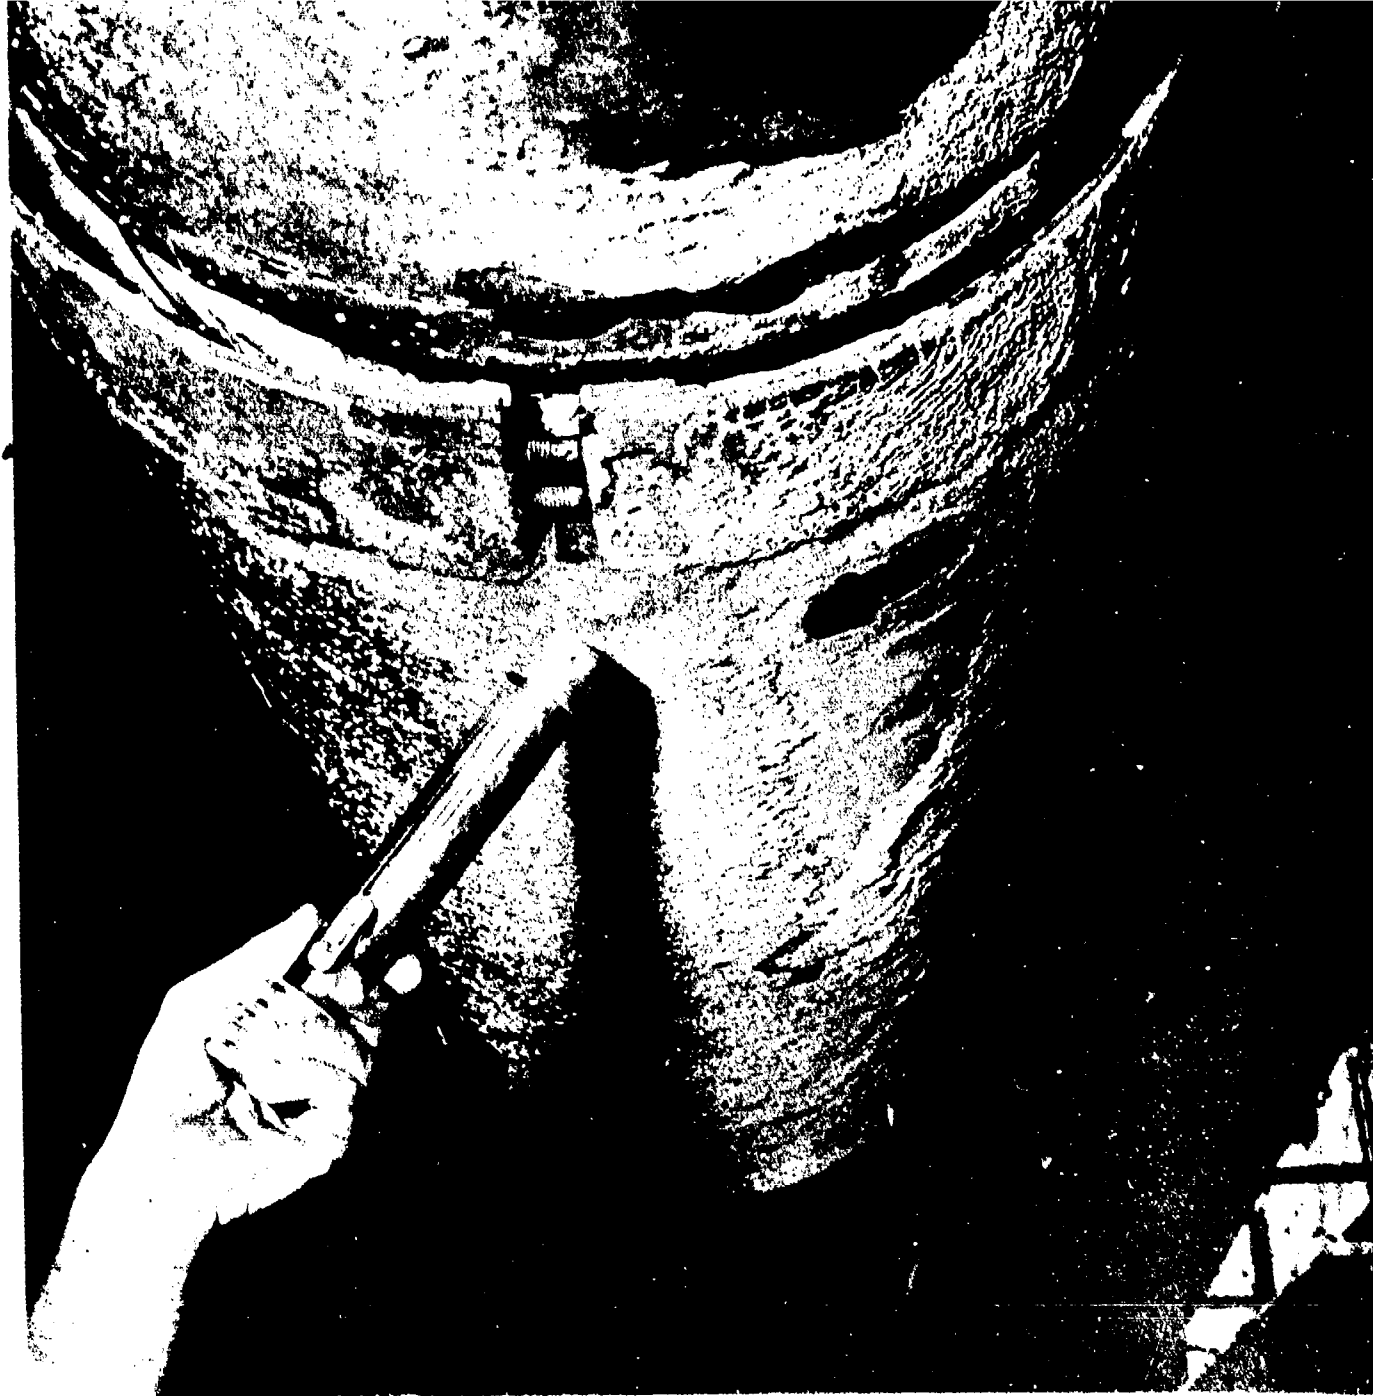
AB-CR-234-4060-5. Starboard intermediate structural fairwater
aft end.
