ELECTRONICS COORDINATING OF
SHIP PREPARATION
and
TARGET INSPECTION

FINAL REPORT
TESTS ABLE AND BAKER

✓ **VOLUME 2**
PHOTOGRAPHIC RECORD

DIRECTOR OF SHIP MATERIAL
JOINT TASK FORCE ONE
OPERATION CROSSROADS

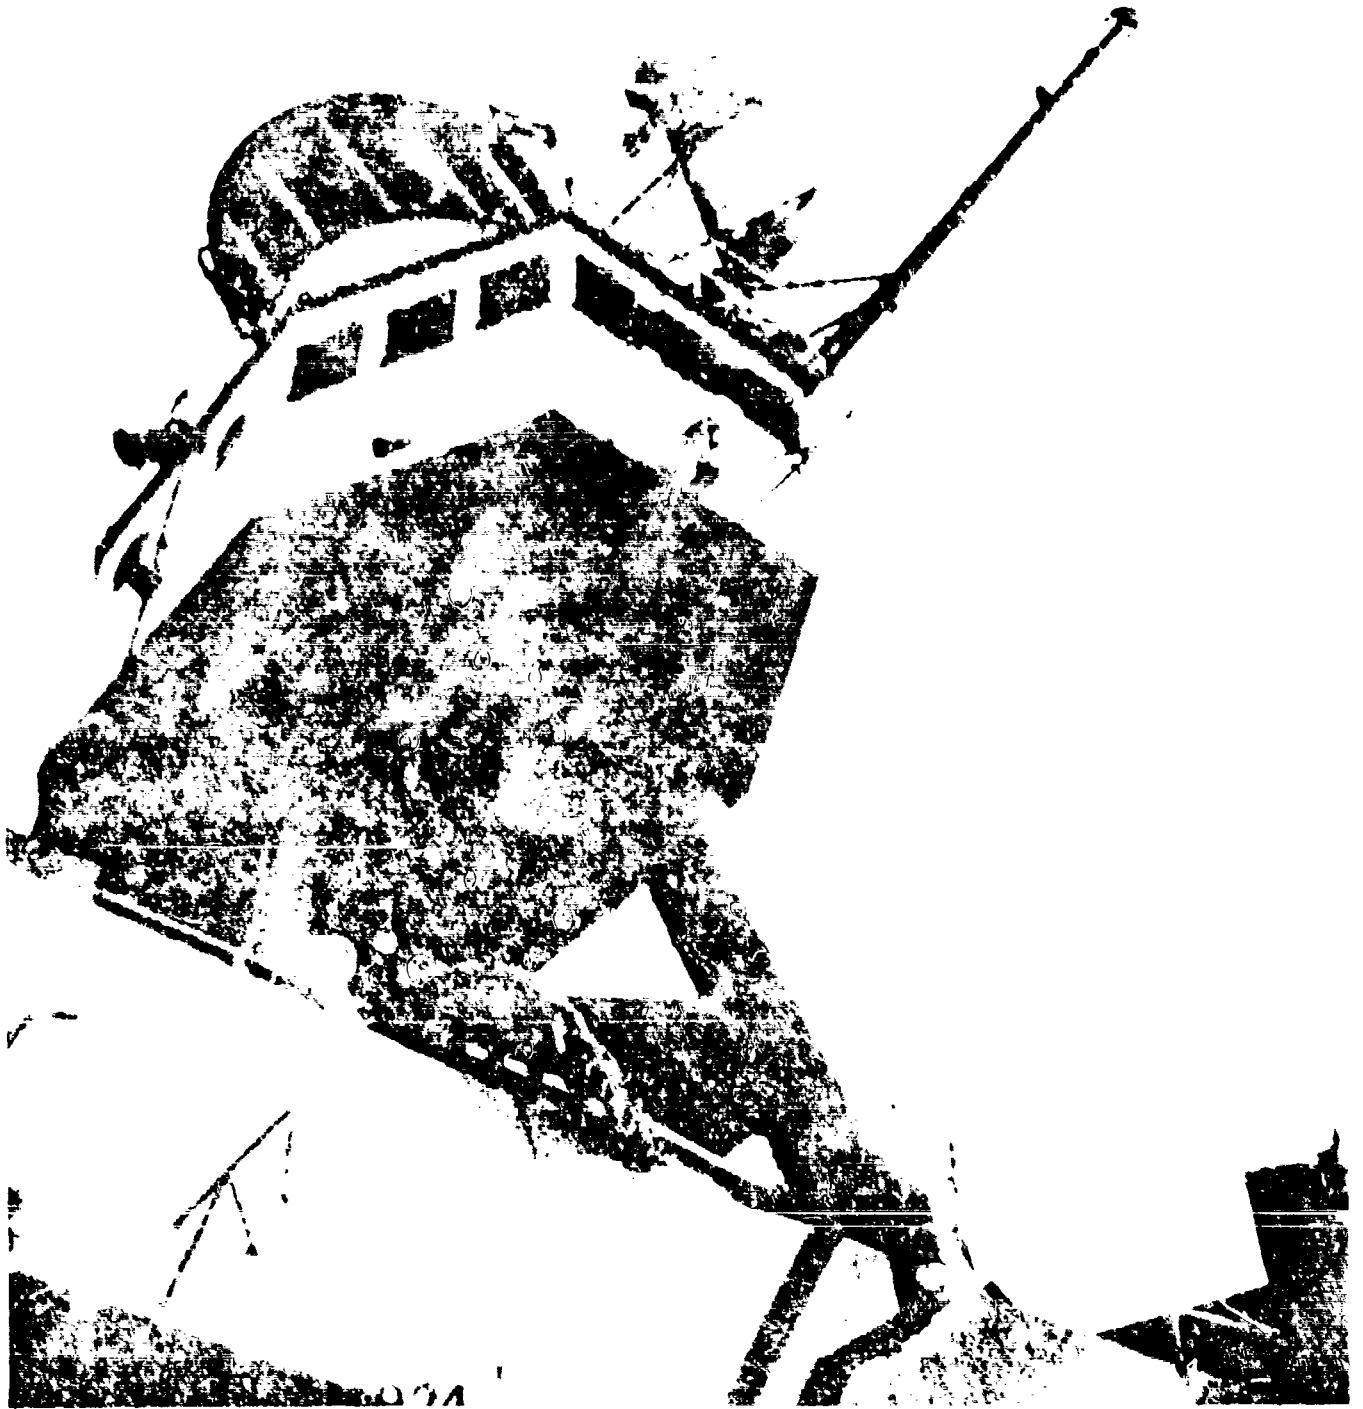
POST ABLE - FORWARD SUPERSTRUCTURE AND FOREMAST. View of general damage caused by test.

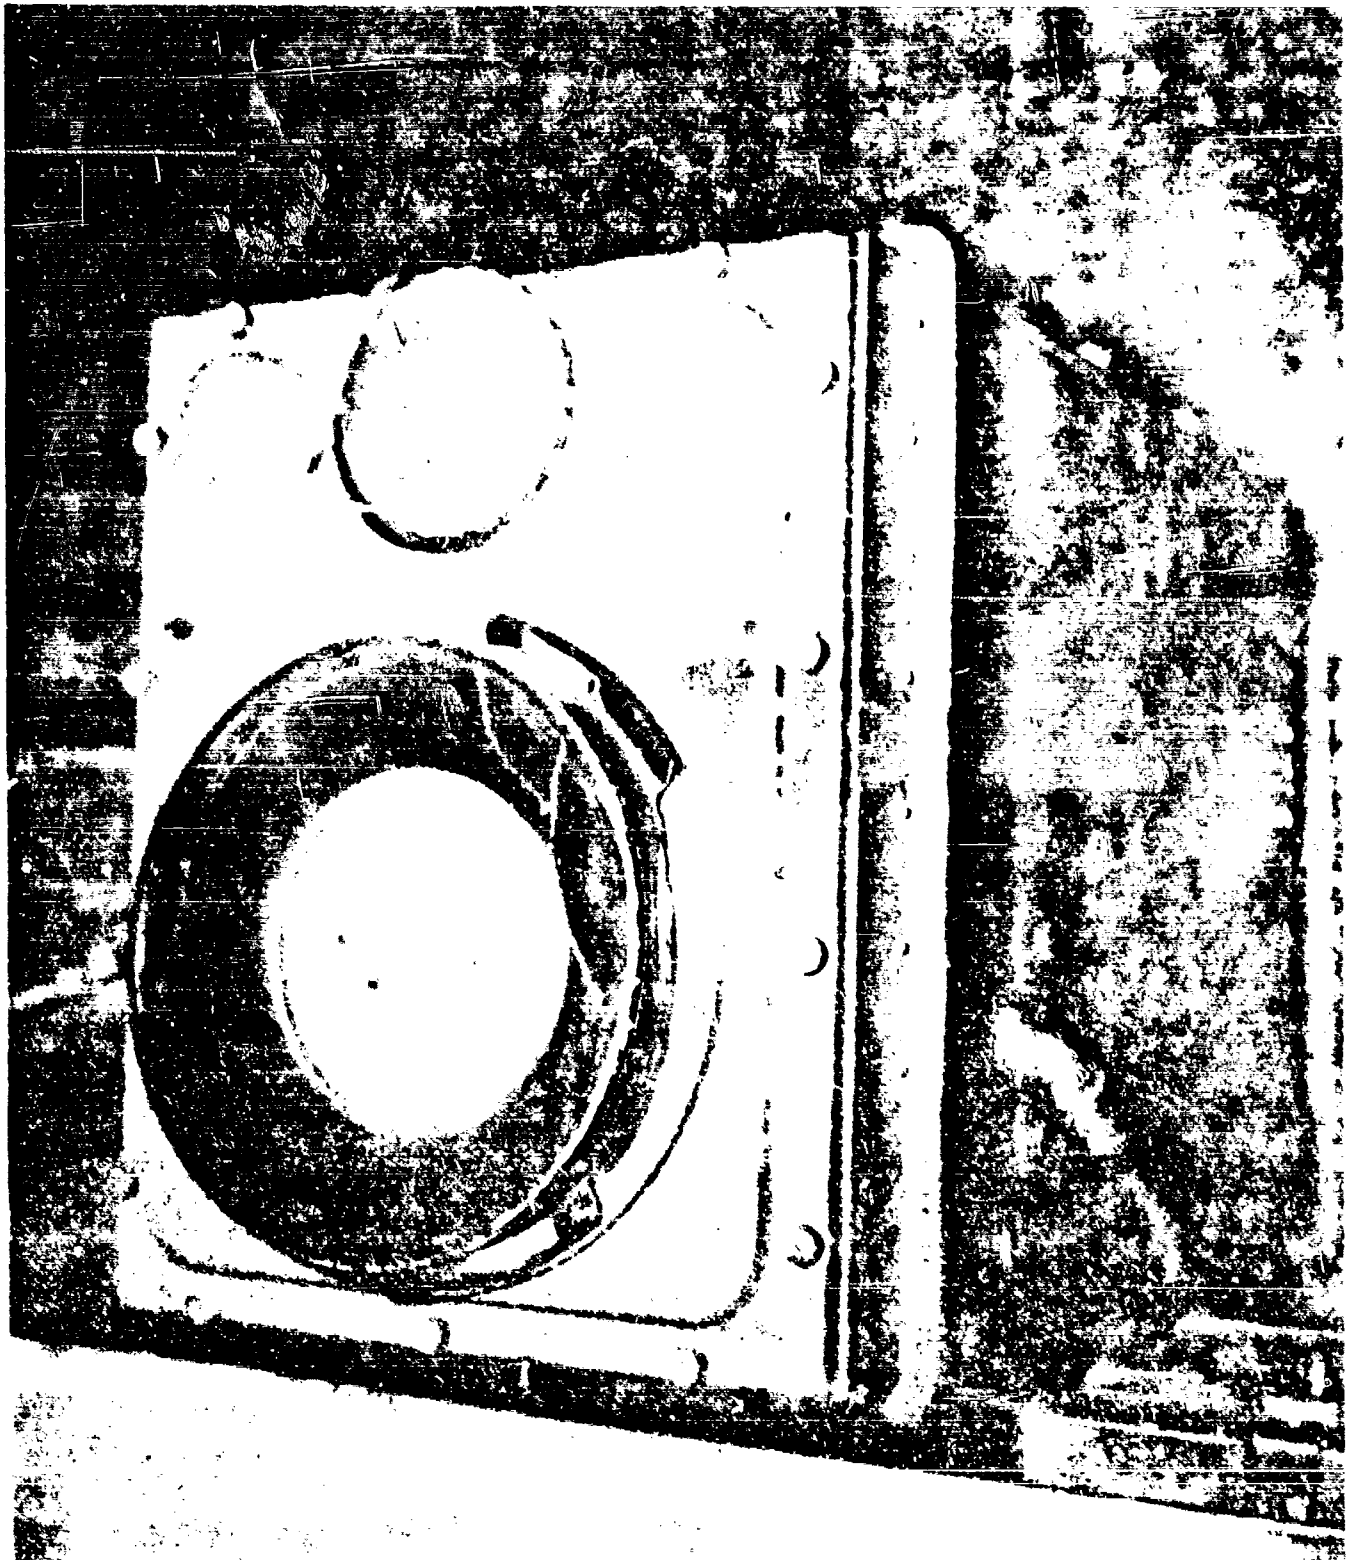
AA CR/00 - 1887 -

POST ABLE - VD-2 PPI REPEATER. The plastic cover over the PPI tube was broken. This had no effect on the operation of the equipment as the tube itself was not broken.

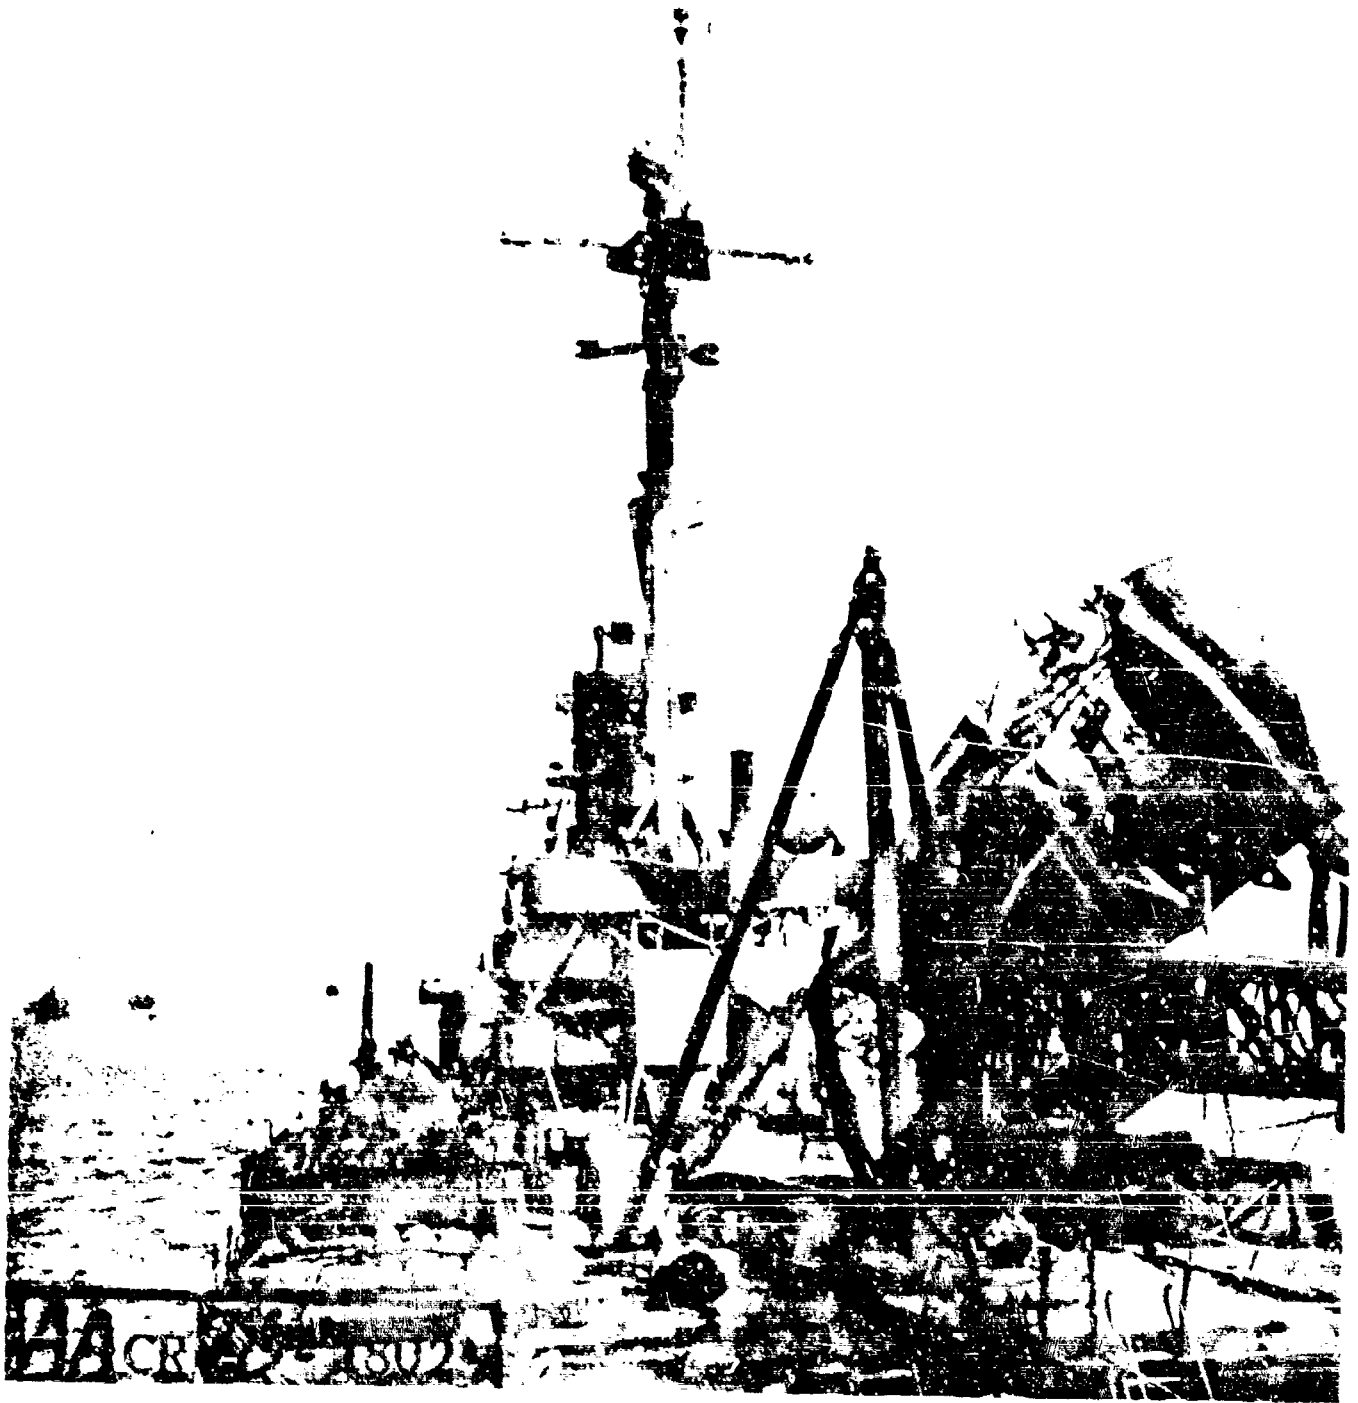
POST ABLE - GENERAL VIEW LOOKING AFT.

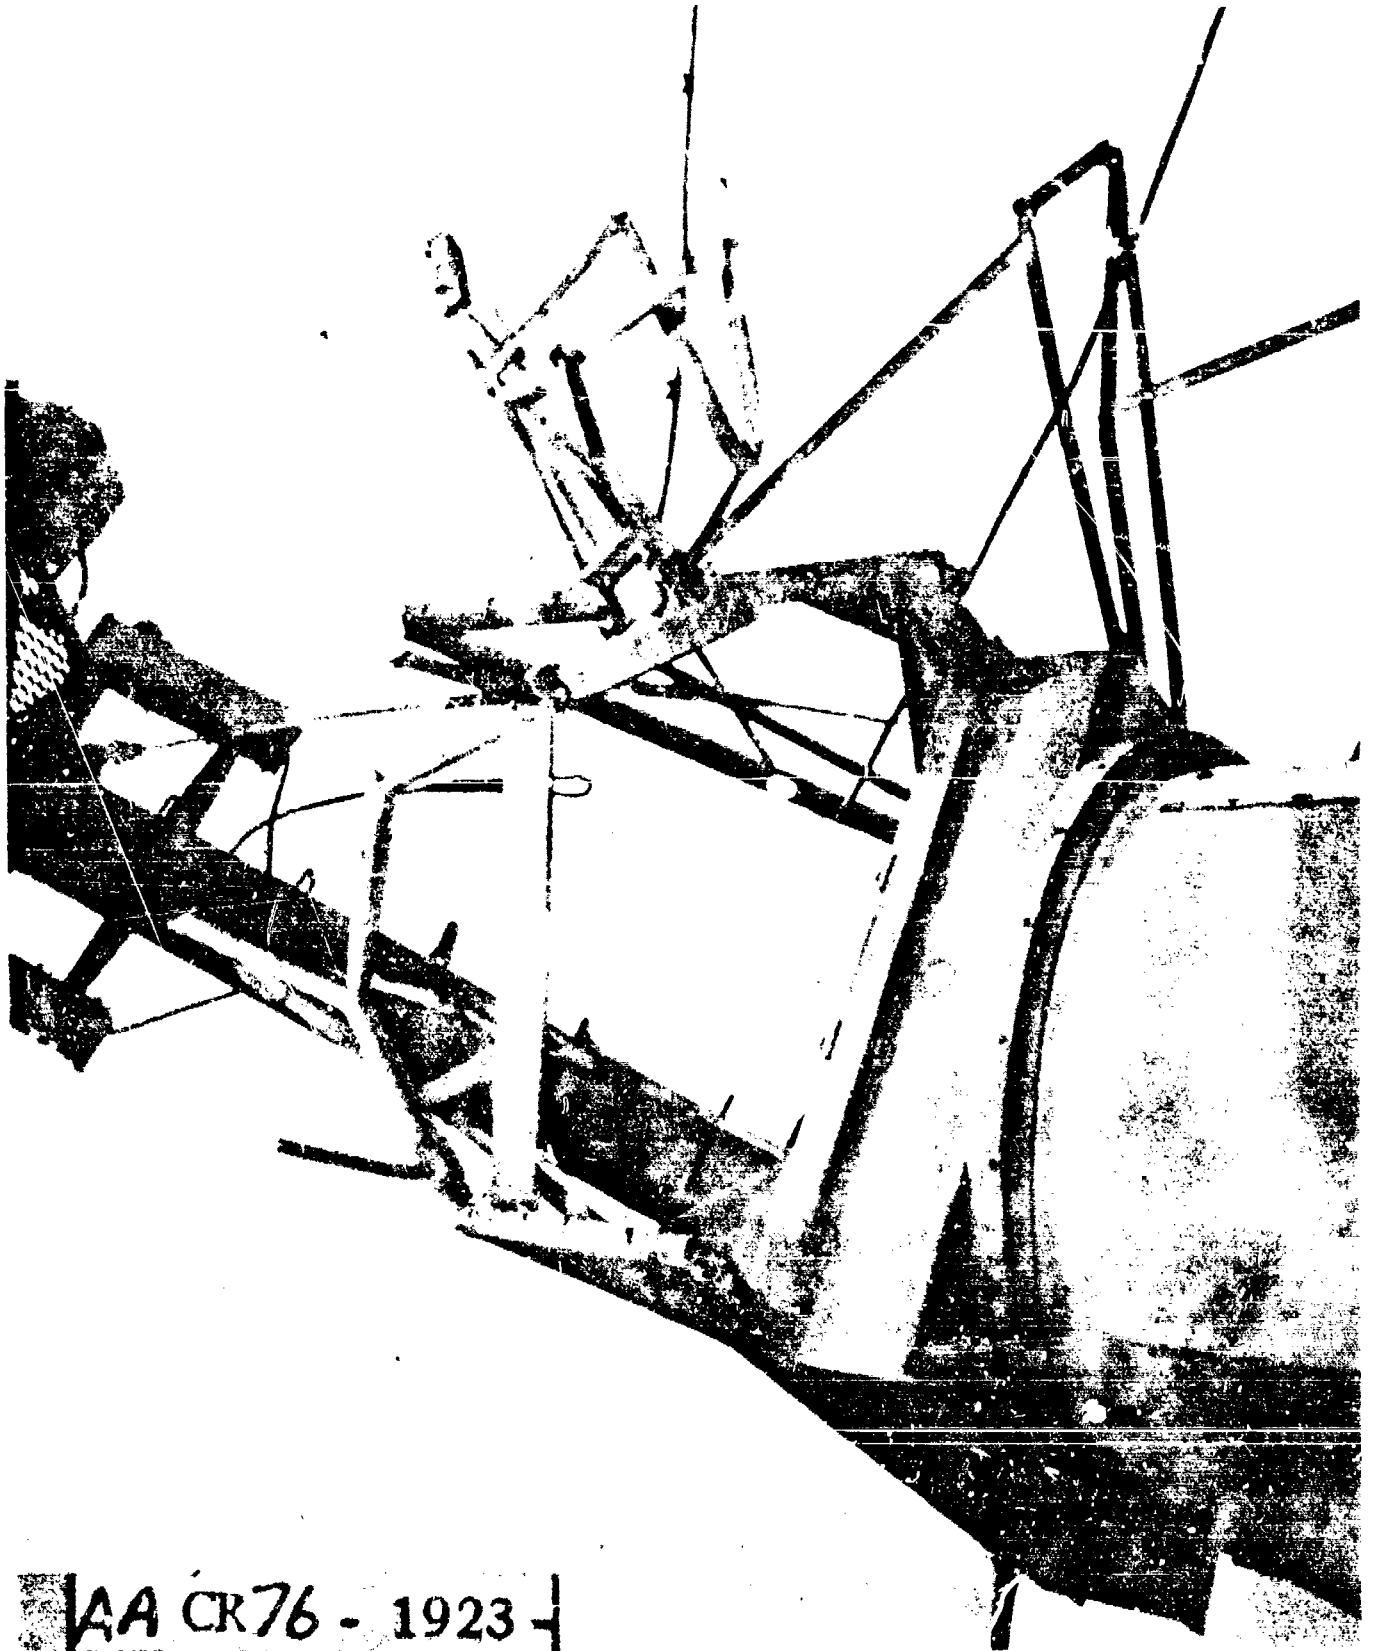
AA CR76 - 1923 -

POST ABLE - SK PEDESTAL. Fragments of antenna remaining.

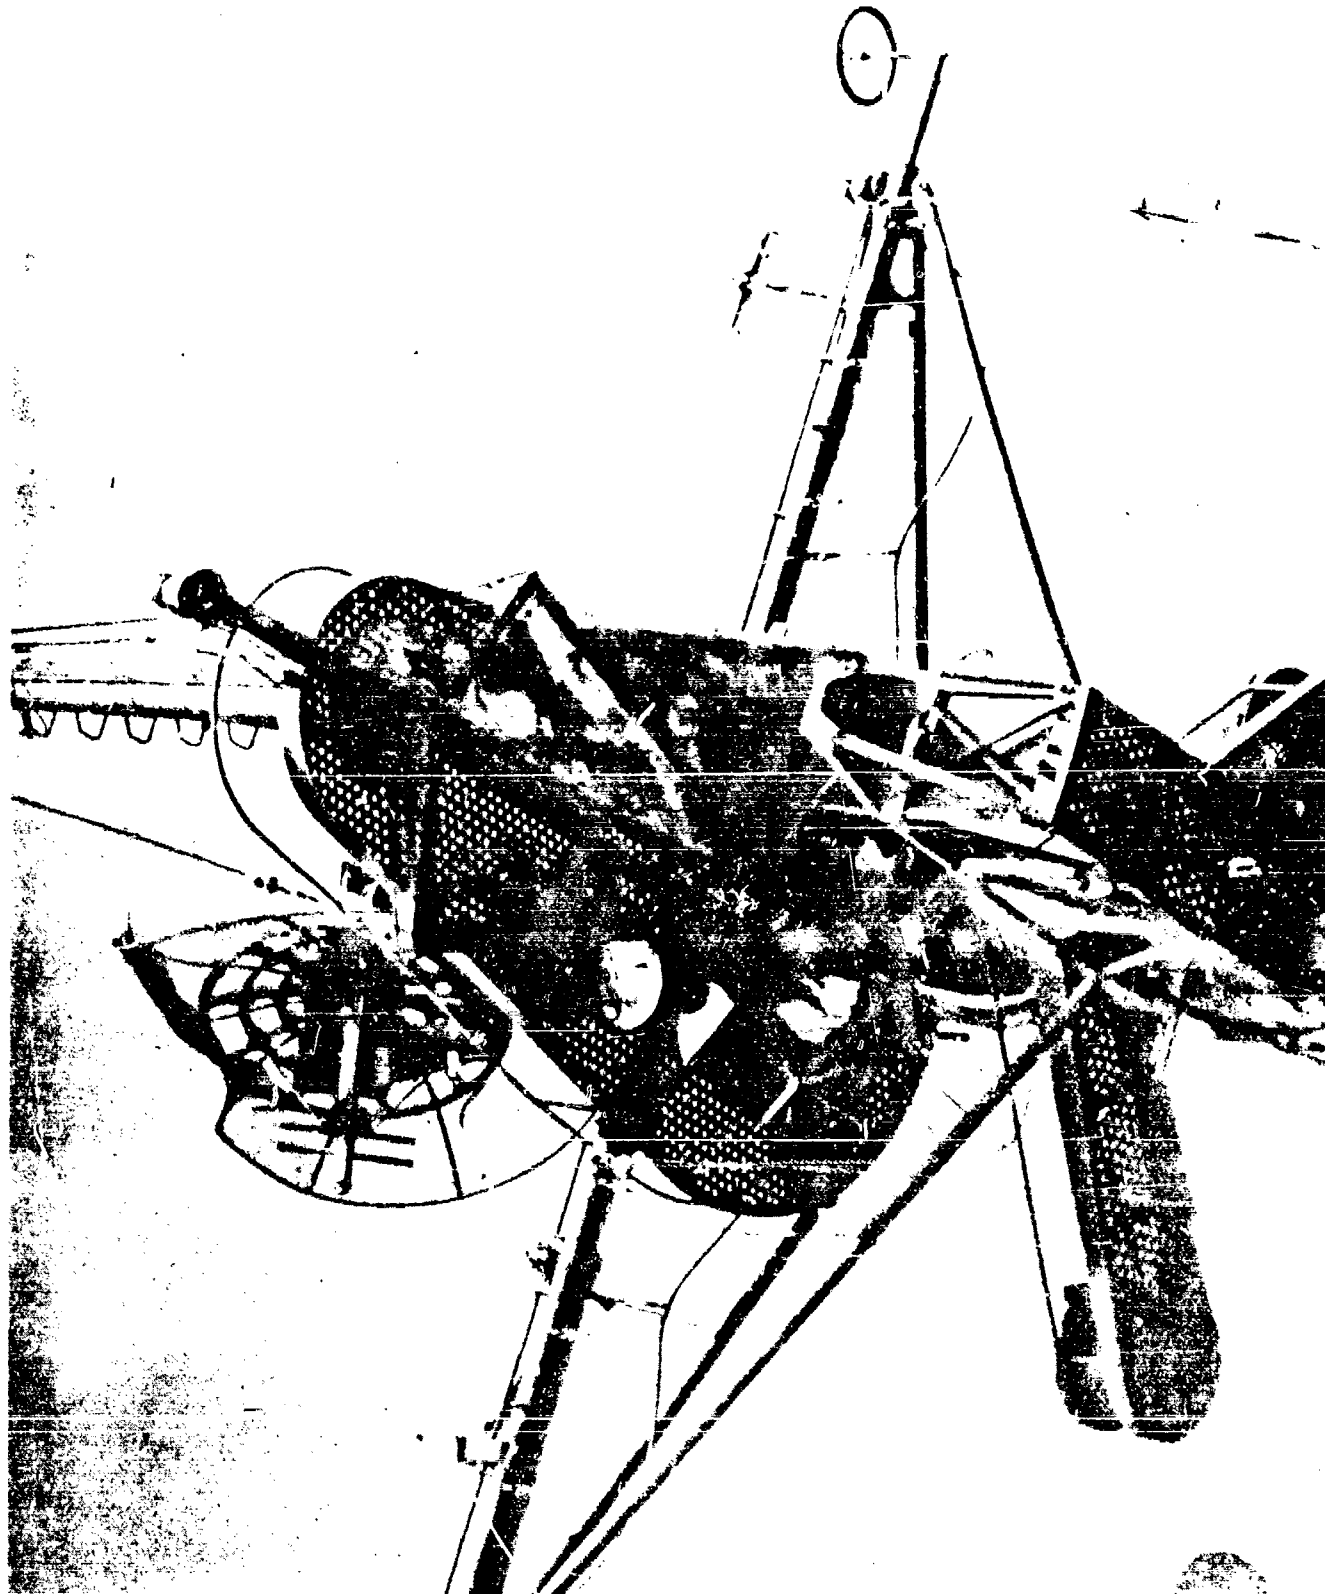
POST ABLE - SP ANTENNA. Echoes were received in spite of damaged condition. Beam pattern was affected, and complete rotation was impossible due to damaged drive assembly in pedestal.

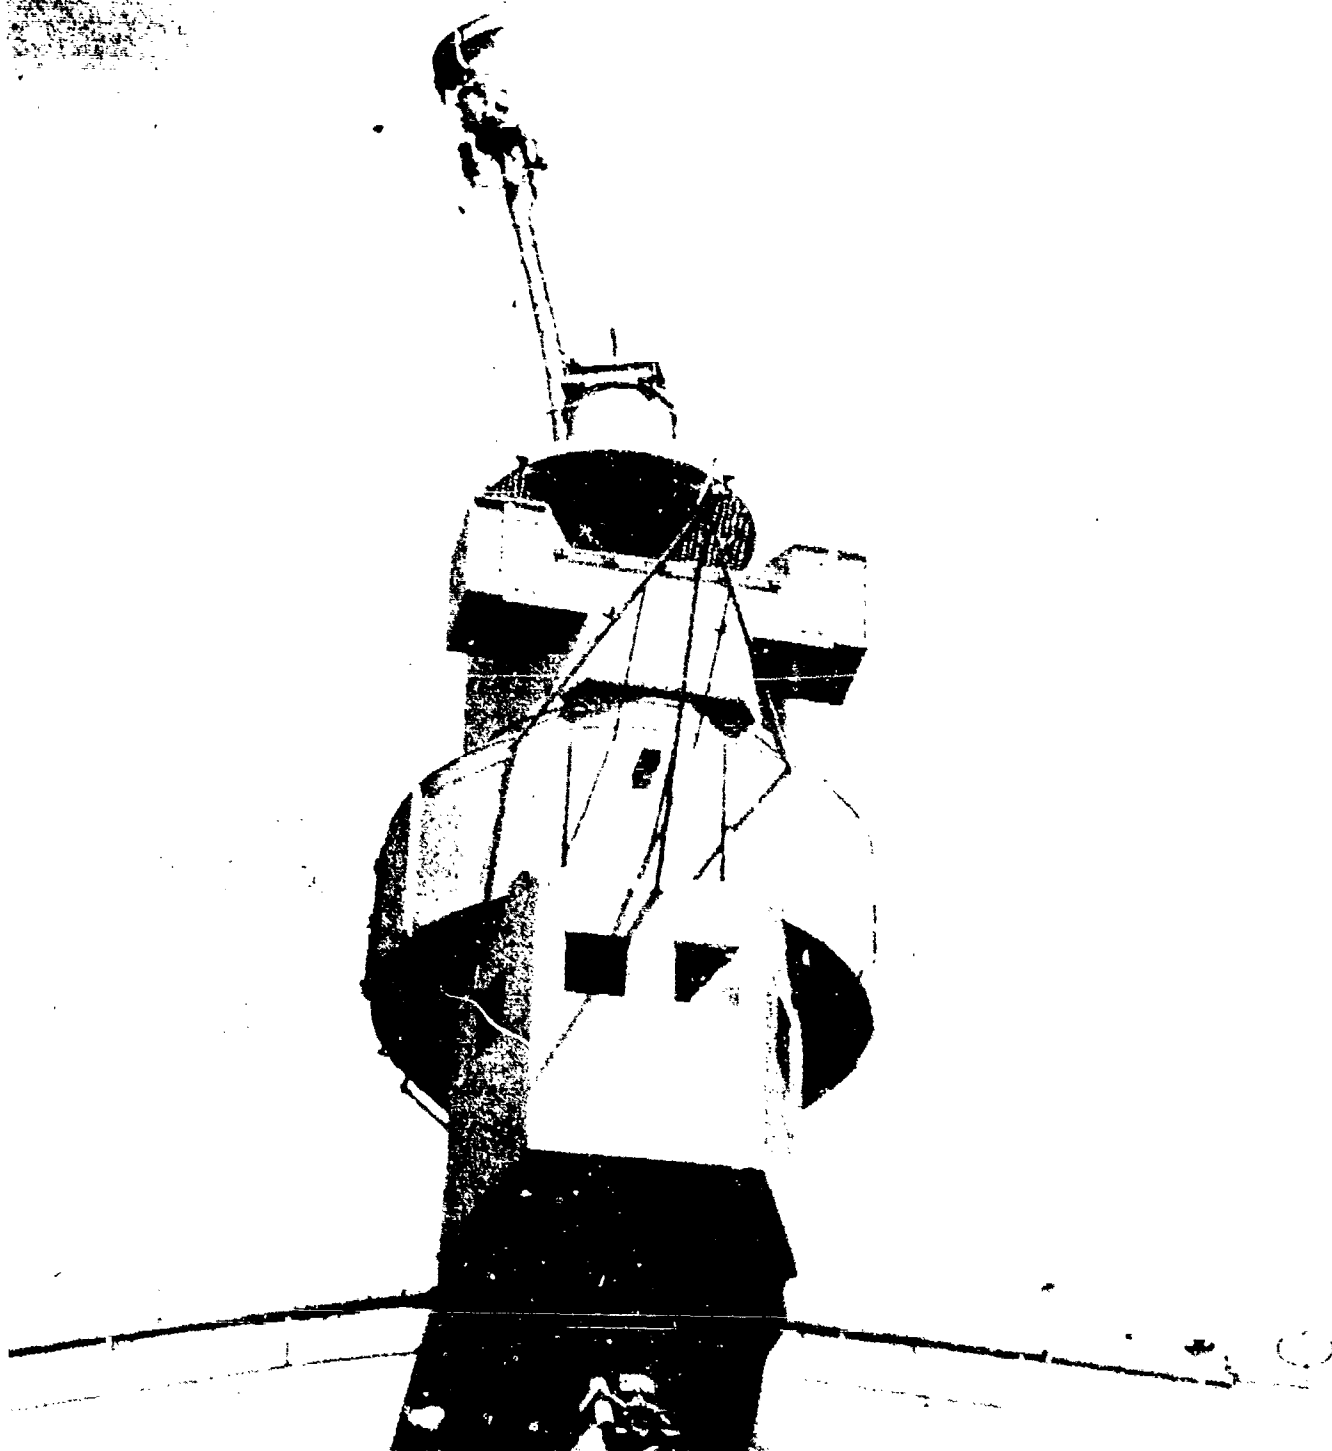
POST ABLE - BENT MAST. The radar at top was still operative, but the bearing and coverage were unsatisfactory.

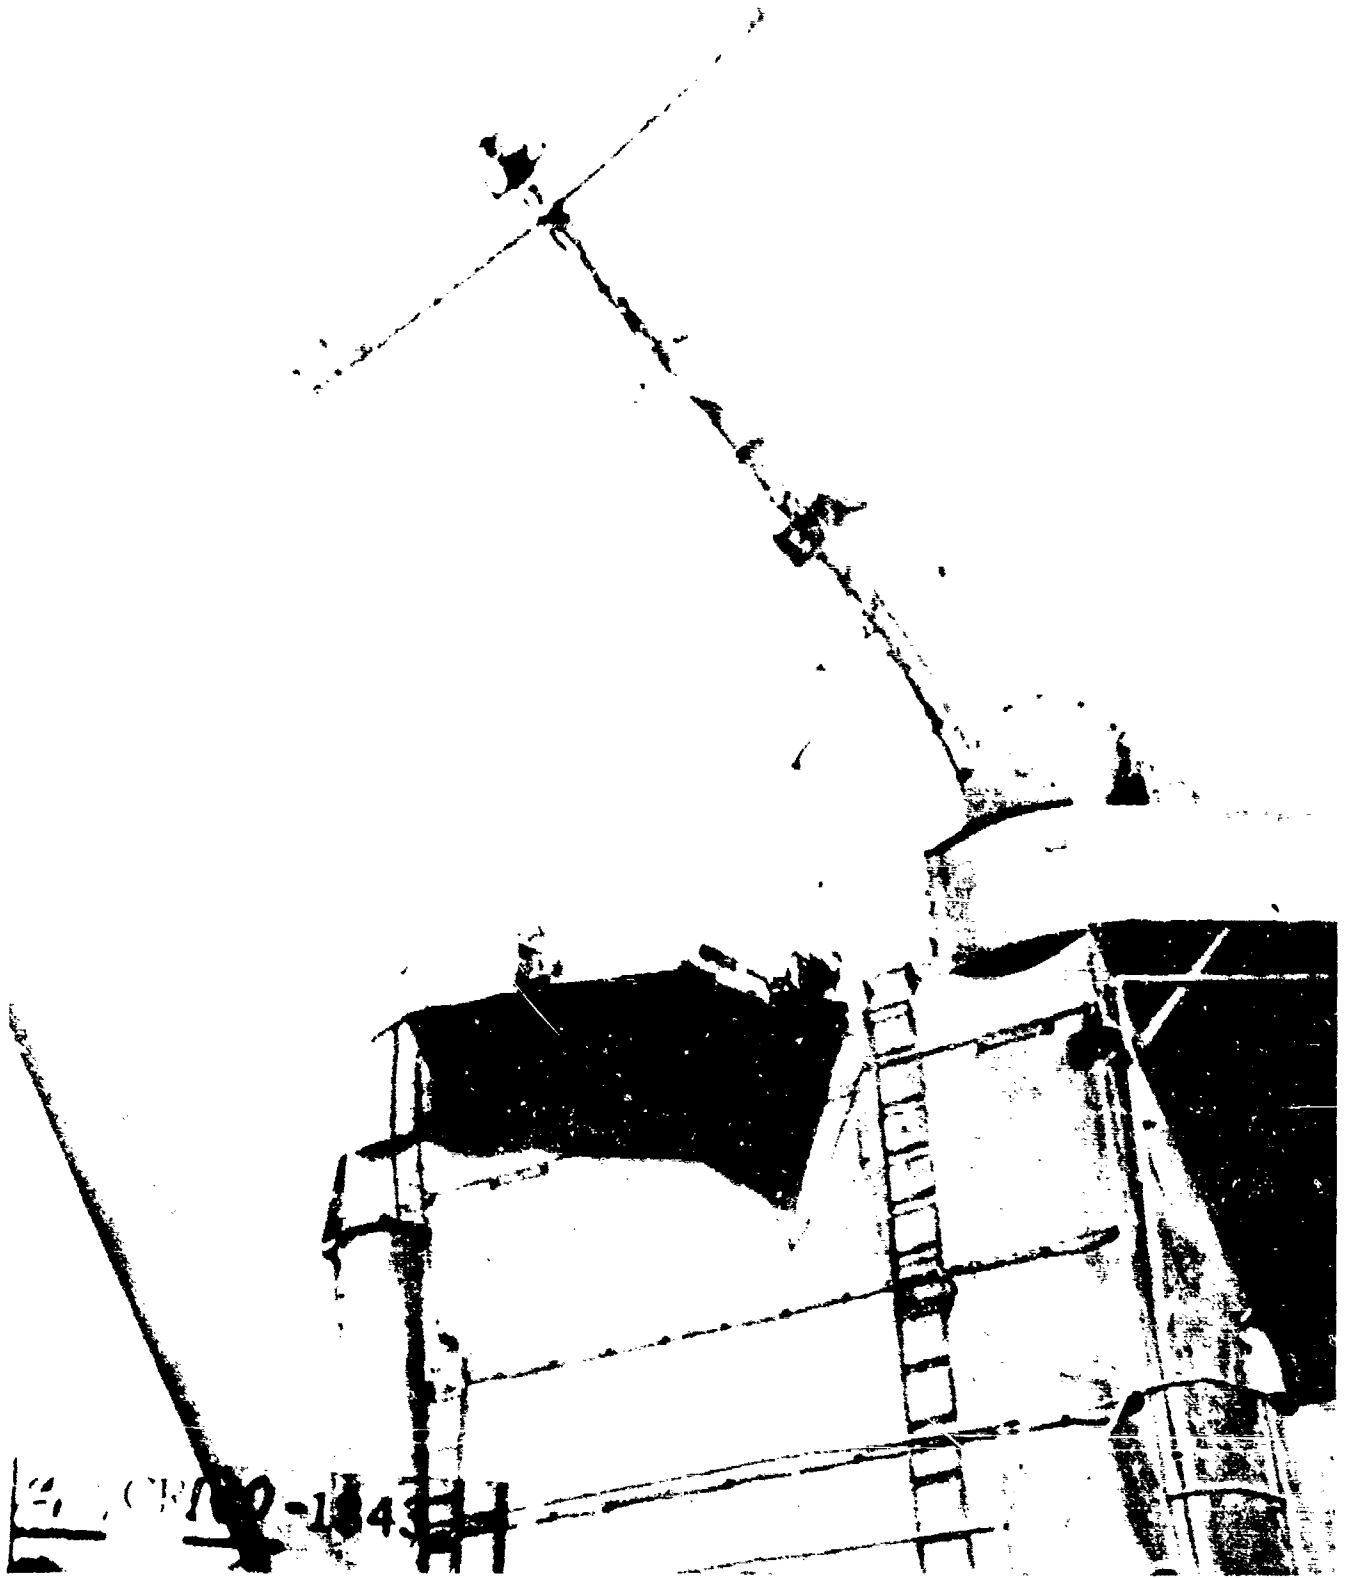
POST ABLE - BENT FOREMAST. Illustrating the manner in which many radio and radar equipments were disabled by loss of antennas.

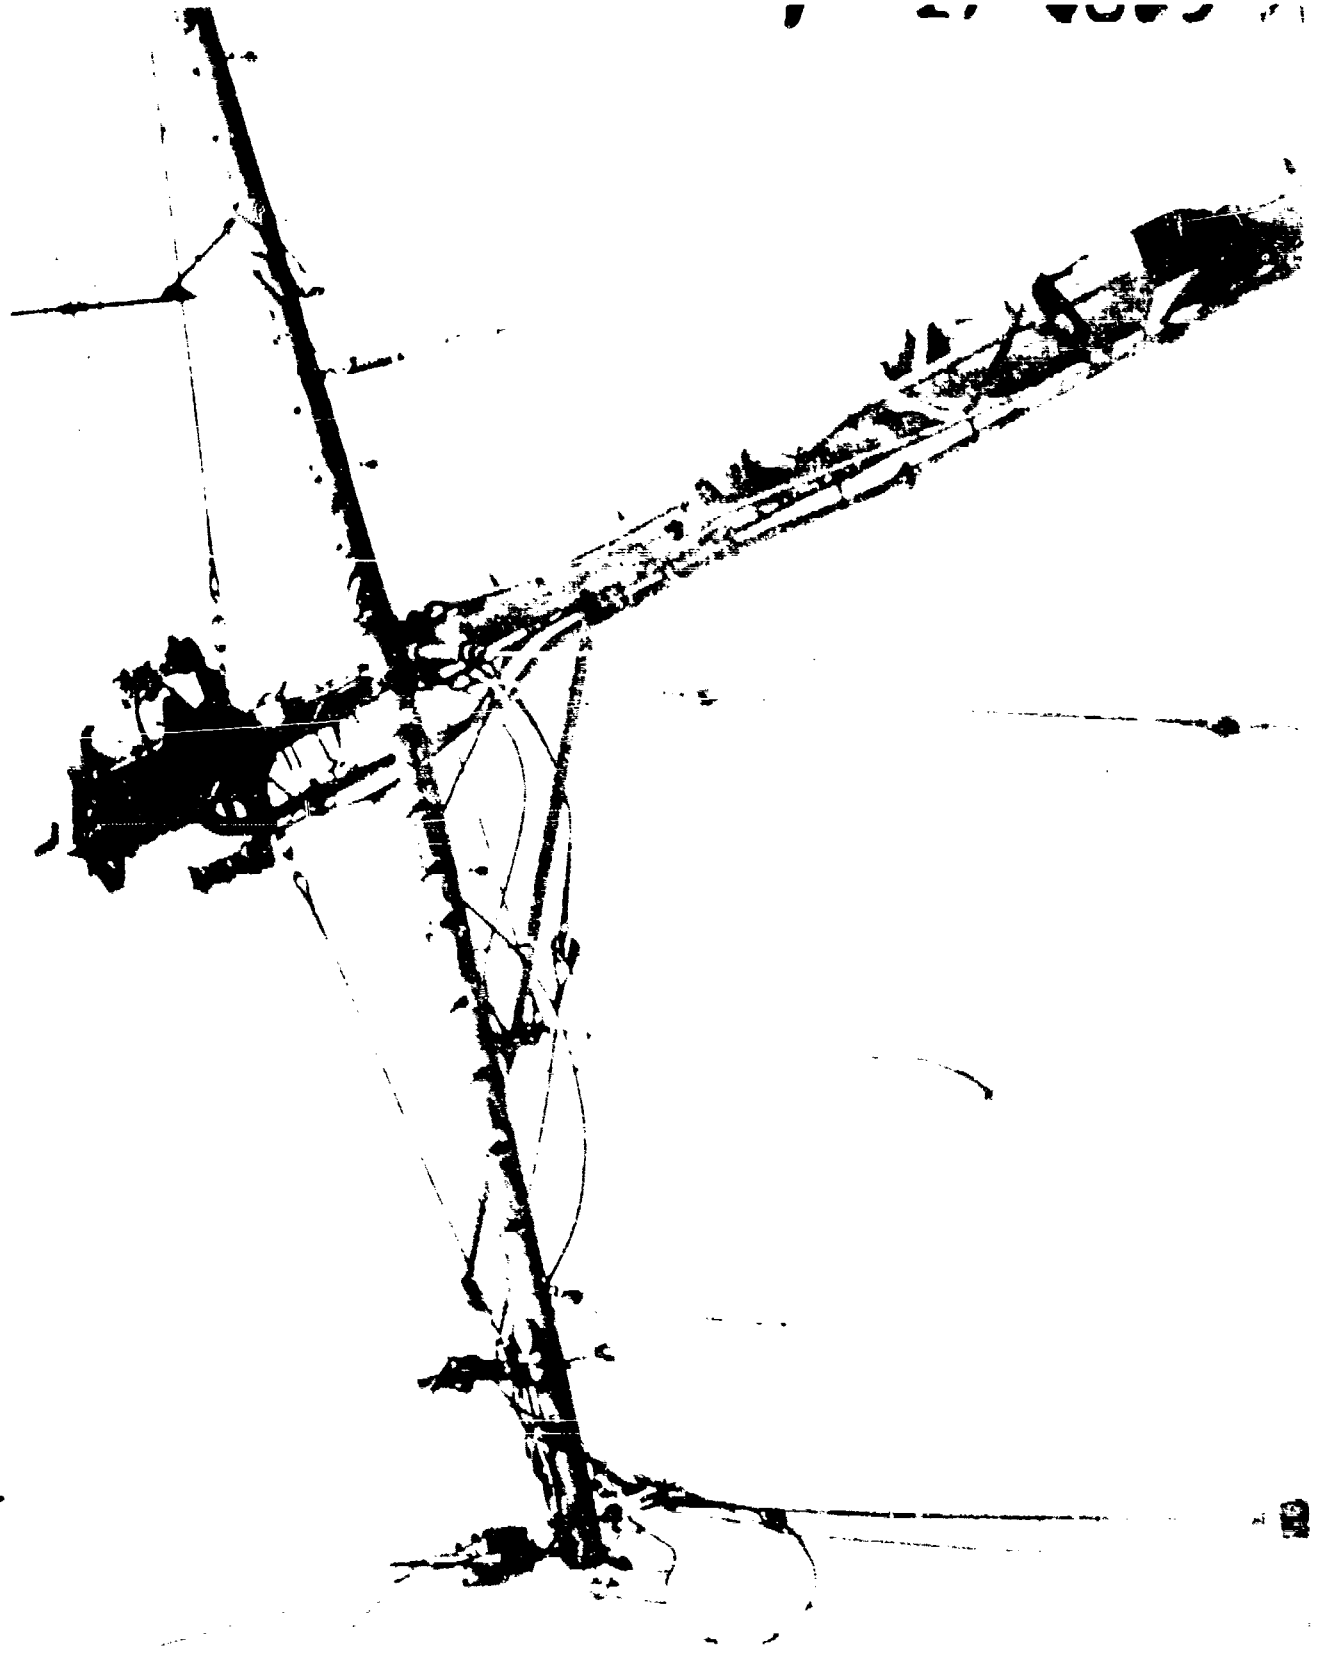
POST ABLE - FOREMAST. Both radio and radar antennas were broken.

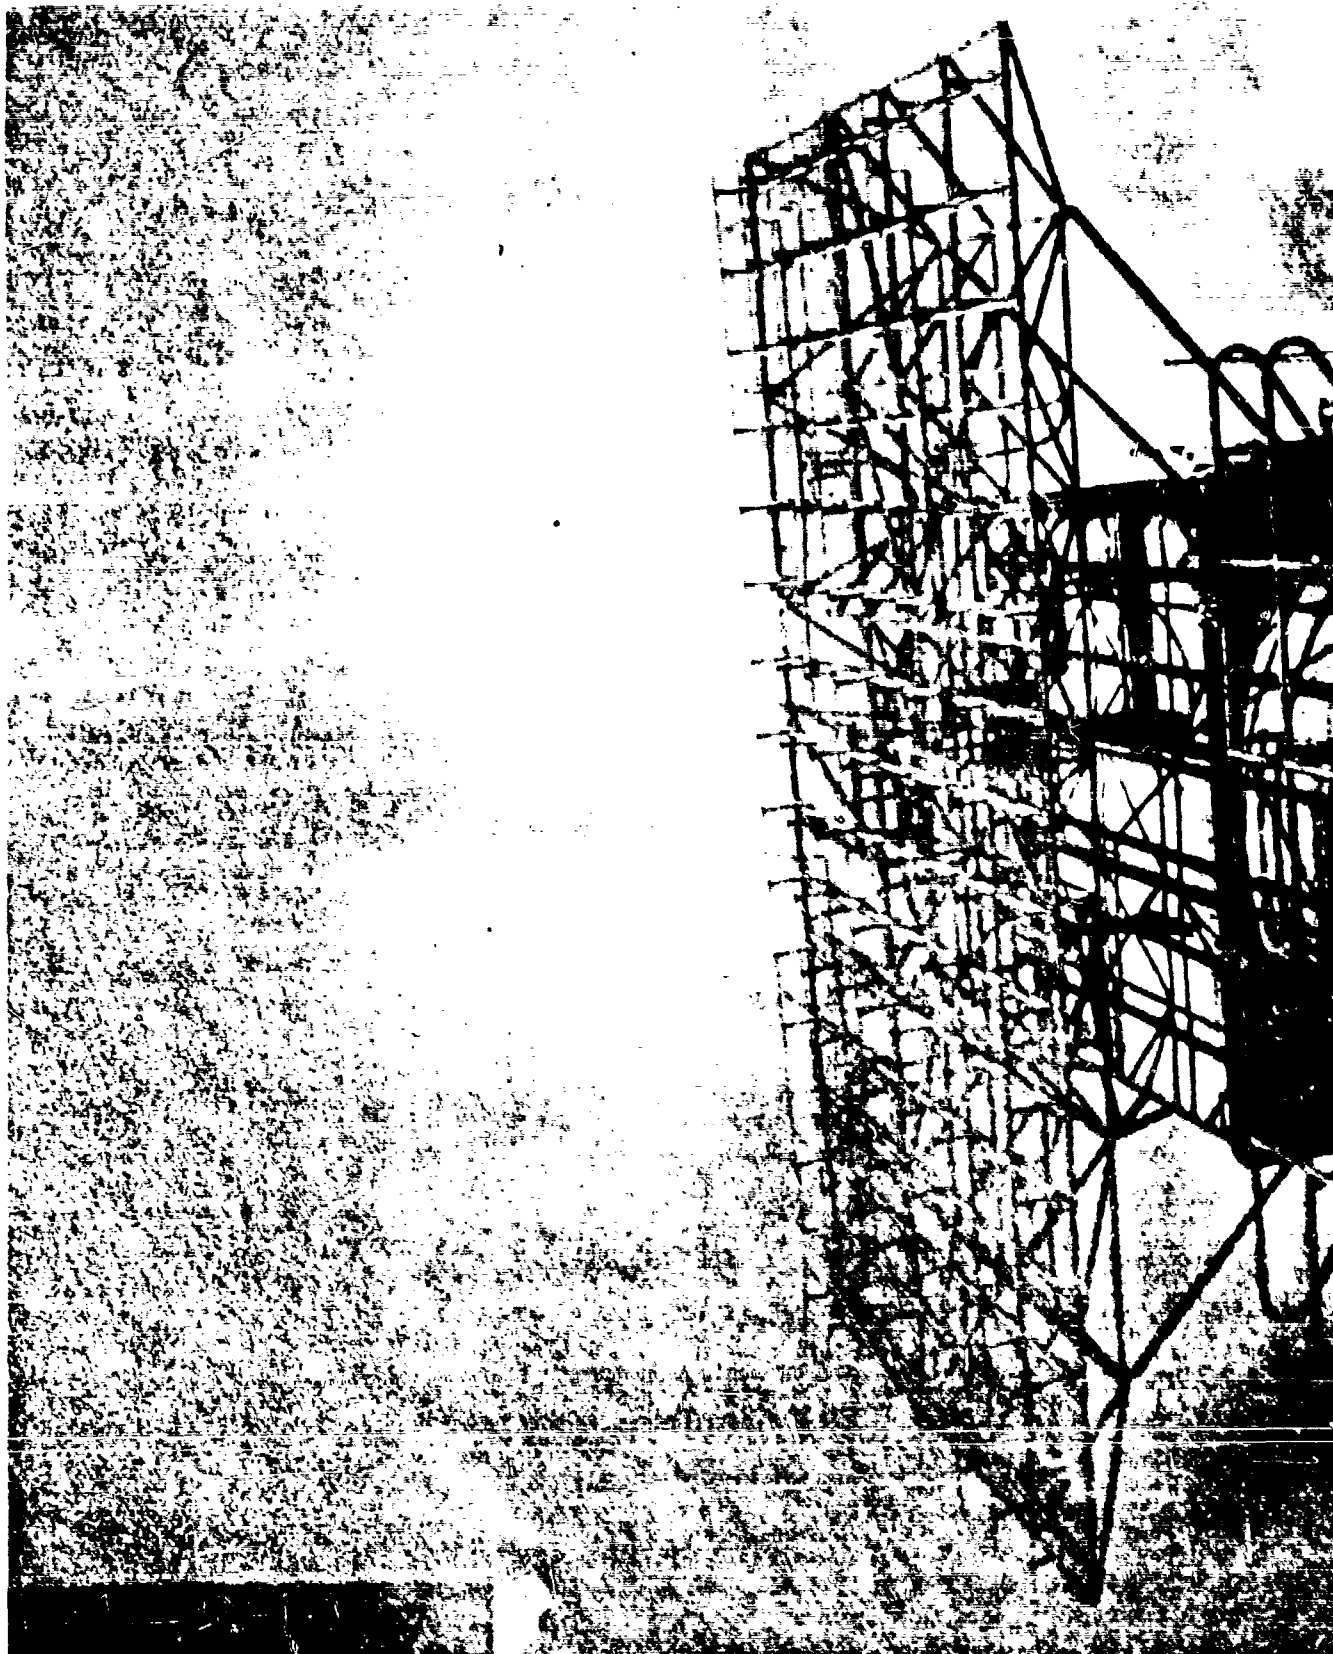
POST ABLE - GERMAN FORWARD FIRE CONTROL RADAR ANTENNA. Close up
of German Fumo Mod 26 Fire Control Radar Antenna. A few dipoles
were bent but not enough to prevent operation.

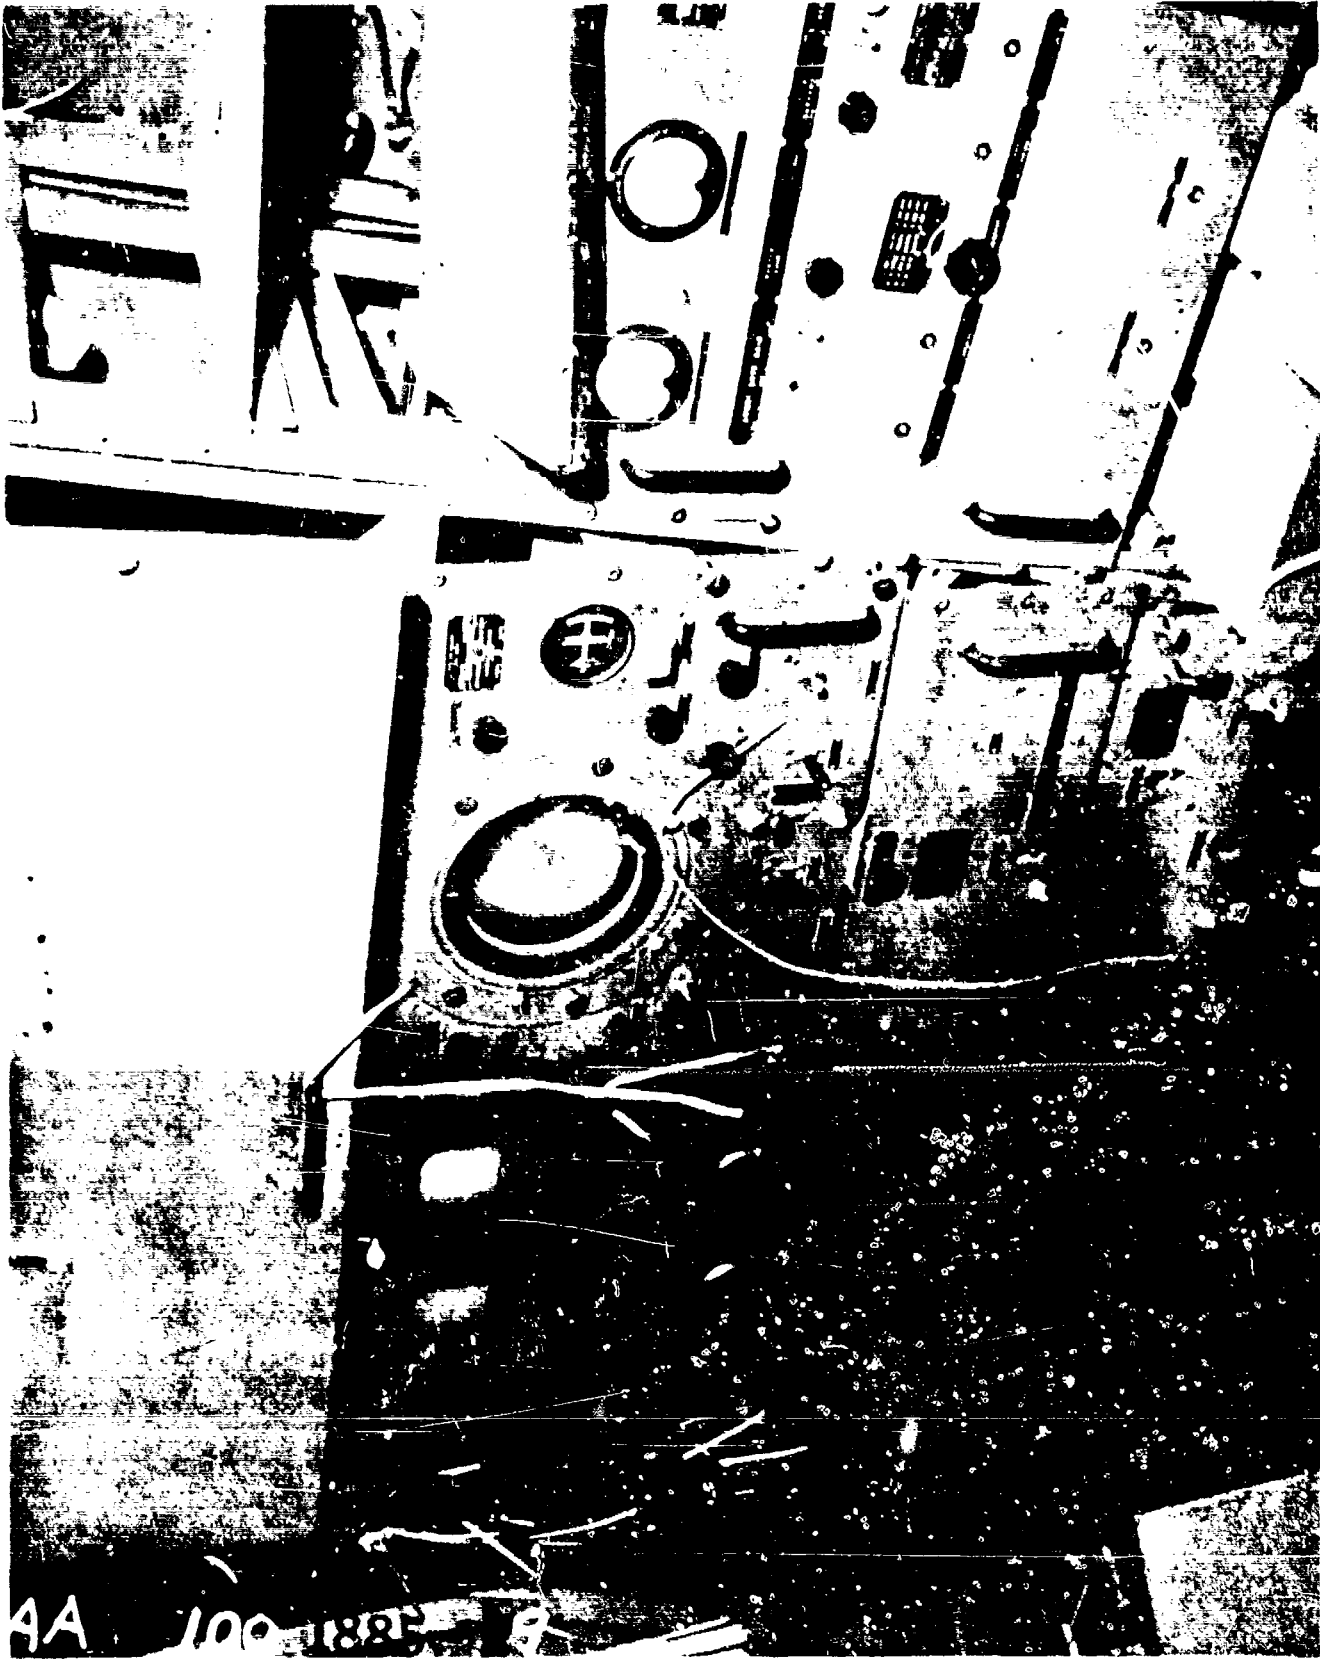
POST ABLE - SPARE SM CONSOLE. Close up of distorted frame and jammed shelves.

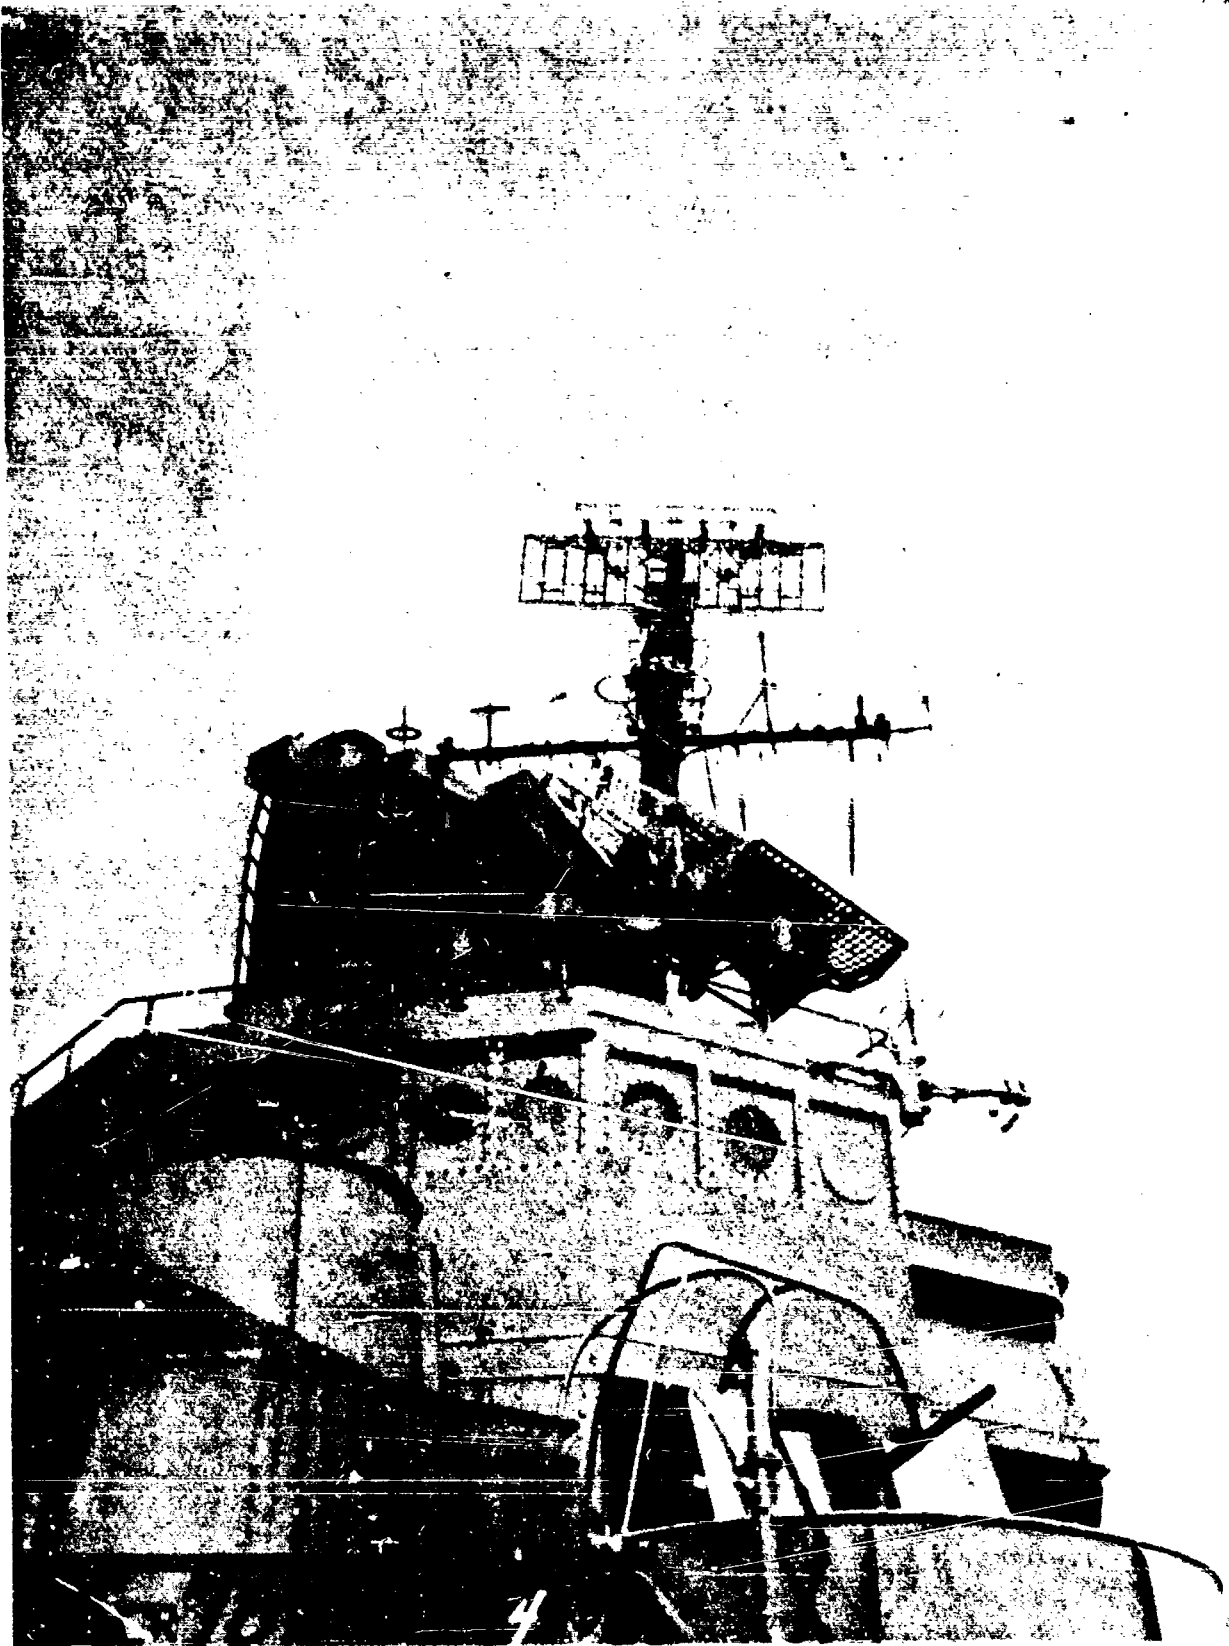
POST ABLE - FOREMAST AND MAIN BATTERY DIRECTOR. Neither the SC or MK 4 radar antenna was materially damaged.
