ELECTRONICS COORDINATING OF
SHIP PREPARATION
and
TARGET INSPECTION

FINAL REPORT
TESTS ABLE AND BAKER

✓ **VOLUME 2**
PHOTOGRAPHIC RECORD

DIRECTOR OF SHIP MATERIAL
JOINT TASK FORCE ONE
OPERATION CROSSROADS

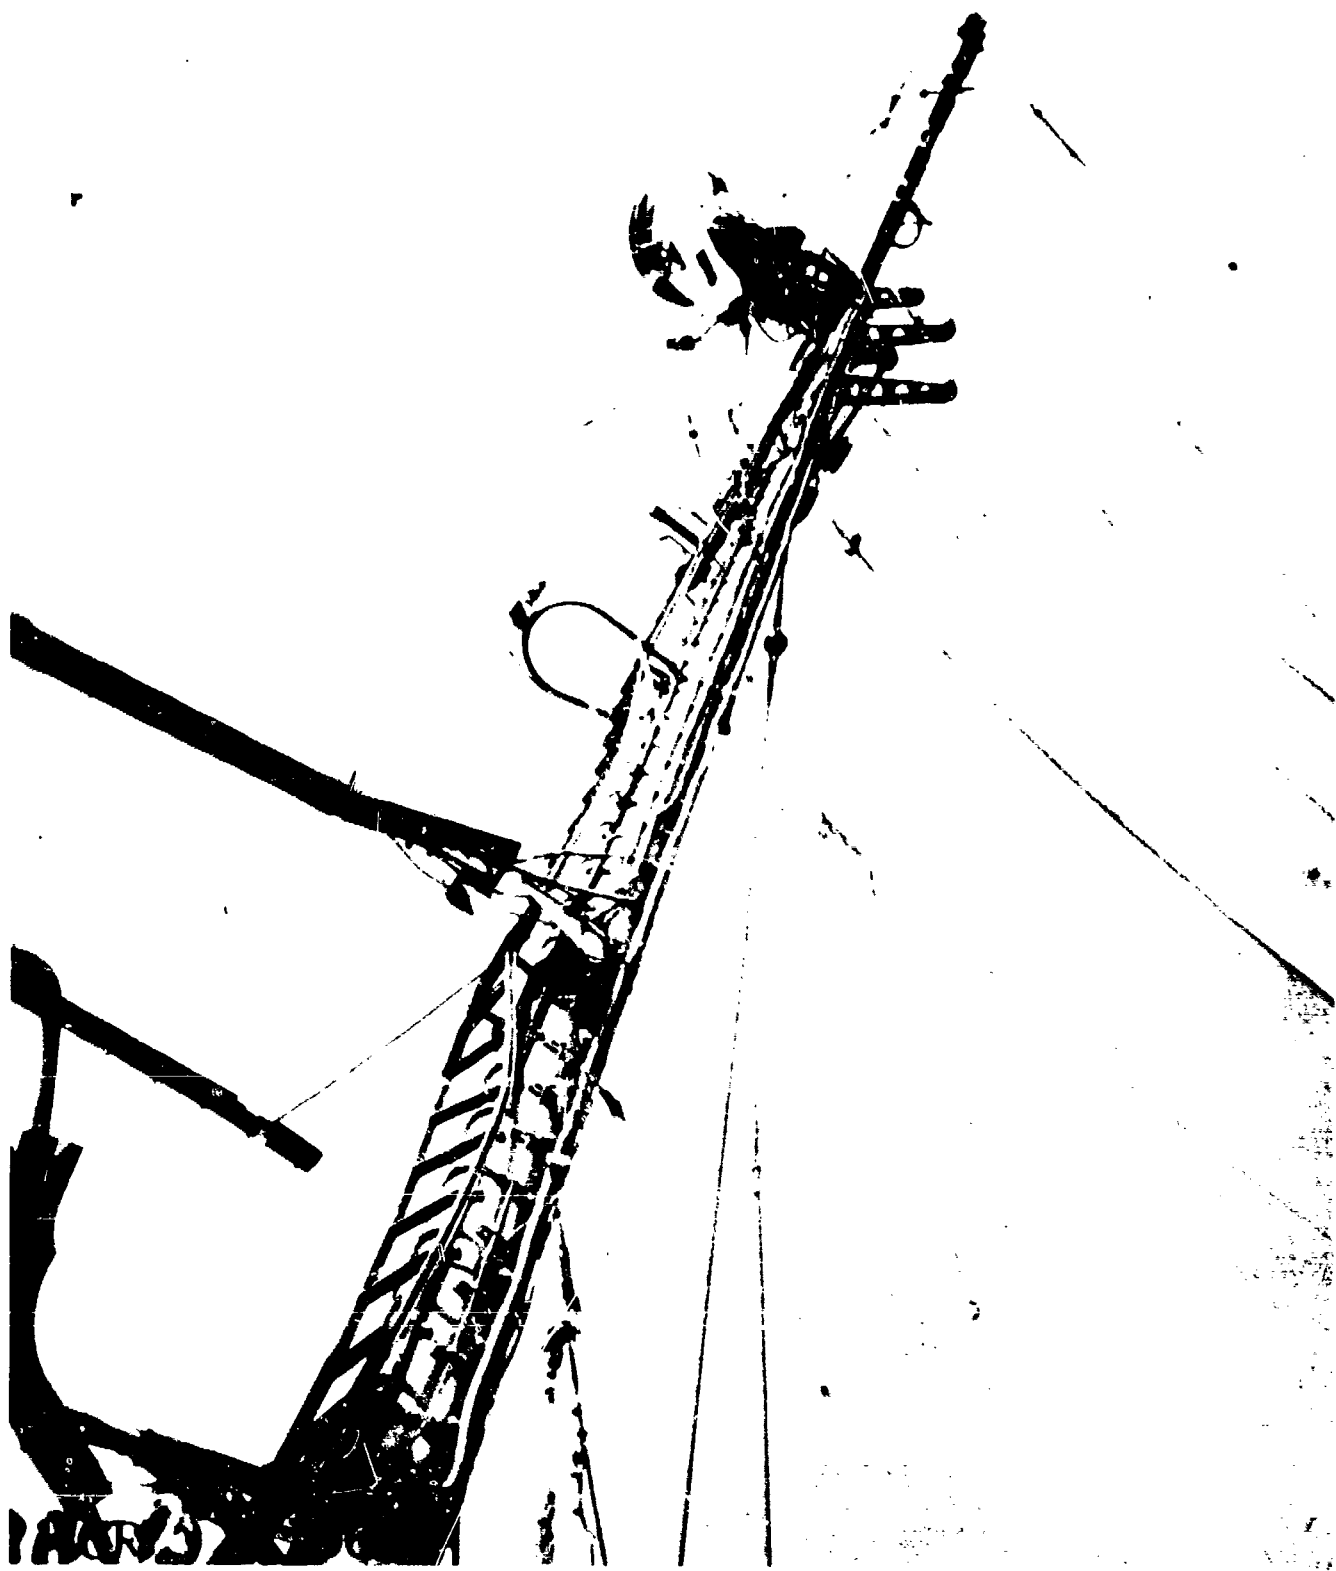
POST ABLE - MAST. View from below the crossarm shows how the mast bent aft at its base and tore away from its bracing. The top section bent forward about 60° & the crossarm, leaving the SG antenna about 40° off normal position.

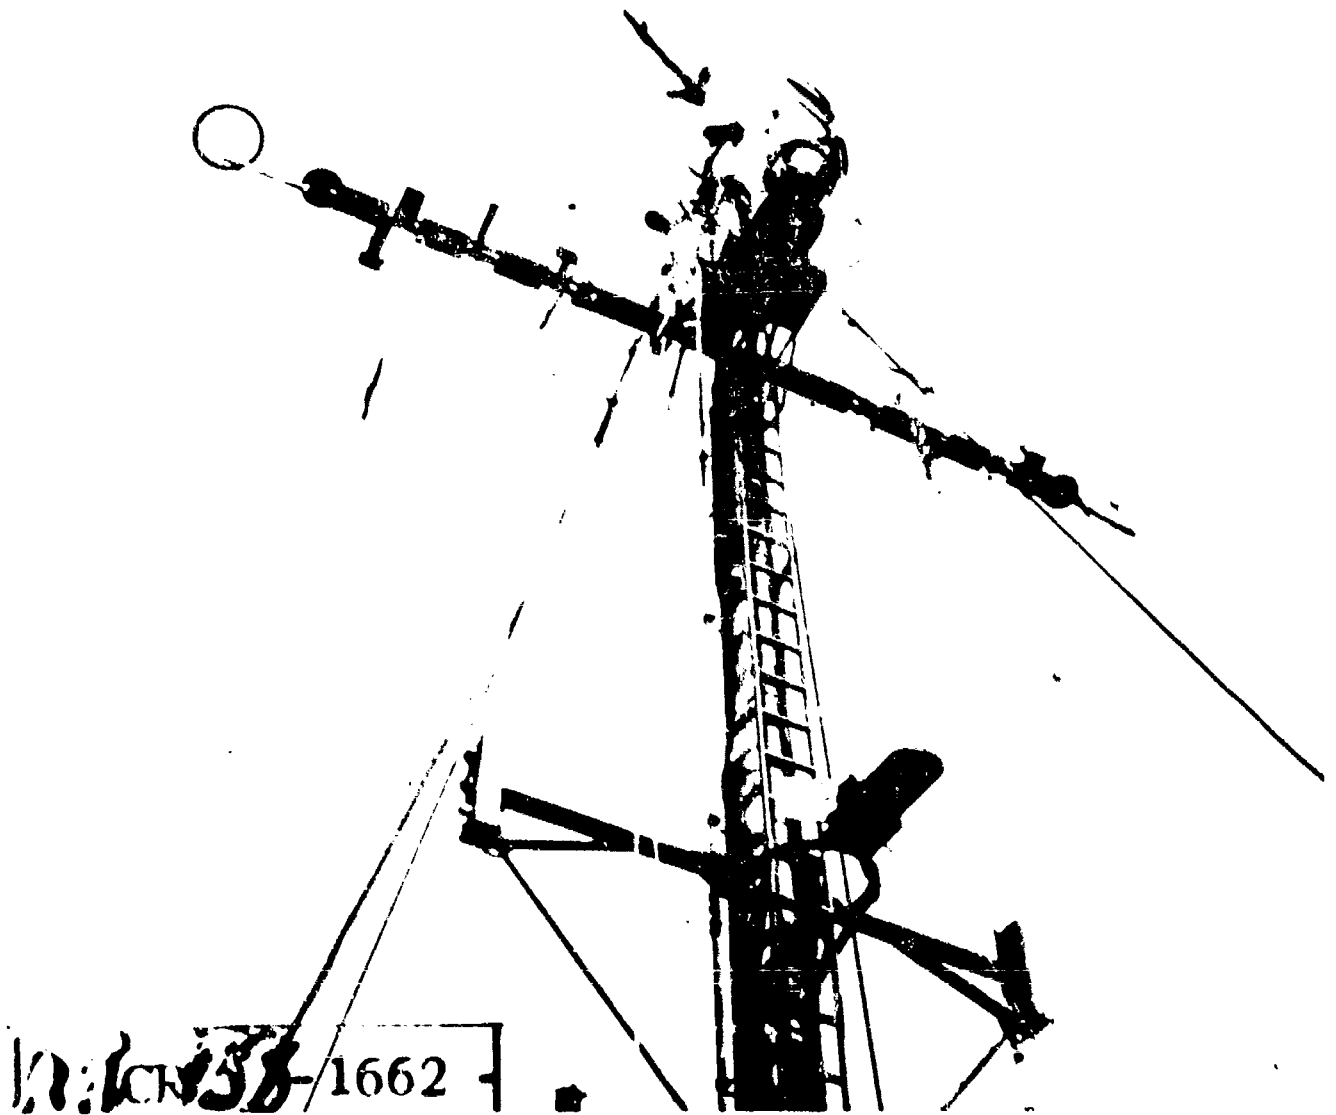
POST ABLE - MAINMAST. SO-2 antenna was swept away from the top of its pedestal (arrow). The pedestal was left intact. The SG antenna and various other antennas on the yardarm were left intact.

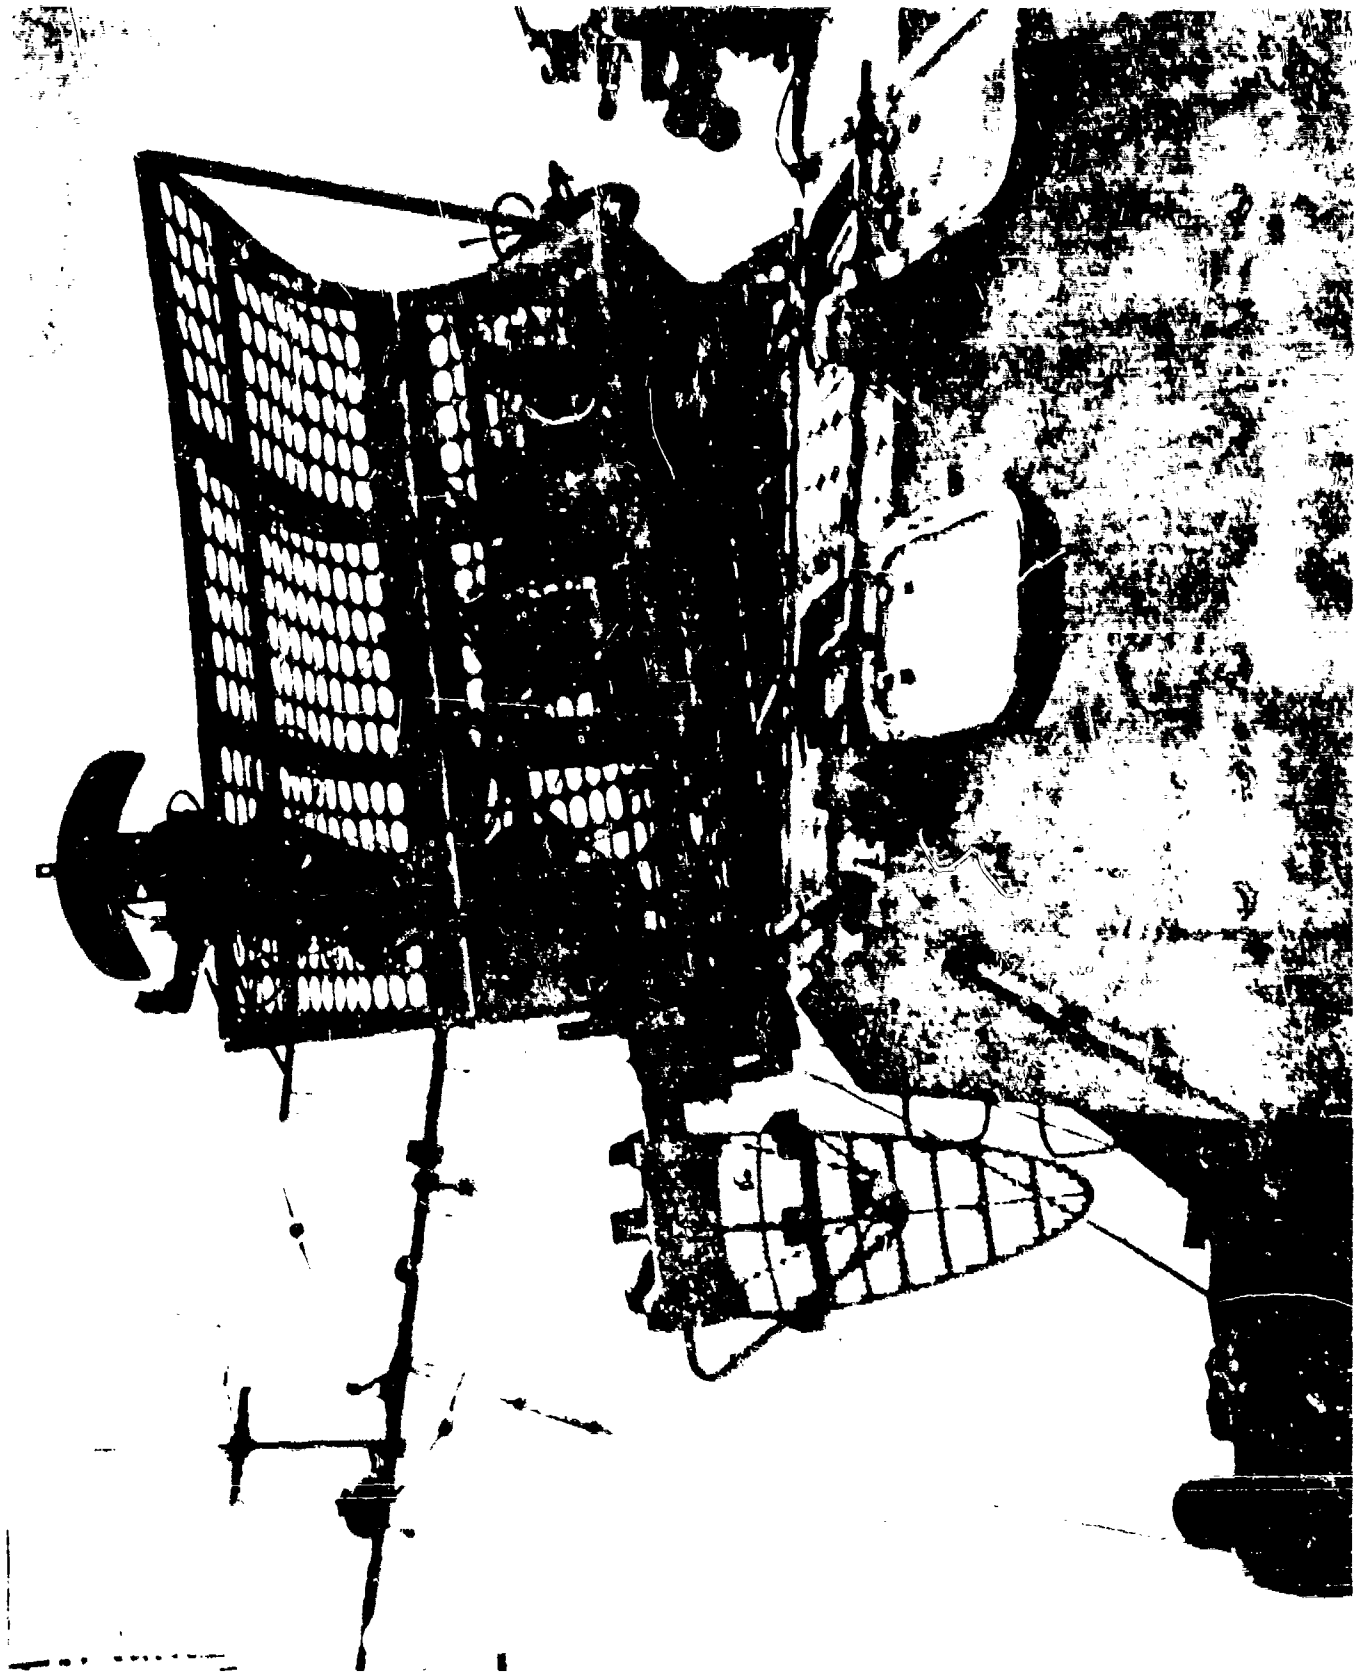
POST ABLE - MK 12 AND MK 22 RADAR ANTENNA. Closeup view.

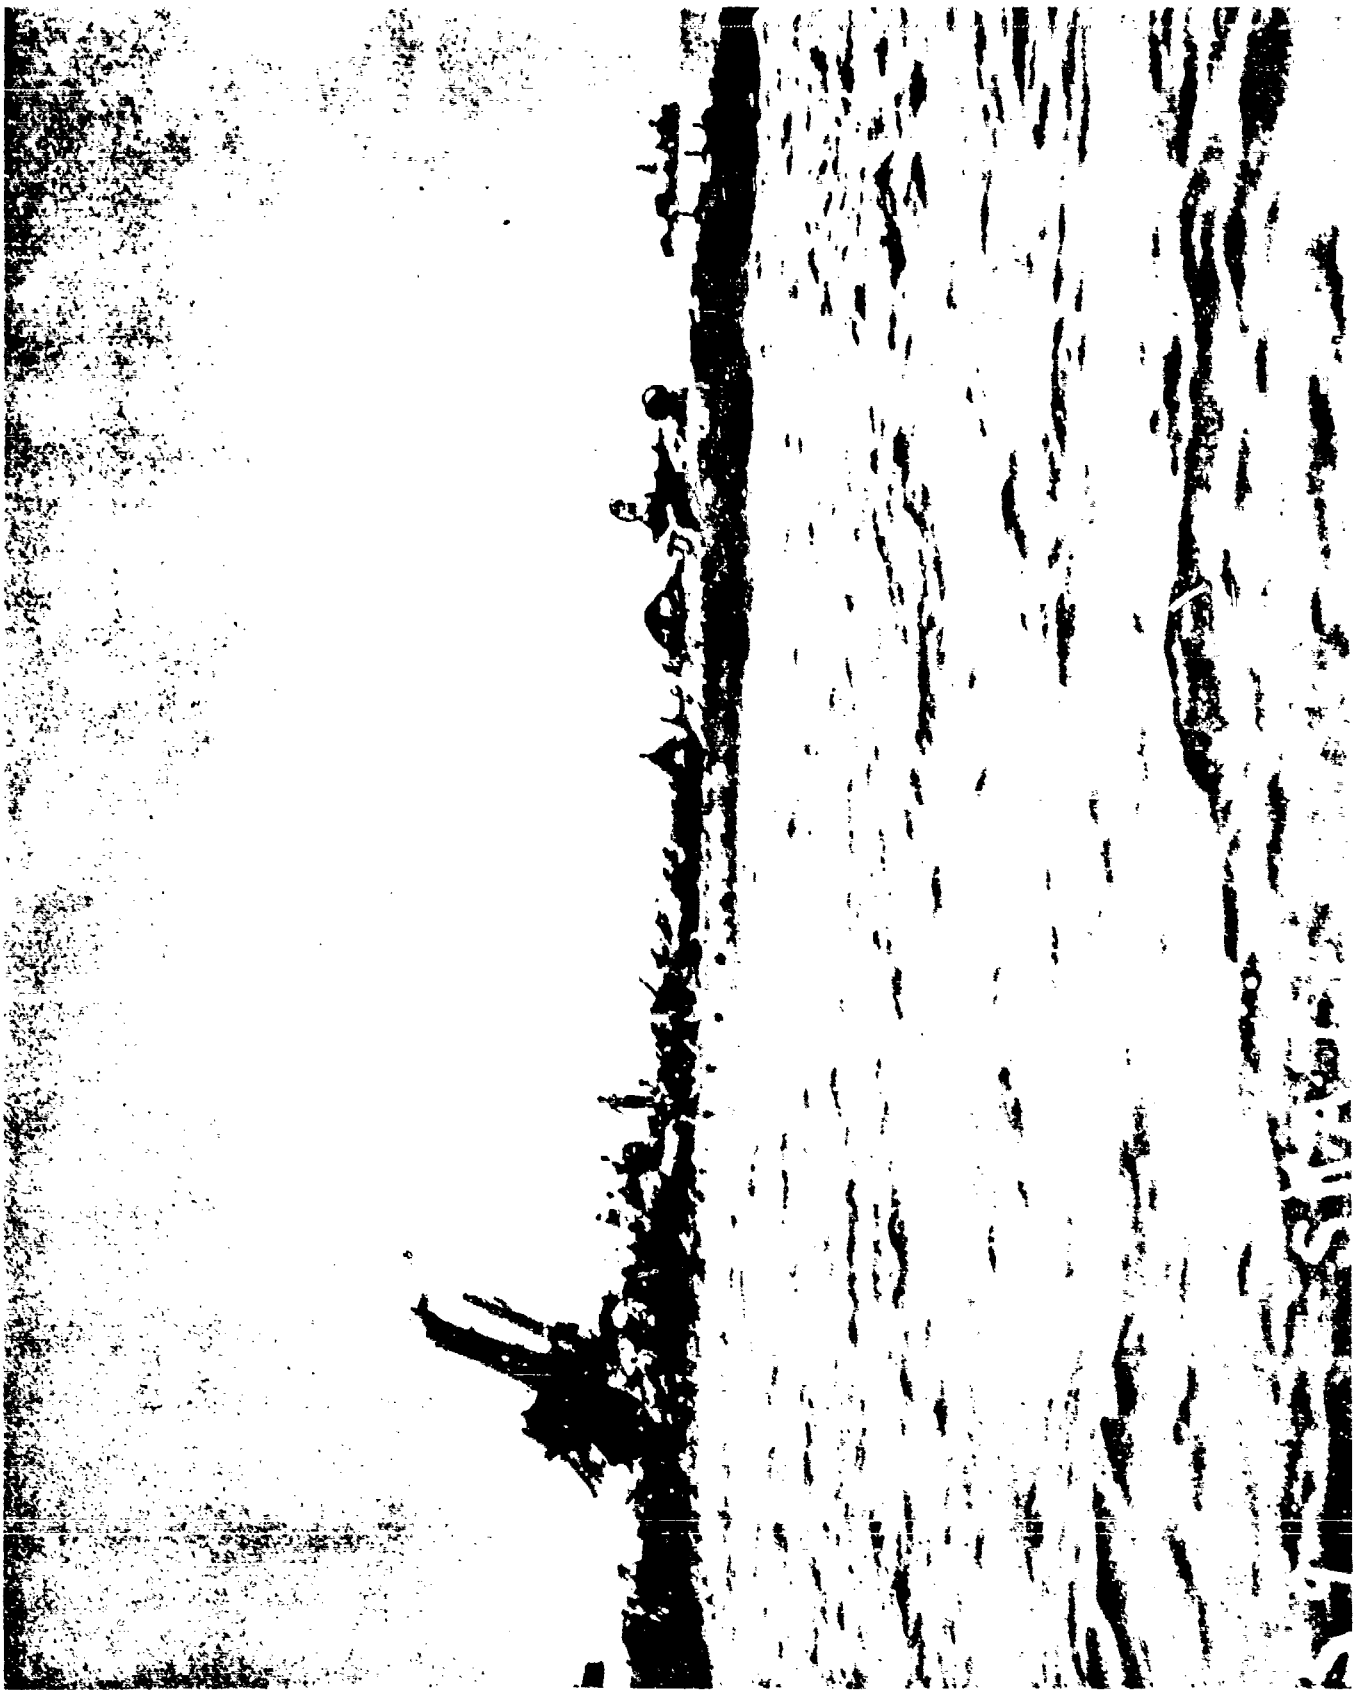
POST ABLE - PORT SIDE. Showing general broadside view.

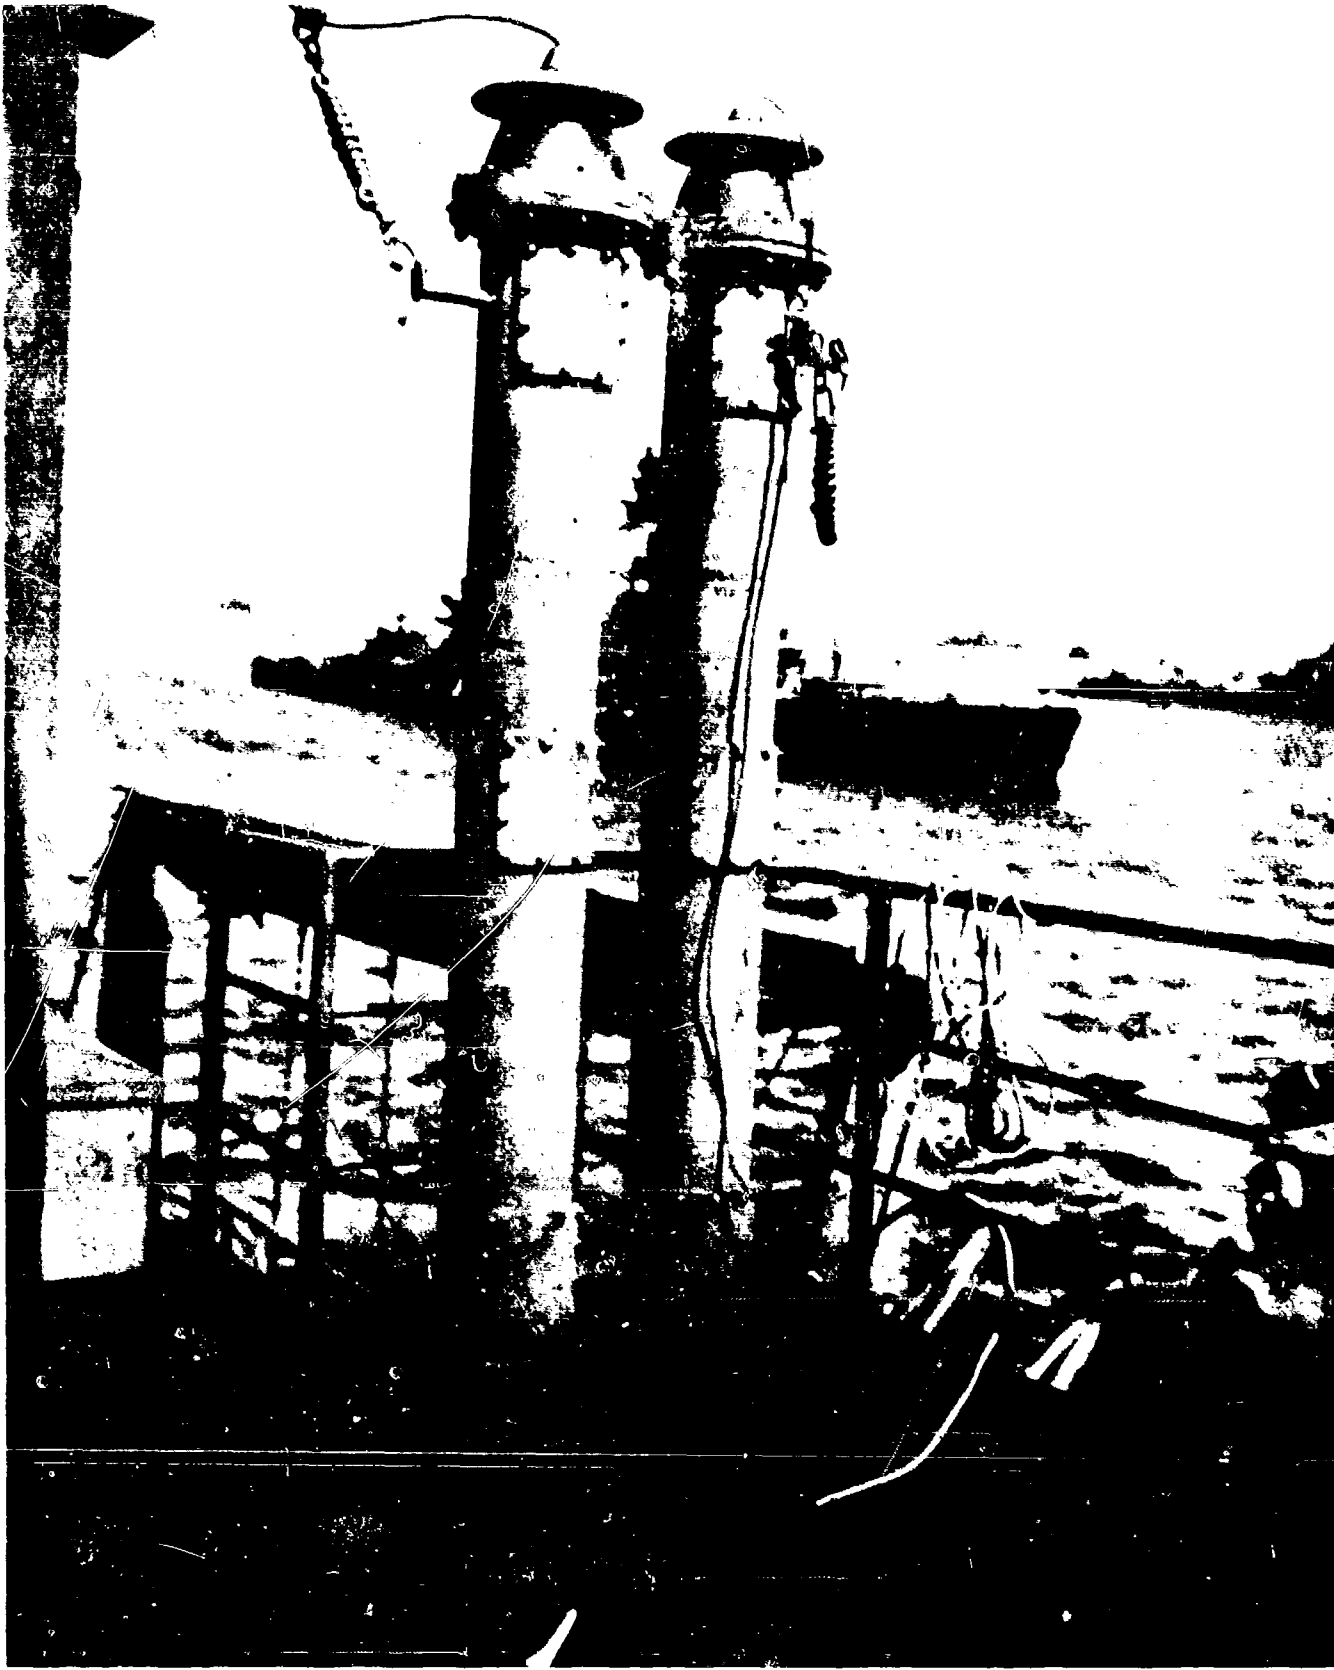
POST ABLE - ANTENNA TRUNKS. Outboard antenna blown down.

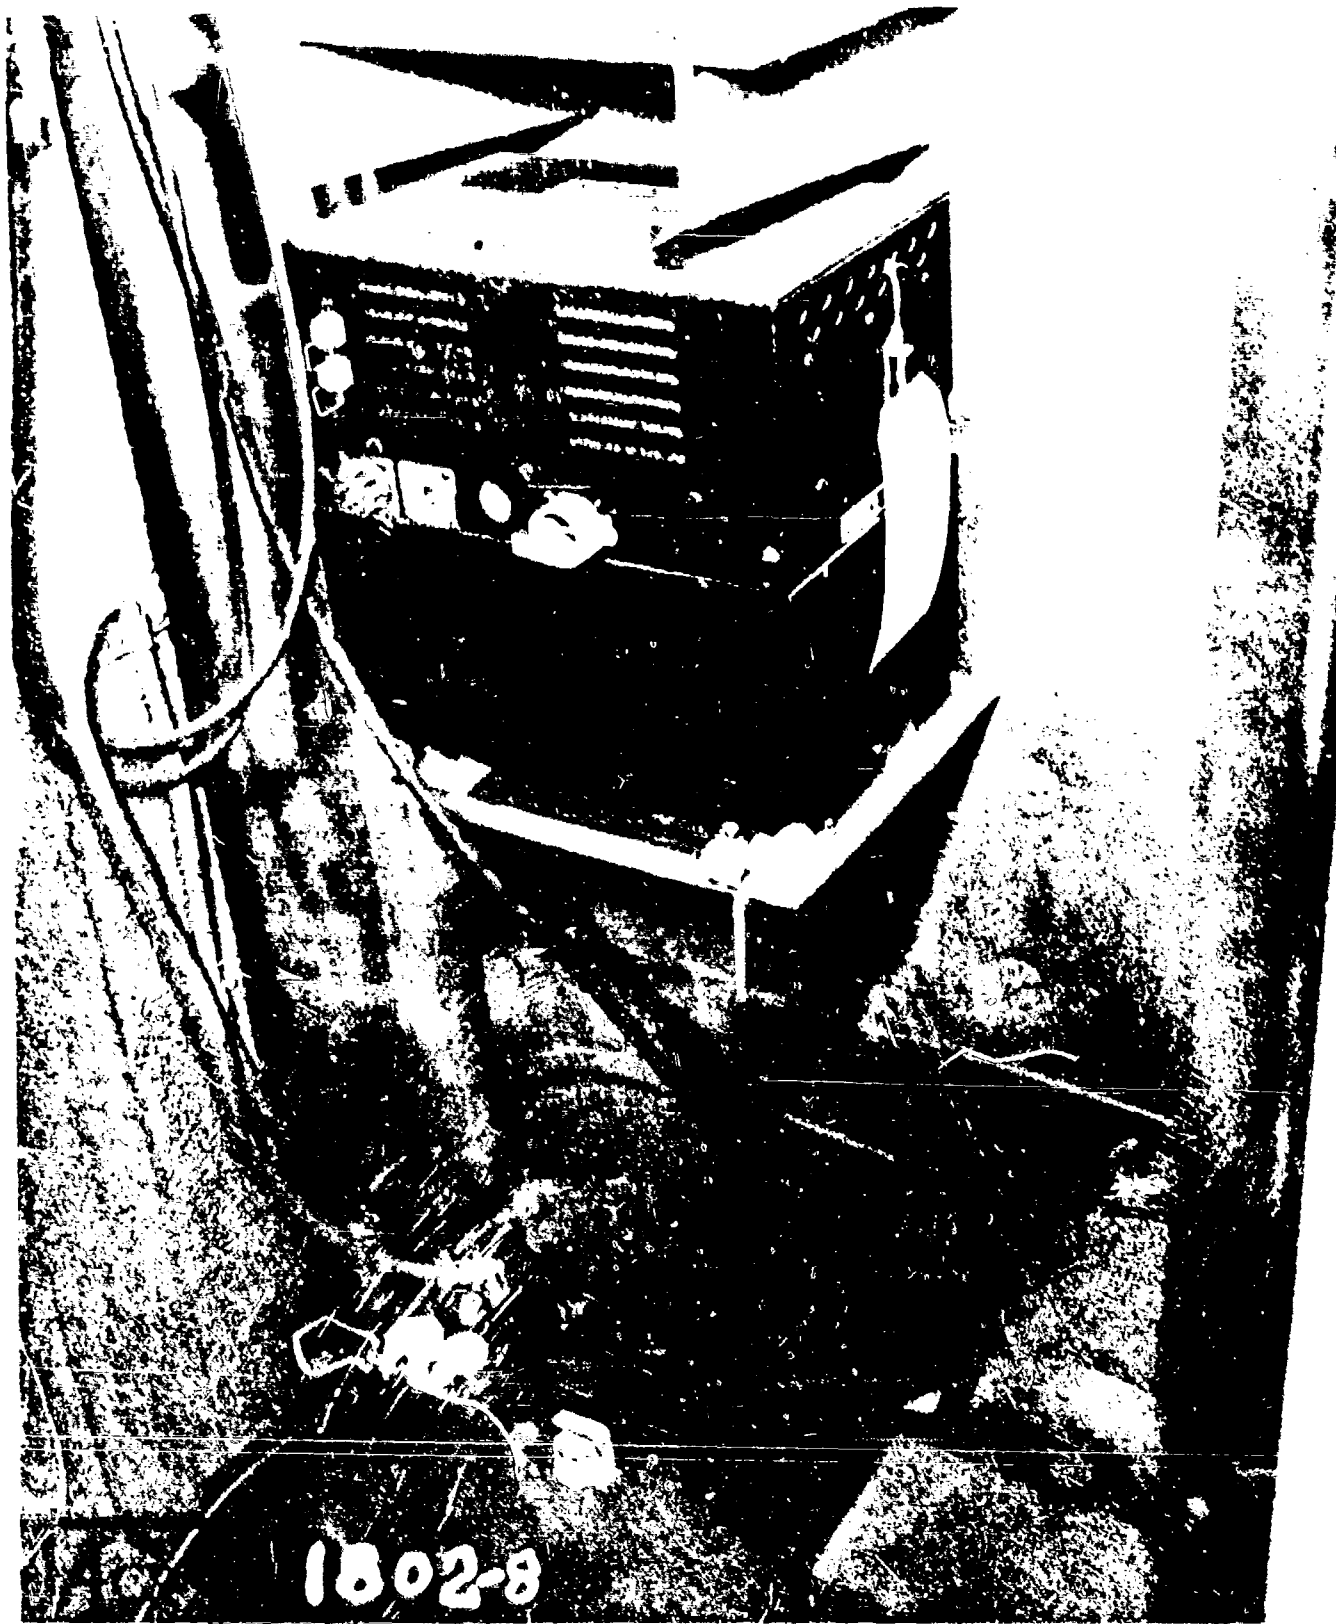
POST ABLE - ABK MOUNTING. Example of ABK mounting failure. The upper unit lies on deck where it fell after breaking plugs on cables at control unit.

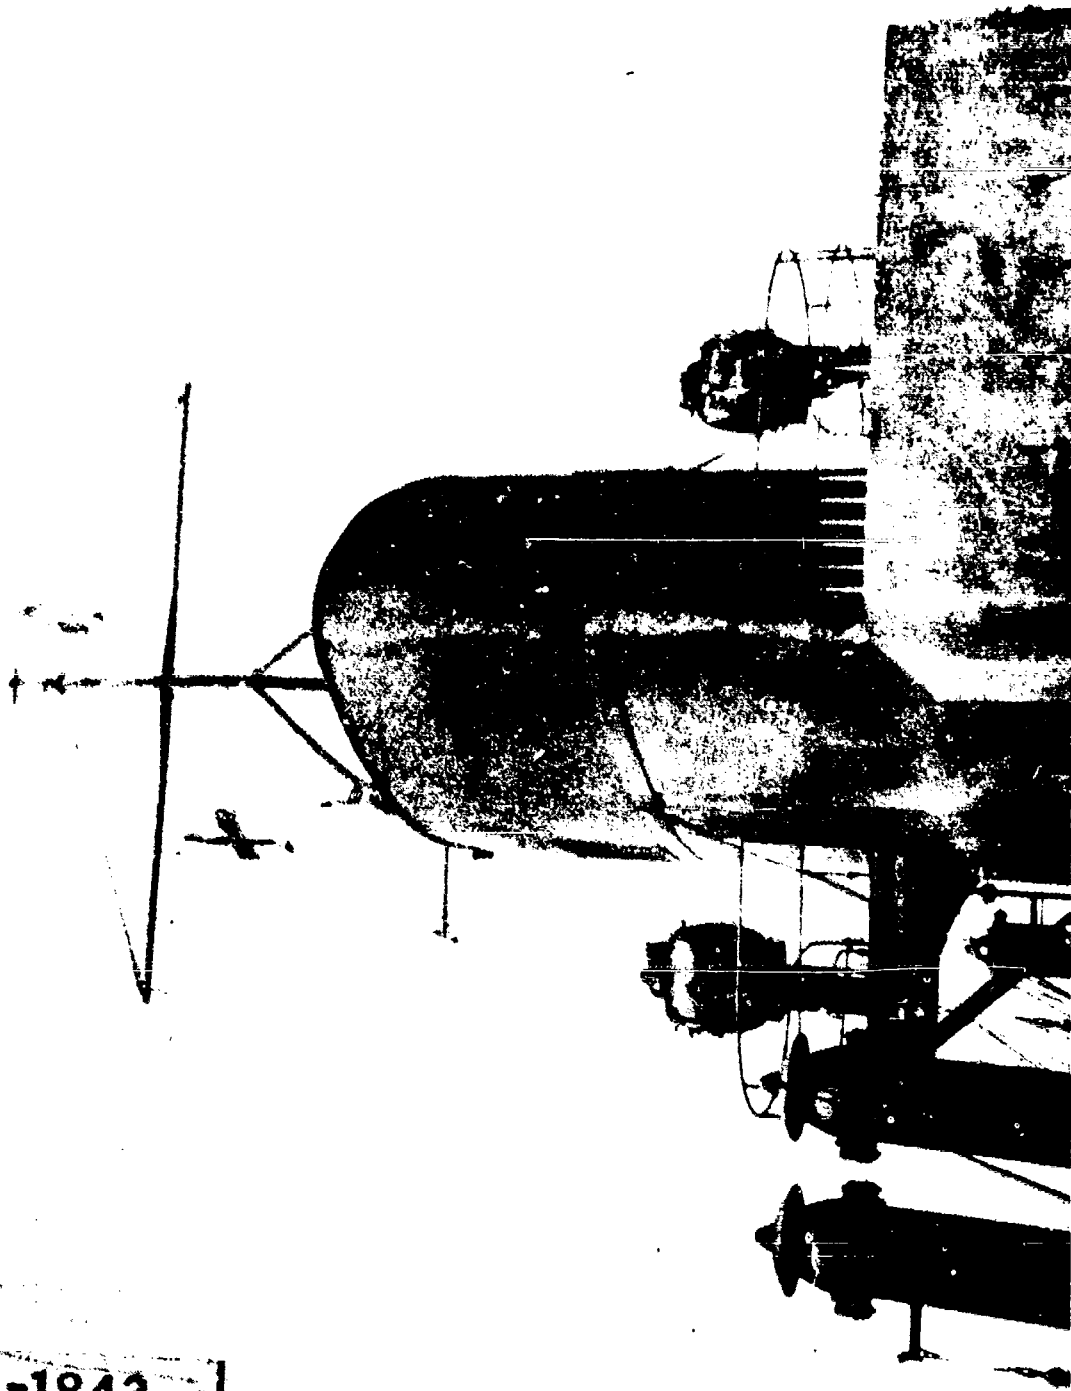
POST ABLE - FOREMAST AND ANTENNA TRUNKS. Radiator of TBS antenna at top of foremast was bent. In left foreground are two radio antenna trunks from which antennas have been torn. Note arrows indicating broken strain insulators.

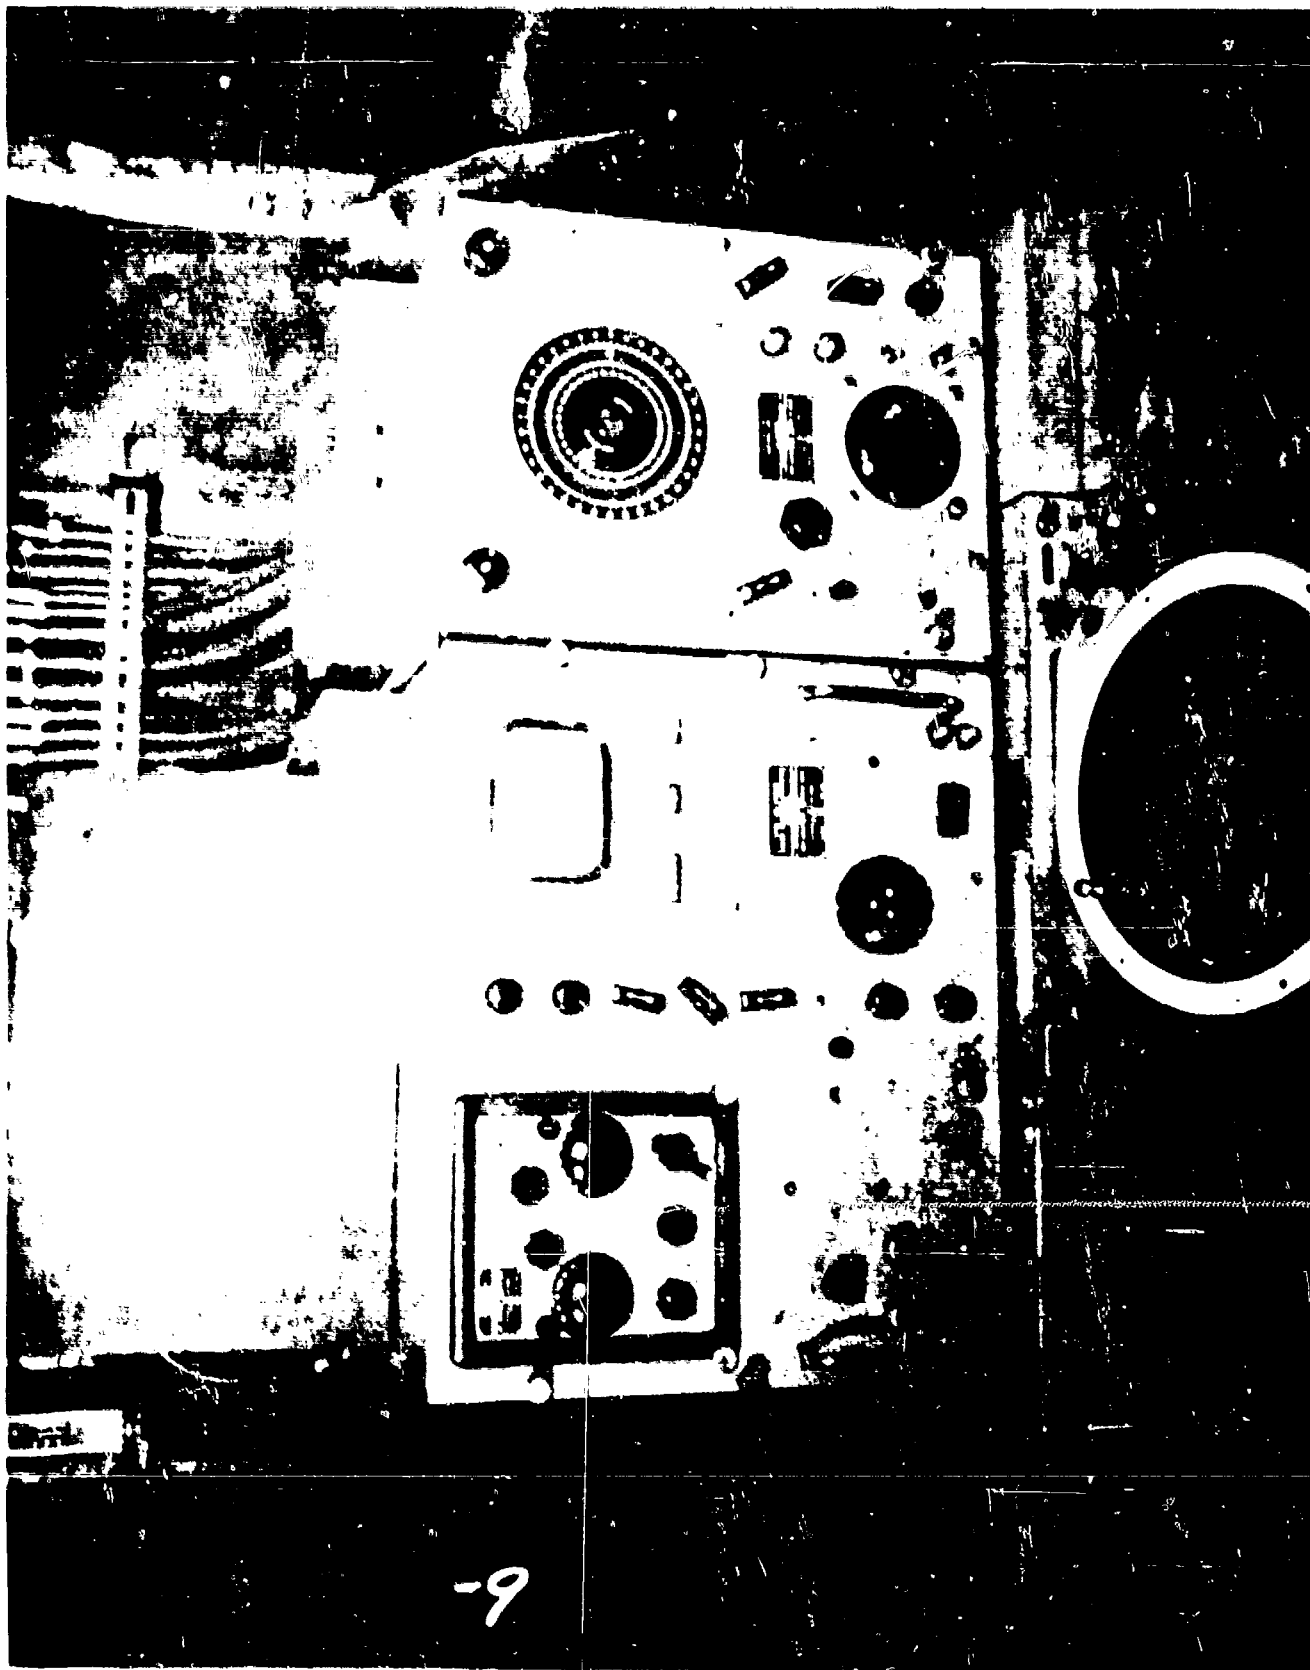
PRE-ABLE SC-4 INDICATOR. Front view.

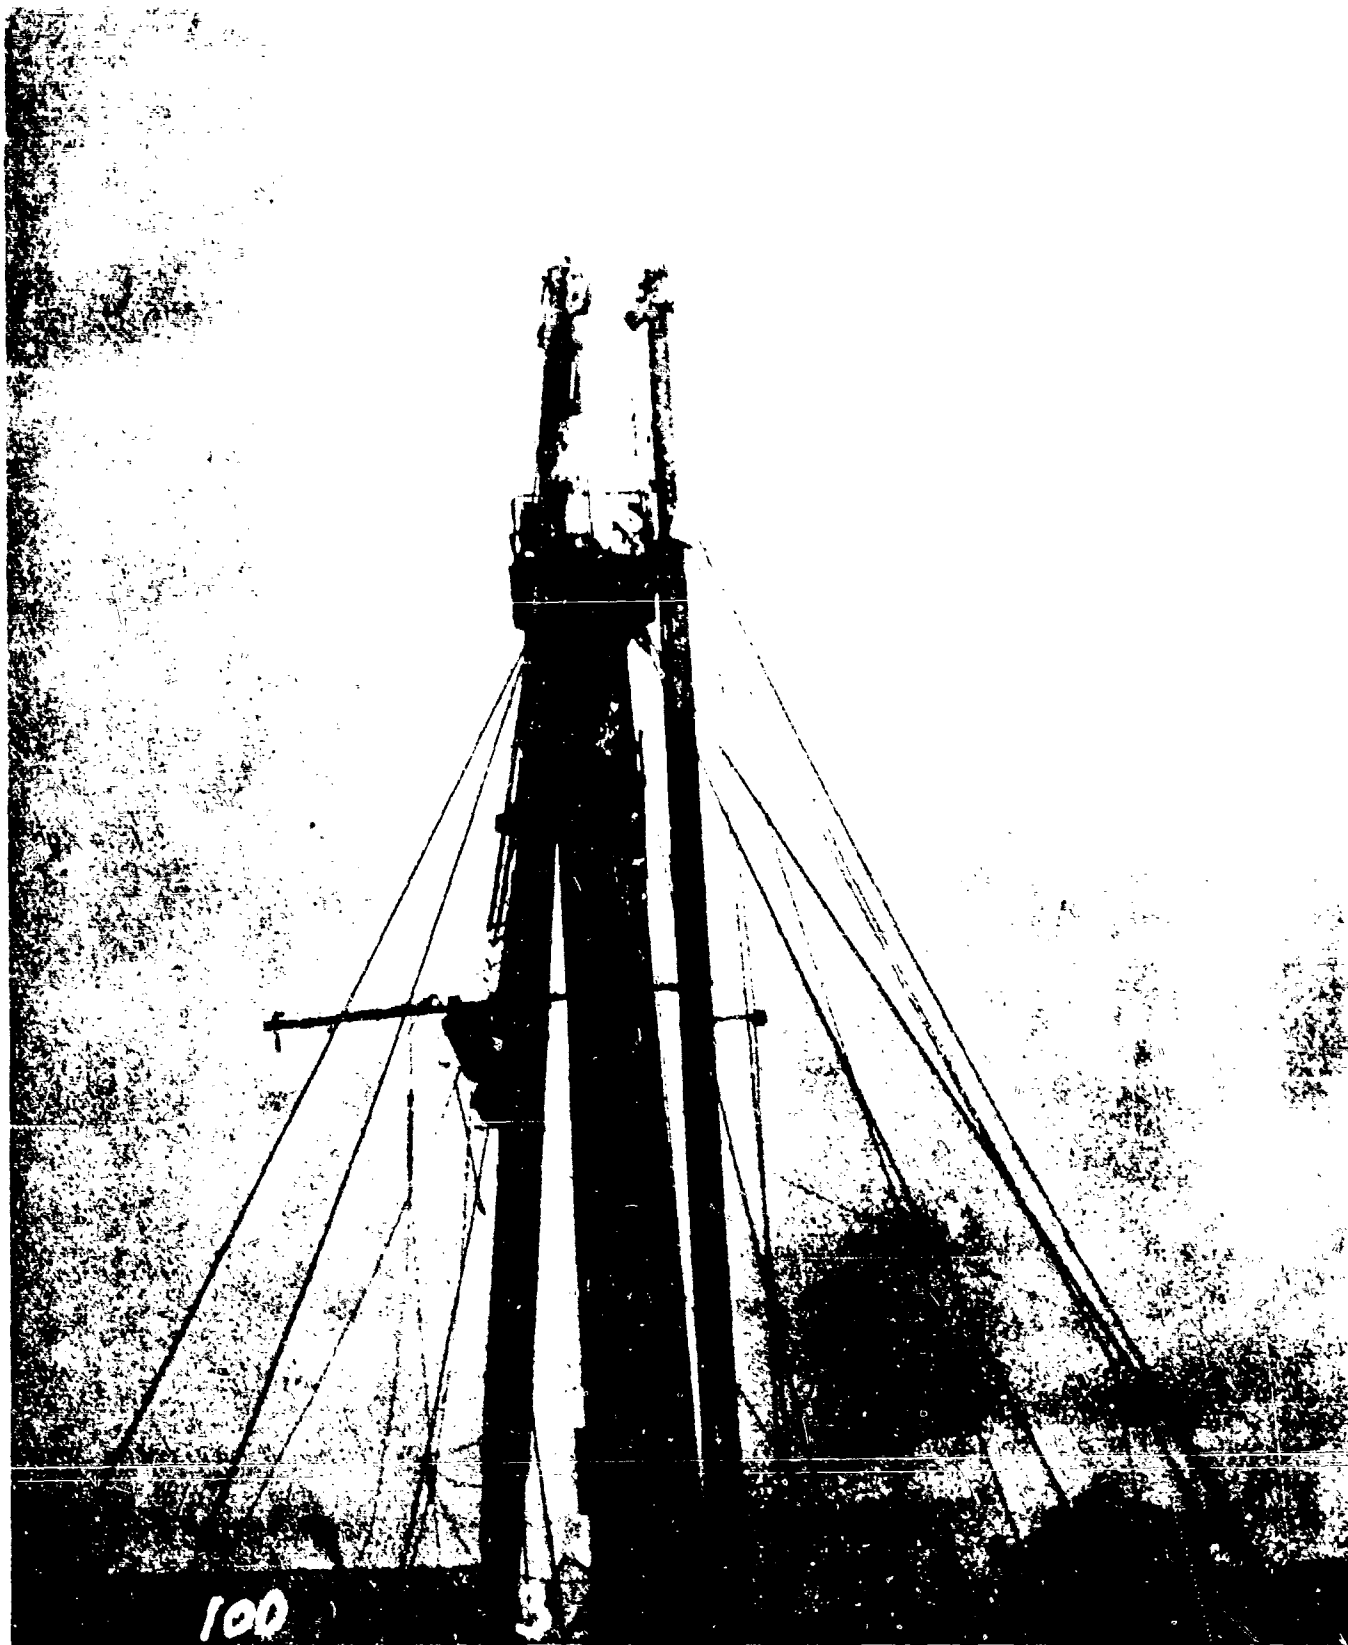
POST ABLE - MAINMAST. Upper section looking aft.

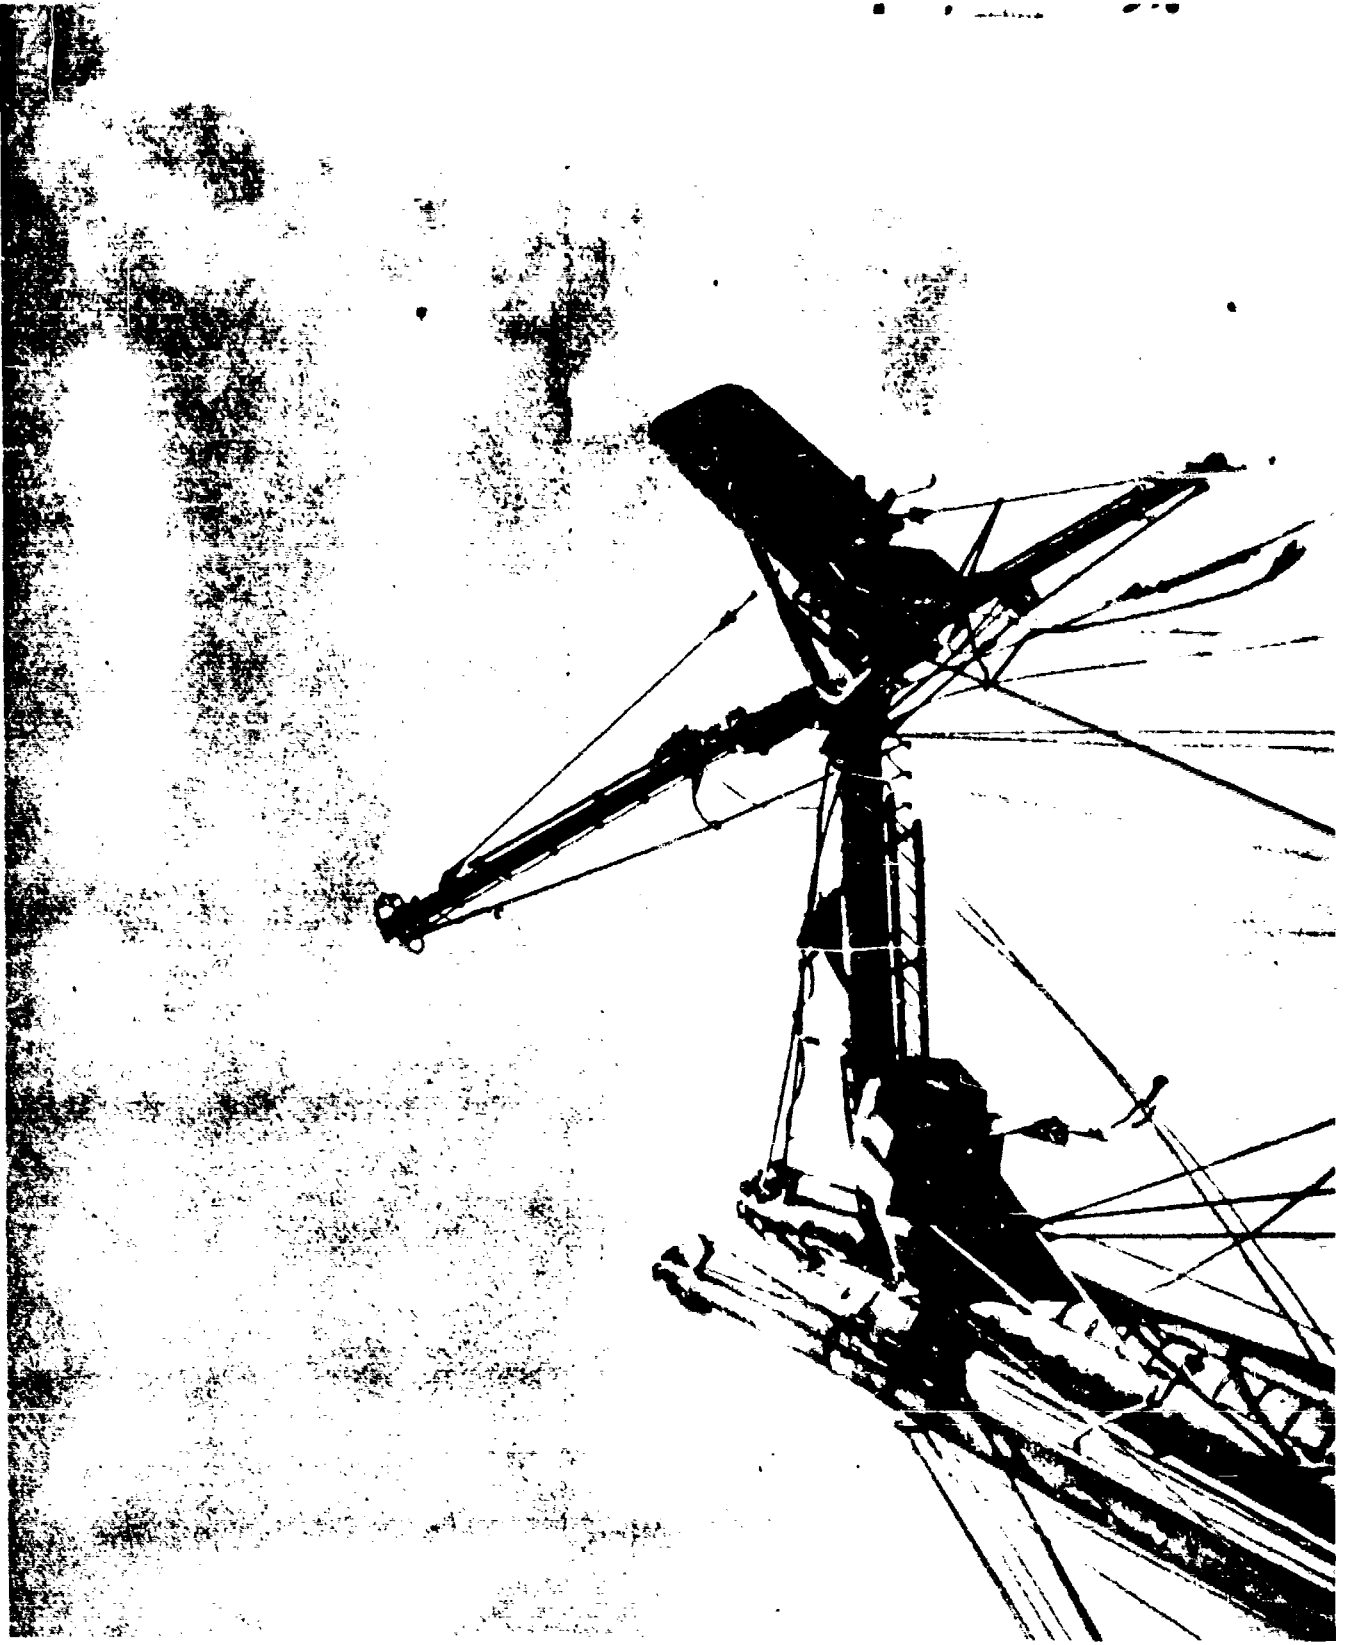
POST ABLE - MAINMAST. Top section blown over. Base ring of SC-4 pedestal still bolted to foundation, with a few fragments of pedestal remaining.

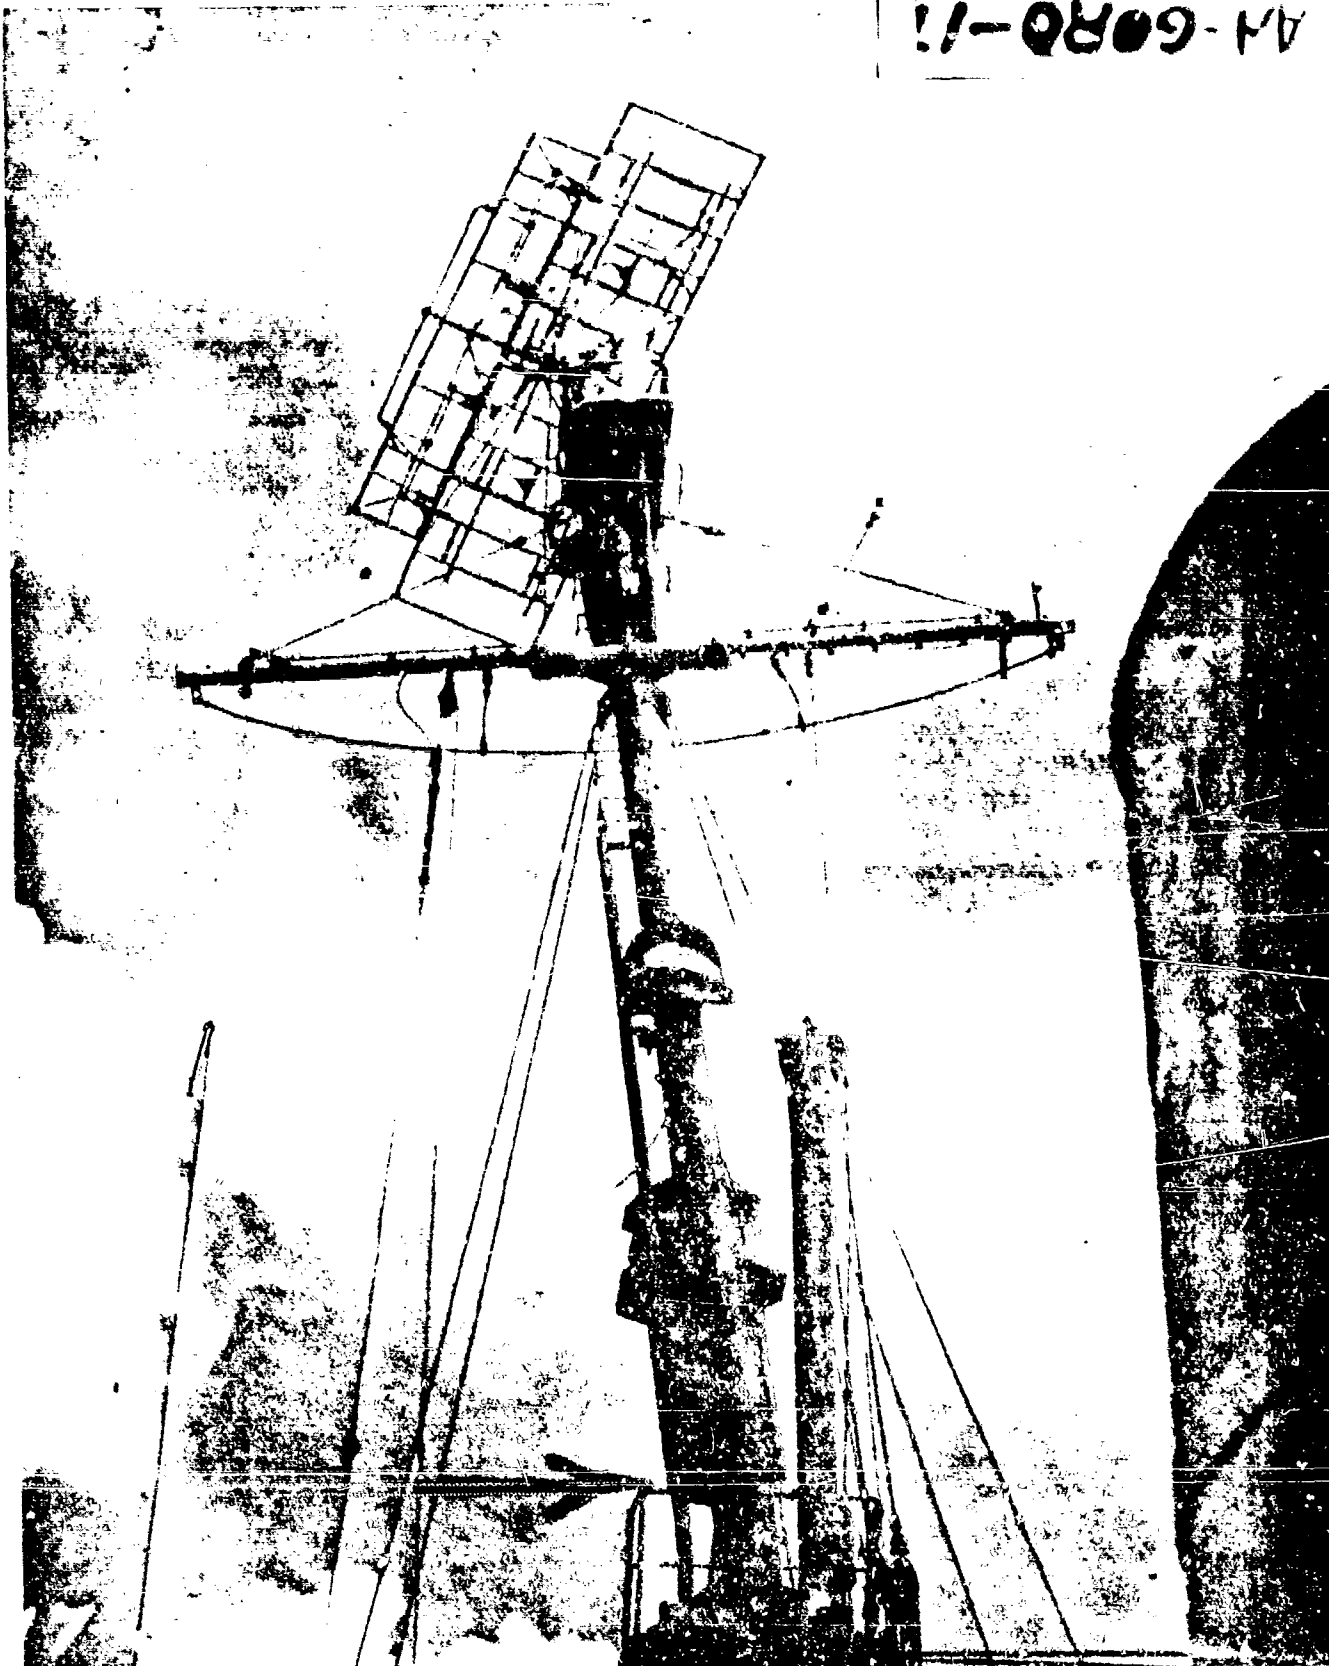
POST ABLE - SC ANTENNA. Mainmast was bent, (see arrow) and SC antenna was tilted by blast.
