ELECTRONICS COORDINATING OF
SHIP PREPARATION
and
TARGET INSPECTION

FINAL REPORT
TESTS ABLE AND BAKER

✓ **VOLUME 2**
PHOTOGRAPHIC RECORD

DIRECTOR OF SHIP MATERIAL
JOINT TASK FORCE ONE
OPERATION CROSSROADS

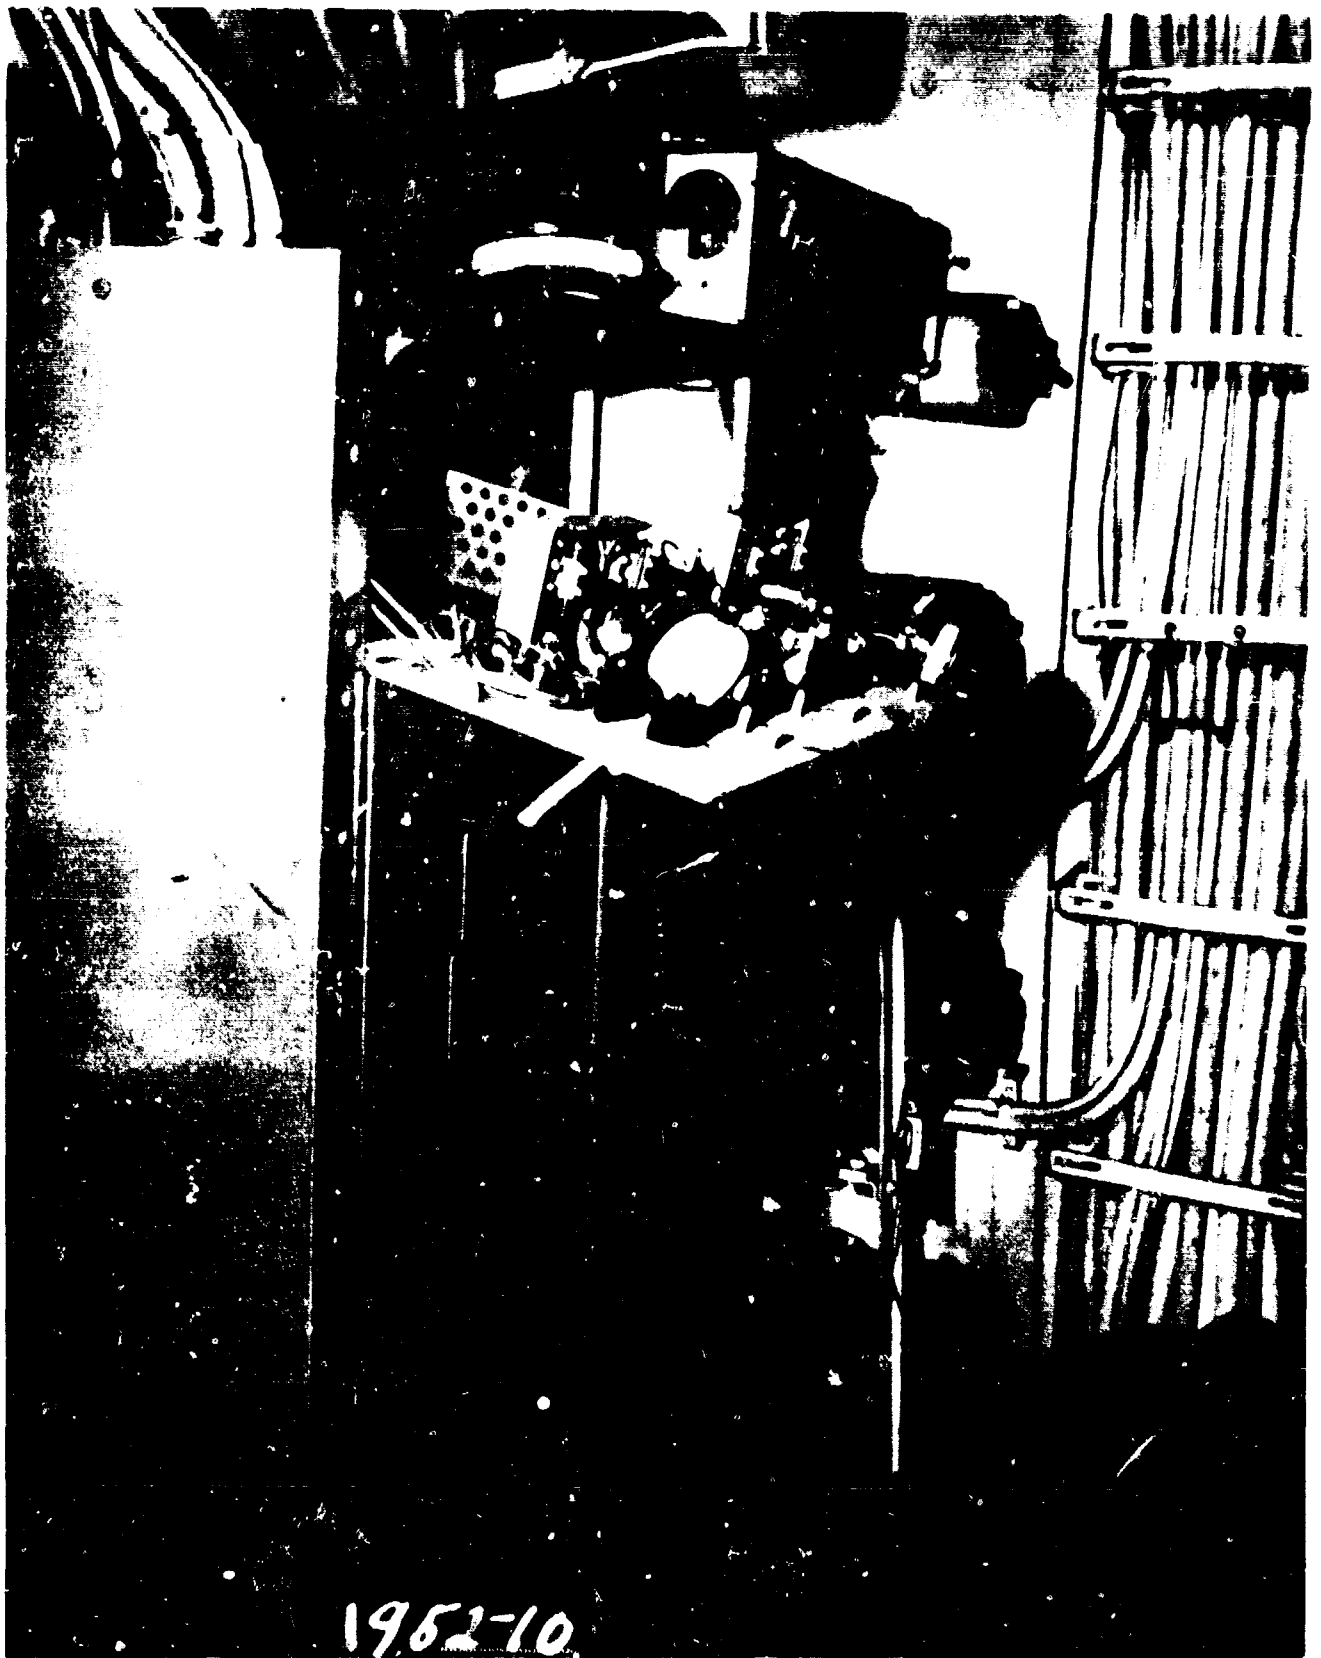
FCST BAKER - SP TRANSMITTER RECEIVER. The shock in this compartment was severe, but the equipment stood up well with the exception of damage to panel securing and meters. Arrow shows broken meter.

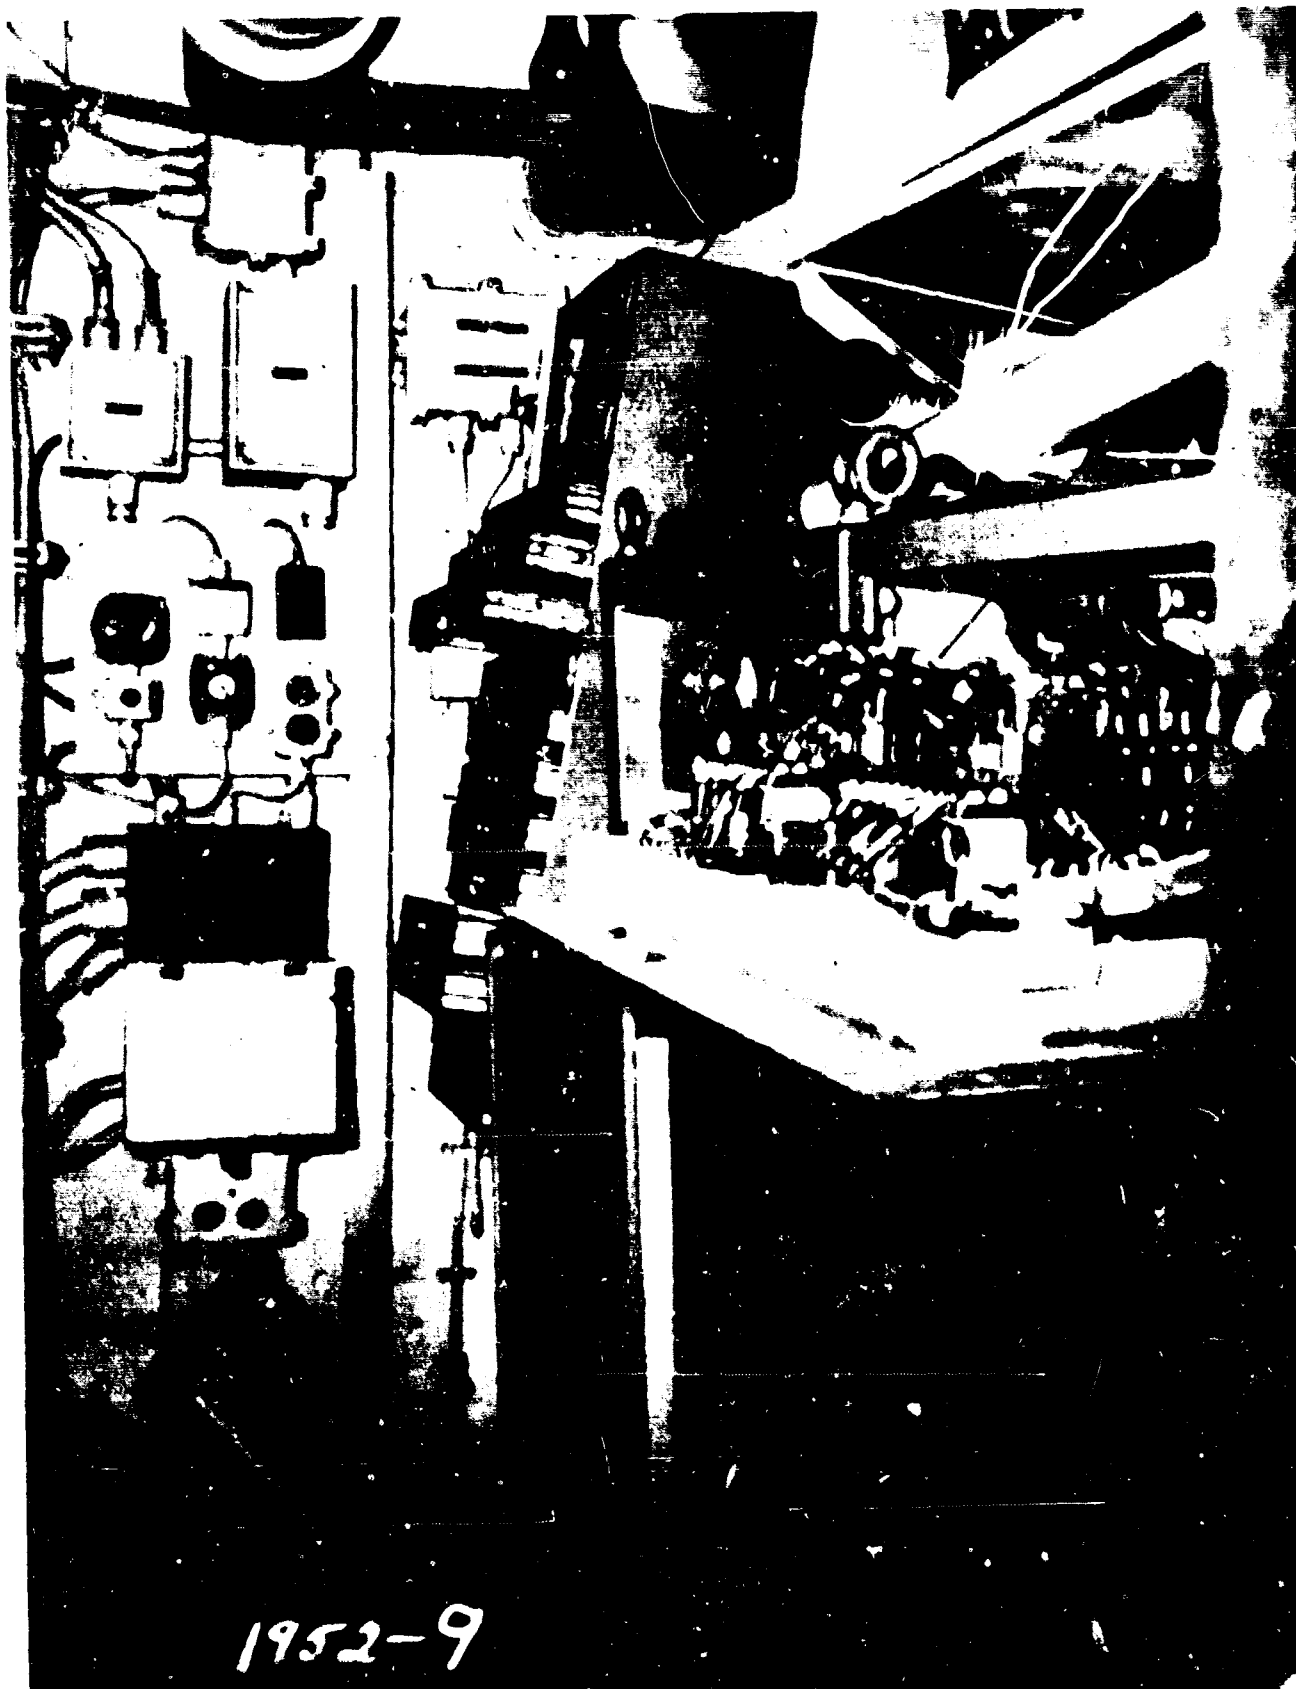
POST BAKER - SP TRANSMITTER RECEIVER. The method of securing panels was inadequate. The damage sustained was due to the failure of the securing screws.

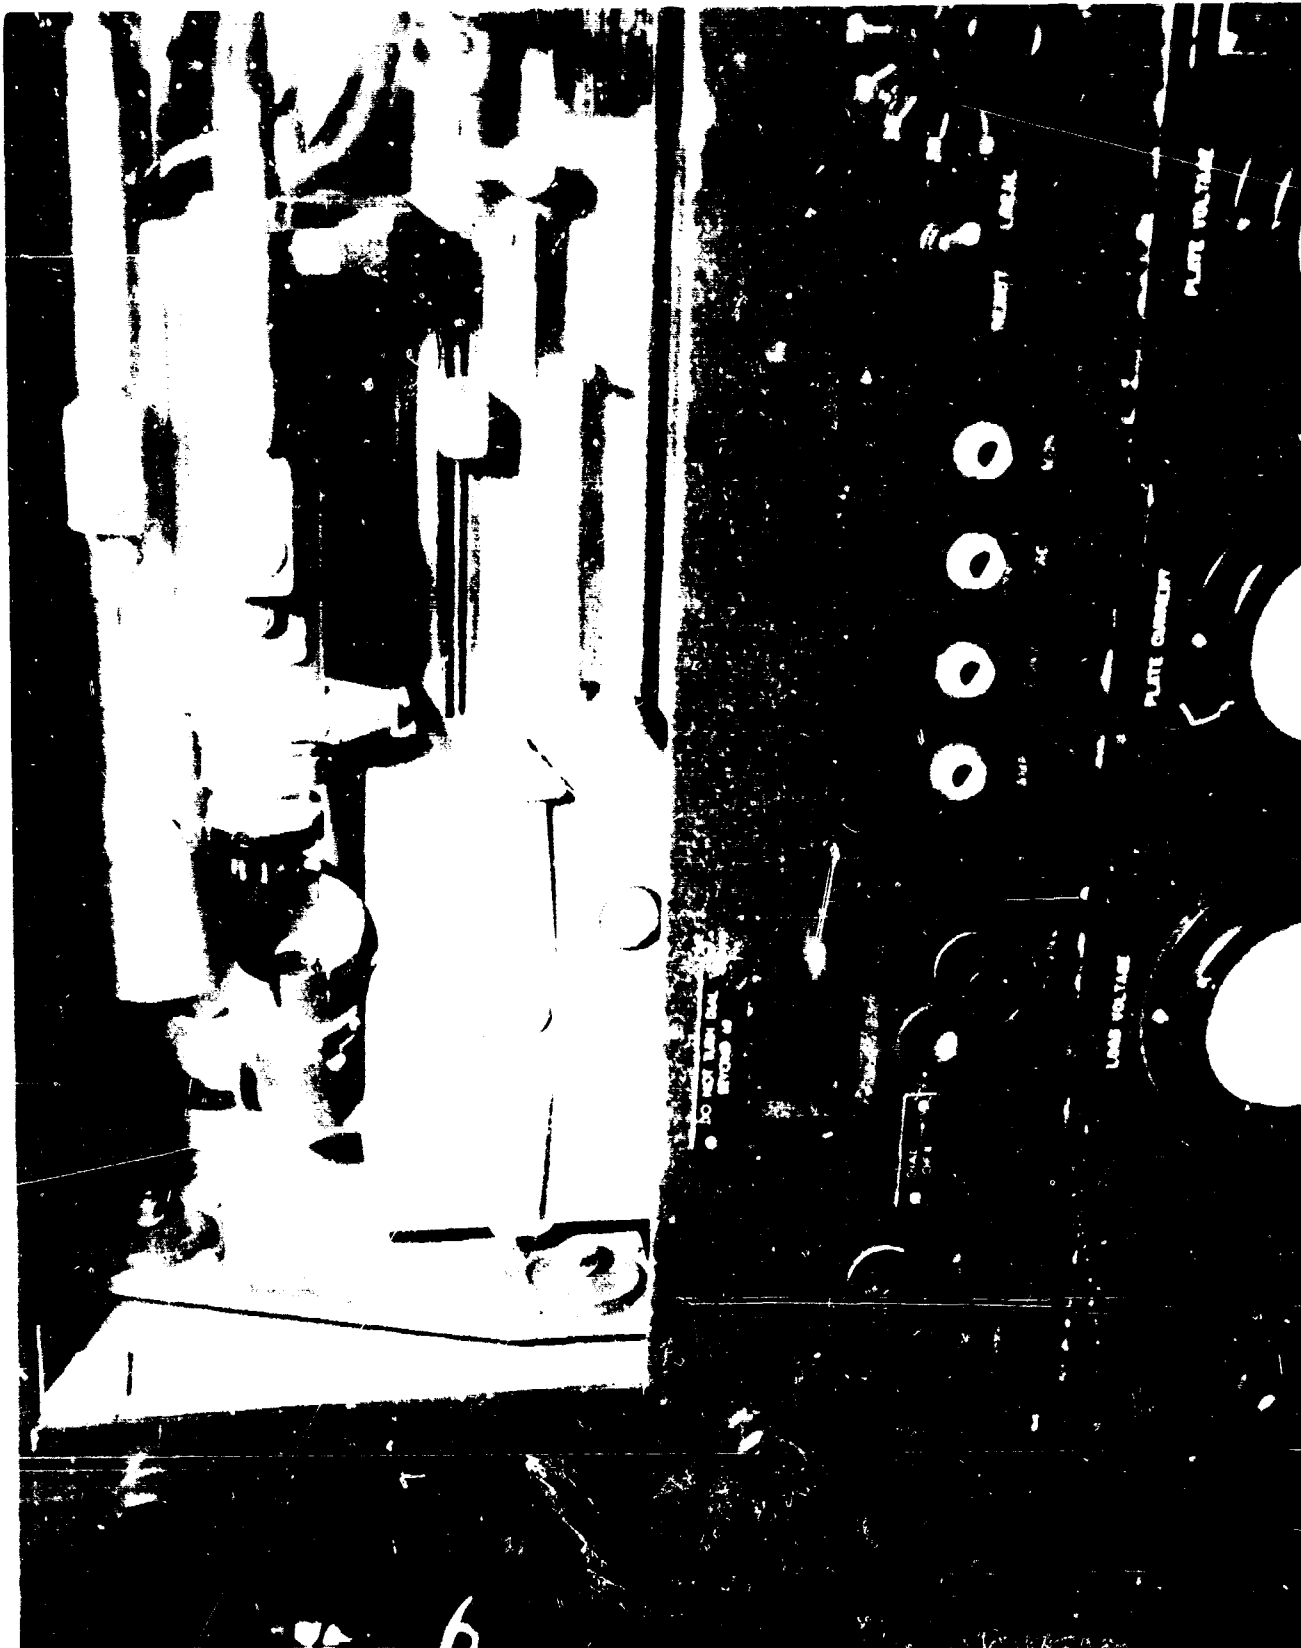
POST BAKER - FORWARD MK 4 RADAR RF AMPLIFIER UNIT. Socket was knocked off and bent. This main frame was not shock mounted.

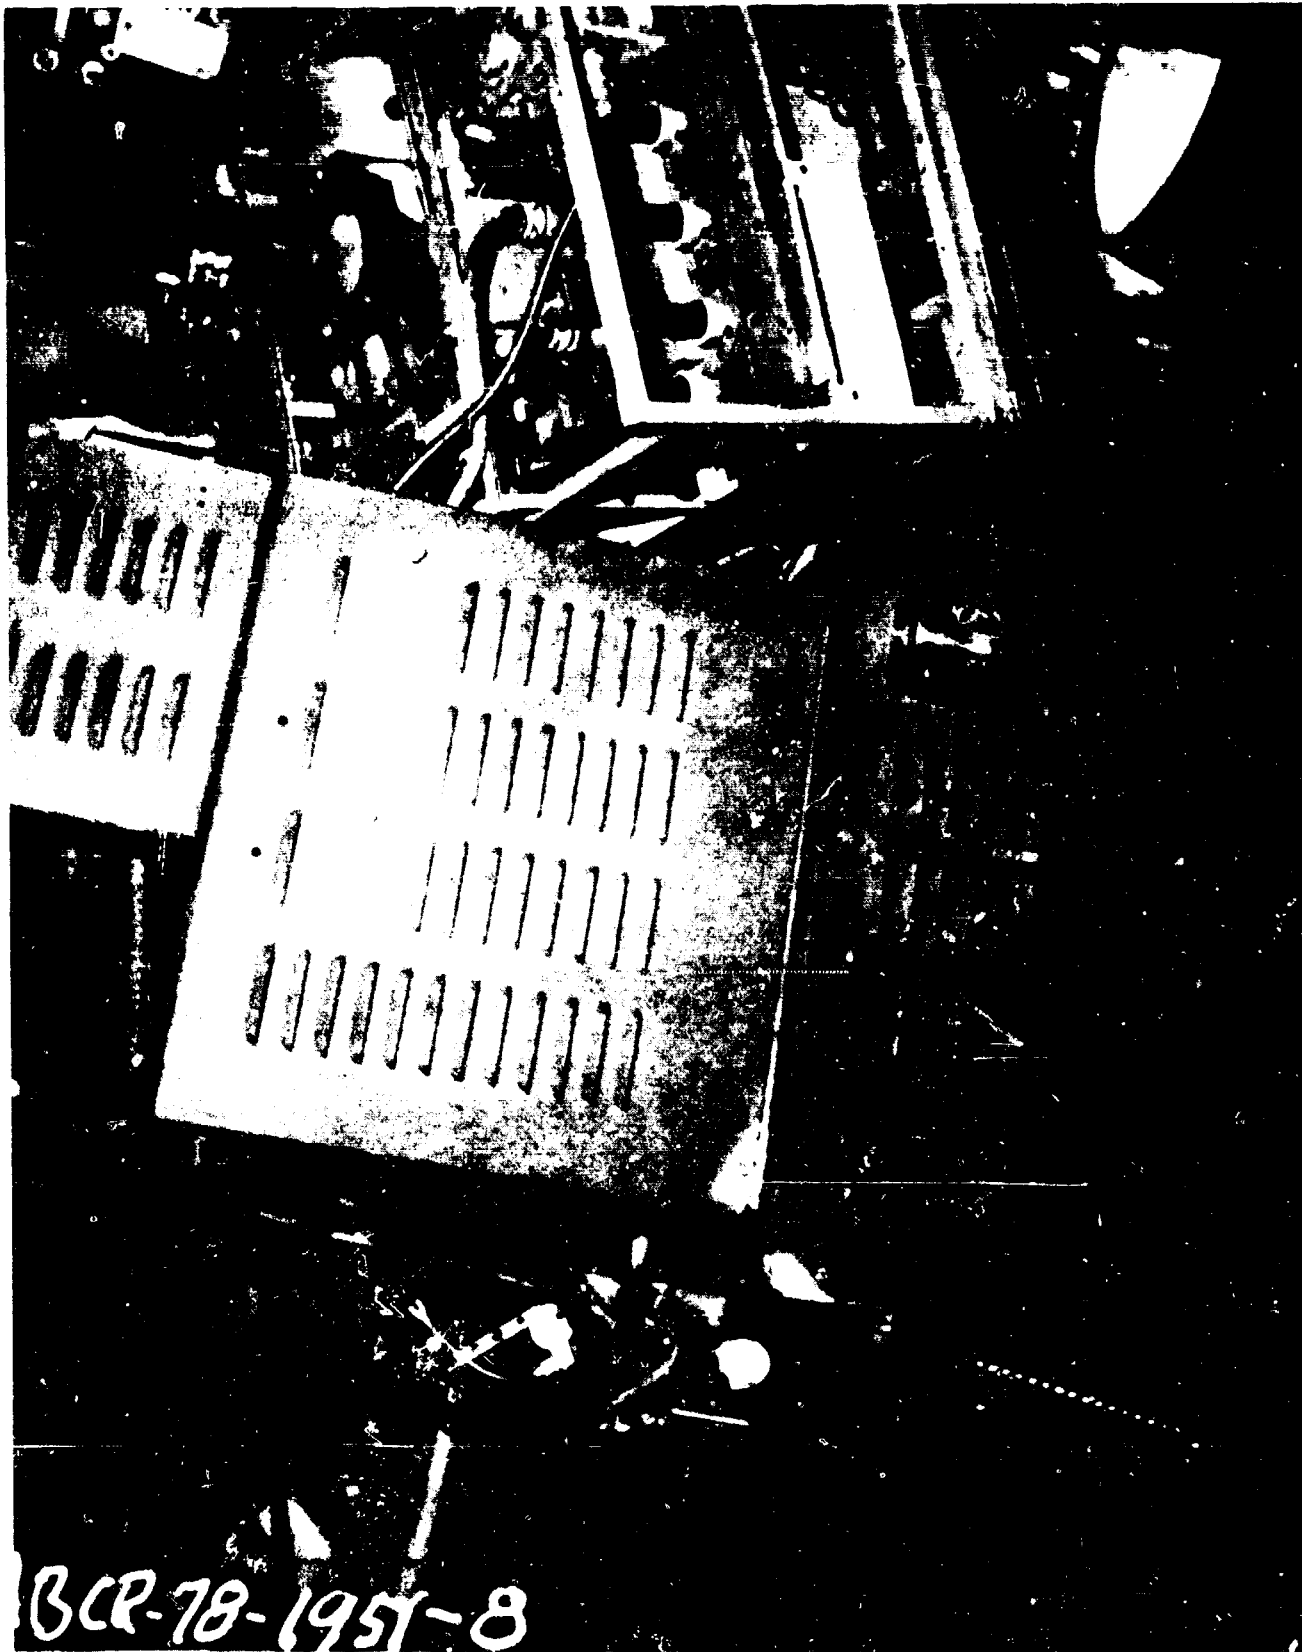
POST BAKER- SC CONSOLE. Top view showing the indicator on the right.

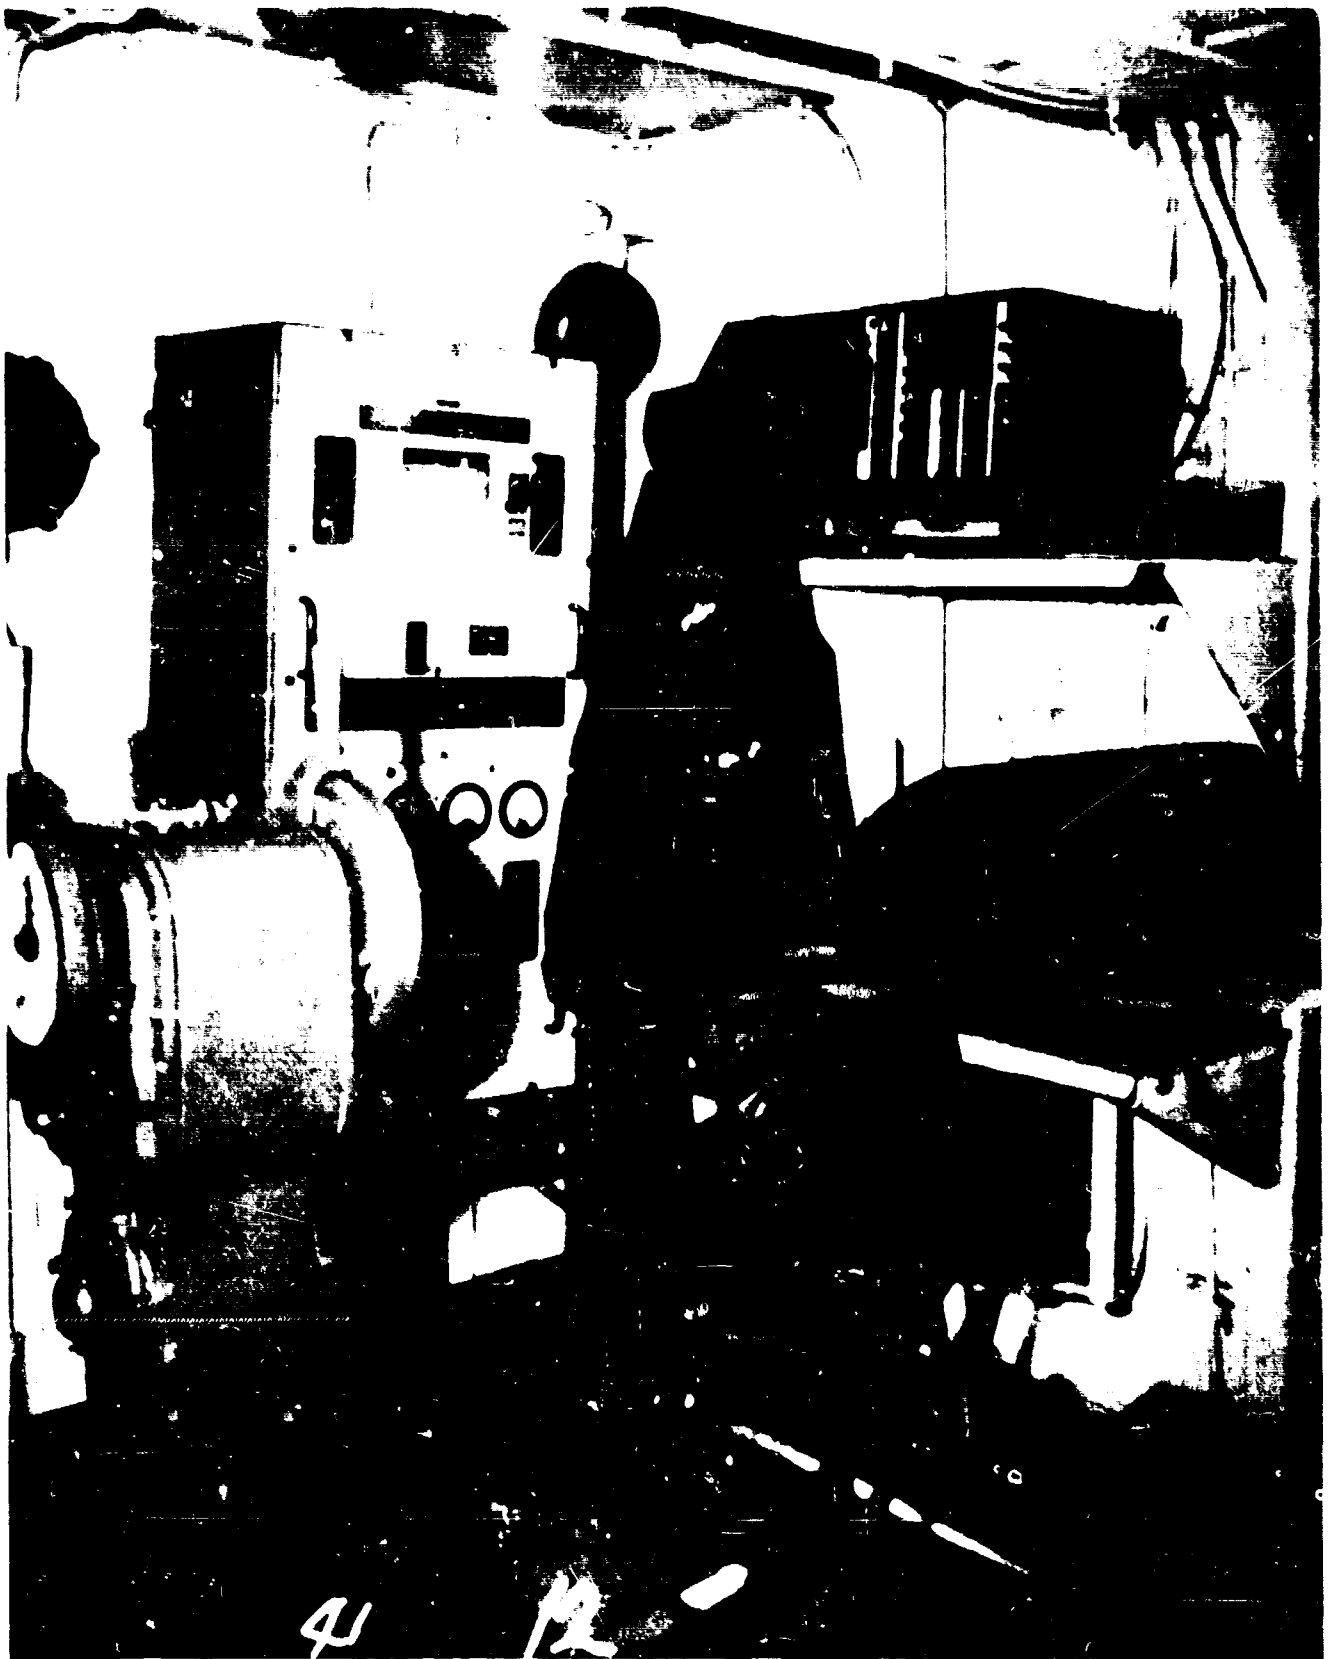
POST BAKER - NMC AND SCR-608. The NMC foundation warped, tilting equipment away from bulkhead. The SCR-608's were partially thrown from their foundations.

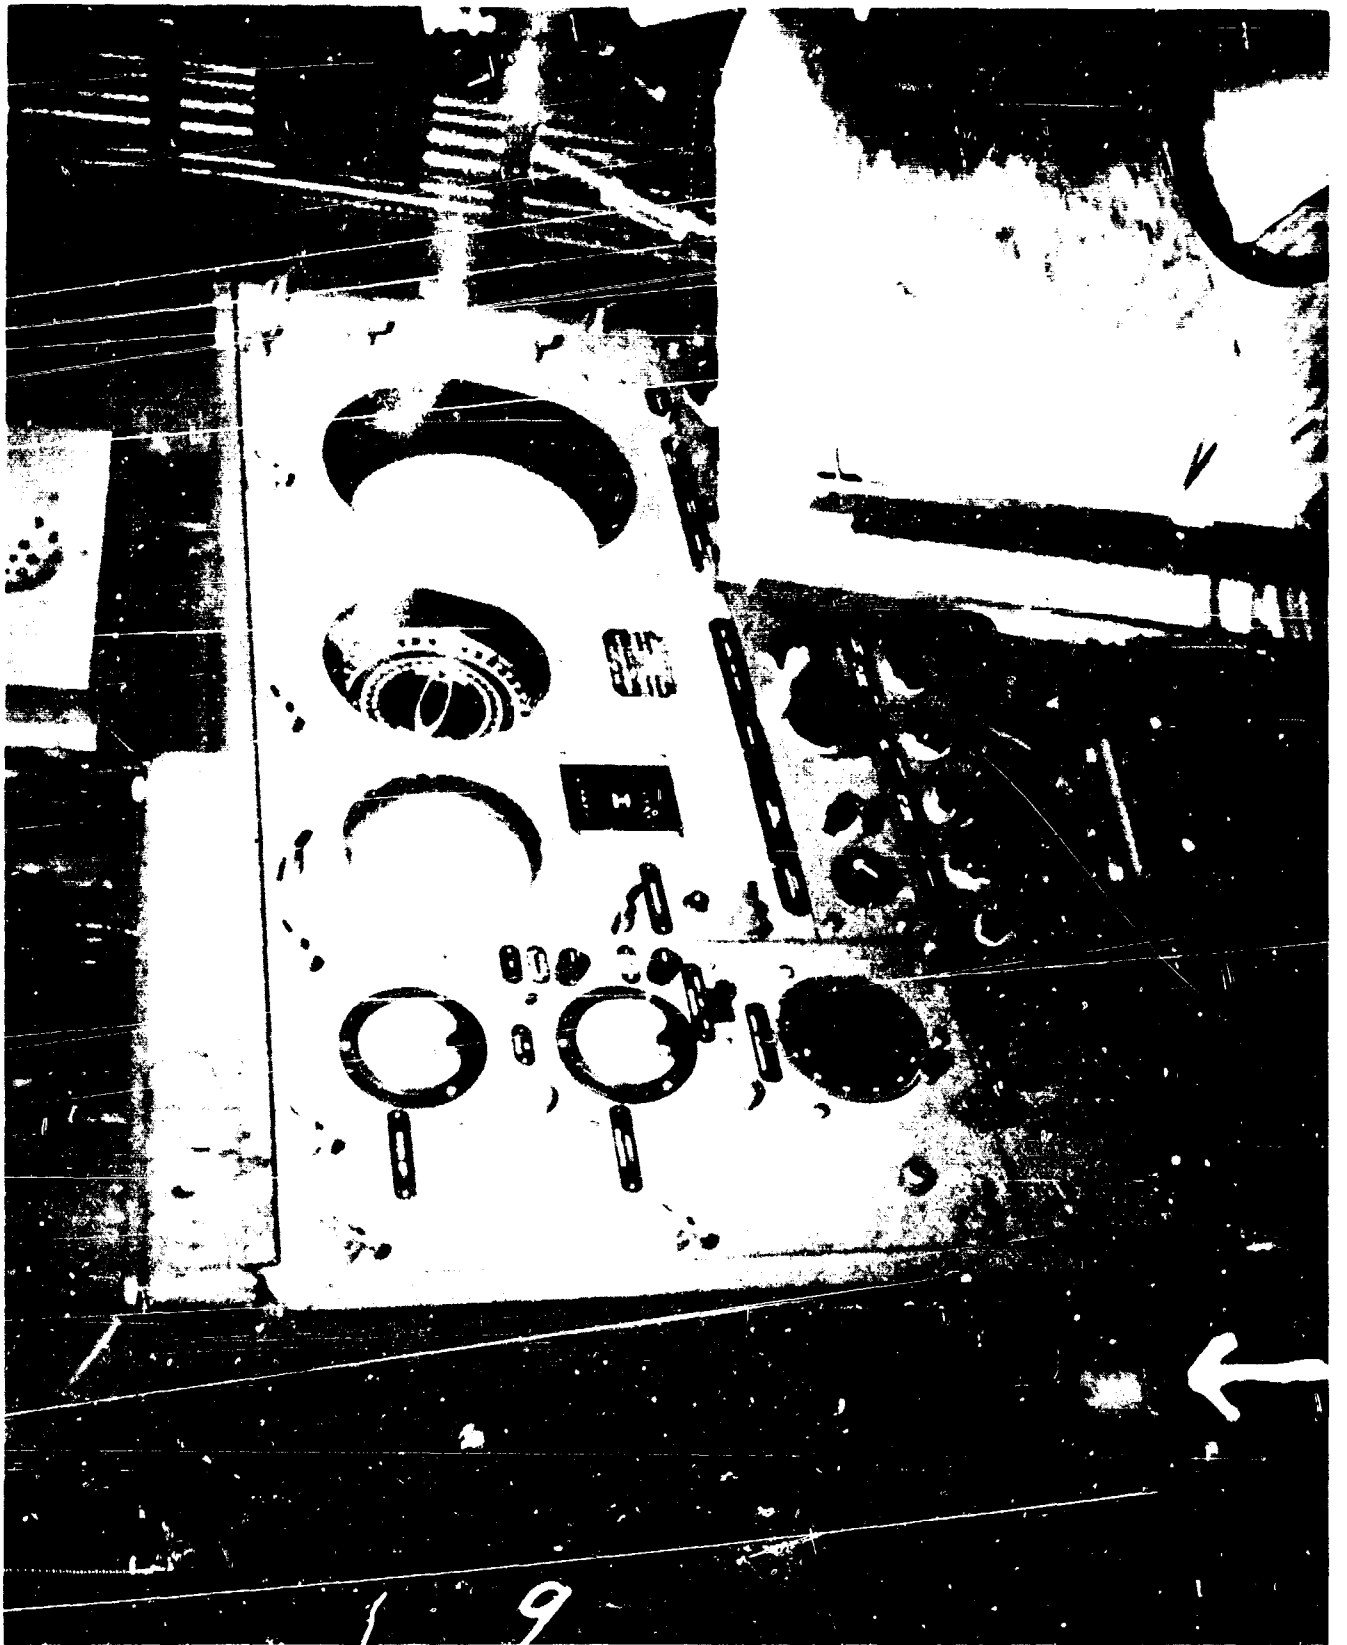
POST BAKER - SG-1 INDICATOR. This was the only equipment of its type in which the shock mount failed. The arrow points to center row of shock mounts. No other damage to indicator was noted.

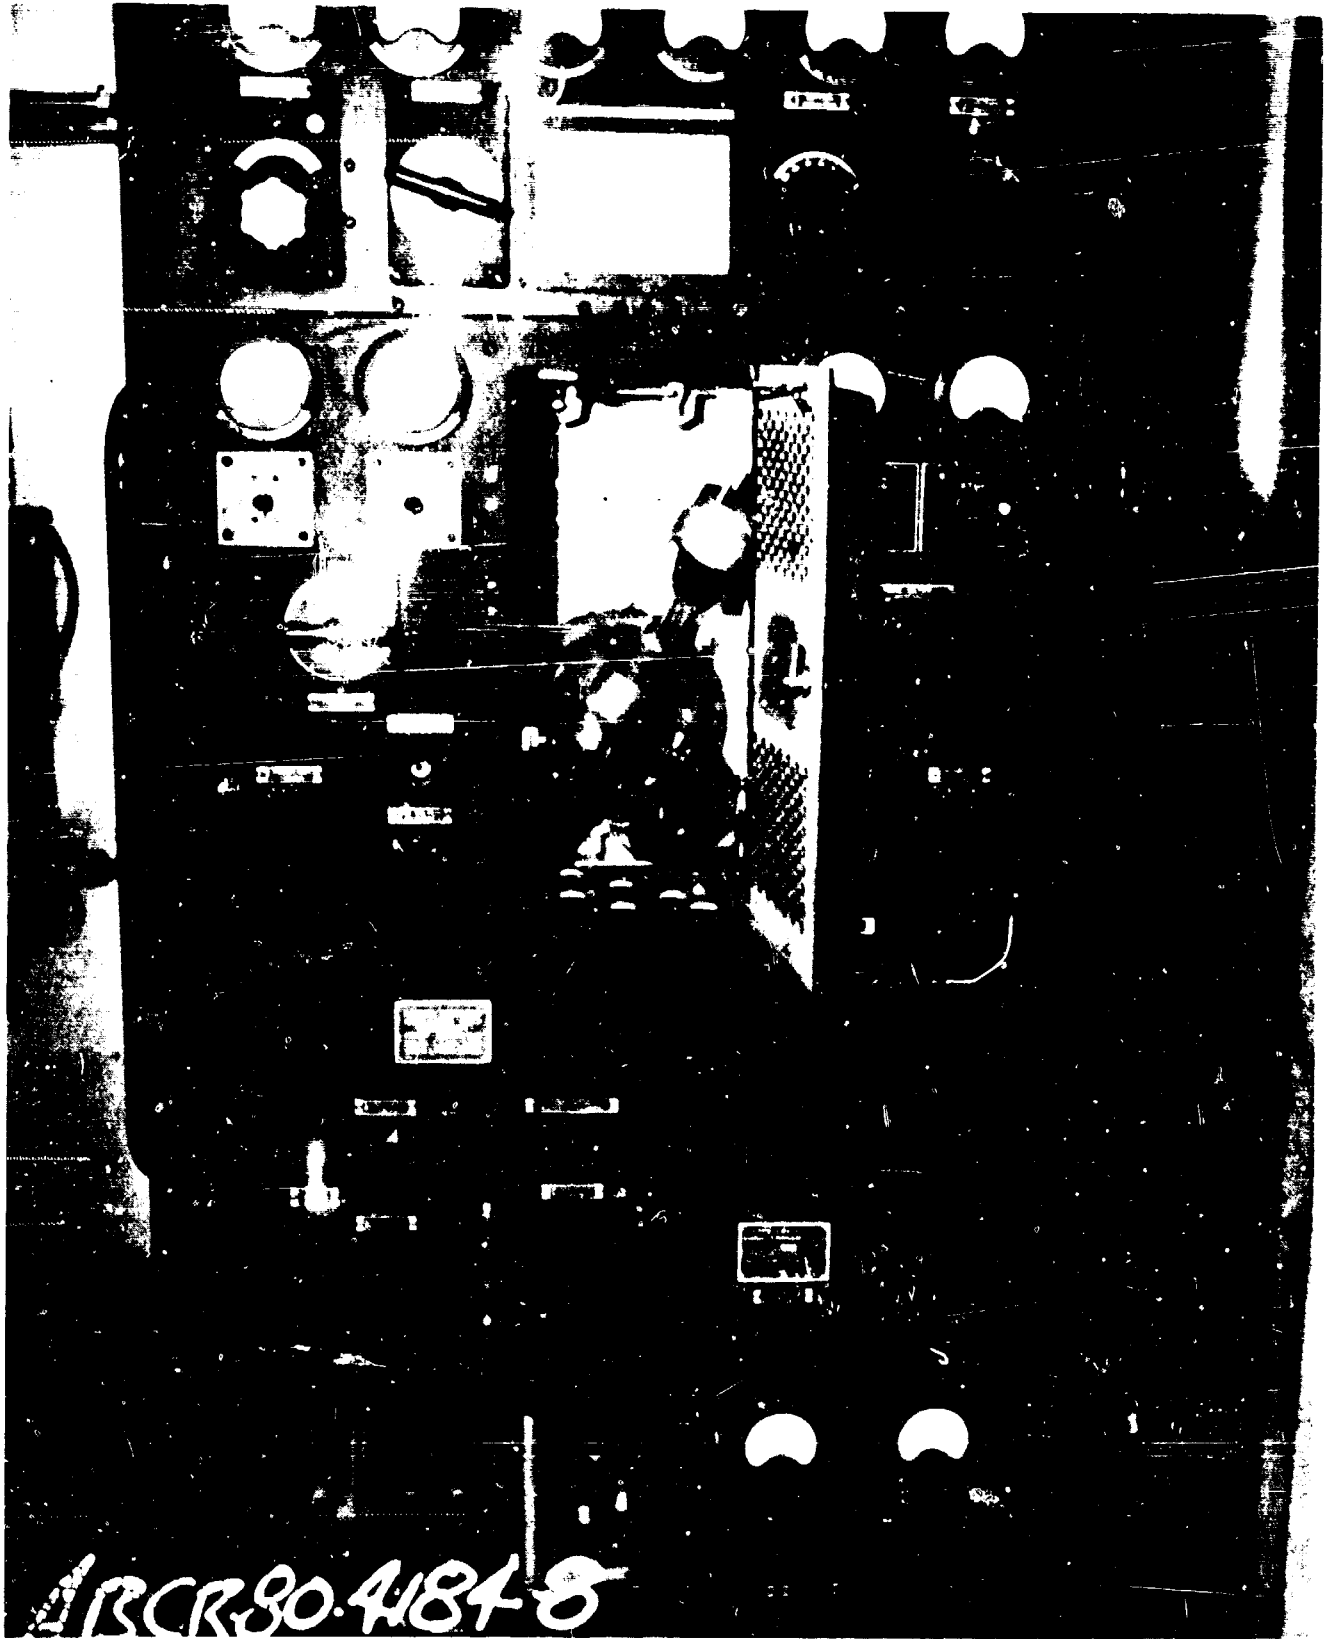
POST BAKER - TBK-17. PA tube was shaken from its mounting clips.

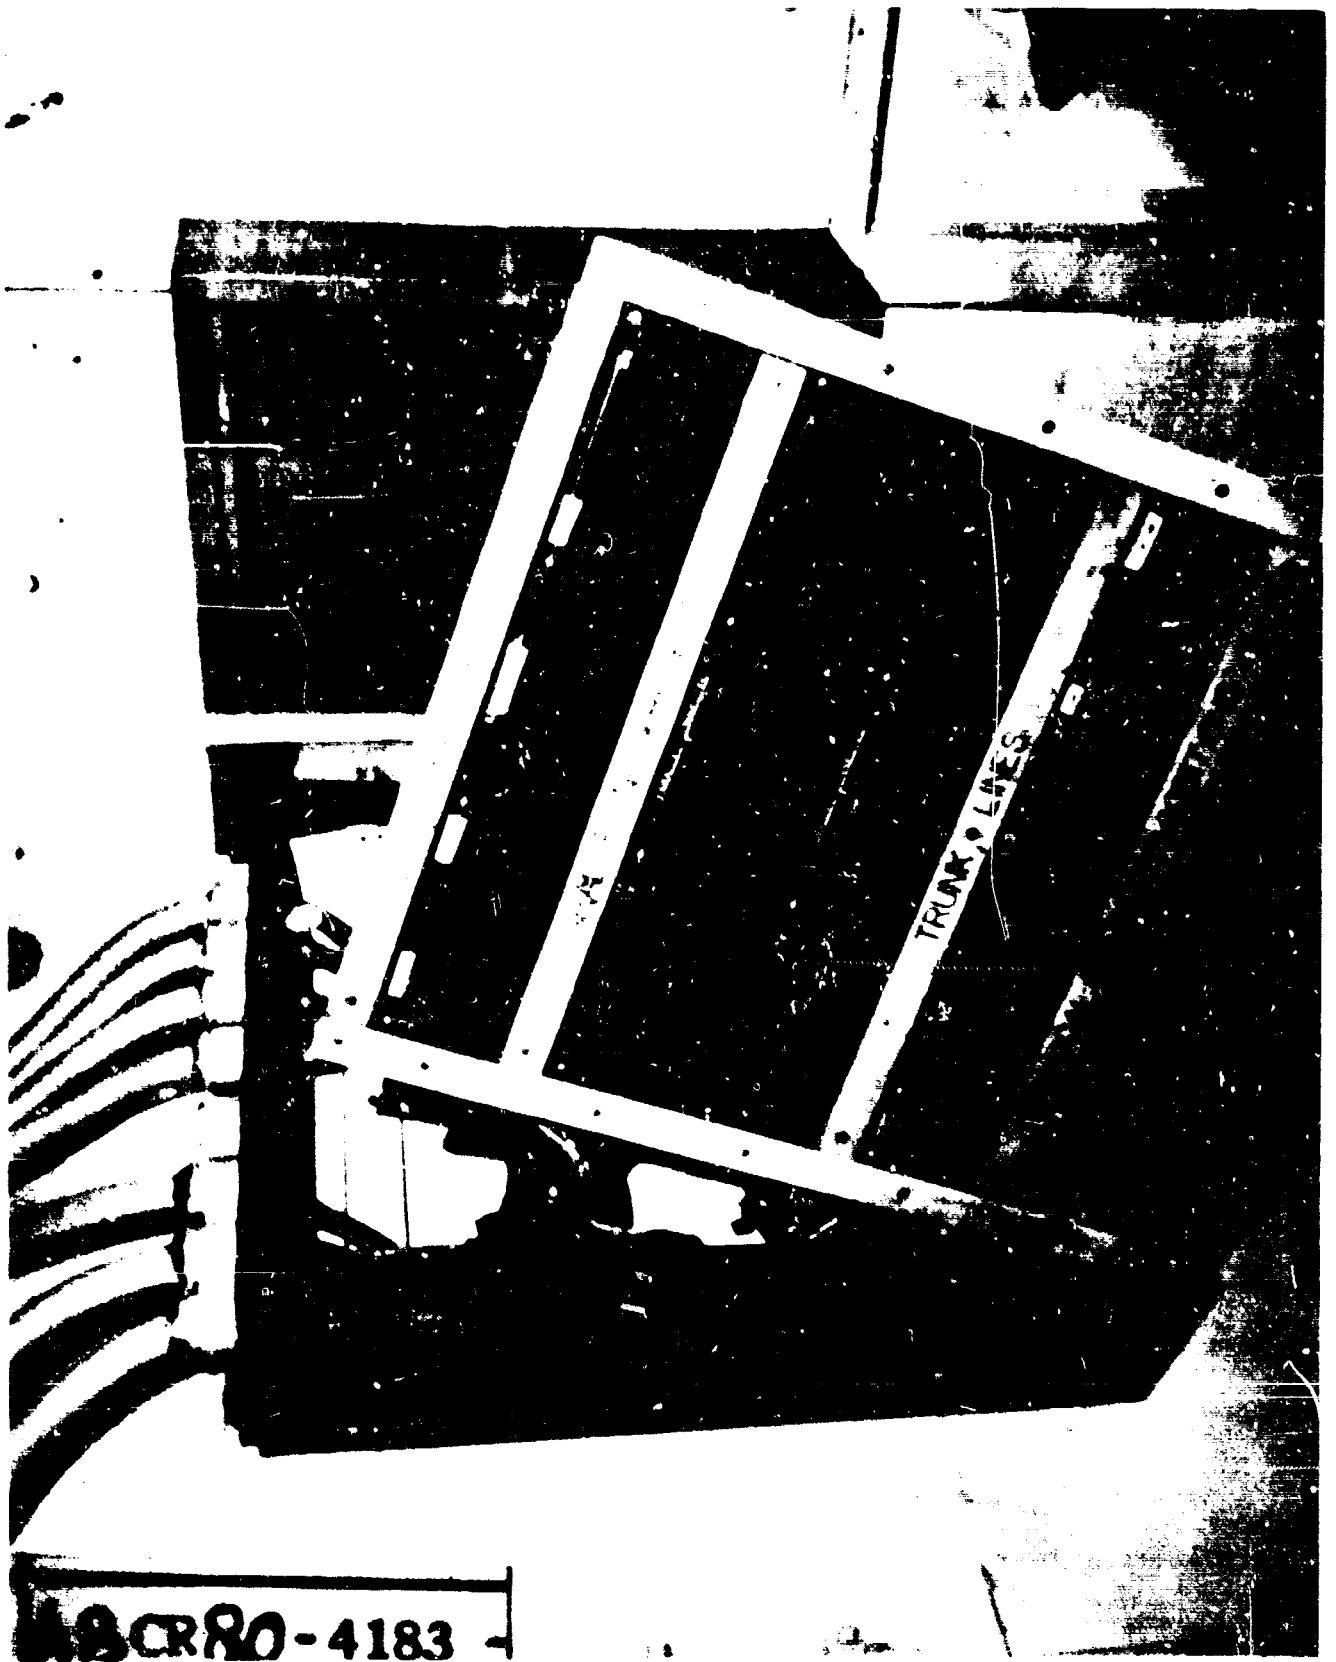
POST BAKER - RADIC I. Radiophone transfer panel. Door was thrown open, ripping off upper hinge, and left hanging on cables in this position. At right is corner of TAJ-19.

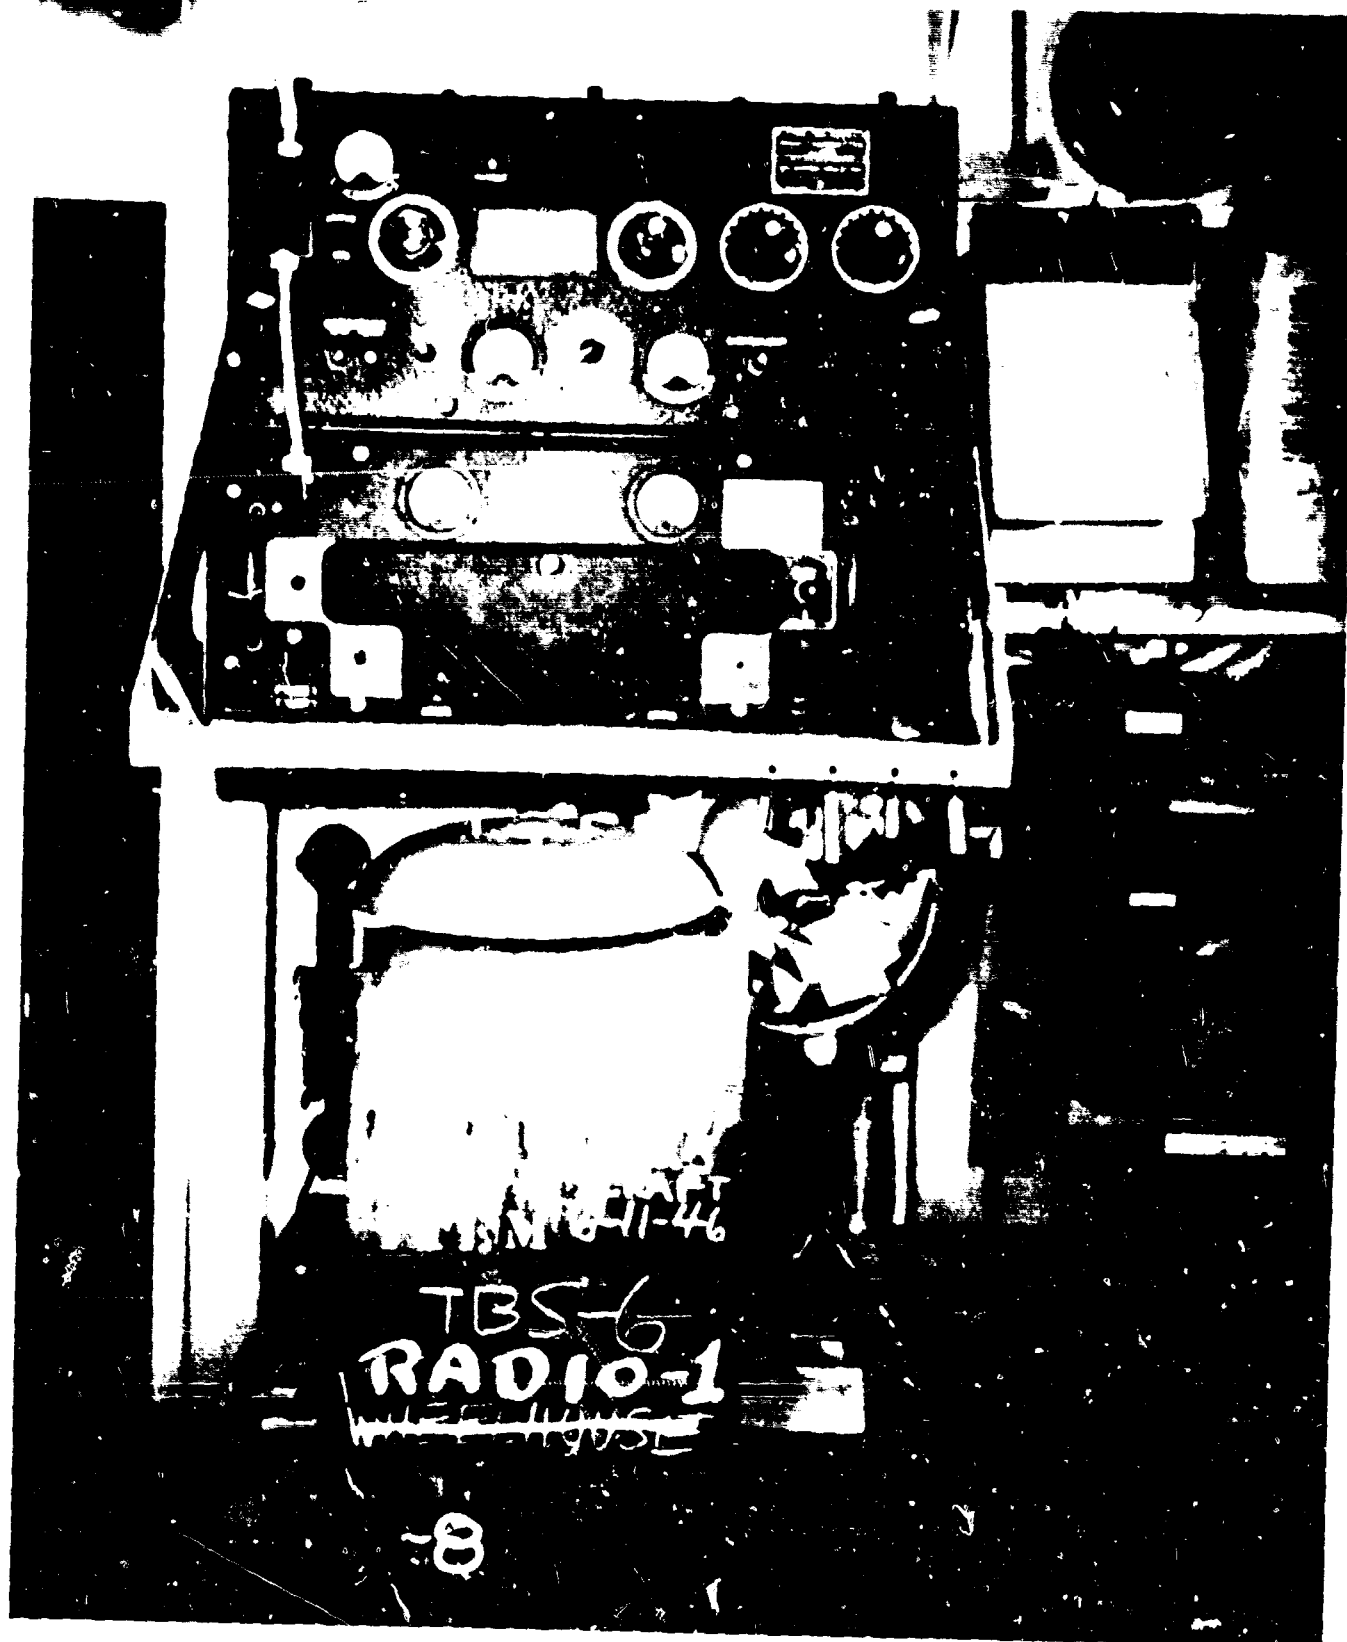
PRE BAKER - RADIO I. View of TBS-6. This equipment was undamaged during Test Able.

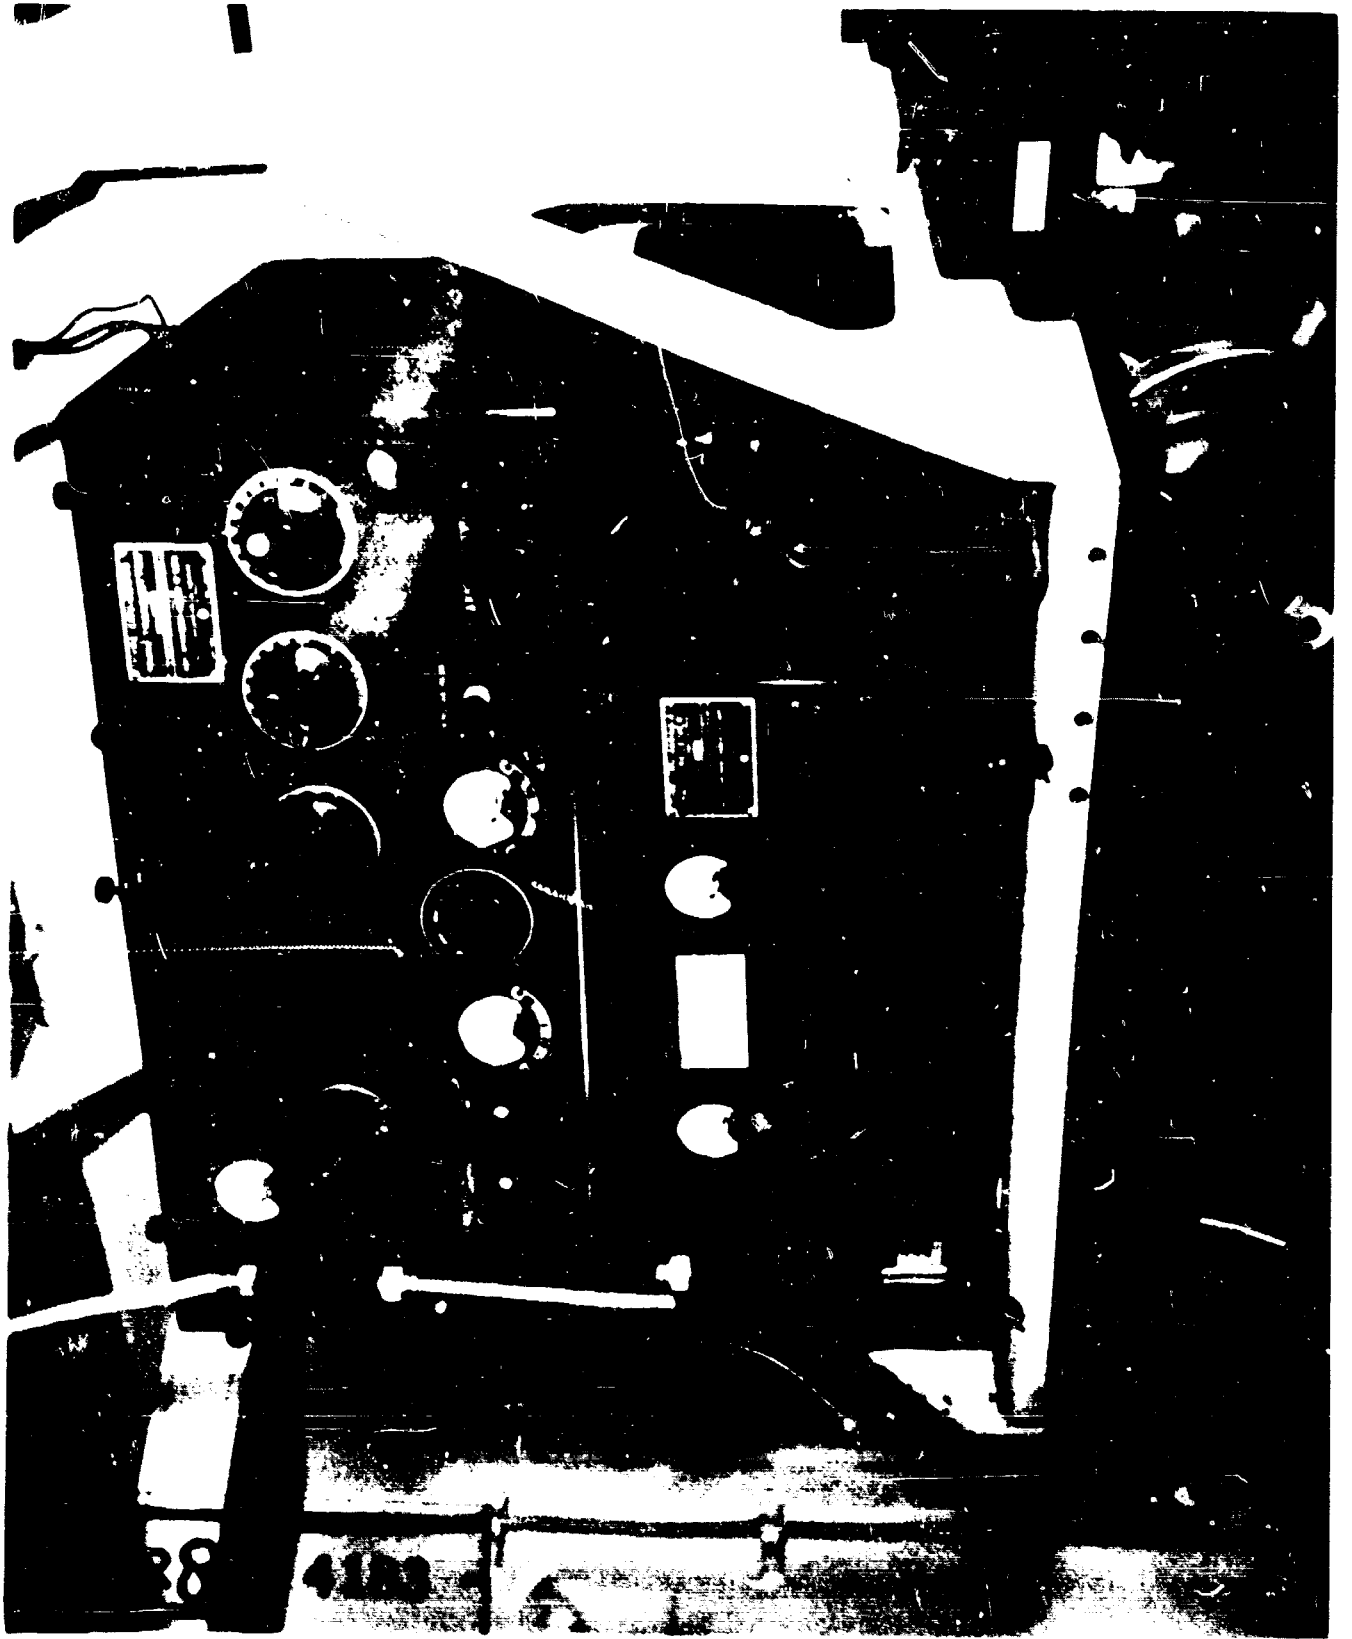
POST BAKER - RADIO I. Violence of shock sheared mounting bolts between receiver and transmitter on TBS-6, resulting in damage to receiver transmission line.
