ELECTRONICS COORDINATING OF
SHIP PREPARATION
and
TARGET INSPECTION

FINAL REPORT
TESTS ABLE AND BAKER

✓ **VOLUME 2**
PHOTOGRAPHIC RECORD

DIRECTOR OF SHIP MATERIAL
JOINT TASK FORCE ONE
OPERATION CROSSROADS

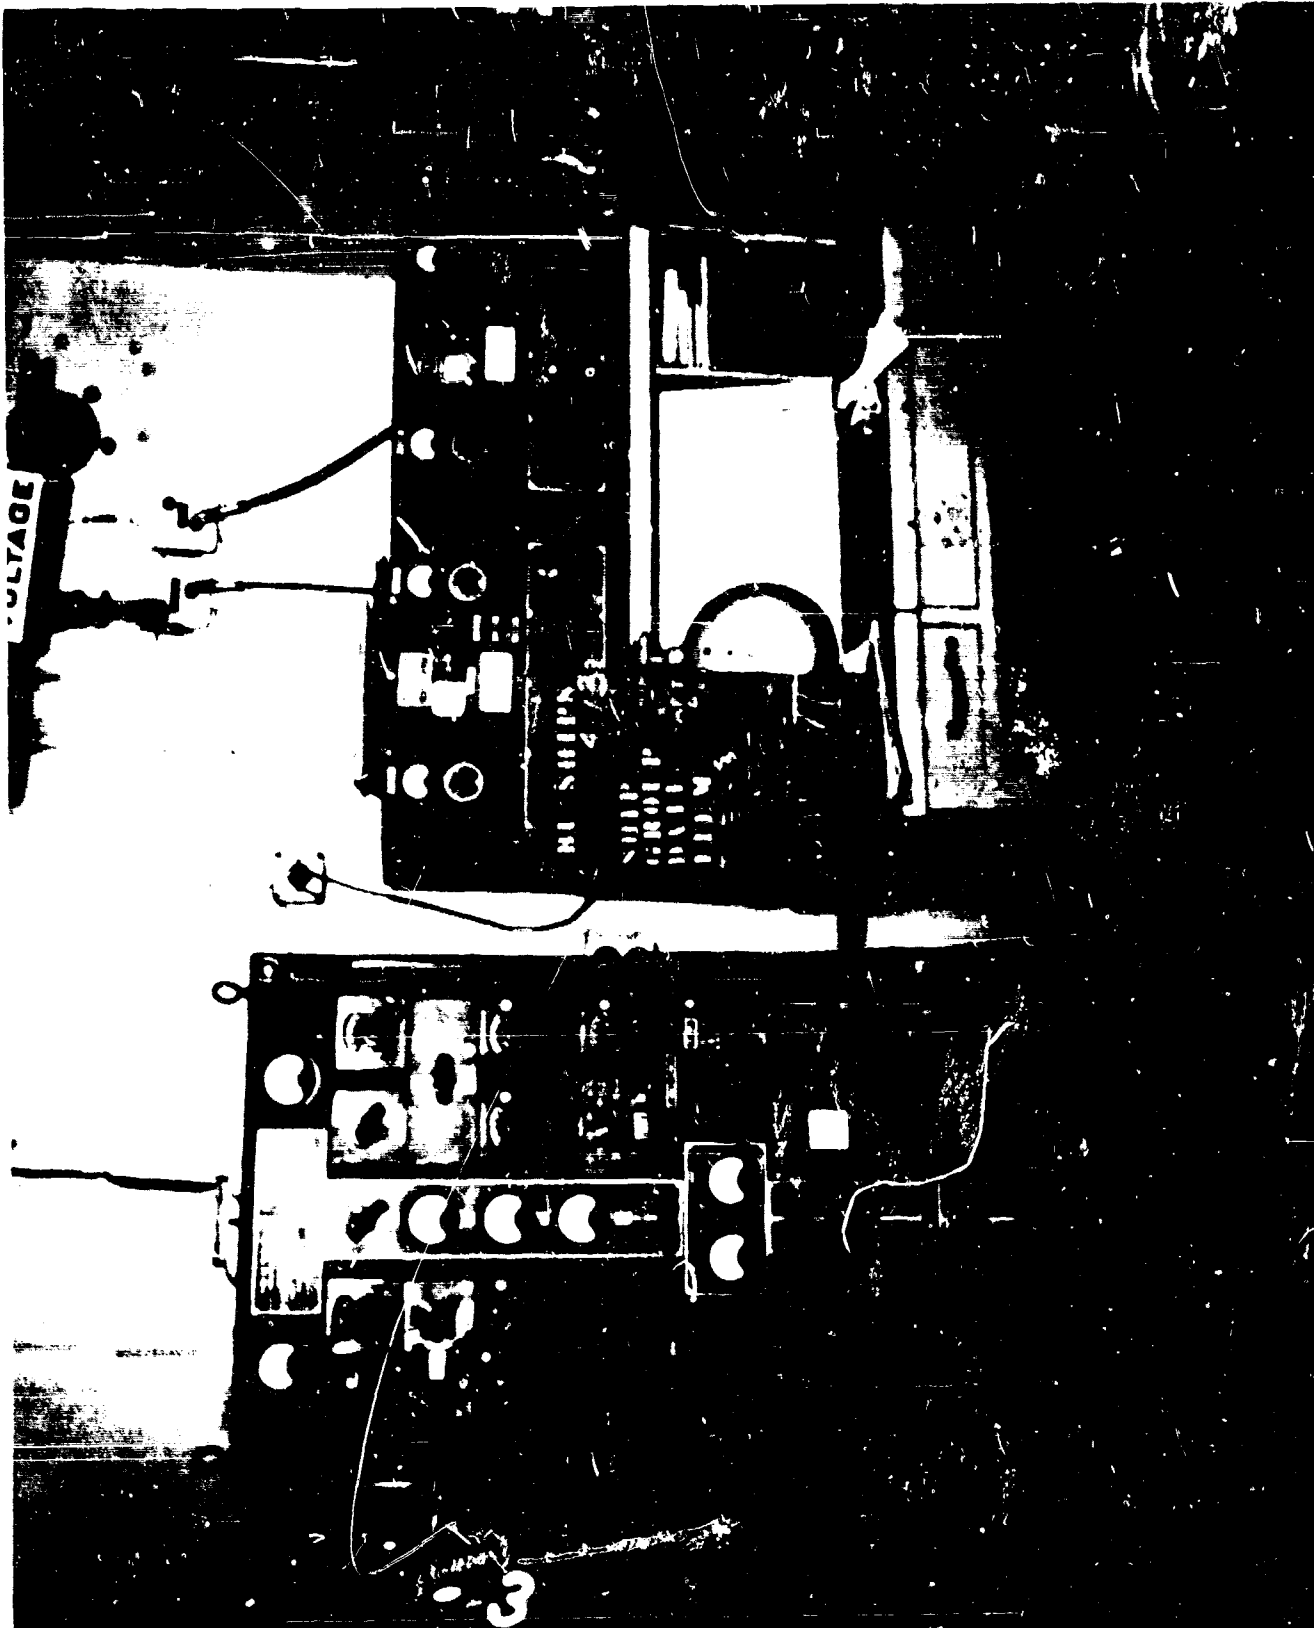
PRE BAKER - RACIA II. Shows TDELS and RAK/RAL. This equipment was undamaged during Test Able.

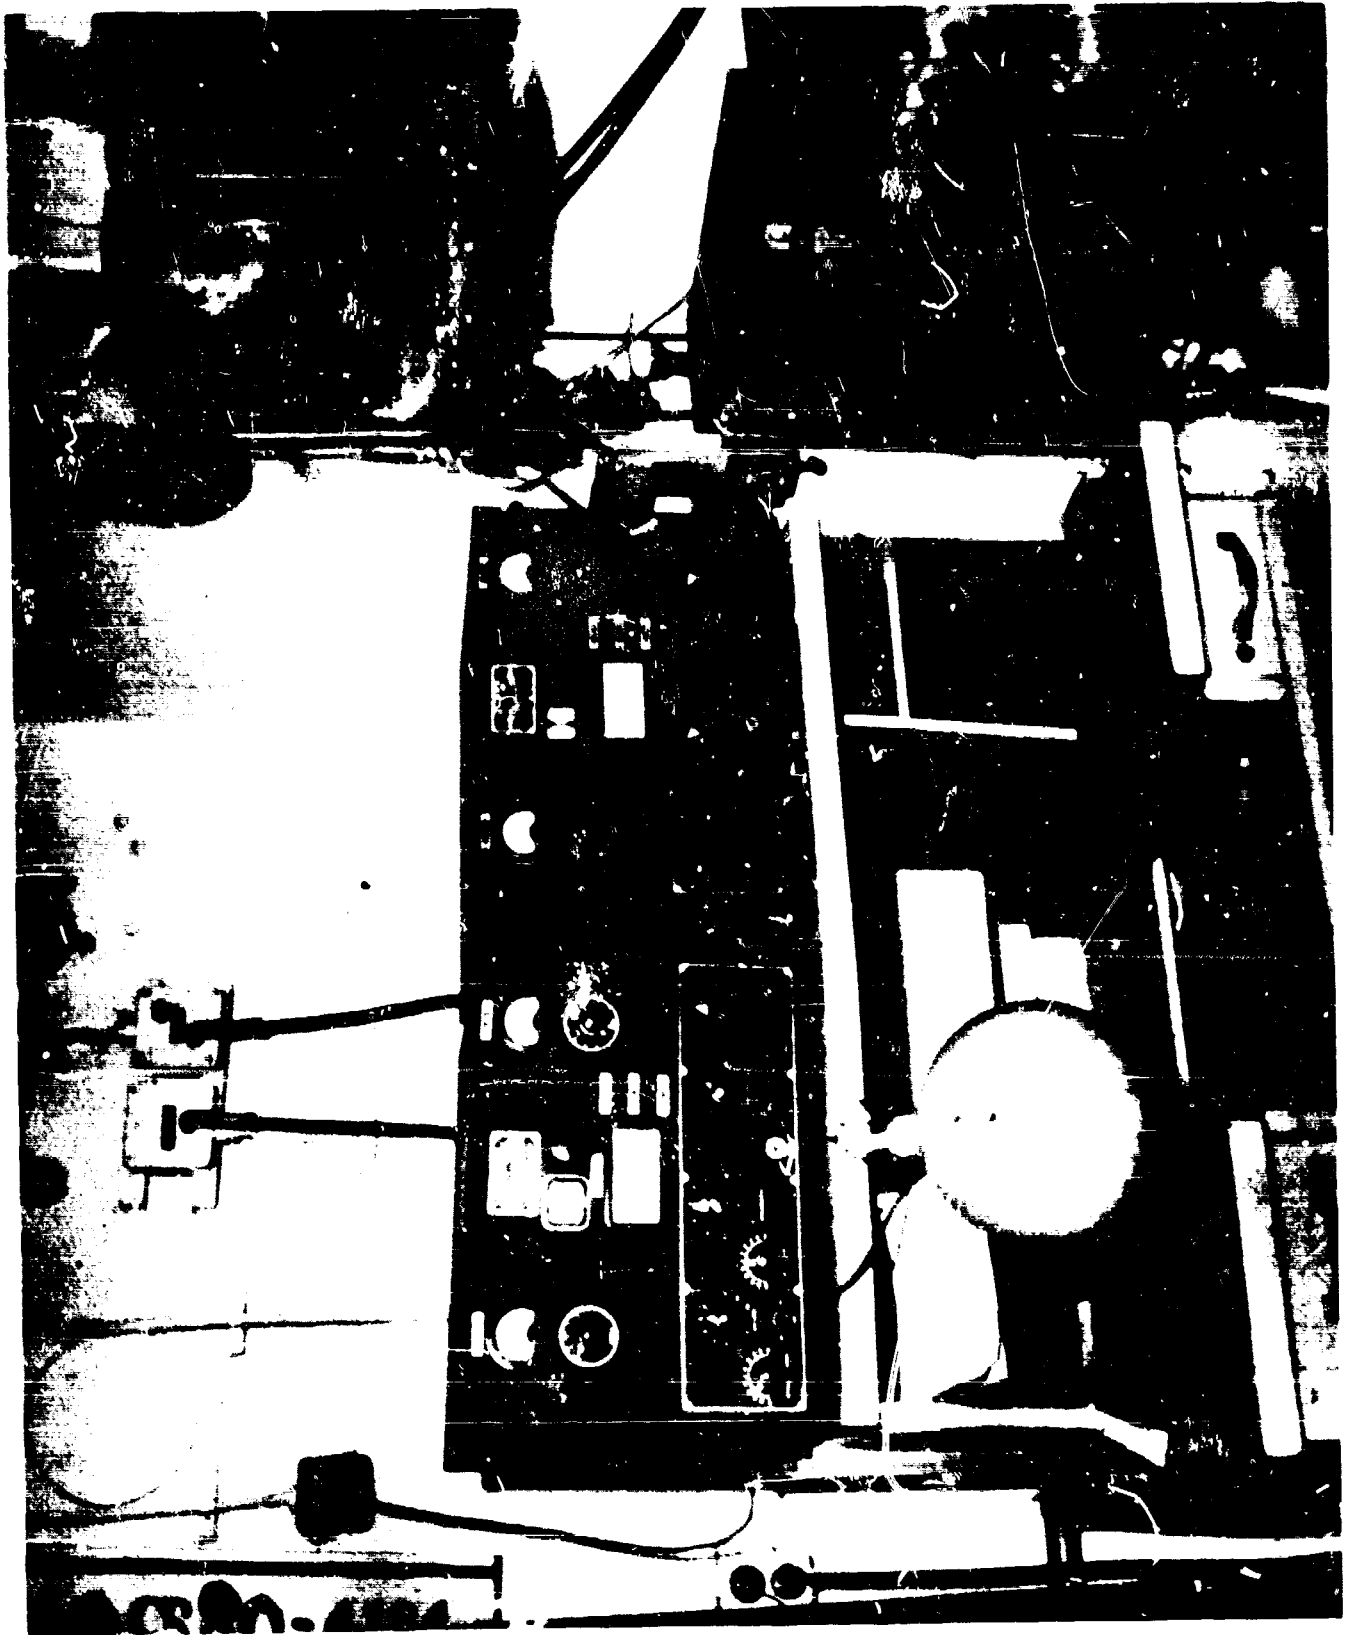
POST BAKER - RADIO II. Operating position showing twisted desk. At extreme lower edge of picture is the empty power supply cabinet from which power supply was thrown to deck.
