**FIFTH QUARTERLY PROGRESS REPORT
EVALUATION OF HIGH-STRENGTH LIGHTWEIGHT
LAMINATED PRESSURE VESSELS OF
LAP-JOINT CONSTRUCTION**

10 April 1963

Period covered: 1 January to 31 March 1963
Republic Aviation Corporation
Farmingdale, L. I., N. Y.

TECHNICAL REPORT NO. WAL TR 766.2/3-4

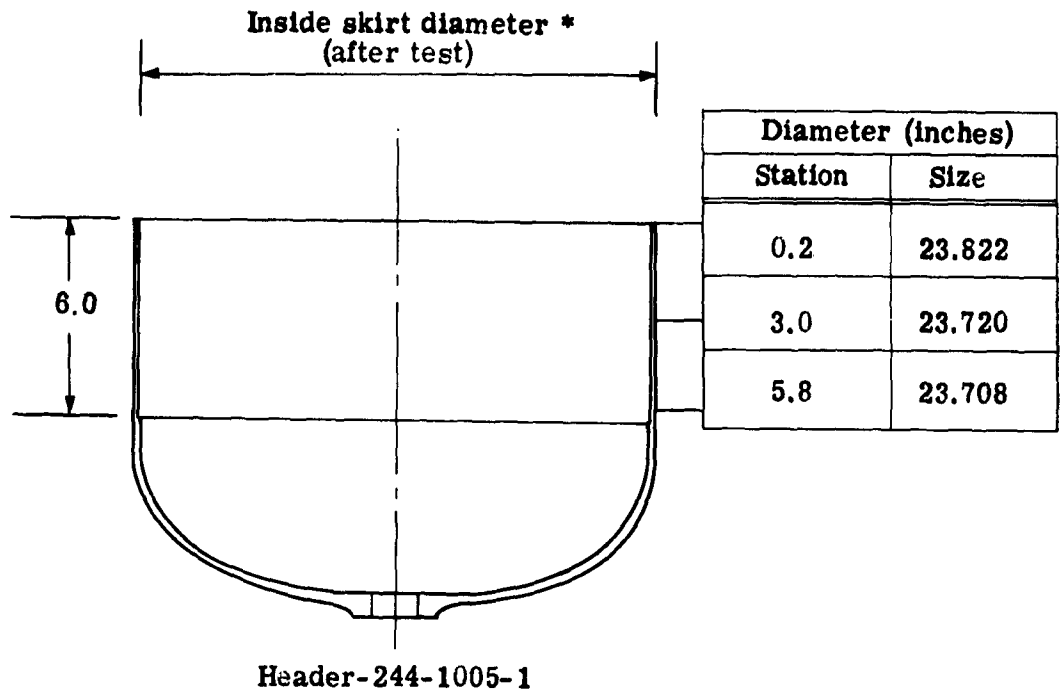
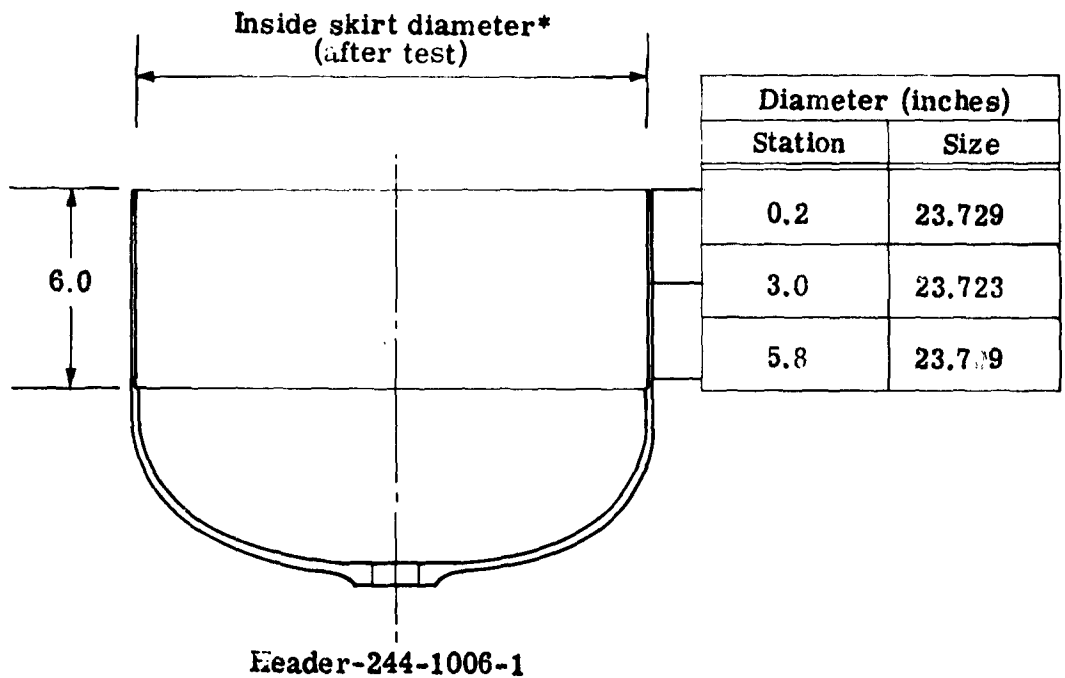
Vessel 2 (III-102) was fabricated using headers 244-1005-1 and 244-1006-1 (see Figures 16 and 17), FM47 adhesive, and three 0.021-inch-thick rings. These headers had been used in the III-101 assembly, and they had sustained permanent deformation. Figure 18 shows the dimensions of the headers before and after the test of assembly III-101. Header 244-1005-1 had been used in pressure vessel tests before this contract. The yield strength of this header was lower than the

Figure 18. Inside Skirt Diameter of Headers after Use in Test Number 1 (III-101)

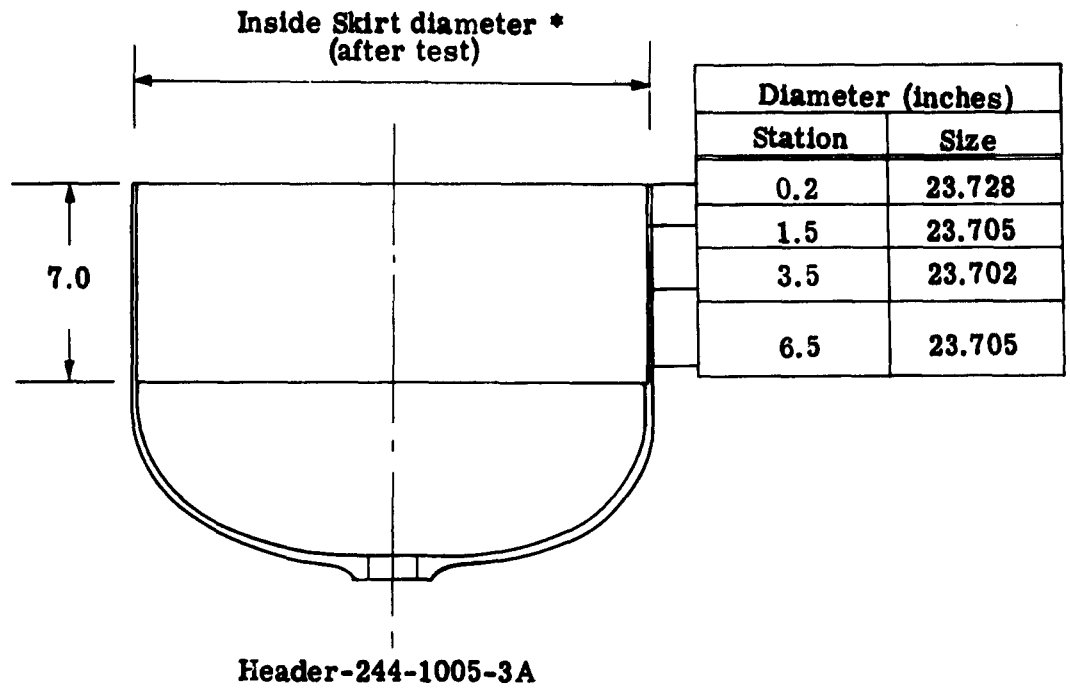
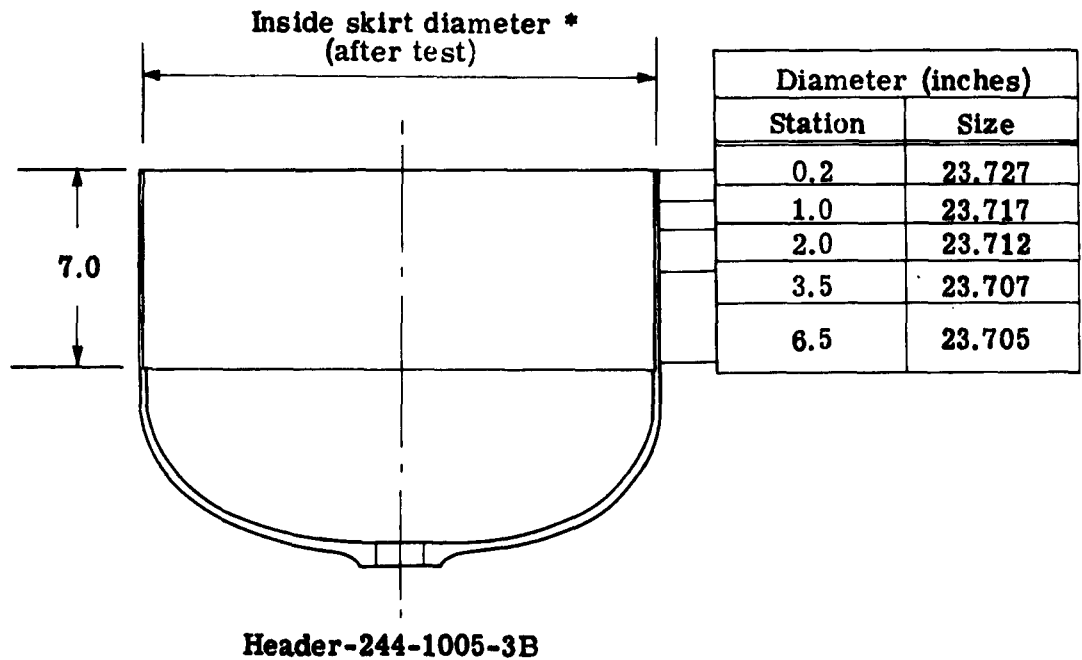
Pressure-vessel assembly 5 (V-202) was manufactured to the same configuration as assembly V-201 with one exception, which was necessitated by the permanent set sustained by the headers. Dimensional changes were made in the skirt portion of the headers because of the very high burst level of vessel V-201; these changes are shown in Figure 25. It can be seen that the magnitude of these changes is less than 0.1 percent of the permanent deformation except at the very edge where the tapered skirt is thinner to reduce the discontinuity effects in the mar-aging steel rings because of the increased thickness of the work-horse-design reusable headers. Because of the permanent set, extra layers of adhesive were used between the header skirt and the mar-aging steel inner-ring faying surfaces during the assembly process. When the assembly was tested, it failed at an internal pressure of 1520 psi. The failure originated in the weldment of the central inner ring at a membrane hoop stress level of 240,000 psi in the metal ring sections. To date, no uniaxial tensile tests have been performed on weldments in this gage of material, but data from tests on the 0.021- and 0.062-inch-thick welded specimens range from 243,000 psi to 265,000 psi (see "Fourth Quarterly Progress Report," Table 2, page 7). The average uniaxial strength of the parent material is 284,600 psi (see Table 6). Visual, X-ray, and stereomicroscopic examination of the weld

Figure 25. Inside Skirt Diameter of Headers after Use in Test Number 4 (V-201)
