Technical Report

PROTECTION OF MOORING BUOYS -  
PART I. INITIATION OF FIELD TESTING

30 June 1963

U. S. NAVAL CIVIL ENGINEERING LABORATORY

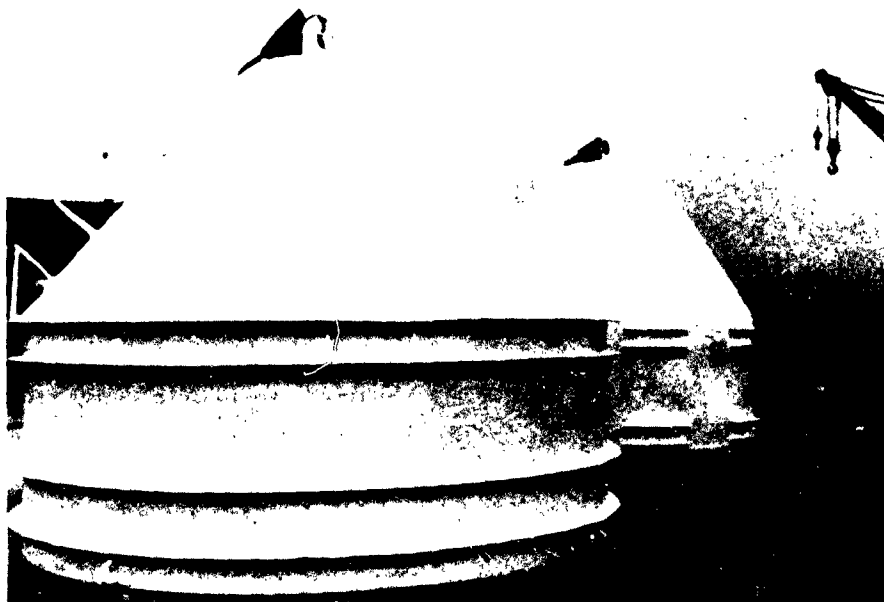
A site in San Diego Bay was selected where Mark I and Mark II peg-top riser-chain buoys provide bow and stern moorings for the fleet. It was felt that the slight difference in size between the Mark I and Mark II buoys (Figure 10) would not significantly affect test results.

Figure 10. Mark I (right) and Mark II (left) buoys coated with Saran. Note the bars on the Mark II buoy for added protection to the anode to be installed later as part of a cathodic protection system.

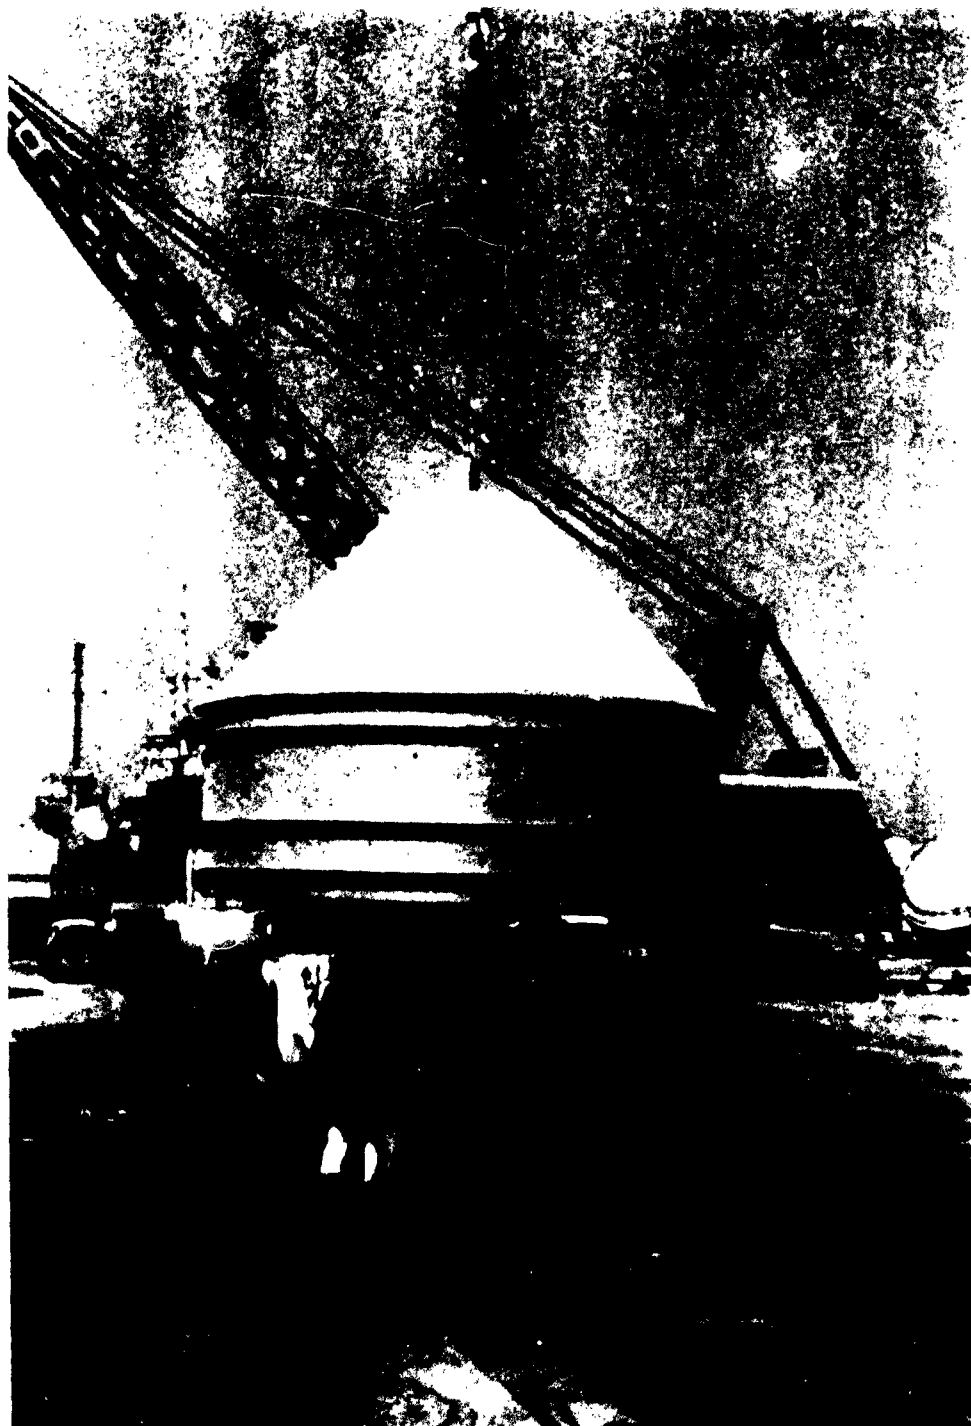
Figure 12. Spraying buoy with phenolic mastic coating; buoy over stumps for added safety.

Spray equipment of the type and size recommended for use with the coating was checked for operational condition. A test patch of coating was applied to the buoy, and this was checked for proper wet film thickness and coating application. Line and gun pressures were adjusted until a proper spray pattern was received. All coatings were applied by spray (Figure 12) unless otherwise noted.

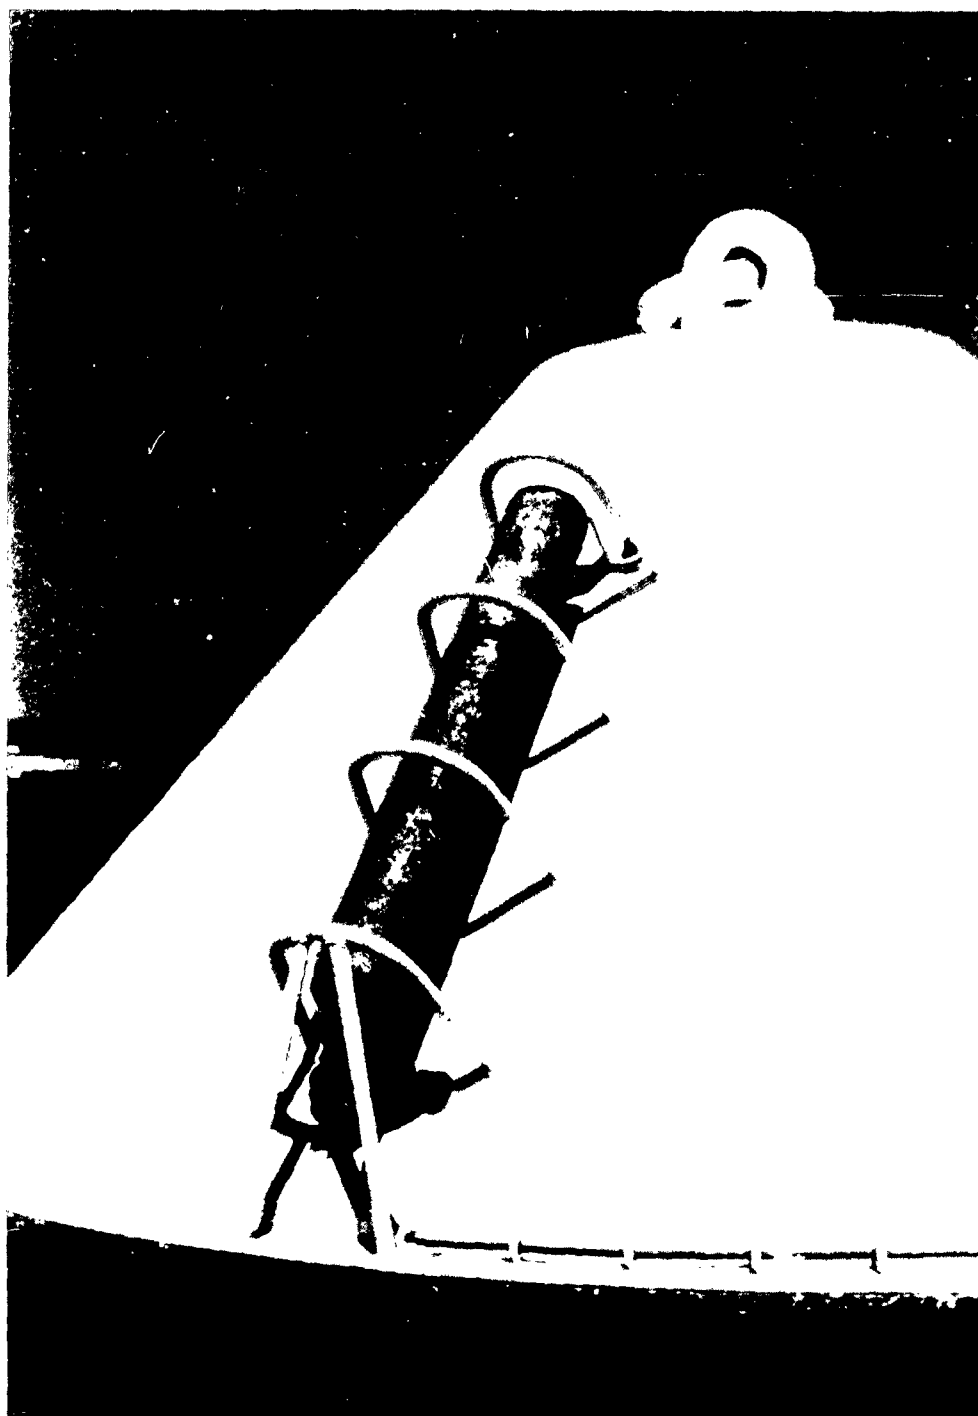
Figure 14. Cathodic protection system installed with anode under protective steel bars and remote ground cable threaded through links.

The remote ground cable was then brought through the lower fender to a point on the side of the buoy above the water line. Here it was soldered to a fitting that had previously been welded to the buoy. Use of the remote ground cable distributes the cathodic protection throughout the underwater portion of the buoy.

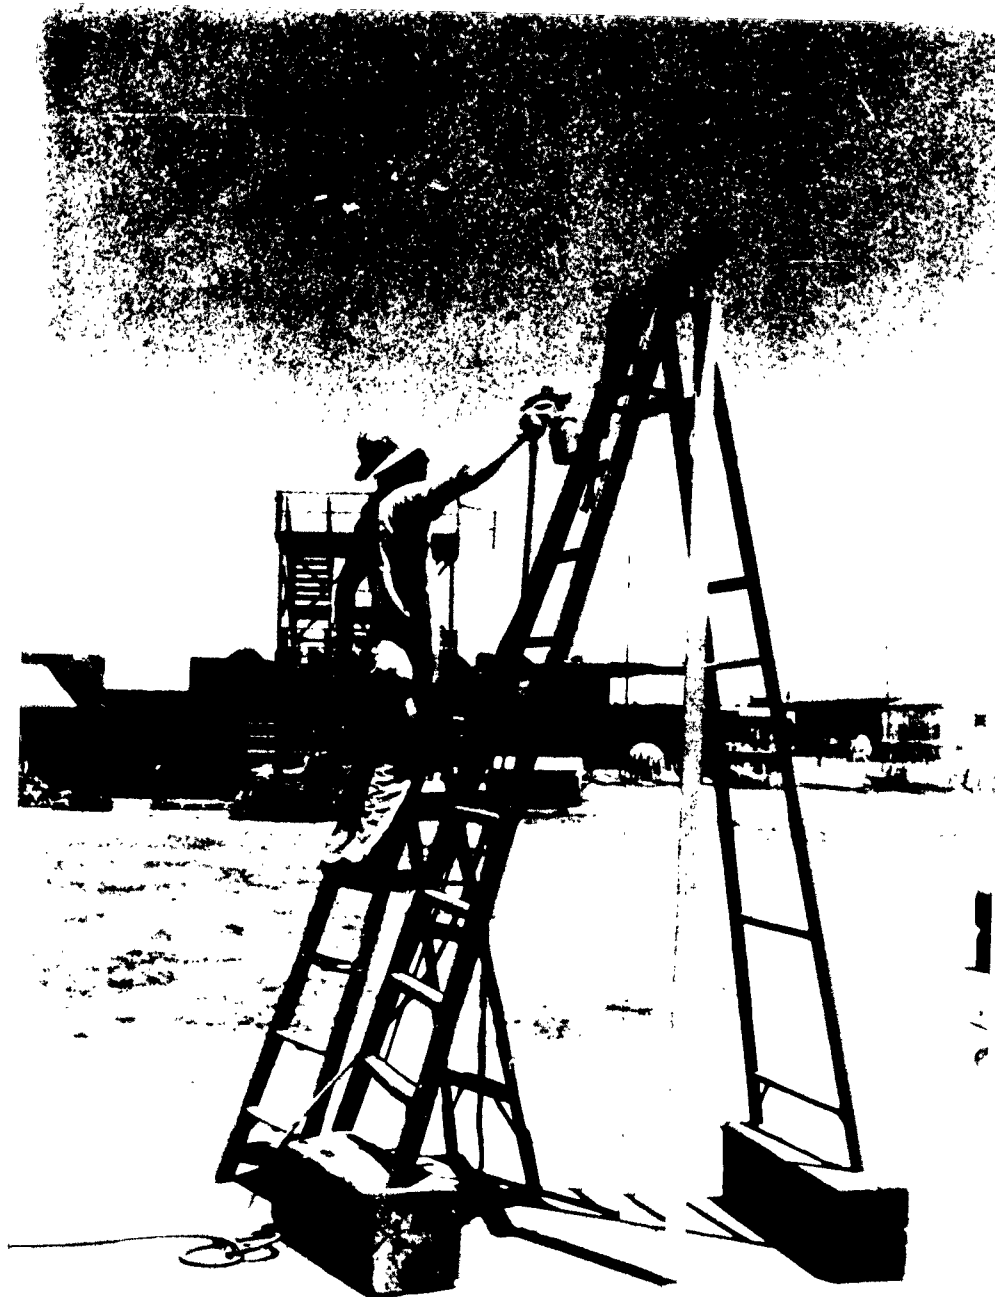
Figure 16. Coating steel test panels.

At the time of coating the test buoys, two steel test panels 10 feet long, 4 inches wide, and 1/4 inch thick were coated with each of the test coating systems with the same equipment and conditions as each of the test buoys (Figure 16). One set of 13 panels was suspended from a pier in San Diego Bay and the other from a pier in Port Hueneme Harbor. They were exposed so that a portion of each panel was continually submerged, another portion was subjected to tidal changes, and a third portion was continually exposed to the atmosphere. These panels may give information on how much protection each coating system provides in a marine environment when abrasive forces are not present.
