TRECOM TECHNICAL REPORT 63-10

Automatic Light Aircraft Readiness Monitor  
Project ALARM

VOLUME I

York Division of The Bendix Corporation  
York, Pennsylvania

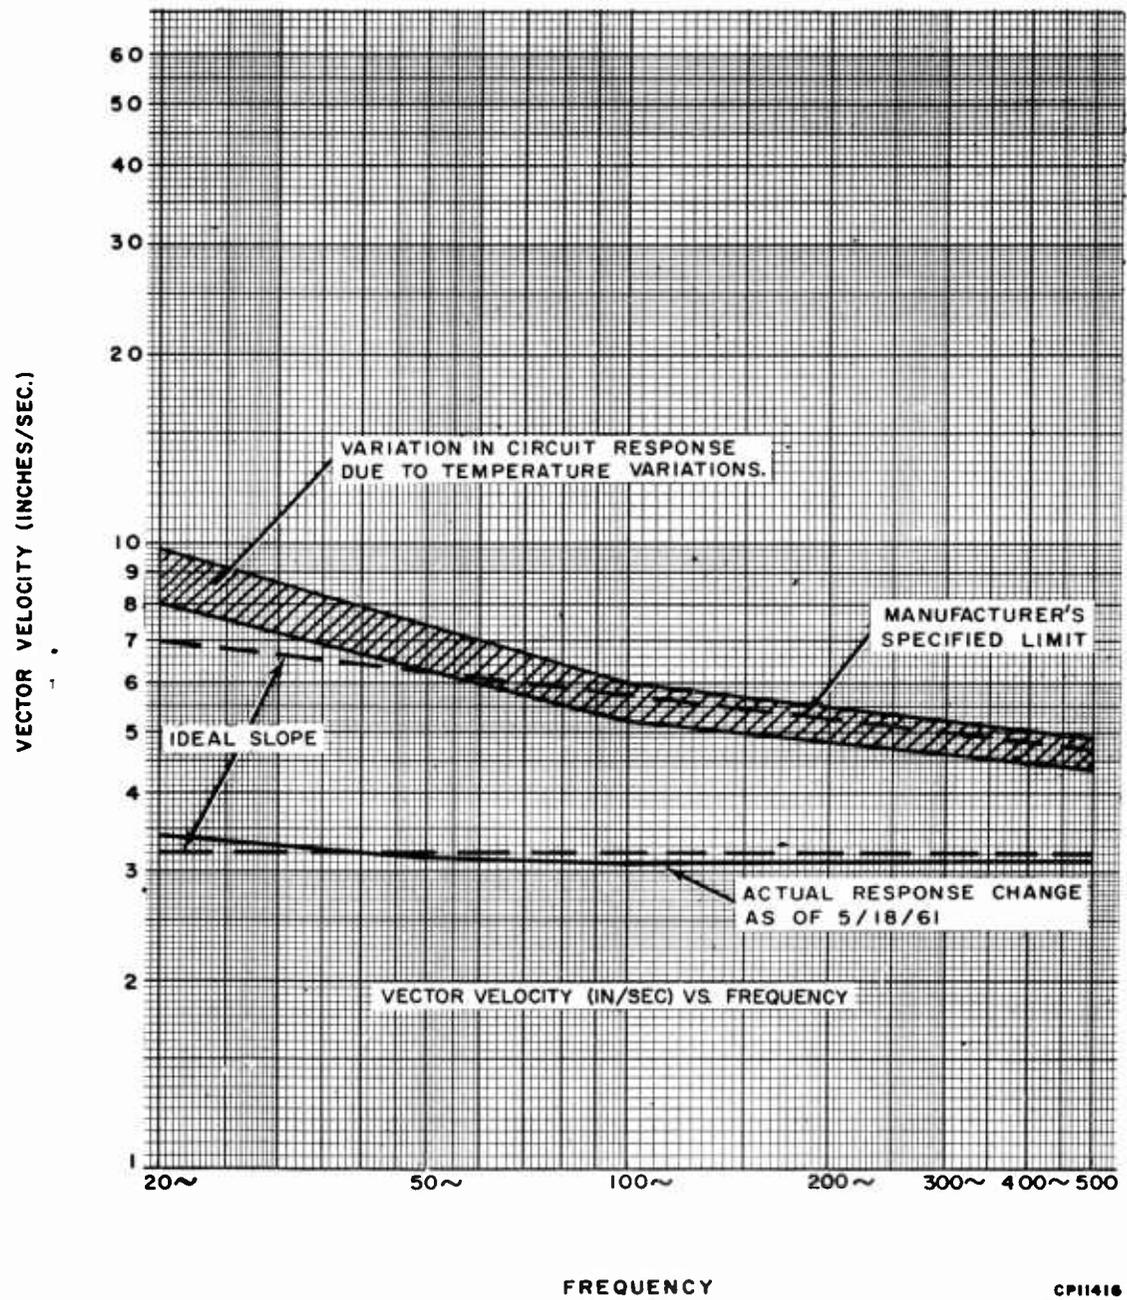
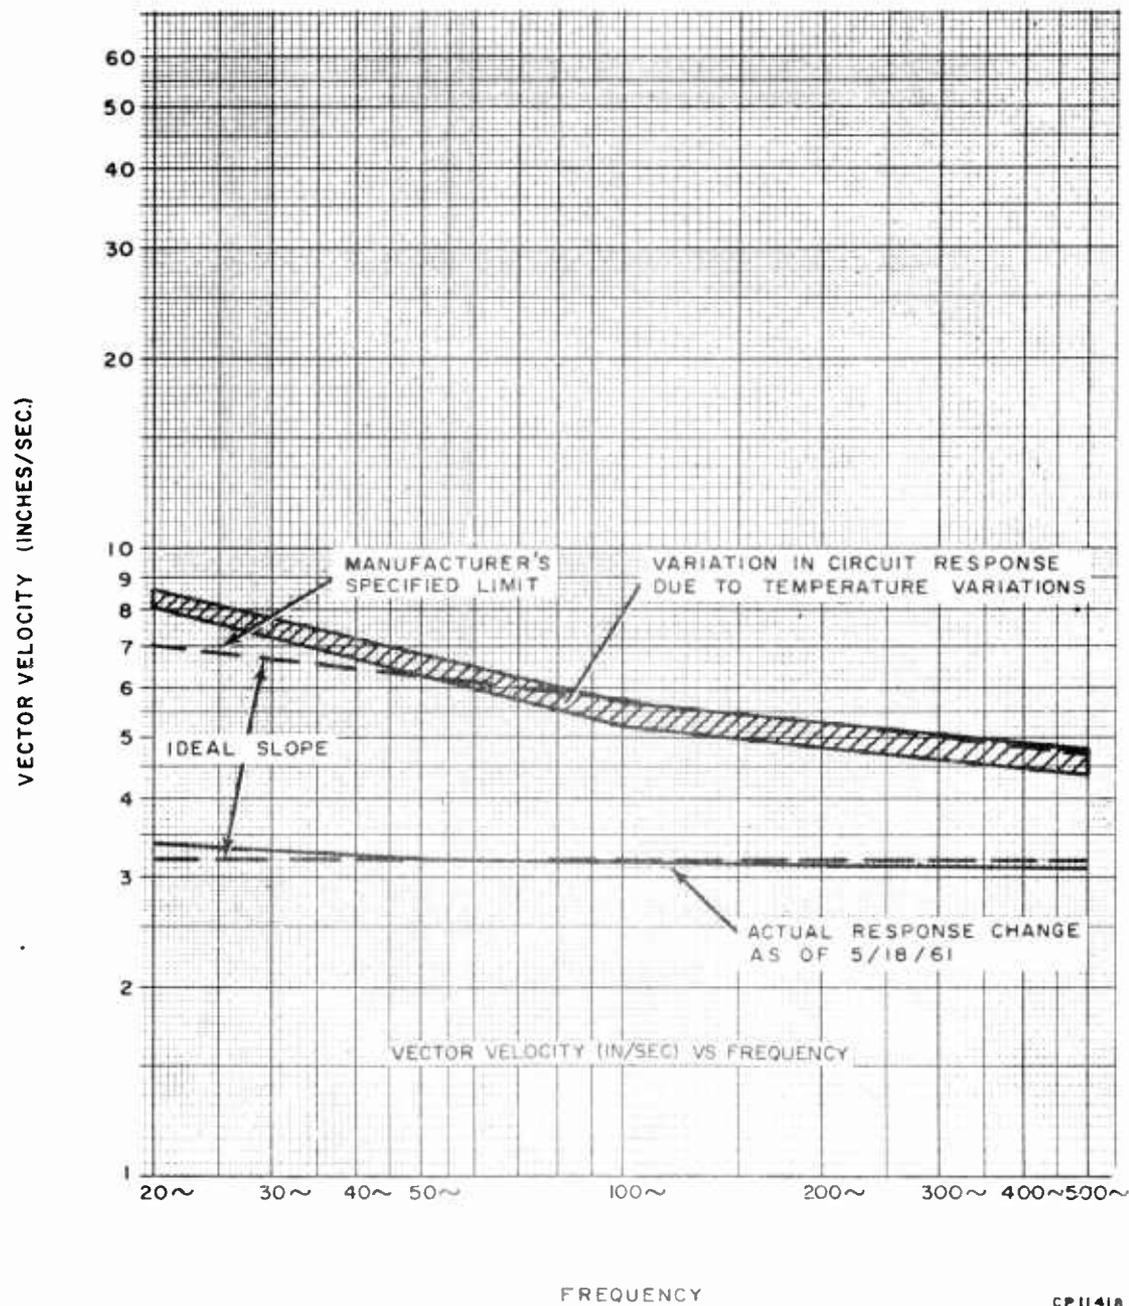
The next five illustrations (7 through 12) show essentially the same categories of data concerning Engine Vibration Channels. Note particularly in Figures 7 and 8 the change made to the detection level; this resulted when it was realized the original detection level, as specified by the manufacturer, was too high to permit any realistic indication of any engine difficulty. At the same time, the ideal slope of this response was changed to a uniform response across the frequency band, at 3.2 inches/second. Even at this decreased detection level, at no time during the Operational Tests did an indication occur on these Channels, verified by observing the maximum amplitudes of plots on Figures 9, 10, and 11. This caused an even further decrease for the detection level used in the Malfunction Tests which are detailed in this document.

FIGURE 7. CHANNEL SENSITIVITY, AFT ENGINE VIBRATION, PLOT

FIGURE 8. CHANNEL SENSITIVITY, FWD ENGINE VIBRATION, PLOT

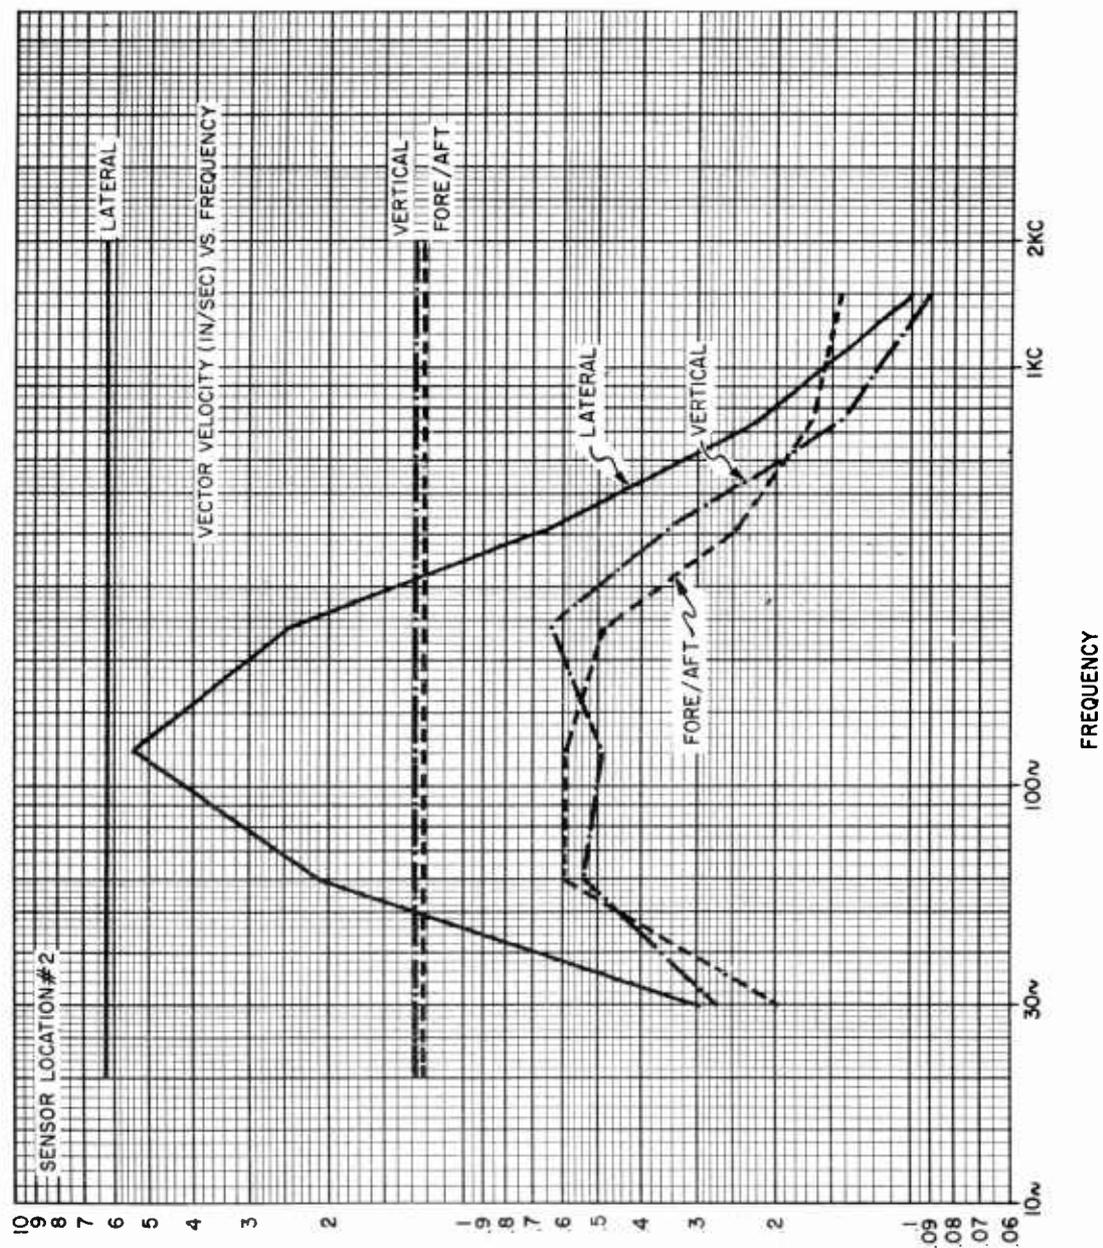
The results of a 3-plane study of tail vibrations, shown in Figure 15, revealed predominate lateral vibration occurring, but it was suspected that the method of sensor mounting for this test resulted in some structural resonances. The sensor was mounted on a solid block of aluminum that had been welded to an aluminum sheet which replaced an inspection panel. This gave a large mass mounted to a thin and flexible base. The data collected while employing this mounting then had to be considered as questionable in value. Final changes were made to the location and mounting, predicated by qualitative analysis of all of these earlier tests. The sensor was eventually mounted on the 90° Gear Box and oriented to transduce the vertical and fore-and-aft planes. This location (#3) was used for the subsequent Malfunction Tests.

FIGURE 15. TAIL VIBRATION, VECTOR VELOCITY VERTICAL, LATERAL, FORE/AFT PICKUP ORIENTATION

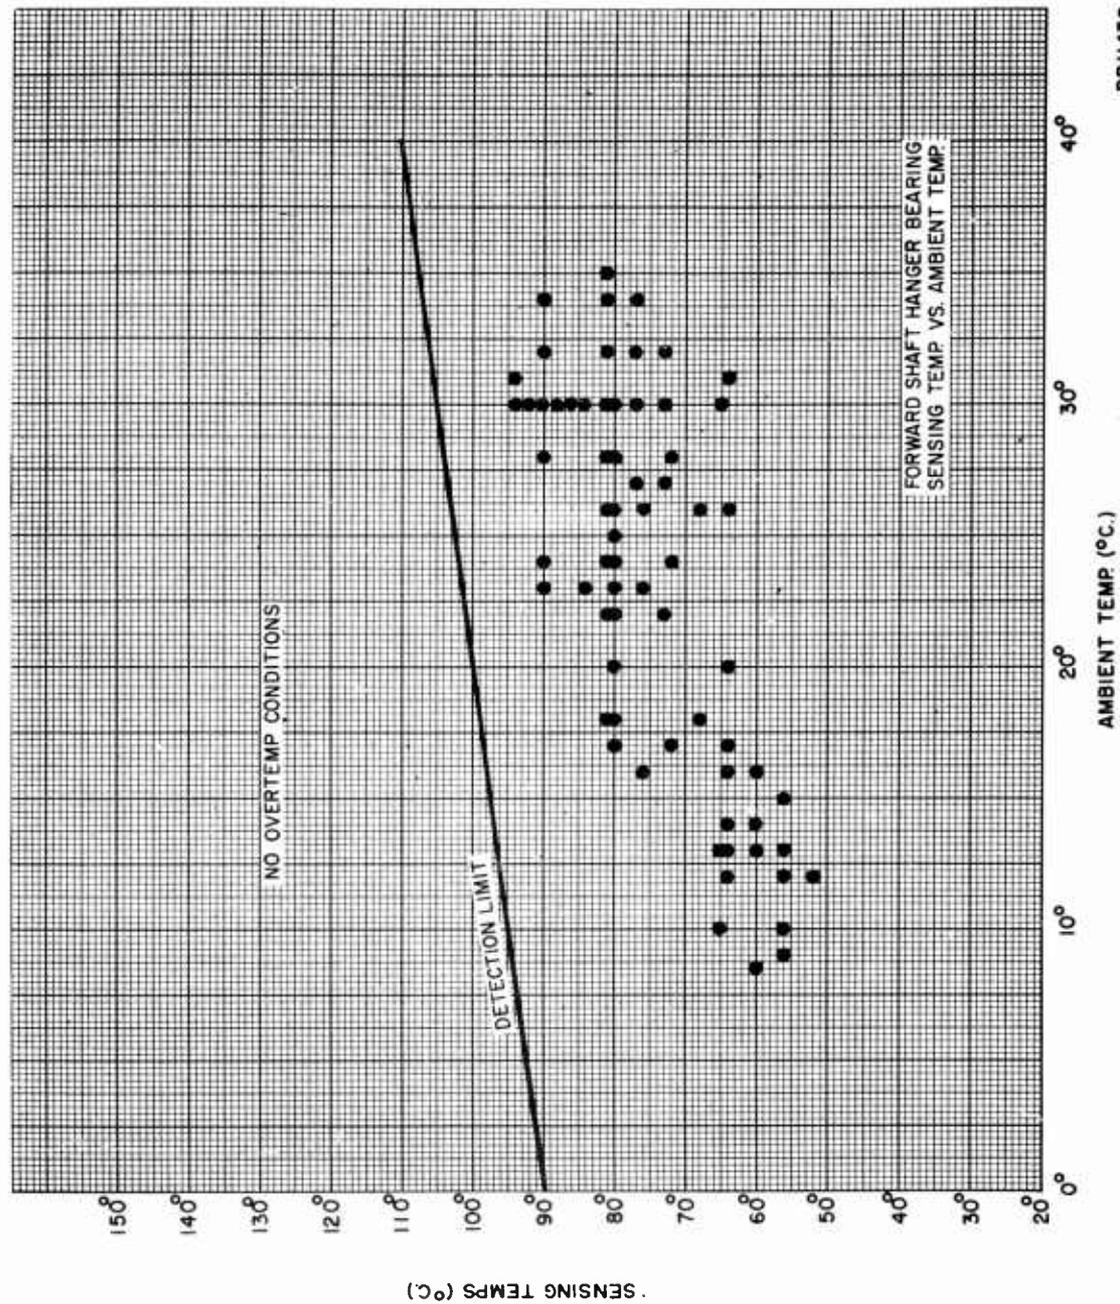
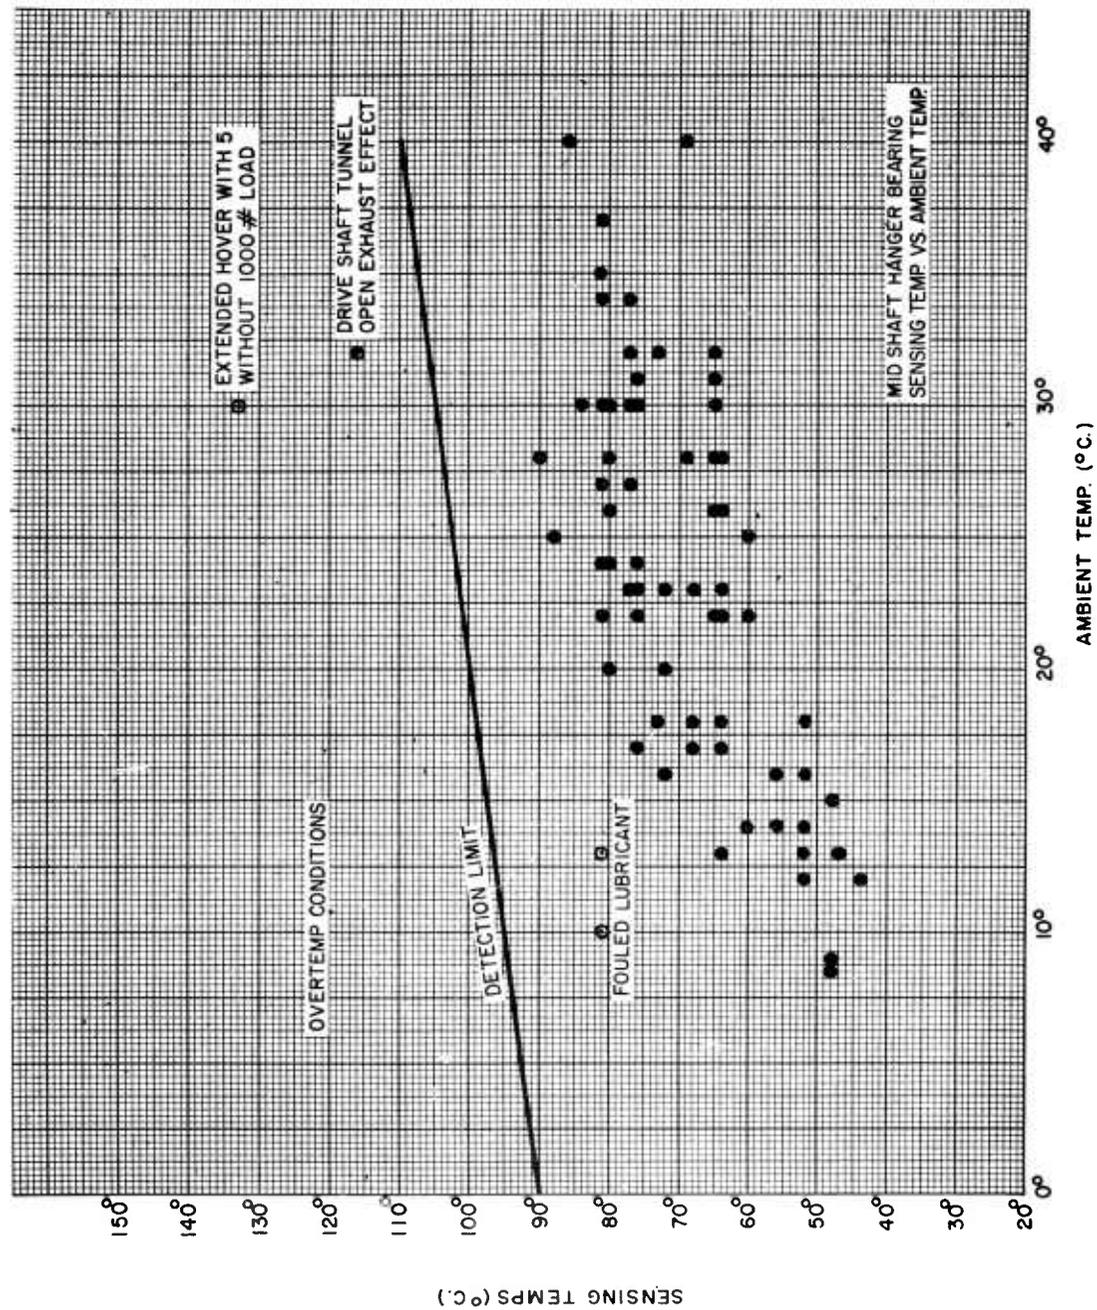
Data on the three Shaft Hanger bearing monitors are shown on Figure 18 and Part 1 of Figure 19. These data represent the accumulation during both Operational and Malfunction Testing. Early in the Operational Test programs, an indication occurred on the Mid Shaft Bearing and upon examination was found to have been caused by contaminated lubricant in the bearing. Upon removal and relubrication, the operating temperature dropped appreciably. This condition was repeated at various times and substantiated. Subsequent periodic indications during extended hovers in high ambient temperatures led to increasing the detection limit to avoid some of these conditions. The hover indication at high ambient temperatures is such that it should be heeded before catastrophic damage to the bearing occurs. It is suspected that the three hanger bearings were all operating at a higher than normal temperature because of the behavior experienced on the Mid Shaft Bearing. All three of these limits may eventually be reduced.

FIGURE 18. FWD SHAFT HANGER BEARING, SENSING TEMPERATURE VS AMBIENT TEMPERATURE (PART 1)

FIGURE 18. MID SHAFT HANGER BEARING, SENSING TEMPERATURE VS AMBIENT TEMPERATURE (PART 2)

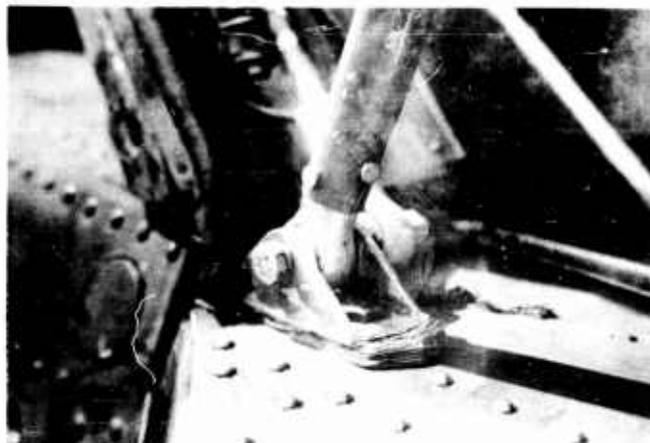
This test was performed by removing aligning shims beneath the right rear engine mount as shown in Figure 26. Results were negative, with no detectable vibration increases occurring when a total of .130 inch of shimming was removed. No abnormal vibration was observed by the pilot or observers during this condition. It must be assumed that the subsequent short-shaft misalignment thus created (if any) was effectively absorbed by the shaft's couplings to the engine and transmission, preventing any abnormal vibratory motion of the engine. It should be noted that when a similar test was conducted early in the test program (involving the original engine), when only .030 inch was removed from the left rear mount, a detectable increase in vibration occurred. This condition was not evaluated further due to the risk to the then flyable aircraft. It has created some anticipation that eventually this condition can be determined as one producing abnormal engine vibration.

Figure 26. Right Rear Engine Mount and Shims, Short Shaft Misalignment Malfunction Test.

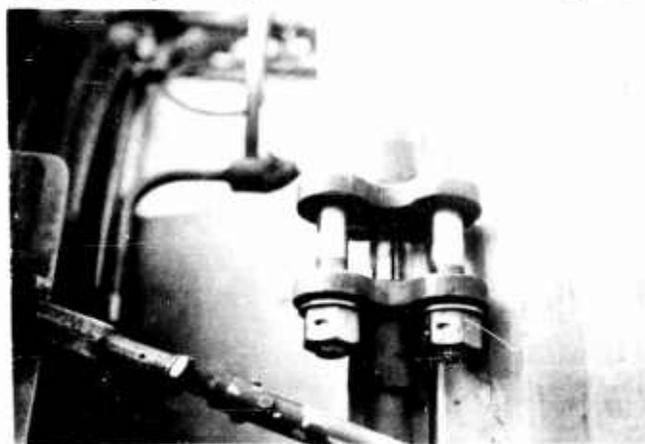
Figure 27. Engine V-Band Coupling Clamp (Loosened), Excessive Engine Vibration Malfunction Test.

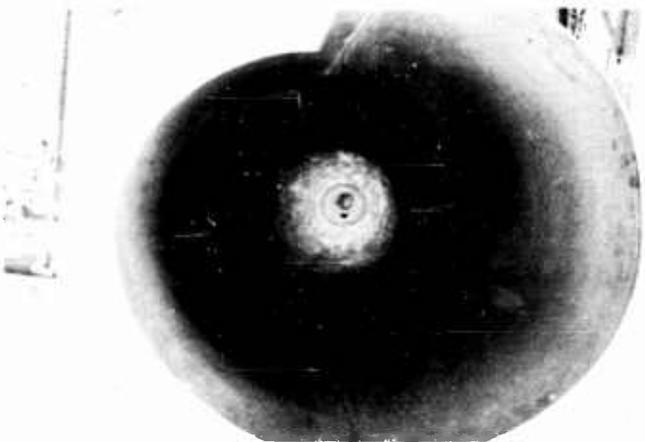
Figure 28. Engine Exhaust Opening Showing "Bishop's Hat", Excessive Engine Vibration Malfunction Test.

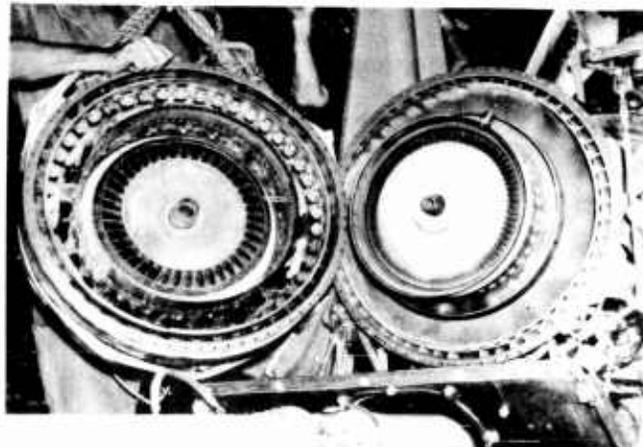
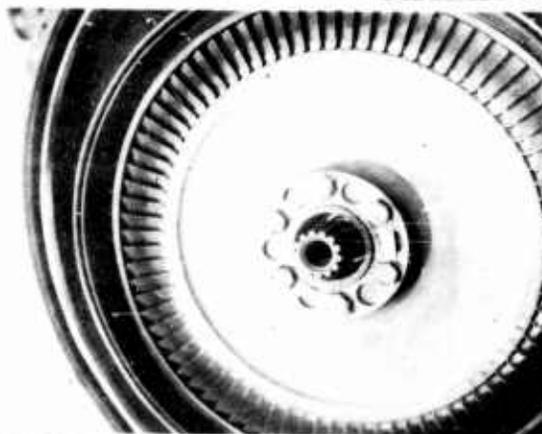
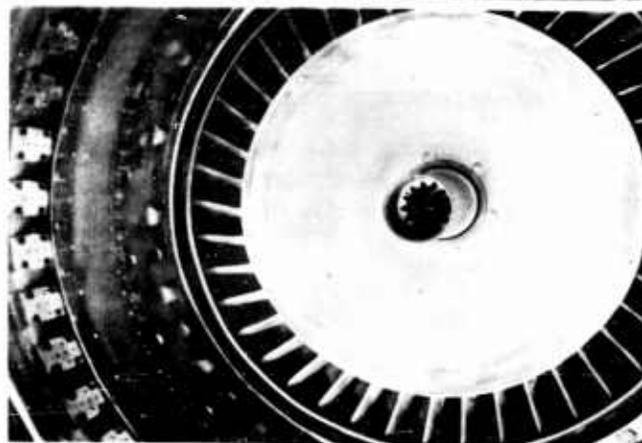
For this test, a series of N<sub>2</sub> turbine wheel rotations were performed as illustrated in Figures 29, 30 and 31. On the first removal, the turbine wheel was carefully marked for reference position on the power shaft, then rotated 90° and reassembled. After that test run, the operation was repeated, placing the turbine wheel at 180° from reference, and another data run conducted.

Figure 29. Combustion Chamber (N2 Turbine) Disassembly, Turbine Wheel Rotation Unbalance Test.

Figure 30. N2 Turbine Showing Marks Used To Determine Location For Turbine Wheel Rotation Unbalance Test.

Figure 31. N1 Turbine In Preparation For The Turbine Wheel Rotation Unbalance Test.

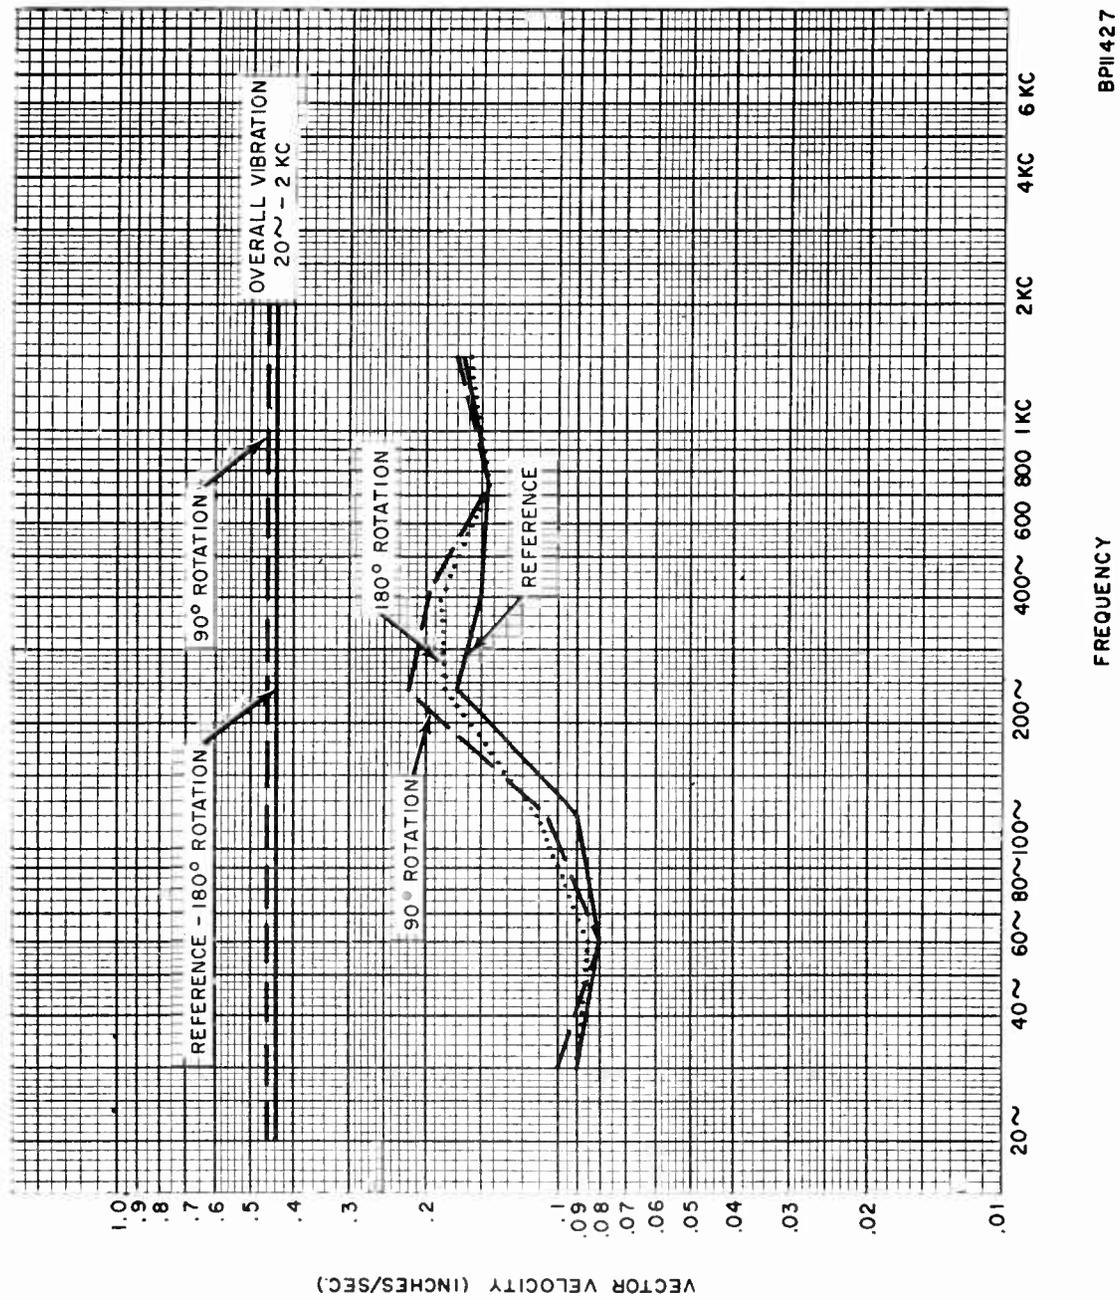
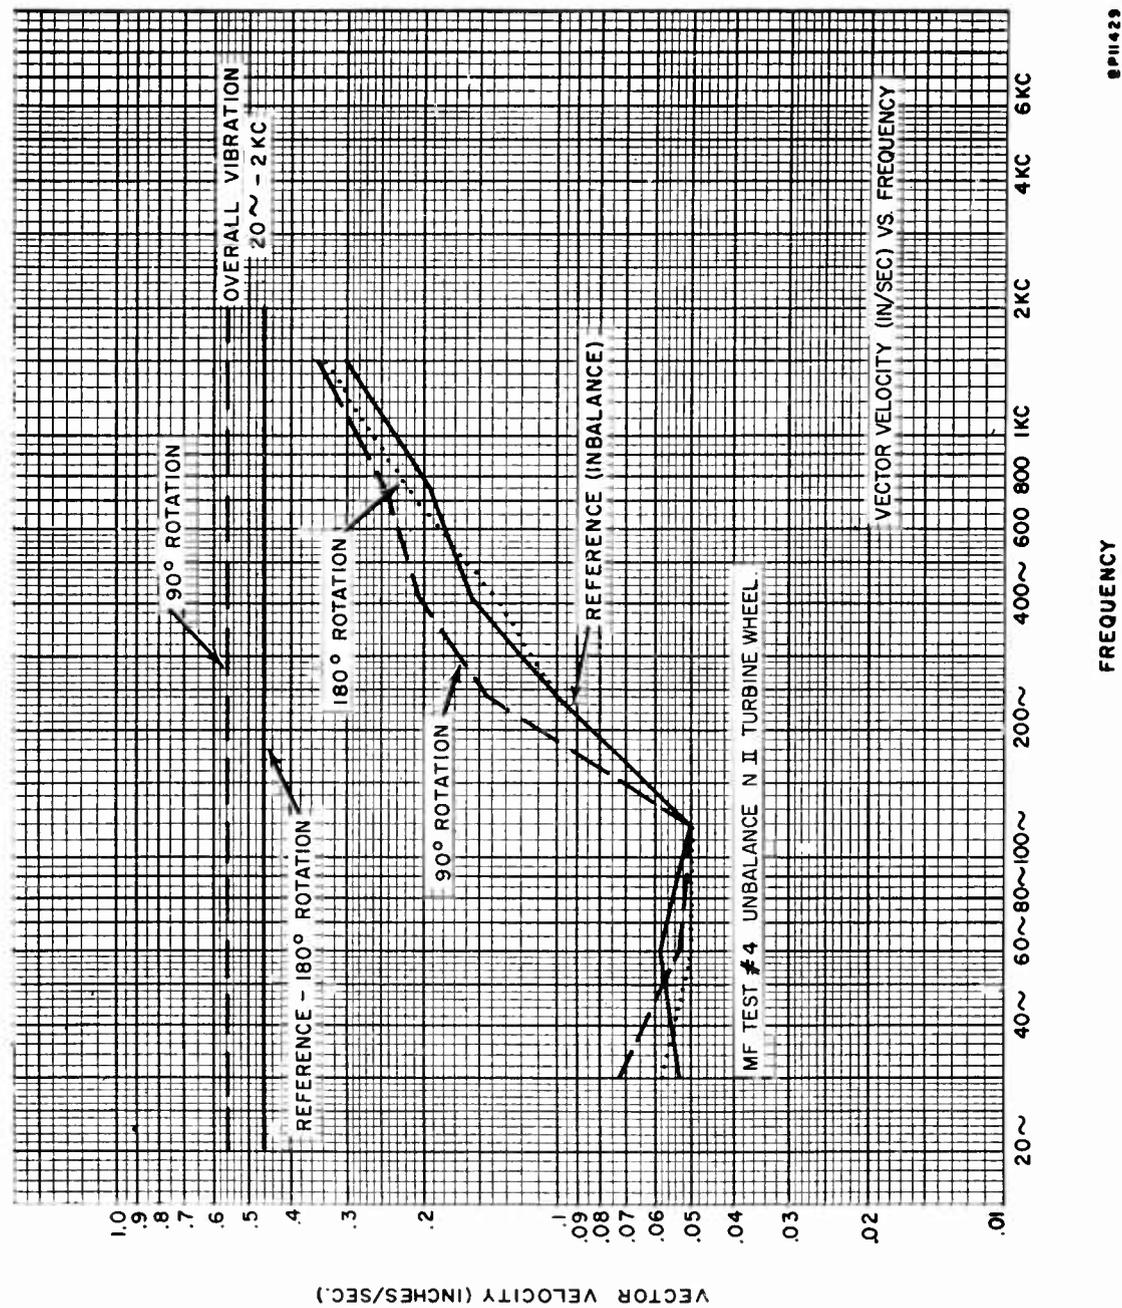
Results of these tests are illustrated graphically in Figure 32 and Figure 33. As shown on the data plots, the most significant vibrational increases

occurred on the Forward Engine vibration and for the 90° position of the N<sub>2</sub> turbine wheel. This channel (Fwd Eng Vib) did indicate during the 90° test as a verification of these data. From these results, it is concluded that the nature of the unbalance was most pronounced when the turbine wheel was rotated to the 90° position. An engine overhaul report, to be supplied by Army depot maintenance, on this particular engine should provide information supporting the results of these tests. It is not known at this time whether the unbalance is beyond any allowable limits. The suspected reason for the greater increase in forward engine vibration than that detected at the aft engine location under these unbalance conditions was that the vibratory motion induced was transmitted by the power shafting and had a more pronounced effect on the forward support bearings due to resonances.

FIGURE 32. AFT ENGINE VIBRATION, VECTOR VELOCITY VS FREQUENCY, PLOT

FIGURE 33. FWD ENGINE VIBRATION, VECTOR VELOCITY VS FREQUENCY, PLOT

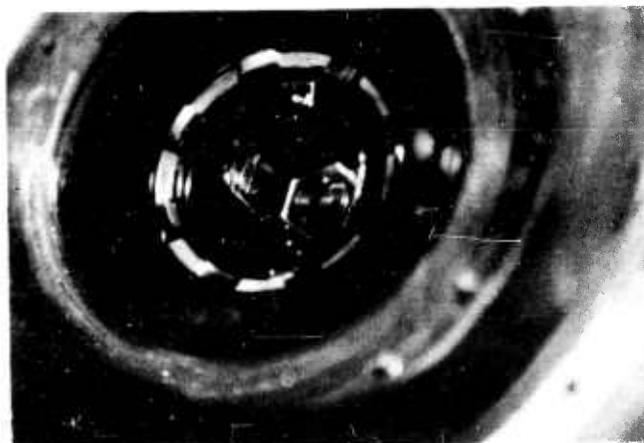
Figure 38. Power Shaft Bolt And Lock Assembly. (Loss of torque, N2 torque wheel mounting bolt, engine malfunction test).

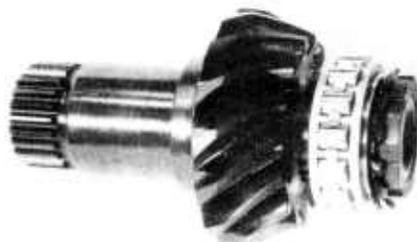
Figure 40. 90° Gear Box Input Quill Gear/ Bearing Prior To Annealing.

The 90° Gear Box Input Quill assembly was removed and disassembled to the bevel gear/bearing combination as shown in Figure 40. This assembly was annealed from a gear hardness of Rockwell C 62 to Rockwell C 34 and re-installed. Approximately 17 total hours of running time was conducted with no change observed. The same disassembly and annealing process was repeated, lowering the gear hardness to Rockwell C 12. This time, on application of T/R torque, a temperature indication occurred as tests of the 42° Gear Box had demonstrated (see Figure 19, Part 2 plot, for data). After approximately 2 more hours, it was decided that an additional forcing condition would be made to provide accelerated gear deterioration for vibration analysis. A major portion of the lubricant was removed from the gear box and the tests continued. This resulted in a temperature and vibration indication on the system, as well as chip detection. Figure 41 shows the vibrational data, while Figure 19 may again be referenced to show the temperature result. Figure 42 shows the condition of the gear as removed after these tests. No catastrophic failure occurred, but sufficient wear occurred to justify the indications obtained on the ALARM System and certainly sufficient to replace this gear box had this condition occurred under normal operation. Figure 43 shows the 90° GB Chip Detector with the particle accumulation as it appeared on removal after this test.

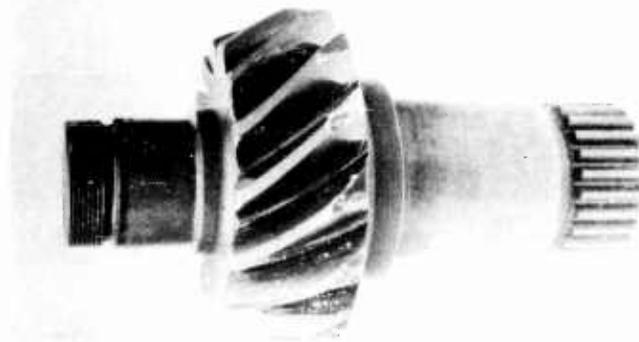
Figure 42. 90° Gear Box Input Quill (Gear after Test #9, heat treated to 1/2 hardness).

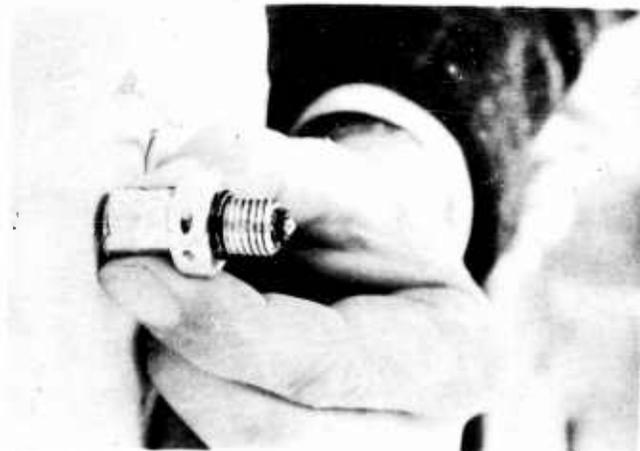
Figure 43. 90° Gear Box Magnetic Chip Detector After Test #9 (Magnetic chip detector accumulation).

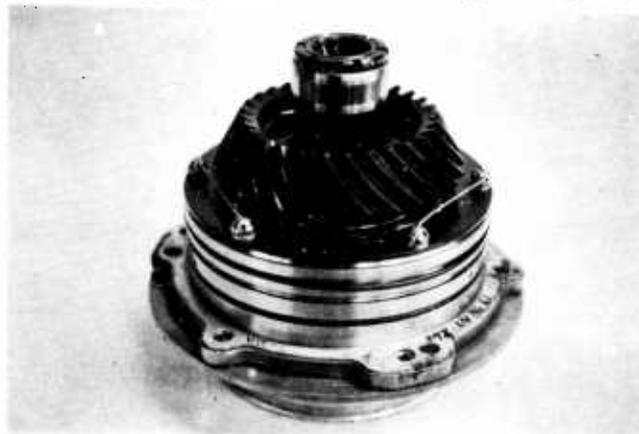
This test was performed by utilizing the Input Quill (shown in Figure 44) removed from another transmission due for overhaul (S/N A12-142). The quill was disassembled to the bevel gear/bearing set, and this portion was subjected to heat treatment to reduce hardness of the gear from Rockwell C 60 to Rockwell C 40. After reassembly and installation in the malfunction transmission (S/N A12-78), the Xmsn Base vibration indicated immediately. Data results are shown in Figure 45 and Figure 46. The Top is shown for reference only; no indication occurred on this channel although some variation is indicated.

Figure 44. Main Transmission Input Quill Prior To Annealing.

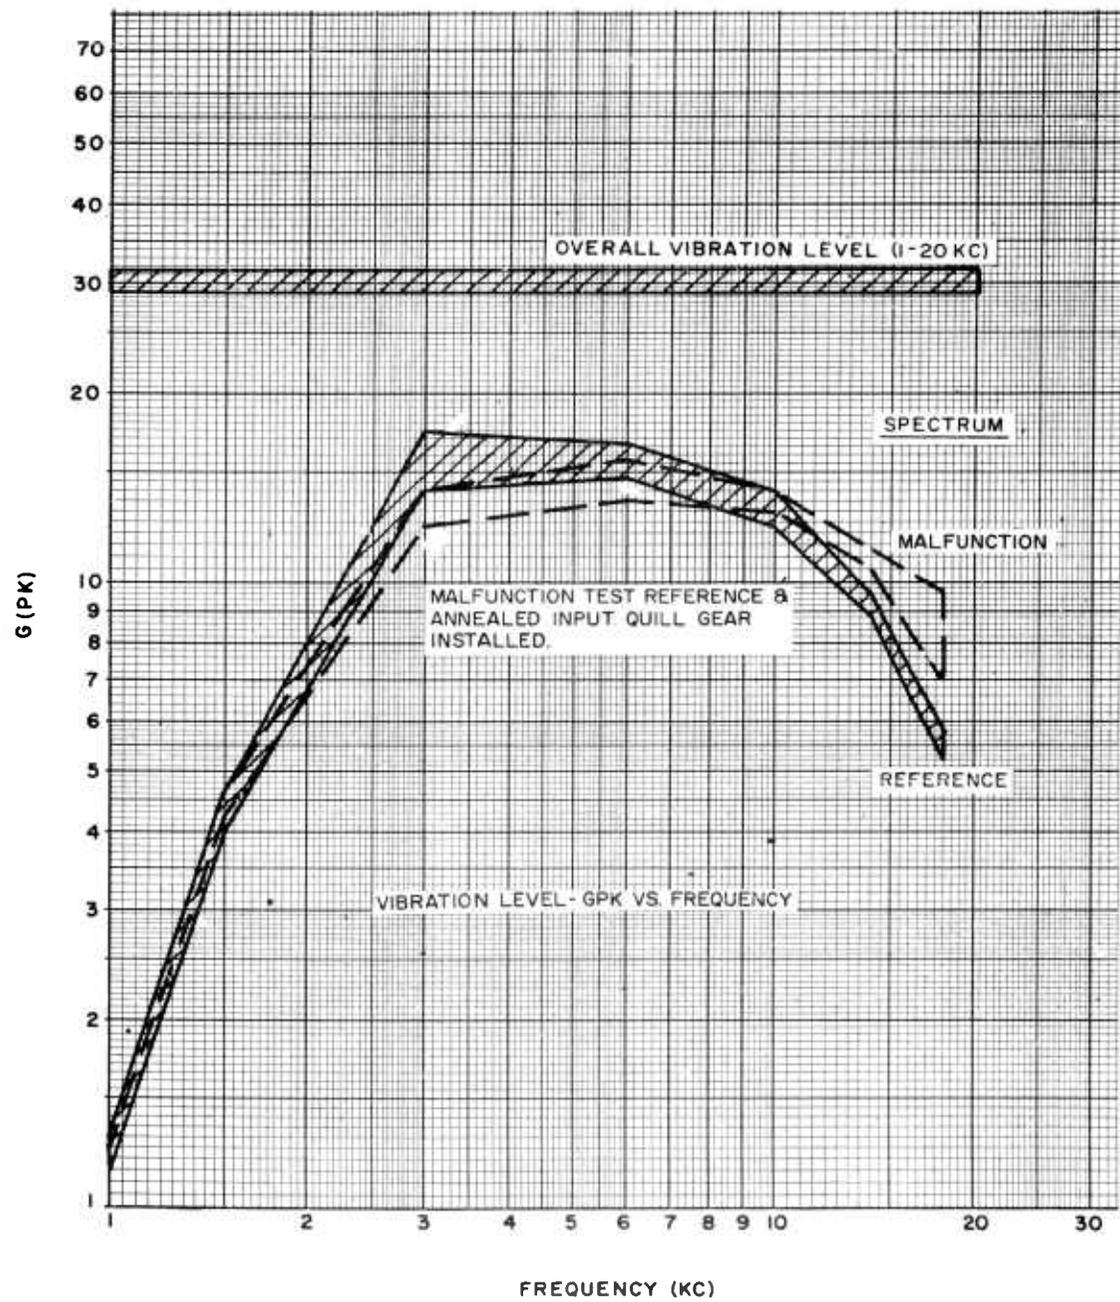
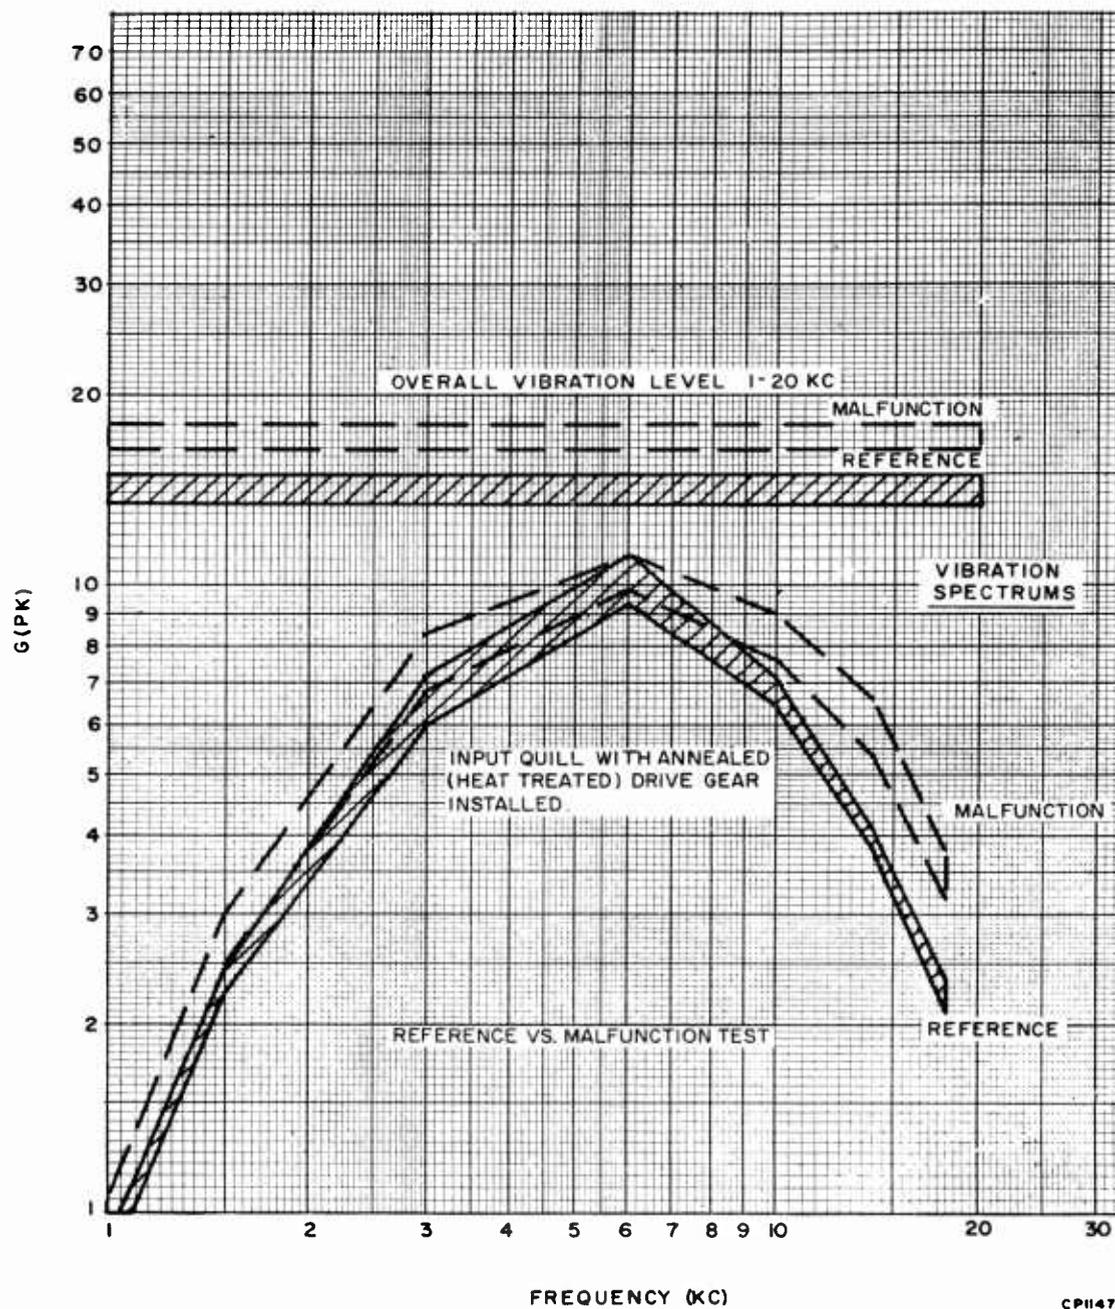
FIGURE 45. XMSN TOP VIBRATION, PLOT

FIGURE 46. XMSN BASE VIBRATION

On subsequent removal and inspection, nothing abnormal could be observed. It was then assumed that the increased vibration was due to variations in gear patterns on this quill compared to the original. This quill was subjected to a total of 12 hours operation with no further vibrational increases attributed to any change in its condition. It was decided not to heat treat the gear any further because catastrophic failure in this area would probably have prevented any further aircraft operation. Overhaul reports (to be supplied by Army depot maintenance) on the transmission will be carefully reviewed for comments concerning this condition.

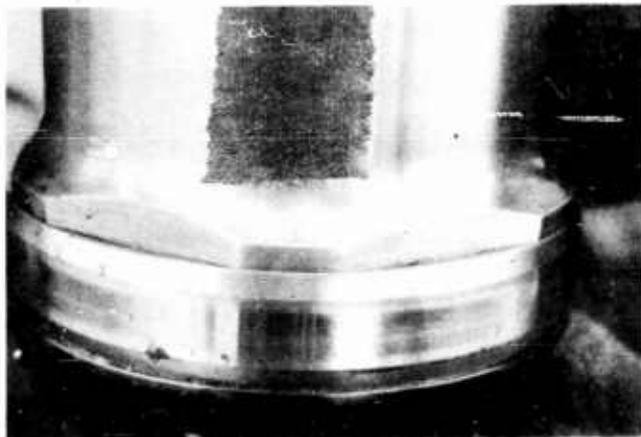
The Main Mast Assembly was removed from the aircraft and the lower mast bearing inner race (see Figure 47 for reference) was ground off to create a 0.015-inch "flat" on the surface as shown in Figure 48. The 0.015-inch dimension represents the depth of the "flat" from the true round of the race.

Figure 47. Lower Mast Bearing Race Before Malfunction Test, Main Transmission.

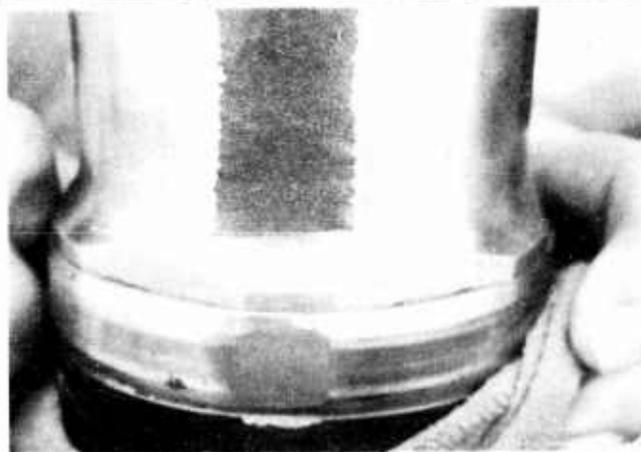
On reinstallation of the main mast and main rotor assembly, test runs were conducted, with the results proving negative. No Xmsn Base vibration increases were detected at any time. It is felt that the "flat" did not create any pronounced bearing impacts as had been anticipated; hence it is considered a poor malfunction test, if a malfunction at all. Here also the overhaul report may reveal additional considerations. For example, if substantial bearing deterioration has occurred, it will indicate this was a true malfunction condition and as such is not detectable by vibration as monitored in the ALARM System.

Figure 48. Lower Mast Bearing Race, With 0.015 Inch Flat.

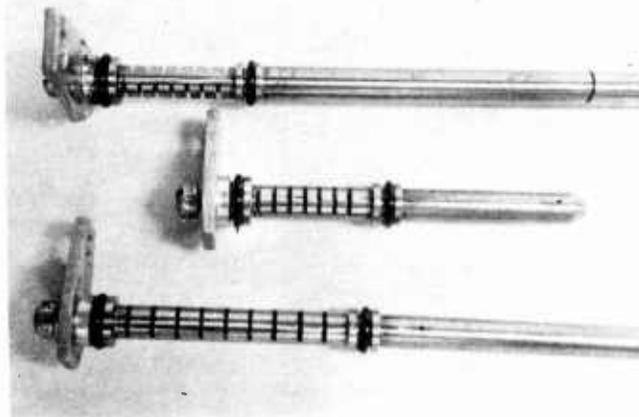
Tests in this area involved the three main transmission lubricating jets shown in Figure 49. Initially it was planned to silver solder the small jet openings closed, but later it was decided to tape the input slots closed for complete blockage.

The first test was to create an increased oil pressure condition for relief valve (Channel 19) operation, and one blocked jet was installed. No indication occurred, and the oil pressure increased as read on the aircraft Xmsn Oil Pressure gauge. The remaining two jets were blocked and the pressure rose from 40 psi to nearly 70 psi. No indication on the Pressure Relief Valve channel occurred. To check proper operation, a regular (unmodified) relief valve was installed and the tests repeated. Pressure increased a total of 8 psi, thus proving that the

Figure 49. Main Transmission Lubricating Jets.

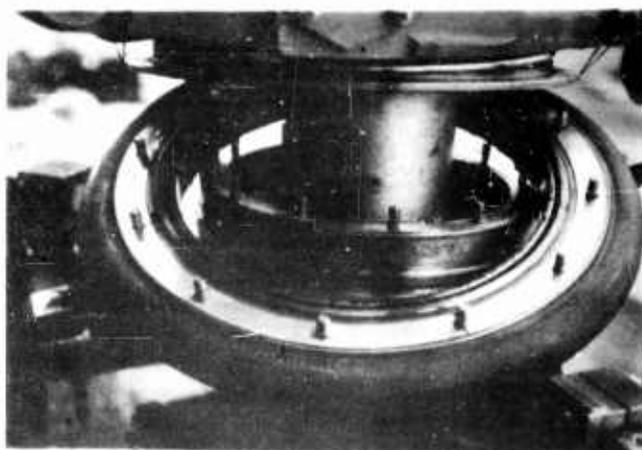
Figure 51. Swashplate Bearing Removed.

Figure 51 shows the swashplate bearing assembly disassembled to permit removal of some of the lubricant. Removal of lubricant was accomplished as thoroughly as possible without complete disassembly of the outer ring by pressure flushing the bearing with a solution of penalene.

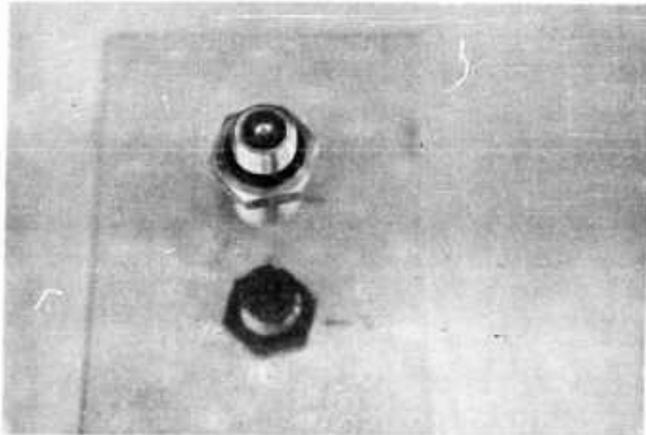
In direct contrast to the results obtained on the 90° Gear Box, the addition of almost 2.5 grams of filings in the 42° Gear Box failed to provide indication. As shown in Figure 59, the detector accumulated practically no particles. The test was repeated using the original magnetic plug and it too failed to accumulate any appreciable amount, as shown in Figure 59. This was considered to be entirely due to the location of the plug within the gear box, and further investigation indicated the plug should be relocated, if possible, to the lowest point in the main reservoir area rather than out along the input quill section of the housing as at present.

Figure 59. 42<sup>o</sup> Gear Box  
Chip Detector After Addition  
Of 2.5 Grams Of Particles.

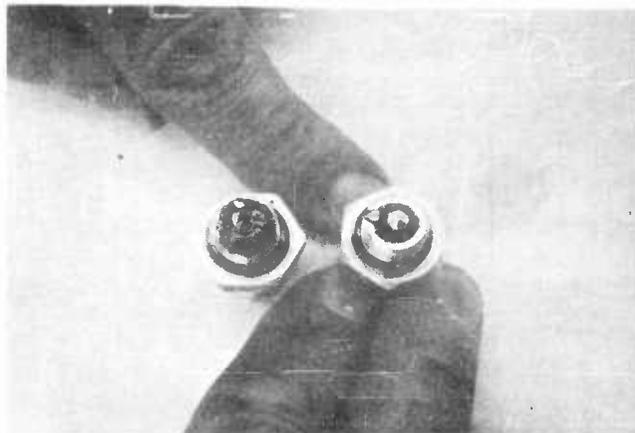
Figure 61. Relocated 42<sup>o</sup>  
Gear Box And Transmission  
Chip Detector Accumulations.

Following this modification the transmission was filled with clean oil. A test run was commenced without adding particles, since it was felt there would be some ferrous particles remaining in the transmission from previous tests. A chip indication occurred immediately on Channel 11, and subsequent inspection revealed the condition seen in Figure 61 (detector on the right side). The two detectors (42<sup>o</sup> GB and Xmsn) are shown together in this photograph because both relocation tests had been conducted concurrently.

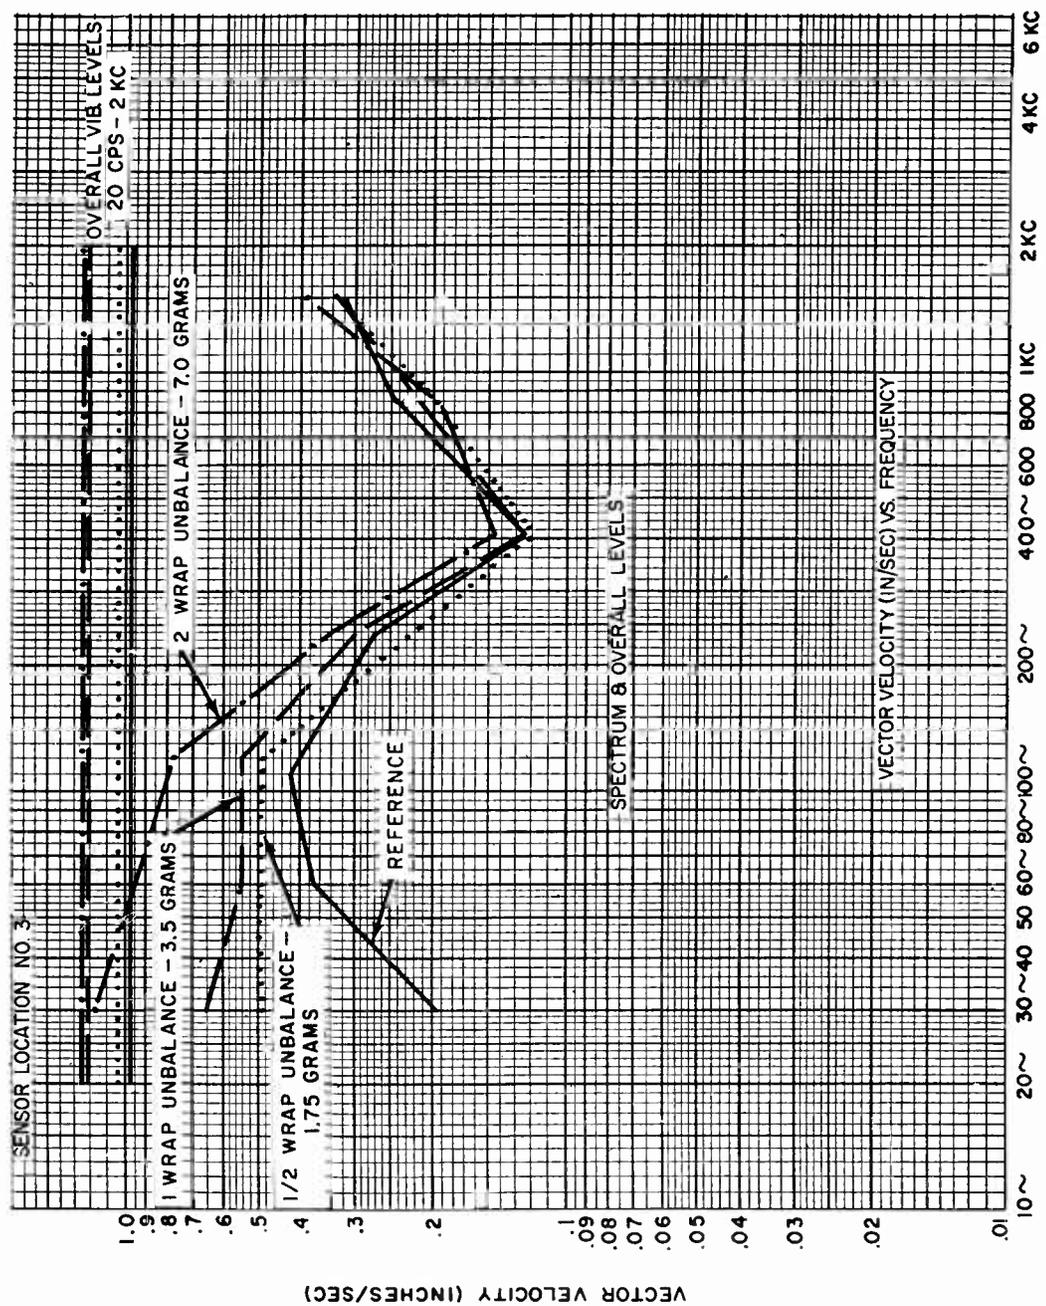
FIGURE 62. TAIL VIBRATION T/R UNBALANCE TESTS

Test conditions consisted of placing successive wraps of 2-inch masking tape about 4 inches from one blade tip and evaluating the resultant vibrational effect. These results are shown in Figure 62 in comparison with reference or balanced condition. "NO GO" indications were obtained for both 1 and 2 wraps. The pilot began to notice high-frequency vibrations in the pedals with two wraps, which support the main objective of the channel, that of being capable of sensing tail vibrations better than the present method of "feel". The channel also detected the 1/2 wrap condition (1.75 grams), but this would have to be considered a marginal sensitivity setting which may cause erroneous indications if set this close to the normal vibration level.
