TRECOM TECHNICAL REPORT 63-10

Automatic Light Aircraft Readiness Monitor  
Project ALARM

VOLUME I

York Division of The Bendix Corporation  
York, Pennsylvania

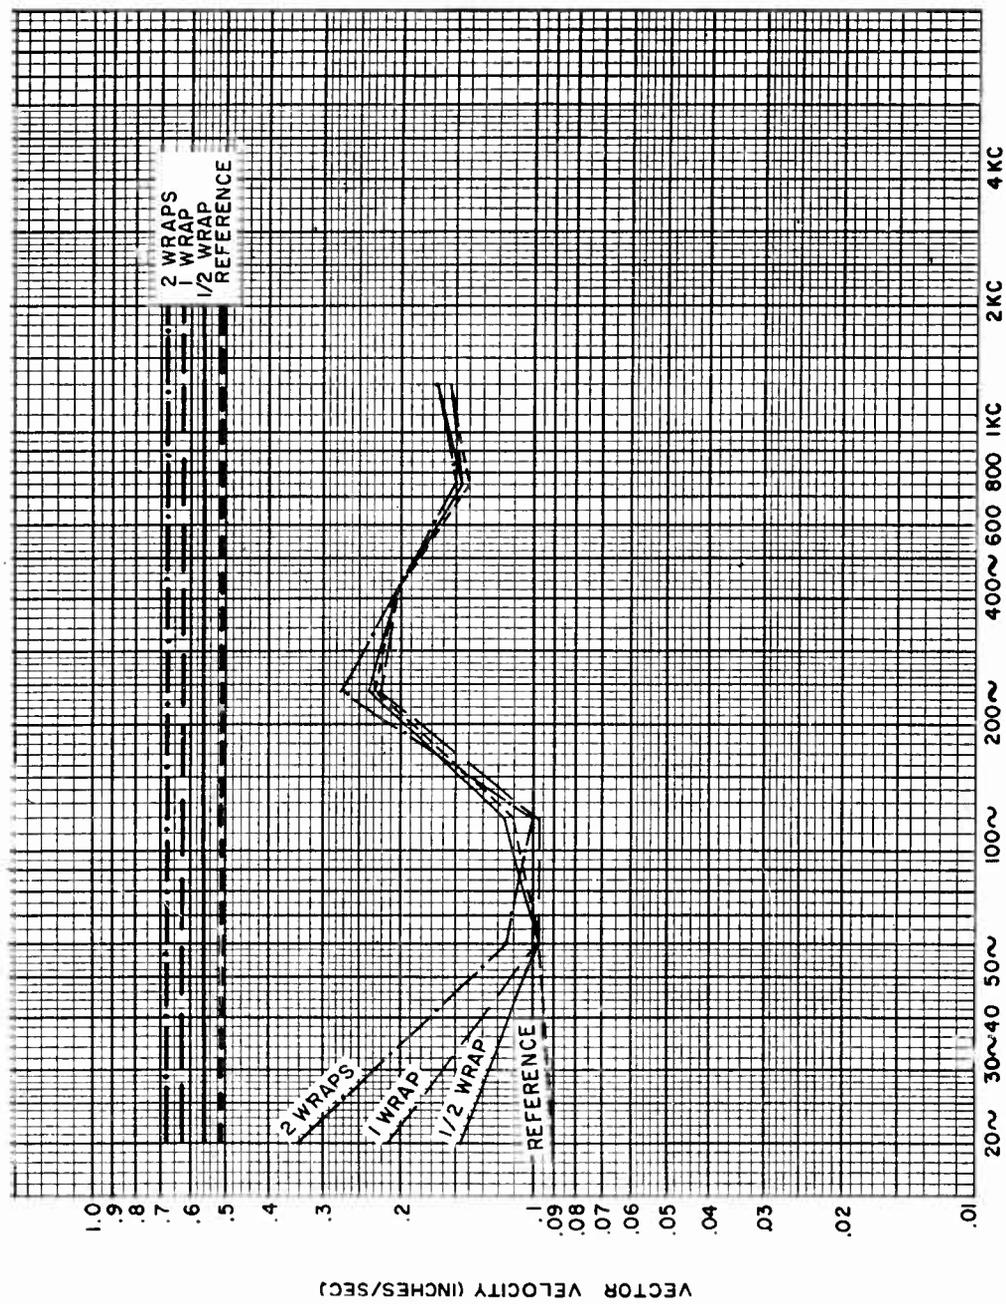
FIGURE 63. AFT ENGINE VIBRATION EFFECT OF T/R UNBALANCE

During these tests it was noticed that the Aft Engine Vibration Channel was indicating "NO GO" with tail rotor unbalances. An analysis of this effect was made, and is shown on Figure 63. The vibration of the tail section under these conditions was being propagated through the structure and influencing the engine area. All were predominantly tail rotor 1/rev influence below 100 cps as shown in the graph. Modification has been made to the Aft Engine Vibration Channel, restricting its frequency response to above 100 cycles to eliminate this undesirable interaction.

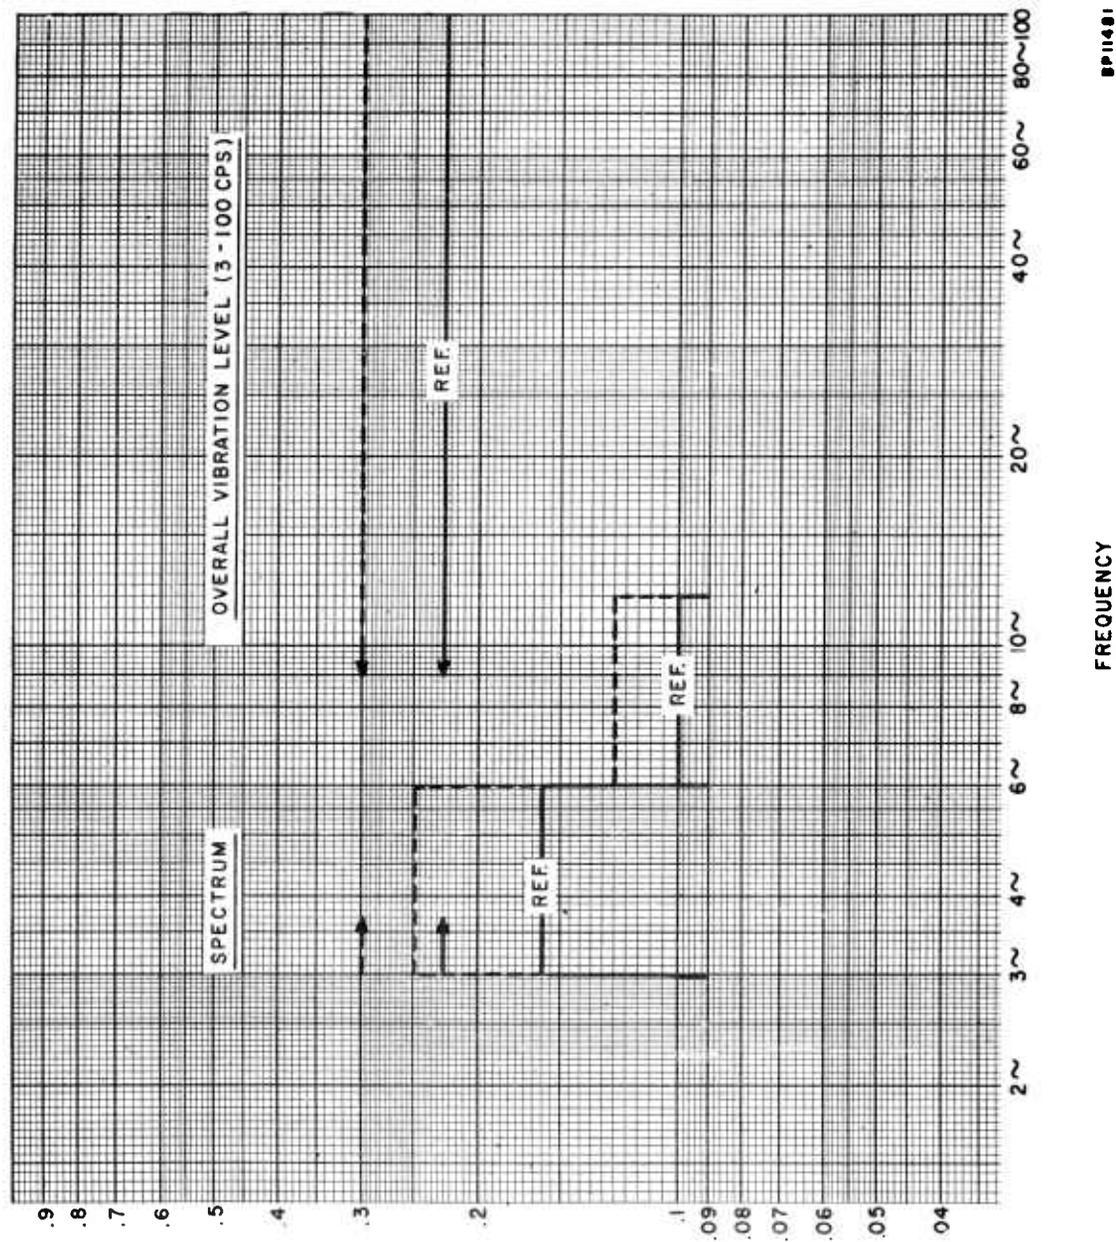
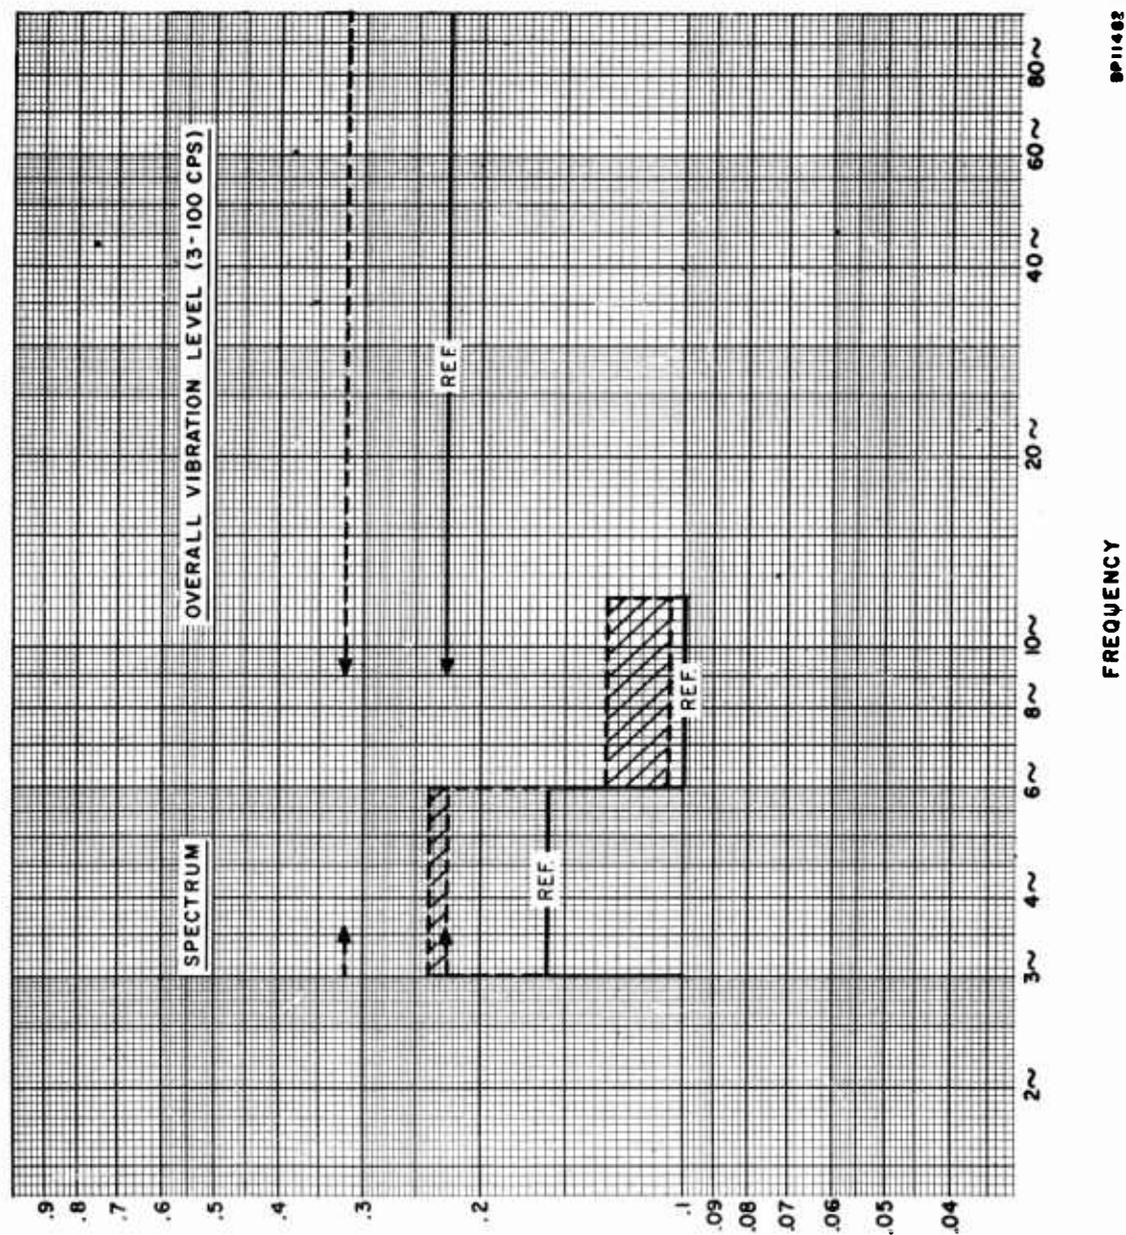
(INCHES/SEC)  
 FIGURE 65. LOW FREQUENCY MAST VIBRATION, UNCENTERED CYCLIC CONTROL (PART 1)

FIGURE 65. LOW FREQUENCY MAST VIBRATION, BLADE SET OVER-TIGHT TIEDOWN (PART 2)

Additional observations made on the channel included those presented in Figure 65. Part 1 shows the effect of an uncentered cyclic control during 6400 rpm ground run operation, indicated as "NO GO" on the channel. This is not an abnormal condition in the main rotor, but does show an improper reference condition which should be recognized and corrected by centering the control before using this channel as the indication of an unbalance or out-of-track condition. Figure 65, Part 2, plots the results from an over-tight main rotor tie-down over a 2-day period which caused a "set" condition in the blade and subsequent 1/rev vibrations which were detected by the channel. A brief period of ground-run operation cleared this condition and the channel indicated "GO".

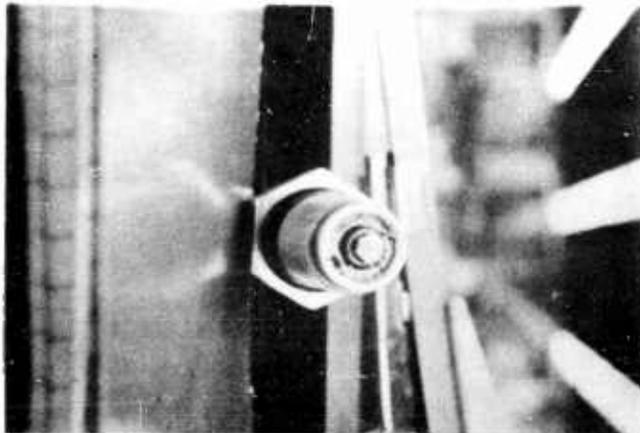
Figure 68. Main Transmission Chip Detector After Addition Of 1 Gram Of Particles.

Throughout all tests involving malfunctions placed in the Main Transmission, no indication occurred on the Main Transmission Chip Detector. On inspection of the detector, never did there appear more than a very slight accumulation of fine, normal-wear particles. Very few particles were picked up and no indication noted after the addition of 1 gram of particles into the oil and nearly 4 hours of A/C operation. Figure 68 shows the detector following this test.

Since it was known that ferrous particles were definitely present in the transmission at these times, the failure of the detector to accumulate them was attributed to the location utilized. The fact that the center of the detector is located 1 inch above the bottom of the sump (which is the location of the present magnetic plug) apparently permits all of these particles to settle on the bottom, with very few coming near enough to the detector magnet to be attracted and detected.

Investigation was begun to relocate the detector, similar to that performed on the 42<sup>o</sup> Gear Box (see Test #15). In order to avoid a structural modification of the Xmsn Sump Case, it was decided to place the detector in the drain opening. This placed the sensor flush with the sump bottom just beneath the pump intake screen (see Figure 71). It was also decided to utilize a smaller detector with a 0.060-inch gap in place of the previous detector which had a gap width of 0.100 inch. The detector from the 42<sup>o</sup> Gear Box was adapted to fit into sump drain opening.

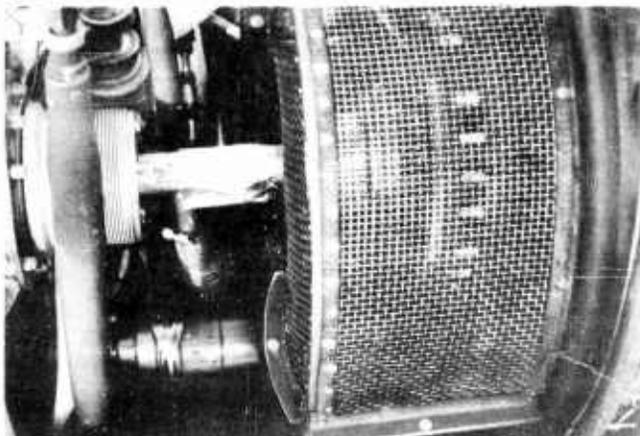
Figure 72. Method Of  
Providing Short Shaft  
Unbalance.

In order to examine where and how shaft-created vibrations might occur, a 20-gram metal weight was attached to the shaft by aluminum tape as shown in Figure 72. During the test run which followed, the Aft Engine Channel indicated "NO GO" consistently and the Fwd Engine Channel intermittently. Figure 73, Part 1 and Part 2, presents the data recorded for this condition.

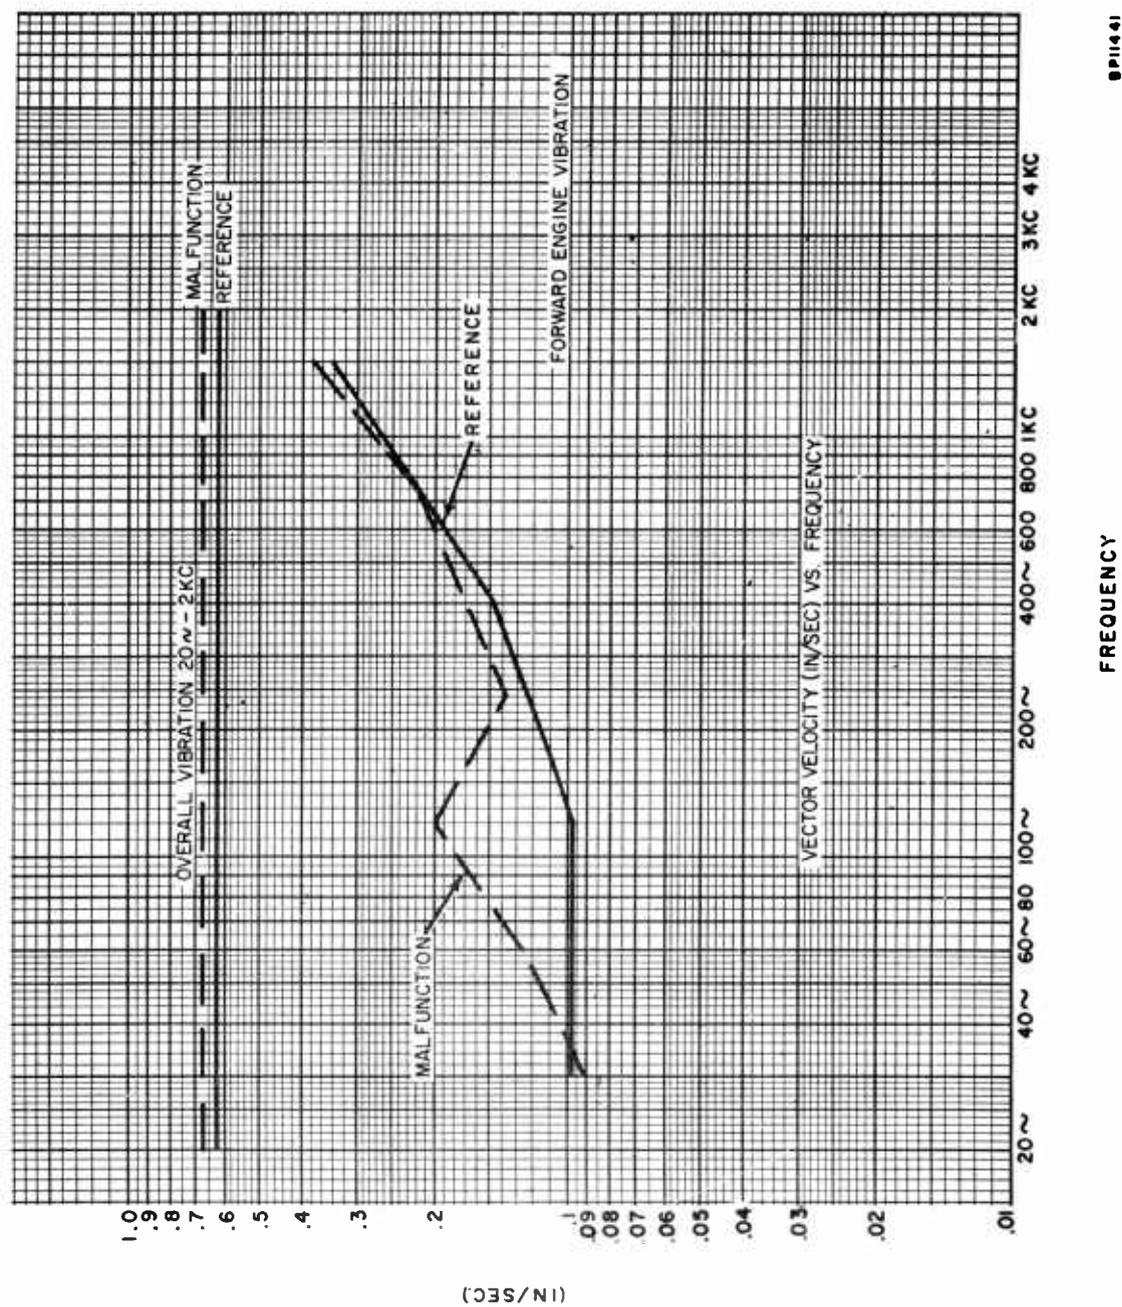
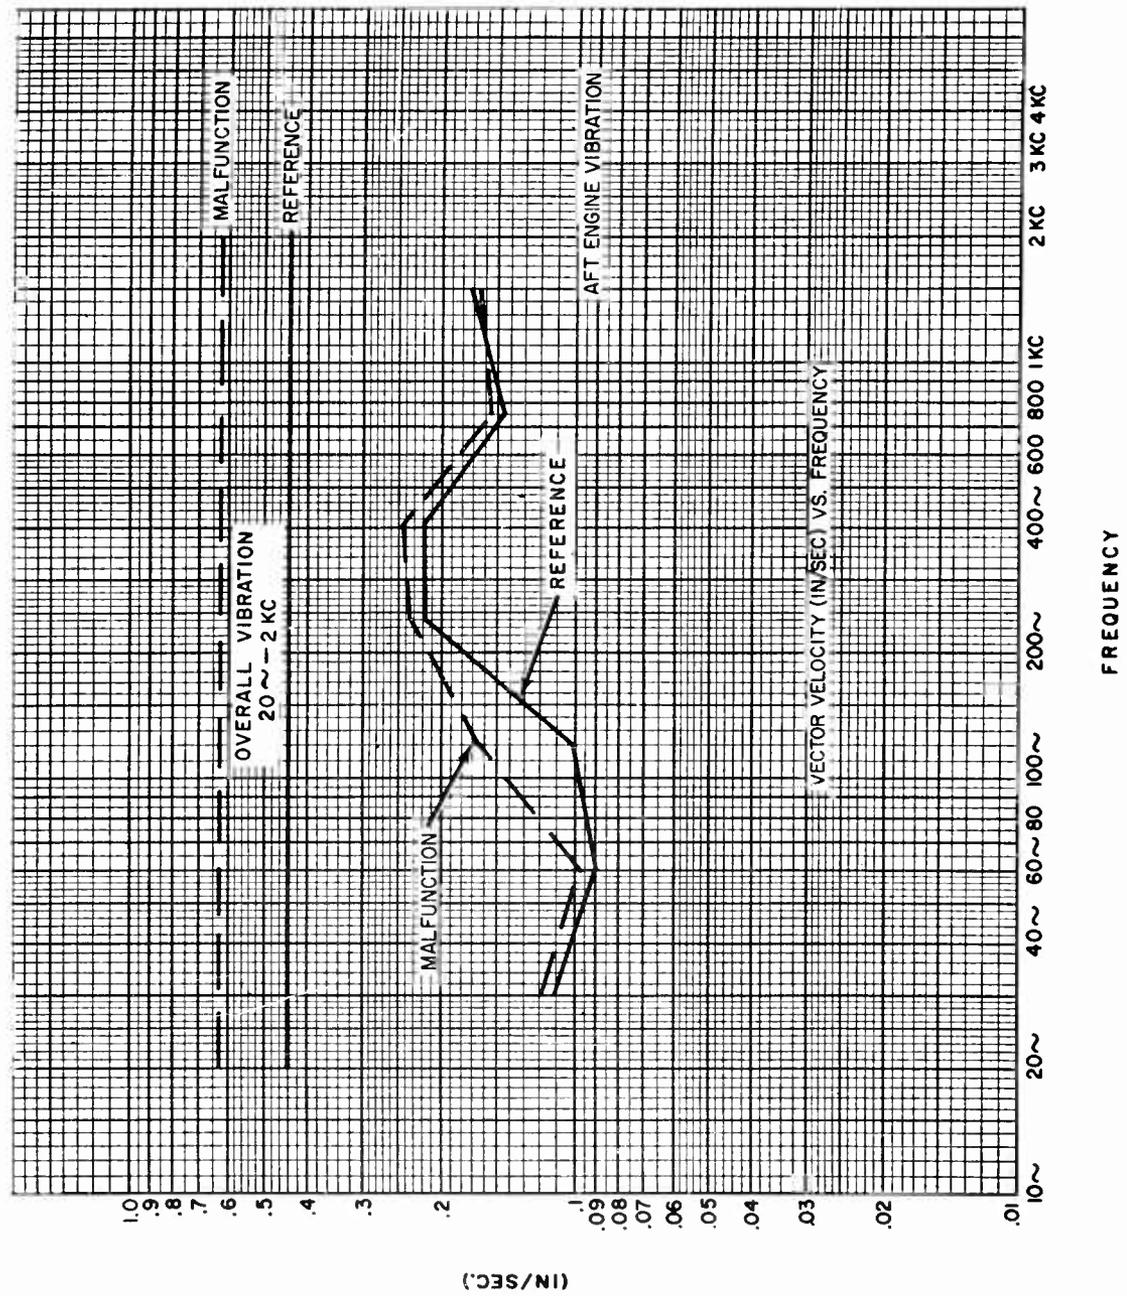
FIGURE 73. MALFUNCTION TEST FWD ENGINE VIBRATION (PART 1)

FIGURE 73. MALFUNCTION TEST AFT ENGINE VIBRATION (PART 2)

It will be recalled from previous discussions (see Test #16) that the Aft Engine Channel response had been limited to above 100 cps due to effects of tail vibrations. This, fortunately, still permits the type of vibration created by short shaft unbalance to be accepted, since the fundamental frequency is about 106 cps. Figure 73 shows the largest increase at 120 cps because the reading taken was through the filter set to accept the range of 60-120 cps.
