# **CRASH INJURY EVALUATION**

## **DYNAMIC TEST OF A COMMERCIAL-TYPE PASSENGER SEAT INSTALLATION IN AN H-21 HELICOPTER**

**One of a Series of Reports  
Pertaining to the Dynamic Crash Test of a U. S. Army H-21 Helicopter**

TRECOM Technical Report 63-24

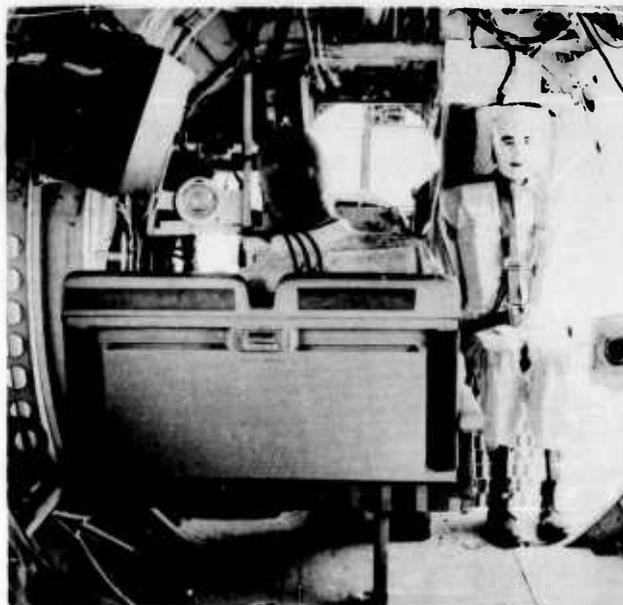
Figure 2. Rear View of Commercial Passenger Seat, Installed.  
Arrow shows 1-1/4-inch O. D. x 0.125-inch wall SAE  
4130 tube used for support of outboard end of seat.

The leg on the aisle side of the seat was connected to a plate on the floor and incorporated a quick disconnect to facilitate folding of the seat. The plate itself was made of two metal flanges bolted together through the honeycomb floor. This can be seen in Figure 2. The installation was similar to that proposed for in-service aircraft.

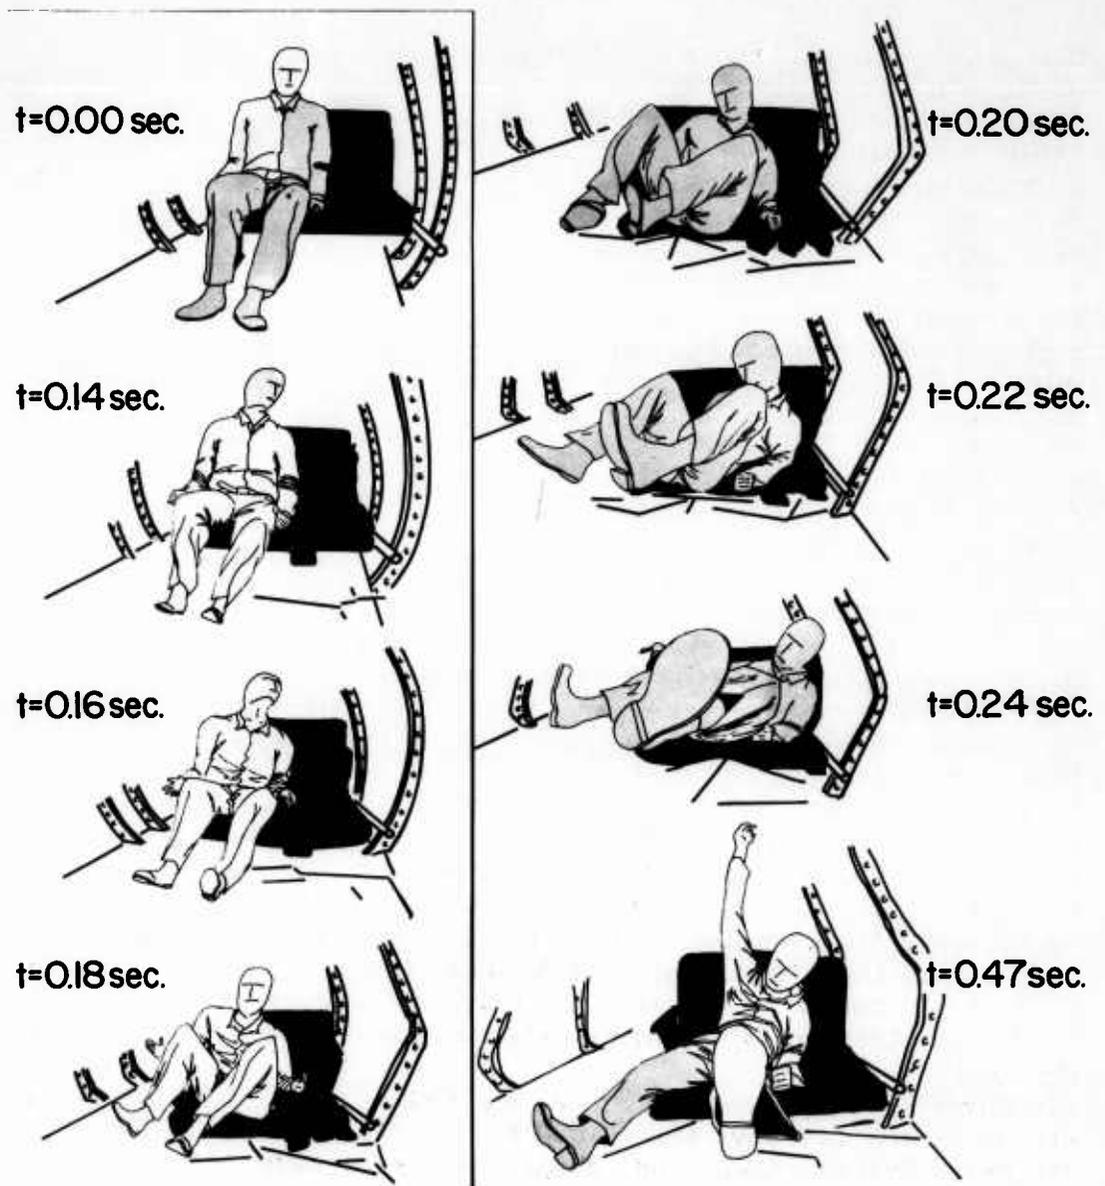
Figure 17. Kinematic Sketch of Seat and Dummy.

Observation of high-speed films from on-board cameras shows, as noted in Figure 16C, that during this interval the floor in the vicinity of the seat underwent the deformation shown in Figures 10 and 11, and that the dummy seat and dummy itself (Figure 17) underwent maximum displacement. Two separate pulses are evident in Figure 16C, i. e., a half sine wave in the interval from 0.15 to 0.19 second, followed by a smaller pulse at 0.21 second. An average of about 33G was maintained for some 0.025 second, accounting for a change in velocity of about 26 feet per second. The recorded "vertical" pulse would have probably been somewhat greater had the dummy remained truly vertical throughout the impact. The recorded "lateral" and "longitudinal" accelerations were more of an oscillatory nature, as seen in Figures 16A and B.
