ROCKETDYNE

R-5316

FINAL REPORT, DEVELOPMENT OF DOWNRATED
ATLAS YLR101-NA-15 VERNIER ENGINE

Contract AF04(695)-306

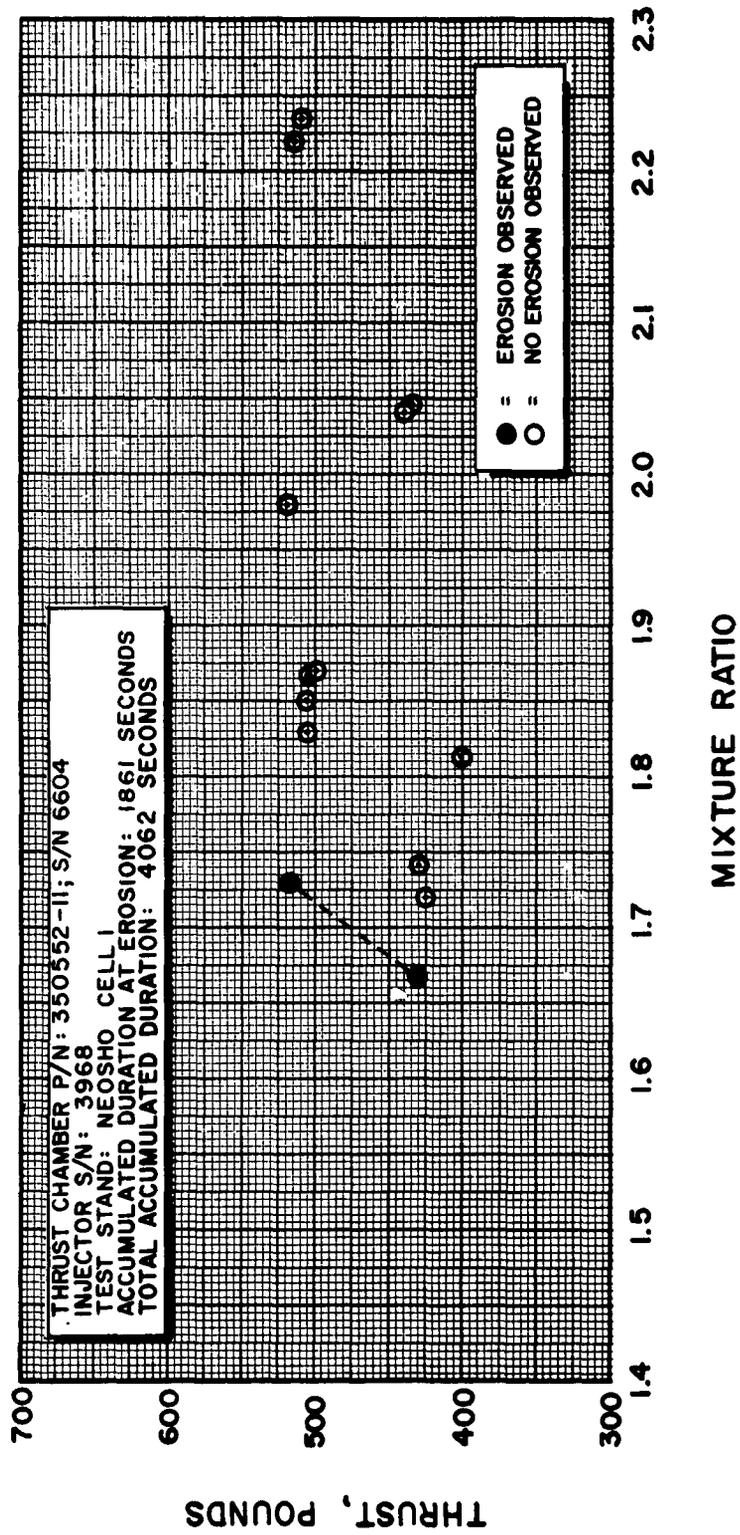
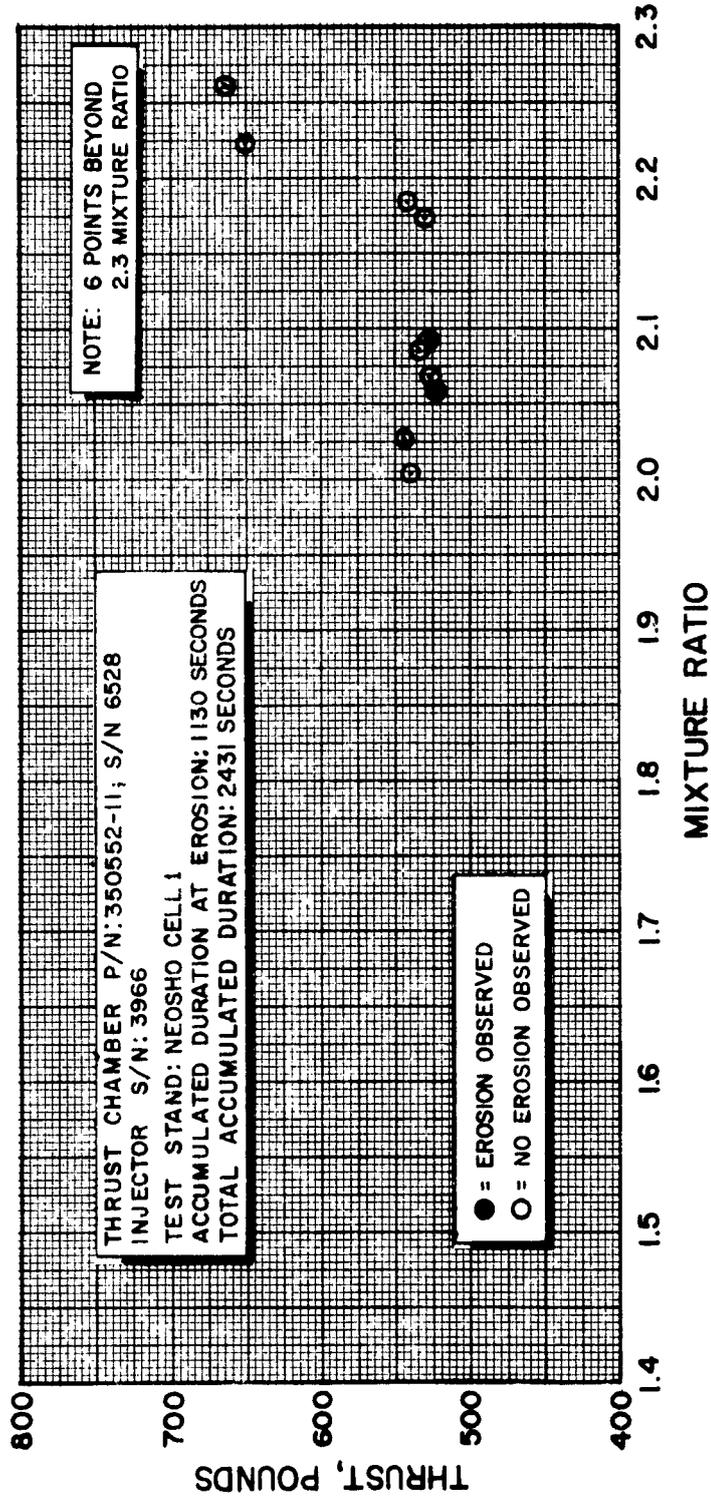
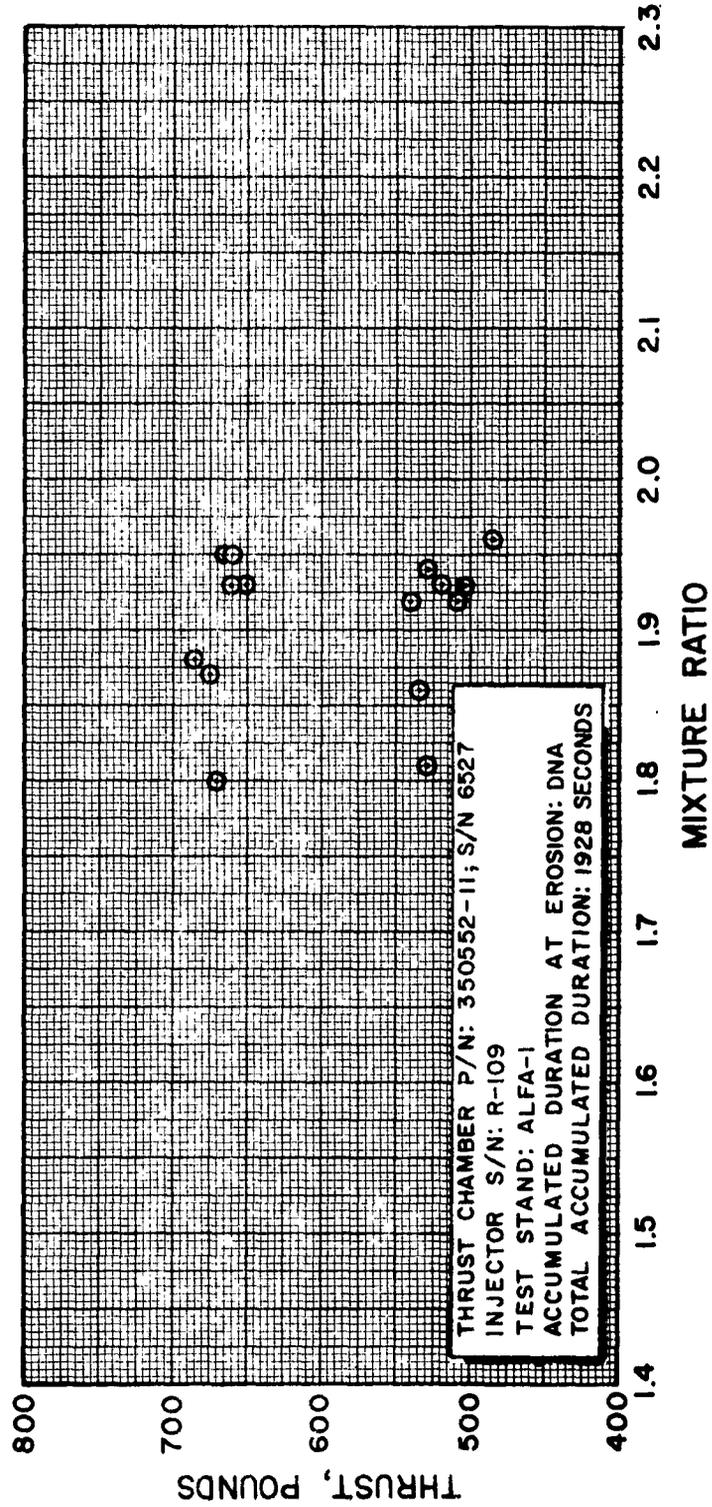
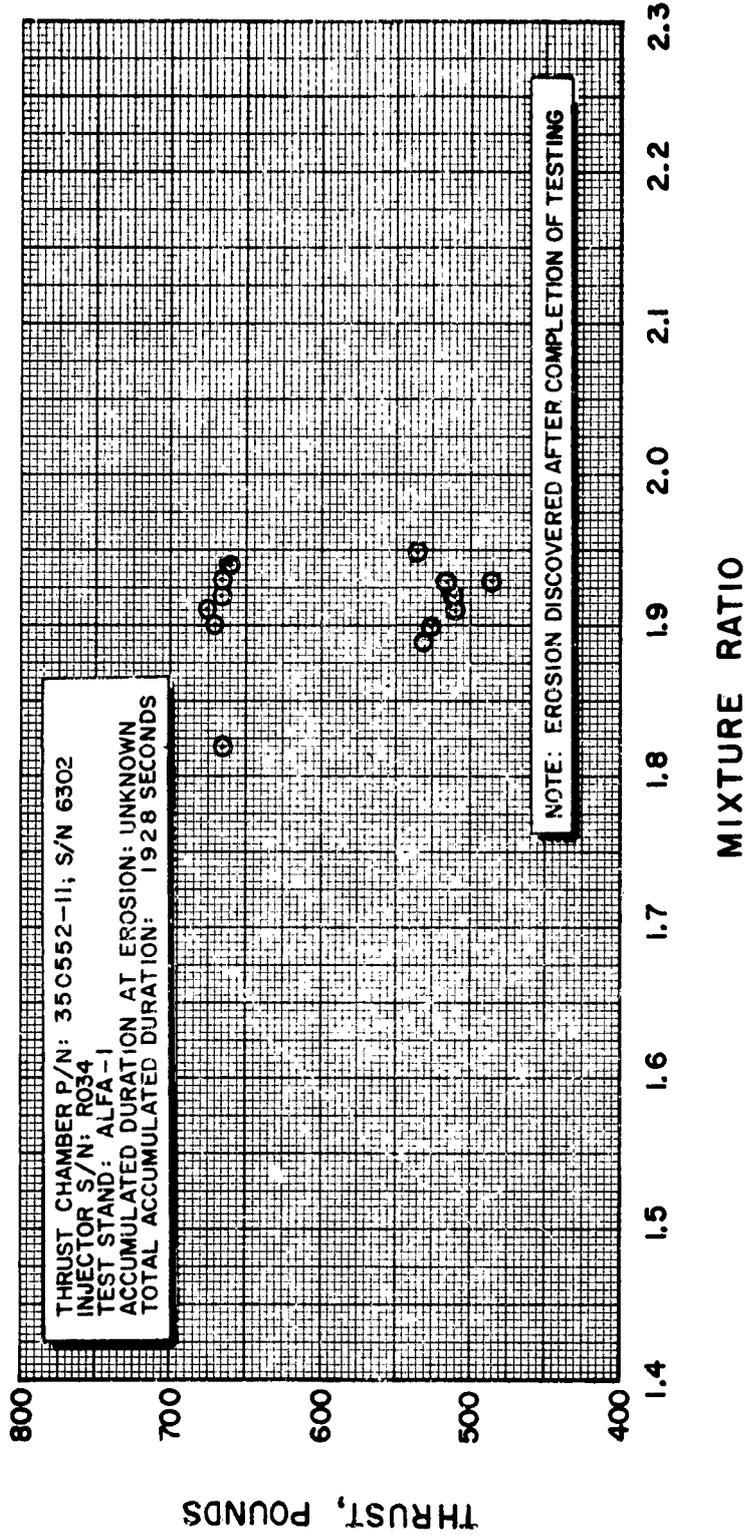
The occurrence of erosion during Phase I testing is shown in Fig. 9 through 13. These figures indicate the operating regime to which each engine was exposed until the first reported instance of erosion.

Figure 9. Operating Regime of Injector P/N 350604 Tested With Engine S/N 0002-6

Figure 10. Operating Regime of Standard Injector P/N 350604
Tested With Engine S/N 0003-4

Figure 12. Operating Regime of Standard Injector P/N 350604
Tested With Engine S/N 0024-1

Figure 13. Operating Regime of Standard Injector P/N 350604
Tested With Engine S/N 0026-1

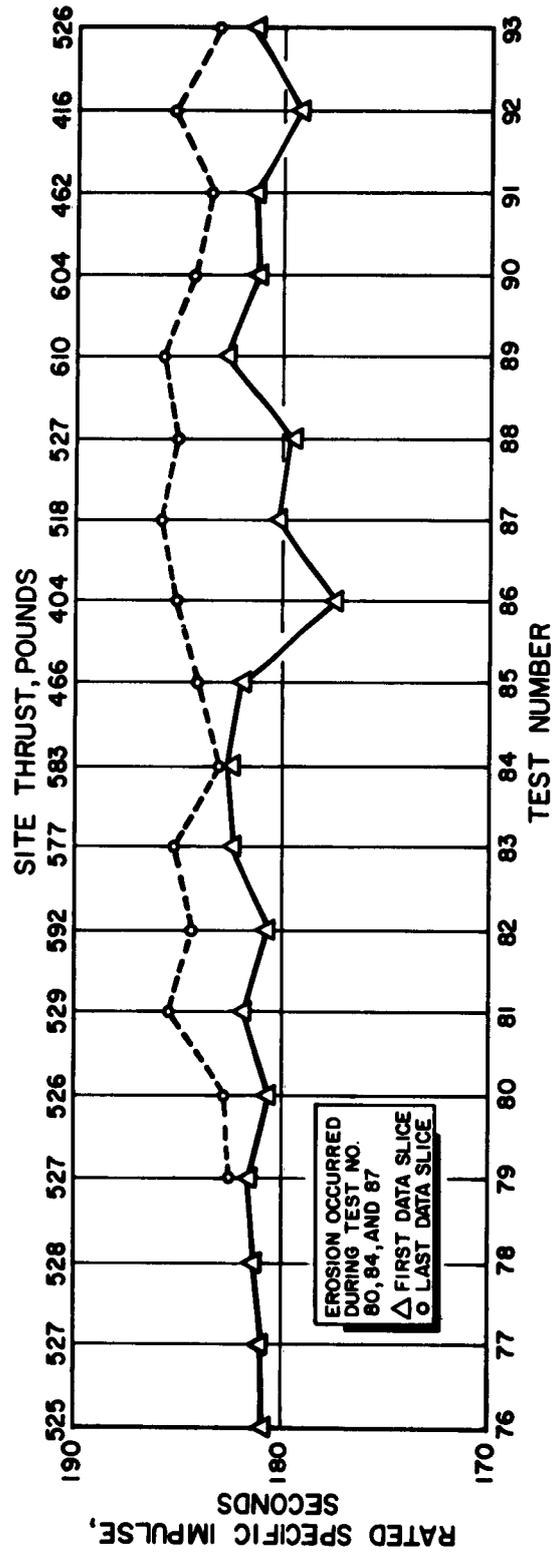
Figure 14. Rated Specific Impulse During Testing With Engine S/N 0003-5

Although the thrust chamber erosions experienced during the Phase I testing were quite severe (Fig. 8), engine transient and steady-state performance were not affected by the damage. Figure 14 is a plot of rated tank-fed specific impulse during testing of engine S/N 0003-5. No significant decrease in specific impulse or operating level occurred as the chamber erosion progressively worsened. The bulk fuel temperature was measured at the fuel injector manifold during the tests on engine S/N 0003-5. During the first 10 to 12 seconds after ignition of each engine, this temperature rose about 120 degrees above the engine fuel inlet temperature. After 60 seconds, the temperature stabilized at 30 to 50 degrees above the fuel inlet temperature. No data are available for comparison, but it is probable that, except for localized hot spots, this stabilized differential temperature was sufficiently low to rule out an excessively high thrust chamber wall temperature.

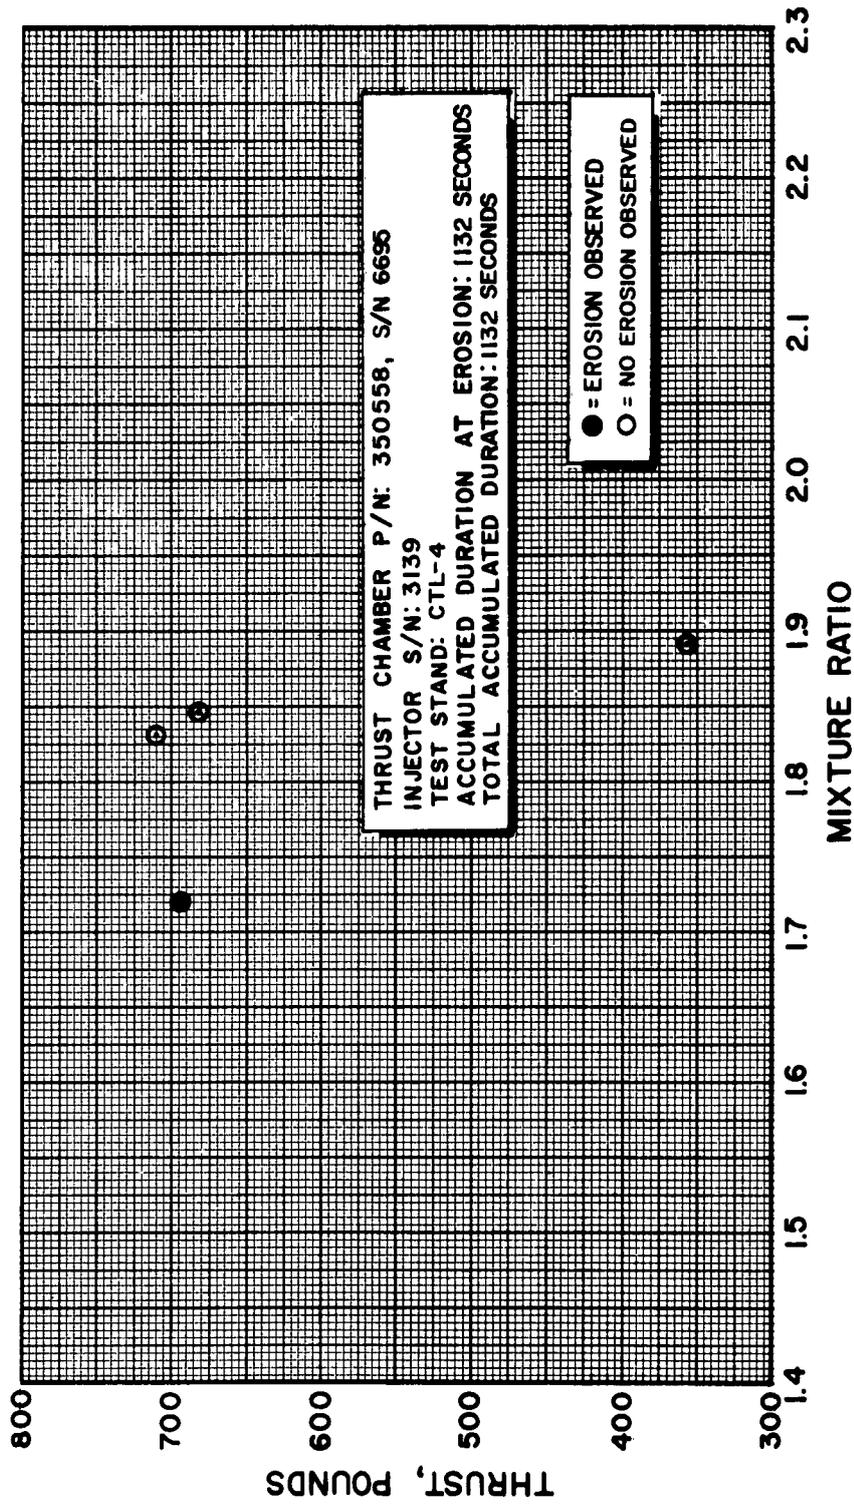
Figure 27. Operating Regime of Injector P/N E0 119924
Tested with Thrust Chamber S/N 6695

Figure 26. Sectioned Vernier Engine Showing Thrust Chamber Erosion Resulting After Tests With Injectors P/N EO 119924 and P/N EO 123830

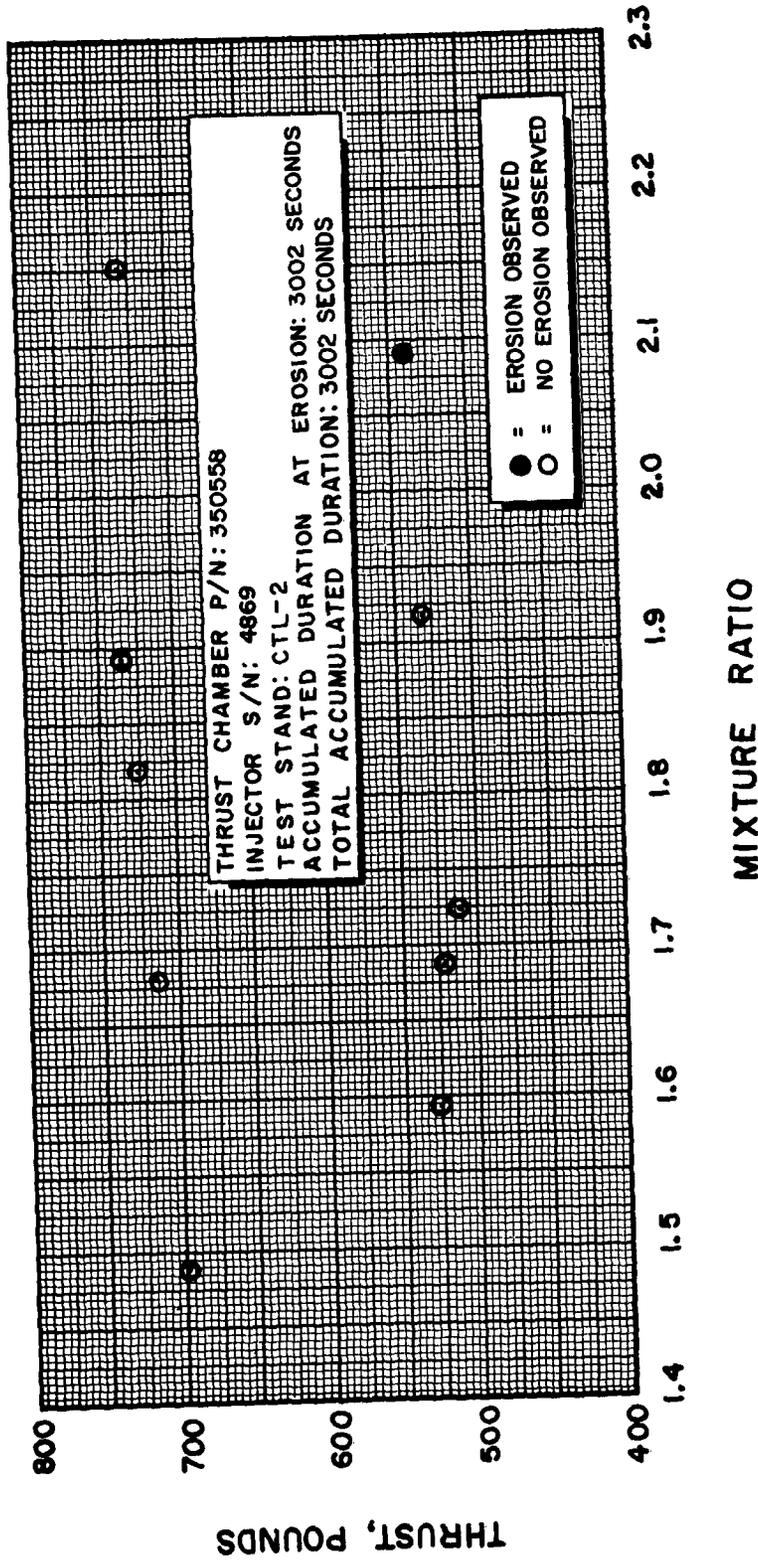
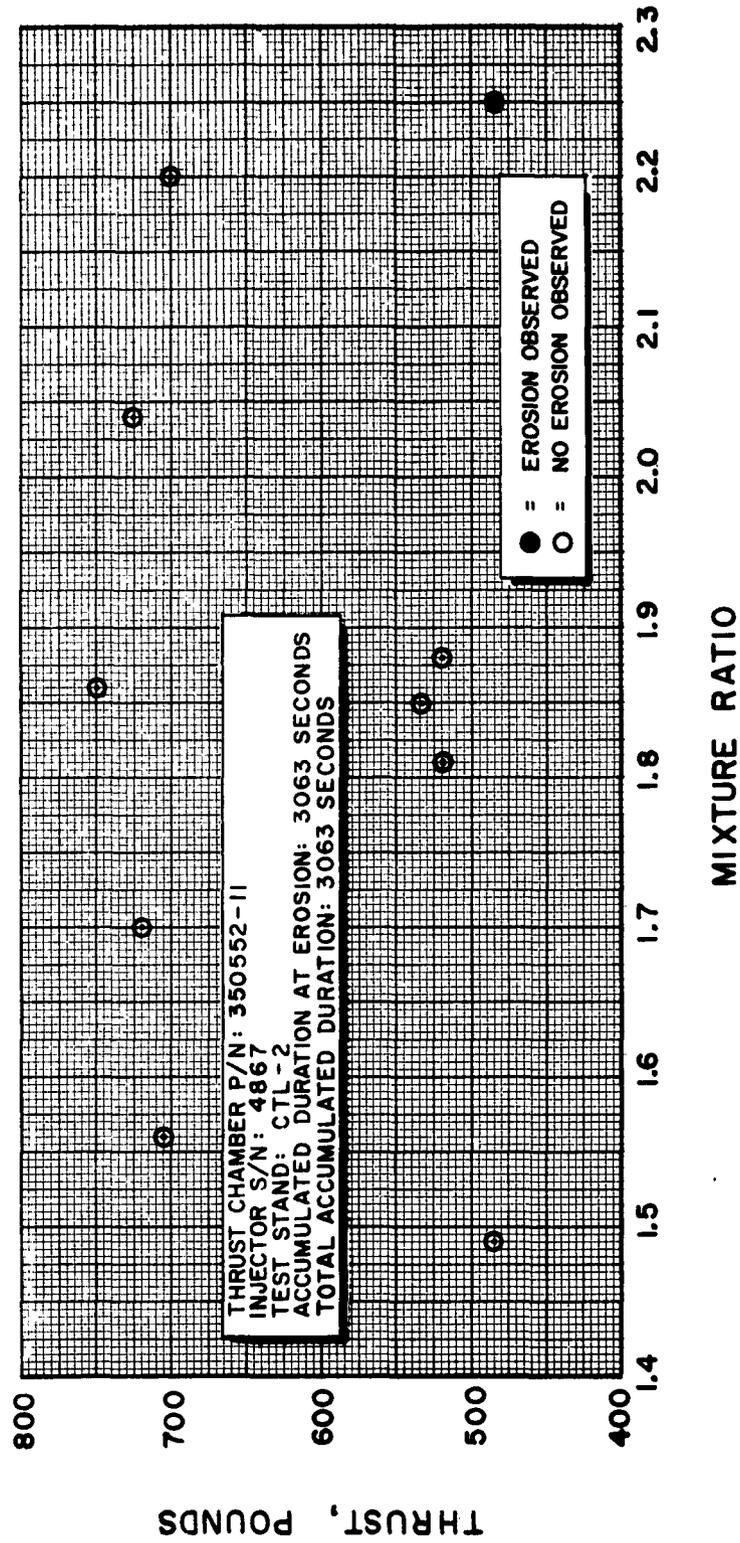
Both units of the P/N E0 123829 configuration injector were subjected to the complete 3000-second test series before producing minor nickel erosion and one minor parent metal erosion upstream of the throat on the last test (Fig. 32). The thrust and mixture ratio values for the tests producing erosion on the two units were 541 pounds at 2.09 and 486 pounds at 2.25. The complete operation regimes of these units are shown in Fig. 33 and 34. Correlation of injector position to thrust chamber erosion determined that the erosion produced by the P/N E0 127829 injectors was not in line with an injector orifice set. It was concluded that the high mixture ratio operating condition, and not injector position or orifice plugging, was the probable cause of erosion.

Figure 33. Operating Regime of Injector P/N E0 123829 Tested With Thrust Chamber S/N 6574

Figure 34. Operating Regime of Injector P/N E0 123829 Tested With Thrust Chamber S/N 6421

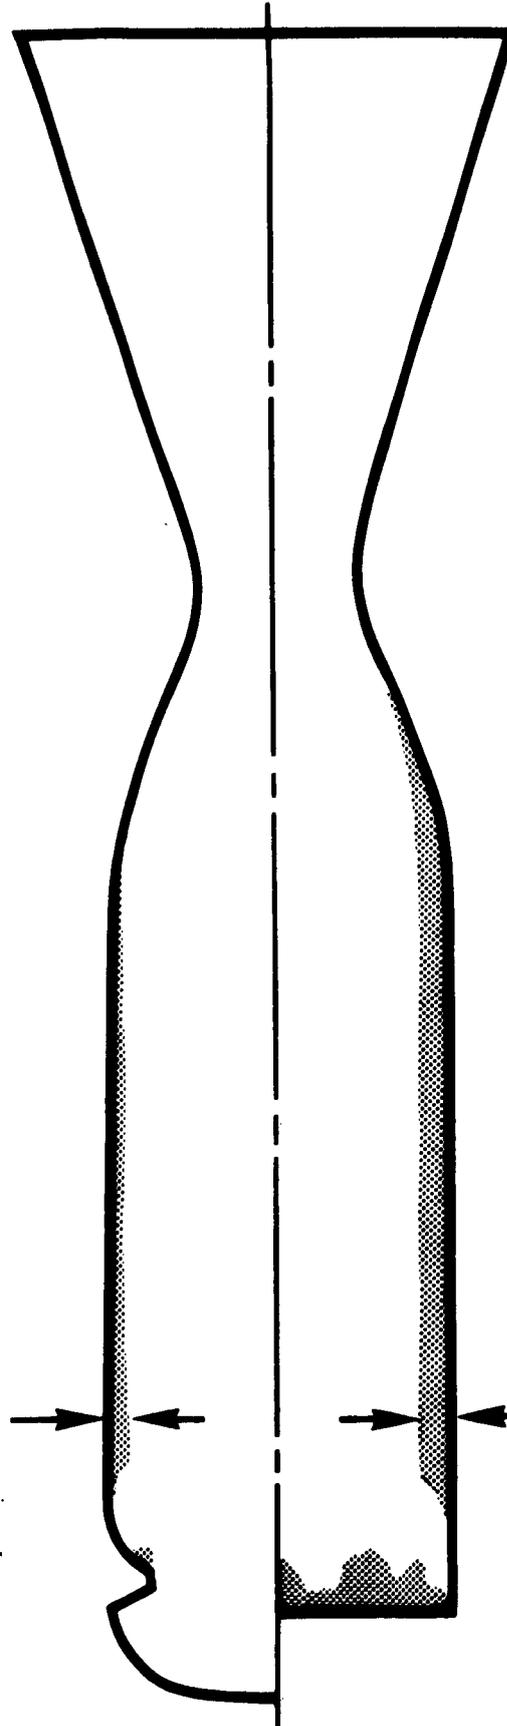
Figure 36. Typical Carbon Buildup During Tests With Splash-Plate and Flat-Face Injectors

Carbon Buildup. Carbon buildup (Fig. 36) was found in the thrust chamber and on the injector face throughout the flat-face injector testing. Hard carbon up to 1/2-inch thick formed on the injector face upstream of the impinging propellant streams, and some pieces of carbon found in the test area showed the orifice pattern. The first three tests on each injector generally exhibited the heaviest carbon buildup, but random buildup was also evident during later tests. Soft carbon on the wall of the thrust chamber in line with each injector fuel orifice spoke gradually built up to a maximum thickness of 0.125 inch after several tests. Carbon buildup in the thrust chamber throat was not evident during the series.

A lesser degree of carbon buildup (Fig. 36) also was visible in the thrust chamber following splash-plate injector tests. Hard carbon on the wall at the injector end reached a 0.040-inch thickness, but decreased to zero thickness approximately 4 inches downstream. No carbon buildup was visible on the splash-plate injector face or in the thrust chamber throat, although it was assumed to have been in the throat as a result of the shifting performance and carbon particles found in the test area.

THRUST CHAMBER USING SPLASH-PLATE INJECTOR

0.040 - INCH MAXIMUM

0.125 - INCH MAXIMUM

THRUST CHAMBER USING FLAT - FACE INJECTOR
