DESIGN, FABRICATION AND HYDROTESTING  
OF A 120-INCH DIAMETER PRESSURE VESSEL  
USING 18 PERCENT NICKEL  
MARAGING STEEL

Research Contract Status Report No. 8

METALLURGICAL ANALYSIS OF FRACTURED CLOSURE PLATE  
OF THE 120-INCH MARAGING STEEL PROTOTYPE VESSEL

Final Report

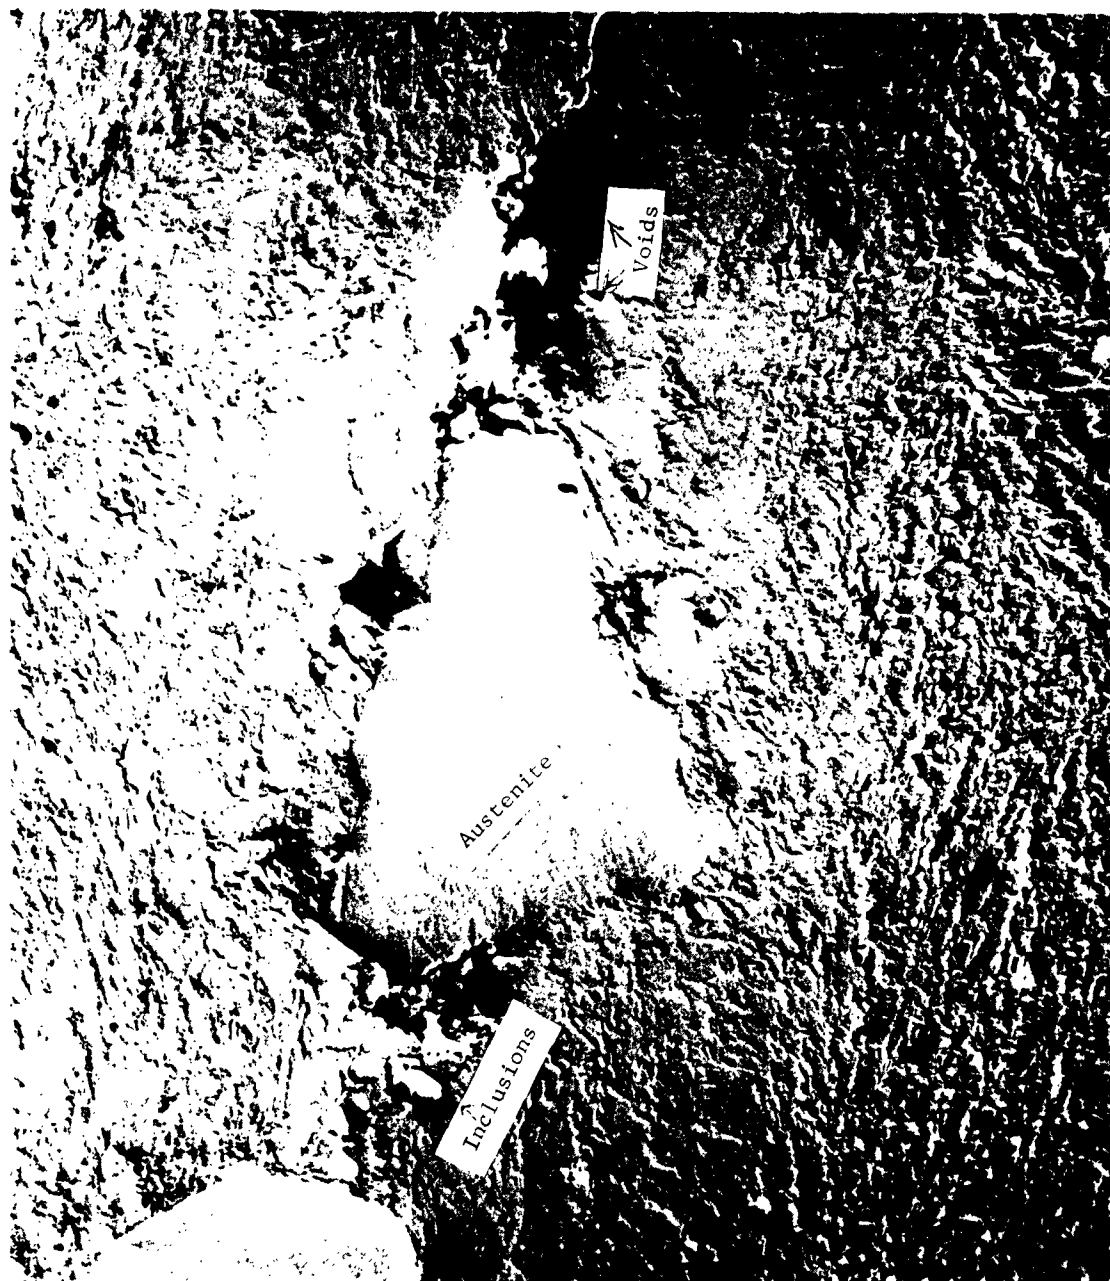
Figure 40. Electron Micrographs Showing Inclusions, Voids and Austenite in Weld-Banded Plate Interface  
6,900X

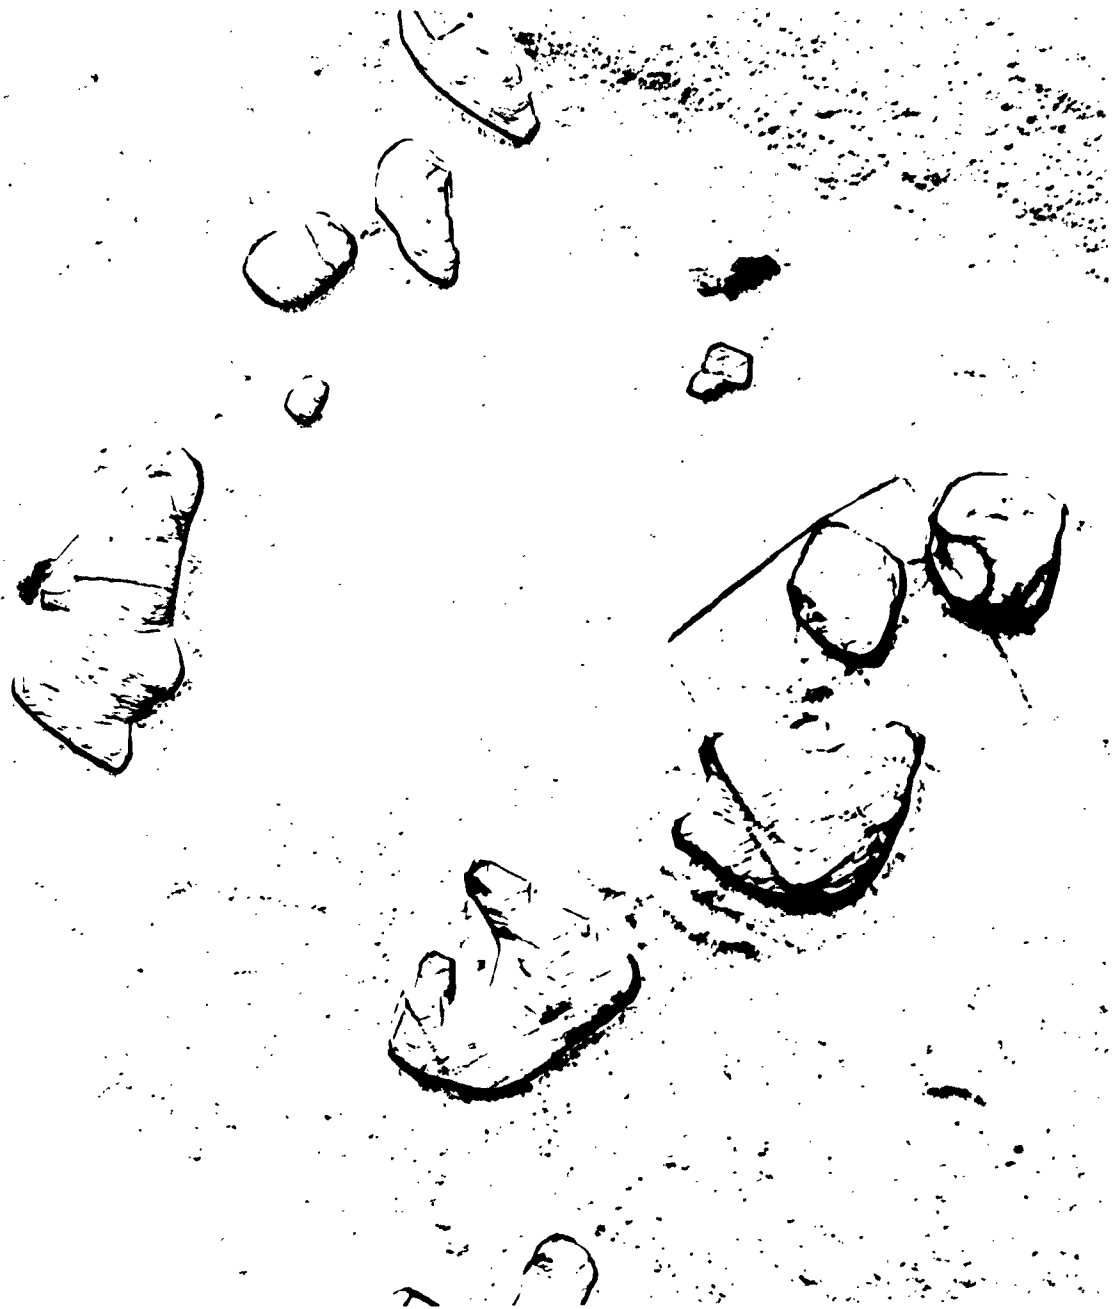
Figure 45. Typical Electron Microstructure Showing Clam Shell Shaped Titanium Carbides or Nitrides at Forging-Weld Fusion Zone. 120 inch Maraging 18Ni Steel Vessel Closure Plate  
24,000X Plastic Replica

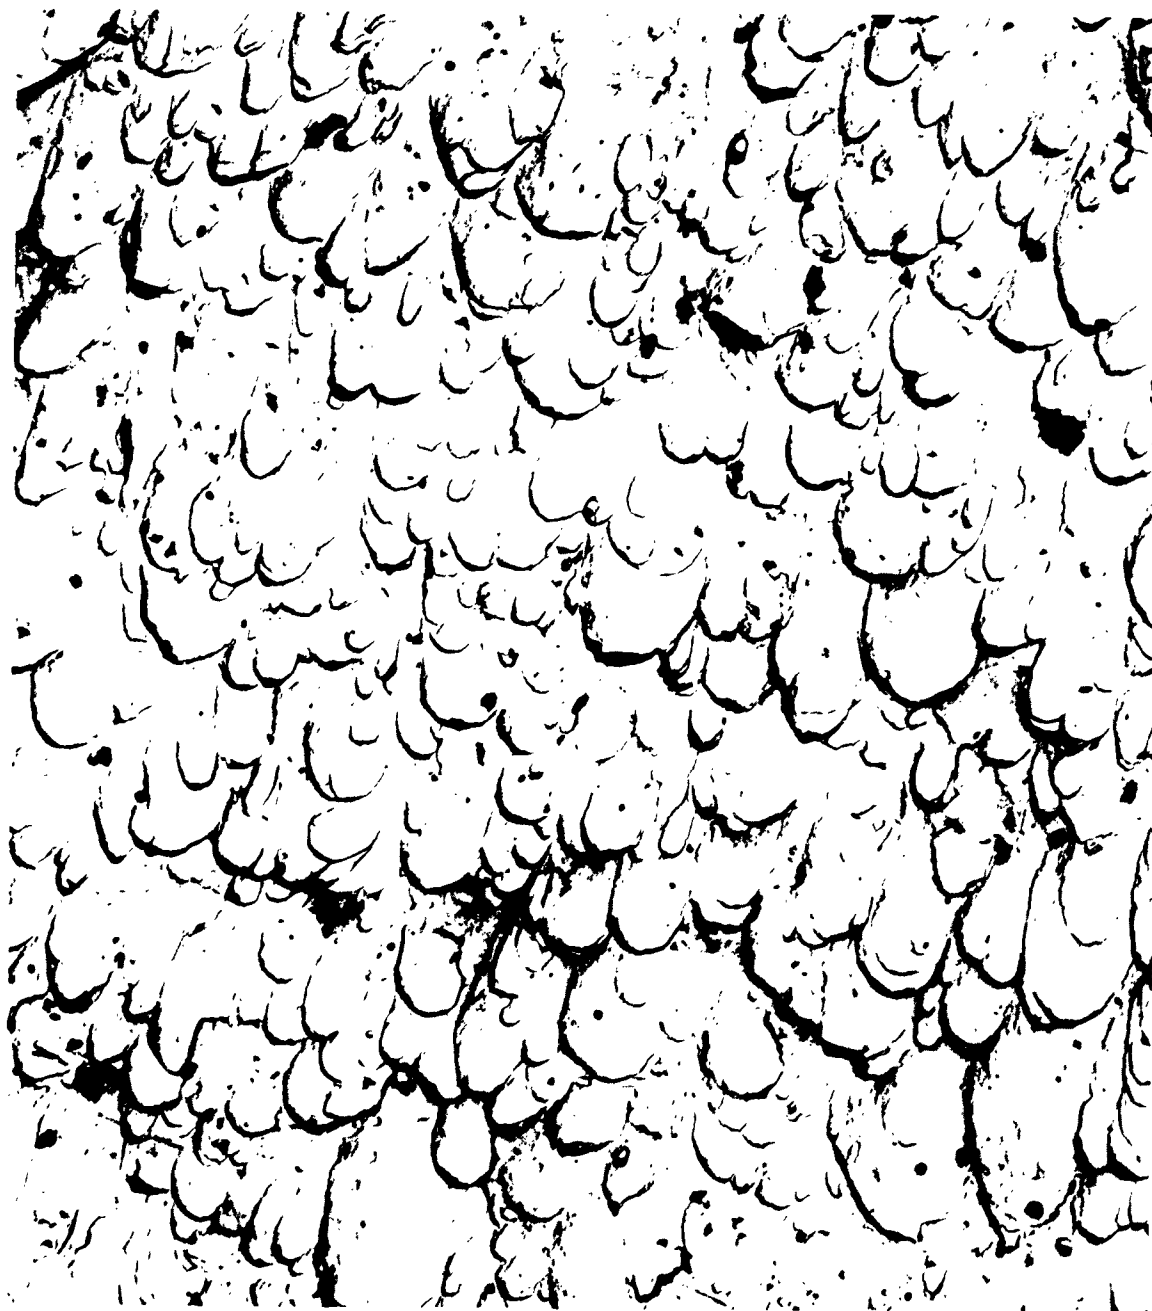
Figure 47 shows typical ductile fracture seen in the forging, consisting of nearly elliptical domains. In the light of systematic studies of

Figure 47. Electron Fractograph Showing Ductile Fracture Surfaces in the Forging  
Consisting of Nearly Elliptical Domains - 120 inch Maraging 18Ni Steel  
Vessel Closure Plate  
12,000X

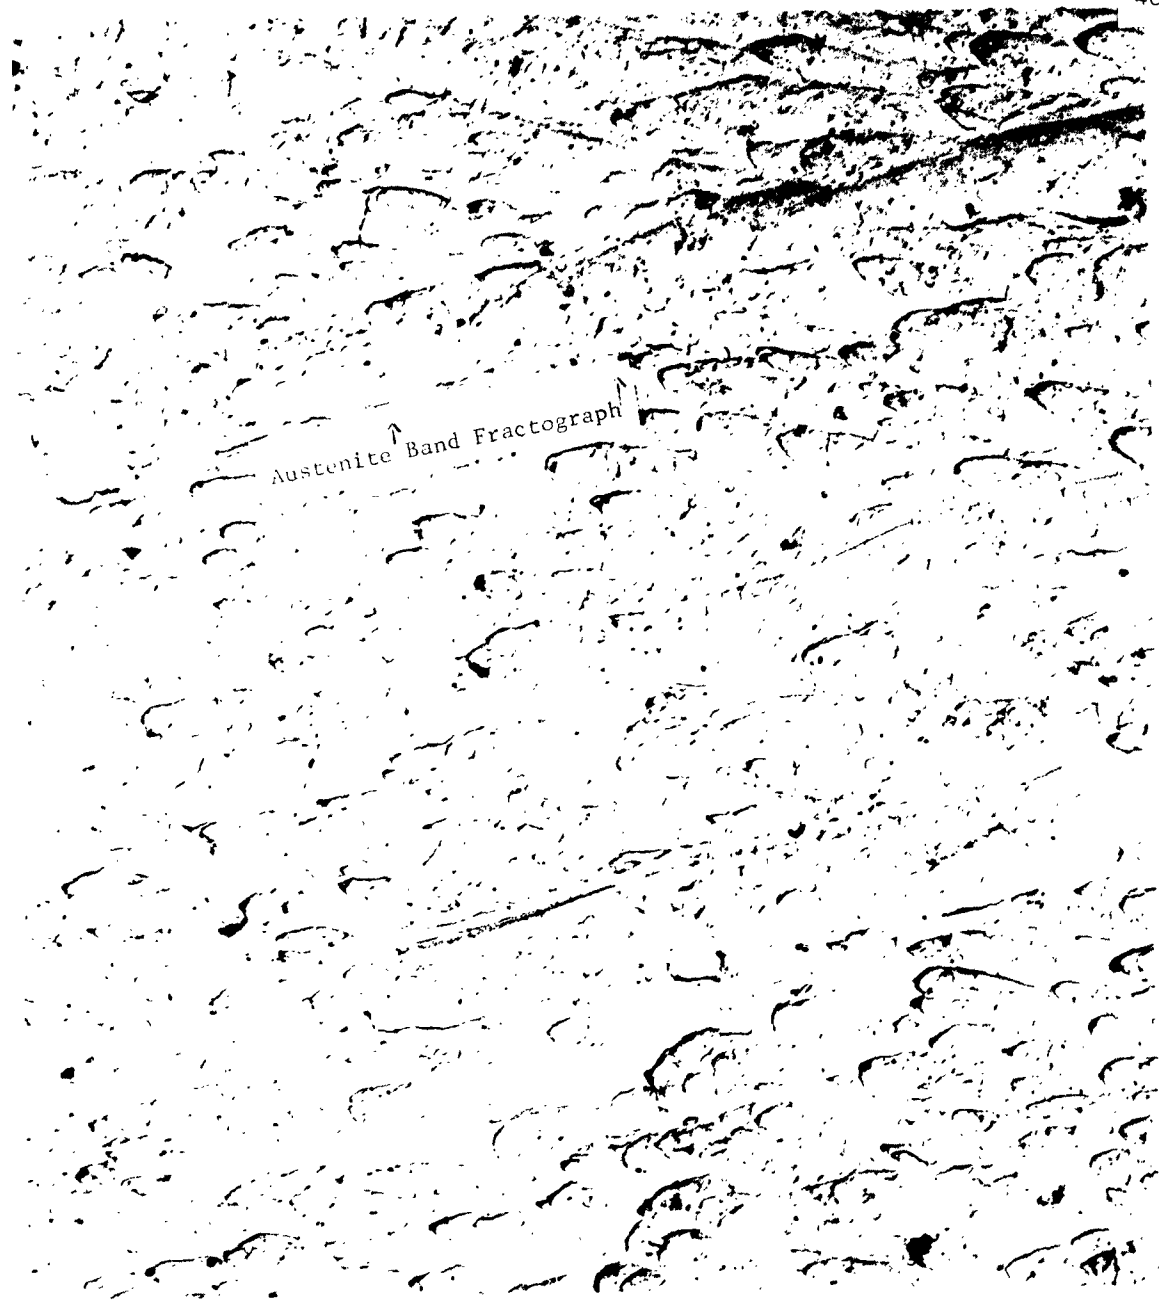
Fracture appearance of austenite rich bands observed the 5/8 inch plate is as shown in Figure 50. The same picture at 24,000 magnification is shown in Figure 51.

Figure 50. Electron Fractograph of Fracture Surfaces in Banded Area of 5/8 inch Thick Plate (120 inch Maraging Steel Vessel Closure Plate)  
7,000X Carbon Replica
