SPECTROMETRIC OIL ANALYSIS FOR THE DETECTION OF INCIPIENT TURBOJET ENGINE FAILURES

TECHNICAL REPORT SEG-TR-65-37

JULY 1965

SYSTEMS ENGINEERING GROUP
RESEARCH AND TECHNOLOGY DIVISION
AIR FORCE SYSTEMS COMMAND
WRIGHT-PATTERSON AIR FORCE BASE, OHIO

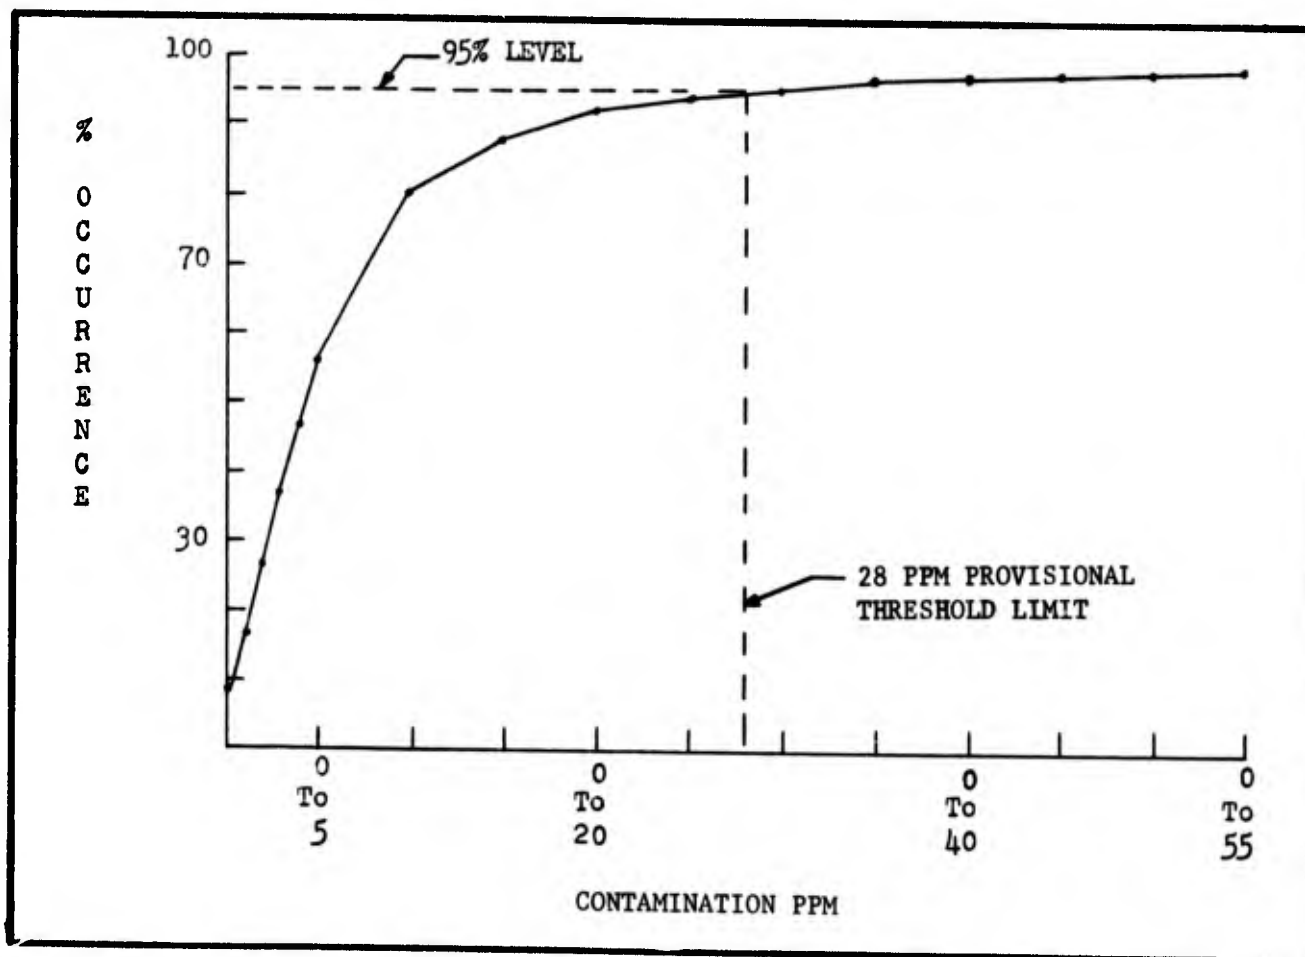
Figure 1. Cumulative Frequency Distribution, Engine Type B, Iron Contamination

Report 2. — The second report, which was in three parts, was used in assessing threshold limits for each of the three models of engine. To achieve this it was necessary to segregate the sample results into stepped increments of particulate contamination and to plot the number of times that each increment had occurred. Figure 1 shows the type of graph producible from this information and illustrates how an interim threshold limit can be determined from apparent engine discrepancies.

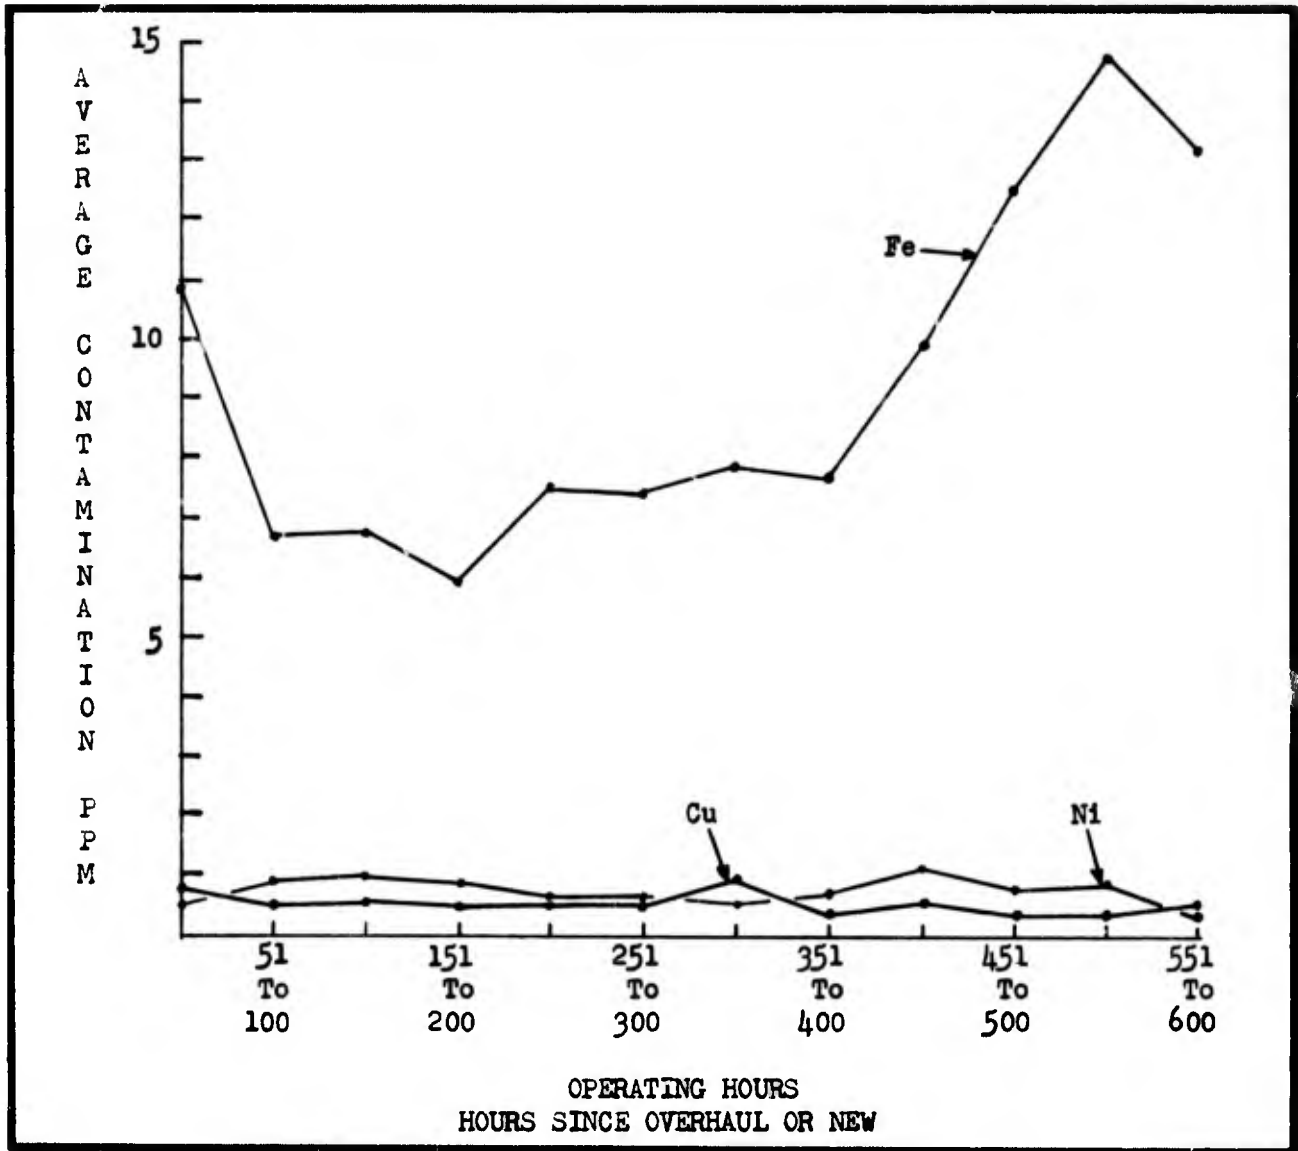
Figure 2. Average Contamination of Iron, Copper, and Nickel Versus Operating Hours, Engine Type B

Reports 4, 5, 6, 8, and 9. — All these reports were concerned with efforts to relate metal contamination to engine running hours since new, overhaul, or oil change. Figure 2 shows the average contamination levels for the metals iron, copper, and nickel for all samples taken during 50 hour increments of

life of engines type B. It will be seen that the average readings for nickel and copper are random and show no trend that can relate average contamination level with engine life. Although, the results for iron are more nearly what would be expected, i.e., an initial contamination reduction after the engine is "run in" and an increase of wear towards the end of engine life, the average wear is still less than 50% of threshold limit at maximum engine life. The same data relative to engines type A and C were similar in result. It is interesting to note that the rate (in relation to engine life) at which actual defects were indicated by oil analysis follows the same pattern, that is, almost all the proved actions occurred in either the first or last third of engine life. However, the rate of these actions towards the end of engine life is not significant enough to suggest a reduction of time between overhauls.

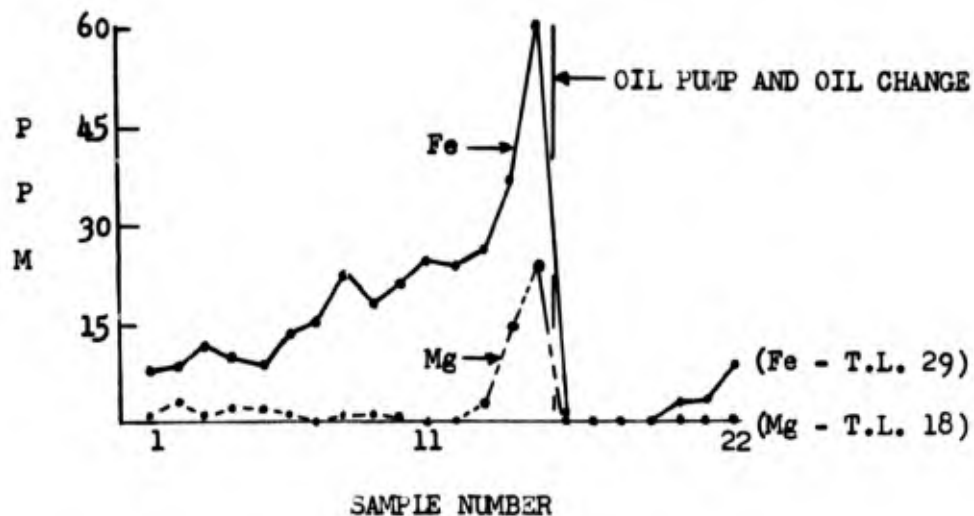
On 4 May 1964 NAS recommended that oil pump be inspected for damage indicated by high iron and magnesium. The base reported excessive scoring in boost and scavenge sections of oil pump.

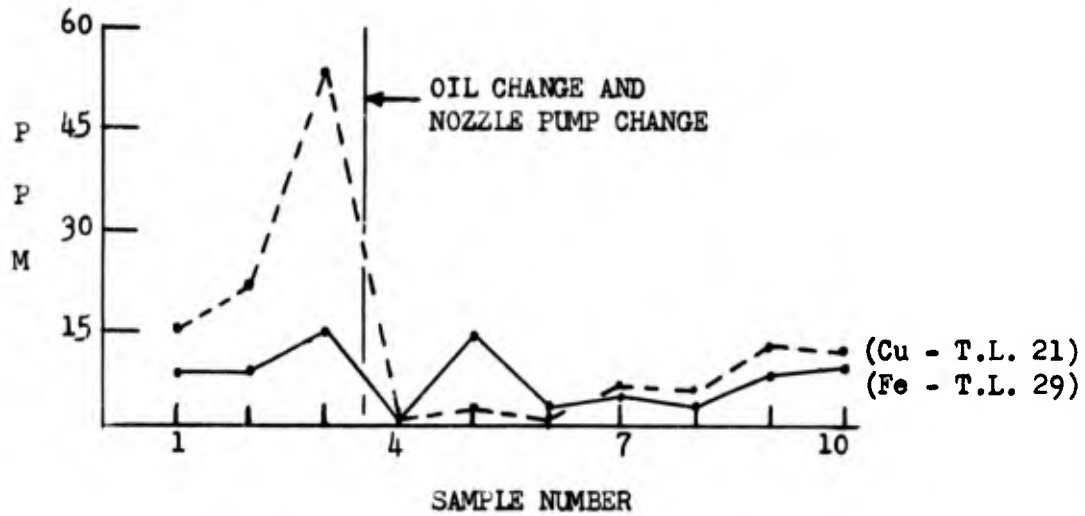
Figure 8. C1 Engine Data - Positive Correlation

Between 27 March and 7 April 1964 analysis showed either high or marginal copper. By 13 May sample analysis showed copper to be high enough for NAS Pensacola to recommend grounding the aircraft and submission of check samples after ground running. At this time the unit changed the emergency nozzle pump and after flushing the system subsequent samples proved to be normal. Motivation for removal of the nozzle pump was the discovery of metal particles in the emergency nozzle system filters during inspection to determine the origin of the oil/metal contamination. Although, there was no visual confirmation of wear of the nozzle pump the metal particulate filter contamination is considered to correlate the oil analysis finding.

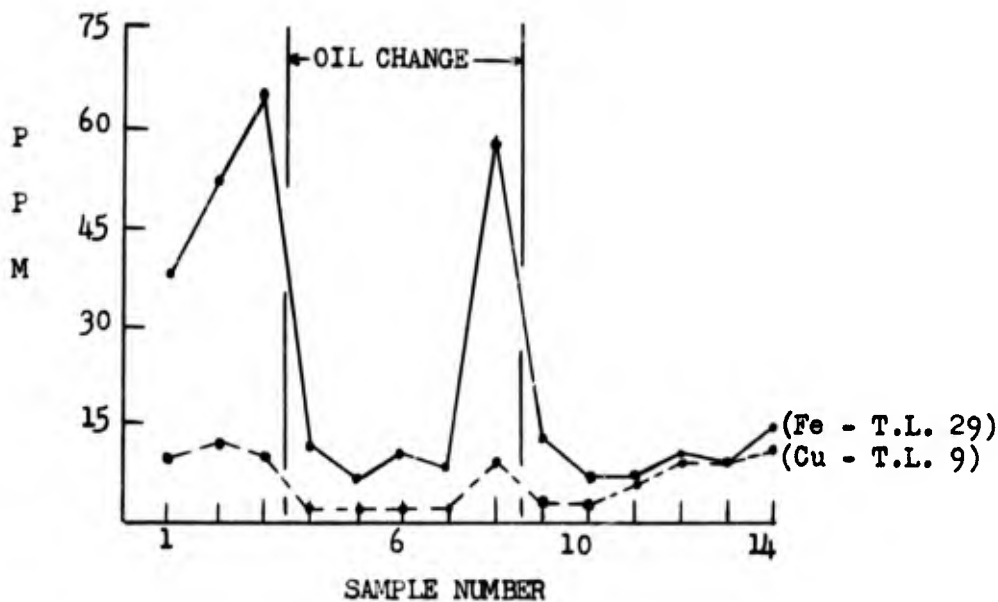
Figure 10. C3 Engine Data - Positive Correlation

On 28 March 1964 NAS Pensacola reported both high iron and copper in oil samples and called for sampling after every flight. On 7 April 1963 after continuing high iron and copper, NAS recommended removal of the engine for examination of nozzle pump, auxiliary pumps, and gearbox. Base removed the designated auxiliary components and sent for TDR. The TDR revealed wear in the oil scavenge pump, the hydraulic emergency pump, and the main lube pump.

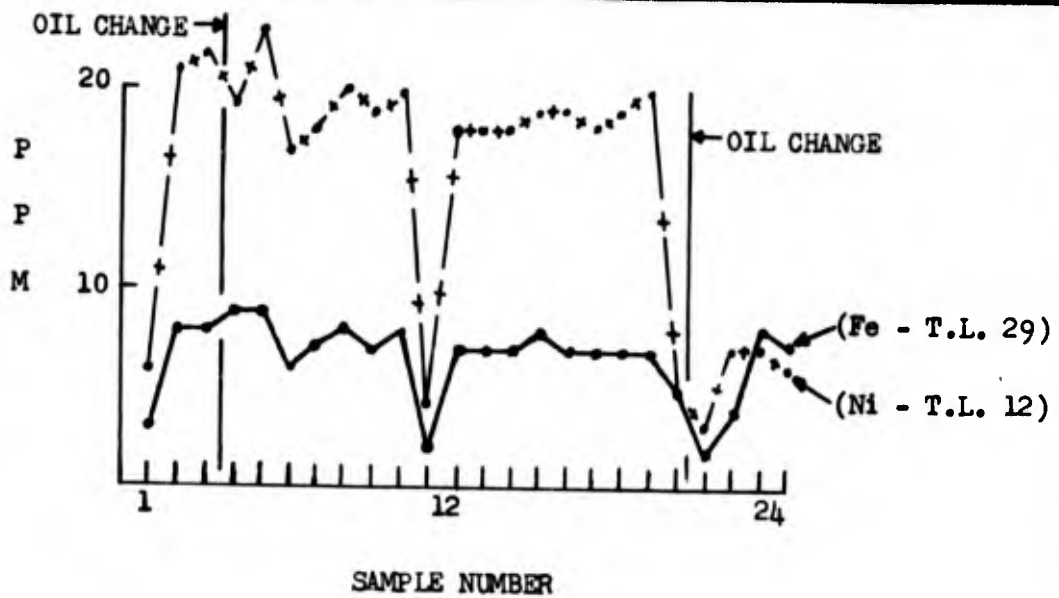
Figure 16. B5 Engine Data - Negative Correlation

Over the period 13 February 1964 to 11 March 1964, NAS Pensacola made several analyses which indicated either marginal or high nickel contamination of the engine oil. On 6 March 1964 NAS recommended the removal of the engine and change of the auxiliary gearbox. The TDR revealed no discrepancies or excessive wear in the auxiliary gearbox or any other oil-wetted engine parts. This TDR was one of several that dictated the change of the nickel threshold limit from 12 ppm to 29 ppm.

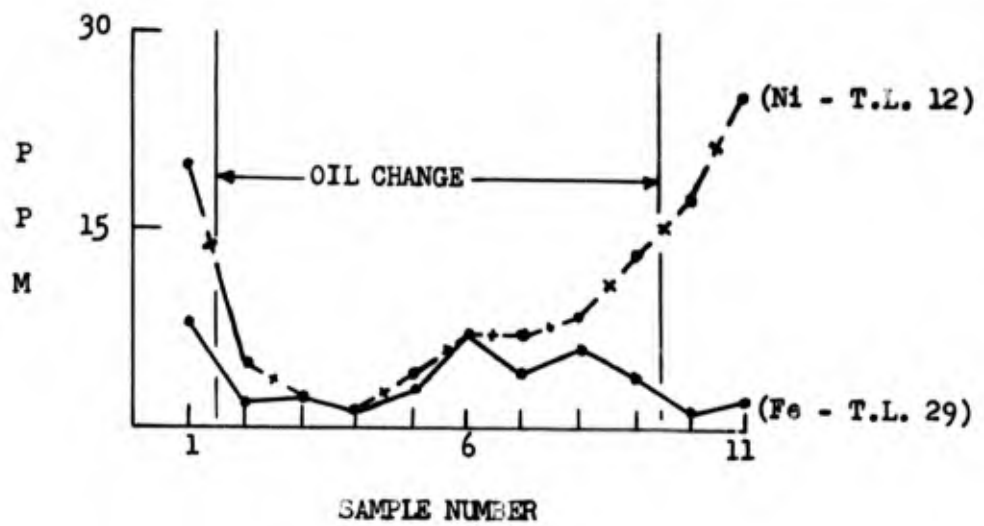
Figure 17. B6 Engine Data - Negative Correlation

On 13 February 1964 NAS Pensacola analysis showed high nickel and the base was advised to change the engine. In a letter dated 19 August 1964, the base advised that no specific maintenance was carried out as a result of NAS report, the gearbox was not changed, and no part was found discrepant. Subject engine flew 73 hours without reported defect between NAS recommendation and the last sample taken from this engine on 29 June 1964. This engine action was one of several that dictated the change of the nickel threshold limit from 12 ppm to 29 ppm.

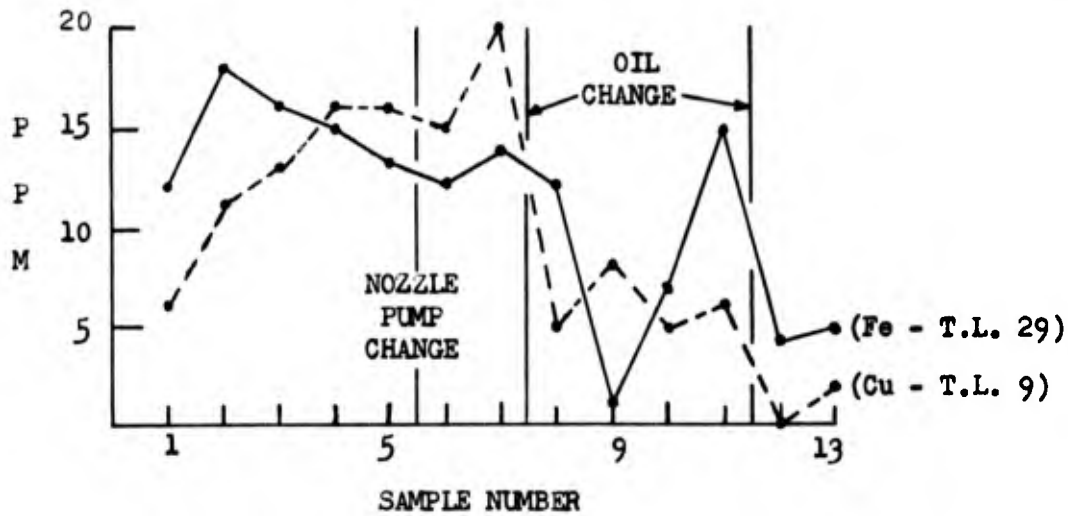
Figure 18. B7 Engine Data - Negative Correlation

Copper content of samples rose from 10 ppm to 16 ppm between 19 November 1963 and 9 January 1964; at the later date the laboratory recommended close observation. On 15 January 1964 a further sample confirmed the 16 ppm reading. On this date, too, the base reported a nozzle pump change. After the reported N.P. change the copper level remained high (15 ppm) until oil change after which the samples were normal. When checking on state of the removed nozzle pump, it was discovered that it had not been changed but only removed, bench checked, and replaced. There was, therefore, no maintenance finding to explain the high copper and no explanation of why the copper level failed to build up again after oil change. At the time of this action the threshold limit for copper was 9 ppm. Because of this action and other actions it was raised to 21 ppm.

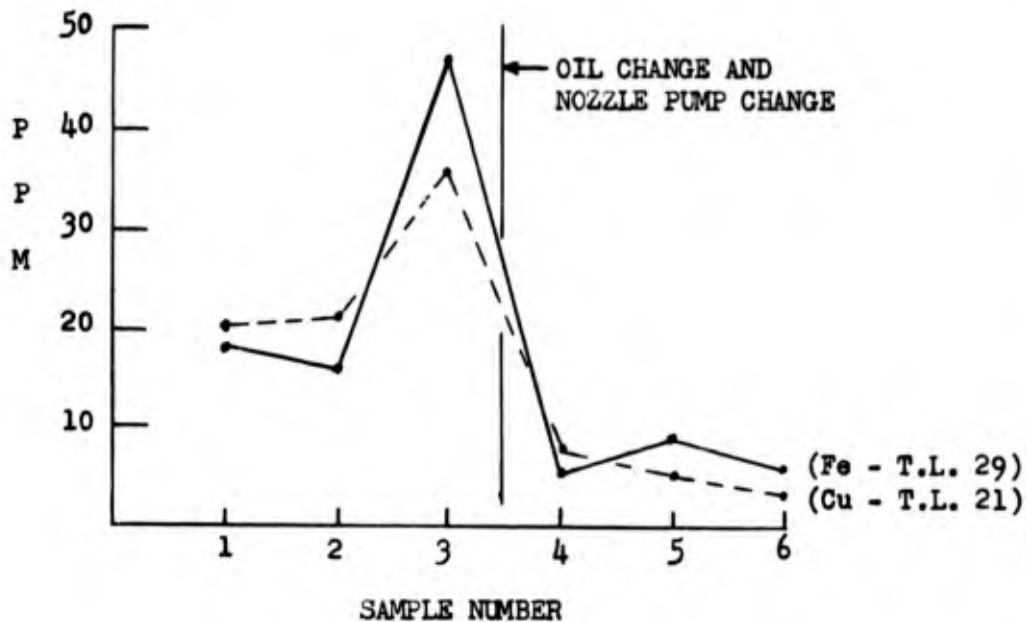
Figure 19. C7 Engine Data - Negative Correlation

On 8 February 1964 Pensacola reported 21 ppm copper and recommended grounding aircraft and checking source. On 18 March 1964 Pensacola reported one sample with high iron and copper with following samples satisfactory after nozzle pump change and six hour test cell run. Subsequent samples were satisfactory. The (defective) pump was shipped for TDR. The TDR stated that disassembly revealed no discrepancies and pump was serviceable on basis of disassembly findings.

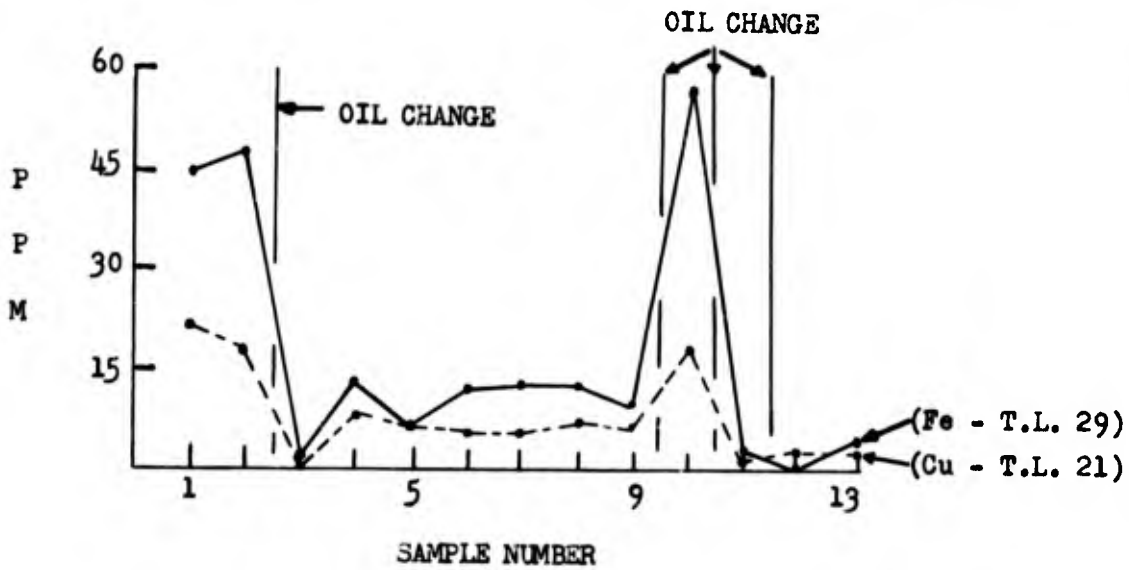
Figure 20. C8 Engine Data - Negative Correlation

On 6 November 1963 Pensacola reported high iron and copper in an oil sample and recommended that the aircraft be grounded and check samples forwarded after ground run. This check sample again showed high iron and copper, and Pensacola recommended changing the oil before submission of a further check sample. This latter sample proved to be normal and engine was released for flight. On 31 March 1964 a sample showed very high iron and copper, and Pensacola recommended that the aircraft be grounded for inspection for probable failure of bearings or emergency nozzle pump. The unit reported examination of all oil-wetted components with negative results. No parts were found defective, or changed. After flushing oil system subsequent samples proved normal.

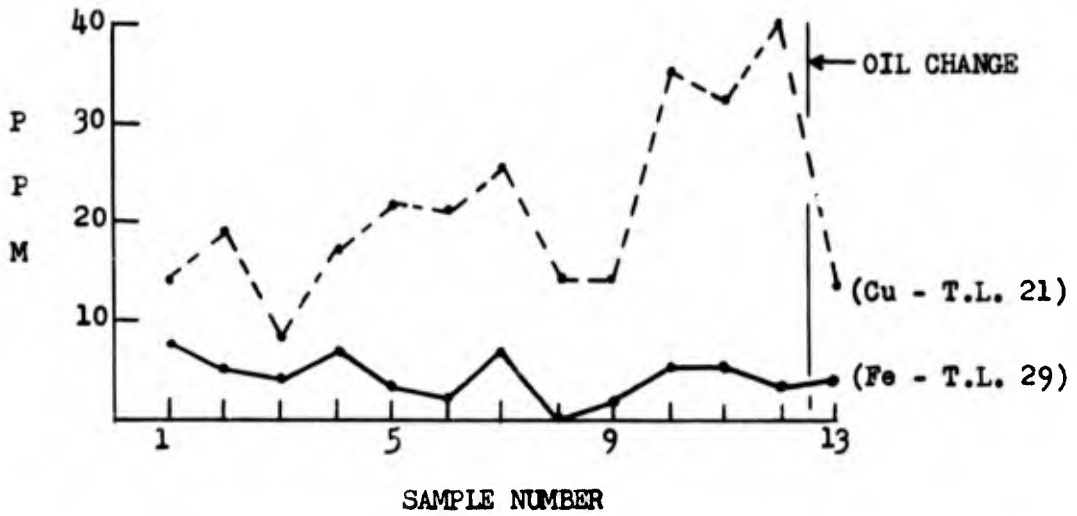
Figure 21. C9 Engine Data - Negative Correlation

Between 14 March 1964 and 13 June 1964 oil samples twice showed marginal copper with subsequent samples showing normal copper. On 7 July 1964 after two samples showing high copper Pensacola recommended inspection of emergency nozzle pump and associated filters for contamination source. Base inspection failed to reveal any reason for contamination and subsequent samples showed normal copper.

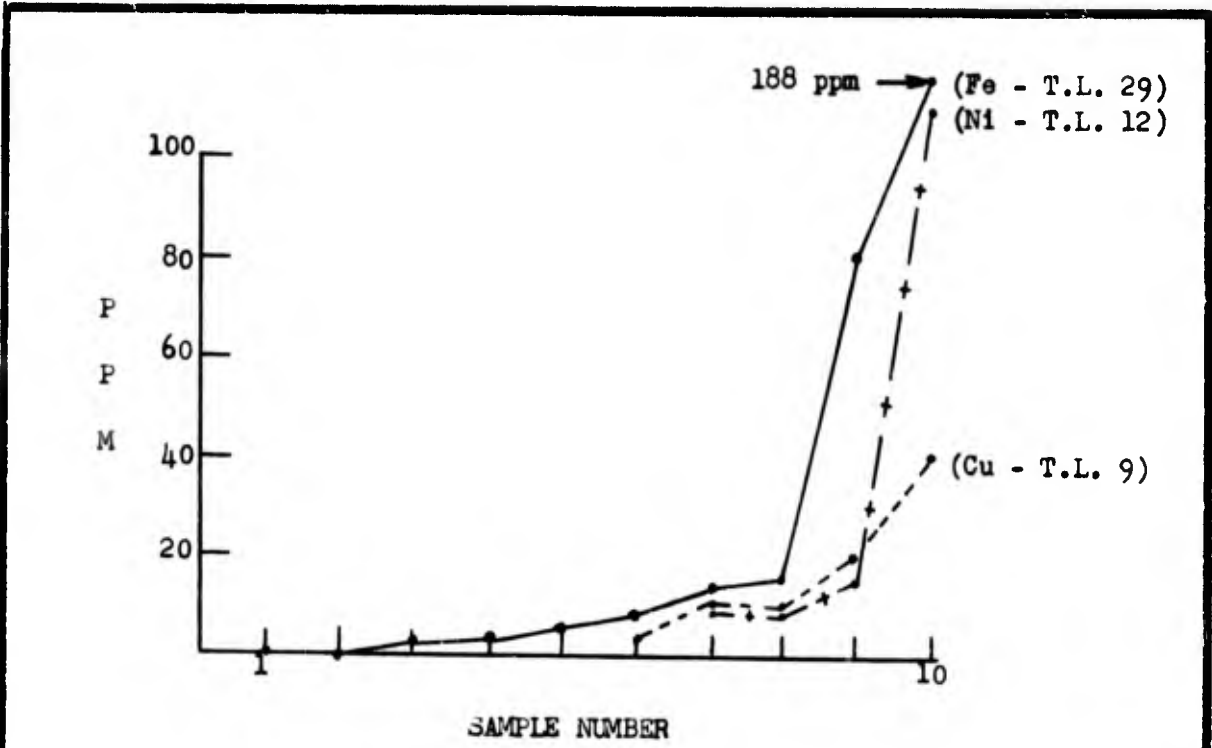
Figure 23. B19 Engine Data - Engine Failure

A sample taken on 30 January was a week in transit and not received by NAS until 6 February. At analysis the iron (particularly) and copper and nickel were so high that Pensacola called the base to advise grounding the aircraft for engine inspection. Unfortunately, the aircraft had crashed on the 3rd of February. Samples taken after the crash showed that the iron had risen still further (from 81 to 188 ppm). With prompt delivery of the sample and the same reaction for the laboratory the aircraft would have been grounded and the engine investigated before the flight which ended in the crash. The accident was caused by an engine failure which was caused by a material failure of the Nr 4 1/2 bearing.

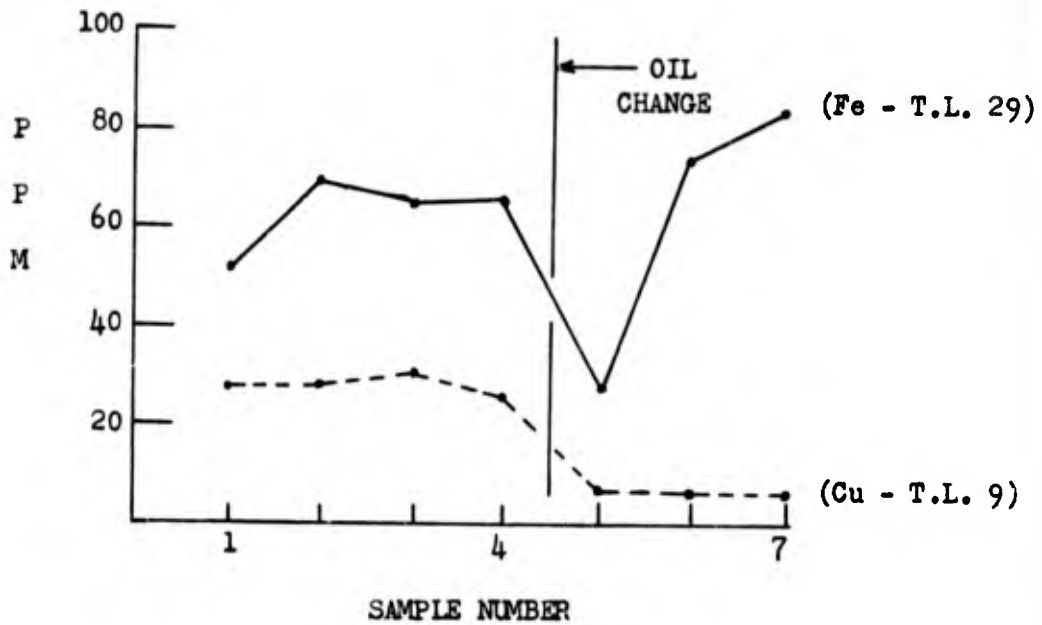
Figure 25. B11 Engine Data - Positive Correlation

Sample analysis ranged through high iron and marginal copper, marginal iron and normal copper to very high iron on 20 August, 3 September, and 9 September respectively. On the last mentioned date, Pensacola recommended grounding the aircraft pending discovery of source of iron. On 5 October 1964 the engine was removed from service for disassembly. Inspection of the engine revealed wear on the Nr 4 bearing.

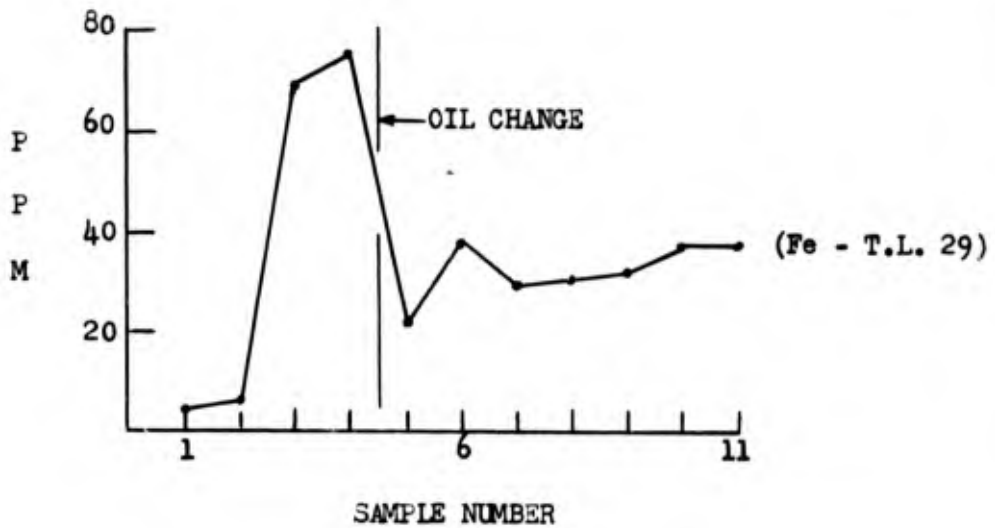
Figure 26. B12 Engine Data - Positive Correlation

In late September 1964 after a routine sample showed high iron contamination, NAS Pensacola recommended grounding the aircraft pending the results of a check sample. The check sample confirmed the previous high iron reading and Pensacola recommended inspection of the oil pump for wear. Further check samples in October, submitted without change of oil pump and taken after periods of ground running, showed a continuing increase in iron contamination. At this stage, NAS Pensacola recommended engine removal for TDR if the contamination source could not definitely be identified as from one of the engine accessories. The engine was sent for TDR which revealed wear on the Nr 4 bearing.

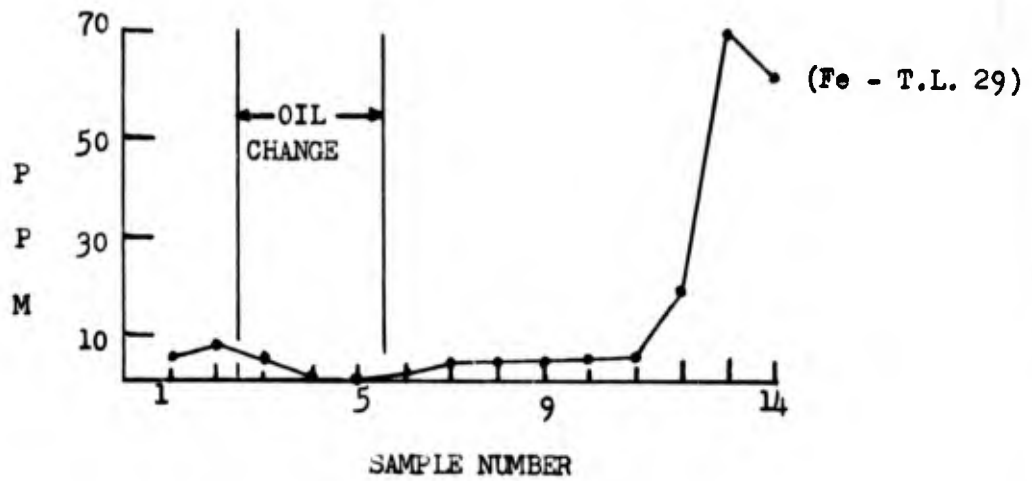
Figure 29. B15 Engine Data - Positive Correlation

On 4 August 1964 NAS Pensacola reported that a routine oil sample showed high iron and requested a check sample as soon as possible without oil change. By 10 August 1964 the check sample was found to confirm the first high iron reading and NAS recommended grounding the aircraft until the source of the oil contamination was determined. Subsequent base inspection revealed a piece of metal, possibly a manufacturing machining, approximately one half by one thirty-second of an inch, in the Nr 4 pump screen. Another piece found in the Nr 4 pump element and gears had grooved the pump body. Further, the Nr 4 bearing balls appeared to be skipping.

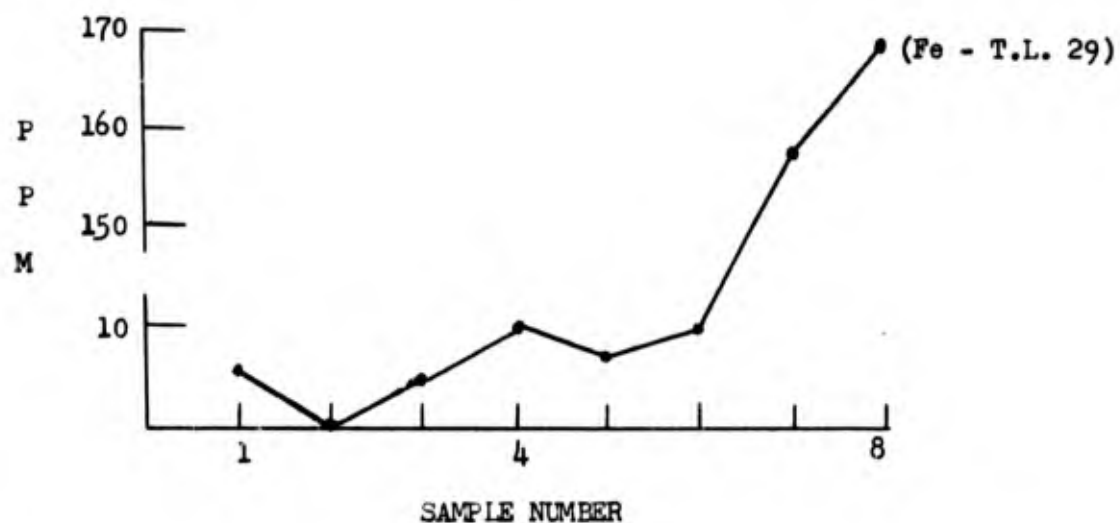
On 18 September 1964 NAS Pensacola reported that a routine oil sample showed very high iron and recommended grounding the aircraft pending results of a check sample. By 21 September 1964 the check sample confirmed the first very high iron reading at which time Pensacola recommended determination of iron contamination source before engine was used for flight. Subsequent base examination revealed wear on the Nr 2, Nr 4, and Nr 5 bearings.

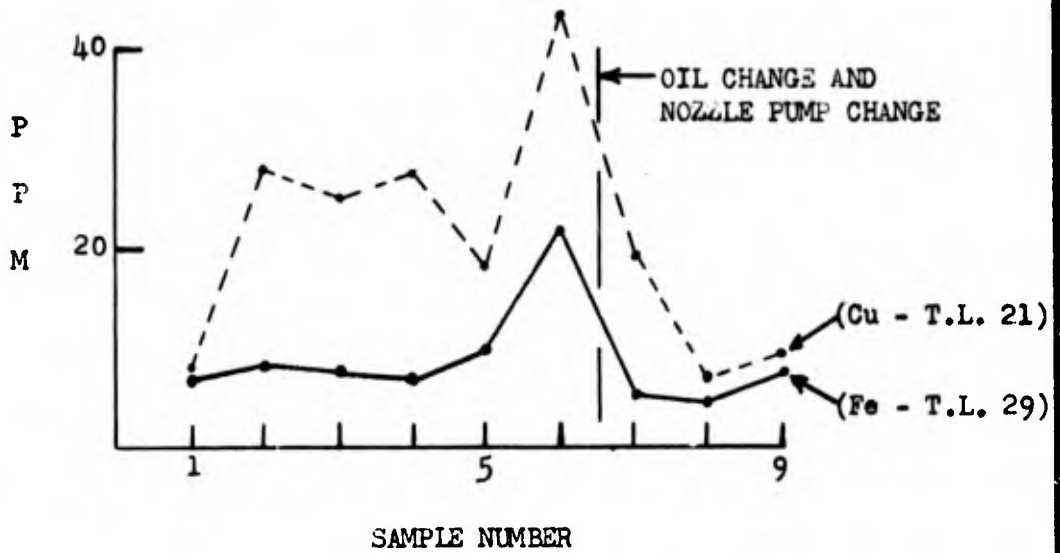
Figure 30. B16 Engine Data - Positive Correlation

On 15 and 25 April 1964 oil samples showed high copper and Pensacola recommended a 5 hour sampling rate. Later, copper contamination reduced to marginal (28 July 64) and normal (8 August 1964). By 24 August copper contamination again increased to the very high level and Pensacola recommended grounding the aircraft for investigation. During investigation the nozzle system filter was pulled and showed evidence of impending pump failure. Examination of the nozzle pump showed excessive wear. The nozzle pump was changed and samples taken afterwards were analyzed as normal.

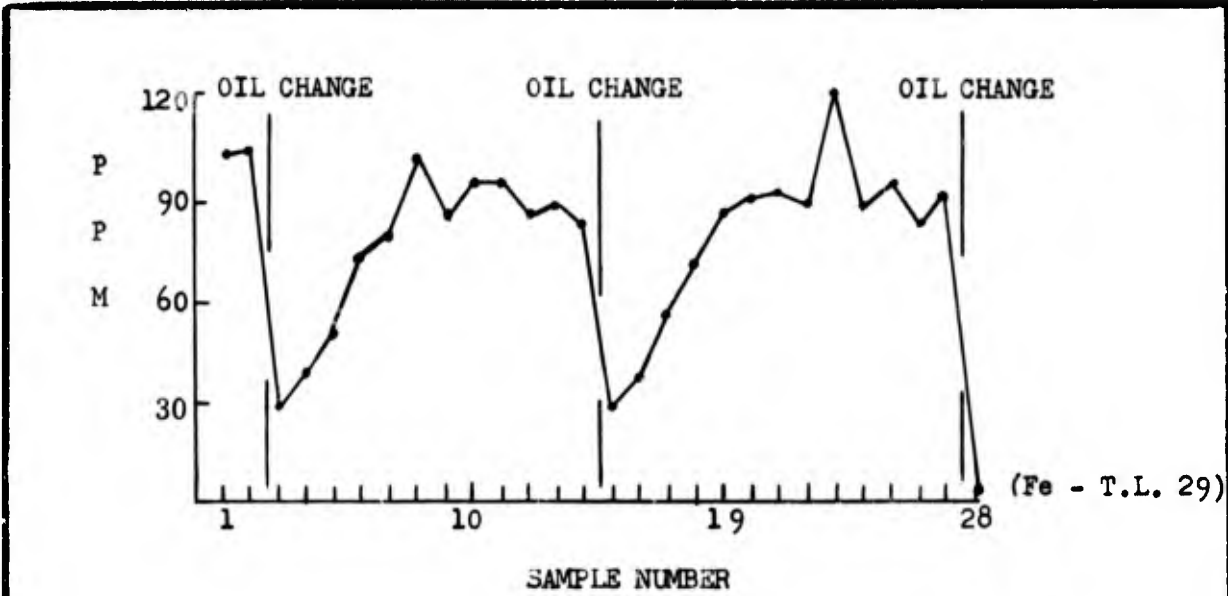
Figure 31. C13 Engine Data - Positive Correlation

The first routine sample submitted by the base was analyzed by NAS as having a very high iron contamination content and a check sample was requested. The second sample confirmed the high iron readings and subsequent samples after oil change also were analyzed as high iron. The engine was removed for TDR, with the results revealing no evidence of wear to support the high iron readings.

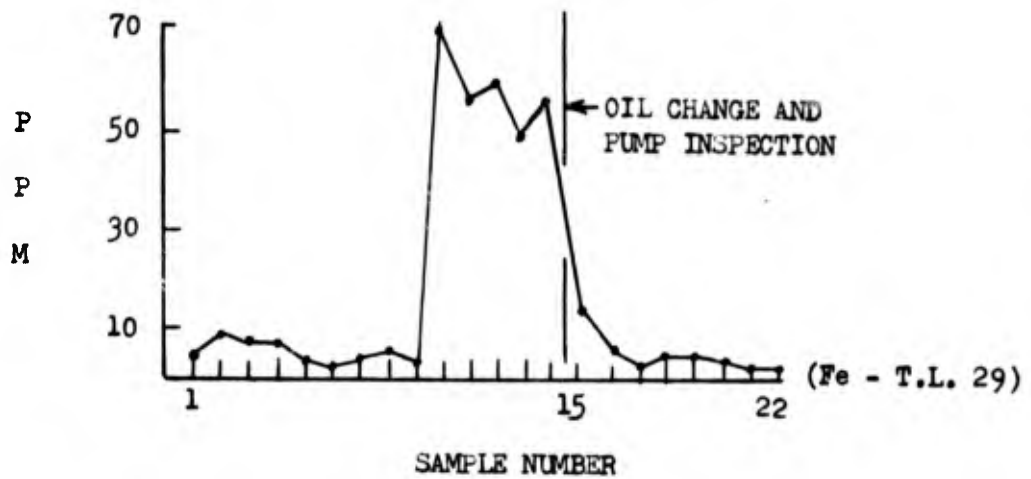
Figure 32. B17 Engine Data - Negative Correlation

On 9 September 1964 NAS Pensacola reported high iron in a routine sample and requested a check sample after fifteen minutes ground run without oil change. By 24 September 1964 the check sample was found to confirm the first high iron reading and a recommendation was made to inspect oil pump and other areas for contamination source. The pump was inspected and found serviceable.

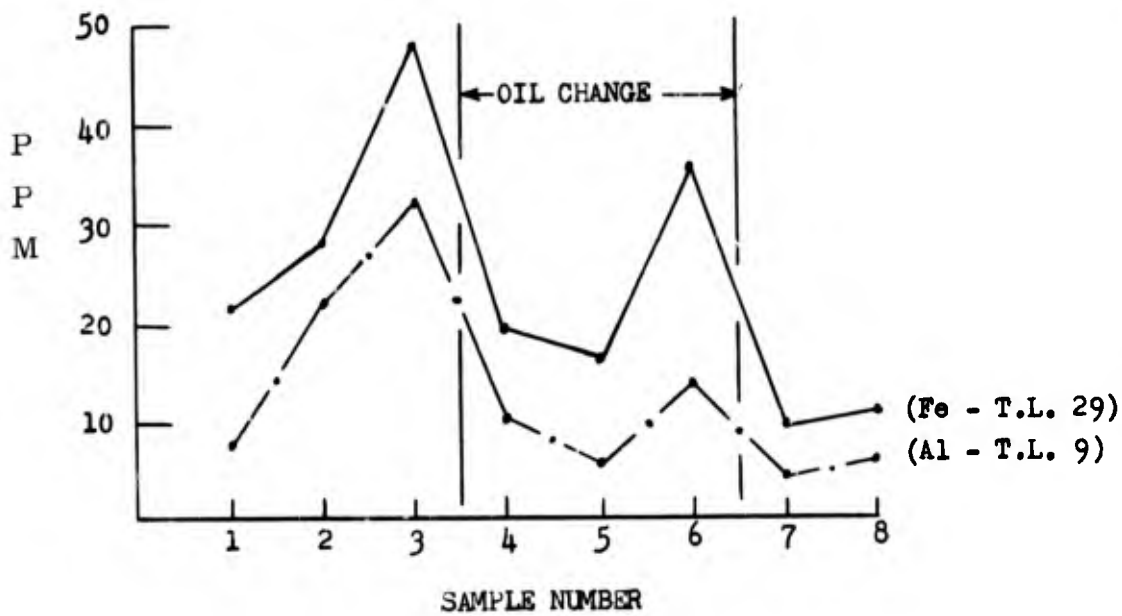
On 28 July 1964 NAS Pensacola reported readings of marginal iron and aluminum in a routine sample and requested a further sample after five hours running without oil change. On 10 August high aluminum and iron were reported and Pensacola recommended grounding the aircraft pending maintenance checks and further oil samples. On 20 August Pensacola recommended 5 hours test cell running and further check samples. By 18 September 1964 oil sample readings had returned to normal. Base reported a negative check of oil wetted components and confirmed that no maintenance, other than oil change, had been carried out.
